**Prudence Review of
Newfoundland and Labrador Hydro
Decisions and Actions
Final Report**

Executive Summary

**The Board of Commissioners of Public Utilities of
Newfoundland and Labrador**

The Liberty Consulting Group

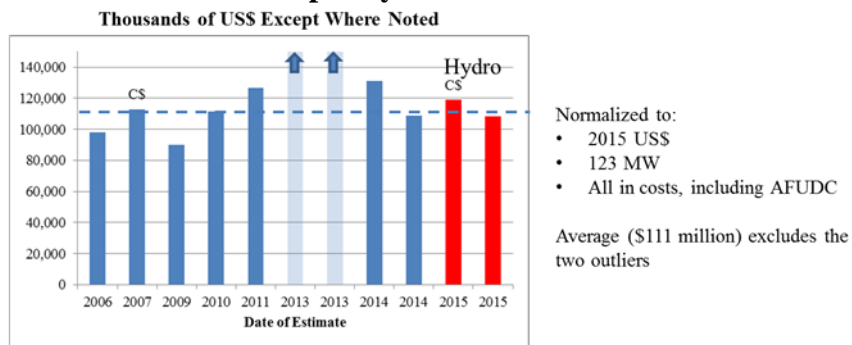
Table 2.2: Simple Cycle CT Construction Costs

Liberty also considered seven additional data points in addition to the EIA plants. These plants were located throughout the US and British Columbia. The complete population, shown in the preceding table, confirms the competitiveness of the Holyrood CT. Holyrood’s costs fall just under the average (the table’s dashed horizontal line).

The Holyrood costs appear to be well in line with the EIA expectations.

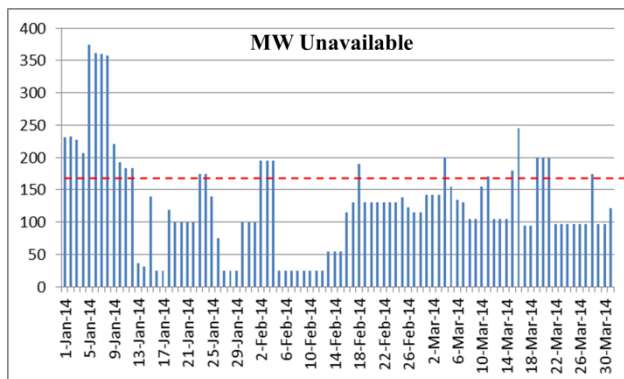
Figure 3.2: MW Unavailable

loss places the system in a position where another significant contingency could potentially produce a loss of load. This condition existed on an additional 13 days in the quarter. This seems high and warrants further study.

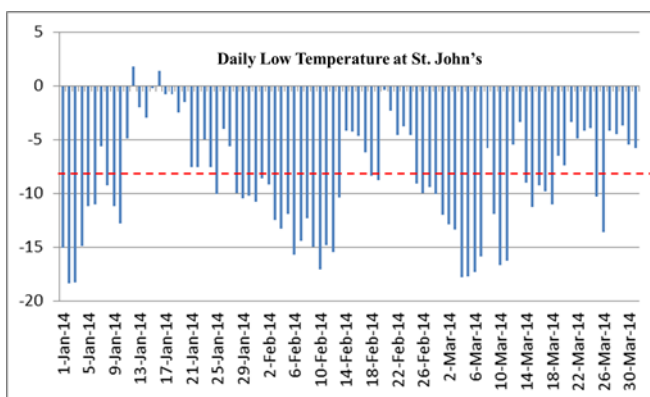
Figure 3.4: Daily Low Temperature

We next examine the effect of weather. The next chart denotes -8°C with a dotted line. When considering the worst temperature in each of the last 30 years, -8°C is the average of the worst annual temperature over those 30 years.⁹ Note that this is not the temperature variable used for planning purposes. That variable incorporates wind chill. Wind chill data was not available for this analysis. Given that the -8°C average is a worst case in each year considered, it would be statistically unusual to expect to see it develop on more than a few days in any given year. Yet the chart is clear; in the post-event period for the balance of the first quarter (78 days), the temperature was lower than -8°C on 50 days.

One can clearly describe such circumstances as extraordinary. When considering costs during the post-event period, it is not surprising that the majority of such costs occurred on the low temperature days, as shown below.

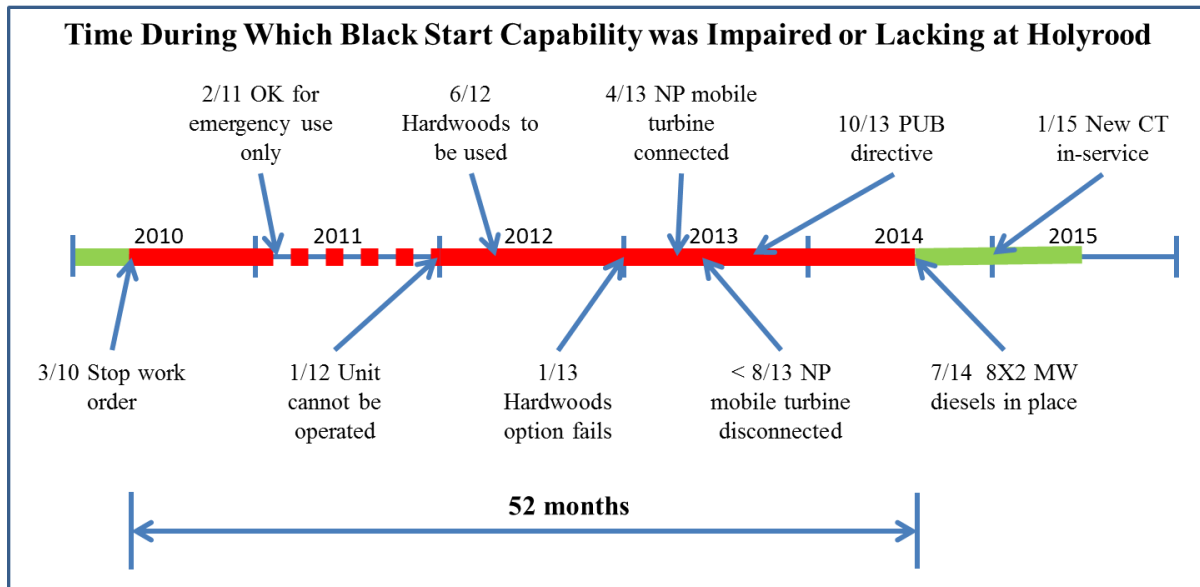
Illustration 10.1: Black Start Chronology

The next illustration shows the periods during which Holyrood lacked or had only impaired black start capability prior to completing installation of the eight diesel generators. The illustration shows how long it took Hydro to succeed in providing black start capability that could work.

Hydro has stated that it believes that the winter of 2010-2011 comprises the only time when it lacked black start capability at Holyrood. Hydro has also stated that:

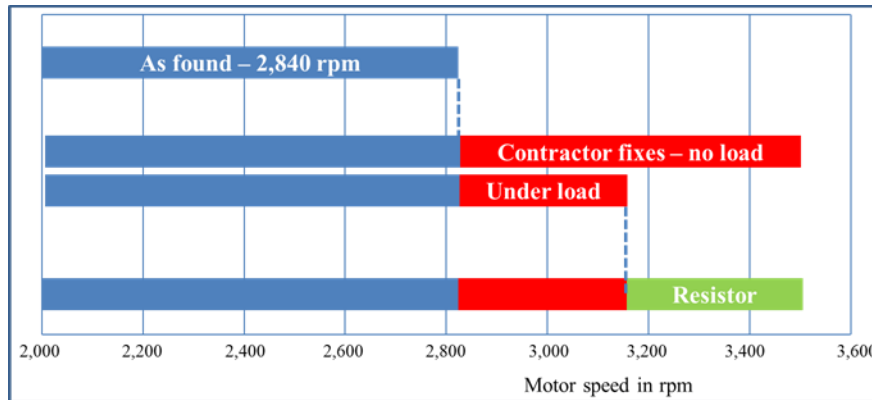
Diagram 11.1: Evolution of Motor Repairs

In an effort to determine the cause of the motor’s inadequacy, Hydro sent it to a contractor for testing. The contractor also could not attain a speed of more than about 2,800 rpm. Further testing found that: (a) the motor’s brush boxes were offset, and (b) the motor’s neutral plane was misaligned. The accompanying insert explains how such flaws affected the motor. After the contractor corrected both items, the motor was able to reach its rated speed of 3,500 rpm under no load conditions. After its return to the Plant, Hydro connected the motor to the pump, but it again was unable to come to speed, reaching only about 3,100 rpm. Subsequent adjustment of a resistor setting allowed the motor successfully to reach rated speed under load. The next diagram illustrates this evolution.

The root cause analysis addressed the source of these problems, which appear about equally responsible for the motor’s failure to perform. The root cause analysis attributed the misalignments to quality issues at a maintenance vendor, indicating that the resistor setting “was moved.” Hydro has stated that the maintenance vendor operated under a standard that required speed testing of the motor before its return. Hydro also states that the vendor did perform the required testing. However, neither Hydro nor the vendor provided documentation sufficient to verify the conduct of speed testing. Hydro recently submitted a copy of the vendor’s invoice, which under the description of the work, included the following notation:⁷¹
