A REVIEW OF SUPPLY DISRUPTIONS AND ROTATING OUTAGES: JANUARY 2-8, 2014

March 24, 2014

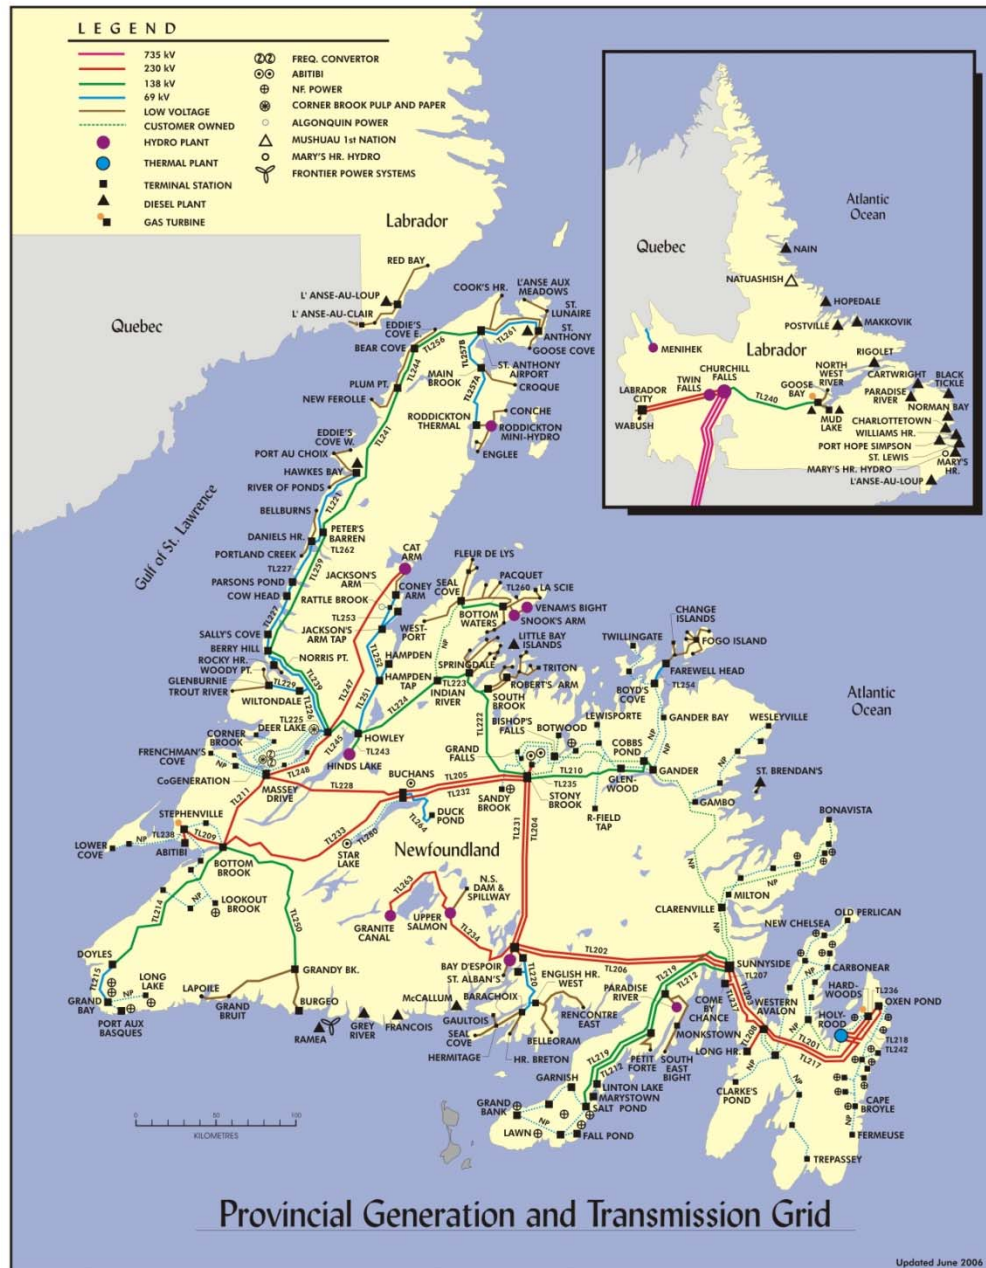
19 The Island Interconnected System is primarily characterized by large hydroelectric generation
20 capability located off the Avalon Peninsula with two parallel 230 kV lines bringing energy to the
21 Avalon Peninsula where demand is concentrated, and a large oil-fired thermal generating plant
22 on the Avalon Peninsula. Figure 3.1 below presents a visual overview of Hydro’s generation and
23 transmission infrastructure both on the island of Newfoundland and in Labrador.

FIGURE 3.1: Hydro's Generation and Transmission Infrastructure
