**Re: Investigation and Hearing into Supply Issues and Power Outages on the Island  
Interconnected System - Transmission System and Terminal Station Asset  
Management Execution Report**

Newfoundland and Labrador Hydro's  
Transmission System and Terminal Station Asset Management  
Execution Report

April 11, 2018

*A Report to the Board of Commissioners of Public Utilities*

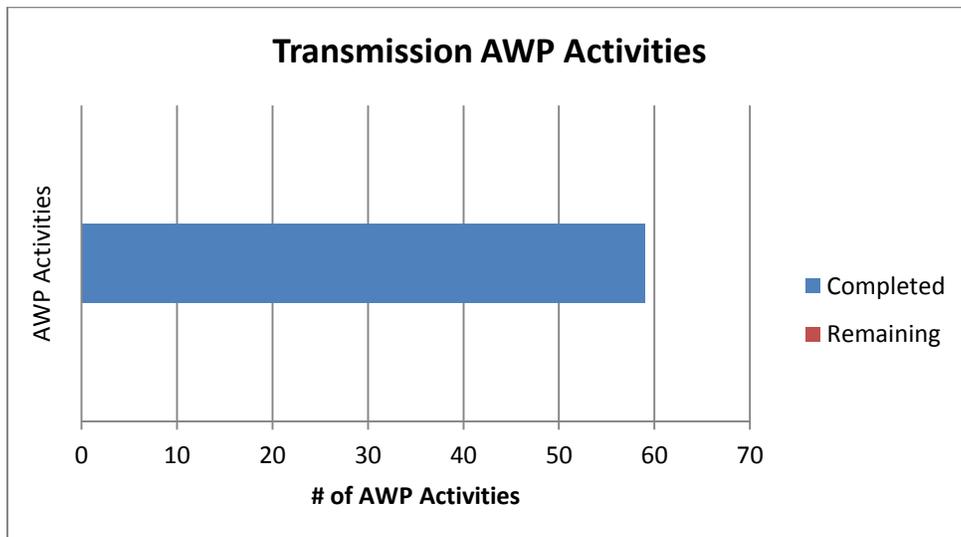
**Figure 1: Transmission – AWP Activities (December 31, 2017)**

10 As shown in Figures 1 and 2, Hydro completed 100% of its planned 2017 transmission AWP and  
11 WR activities.

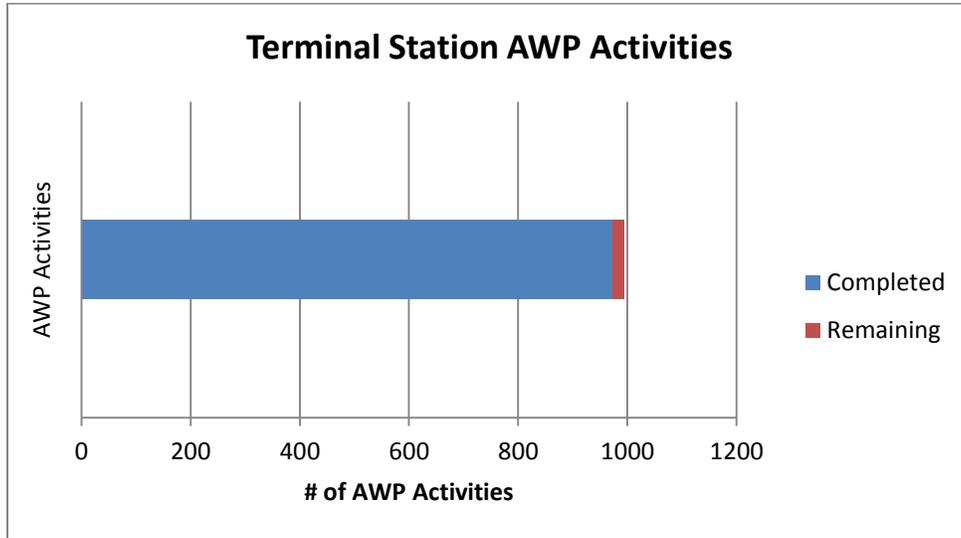
Figure 3: Terminal Stations – AWP Activities (December 31, 2017)

- 2 As shown in Figures 3 and 4, Hydro completed 97.9% of its planned 2017 terminal station AWP  
 3 and 99.7 % of its WR activities as of December 31, 2018.

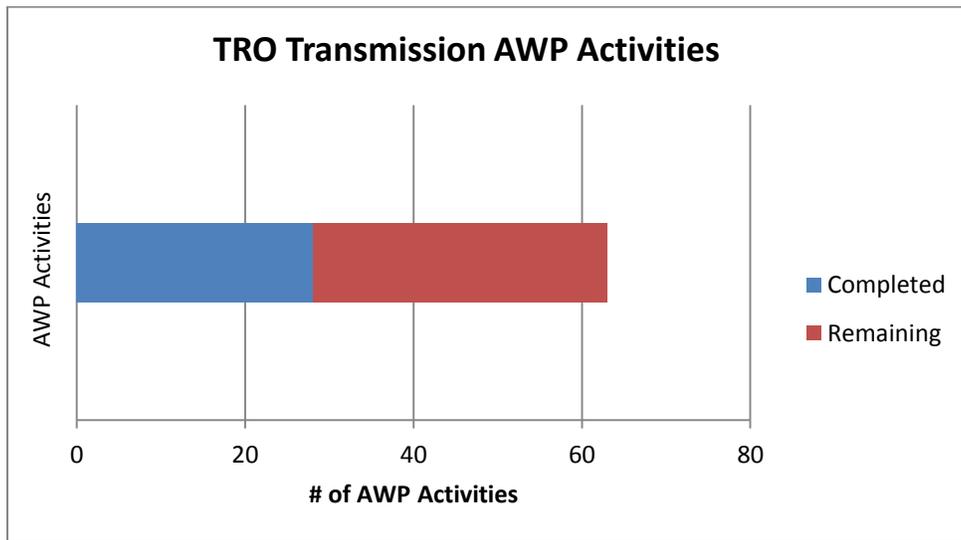
Figure 5: Transmission – AWP Activities (March 24, 2018)

3 As shown in Figures 5 and 6, Hydro has completed 44% of its planned 2018 transmission AWP  
4 activities and 0% of its 2018 WR activities as of March 24, 2018.

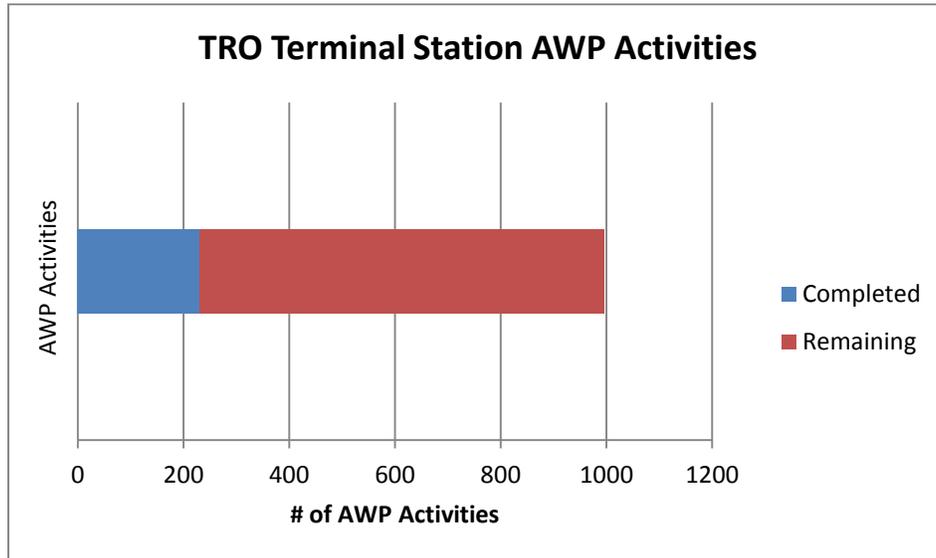
Figure 7: Terminal Stations – AWP Activities (March 24, 2018)

- 2 As shown in Figures 7 and 8, Hydro has completed 23% of its planned 2018 terminal station
- 3 AWP activities and 0% of its 2018 WR activities as of March 24, 2018.

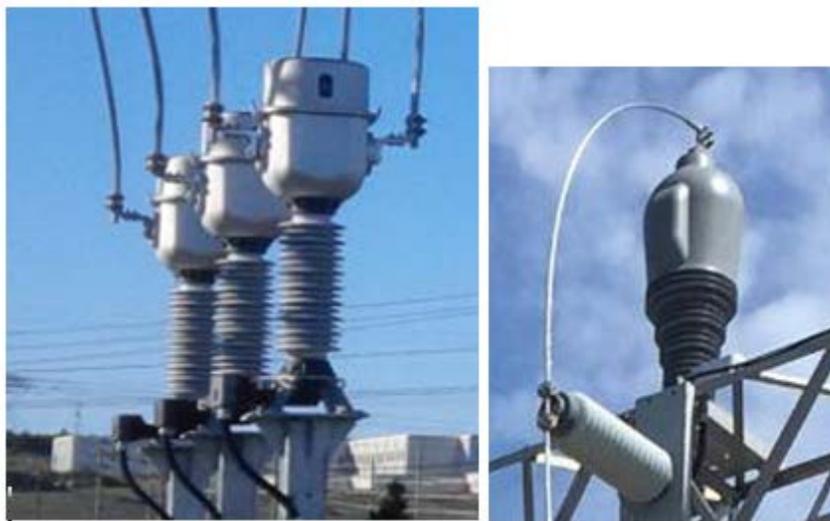
1 (CT) and a potential transformer (PT) respectively. CT and PT are collectively known as  
2 instrument transformers (IT). Hydro has approximately 900 individual high voltage instrument  
3 transformers within the Island and Labrador Interconnected Systems.  
4 A high-voltage IT consists of an insulated electrical primary and secondary winding, tank and  
5 bushing components. The insulation system involves the use of insulating oil or dry type  
6 insulation and a high voltage porcelain bushing which allows the safe connection of the winding  
7 to high voltage conductors. The winding is enclosed in a steel tank.

Figure 1: 69kV CT (Left) and PT (Right)

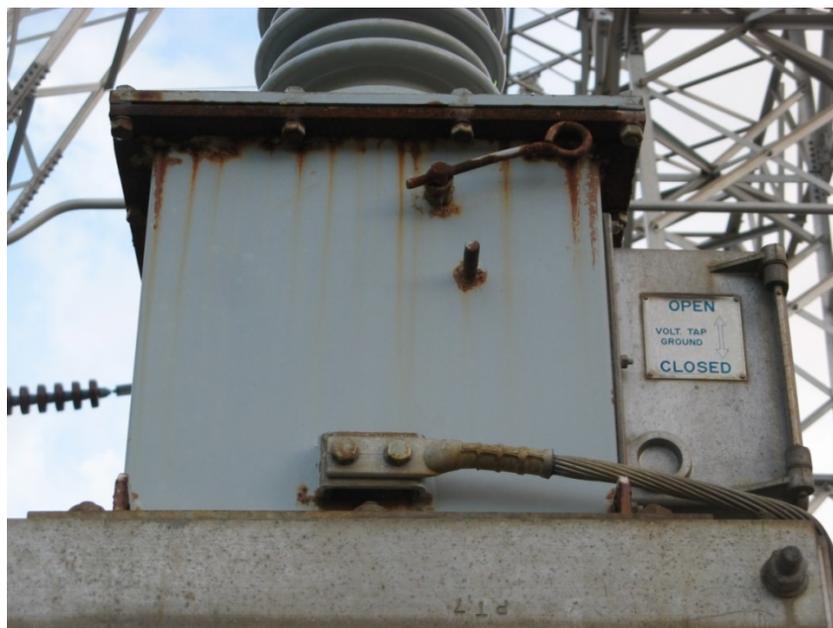
1 result in an oil spill. Also, in some situations pieces of the IT may be forcibly projected resulting  
2 in a safety risk for personnel in the area, or damage to other infrastructure.  
3  
4 Damage to an IT normally results from vandalism, impacts from catastrophically failed  
5 equipment or accidental contact of mobile equipment. Upon such incidents, Hydro assesses  
6 the electrical and physical integrity of IT to determine if replacement is required.  
7 Hydro monitors IT for physical and electrical deterioration by conducting regular visual  
8 inspections of the units as part of its station inspection program plus regularly scheduled  
9 station IR inspections and electrical insulation testing.  
10  
11 Physical deterioration involves conditions such as oil leaks, rusting, or small chips and cracks in  
12 the insulation. Figure 2 shows an example of rusting on a PT tanks.

**Figure 2: Rusting PT**

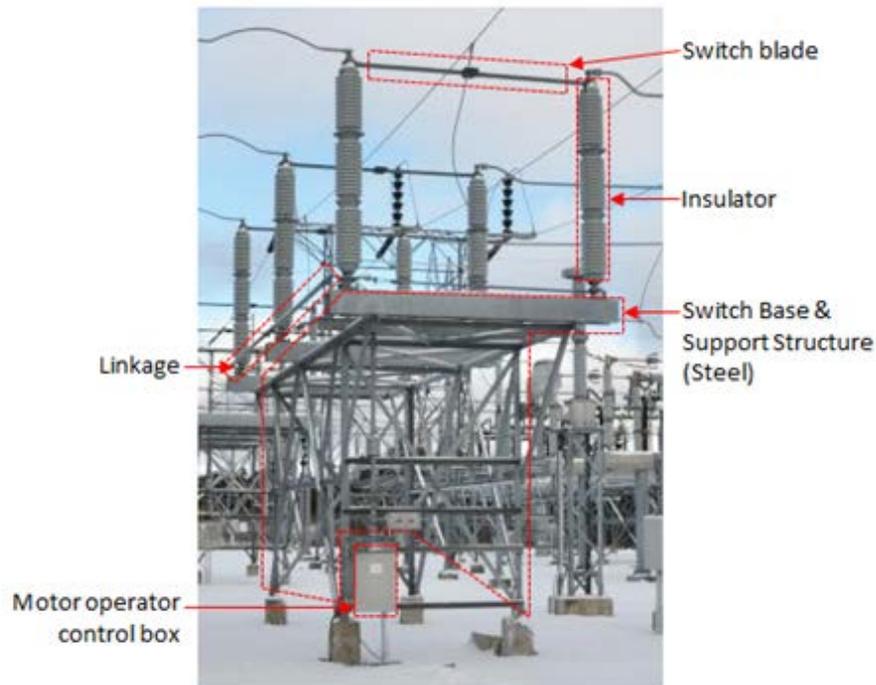
11 The basic components of a disconnect switch are the blade assembly, insulators, switch base  
12 and operating mechanism. The blade assembly is the current carrying component in the switch  
13 and the operating mechanism moves it to open and close the switch. The insulators are made  
14 of porcelain and insulate the switch base and operating mechanism from the current carrying  
15 parts. The switch base supports the insulators and is mounted to a metal frame support  
16 structure. The operating mechanism is operated either manually, by using a handle at ground  
17 level to open and close the blade, or by a motor operated device, in which case the switch is  
18 known as a Motor-Operated Disconnect (MOD). A disconnect and its associated components  
19 are shown in Figure 3.

**Figure 3: The various components of a high-voltage disconnect switch**

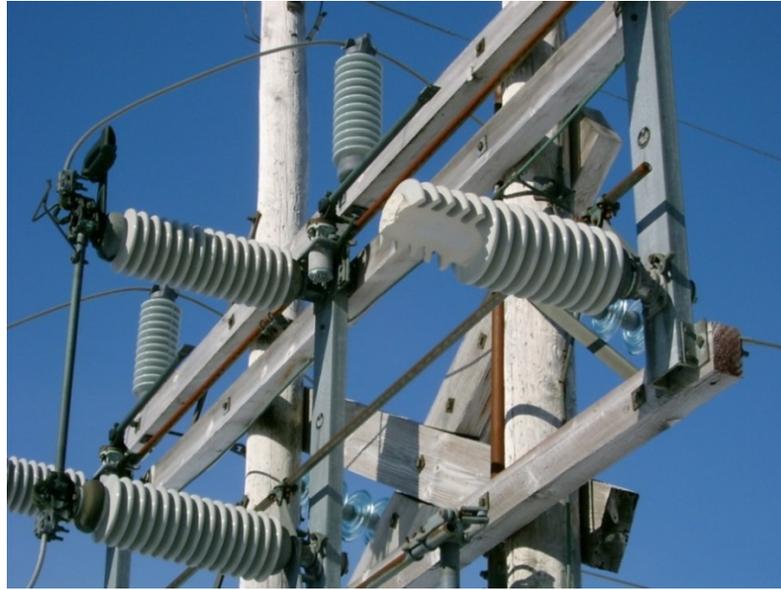
- 9 do not require immediate replacement are designated for replacement under this program.
- 10
- 11 Figure 4 shows an example of a badly damaged disconnect switch.

**Figure 4: Broken insulator on 69 kV disconnect switch**

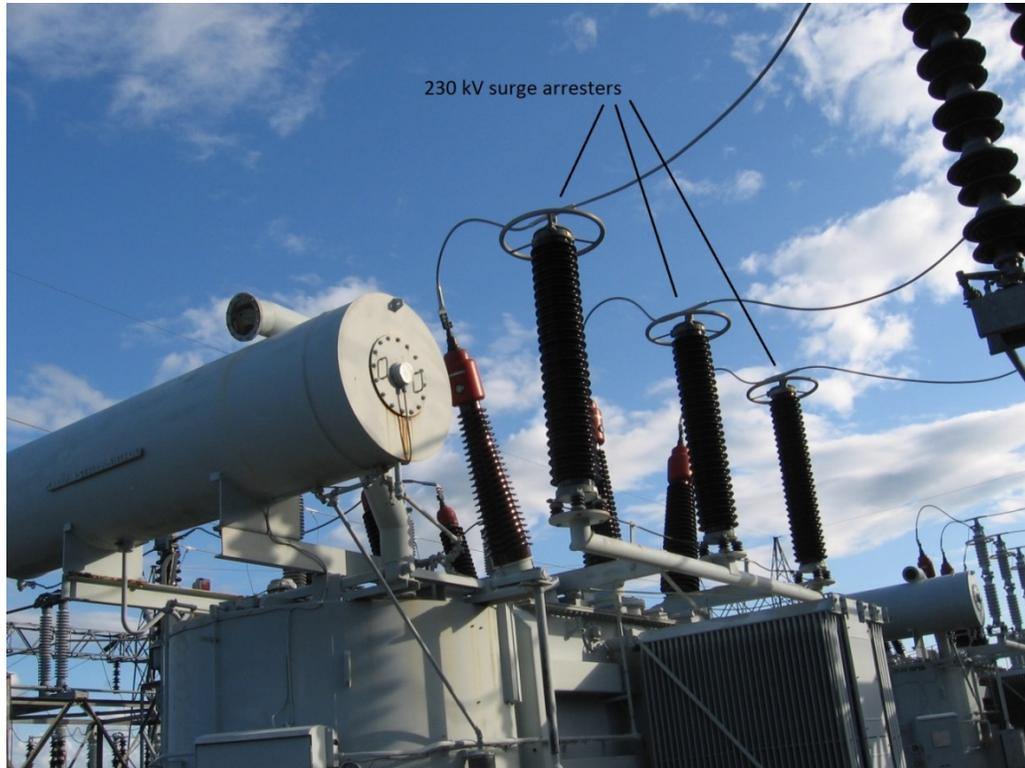
11 Figure 5 shows the arrestors on a 230kV power transformer.

**Figure 5: Western Avalon Terminal Station Transformer T3 230kV Surge Arresters**

- 1 Surge arrestors can fail because of the cumulative effects of prolonged or multiple  
2 overvoltages. When a surge arrester fails, it is not repairable and must be replaced  
3 immediately; otherwise the major equipment maybe exposed to damaging overvoltages. The  
4 older arrester designs have a higher incidence of failure than the newer designs.  
5  
6 Hydro's surge arrester asset management program replaces surge arrestors based upon the  
7 following criteria:

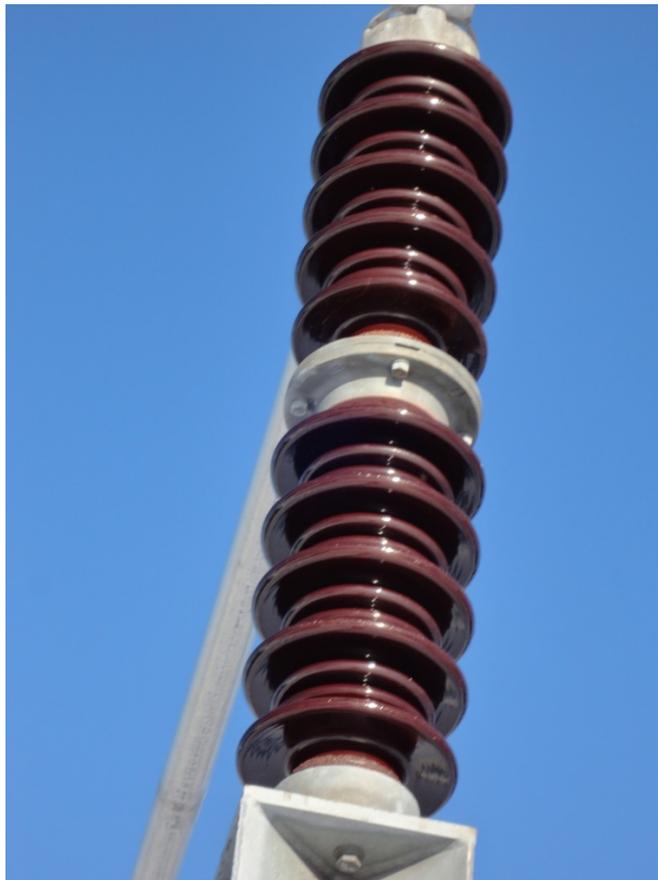
5 Insulators consist of insulating material such as glass, porcelain and metal end fittings to attach  
6 the insulator to the structure and the conductor. The metallic hardware is mated with the  
7 porcelain or glass insulator using cement. There are different styles of insulators. An example  
8 of a suspension insulator is shown in Figure 6.

**Figure 6: A multi-cone type insulator prone to failure due to cement growth**

1 For insulators using porcelain, cement used in mating the porcelain and metal hardware. Some  
2 older insulators have been damaged by a phenomenon known as cement growth. This is a  
3 common problem in the utility industry. In such situations water is absorbed into the concrete  
4 causing swelling of the cement, during freeze/thaw cycles, placing stress upon the porcelain.  
5 Over time, the increasing pressure caused by cement growth will crack or break the porcelain  
6 resulting in insulator failure. In such situations, porcelain may fall presenting a safety hazard to  
7 crews or damaging equipment below. Also faults resulting in outages to customers often occur,  
8 when insulator failure leads to flash-over. Sometime ago insulator manufacturers identified and  
9 researched cement growth problems, and have improved their cement quality to eliminate this  
10 problem.

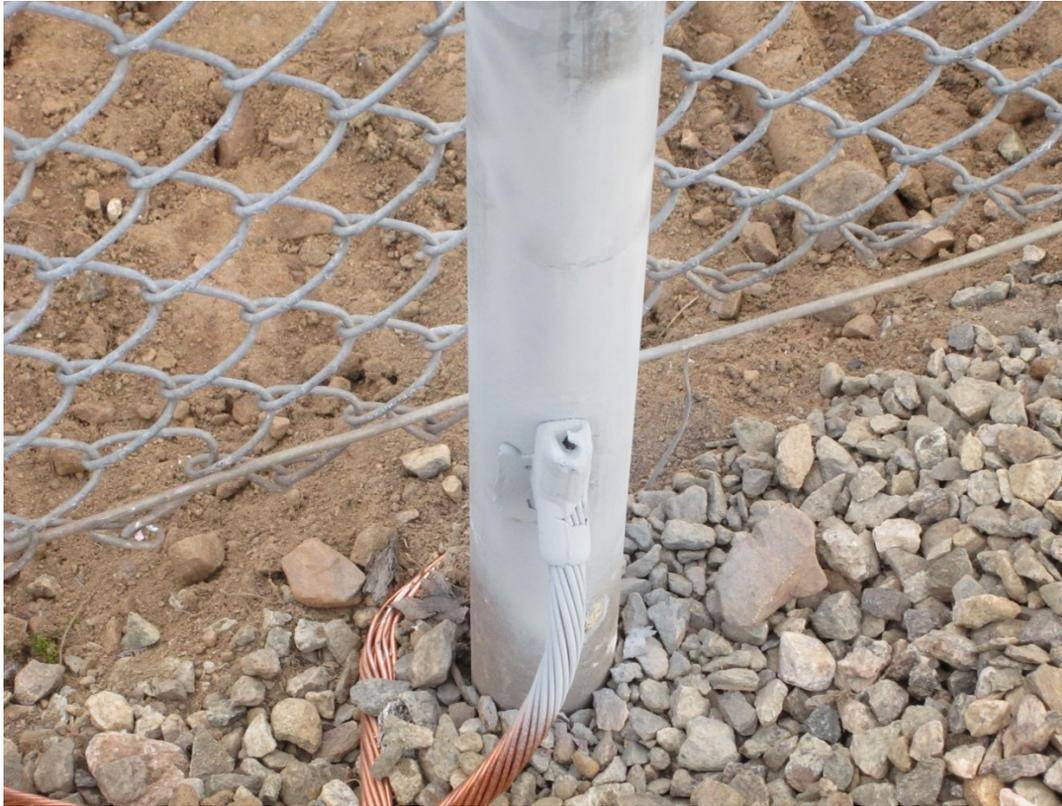
23 Effective station grounding reduces these potentials to eliminate the hazard.

**Figure 7: Typical grounding connection on terminal station fence**

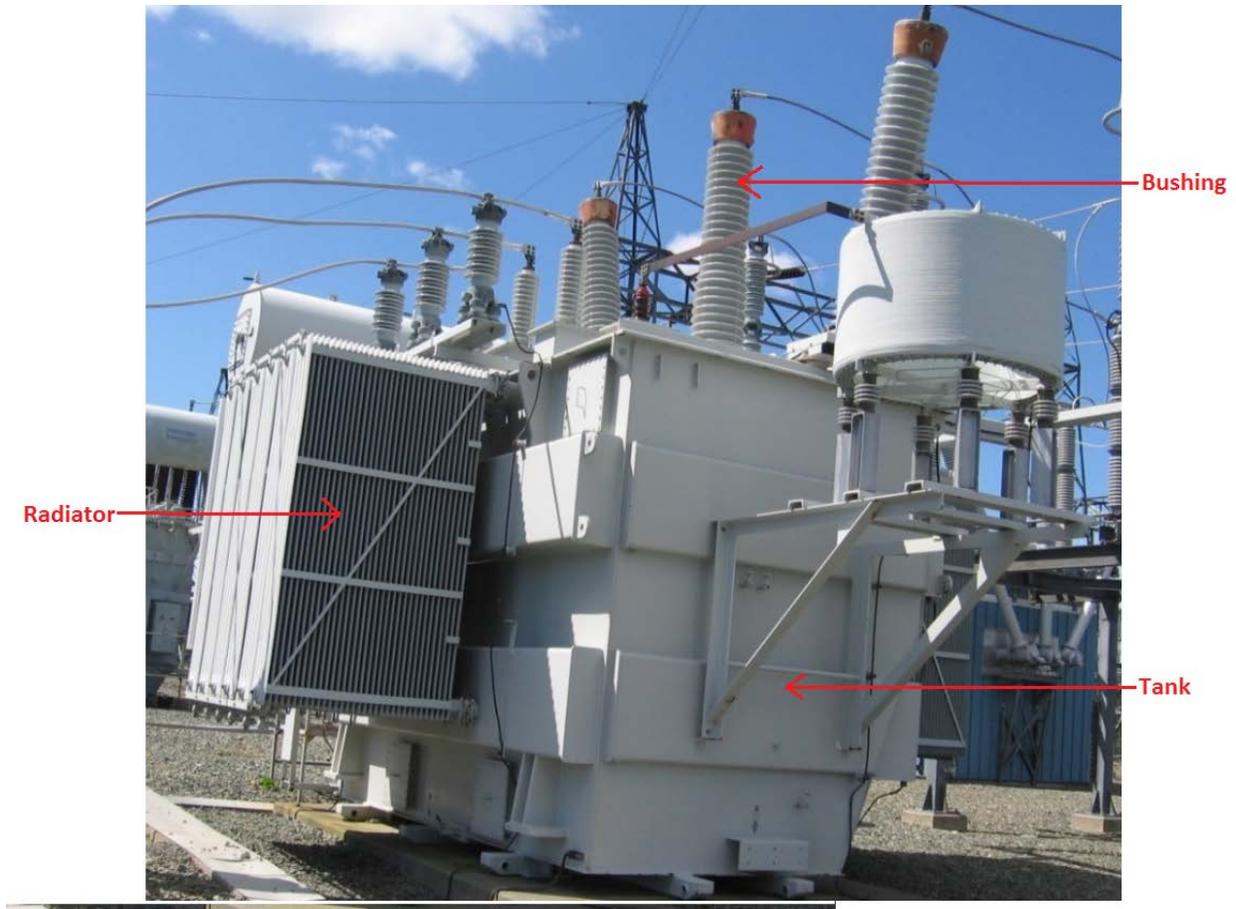
22  
23 Figure 8 shows a picture of a 75 MVA, 230/66 kV power transformer at Hardwoods Terminal  
24 Station.

**Figure 8: Power Transformer**

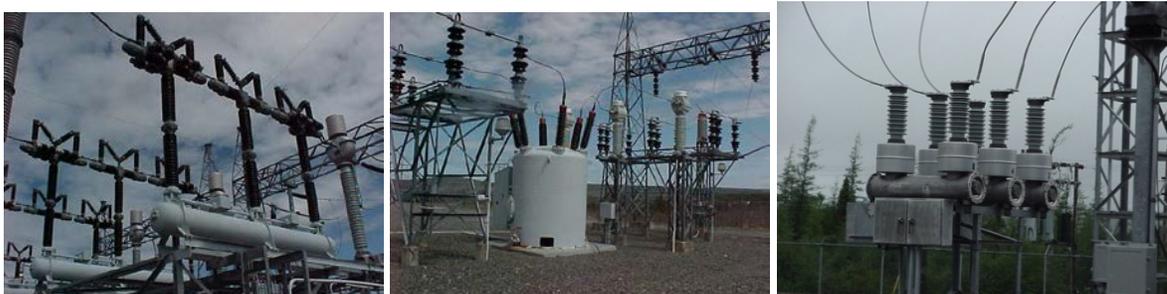
- 10 3. Sulphur Hexafluoride (SF<sub>6</sub>) Circuit Breakers, which use SF<sub>6</sub> gas to interrupt current and  
11 installation of these breakers started in 1979 and is used for all new installations. In the  
12 2016 Capital Budget Application “Upgrade Circuit Breakers – Various Sites” project,  
13 approval was obtained, until the end of 2020, for the mid-life refurbishment and  
14 replacement of SF<sub>6</sub> circuit breakers with voltage rates 66 KV and above. From 2017, any  
15 SF<sub>6</sub> replacements and refurbishments not previously approved in the 2016 Application  
16 will be included in the work conducted under this section of the Overview.

**Figure 9: Circuit Breakers – ABCB (left), Oil (middle), and SF<sub>6</sub> (right)**

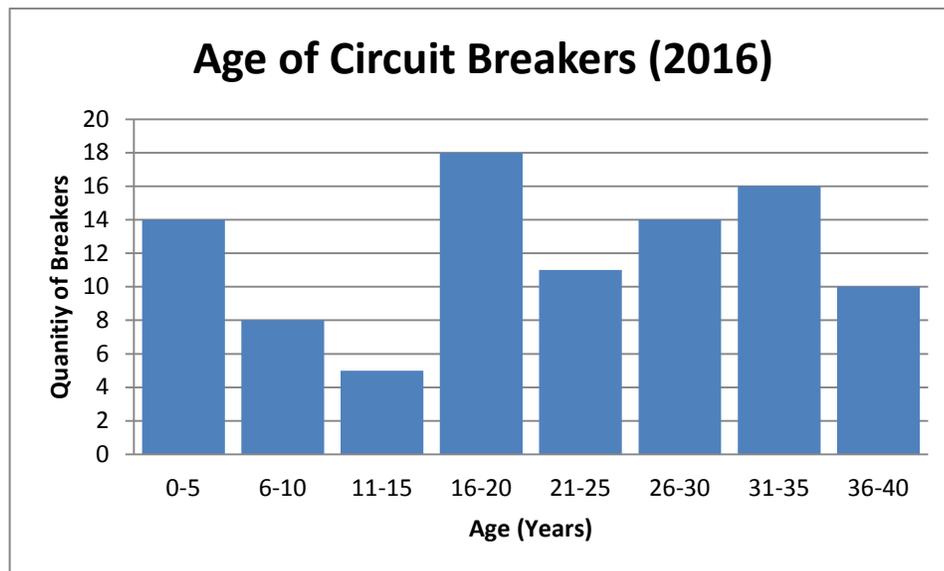
8 Figure 10 shows the age distribution of circuit breakers not approved for replacement prior to  
 9 2017.

Figure 10: Age of Circuit Breakers Not Included in Ongoing Replacement Program

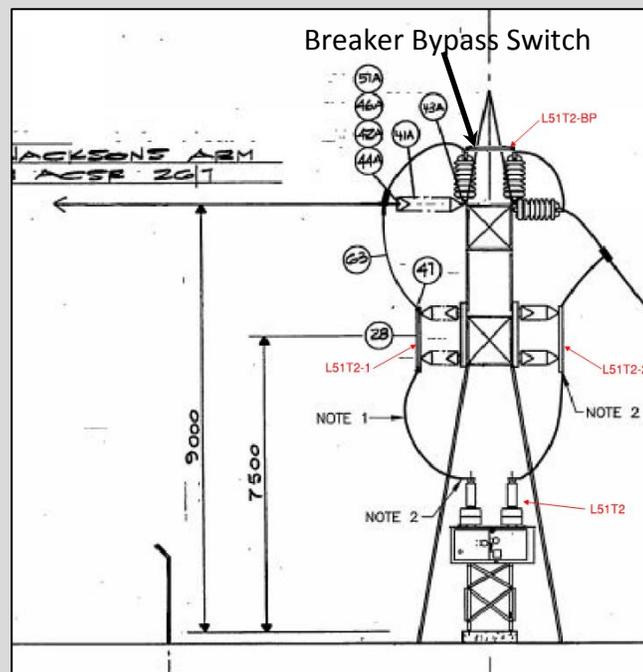
5 High voltage circuit breakers, with their associated protection and control equipment, are used  
6 to control the flow of electrical current to ensure safe and reliable operation of the electrical  
7 system. When a breaker is removed for service for maintenance, troubleshooting,  
8 refurbishment, or replacement, an alternate electrical path must be implemented to avoid  
9 customer outages. On radial systems<sup>3</sup>, this alternate path is accomplished using a bypass  
10 switch. When closed, the bypass switch permits electricity to flow around the breaker allowing  
11 the breaker to be safely de-energized, while maintaining service continuity.

**Figure 11: Example of Bypass Switch Installation**

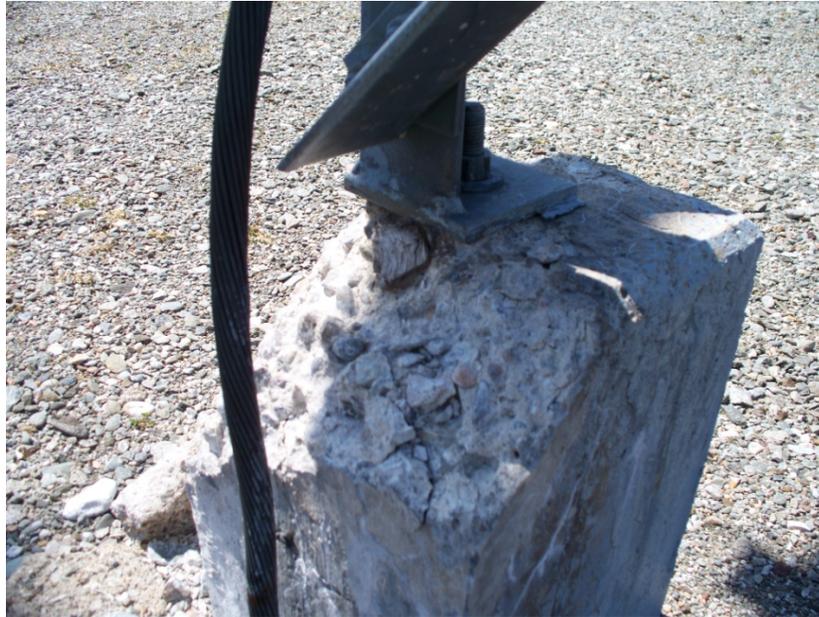
11 The service life of galvanized steel structures varies depending on the operating environment,  
12 but can exceed 100 years, outliving the foundations on which they are built. A number of the  
13 foundations in Hydro terminal stations have deteriorated significantly due to repeated  
14 exposure to damaging freeze/thaw cycles, weathering, and age, leading to concerns over their  
15 integrity. Degraded structure foundations are shown in figures 11 and 12.

**Figure 12: Structure B1T1 Bottom Brook Terminal Station**

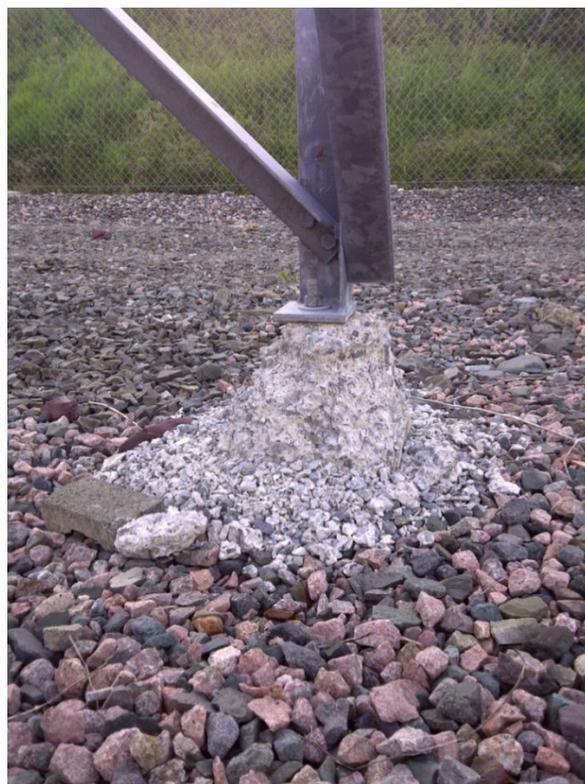
**Figure 13: Structure L01L37-1 Western Avalon Terminal Station**

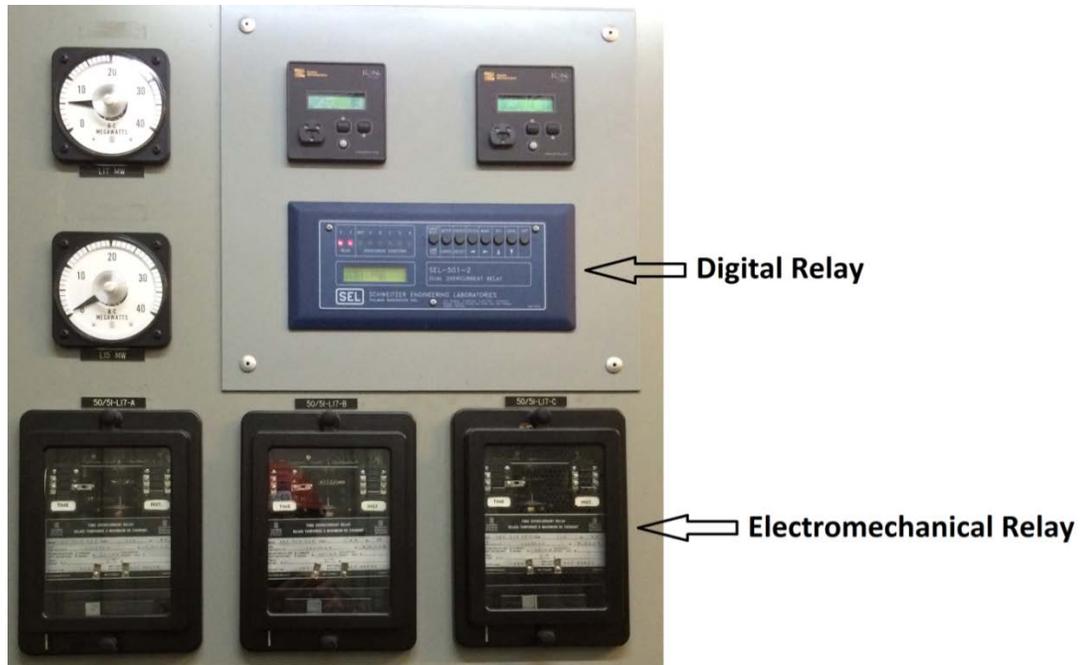
15 Older relays existing on Hydro's system are the electromechanical and older solid state types,  
16 and lack features such as data storage and event recording capability. Modern digital  
17 multifunction relays are used to replace these older style relays, as they have increased setting  
18 flexibility, fault disturbance monitoring, communications capability and metering functionality,  
19 and offer greater dependability and security, enhancing system reliability. Digital and  
20 electromechanical relays are showing in Figure 14.

**Figure 14: Digital and Electromechanical Relays**

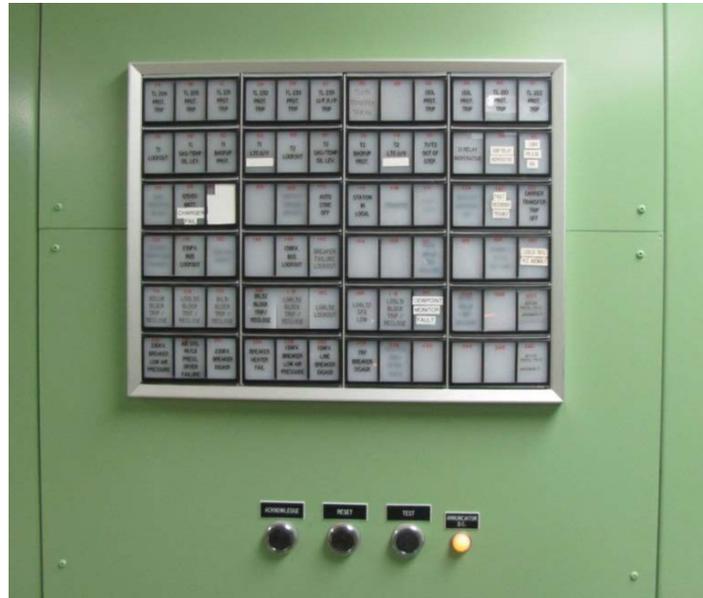
22    Alarms inform the Energy Control Center and operating personnel that equipment and relaying  
23    requires attention, and are communicated to the Energy Control Centre, and/or displayed  
24    locally on the station annunciator.

**Figure 15: An annunciator commonly found in Hydro terminal stations**
