Schedule 7: Capital Programs and Projects (Cont'd)

L23/L24 Tower Remediation Cost Estimate

Cost estimate for proposed structural reinforcements, repair and member replacements of steel lattice towers for the 230kV transmission lines between Churchill Falls and Wabush (L23, L23A, L24 and L24A)

**NEWFOUNDLAND AND LABRADOR HYDRO
230KV TOWERS – DEFICIENCIES ANALYSIS
OF LINES L23, L24**
Results Summary and Remedy Planning

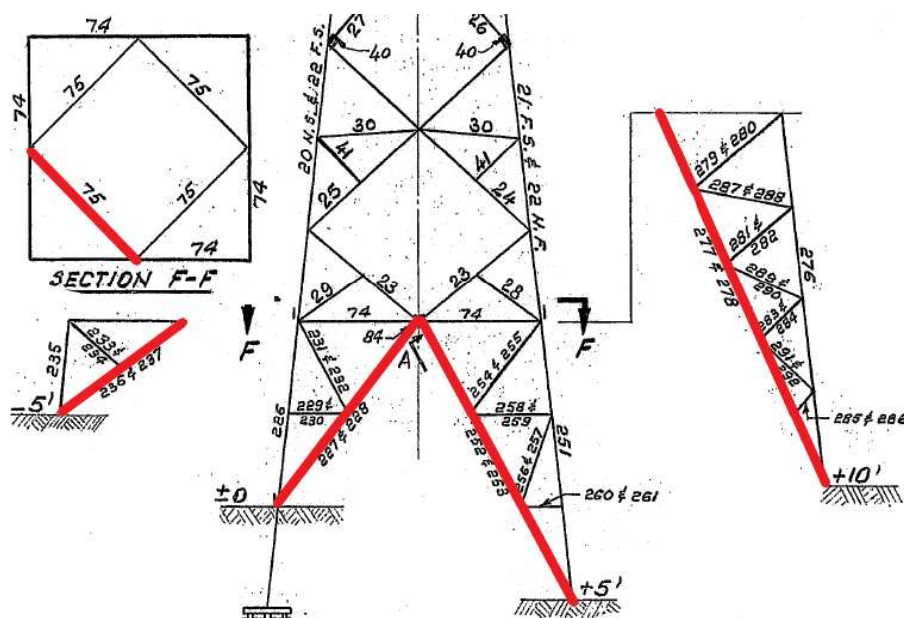
Figure 2 – Predominant Deficient Members, L24 Type BB Tower

Table 8 provides the same breakdown as Table 7 but for line L24, with Figure 2 depicting the members.

Member ID	Description	Tower Type	Frequency
75	Plan brace in horizontal diaphragm	BB	27%
227 / 228	Main leg diagonal bracing (0ft leg extension)	BB	30%
236 / 237	Main leg diagonal bracing (-5ft leg extension)	BB	18%
252 / 253	Main leg diagonal bracing (5ft leg extension)	BB	13%
277 / 278	Main leg diagonal bracing (10ft leg extension)	BB	12%

Some trends could also be observed within the results for broken members and missing members, though these trends are not as significant due to the lower number of occurrences of broken members.

- L23 – of the broken members, 71% were member #131 in the Type S tower.
 - #131 = main inside leg diagonal (0ft leg extension), same as in Table 7.

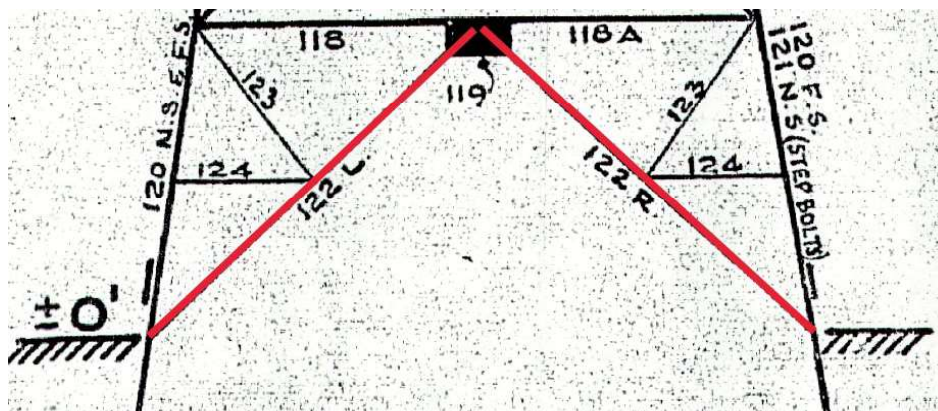
Figure 3 – Deficient Member (122) on Structure #492 (Type C)

Therefore, a very large jump in usage due to deficiency is observed at structure #492. This is a heavy anchor structure with ground wire, so the loading conditions (security loads) are more stringent than for suspension or semi-anchor structure as outlined in section 5.2. The deficiency simulation impact is emphasized greatly at this structure so special attention must be given to the remedy work plan.

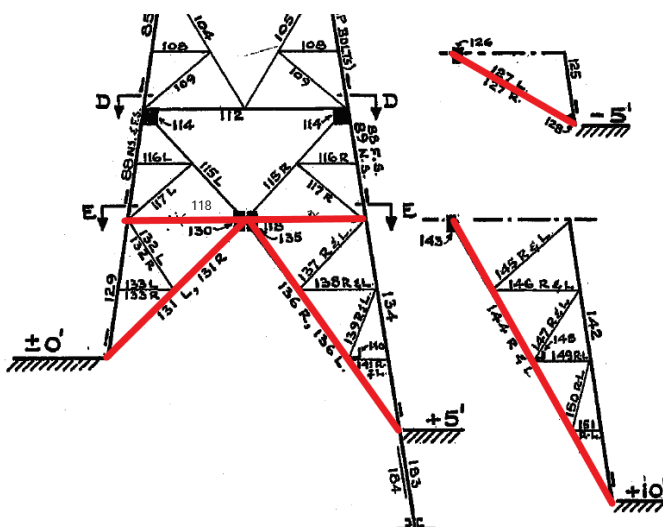
Figure 1 - Key Deficient Members, L23 Type S Tower

Table 8 - Bent Members, L23 (by % of occurrences)

Member ID	Description	Tower Type	Frequency
118	Horizontal diaphragm (belt member)	S	2%
124	Main leg diagonal bracing (0ft leg extension)	T	6%
127	Main leg diagonal bracing (-5ft leg extension)	S	10%
131	Main leg diagonal bracing (0ft leg extension)	S	59%
136	Main leg diagonal bracing (5ft leg extension)	S	7%

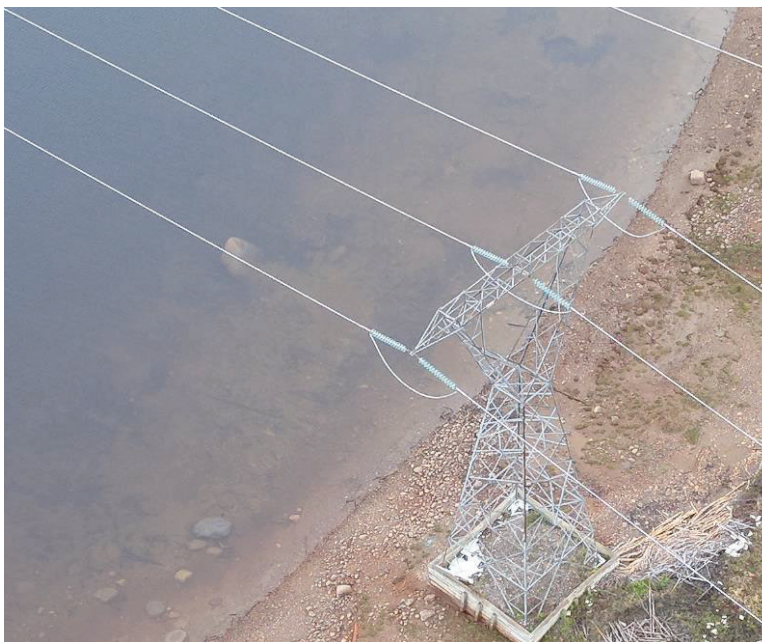
Figure 4 - Structure #95, Type S tower in L23

located at a water crossing, or because some sort of maintenance/repair work was done in the past in this area. As the Type S tower was not designed for semi-anchor or heavy anchor tower loadings, analysis of structure #95 was completed with suspension/tangent criteria per Section 5.2. Due to the circumstances at this structure and also considering analysis results, this is considered a high priority location.

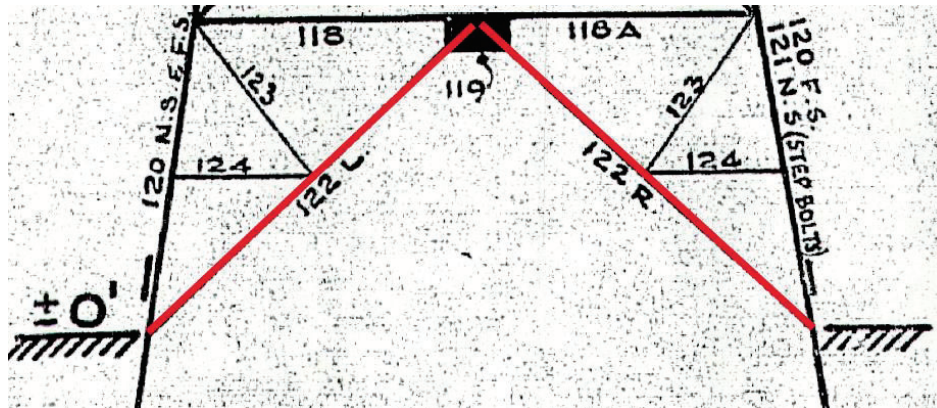
Figure 6 - Deficient Member (#122), Structure #407 (Type C)

A very large jump in usage due to deficiency is observed at structure #407, a Type C structure. This is a heavy anchor structure with ground wire, so the loading conditions (security loads) are more stringent than for suspension or semi-anchor structure as outlined in Section 5.2. The deficiency simulation impact

is emphasized greatly at this structure so special attention must be given to the remedy work plan. Figure 6 displays the deficient member of this location (#407), responsible for the large increase in usage.

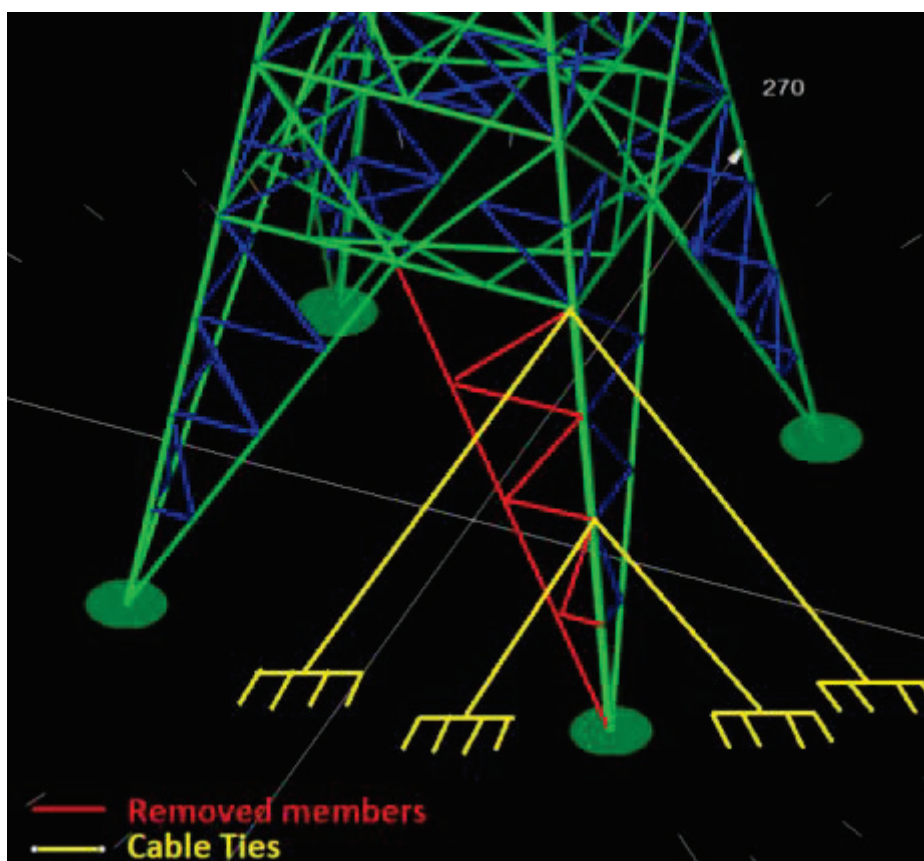
Figure 16 - Potential Cable Tie Support Solution, L23 Type S

Figure 16 depicts a possible temporary support solution to reinforce legs via temporary cable ties. Another option would be to support the tower at critical points with a crane, or completely unload the tower (temporarily lifting of conductors and ground wires). The cable tie option would provide increased member stability if cables are installed at the leg joints, but it would increase compressive loads in the supported member. The feasibility of cable ties should only be determined with detailed analysis.

Furthermore, as the majority of deficient members across all structure types across all four lines/circuits are primary, secondary, or redundant members in the tower legs, the default recommended solution to allow for prescribed remedy/repair works is to provide additional support to the tower legs on which work is being done. This additional support should be provided as close to redundant connection points as possible.

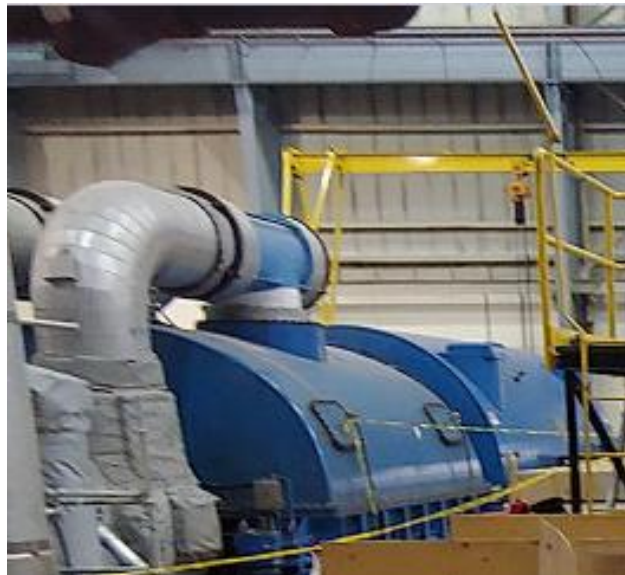
Figure 1: Holyrood TGS Unit 2 Turbine Generator

12 The Unit 2 generator and turbine were manufactured by General Electric in 1969. The generator is
13 comprised of two primary components, a stator and a rotating field (“rotor”). The rotor is coupled to
14 and driven by the steam turbine (as shown in Figure 1) and rotates inside the stator to produce
15 electricity in the stator windings.

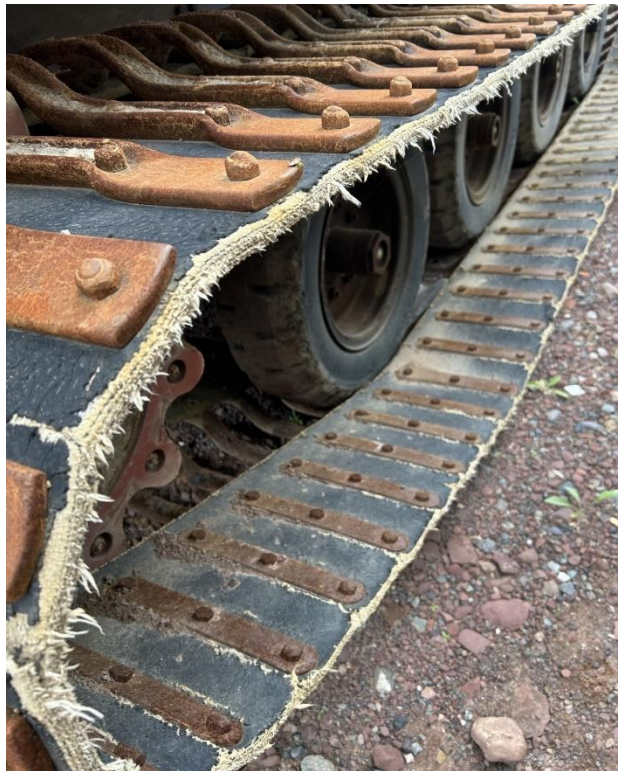
Figure 2: V7206 Undercarriage

17 To maintain this unit and upgrade the undercarriage would require an extensive rebuild. This would not
18 be prudent as body fatigue is also present, which limits its viability due to the increased risk of other
19 operational issues. This unit will be replaced with a modern, comparable version.

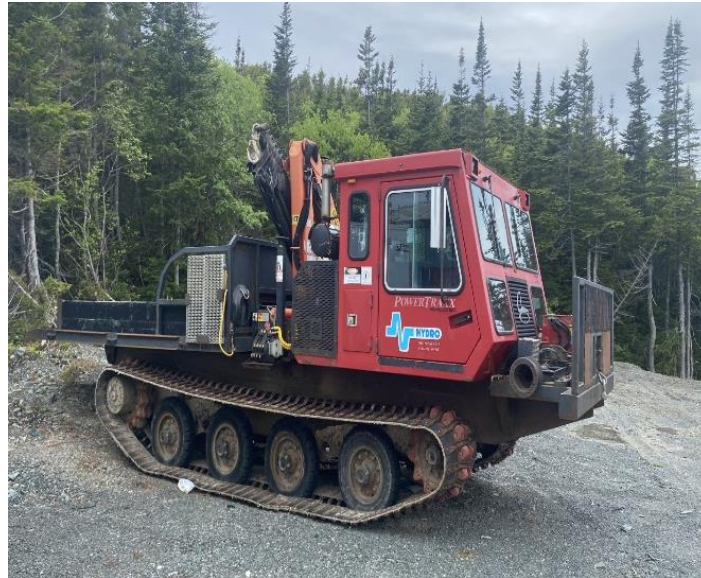
Figure 3: V7117

1 V7117, as shown in Figure 3, has been in service since 2007 and is at the end of its useful life. This unit will
2 be 20 years old, five years beyond the replacement age criteria-when a replacement unit is received. Any
3 further service extension will pose significant reliability risks and increased maintenance costs. This unit will
4 be replaced with a modern aerial device-equipped track unit with increased reach and lifting capabilities.

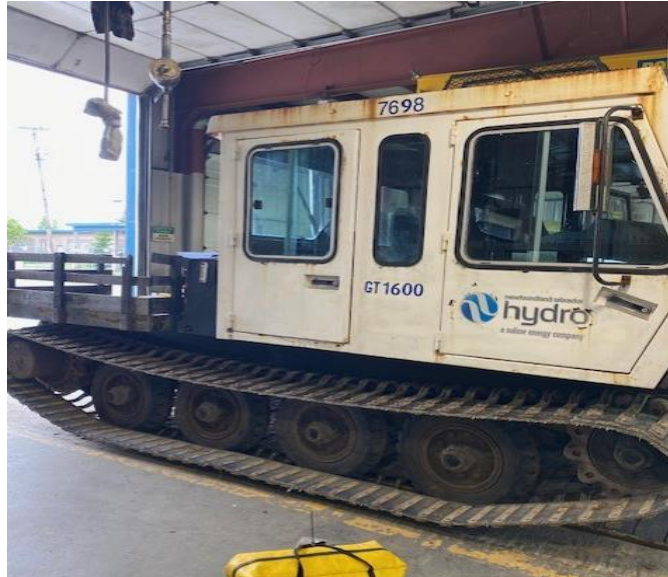
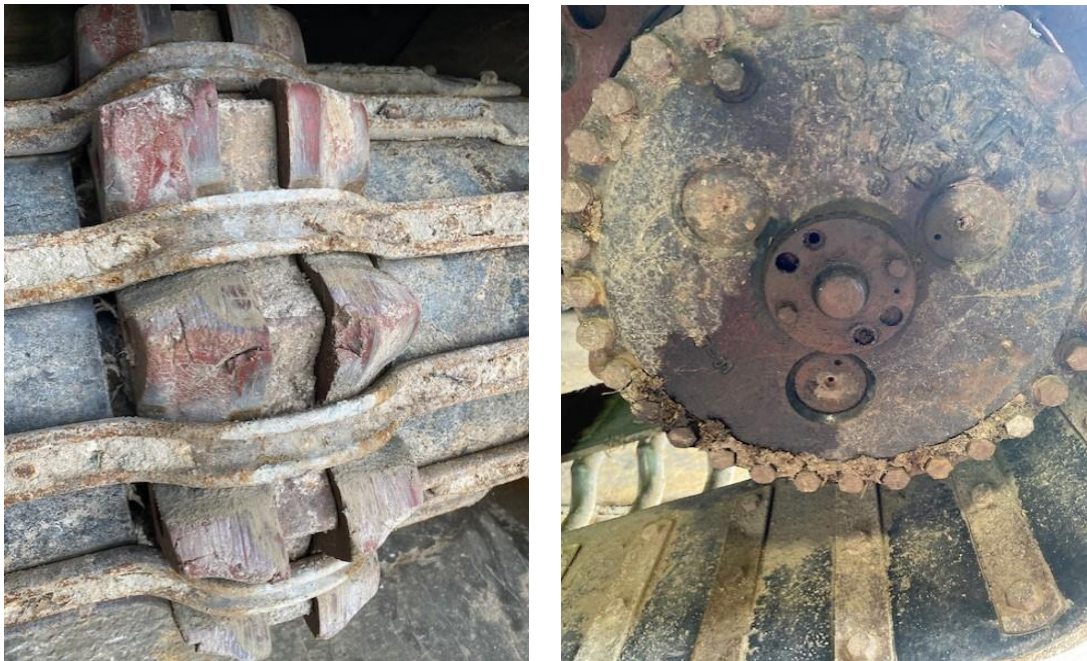
5 V7698 has been in service since 2001, is at the end of its useful life, and is considerably beyond
6 replacement age criteria. The current functionality of this aged unit is no longer required, and the age
7 and condition of this unit pose a reliability and maintenance risk, as shown in Figure 4 and Figure 5. This
8 unit will be replaced with a modern, aerial device-equipped track unit. Replacing this with an aerial
9 device-equipped tracked unit helps to meet current and future demands, which require Hydro to
10 increase its lifting and reach capabilities within its track unit fleet.

Figure 4: V7698

Figure 5: V7698 Final Drive and Sprocket Condition

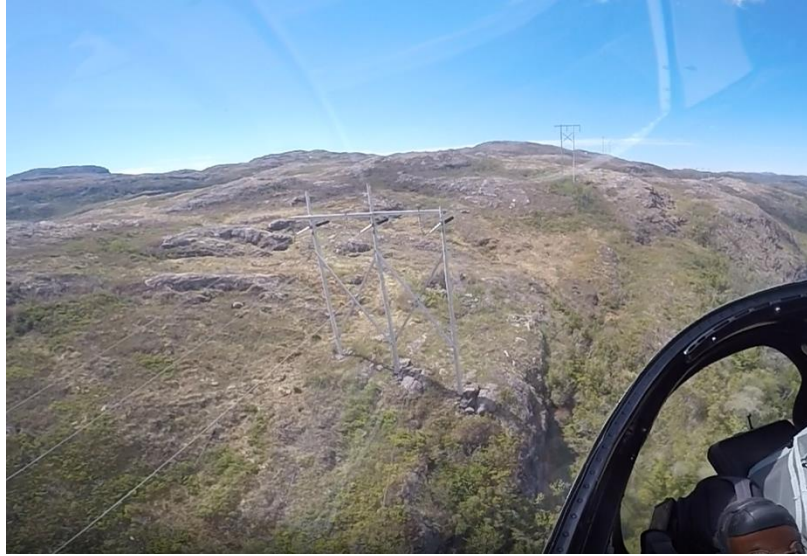
Figure 2: TL220 Helicopter Patrol: Southern Section

10 Newfoundland and Labrador Hydro (“Hydro”) is proposing to reroute the southern section of TL220,
 11 which contains deteriorated poles and is located in a challenging area that is inaccessible by current-day
 12 transmission line construction equipment, as shown in Figure 2. The section of line in question is
 13 between Structures 288 to Structure 334, from the English Harbour West Terminal Station (“EHWTS”) to
 14 BCXTS. The proposed reroute is approximately 10.6 km in length alongside Route 360 and will consist of
 15 approximately 120 poles, with most of the line being constructed in a single-pole configuration.

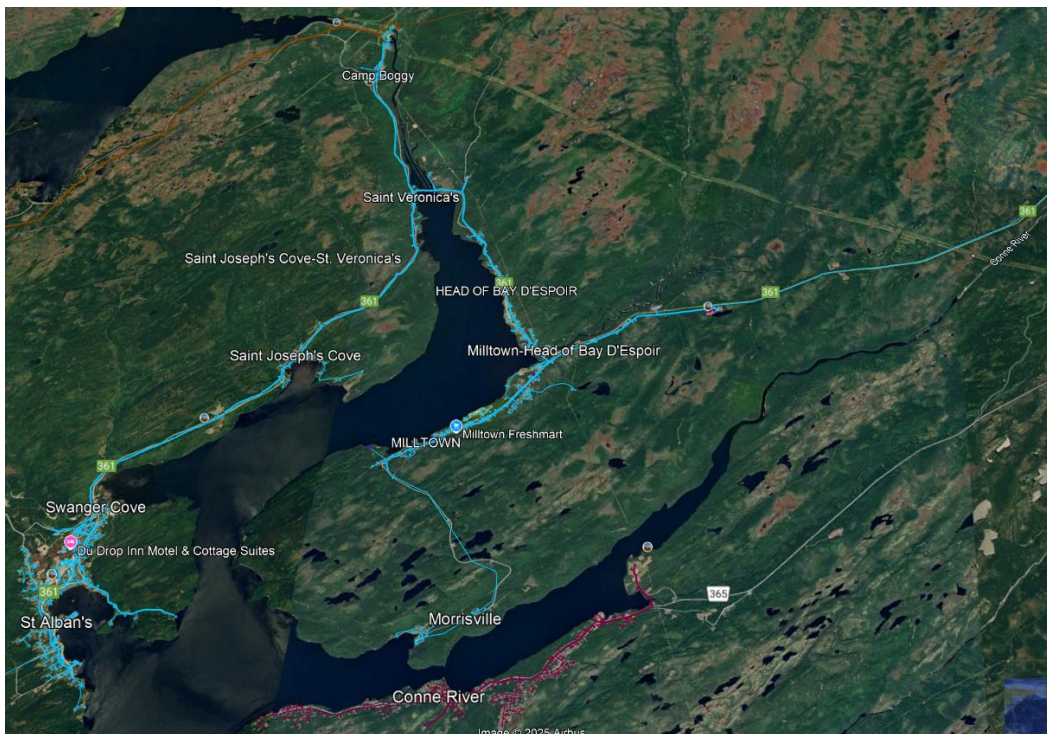
Figure 1: Layout – BDE-L1

5 BDE-L1 is a three-phase, 25 kV distribution feeder originating from the Bay d’Espoir Terminal Station and
6 was constructed in the 1960s. Currently it supplies power to 1297 customers. The feeder extends from
7 the Bay d’Espoir Terminal Station toward Camp Boggy and St. Veronica, where it splits into two
8 branches. One branch continues toward Head of Bay d’Espoir, Milltown, and Morrisville, while the other
9 serves the communities of St. Joseph’s Cove and St. Alban’s. The location of the BDE-L1 feeder is shown
10 in Figure 1.

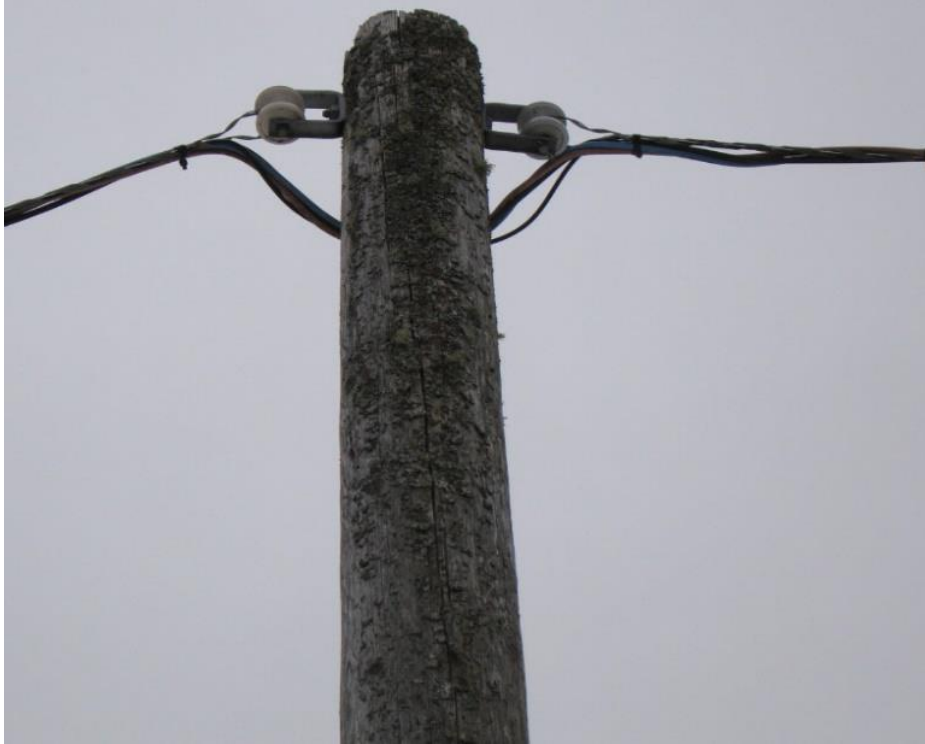
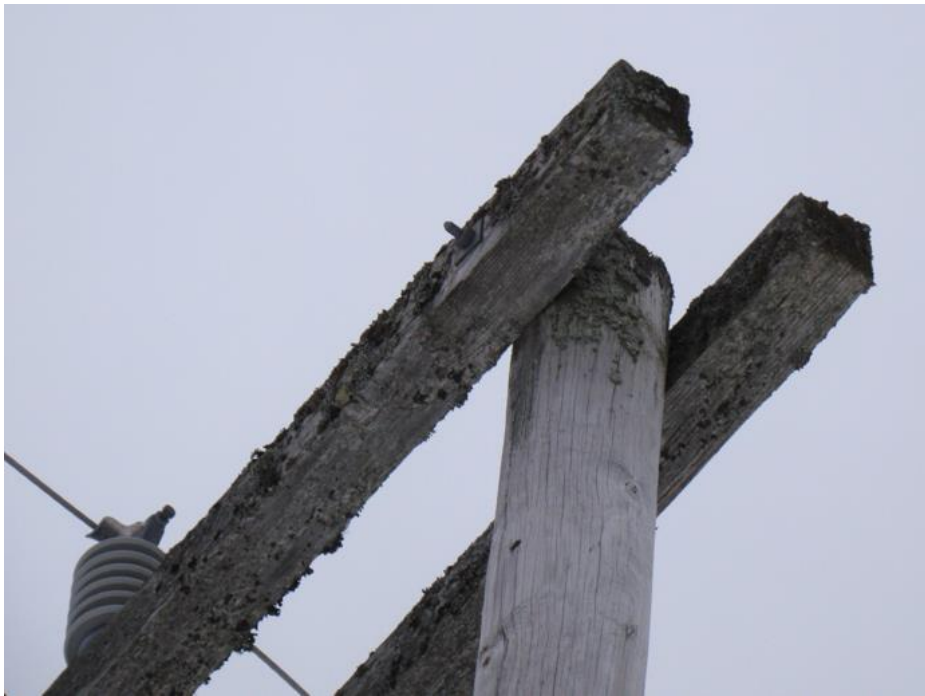
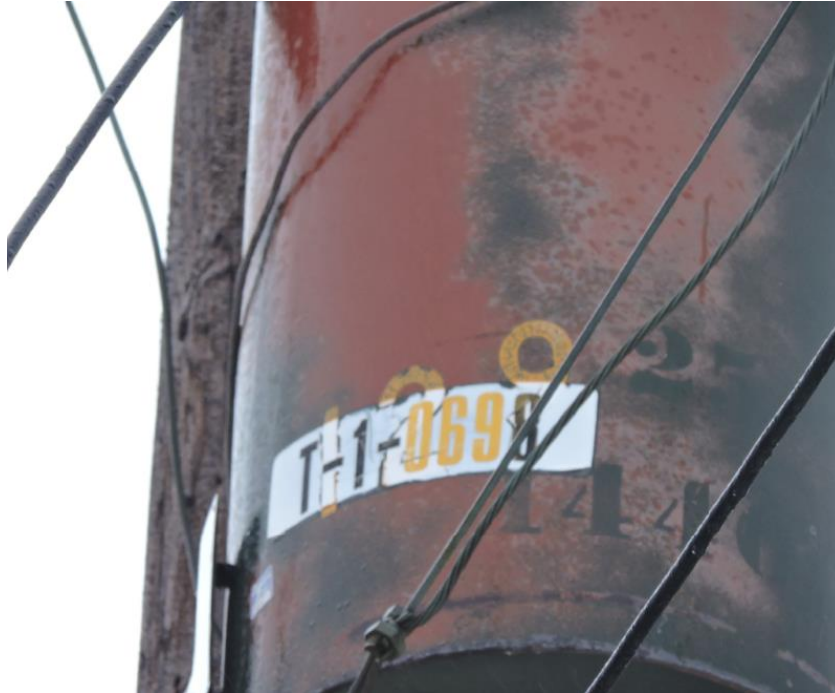
21 Examples of a deteriorated pole, crossarms, and transformer tank, such as those observed during recent
22 inspections of BDE-L1, are provided in Figure 2, Figure 3, and Figure 4

Figure 2: Example of a Deteriorated Pole

Figure 3: Example of a Deteriorated Crossarm

Figure 4: Example of a Deteriorated Transformer Tank

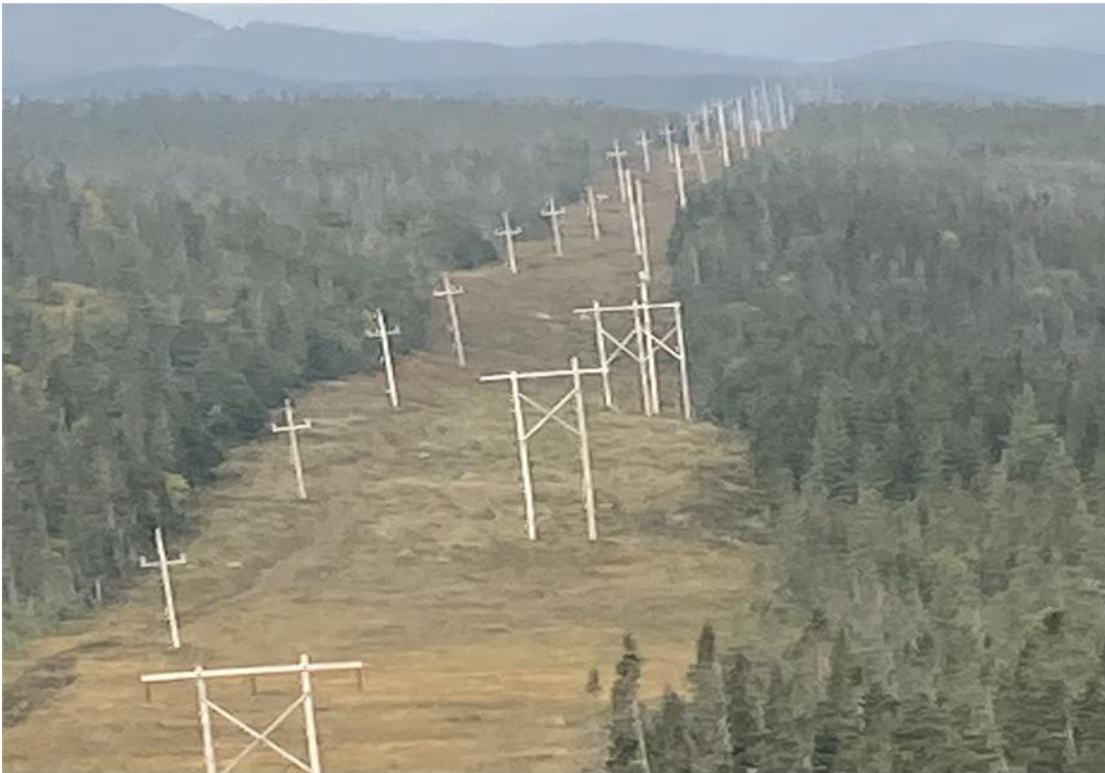
Figure 2: Narrowing of the ROW at the Southern Park Boundary

- 1 50%. The TLs were constructed with narrowed ROW widths to minimize the quantity of vegetation
- 2 cleared within the Park, as demonstrated in Figure 2.

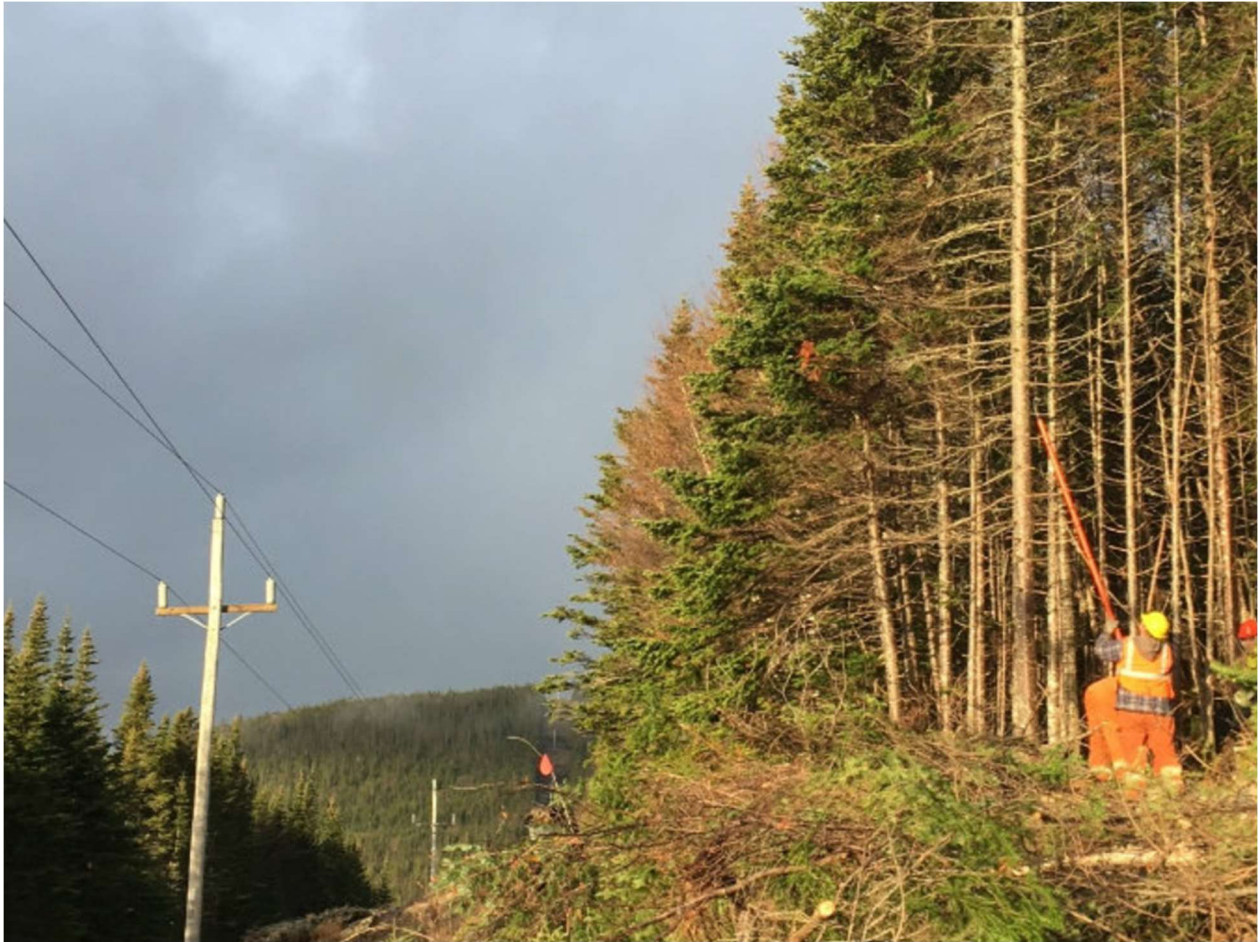
Figure 7. Typical Widening Location (TL 229)

ROW corridor widening is generally limited to locations where tall trees encroach on the transmission lines or where they would contact the lines should they fall or become structurally compromised. As such, Project impacts to vegetation are generally limited to mature forested ecosystems while Project access requirements may interface with a broader range of habitats, including wetlands and riparian areas. Figure 7 illustrates the typical environmental setting where vegetation removal, trimming, or topping are required to mitigate risk.

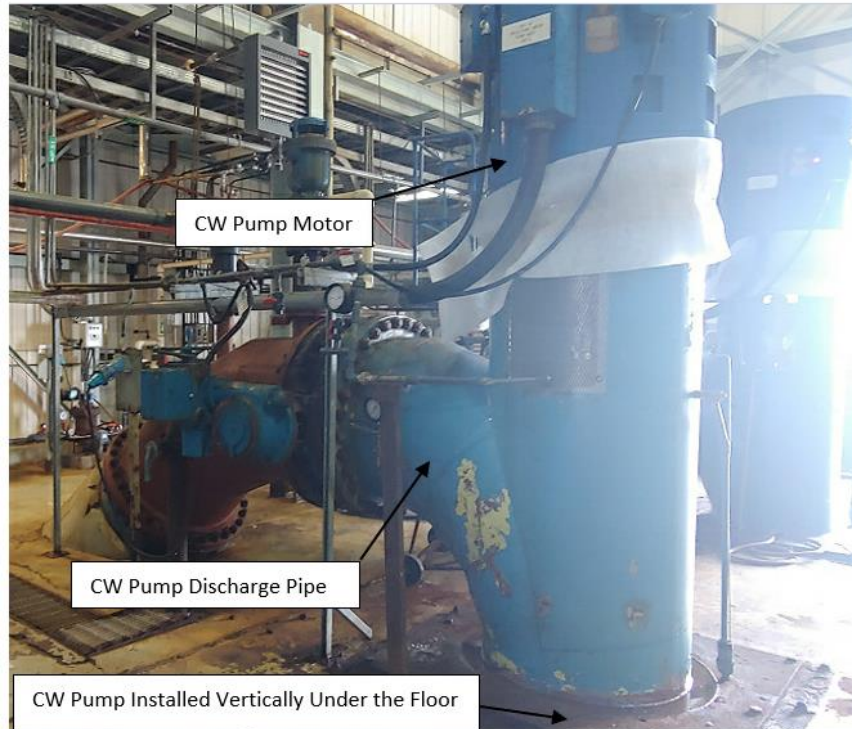
Figure 2: CW Pump

2 The Unit 1 East CW Pump is one of two identical vertical pumps (Figure 2) inside Pumphouse 1. The two
3 CW pumps share the required capacity to supply seawater to the condenser to cool steam after it exits
4 the turbine, and also cooling water for other closed-loop systems. Both CW pumps are needed for Unit 1
5 to produce its full generating capacity of 170 MW. With one pump in service, the unit can produce about
6 50% of its generating capacity.

7 The Unit 1 East CW Pump is a single-stage pump that draws ocean water through a set of travelling
8 screens to filter debris. The pump supplies CW to the condenser inside the powerhouse through 60-inch
9 discharge piping that is extended underground from Pumphouse 1 to the powerhouse. It is necessary
10 that the CW systems operate efficiently to maintain optimal plant thermal efficiency by minimizing
11 steam turbine condenser backpressures.

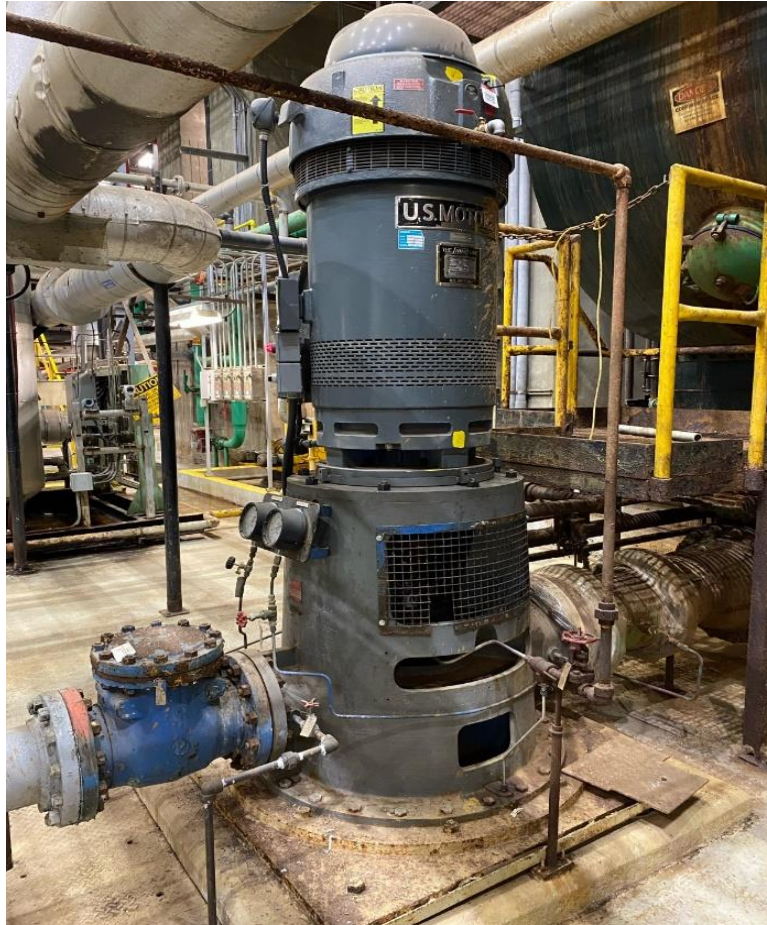
Figure 3: CE Pump

5 Inefficient condensate removal affects power generation, potentially causing fluctuations in output and
6 requiring more frequent maintenance. Moreover, inadequate condensate extraction poses risks of
7 equipment damage and safety hazards, including turbine overheating and potential failures. A degraded
8 CE pump can lead to reduced efficiency, decreased performance, and increased operating costs. The
9 most likely issues leading to pump degradation are failure of the seals, bearings, and impeller. In

10 addition, failure of a CE pump or its motor would cause a loss of 60% of the unit's generation.

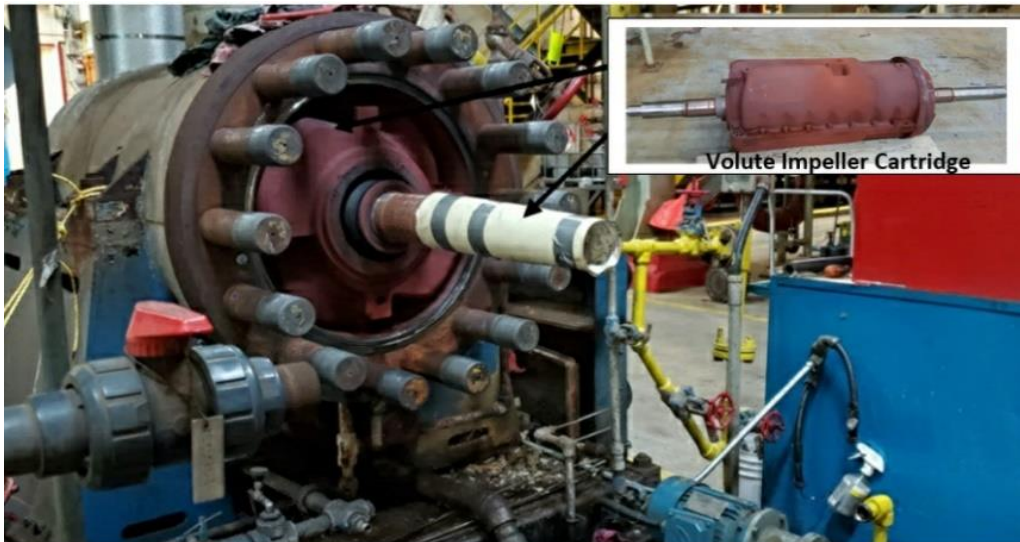
Figure 4: BF Pump Volute Impeller Cartridge During Disassembly

10 For the BF pump, the volute impeller cartridge will be replaced with a refurbished cartridge from
11 Hydro's spares inventory. The volute impeller cartridge, which is removed from the BF pump, will then
12 be refurbished and returned to inventory as a critical spare to support the identical Units 1 and 2 BF
13 Pumps prior to the next winter operating season. Figure 4 shows the volute impeller cartridge.

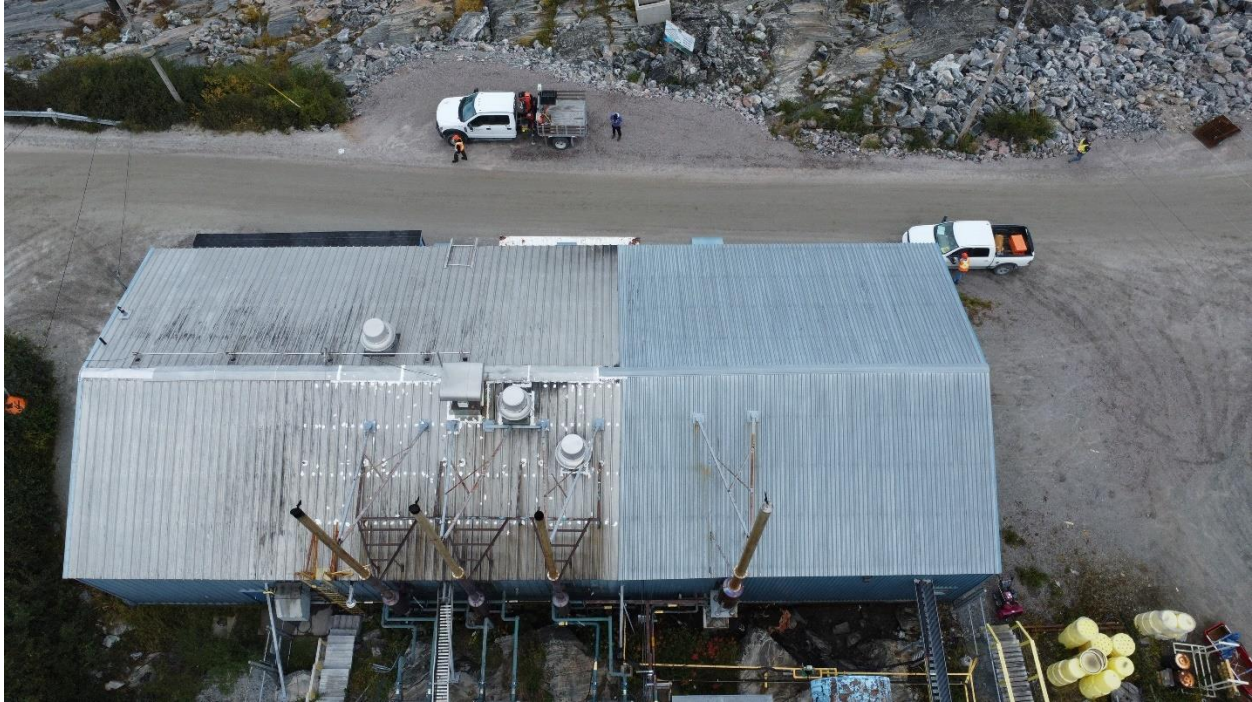
Figure 1: Hopedale Diesel Generating Station Roof

25 The Hopedale Diesel Generating Station was built in 1991. In 2013, the facility underwent a significant
26 upgrade to extend the engine hall to accommodate the addition of another generating unit. The original
27 portion of the building envelope roof and the rooftop exhaust fans are now 34 years old, as shown in
28 Figure 1. The roofing section for the building extension, shown on the right in Figure 1, is 12 years old.

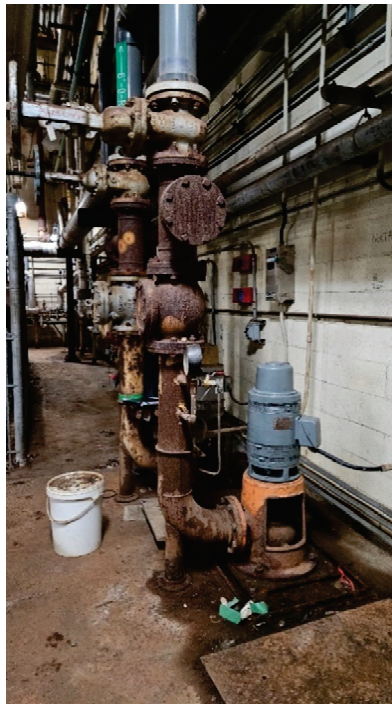
Photo 1: Raw Water Pumps

The system is also equipped with a chemical injection system including the injectors and a mixer which is installed in a bypass line. This bypass line is only opened when chemicals are injected upstream. Chemical injection is not used frequently, and the bypass line is normally closed.

Regular maintenance and inspection should allow these pumps to serve the system to the end of 2030. If the date is extended five or more years past 2030, then replacement of one or both pumps should be considered at that time. The redundancy will provide reassurance that the system can fully operate without issue as long as one of the two pumps are in service.

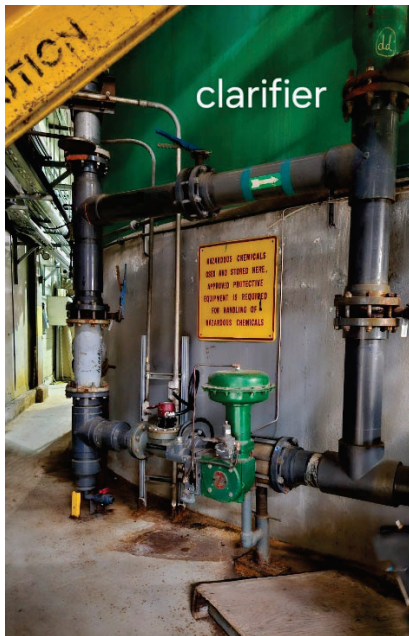
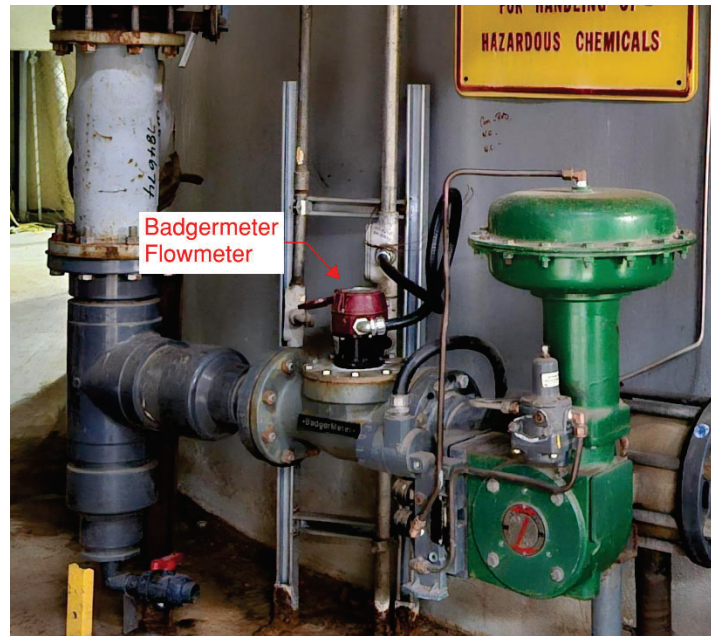
Photos 2A & 2B: Clarifier Piping and Badgermeter Flowmeter.

Visibility on top of the clarifier tank is poor due to broken light fixtures, spot lighting that has been added to the area to illuminate over the tank is not properly supported and have been angled over the tank using rope tied to the handrail of the platform.

The turbidity monitoring system looks new and in good condition, labels on the equipment indicate the system was serviced and calibrated in Jan. 2024 with the next service date in Jan. 2025.

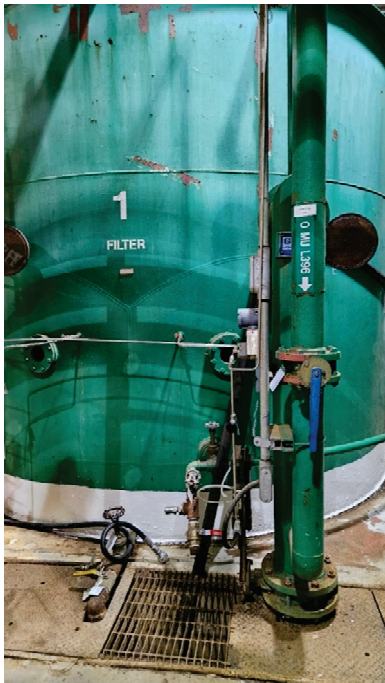
Photo 4A - Sand Filter #1 (typical)

From the clarifier, the water is fed to the three sand filters. Water from the clarifier flows equally to each of the sand filters. The water is piped from sand filter #1, through filter #2 and #3, then to the splitter box, and onto the Clearwell. Similarly, sand filter #2 is piped through #3 into the splitter box and onto the Clearwell. Sand filter #3 is piped directly to the splitter box and then into the Clearwell.

A laser scan was completed by Acuren for the three filters, and each had issues with the bottom portion of the tank. Since then, the bottom section has been coated with Amerlock 400 (white section in photo below) to help with corrosion, and additional repairs were applied to #3 as described below. There are rust stains around the base of each filter, but some more than others. More detailed information is provided in the individual sections which follow.

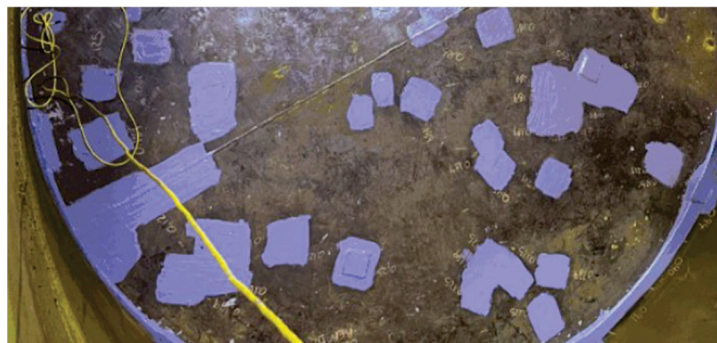
Photo 9: Repairs to Clearwell Bottom

The floor of the Clearwell was measured with UT and construction was confirmed to be 0.250" thick plate. Pitting was found throughout the tank floor with pits ranging in depths from 0.0675"-0.313". Eight pits were noted to have 0.250" depths or more and were considered as through holes. Several other pit depths ranged from 0.125" up to 0.250". The recommendation was to restore the tank thickness by using Belzona wherever the pit depth was more than 0.150" (these areas would not meet the API 653 minimum required thickness). A similar procedure as described above was applied to the tank bottom, see photo below.

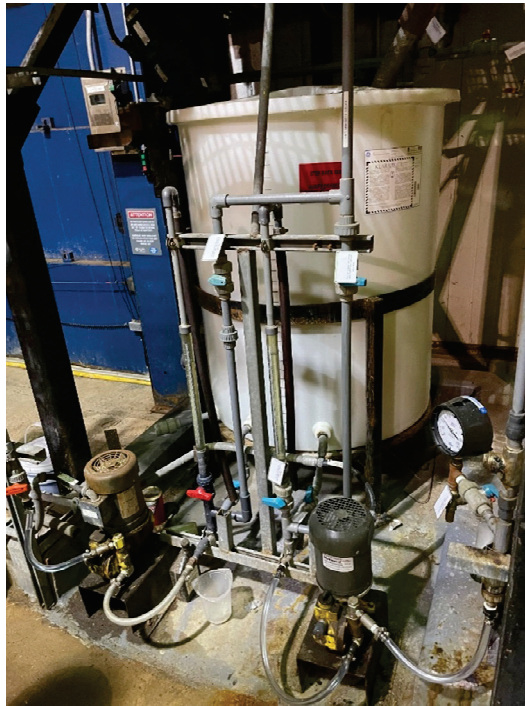
Photo 13: Coagulant Tank and Pumps

The results from the onsite inspection showed no apparent issues for the coagulant tank and pumps, and no known problems were indicated from facility staff.

The disconnect switches for the pumps and agitator have no visible arc flash labels.

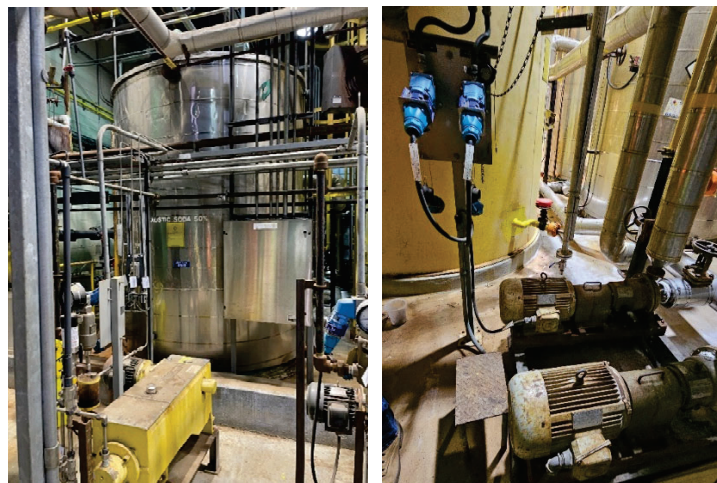
Photo 14 & 15: Caustic Tank (50%) and Pumps

While on site it was noted that the two caustic tanks were inspected in 2021, but the pumps were not included in this inspection. The inspection results are listed below and from discussions and visual inspections during the site visit, the tanks and pumps appear to be in good condition and no issues noted.

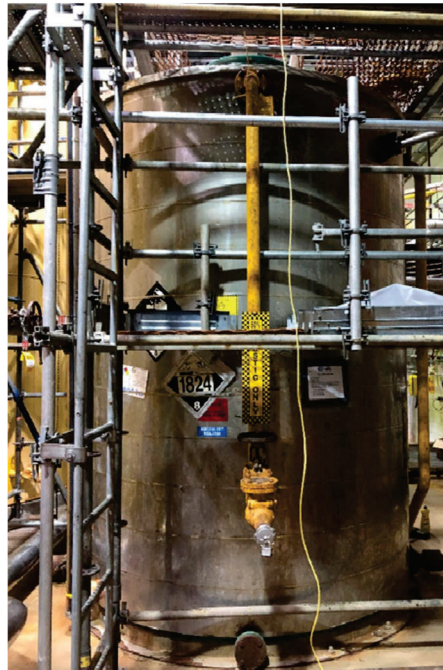
Photo 16: South 50% Caustic Tank (50%)

As with the North tank, from discussions onsite and visual inspections, the tanks and pumps appear to be in good condition and no issues noted.

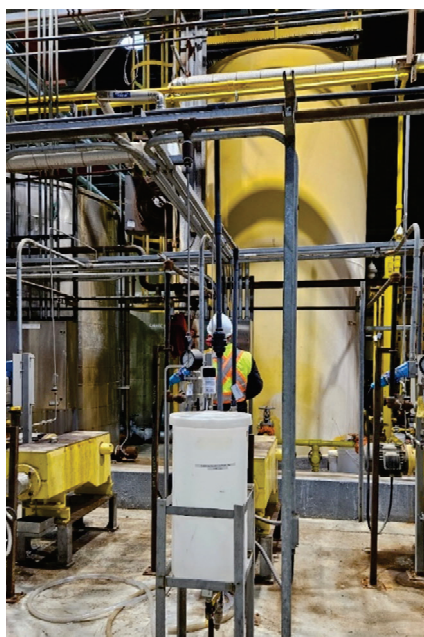
Photo 17: North Bulk Acid Storage Tank

As with the Caustic Soda tanks, the nozzles and attachments are shown in the table as 'not acceptable, with description of issues noted below:

- Internal corrosion was noted on the 3" inlet welds (nozzle 6) and 3" roof vent welds (nozzle 8).
- Magnetic Particle Testing (MT) revealed issues with the 2" sight glass weld on nozzle 5.
- Ultrasonic Testing (UT) readings indicated minimum nozzle neck thickness requirements for API 653 were not met for the 2" outlet, 2" sight glass, 2" drain, and 2" overflow (nozzles 1, 2, 3, and 4).
- 3" inlet (nozzle 6) is out of service due to severe corrosion.

- Repair 3" roof vent internal weld (nozzle 8).
- Repair external weld on 2" sight glass weld (nozzle 5).
- Repair two pinholes noted on first course internal vertical shell seam
- Replace 2" outlet, 2" sight glass (lower shell), 2" drain, and 2" overflow (nozzles 1, 2, 3, and 4).
- Replace 3" inlet (nozzle 6)

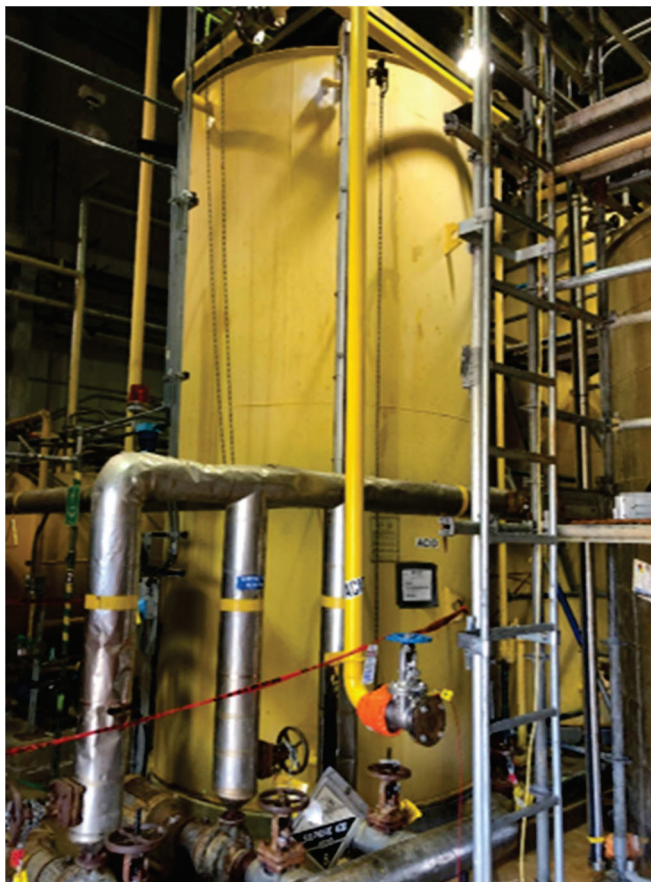
Photo 18: South Bulk Acid Storage Tank and Pumps

Again, the nozzles and attachments are shown in the table as ‘not acceptable. Reasons for this were noted as follows:

- Visual Testing (VT) revealed Internal corrosion of 2" outlet welds (nozzle 1) and internal corrosion and pinholes on the 2" sight glass weld (nozzle 2).
- Magnetic Particle Testing (MT) revealed issues with the 3" overflow weld (nozzle 3).

- Repair internal welds on 2" outlet welds (nozzle 1) and 2" sight glass weld (nozzle 2, lower shell).
- Repair external weld on 3" overflow (nozzle 3).
- Replace 2" outlet, 2" overflow, 2" sight glass, and 3" inlet (nozzles 1, 2, 4, 5 and 6).

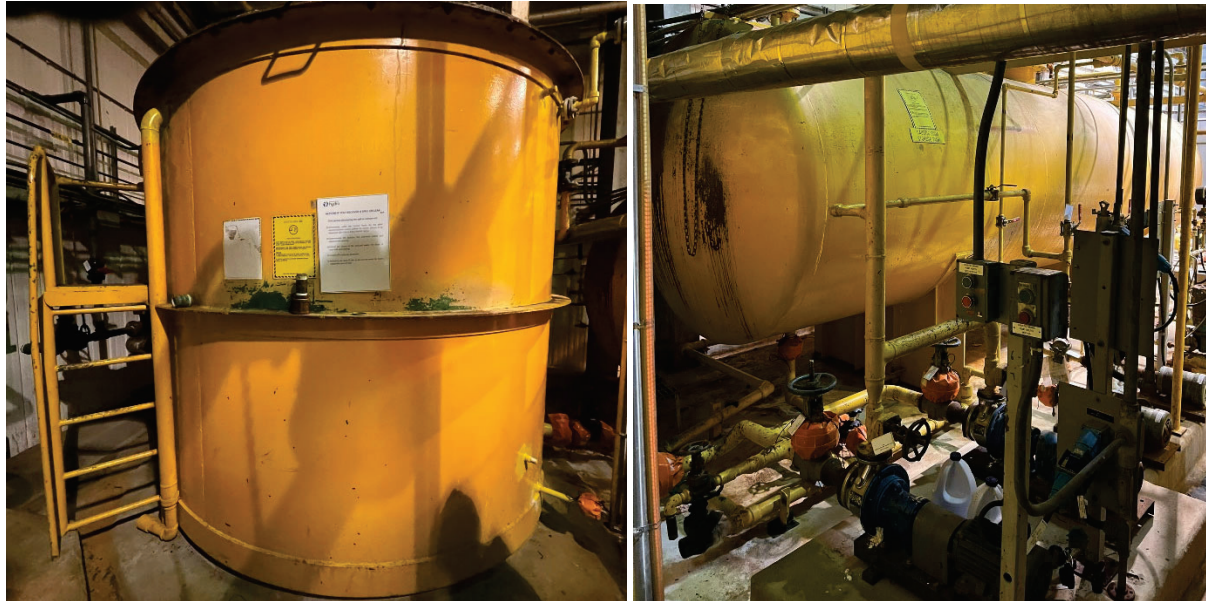
Visibility around the melting tank and associated pumps is poor due to broken or blown light fixtures.

Photos 19 & 20: Melting Tank and Transfer Pumps

- Visual Testing (VT) of the bottom-to-shell weld was completed for the entire weld around the internal and external circumference of the tank – 85" of the internal floor-to-shell was flagged for repair.
- VT of nozzles and manways: internal corrosion on 4" outlet, 1" sight glass (lower shell and top shell), 2" inlet, 1" sight glass (top shell), 3" overflow, and 2" dilution water inlet welds (nozzles 1, 2, 5, 6, 8 & 10).
- Ultrasonic Testing (UT) readings: 4" outlet, 1.25" sight glass (lower shell and top shell), 2" inlet, 3"

- Repair the 85" of floor-to-shell weld on the internal of the tank.
- 1.25" internal nozzle to be welded (high level alarm (nozzle 9)).
- Replace 4" outlet, 1" and 1.25" sight glasses (lower shell and top shell), 2" inlet, 3" overflow and 2" dilution water inlet (nozzles 1, 2, 5, 6, 8 & 10).
