Schedule 7: Capital Programs and Projects (Cont'd)

L23/L24 Tower Remediation Cost Estimate

Cost estimate for proposed structural reinforcements, repair and member replacements of steel lattice towers for the 230kV transmission lines between Churchill Falls and Wabush (L23, L23A, L24 and L24A)

**NEWFOUNDLAND AND LABRADOR HYDRO
230KV TOWERS – DEFICIENCIES ANALYSIS
OF LINES L23, L24**
Results Summary and Remedy Planning

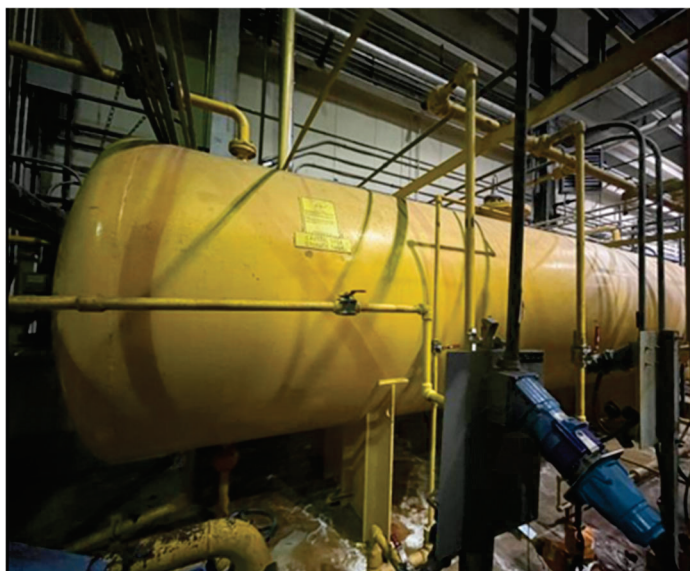
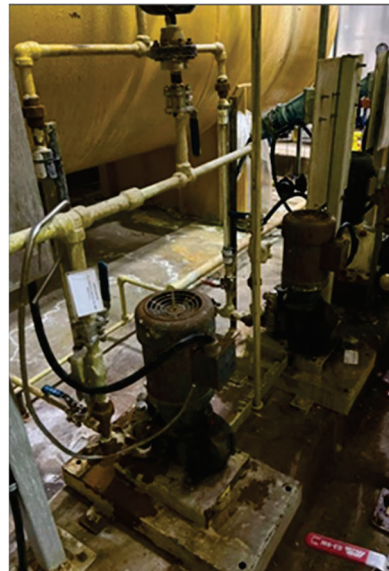
The horizontal caustic soda storage tank was inspected by Acuren inspected in 2021 while out of service. The results of the inspection are presented below, and the pumps were not included in the Acuren inspection. The pumps were observed during the site visit and no apparent issues were noted, and no known issued were mentioned.

Photos 21 & 22: Caustic Soda Storage Tank and Transfer Pumps

The inspection included the tank heads, shell, interior, support structure and nozzles. The only items that were noted for recommended repairs included:

All other components of the tank were inspected visually and underwent ultrasonic testing, and no other concerns were noted. The tank heads, shell, interior and exterior and support structure were all deemed either satisfactory or in good condition. As stated earlier, the pumps were observed during the site visit and no apparent issues were noted or provided by facility staff.

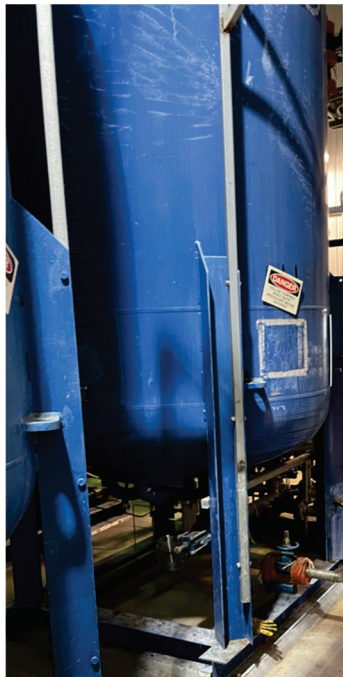
As noted for the cation tanks, the inspection and discussions with facility personnel indicated that the anion tanks appear to all be in good condition and have had minimal issues since they have been installed in 1997.

Photo 25: Anion Tank C (Cation Tank C in foreground)

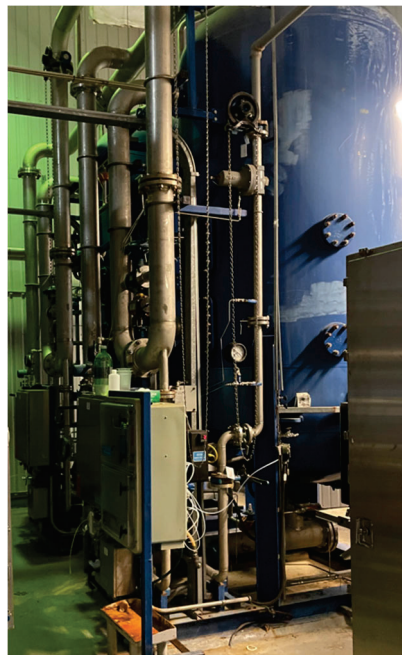
However, one issue was noted regarding the poor visibility around the mixed bed tanks due to broken/blown light fixtures.

Photo 26: Mixed Bed Tanks (Edge of control panel in foreground)

As stated previously, the three cation, anion and two mixed bed tanks were all discussed as one system during the site visit and the notes in the cation section should be referred to for this condition and proposed recommendations. As with the other six tanks, the two mixed bed tanks appear to be in good condition and minimal issues since installation.

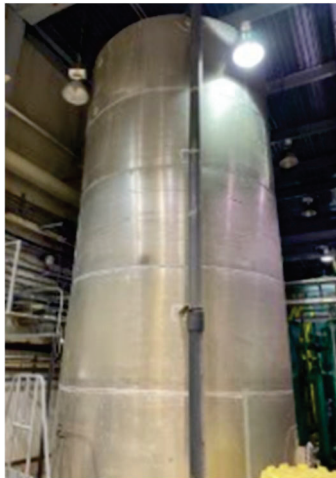
The demineralization tank is constructed of stainless steel and was fabricated in 1969. In 2002, the tank was disassembled, inspected, and then rebuilt. The tank appears to be in good condition with no leaks and no other known issues were noted during the site visit. While discussing the tank condition, a comment was made by an NL Hydro representative that tank is only welded on the outside, and not on the inside. This was noted by Acuren in a previous inspection on September 12, 2024. There have been no problems with the tank to date since it was reassembled and has been in service for over 20 years.

Photo 27: Demineralization Tank

The following is a summary of the recent inspection completed by Acuren. An internal visual inspection was completed on the tank when it was disassembled and then reconstructed inside of the process water treatment plant. The visual inspection was followed by NDE. Liquid Penetrant Testing (PT), Ultrasonic Thickness (UT), and Positive Material Identification (PMI). An external laser scan was also performed to check for plumbness and roundness. An analysis was completed to confirm the tank meets the reconstruction criteria of API 653.

Upon completion of the inspection, the results noted that welding was only completed on the outside of the tank shell, and not on the interior. Final conclusion was that the tank is "*deemed to be in overall serviceable condition*".

- construction weld defect - full penetration butt welds should have been completed during the reconstruction of the tank. During inspection it was noticed that no welding was completed on the internal side of the tank.
 - Acuren recommended an engineering fitness for service to ensure suitability for service.
- roundness analysis was completed using a laser scanner and the tank did not meet the requirements for API 653.
 - Acuren recommendation – complete an engineering fitness for service test to ensure suitability for service.

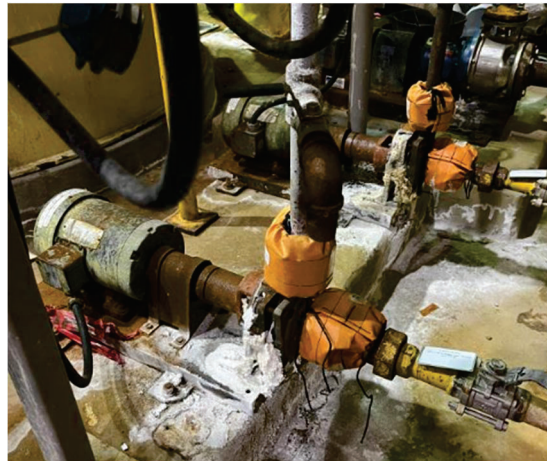
The two caustic transfer pumps serve the condensate polisher storage tanks. As shown in the photo, the existing pumps appear to be leaking (or were at some time), but according to facility staff the pumps are reliable and do not have significant issues. The pumps should be monitored on a regular basis however to ensure the leaks do not return (or increase).

Photo 30: Caustic Transfer Pumps (2)

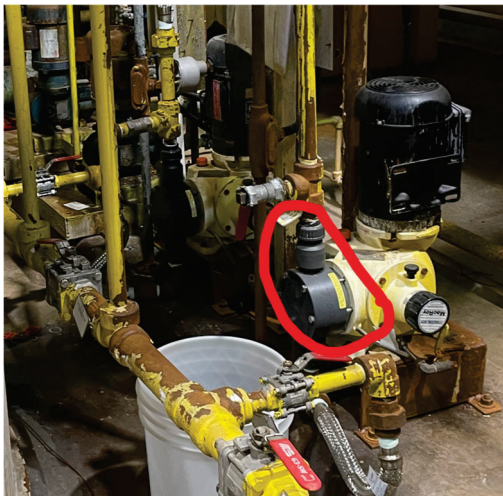
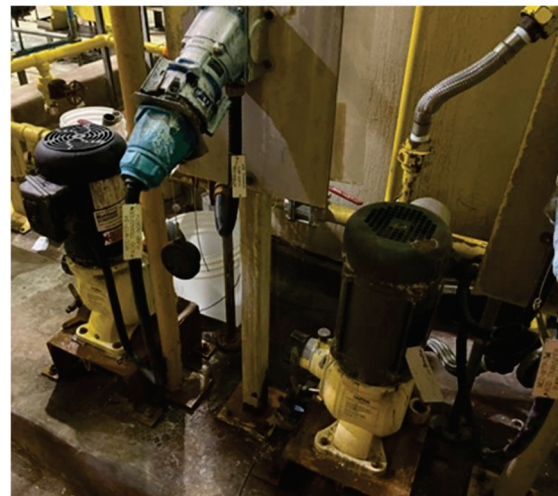
The acid transfer pumps were described as reliable and with no major issues. One concern was raised however regarding the plastic heads on the pumps. It was noted that one of these ‘exploded’ one day and if anyone had been in the area at the time it could have been serious. Measures should be considered to prevent this from happening in the future by placing guards around the pumps or replacing them with pumps with more conventional construction. On the day of the site visit, these pumps were observed and there were no apparent issues.

Photos 31 & 32: Acid Transfer Pumps (2)

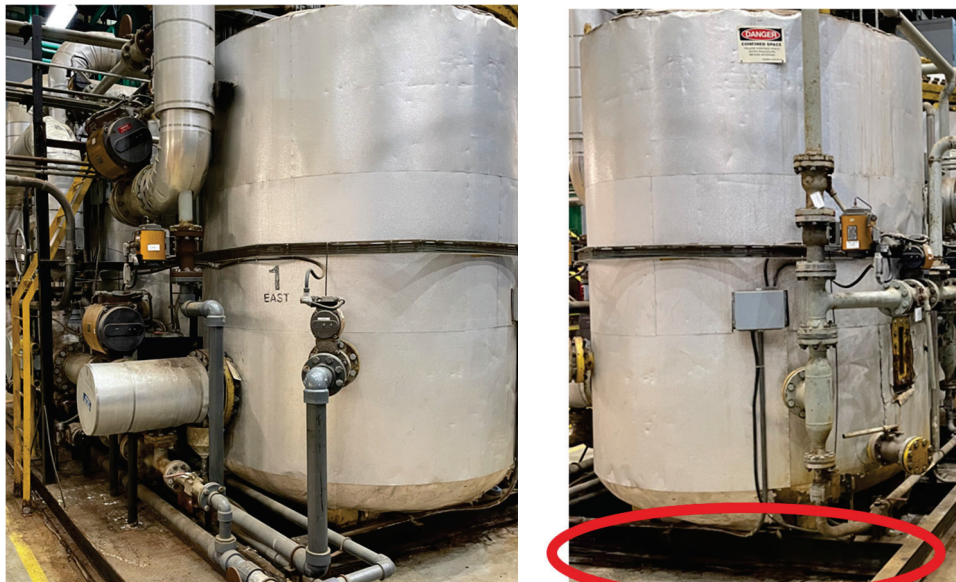
The unit 1 condensate polishers were confirmed to be original equipment and could not be inspected visually as they are insulated. It is unclear why the units are insulated, and this may not be required, and it is assumed that these units are reaching the end of their expected service life. The resin is approximately 10 years old, and replacement should also be considered as this is a common industry standard for resin replacement.

Photos 33 & 34A: Unit 1 Condensate Polishers

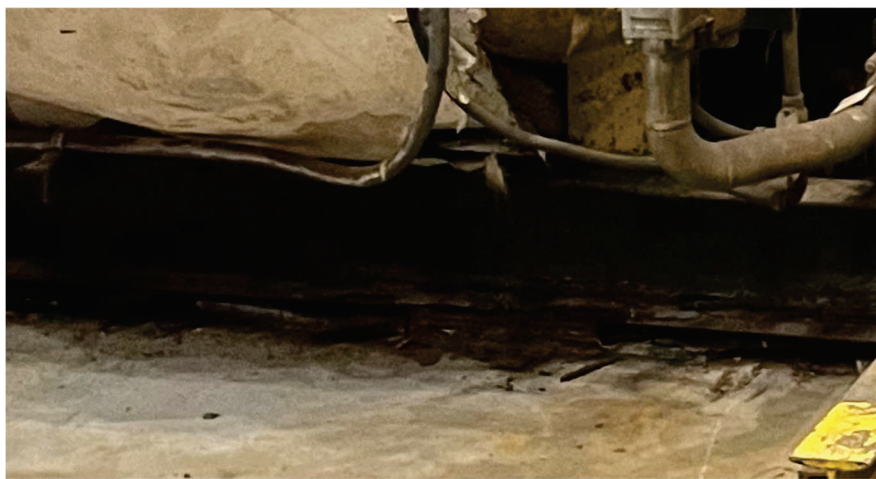
There is severe corrosion on some of the support beams for the polishers as shown in the second photo below. To replace these would be difficult if the polishers remained in service but the structure could possibly be reinforced.

Photo 34B: Unit 1 Polisher Corrosion on Structural Supports

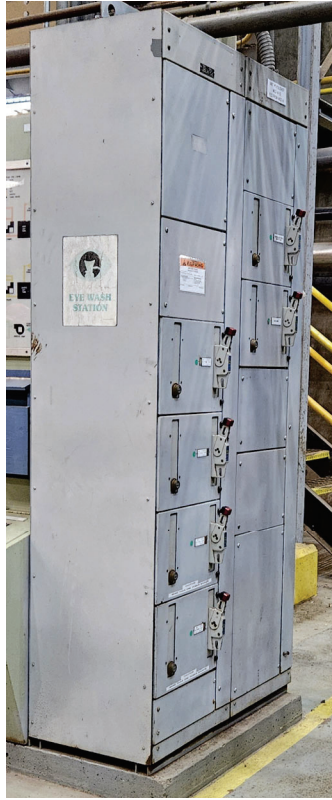
Unit #1 Polisher MCC-A1-3 is antiquated and has outdated arc flash labels.

Photo 34C: Unit 1 MCC

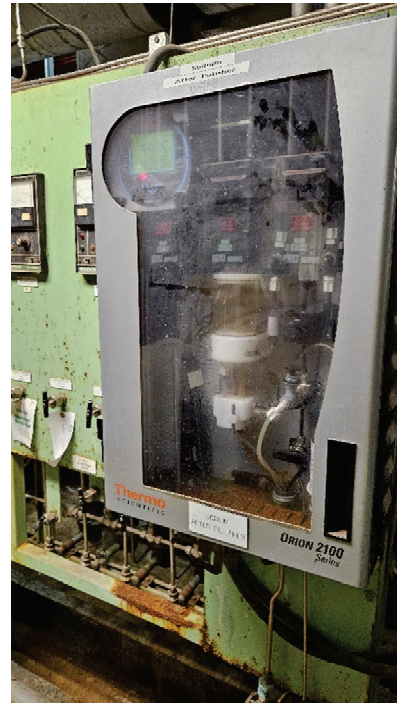
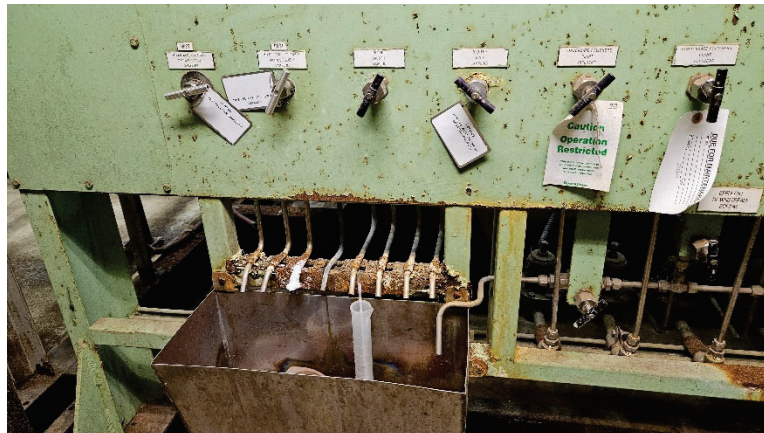
The sampling station is original equipment. The Beckman conductivity meters are not in use any longer. The sampling valves look to be in reasonable condition, a few look to be new, however the sampling tubes and tube support are heavily corroded. The sodium after polisher looks new but the bottom of the enclosure seems to be corroding.

Photos 34D, 34E & 34F: Unit 1 Sampling Station and Sodium after Polisher

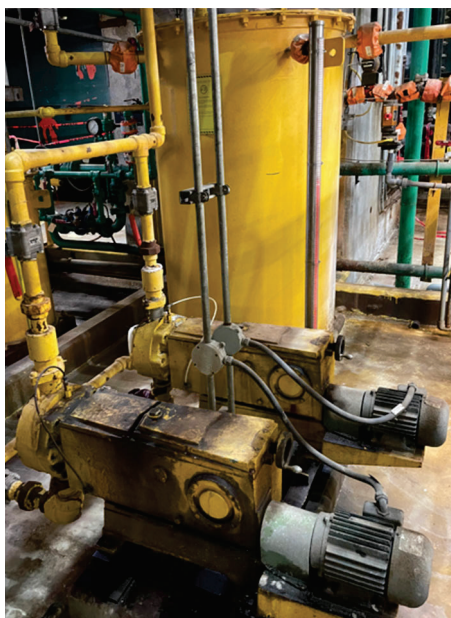
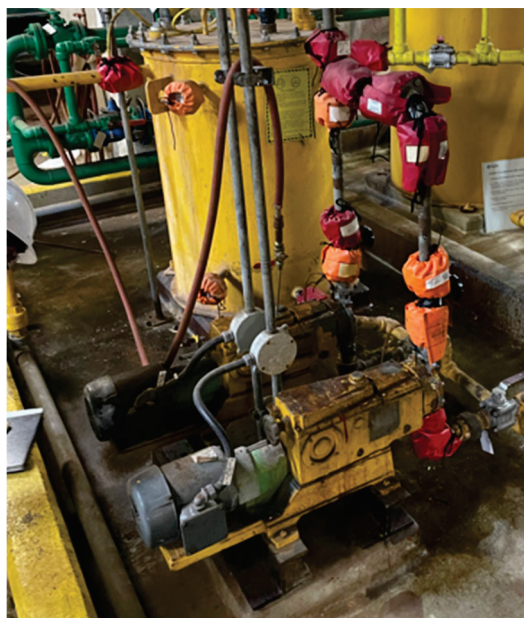
It was also noted that the coating on the tanks was beginning to breakdown, but the corrosion on the exterior of the tank was not considered significant and the average shell thickness confirmed the level of corrosion was not excessive.

Photo 35A & 35B: Unit 1 Caustic Transfer Pumps and Day Tank (left) and Acid Transfer Pumps and Day Tank (right)

- Caustic Day Tank: Shell & Nozzles - no corrosion issues found.
- Acid Day Tank:
 - Shell: no corrosion issues found
 - Nozzle: nozzle 5 was installed as Schedule 40.

Although the nozzle was installed as Schedule 40, the measured thickness of 0.118" is still above the 0.100" minimum required, so there are no issues.

The caustic pumps for Unit 1 are designed to run one pump at a time. Both pumps appear to be in poor condition, but the redundancy means if one pump requires refurbishment, the other can still serve the system.

The acid transfer pumps are set up in the same operating sequence and thus have redundancy should one of the pumps experience issues. These pumps also appear to be in poor condition.

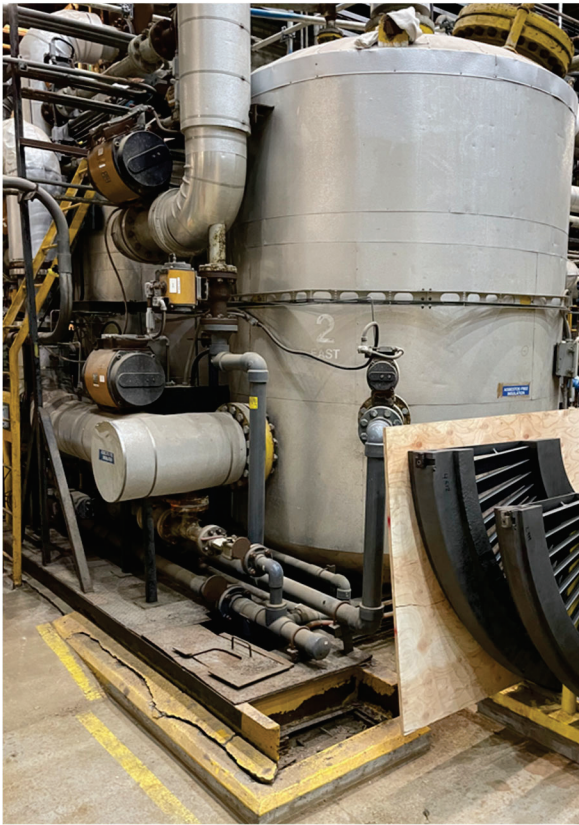
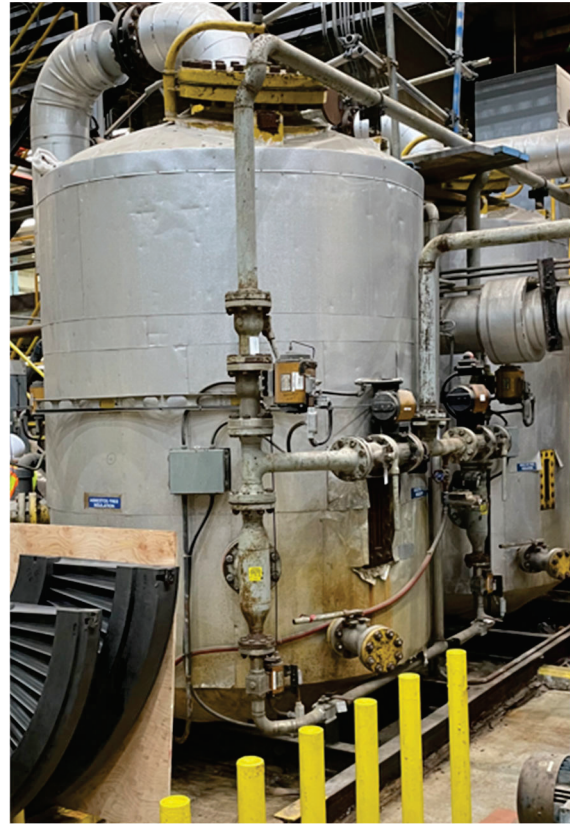
Similar to Unit 1, Unit 2 condensate polishers include all original equipment, they are insulated, and the polishers could not be inspected directly. The same assumption applies with respect to the equipment reaching the end of its service life expectancy. The resin was also confirmed to be approximately 10 years old in this unit and should be considered for replacement.

Photos 37 & 38: Unit 2 Condensate Polishers (see deteriorating supports)

The visual inspection of Unit 2 revealed severe corrosion of the beams under the polishers with some of the webs corroded through. In one area, one of the pipes appears to be cracking at the flange as the unit has dropped due to lack of support and is pulling the pipe down as well. To replace these beams would be difficult if the polishers remained in service but with this unit shifting it may be necessary to prevent the piping from breaking at the flange. See photo below.

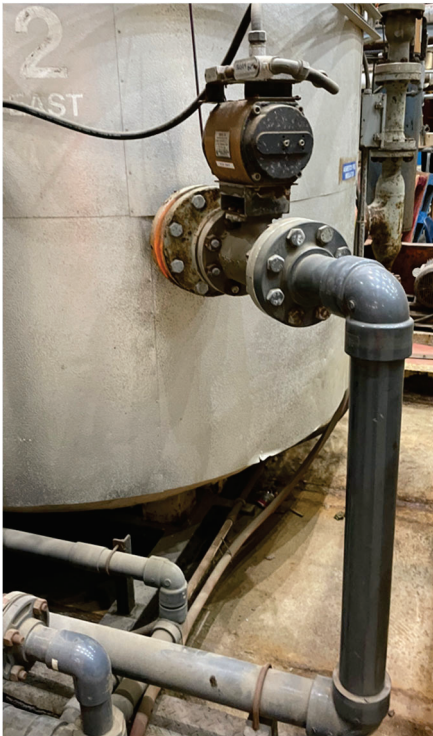
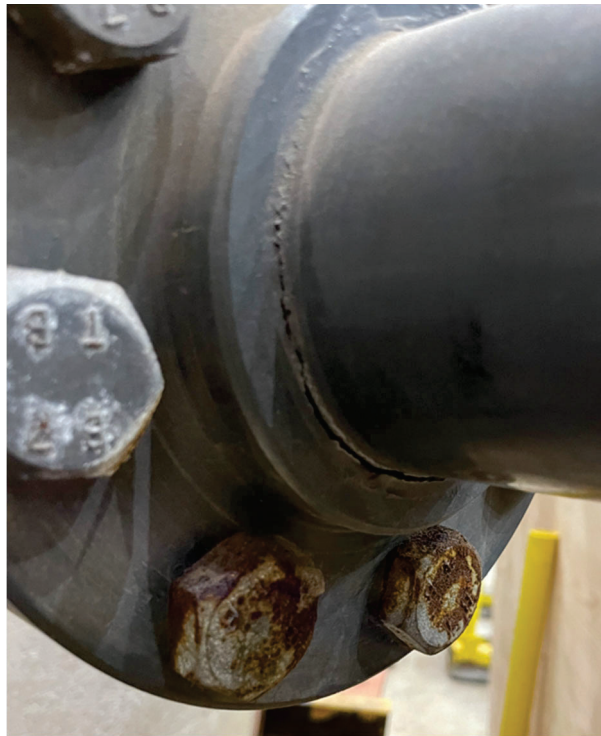
Photos 39A & 39B: Unit 2 Piping Starting to Separate due to Polishers Dropping

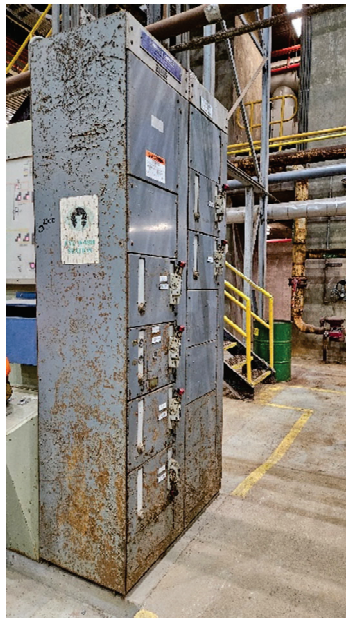
Unit #2 Polisher MCC-B1-3 is antiquated and has outdated arc flash labels and has some surface corrosion.

Photo 40A: Unit 2 MCC

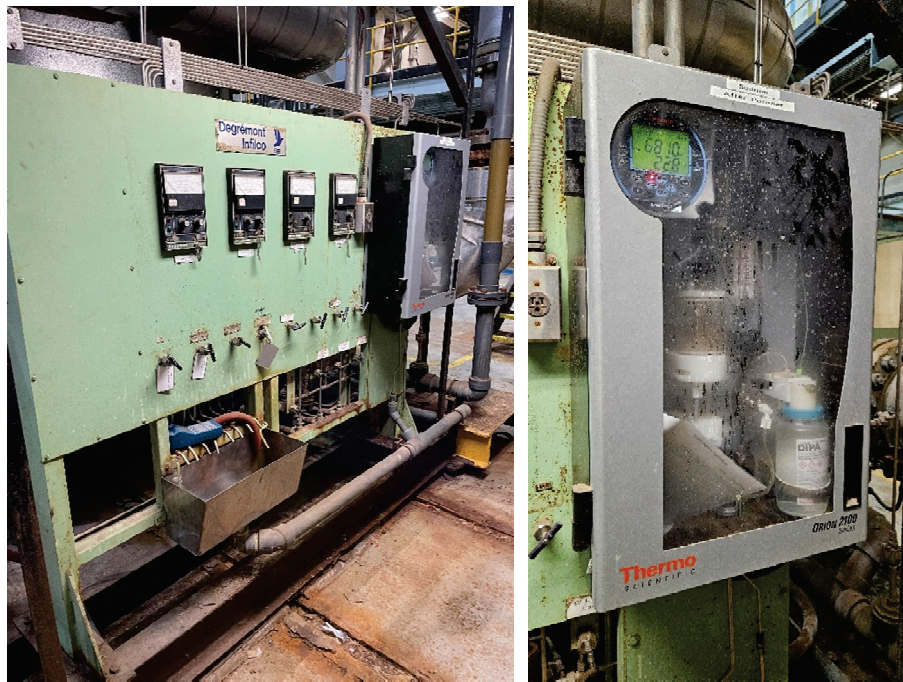
The sampling station is original equipment. The conductivity meters do not seem to be in use any longer. Most of the sampling valves look to be in reasonable condition, the diluted acid sampling valve is heavily corroded and the panel around where the valve is mounted has corroded away. The sampling tubes, tube support, and panel is corroding. The sodium after polisher looks new and in good condition.

Photos 40B, 40C, & 40D: Unit 2 Sampling Station and Sodium After Polisher

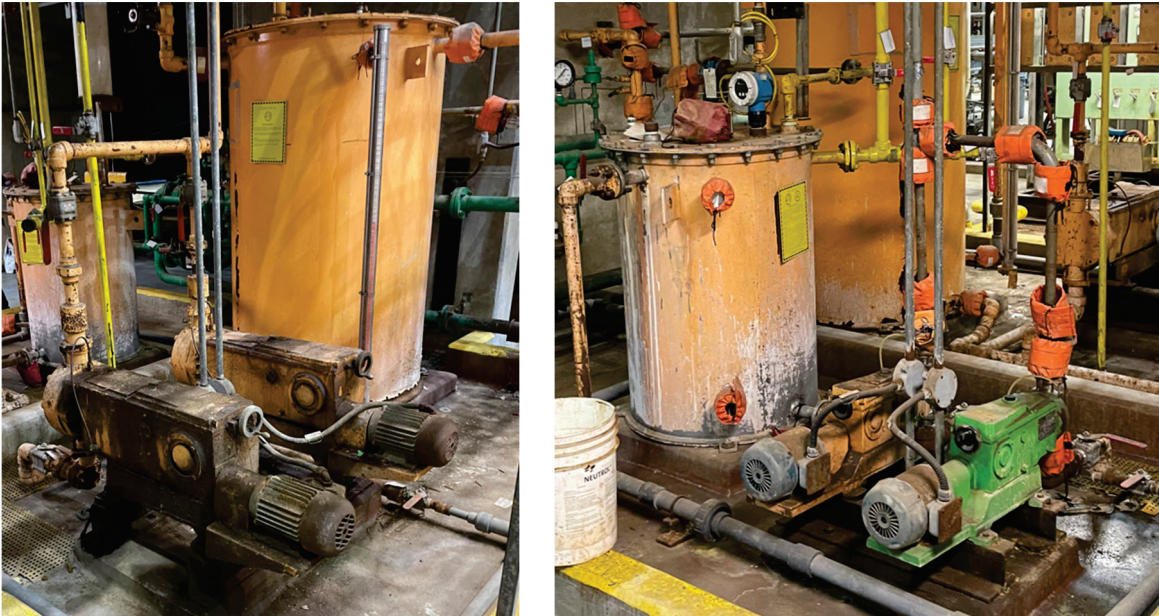
Photo 41 & 42: Unit 2 Caustic Transfer Pumps and Day Tank (left) and Acid Transfer Pumps and Day Tank (right)

The caustic and acid transfer pumps are setup for redundancy as only one of each set runs at a time. The pumps all appear to be in poor condition and one of the acid pumps has been repaired three times in recent years and this pump as a minimum should be considered for replacement.

The tank shells far exceeded the minimum required thickness (MRT) as per API 653, and nozzles were also within the recommended MRT. It was noted that the coating on the tanks was beginning to breakdown, but the corrosion on the exterior of the tank was not considered significant and the average shell thickness confirmed the level of corrosion was not excessive.

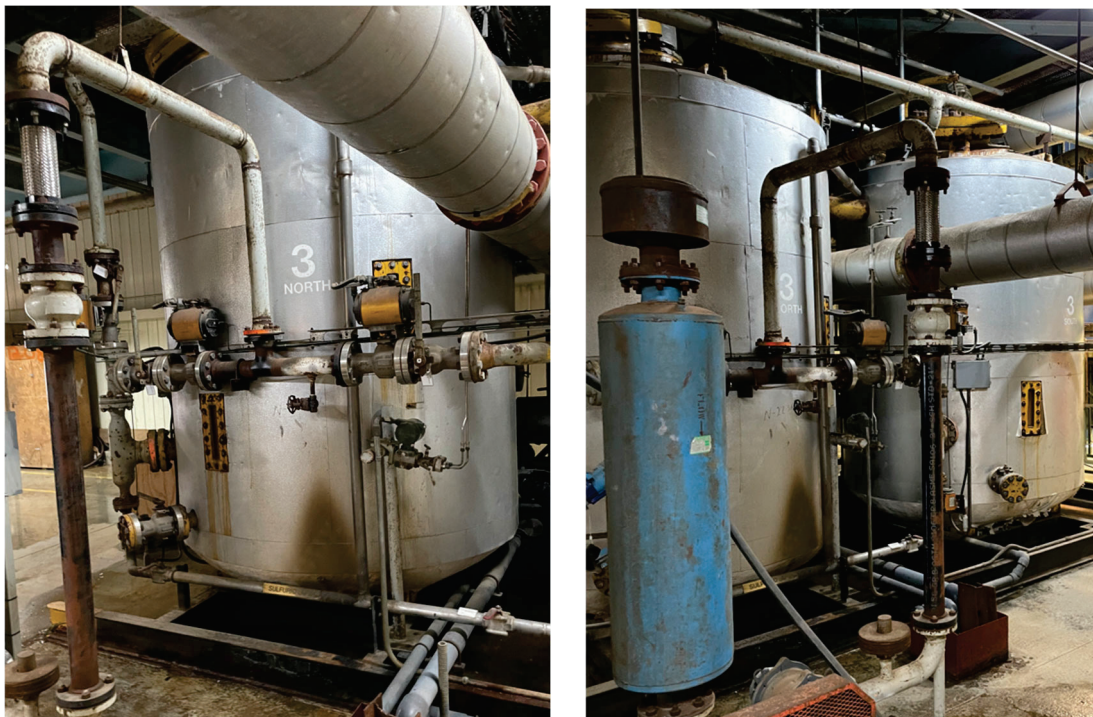
The unit 3 condensate polishers are also the original equipment and are insulated. Again, the equipment could not be inspected directly but it is assumed to be reaching the end of its expected service life as it has been in operation for over 50 years since it is original to the building construction. The resin is about 10 years old which is due for replacement based on industry standard recommendations for 10 year replacement.

In discussions with on-site personnel, it was stated that the flow meters for unit 3 have frozen occasionally since they are close to the exterior wall and the overhead door is sometimes left open in the winter. This sometimes causes false readings which affects the actuated valves they control, and they do not open/close as required. These large valves are noted to be very difficult to open/close manually when automation issues occur. Overall, a comment was made that the 'system is just very old'.

Photos 43A & 43B: Unit 3 Condensate Polishers

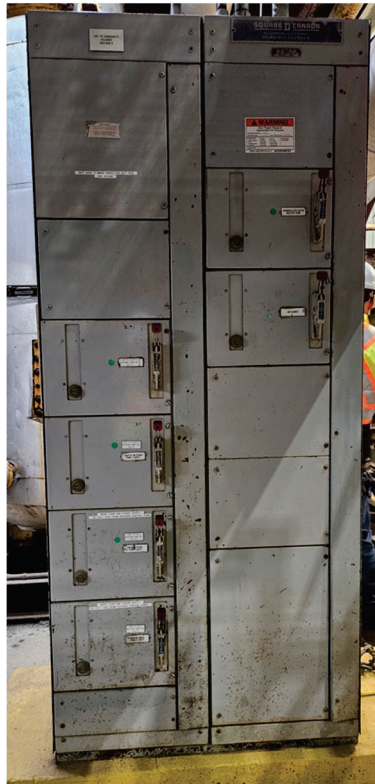
Photo 44A: Unit 3 MCC

Unit #3 Polisher MCC-BAB-3 is antiquated and has outdated arc flash labels and has small amounts of surface corrosion.

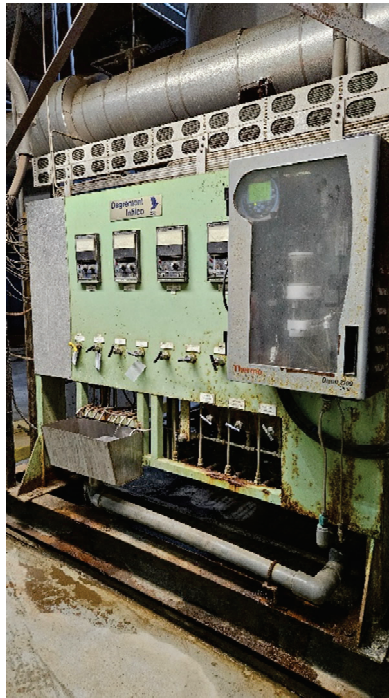
Photo 44B: Unit 3 Sampling Station

The sampling station is original equipment. The conductivity meters do not seem to be in use any longer. The sampling valves look to be in reasonable condition, the sampling tubes look adequate, and the tube support area and panel front is corroding. The sodium after polisher looks new but the enclosure has some minor surface corrosion.

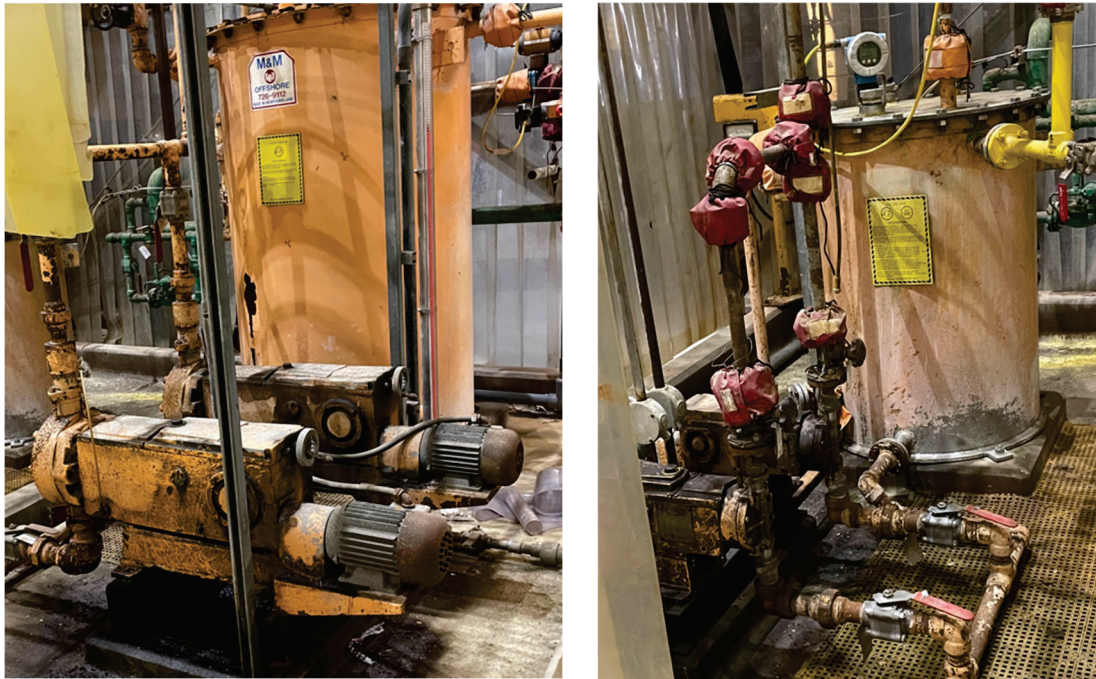
The tank shell thickness measurements exceed the minimum required thickness (MRT) as per API 653, and nozzles were also within the recommended MRT. The tank coatings were also evaluated and were noted as beginning to breakdown, but the corrosion on the exterior of the tank was not considered significant based on the average shell thickness recorded.

Photos 45A & 45B: Unit 3 Caustic Transfer Pumps and Day Tank (left) and Acid Transfer Pumps and Day Tank (right)

The caustic and acid transfer pumps are setup for redundancy as only one of each set runs at a time. The pumps all appear to be in poor condition.

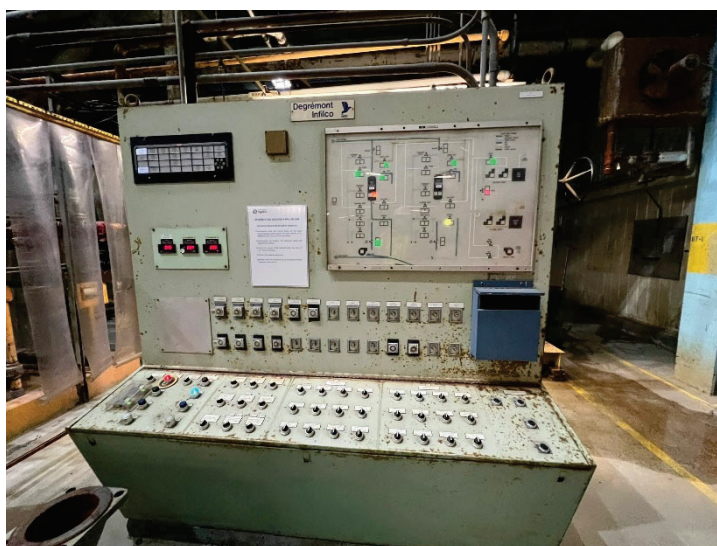
Photo 46: Unit 3 Control Panel

The control panel is original equipment and has exceeded its lifespan. The panel is located near an exterior door which gets left open, causing snow and water buildup on the panel during days of poor weather. This has caused the panel to deteriorate and corrode resulting in the panel to not operate properly. The auto control no longer works so control is done manually which is tedious and raises safety concerns. The level alarms are no longer received and need to be checked manually, and the pneumatic tubing freezes up due to moisture in the air and cold temperatures when the door gets left open. Most of the lights on the mimic screen have blown as the “push to test” button no longer illuminates the lights.

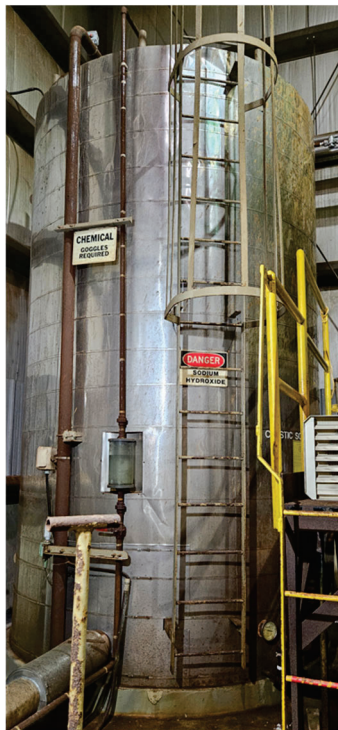
Photo 47: WWTP Caustic Tank

An internal and external out-of-service inspection of this caustic tank was previously completed in August 2021.

These repairs were completed in 2021 prior to returning the tank to service, so the tank is deemed to be fit to remain in service. From the latest onsite inspection, there are no apparent issues after inspecting the caustic tank.

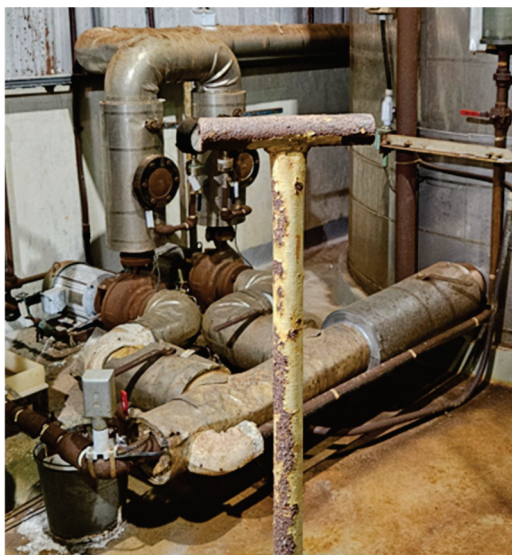
Photo 48: Caustic Transfer Pumps (2)

The two caustic transfer pumps are approximately 30 years old and during the site inspection it was mentioned that these were not used for the last 15 years. More information was provided from the facility personnel since the site visit and confirmed that the pumps were used to transfer caustic from the WWTP back to the water treatment plant. The site person has only witnessed these pumps in operation once in the past 25 years (this was about 12 years ago). However, they tried to use them within the past five years, and they appear to be seized.

The disconnect switches for the pumps have no visible arc flash labels.

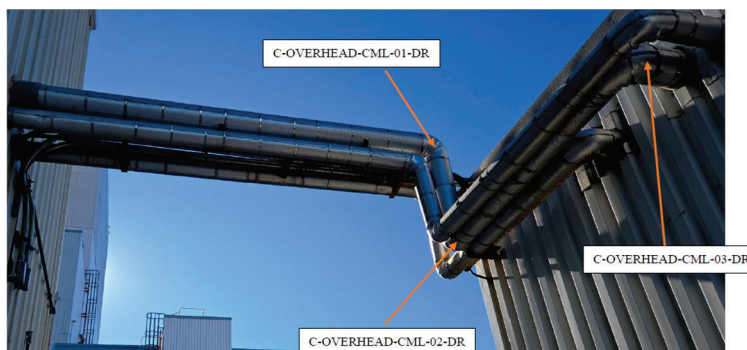
Photo 49: Overhead Caustic Piping (Exterior)

The WWTP piping was recently inspected by Acuren on November 8, 2024. The piping between Pumphouse 1 and the WWTP is shown in the photo below labelled as 'Overhead', and the piping in the Utilidor is also shown in the photos.

- Utilidor piping – 38.7% wall thickness loss UTILIDOR CML No. 1 & 3 but still has a calculated remaining useful life (RUL) of 31.9 years.
- Overhead piping - weld erosion noted on 3" line but wall thickness still above the nominal thickness.

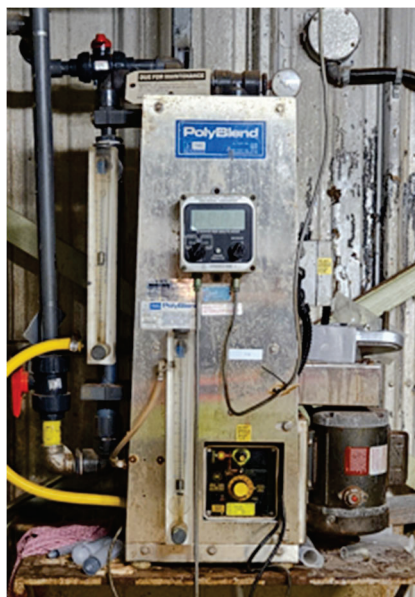
Photo 52: Polymer Pump

The polymer pump observed on site and facility personnel did not note any issues with the pump. There is only one pump for this system so any issues in operation should be addressed immediately and preventative maintenance should be completed in accordance with manufacturer's recommendations to ensure the system is ready for use whenever needed.

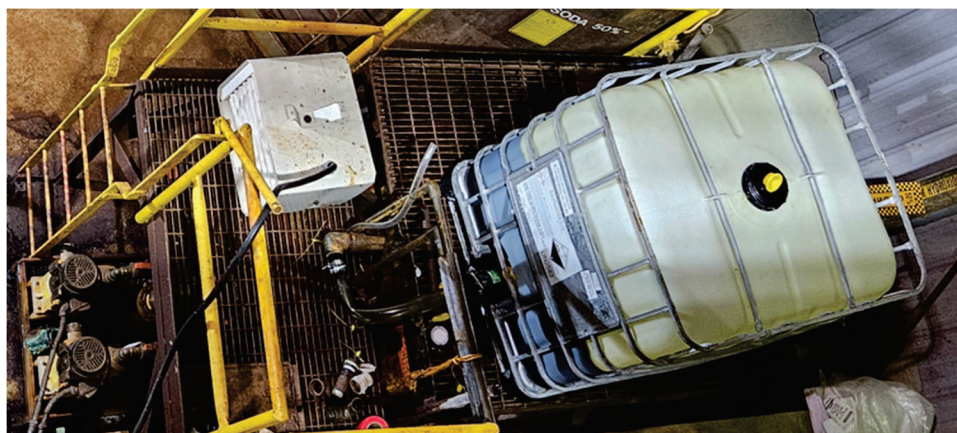
Photo 53: Ferric Chloride Pumps (2) and Tote

The two ferric chloride pumps appear to be the original pumps to the building and seem to be in fair to poor condition. No issues were noted on site and there is redundancy which allows for repair or replacement of a pump which has failed. With the age of the equipment and observed condition, the operation of the pumps should be checked and maintained regularly in accordance with manufacturer's recommendations to ensure no interruptions to operations or processes for the plant.

The disconnect switches for the pumps have no visible arc flash labels.

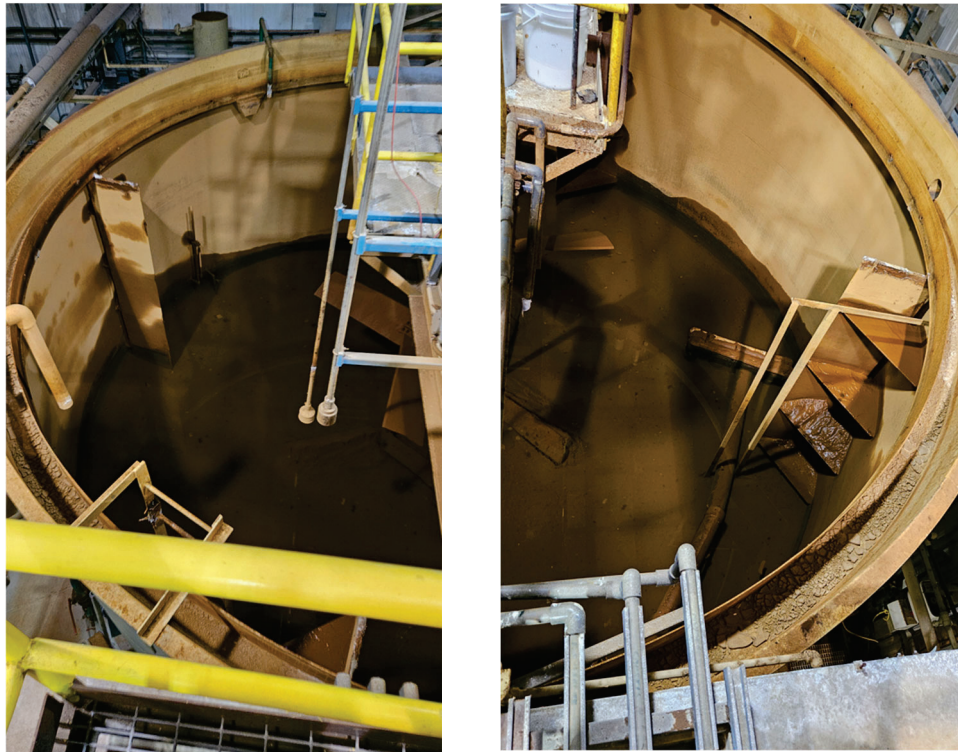
Photos 54 & 55: Batch Reactor

During the site visit it was mentioned that the batch reactor does not have many issues, and it is a relatively simple process. Caustic soda is added to the batch tank to increase the pH to 8. The acid precipitates the metals and when the agitator is turned off, they settle to the bottom, and then the clean water is pumped out. The sludge at the bottom of the reactor is then pumped to the filter press, and into dumpsters. The dumpsters are then taken to the landfill where it will eventually be picked up again and then retreated again. NL Hydro plans to have a full inspection of the reactor under the upcoming 2026-2027 project, which will include internal inspection to measure shell thickness. This should be fine as it was stated by facility staff that there are no issues with the reactor.

It was noted during the site visit that some of the light fixtures above the batch reactor have blown and the lighting in the area is poor. The locations of these light fixtures are not easily accessible and therefore maintenance of the fixtures is left undone.

The agitator disconnect switch has no visible arc flash label and the termination junction box on the motor has corrosion.

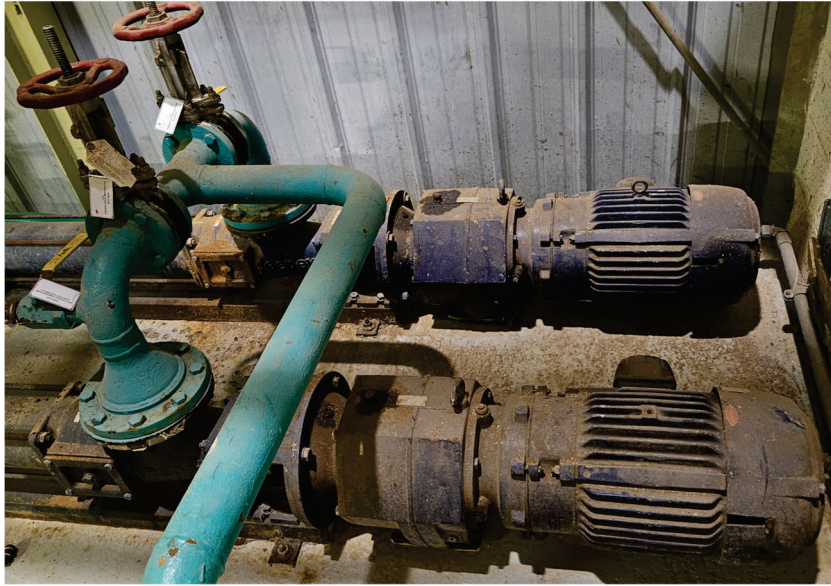
Photo 56: Sludge Pumps

The two sludge pumps appear to be original, but it was confirmed with site personnel that there are no issues with them. They are showing some moderate corrosion on the pump casings, but the redundancy allows for one pump to be repaired or replaced while the other can maintain service. Due to the age of the pumps and the environment in which they operate, operation should be monitored during preventative maintenance as per manufacturer's recommendations ensure any issues are identified early.

The disconnect switches for the pumps have no visible arc flash labels.

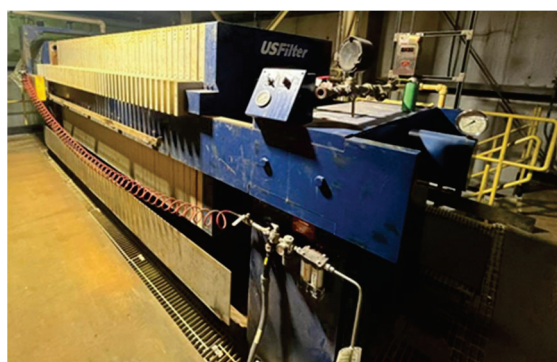
Photo 59: Filter Press

The filter press was confirmed to be working well with minimal issues and the visual inspection did not reveal any issues of concern. The only minor issue reported is that the rubber seals occasionally need to be replaced, but this can be done by maintenance on site.

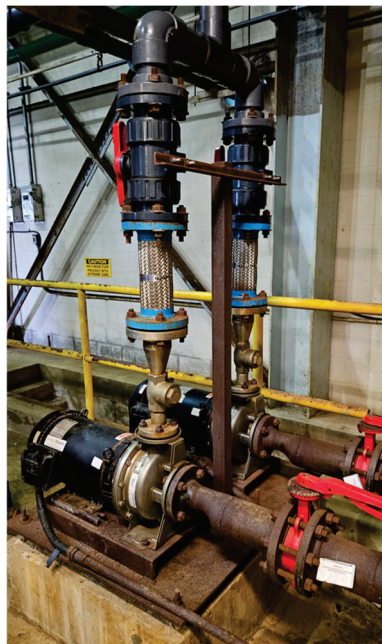
Photo 61: Pumps 8A/8B

Pumps 8A and 8B are located in Pumphouse 1 and they pump to the raw water sump and firewater system.

During the inspection, these pumps were noted as previously being 'problematic', but after the addition of the recirculation line, it is now working fine.

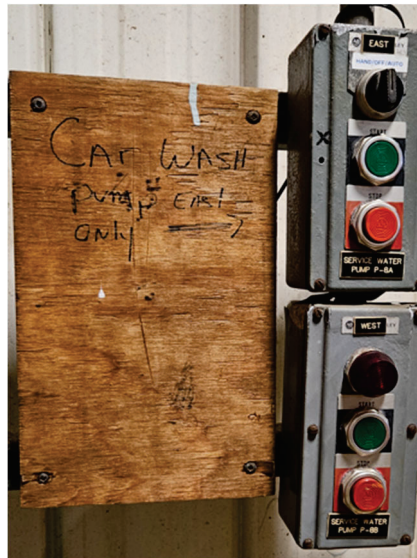
Photo 62: 'Makeshift' Control Panel for Pumps 8A/8B

However, another addition to the system which has caused some issues recently is the 'makeshift' car wash supply and raw water / fire water control panel. The control panel has "P-8A" and "P-8B" start and stop buttons and sometimes the wrong button is pushed which causes issues. "P-8A" is for the car wash but the timer no longer works so if the operator forgets to come back into the building and turn the pump off it will run continuously. "P-8B" is sometimes pushed by mistake when they want to use the car wash, and this switch has no timer and will run until someone turns it off. If the timer on the car wash pump worked, then this would fix the problem (providing people only turn on the car wash pump as required).

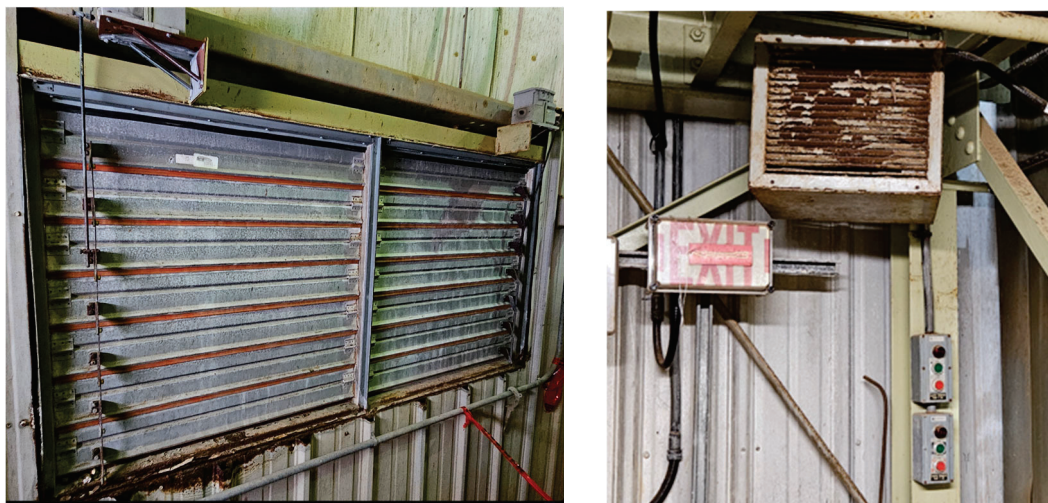
Photos 63 & 64: Existing Air Intake Louvre and Typical Unit Heater

- Three (3) rooftop exhaust fans (originally there was only 1)
- Two (2) louvres on the lower level
- Several electric unit heaters through the building

At the time of the site visit, it was not confirmed that the controls for the louvres were working as it was not clear where the signal came from, but it assumed to be linked to the exhaust fans (ie. louvres to open on a start signal from the fans). The louvres were in fair to poor condition but whether they automatically open and close through the control system is not confirmed.

As mentioned earlier, the duct heaters have built-in thermostats, but these do not work so they do not shut off and run continuously. With the cold inside temperatures in the winter many of these unit heaters would not shut down even if the thermostats were working. Unit heaters have various levels of corrosion. Cable is strung in a haphazard way, looped around handrails to power a unit heater that is sitting on a catwalk near the caustic tank.

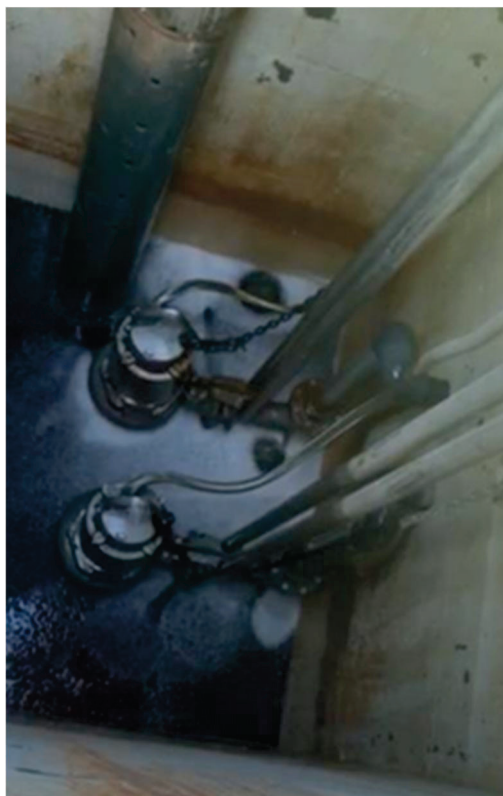
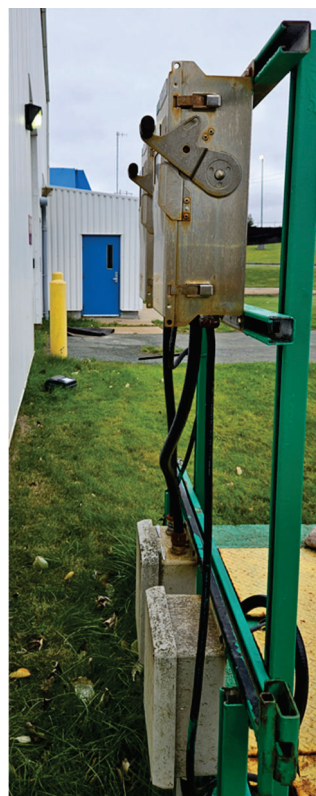
Photos 66 & 67: Pumps 5A/5B and Associated Electrical Equipment

These pumps transfer sludge from clarifier blow down and sand filter backwashes and discharge to the continuous basin for treatment.

These pumps are located in the well near the entrance to the main powerhouse, under the yellow checker plate covers shown in the photo above. The pumps are setup in a lead/lag setup and controlled by the water level inside the sump. One pump will start up as the lower cut-in water level is reached and if the water keeps rising and reached the second setpoint level then the second pump will start up. It was stated during the site visit that there were no issues with the pump operation and there was nothing noted from the visual inspection.

The disconnect switches for the pumps have no visible arc flash labels, and the junction boxes and cable connectors have varying degrees of corrosion.

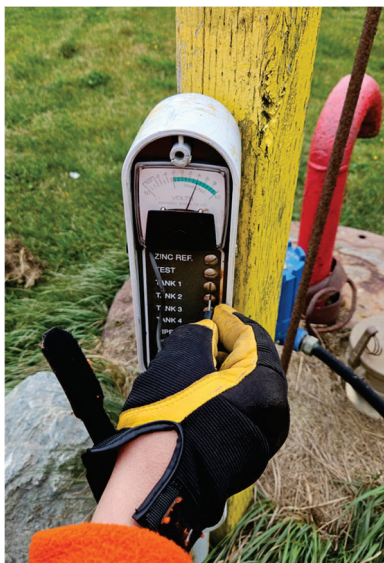
Photo 70: OWS No.2 Cathodic Protection Test

During the site visit, the cathodic protection for OWS No.2 was tested and it appears to be working. Functionality of the cathodic protection test meters needs to be verified if steel tank is to be kept in service. It was confirmed from facility personnel after the site visit that cathodic protection tests are completed monthly on OWS No.1 and No.2, and results are logged in a spreadsheet. They also stated readings are generally good, but sometimes during high levels of precipitation the results are affected slightly.

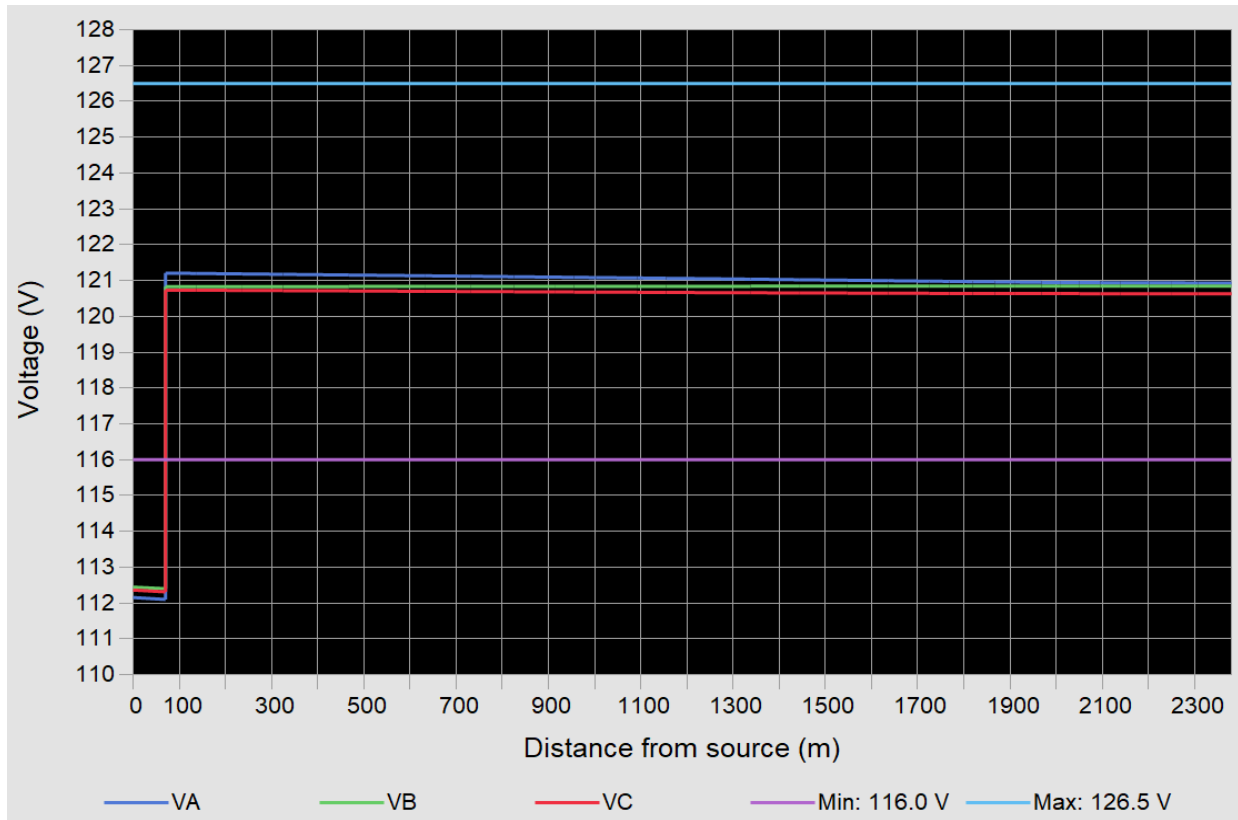
Figure 4: WDL-L1 Voltage Profile with Voltage Regulators

17 To address the low voltage issue, the installation of voltage regulators is required. This work involves the
18 installation of a set of 100-amp (A) voltage regulators at the start of WDL-L1. Figure 4 illustrates the
19 voltage profile of WDL-L1 following the installation of voltage regulators. As shown, the voltage levels
20 remain above the minimum required threshold of 116 V.⁸

⁸ Please note there are no customers within the first few meters of the distribution system before the proposed location of the voltage regulators, contributing to voltage values on the graph below Hydro’s normal low-voltage planning criteria.
