Schedule 7: Capital Programs and Projects (Cont'd)

L23/L24 Tower Remediation Cost Estimate

Cost estimate for proposed structural reinforcements, repair and member replacements of steel lattice towers for the 230kV transmission lines between Churchill Falls and Wabush (L23, L23A, L24 and L24A)

**NEWFOUNDLAND AND LABRADOR HYDRO
230KV TOWERS – DEFICIENCIES ANALYSIS
OF LINES L23, L24**
Results Summary and Remedy Planning

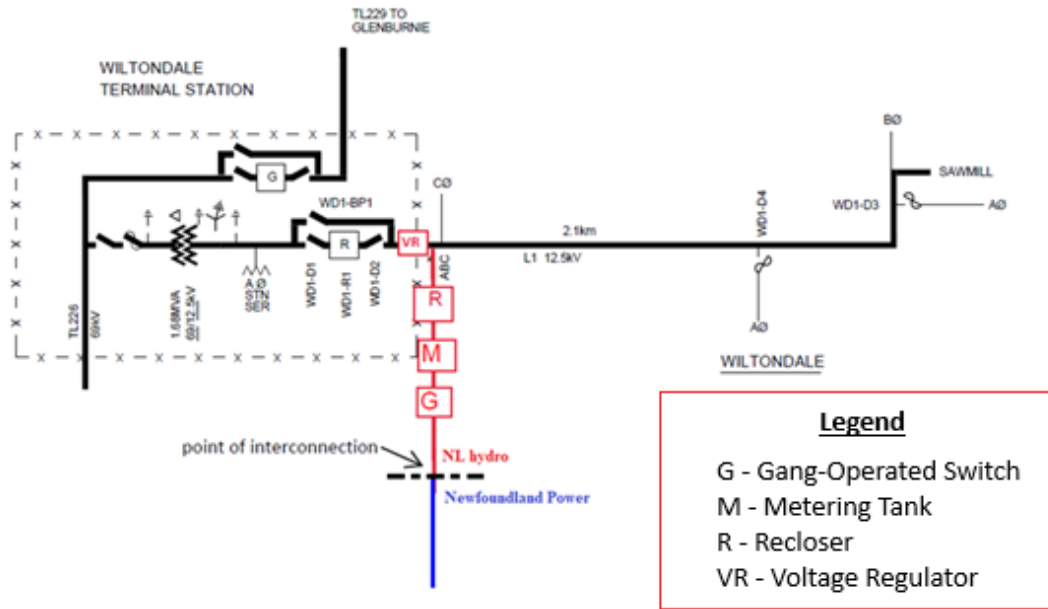
Figure 5: Single-Line Diagram with Point of Interconnection

- 1 The point of interconnection is identified in the single-line diagram in Figure 5. The voltage regulators
- 2 will be installed downstream of the existing recloser WD1-R1. This project will involve the construction
- 3 of a three-phase tap downstream of the new voltage regulators to the interconnection point,
- 4 incorporating a recloser, a metering tank and a gang-operated switch.

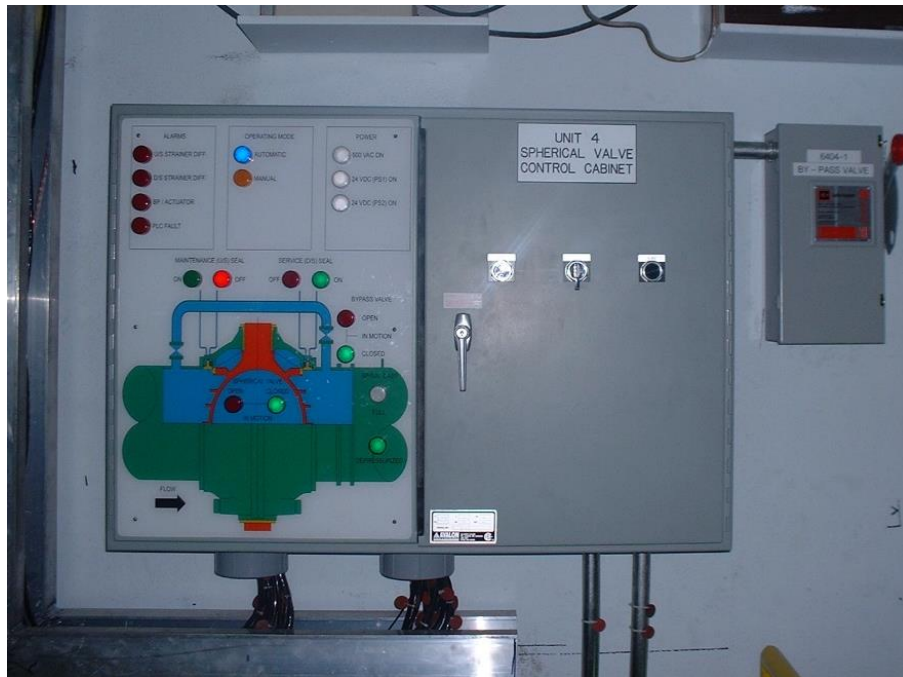
Figure 1: Spherical Valve Control Panel Exterior

- 1 spherical valve auxiliary field devices. Figure 1 and Figure 2 show the exterior and interior of the
- 2 spherical valve control panel, respectively.

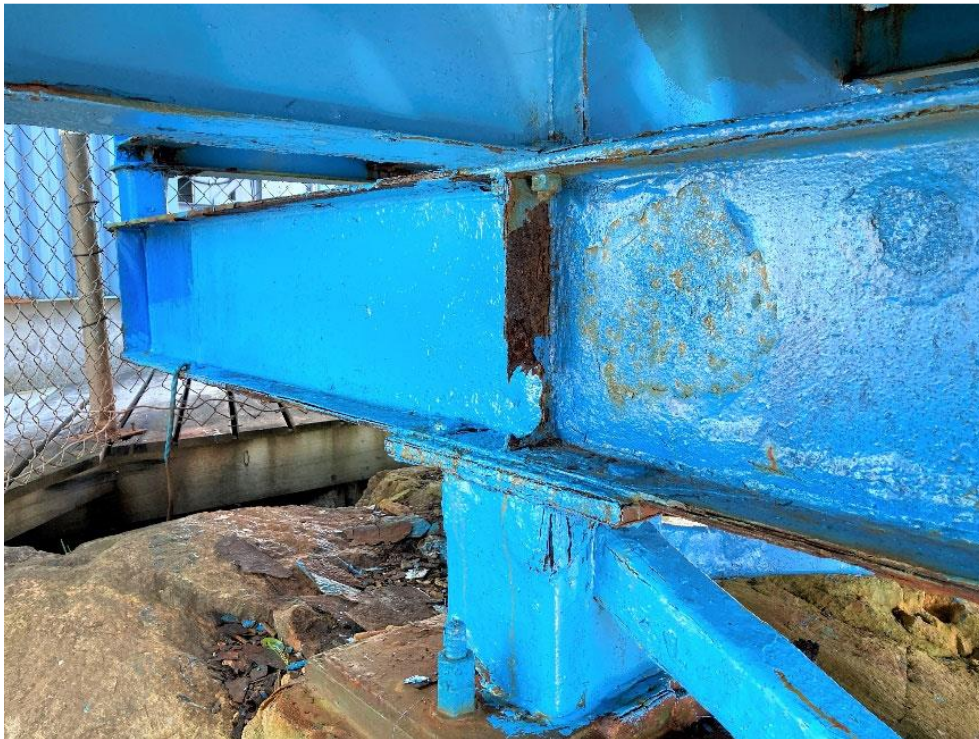
Figure 2: Corrosion through Stiffener on Main Support Beam

7 The existing bulk fuel storage tank’s steel support structure has deteriorated to the point at which its
8 structural integrity has been compromised, as further evidenced in Attachment 1. The support beams
9 show signs of corrosion and wear, and members have experienced significant section loss, as can be
10 seen in Figure 2 and Figure 3.

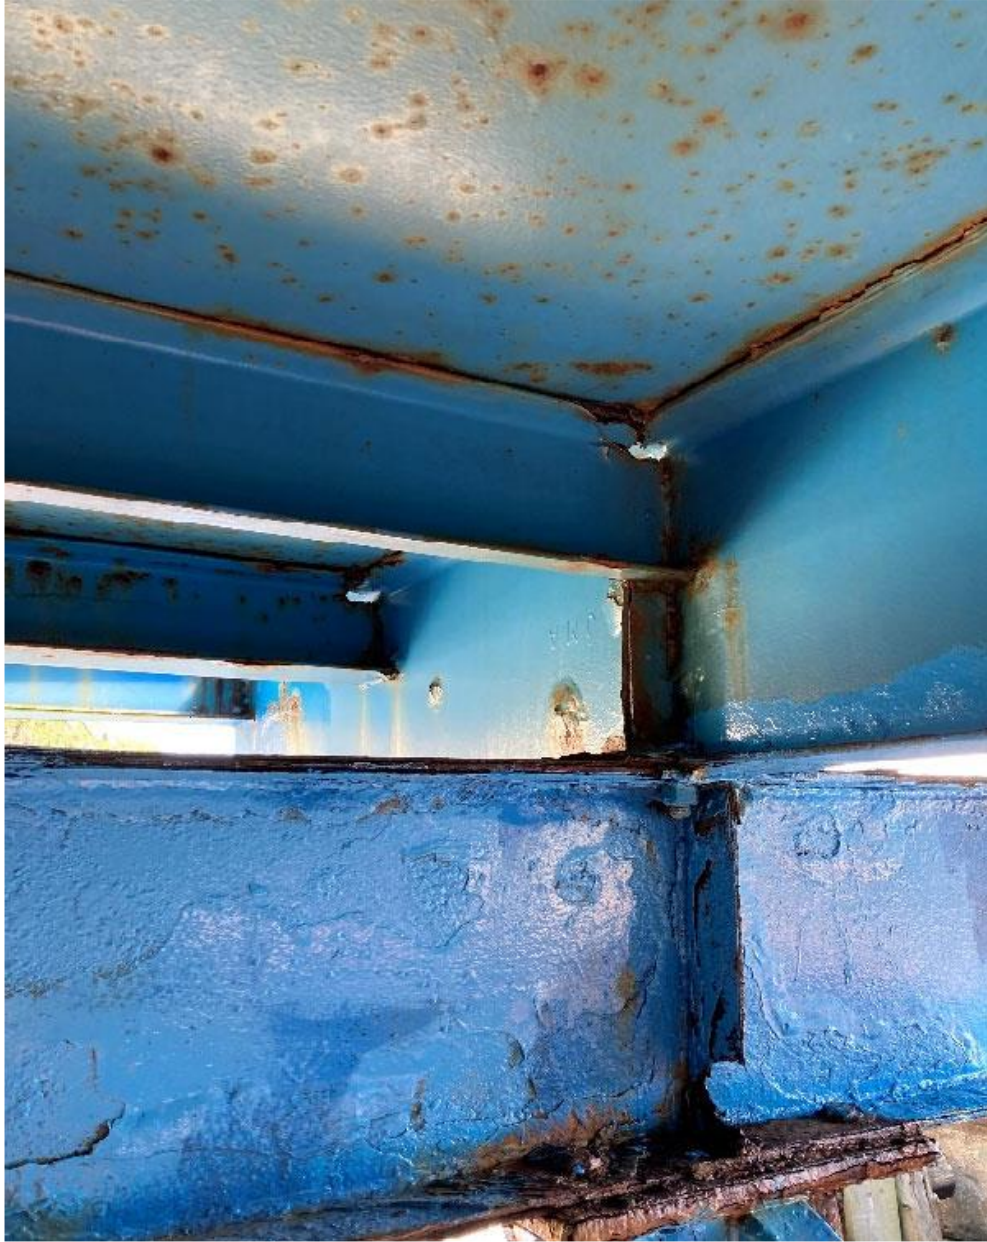
Figure 3: Corrosion of Beams and Connections

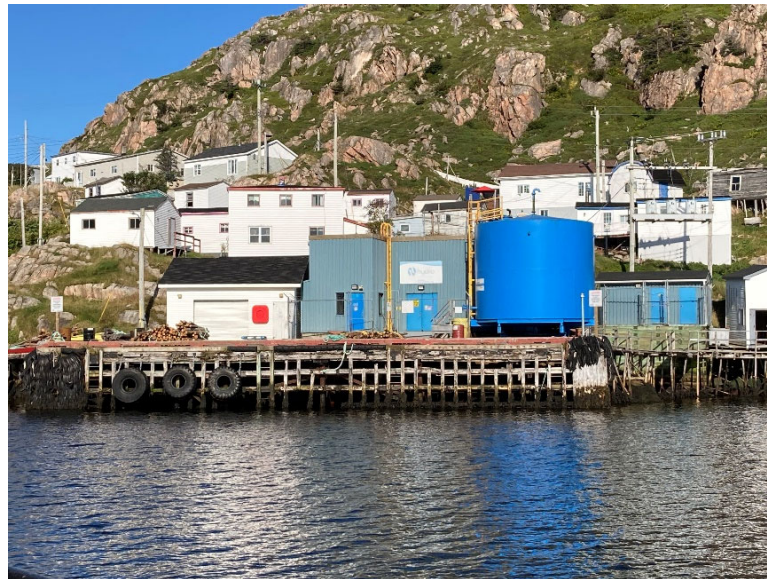
Photo 1: View of existing tank located behind the wharf

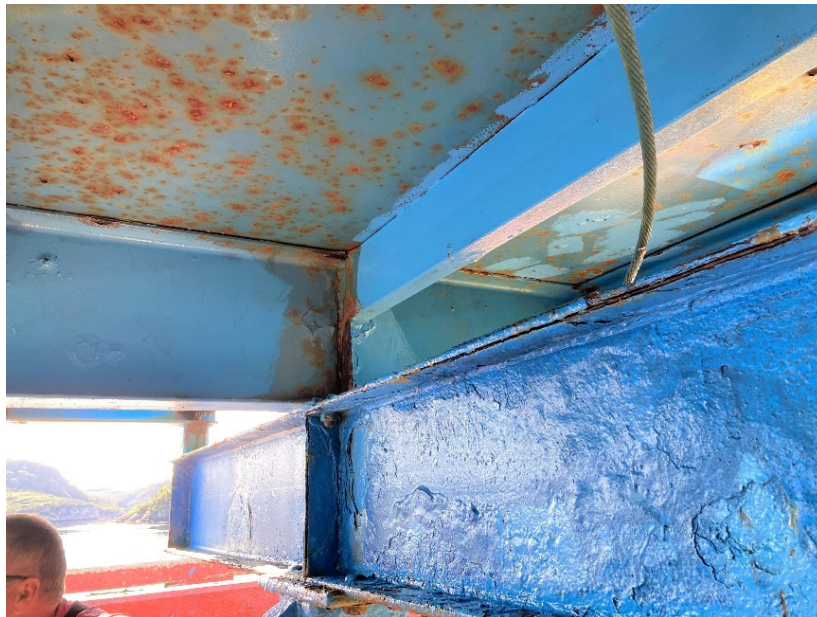
Photo 2: View of main support beam

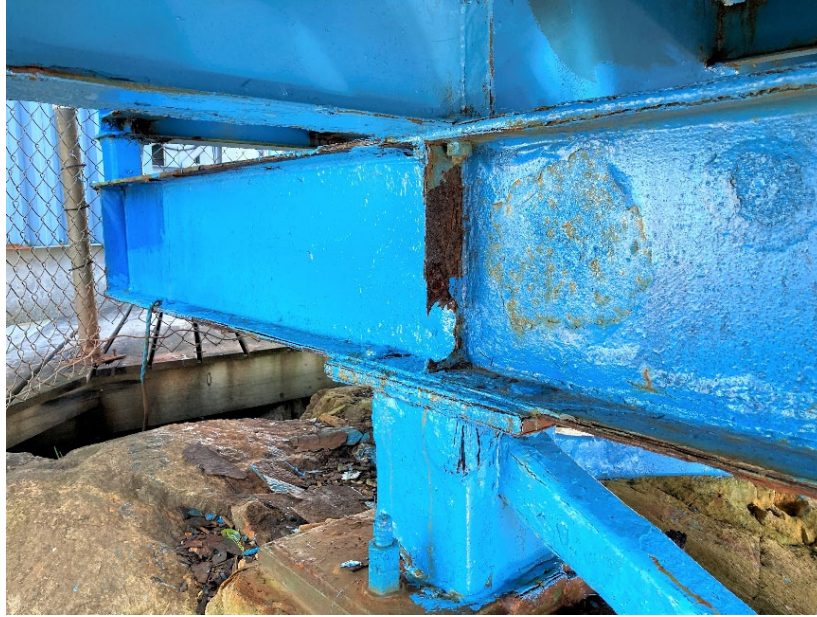
Photo 3: View along main support beam/corrosion through stiffener

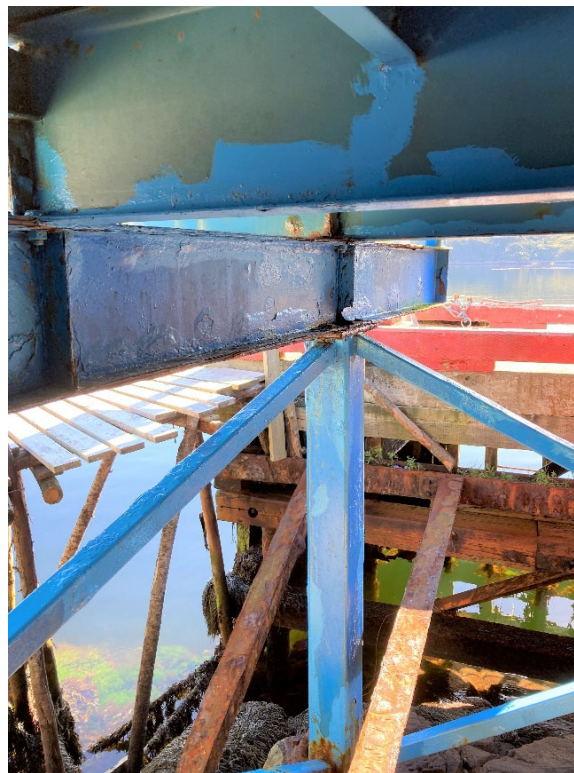
Photo 4: View at underside of tank – existing beams, column, and bracing members

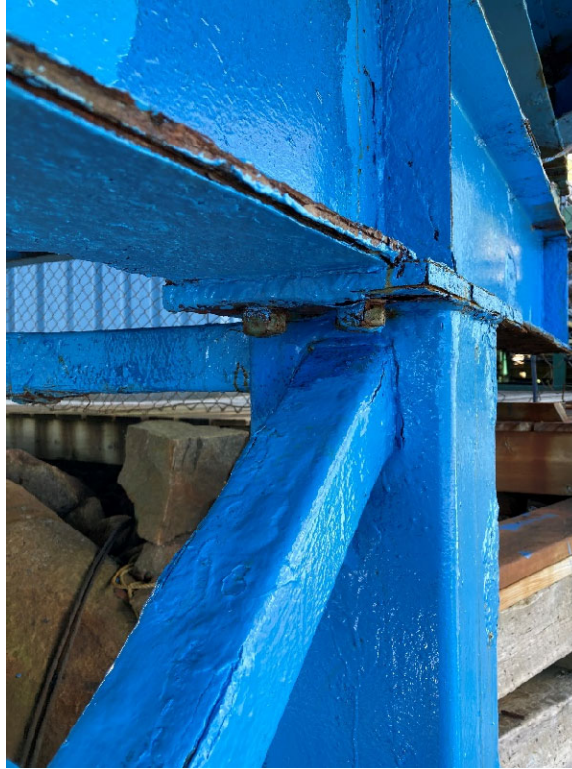
Photo 5: Corrosion along flange of beam

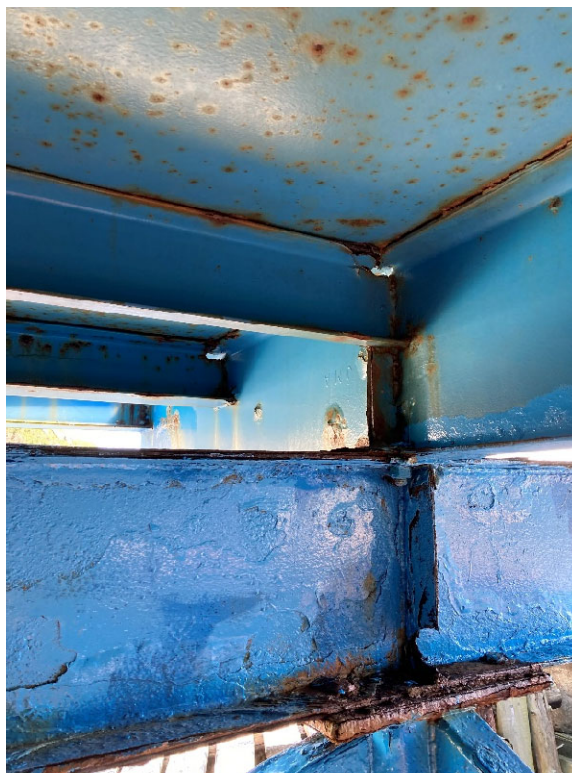
Photo 6: Corrosion beams and connections

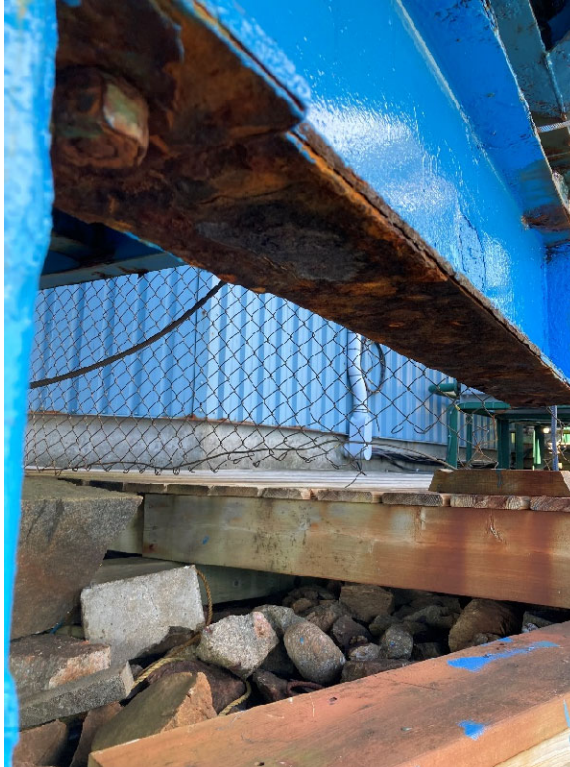
Photo 7: Corrosion at underside of beam

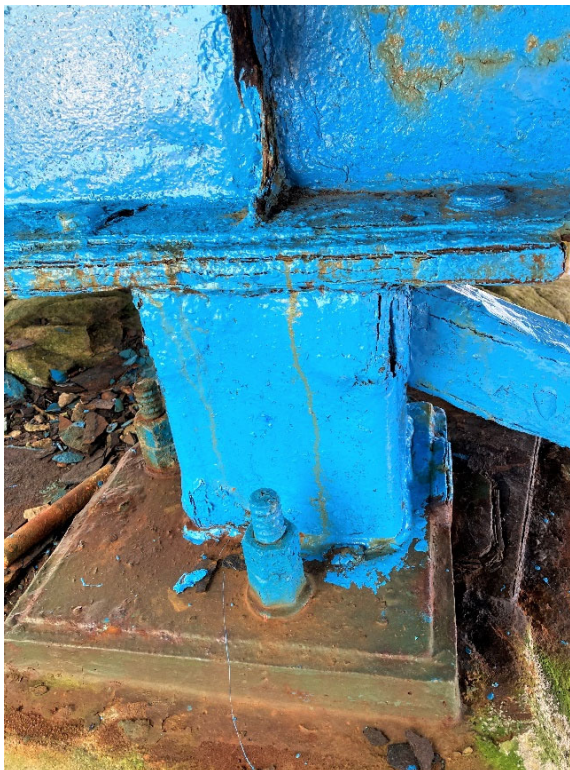
Photo 8: Loss in stiffener above column connection

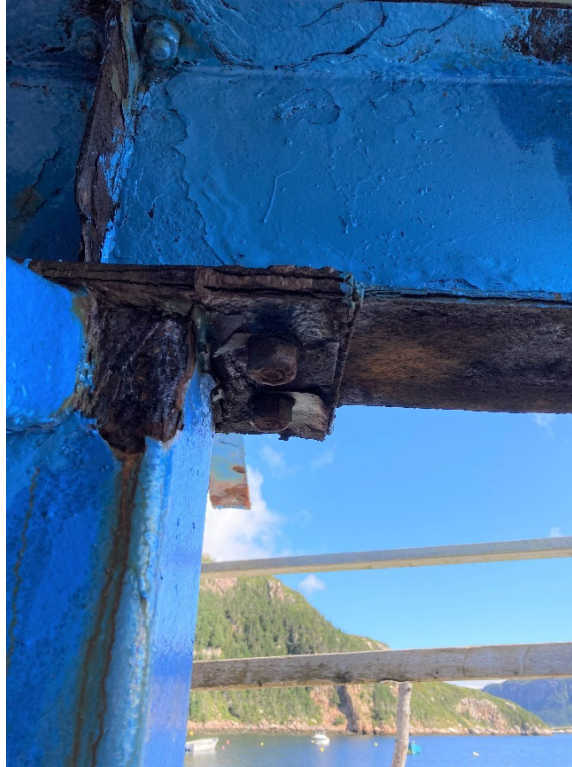
Photo 9: Corrosion at beam/column connection

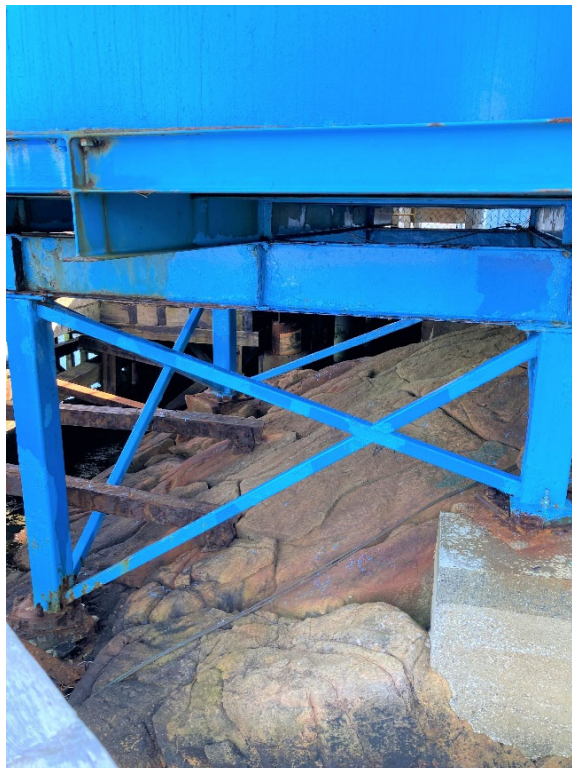
Photo 10: View of beams, columns, and bracing members for the support structure

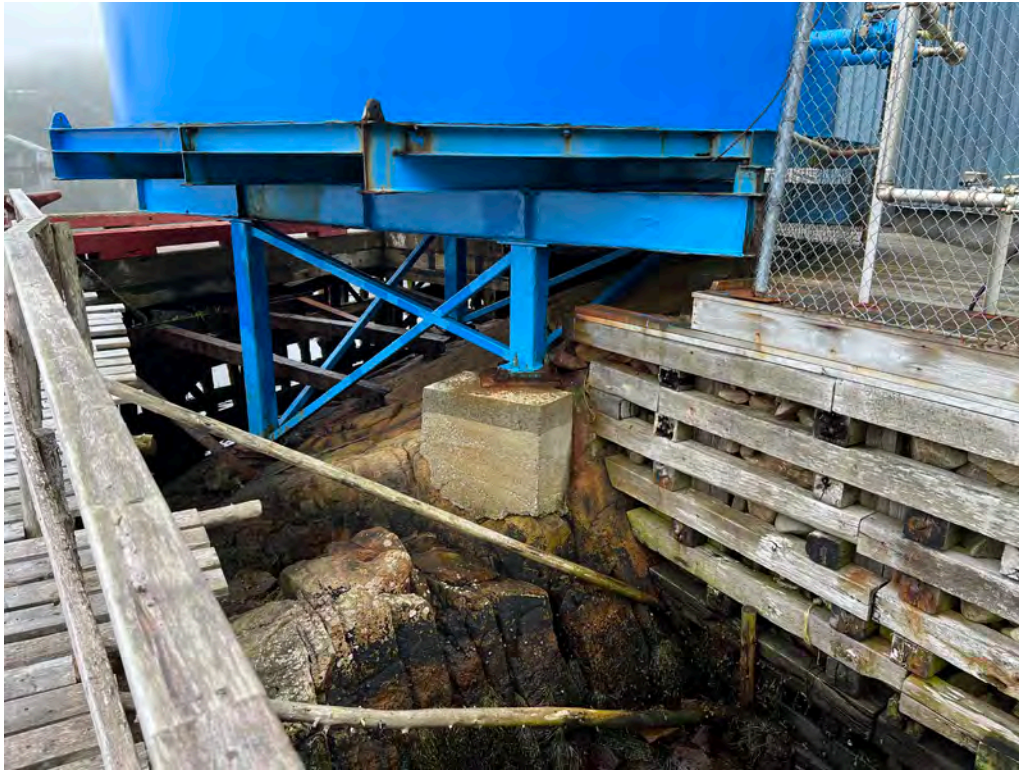
Elevated tank on east end behind Row "B" of wharf

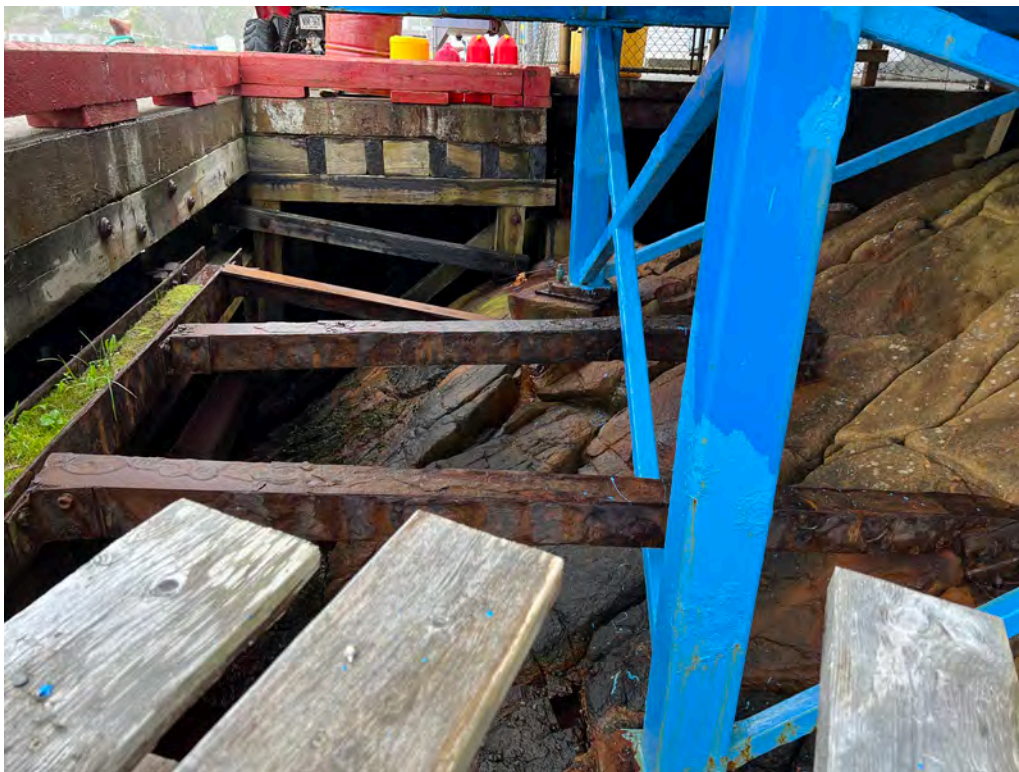
Tie-back angled bracing behind piles 1B and 2B

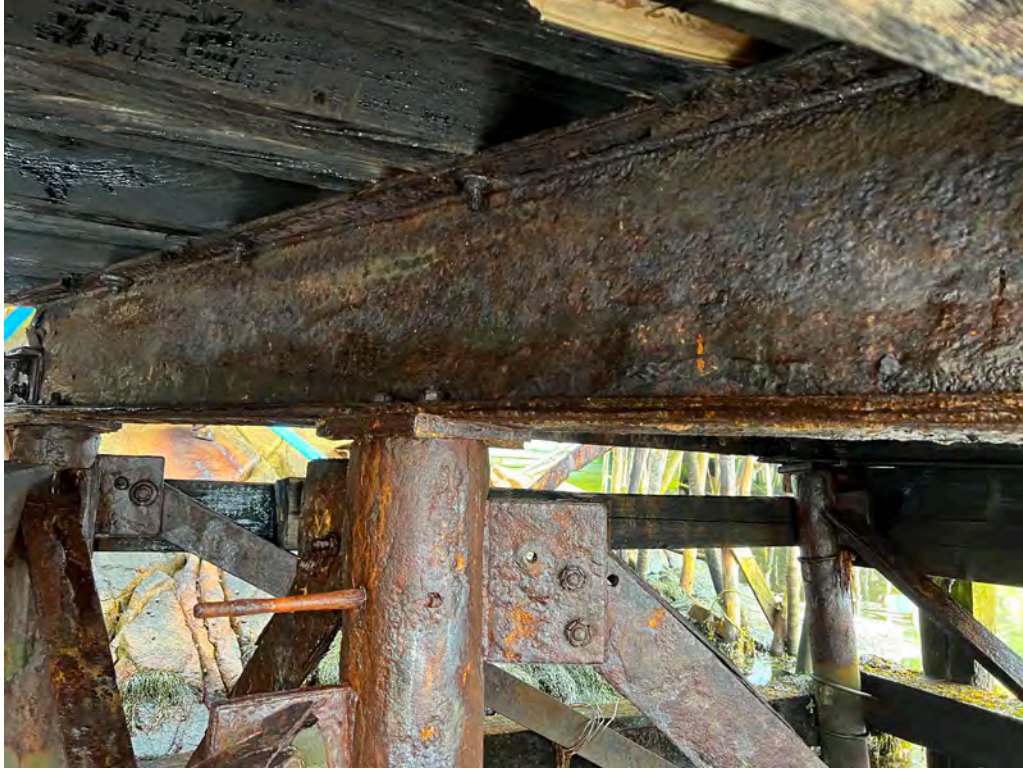
Piles, bracing and pile cap (typical)

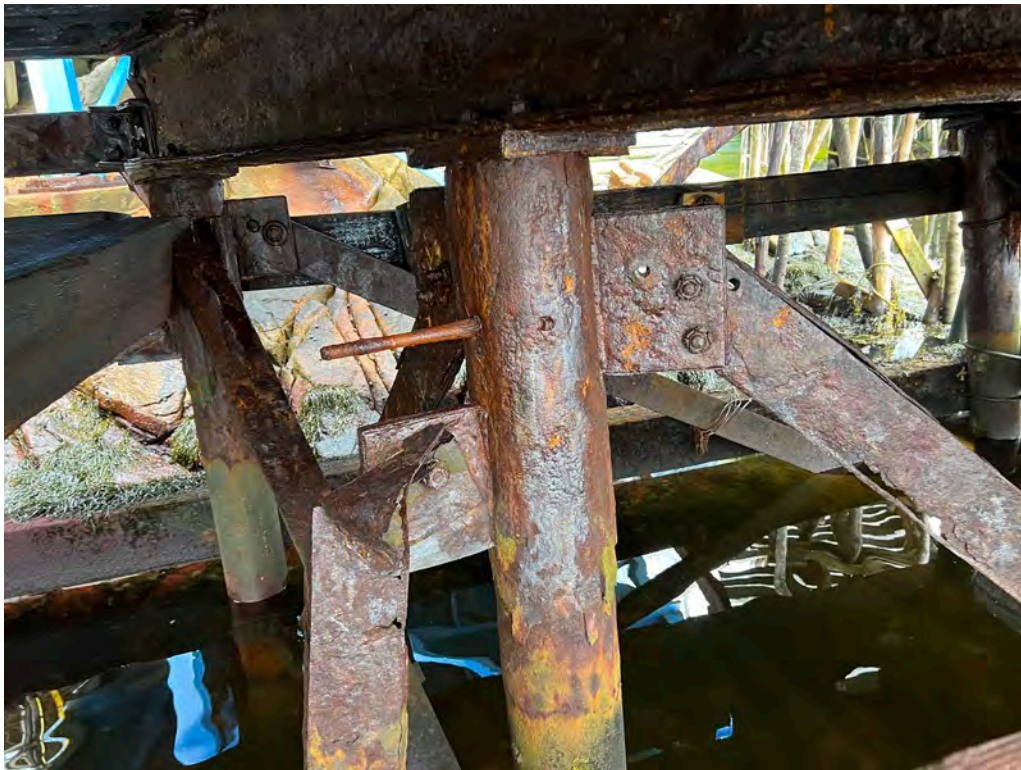
Piles, bracing and pile cap (typical)

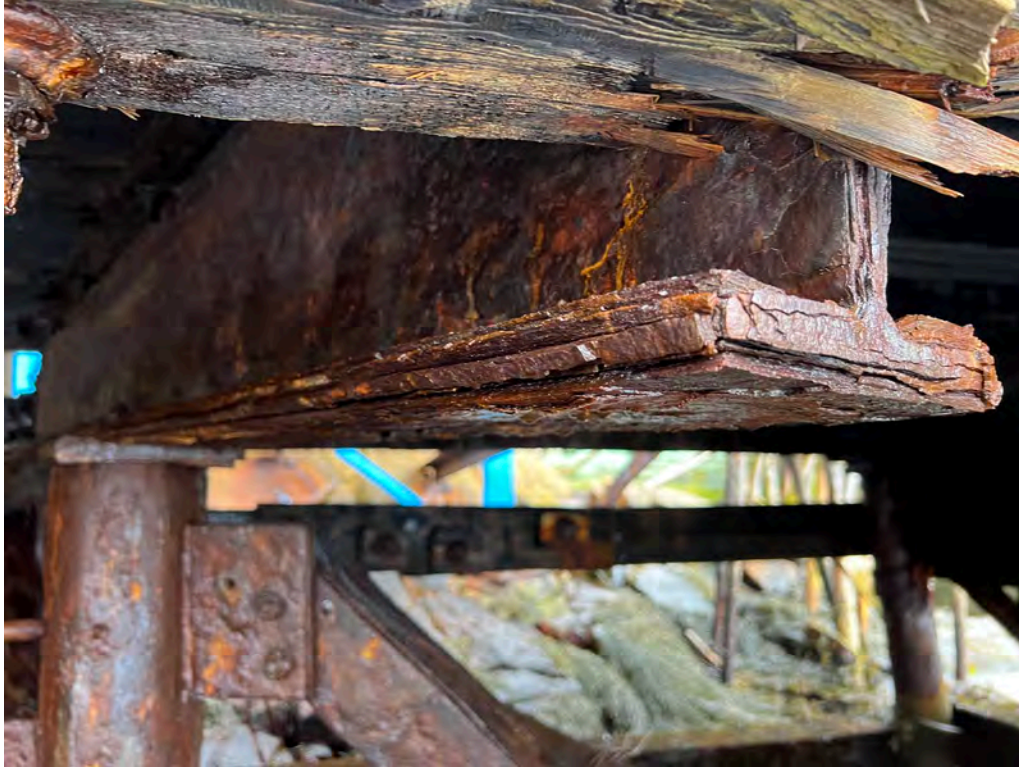
Pile cap (typical)

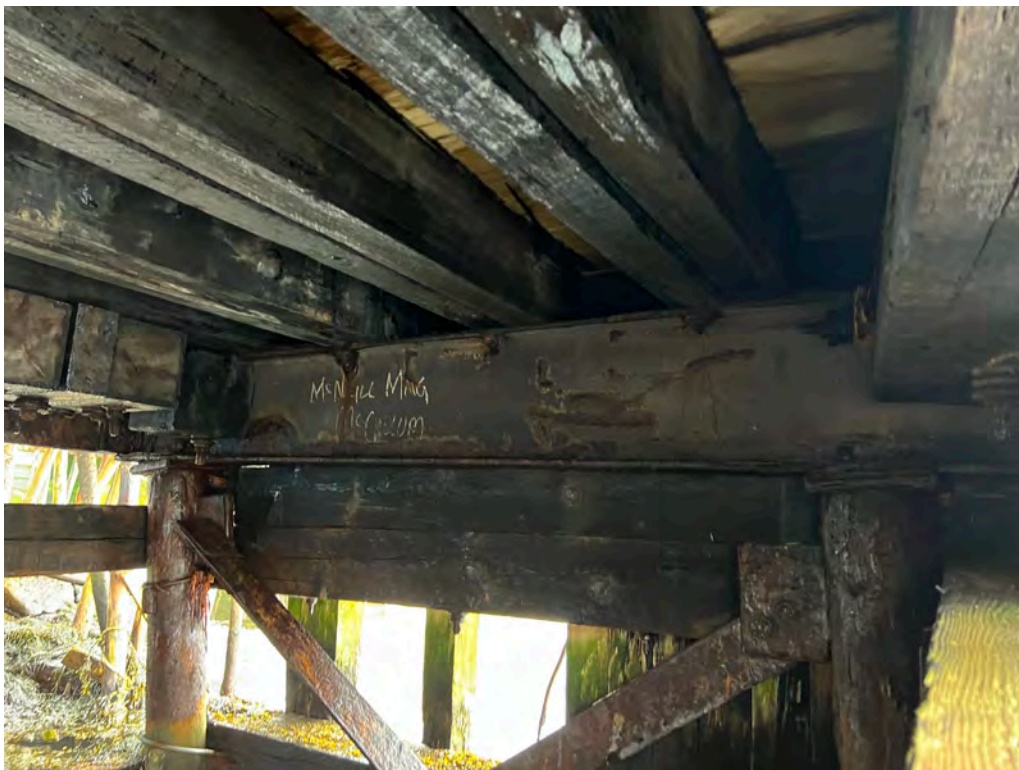
Typical underside showing timber deck beams

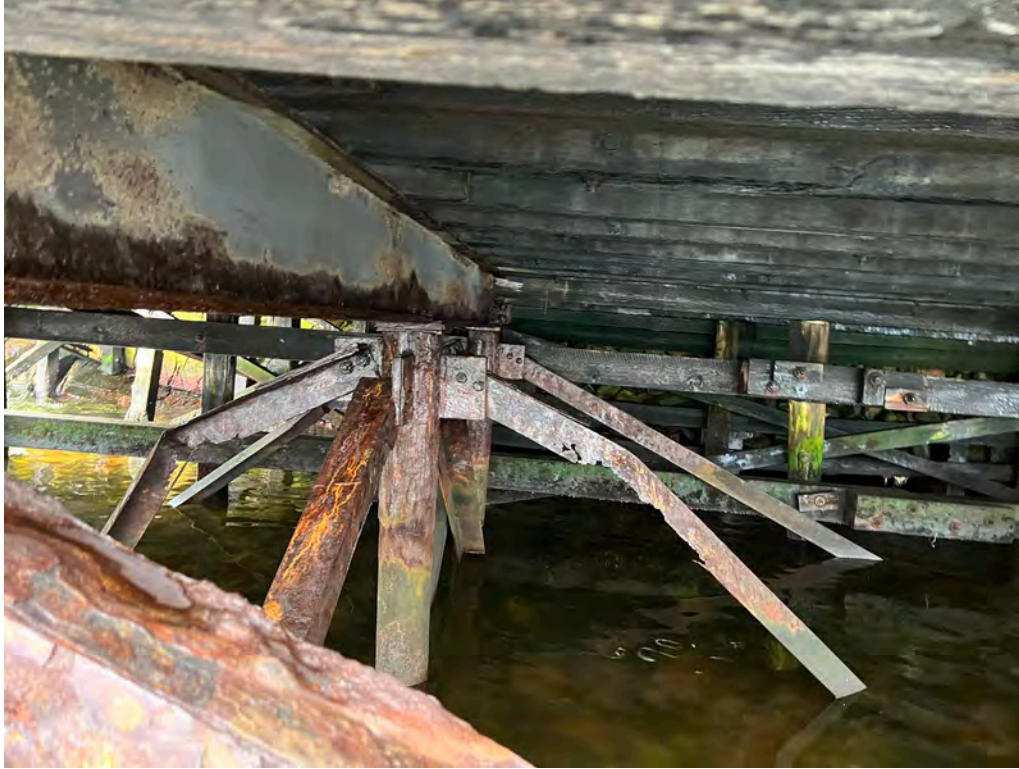
Poor condition of bracing

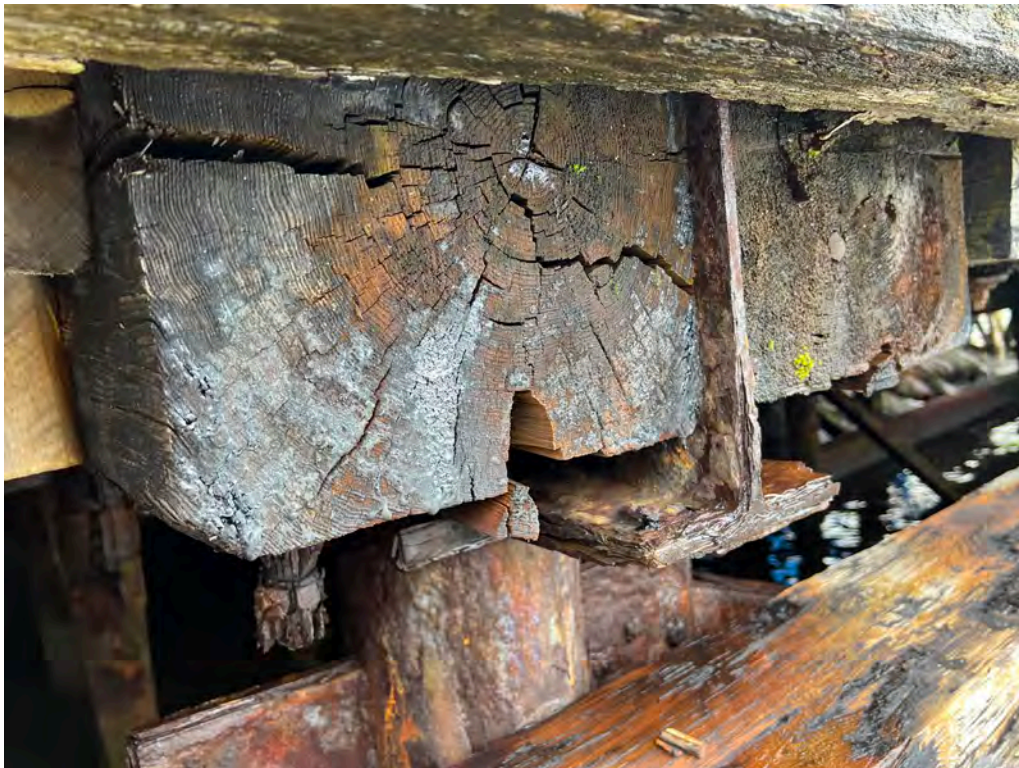
Caps with timber blocking on either side of web

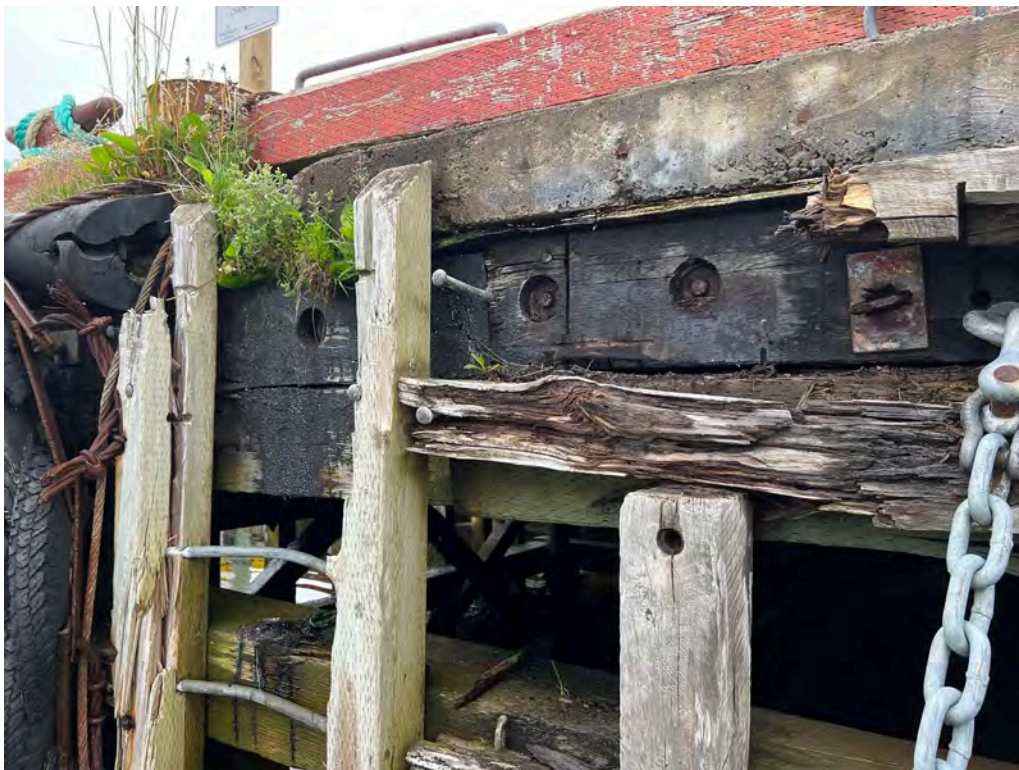
Poor condition of ladder, chocks and top rubber fender

Diving crew noted a total of three ladders along the wharf. One ladder is functional and appears to be in good condition while the other two ladders noted appear to be missing rungs and timber along the sides to be rotted.

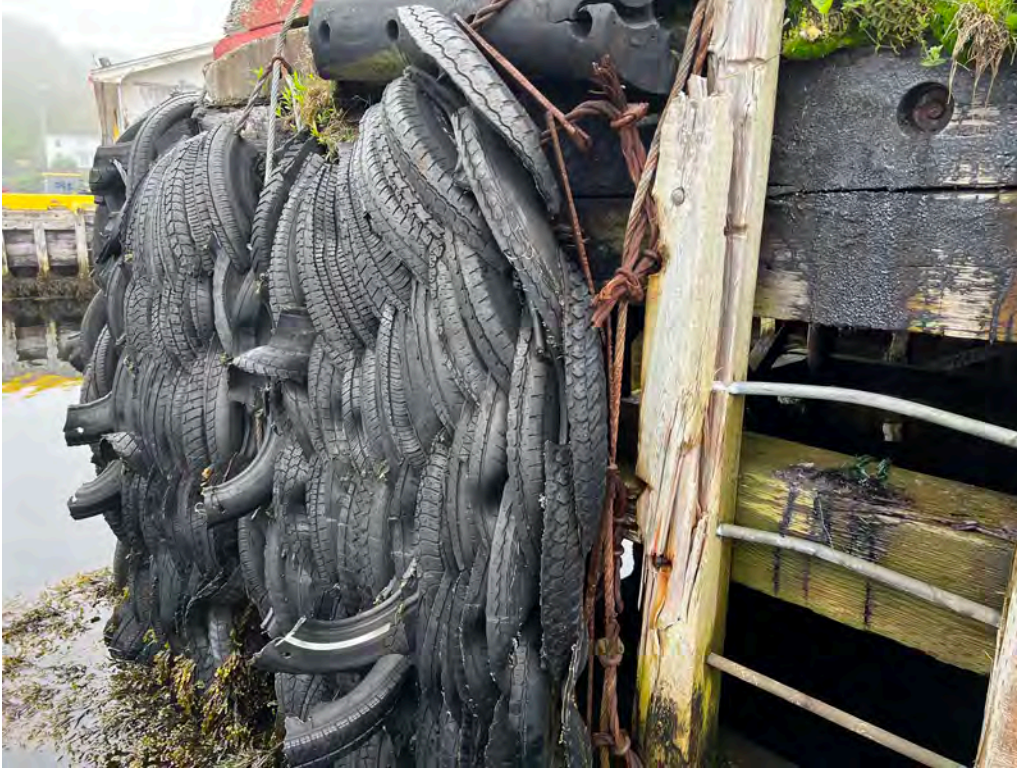
Corner blasting mat and poor condition of ladder

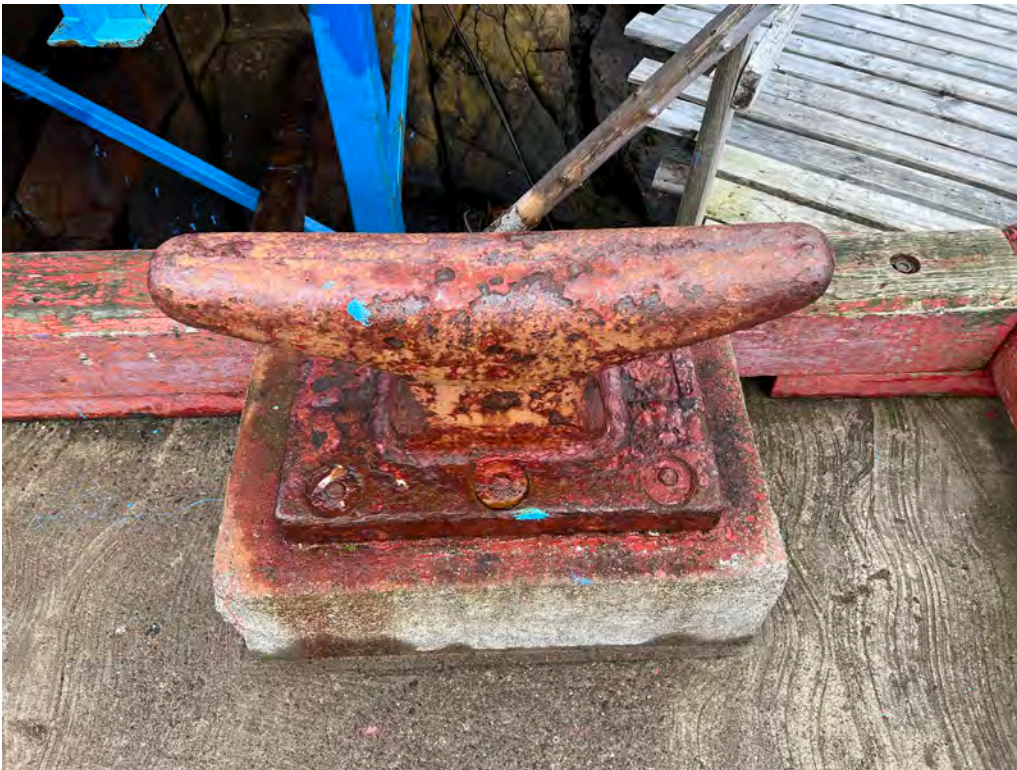
Typical cleat

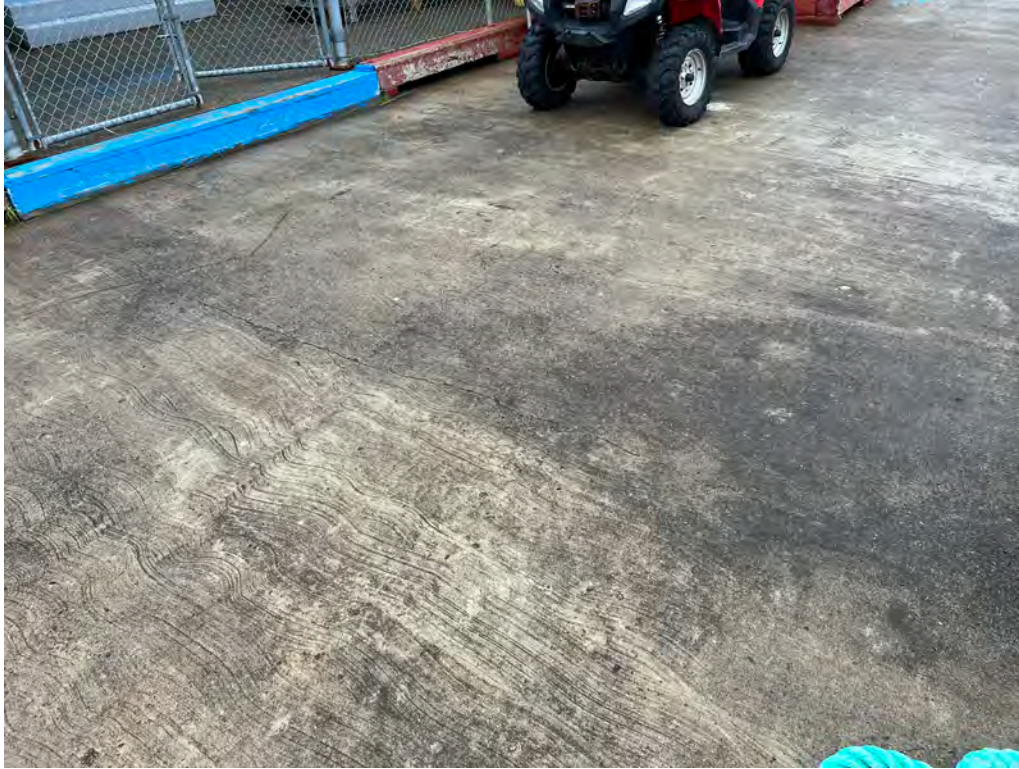
Concrete deck surface

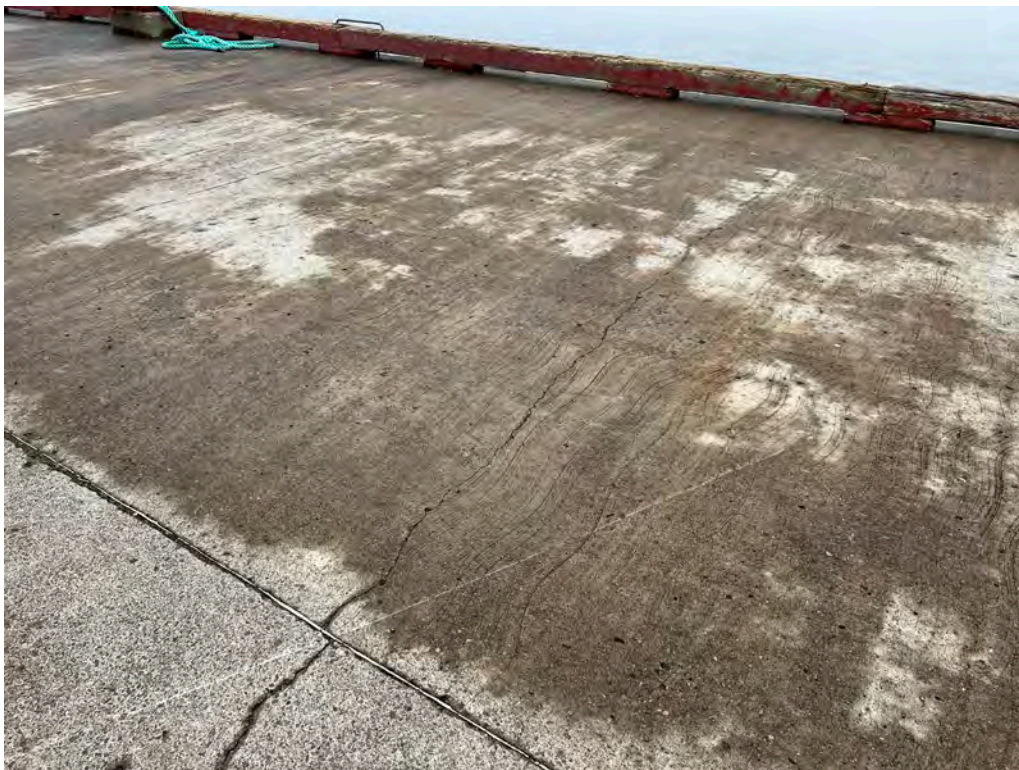
Transverse deck crack

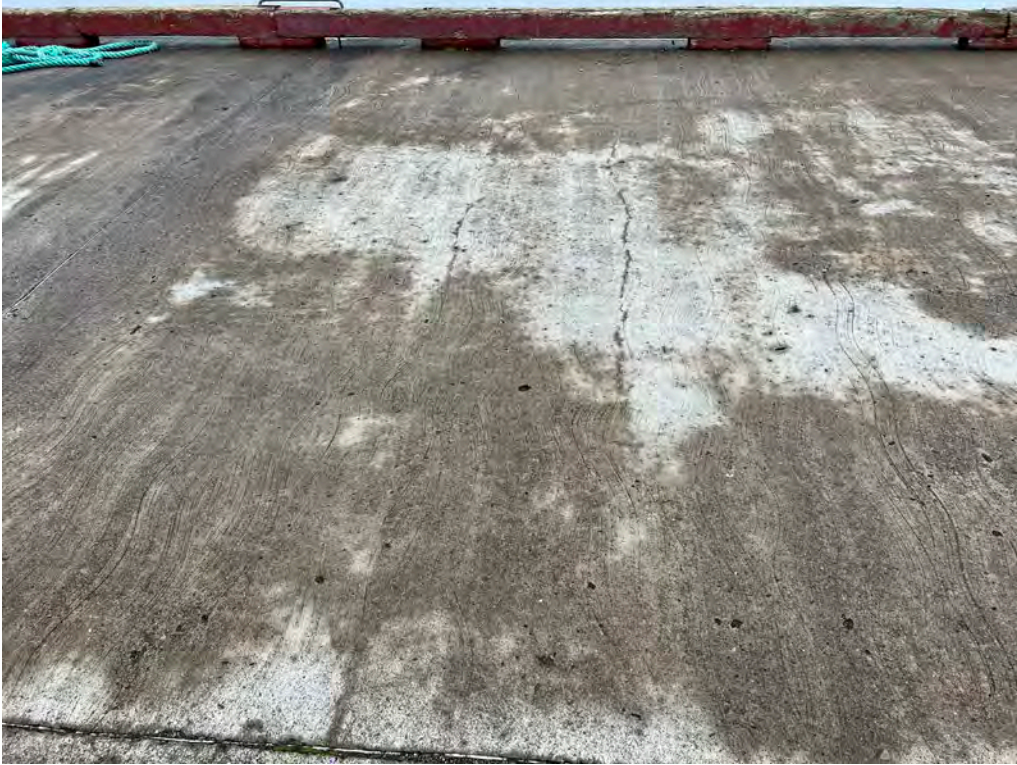
Concrete deck surface

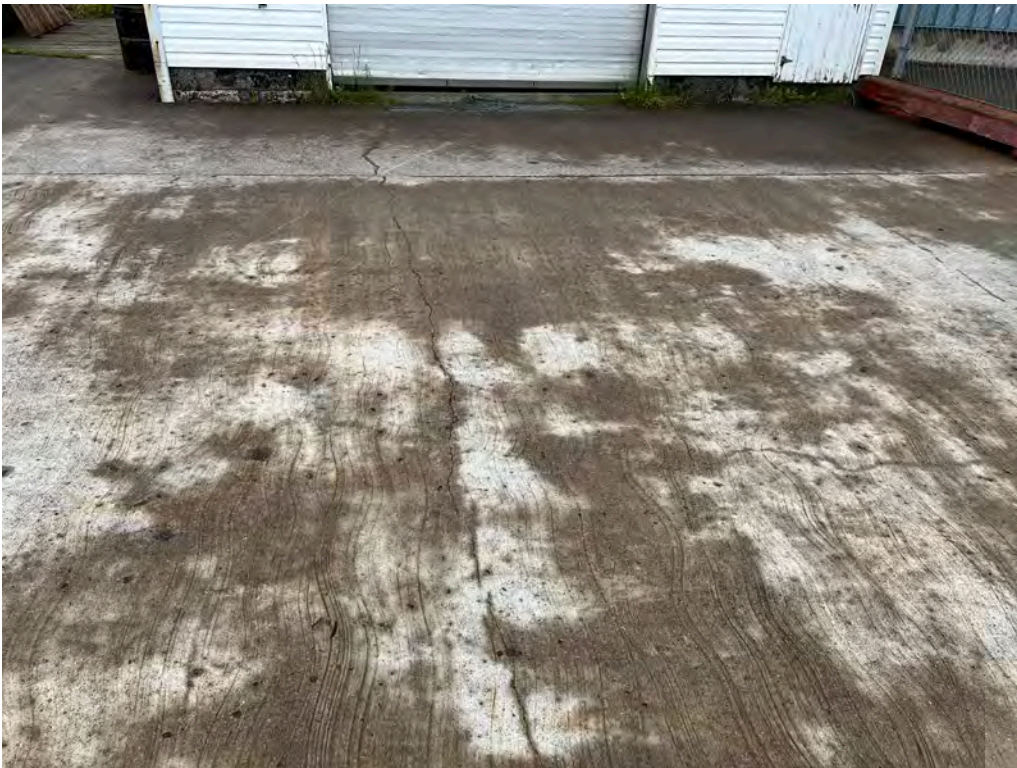
Concrete deck surface

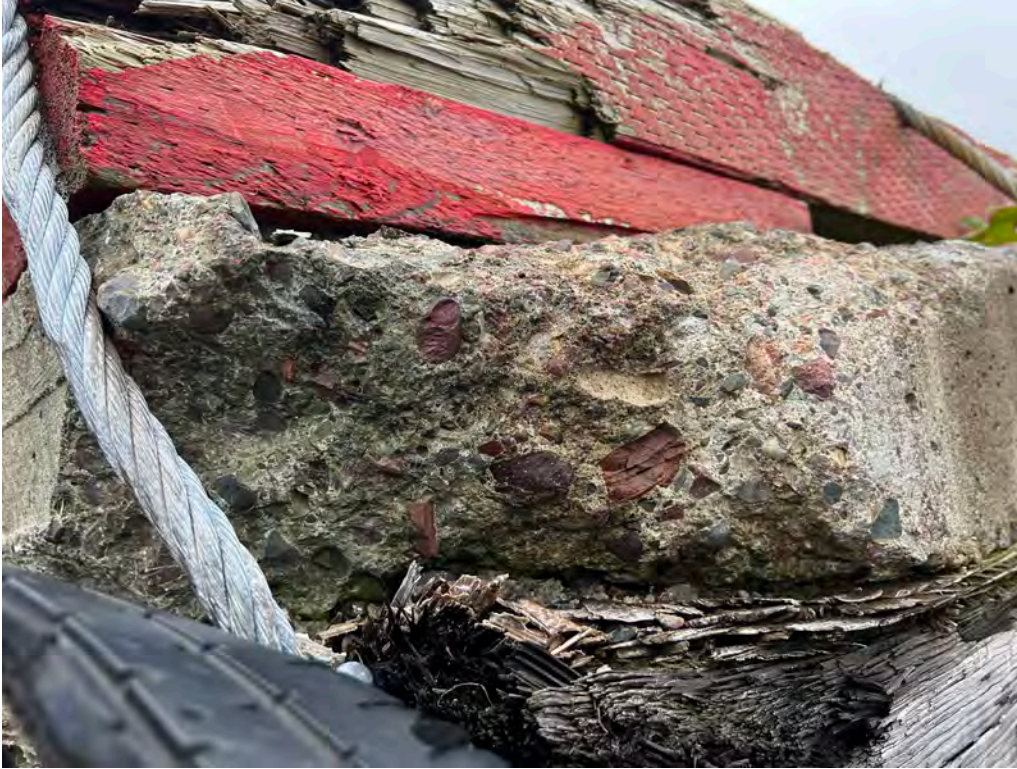
Concrete edge showing aggregate

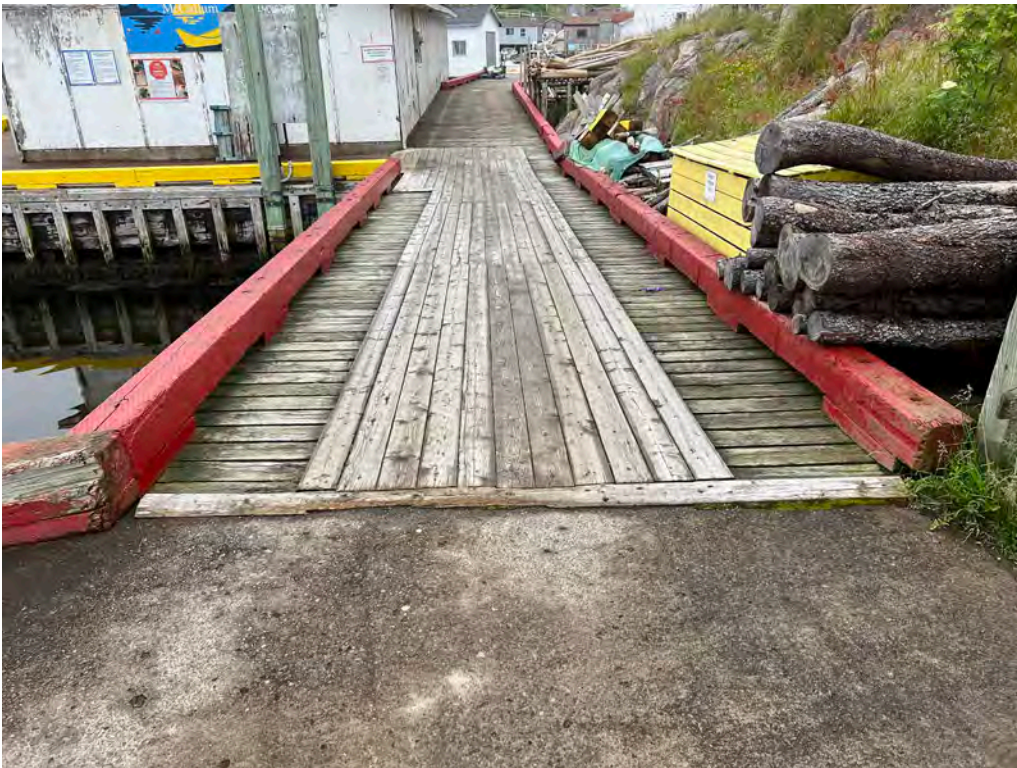
Western walkway approach

Walkway travelling from one wharf to another is built on 8' x 8' timbers which approximately span six feet apart. Minor deterioration around LNT is noted but all timbers appear to be intact with bracing all accounted for tying into bedrock. As dive crew travelled diving equipment across walkway, they noticed decking in good shape and walkway felt solid.

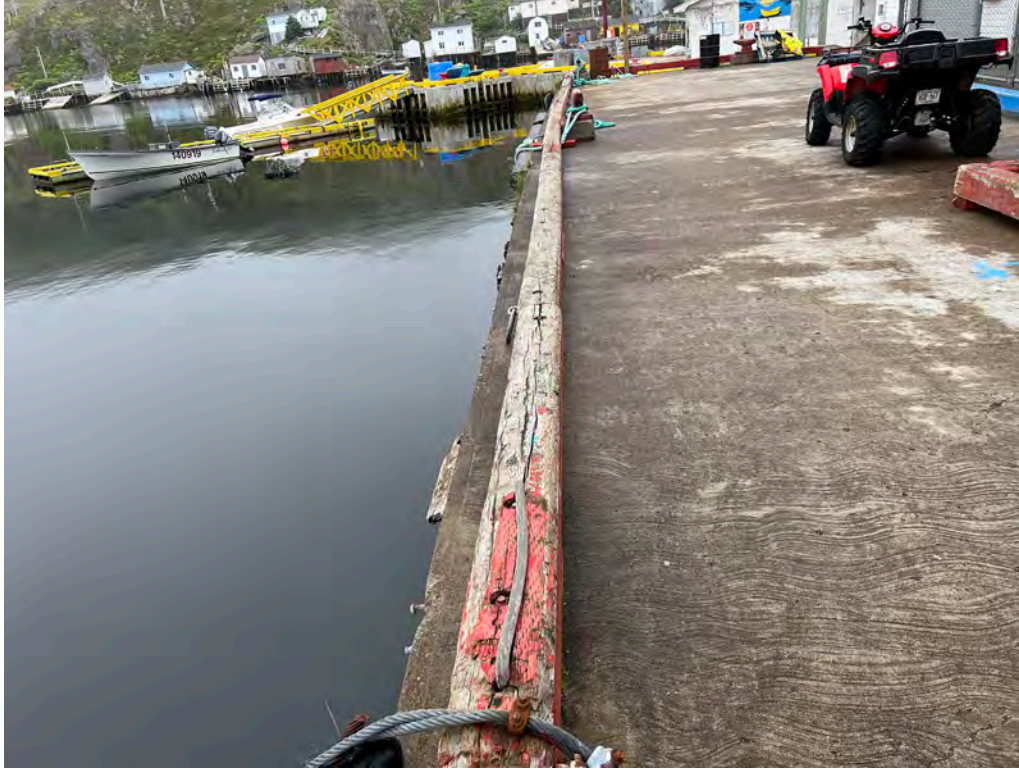
Wheelguard and top ladder handgrips on wheelguard

Overall, the wheel guard appears to be in decent shape in most locations. In the heavy traffic area “tie up” zone of the wharf the wheel guard appears to show signs of wear but is still functional with no hardware showing or splitting. Pictures in report to show.
