MARITIME LINK PRELIMINARY INTERCONNECTION STUDY

Newfoundland and Labrador Hydro

July 2014

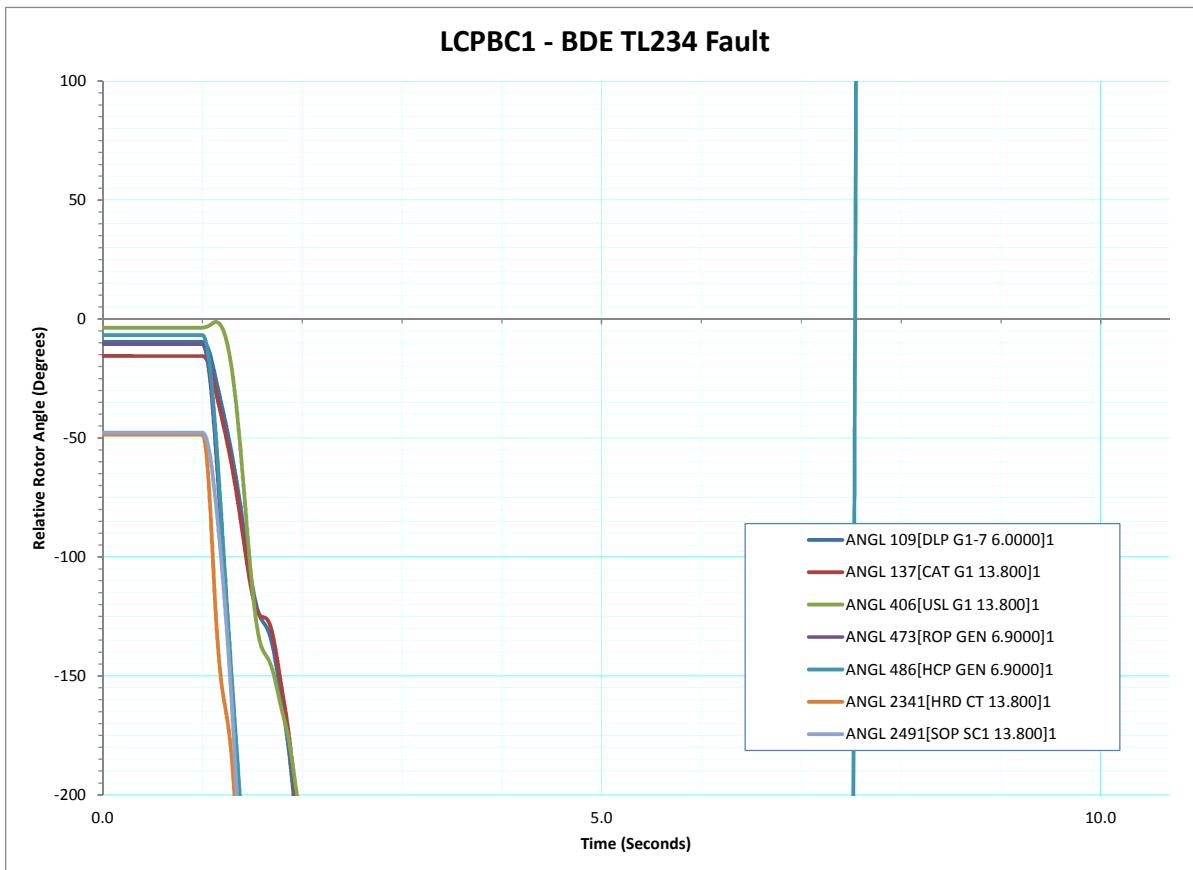
It should be noted that faults at Bay d'Espoir have been classified as “exceptional contingencies” and it has been accepted that their occurrence under heavy load conditions may lead to instability. Detailed analysis of these faults is beyond the scope of this investigation. Some examples of instability due to BDE faults are provided in the figures below.

Figure 1 - LCPBC1 - BDE TL234 Fault - Relative Rotor Angle (Degrees)

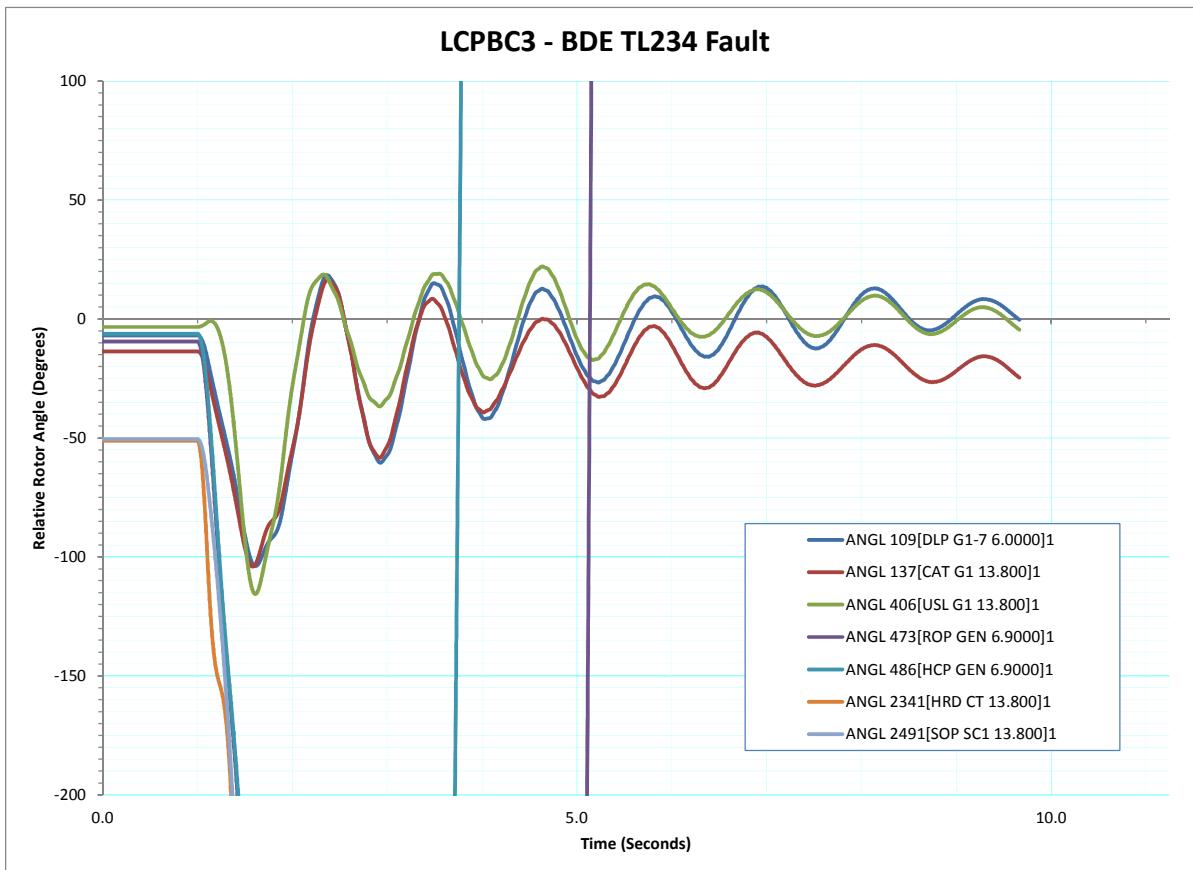
Figure 2 - LCPBC3 - BDE TL234 Fault - Relative Rotor Angle (Degrees)

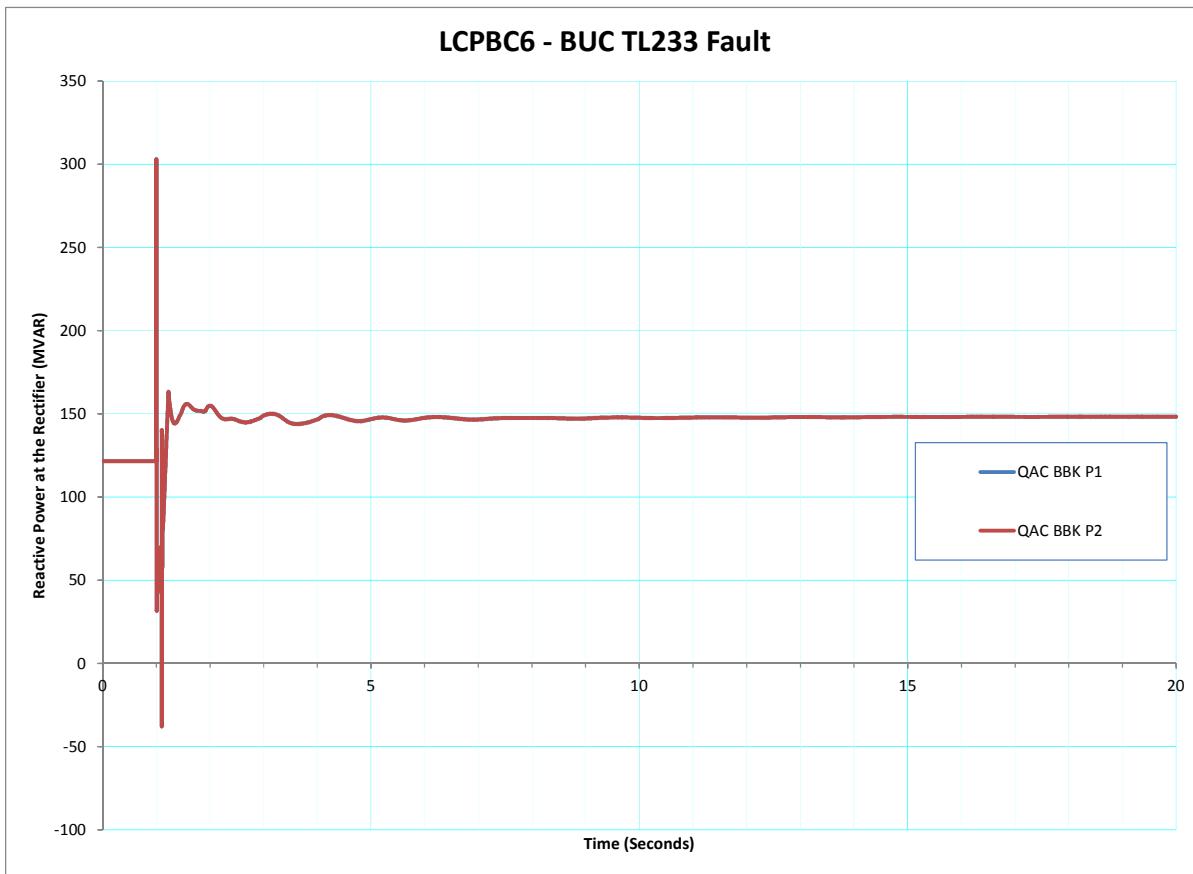
Transient analysis indicates that ac faults at selected terminals stations in western Newfoundland will cause the reactive power output of the VSC converter in BBK to exceed the specified limit of 125 MVAR per pole. This was found to be the case in load flow scenarios where the ML was operating at its rated output of 500 MW. A list of these scenarios is provided in Table 4 and illustrated in the figures below.

Figure 3 - LCPBC6 - BUC TL233 Fault - Reactive Power at the Rectifier (MVAR)

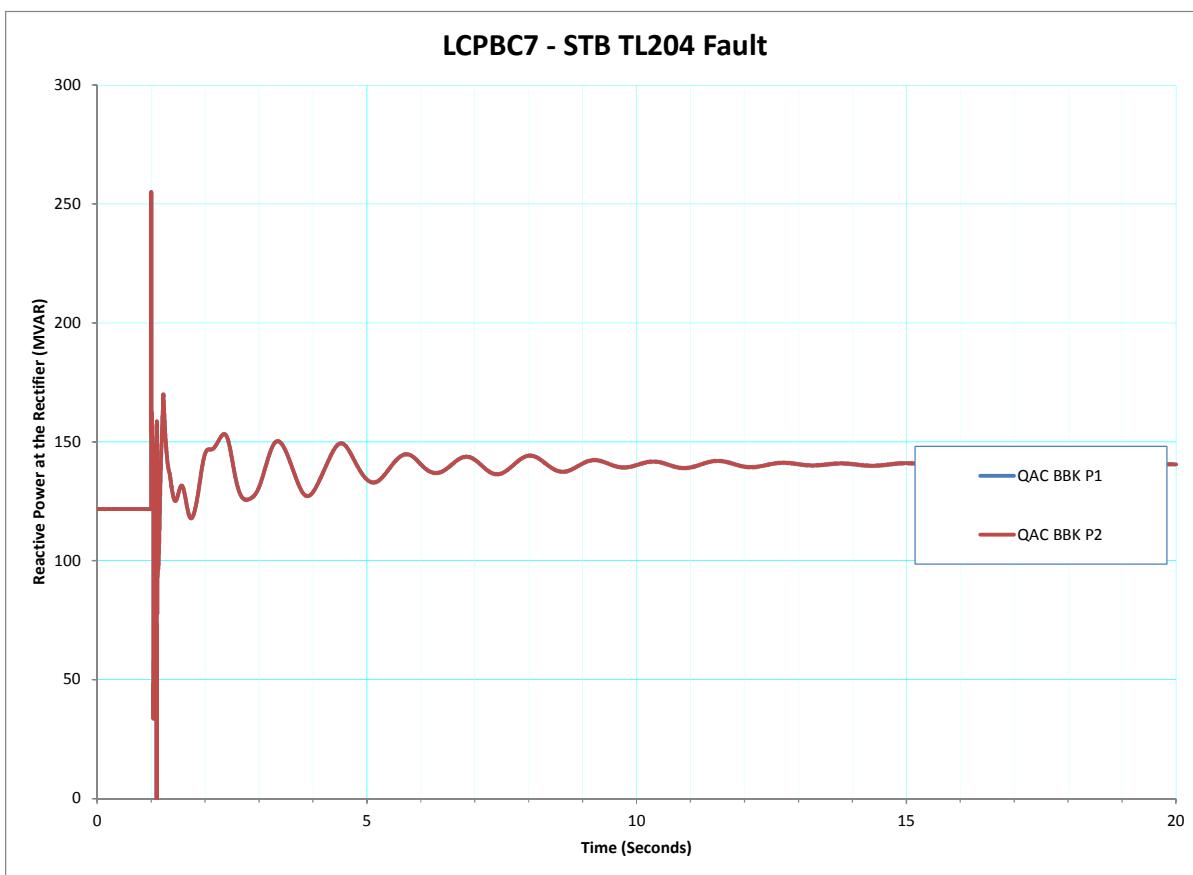
Figure 4 - LCPBC7 - STB TL204 Fault - Reactive Power at the Rectifier (MVAR)

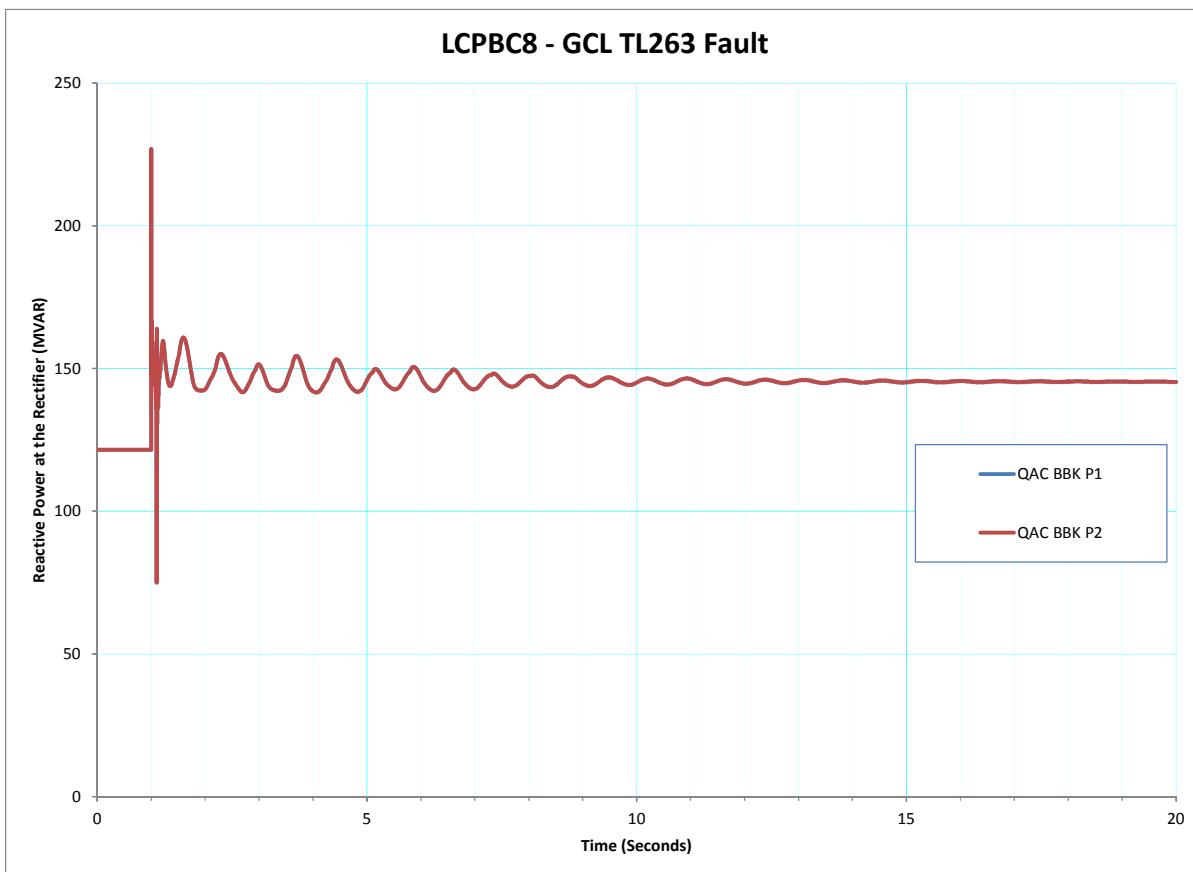
Figure 5 - LCPBC8 - GCL TL263 Fault - Reactive Power at the Rectifier (MVAR)

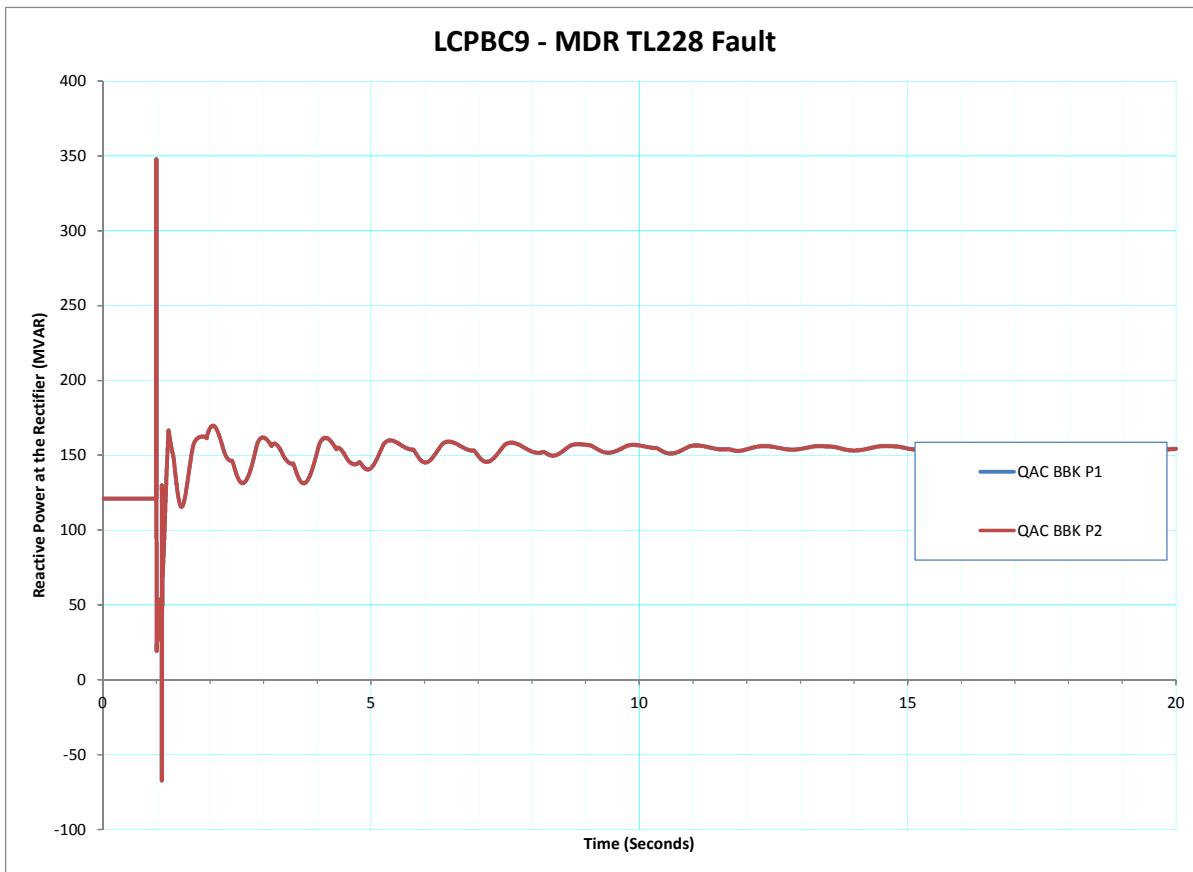
Figure 6 - LCPBC9 - MDR TL228 Fault - Reactive Power at the Rectifier (MVAR)

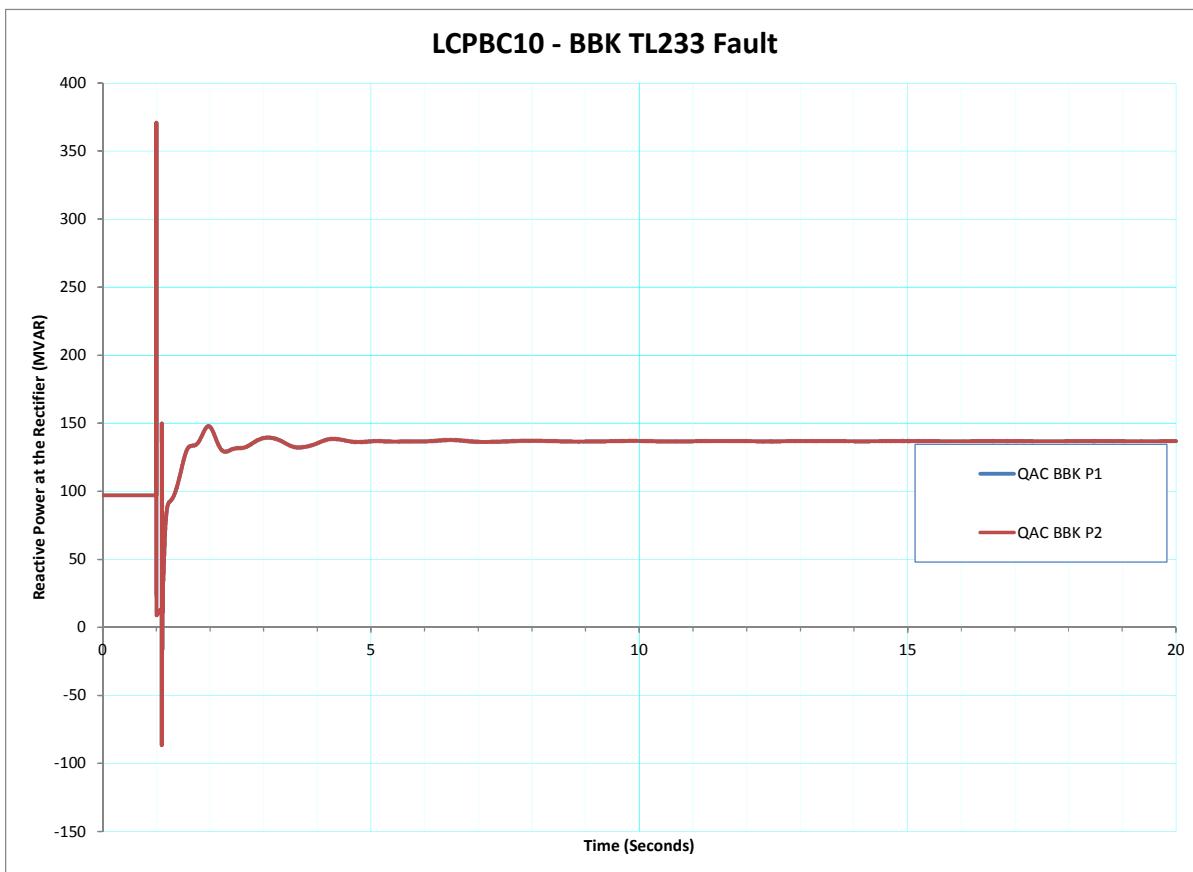
Figure 7 - LCPBC10 - BBK TL233 Fault - Reactive Power at the Rectifier (MVAR)

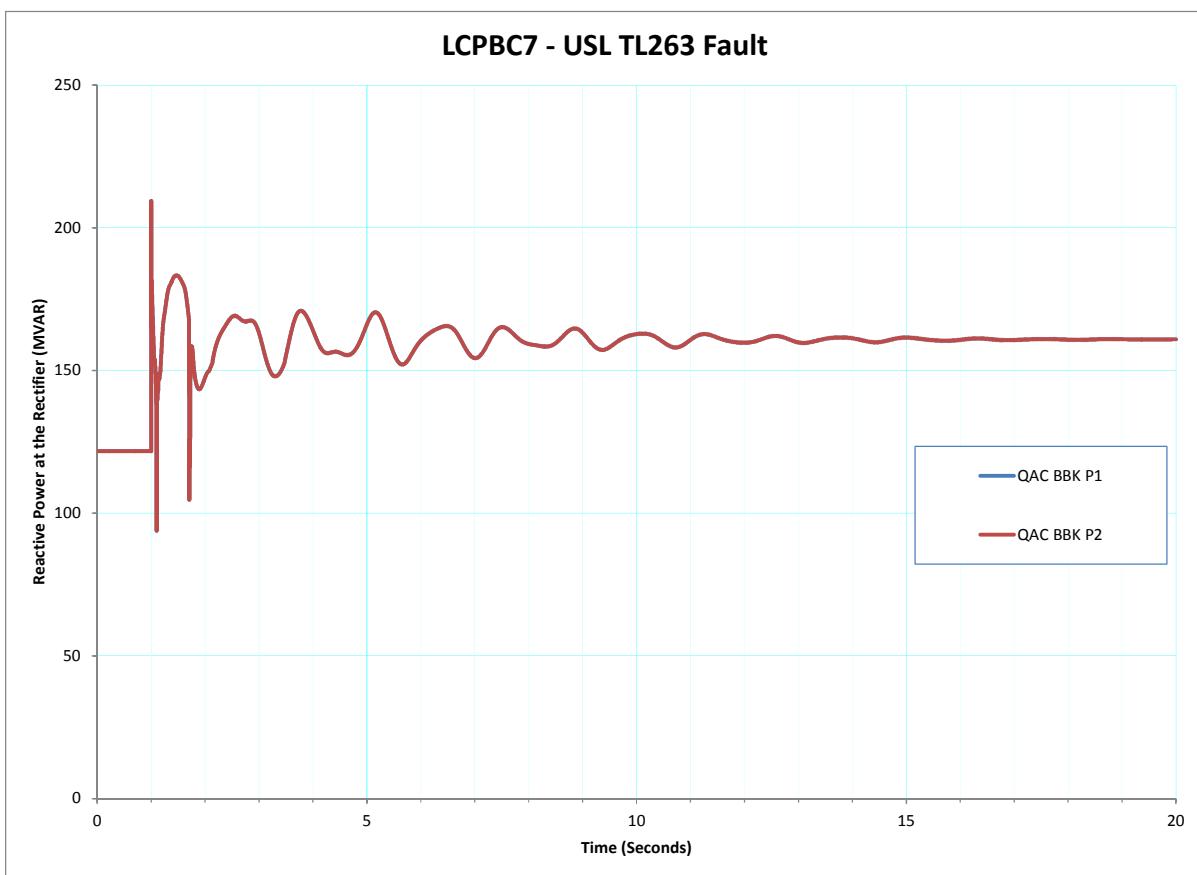
Figure 8 - LCPBC7 - USL TL263 Fault - Reactive Power at the Rectifier (MVAR)

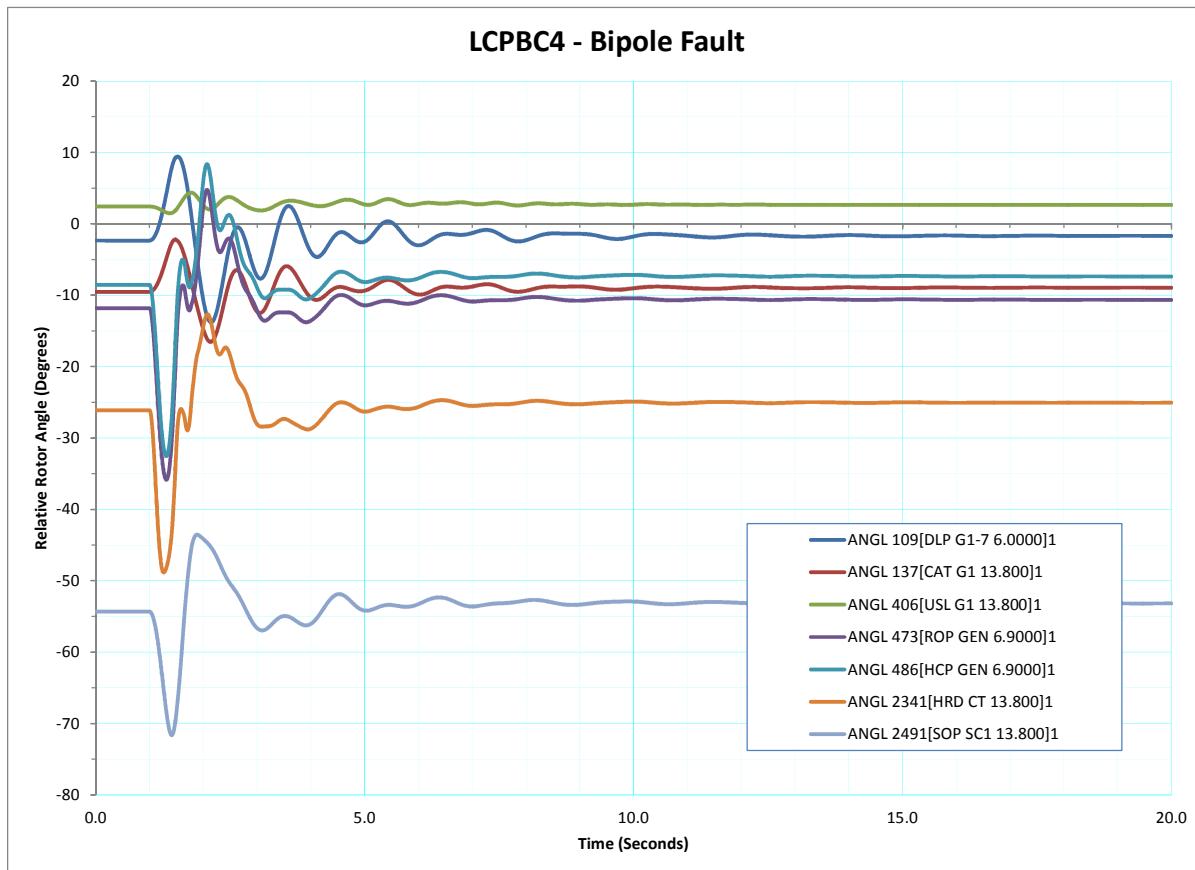
In the event of a temporary bipole fault (or a monopole fault), undesirable system conditions were found for the scenarios listed in Table 5. Plots of the system conditions are provided in the figures below.

Figure 9 - LCPBC4 - Bipole Fault - Relative Rotor Angle (Degrees)

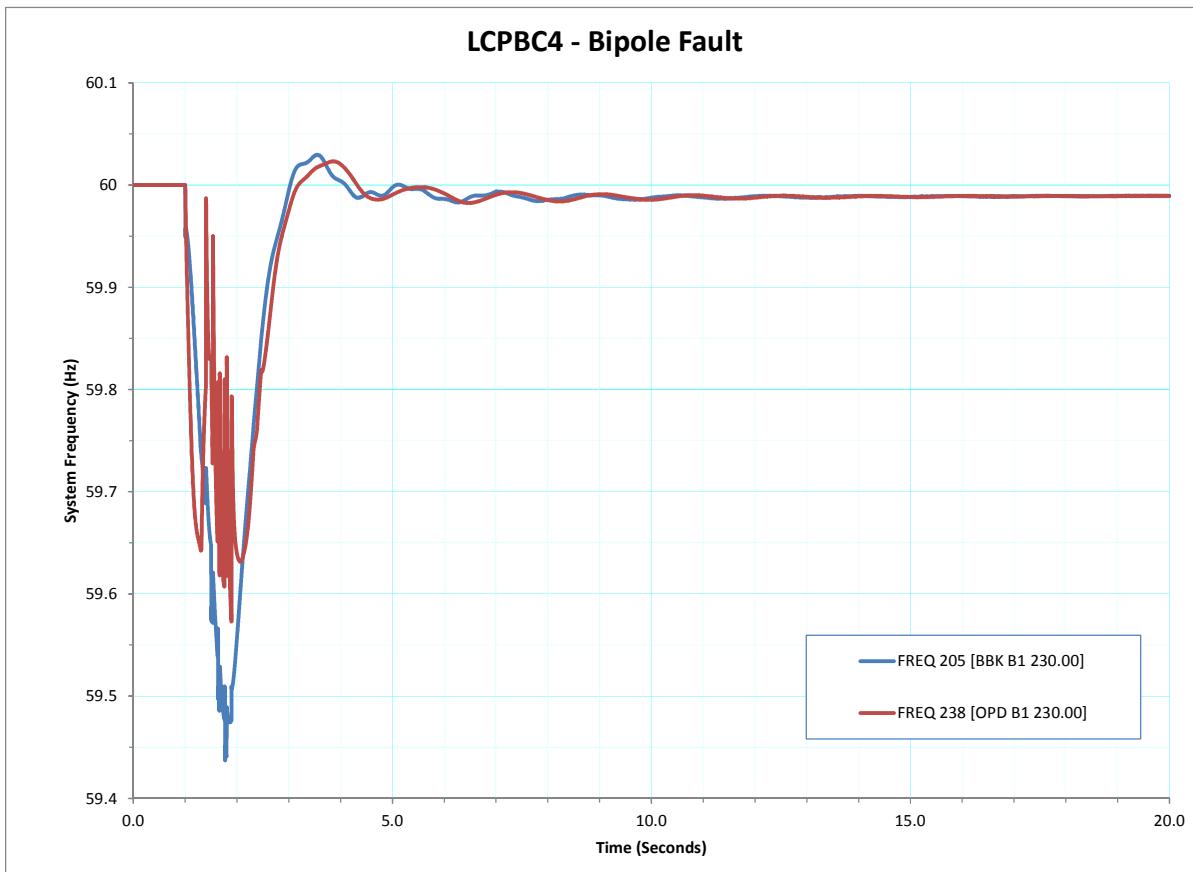
Figure 10 - LCPBC4 - Bipole Fault - System Frequency (Hz)

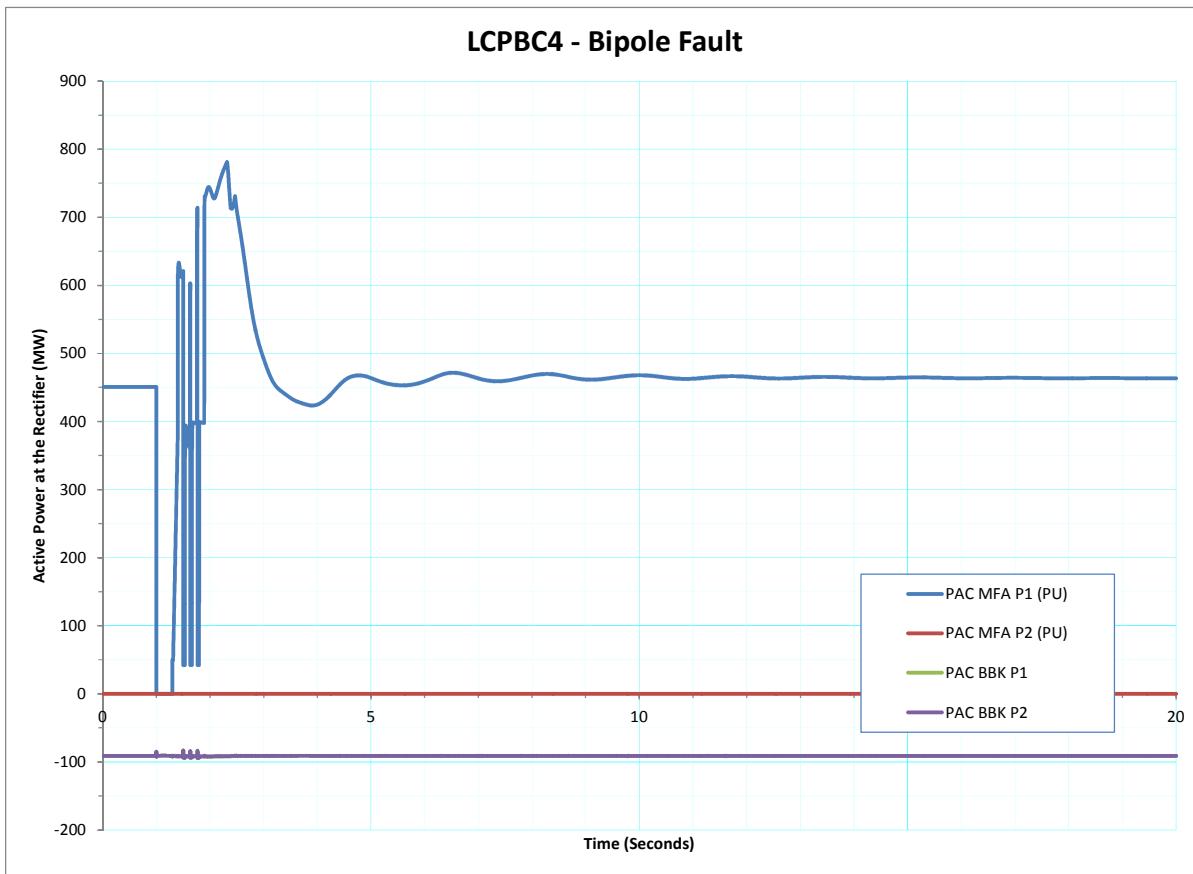
Figure 11 - LCPBC4 - Bipole Fault - Active Power at the Rectifier (MW)

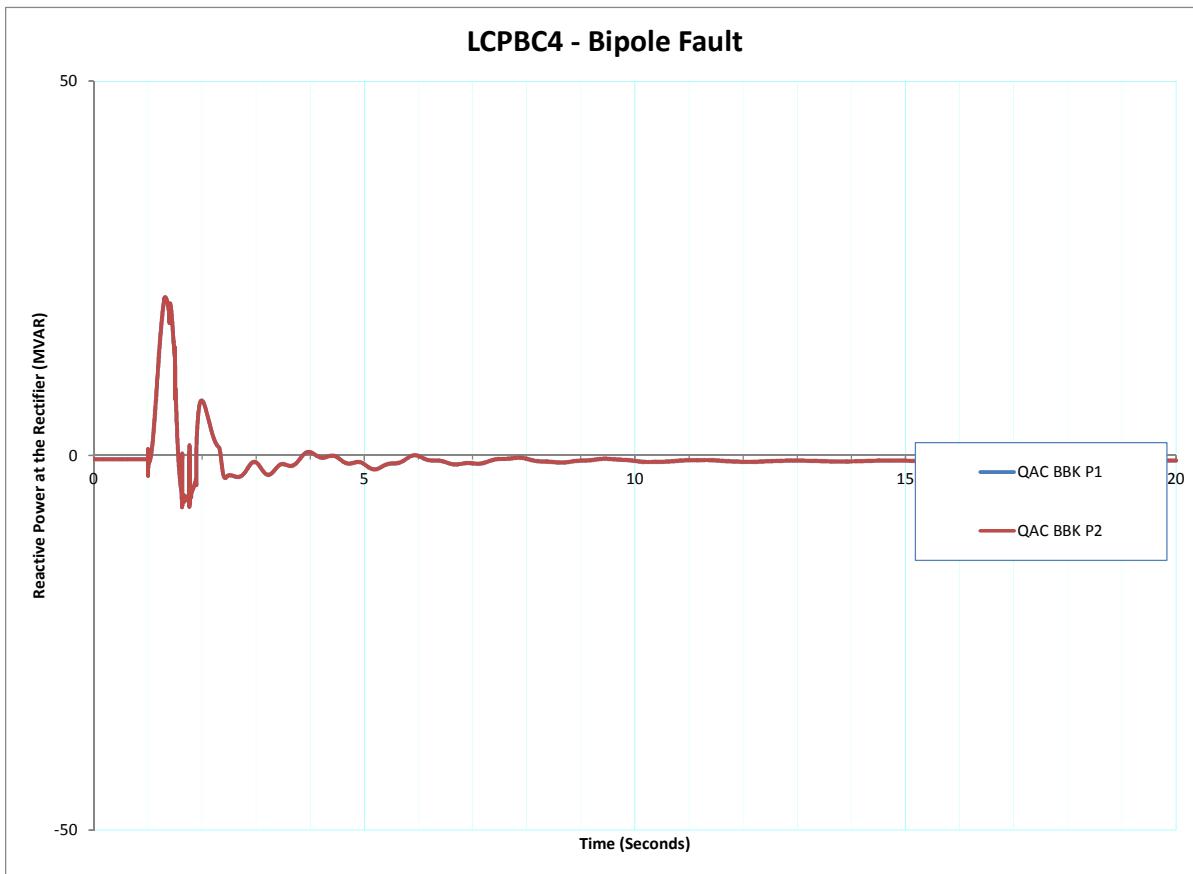
Figure 12 - LCPBC4 - Bipole Fault - Reactive Power at the Rectifier (MVAR)

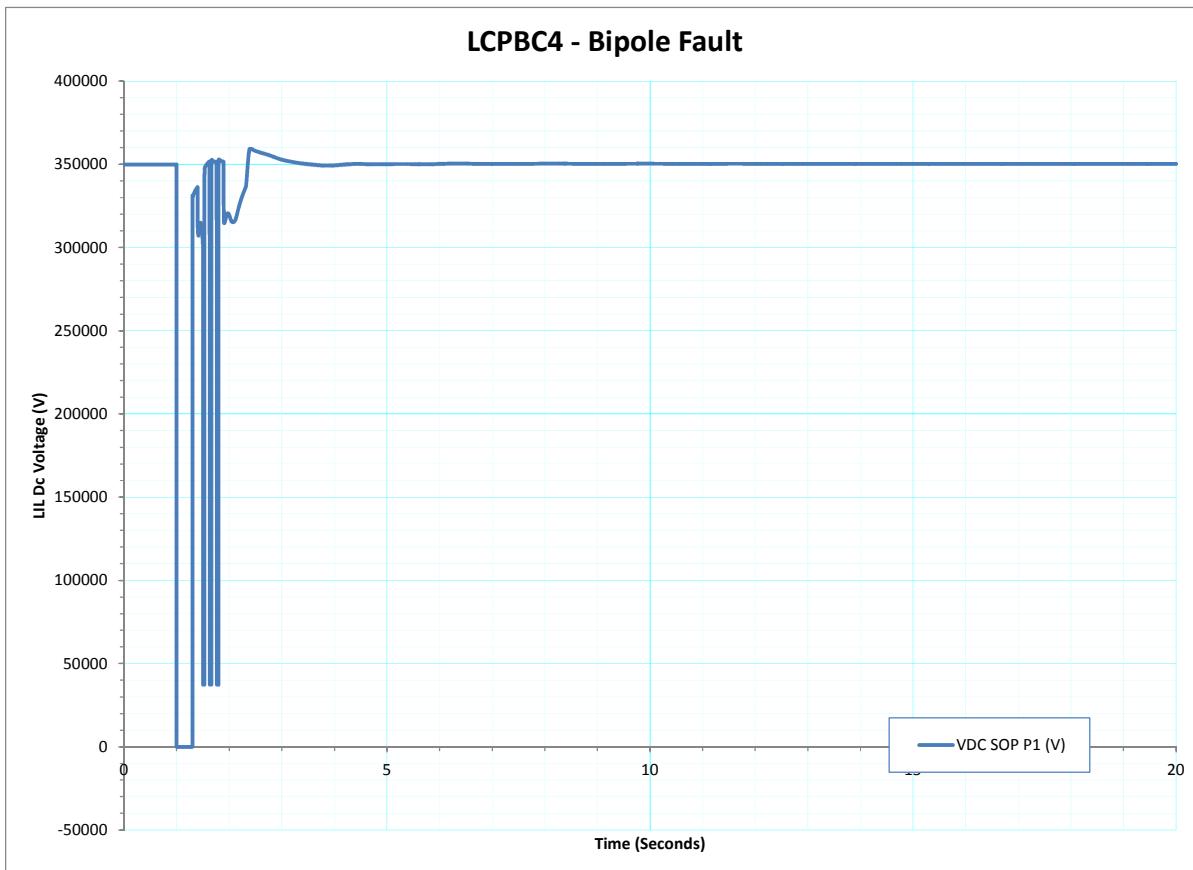
Figure 13 - LCPBC4 - Bipole Fault - LIL Dc Voltage (V)

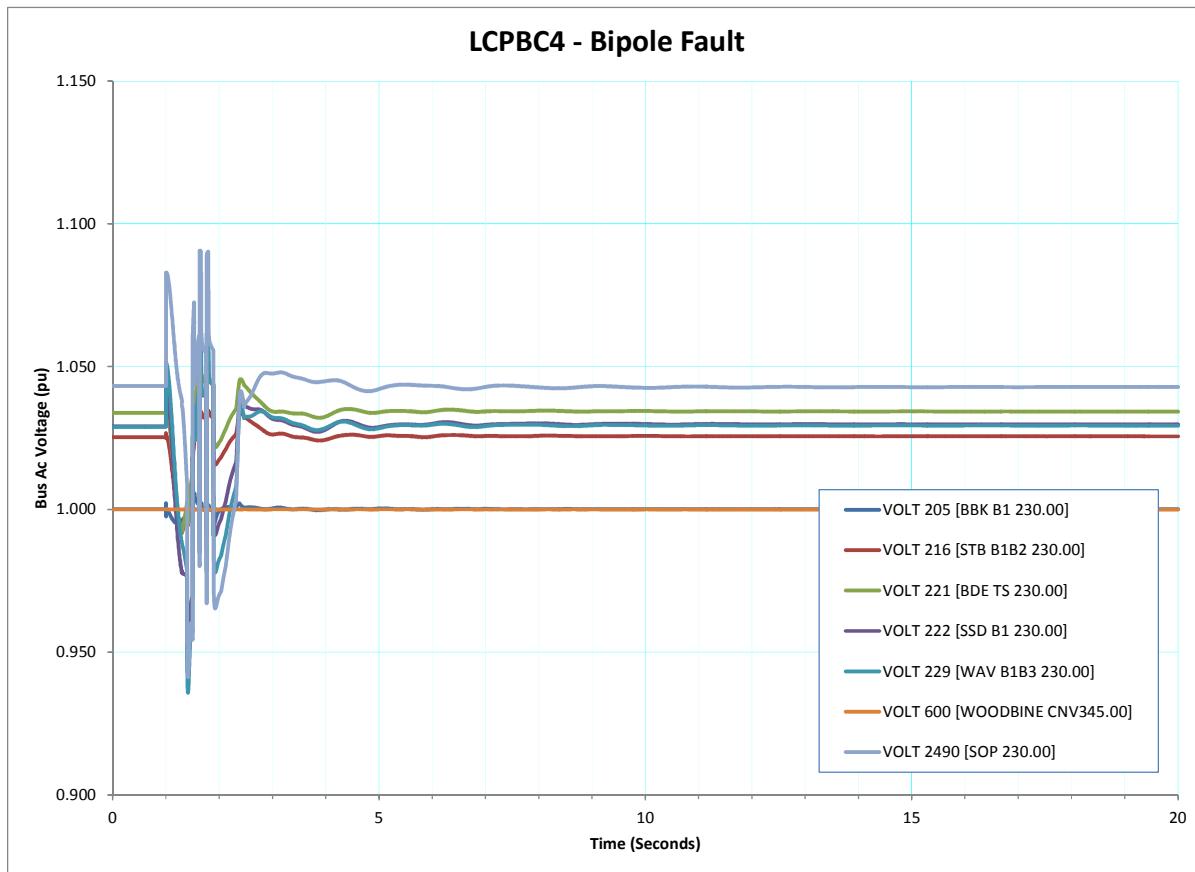
Figure 14 - LCPBC4 - Bipole Fault - Bus Ac Voltage (pu)

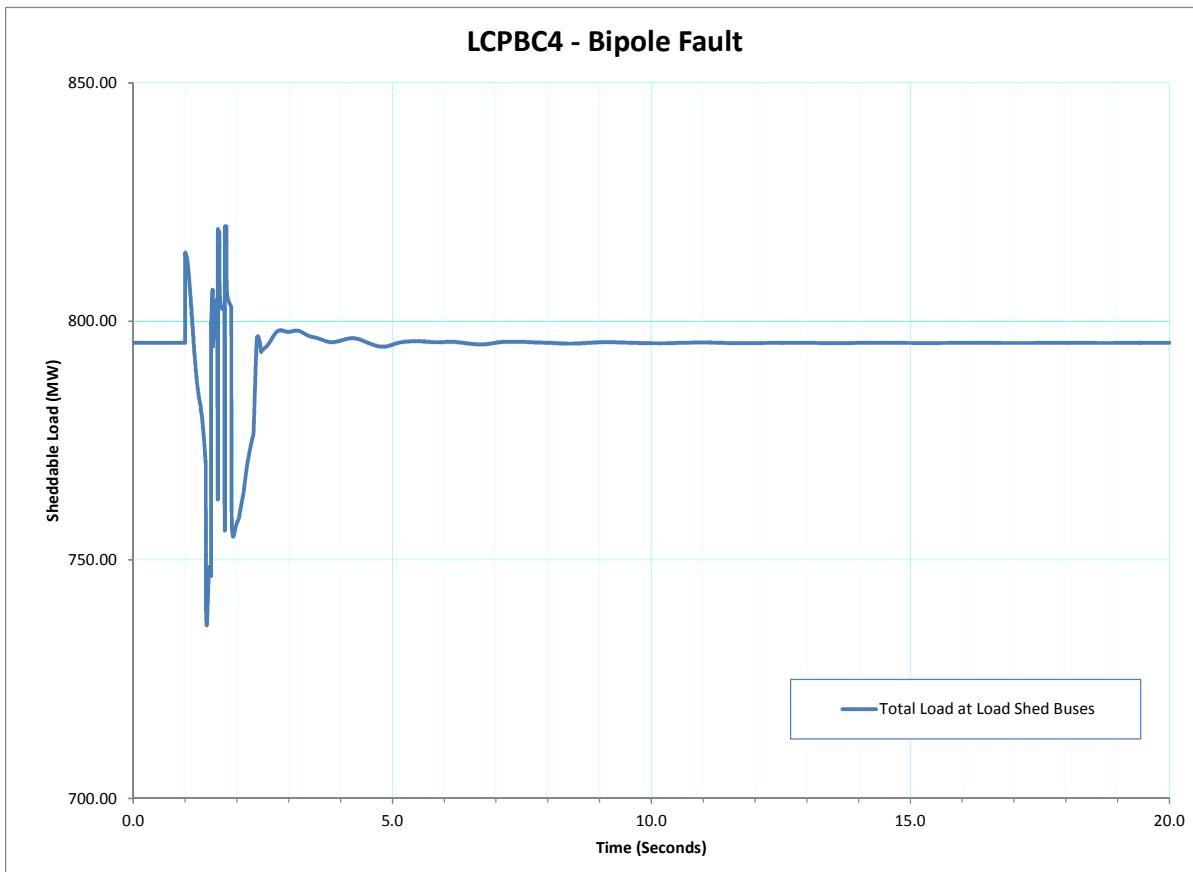
Figure 15 - LCPBC4 - Bipole Fault - Sheddable Load (MW)

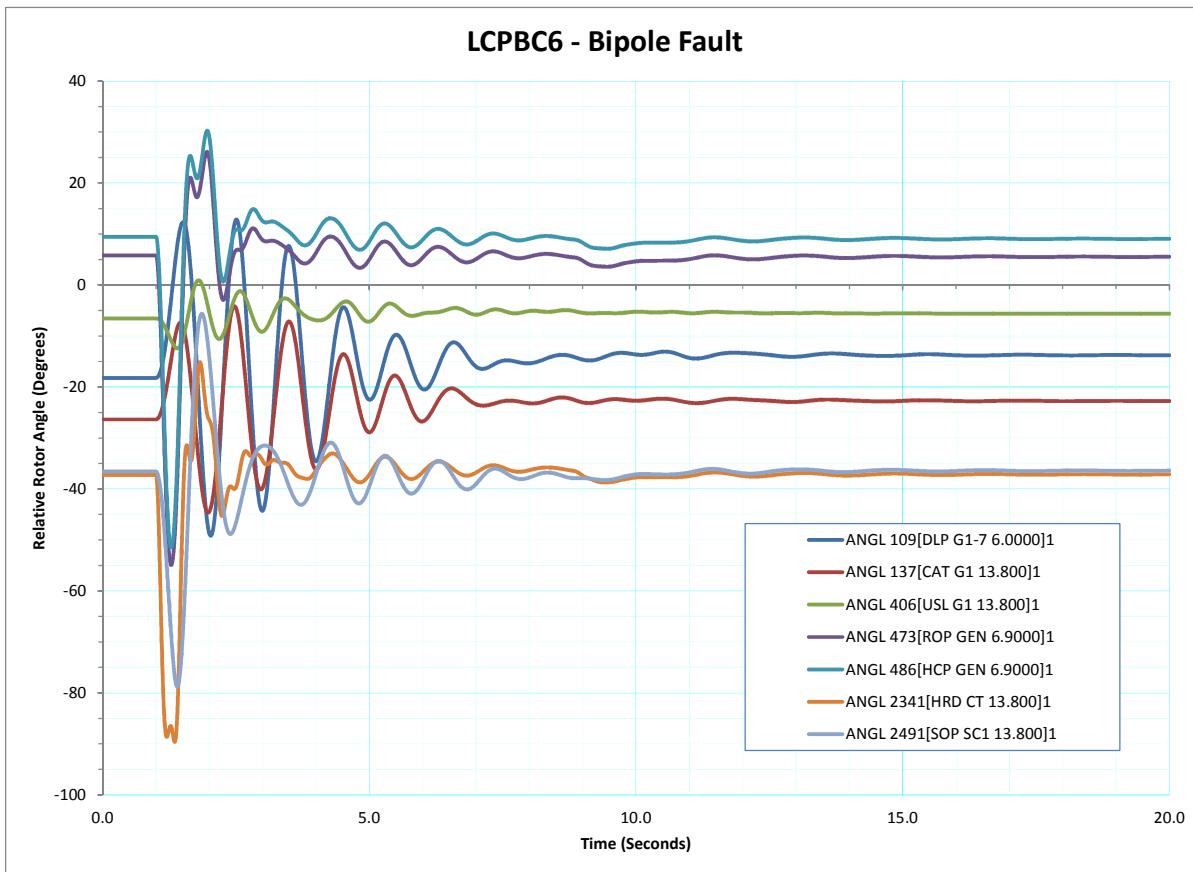
Figure 16 - LCPBC6 - Bipole Fault - Relative Rotor Angle (Degrees)

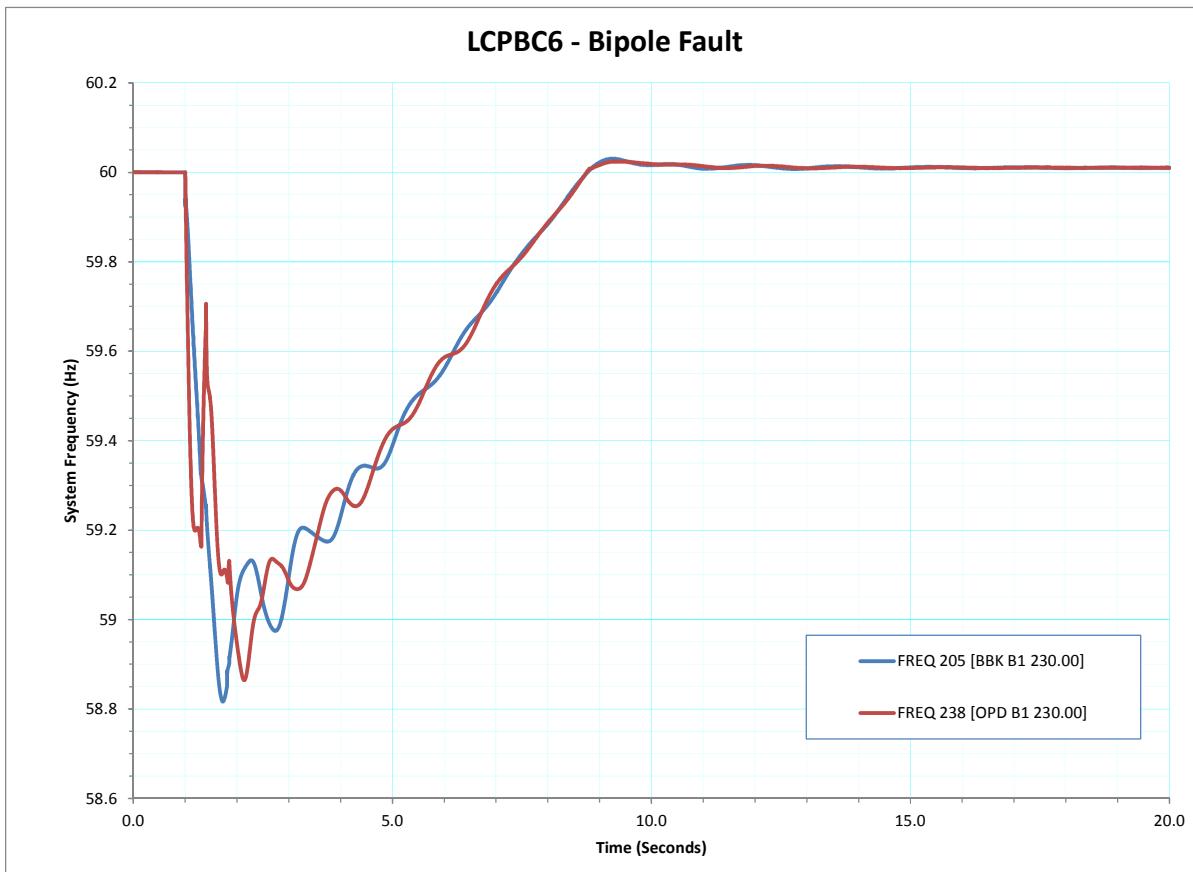
Figure 17 - LCPBC6 - Bipole Fault - System Frequency (Hz)

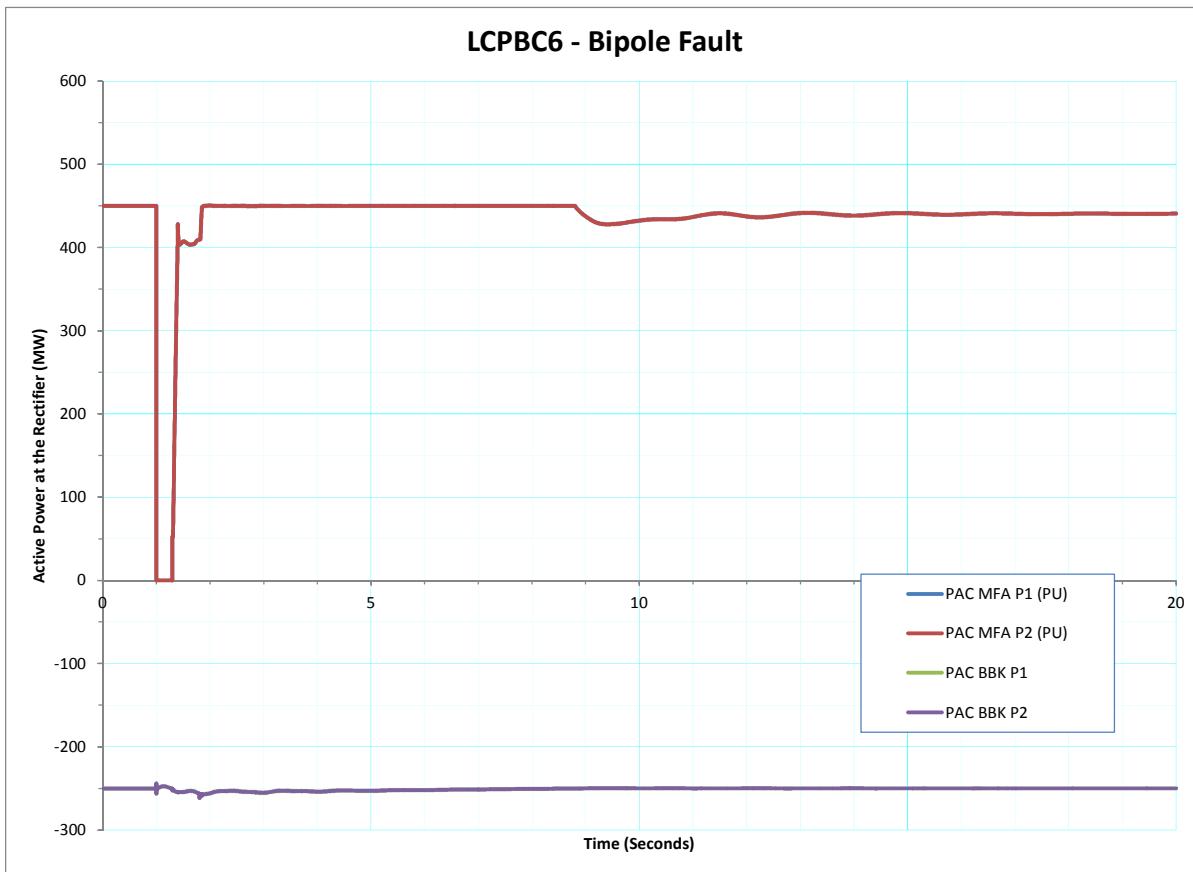
Figure 18 - LCPBC6 - Bipole Fault - Active Power at the Rectifier (MW)

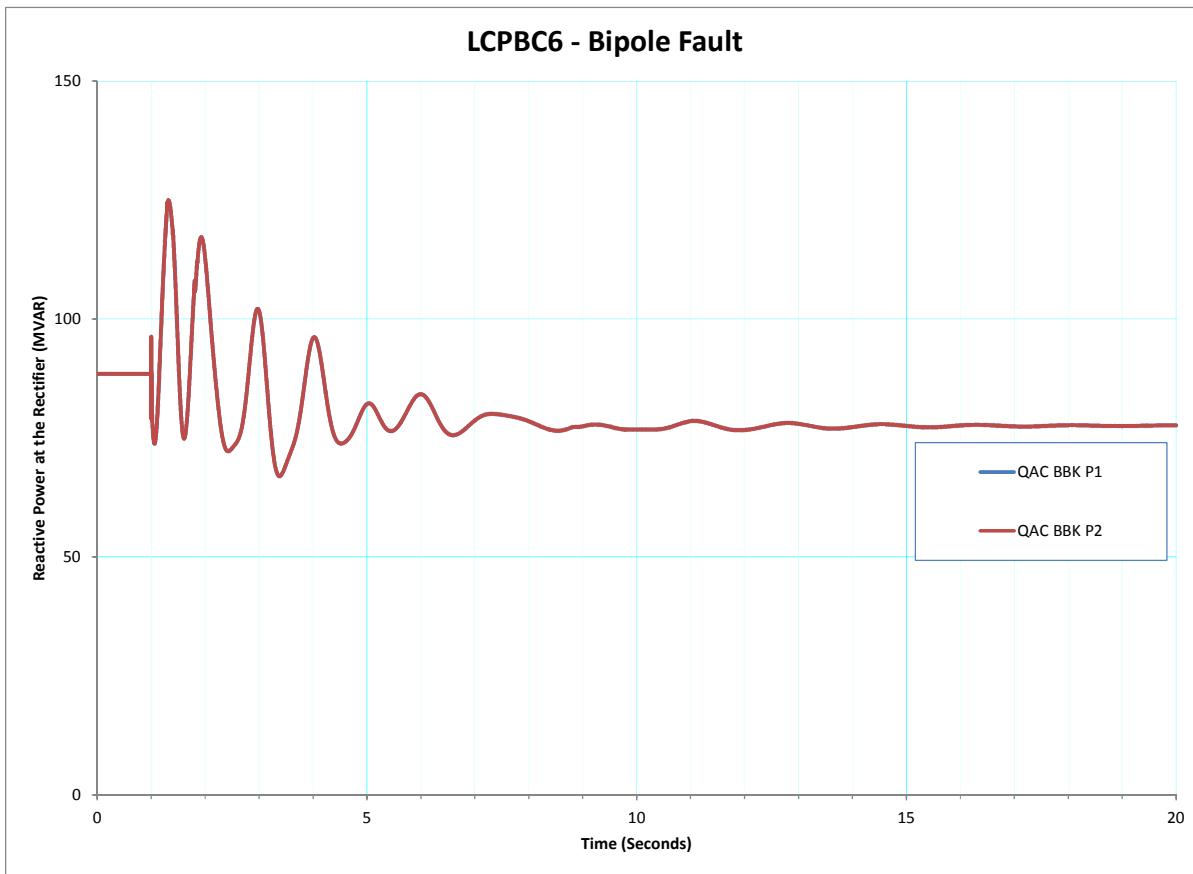
Figure 19 - LCPBC6 - Bipole Fault - Reactive Power at the Rectifier (MVAR)

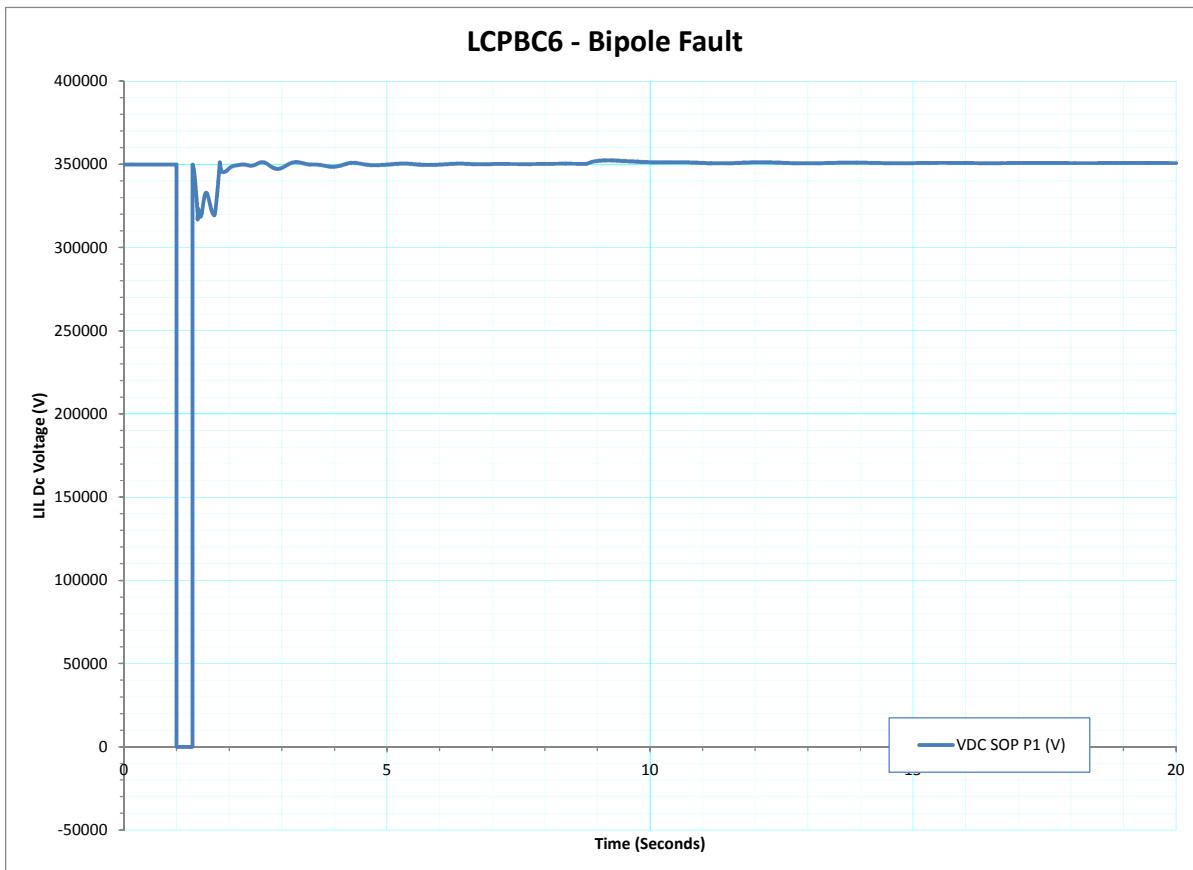
Figure 20 - LCPBC6 - Bipole Fault - LIL Dc Voltage (V)

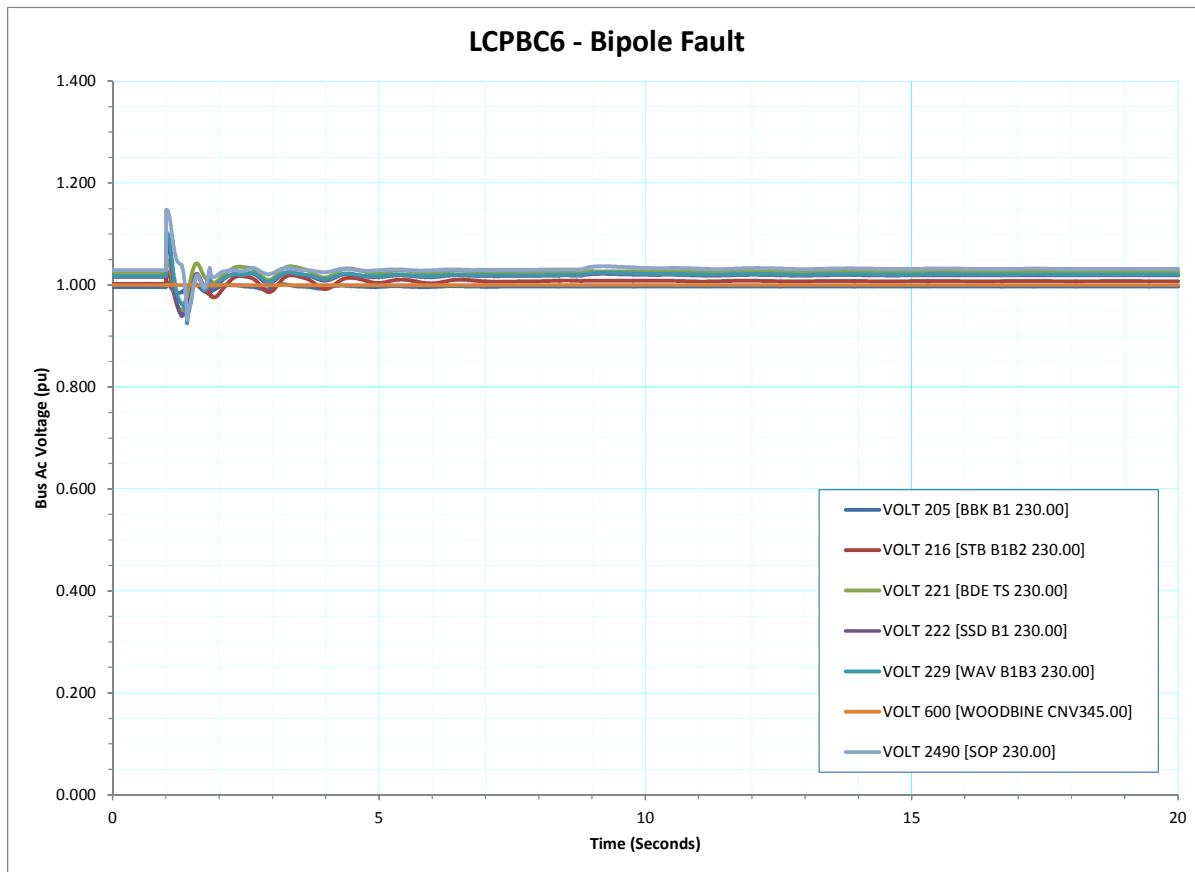
Figure 21 - LCPBC6 - Bipole Fault - Bus Ac Voltage (pu)
