MARITIME LINK PRELIMINARY INTERCONNECTION STUDY

Newfoundland and Labrador Hydro

July 2014

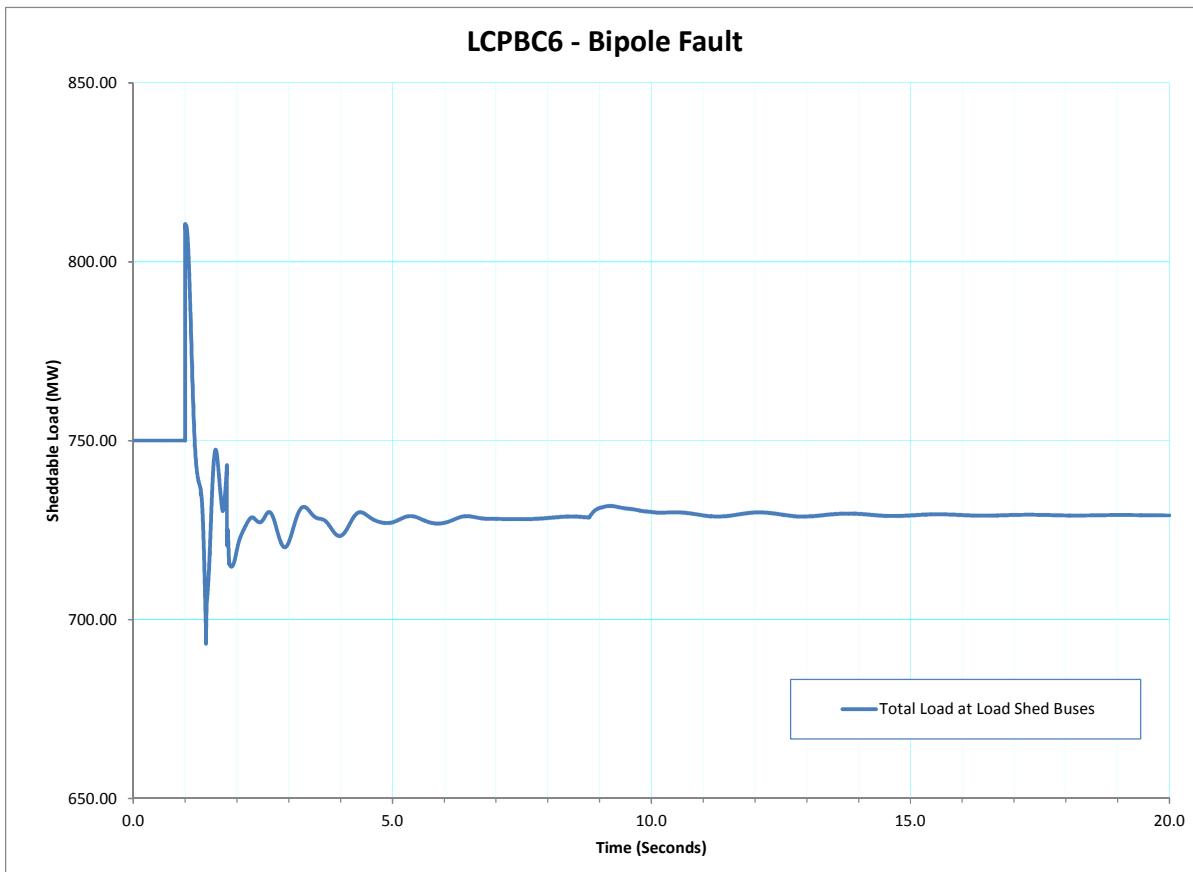
Figure 22 - LCPBC6 - Bipole Fault - Shedtable Load (MW)

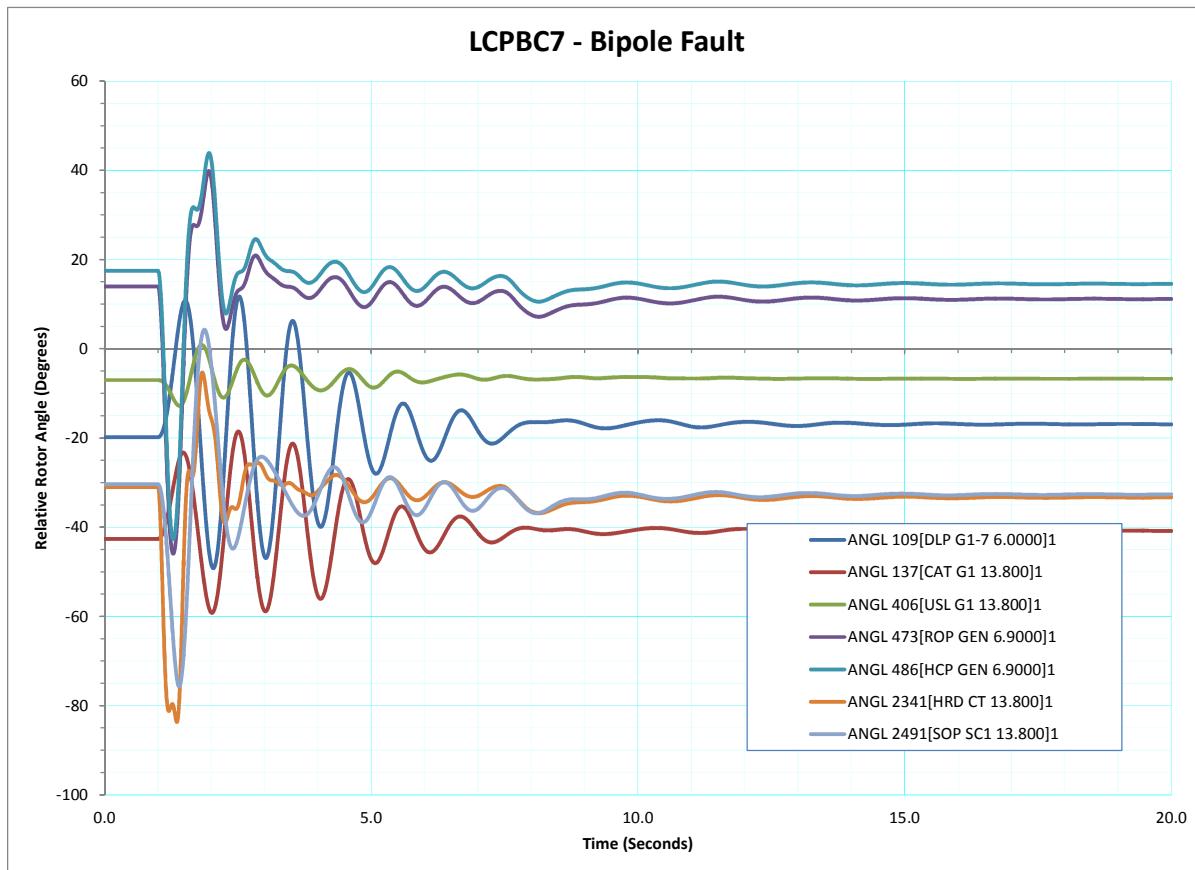
Figure 23 - LCPBC7 - Bipole Fault - Relative Rotor Angle (Degrees)

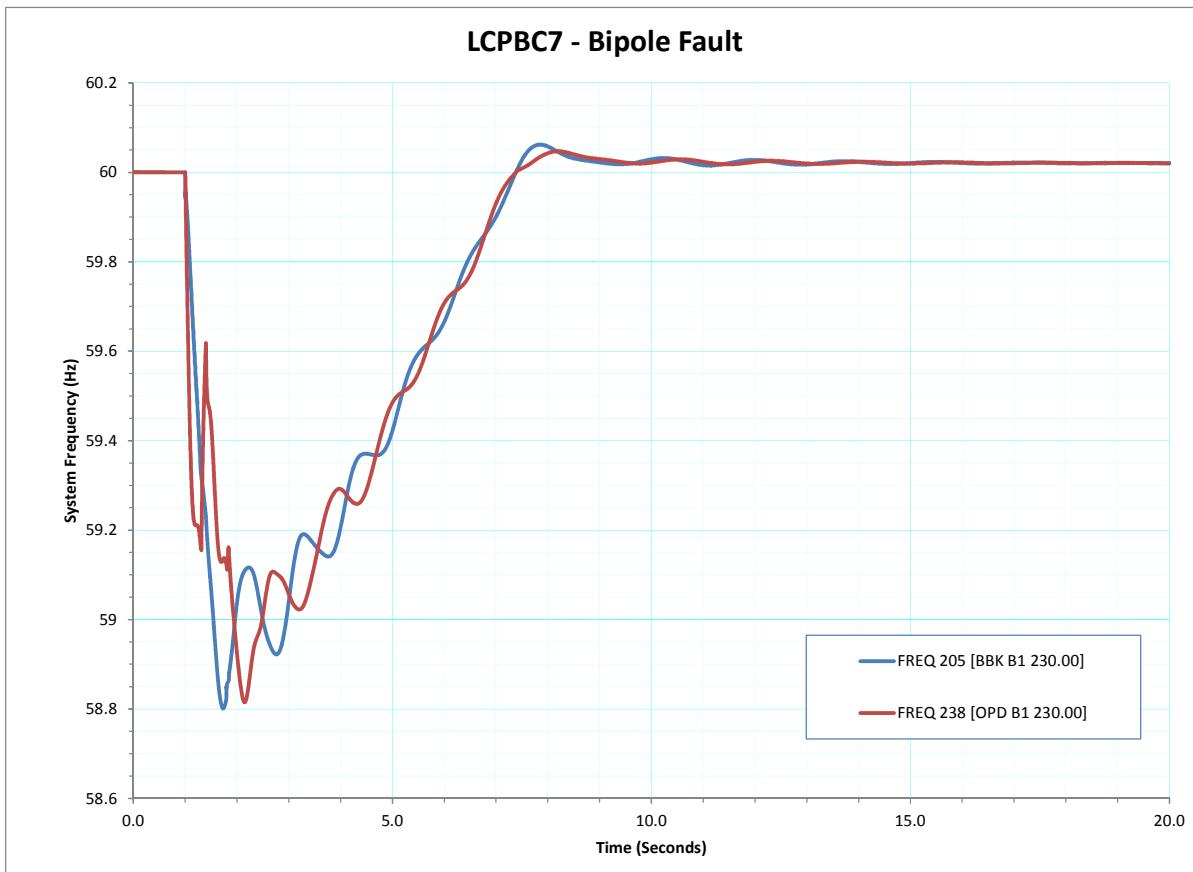
Figure 24 - LCPBC7 - Bipole Fault - System Frequency (Hz)

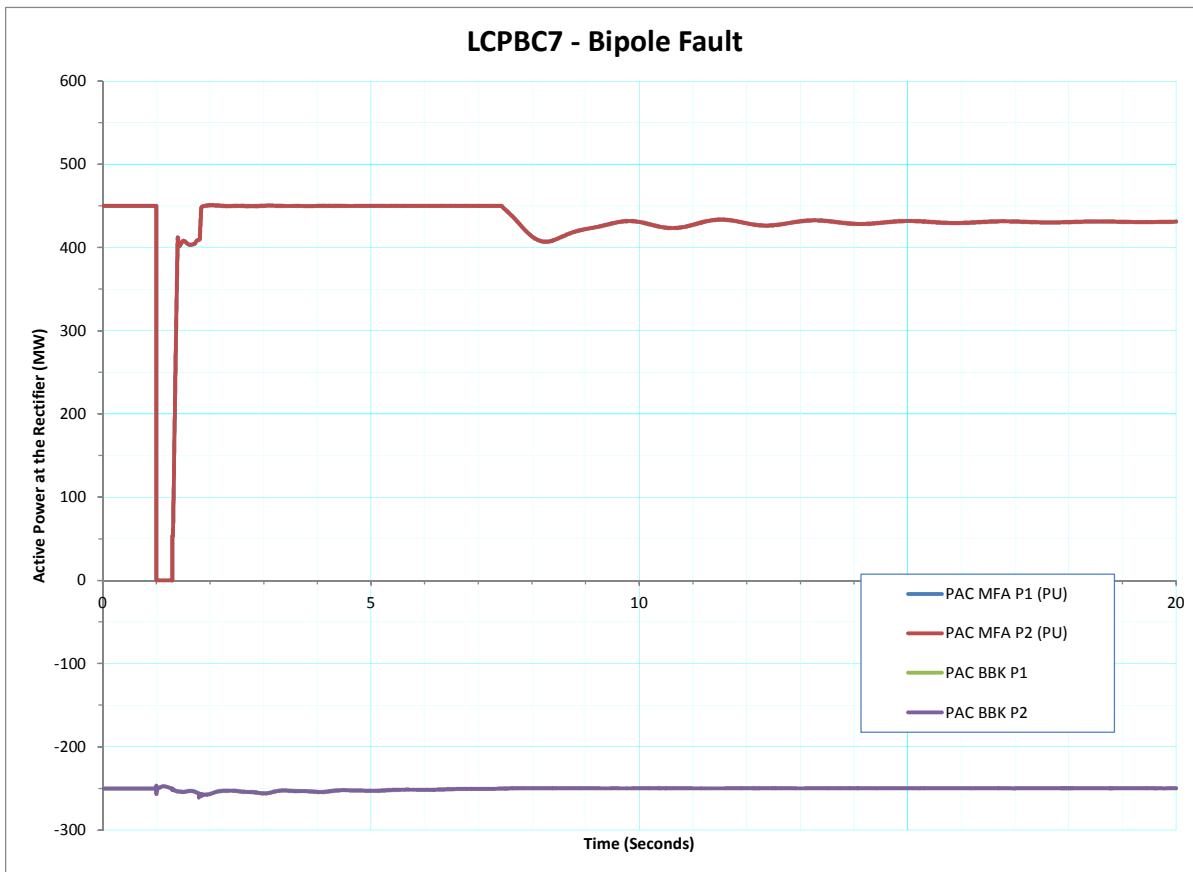
Figure 25 - LCPBC7 - Bipole Fault - Active Power at the Rectifier (MW)

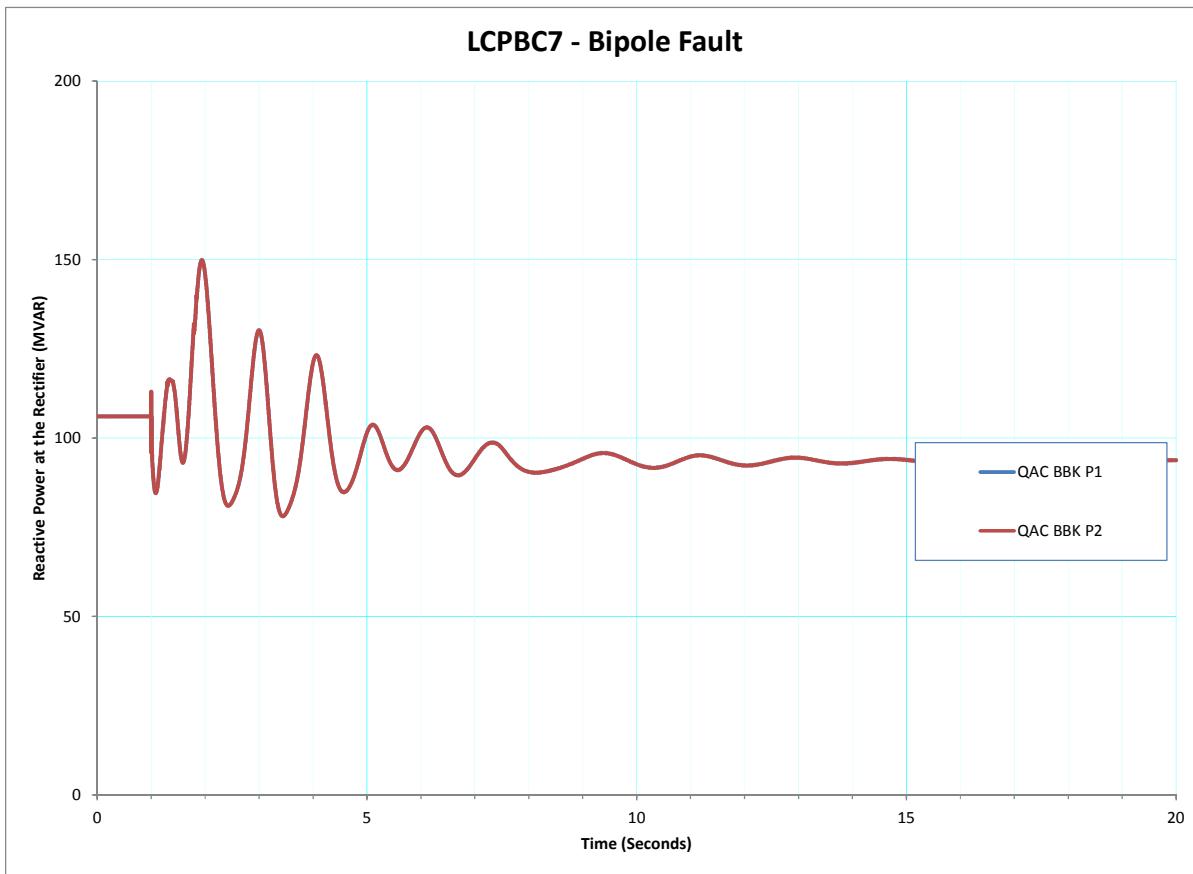
Figure 26 - LCPBC7 - Bipole Fault - Reactive Power at the Rectifier (MVAR)

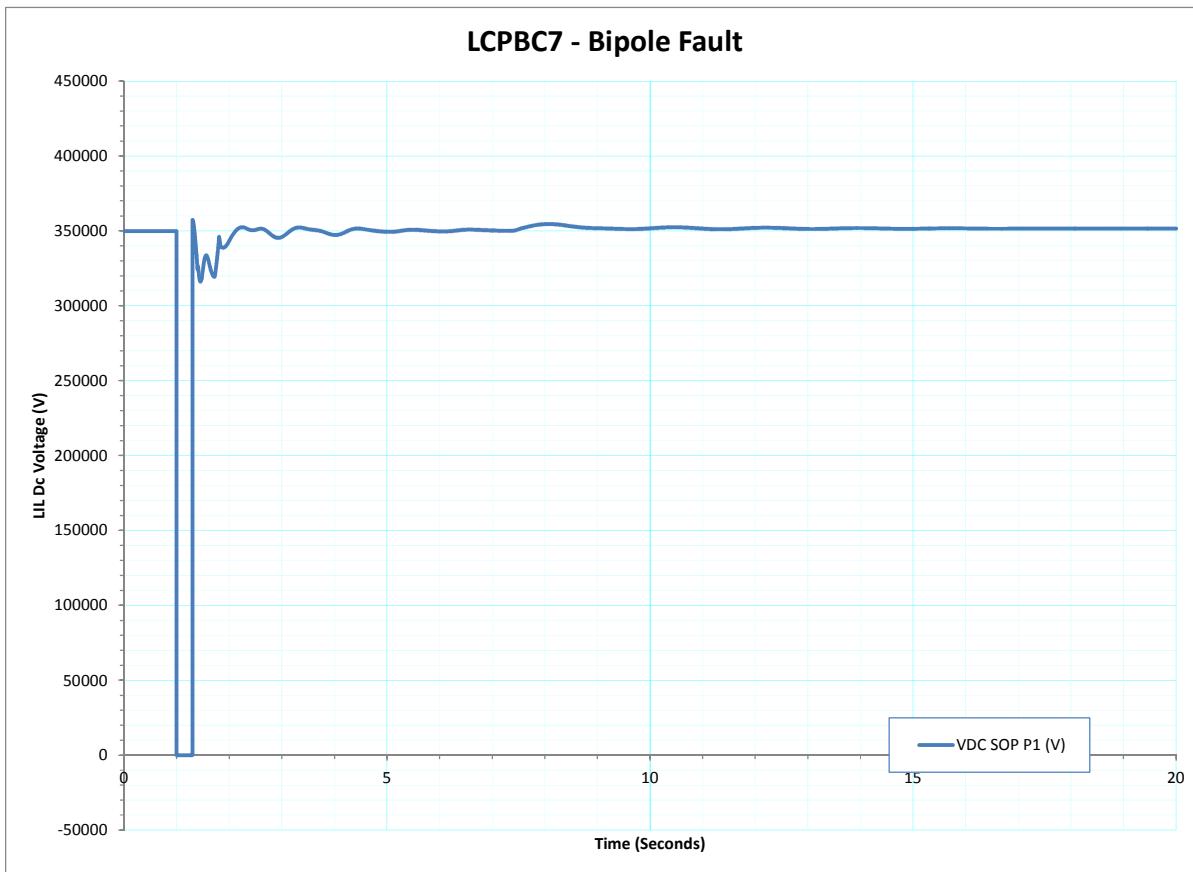
Figure 27 - LCPBC7 - Bipole Fault - LIL Dc Voltage (V)

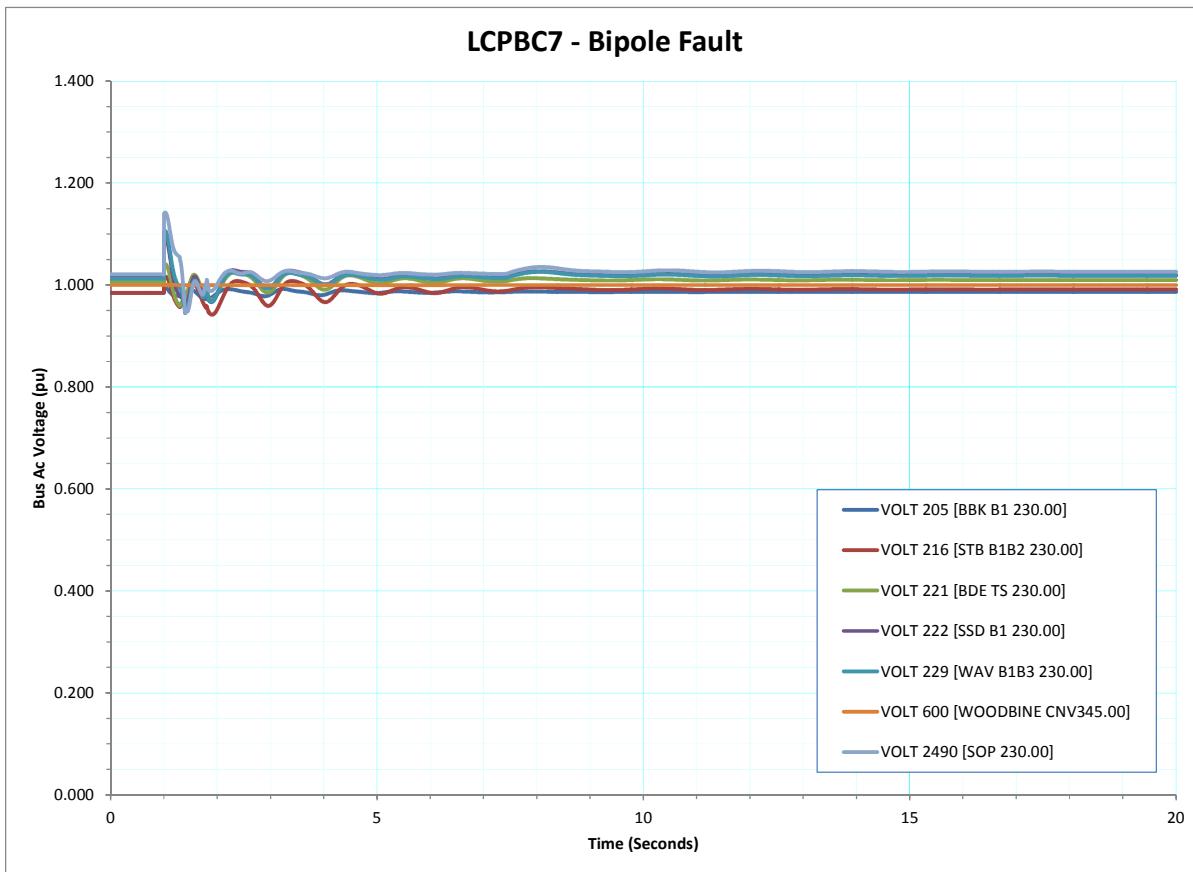
Figure 28 - LCPBC7 - Bipole Fault - Bus Ac Voltage (pu)

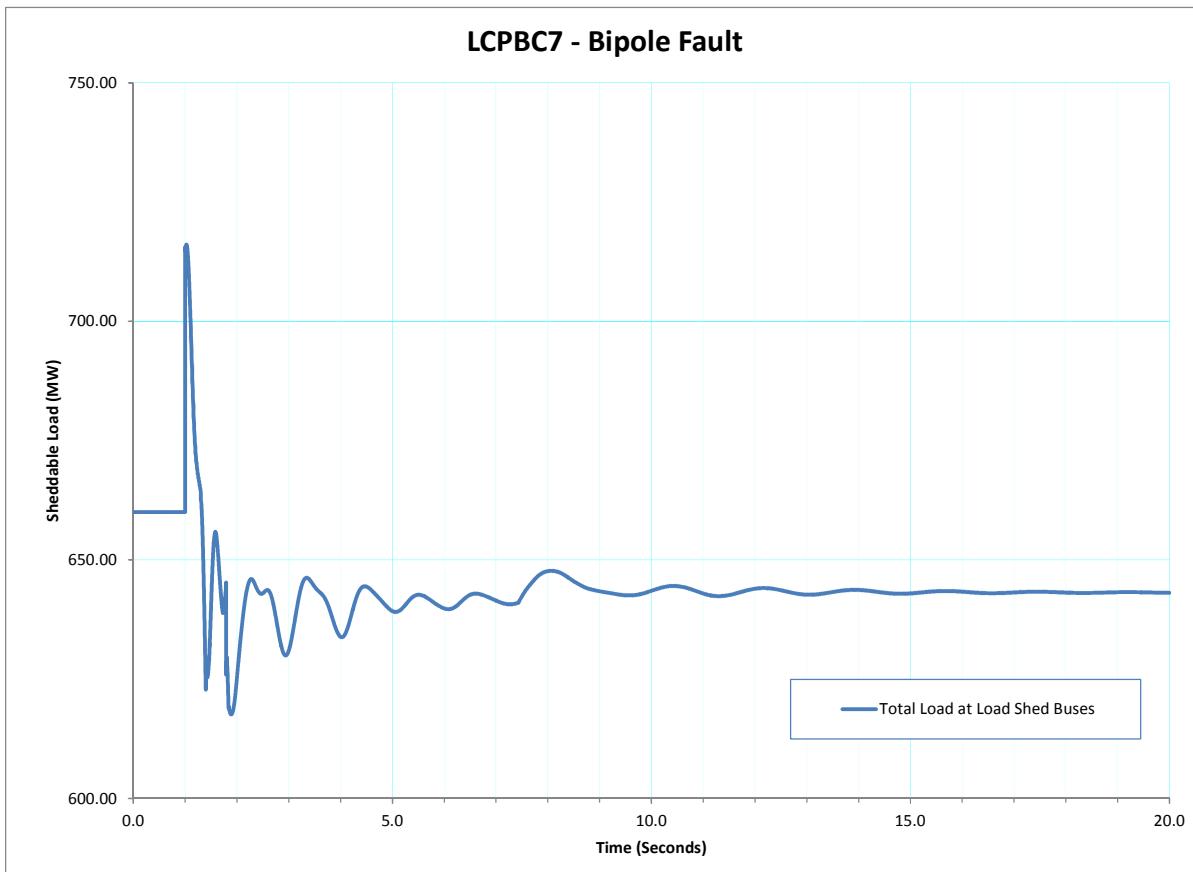
Figure 29 - LCPBC7 - Bipole Fault - Shedtable Load (MW)

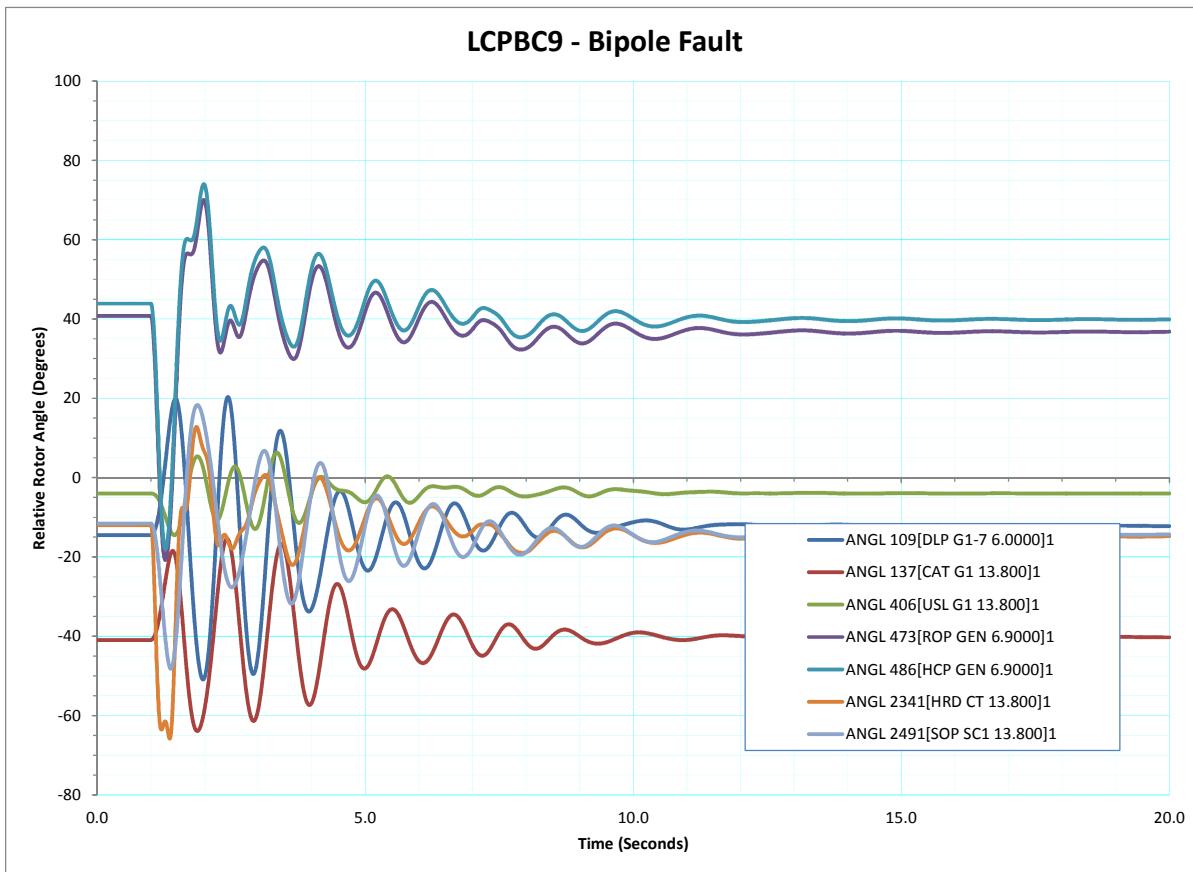
Figure 30 - LCPBC9 - Bipole Fault - Relative Rotor Angle (Degrees)

It should be noted that the curtailment of ML export resulted in an undamped system response for BC9. However, this base case represents an extreme operating scenario where both the LIL and ML are operating at rated capacity while minimal generation is dispatched within the Interconnected Island System. To avoid such a response, operating limitations must be defined for the system. Such limitations will ensure that extreme operating conditions are avoided and that system performance is acceptable.

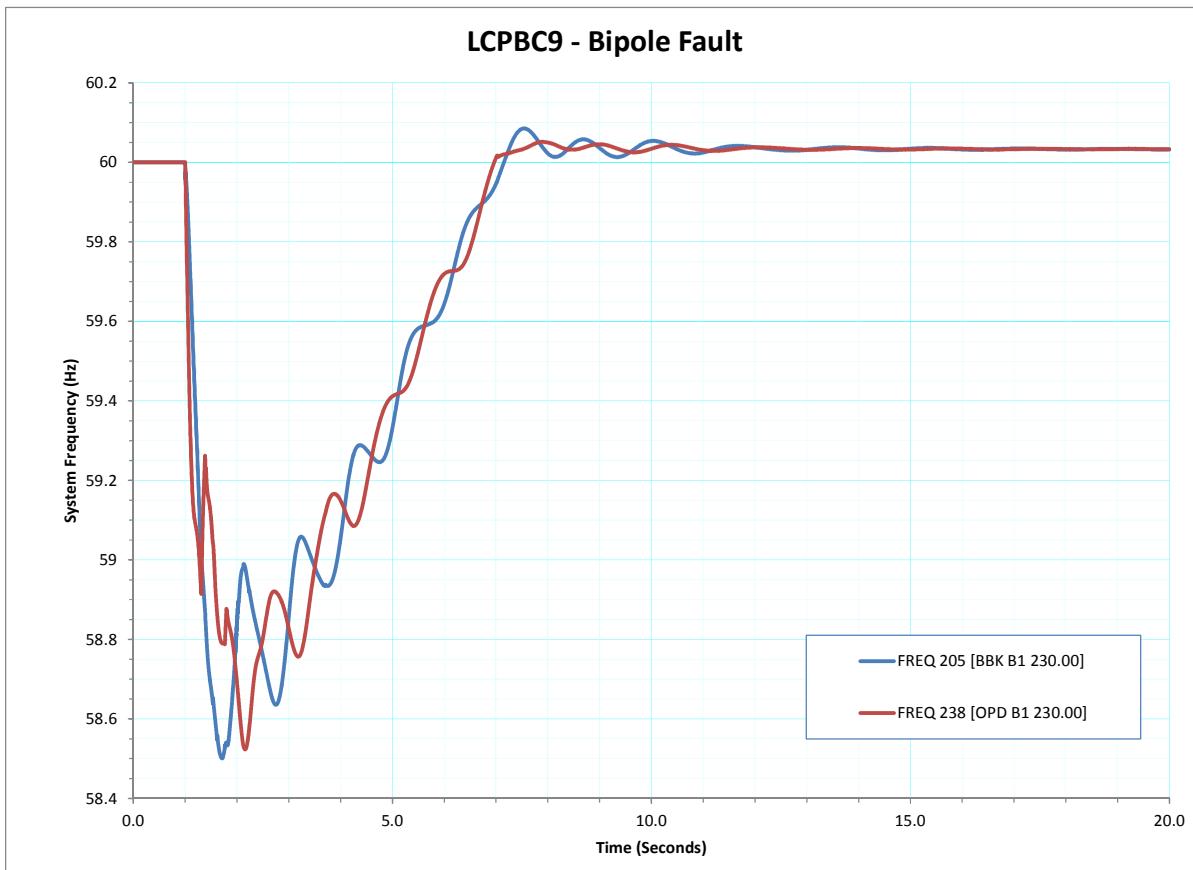
Figure 31 - LCPBC9 - Bipole Fault - System Frequency (Hz)

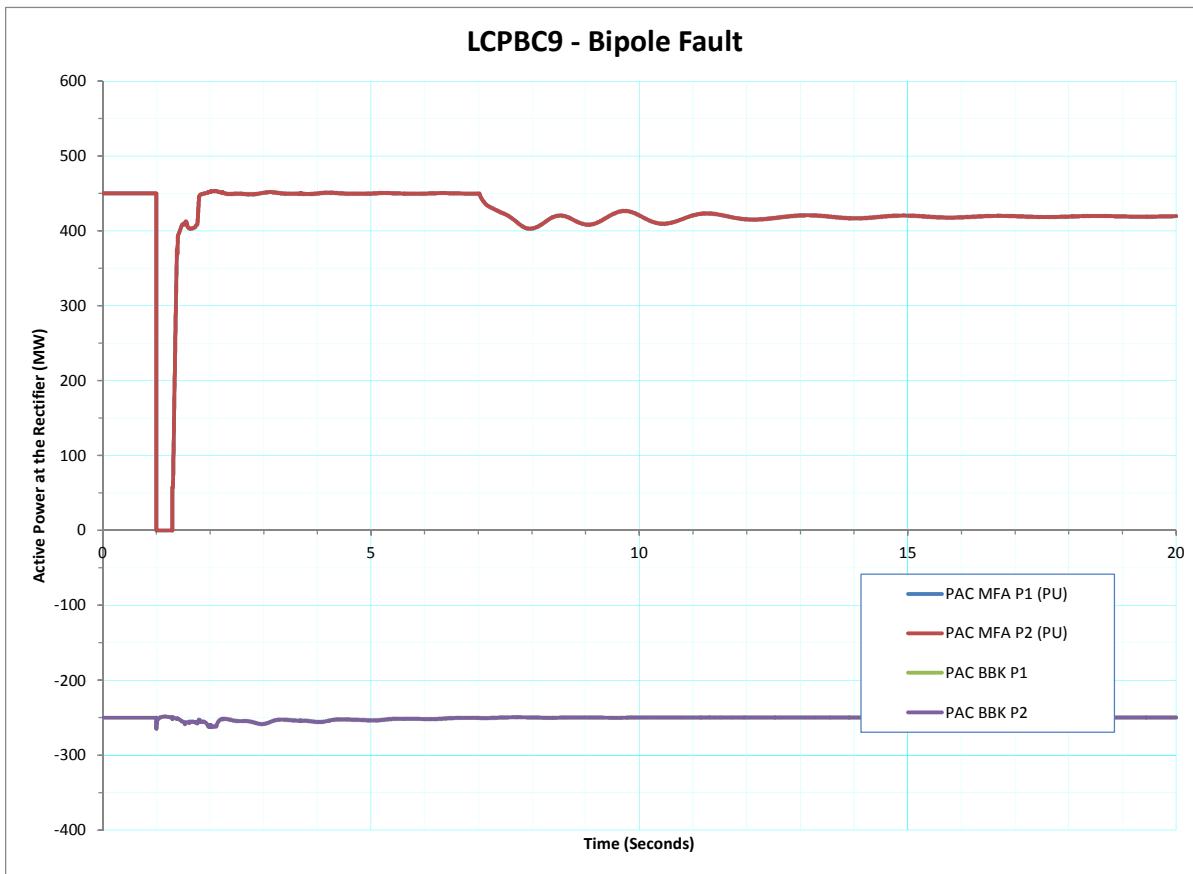
Figure 32 - LCPBC9 - Bipole Fault - Active Power at the Rectifier (MW)

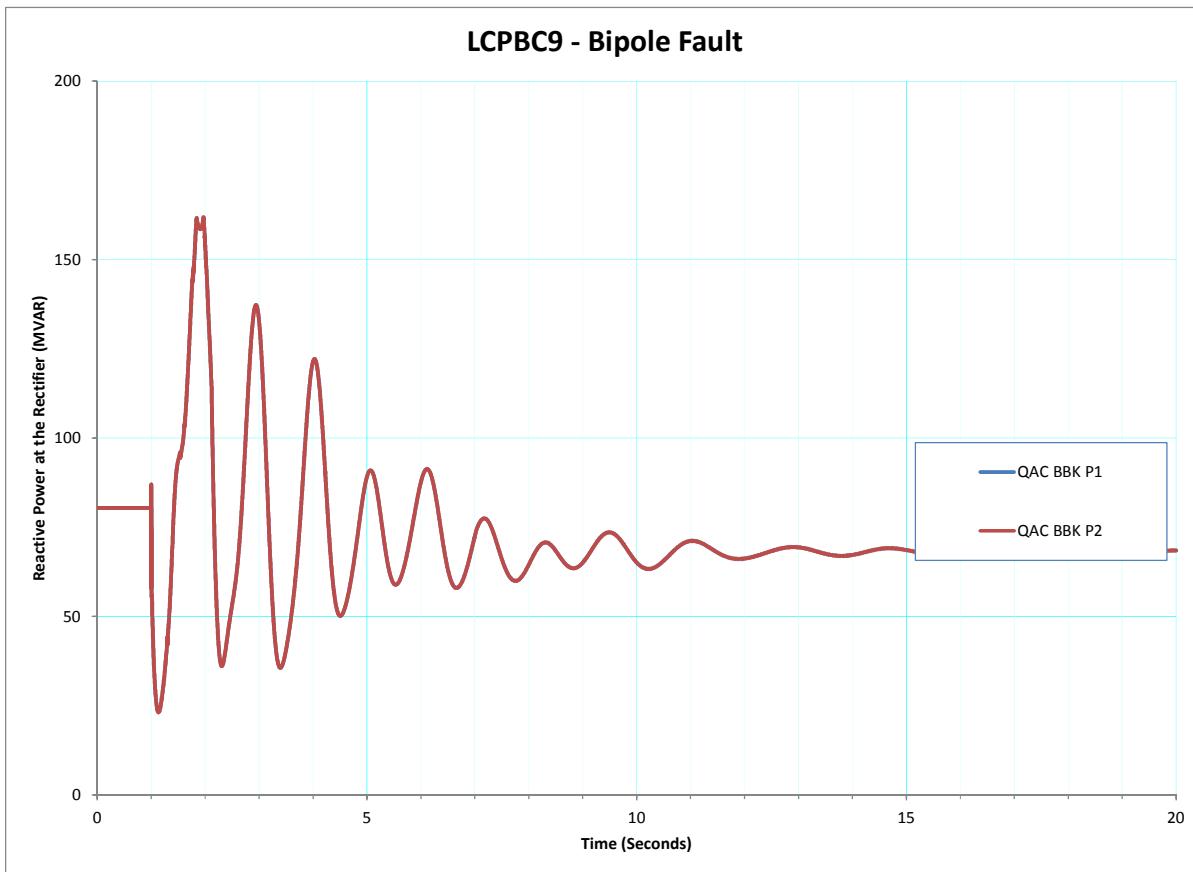
Figure 33 - LCPBC9 - Bipole Fault - Reactive Power at the Rectifier (MVAR)

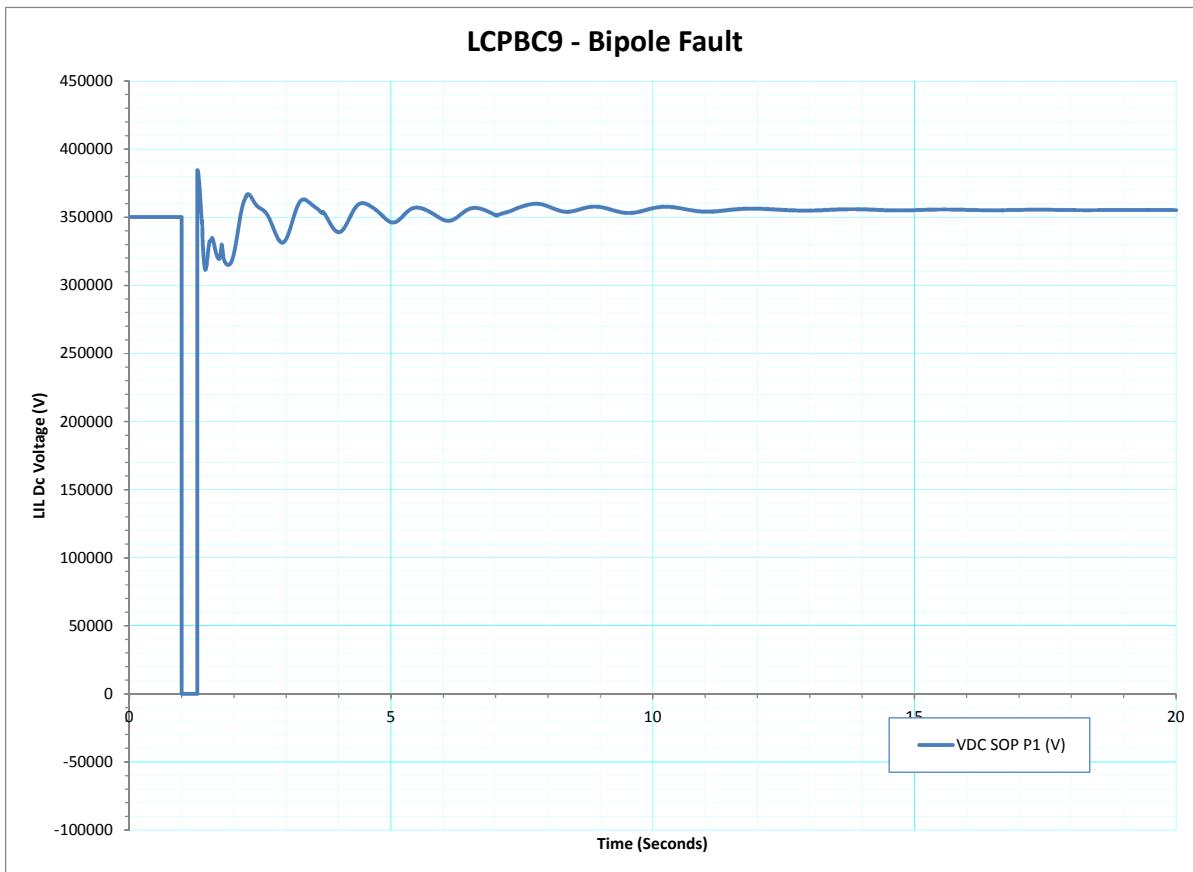
Figure 34 - LCPBC9 - Bipole Fault - LIL Dc Voltage (V)

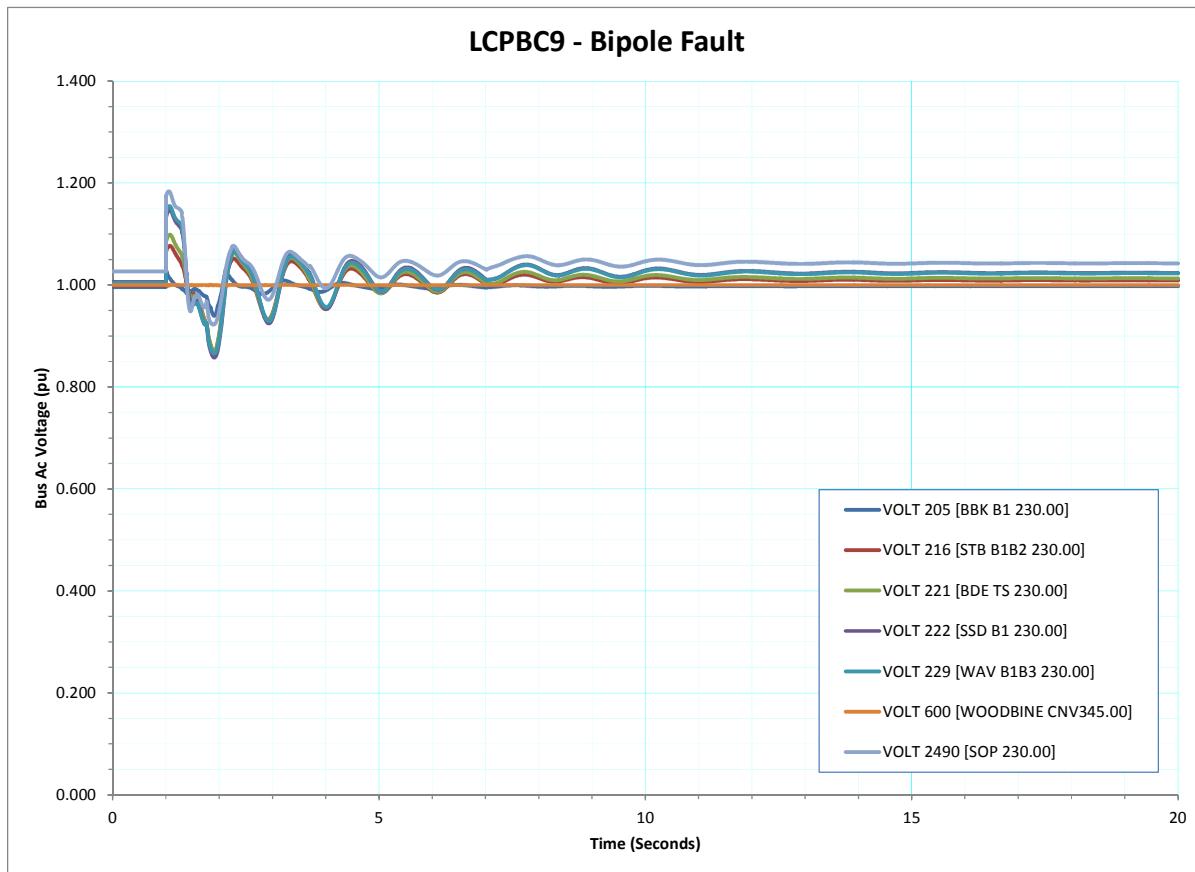
Figure 35 - LCPBC9 - Bipole Fault - Bus Ac Voltage (pu)

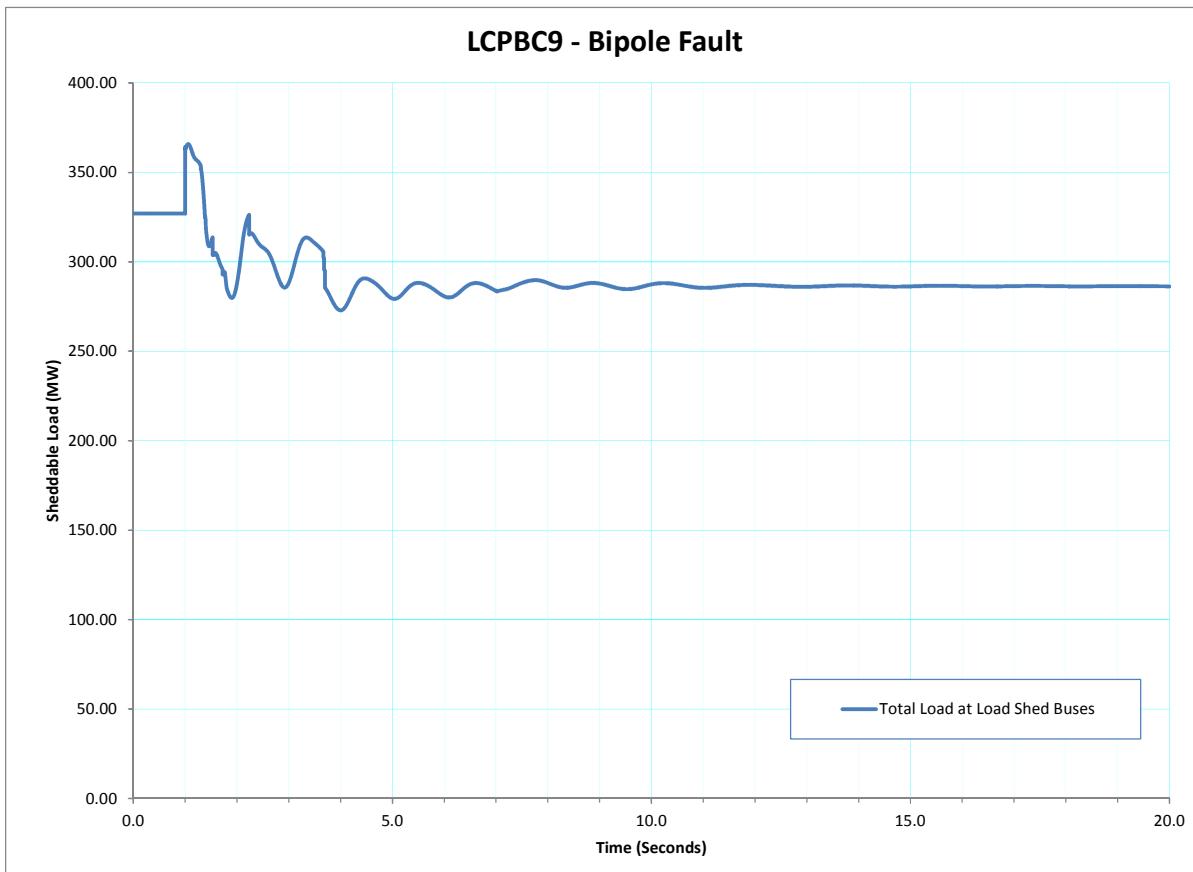
Figure 36 - LCPBC9 - Bipole Fault - Sheddable Load (MW)

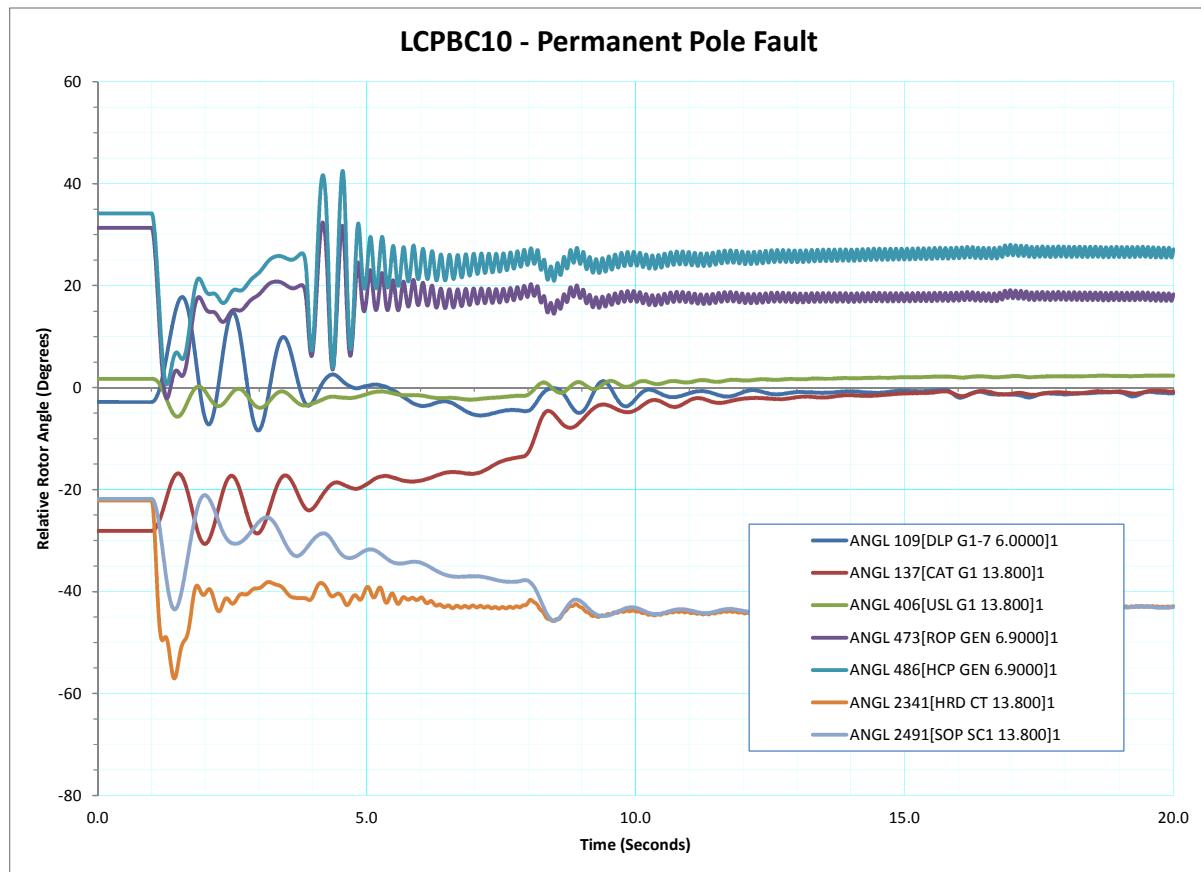
Instability was found in BC10, a monopolar cases where 550 MW is being imported over the LIL, while 500 MW is exported over the ML. This instability is illustrated in the figures below.

Figure 37 - LCPBC10 - Permanent Pole Fault - Relative Rotor Angle (Degrees)

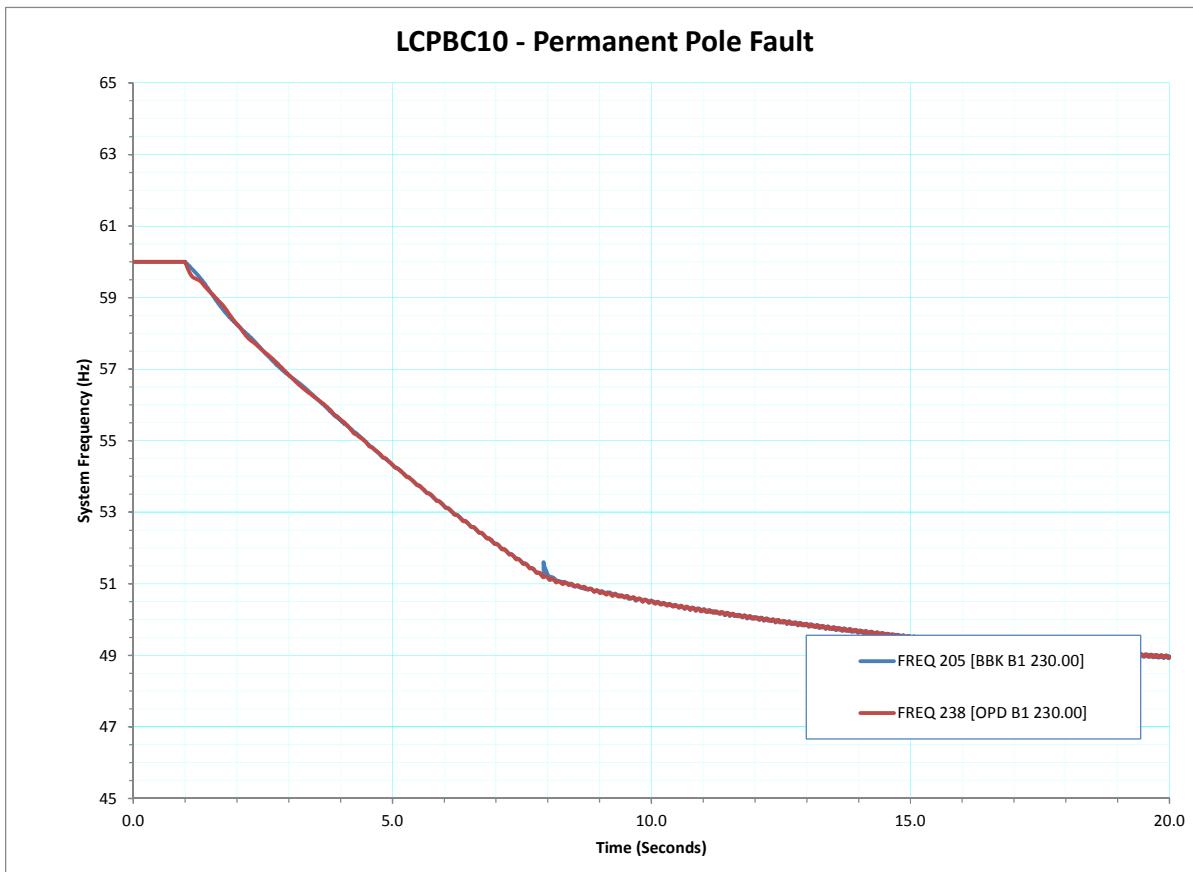
Figure 38 - LCPBC10 - Permanent Pole Fault - System Frequency (Hz)

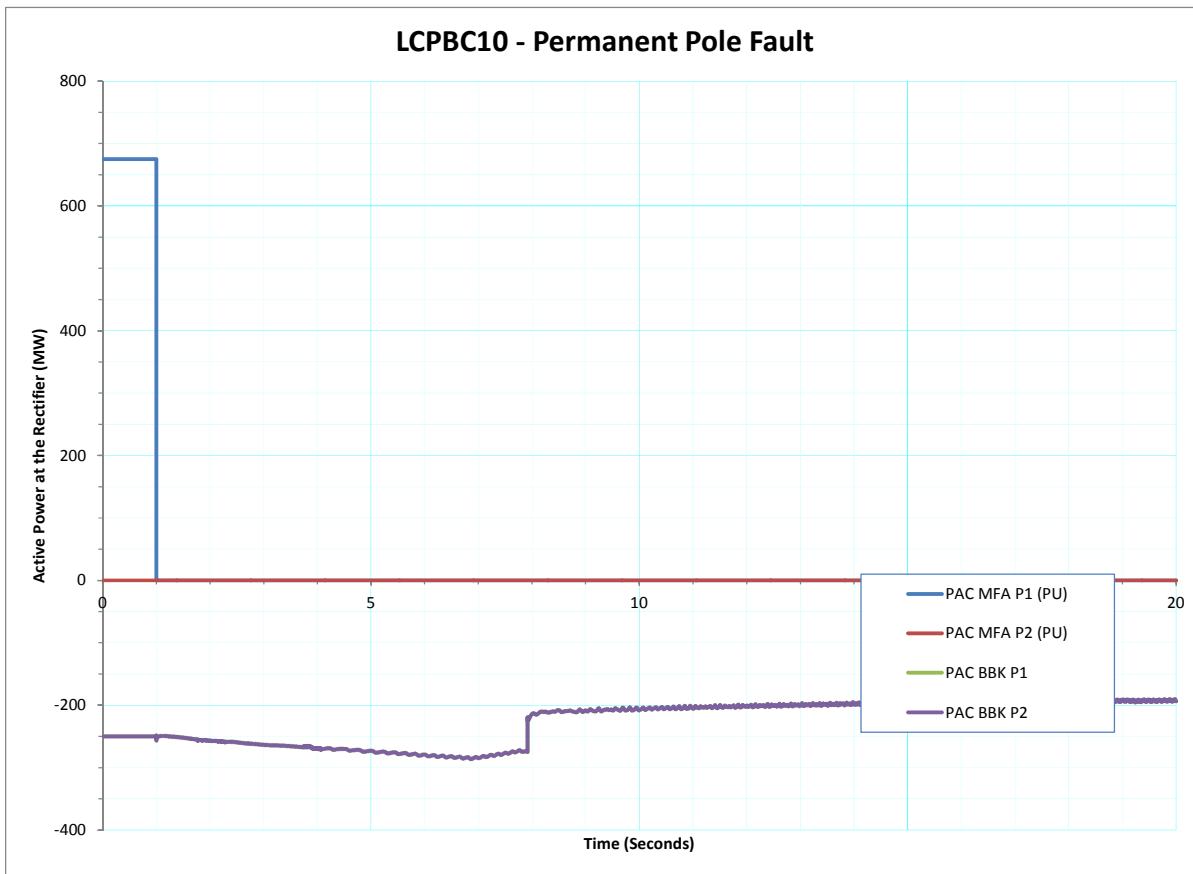
Figure 39 - LCPBC10 - Permanent Pole Fault - Active Power at the Rectifier (MW)

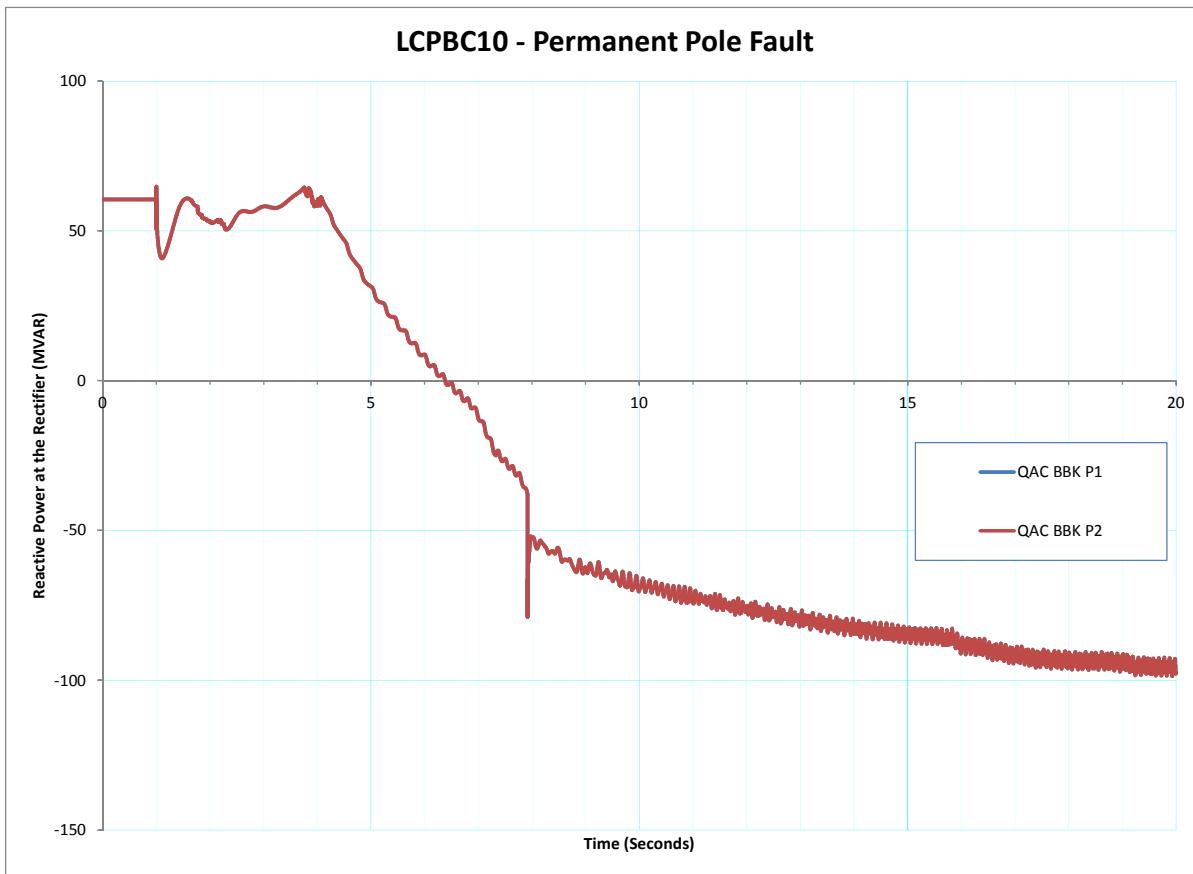
Figure 40 - LCPBC10 - Permanent Pole Fault - Reactive Power at the Rectifier (MVAR)

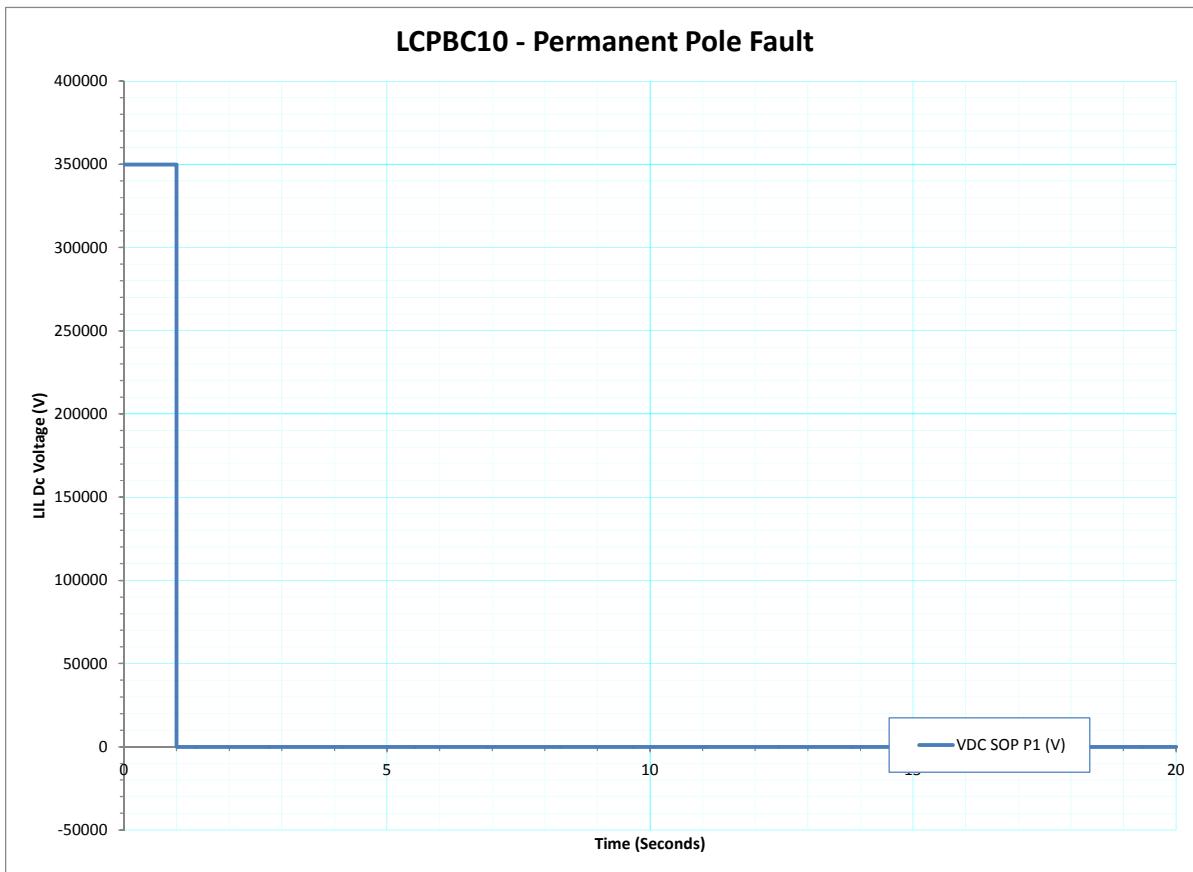
Figure 41 - LCPBC10 - Permanent Pole Fault - LIL Dc Voltage (V)

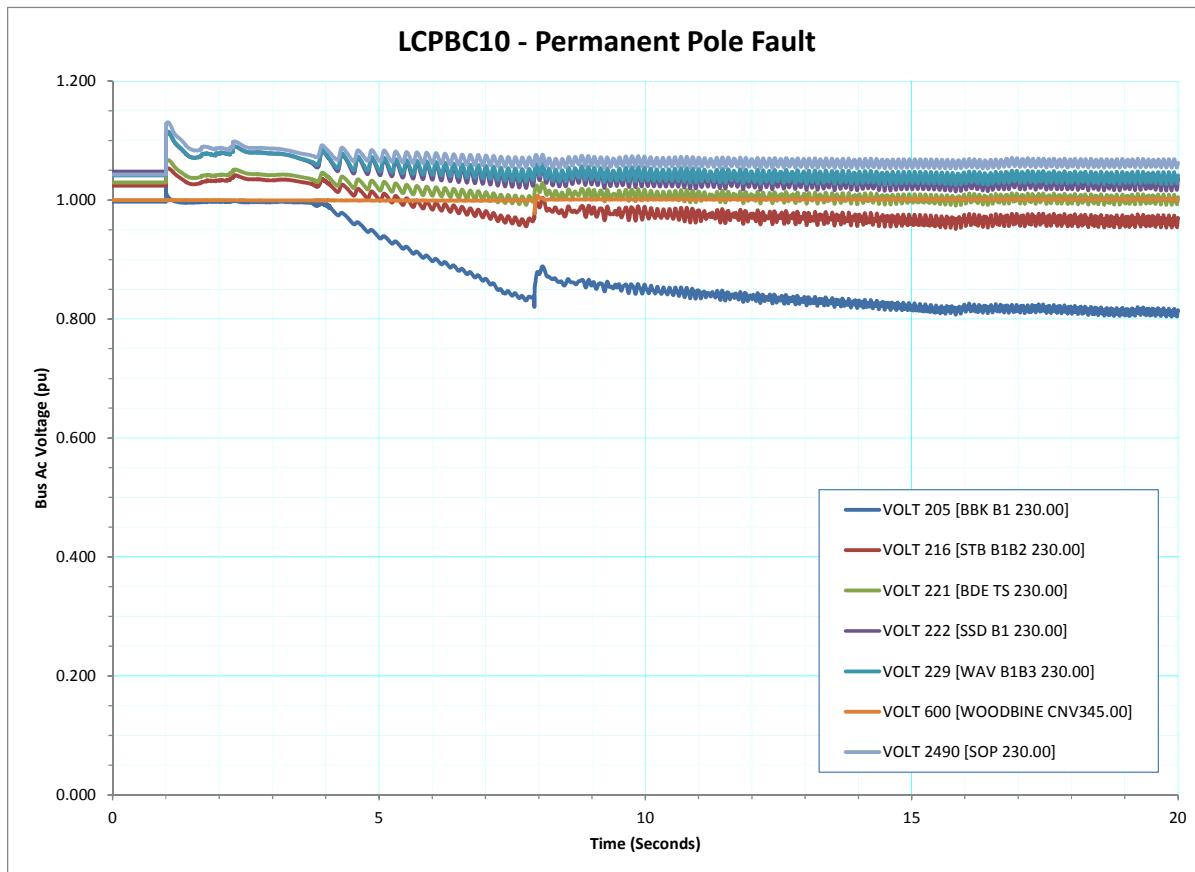
Figure 42 - LCPBC10 - Permanent Pole Fault - Bus Ac Voltage (pu)
