MARITIME LINK PRELIMINARY INTERCONNECTION STUDY

Newfoundland and Labrador Hydro

July 2014

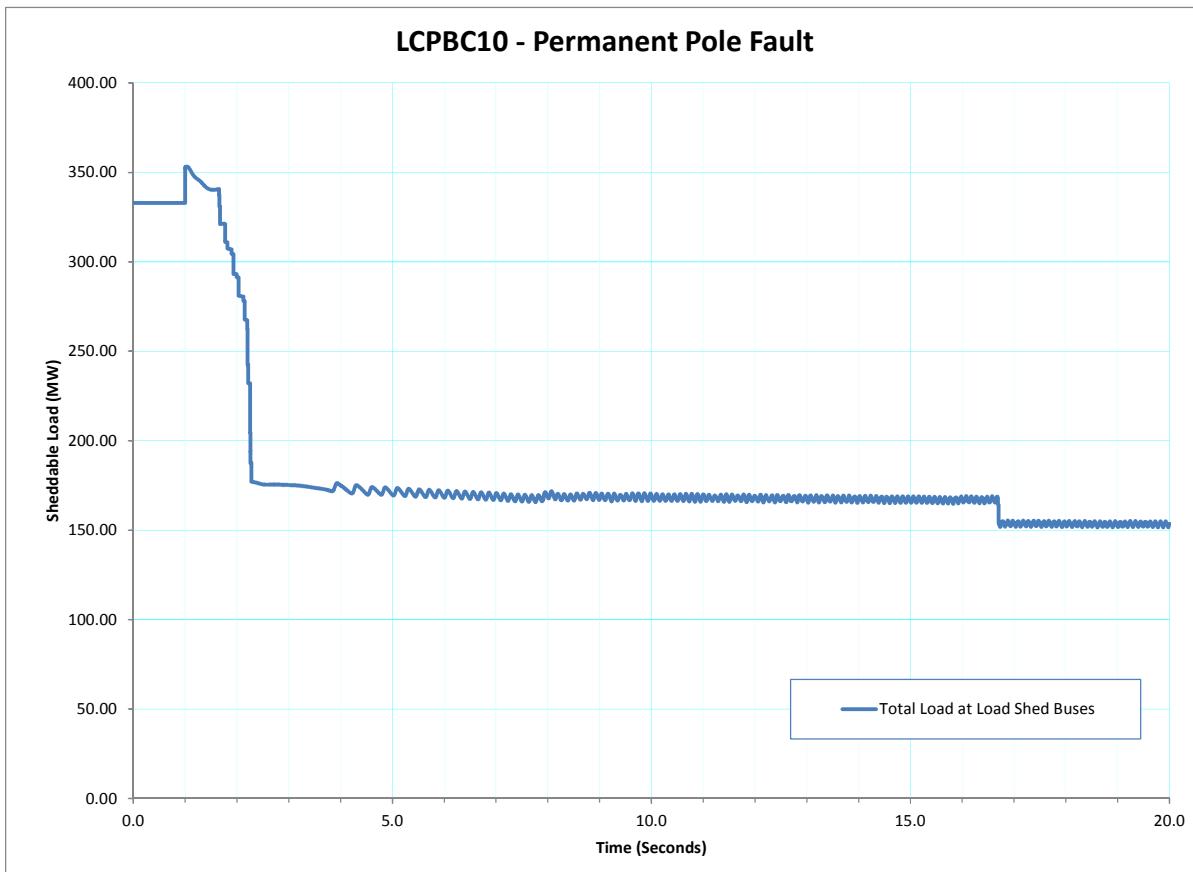
Instability was found in BC10, a monopolar cases where 550 MW is being imported over the LIL, while 500 MW is exported over the ML. This instability is illustrated in the figures below.

Figure 43 - LCPBC10 - Permanent Pole Fault - Shedtable Load (MW)

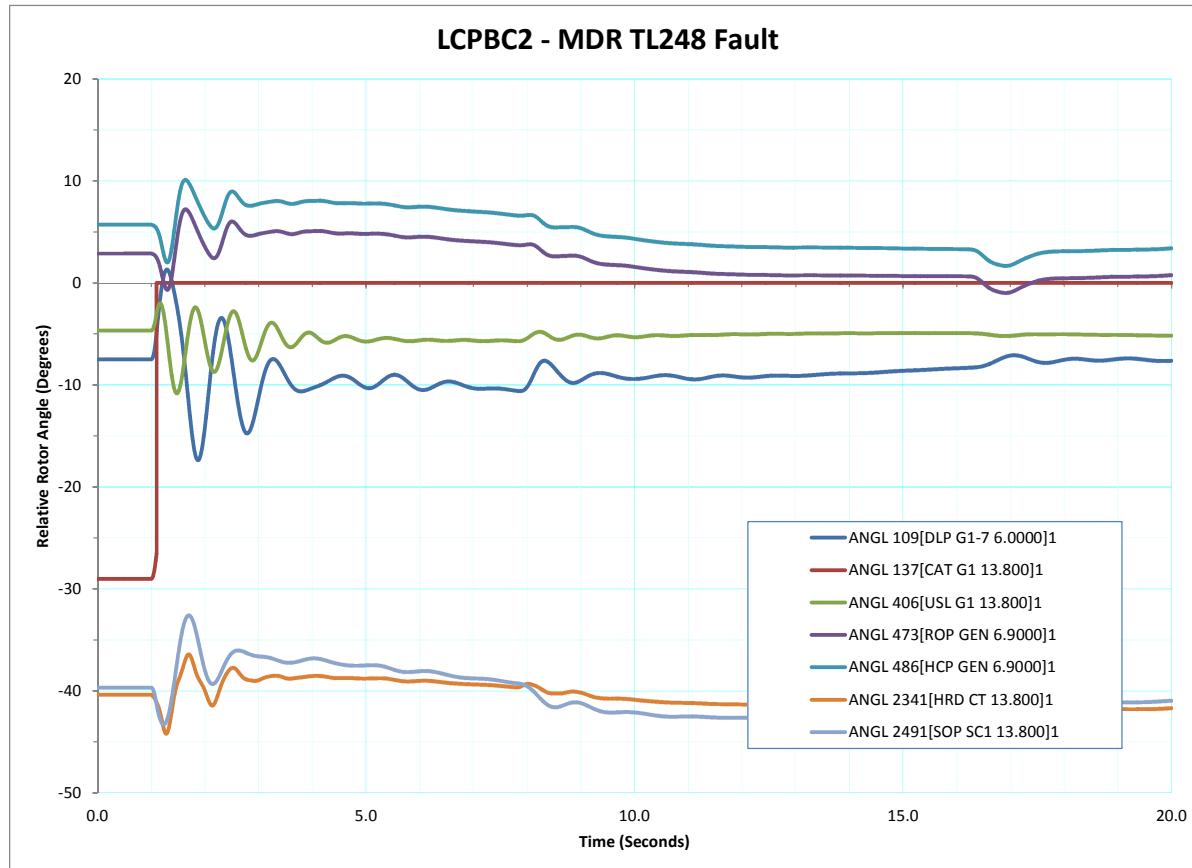
When the LIL is operating at or near rated capacity, the loss of generation within the Island Interconnected Transmission System results in UFLS. This was found to be the case for contingencies involving the loss of generation at USL, BDE, or the isolation of Cat Arm (CAT) generation during the tripping of TL248 and cross-tripping of TL247⁵. These cases are listed in Table 7 with examples provided in the figures below.

Figure 45 - LCPBC2 - MDR TL248 Fault - Relative Rotor Angle (Degrees)

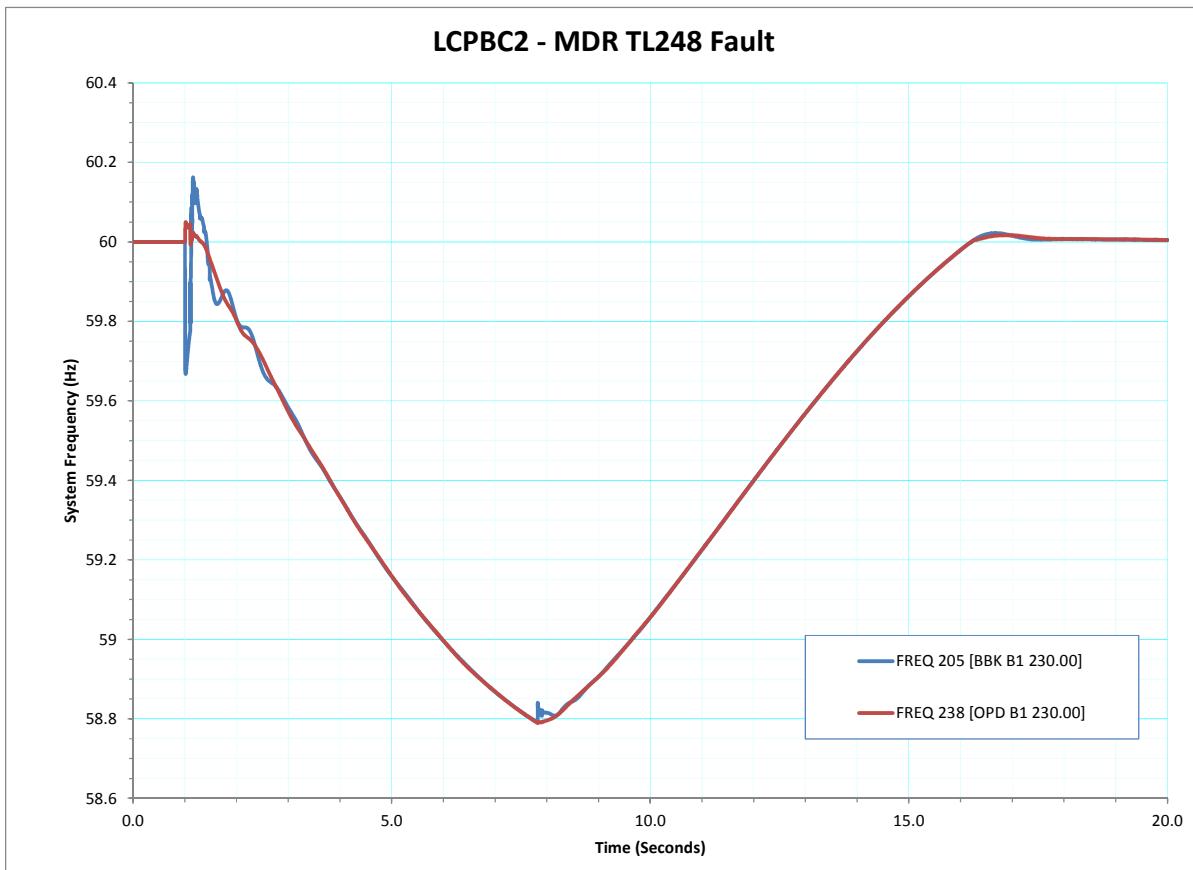
Figure 46 - LCPBC2 - MDR TL248 Fault - System Frequency (Hz)

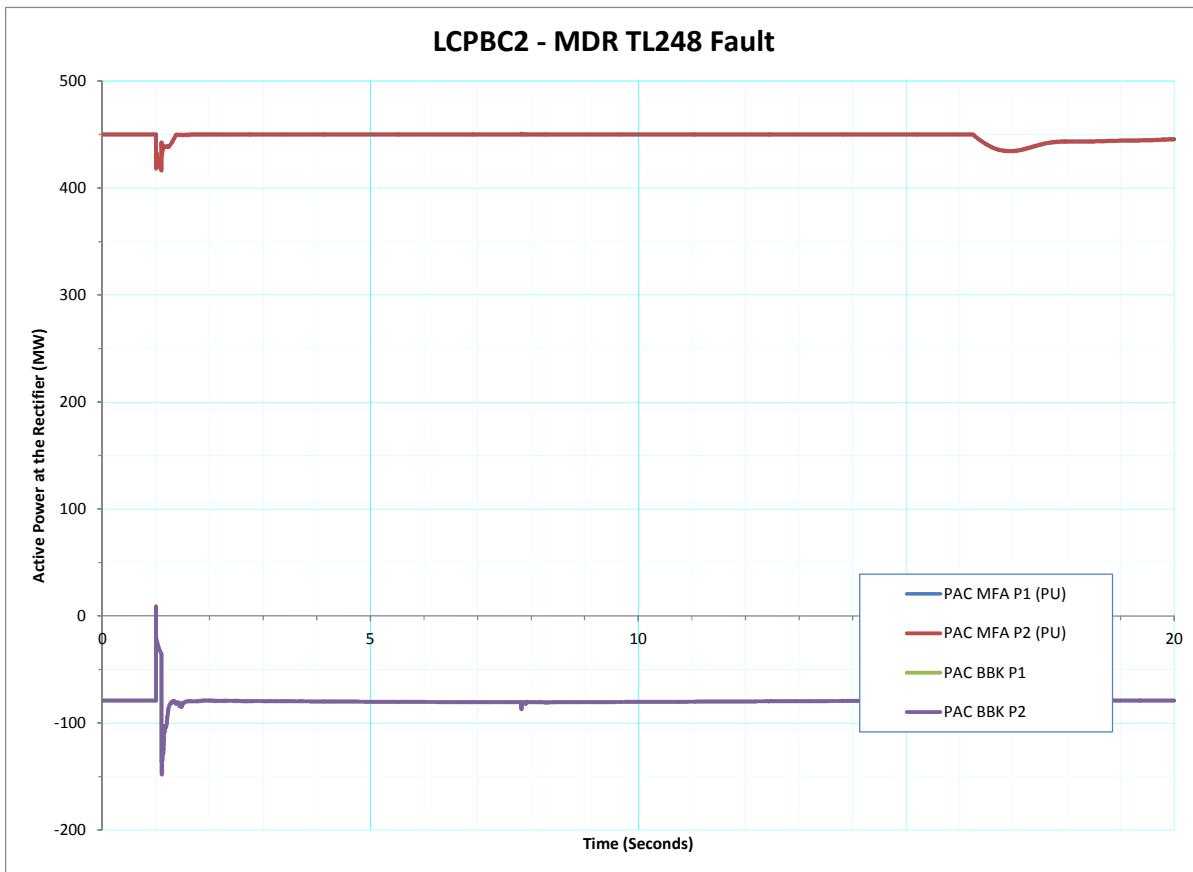
Figure 47 - LCPBC2 - MDR TL248 Fault - Active Power at the Rectifier (MW)

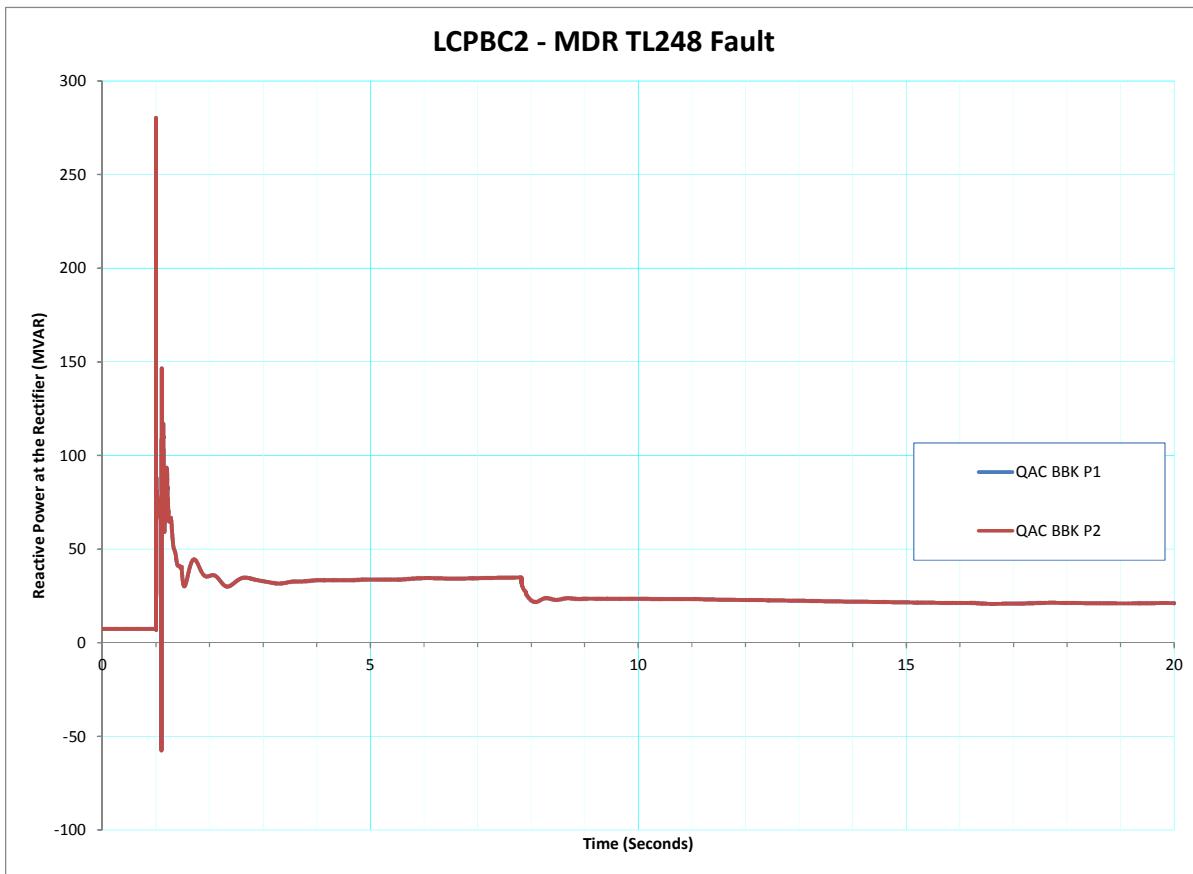
Figure 48 - LCPBC2 - MDR TL248 Fault - Reactive Power at the Rectifier (MVAR)

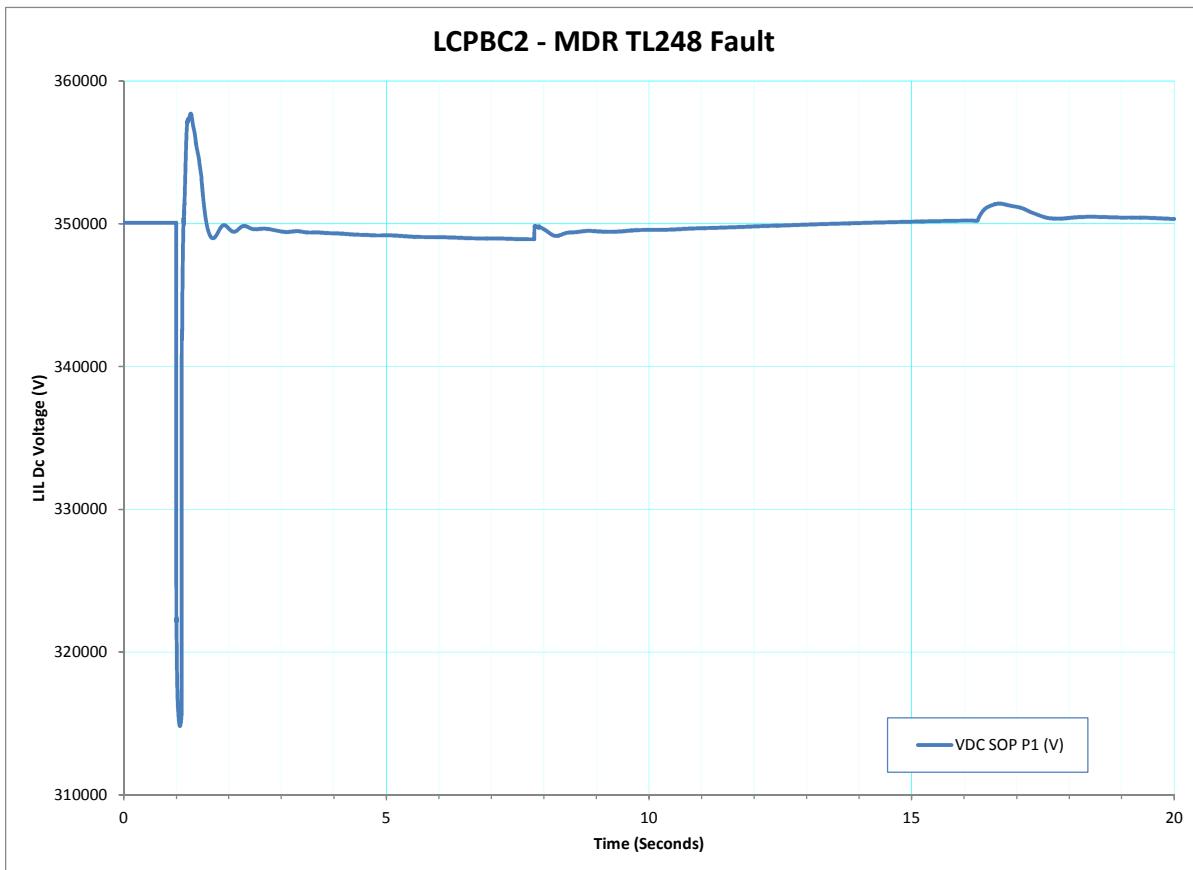
Figure 49 - LCPBC2 - MDR TL248 Fault - LIL Dc Voltage (V)

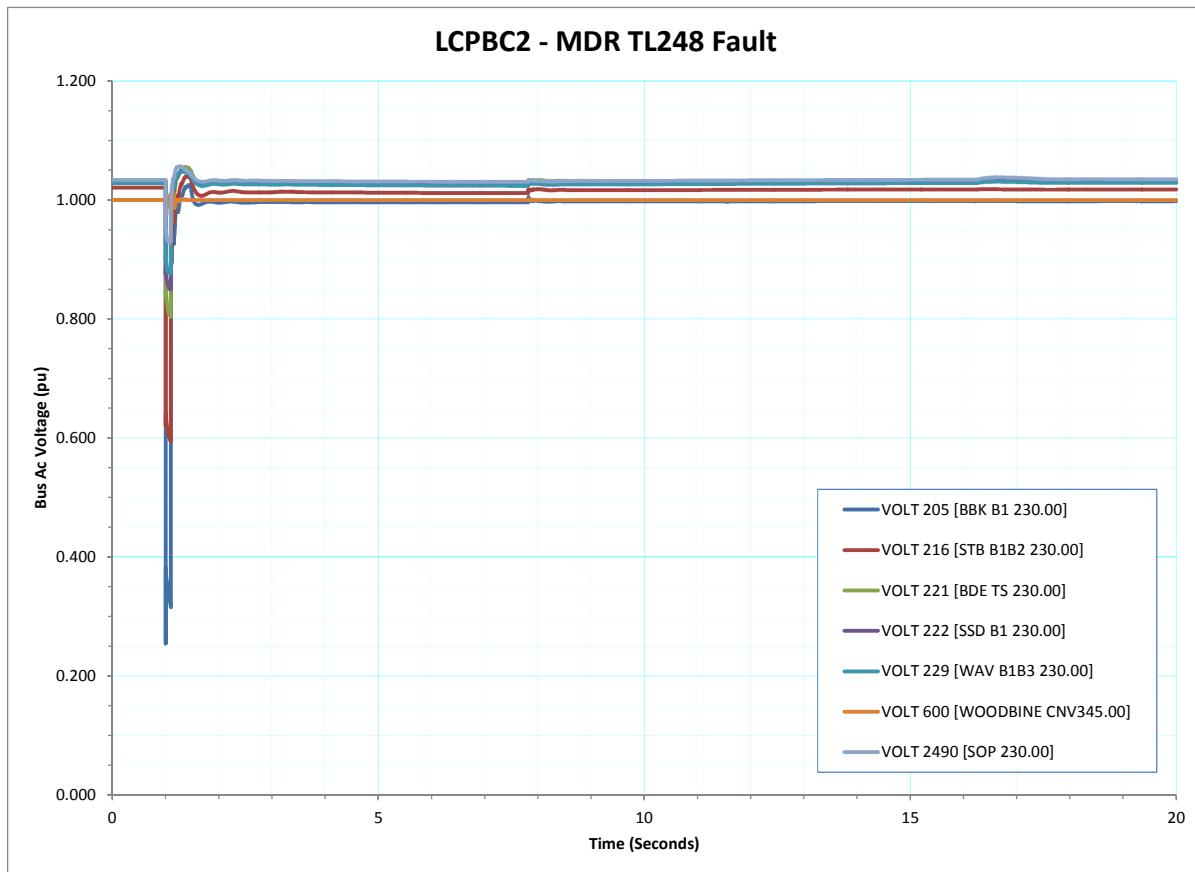
Figure 50 - LCPBC2 - MDR TL248 Fault - Bus Ac Voltage (pu)

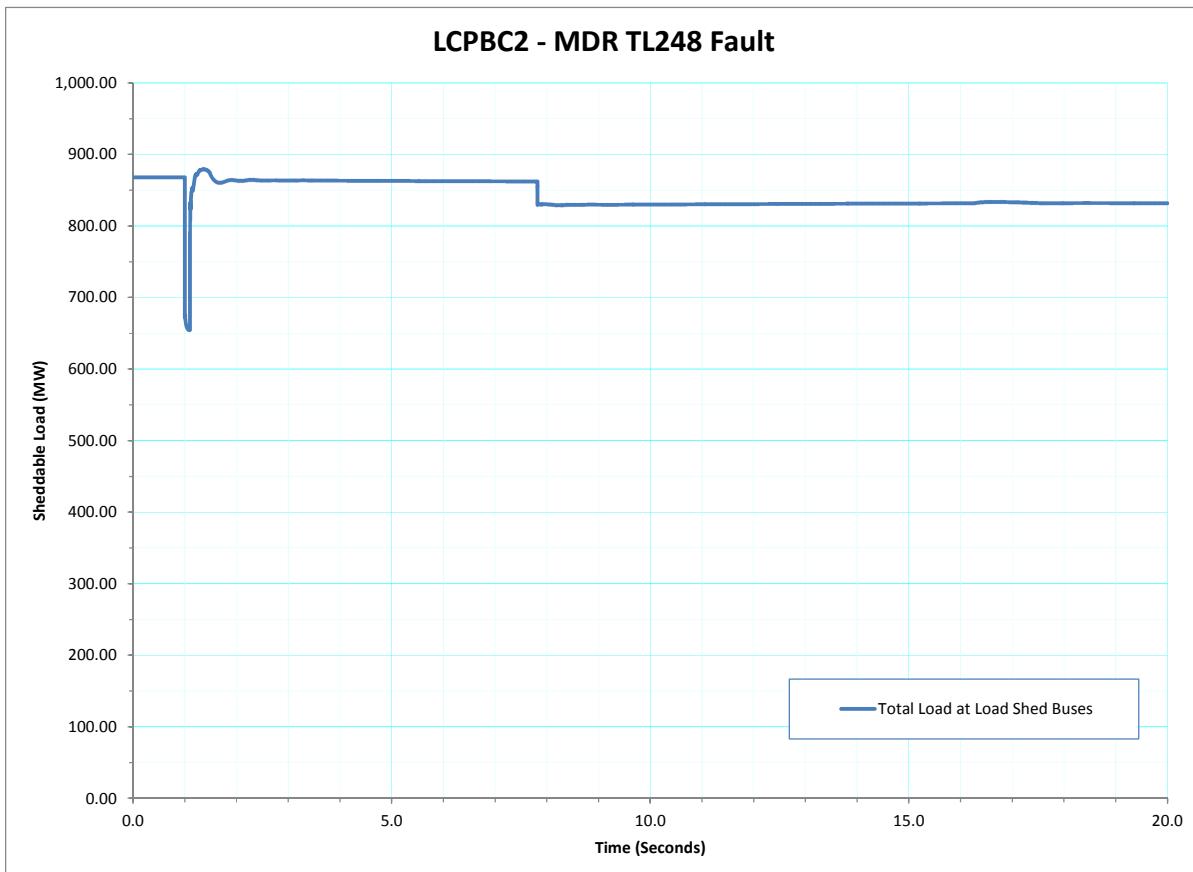
Figure 51 - LCPBC2 - MDR TL248 Fault - Shedtable Load (MW)

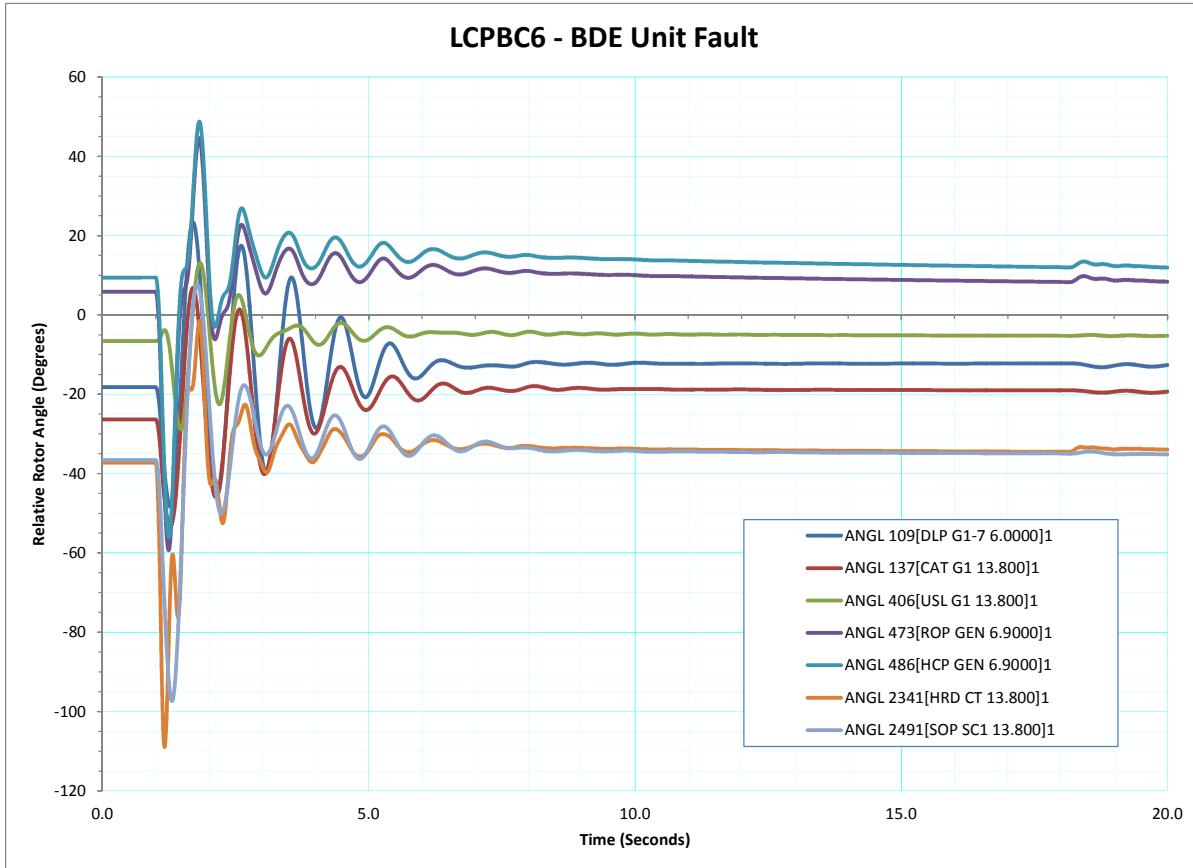
Figure 52 - LCPBC6 - BDE Unit Fault - Relative Rotor Angle (Degrees)

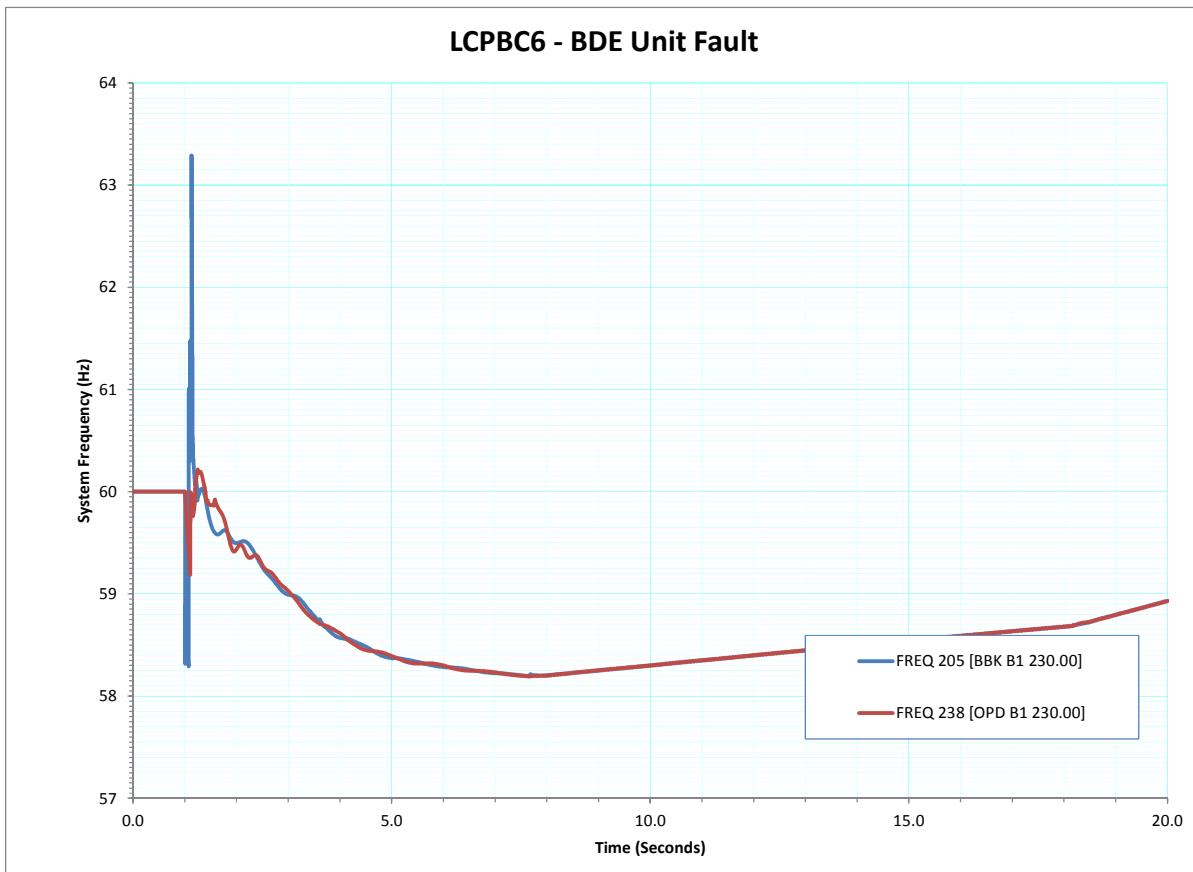
Figure 53 - LCPBC6 - BDE Unit Fault - System Frequency (Hz)

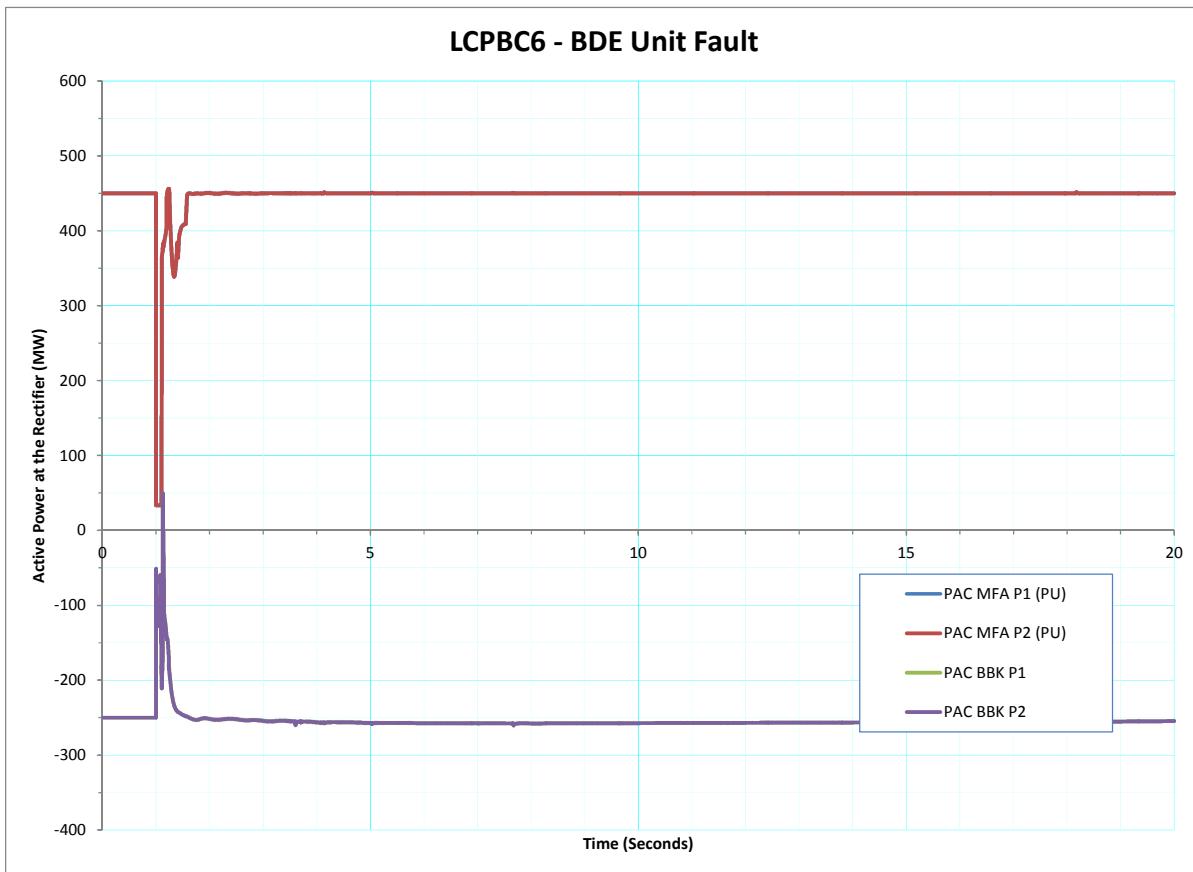
Figure 54 - LCPBC6 - BDE Unit Fault - Active Power at the Rectifier (MW)

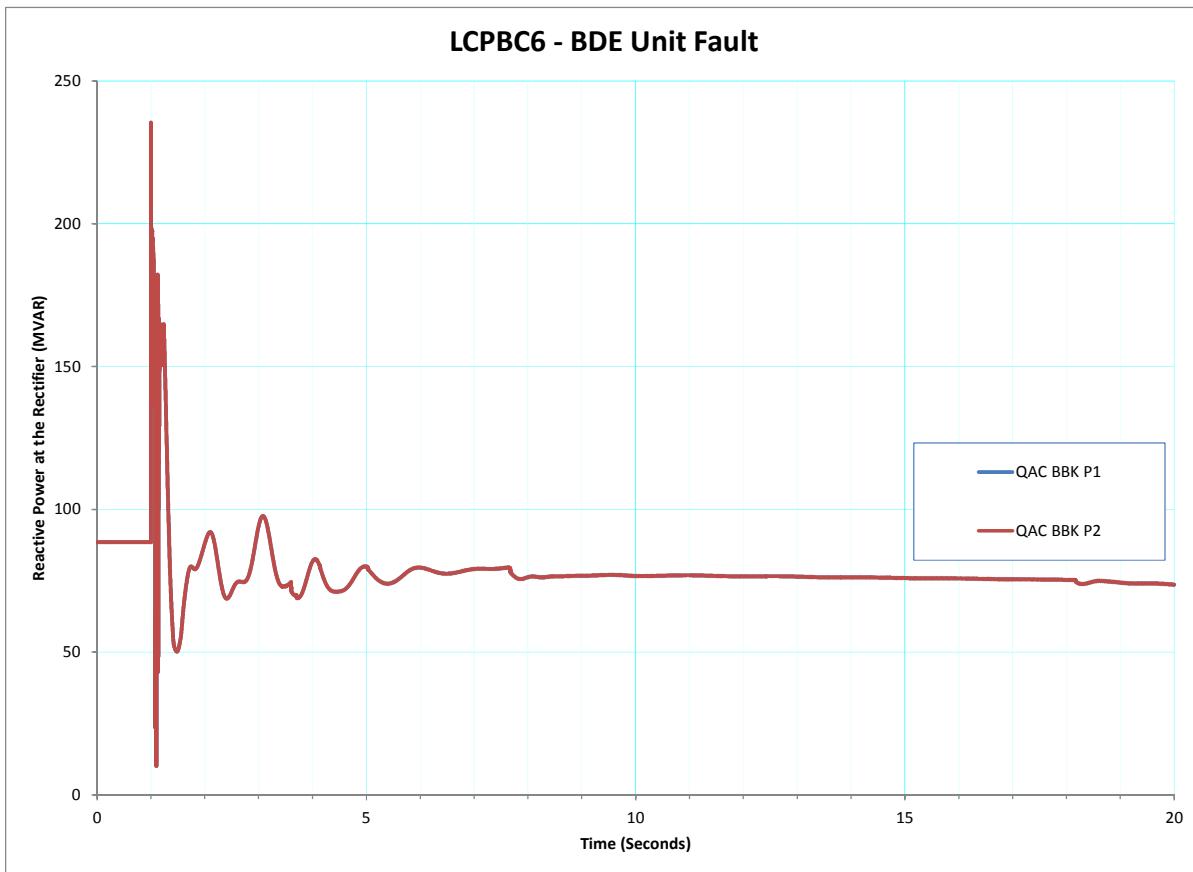
Figure 55 - LCPBC6 - BDE Unit Fault - Reactive Power at the Rectifier (MVAR)

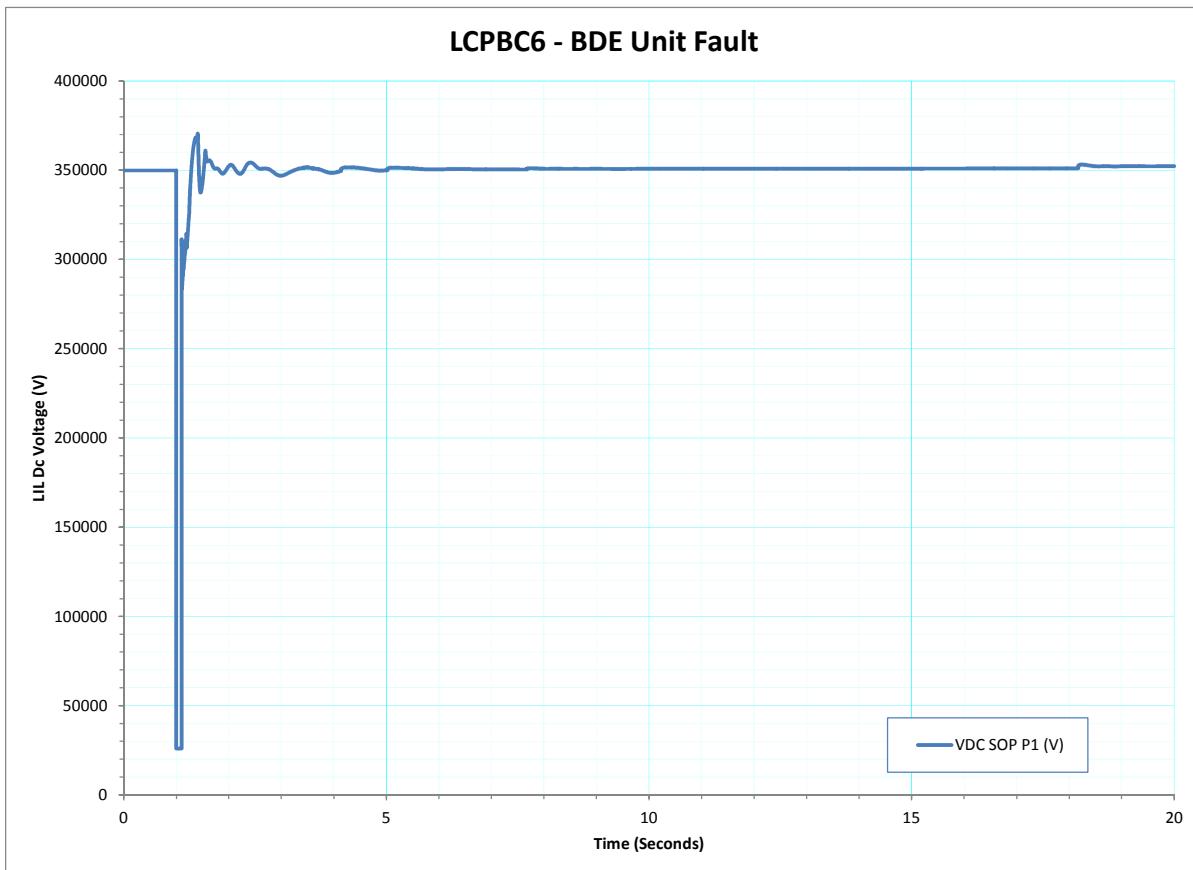
Figure 56 - LCPBC6 - BDE Unit Fault - LIL Dc Voltage (V)

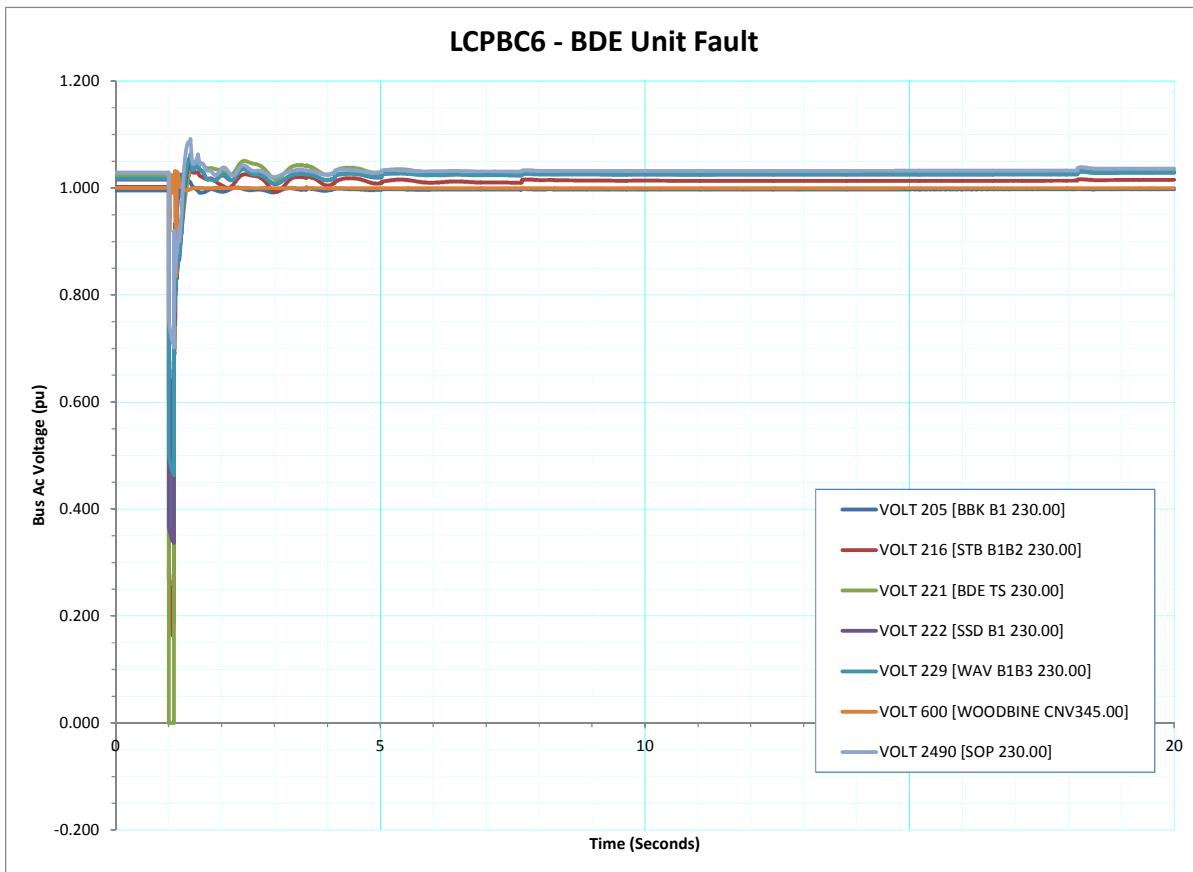
Figure 57 - LCPBC6 - BDE Unit Fault - Bus Ac Voltage (pu)

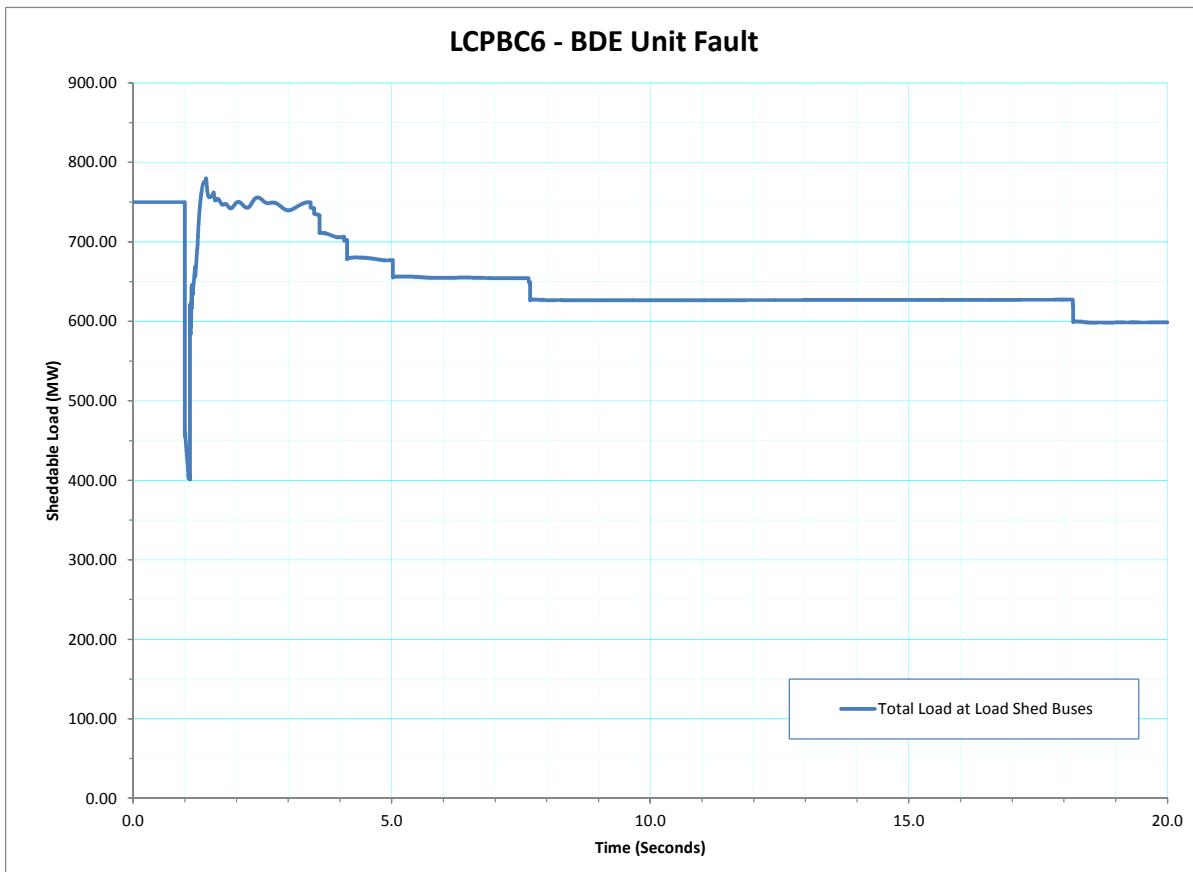
Figure 58 - LCPBC6 - BDE Unit Fault - Shedtable Load (MW)

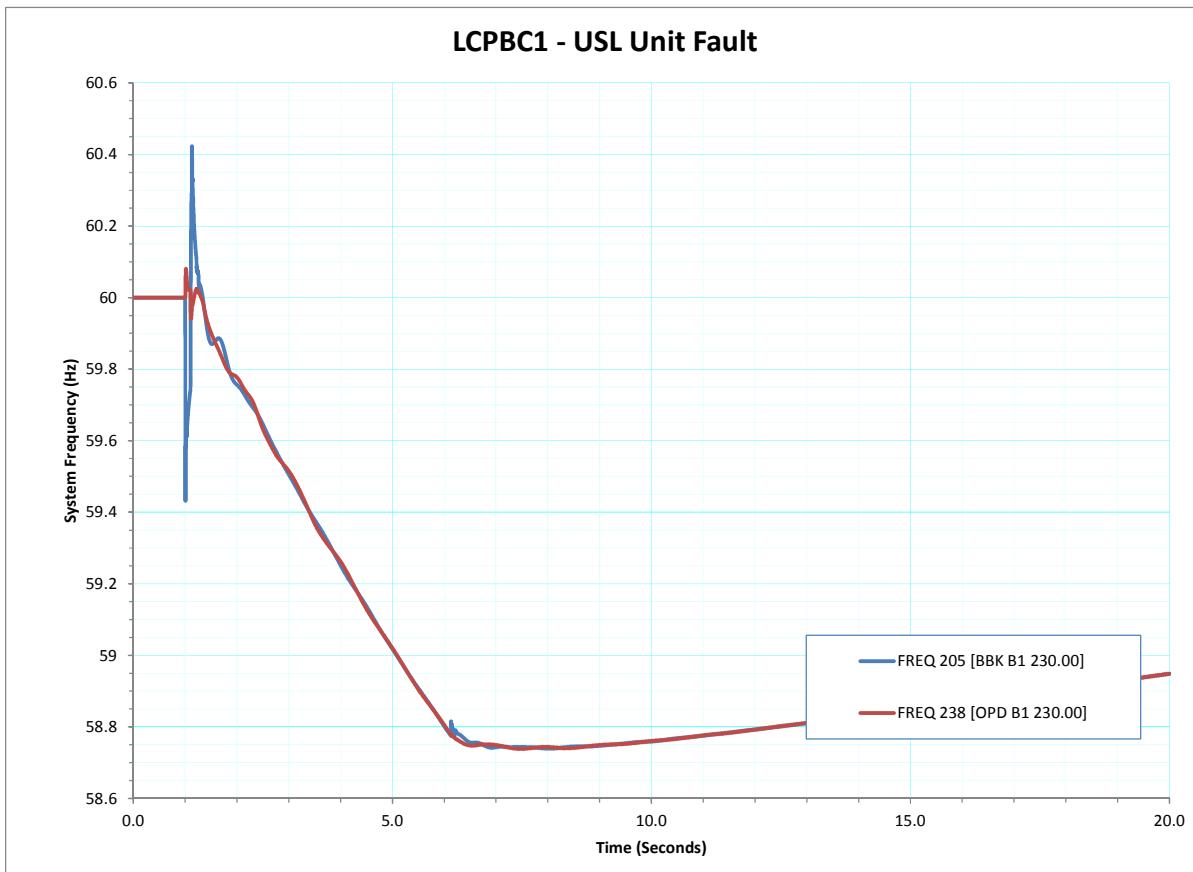
Figure 59 - LCPBC1 - USL Unit Fault - System Frequency (Hz)

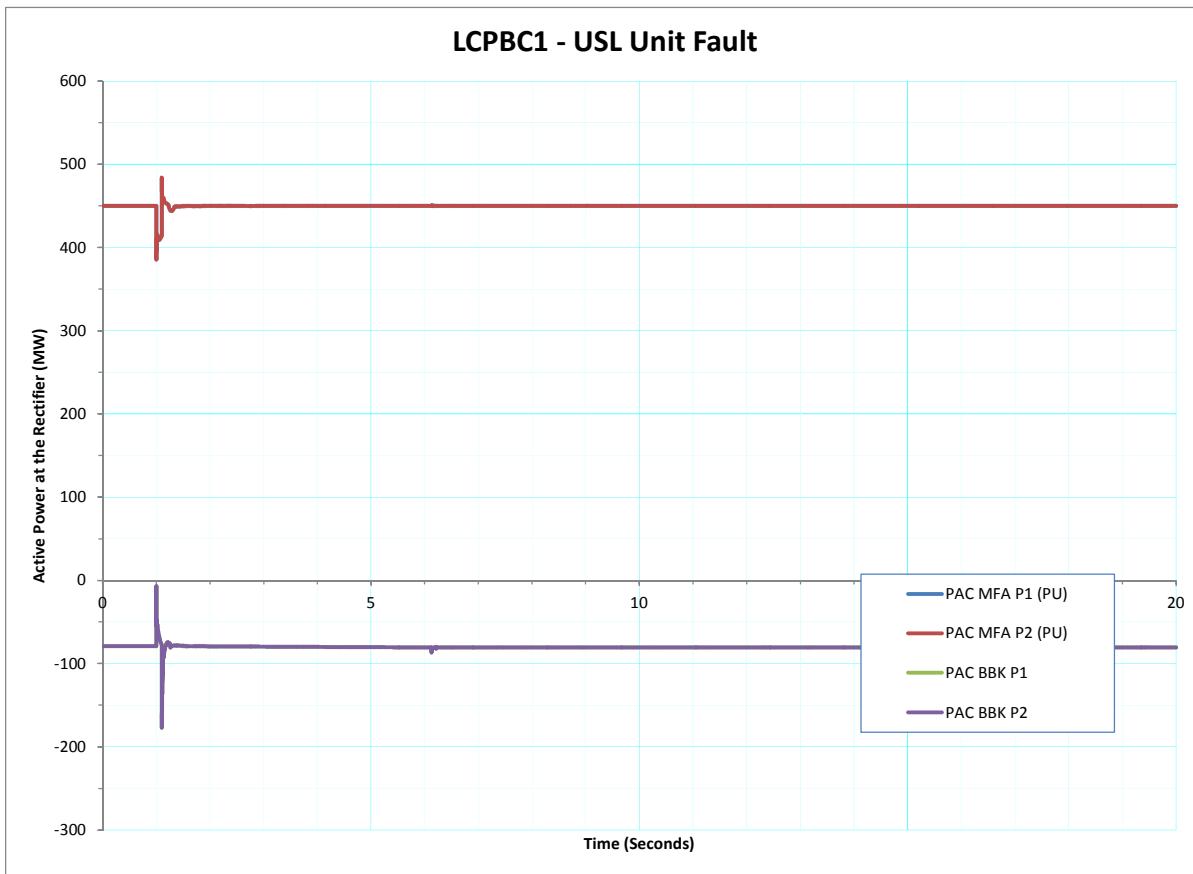
Figure 60 - LCPBC1 - USL Unit Fault - Active Power at the Rectifier (MW)

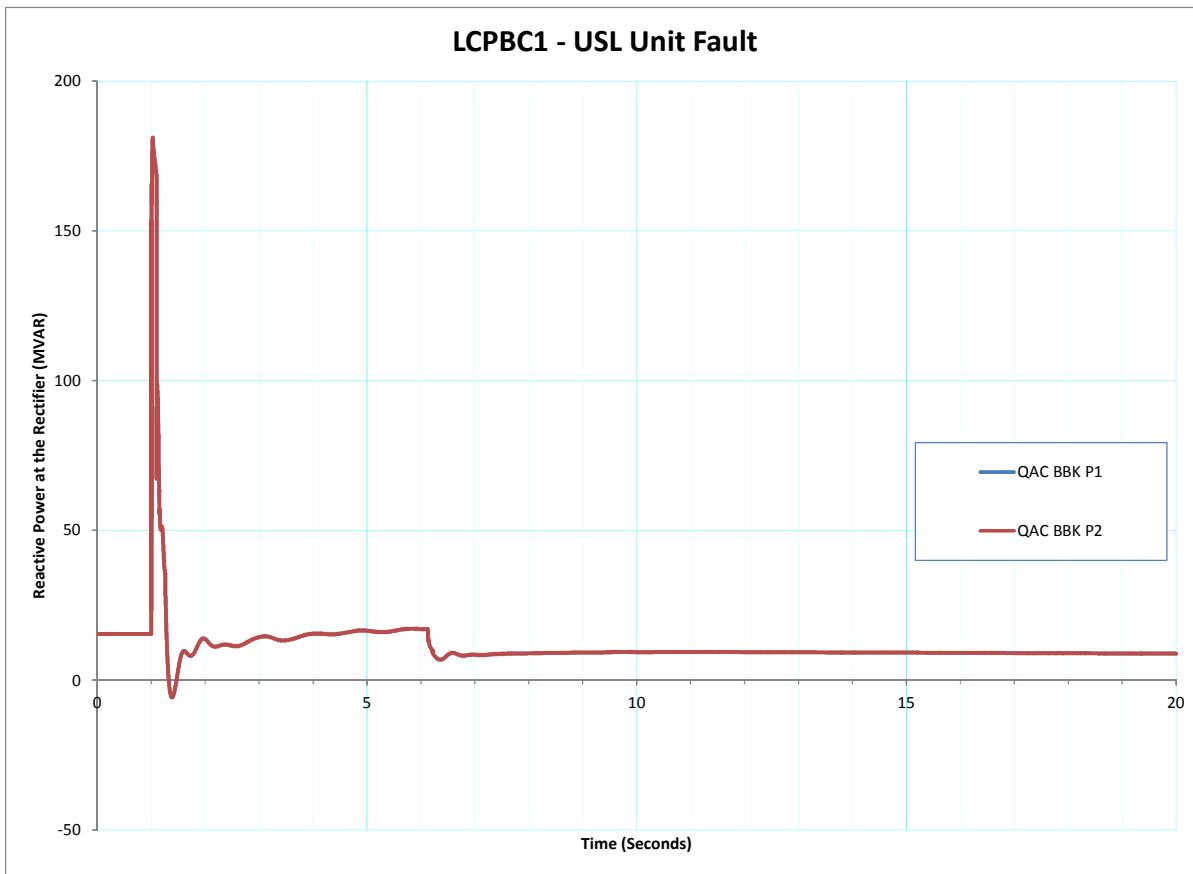
Figure 61 - LCPBC1 - USL Unit Fault - Reactive Power at the Rectifier (MVAR)

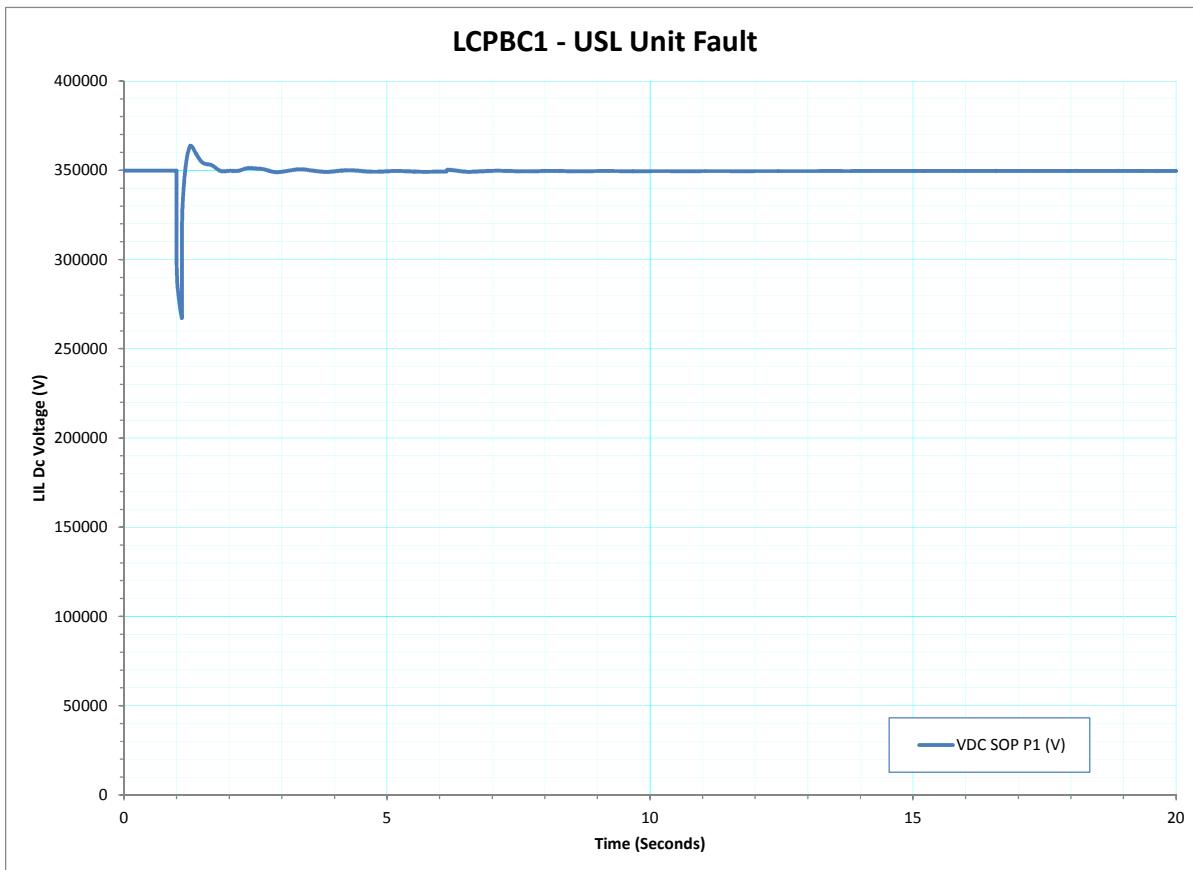
Figure 62 - LCPBC1 - USL Unit Fault - LIL Dc Voltage (V)

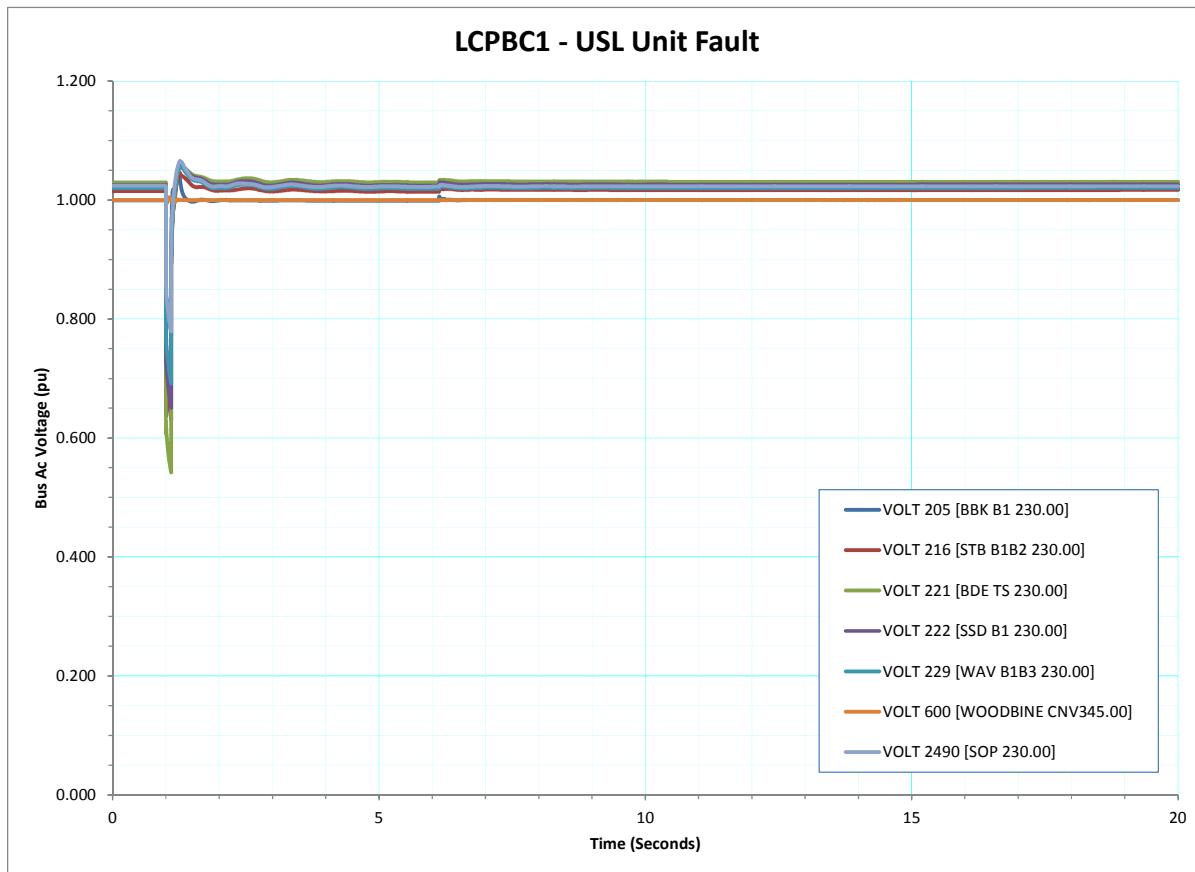
Figure 63 - LCPBC1 - USL Unit Fault - Bus Ac Voltage (pu)

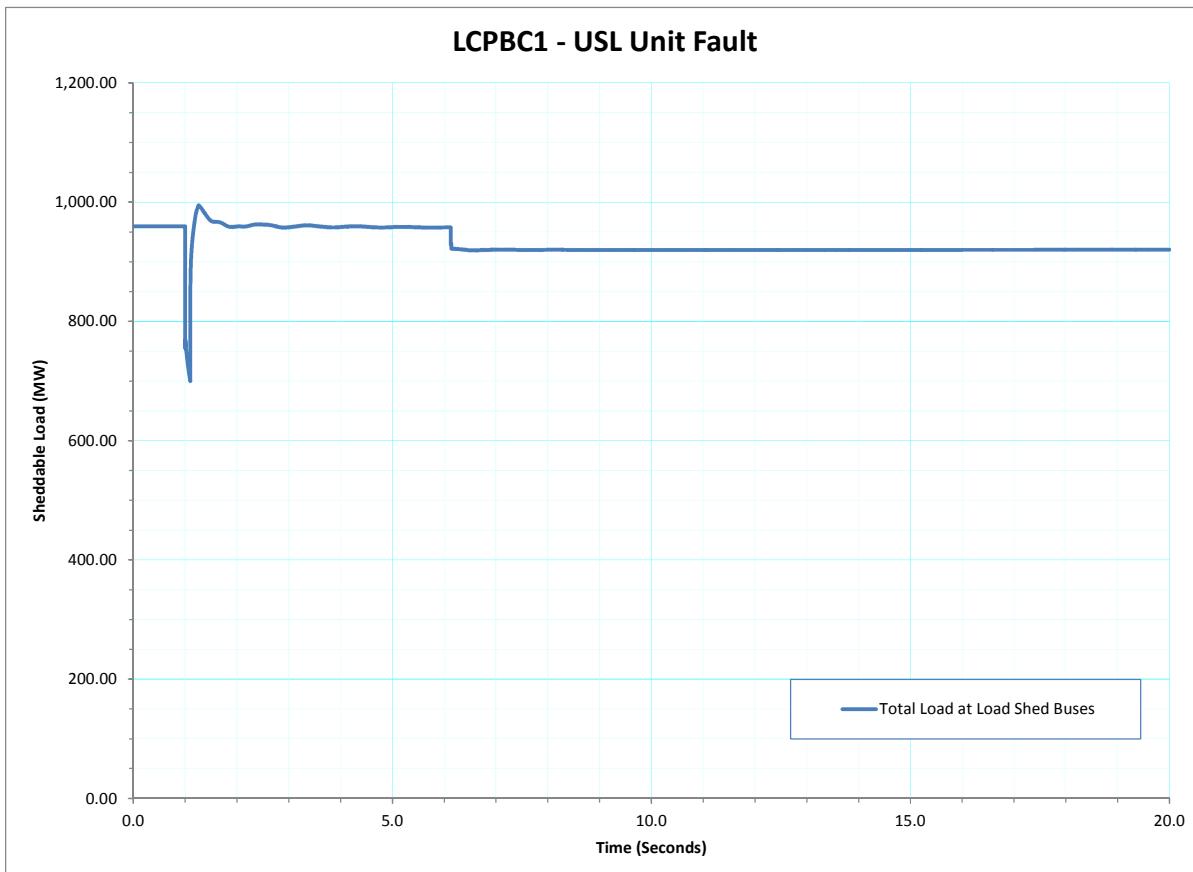
Figure 64 - LCPBC1 - USL Unit Fault - Shedtable Load (MW)
