MARITIME LINK PRELIMINARY INTERCONNECTION STUDY

Newfoundland and Labrador Hydro

July 2014

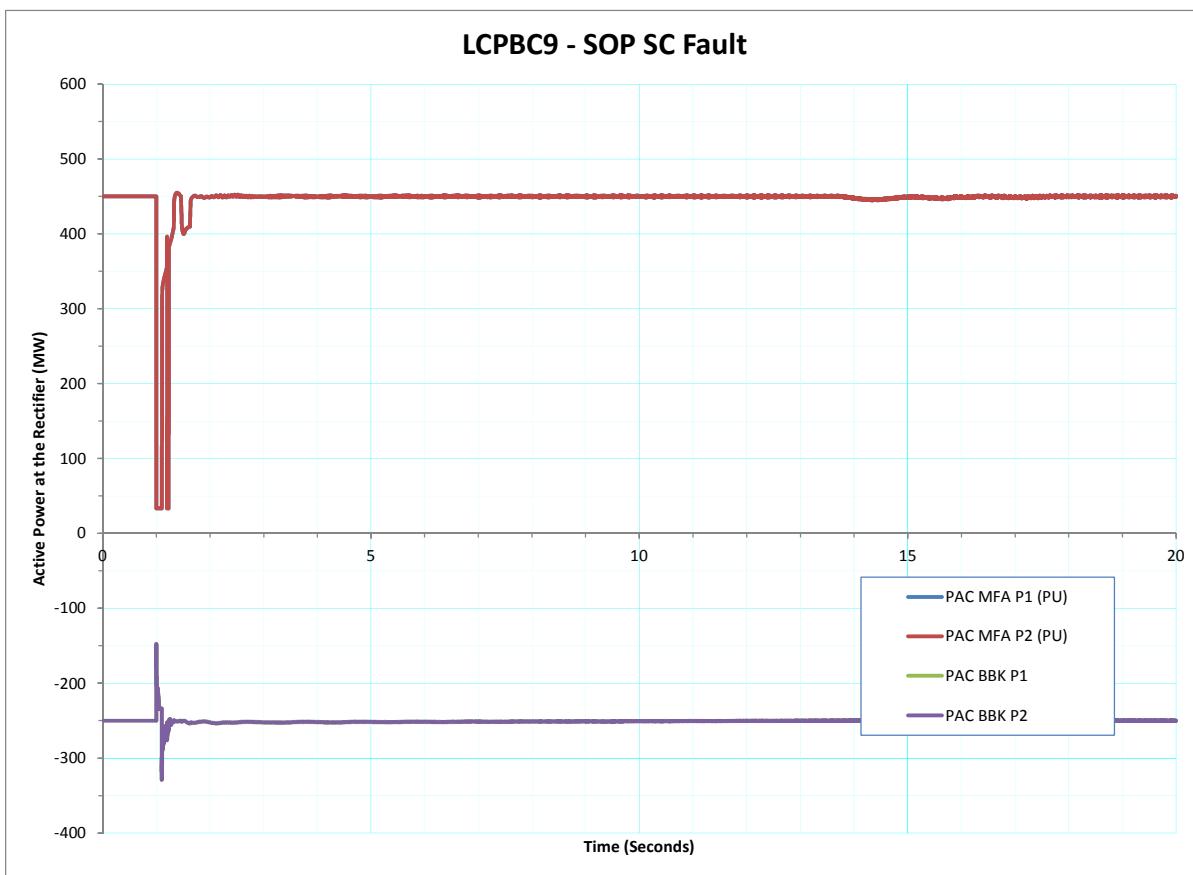
In this case, the LIL and ML are operating at capacity, while the generation on the Island Interconnected Transmission System is reduced to approximately 370 MW. The loss of a synchronous condenser at SOP results in a deficit of reactive power, particularly as the export of 500 MW over the ML is not interrupted by the fault. This is illustrated in the figures below.

Figure 65 - LCPBC9 - SOP SC Fault - Active Power at the Rectifier (MW)

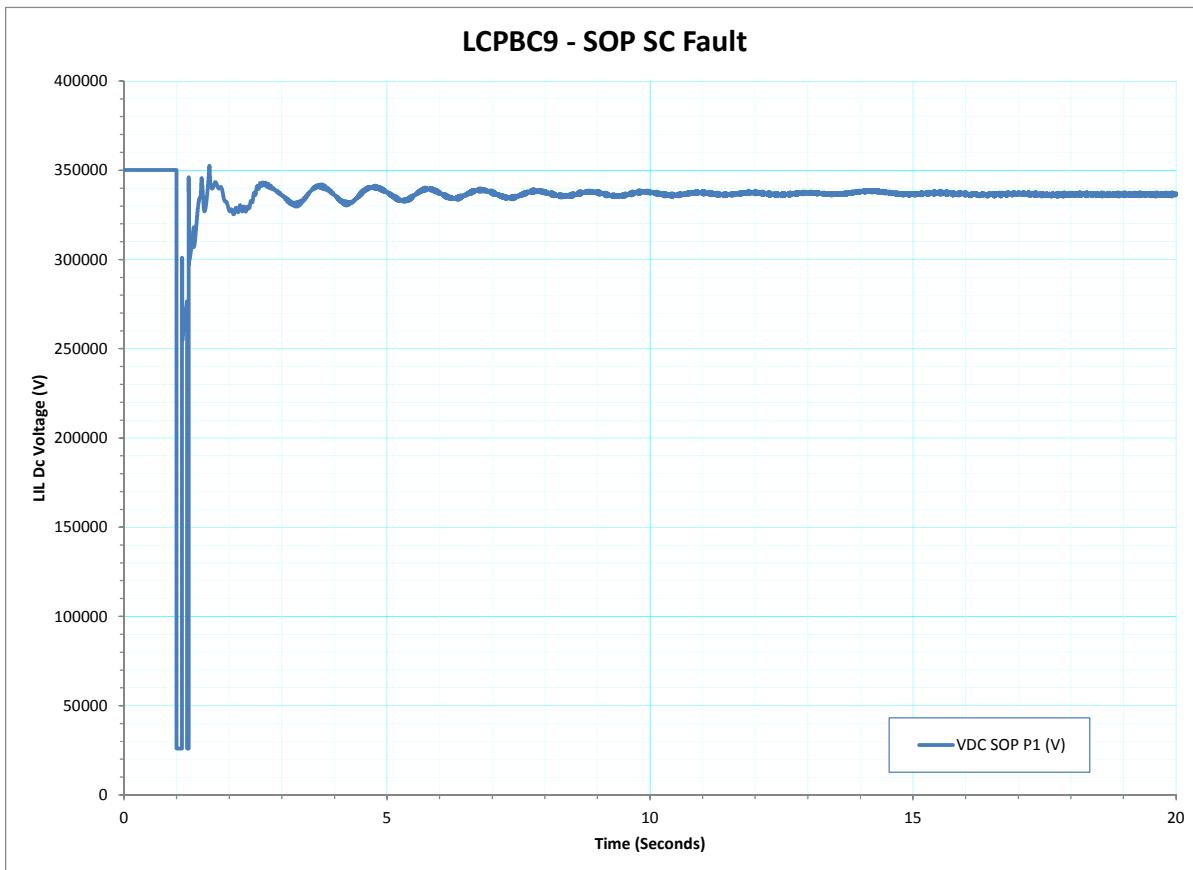
Figure 66 - LCPBC9 - SOP SC Fault - LIL Dc Voltage (V)

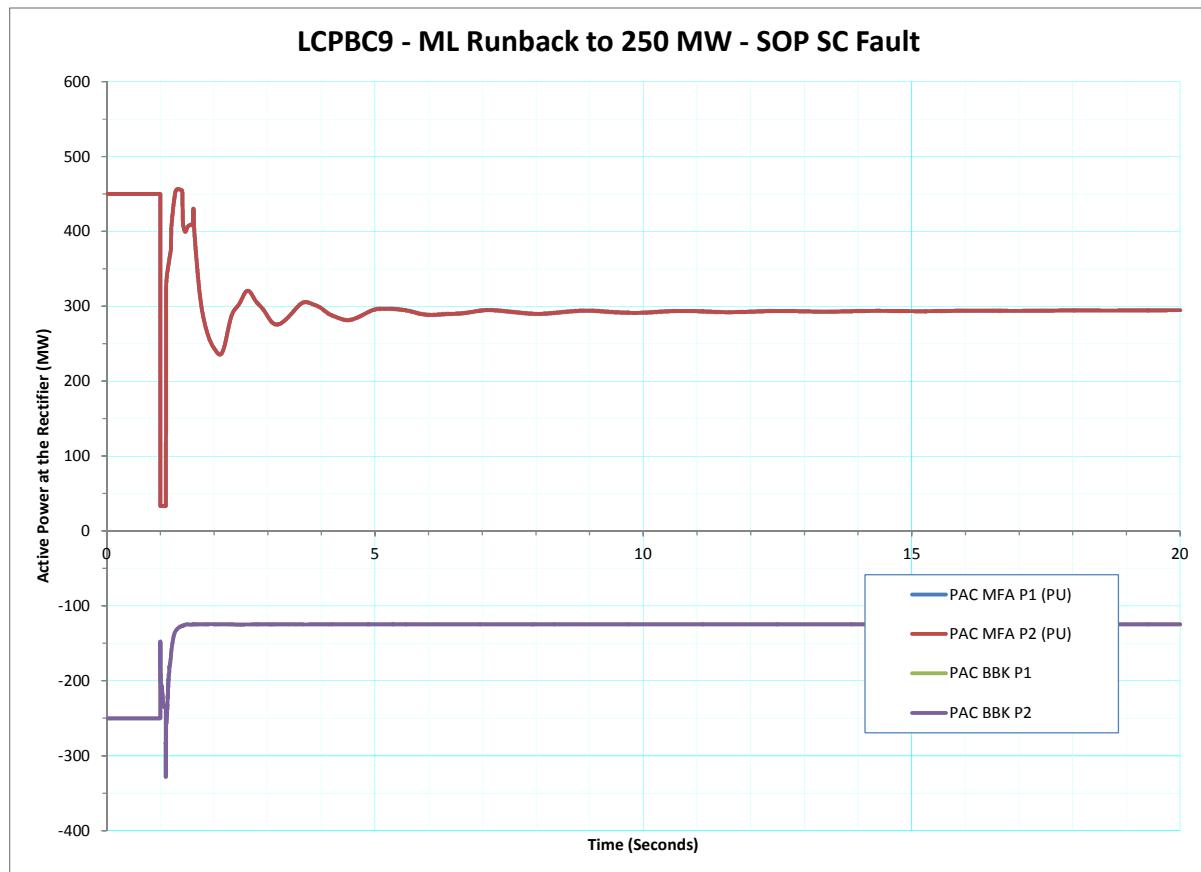
Additional analysis was performed to investigate the impact of curtailing the ML in the event of the SOP fault. As indicated below, the commutation failure is eliminated if the export is reduced from 500 MW to 250 MW.

Figure 67 - LCPBC9 - ML Runback to 250 MW - SOP SC Fault - Active Power at the Rectifier (MW)

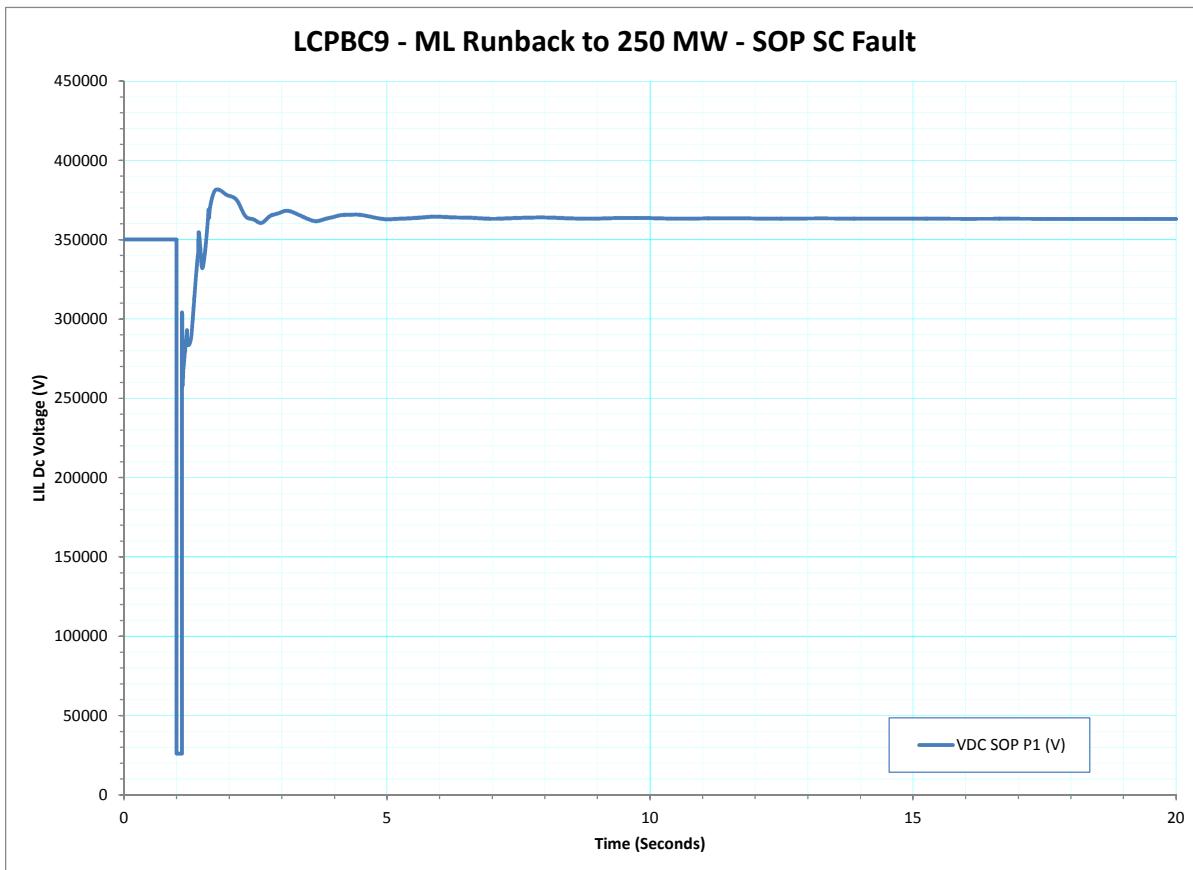
Figure 68 - LCPBC9 - ML Runback to 250 MW - SOP SC Fault - LIL Dc Voltage (V)

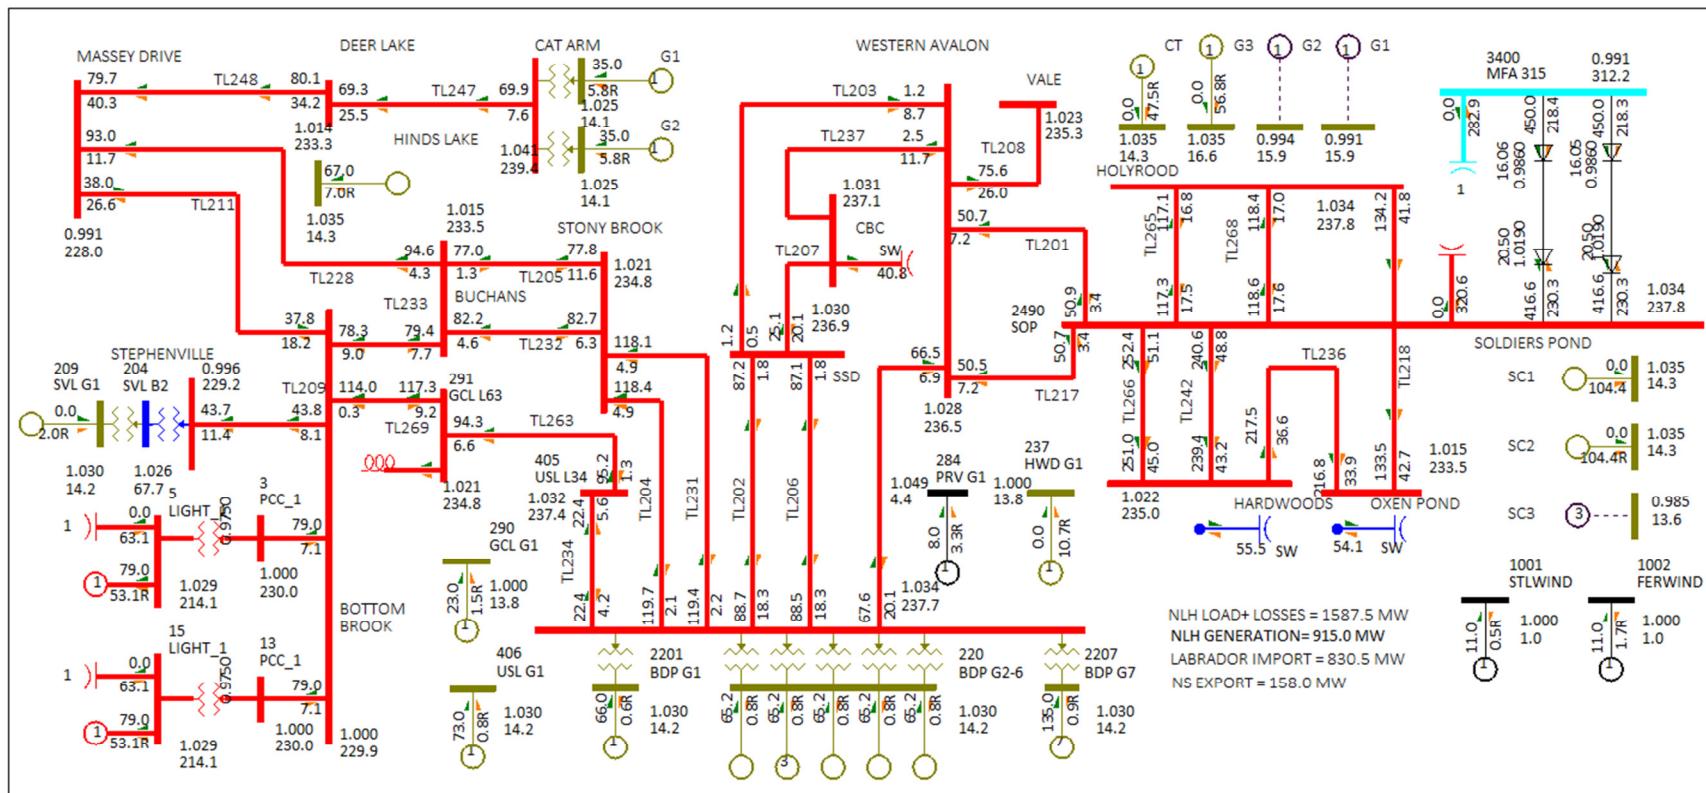
Figure 70 – Load Flow Plot – Base Case 2

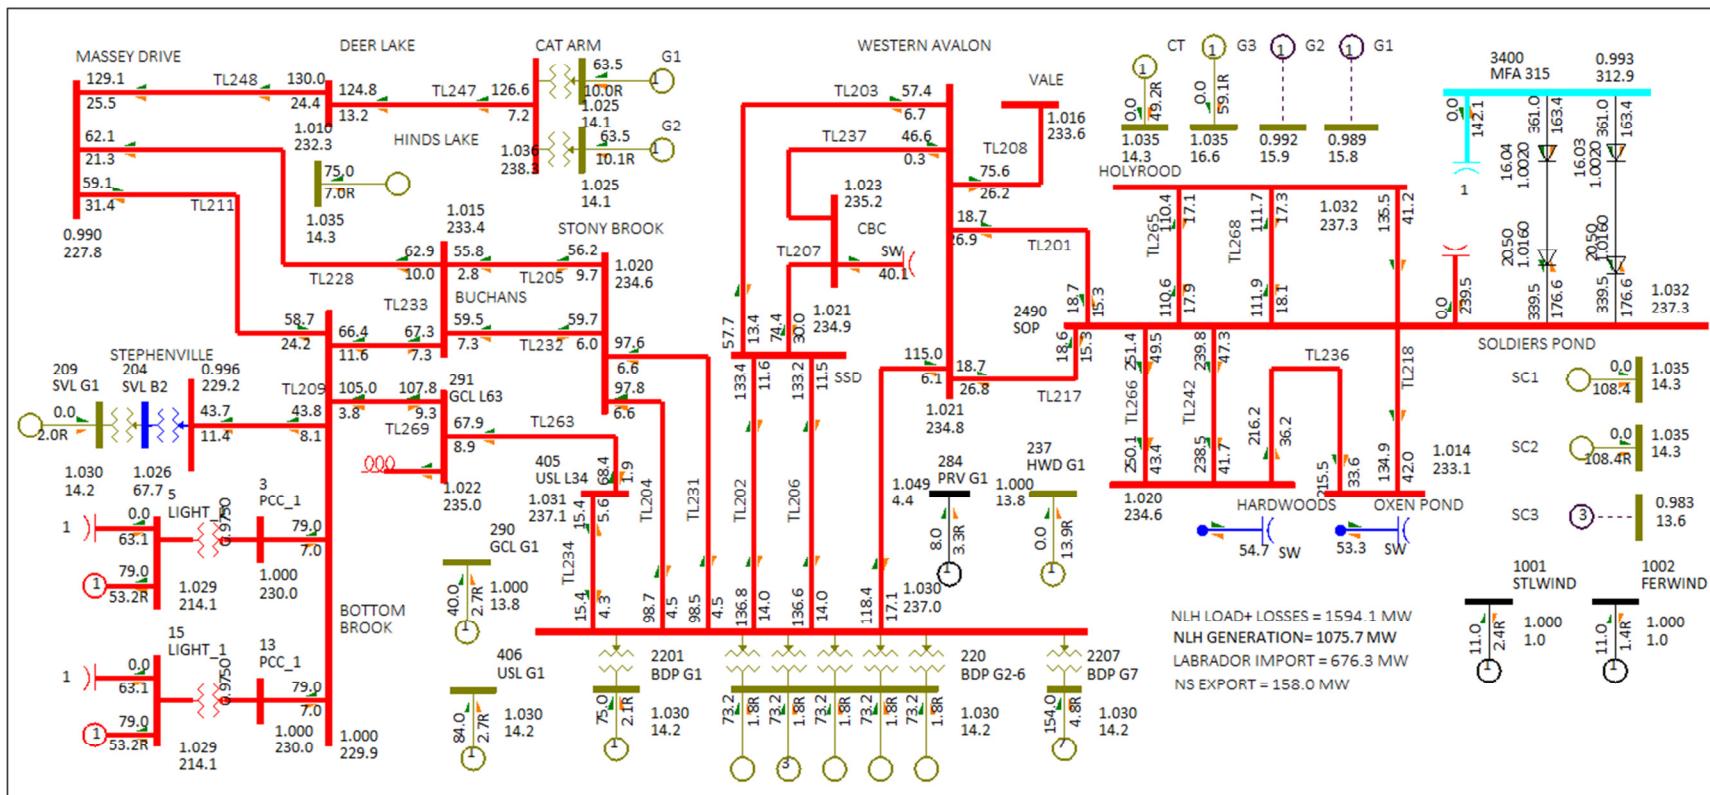
Figure 71 – Load Flow Plot – Base Case 3

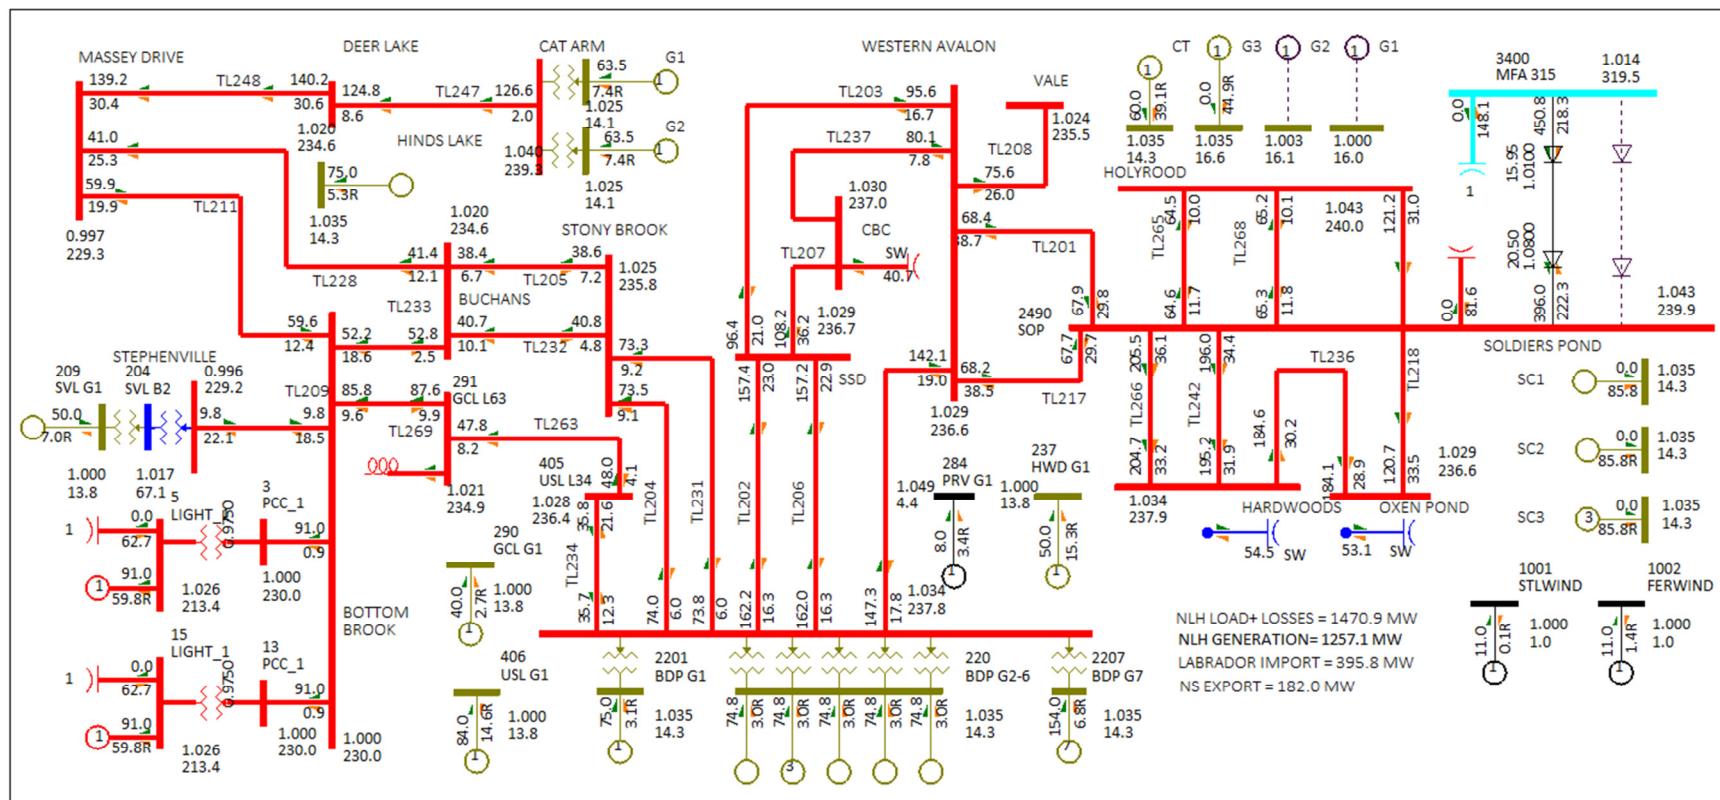
Figure 72 – Load Flow Plot – Base Case 4

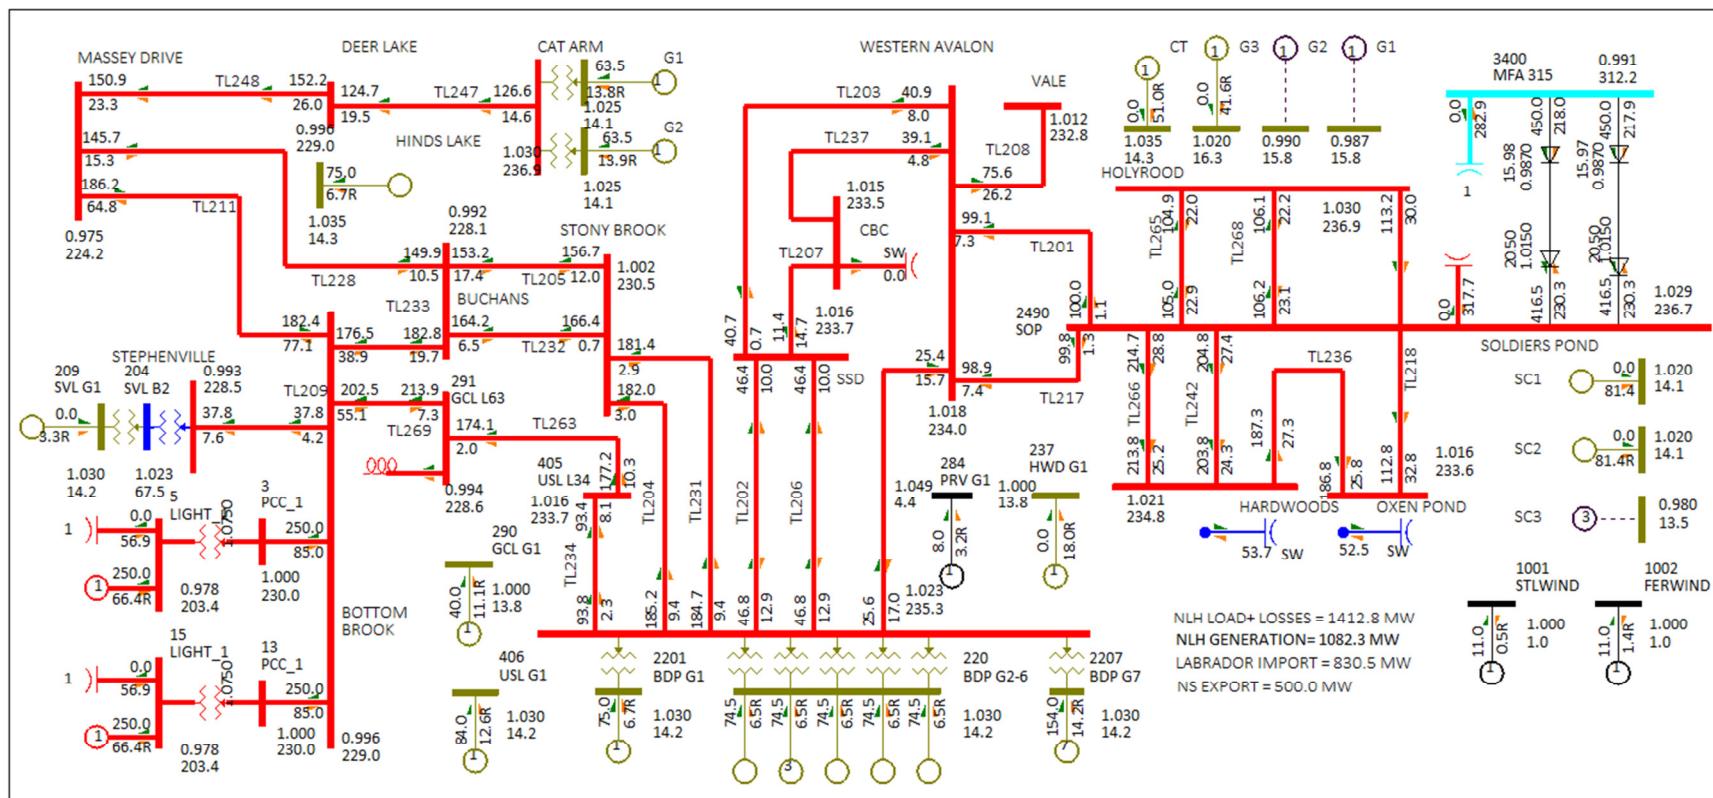
Figure 73 – Load Flow Plot – Base Case 6

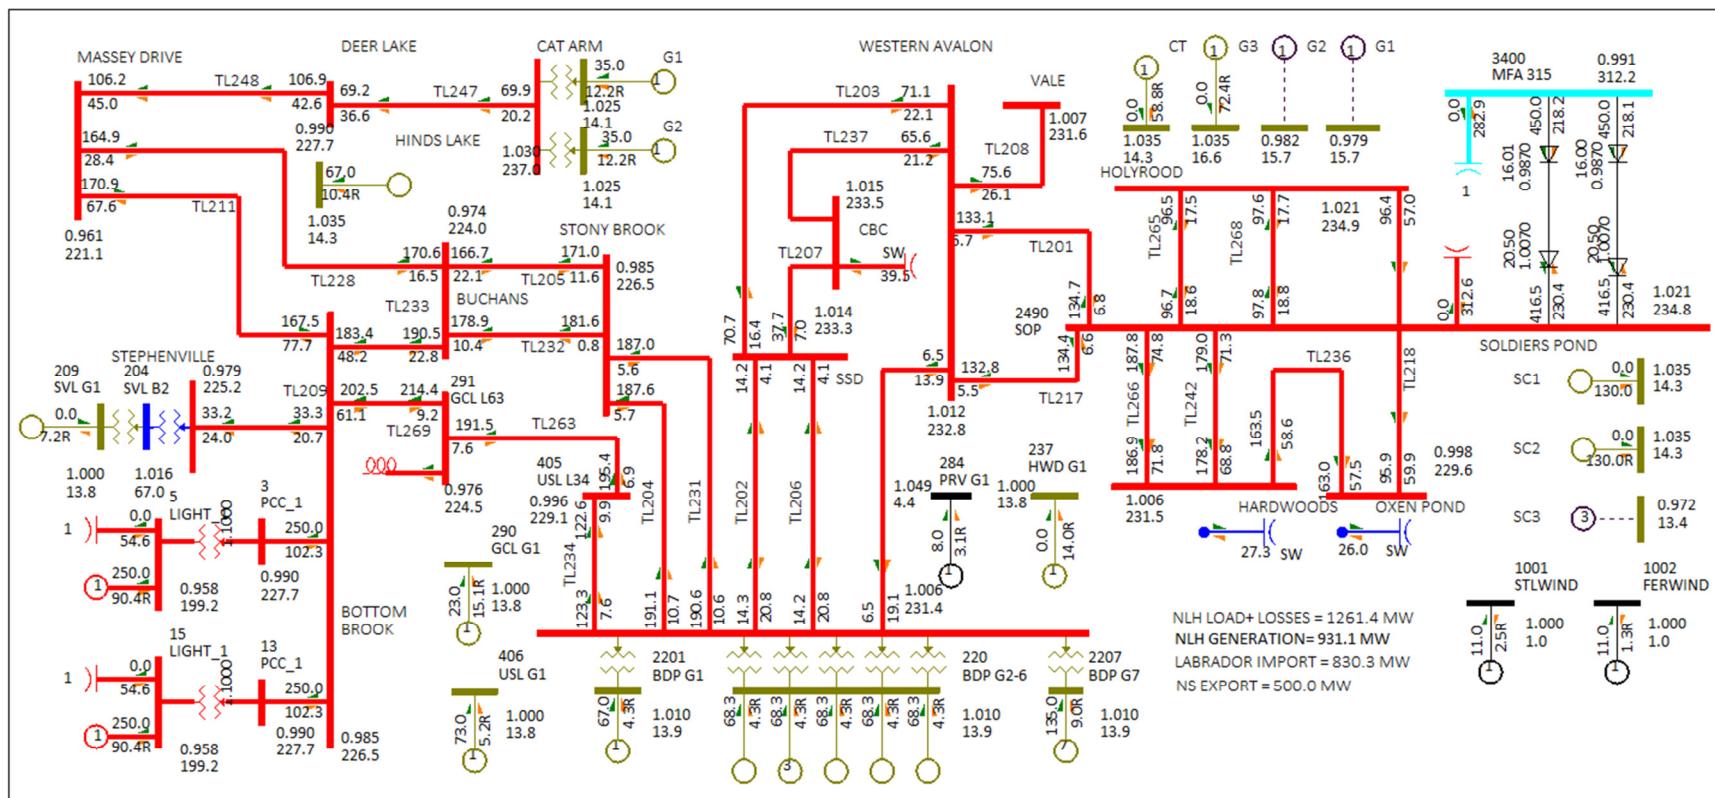
Figure 74 – Load Flow Plot – Base Case 7

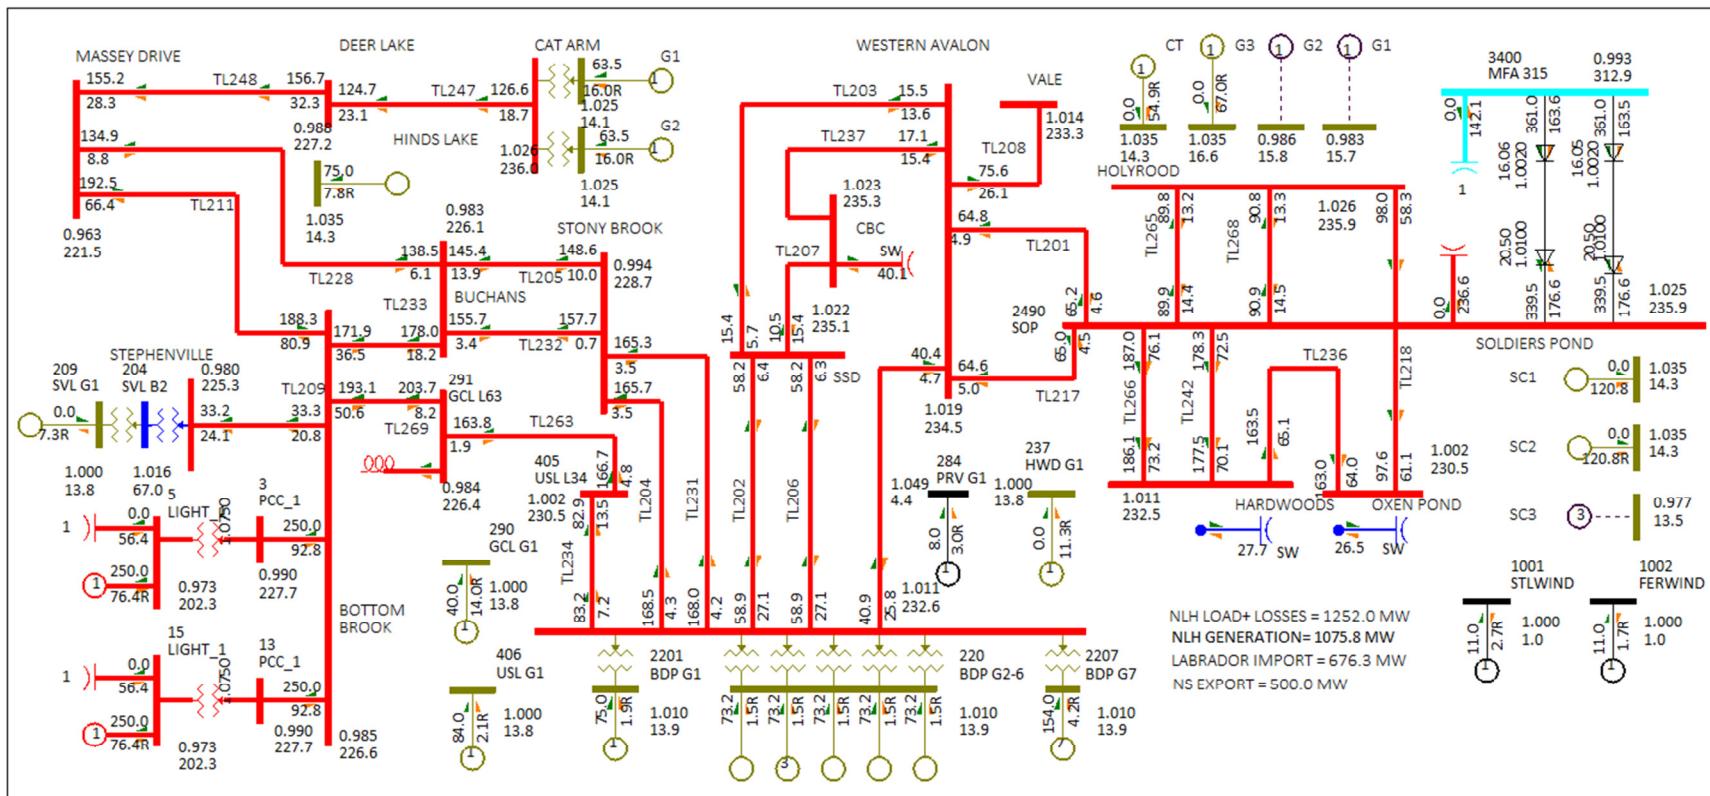
Figure 75 – Load Flow Plot – Base Case 8

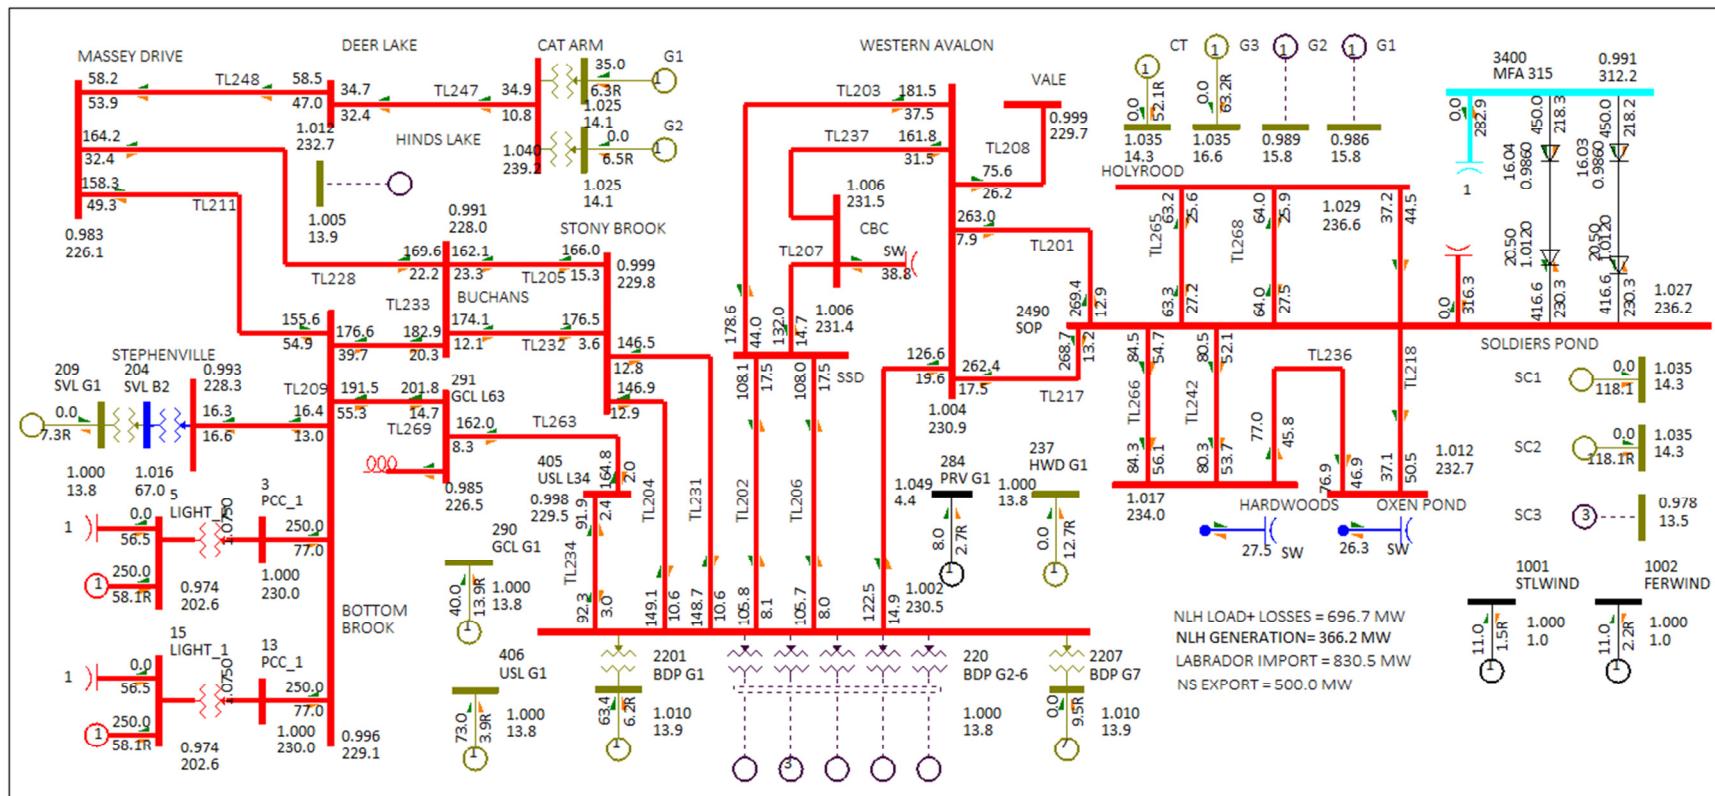
Figure 76 – Load Flow Plot – Base Case 9

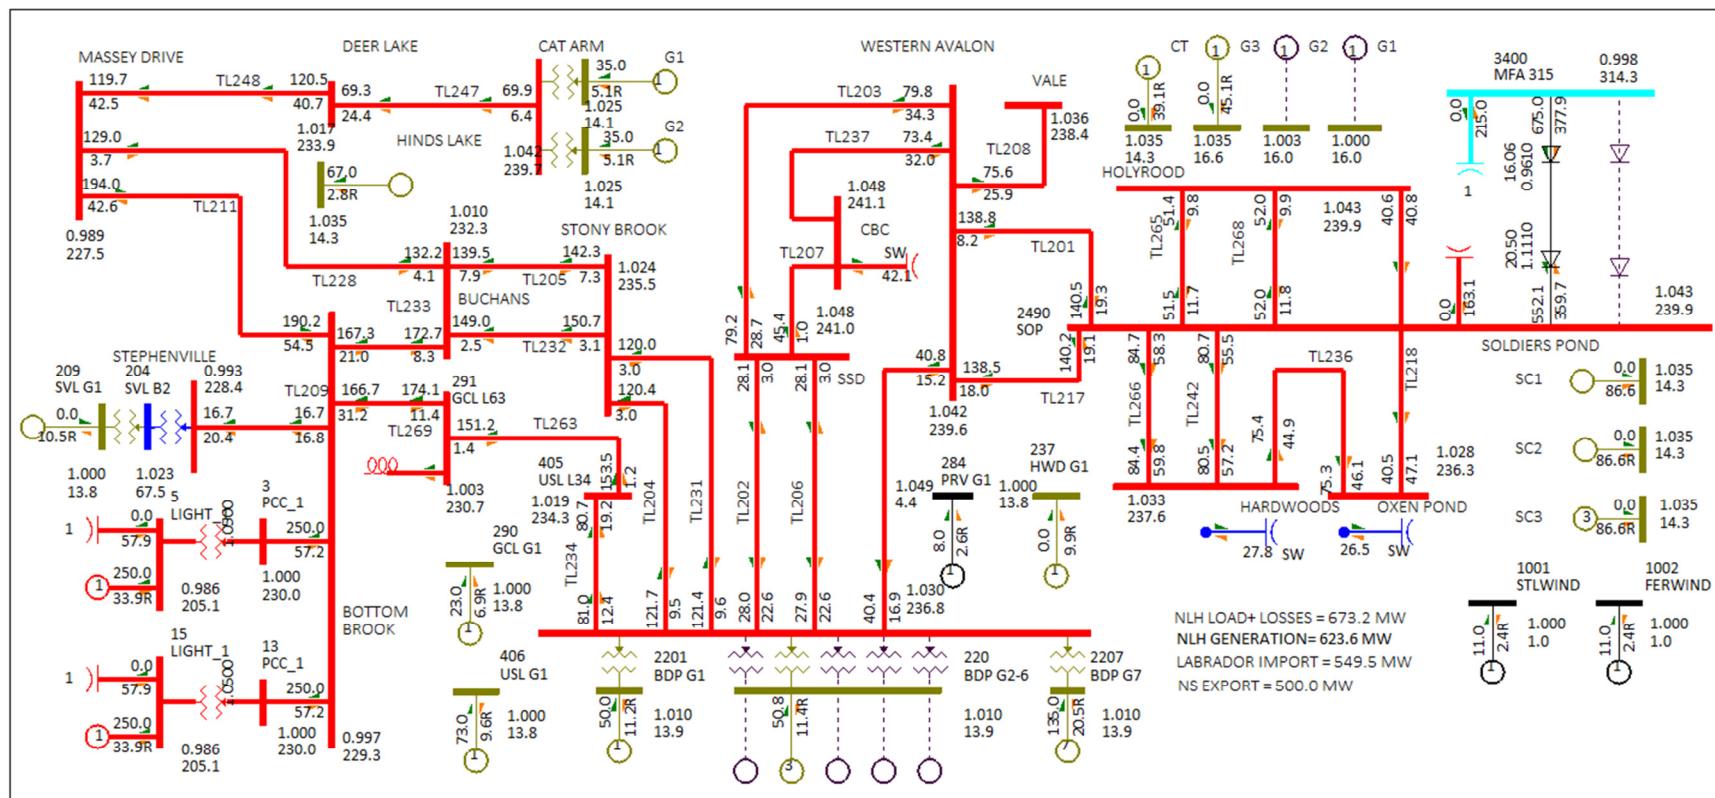
Figure 77 – Load Flow Plot – Base Case 10

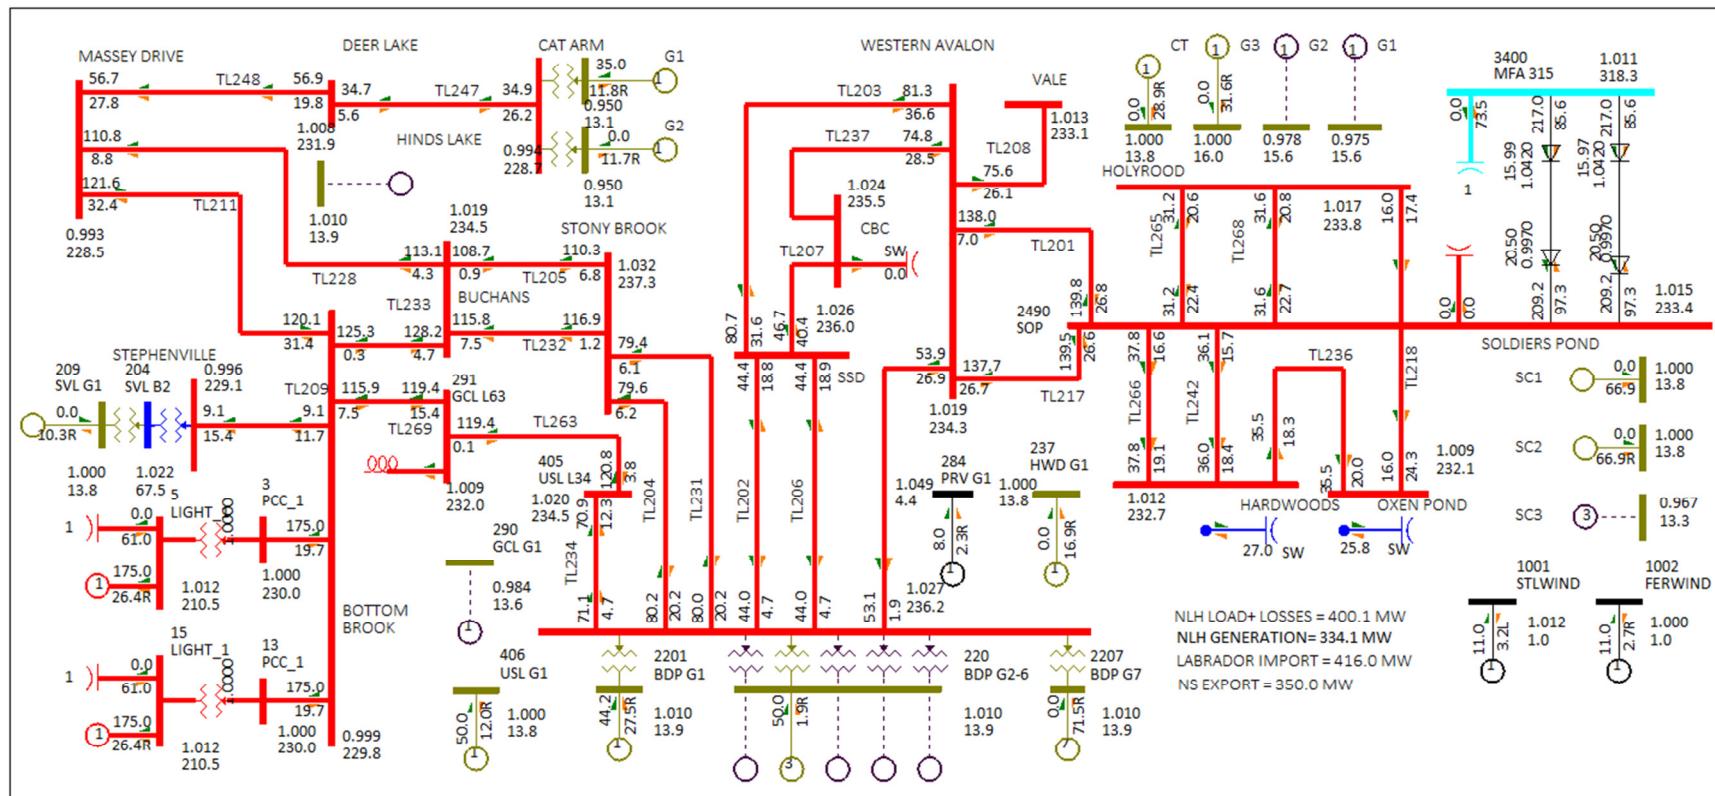
Figure 78 – Load Flow Plot – Base Case 11

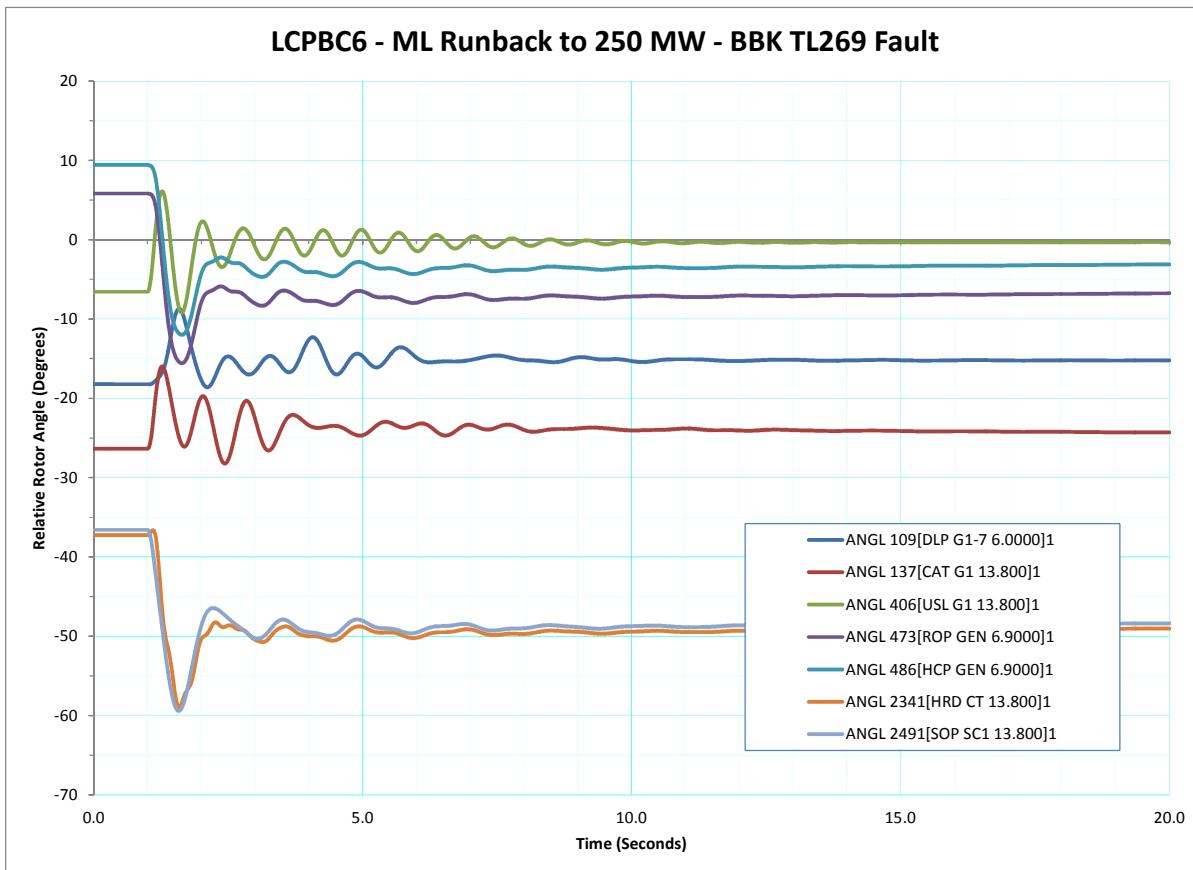
Figure 79 - LCPBC6 - ML Runback to 250 MW - BBK TL269 Fault - Relative Rotor Angle (Degrees)

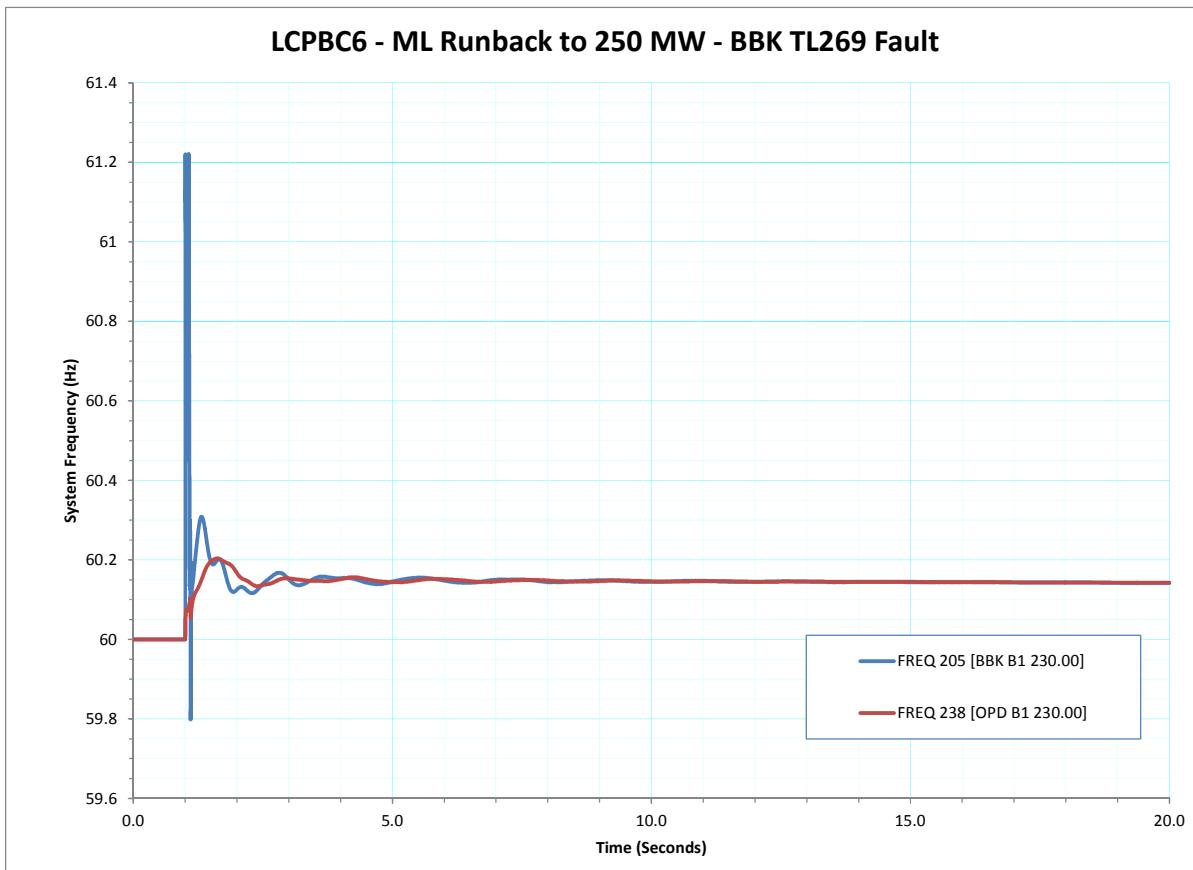
Figure 80 - LCPBC6 - ML Runback to 250 MW - BBK TL269 Fault - System Frequency (Hz)

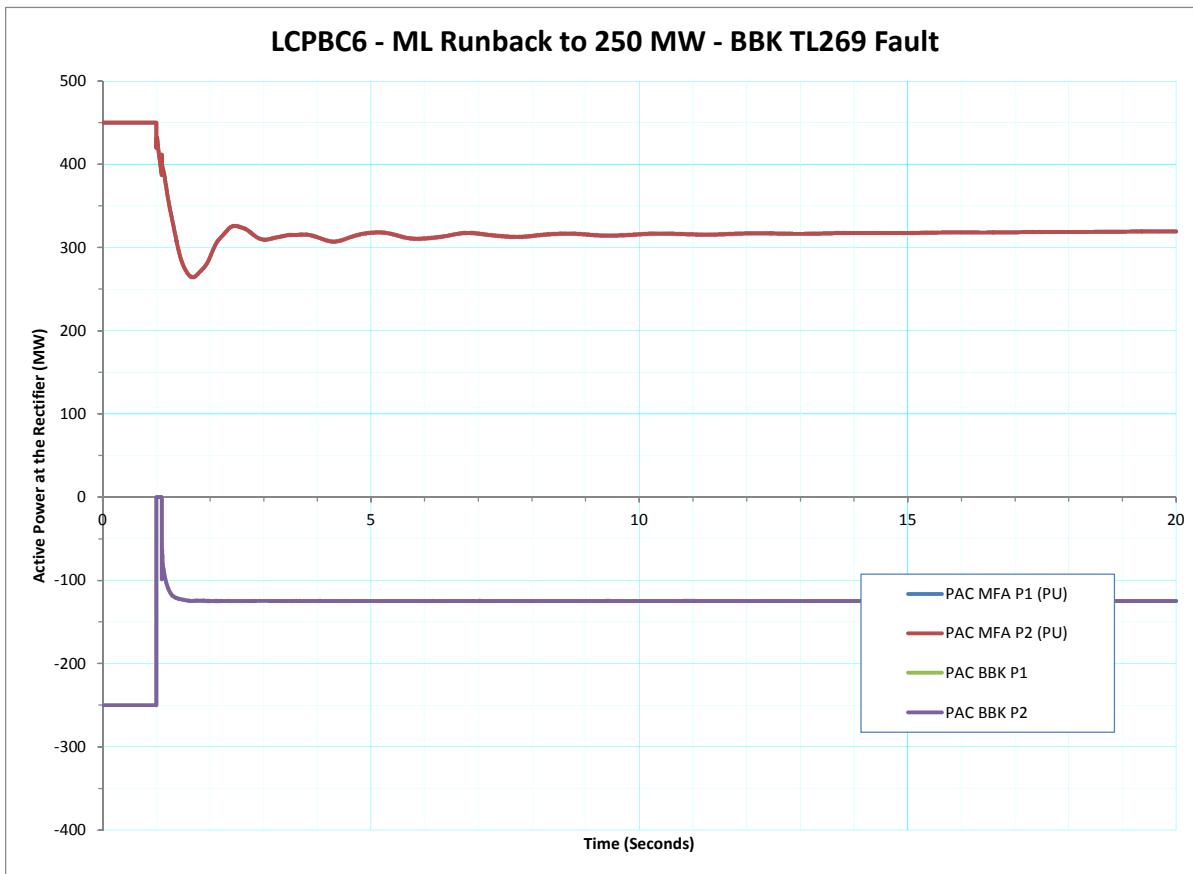
Figure 81 - LCPBC6 - ML Runback to 250 MW - BBK TL269 Fault - Active Power at the Rectifier (MW)

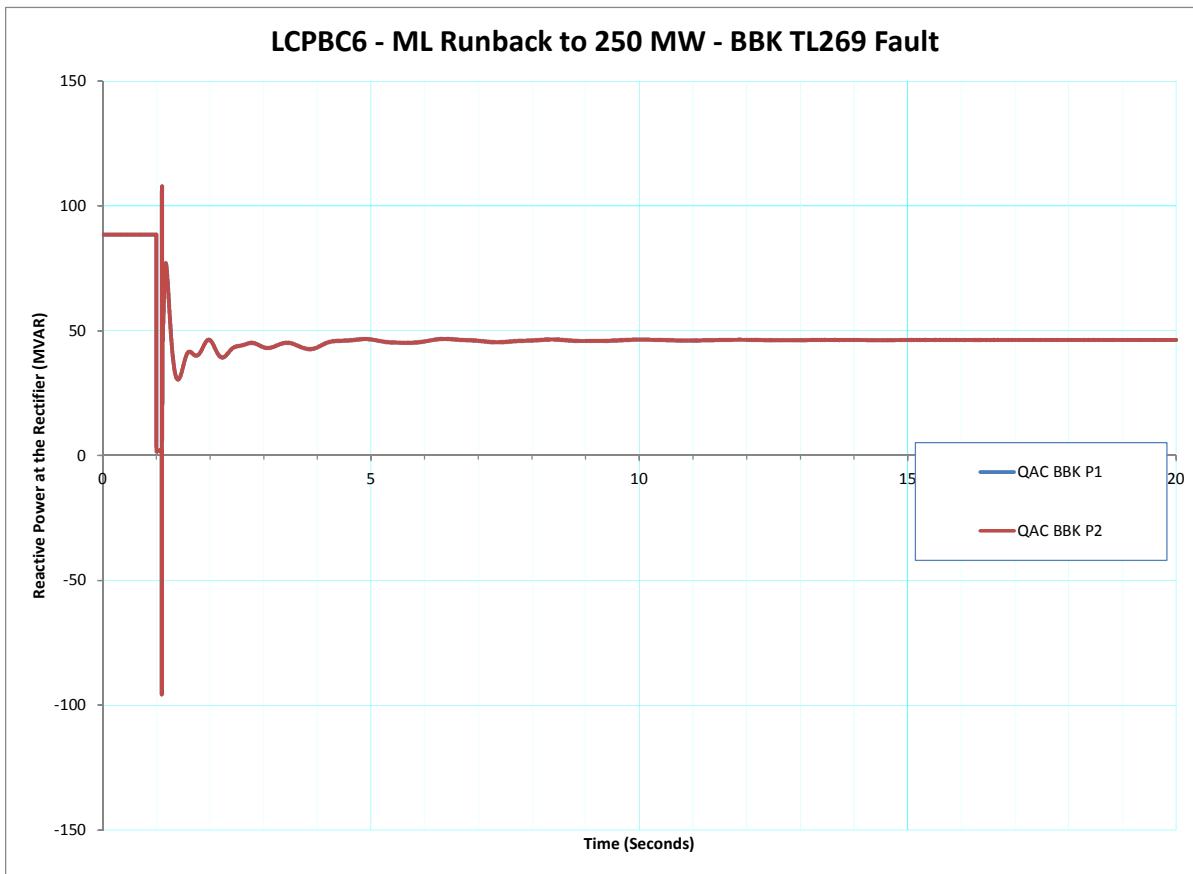
Figure 82 - LCPBC6 - ML Runback to 250 MW - BBK TL269 Fault - Reactive Power at the Rectifier (MVAR)

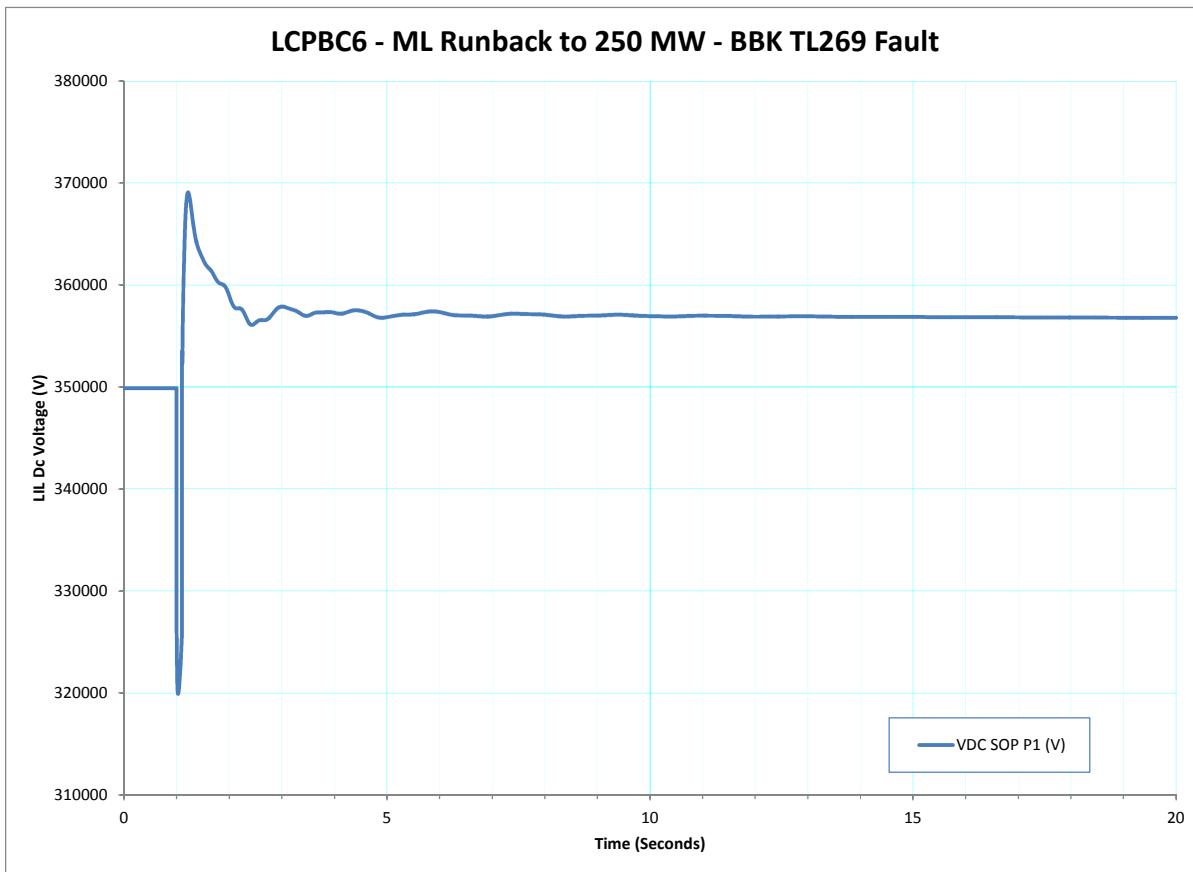
Figure 83 - LCPBC6 - ML Runback to 250 MW - BBK TL269 Fault - LIL Dc Voltage (V)

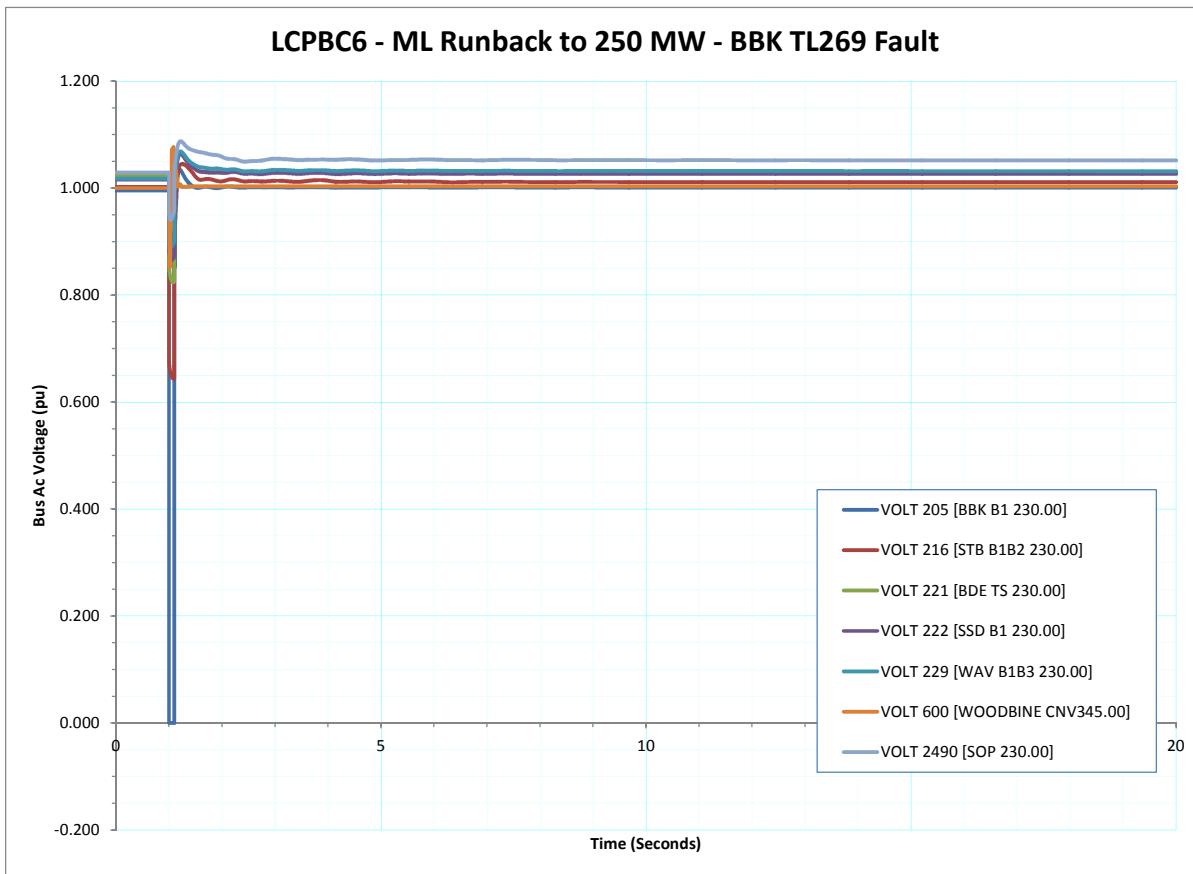
Figure 84 - LCPBC6 - ML Runback to 250 MW - BBK TL269 Fault - Bus Ac Voltage (pu)
