MARITIME LINK PRELIMINARY INTERCONNECTION STUDY

Newfoundland and Labrador Hydro

July 2014

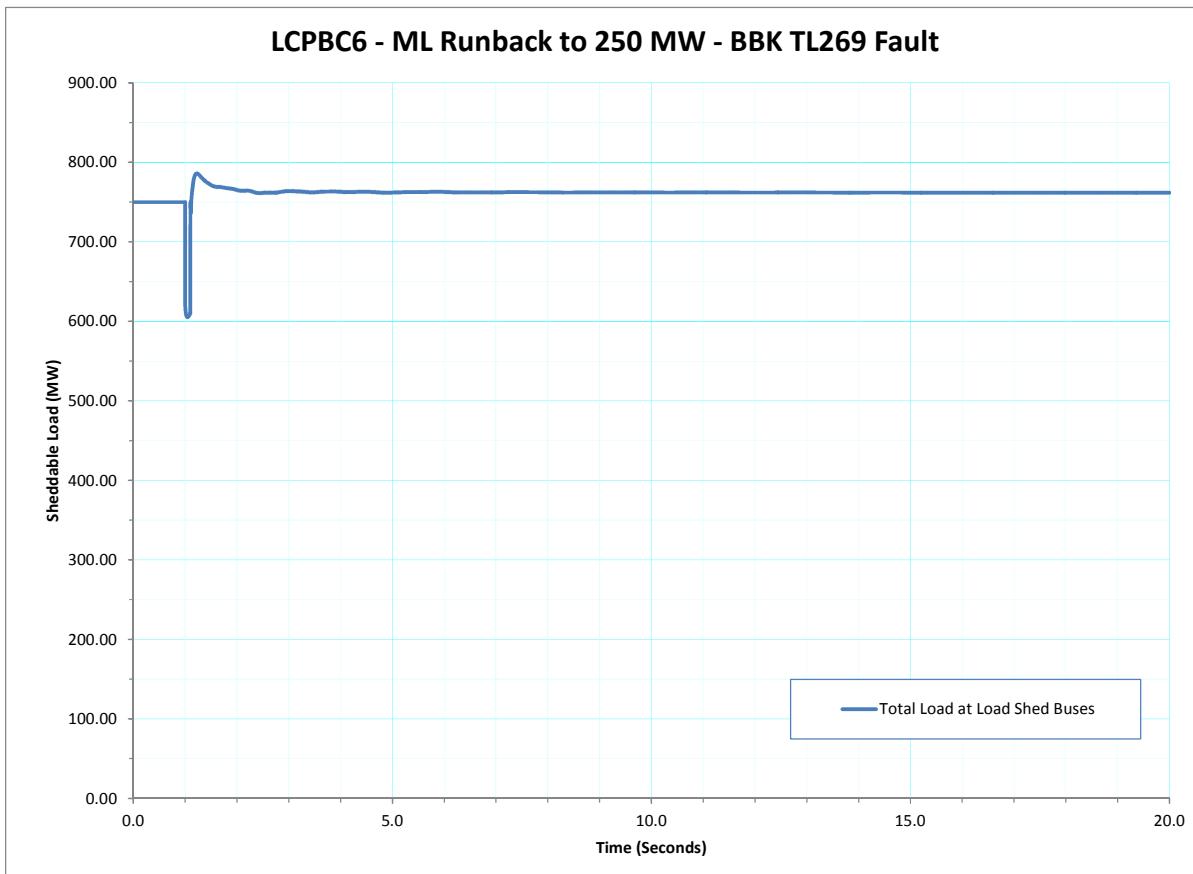
Figure 85 - LCPBC6 - ML Runback to 250 MW - BBK TL269 Fault - Sheddable Load (MW)

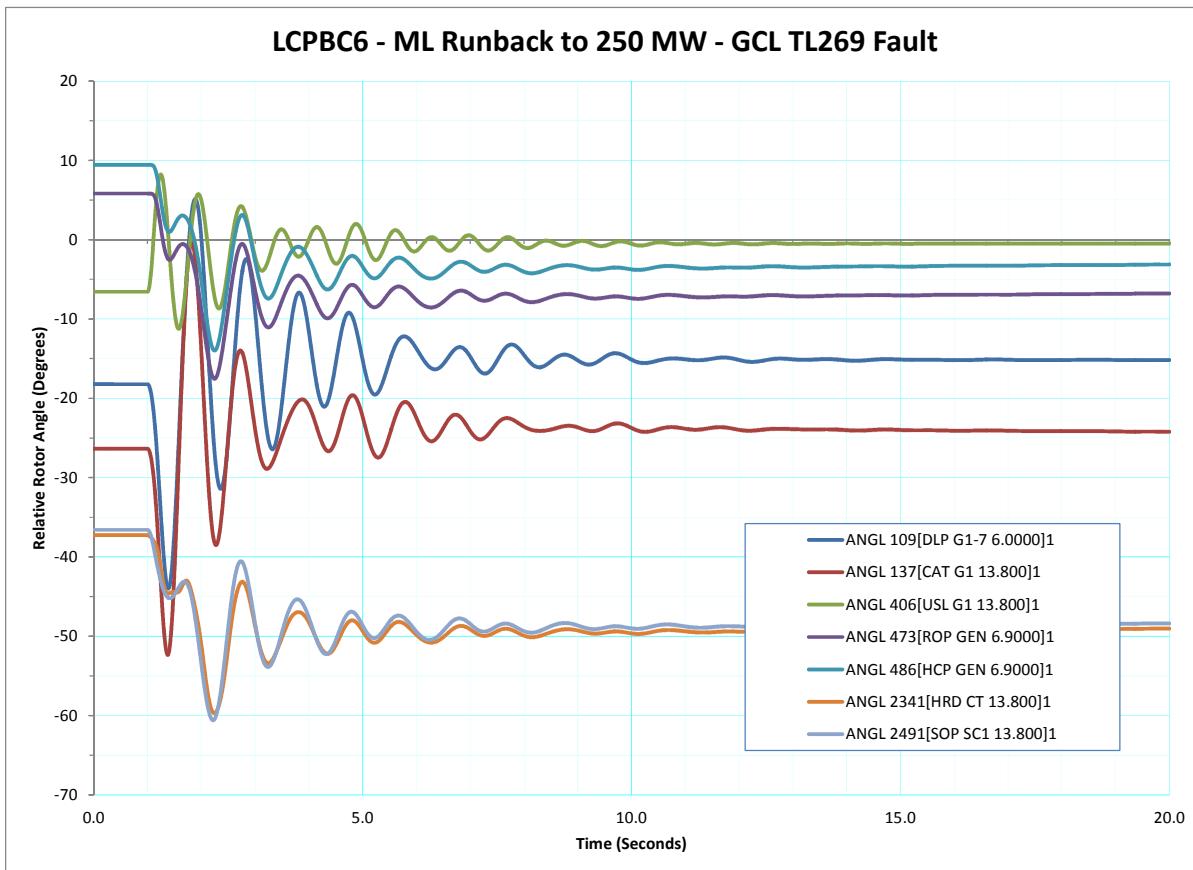
Figure 86 - LCPBC6 - ML Runback to 250 MW - GCL TL269 Fault - Relative Rotor Angle (Degrees)

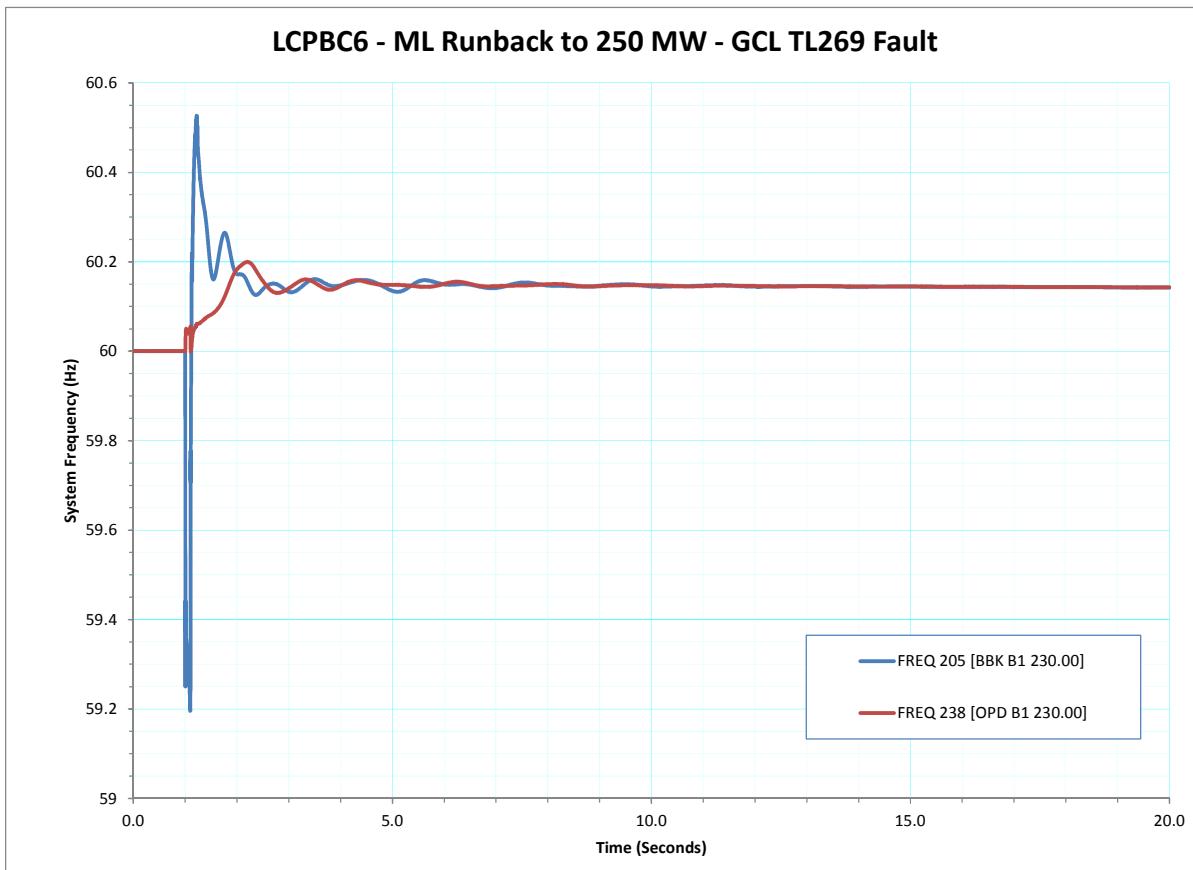
Figure 87 - LCPBC6 - ML Runback to 250 MW - GCL TL269 Fault - System Frequency (Hz)

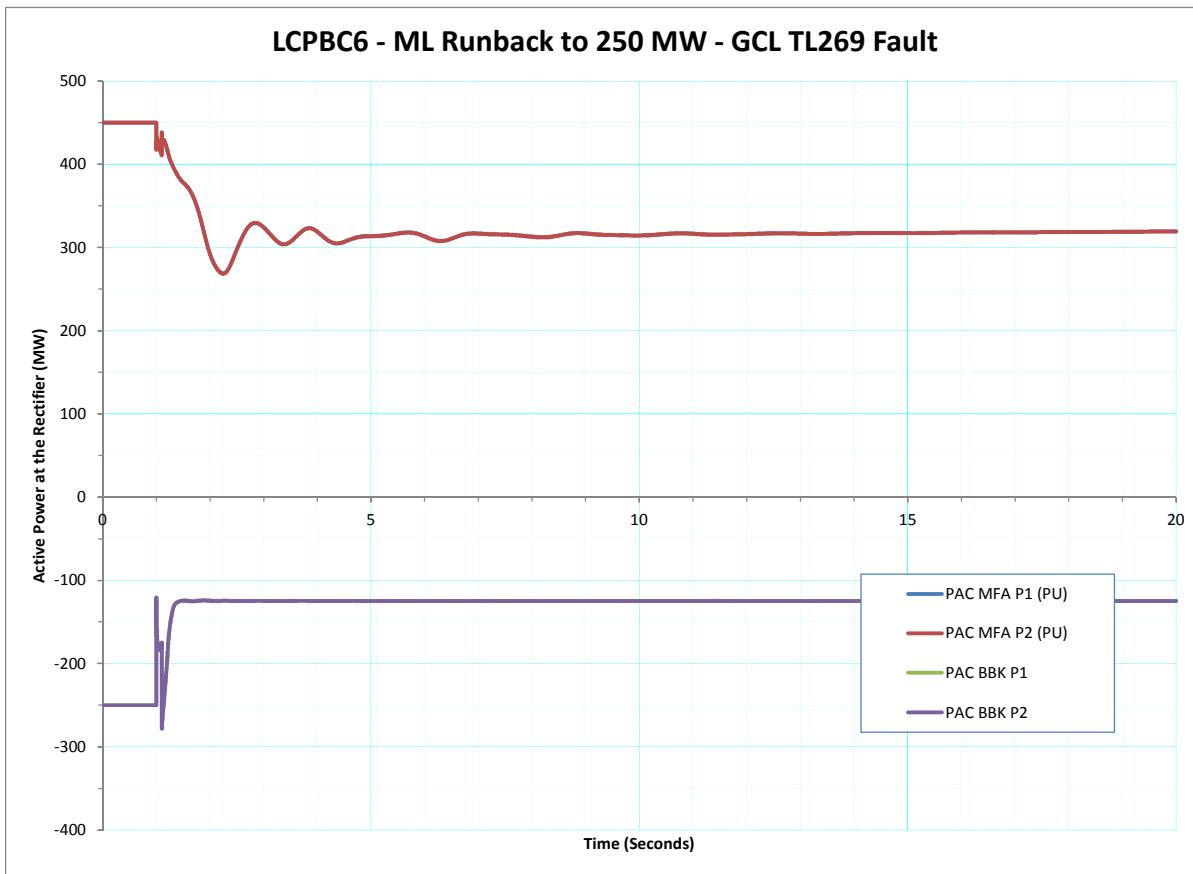
Figure 88 - LCPBC6 - ML Runback to 250 MW - GCL TL269 Fault - Active Power at the Rectifier (MW)

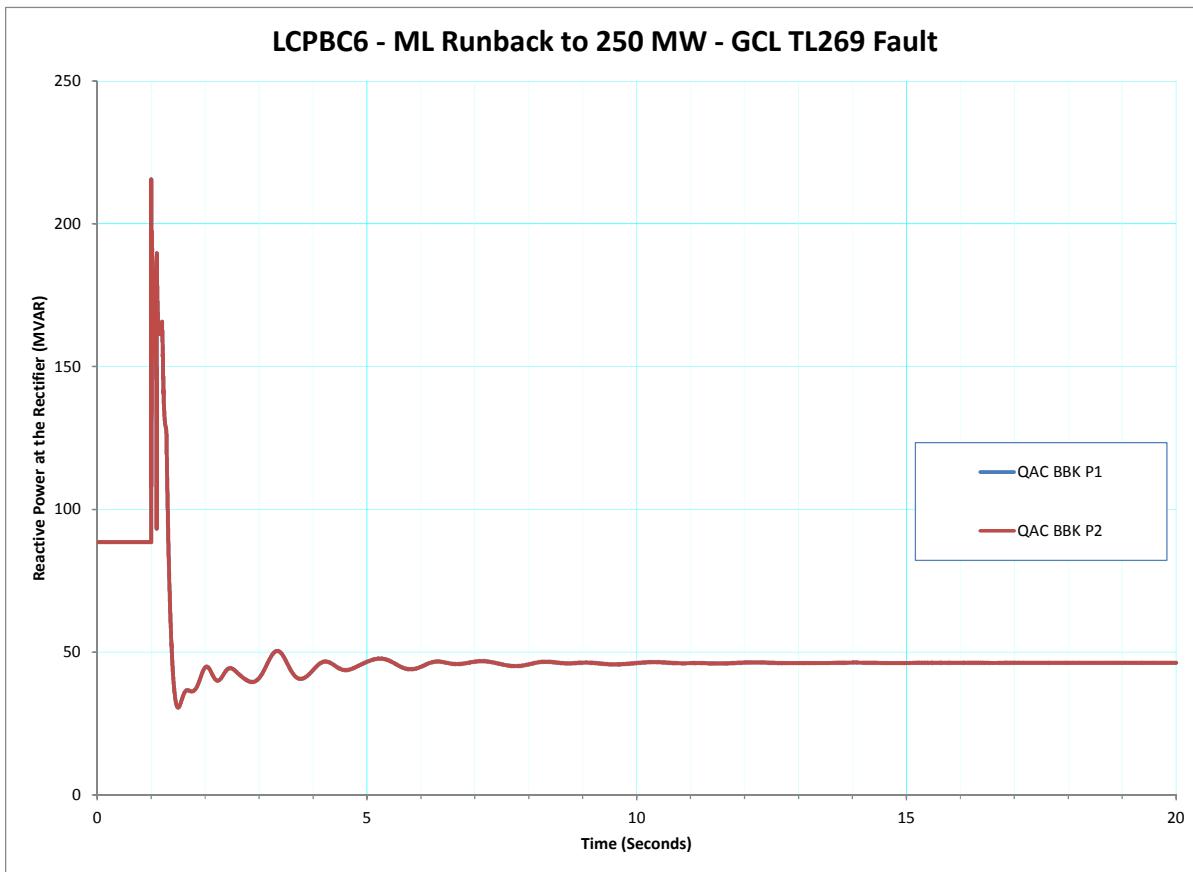
Figure 89 - LCPBC6 - ML Runback to 250 MW - GCL TL269 Fault - Reactive Power at the Rectifier (MVAR)

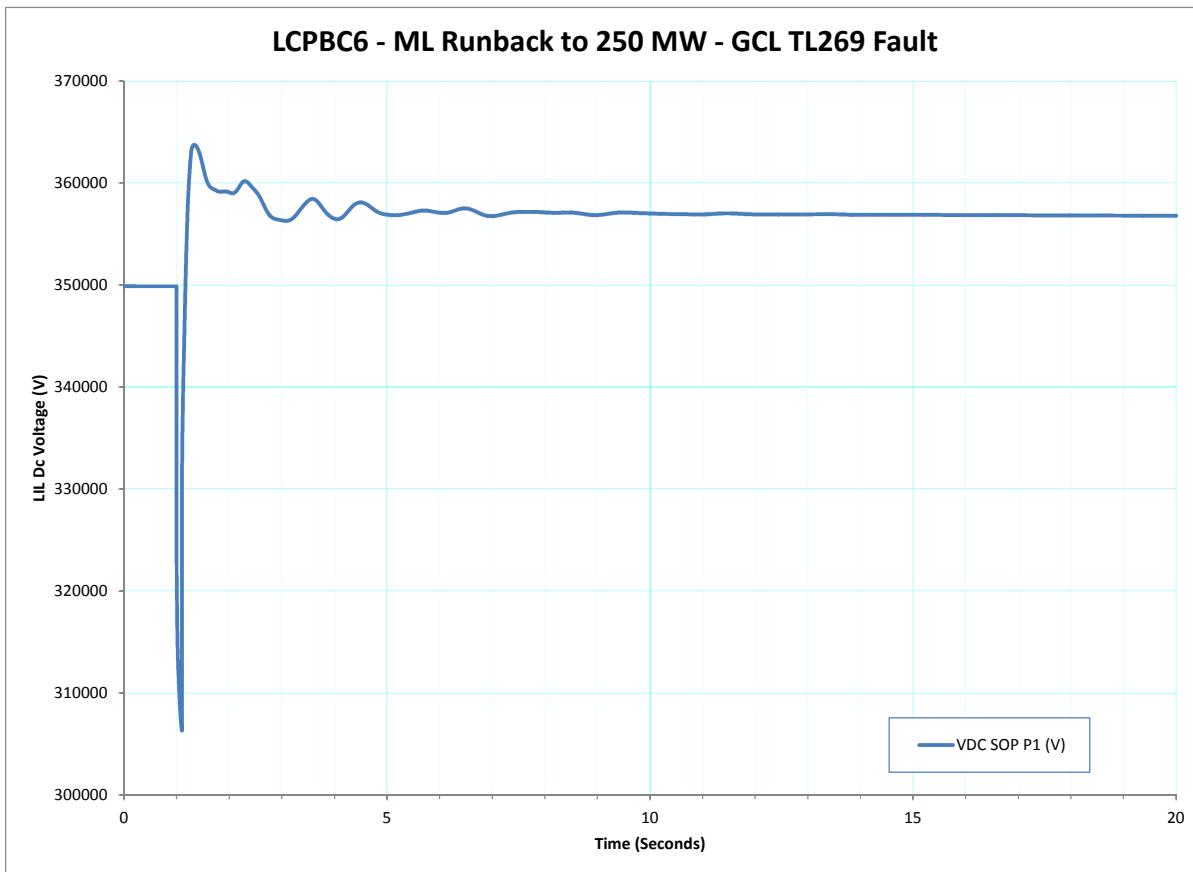
Figure 90 - LCPBC6 - ML Runback to 250 MW - GCL TL269 Fault - LIL Dc Voltage (V)

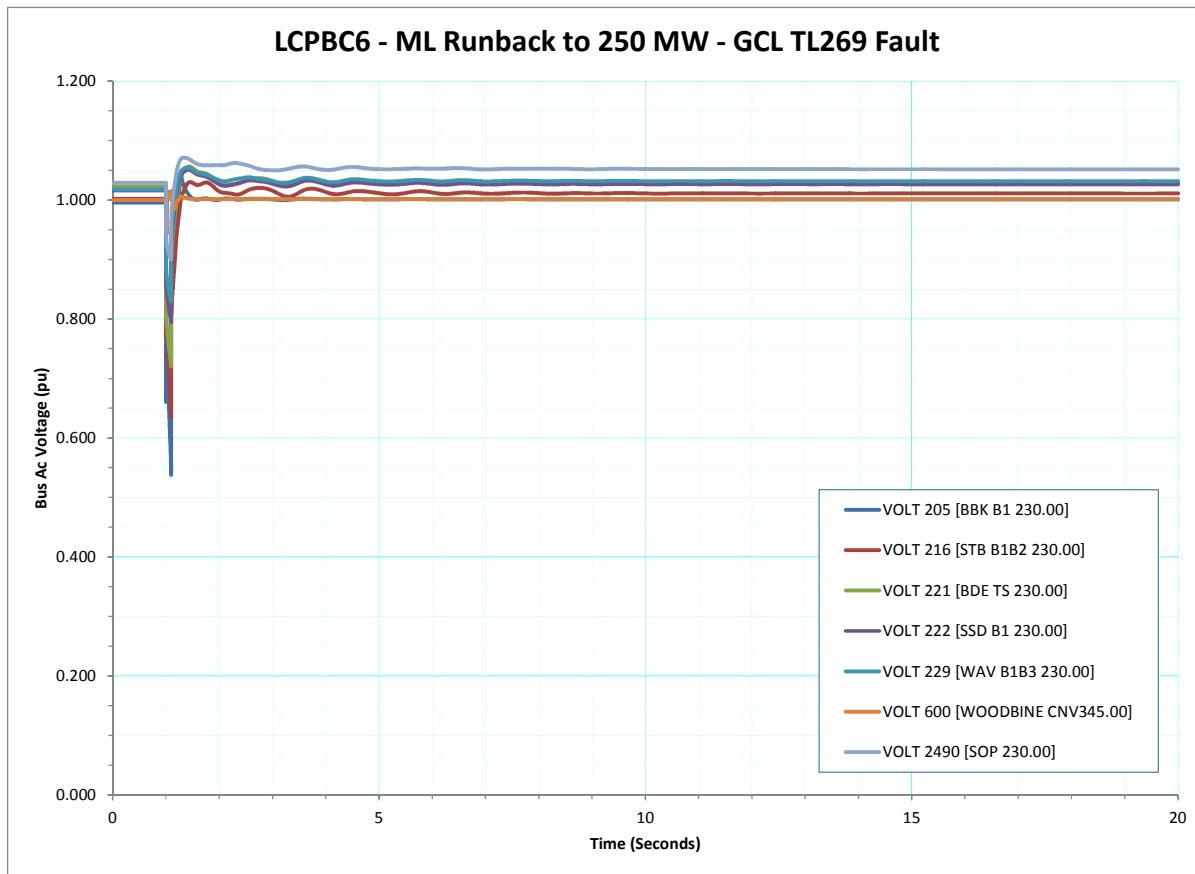
Figure 91 - LCPBC6 - ML Runback to 250 MW - GCL TL269 Fault - Bus Ac Voltage (pu)

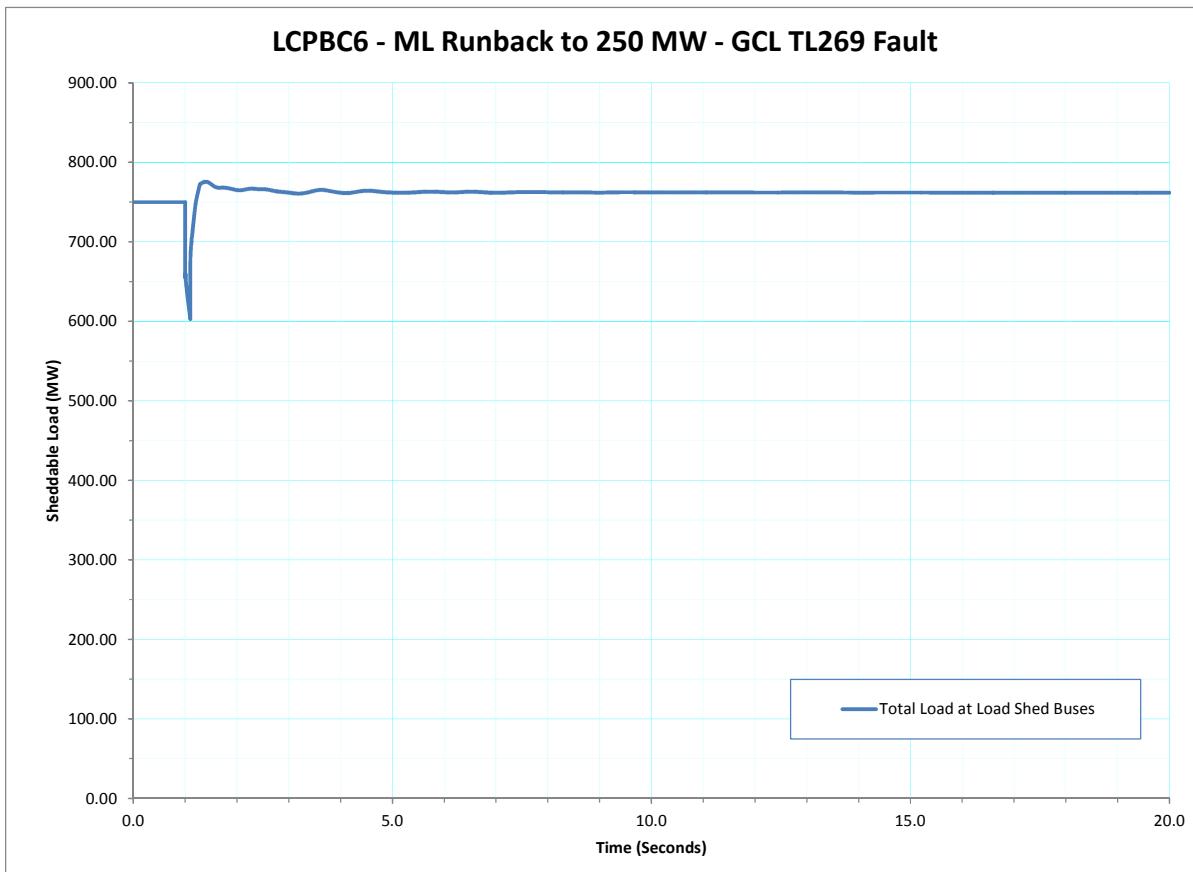
Figure 92 - LCPBC6 - ML Runback to 250 MW - GCL TL269 Fault - Sheddable Load (MW)

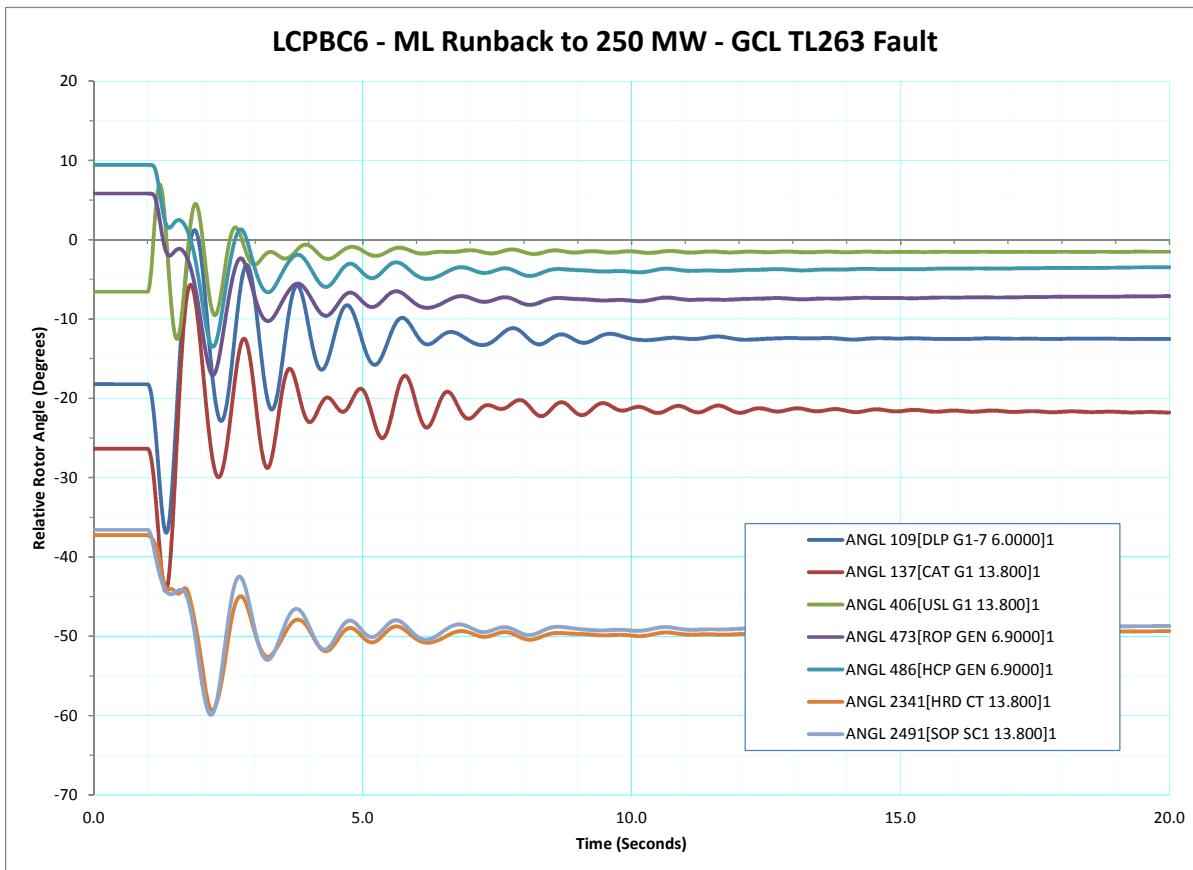
Figure 93 - LCPBC6 - ML Runback to 250 MW - GCL TL263 Fault - Relative Rotor Angle (Degrees)

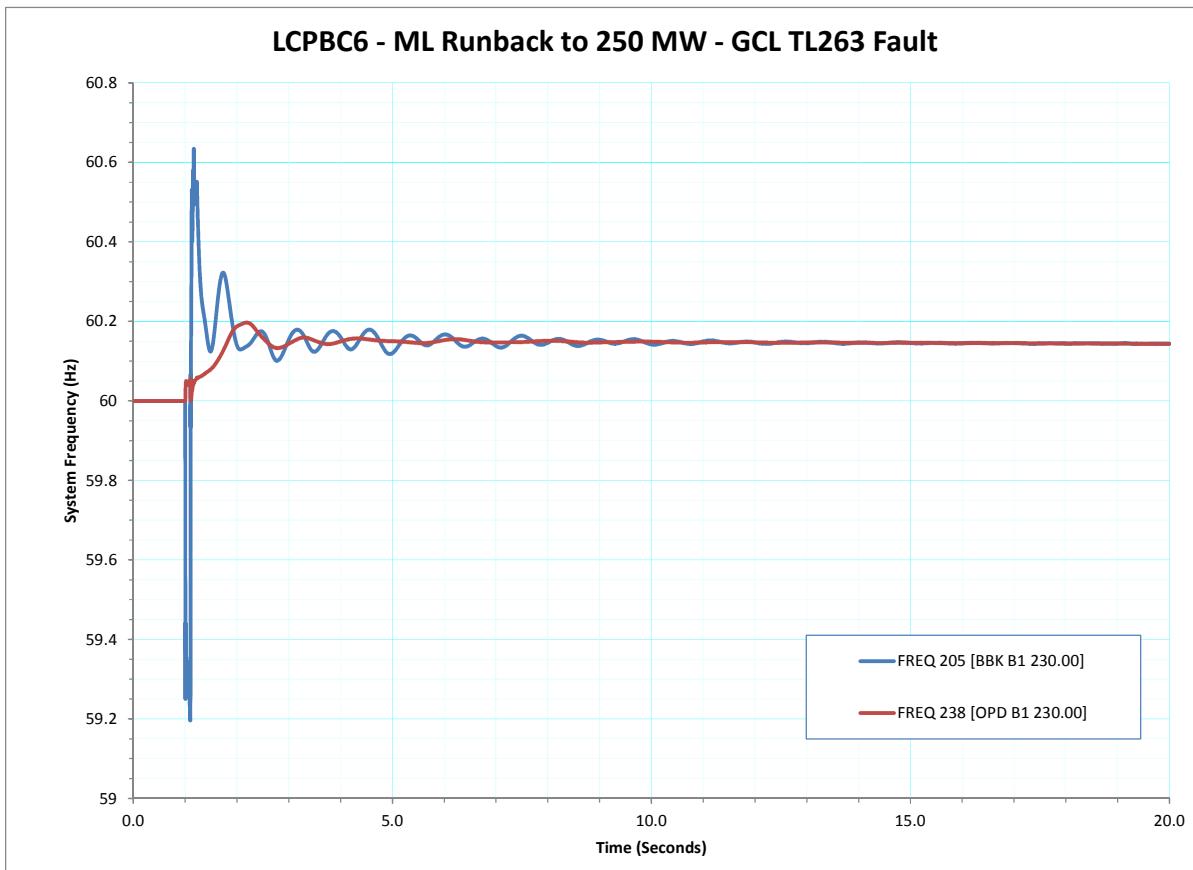
Figure 94 - LCPBC6 - ML Runback to 250 MW - GCL TL263 Fault - System Frequency (Hz)

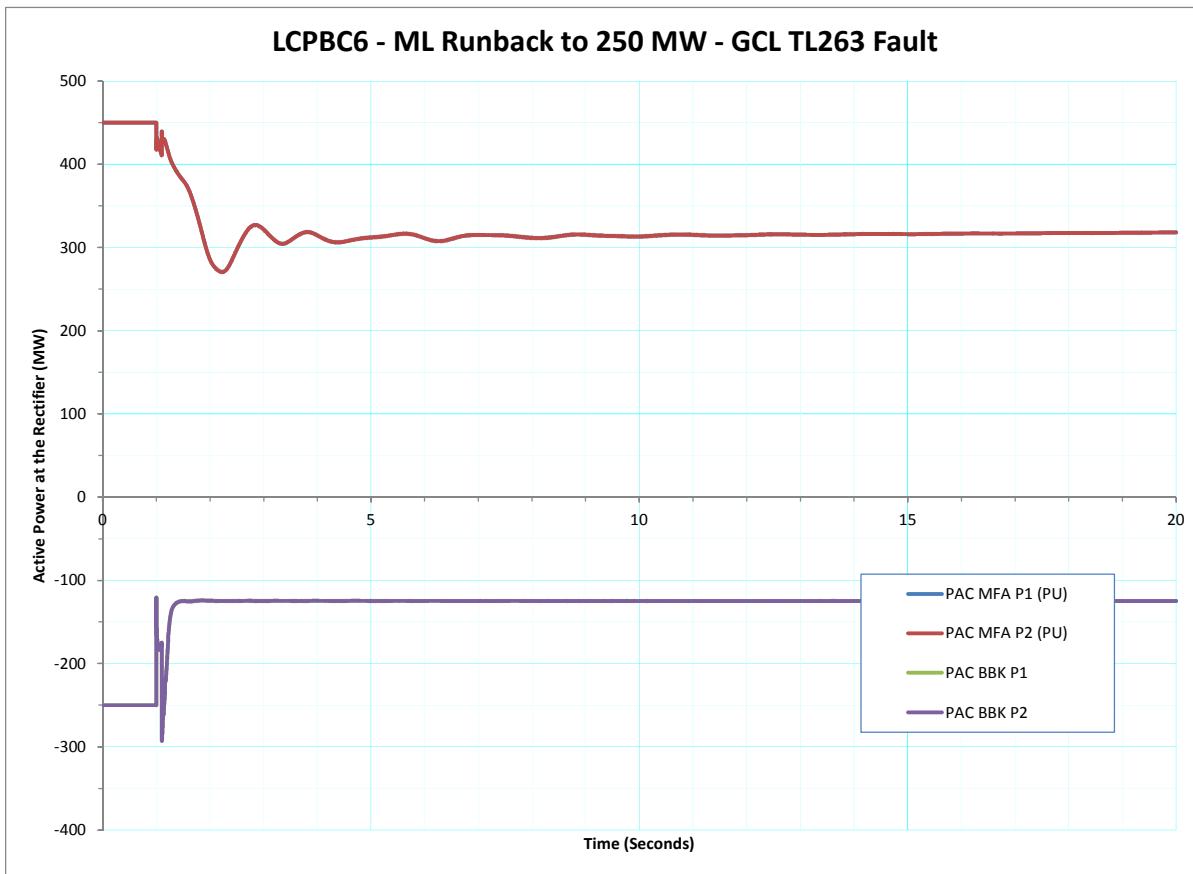
Figure 95 - LCPBC6 - ML Runback to 250 MW - GCL TL263 Fault - Active Power at the Rectifier (MW)

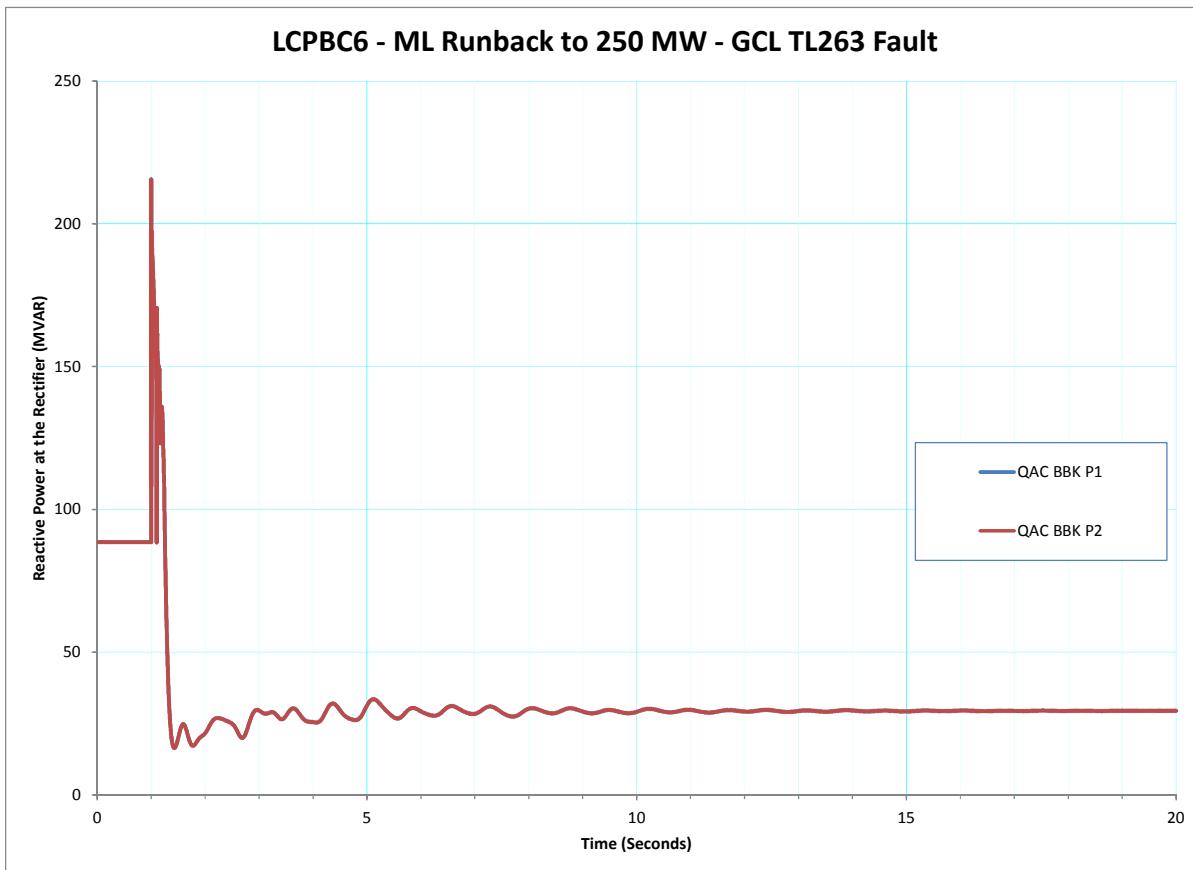
Figure 96 - LCPBC6 - ML Runback to 250 MW - GCL TL263 Fault - Reactive Power at the Rectifier (MVAR)

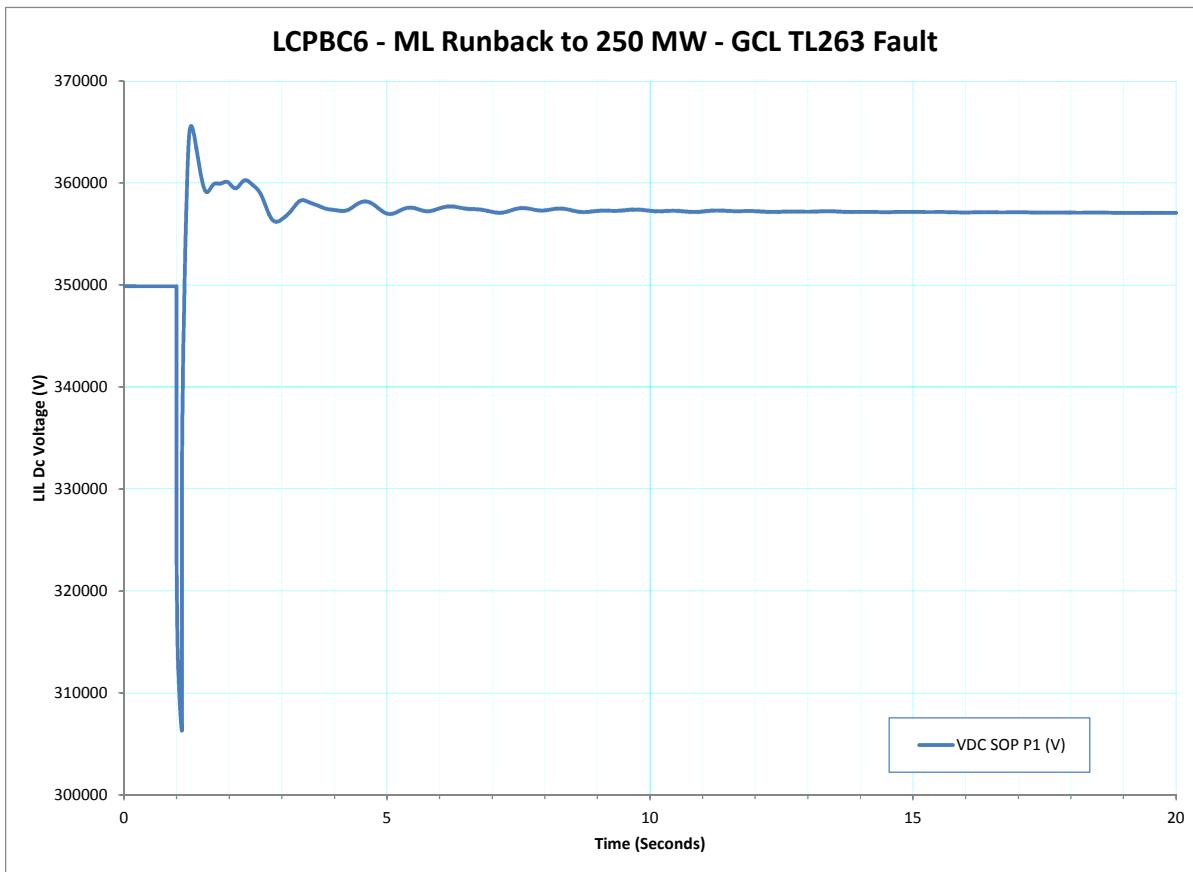
Figure 97 - LCPBC6 - ML Runback to 250 MW - GCL TL263 Fault - LIL Dc Voltage (V)

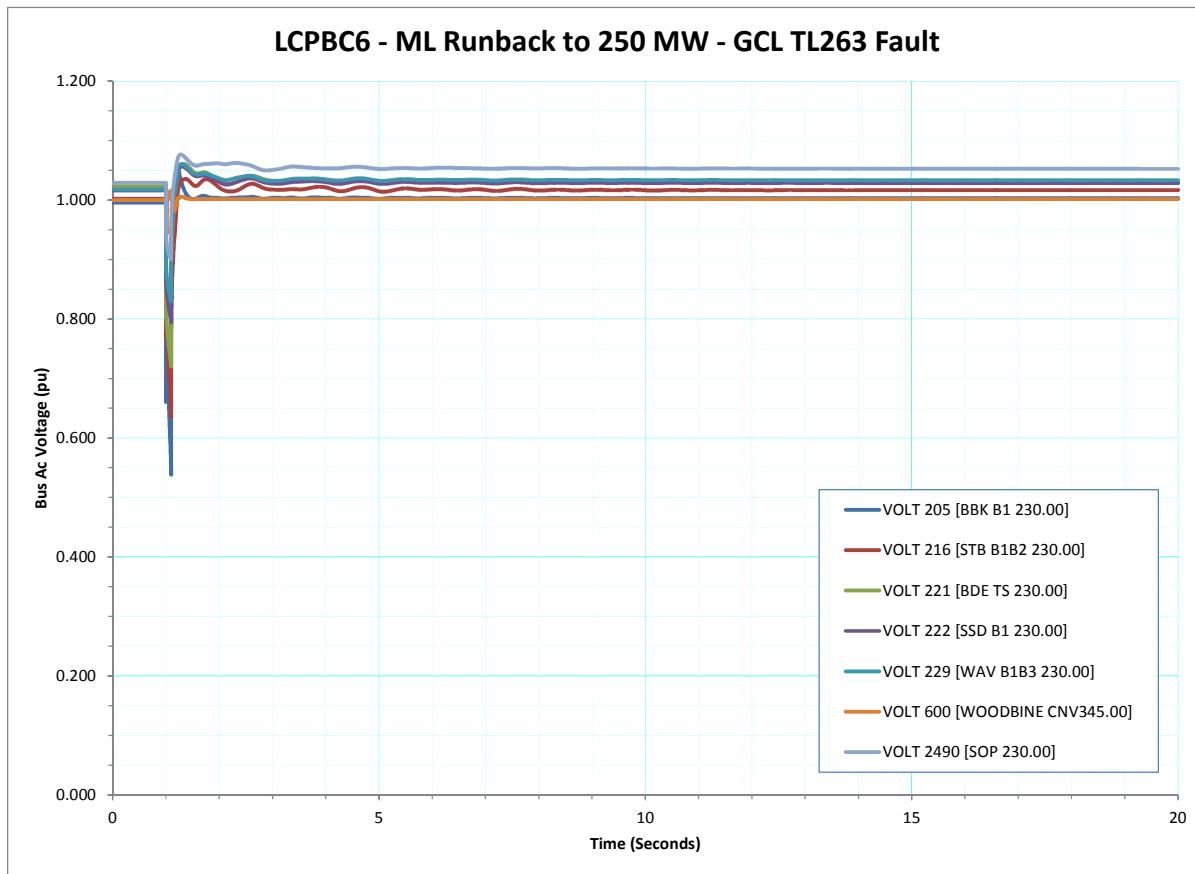
Figure 98 - LCPBC6 - ML Runback to 250 MW - GCL TL263 Fault - Bus Ac Voltage (pu)

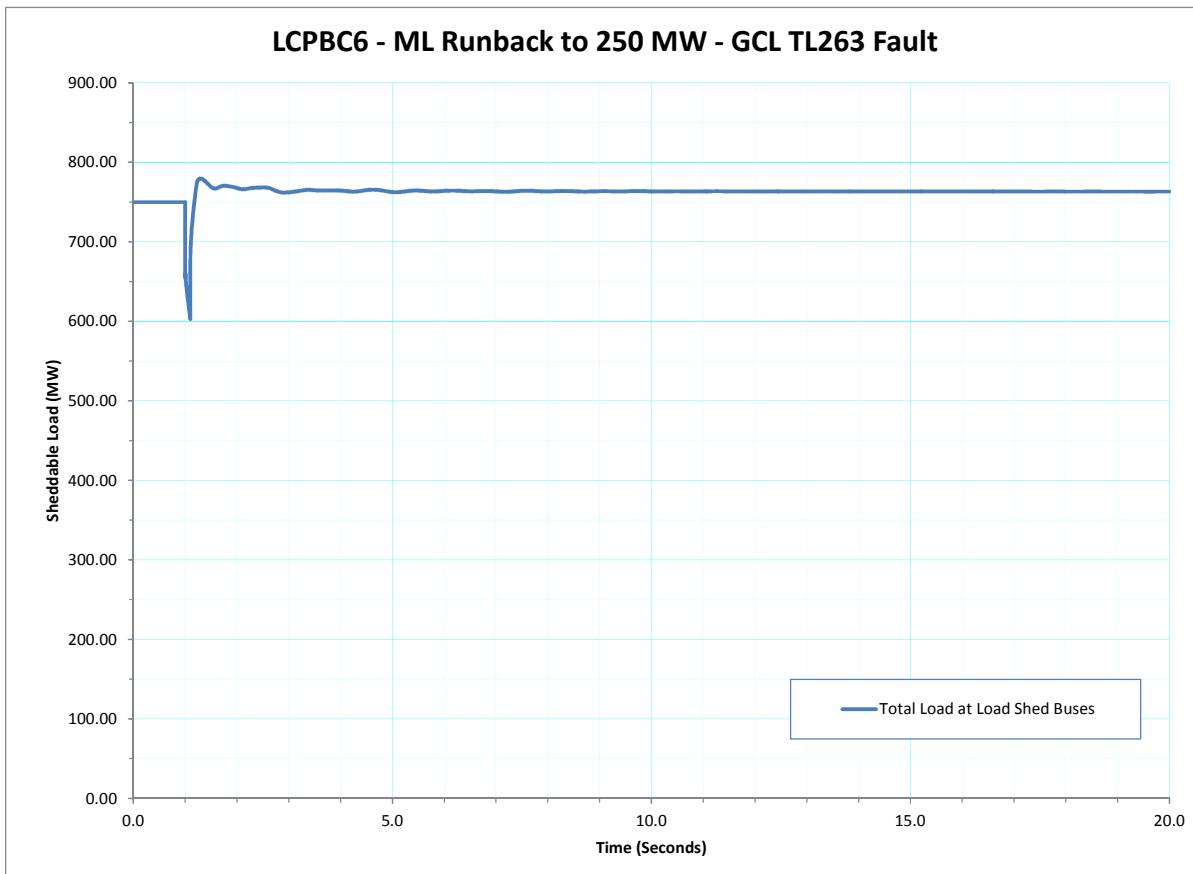
Figure 99 - LCPBC6 - ML Runback to 250 MW - GCL TL263 Fault - Sheddable Load (MW)

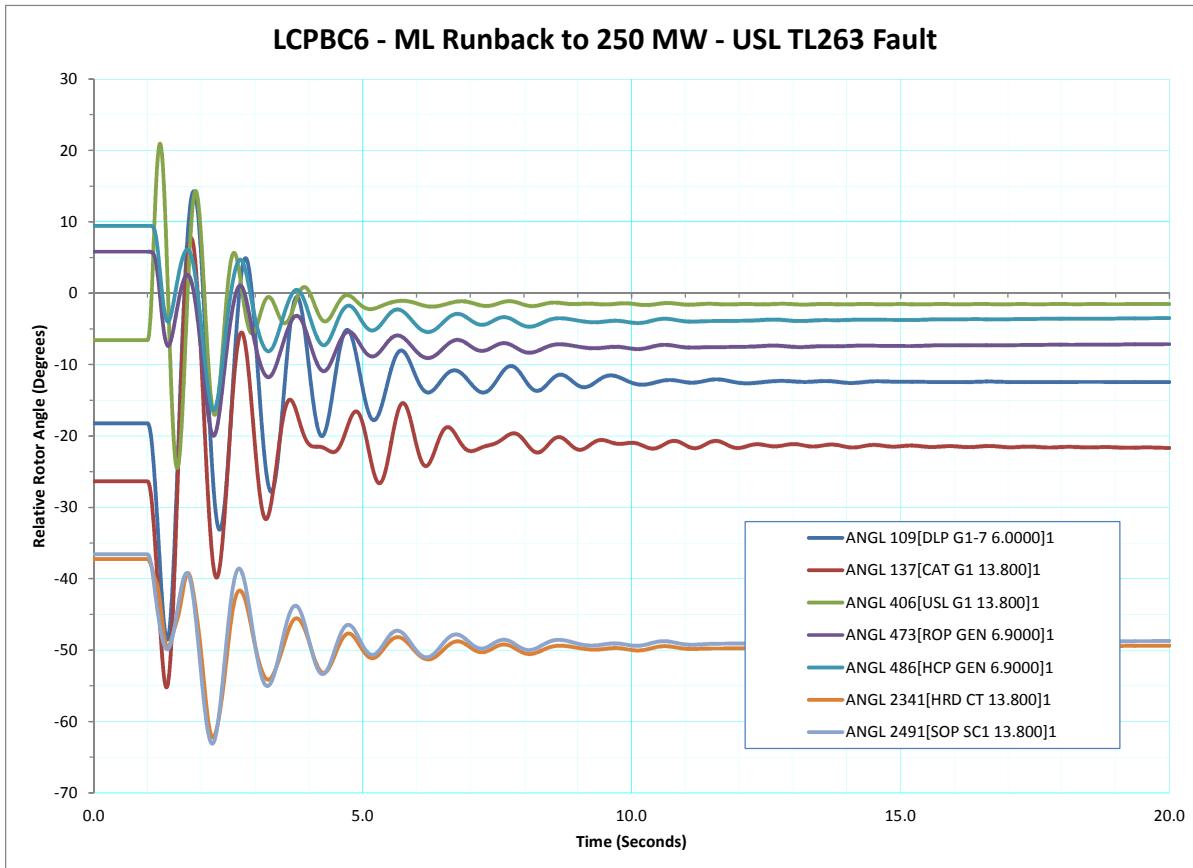
Figure 100 - LCPBC6 - ML Runback to 250 MW - USL TL263 Fault - Relative Rotor Angle (Degrees)

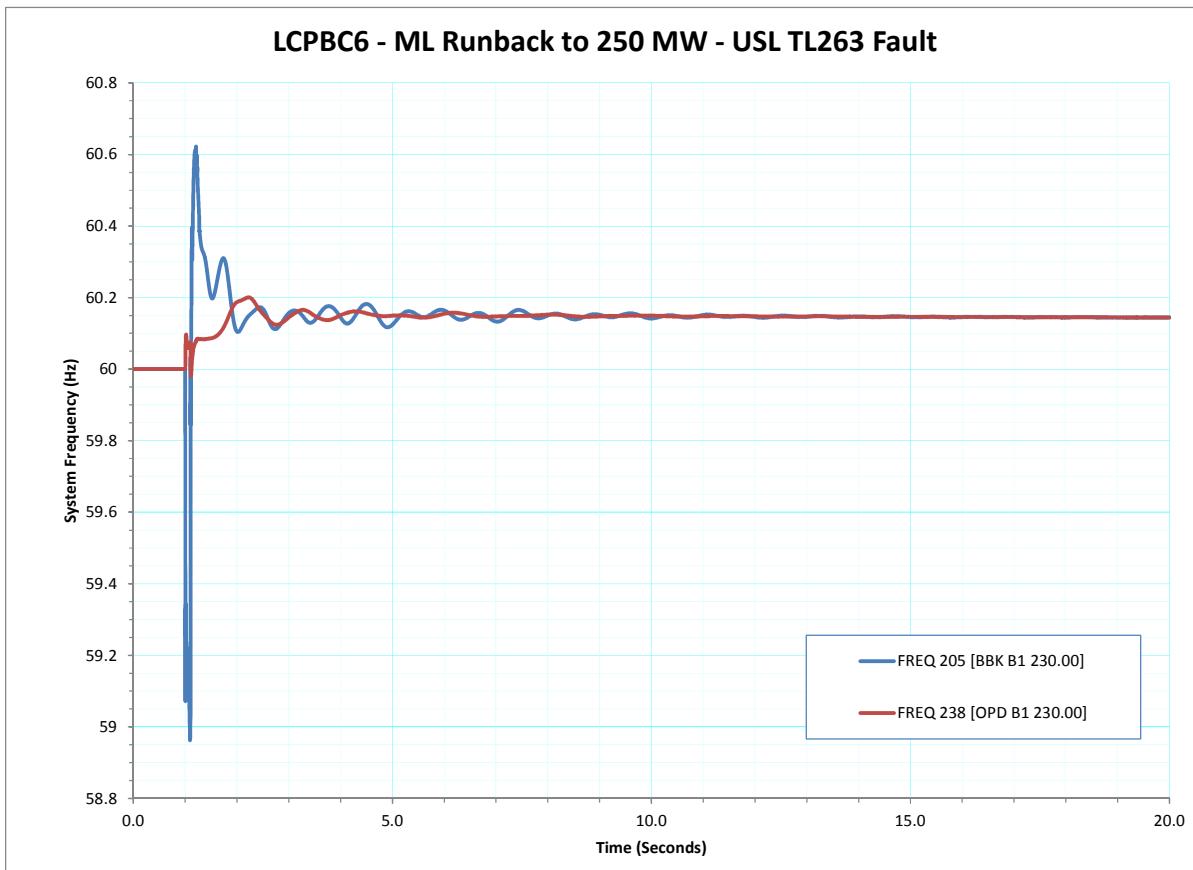
Figure 101 - LCPBC6 - ML Runback to 250 MW - USL TL263 Fault - System Frequency (Hz)

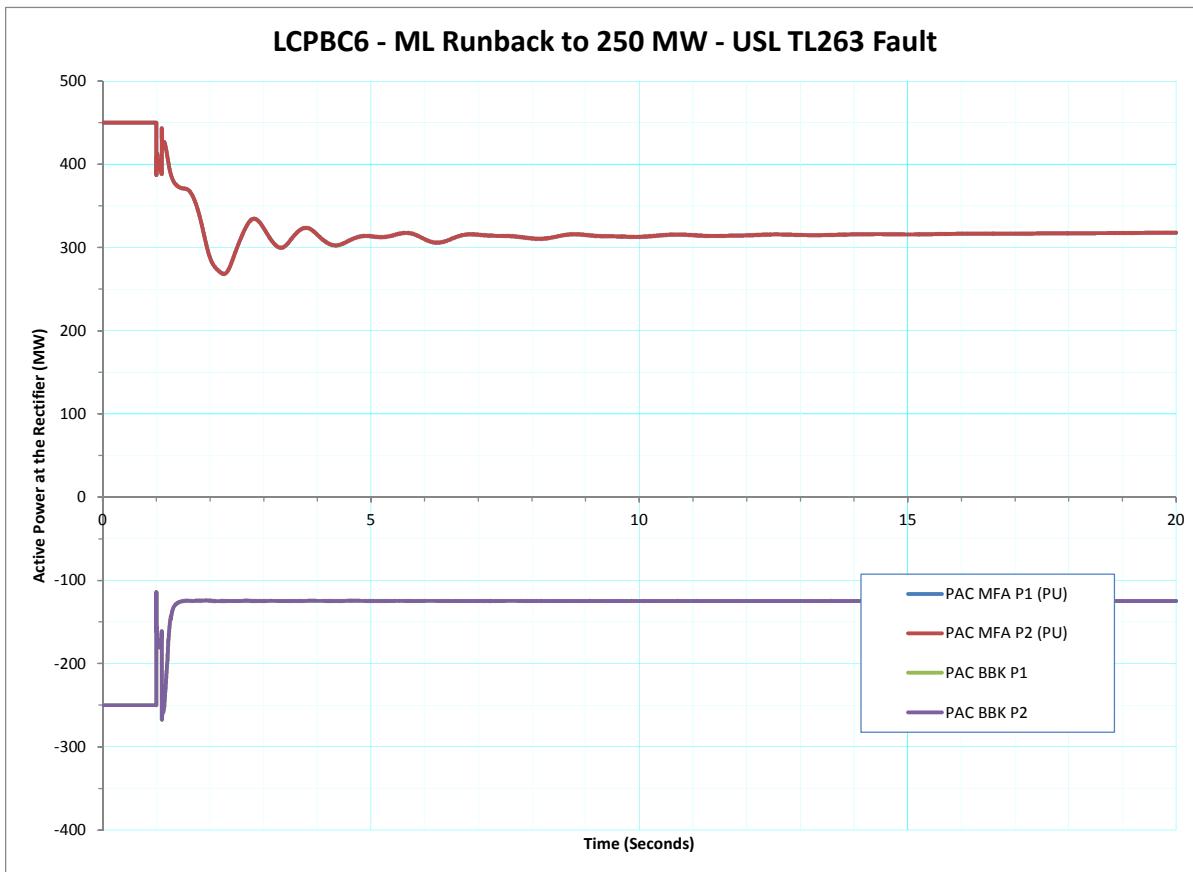
Figure 102 - LCPBC6 - ML Runback to 250 MW - USL TL263 Fault - Active Power at the Rectifier (MW)

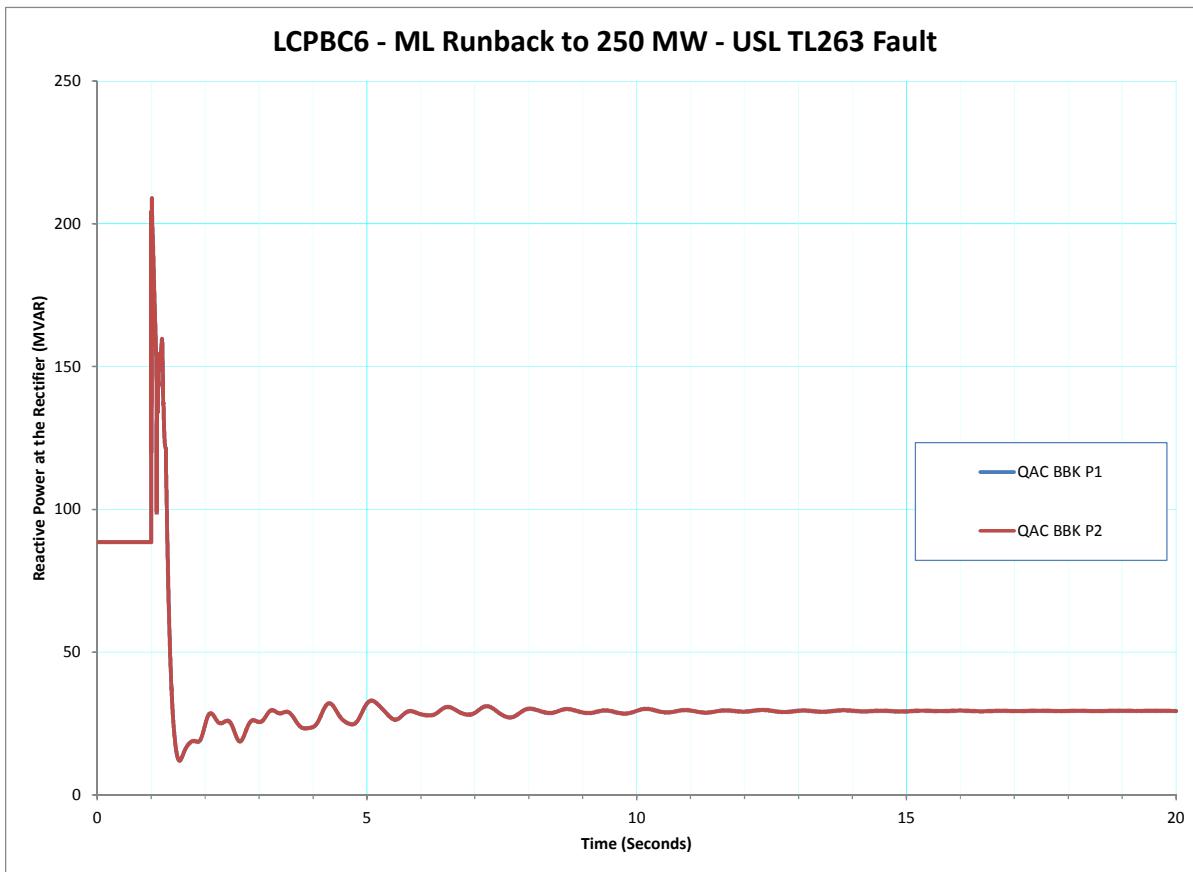
Figure 103 - LCPBC6 - ML Runback to 250 MW - USL TL263 Fault - Reactive Power at the Rectifier (MVAR)

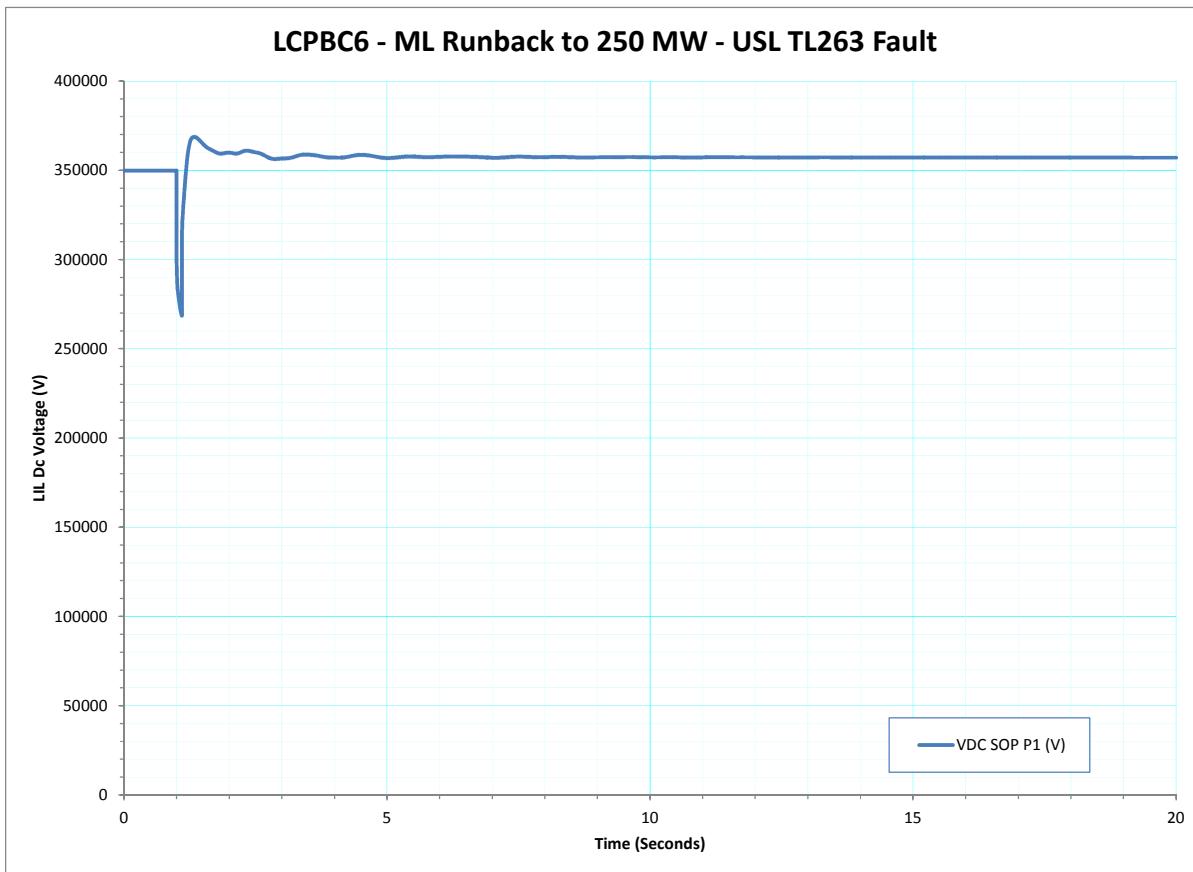
Figure 104 - LCPBC6 - ML Runback to 250 MW - USL TL263 Fault - LIL Dc Voltage (V)

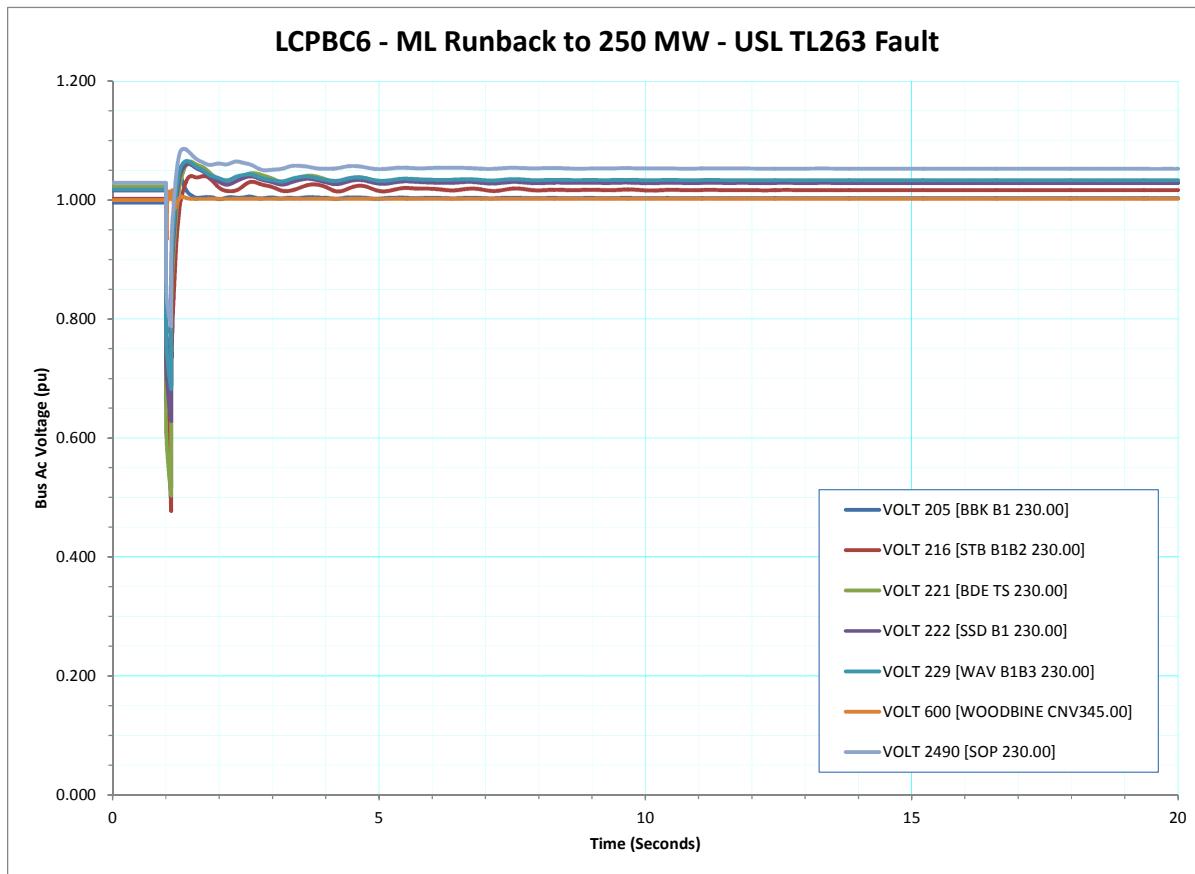
Figure 105 - LCPBC6 - ML Runback to 250 MW - USL TL263 Fault - Bus Ac Voltage (pu)
