MARITIME LINK PRELIMINARY INTERCONNECTION STUDY

Newfoundland and Labrador Hydro

July 2014

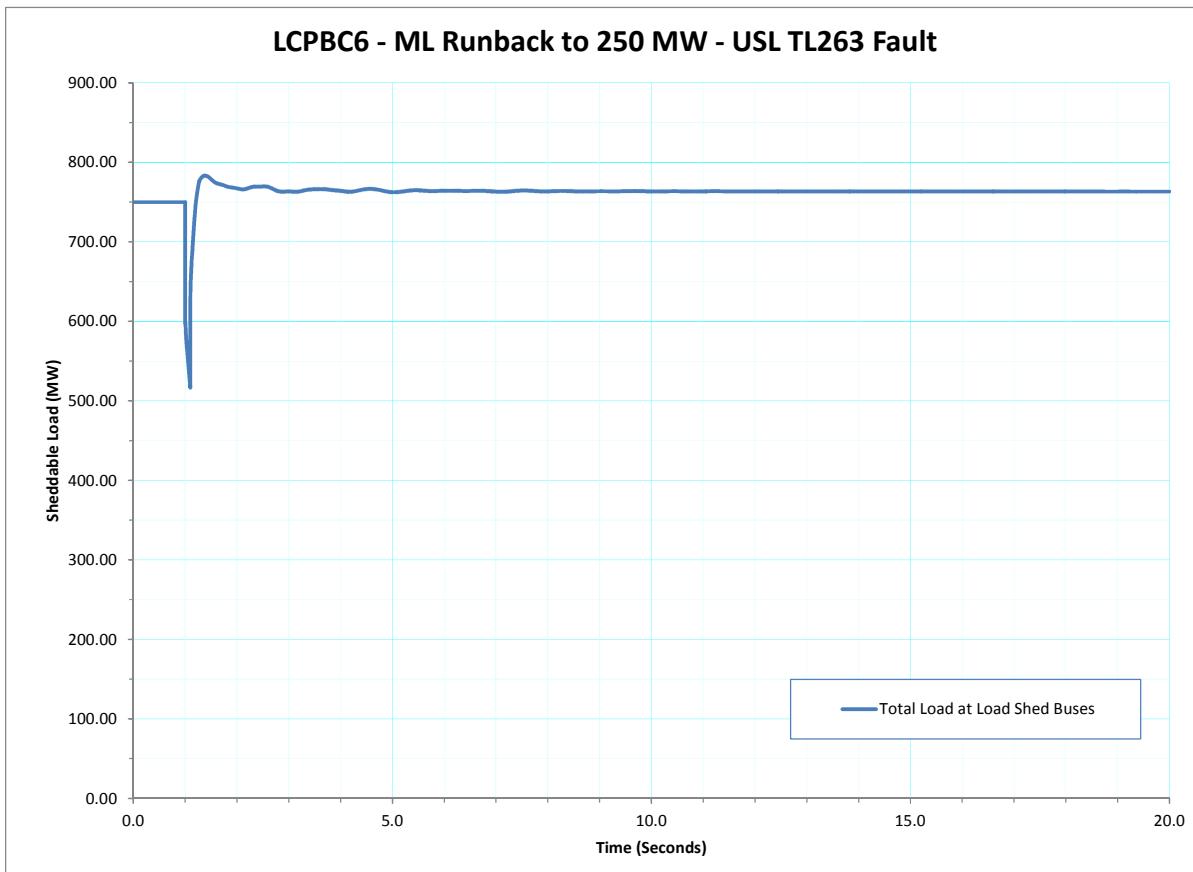
Figure 106 - LCPBC6 - ML Runback to 250 MW - USL TL263 Fault - Sheddable Load (MW)

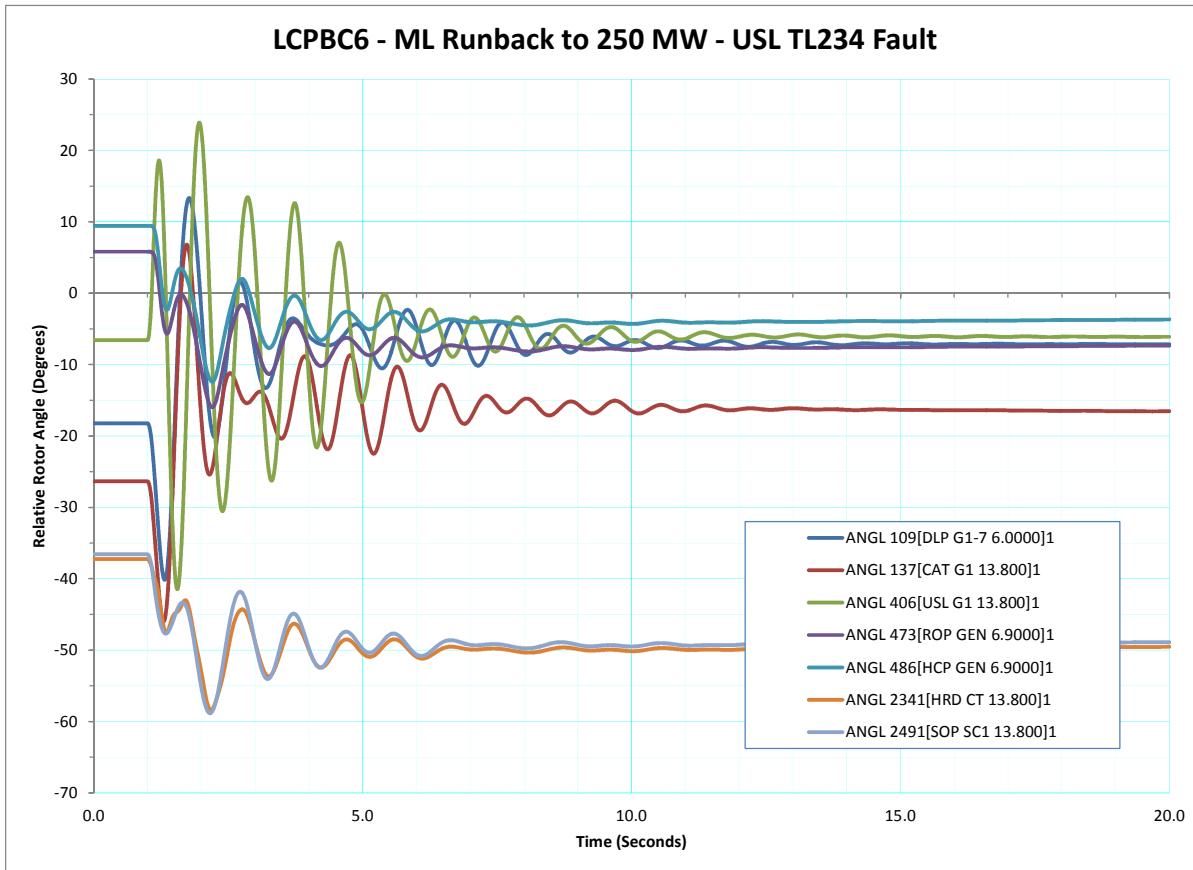
Figure 107 - LCPBC6 - ML Runback to 250 MW - USL TL234 Fault - Relative Rotor Angle (Degrees)

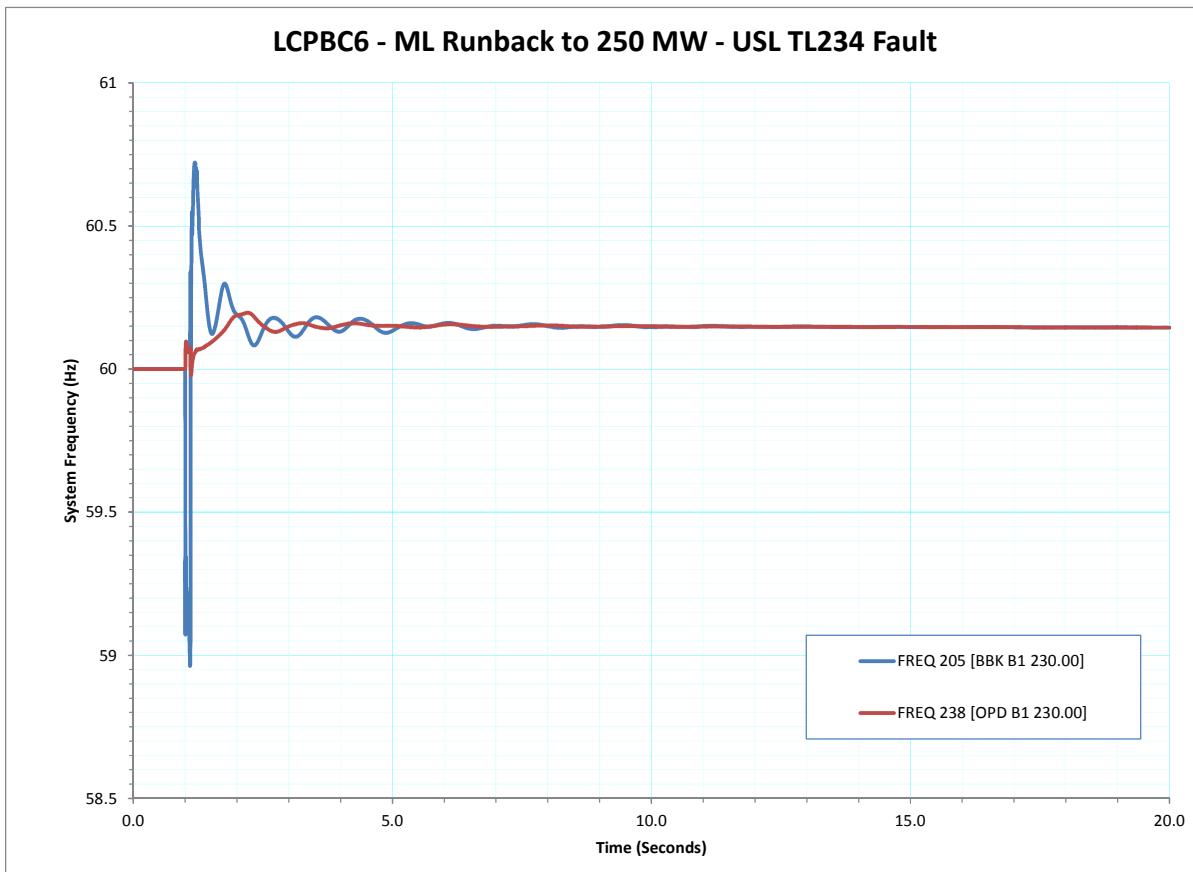
Figure 108 - LCPBC6 - ML Runback to 250 MW - USL TL234 Fault - System Frequency (Hz)

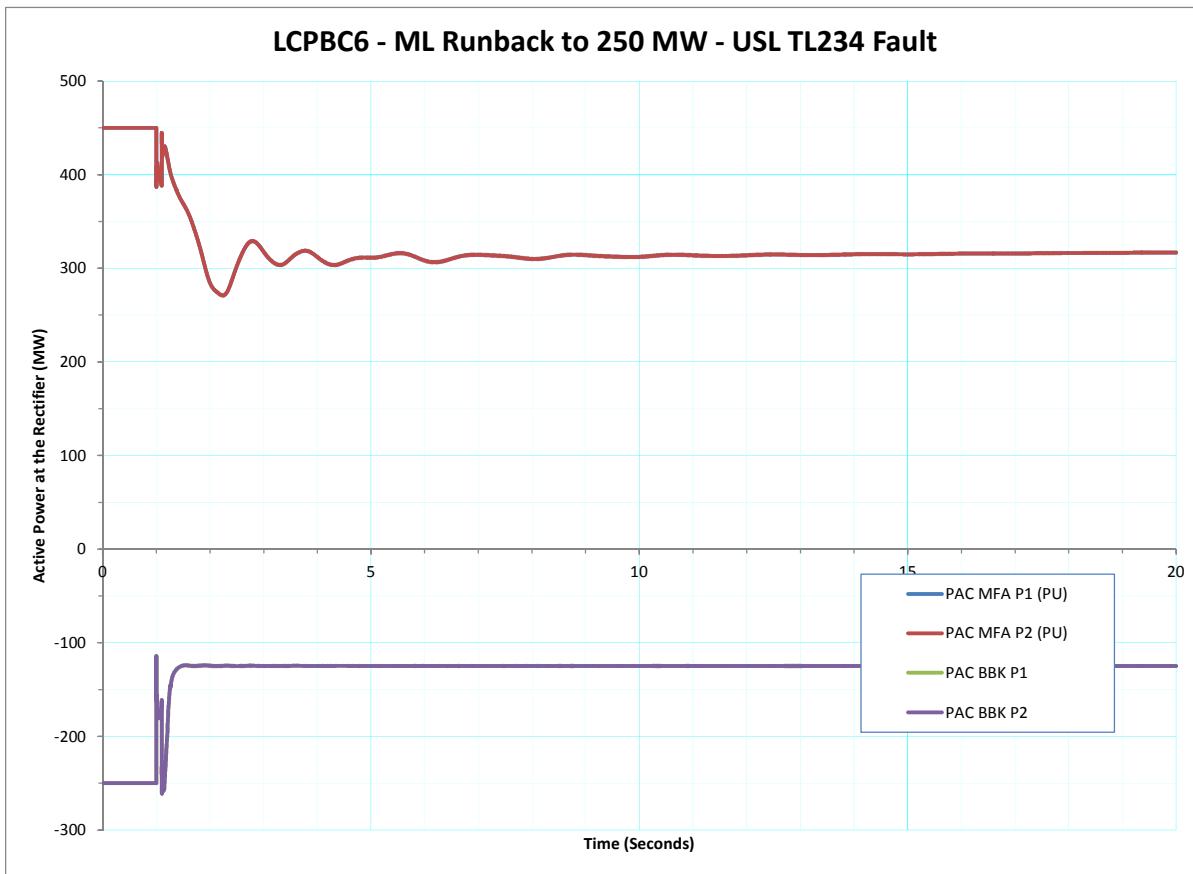
Figure 109 - LCPBC6 - ML Runback to 250 MW - USL TL234 Fault - Active Power at the Rectifier (MW)

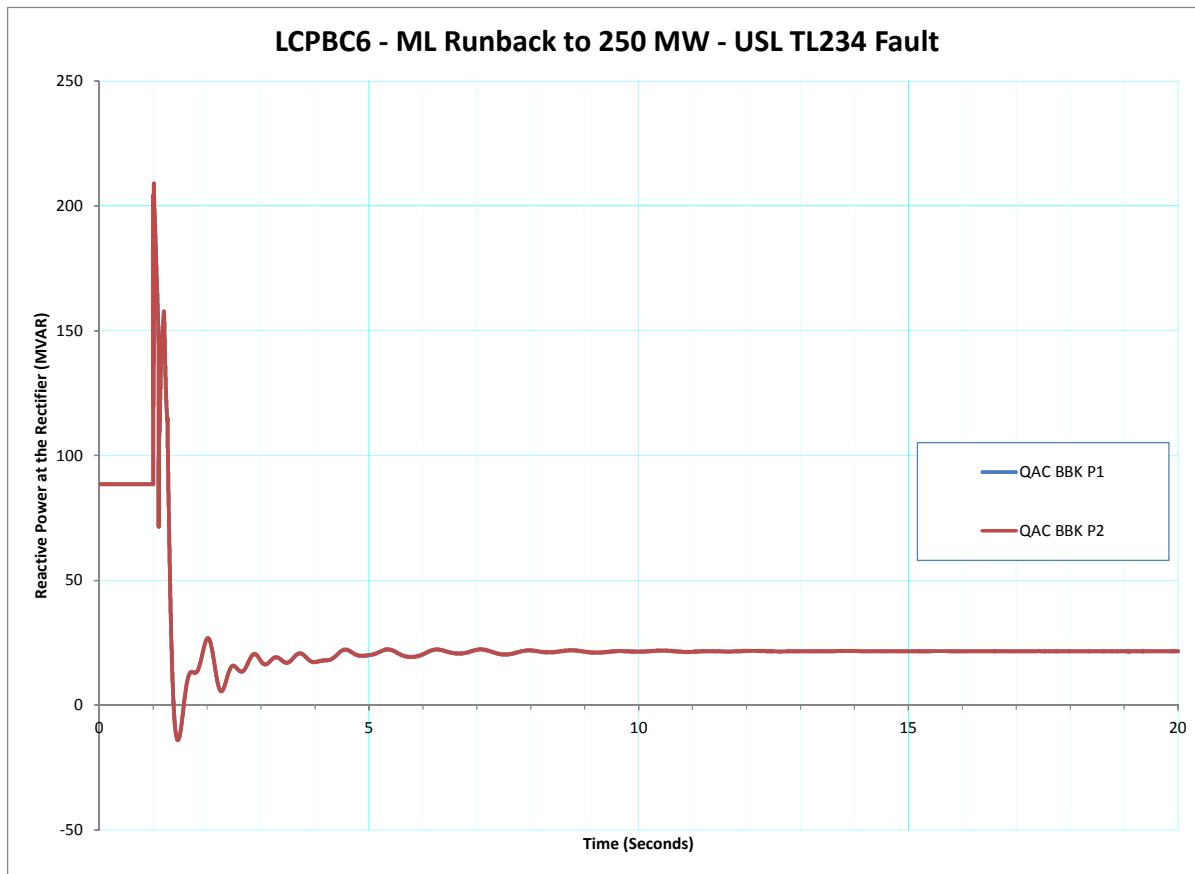
Figure 110 - LCPBC6 - ML Runback to 250 MW - USL TL234 Fault - Reactive Power at the Rectifier (MVAR)

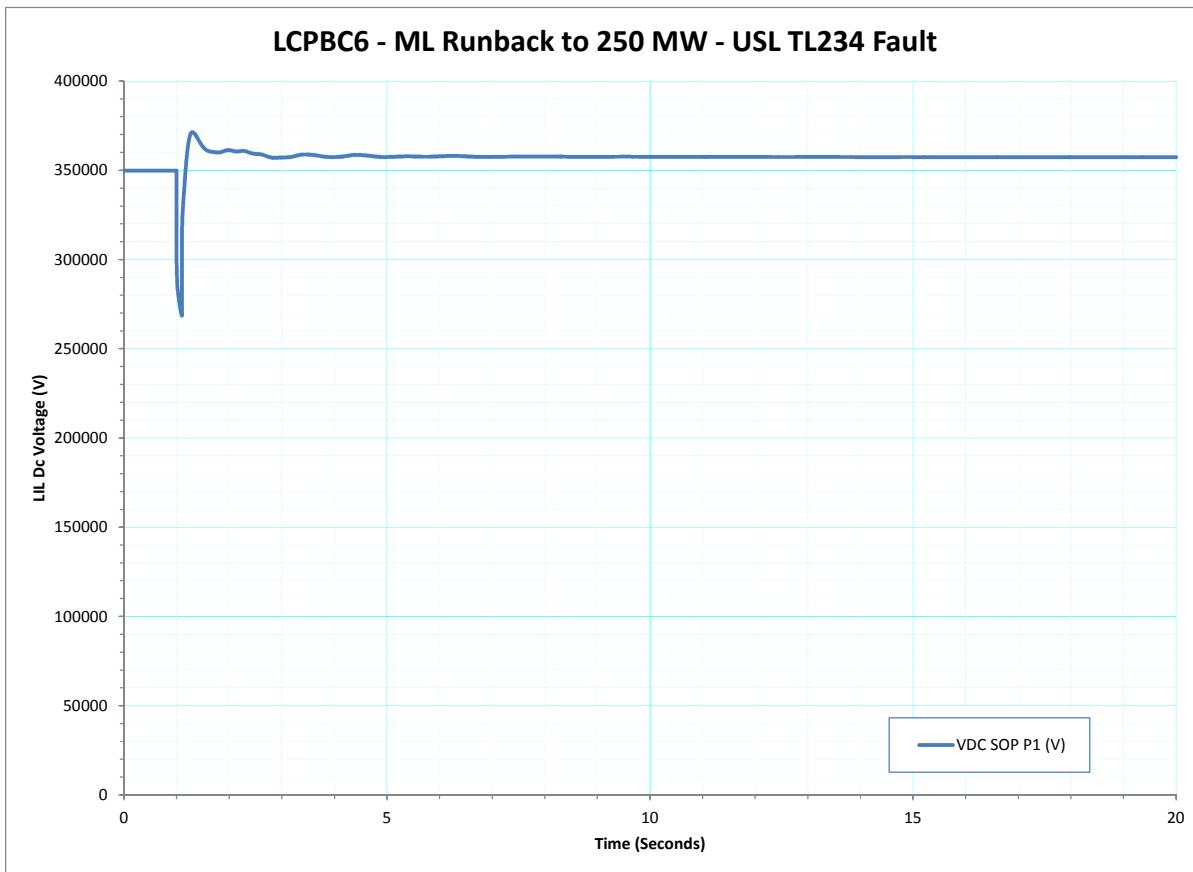
Figure 111 - LCPBC6 - ML Runback to 250 MW - USL TL234 Fault - LIL Dc Voltage (V)

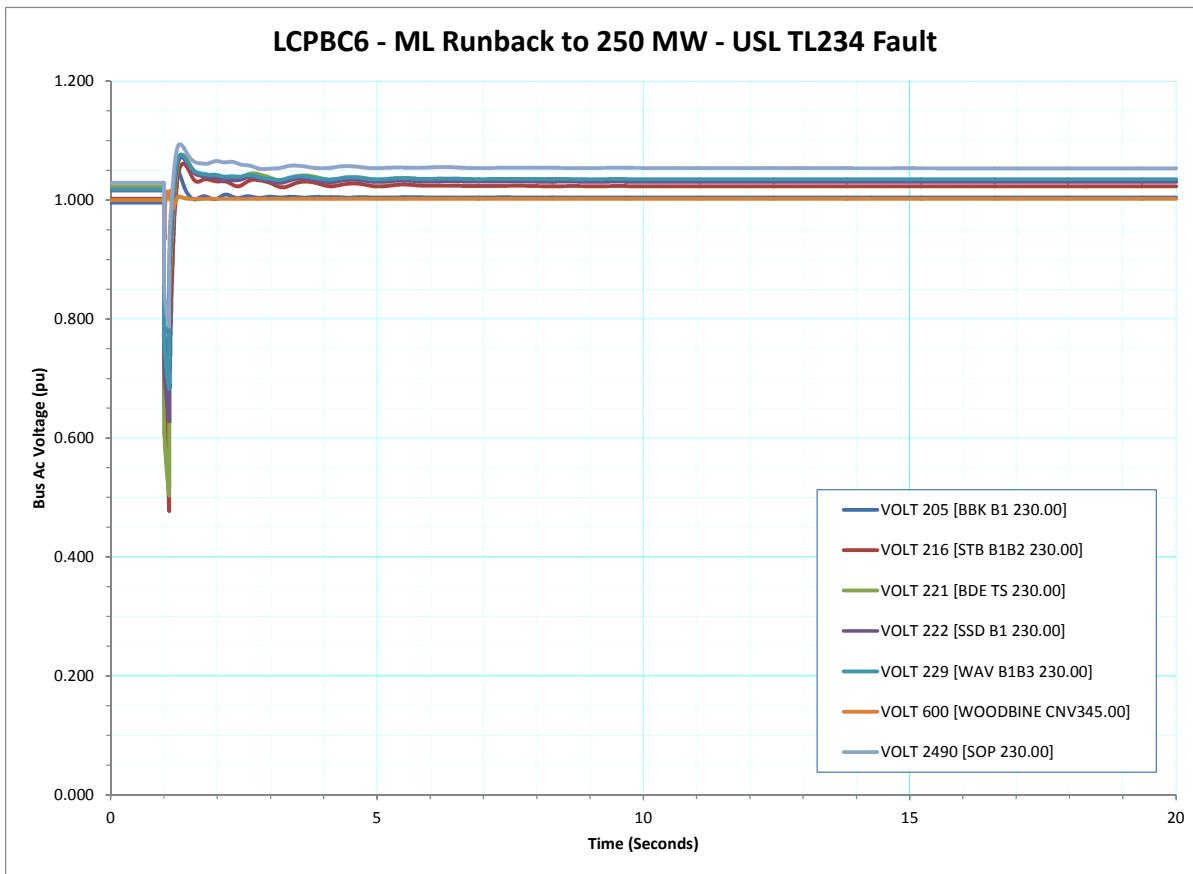
Figure 112 - LCPBC6 - ML Runback to 250 MW - USL TL234 Fault - Bus Ac Voltage (pu)

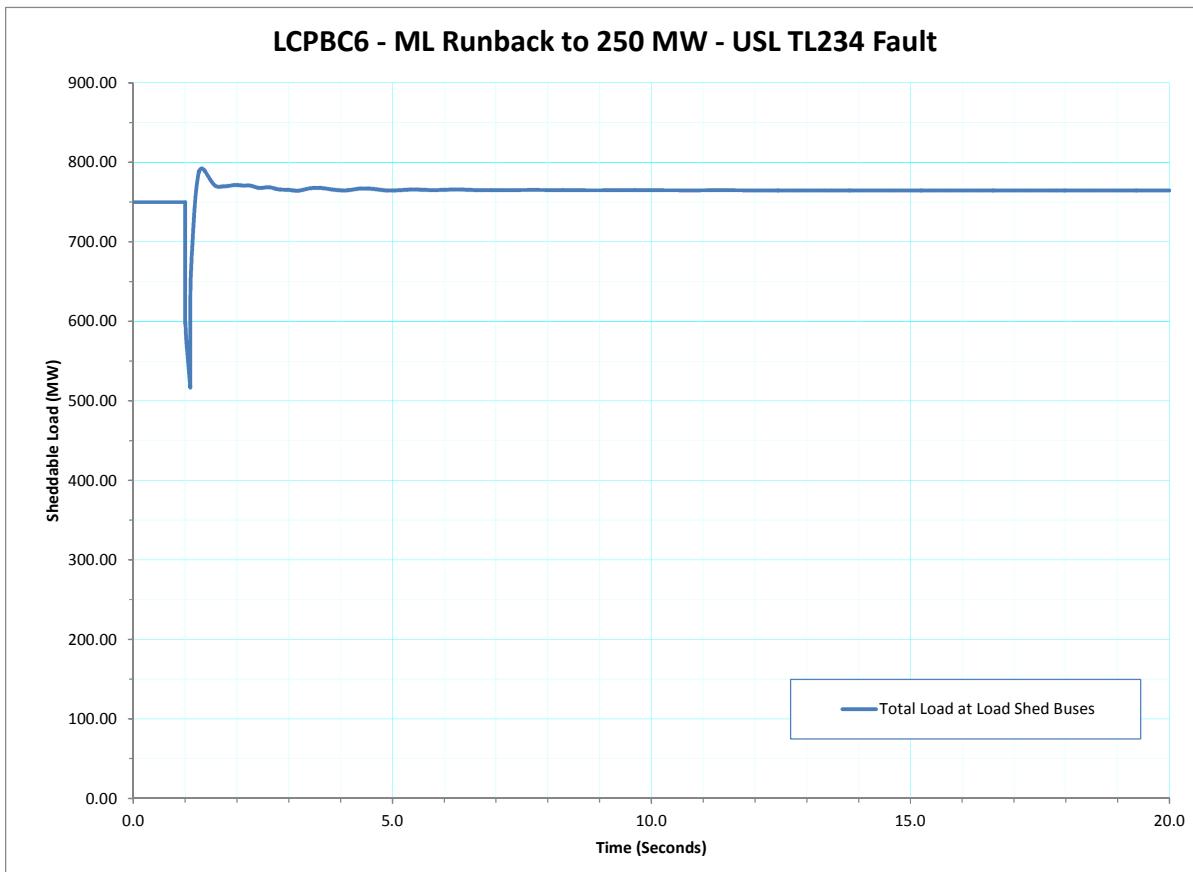
Figure 113 - LCPBC6 - ML Runback to 250 MW - USL TL234 Fault - Sheddable Load (MW)

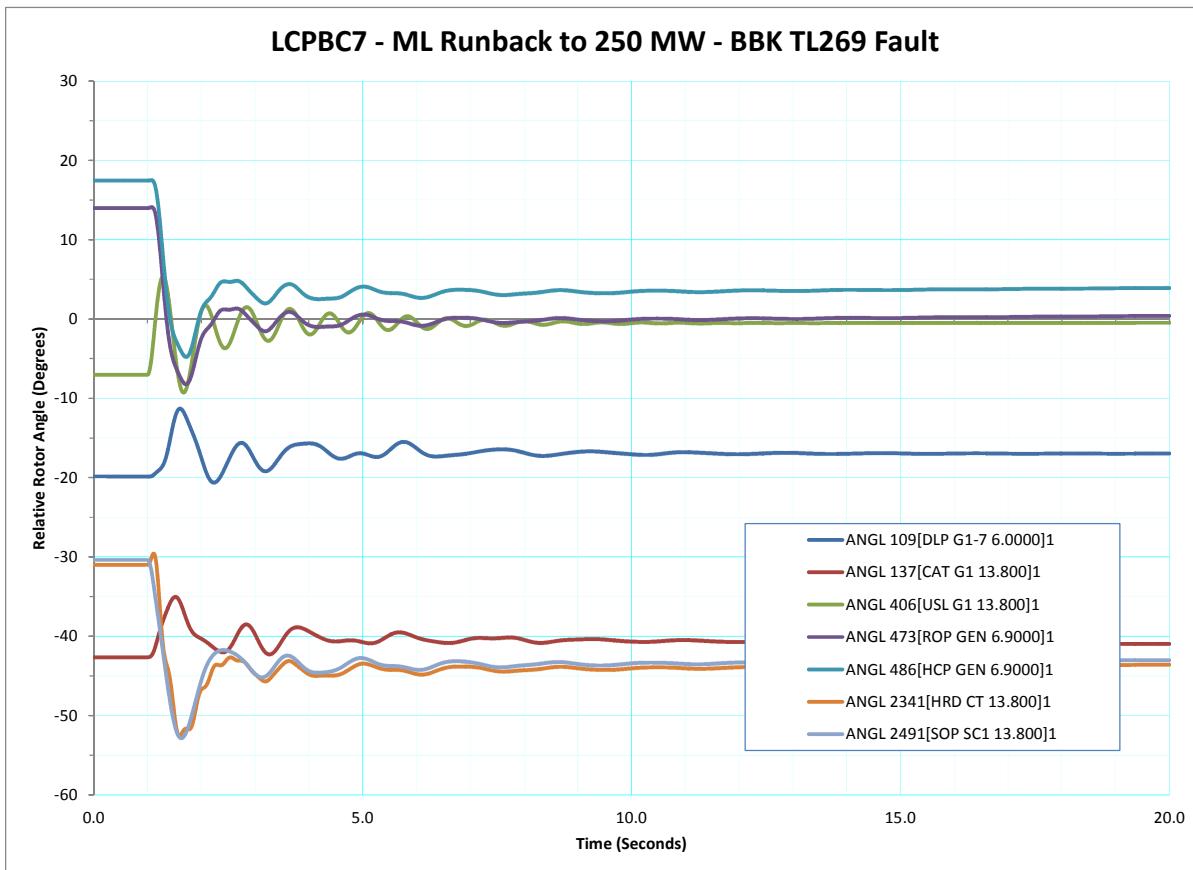
Figure 114 - LCPBC7 - ML Runback to 250 MW - BBK TL269 Fault - Relative Rotor Angle (Degrees)

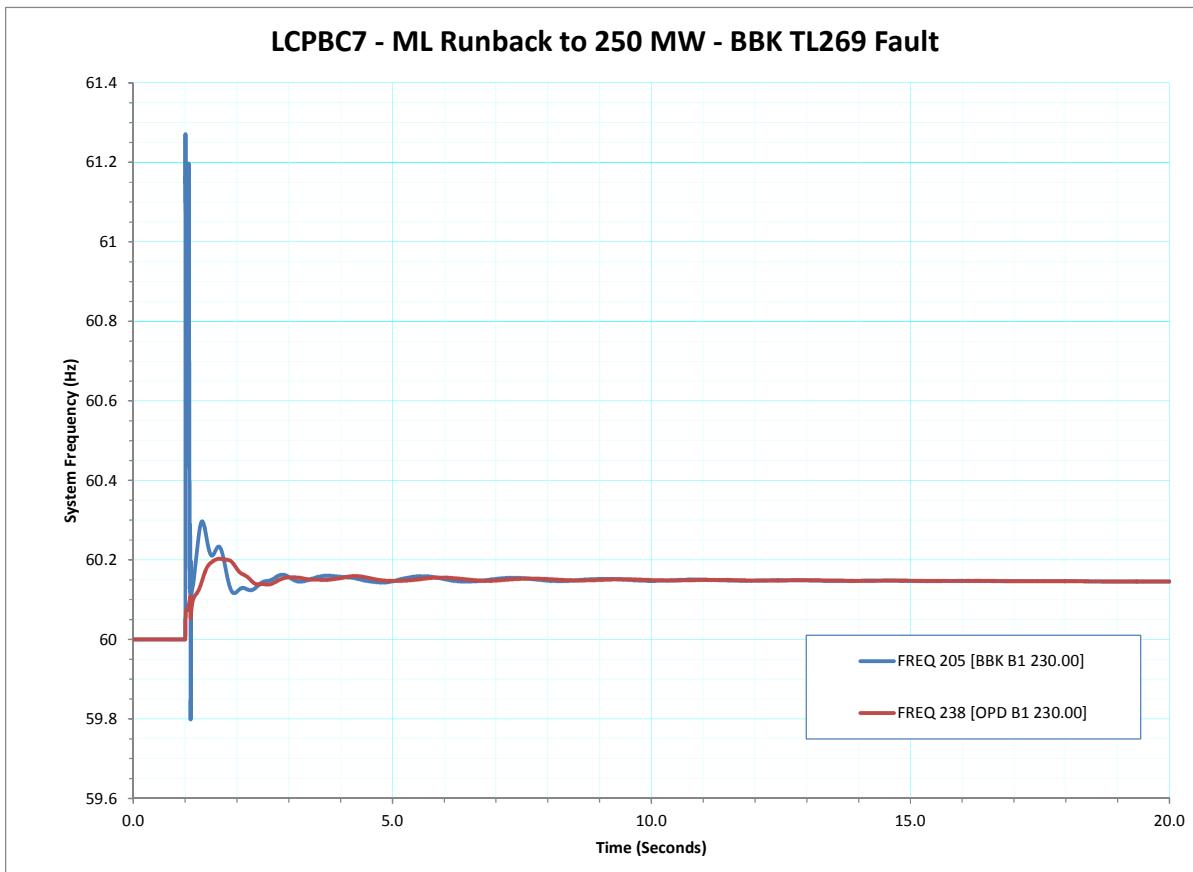
Figure 115 - LCPBC7 - ML Runback to 250 MW - BBK TL269 Fault - System Frequency (Hz)

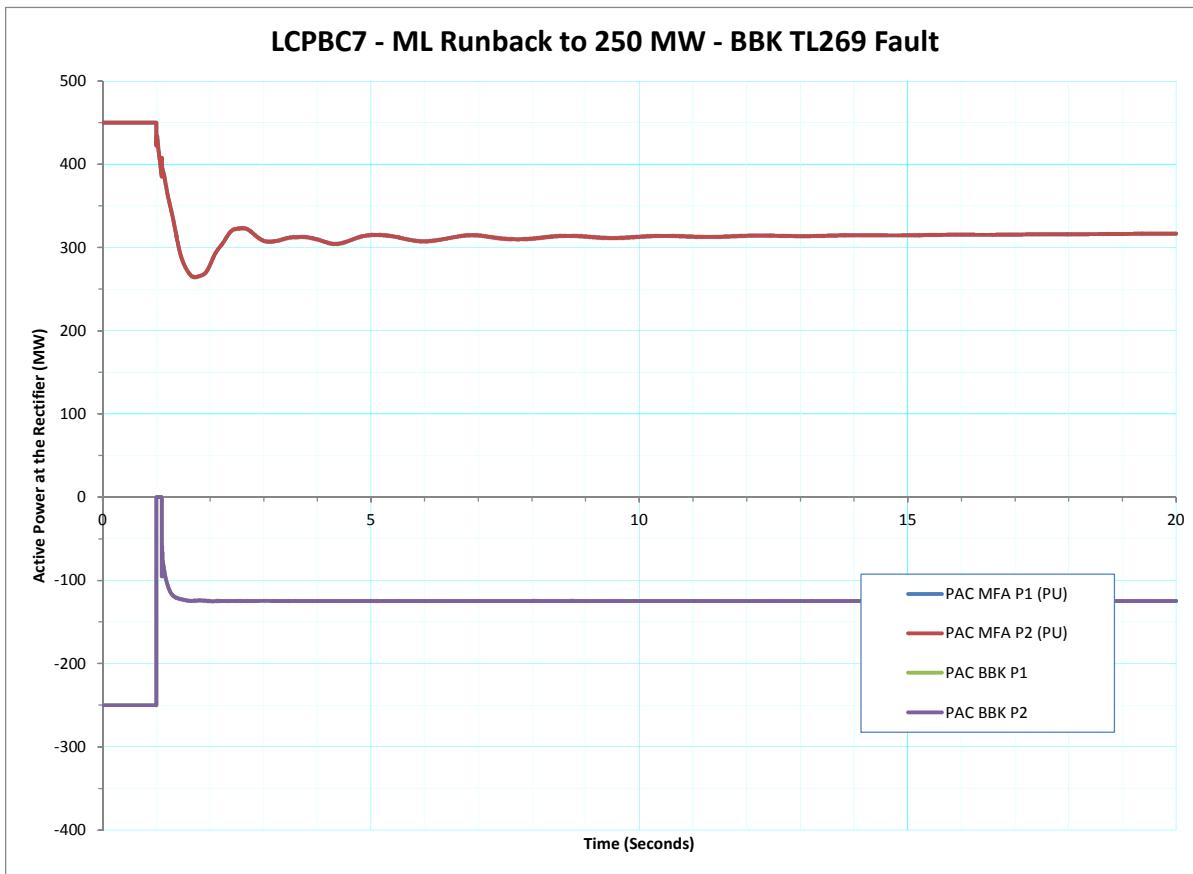
Figure 116 - LCPBC7 - ML Runback to 250 MW - BBK TL269 Fault - Active Power at the Rectifier (MW)

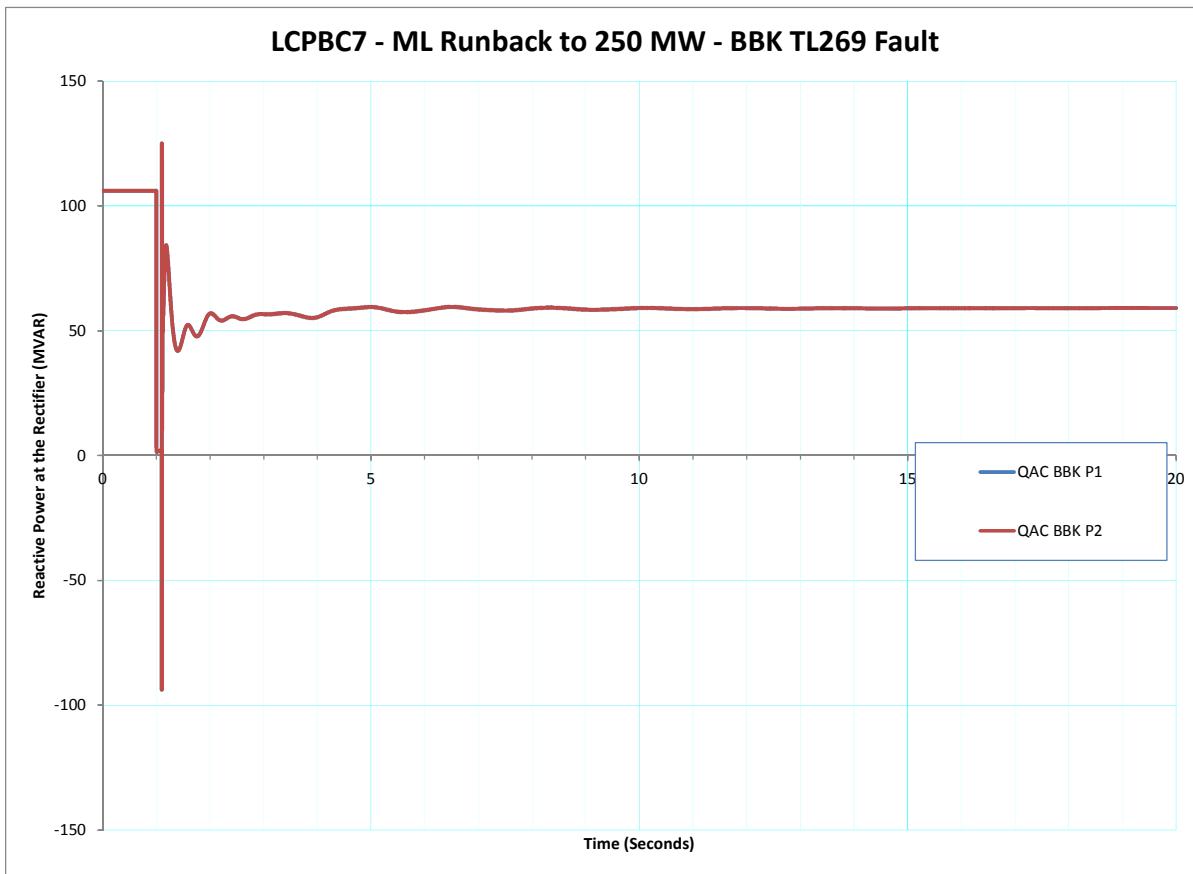
Figure 117 - LCPBC7 - ML Runback to 250 MW - BBK TL269 Fault - Reactive Power at the Rectifier (MVAR)

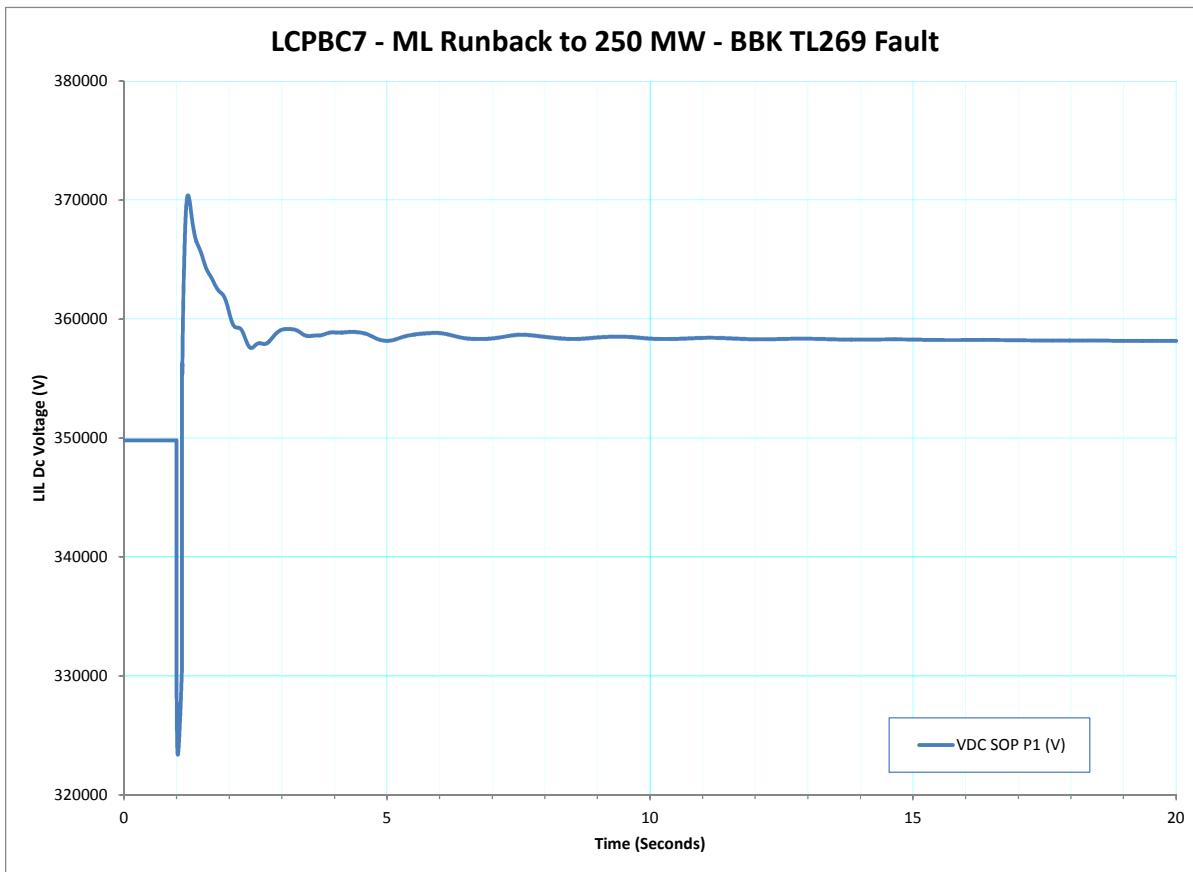
Figure 118 - LCPBC7 - ML Runback to 250 MW - BBK TL269 Fault - LIL Dc Voltage (V)

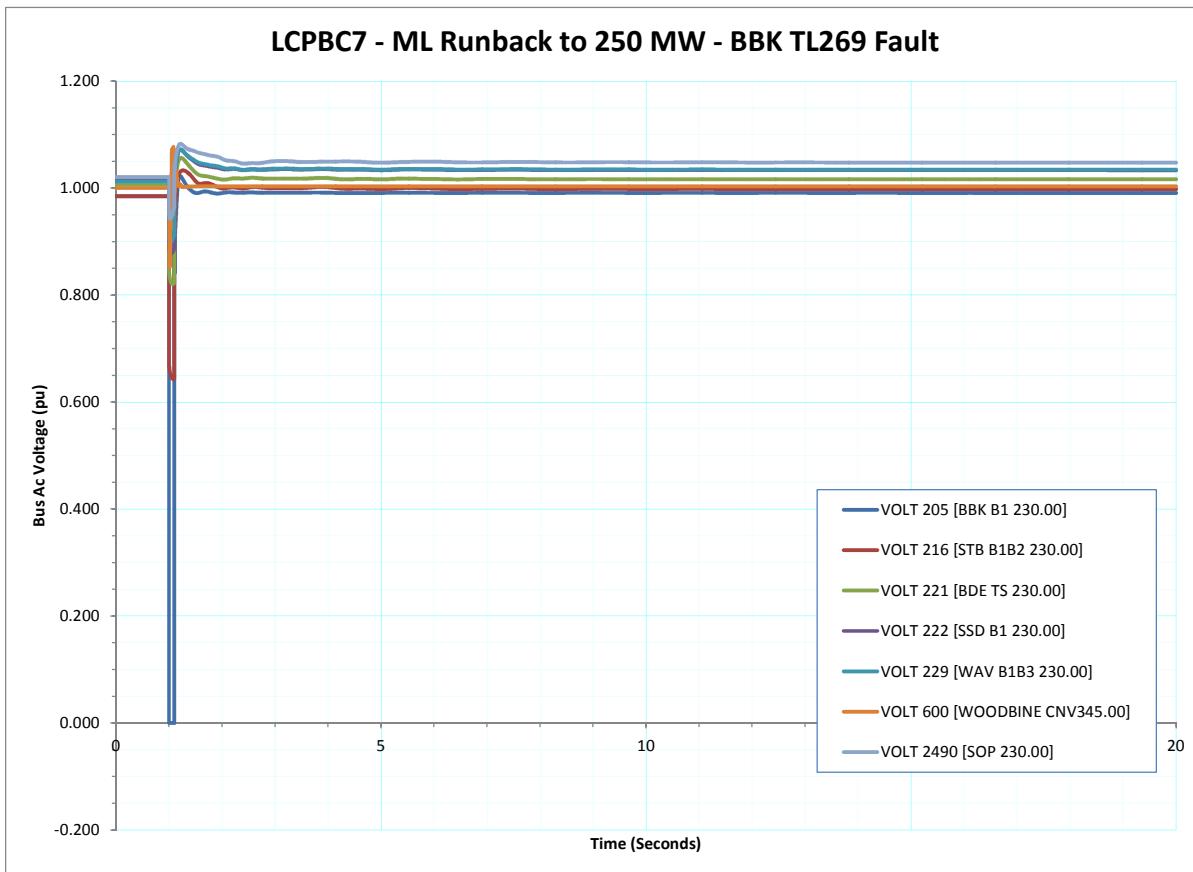
Figure 119 - LCPBC7 - ML Runback to 250 MW - BBK TL269 Fault - Bus Ac Voltage (pu)

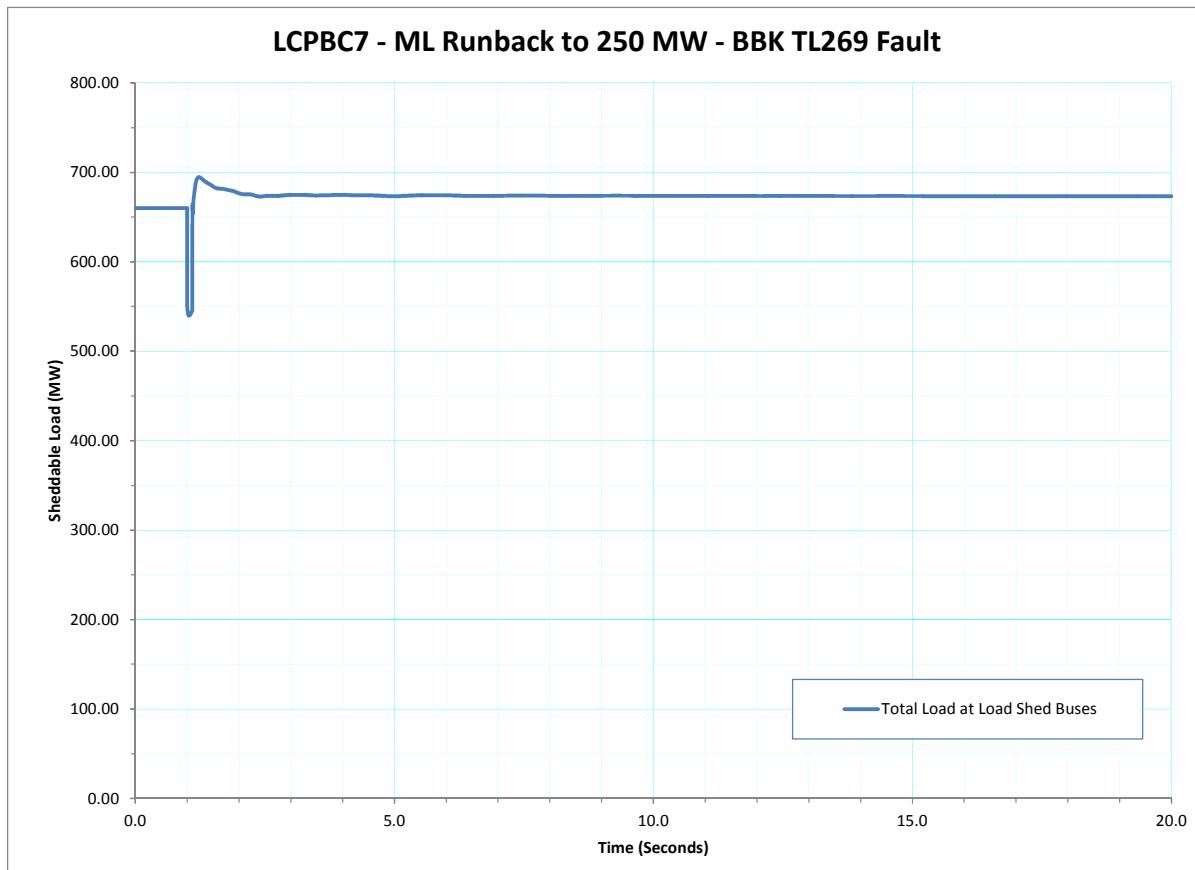
Figure 120 - LCPBC7 - ML Runback to 250 MW - BBK TL269 Fault - Sheddable Load (MW)

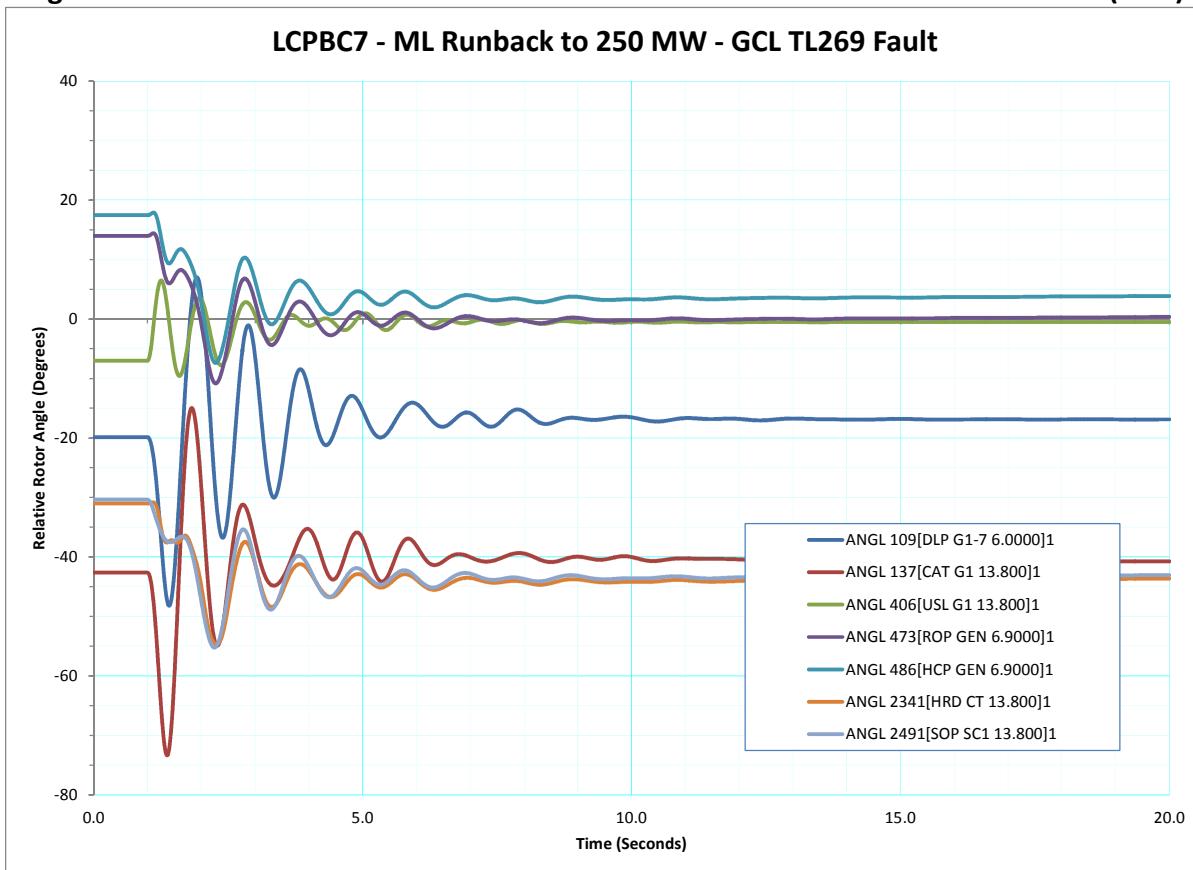
Figure 121 - LCPBC7 - ML Runback to 250 MW - GCL TL269 Fault - Relative Rotor Angle (Degrees)

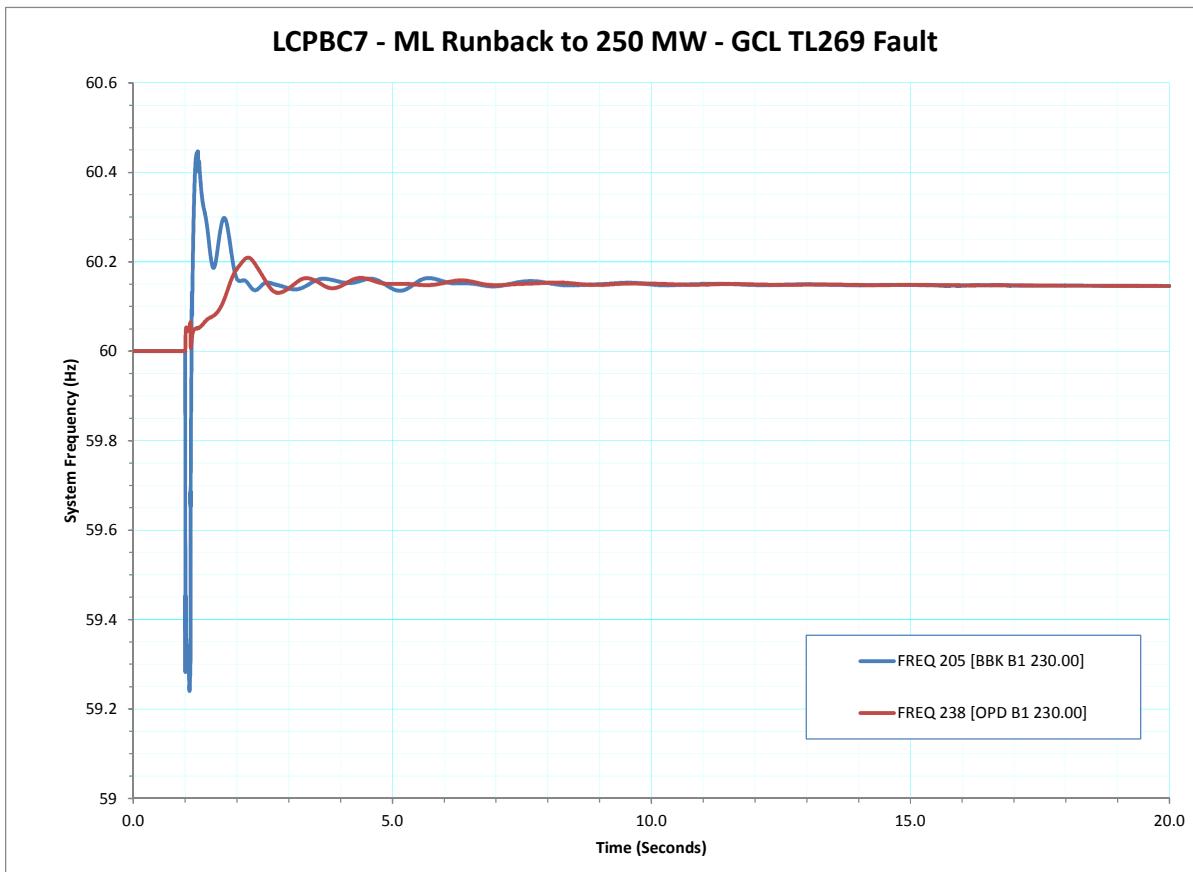
Figure 122 - LCPBC7 - ML Runback to 250 MW - GCL TL269 Fault - System Frequency (Hz)

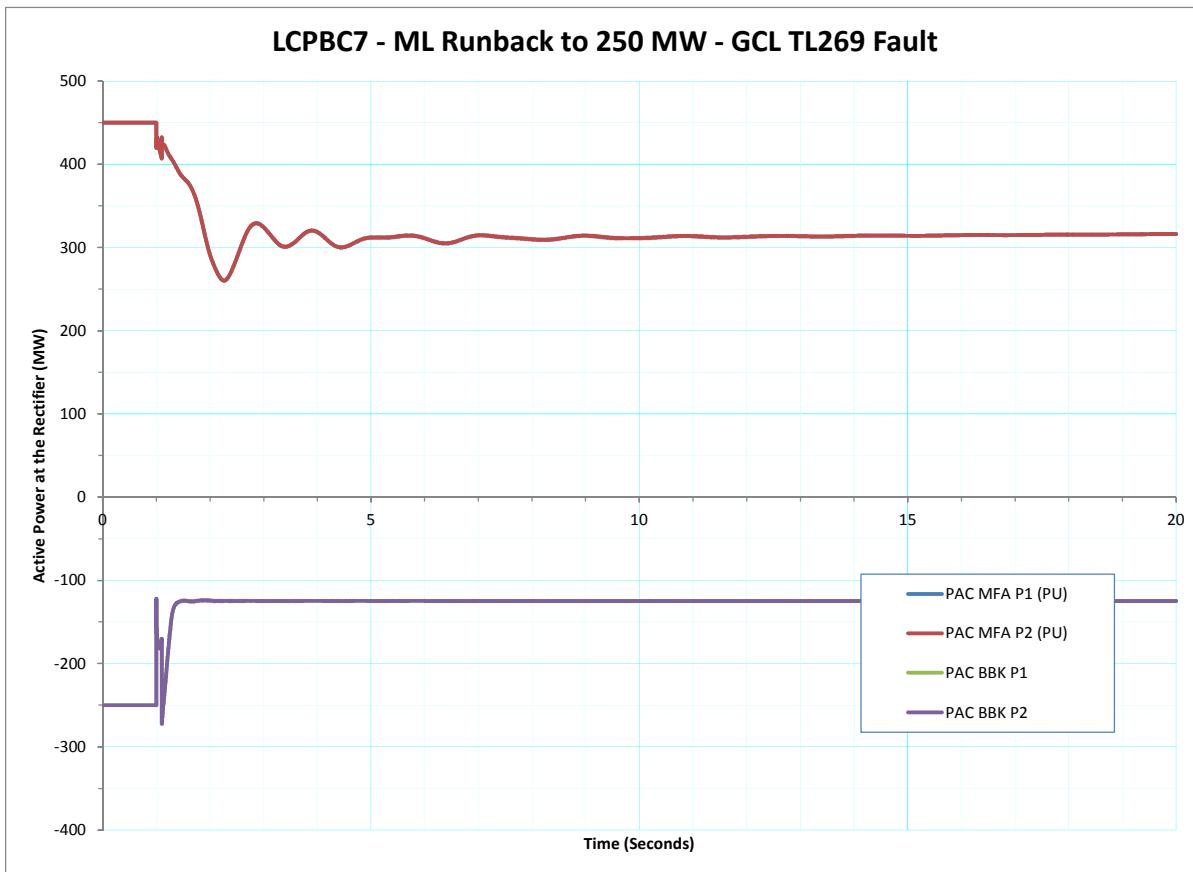
Figure 123 - LCPBC7 - ML Runback to 250 MW - GCL TL269 Fault - Active Power at the Rectifier (MW)

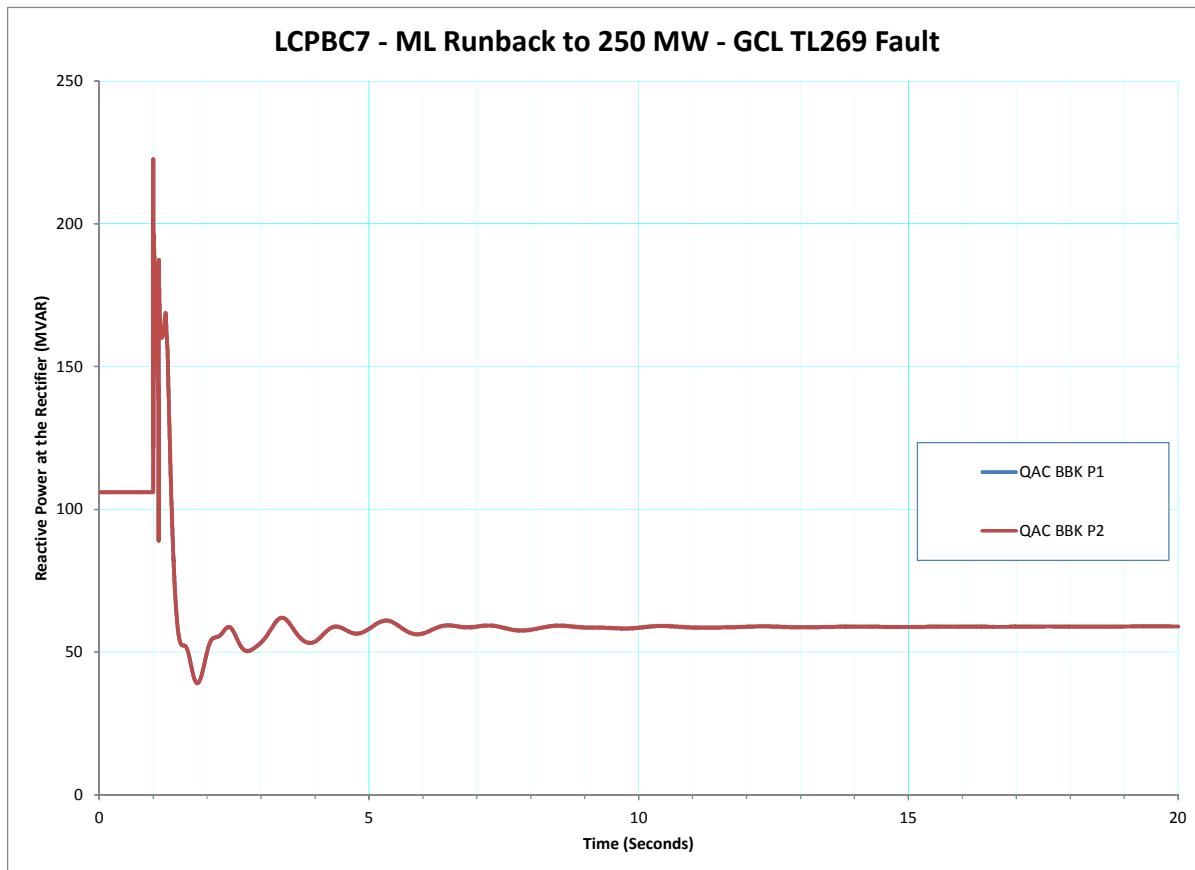
Figure 124 - LCPBC7 - ML Runback to 250 MW - GCL TL269 Fault - Reactive Power at the Rectifier (MVAR)

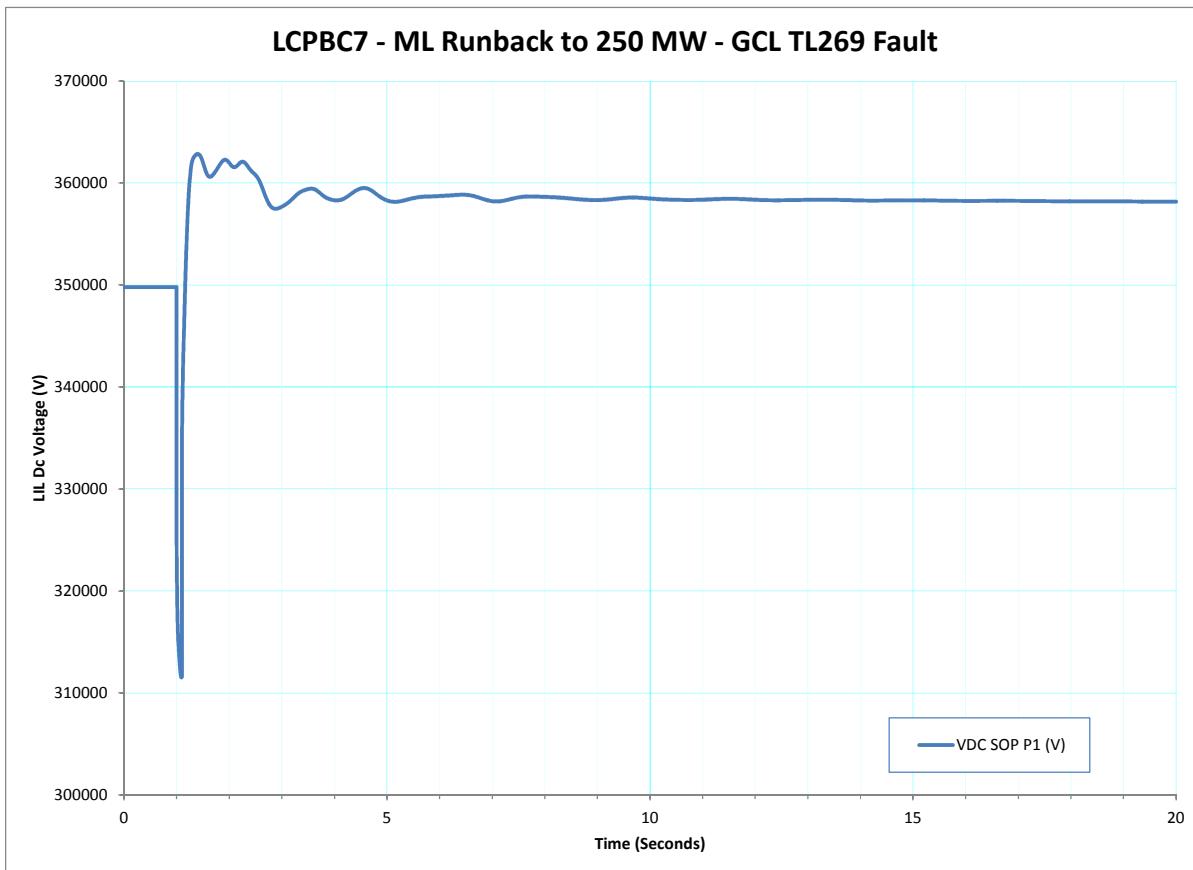
Figure 125 - LCPBC7 - ML Runback to 250 MW - GCL TL269 Fault - LIL Dc Voltage (V)

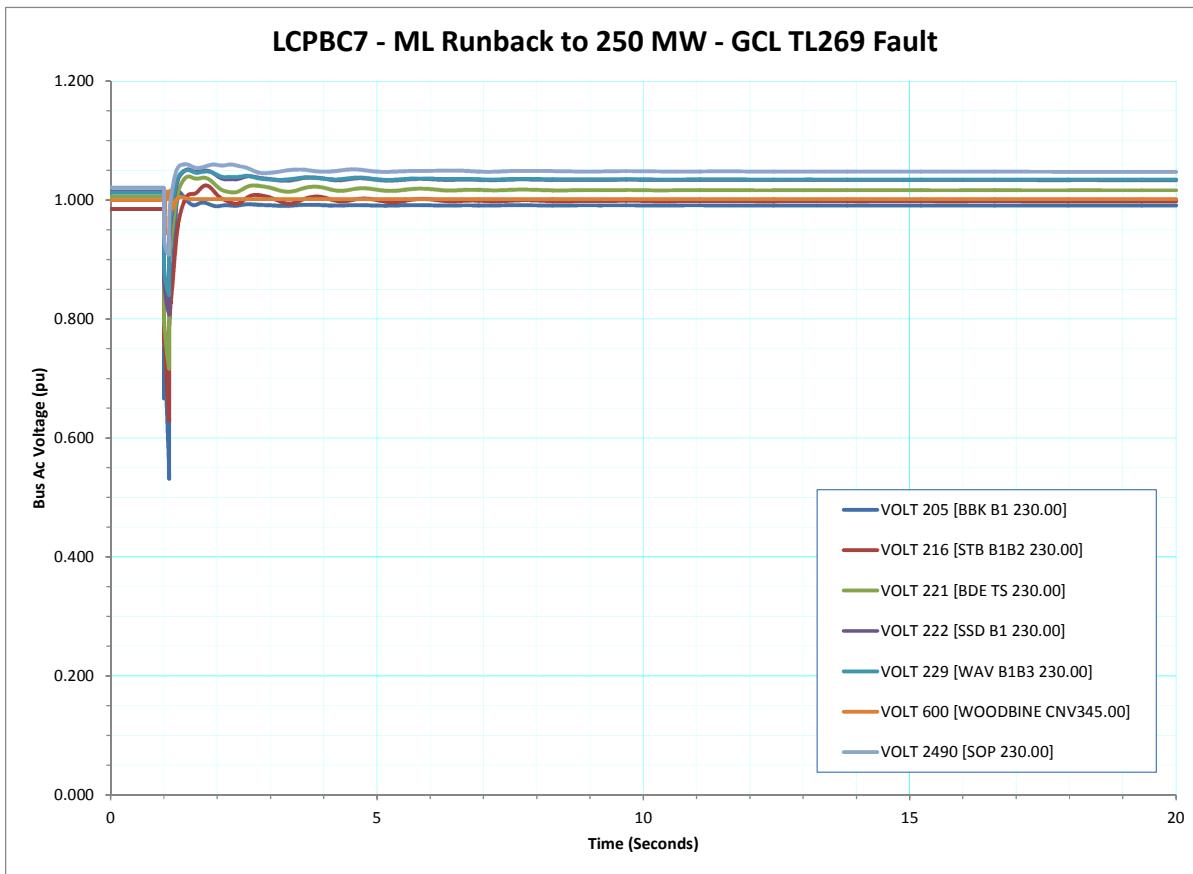
Figure 126 - LCPBC7 - ML Runback to 250 MW - GCL TL269 Fault - Bus Ac Voltage (pu)
