MARITIME LINK PRELIMINARY INTERCONNECTION STUDY

Newfoundland and Labrador Hydro

July 2014

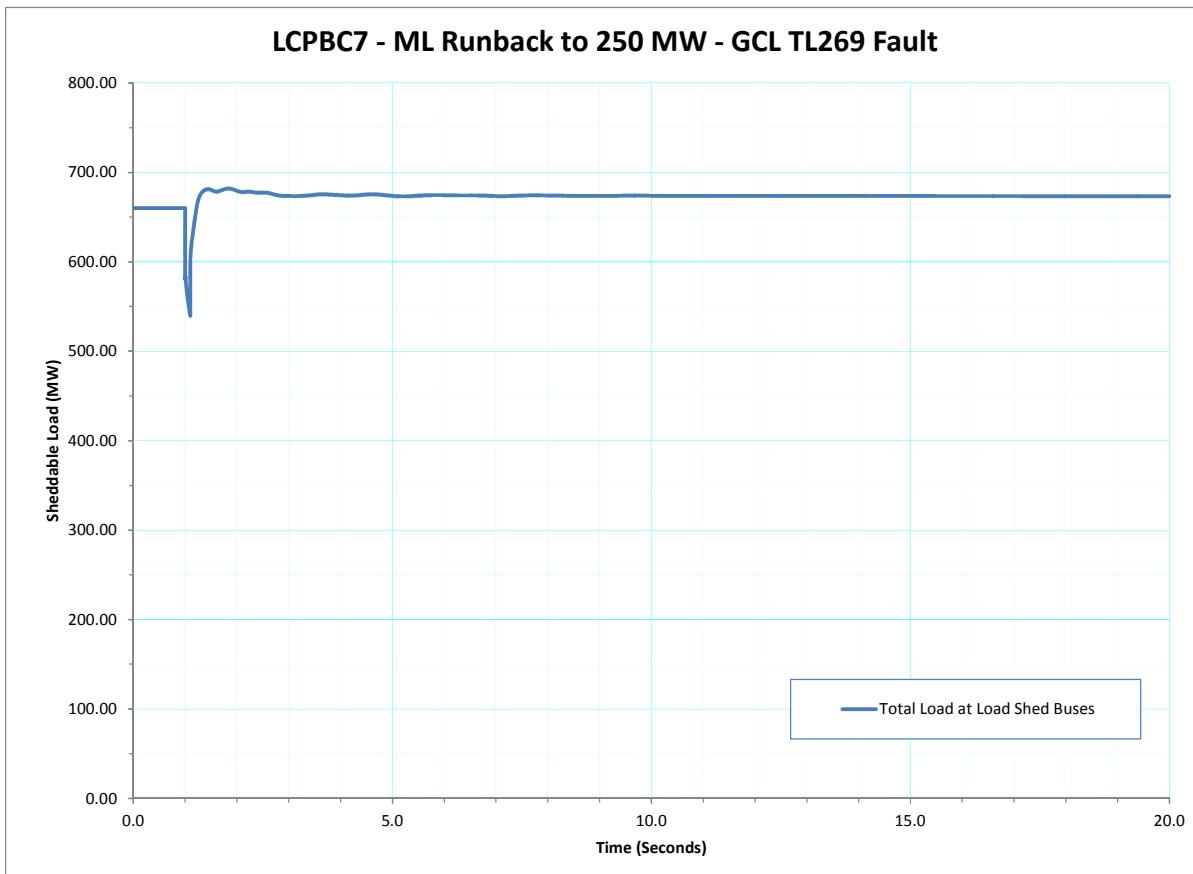
Figure 127 - LCPBC7 - ML Runback to 250 MW - GCL TL269 Fault - Sheddable Load (MW)

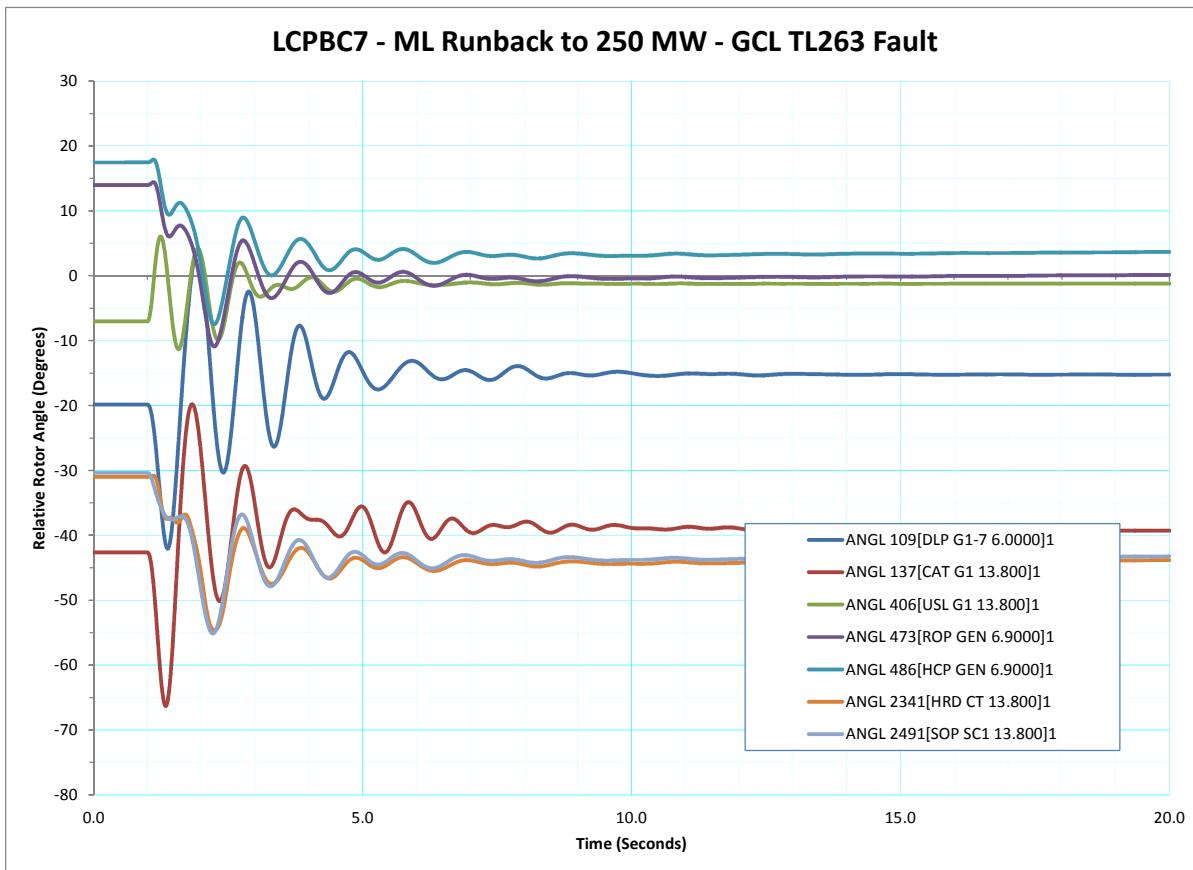
Figure 128 - LCPBC7 - ML Runback to 250 MW - GCL TL263 Fault - Relative Rotor Angle (Degrees)

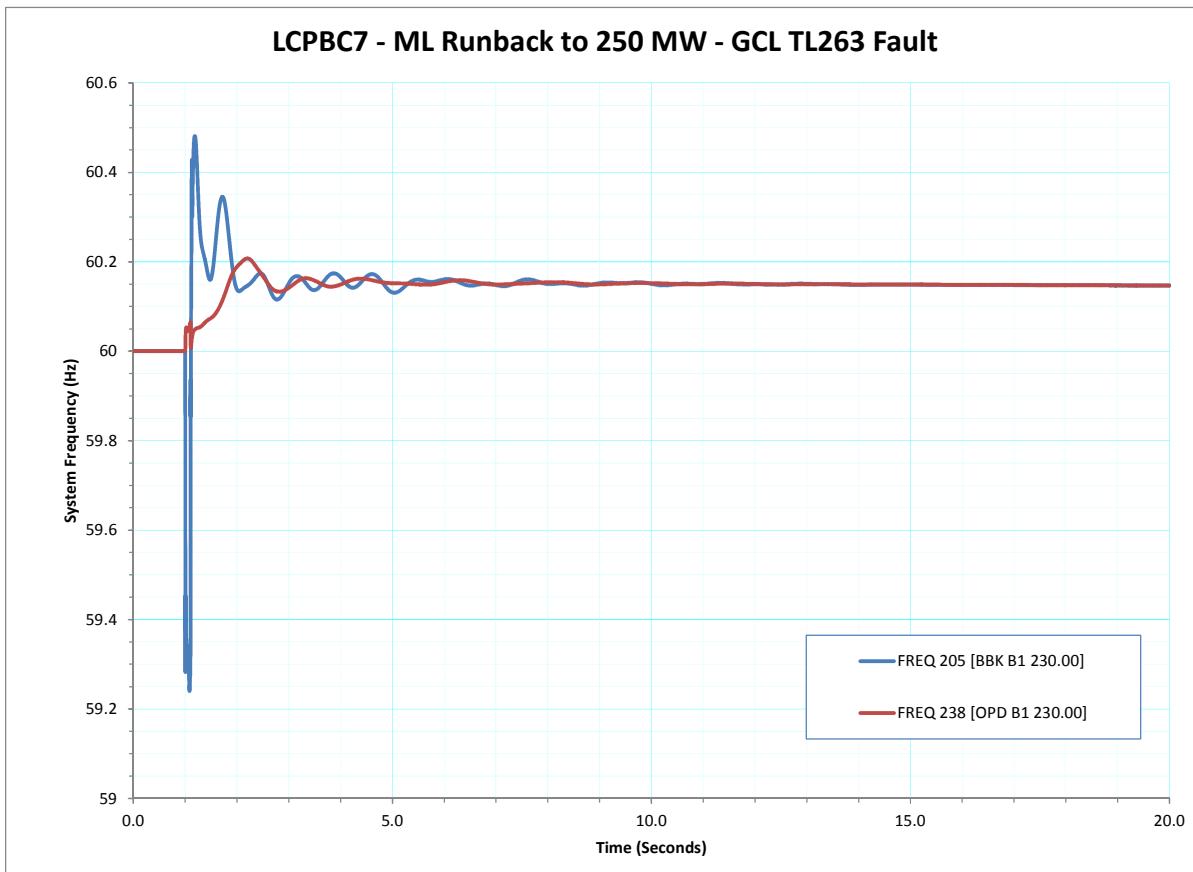
Figure 129 - LCPBC7 - ML Runback to 250 MW - GCL TL263 Fault - System Frequency (Hz)

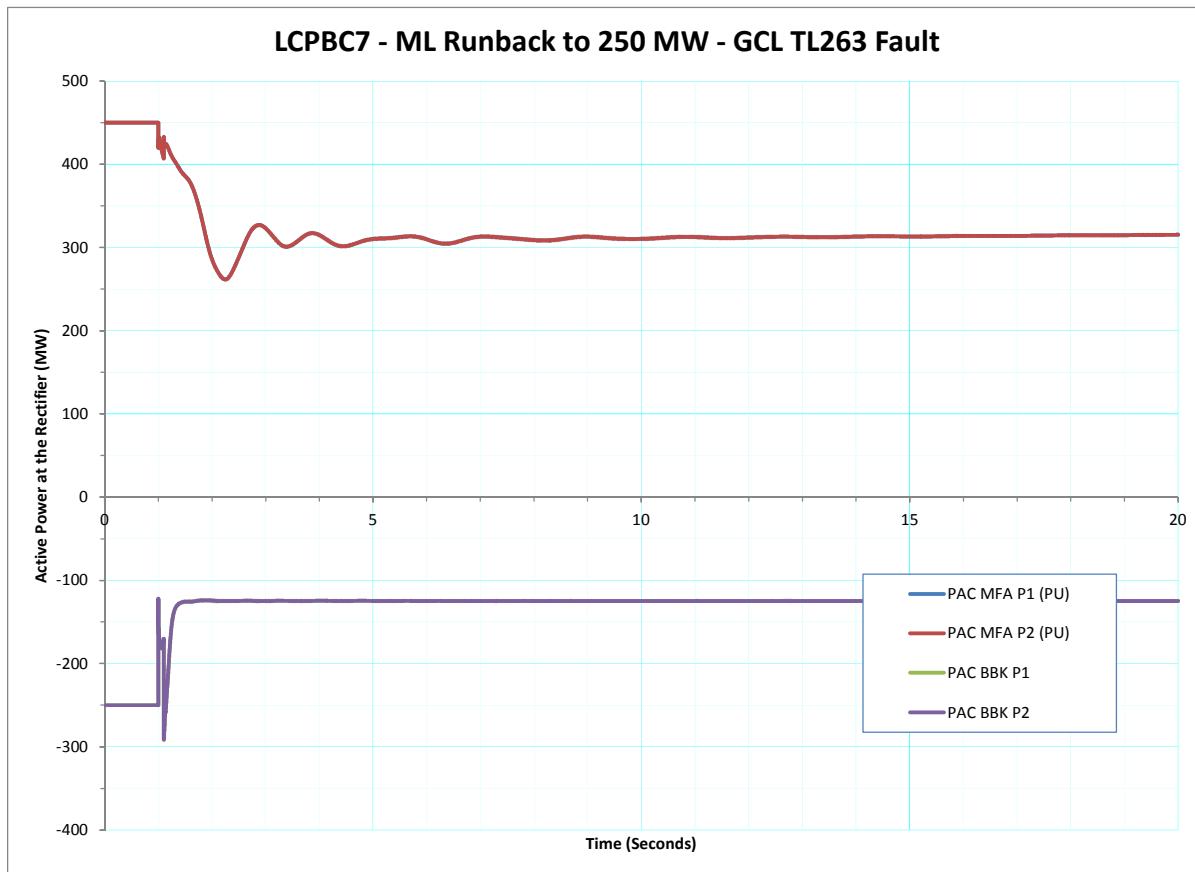
Figure 130 - LCPBC7 - ML Runback to 250 MW - GCL TL263 Fault - Active Power at the Rectifier (MW)

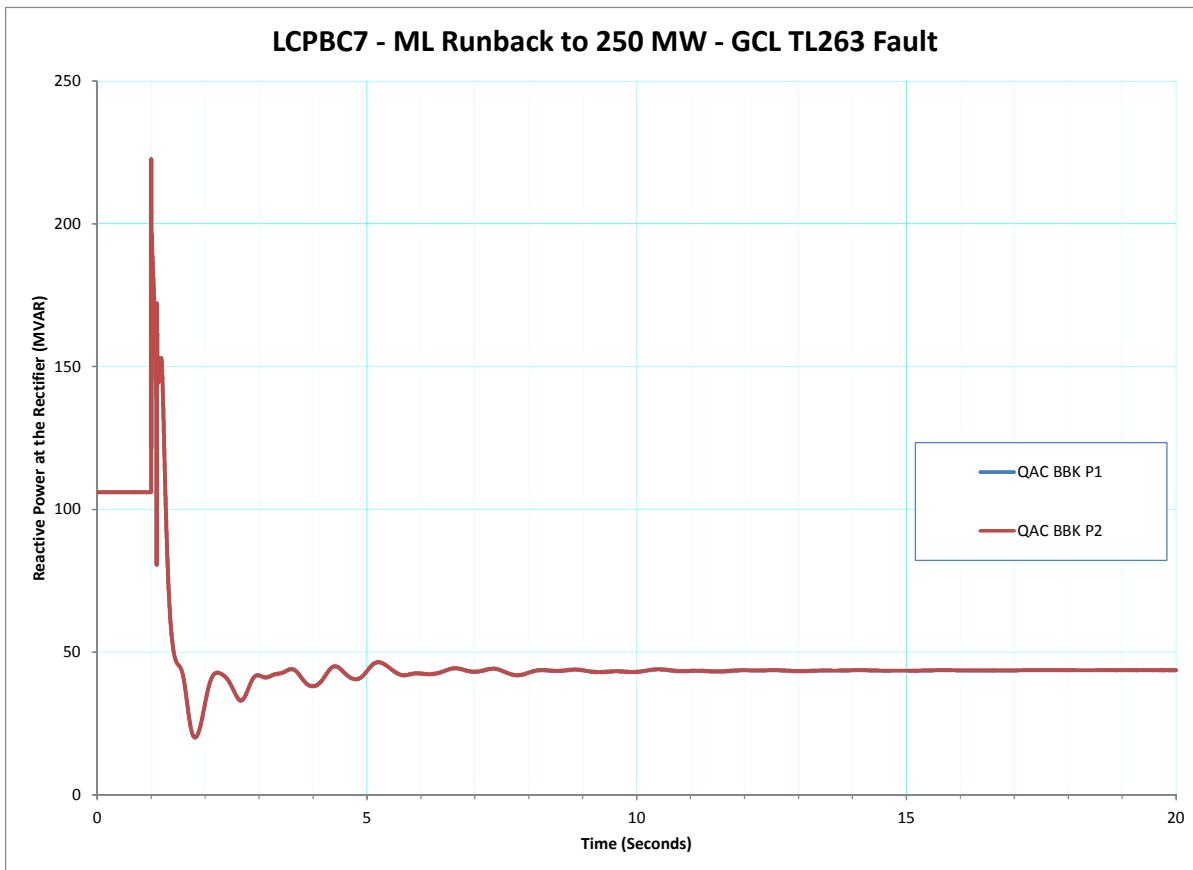
Figure 131 - LCPBC7 - ML Runback to 250 MW - GCL TL263 Fault - Reactive Power at the Rectifier (MVAR)

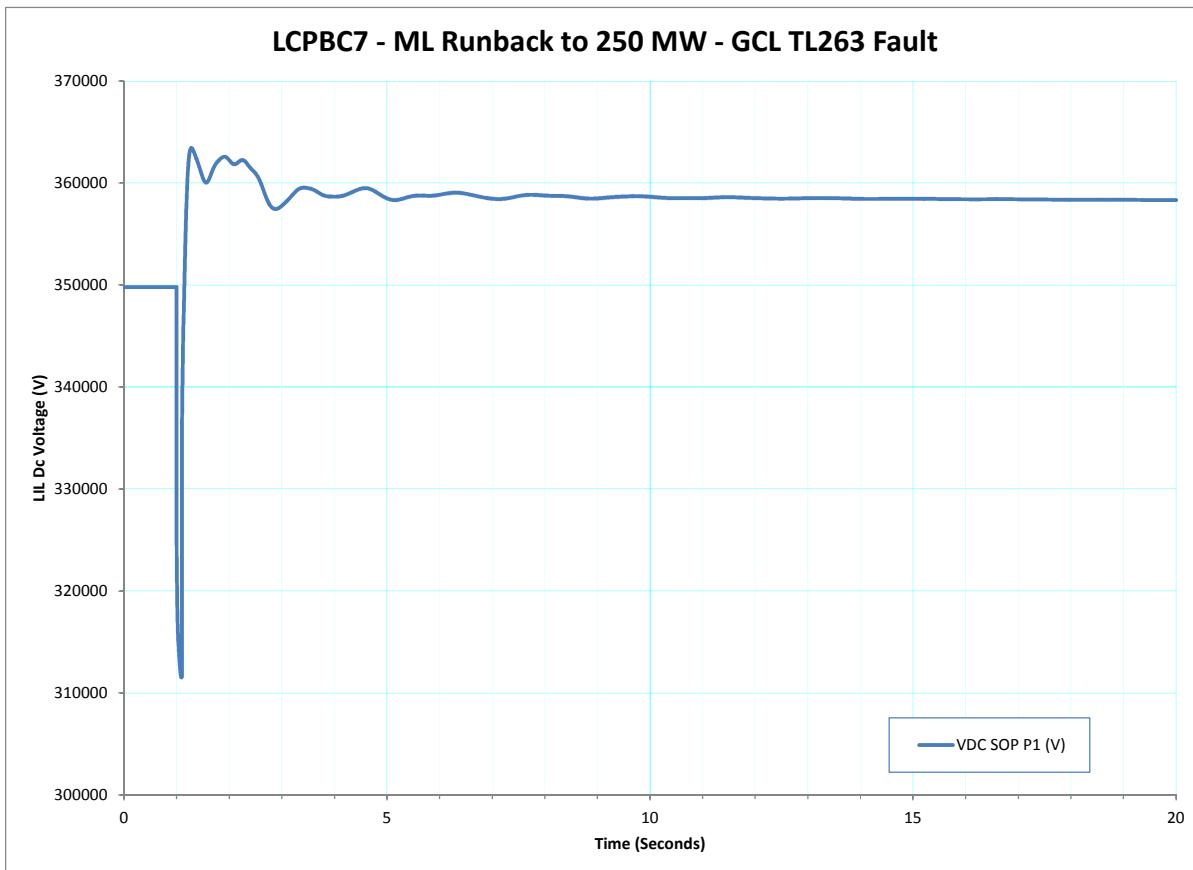
Figure 132 - LCPBC7 - ML Runback to 250 MW - GCL TL263 Fault - LIL Dc Voltage (V)

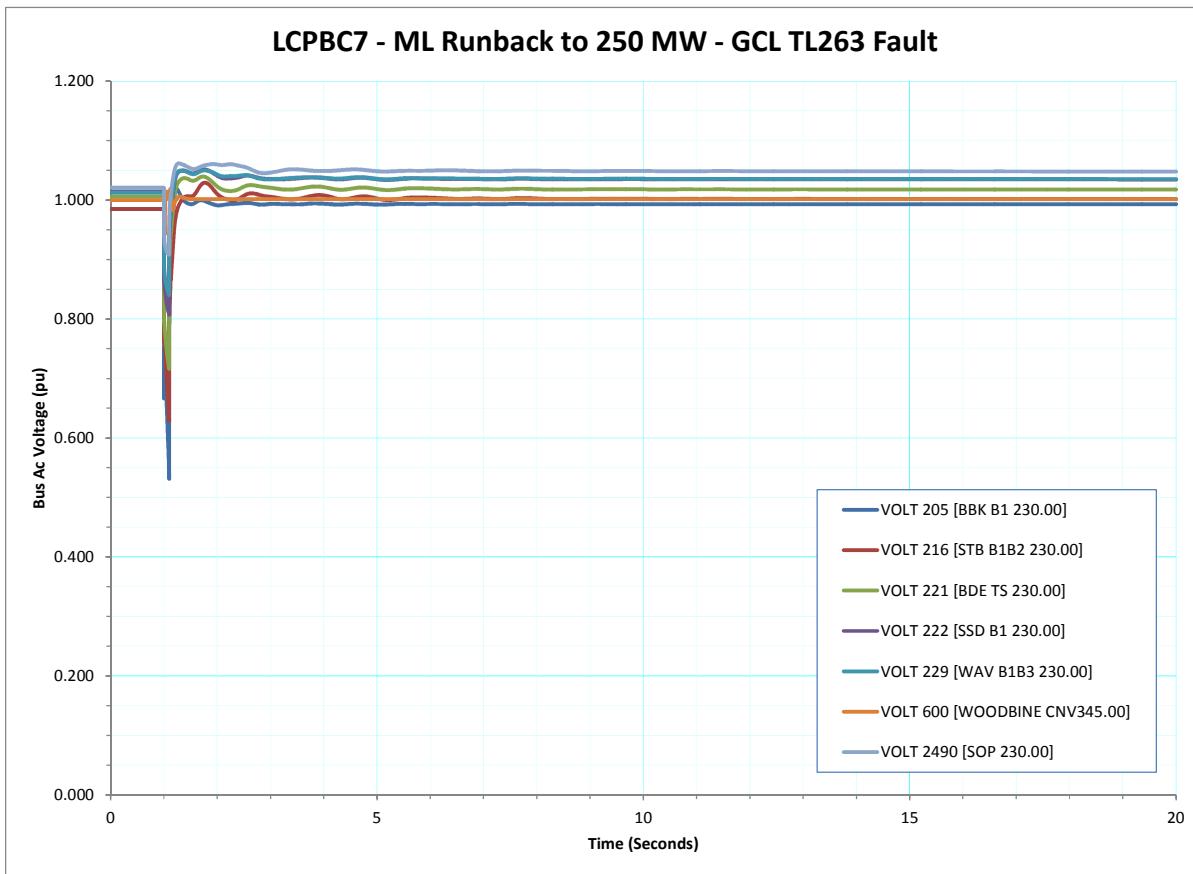
Figure 133 - LCPBC7 - ML Runback to 250 MW - GCL TL263 Fault - Bus Ac Voltage (pu)

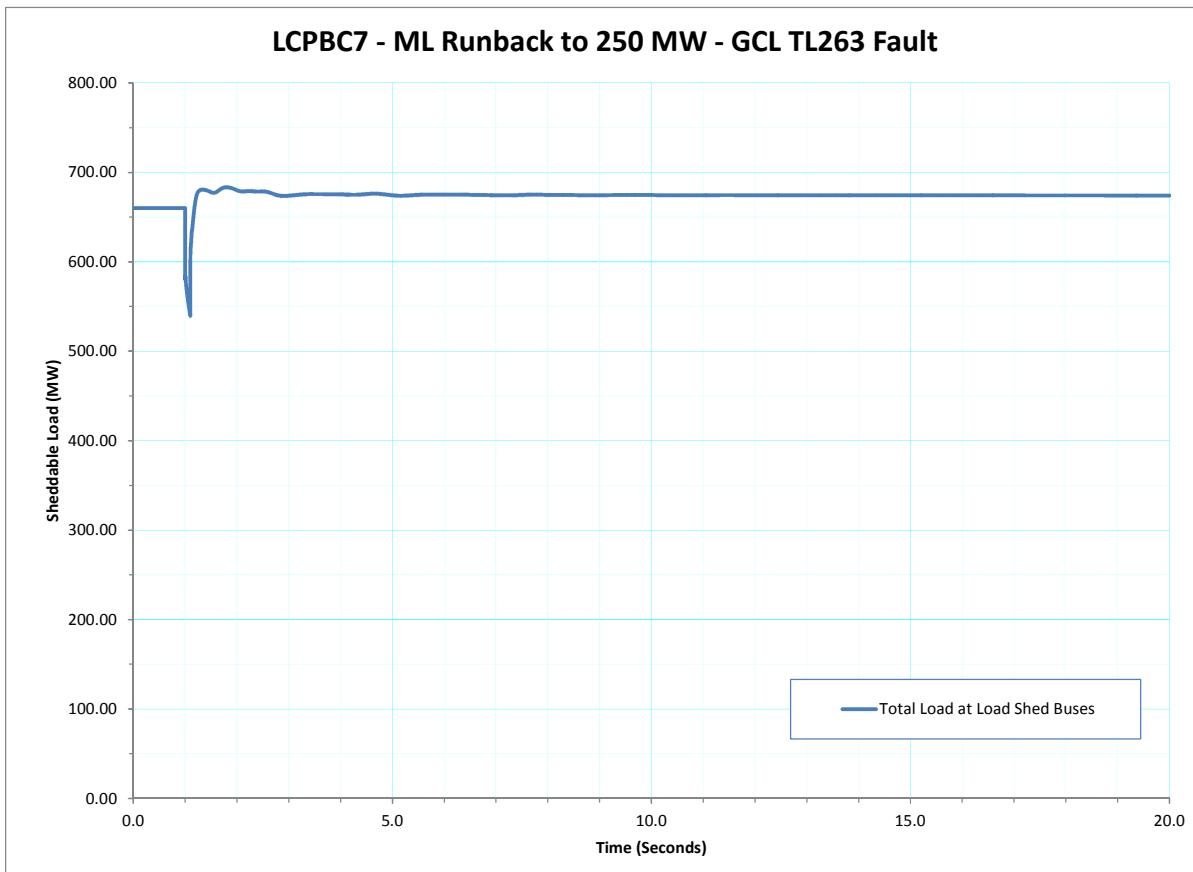
Figure 134 - LCPBC7 - ML Runback to 250 MW - GCL TL263 Fault - Sheddable Load (MW)

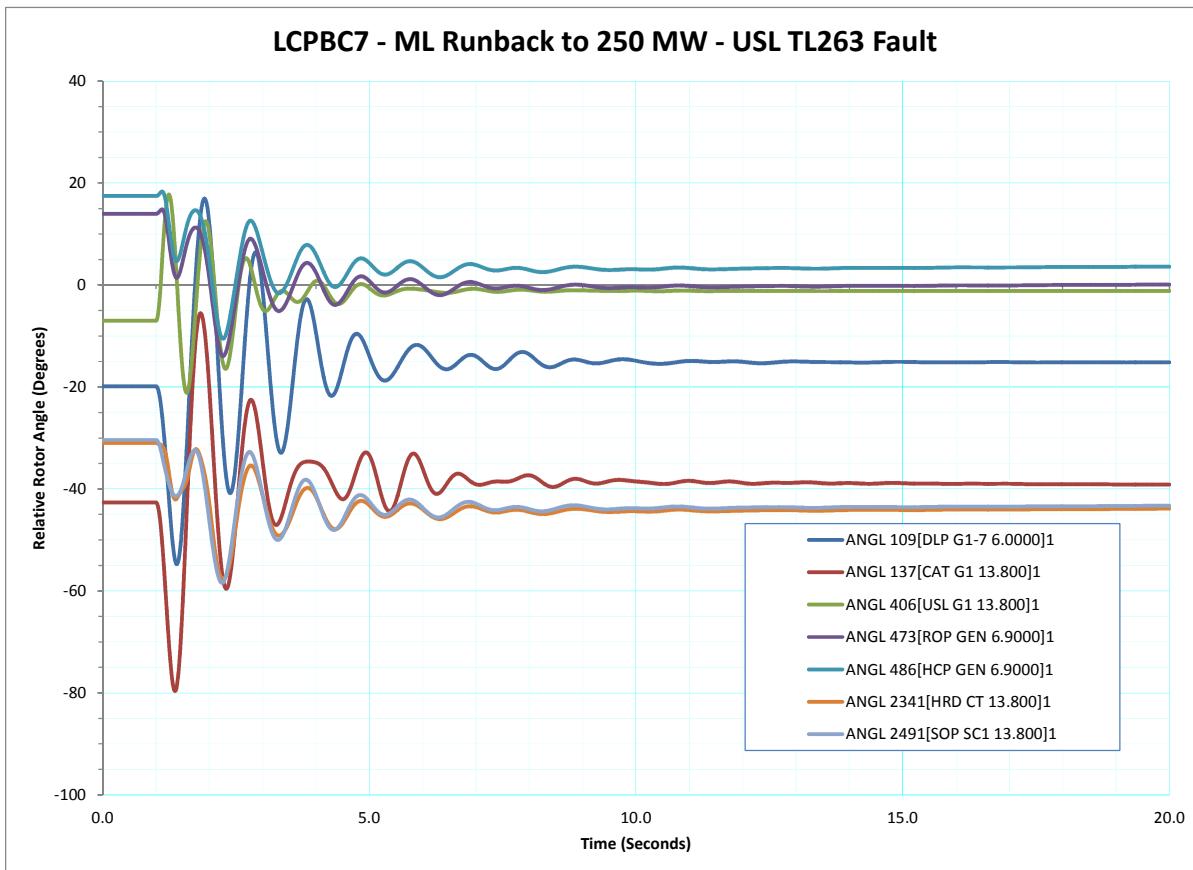
Figure 135 - LCPBC7 - ML Runback to 250 MW - USL TL263 Fault - Relative Rotor Angle (Degrees)

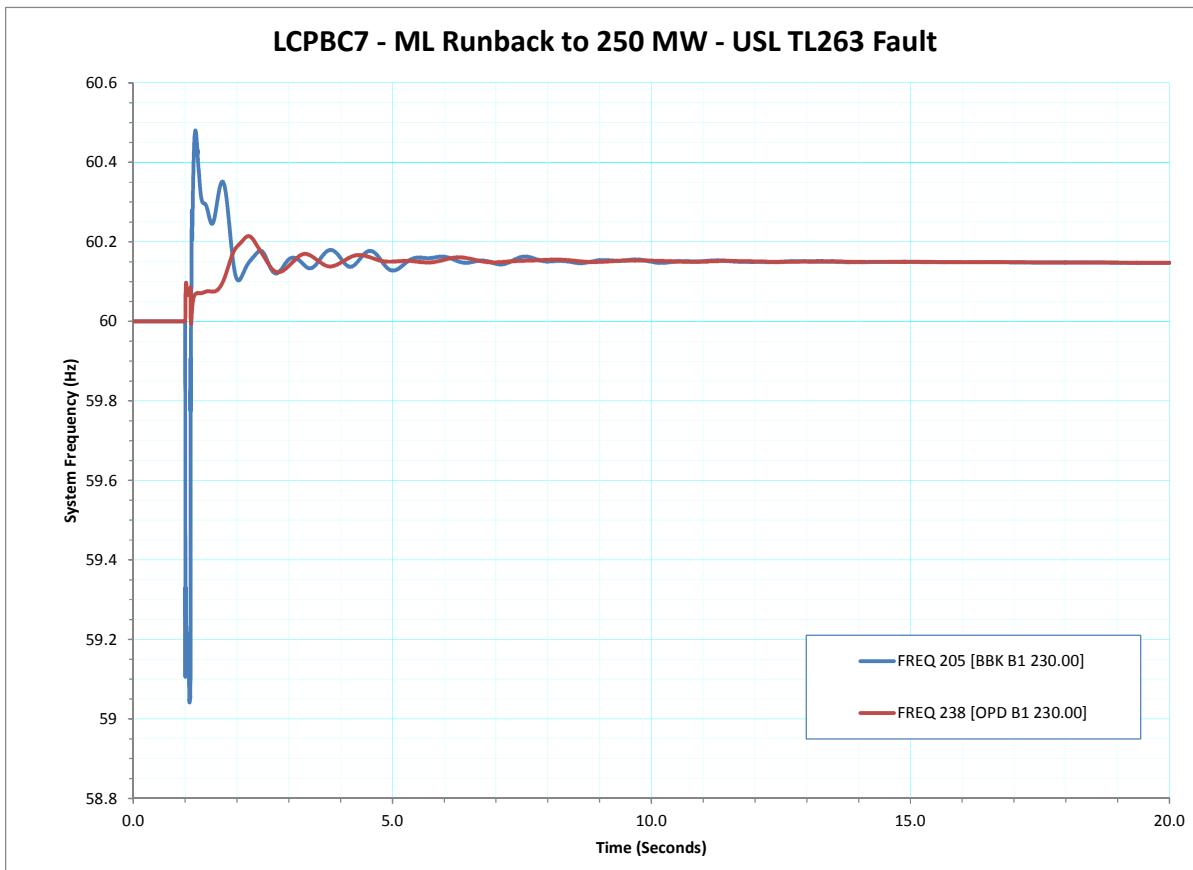
Figure 136 - LCPBC7 - ML Runback to 250 MW - USL TL263 Fault - System Frequency (Hz)

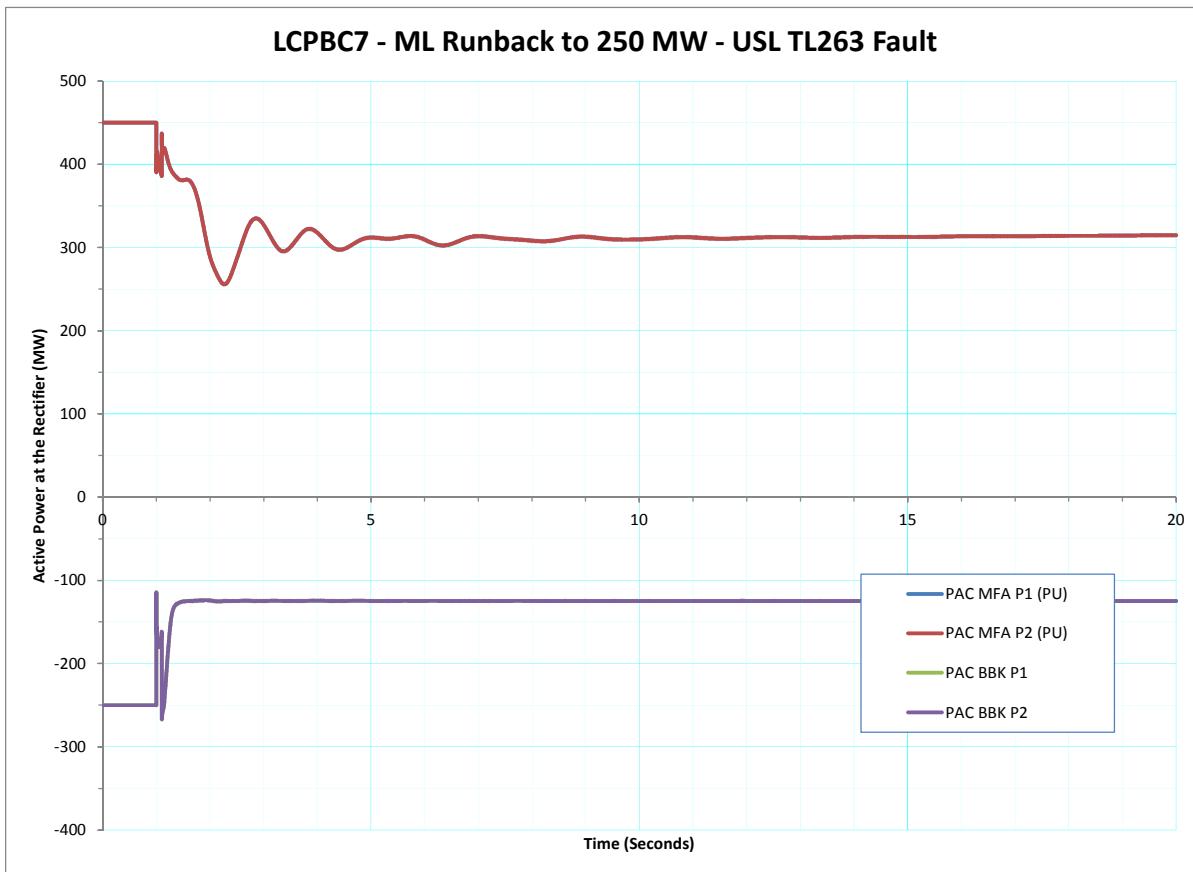
Figure 137 - LCPBC7 - ML Runback to 250 MW - USL TL263 Fault - Active Power at the Rectifier (MW)

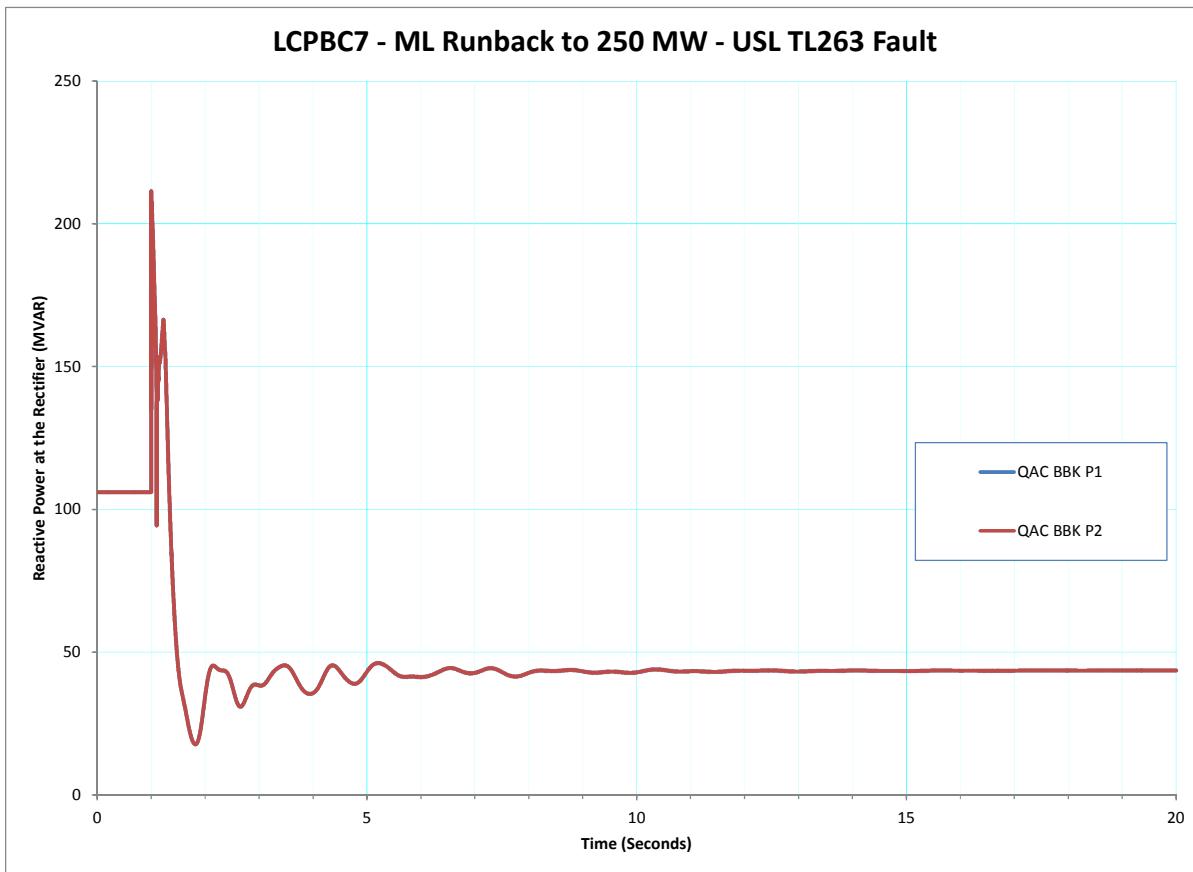
Figure 138 - LCPBC7 - ML Runback to 250 MW - USL TL263 Fault - Reactive Power at the Rectifier (MVAR)

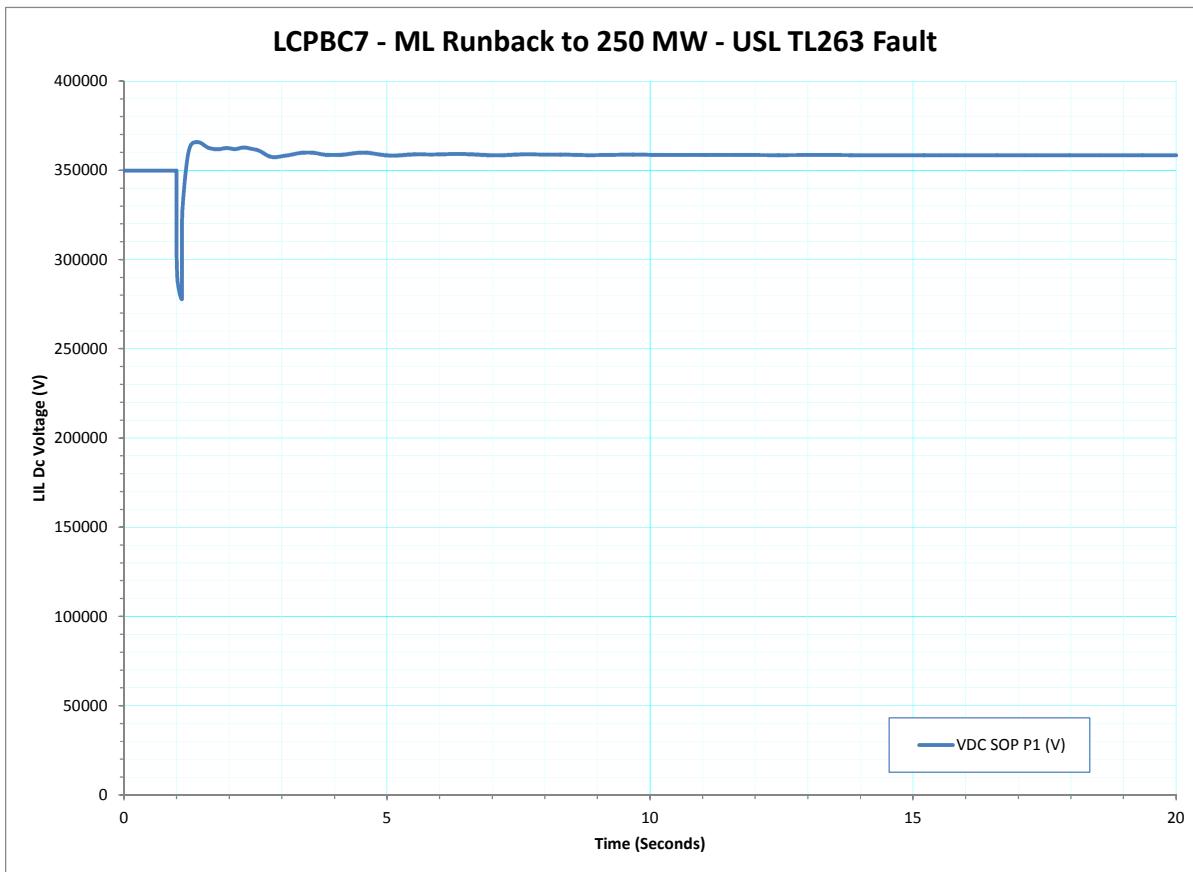
Figure 139 - LCPBC7 - ML Runback to 250 MW - USL TL263 Fault - LIL Dc Voltage (V)

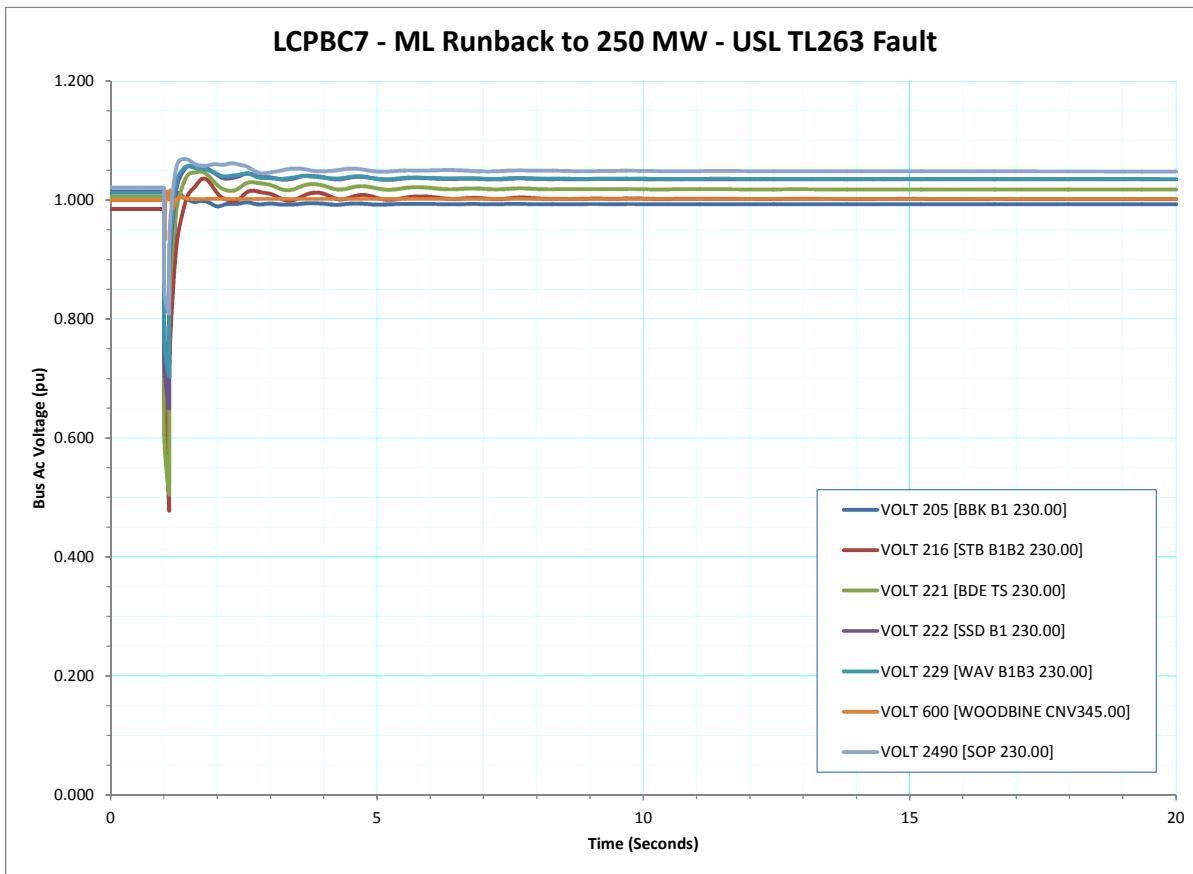
Figure 140 - LCPBC7 - ML Runback to 250 MW - USL TL263 Fault - Bus Ac Voltage (pu)

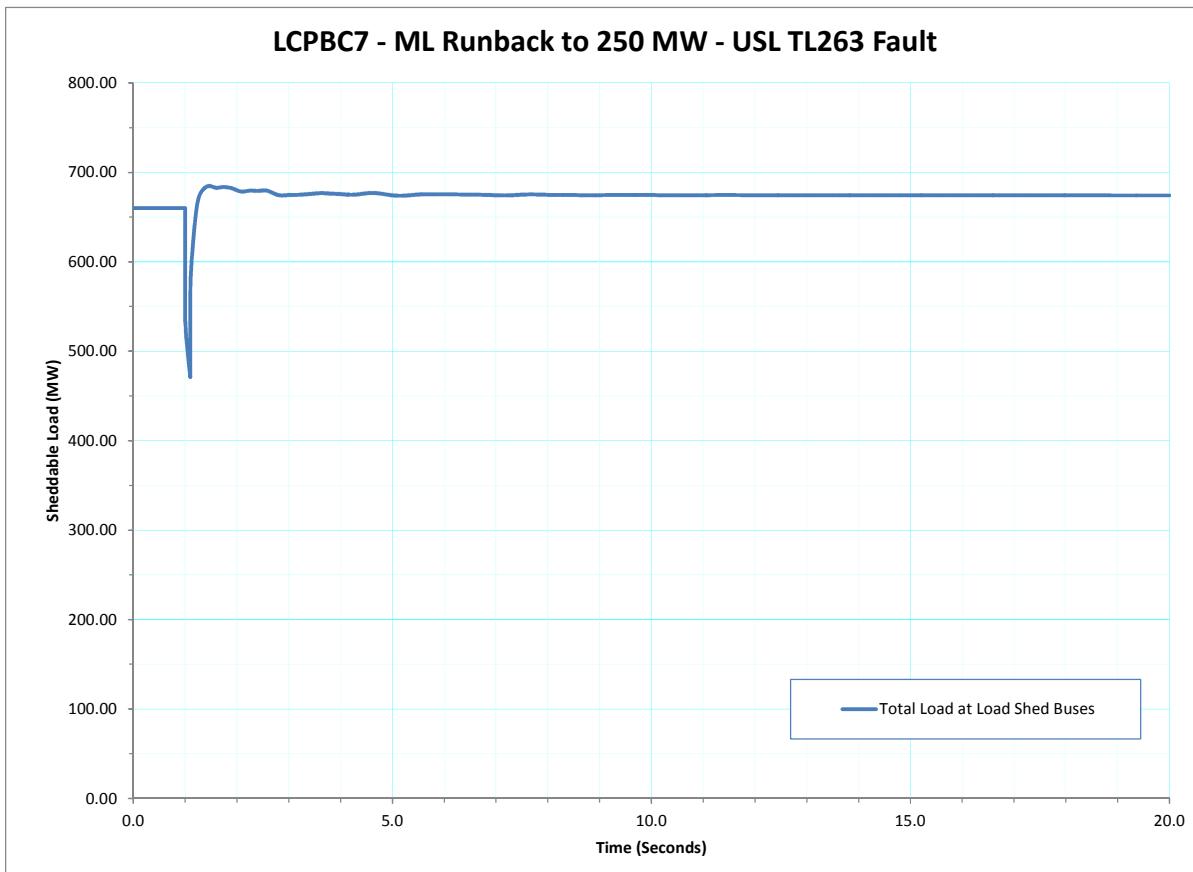
Figure 141 - LCPBC7 - ML Runback to 250 MW - USL TL263 Fault - Sheddable Load (MW)

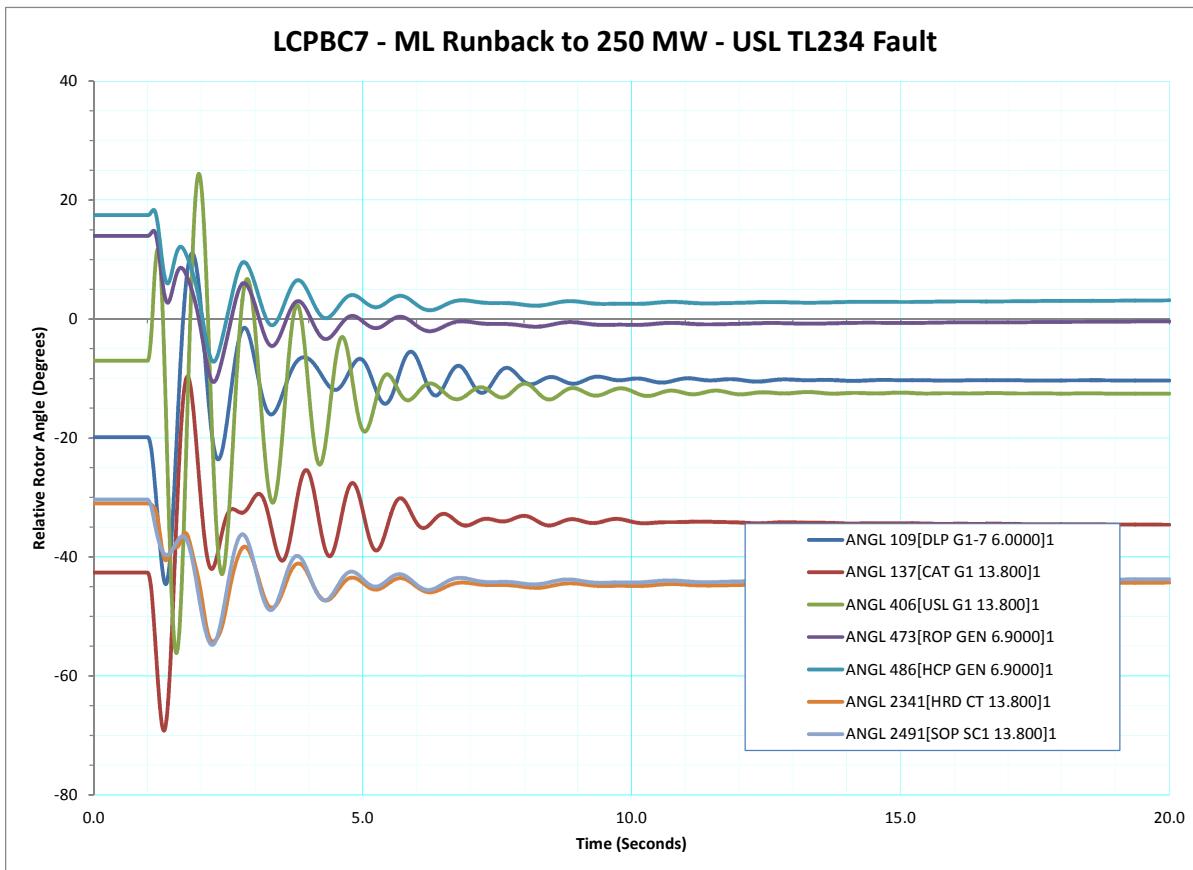
Figure 142 - LCPBC7 - ML Runback to 250 MW - USL TL234 Fault - Relative Rotor Angle (Degrees)

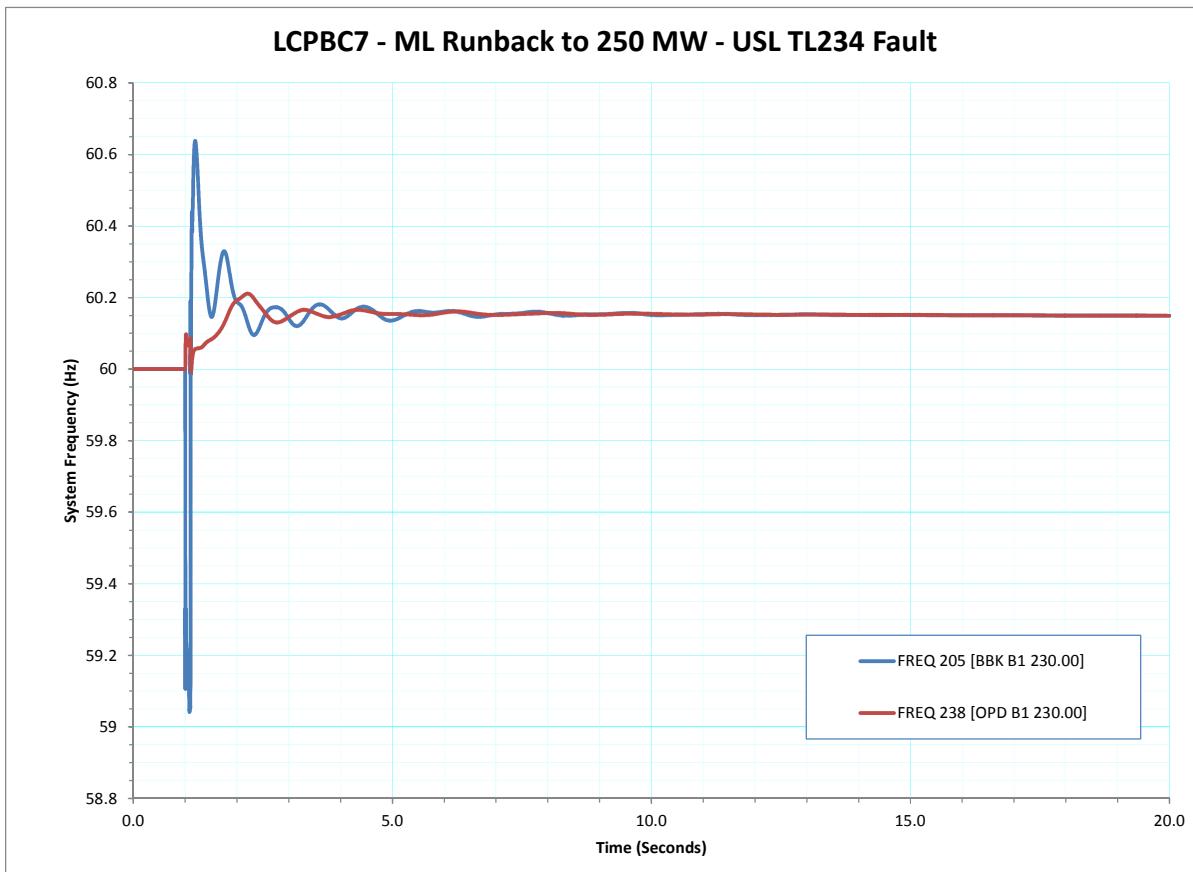
Figure 143 - LCPBC7 - ML Runback to 250 MW - USL TL234 Fault - System Frequency (Hz)

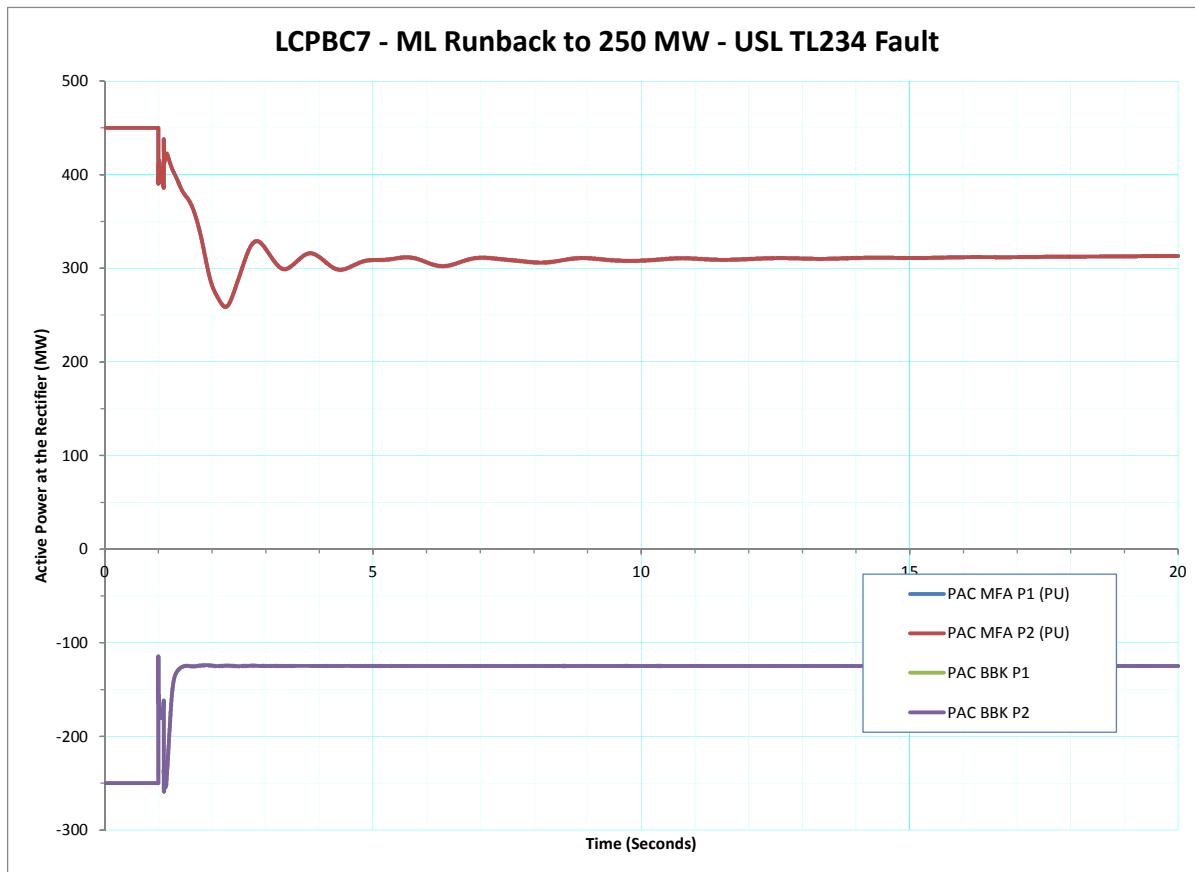
Figure 144 - LCPBC7 - ML Runback to 250 MW - USL TL234 Fault - Active Power at the Rectifier (MW)

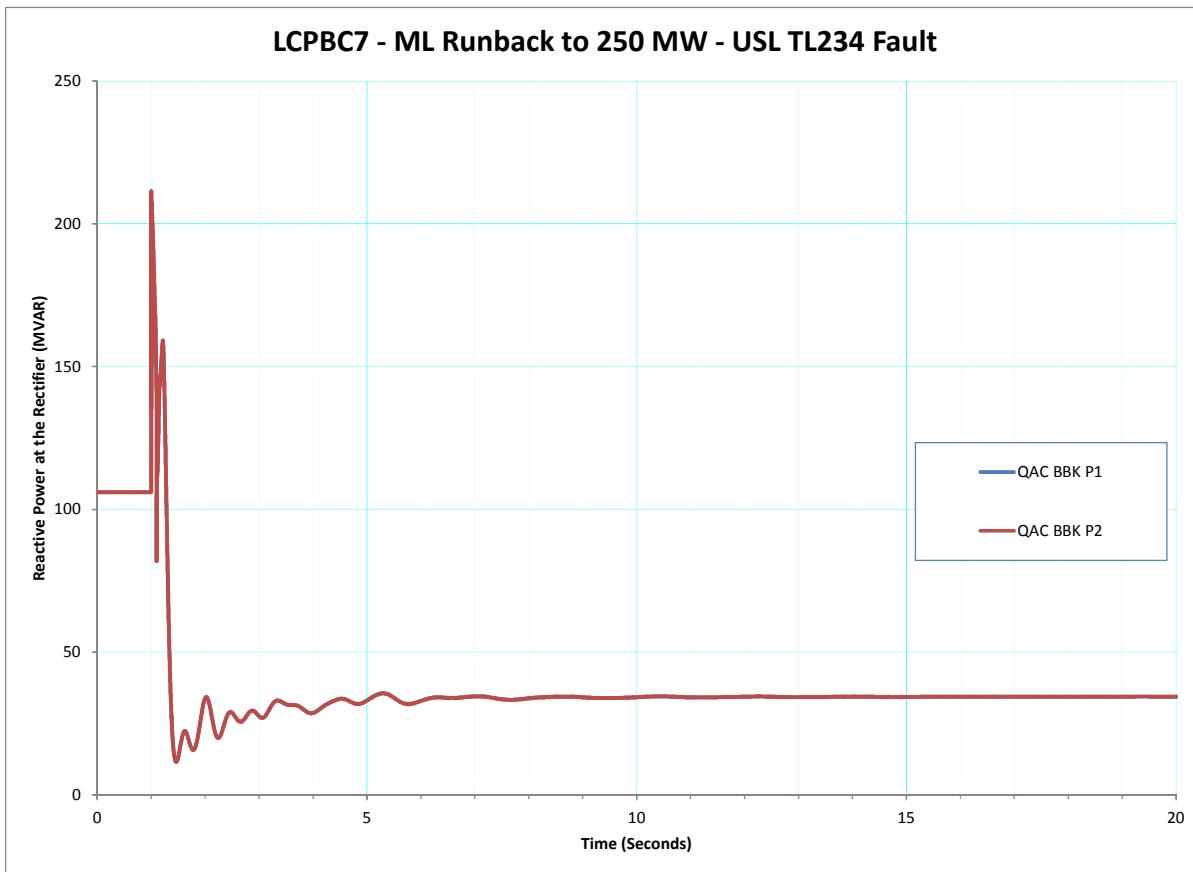
Figure 145 - LCPBC7 - ML Runback to 250 MW - USL TL234 Fault - Reactive Power at the Rectifier (MVAR)

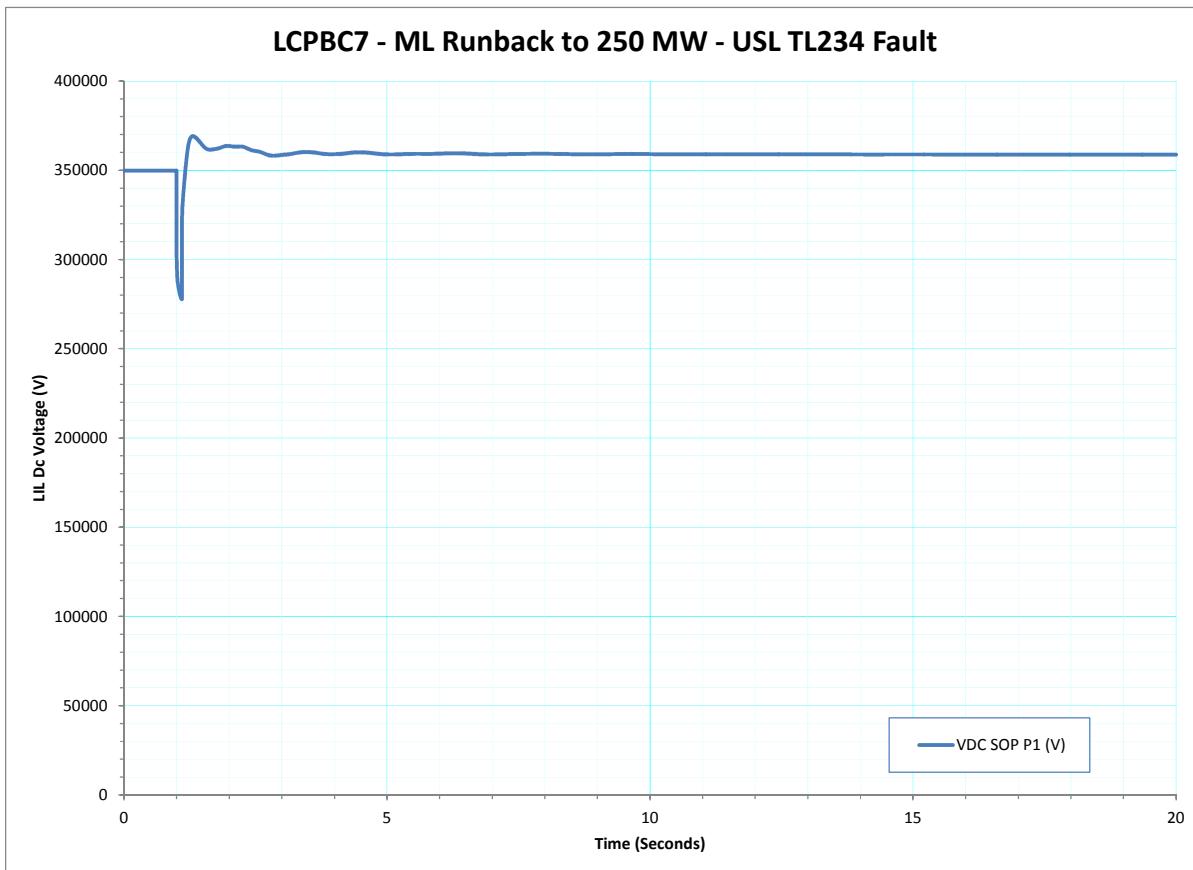
Figure 146 - LCPBC7 - ML Runback to 250 MW - USL TL234 Fault - LIL Dc Voltage (V)

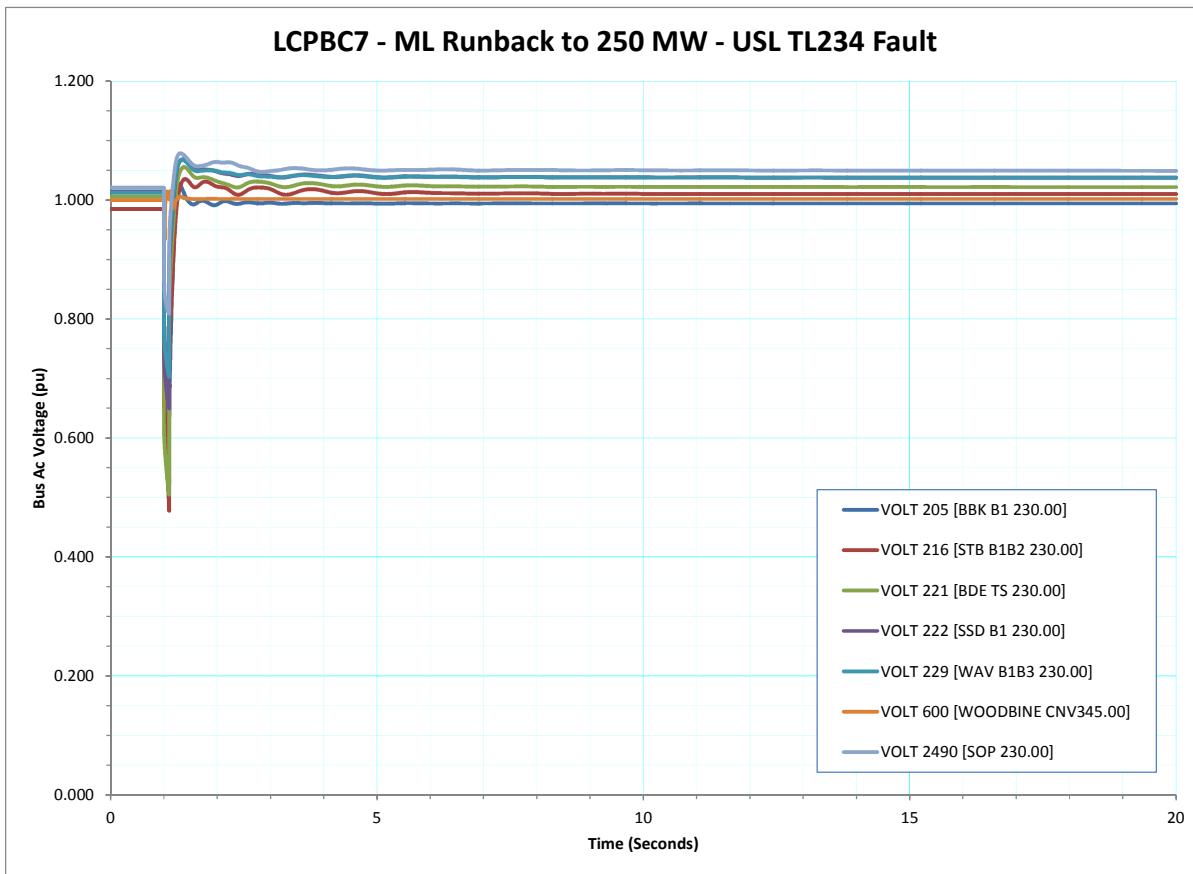
Figure 147 - LCPBC7 - ML Runback to 250 MW - USL TL234 Fault - Bus Ac Voltage (pu)
