MARITIME LINK PRELIMINARY INTERCONNECTION STUDY

Newfoundland and Labrador Hydro

July 2014

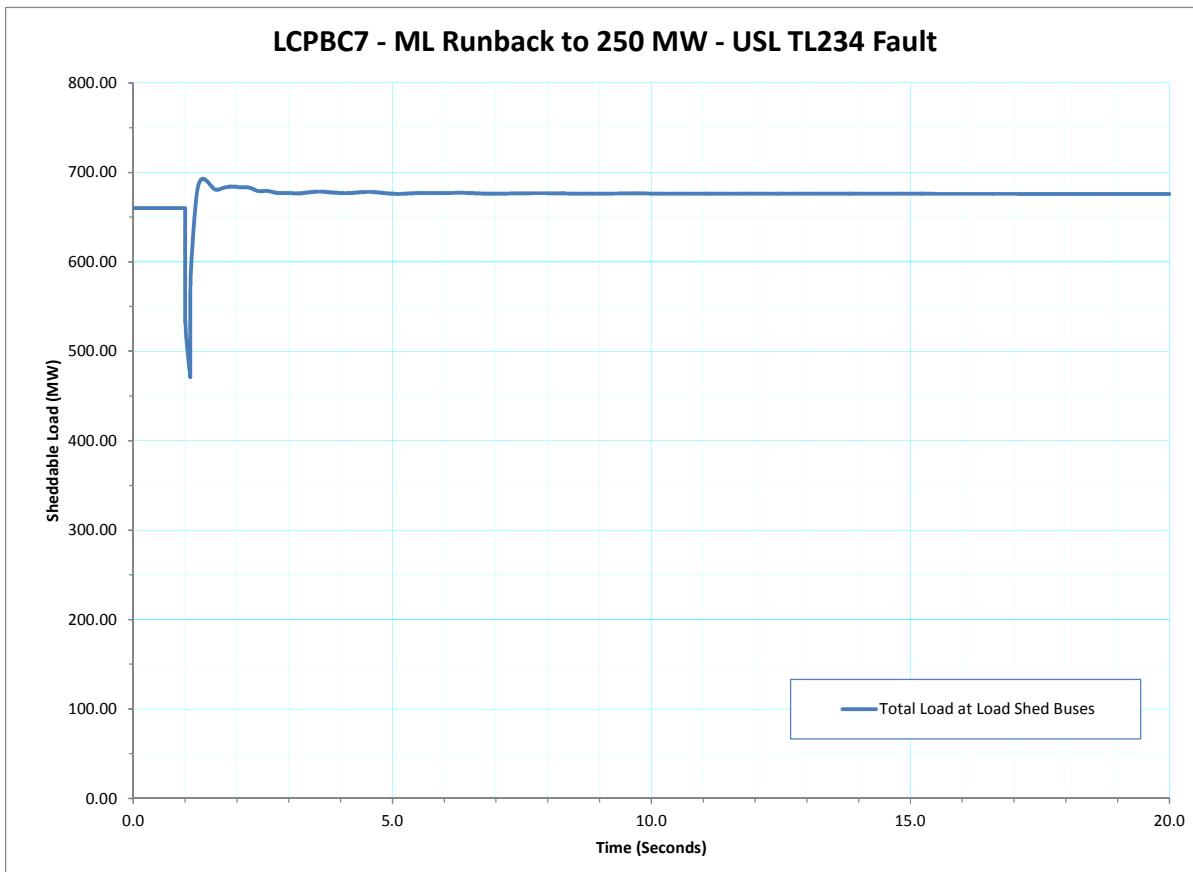
Figure 148 - LCPBC7 - ML Runback to 250 MW - USL TL234 Fault - Sheddable Load (MW)

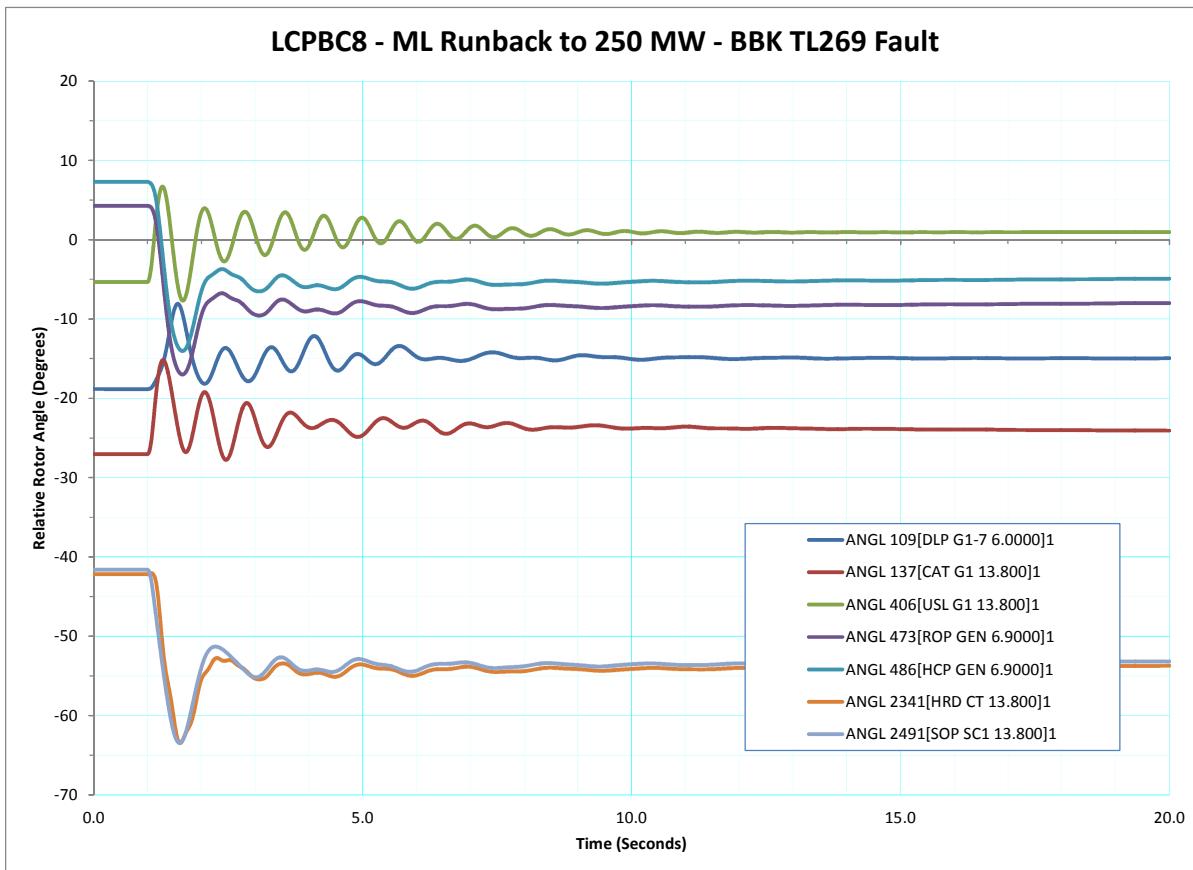
Figure 149 - LCPBC8 - ML Runback to 250 MW - BBK TL269 Fault - Relative Rotor Angle (Degrees)

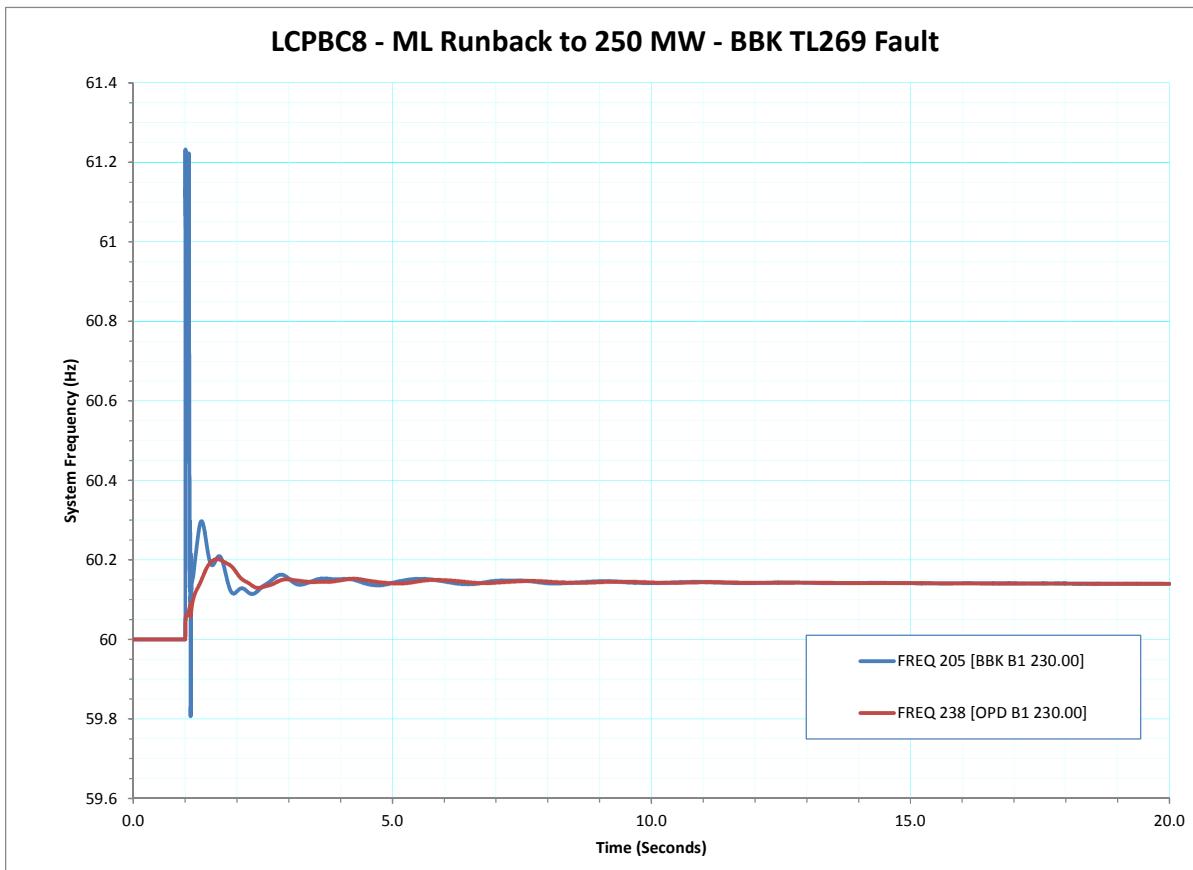
Figure 150 - LCPBC8 - ML Runback to 250 MW - BBK TL269 Fault - System Frequency (Hz)

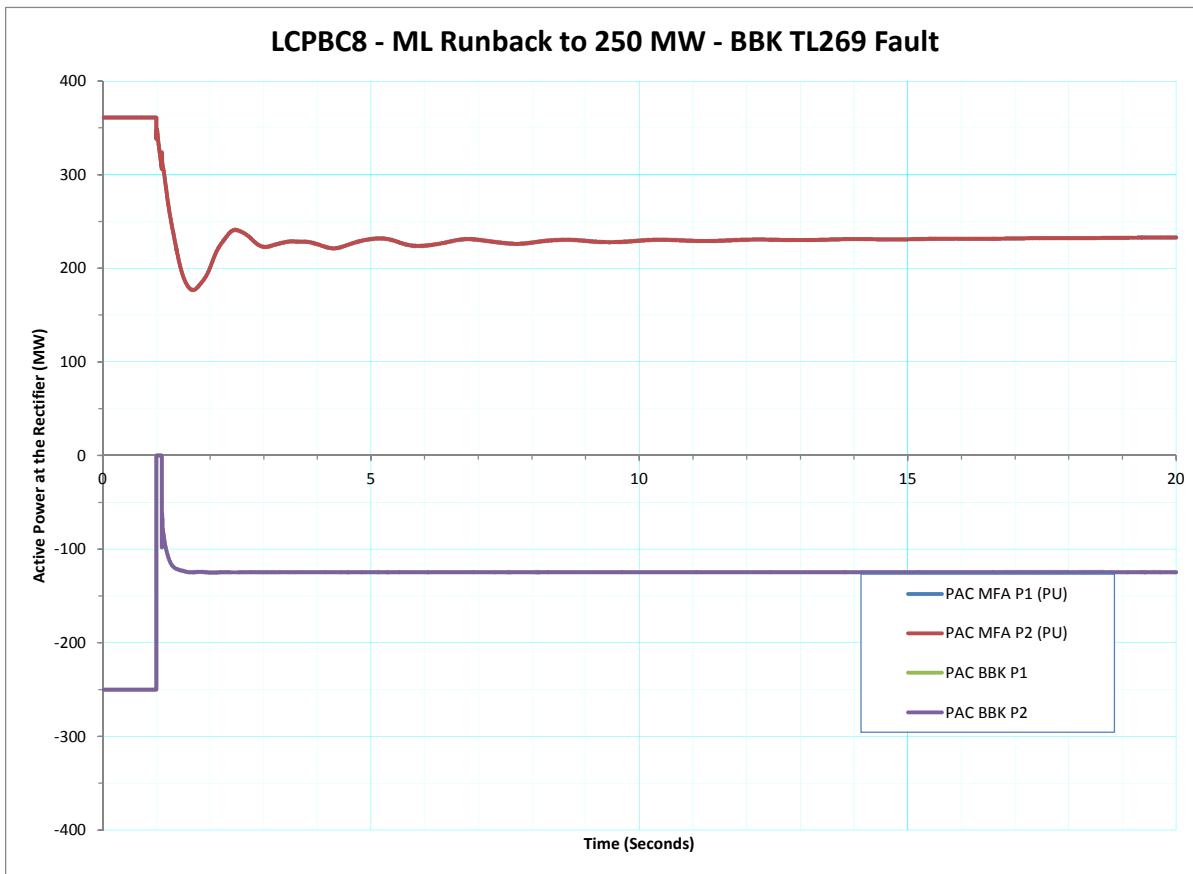
Figure 151 - LCPBC8 - ML Runback to 250 MW - BBK TL269 Fault - Active Power at the Rectifier (MW)

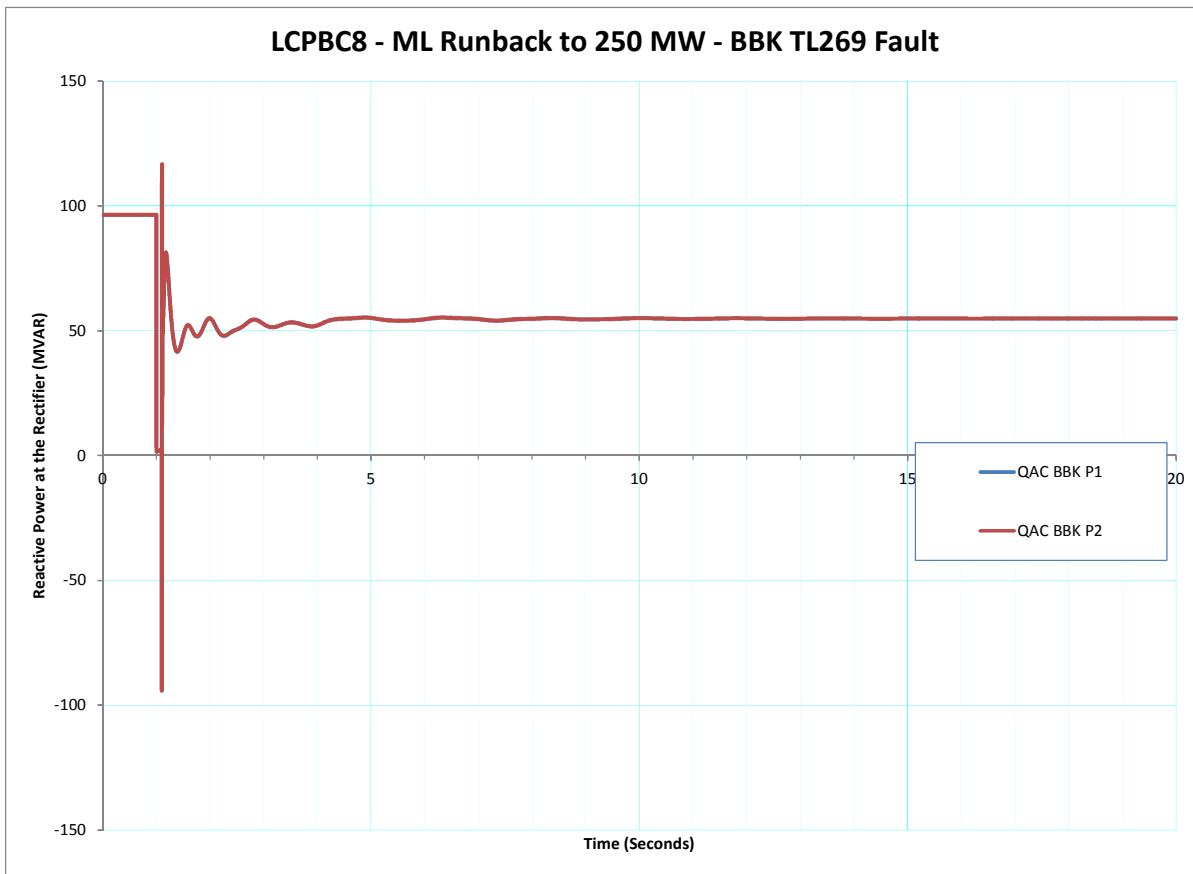
Figure 152 - LCPBC8 - ML Runback to 250 MW - BBK TL269 Fault - Reactive Power at the Rectifier (MVAR)

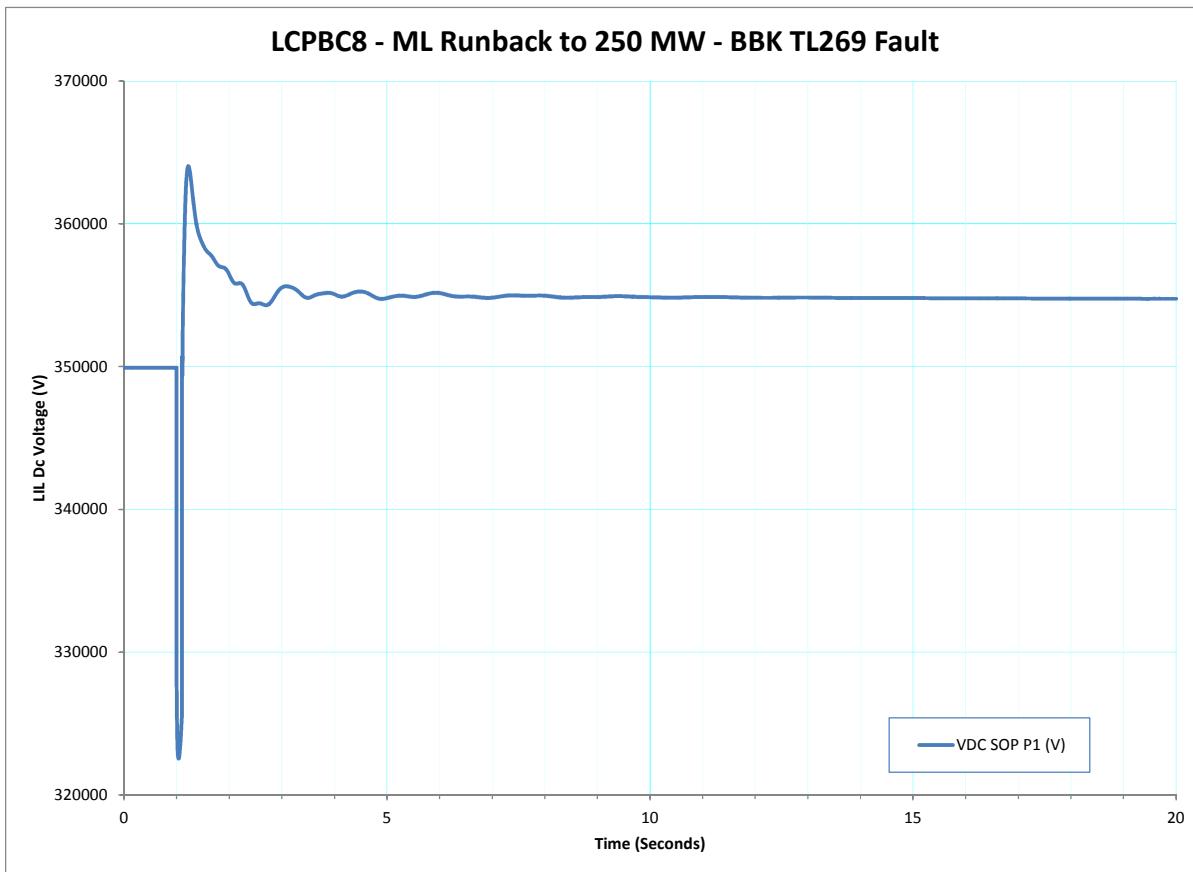
Figure 153 - LCPBC8 - ML Runback to 250 MW - BBK TL269 Fault - LIL Dc Voltage (V)

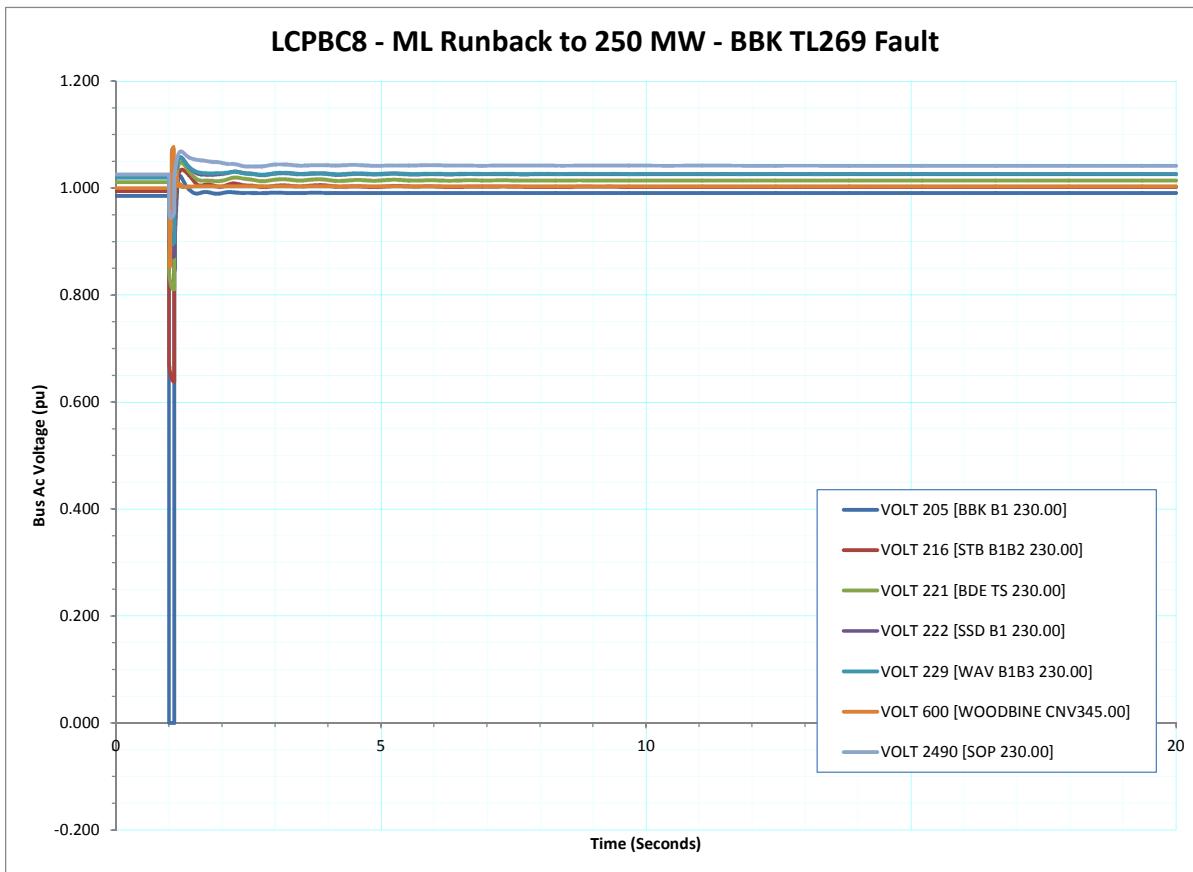
Figure 154 - LCPBC8 - ML Runback to 250 MW - BBK TL269 Fault - Bus Ac Voltage (pu)

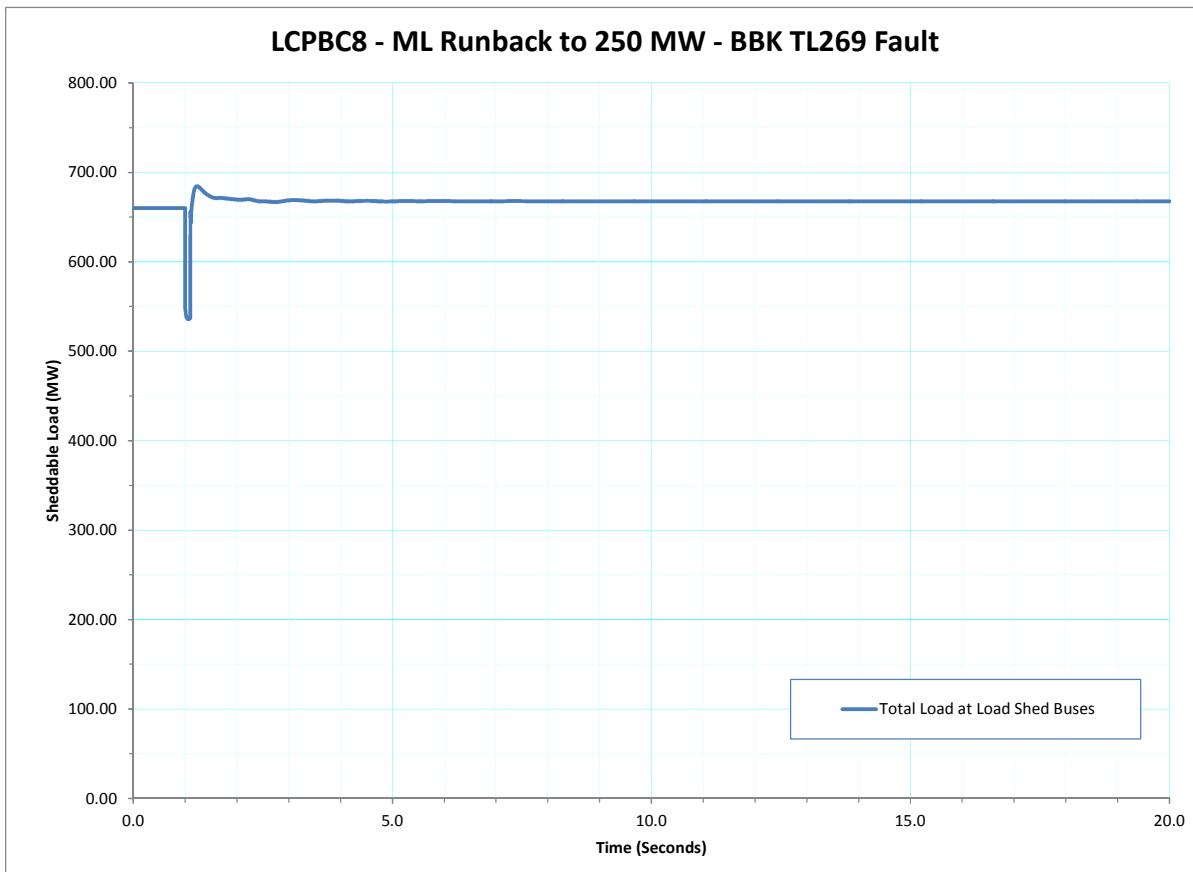
Figure 155 - LCPBC8 - ML Runback to 250 MW - BBK TL269 Fault - Sheddable Load (MW)

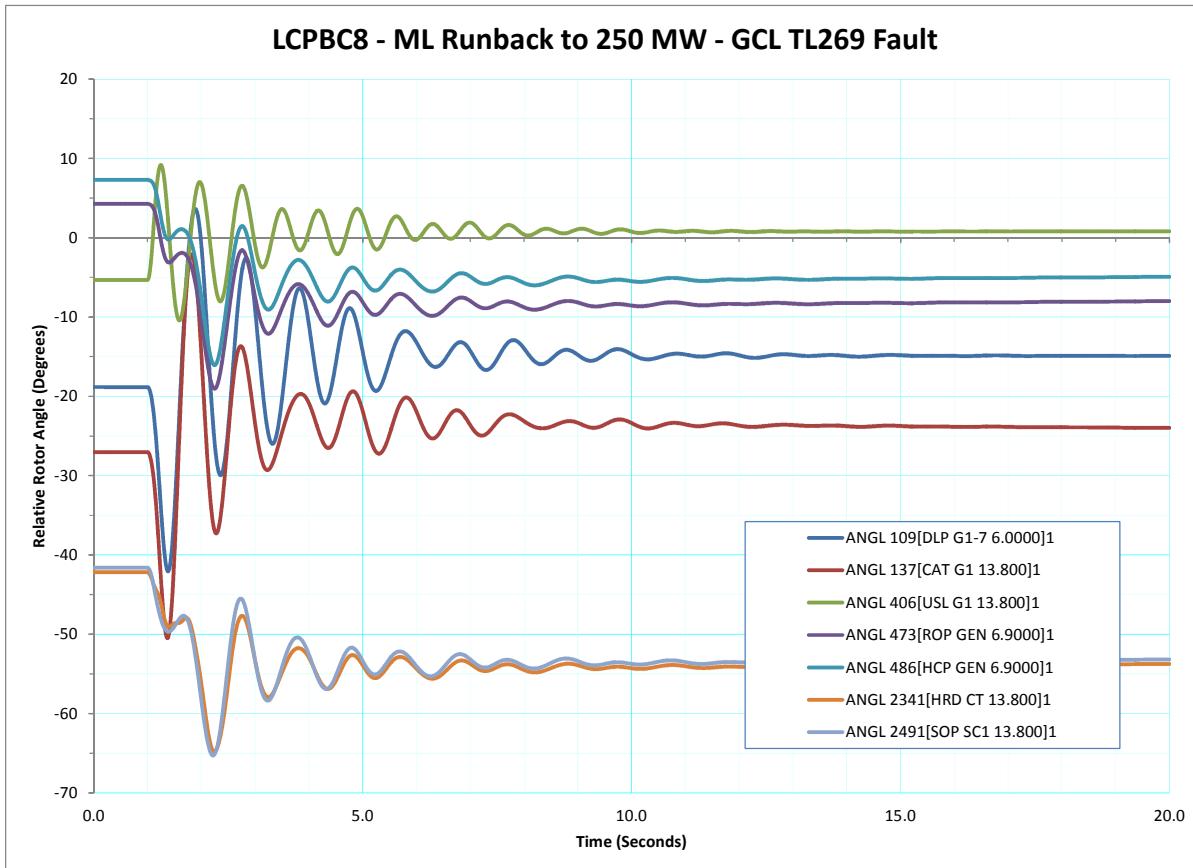
Figure 156 - LCPBC8 - ML Runback to 250 MW - GCL TL269 Fault - Relative Rotor Angle (Degrees)

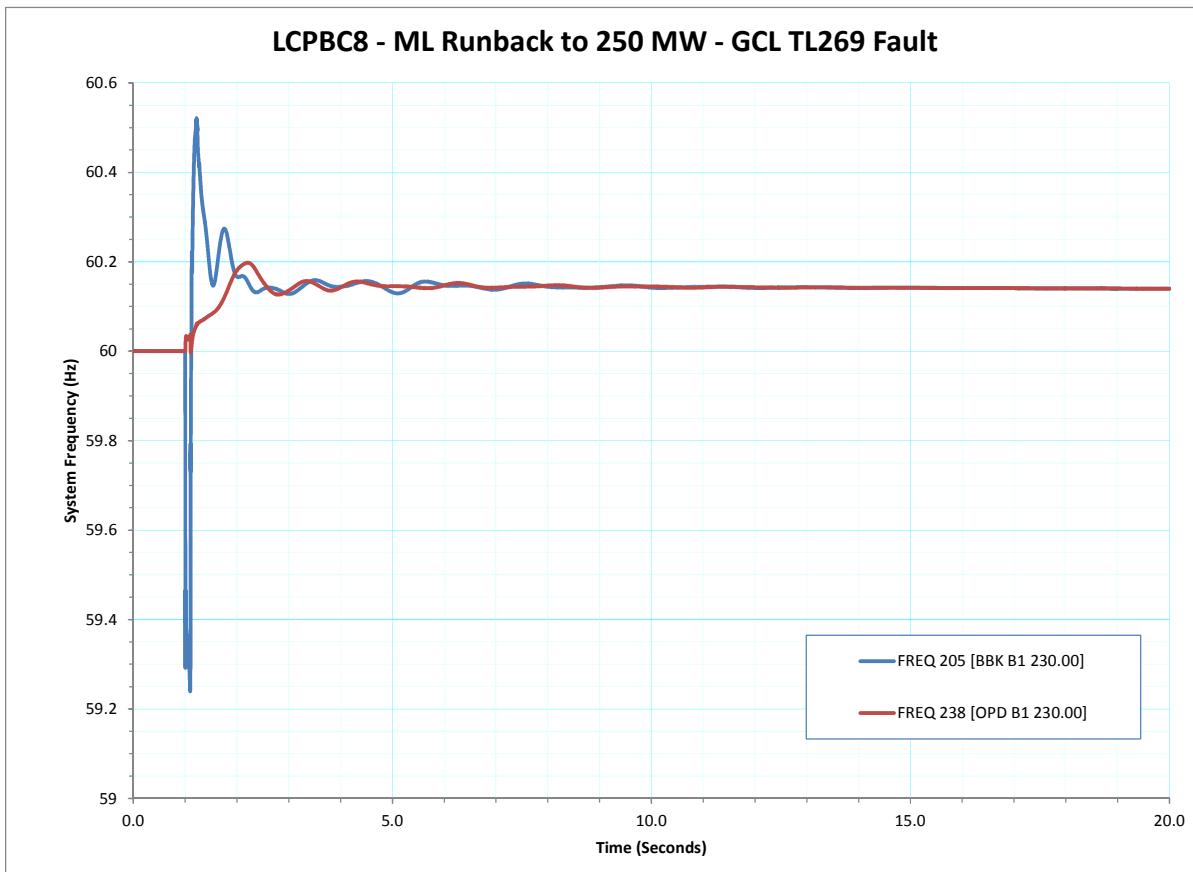
Figure 157 - LCPBC8 - ML Runback to 250 MW - GCL TL269 Fault - System Frequency (Hz)

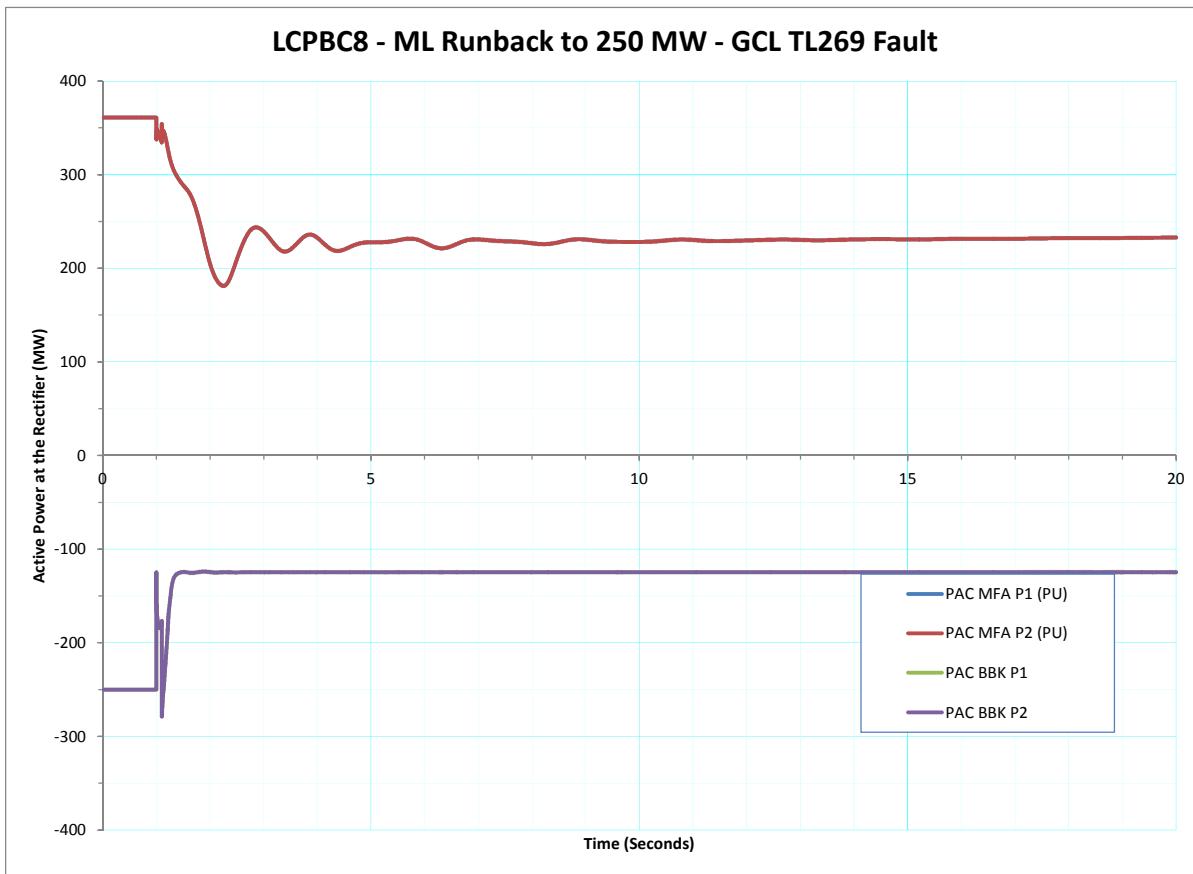
Figure 158 - LCPBC8 - ML Runback to 250 MW - GCL TL269 Fault - Active Power at the Rectifier (MW)

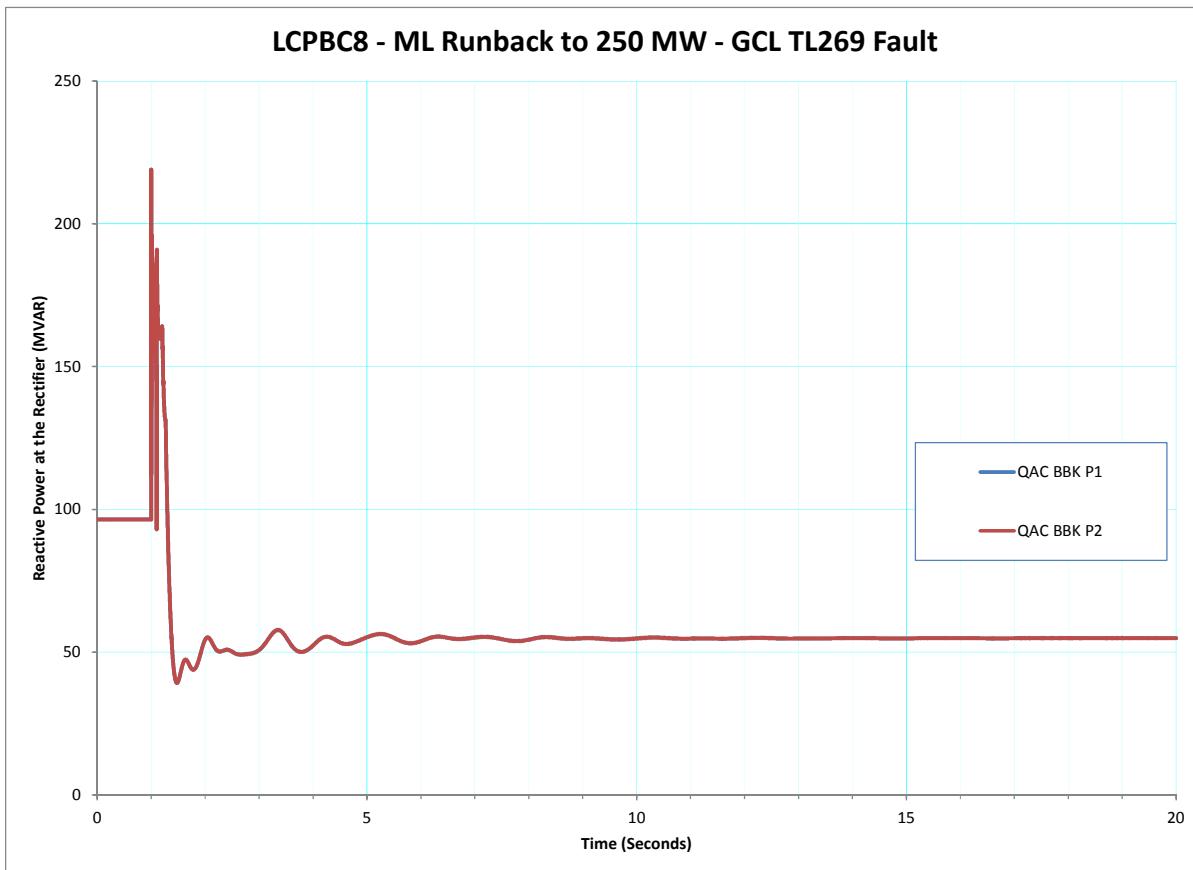
Figure 159 - LCPBC8 - ML Runback to 250 MW - GCL TL269 Fault - Reactive Power at the Rectifier (MVAR)

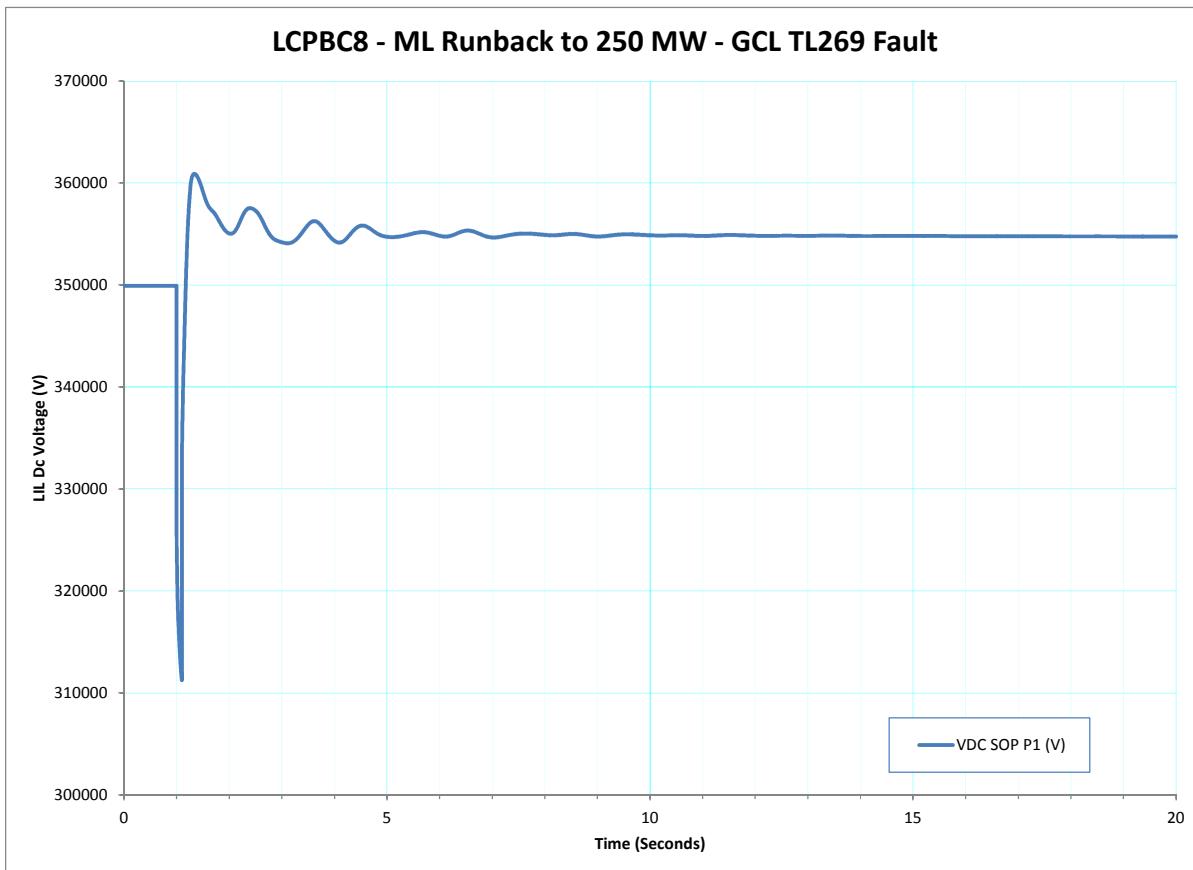
Figure 160 - LCPBC8 - ML Runback to 250 MW - GCL TL269 Fault - LIL Dc Voltage (V)

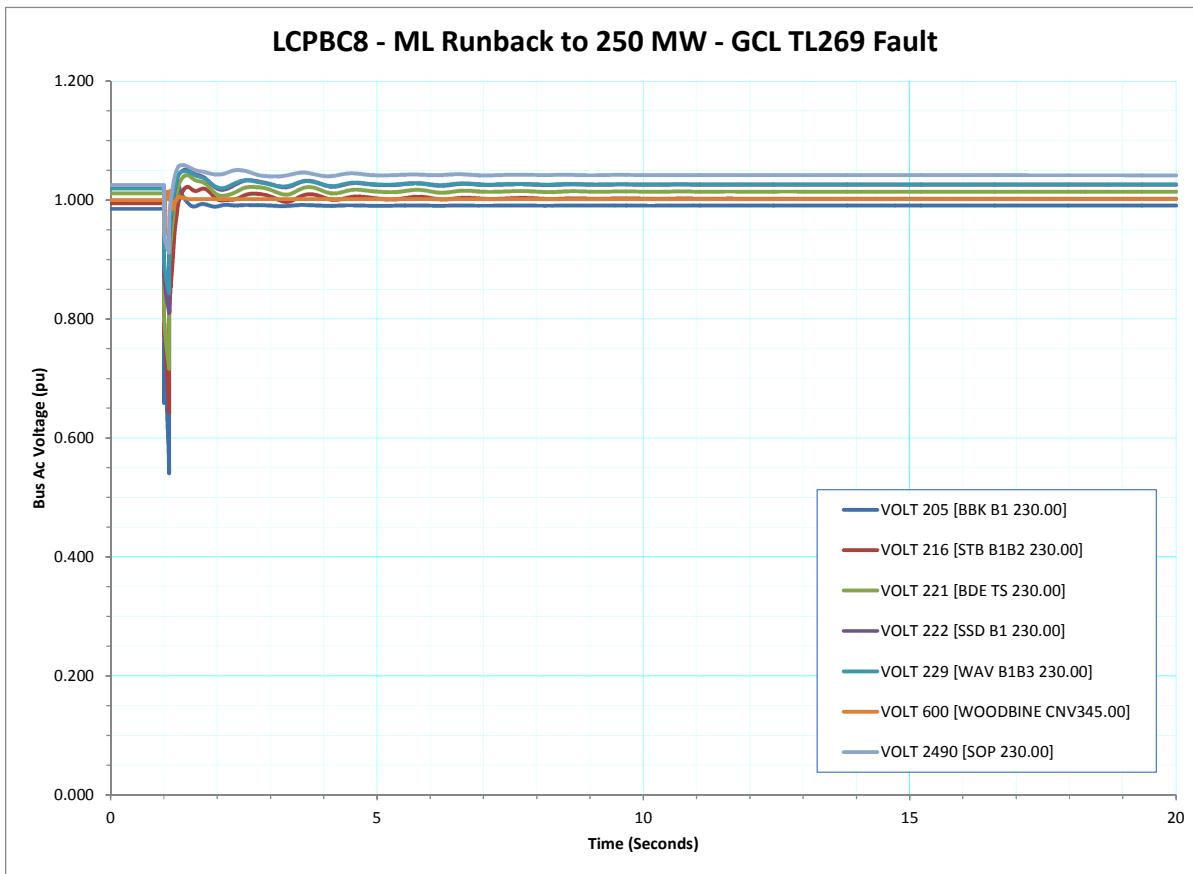
Figure 161 - LCPBC8 - ML Runback to 250 MW - GCL TL269 Fault - Bus Ac Voltage (pu)

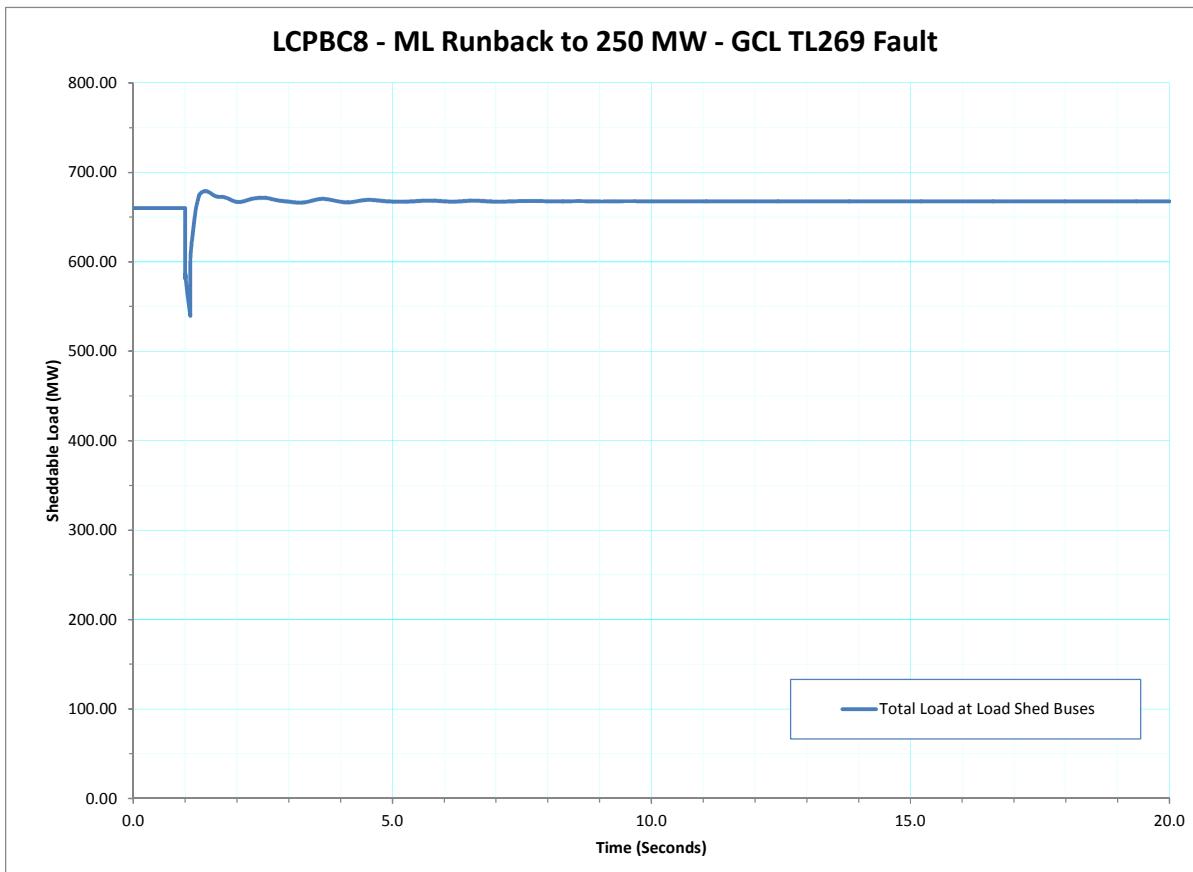
Figure 162 - LCPBC8 - ML Runback to 250 MW - GCL TL269 Fault - Sheddable Load (MW)

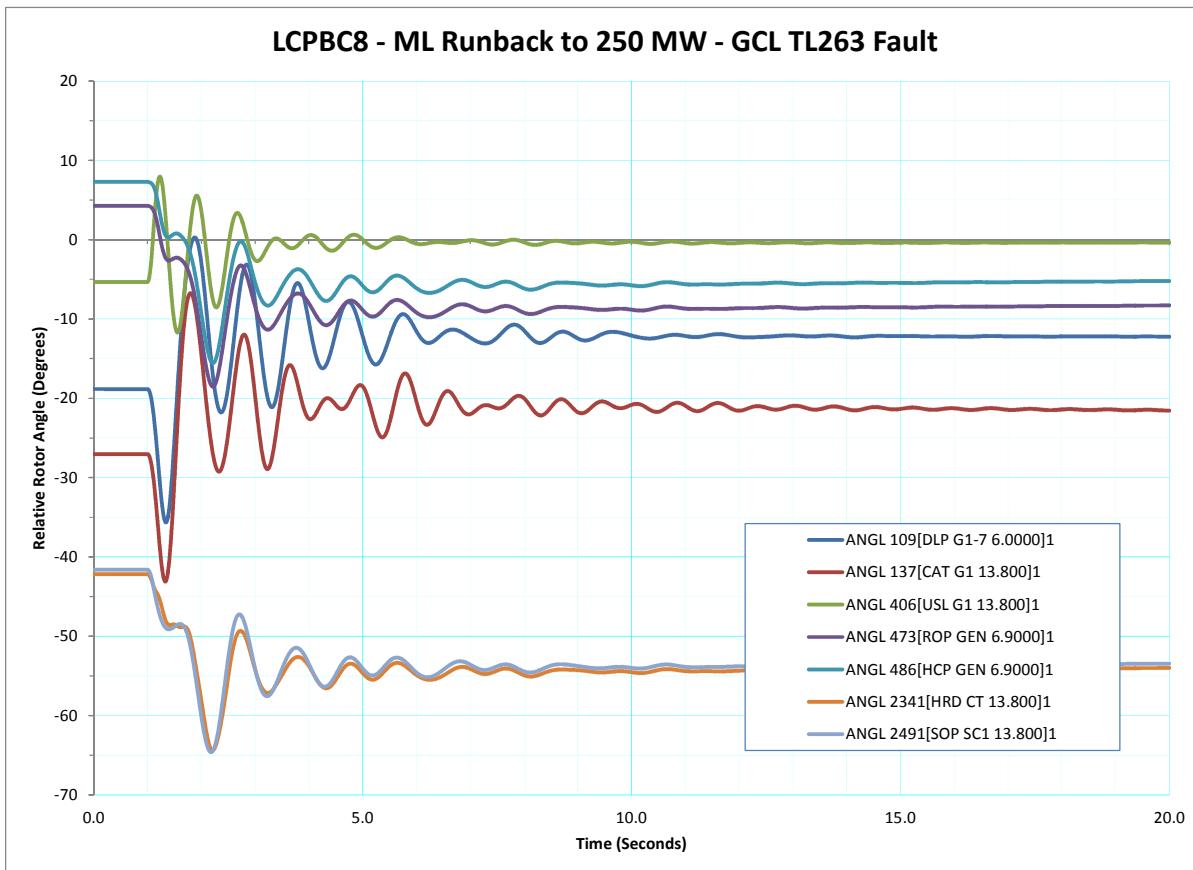
Figure 163 - LCPBC8 - ML Runback to 250 MW - GCL TL263 Fault - Relative Rotor Angle (Degrees)

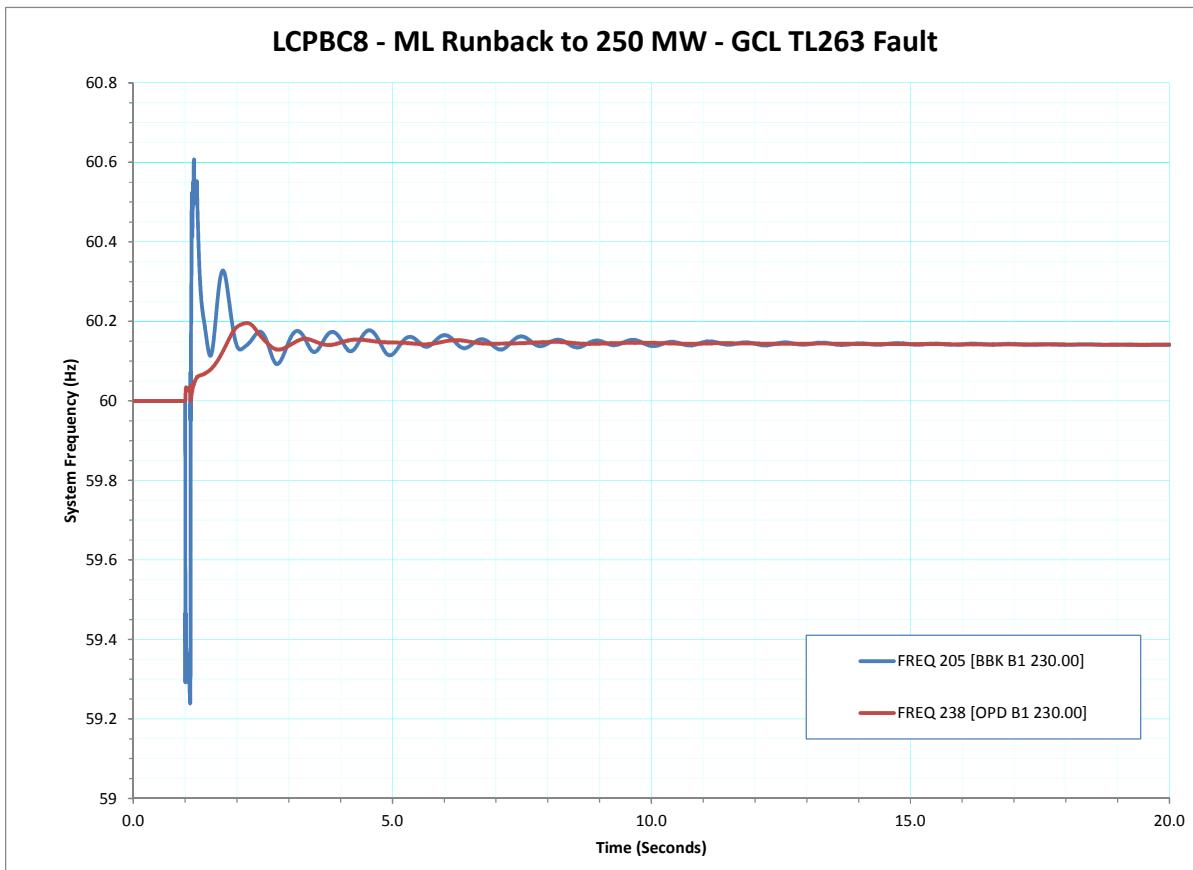
Figure 164 - LCPBC8 - ML Runback to 250 MW - GCL TL263 Fault - System Frequency (Hz)

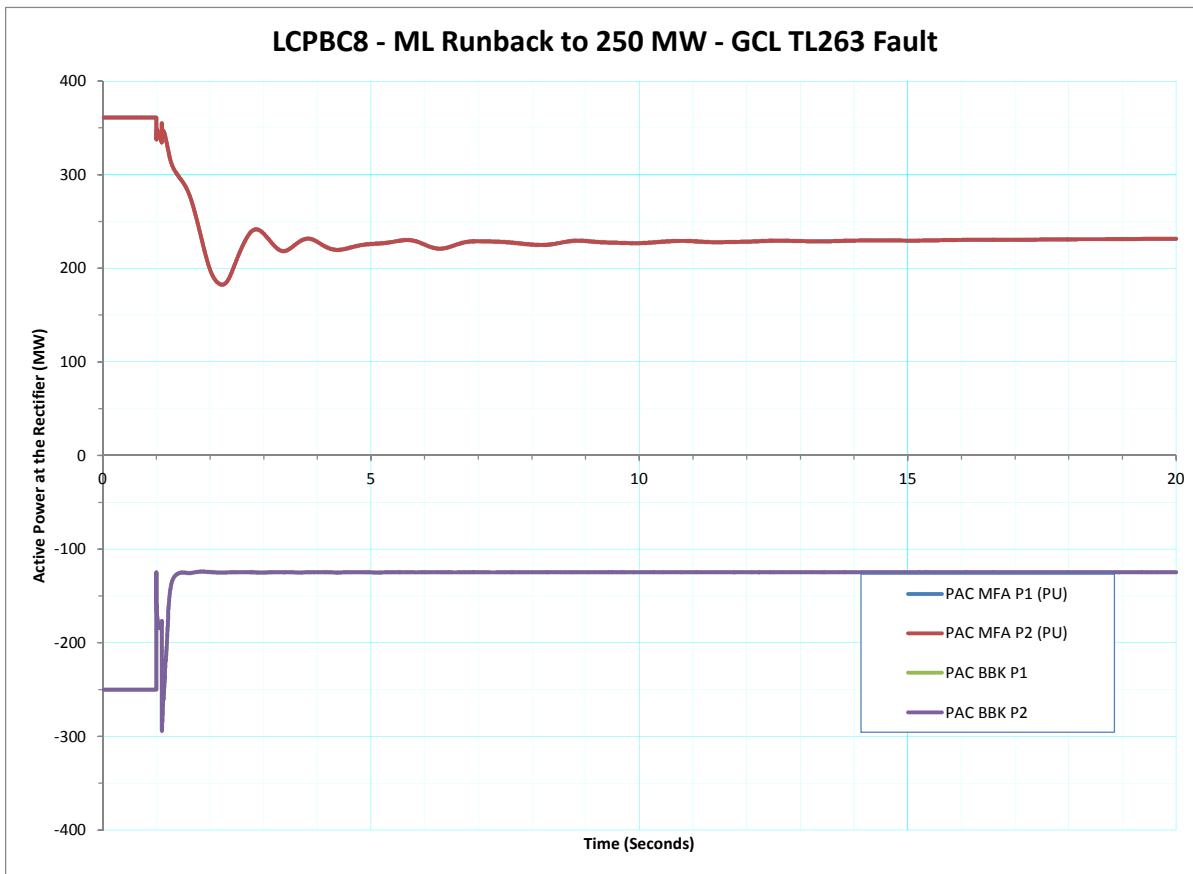
Figure 165 - LCPBC8 - ML Runback to 250 MW - GCL TL263 Fault - Active Power at the Rectifier (MW)

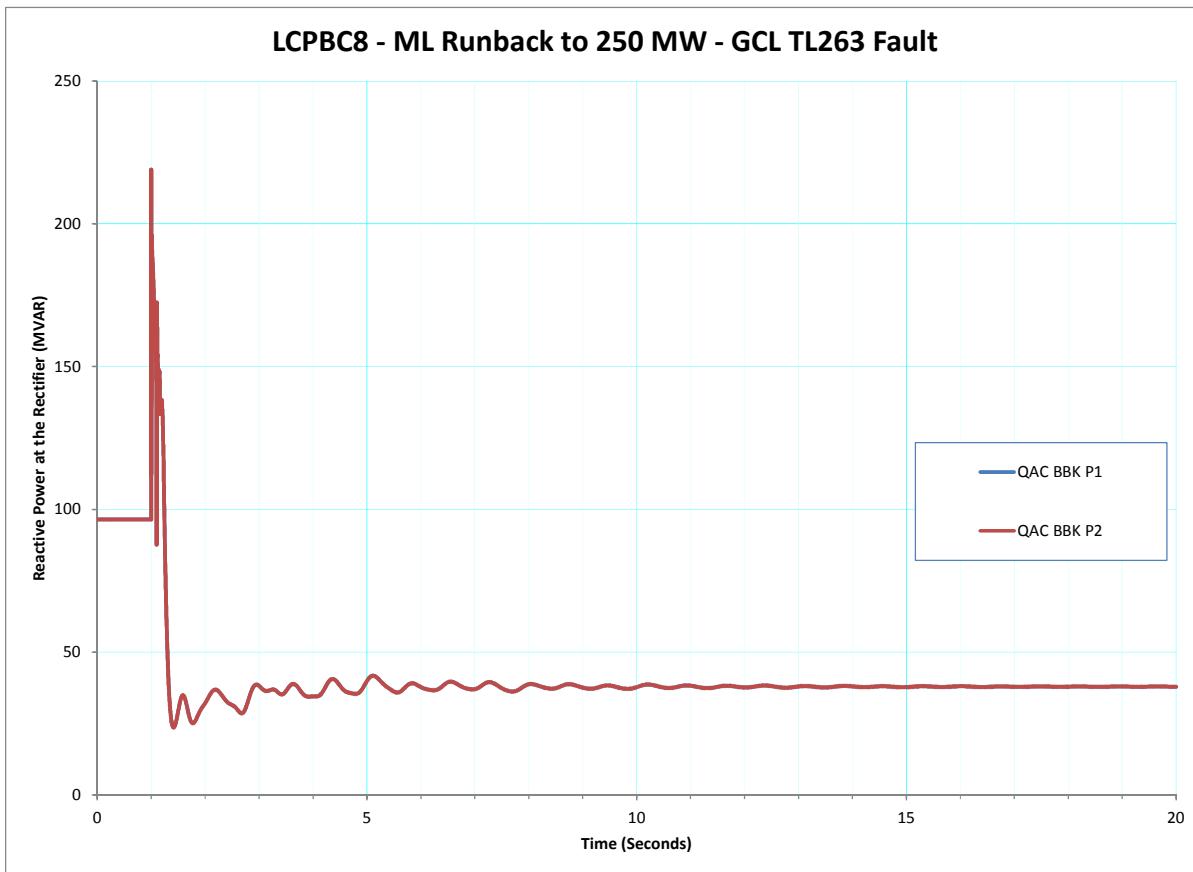
Figure 166 - LCPBC8 - ML Runback to 250 MW - GCL TL263 Fault - Reactive Power at the Rectifier (MVAR)

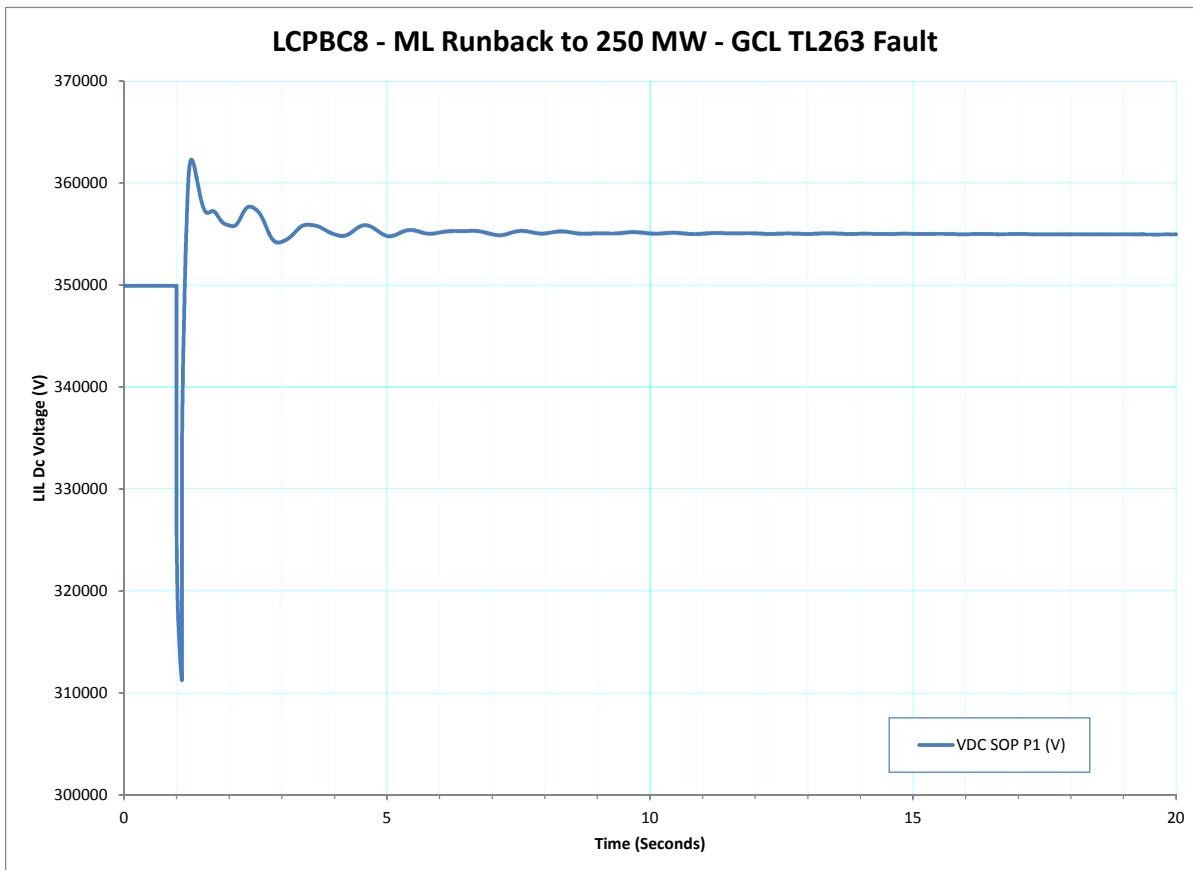
Figure 167 - LCPBC8 - ML Runback to 250 MW - GCL TL263 Fault - LIL Dc Voltage (V)

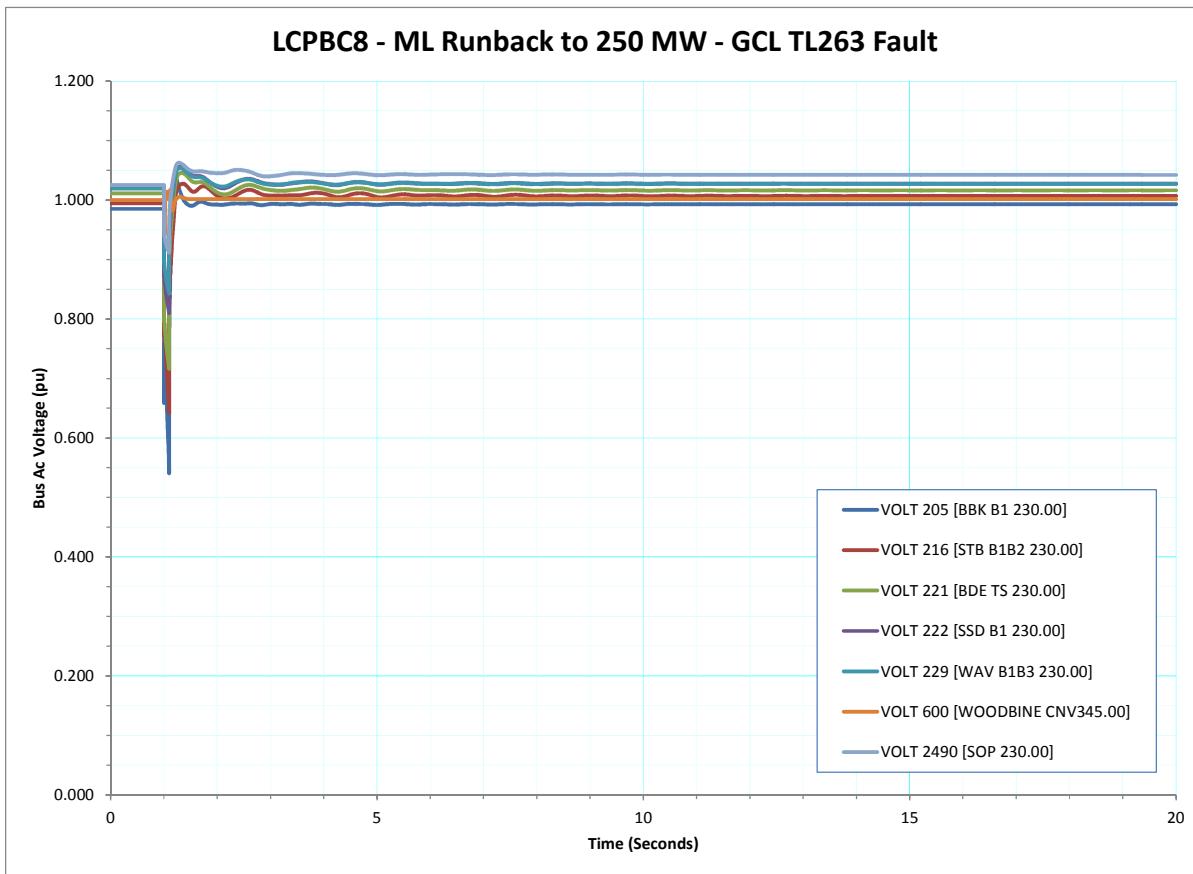
Figure 168 - LCPBC8 - ML Runback to 250 MW - GCL TL263 Fault - Bus Ac Voltage (pu)
