MARITIME LINK PRELIMINARY INTERCONNECTION STUDY

Newfoundland and Labrador Hydro

July 2014

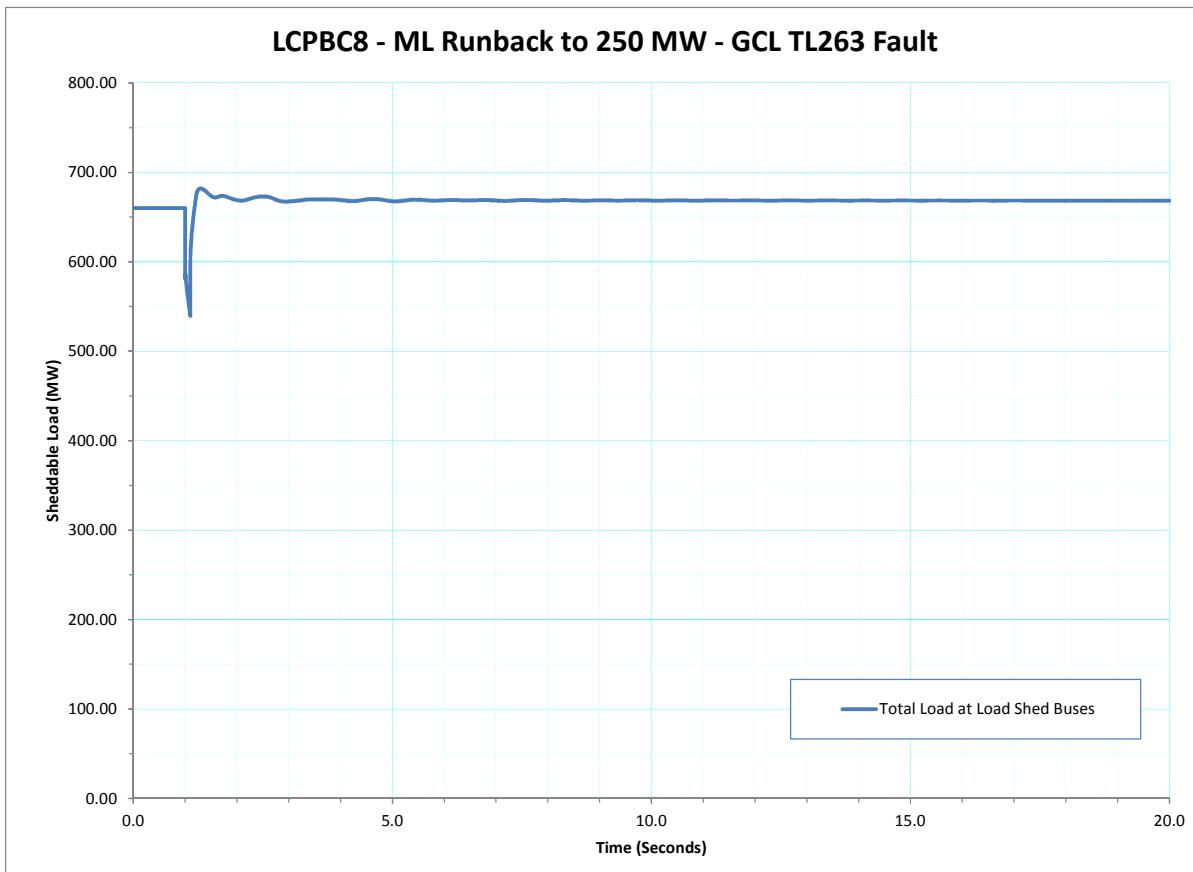
Figure 169 - LCPBC8 - ML Runback to 250 MW - GCL TL263 Fault - Sheddable Load (MW)

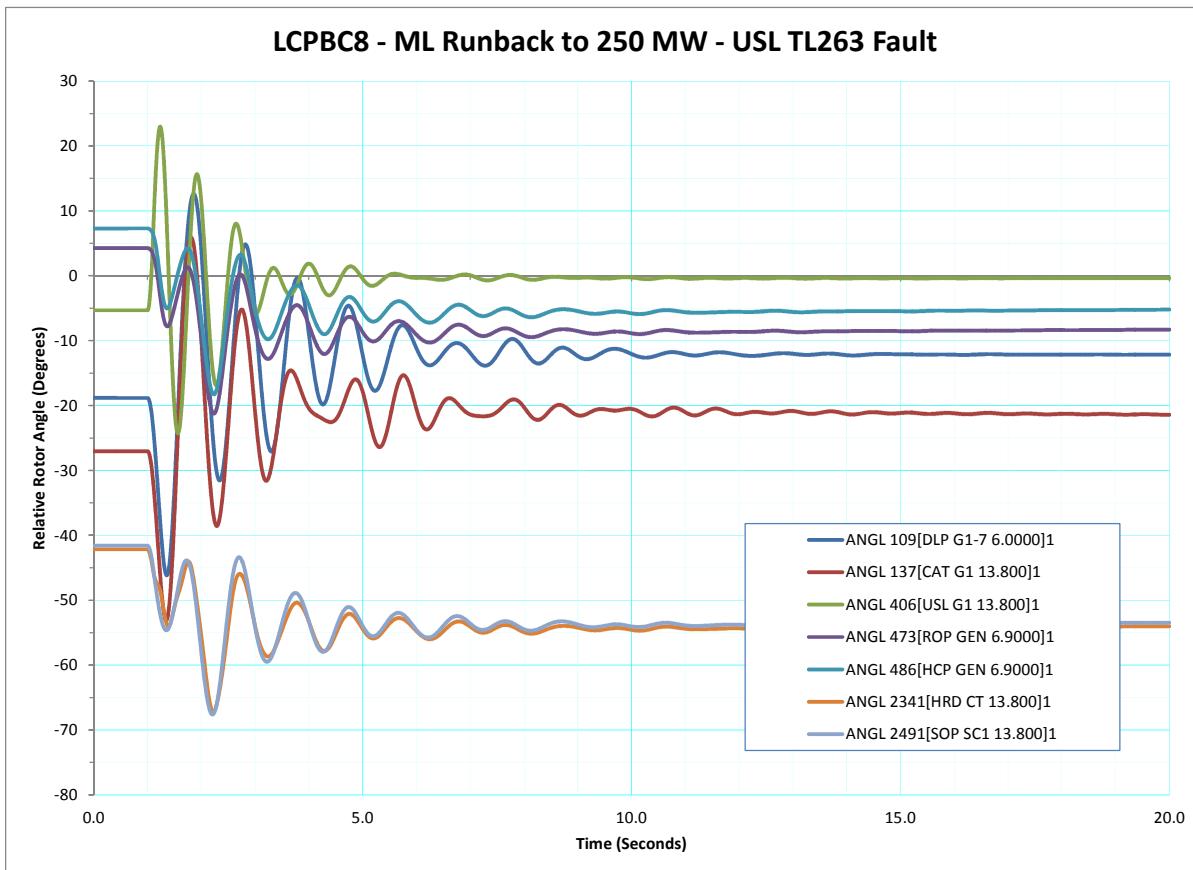
Figure 170 - LCPBC8 - ML Runback to 250 MW - USL TL263 Fault - Relative Rotor Angle (Degrees)

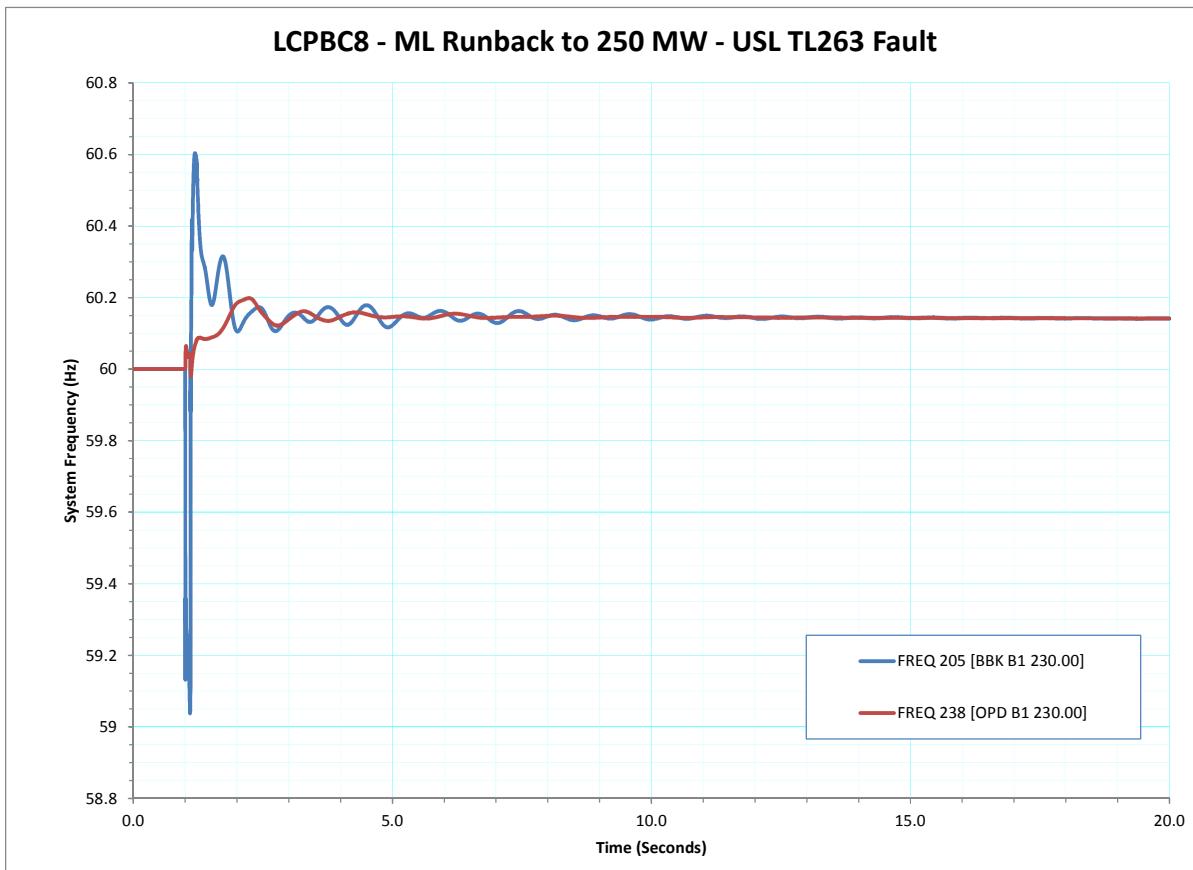
Figure 171 - LCPBC8 - ML Runback to 250 MW - USL TL263 Fault - System Frequency (Hz)

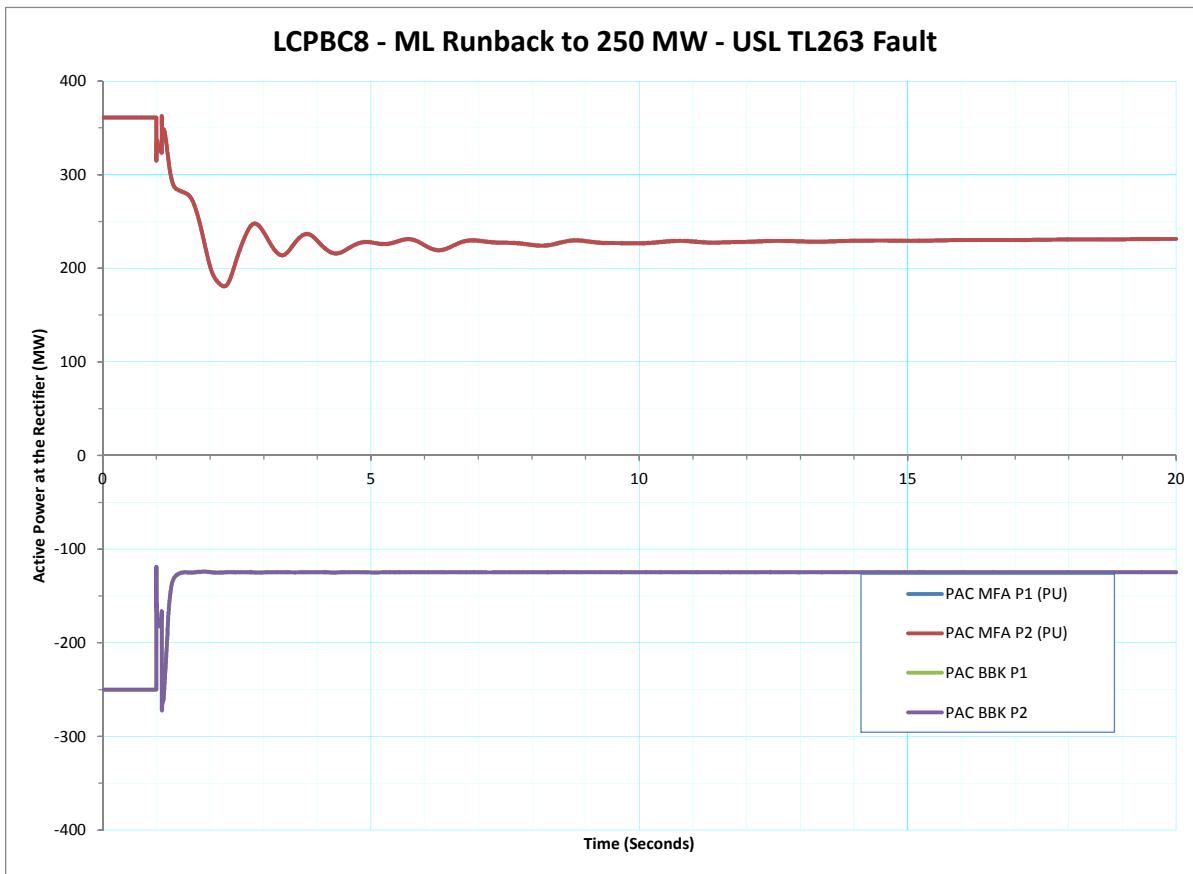
Figure 172 - LCPBC8 - ML Runback to 250 MW - USL TL263 Fault - Active Power at the Rectifier (MW)

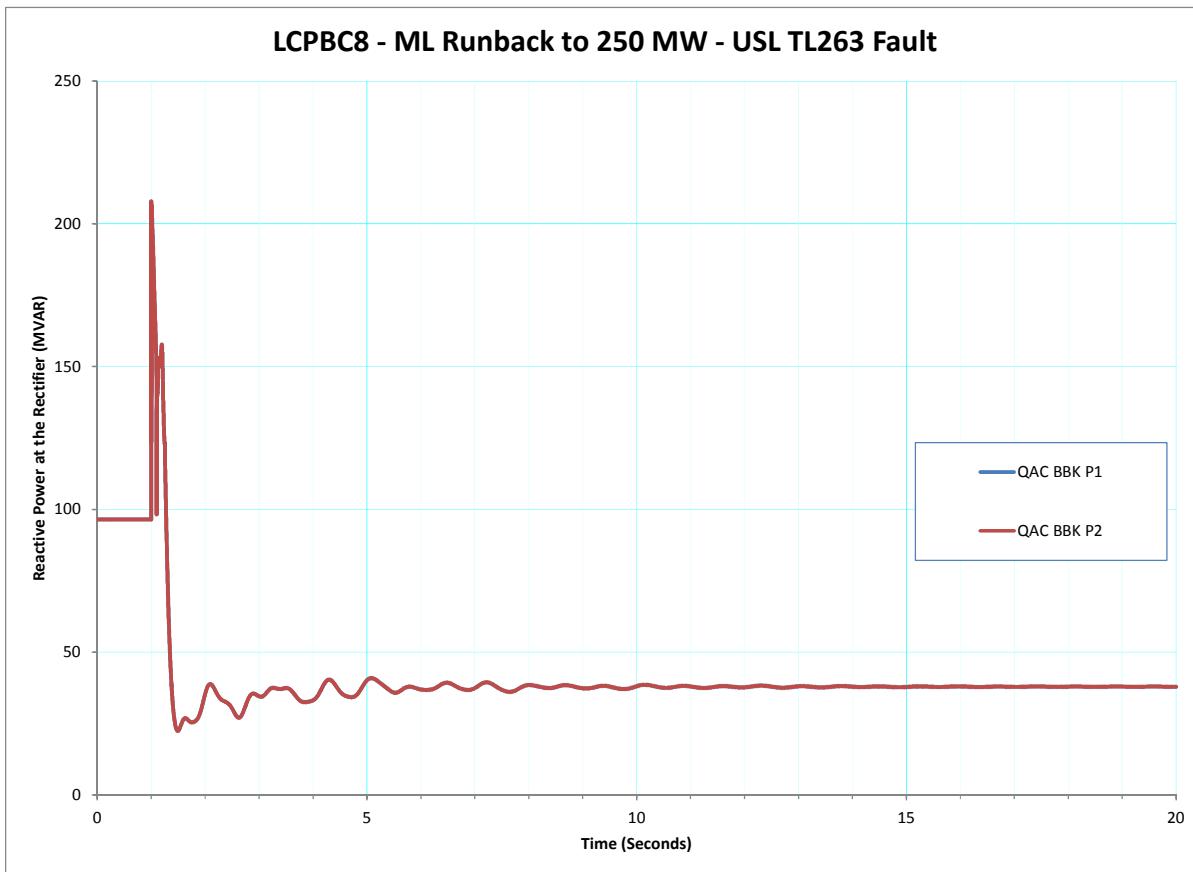
Figure 173 - LCPBC8 - ML Runback to 250 MW - USL TL263 Fault - Reactive Power at the Rectifier (MVAR)

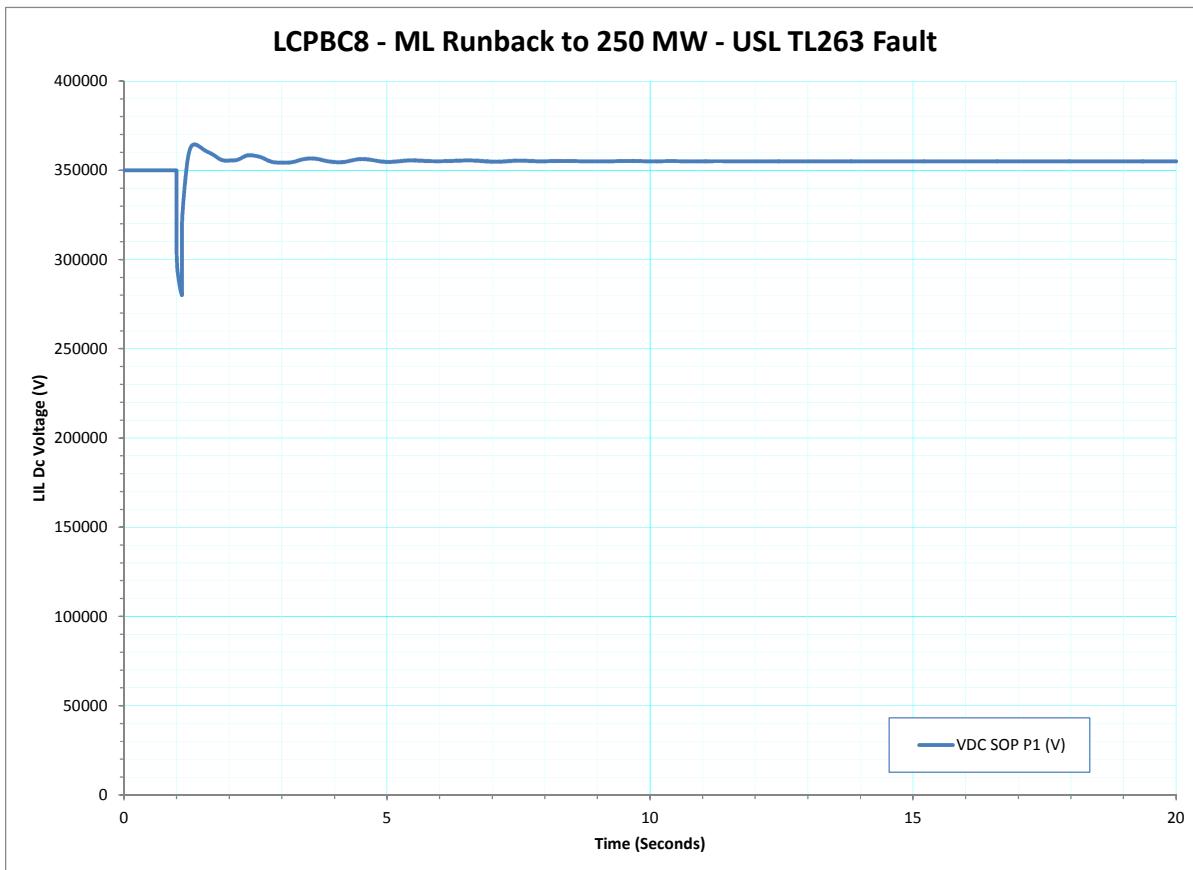
Figure 174 - LCPBC8 - ML Runback to 250 MW - USL TL263 Fault - LIL Dc Voltage (V)

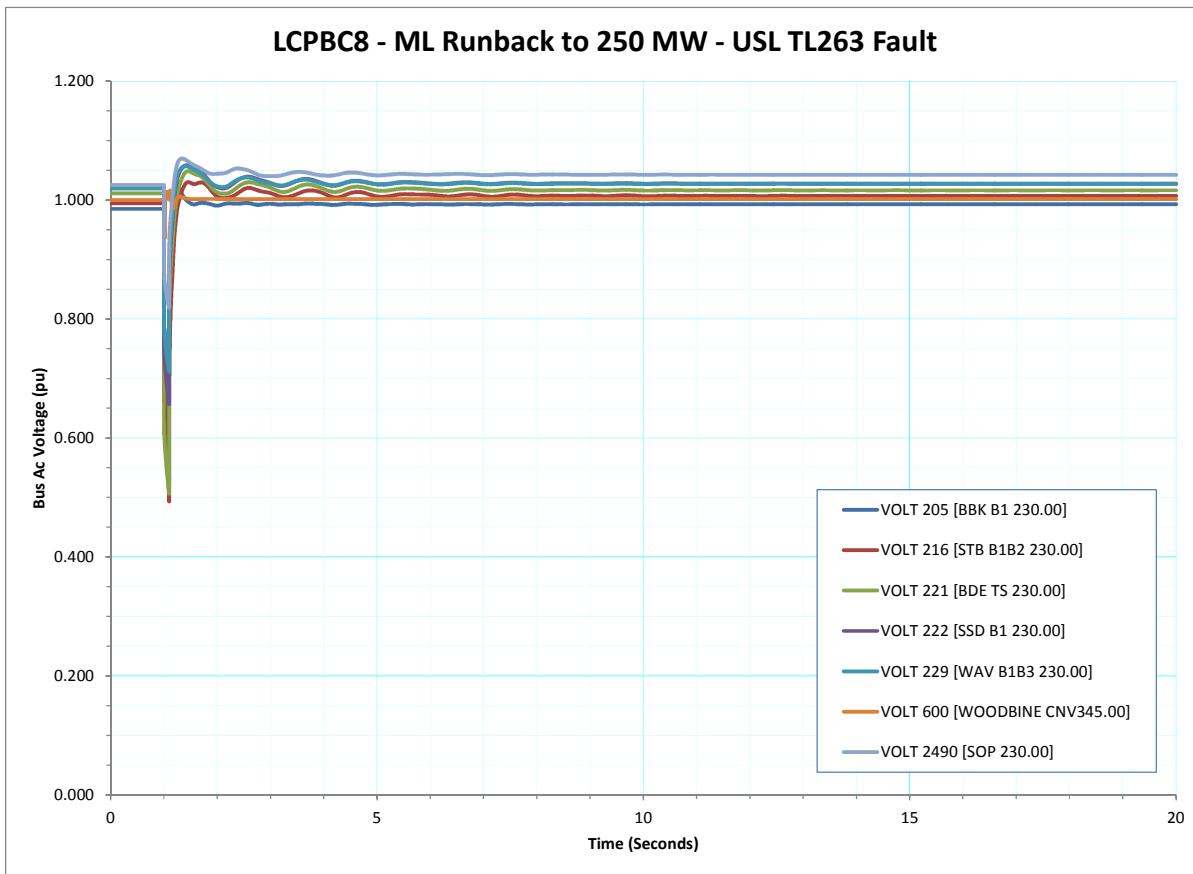
Figure 175 - LCPBC8 - ML Runback to 250 MW - USL TL263 Fault - Bus Ac Voltage (pu)

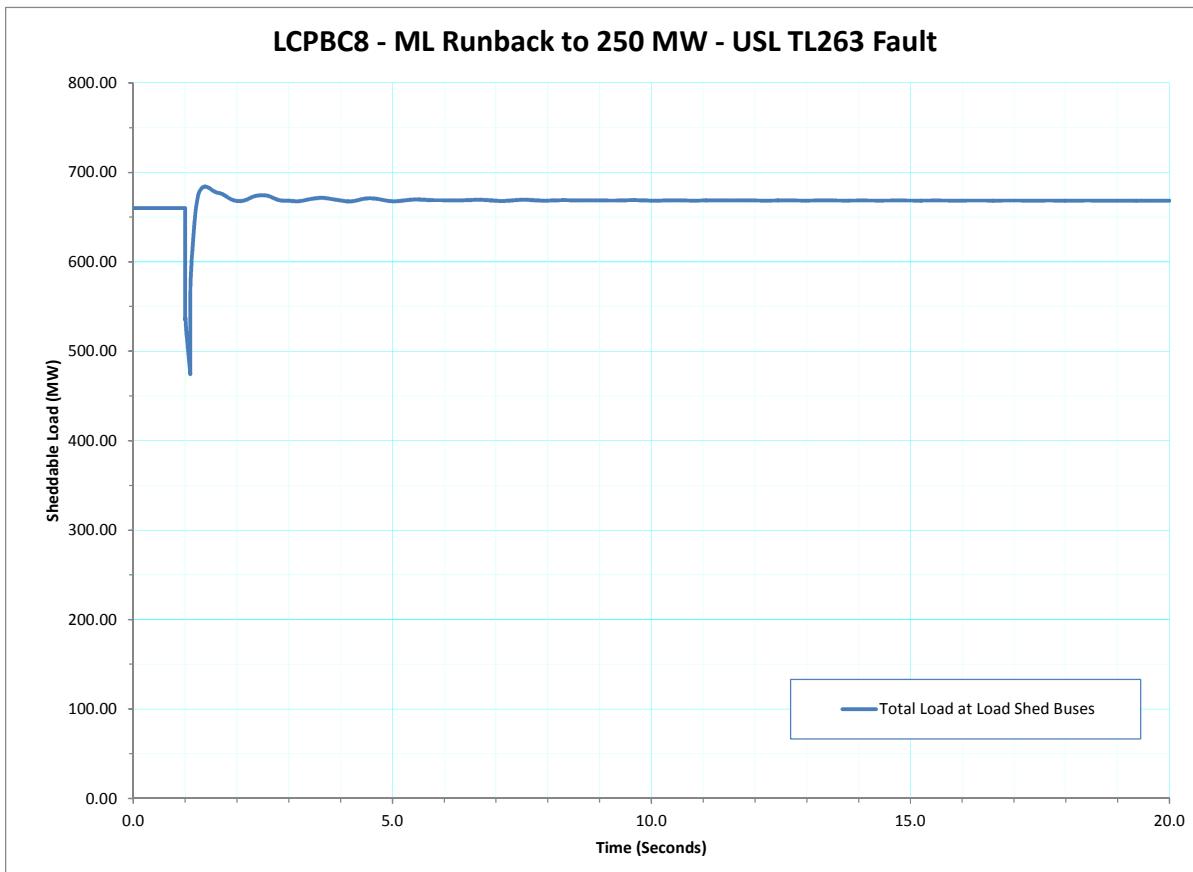
Figure 176 - LCPBC8 - ML Runback to 250 MW - USL TL263 Fault - Sheddable Load (MW)

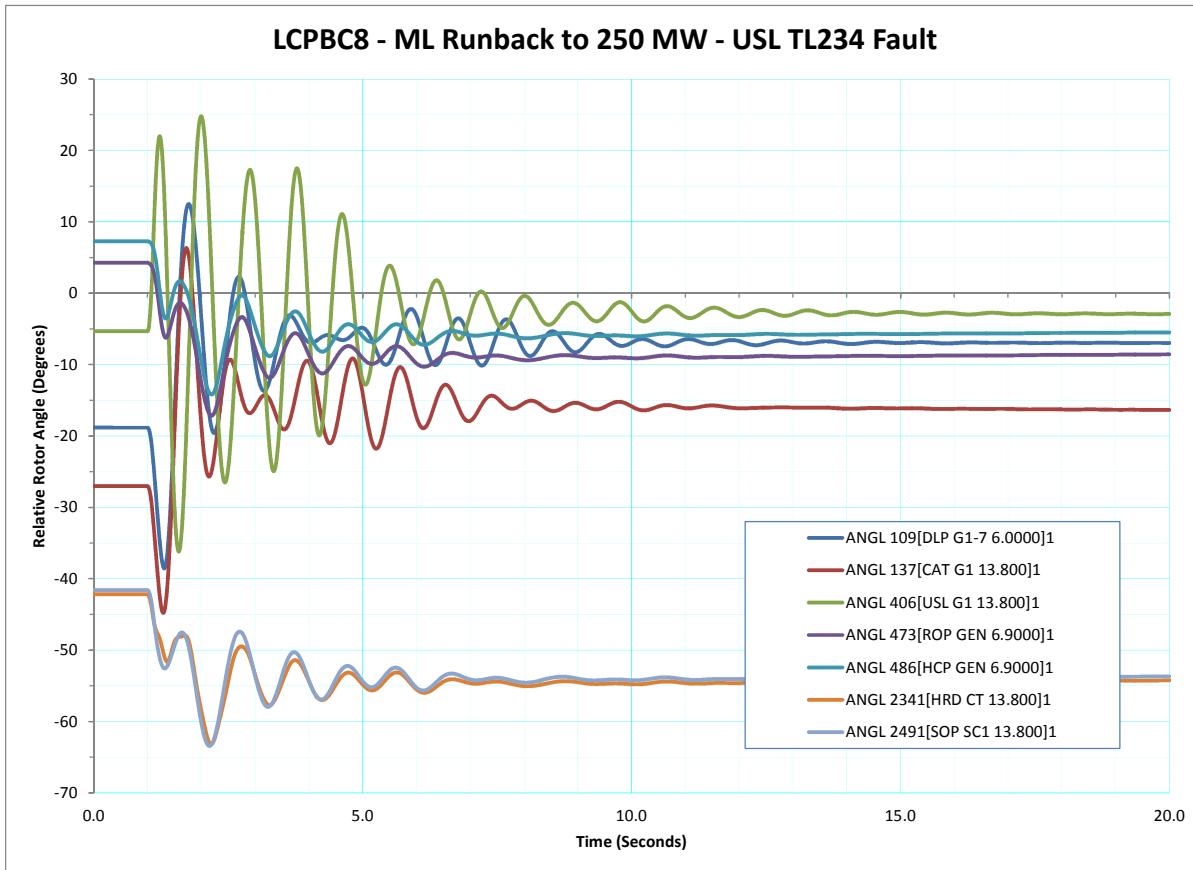
Figure 177 - LCPBC8 - ML Runback to 250 MW - USL TL234 Fault - Relative Rotor Angle (Degrees)

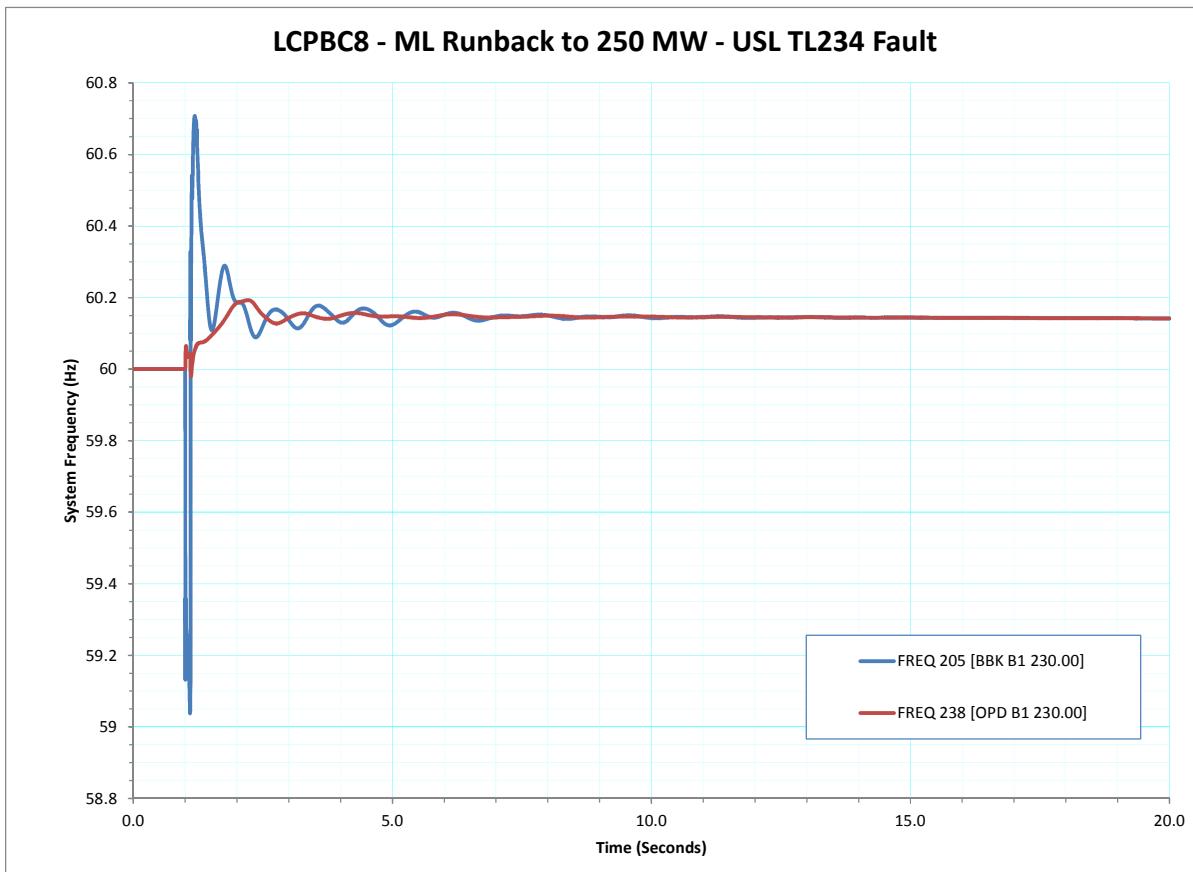
Figure 178 - LCPBC8 - ML Runback to 250 MW - USL TL234 Fault - System Frequency (Hz)

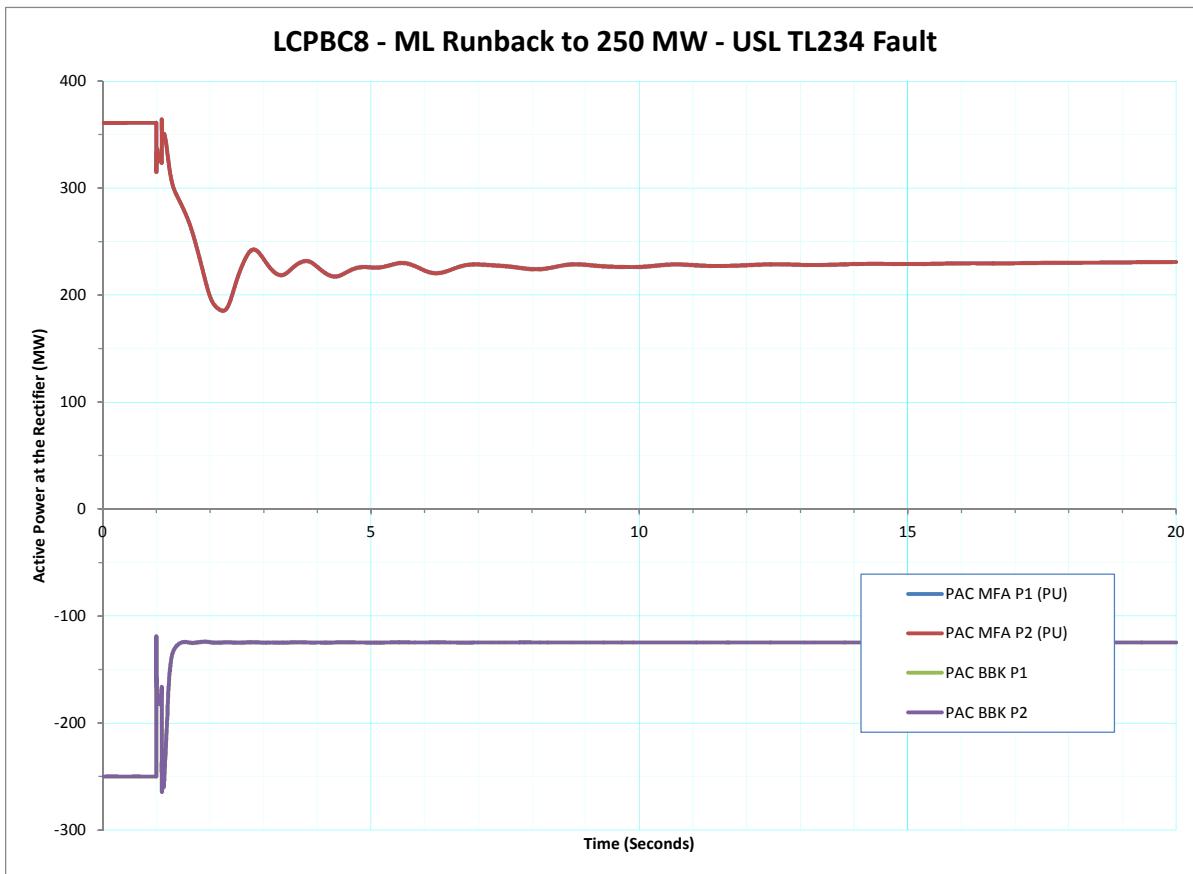
Figure 179 - LCPBC8 - ML Runback to 250 MW - USL TL234 Fault - Active Power at the Rectifier (MW)

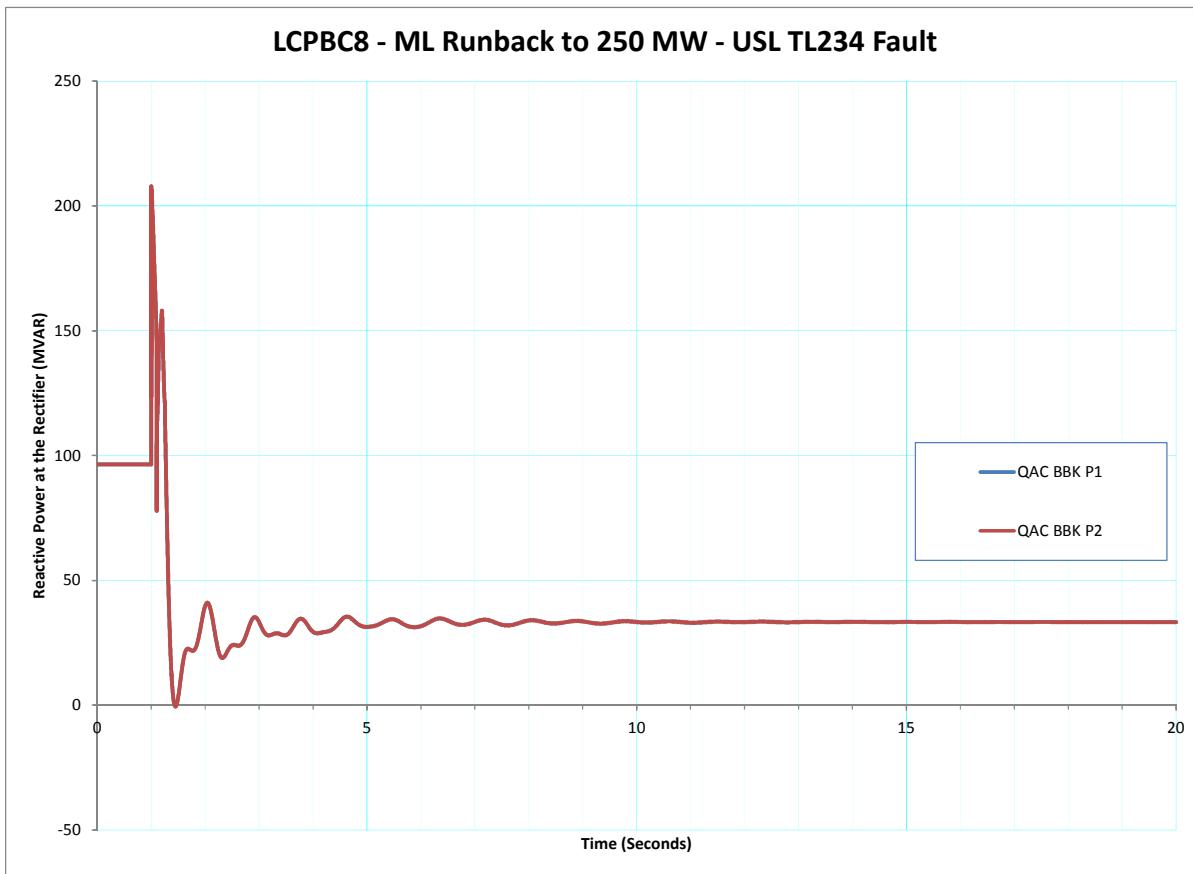
Figure 180 - LCPBC8 - ML Runback to 250 MW - USL TL234 Fault - Reactive Power at the Rectifier (MVAR)

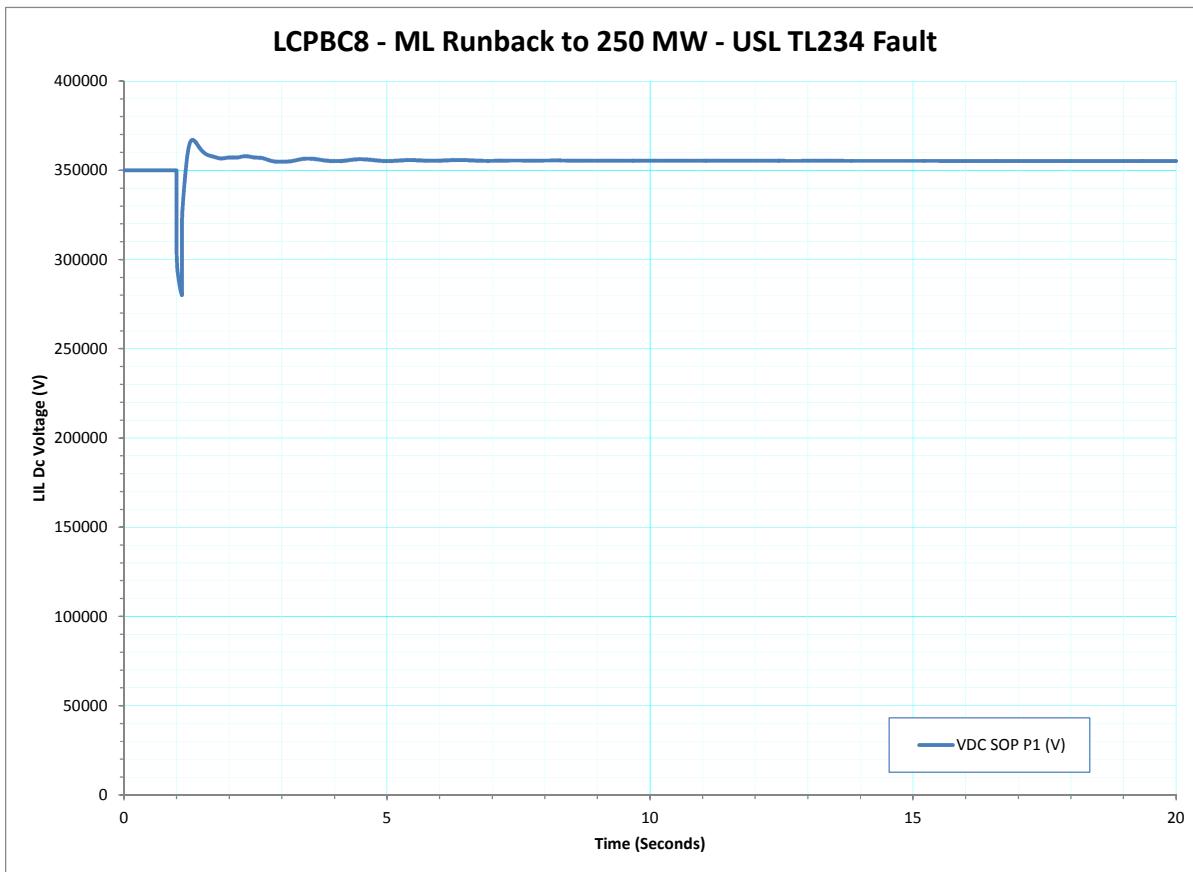
Figure 181 - LCPBC8 - ML Runback to 250 MW - USL TL234 Fault - LIL Dc Voltage (V)

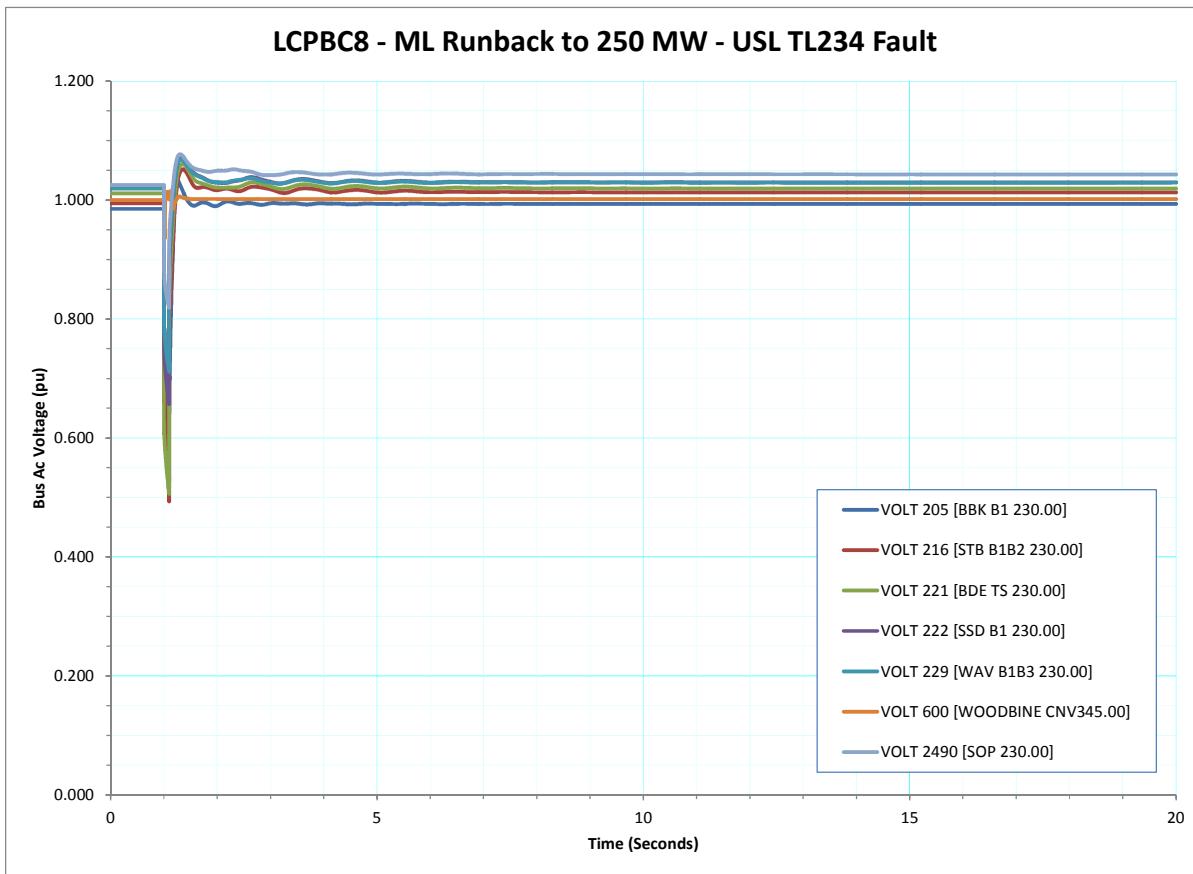
Figure 182 - LCPBC8 - ML Runback to 250 MW - USL TL234 Fault - Bus Ac Voltage (pu)

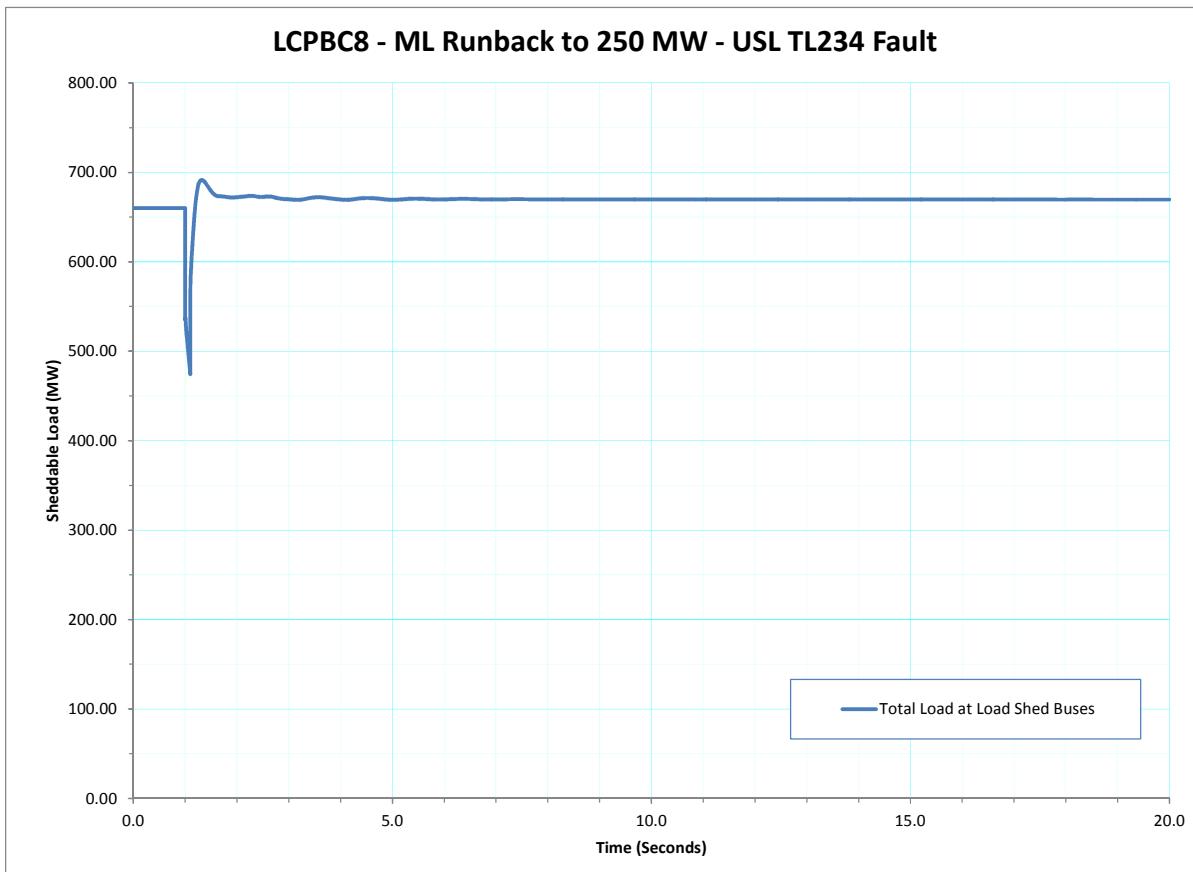
Figure 183 - LCPBC8 - ML Runback to 250 MW - USL TL234 Fault - Sheddable Load (MW)

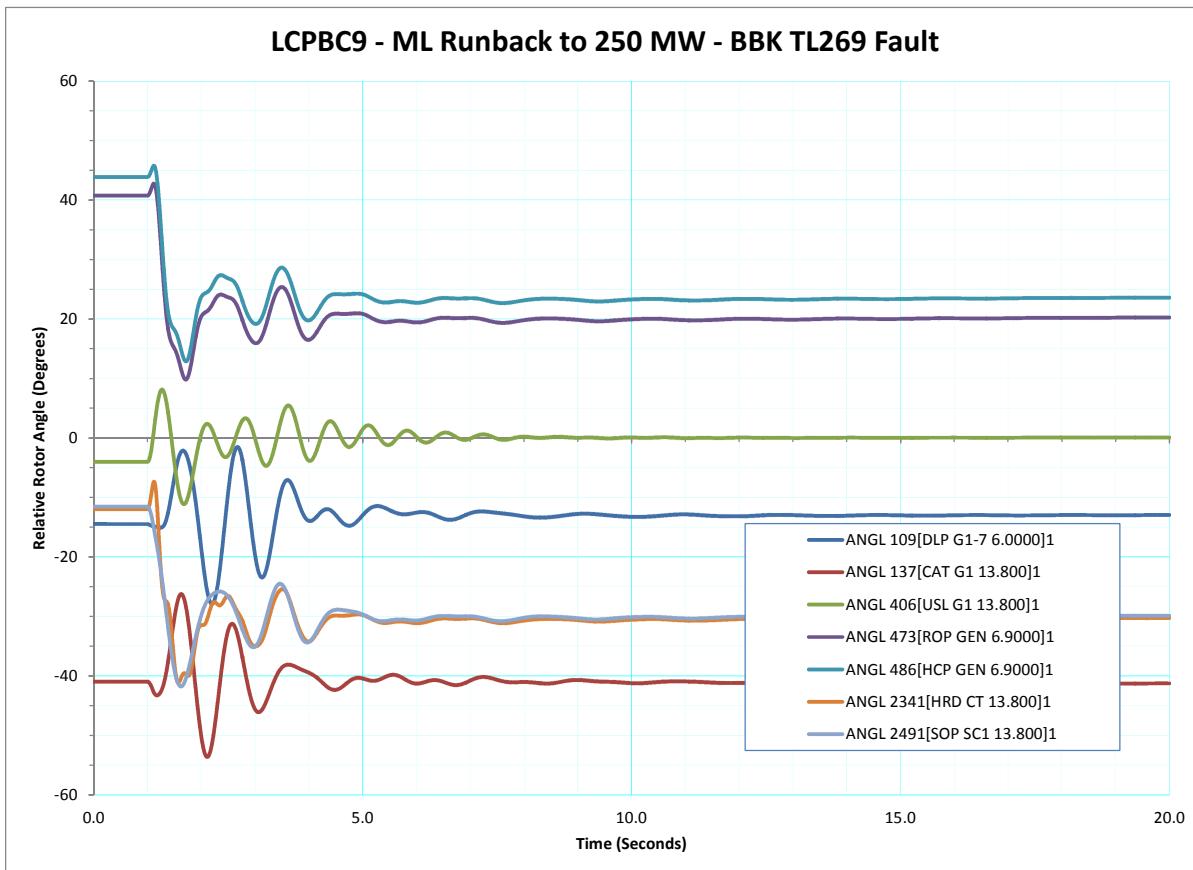
Figure 184 - LCPBC9 - ML Runback to 250 MW - BBK TL269 Fault - Relative Rotor Angle (Degrees)

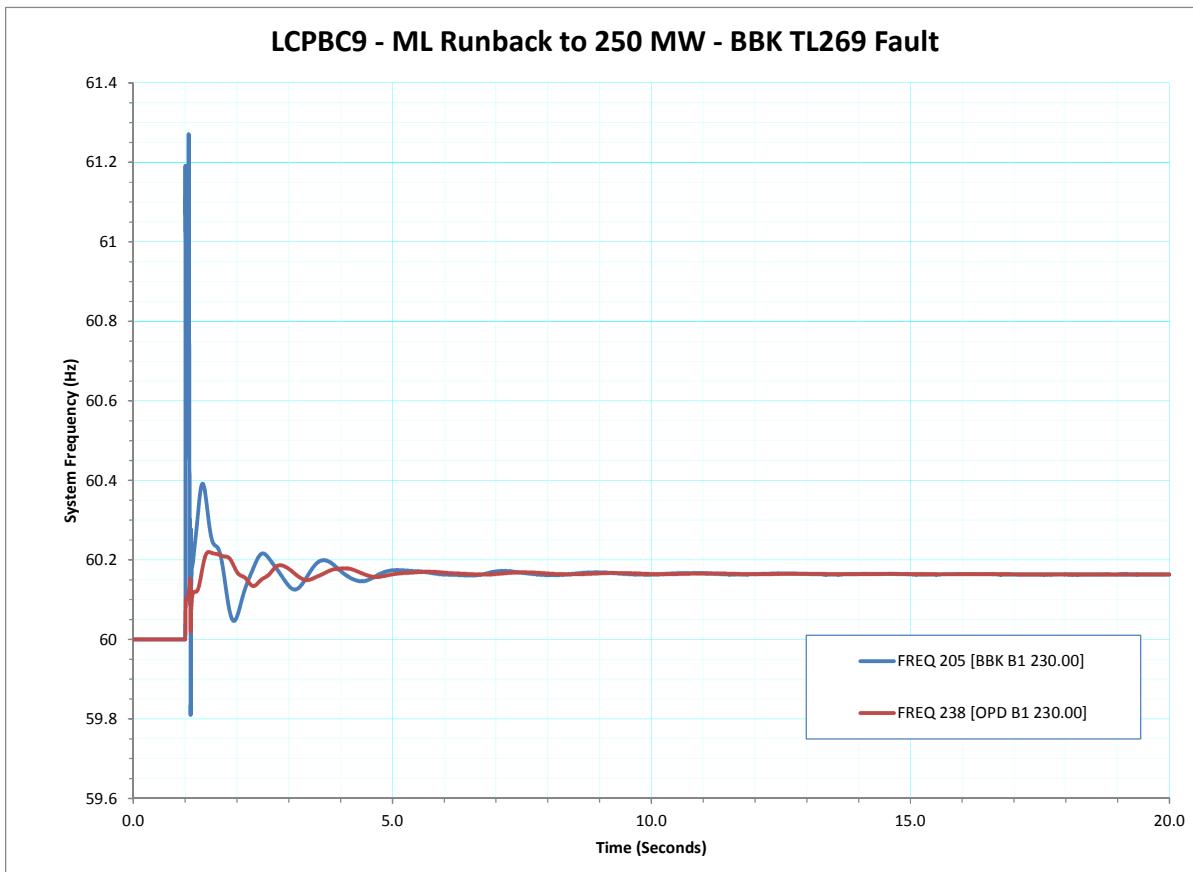
Figure 185 - LCPBC9 - ML Runback to 250 MW - BBK TL269 Fault - System Frequency (Hz)

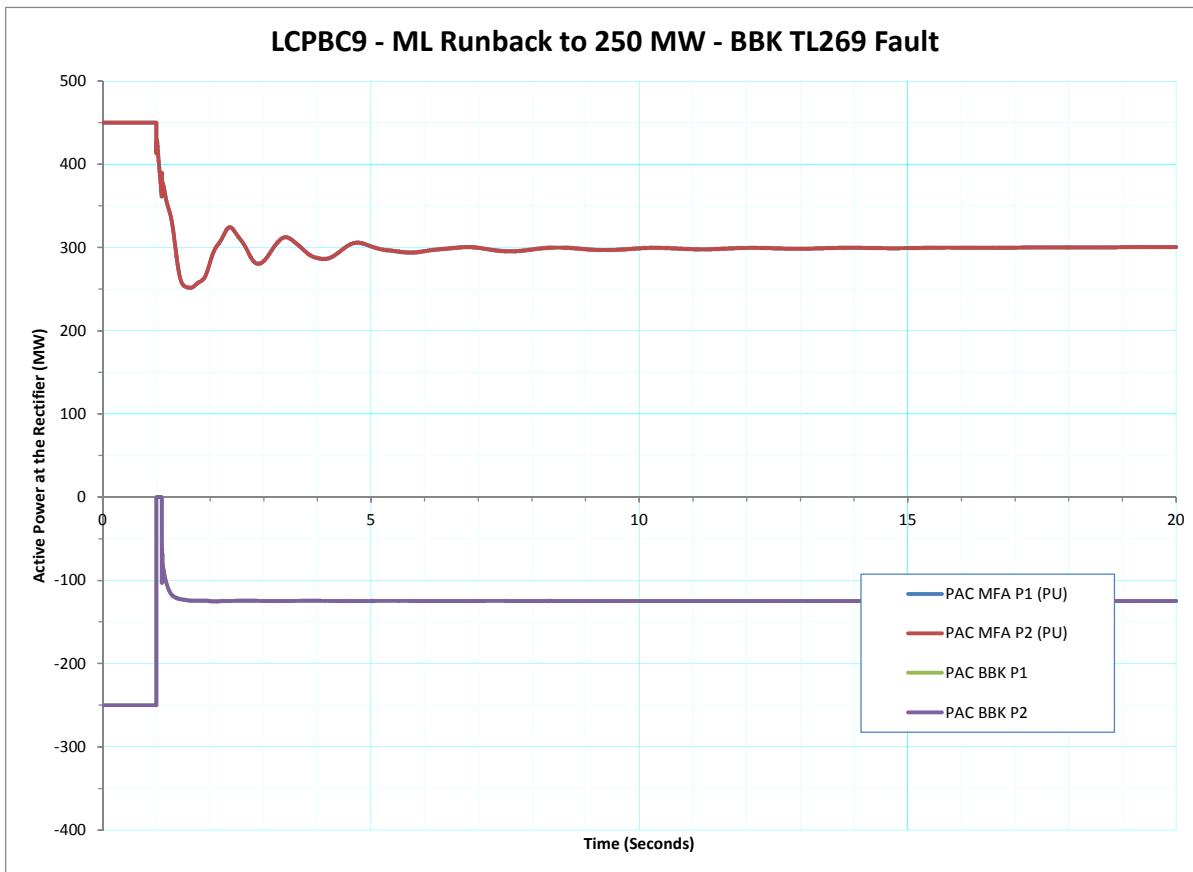
Figure 186 - LCPBC9 - ML Runback to 250 MW - BBK TL269 Fault - Active Power at the Rectifier (MW)

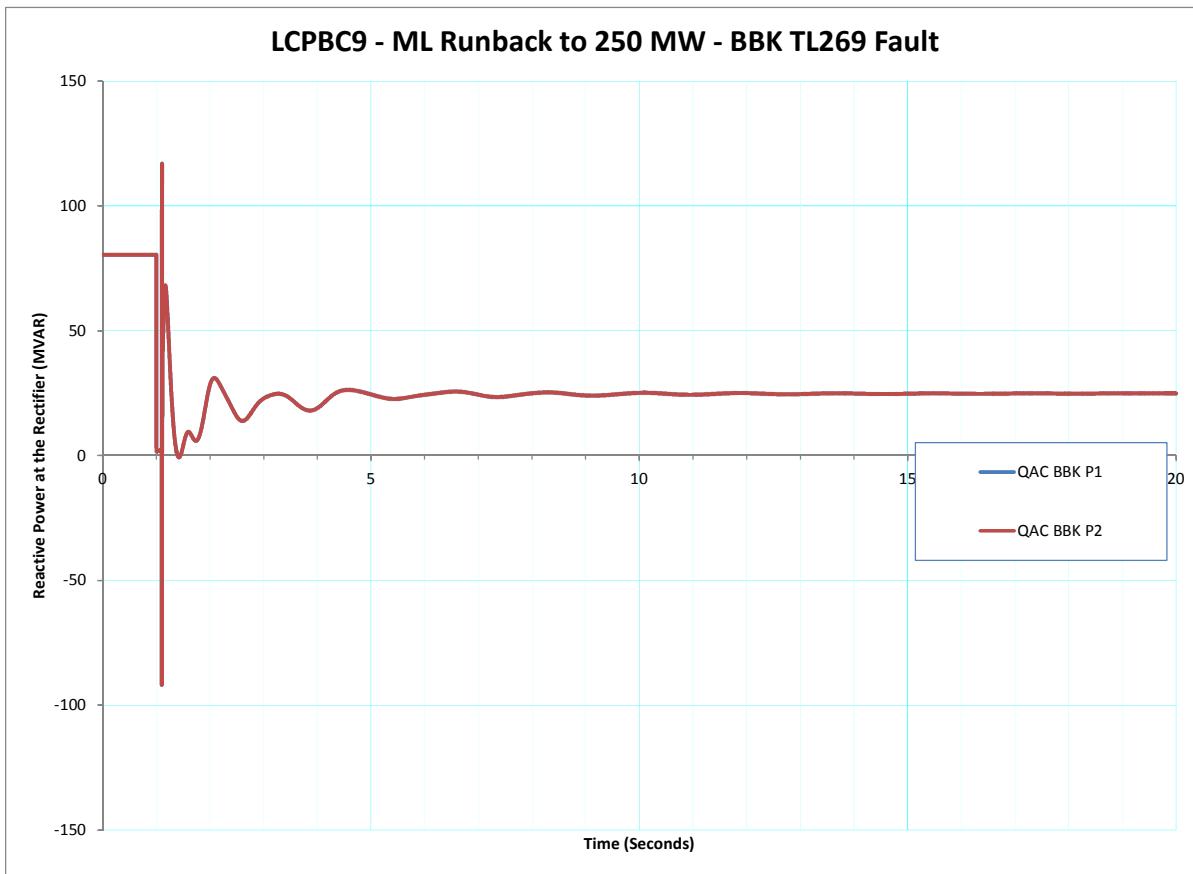
Figure 187 - LCPBC9 - ML Runback to 250 MW - BBK TL269 Fault - Reactive Power at the Rectifier (MVAR)

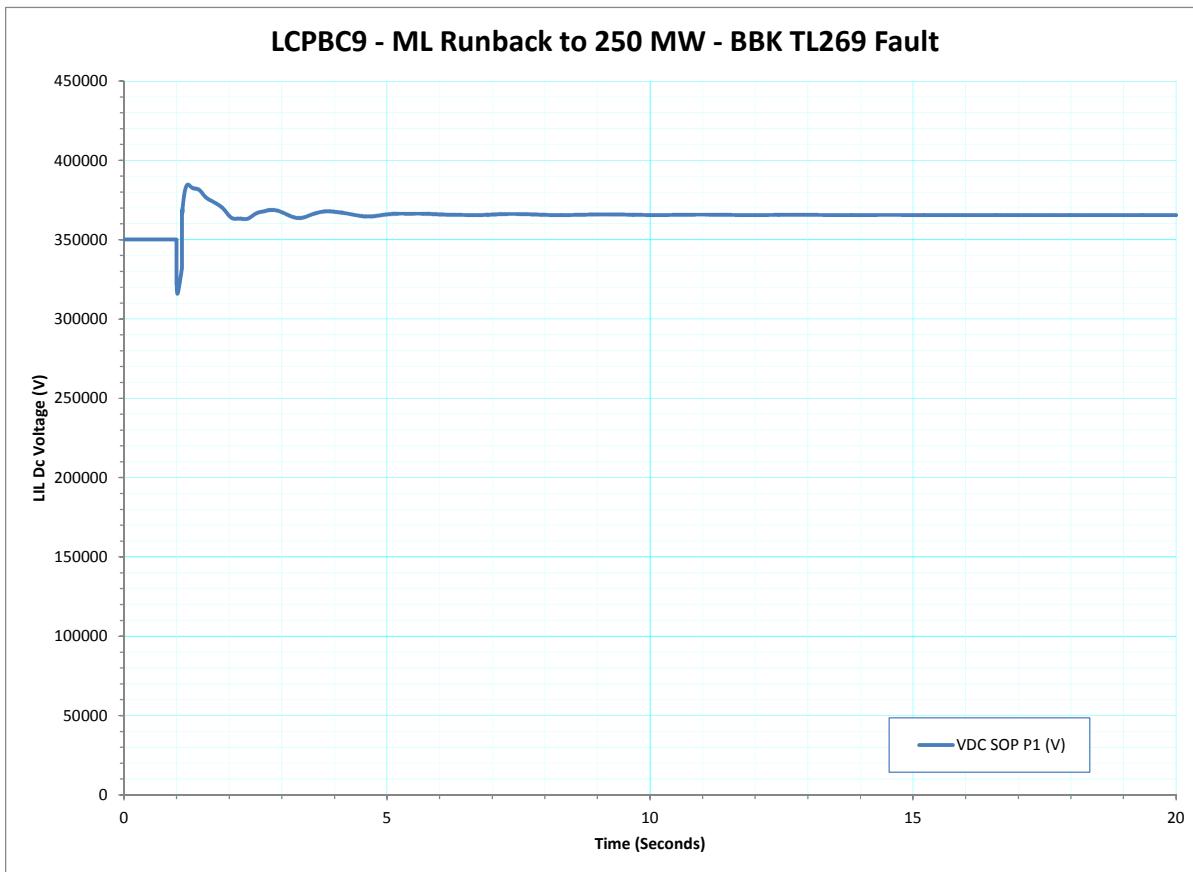
Figure 188 - LCPBC9 - ML Runback to 250 MW - BBK TL269 Fault - LIL Dc Voltage (V)

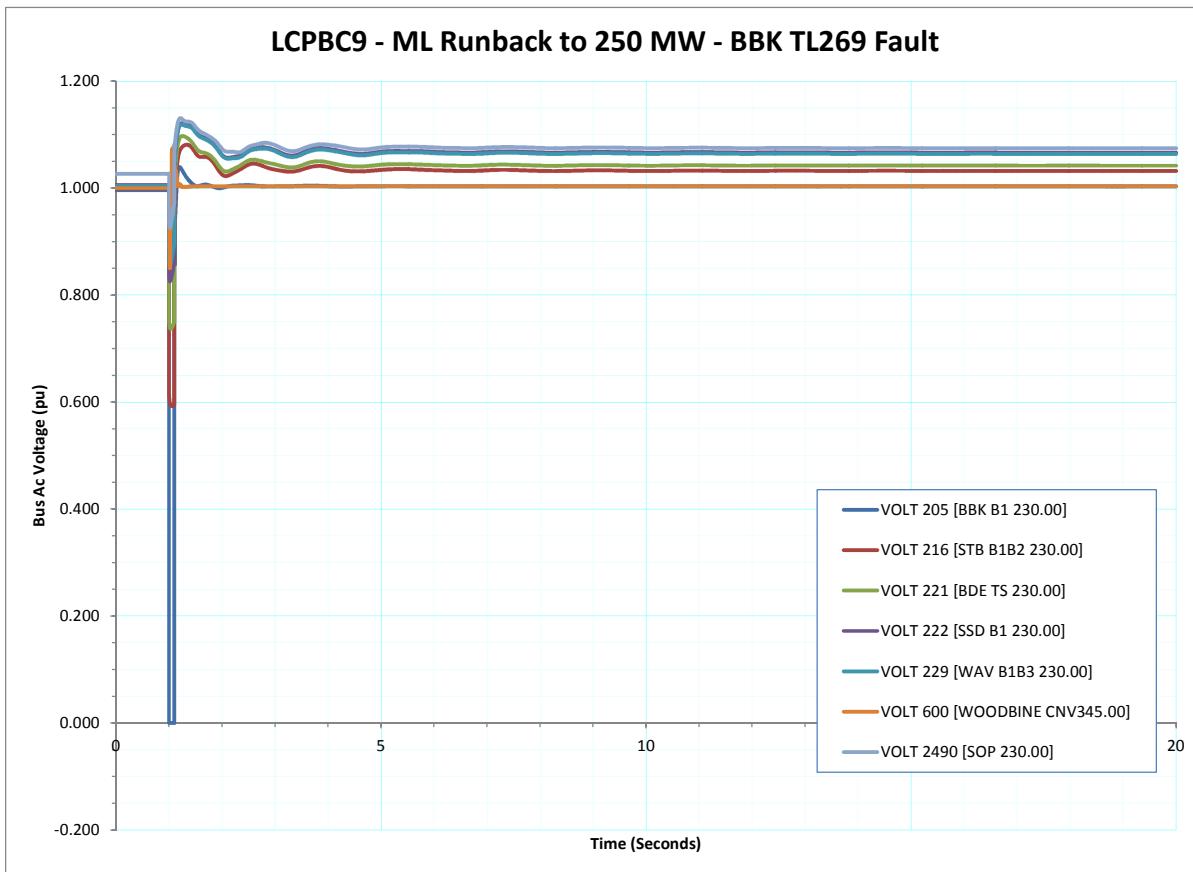
Figure 189 - LCPBC9 - ML Runback to 250 MW - BBK TL269 Fault - Bus Ac Voltage (pu)
