MARITIME LINK PRELIMINARY INTERCONNECTION STUDY

Newfoundland and Labrador Hydro

July 2014

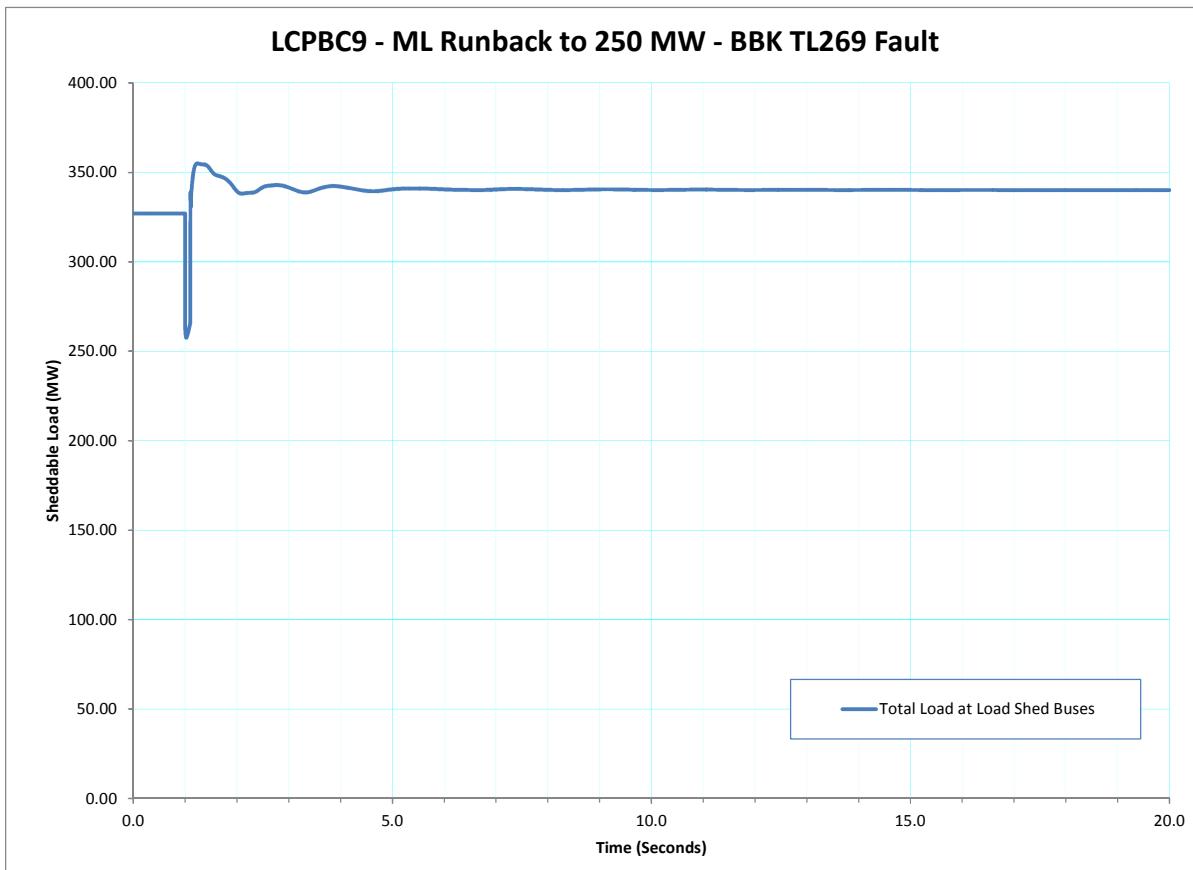
Figure 190 - LCPBC9 - ML Runback to 250 MW - BBK TL269 Fault - Sheddable Load (MW)

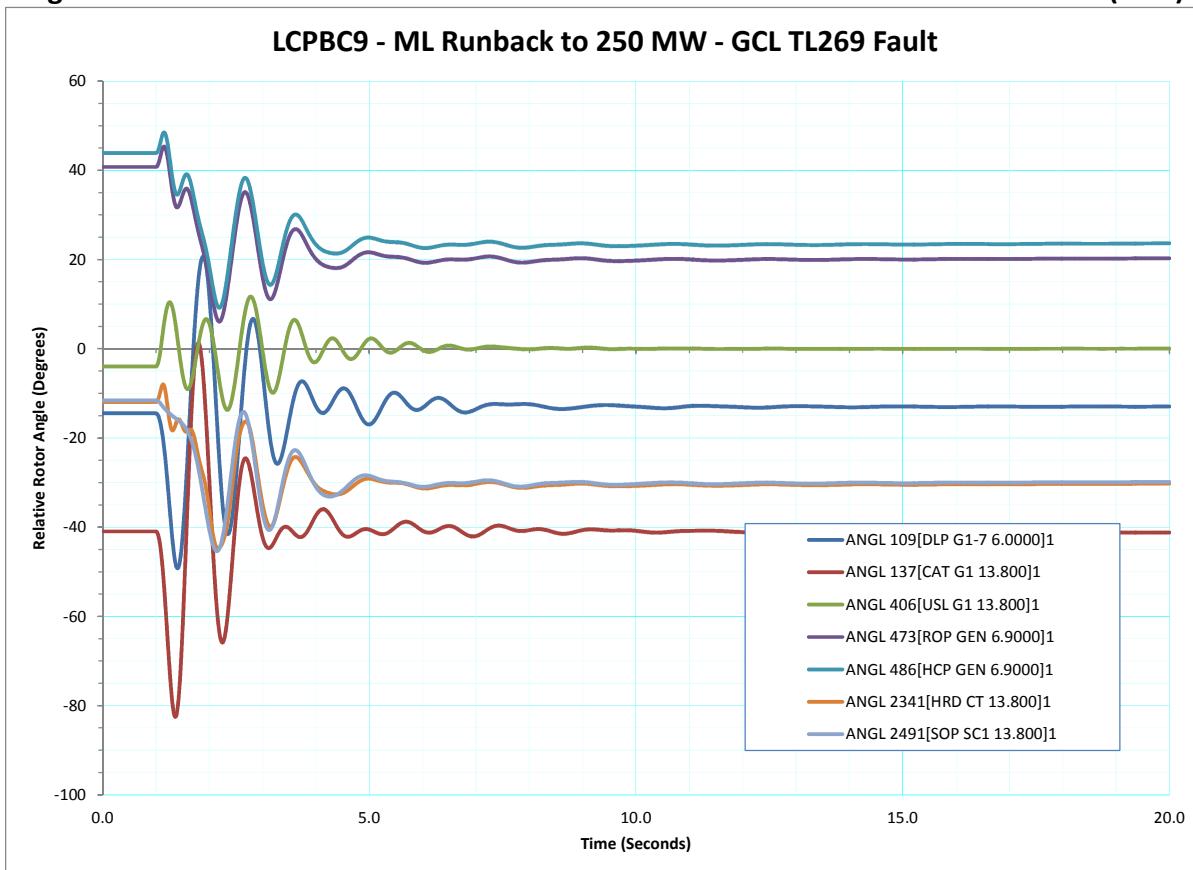
Figure 191 - LCPBC9 - ML Runback to 250 MW - GCL TL269 Fault - Relative Rotor Angle (Degrees)

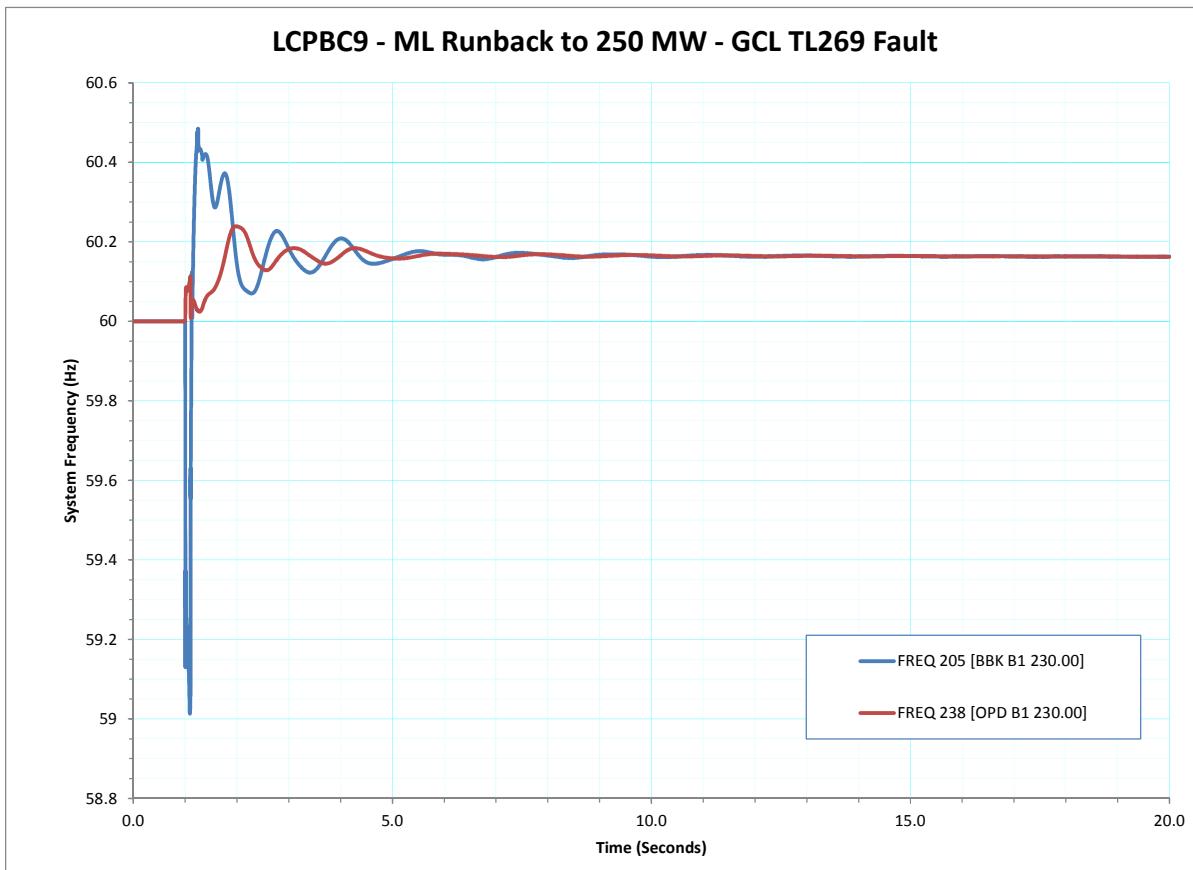
Figure 192 - LCPBC9 - ML Runback to 250 MW - GCL TL269 Fault - System Frequency (Hz)

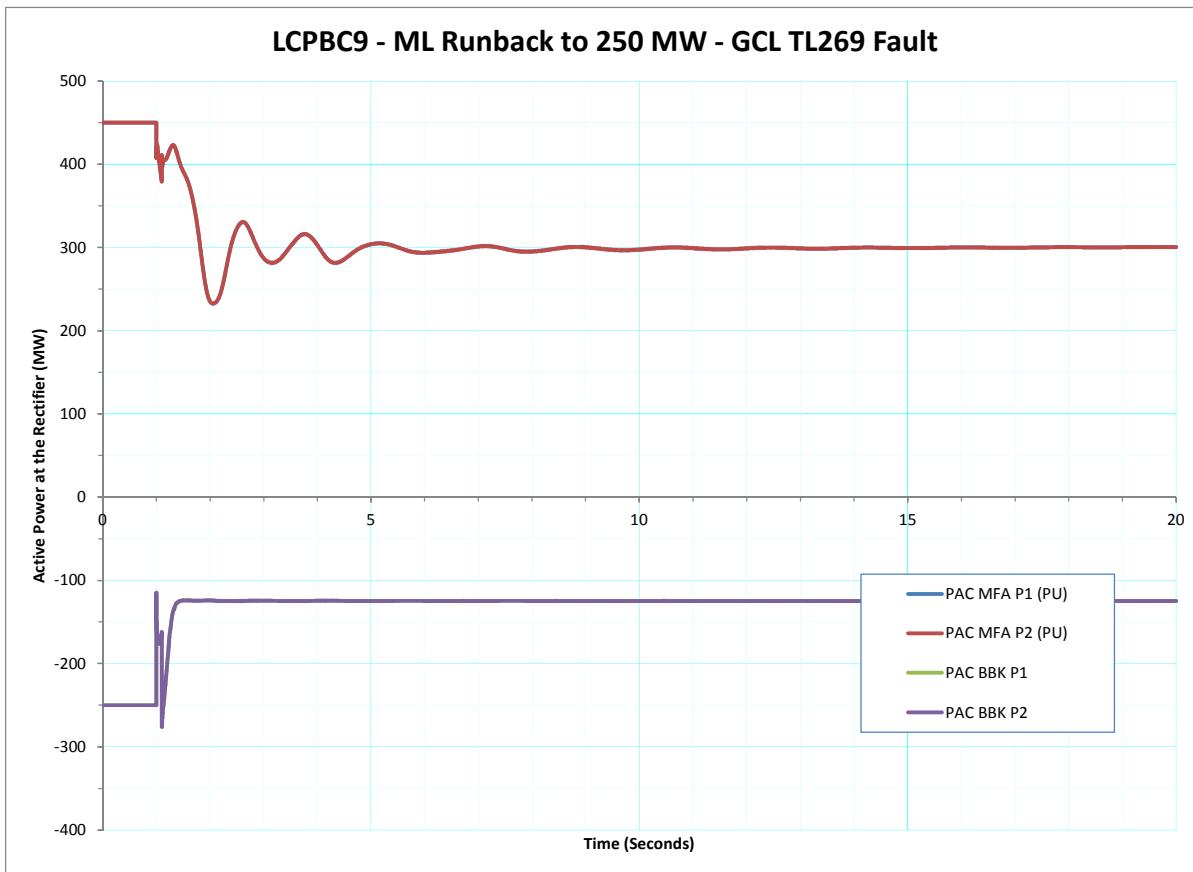
Figure 193 - LCPBC9 - ML Runback to 250 MW - GCL TL269 Fault - Active Power at the Rectifier (MW)

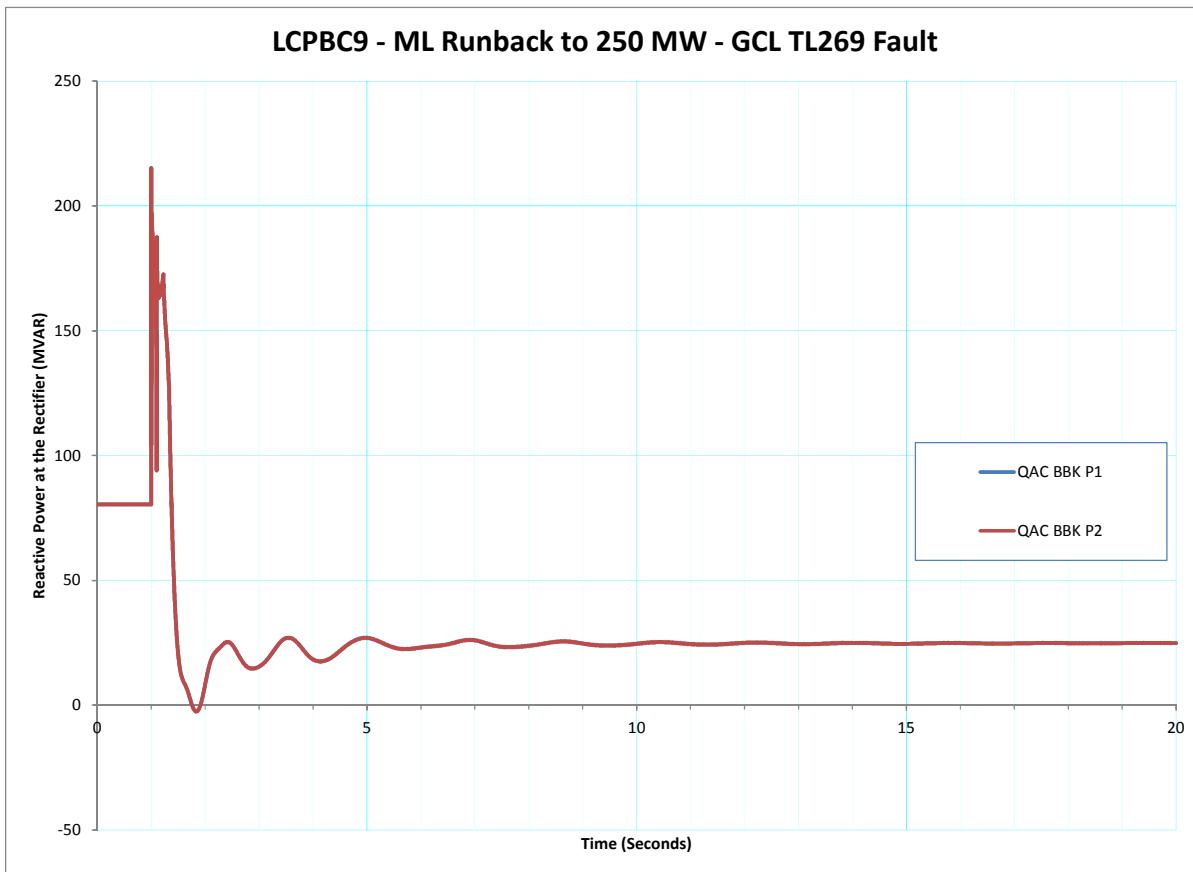
Figure 194 - LCPBC9 - ML Runback to 250 MW - GCL TL269 Fault - Reactive Power at the Rectifier (MVAR)

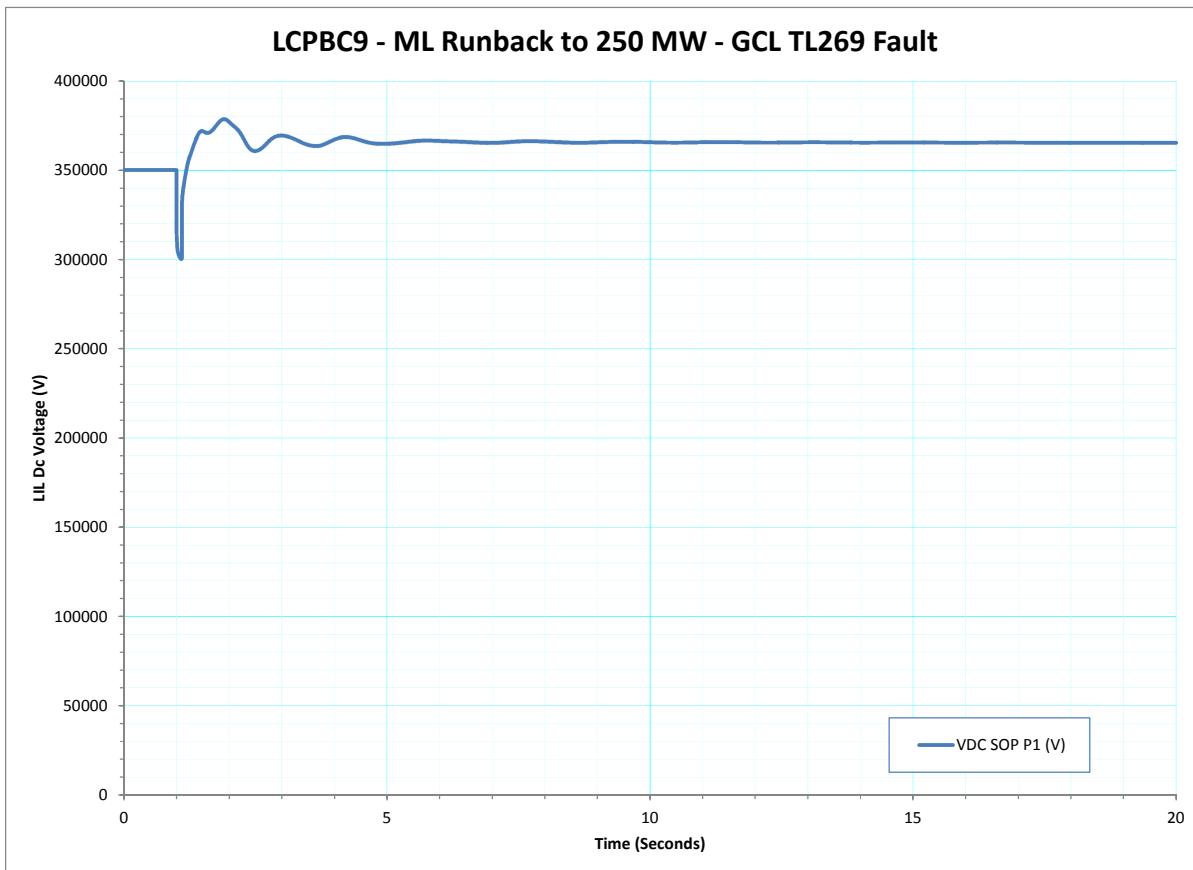
Figure 195 - LCPBC9 - ML Runback to 250 MW - GCL TL269 Fault - LIL Dc Voltage (V)

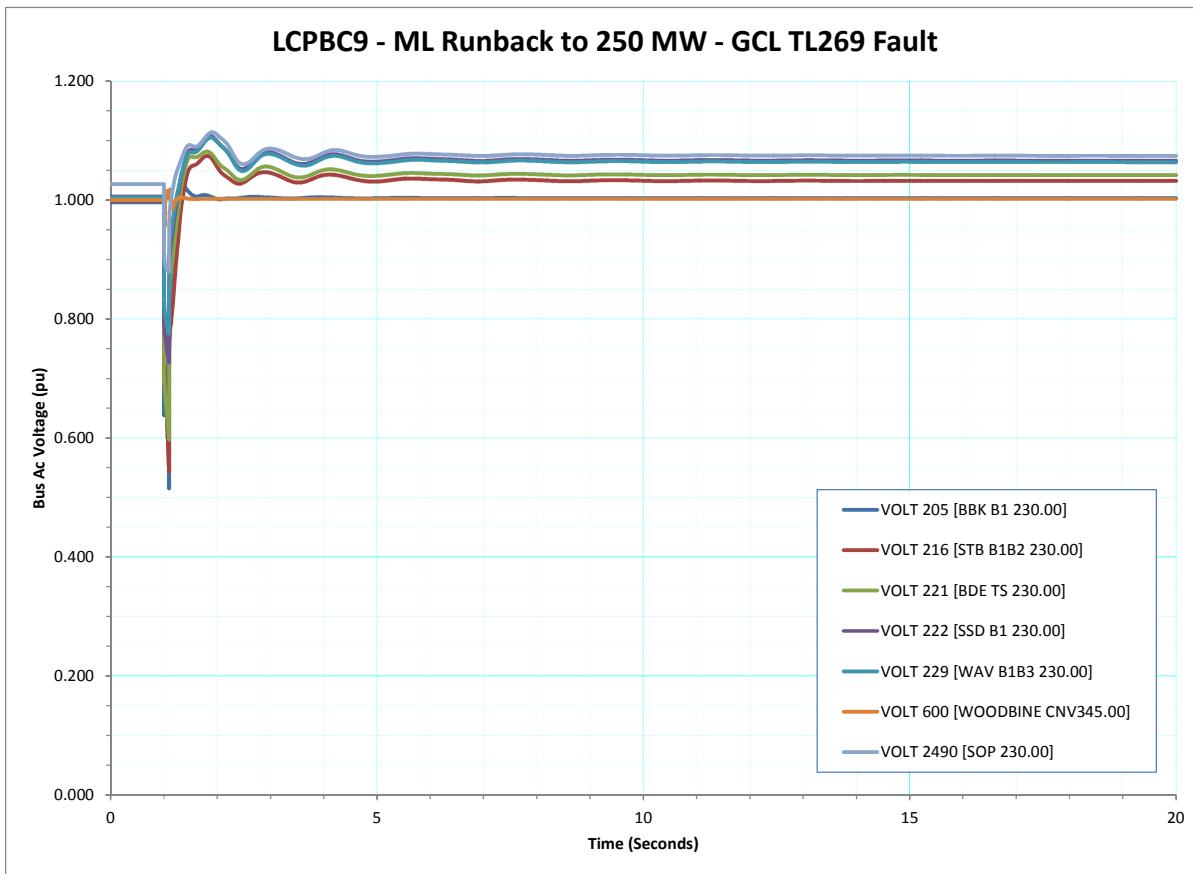
Figure 196 - LCPBC9 - ML Runback to 250 MW - GCL TL269 Fault - Bus Ac Voltage (pu)

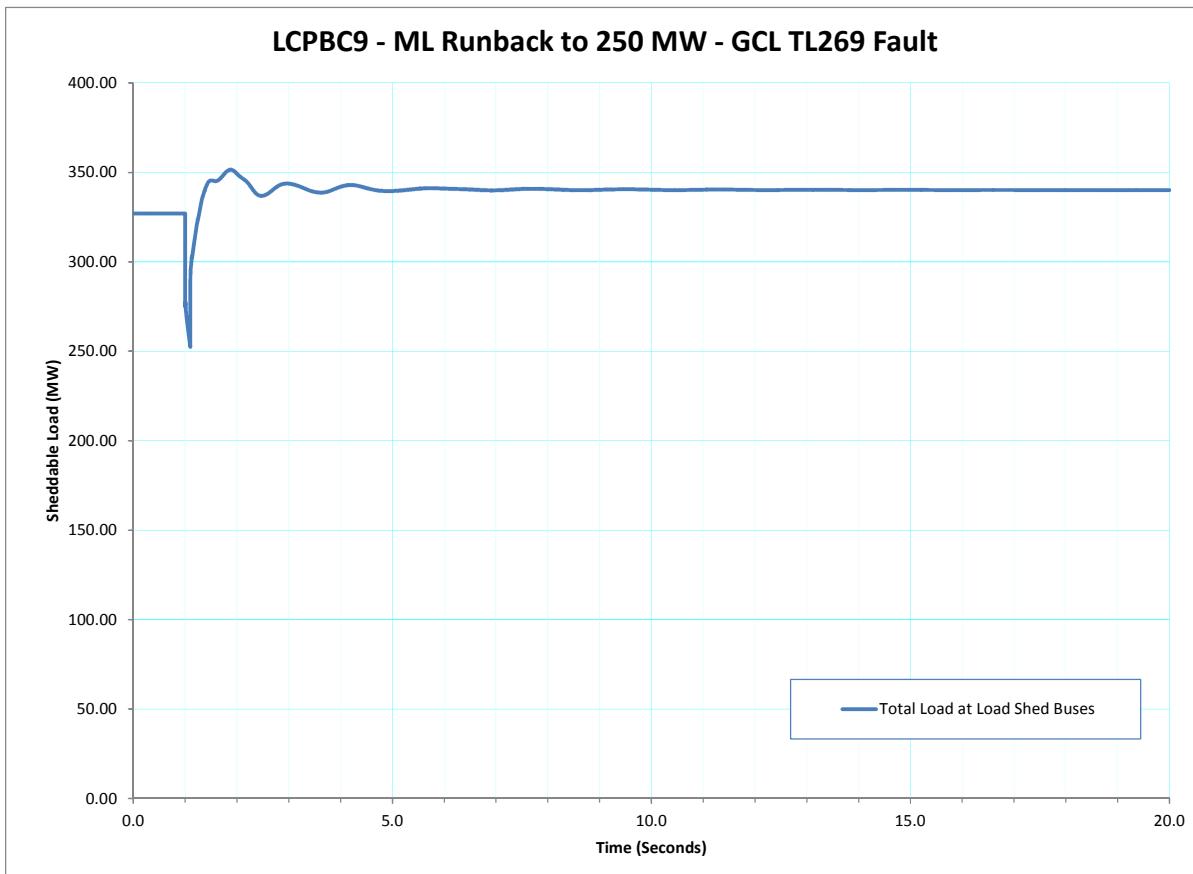
Figure 197 - LCPBC9 - ML Runback to 250 MW - GCL TL269 Fault - Sheddable Load (MW)

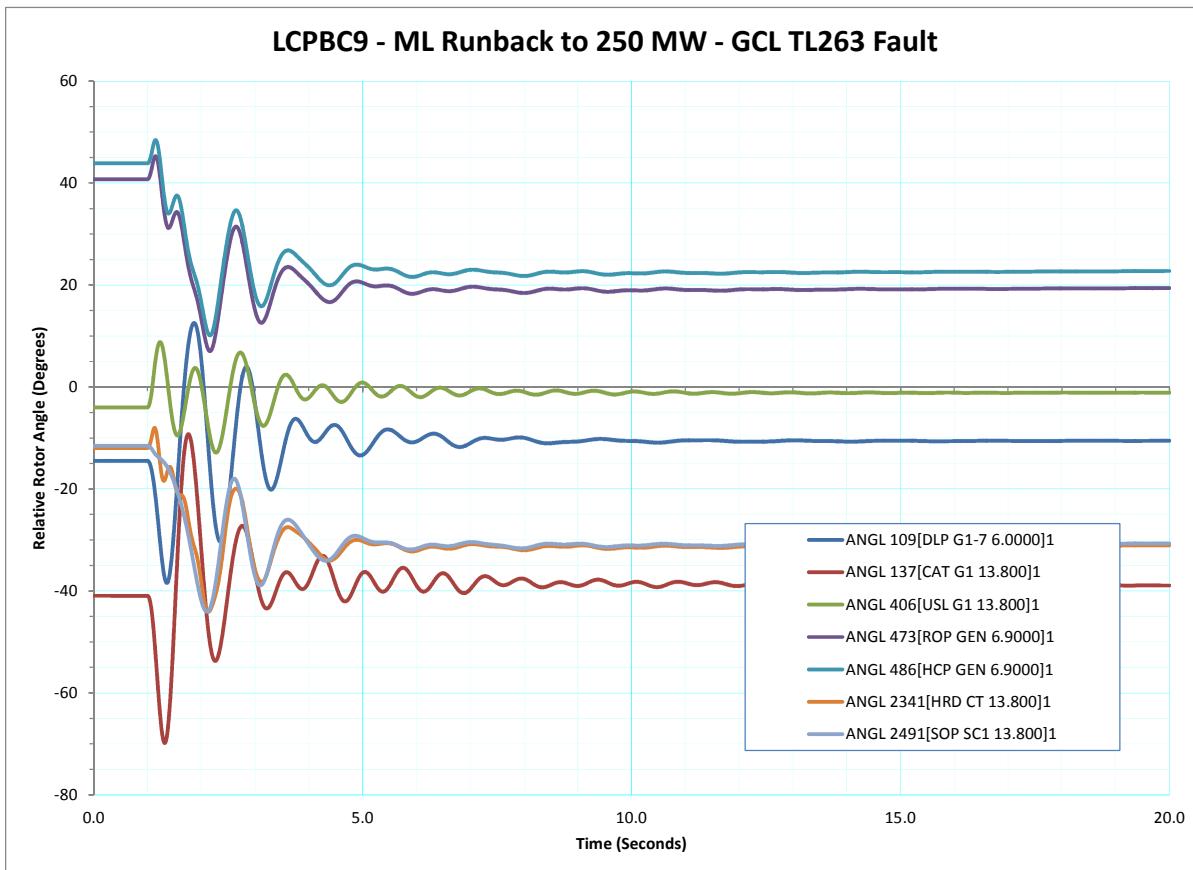
Figure 198 - LCPBC9 - ML Runback to 250 MW - GCL TL263 Fault - Relative Rotor Angle (Degrees)

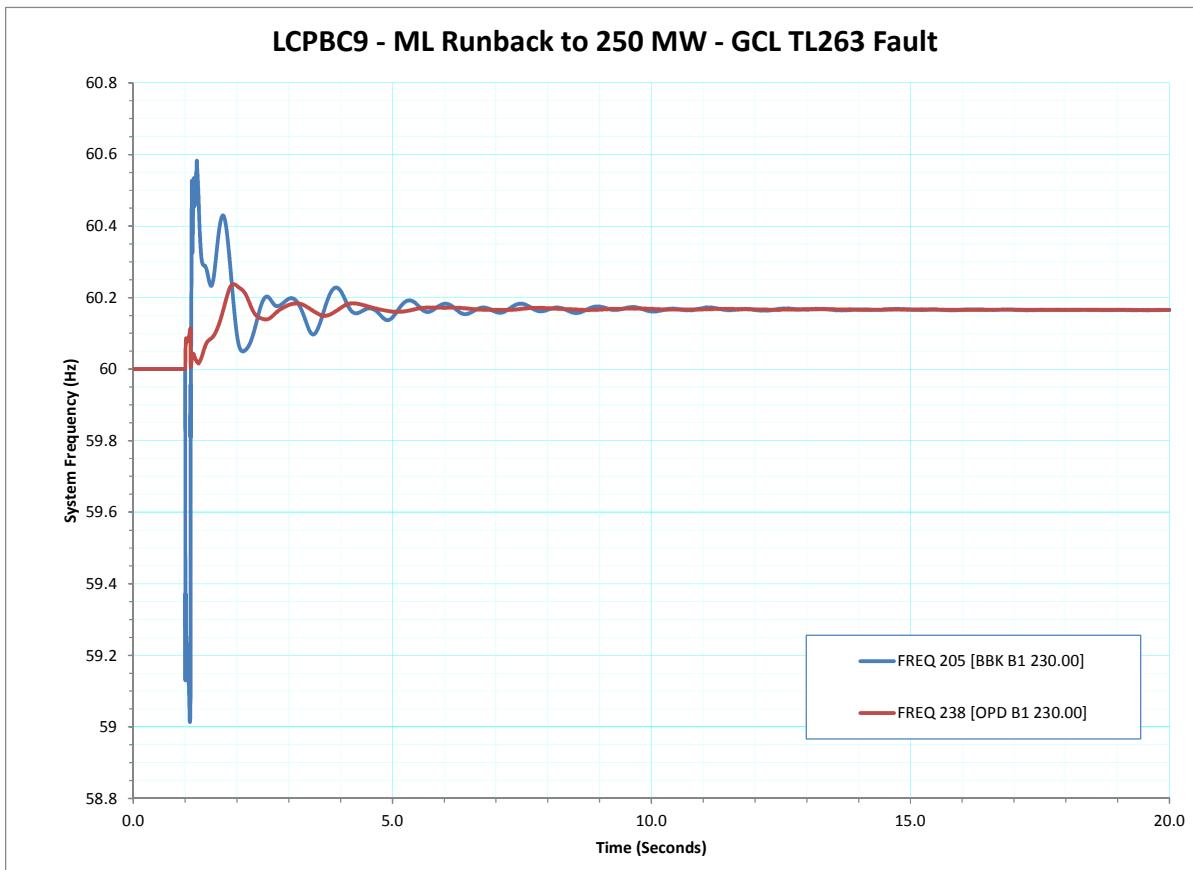
Figure 199 - LCPBC9 - ML Runback to 250 MW - GCL TL263 Fault - System Frequency (Hz)

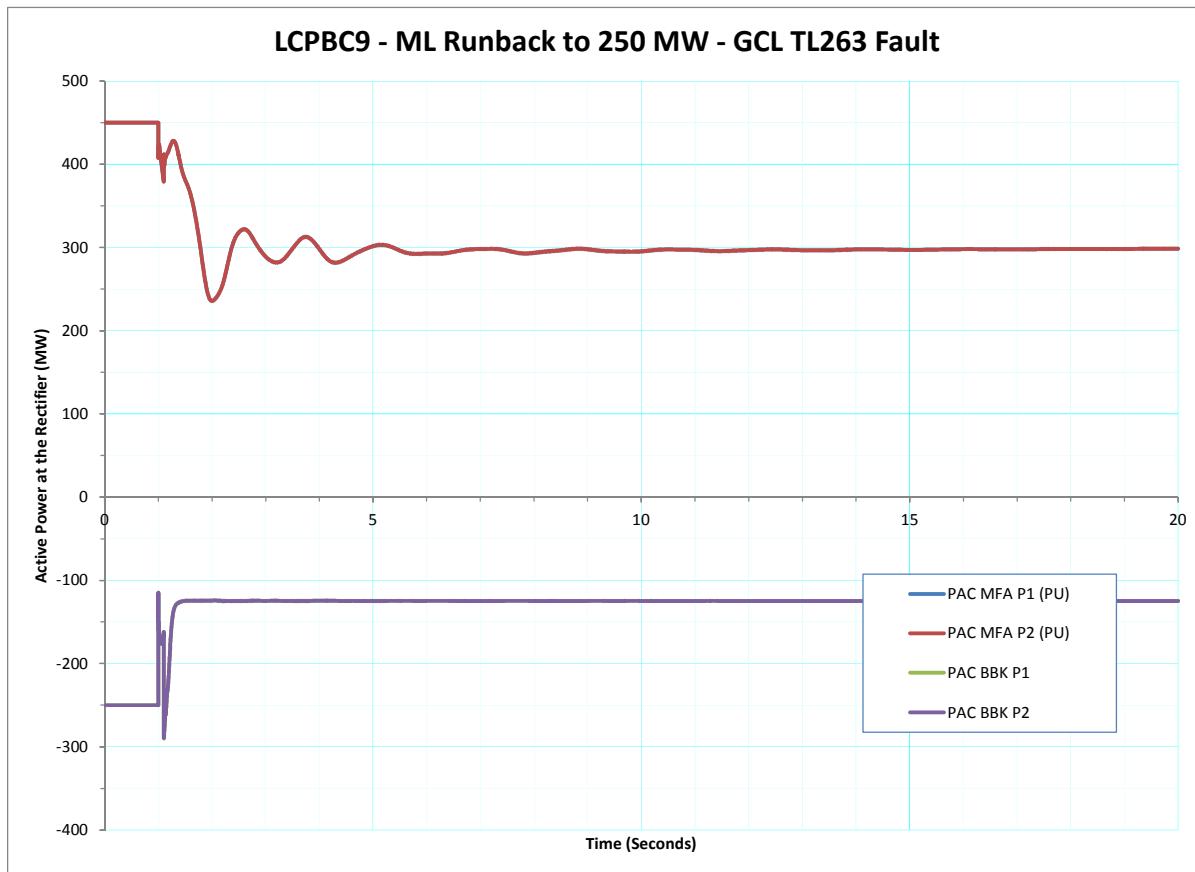
Figure 200 - LCPBC9 - ML Runback to 250 MW - GCL TL263 Fault - Active Power at the Rectifier (MW)

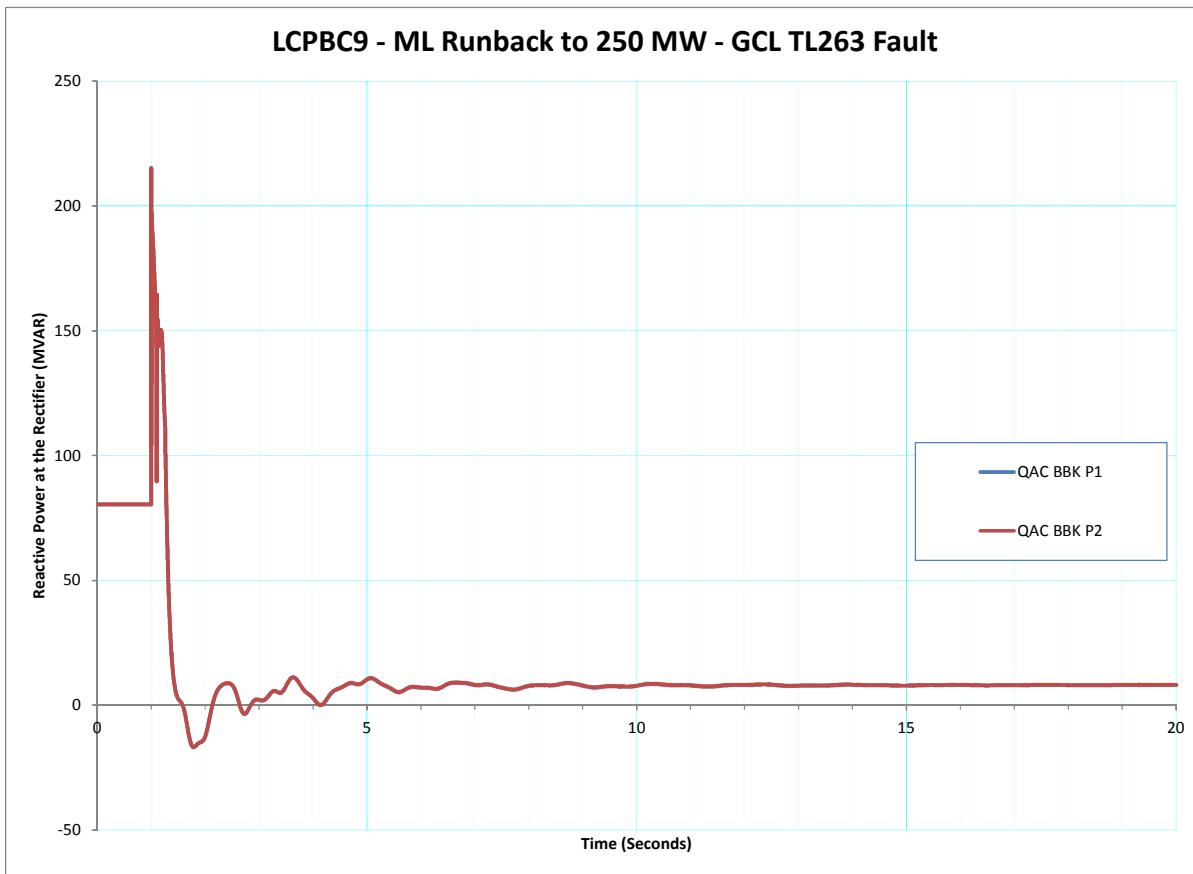
Figure 201 - LCPBC9 - ML Runback to 250 MW - GCL TL263 Fault - Reactive Power at the Rectifier (MVAR)

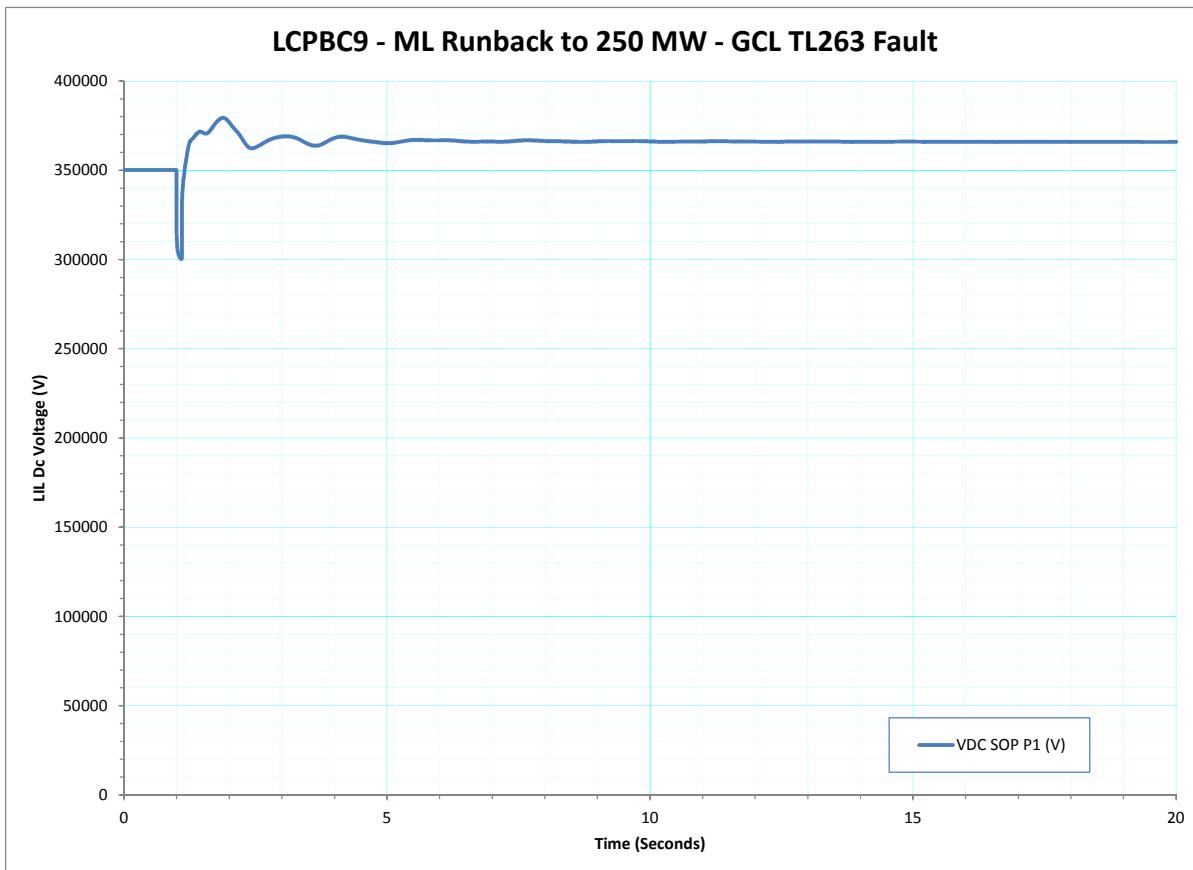
Figure 202 - LCPBC9 - ML Runback to 250 MW - GCL TL263 Fault - LIL Dc Voltage (V)

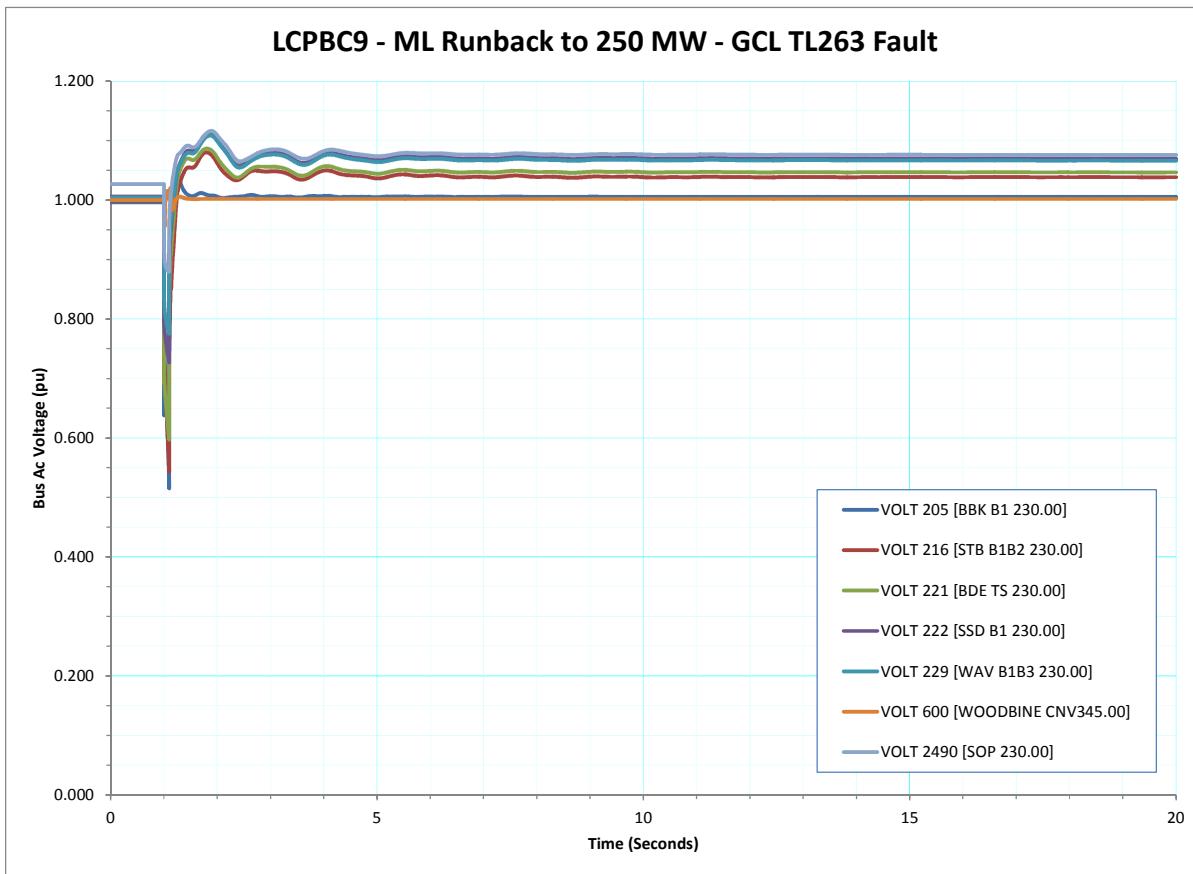
Figure 203 - LCPBC9 - ML Runback to 250 MW - GCL TL263 Fault - Bus Ac Voltage (pu)

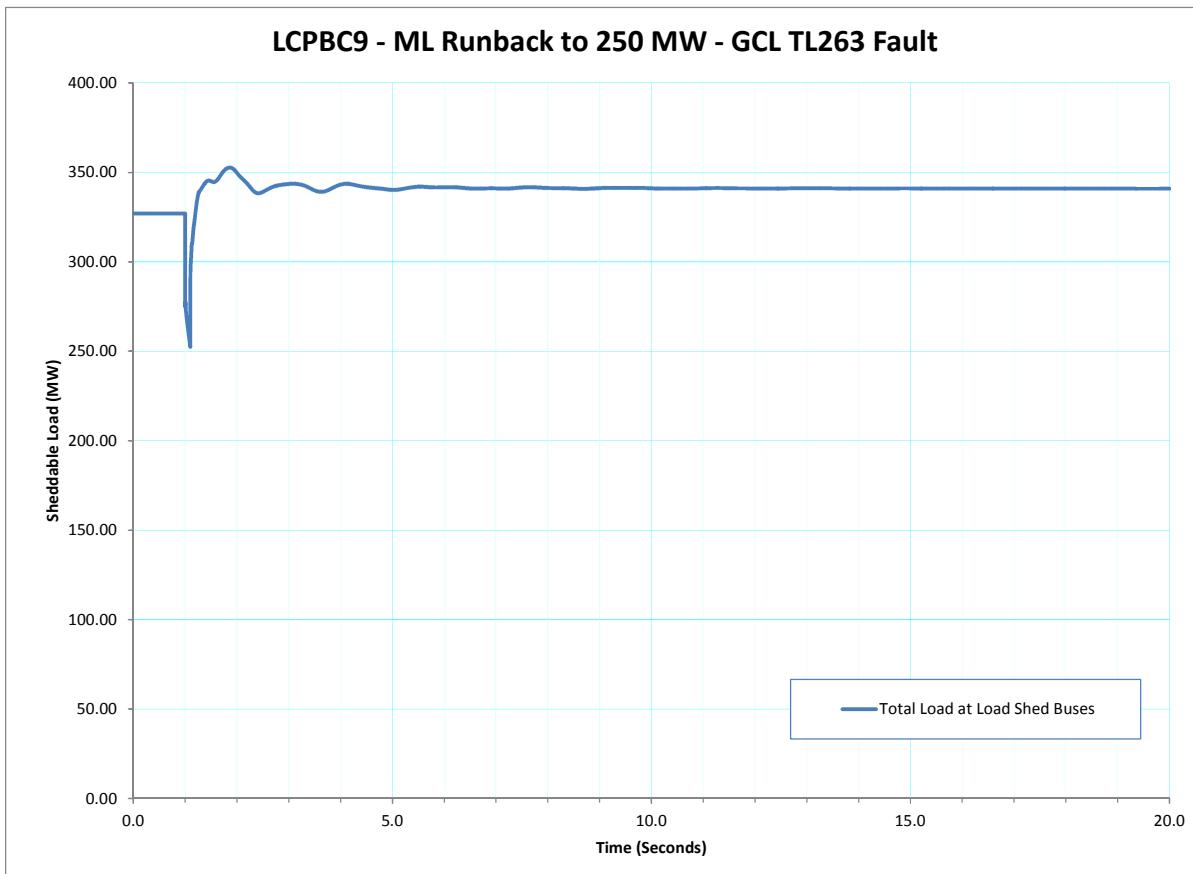
Figure 204 - LCPBC9 - ML Runback to 250 MW - GCL TL263 Fault - Sheddable Load (MW)

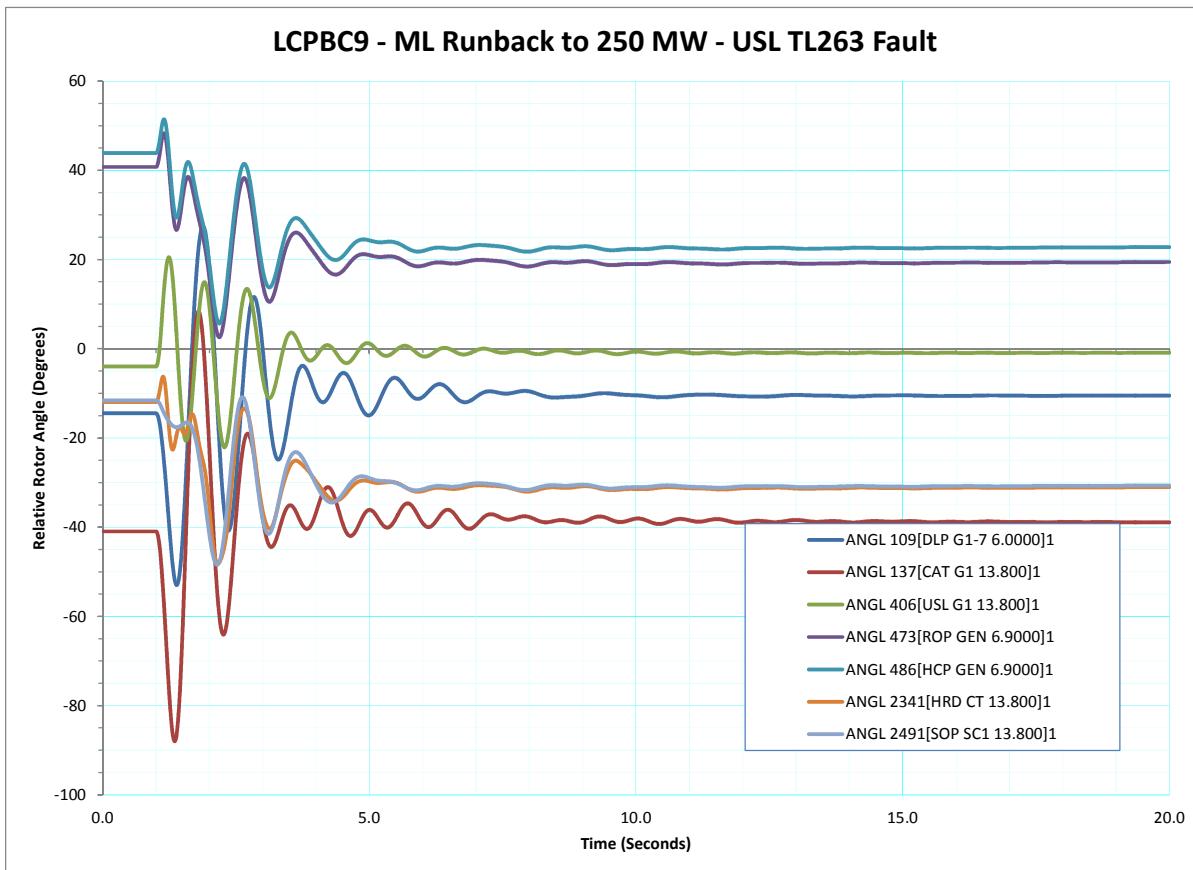
Figure 205 - LCPBC9 - ML Runback to 250 MW - USL TL263 Fault - Relative Rotor Angle (Degrees)

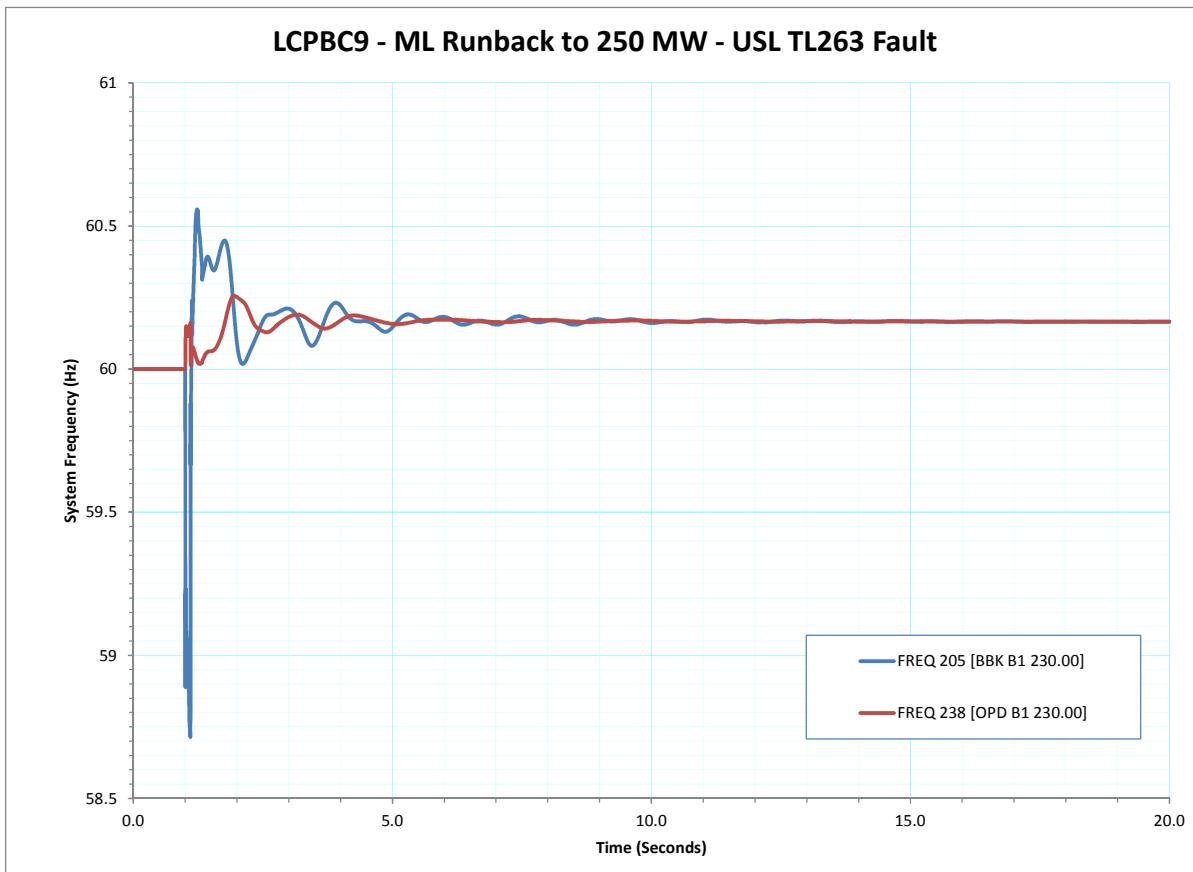
Figure 206 - LCPBC9 - ML Runback to 250 MW - USL TL263 Fault - System Frequency (Hz)

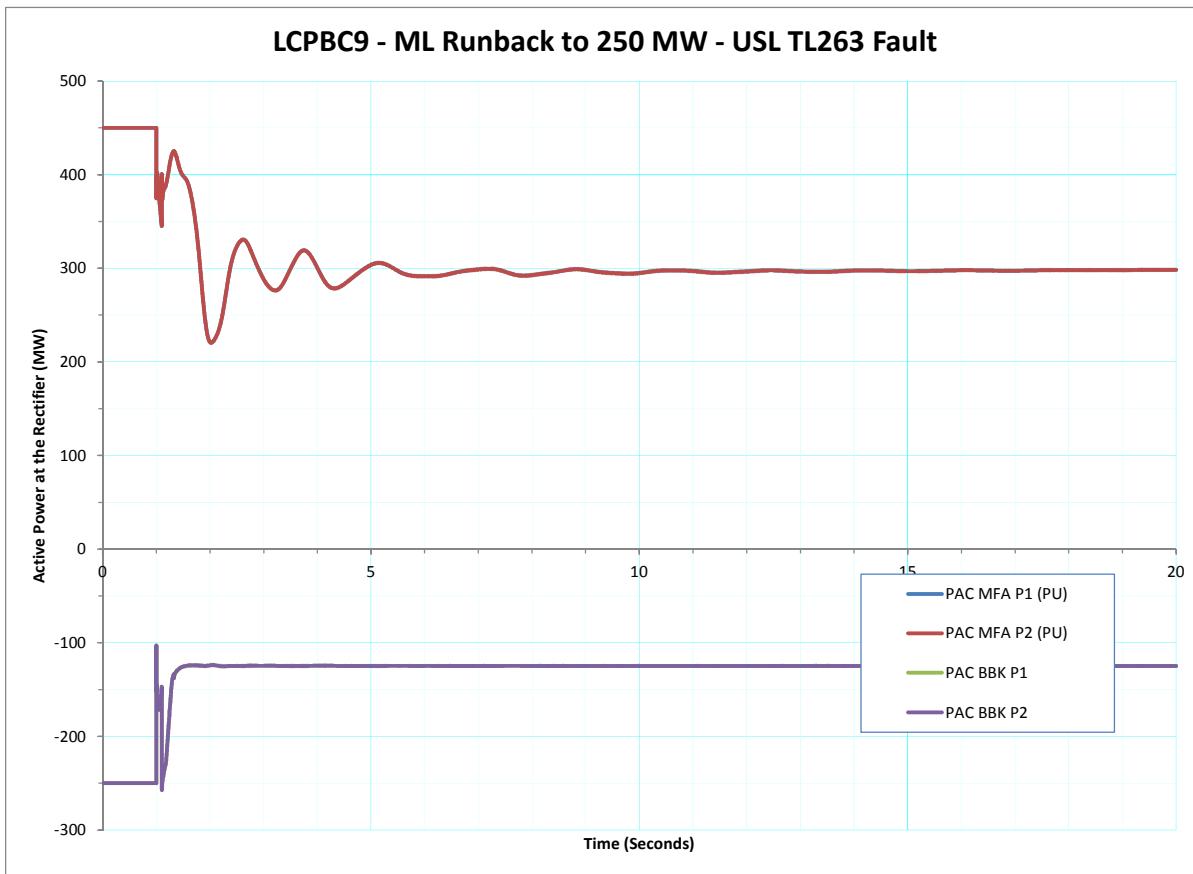
Figure 207 - LCPBC9 - ML Runback to 250 MW - USL TL263 Fault - Active Power at the Rectifier (MW)

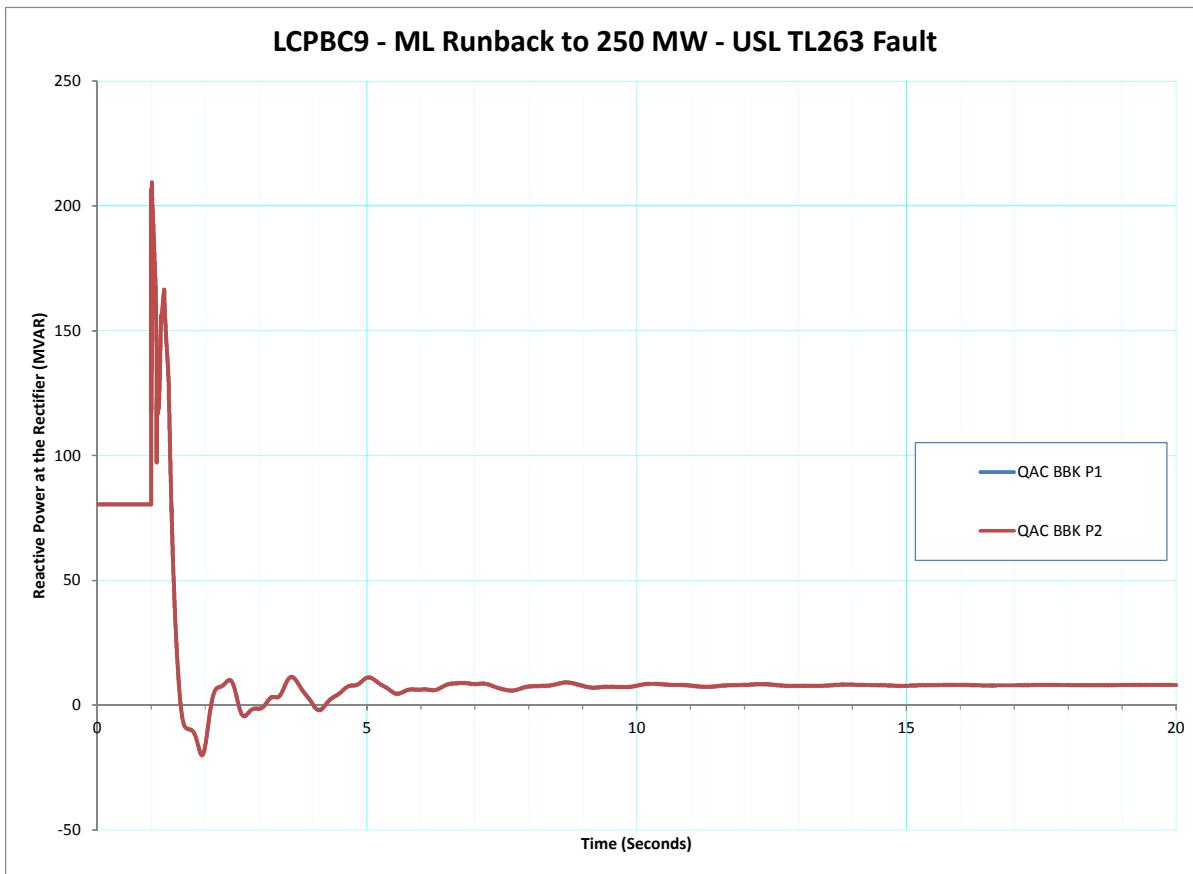
Figure 208 - LCPBC9 - ML Runback to 250 MW - USL TL263 Fault - Reactive Power at the Rectifier (MVAR)

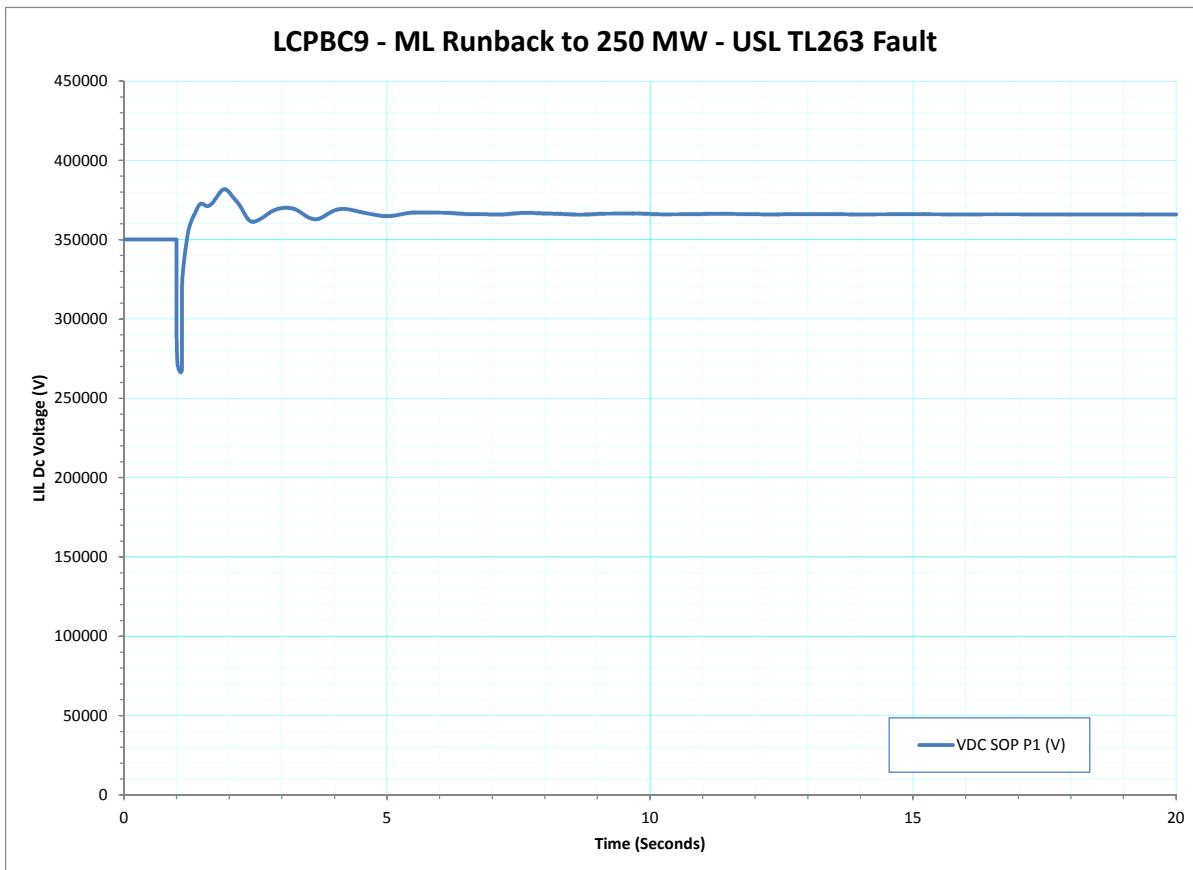
Figure 209 - LCPBC9 - ML Runback to 250 MW - USL TL263 Fault - LIL Dc Voltage (V)

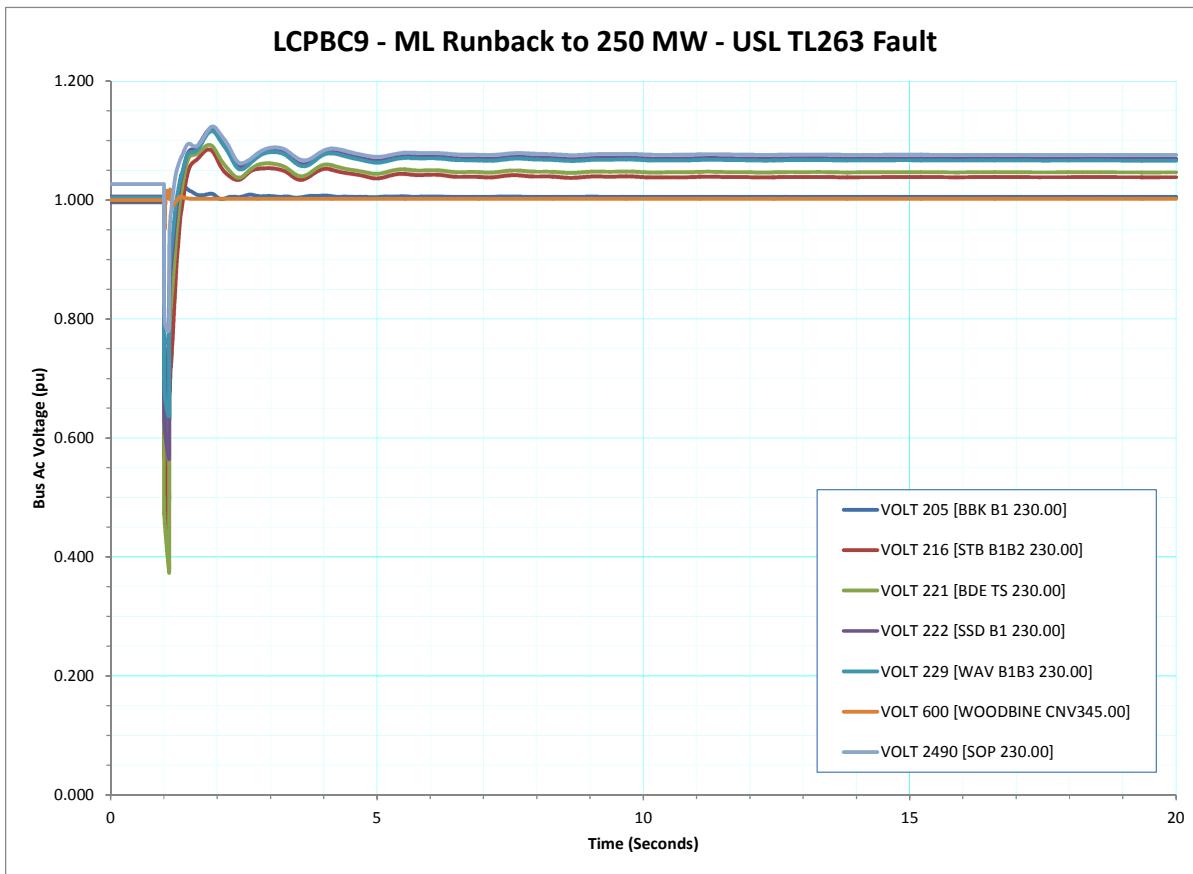
Figure 210 - LCPBC9 - ML Runback to 250 MW - USL TL263 Fault - Bus Ac Voltage (pu)
