MARITIME LINK PRELIMINARY INTERCONNECTION STUDY

Newfoundland and Labrador Hydro

July 2014

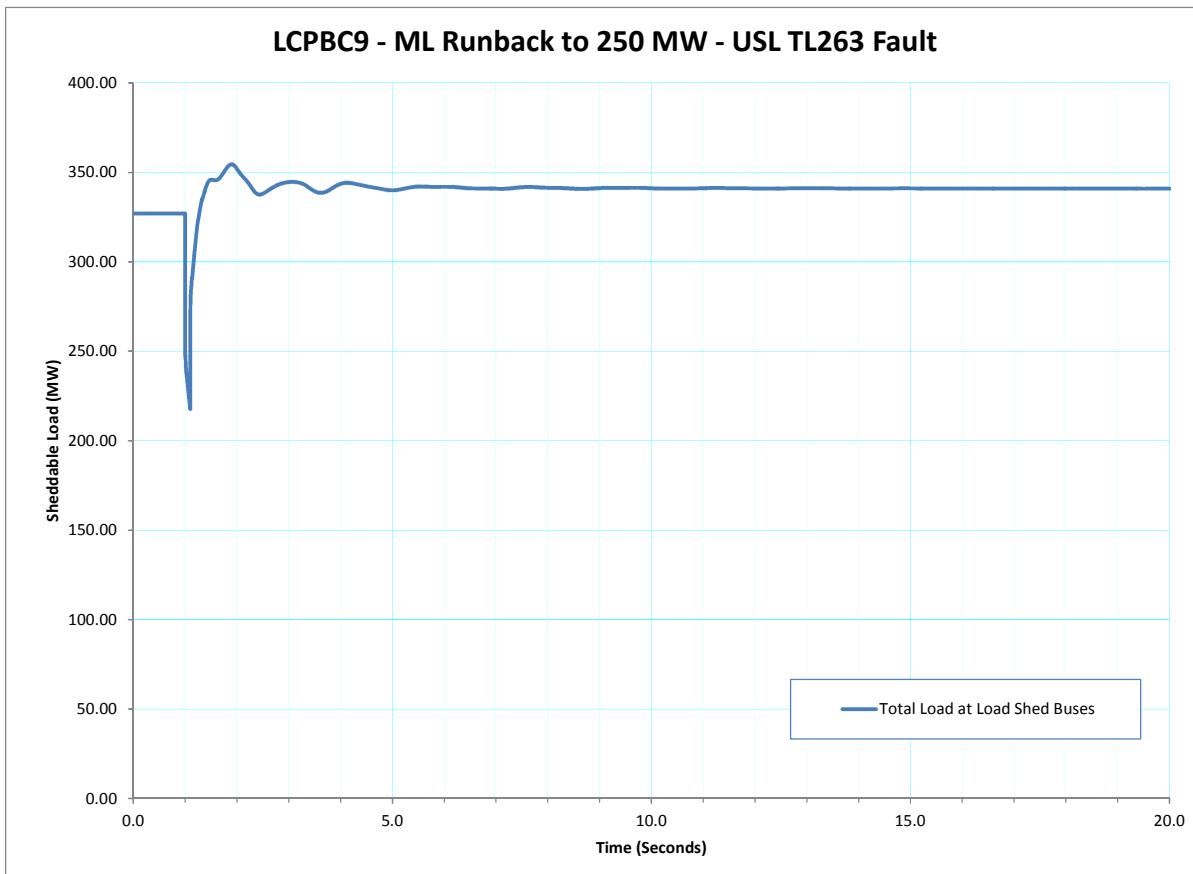
Figure 211 - LCPBC9 - ML Runback to 250 MW - USL TL263 Fault - Sheddable Load (MW)

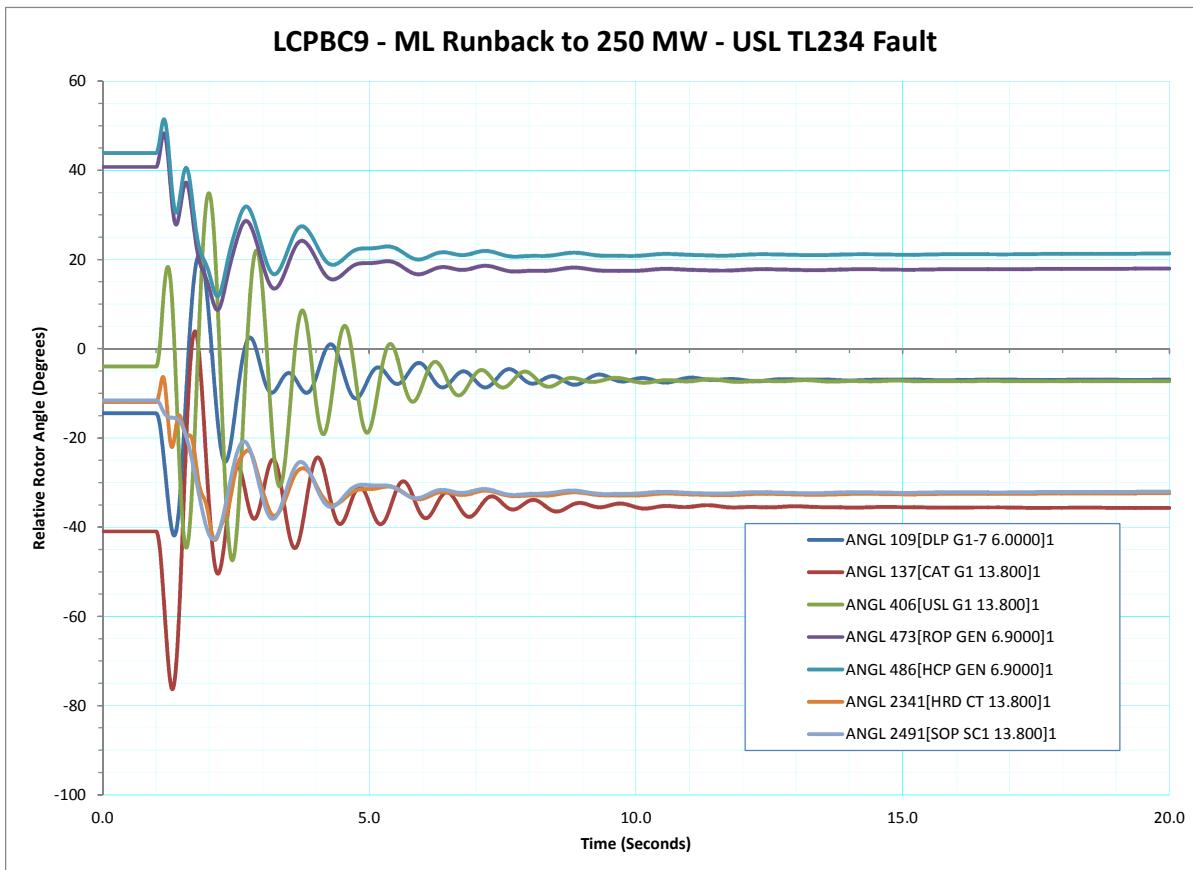
Figure 212 - LCPBC9 - ML Runback to 250 MW - USL TL234 Fault - Relative Rotor Angle (Degrees)

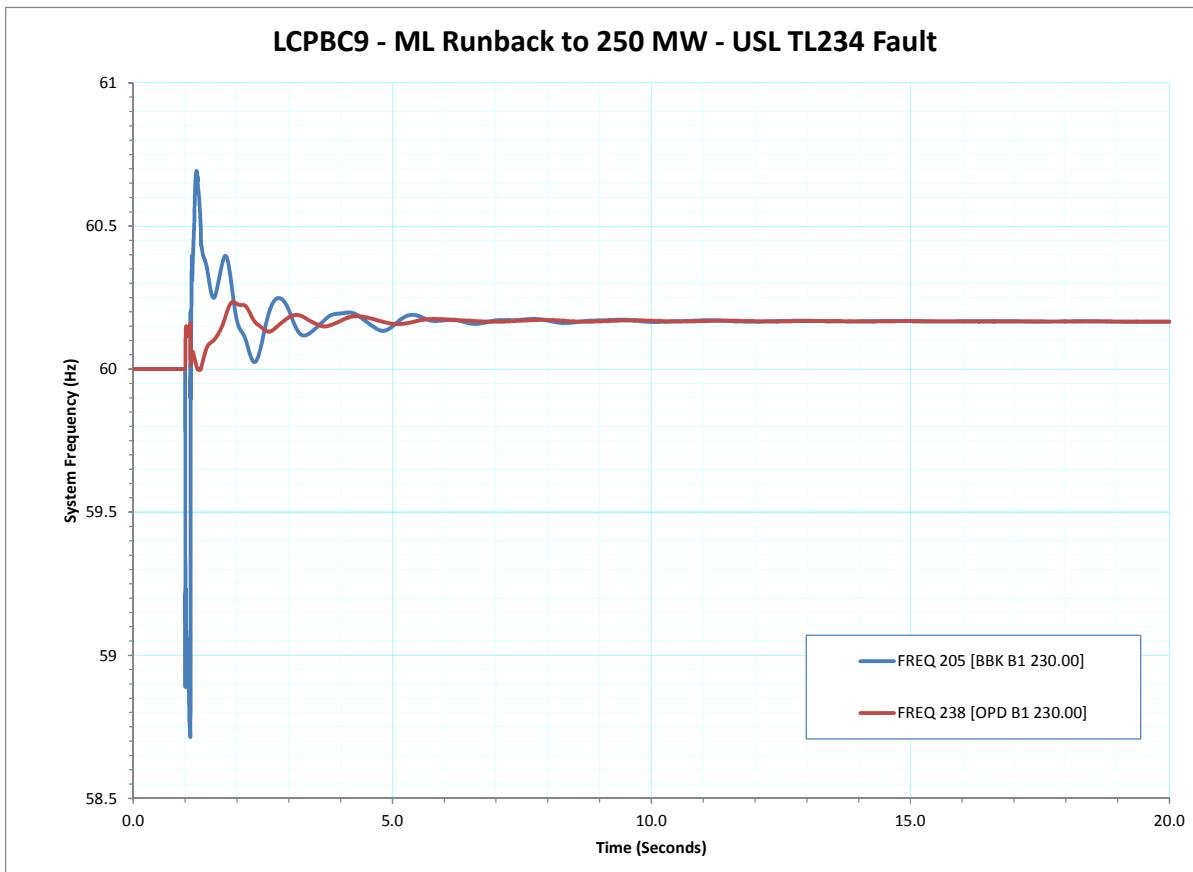
Figure 213 - LCPBC9 - ML Runback to 250 MW - USL TL234 Fault - System Frequency (Hz)

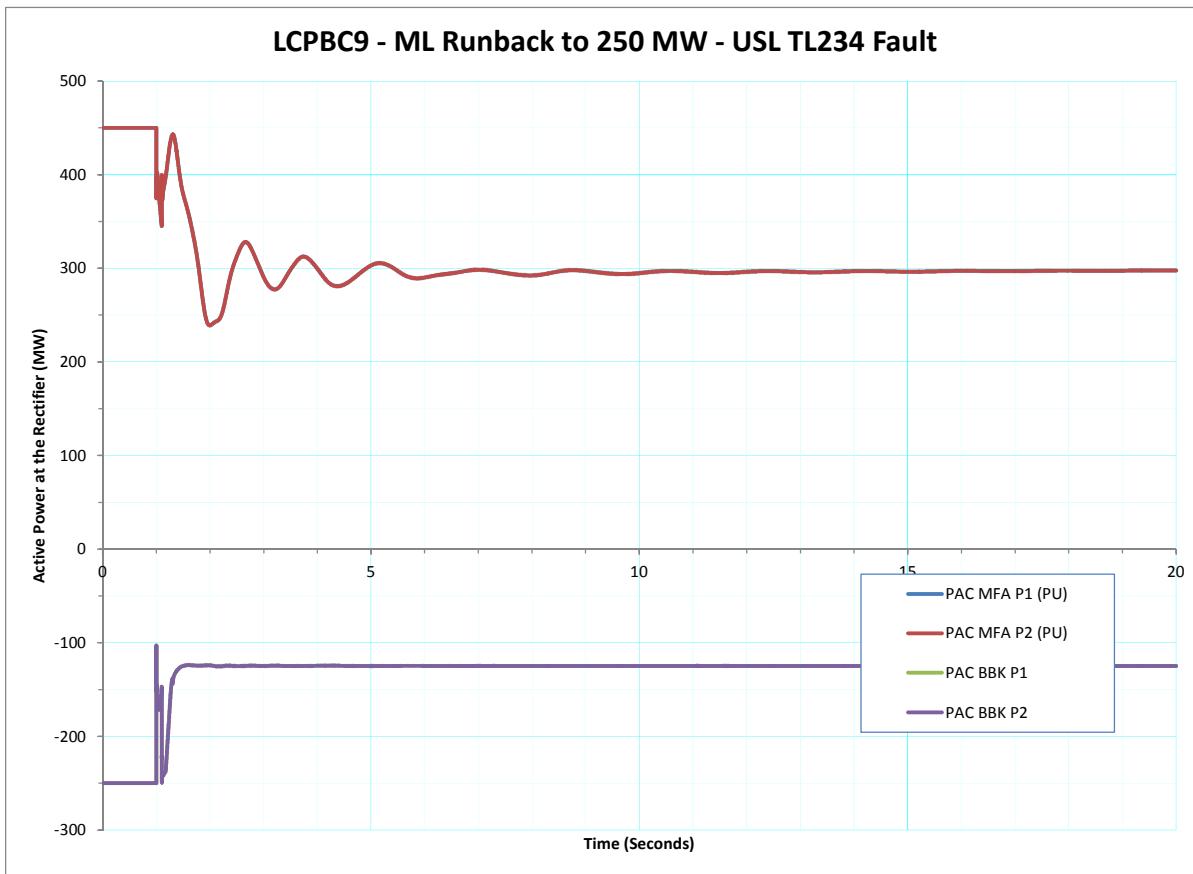
Figure 214 - LCPBC9 - ML Runback to 250 MW - USL TL234 Fault - Active Power at the Rectifier (MW)

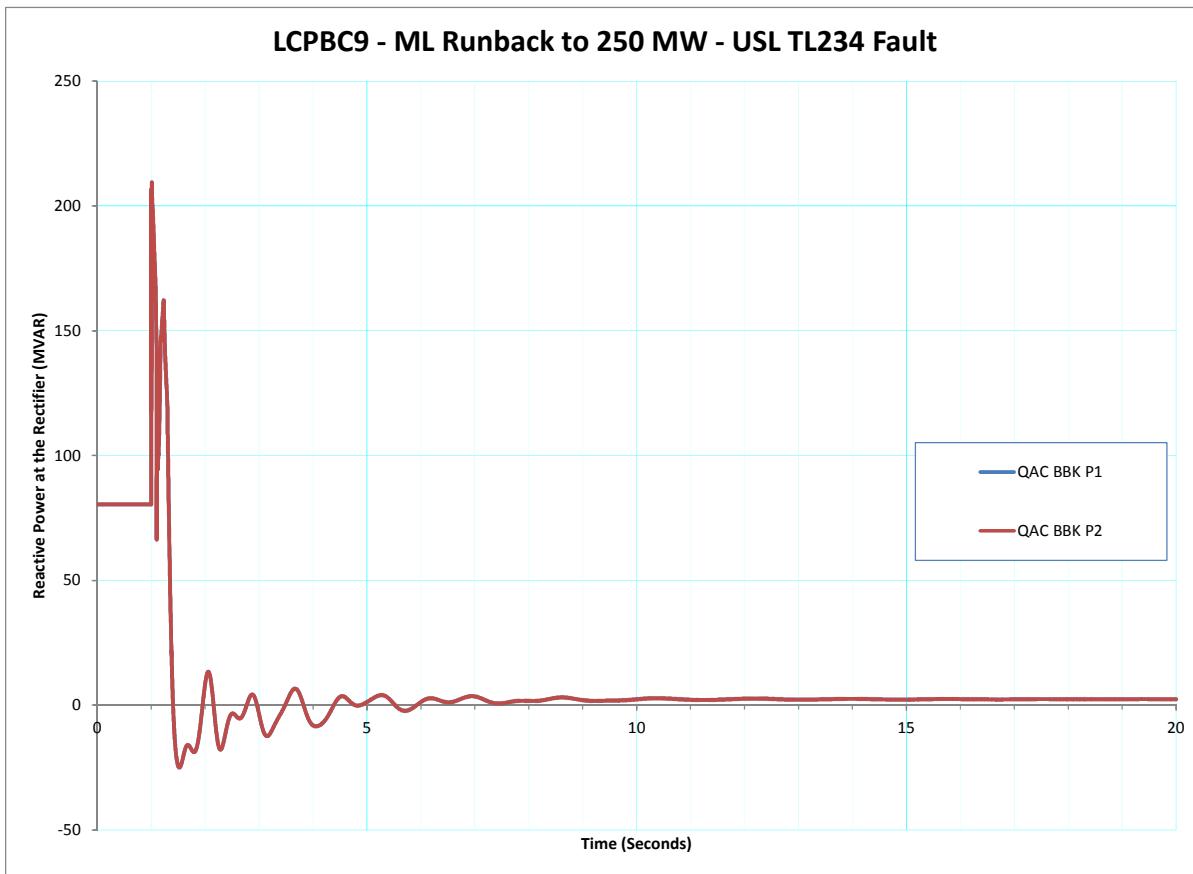
Figure 215 - LCPBC9 - ML Runback to 250 MW - USL TL234 Fault - Reactive Power at the Rectifier (MVAR)

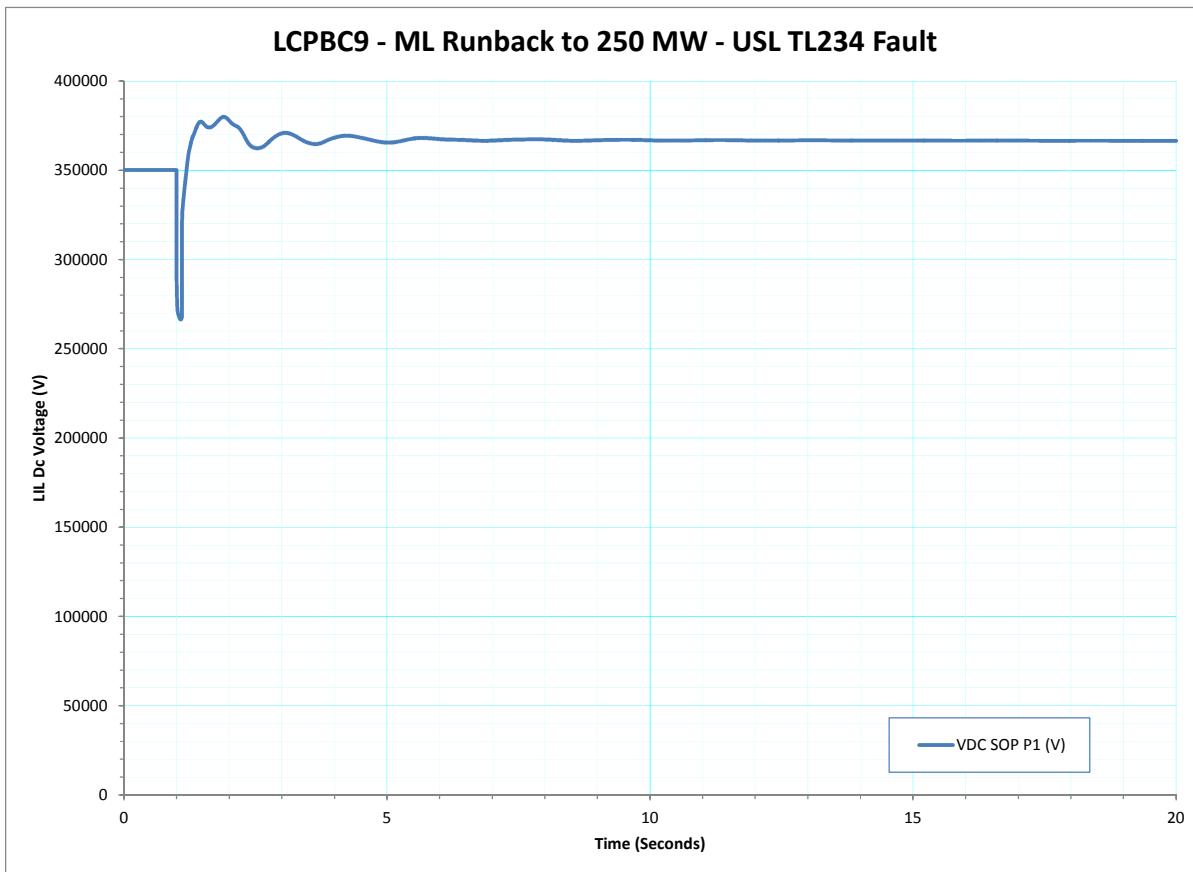
Figure 216 - LCPBC9 - ML Runback to 250 MW - USL TL234 Fault - LIL Dc Voltage (V)

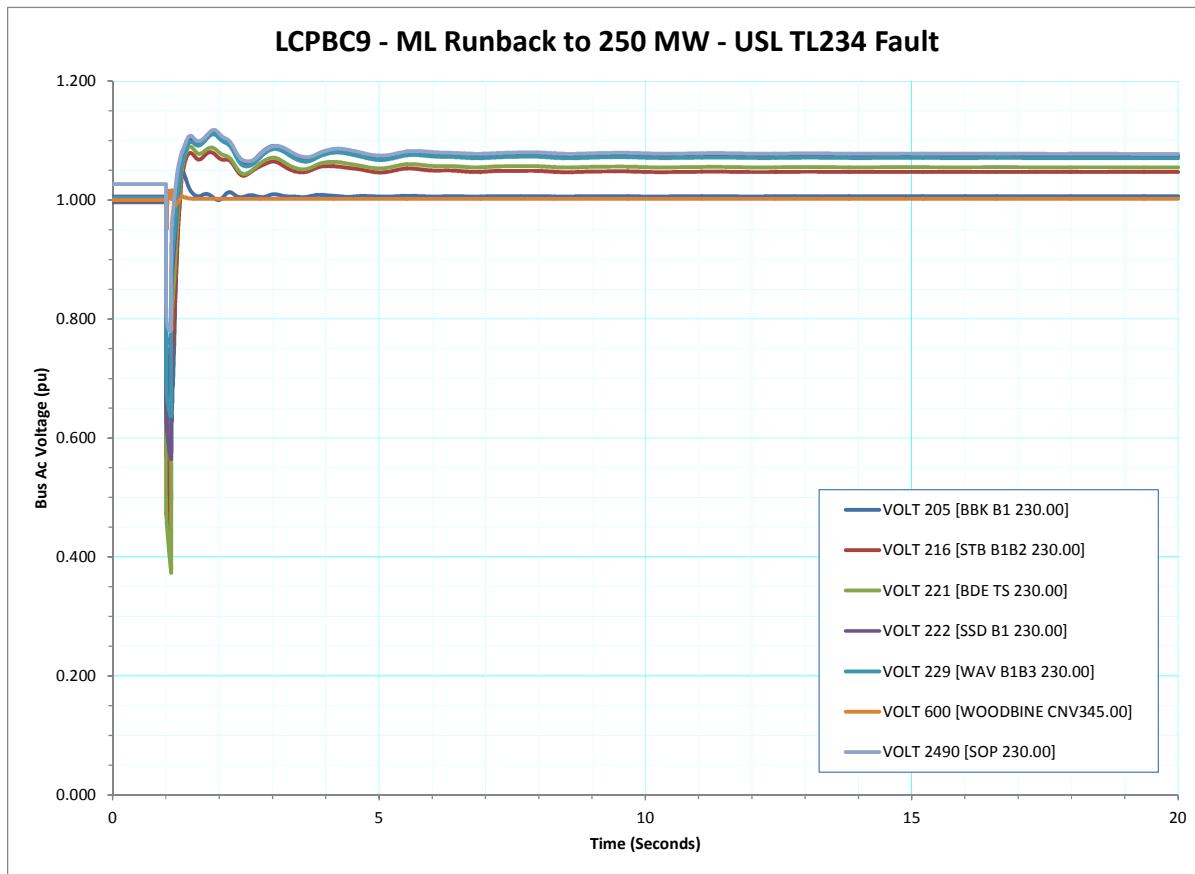
Figure 217 - LCPBC9 - ML Runback to 250 MW - USL TL234 Fault - Bus Ac Voltage (pu)

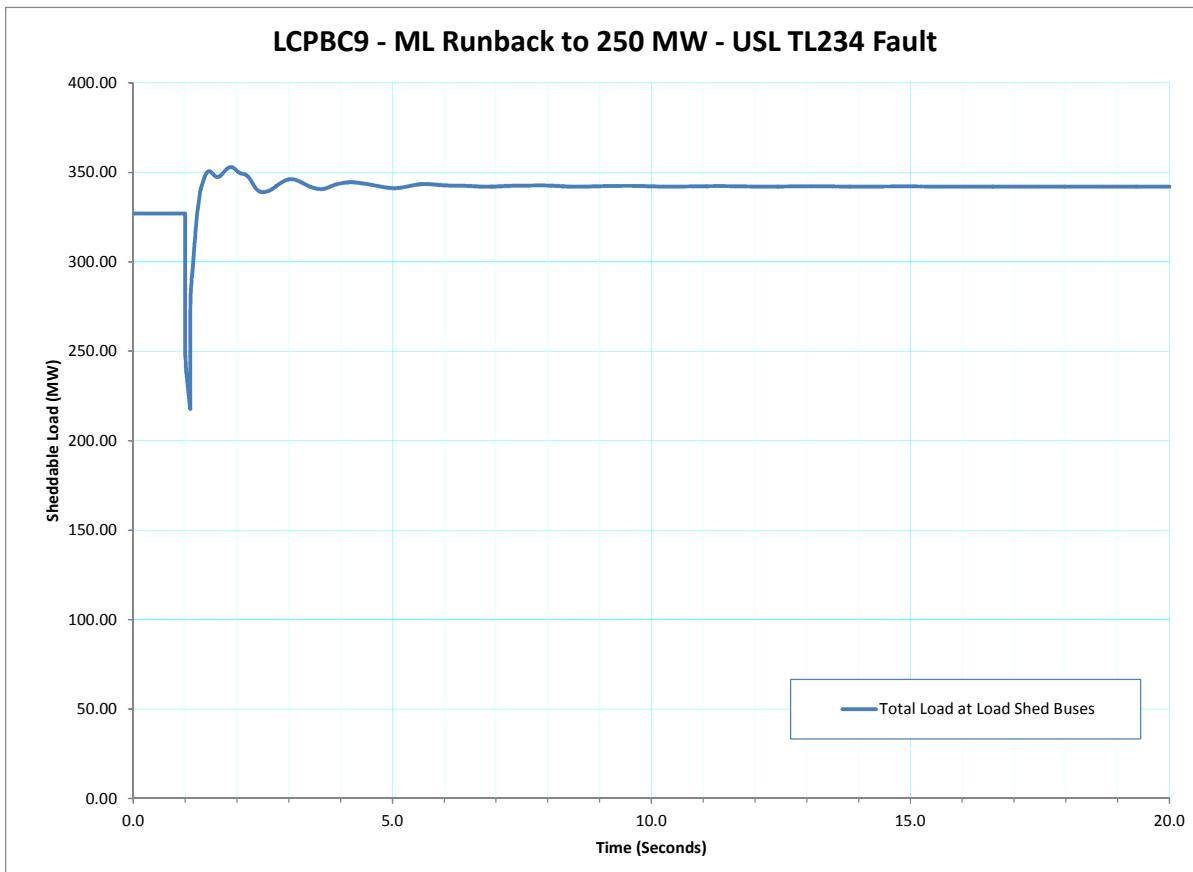
Figure 218 - LCPBC9 - ML Runback to 250 MW - USL TL234 Fault - Sheddable Load (MW)

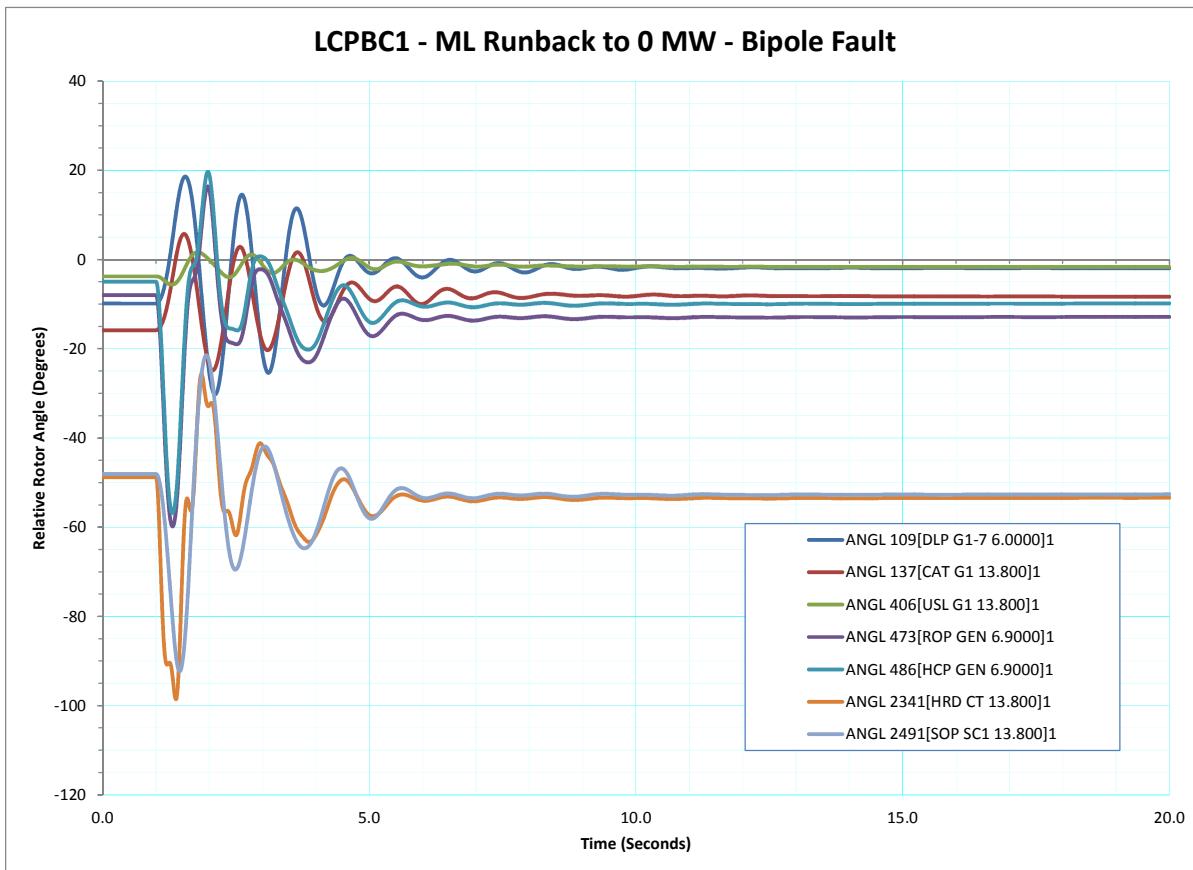
Figure 219 - LCPBC1 - ML Runback to 0 MW - Bipole Fault - Relative Rotor Angle (Degrees)

The curtailment of ML export helps to maintain system stability and to improve system performance. Appendix D contains transient stability plots demonstrating system performance in all base cases when the ML export is curtailed. In BC6 and BC7, the curtailment of ML export from 500 MW to 250 MW was sufficient to eliminate UFLS. In monopolar cases (BC4 and BC10), ML export must be curtailed to 0 MW to ensure that there are no LIL commutation failures.

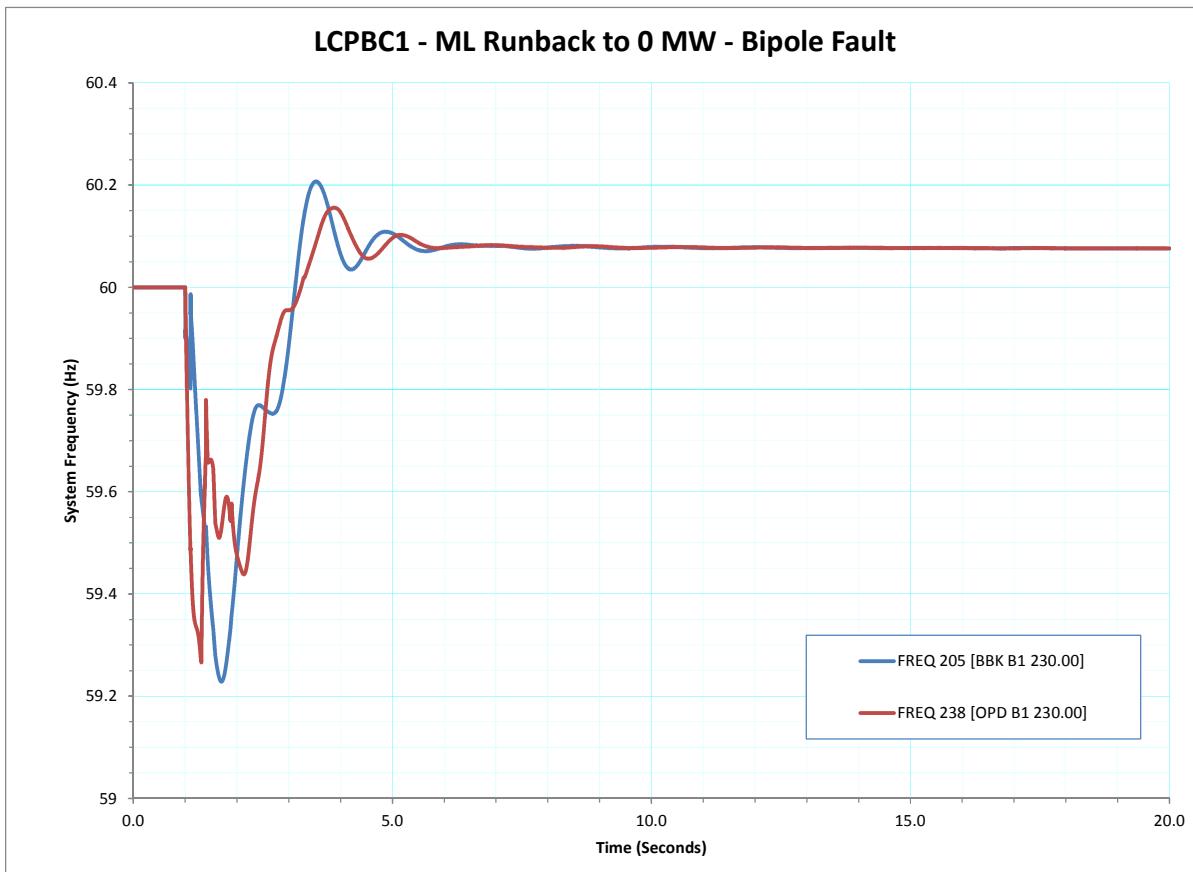
Figure 220 - LCPBC1 - ML Runback to 0 MW - Bipole Fault - System Frequency (Hz)

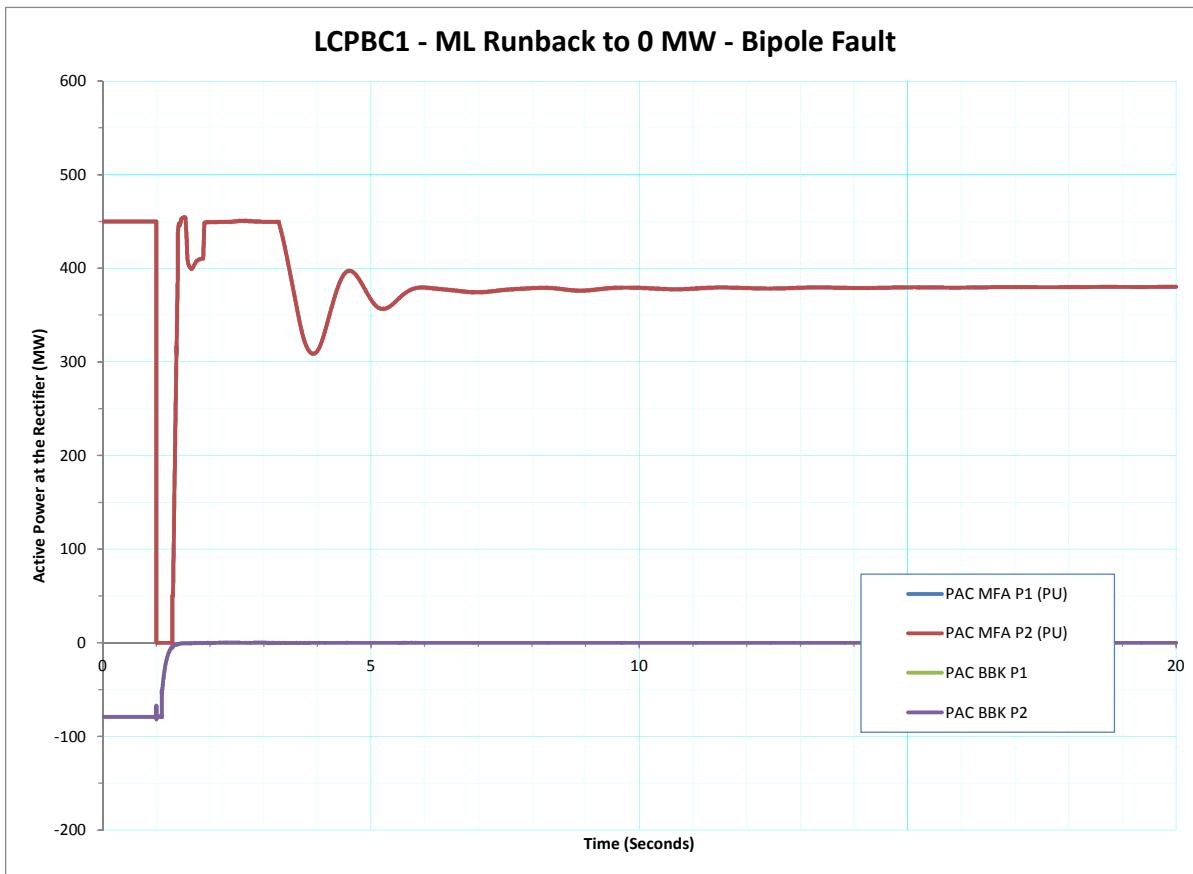
Figure 221 - LCPBC1 - ML Runback to 0 MW - Bipole Fault - Active Power at the Rectifier (MW)

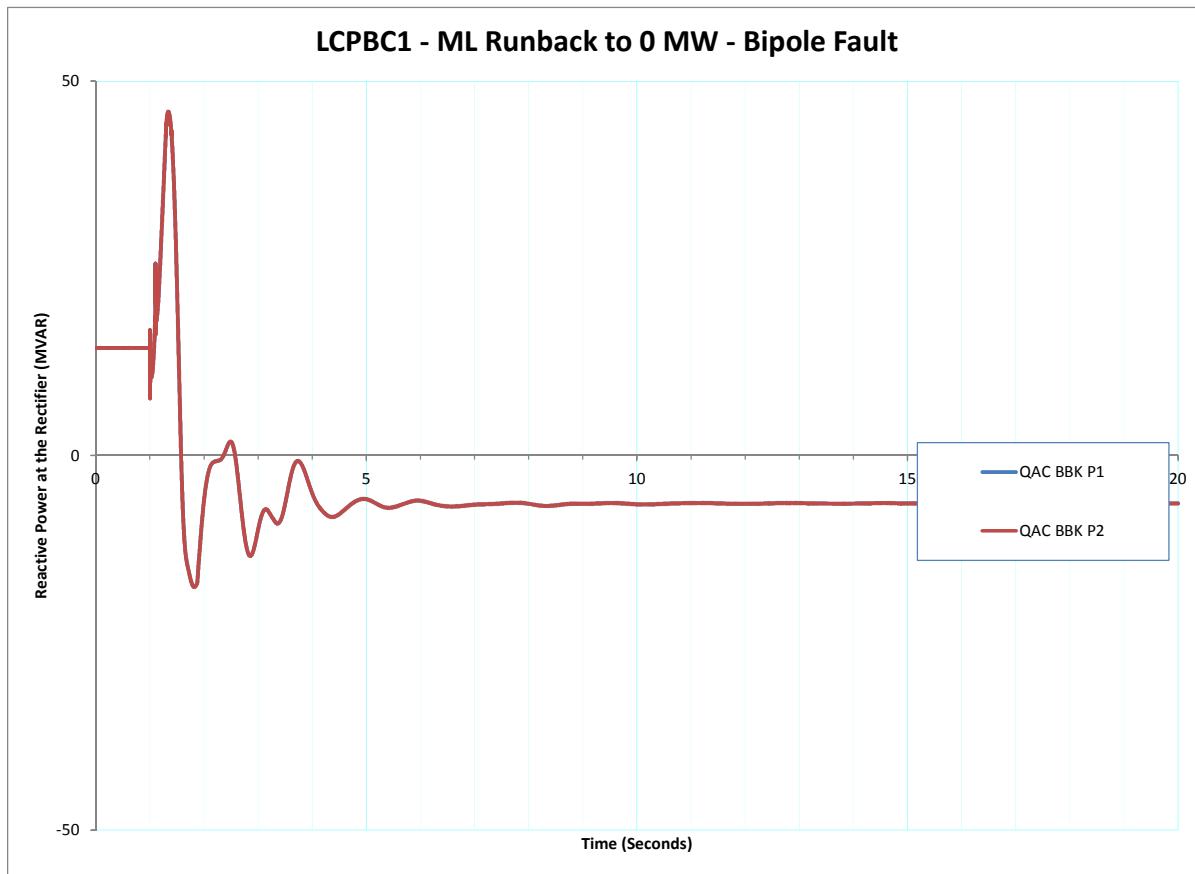
Figure 222 - LCPBC1 - ML Runback to 0 MW - Bipole Fault - Reactive Power at the Rectifier (MVAR)

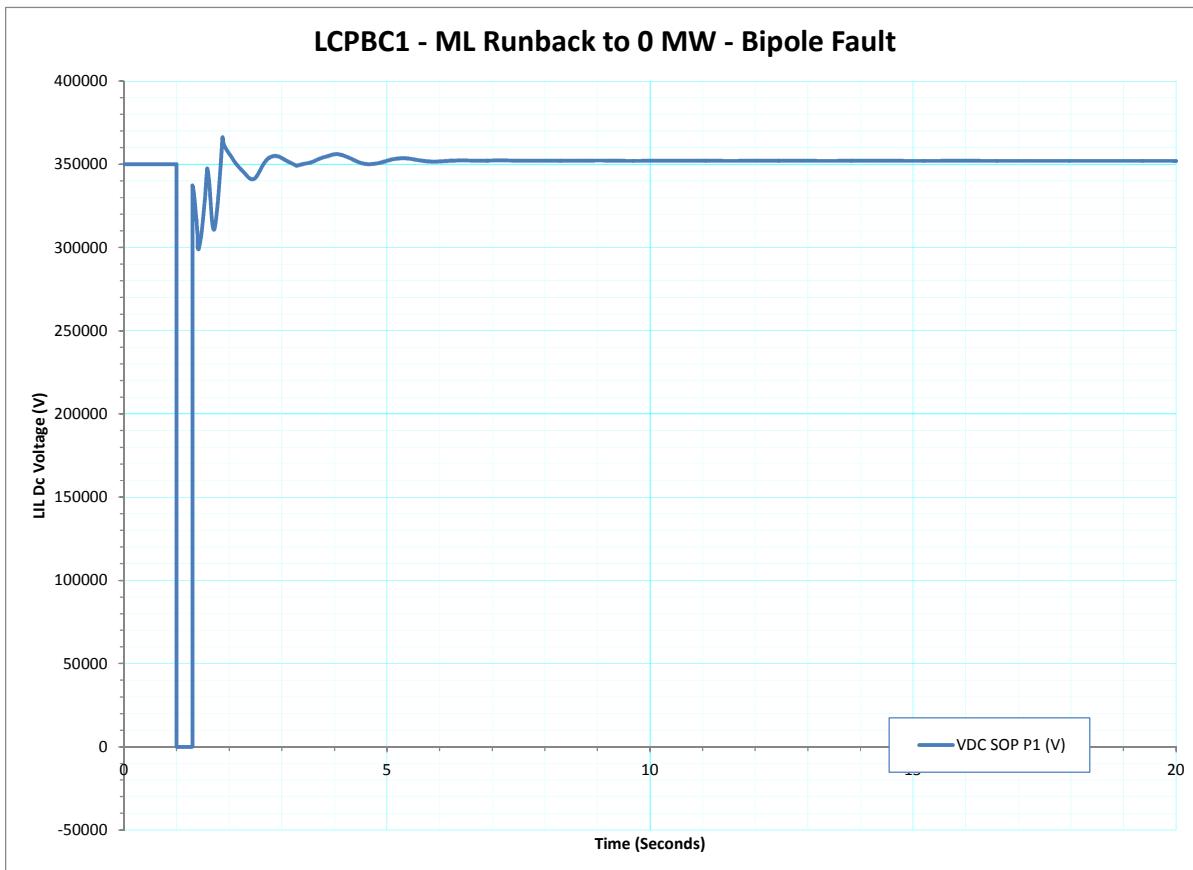
Figure 223 - LCPBC1 - ML Runback to 0 MW - Bipole Fault - LIL Dc Voltage (V)

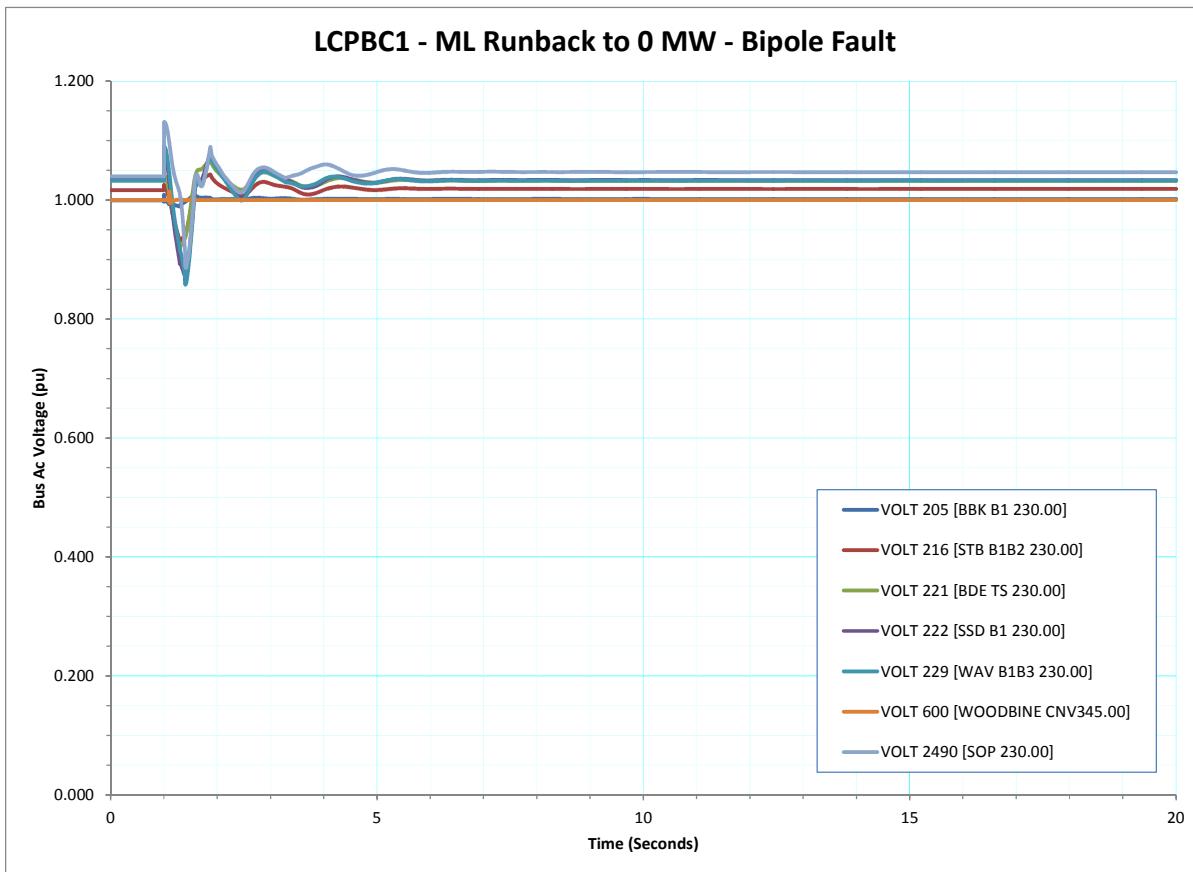
Figure 224 - LCPBC1 - ML Runback to 0 MW - Bipole Fault - Bus Ac Voltage (pu)

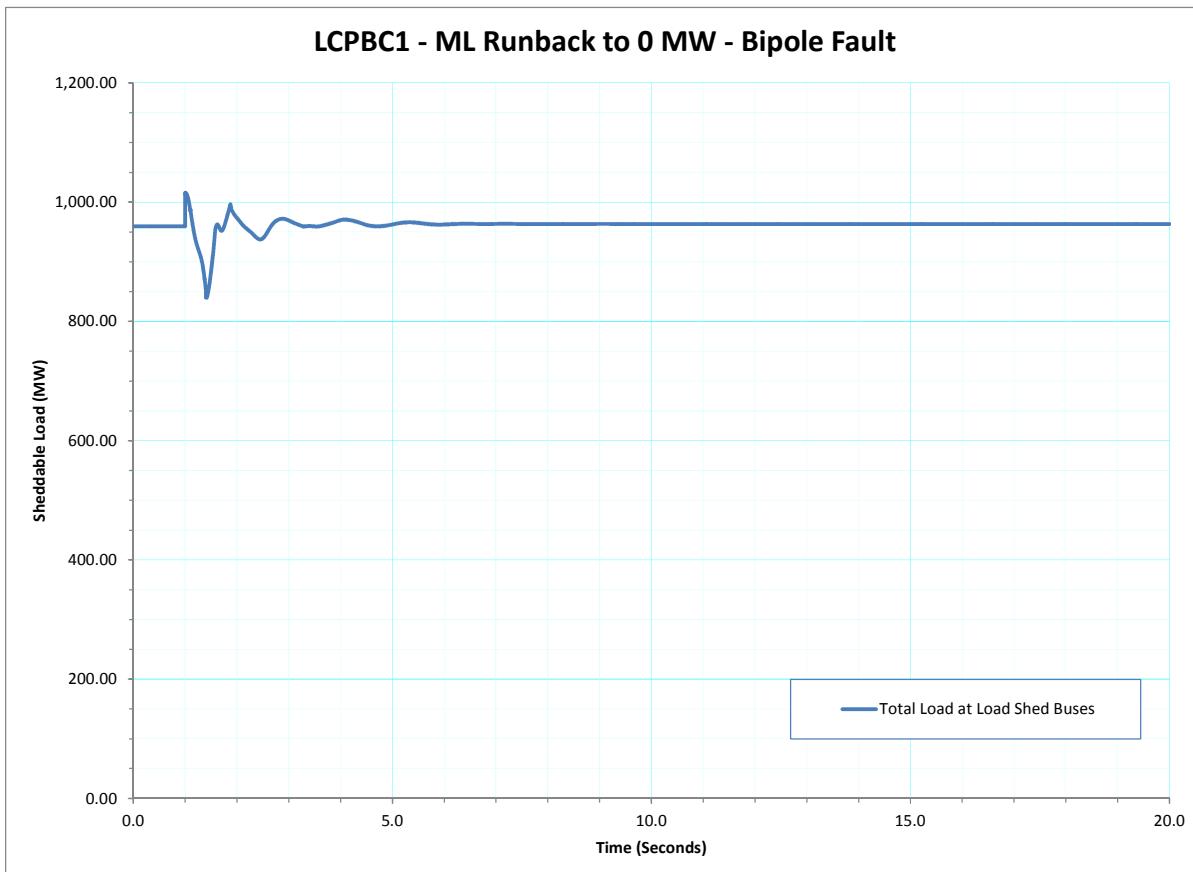
Figure 225 - LCPBC1 - ML Runback to 0 MW - Bipole Fault - Shedtable Load (MW)

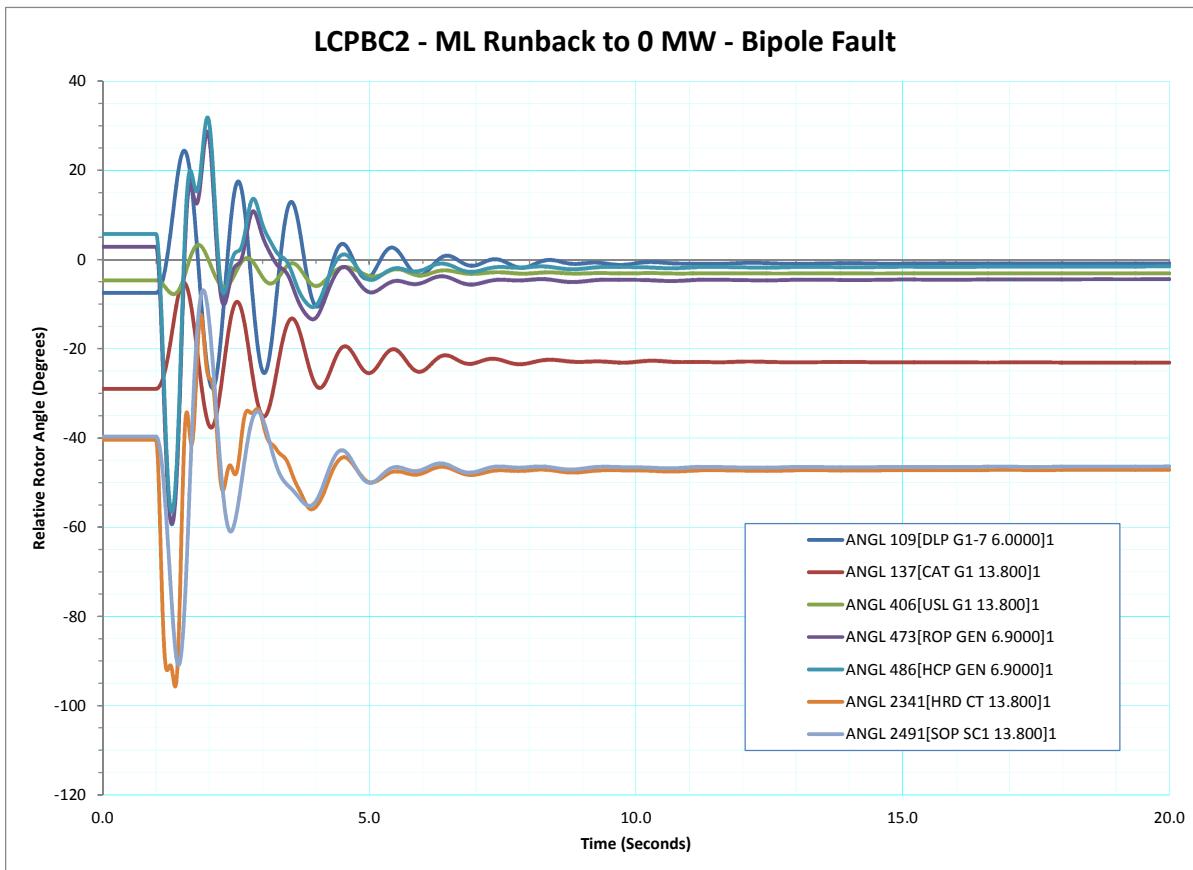
Figure 226 - LCPBC2 - ML Runback to 0 MW - Bipole Fault - Relative Rotor Angle (Degrees)

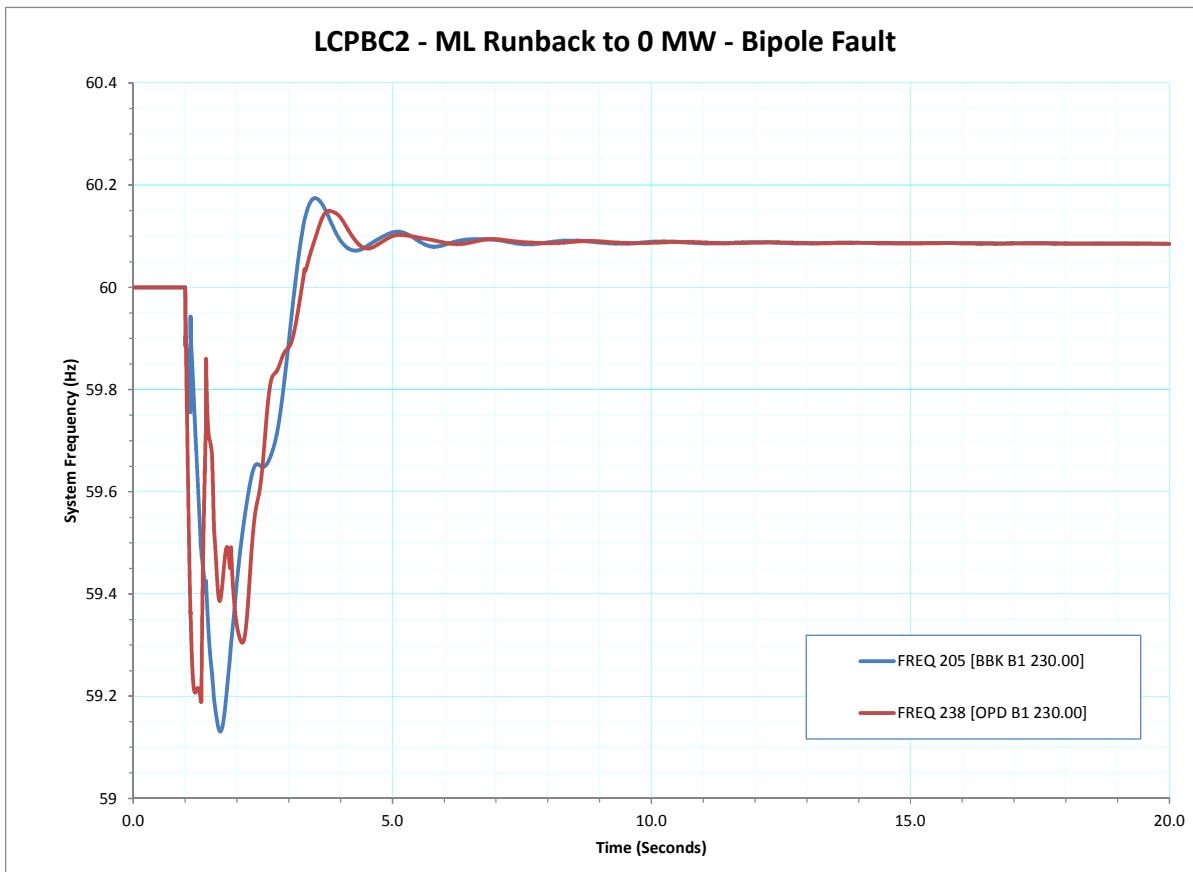
Figure 227 - LCPBC2 - ML Runback to 0 MW - Bipole Fault - System Frequency (Hz)

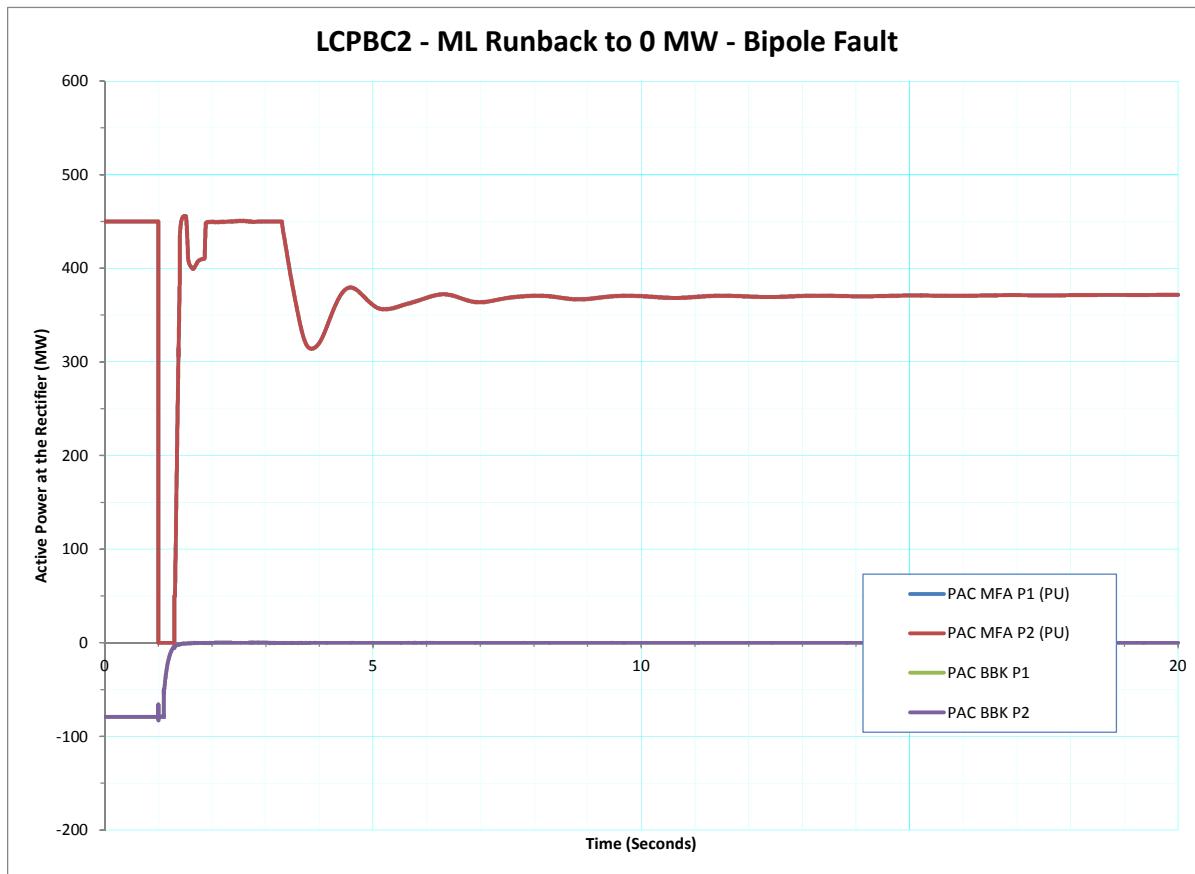
Figure 228 - LCPBC2 - ML Runback to 0 MW - Bipole Fault - Active Power at the Rectifier (MW)

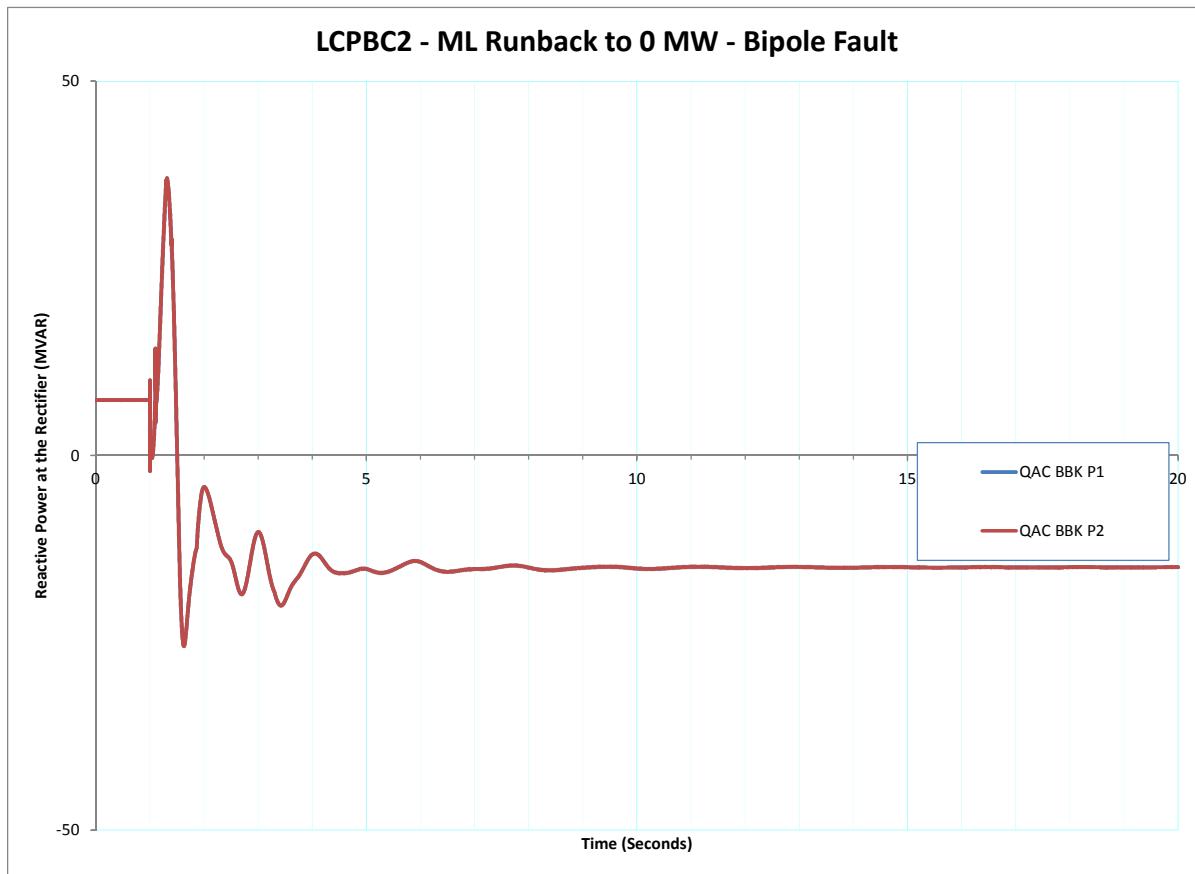
Figure 229 - LCPBC2 - ML Runback to 0 MW - Bipole Fault - Reactive Power at the Rectifier (MVAR)

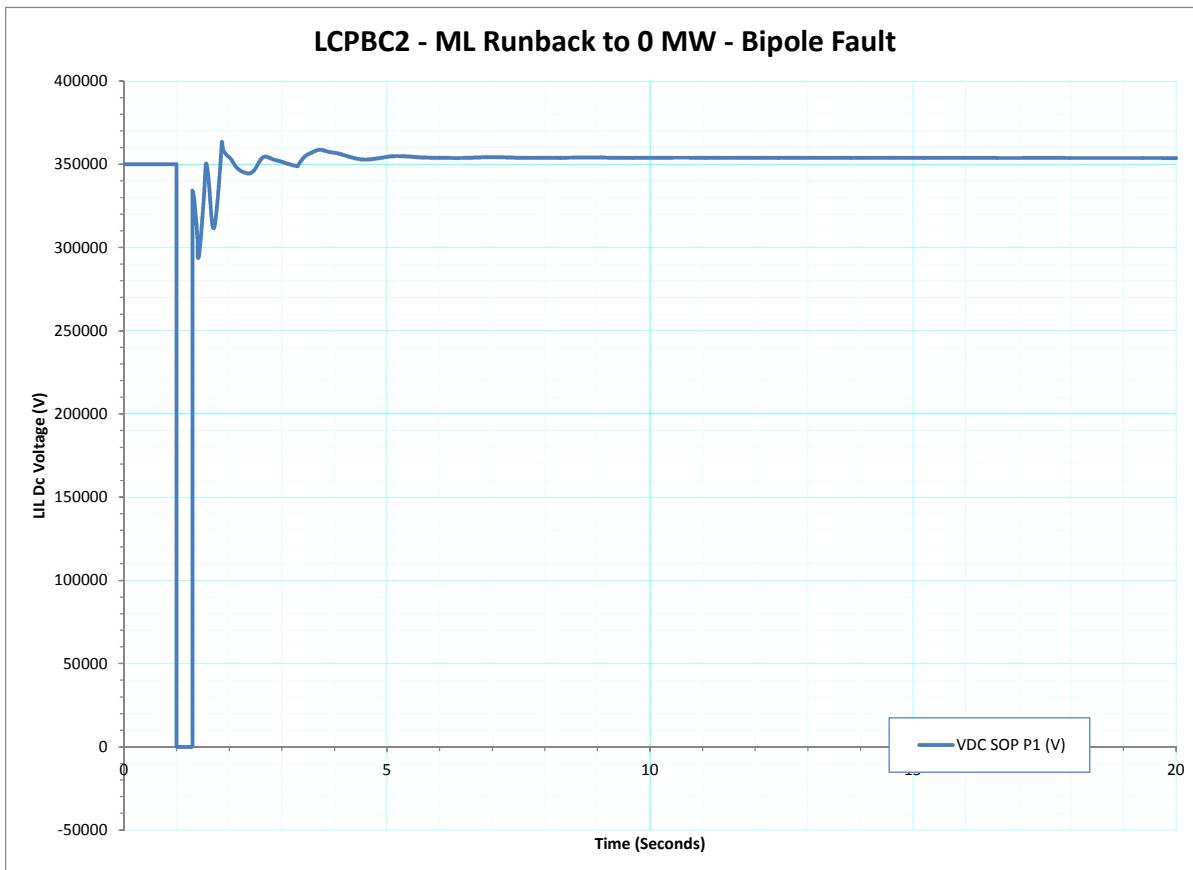
Figure 230 - LCPBC2 - ML Runback to 0 MW - Bipole Fault - LIL Dc Voltage (V)

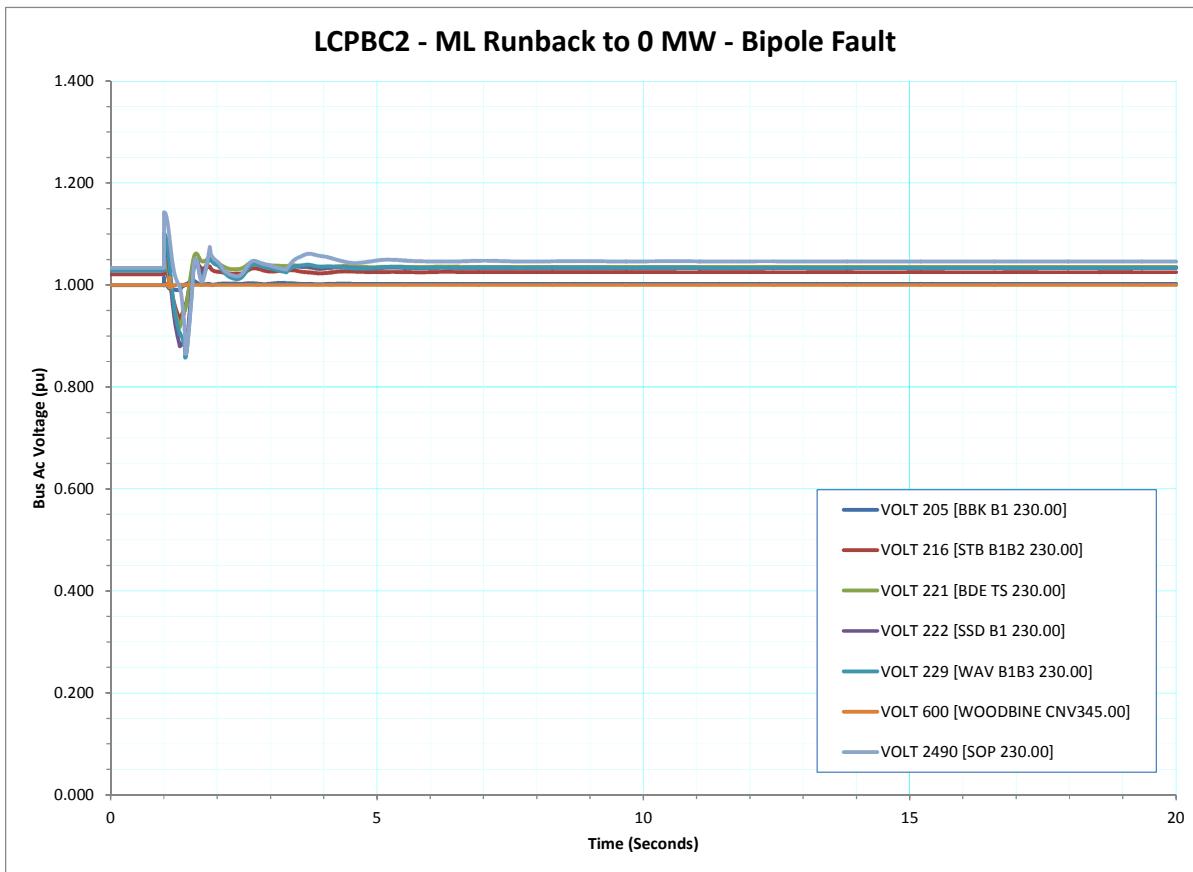
Figure 231 - LCPBC2 - ML Runback to 0 MW - Bipole Fault - Bus Ac Voltage (pu)
