MARITIME LINK PRELIMINARY INTERCONNECTION STUDY

Newfoundland and Labrador Hydro

July 2014

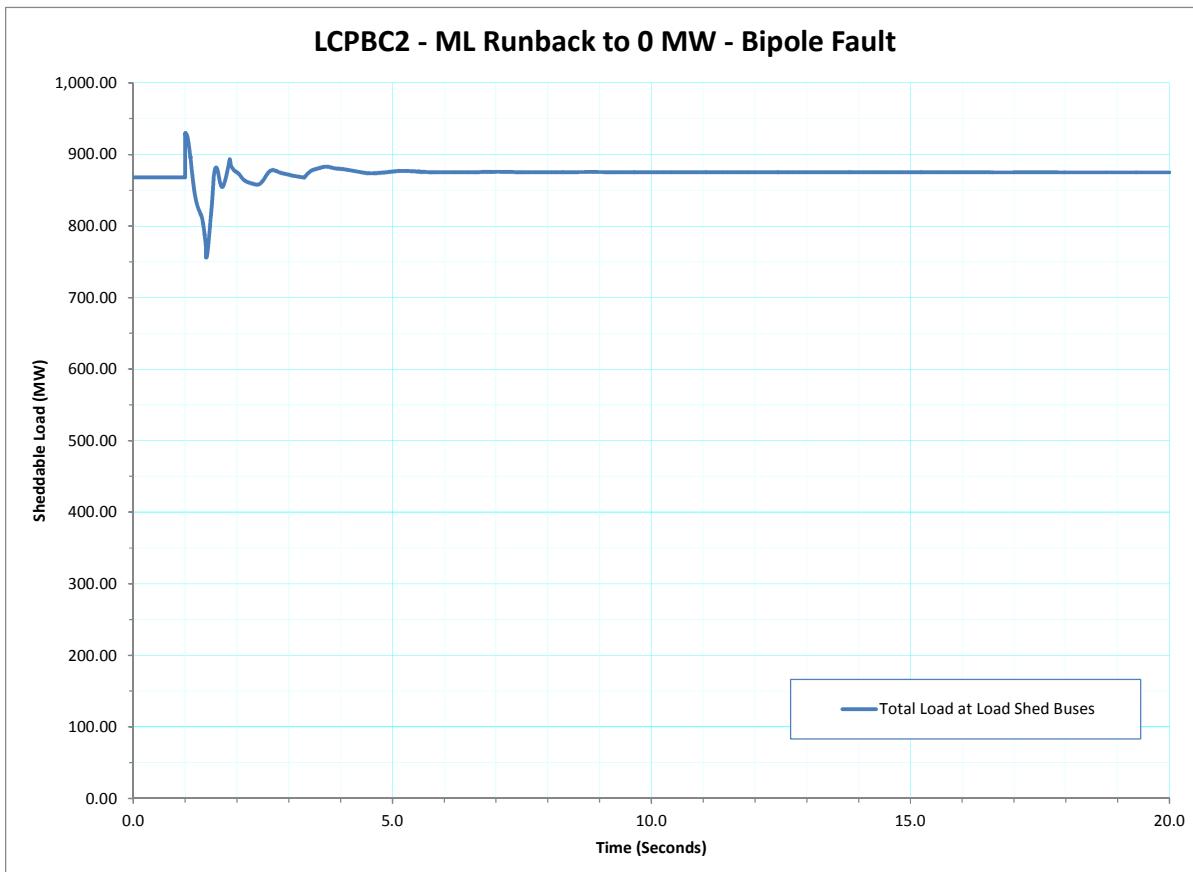
Figure 232 - LCPBC2 - ML Runback to 0 MW - Bipole Fault - Shedtable Load (MW)

The curtailment of ML export helps to maintain system stability and to improve system performance. Appendix D contains transient stability plots demonstrating system performance in all base cases when the ML export is curtailed. In BC6 and BC7, the curtailment of ML export from 500 MW to 250 MW was sufficient to eliminate UFLS. In monopolar cases (BC4 and BC10), ML export must be curtailed to 0 MW to ensure that there are no LIL commutation failures.

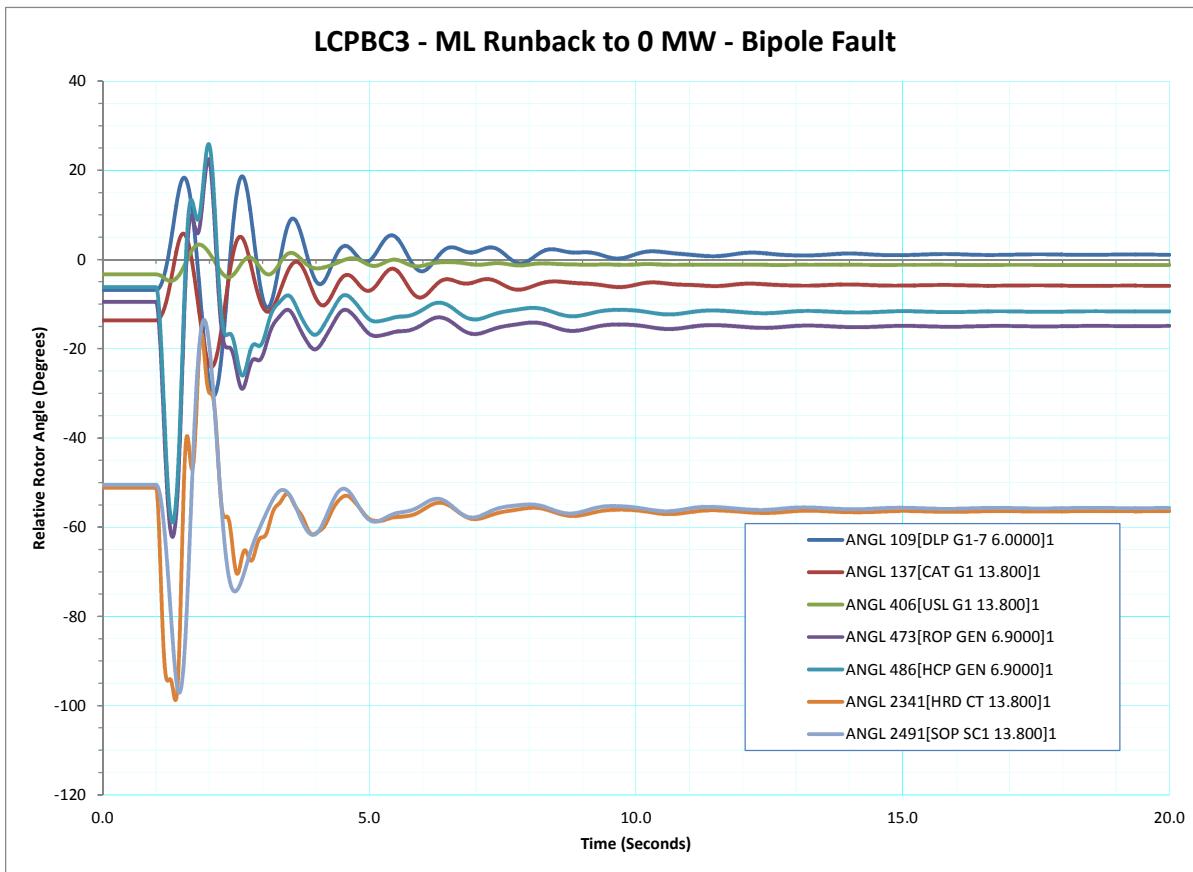
Figure 233 - LCPBC3 - ML Runback to 0 MW - Bipole Fault - Relative Rotor Angle (Degrees)

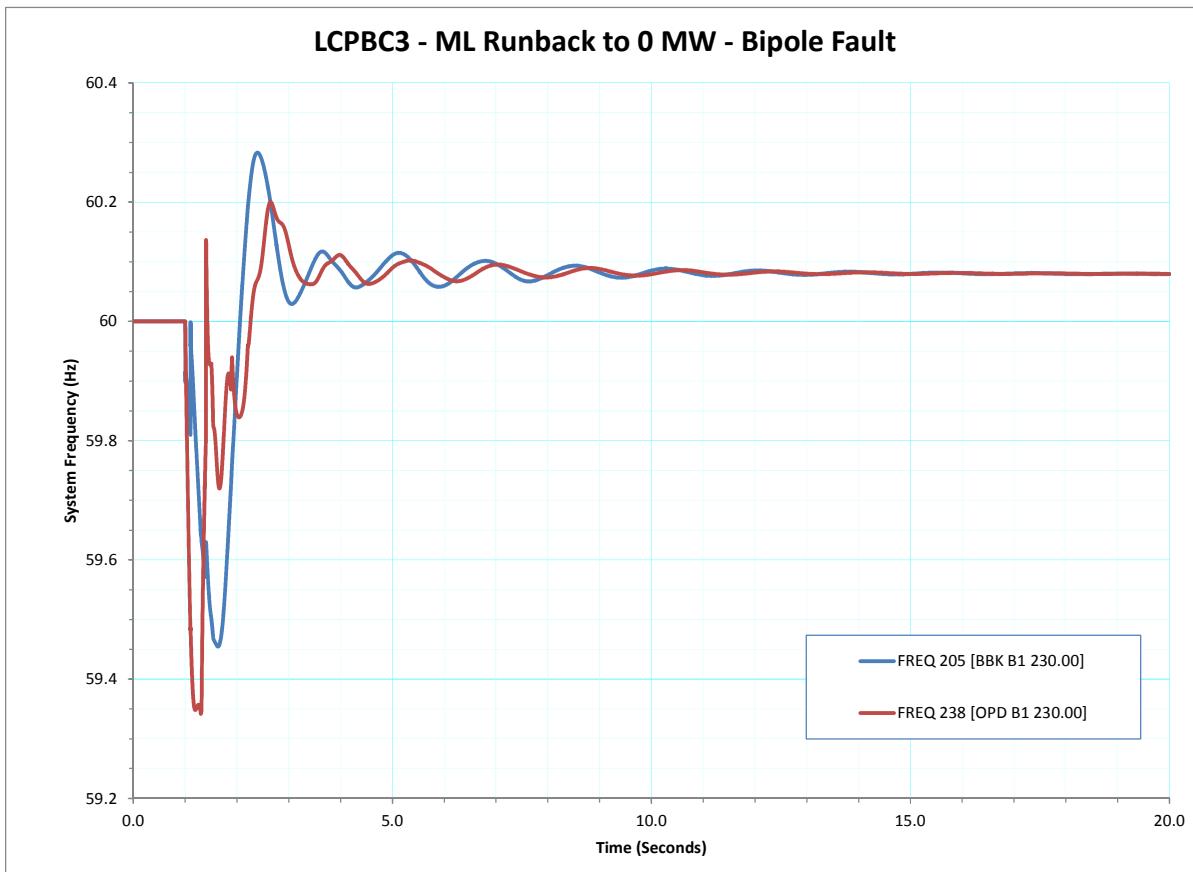
Figure 234 - LCPBC3 - ML Runback to 0 MW - Bipole Fault - System Frequency (Hz)

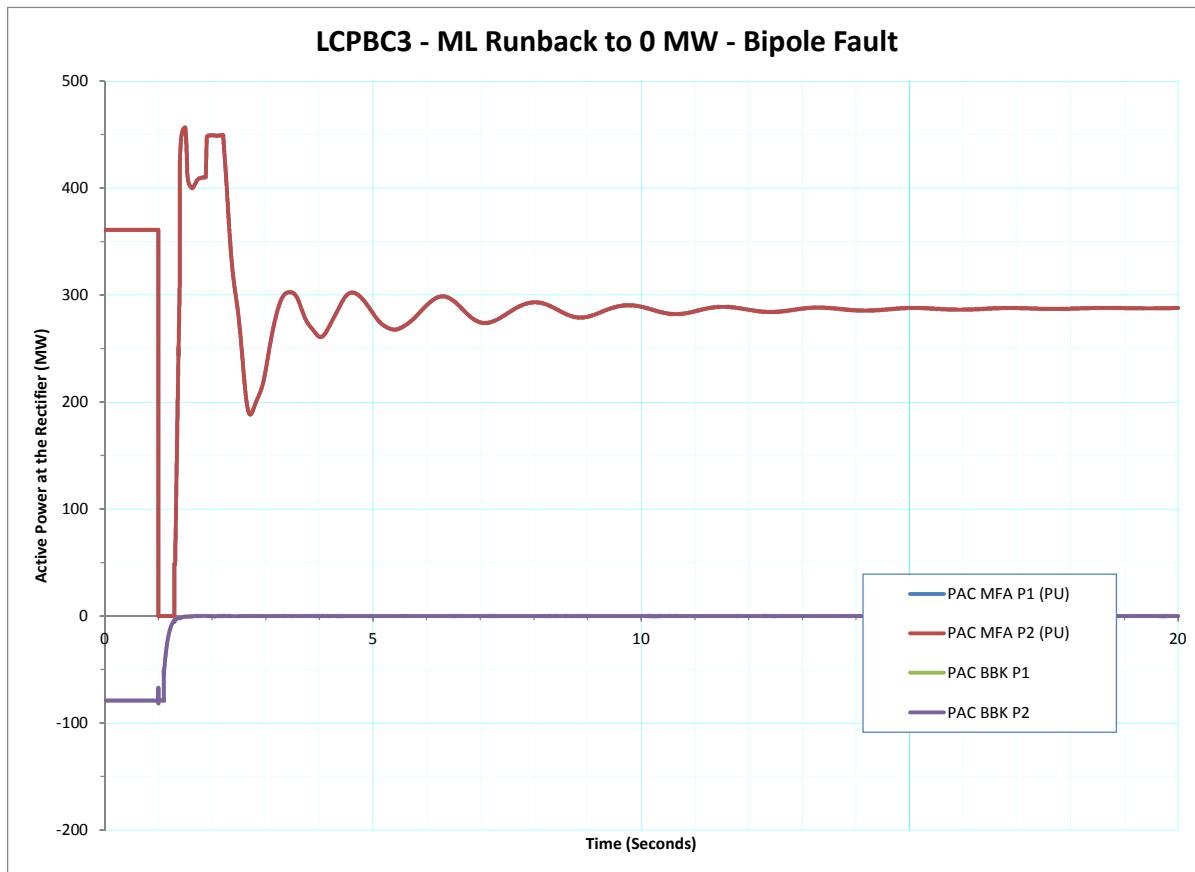
Figure 235 - LCPBC3 - ML Runback to 0 MW - Bipole Fault - Active Power at the Rectifier (MW)

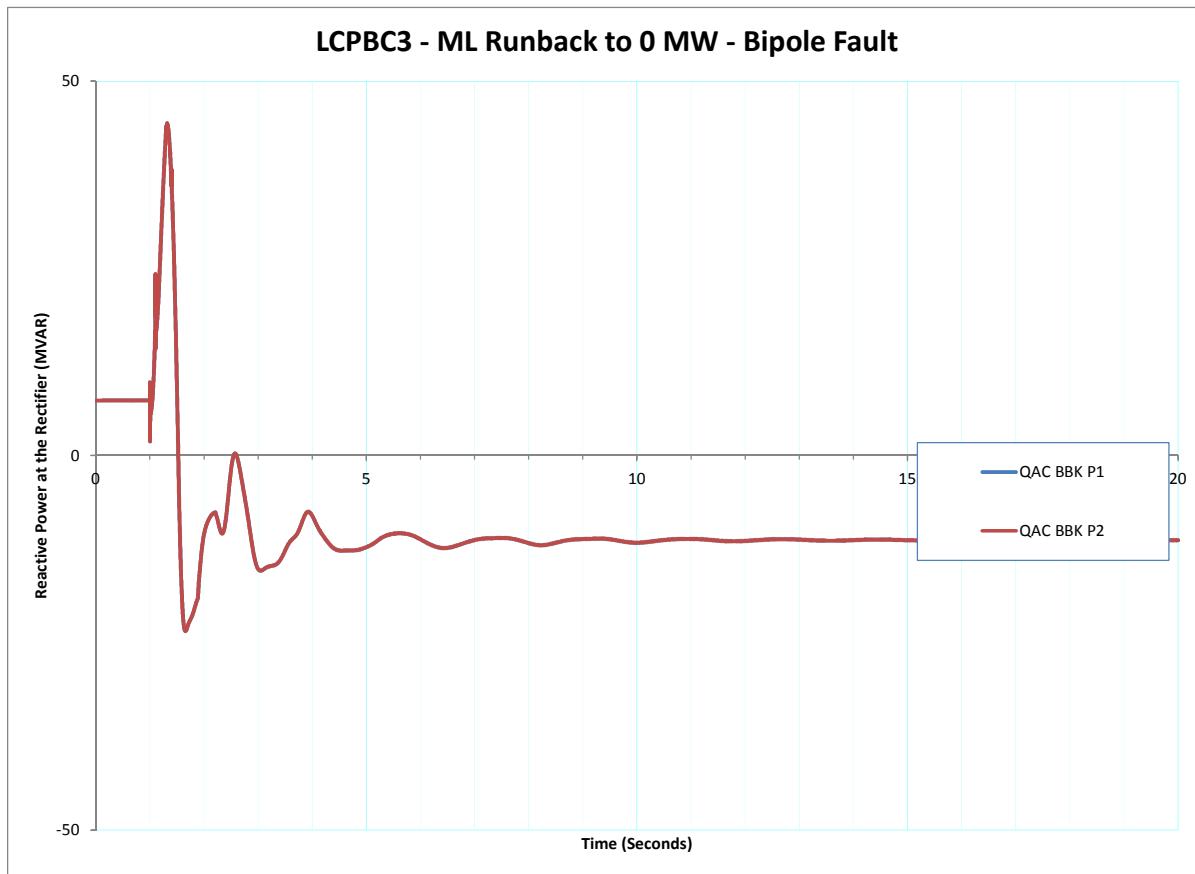
Figure 236 - LCPBC3 - ML Runback to 0 MW - Bipole Fault - Reactive Power at the Rectifier (MVAR)

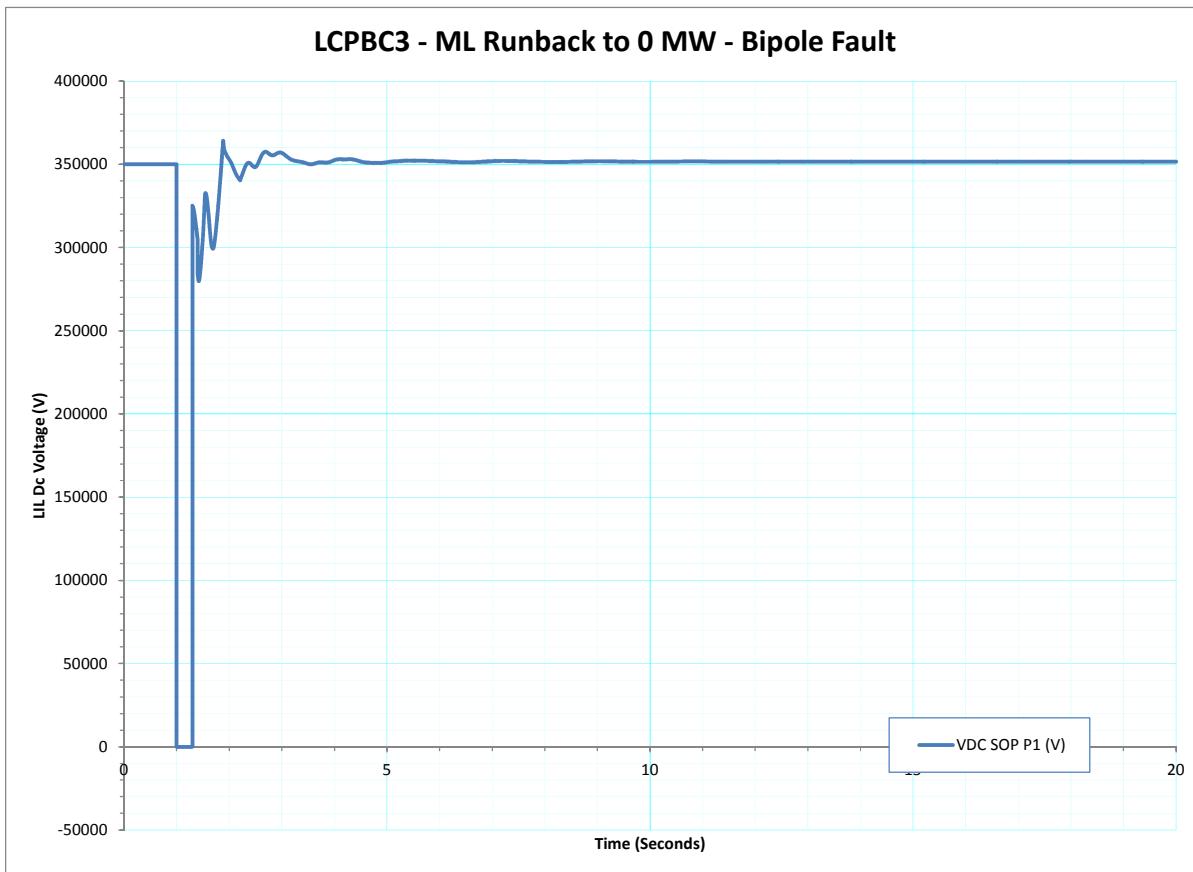
Figure 237 - LCPBC3 - ML Runback to 0 MW - Bipole Fault - LIL Dc Voltage (V)

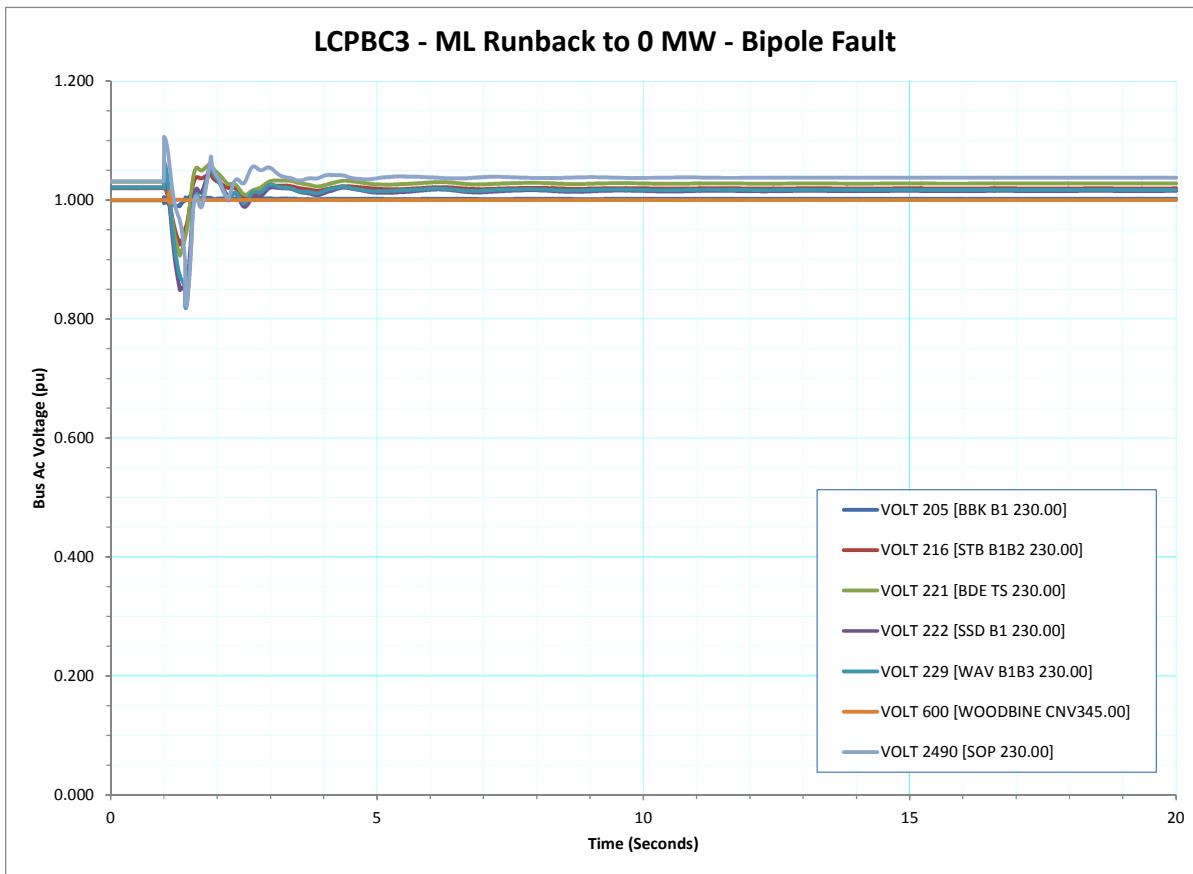
Figure 238 - LCPBC3 - ML Runback to 0 MW - Bipole Fault - Bus Ac Voltage (pu)

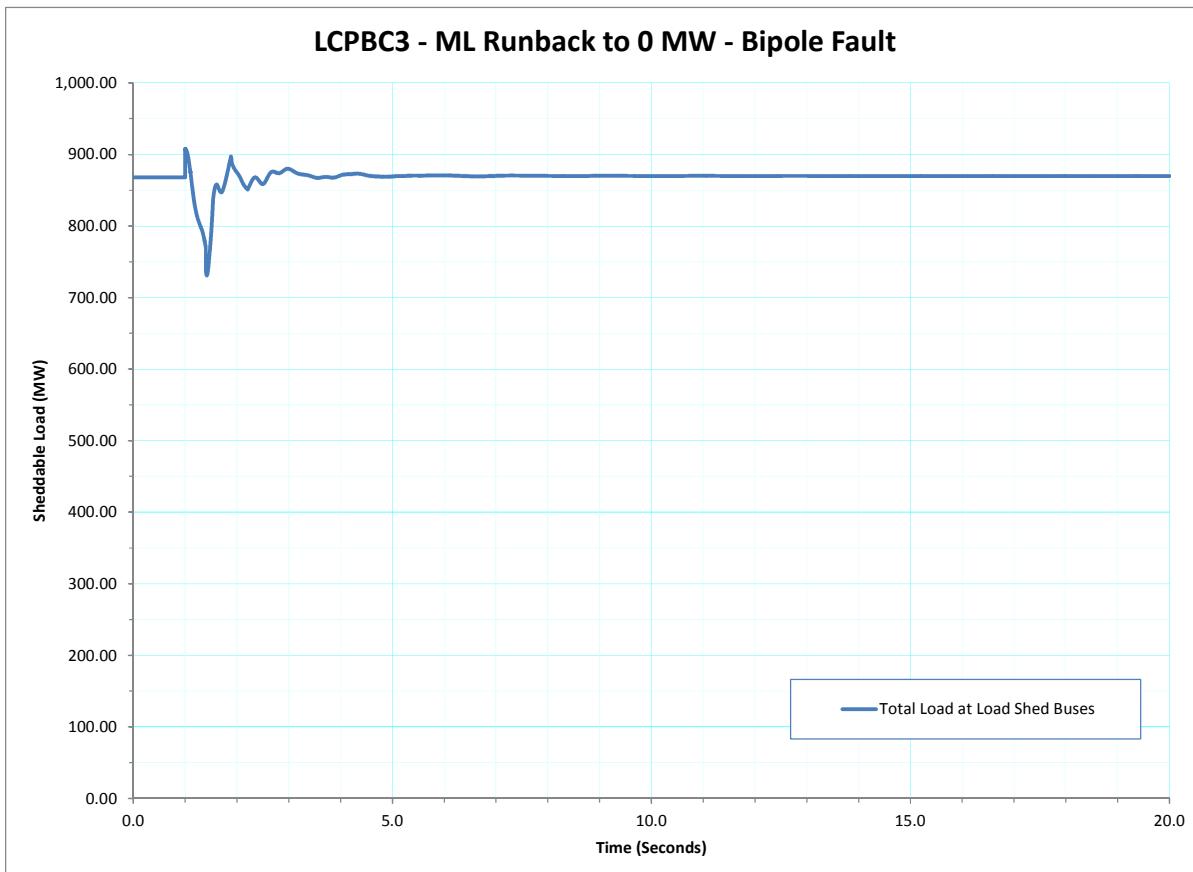
Figure 239 - LCPBC3 - ML Runback to 0 MW - Bipole Fault - Shedtable Load (MW)

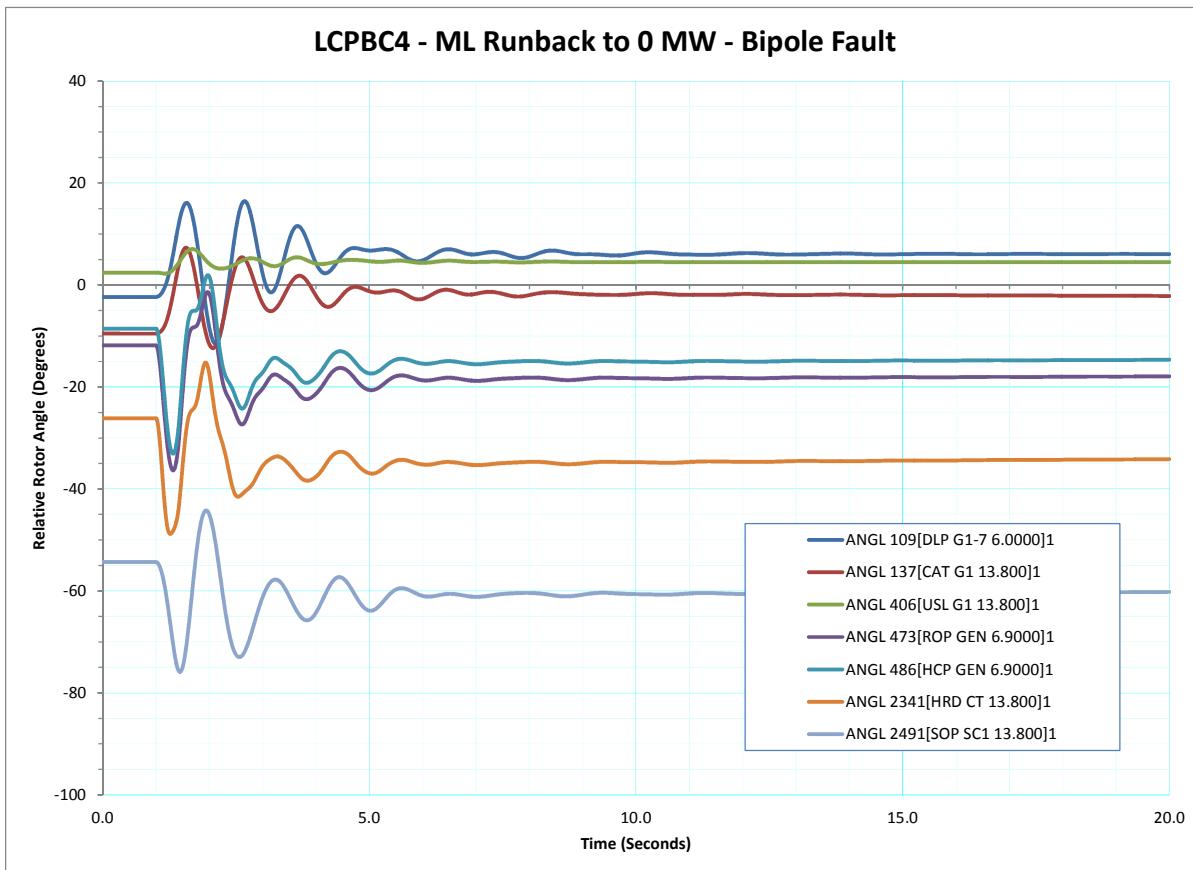
Figure 240 - LCPBC4 - ML Runback to 0 MW - Bipole Fault - Relative Rotor Angle (Degrees)

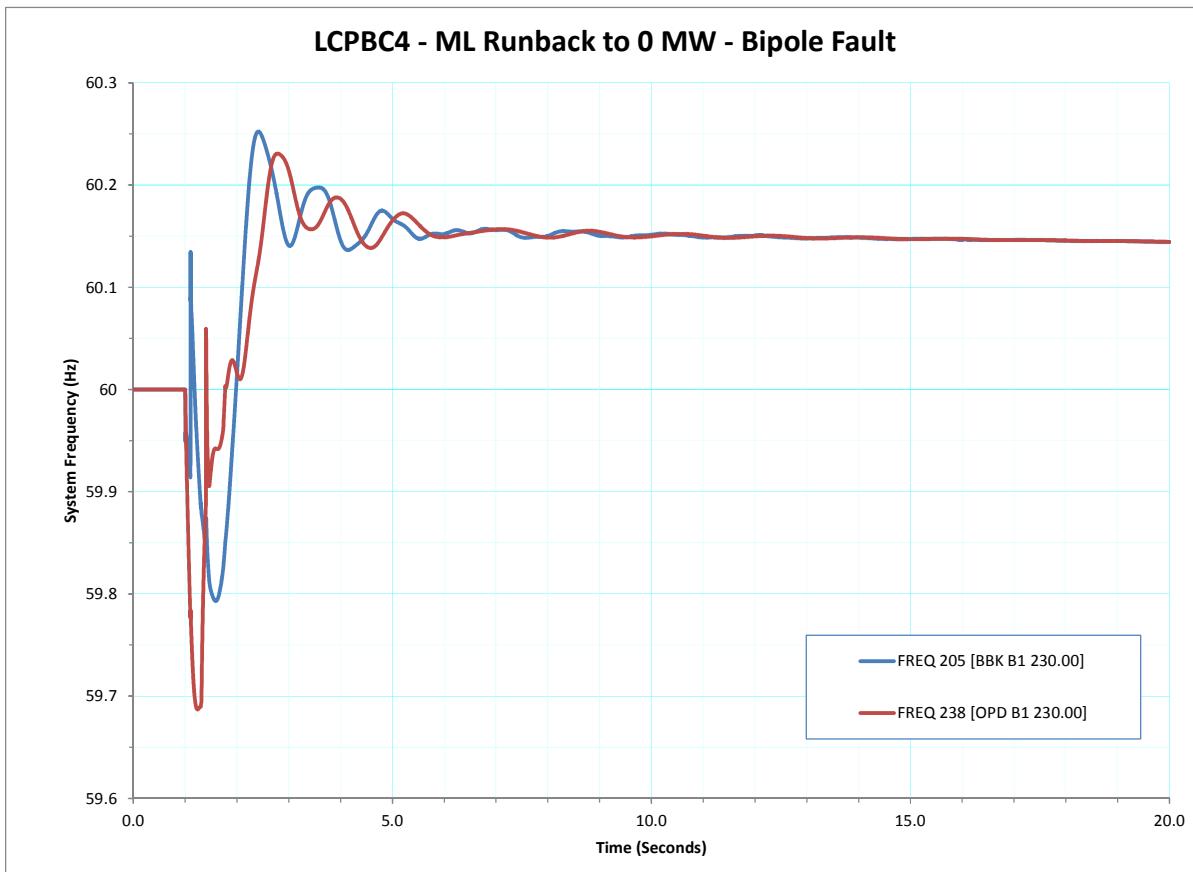
Figure 241 - LCPBC4 - ML Runback to 0 MW - Bipole Fault - System Frequency (Hz)

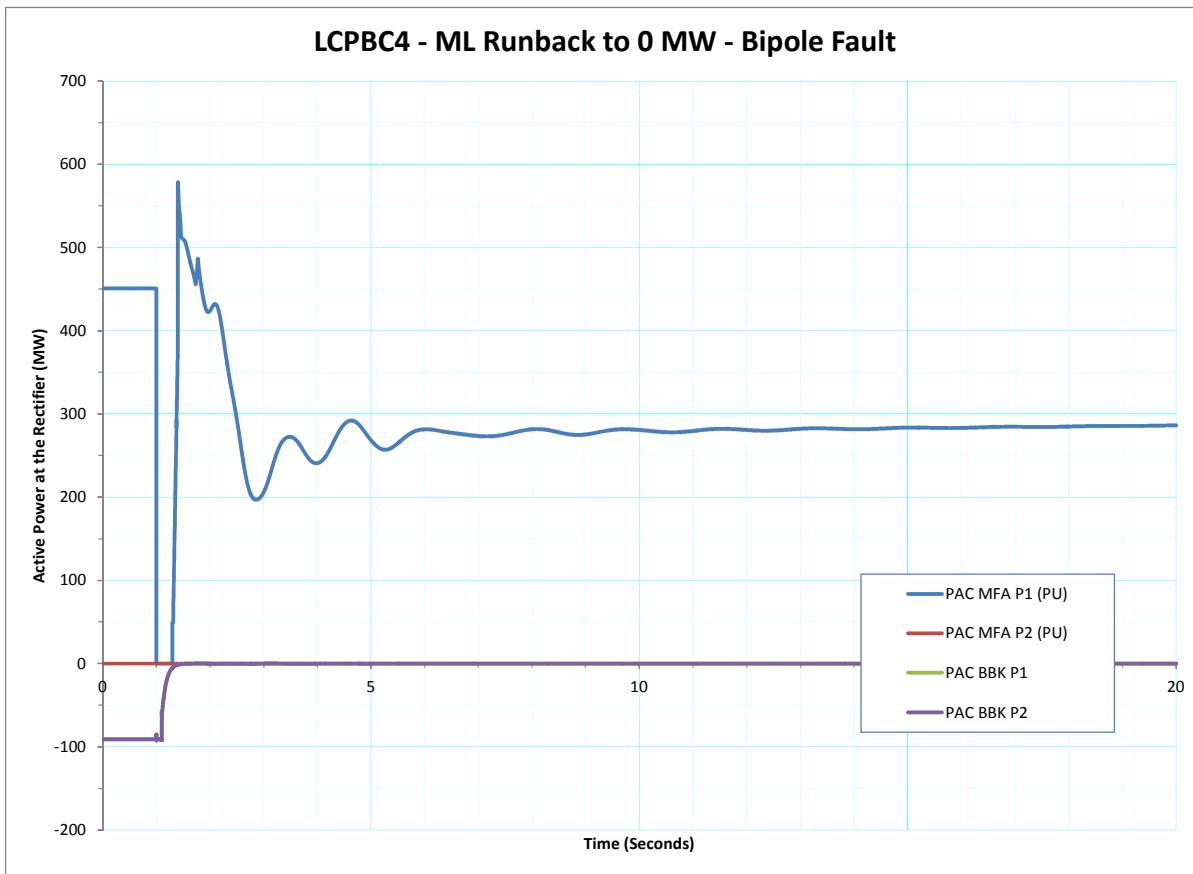
Figure 242 - LCPBC4 - ML Runback to 0 MW - Bipole Fault - Active Power at the Rectifier (MW)

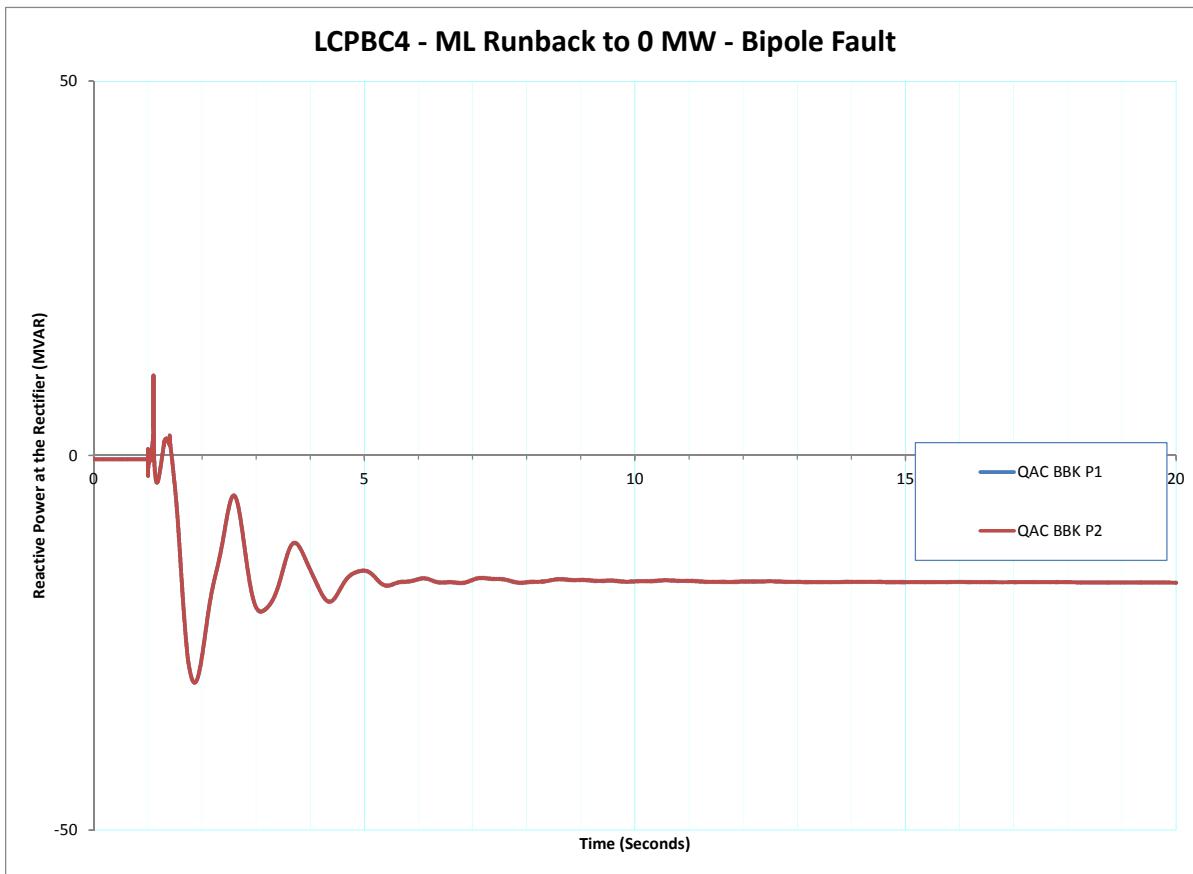
Figure 243 - LCPBC4 - ML Runback to 0 MW - Bipole Fault - Reactive Power at the Rectifier (MVAR)

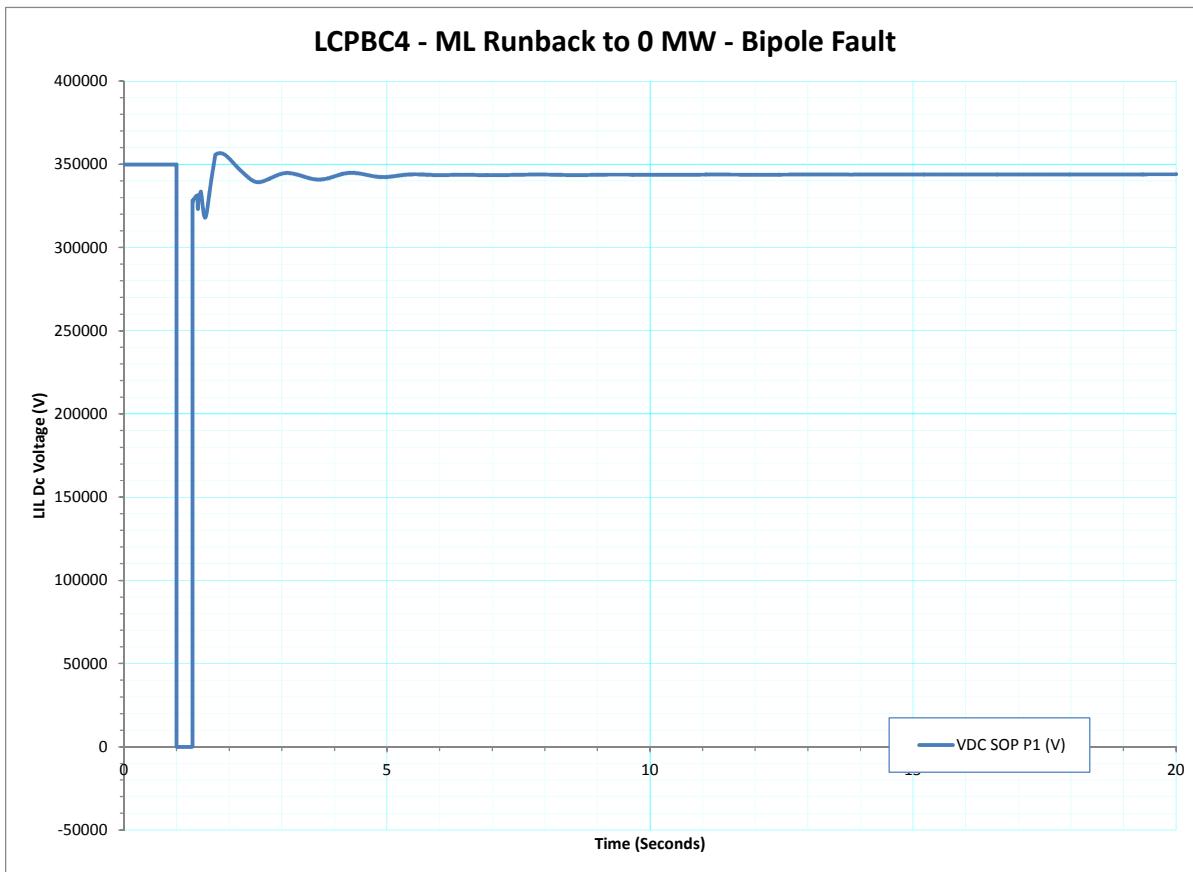
Figure 244 - LCPBC4 - ML Runback to 0 MW - Bipole Fault - LIL Dc Voltage (V)

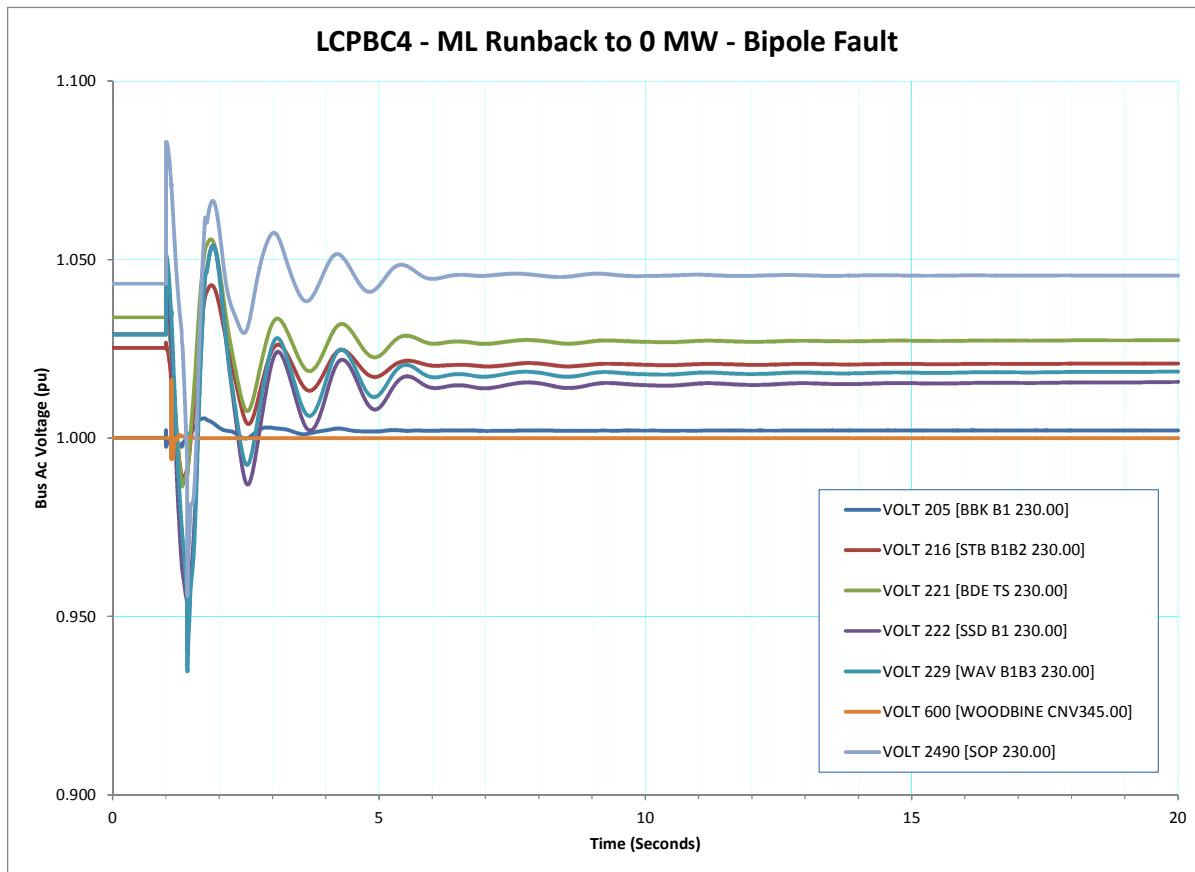
Figure 245 - LCPBC4 - ML Runback to 0 MW - Bipole Fault - Bus Ac Voltage (pu)

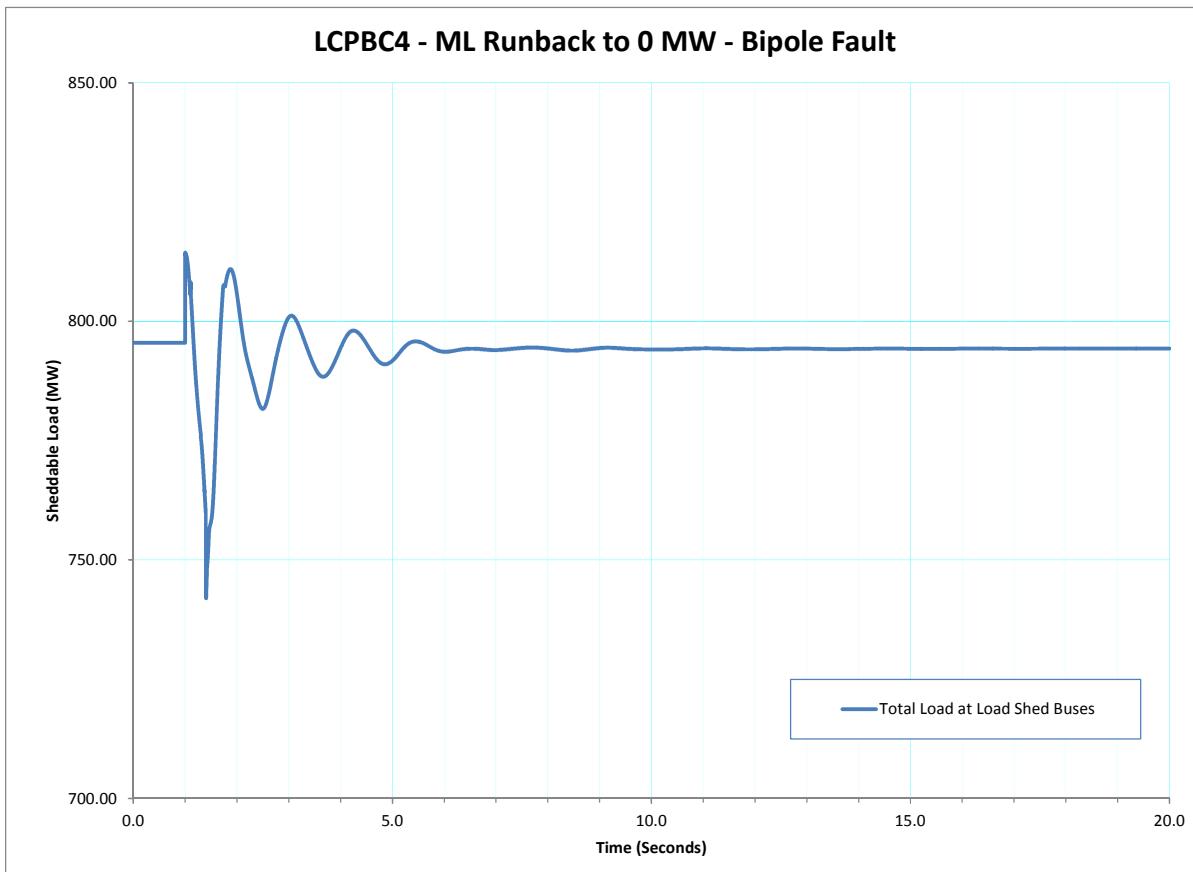
Figure 246 - LCPBC4 - ML Runback to 0 MW - Bipole Fault - Shedtable Load (MW)

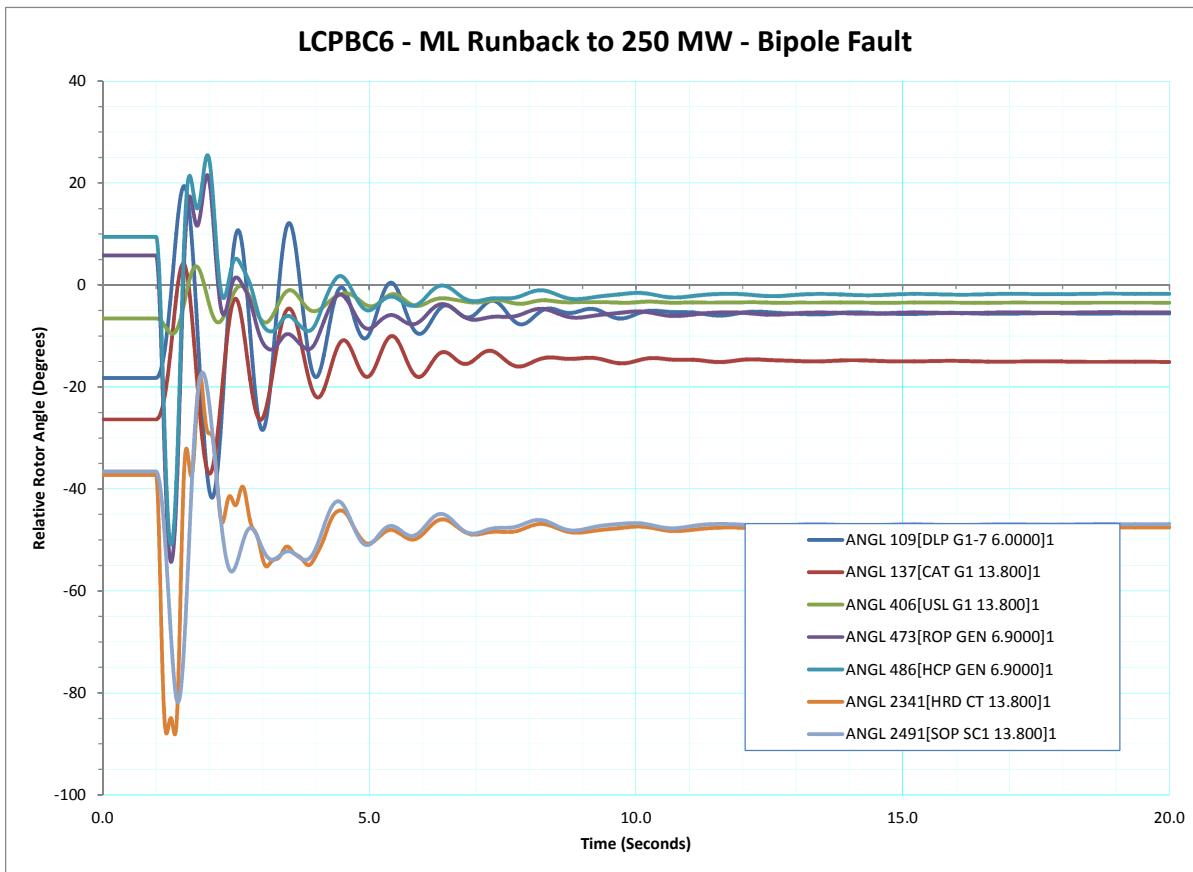
Figure 247 - LCPBC6 - ML Runback to 250 MW - Bipole Fault - Relative Rotor Angle (Degrees)

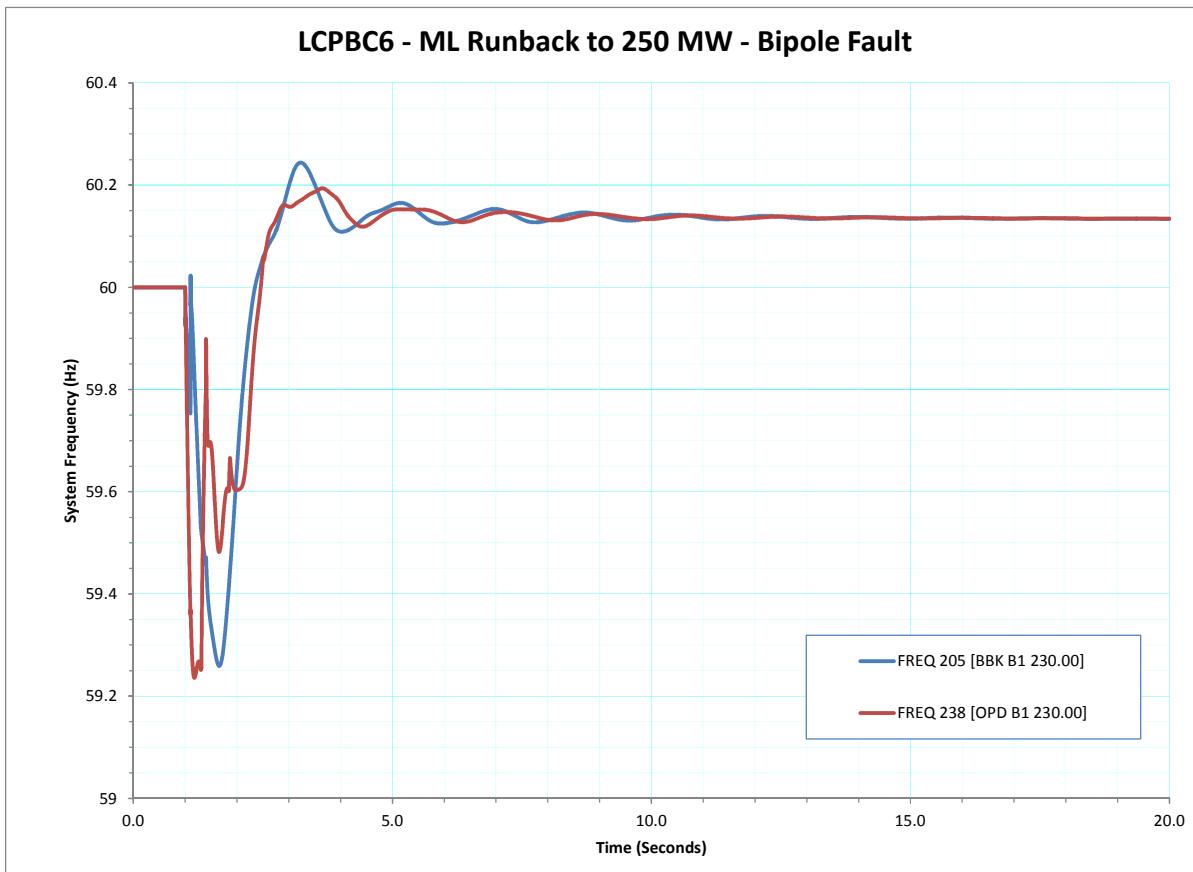
Figure 248 - LCPBC6 - ML Runback to 250 MW - Bipole Fault - System Frequency (Hz)

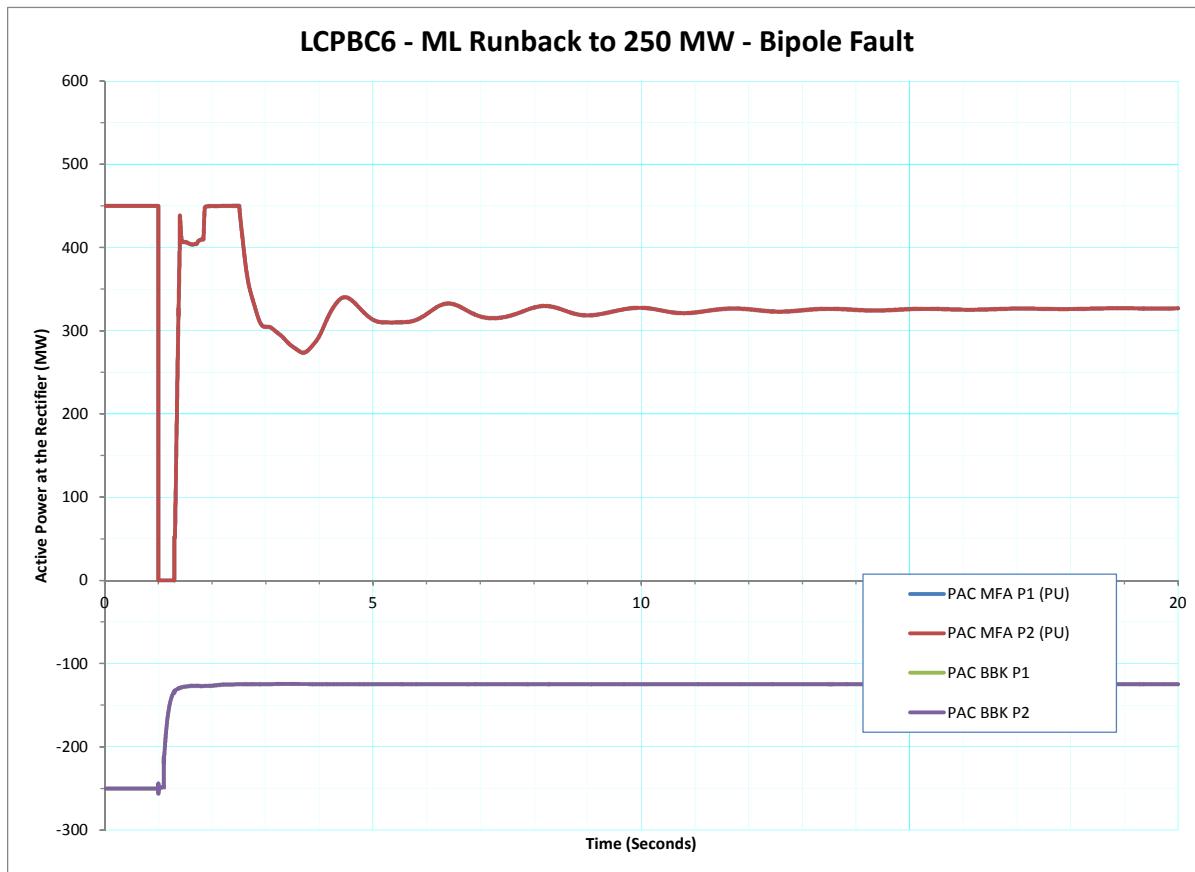
Figure 249 - LCPBC6 - ML Runback to 250 MW - Bipole Fault - Active Power at the Rectifier (MW)

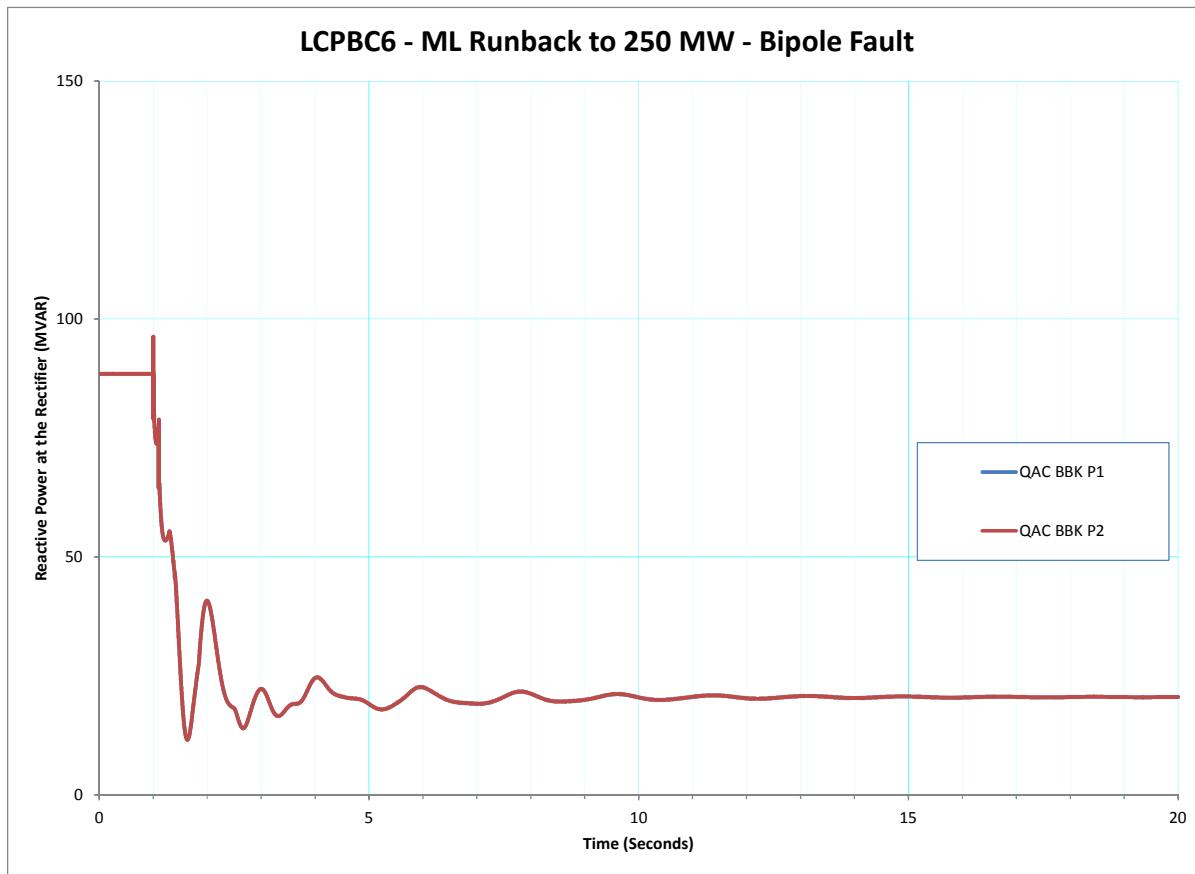
Figure 250 - LCPBC6 - ML Runback to 250 MW - Bipole Fault - Reactive Power at the Rectifier (MVAR)

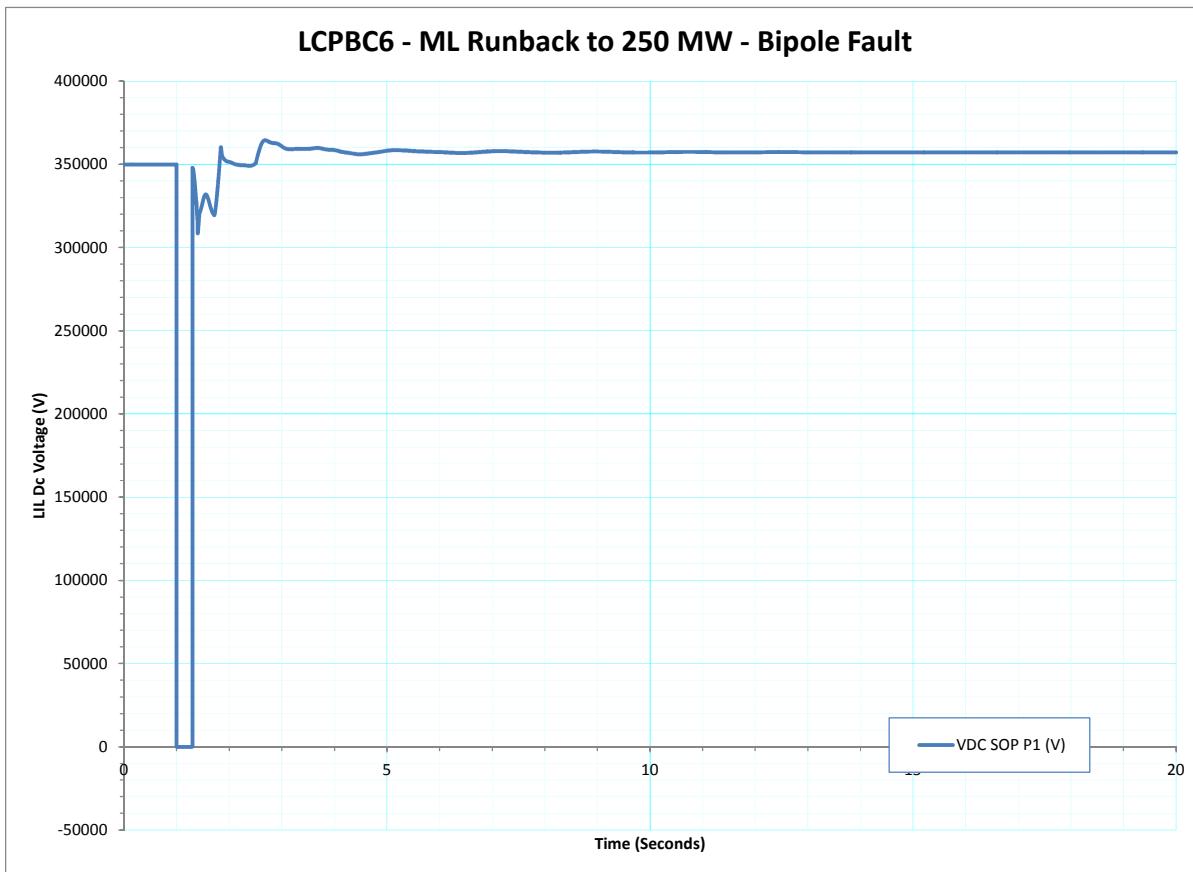
Figure 251 - LCPBC6 - ML Runback to 250 MW - Bipole Fault - LIL Dc Voltage (V)

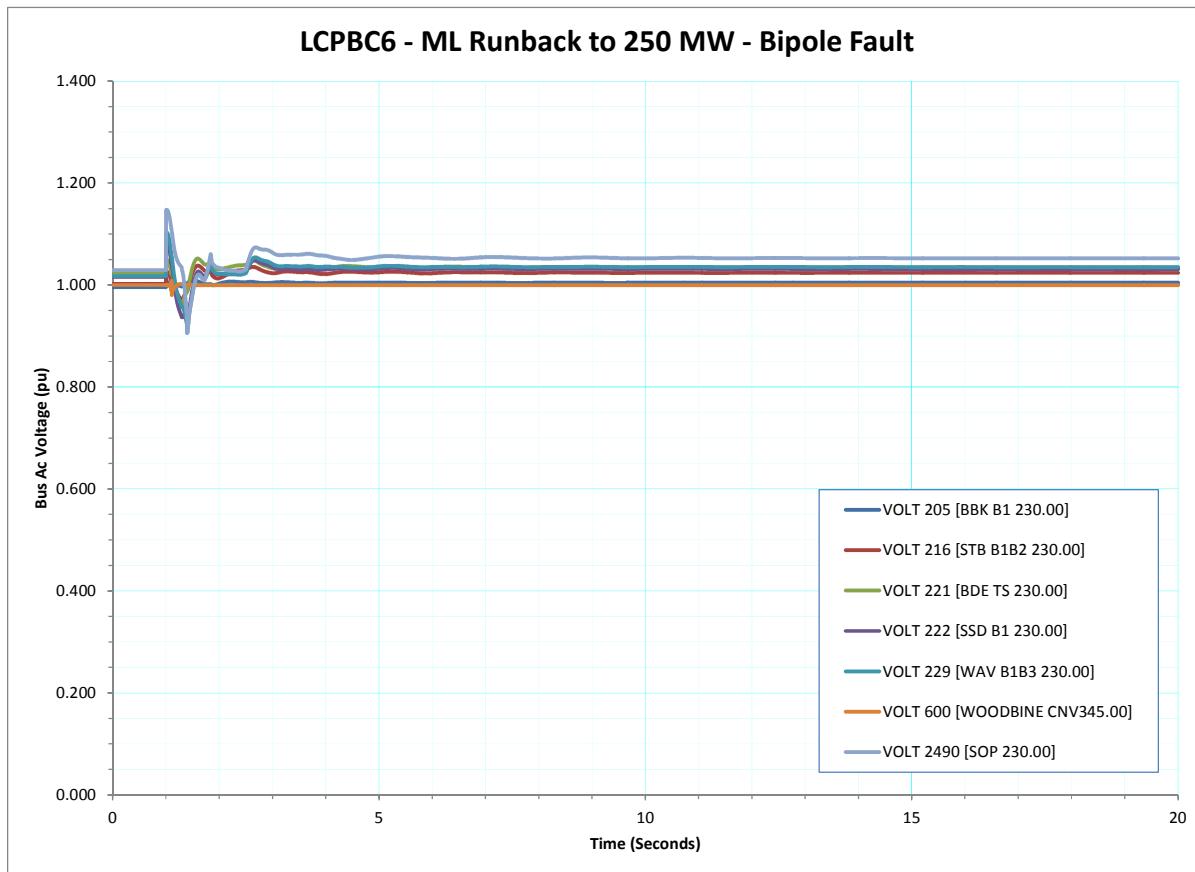
Figure 252 - LCPBC6 - ML Runback to 250 MW - Bipole Fault - Bus Ac Voltage (pu)
