MARITIME LINK PRELIMINARY INTERCONNECTION STUDY

Newfoundland and Labrador Hydro

July 2014

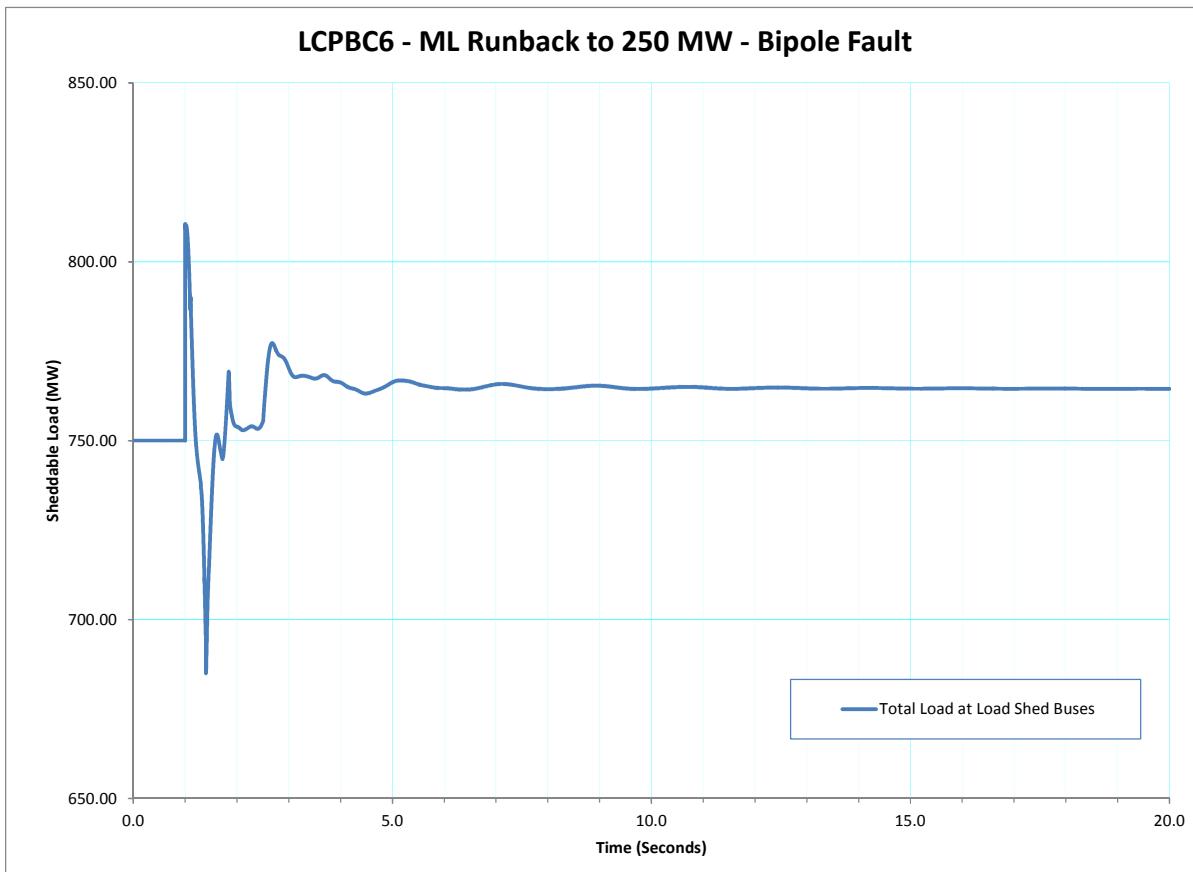
Figure 253 - LCPBC6 - ML Runback to 250 MW - Bipole Fault - Sheddable Load (MW)

The curtailment of ML export helps to maintain system stability and to improve system performance. Appendix D contains transient stability plots demonstrating system performance in all base cases when the ML export is curtailed. In BC6 and BC7, the curtailment of ML export from 500 MW to 250 MW was sufficient to eliminate UFLS. In monopolar cases (BC4 and BC10), ML export must be curtailed to 0 MW to ensure that there are no LIL commutation failures.

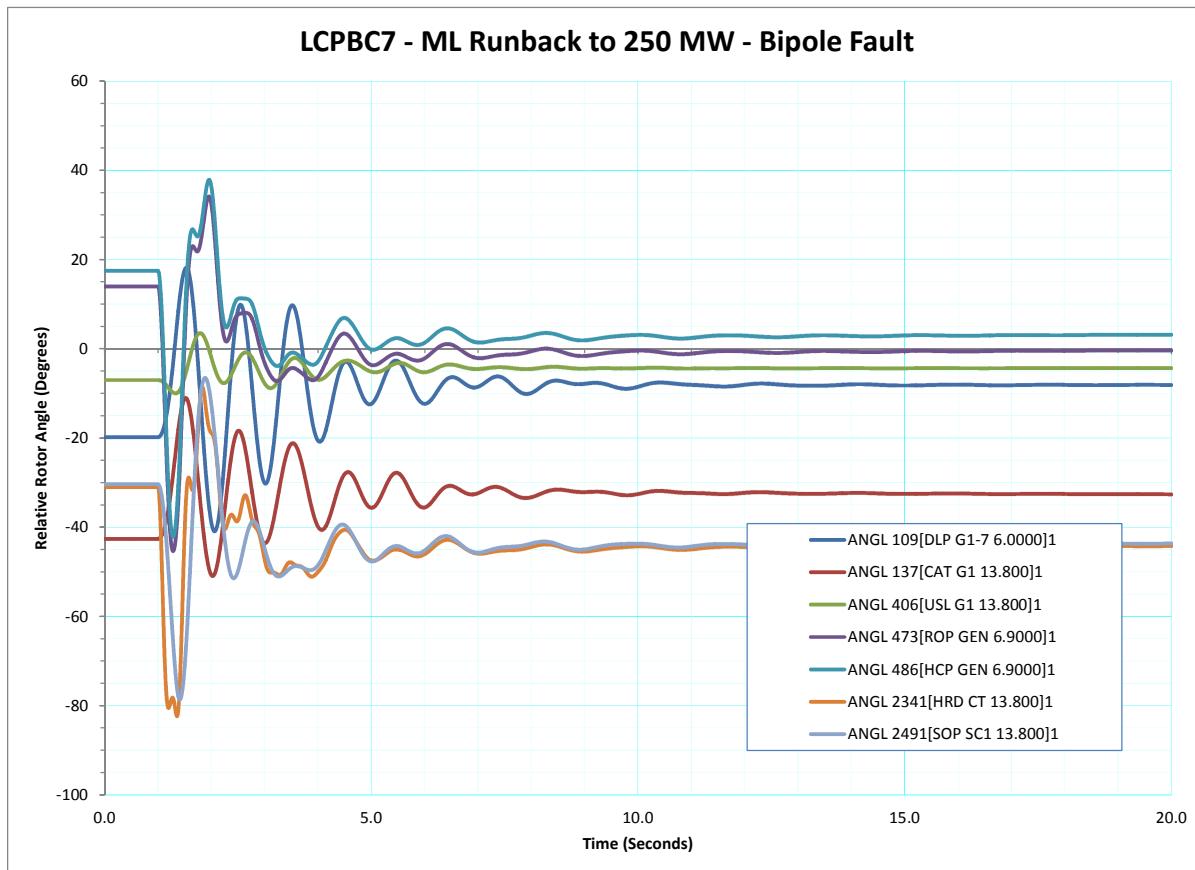
Figure 254 - LCPBC7 - ML Runback to 250 MW - Bipole Fault - Relative Rotor Angle (Degrees)

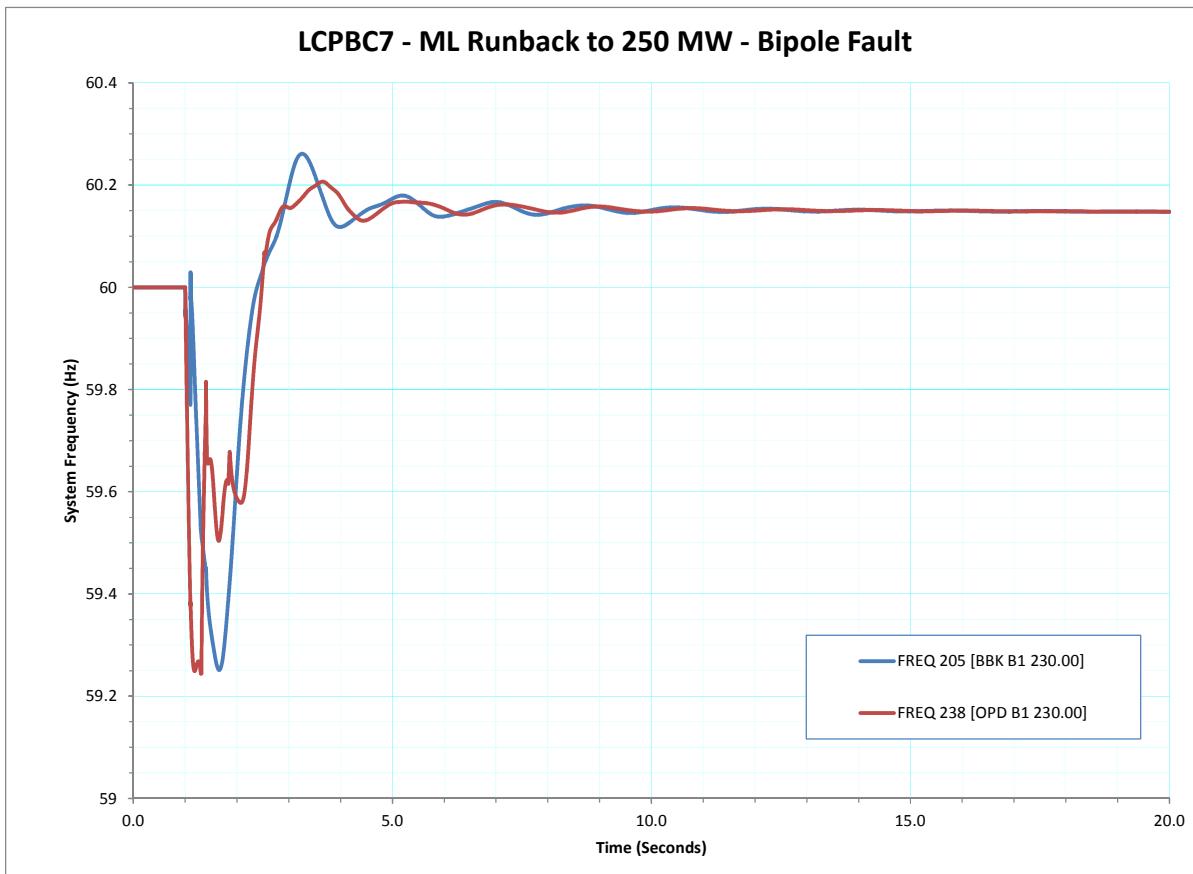
Figure 255 - LCPBC7 - ML Runback to 250 MW - Bipole Fault - System Frequency (Hz)

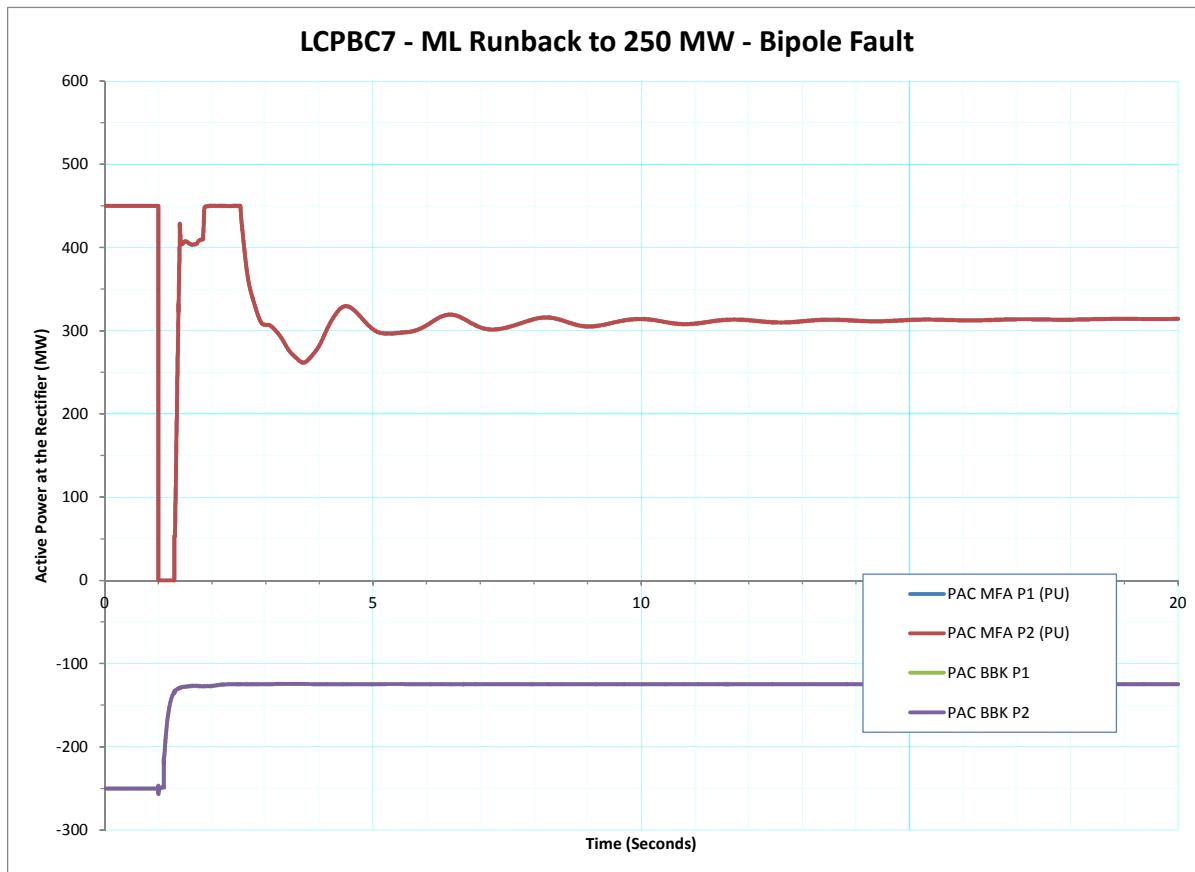
Figure 256 - LCPBC7 - ML Runback to 250 MW - Bipole Fault - Active Power at the Rectifier (MW)

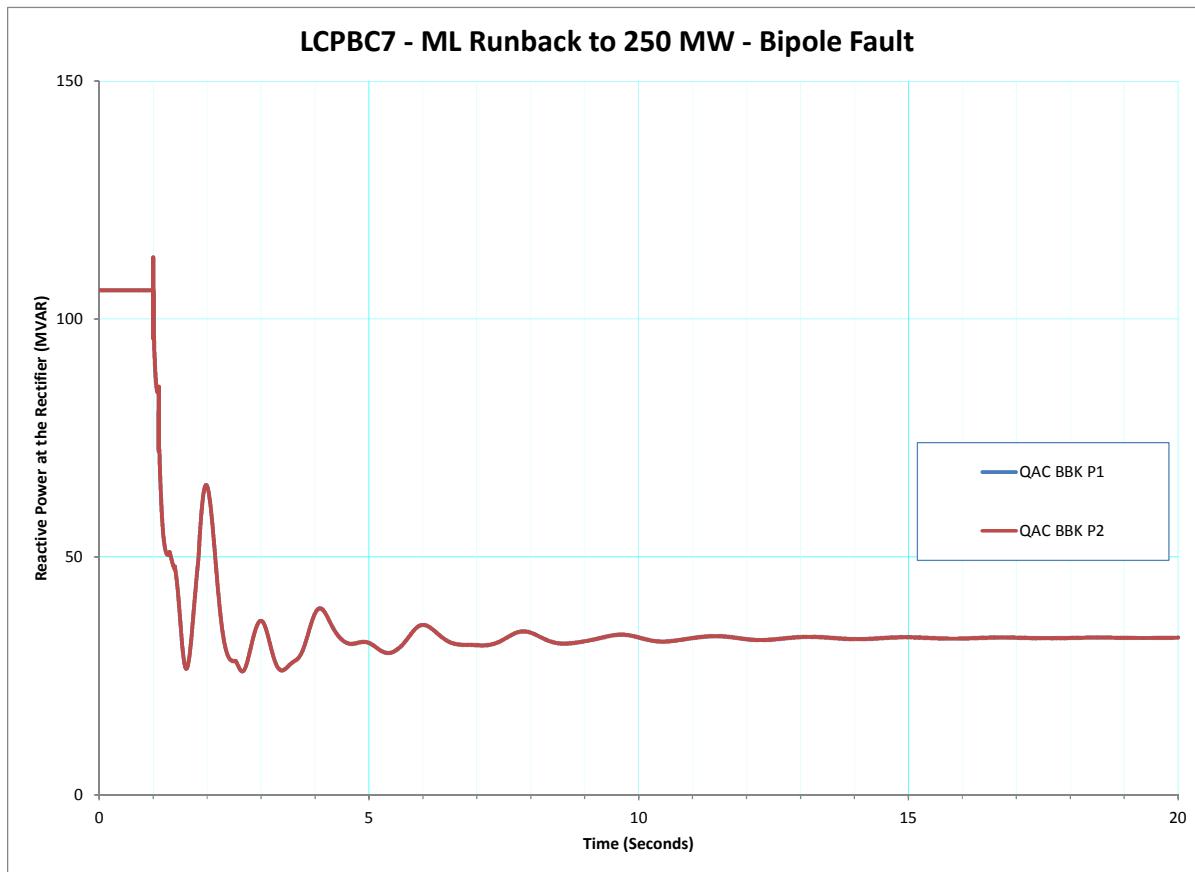
Figure 257 - LCPBC7 - ML Runback to 250 MW - Bipole Fault - Reactive Power at the Rectifier (MVAR)

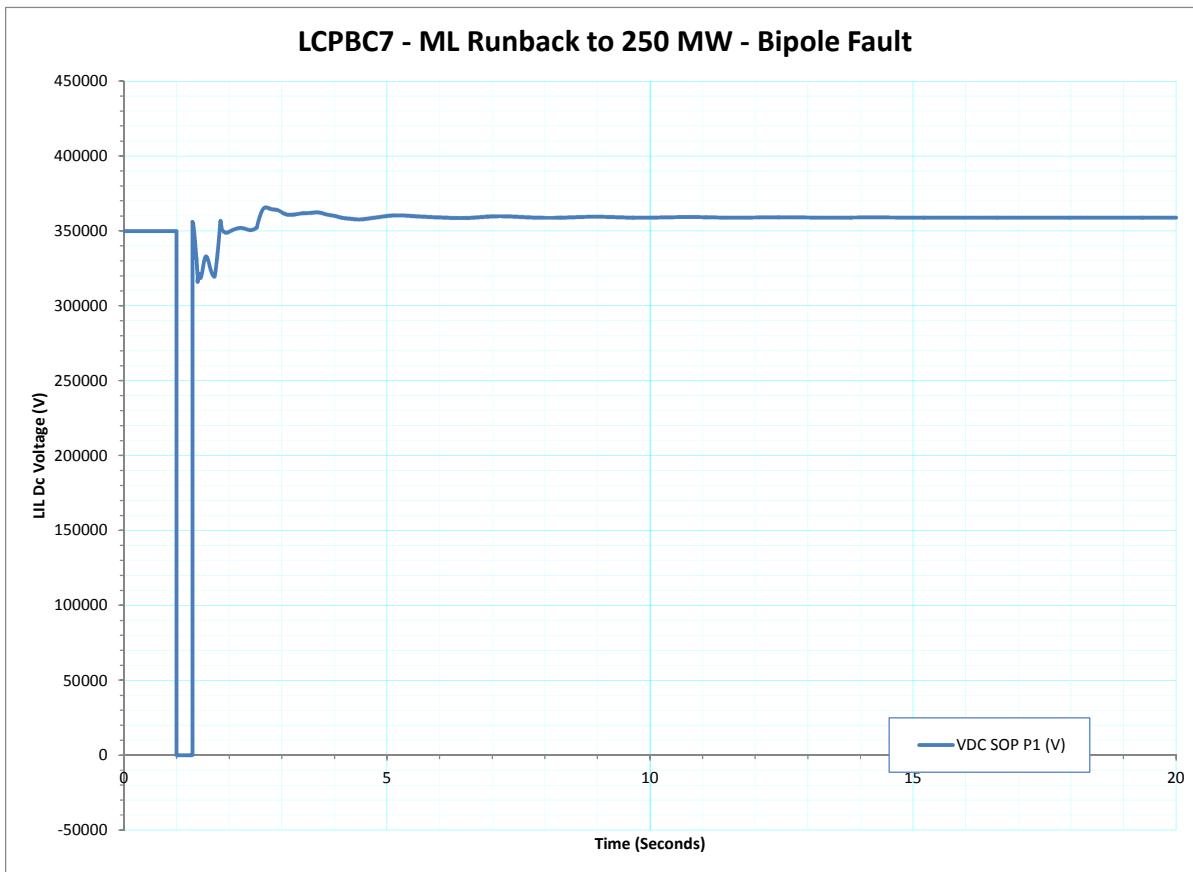
Figure 258 - LCPBC7 - ML Runback to 250 MW - Bipole Fault - LIL Dc Voltage (V)

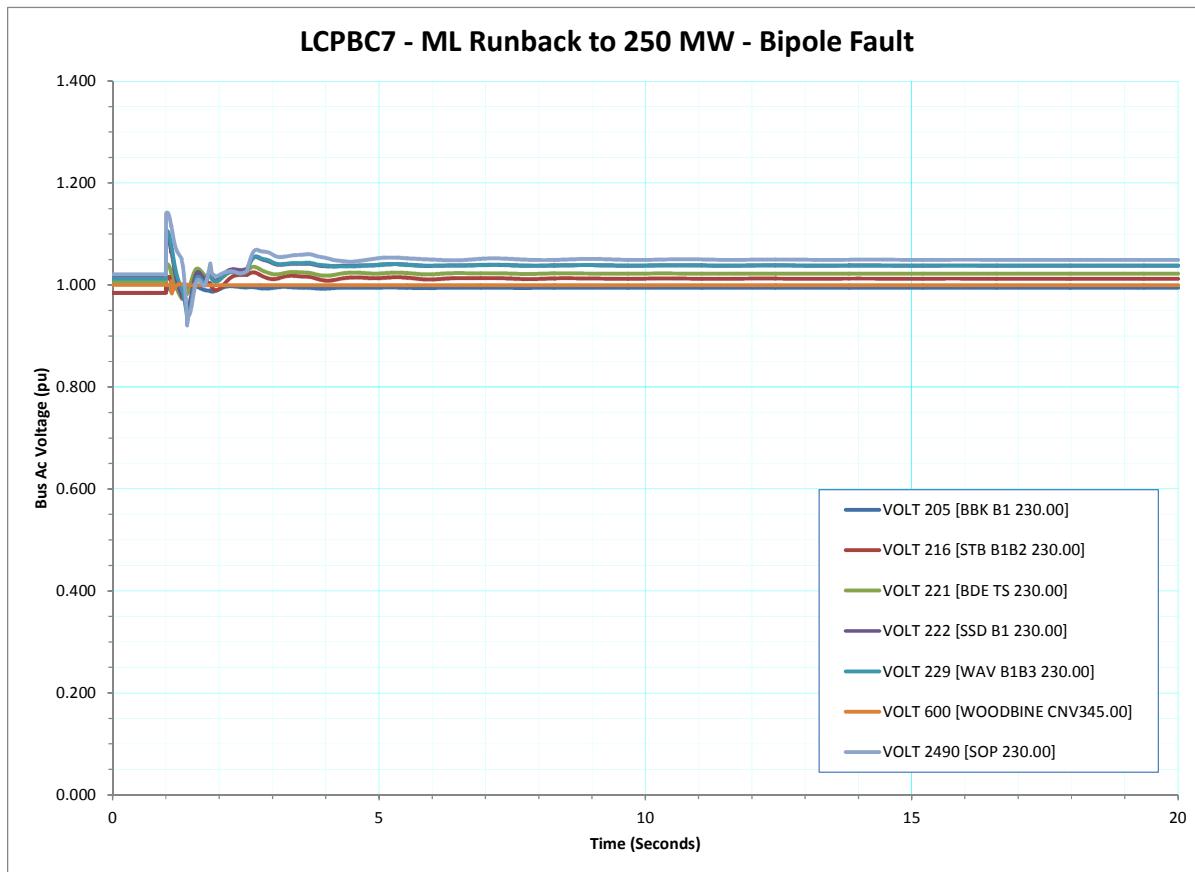
Figure 259 - LCPBC7 - ML Runback to 250 MW - Bipole Fault - Bus Ac Voltage (pu)

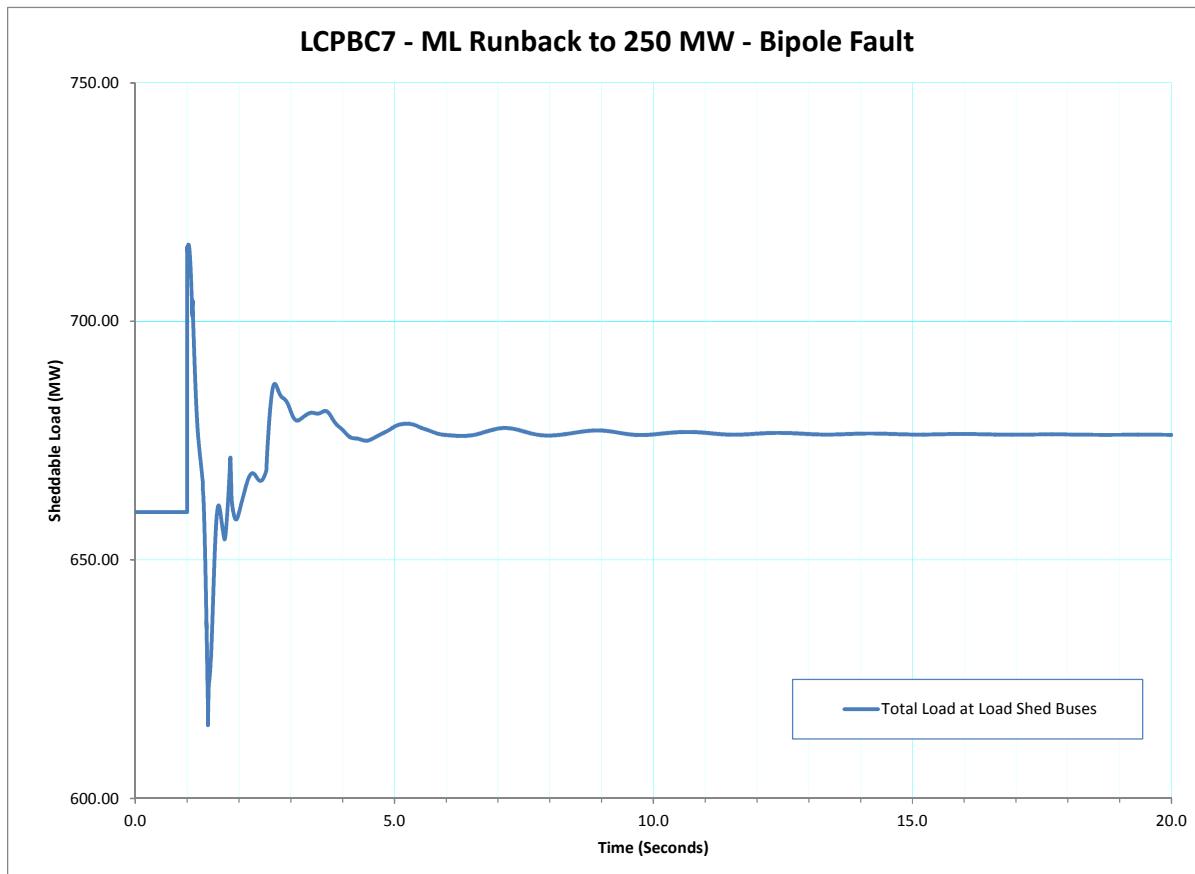
Figure 260 - LCPBC7 - ML Runback to 250 MW - Bipole Fault - Shedtable Load (MW)

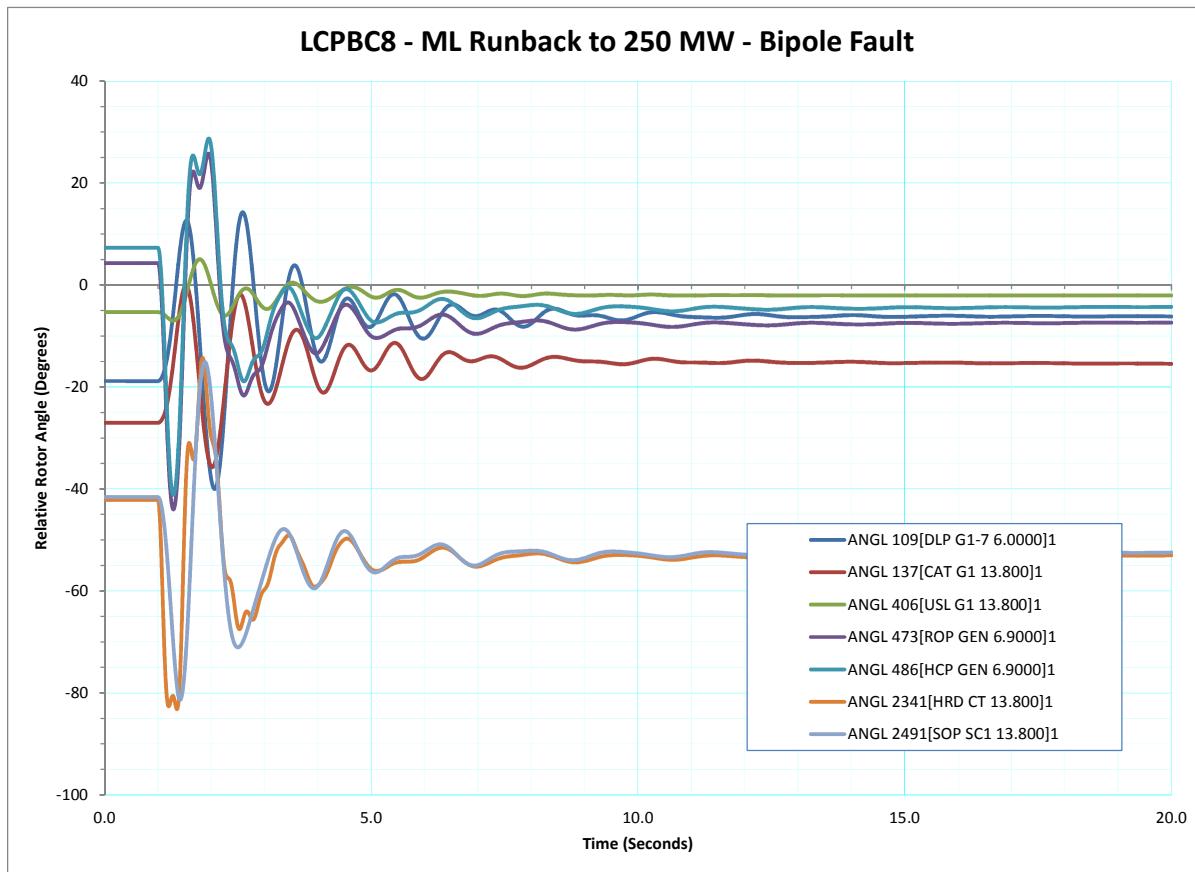
Figure 261 - LCPBC8 - ML Runback to 250 MW - Bipole Fault - Relative Rotor Angle (Degrees)

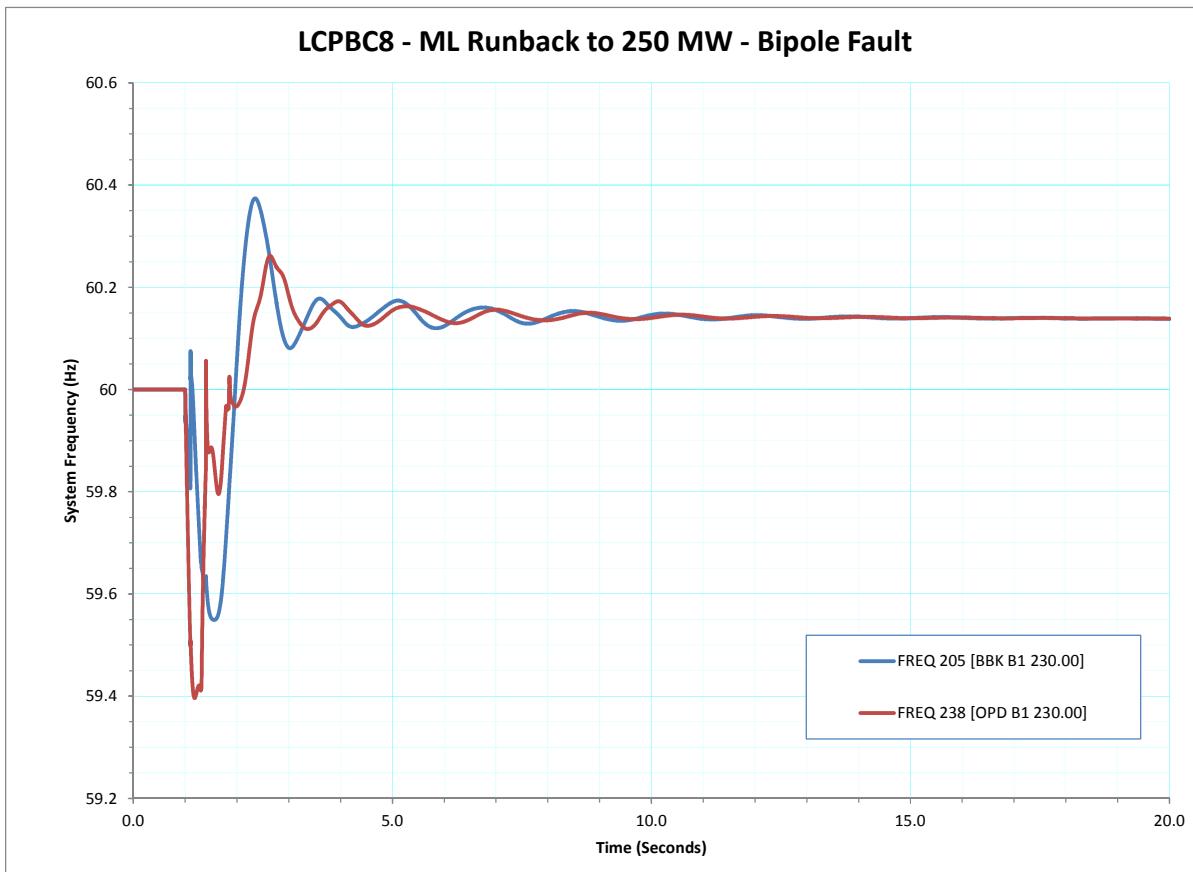
Figure 262 - LCPBC8 - ML Runback to 250 MW - Bipole Fault - System Frequency (Hz)

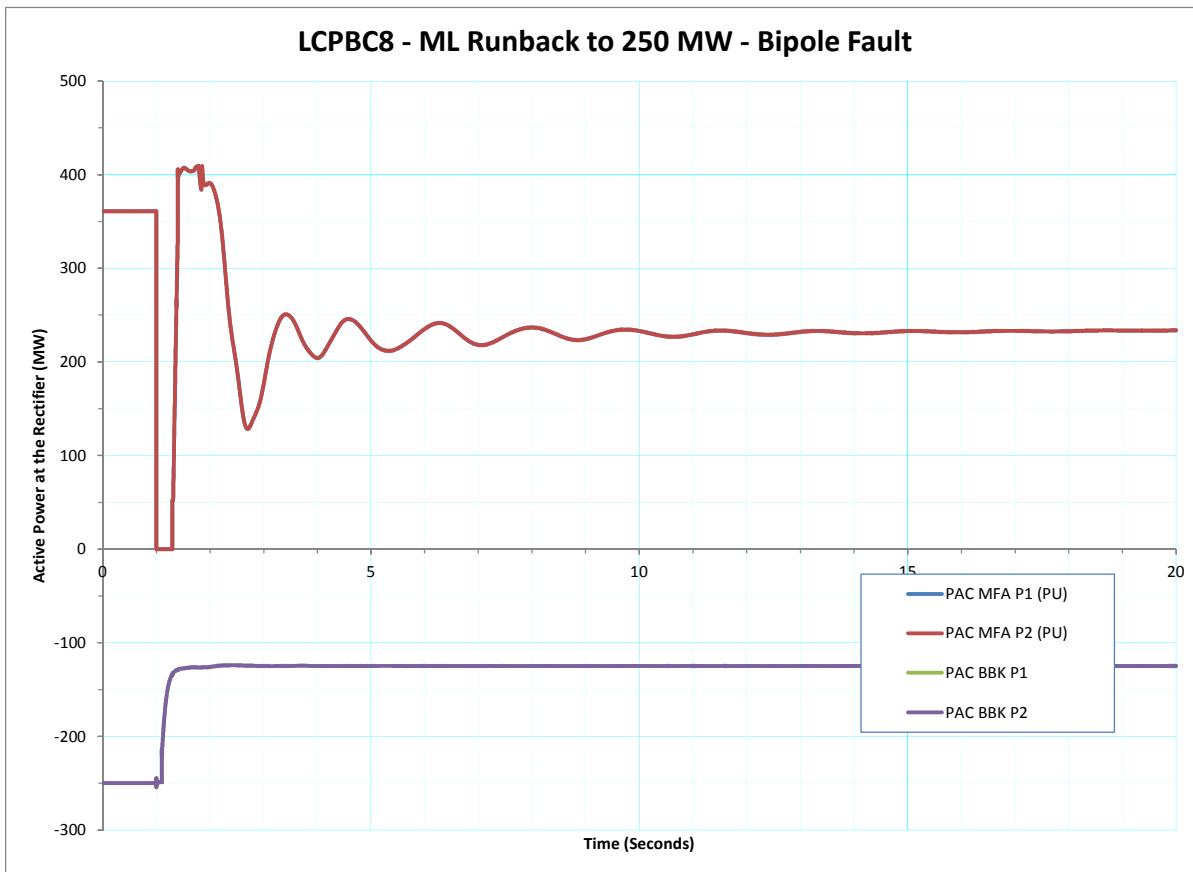
Figure 263 - LCPBC8 - ML Runback to 250 MW - Bipole Fault - Active Power at the Rectifier (MW)

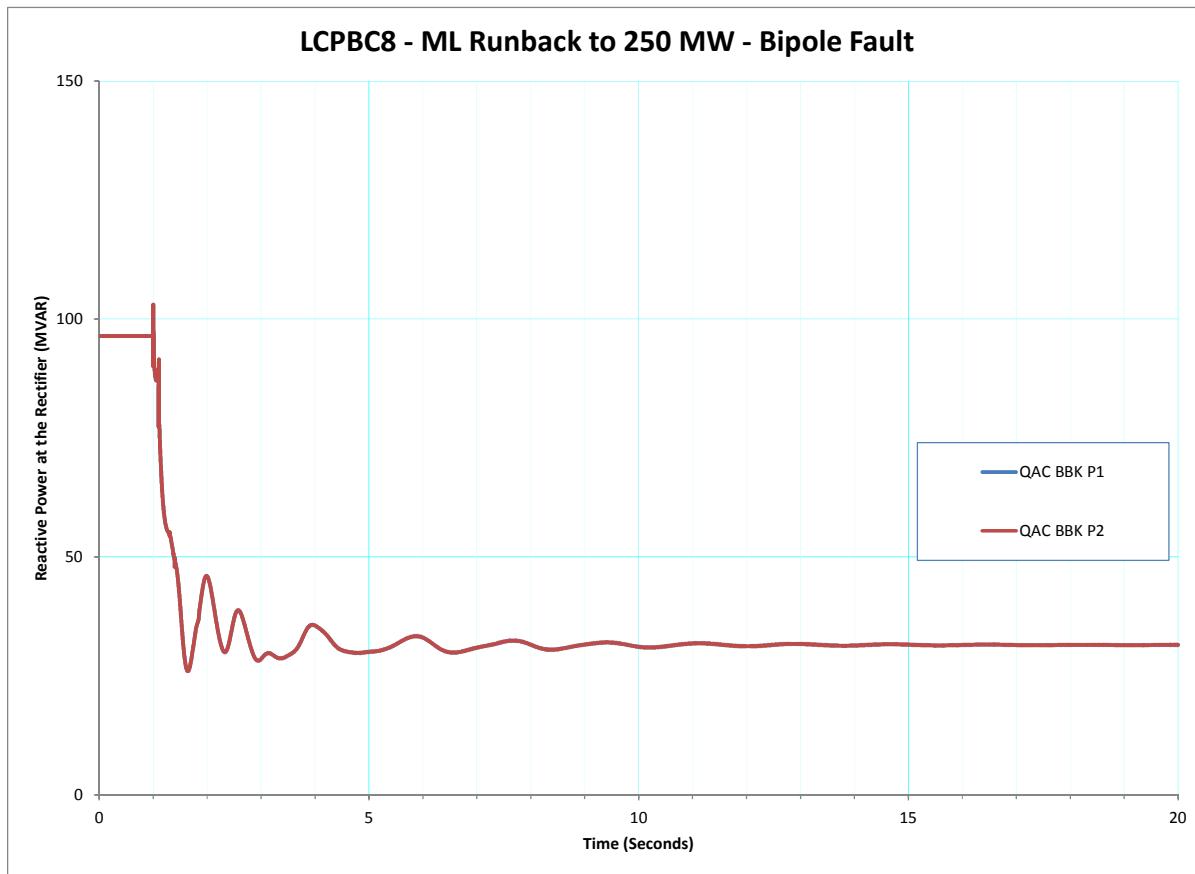
Figure 264 - LCPBC8 - ML Runback to 250 MW - Bipole Fault - Reactive Power at the Rectifier (MVAR)

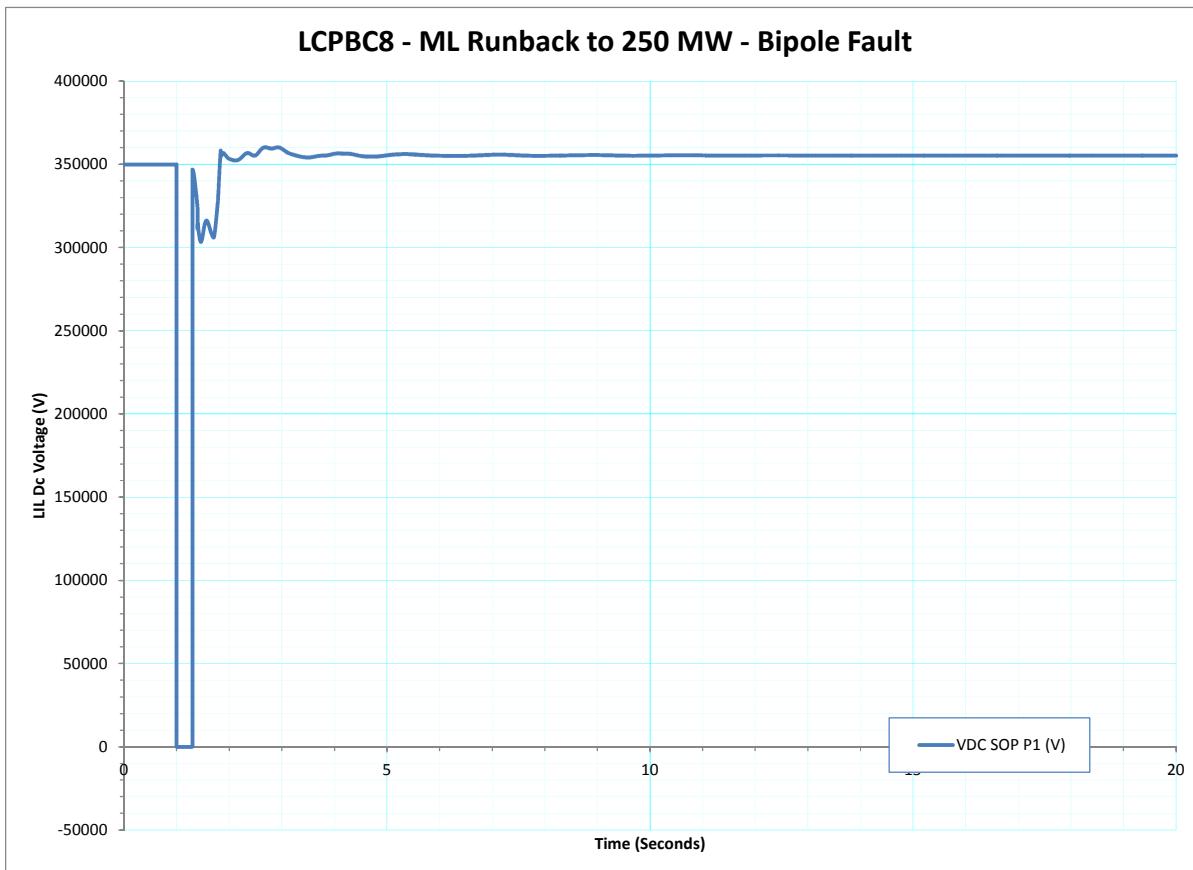
Figure 265 - LCPBC8 - ML Runback to 250 MW - Bipole Fault - LIL Dc Voltage (V)

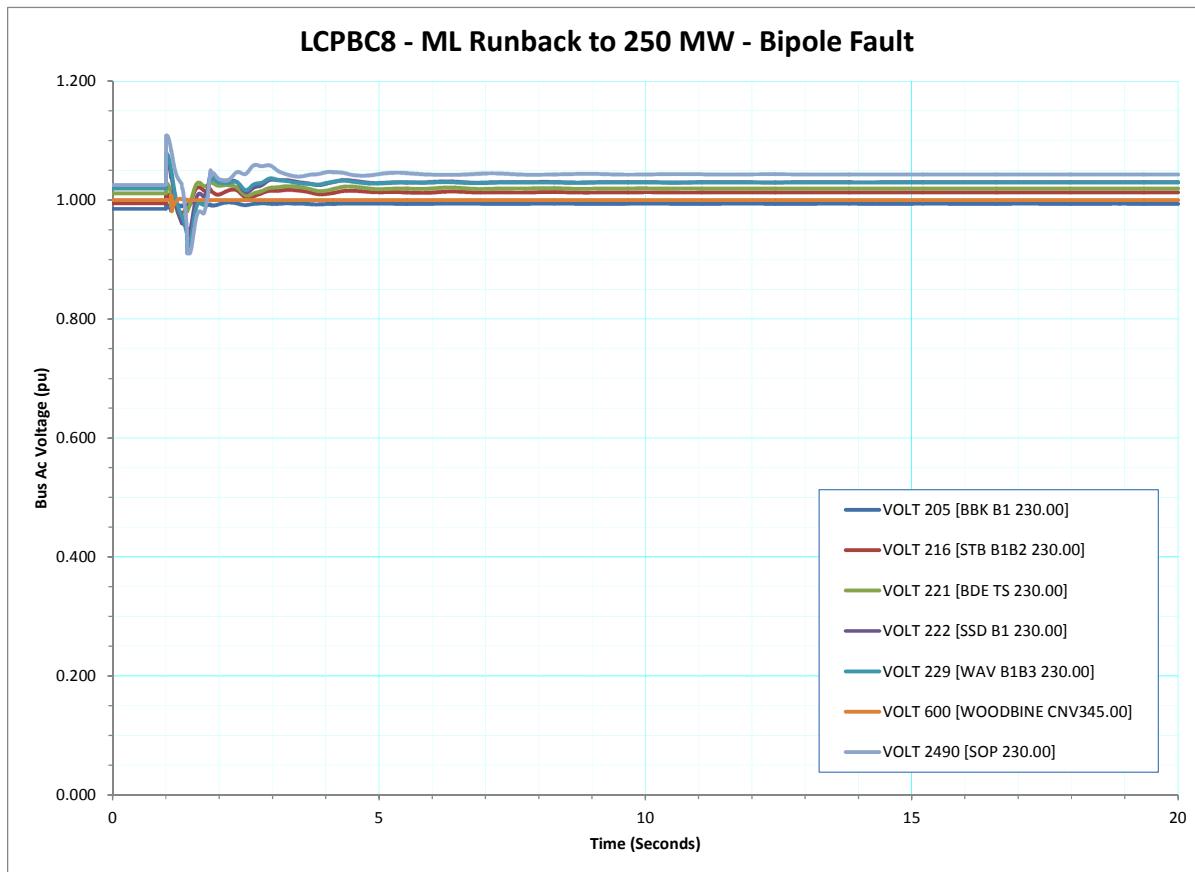
Figure 266 - LCPBC8 - ML Runback to 250 MW - Bipole Fault - Bus Ac Voltage (pu)

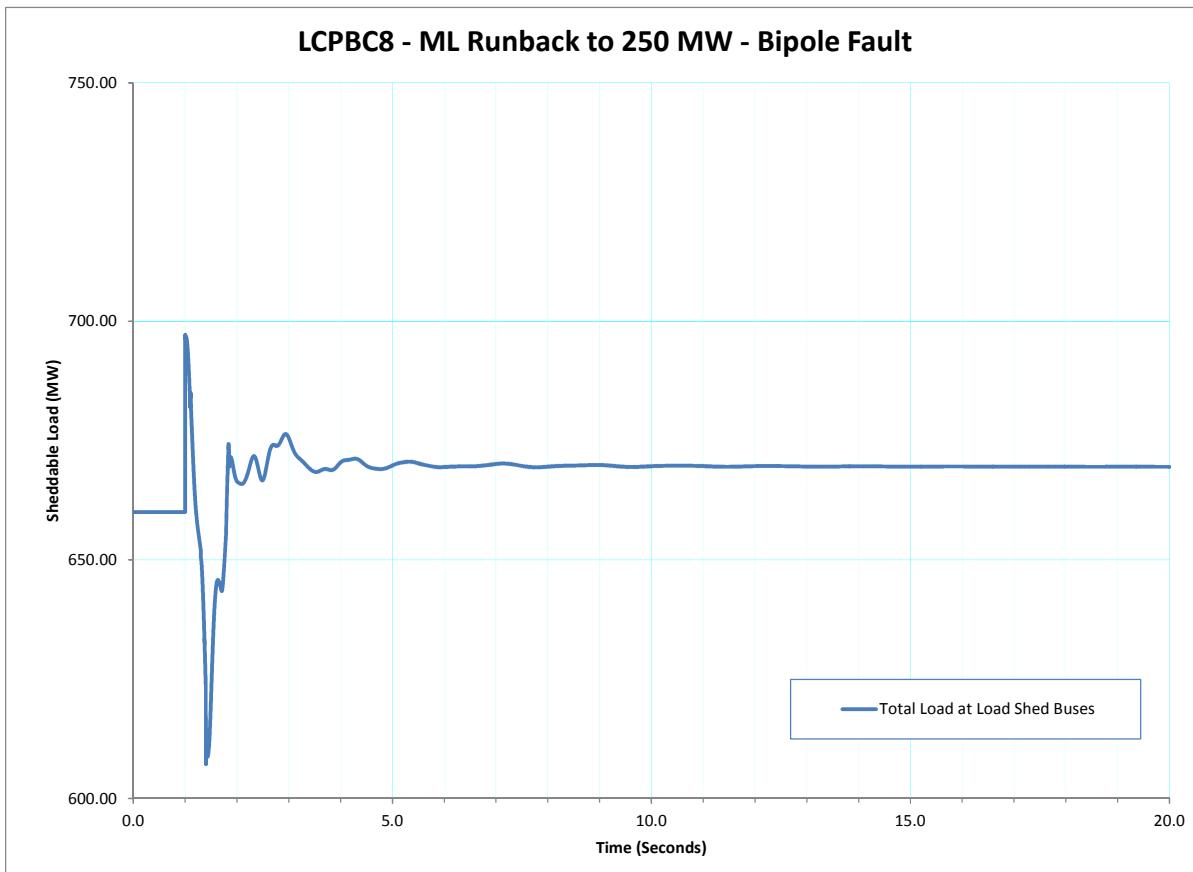
Figure 267 - LCPBC8 - ML Runback to 250 MW - Bipole Fault - Shedtable Load (MW)

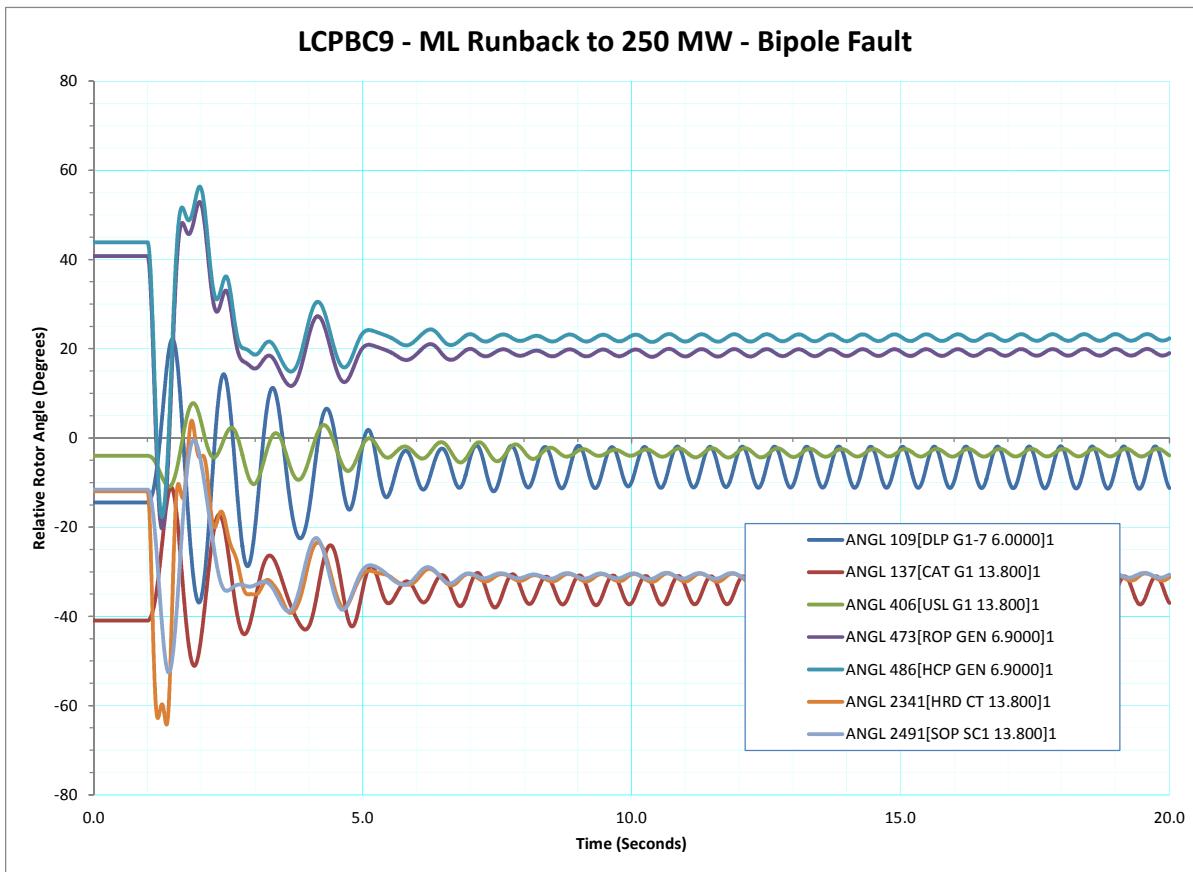
Figure 268 - LCPBC9 - ML Runback to 250 MW - Bipole Fault - Relative Rotor Angle (Degrees)

It should be noted that the curtailment of ML export resulted in an undamped system response for BC9. However, this base case represents an extreme operating scenario where both the LIL and ML are operating at rated capacity while minimal generation is dispatched within the Interconnected Island System. To avoid such a response, operating limitations must be defined for the system. Such limitations will ensure that extreme operating conditions are avoided and that system performance is acceptable.

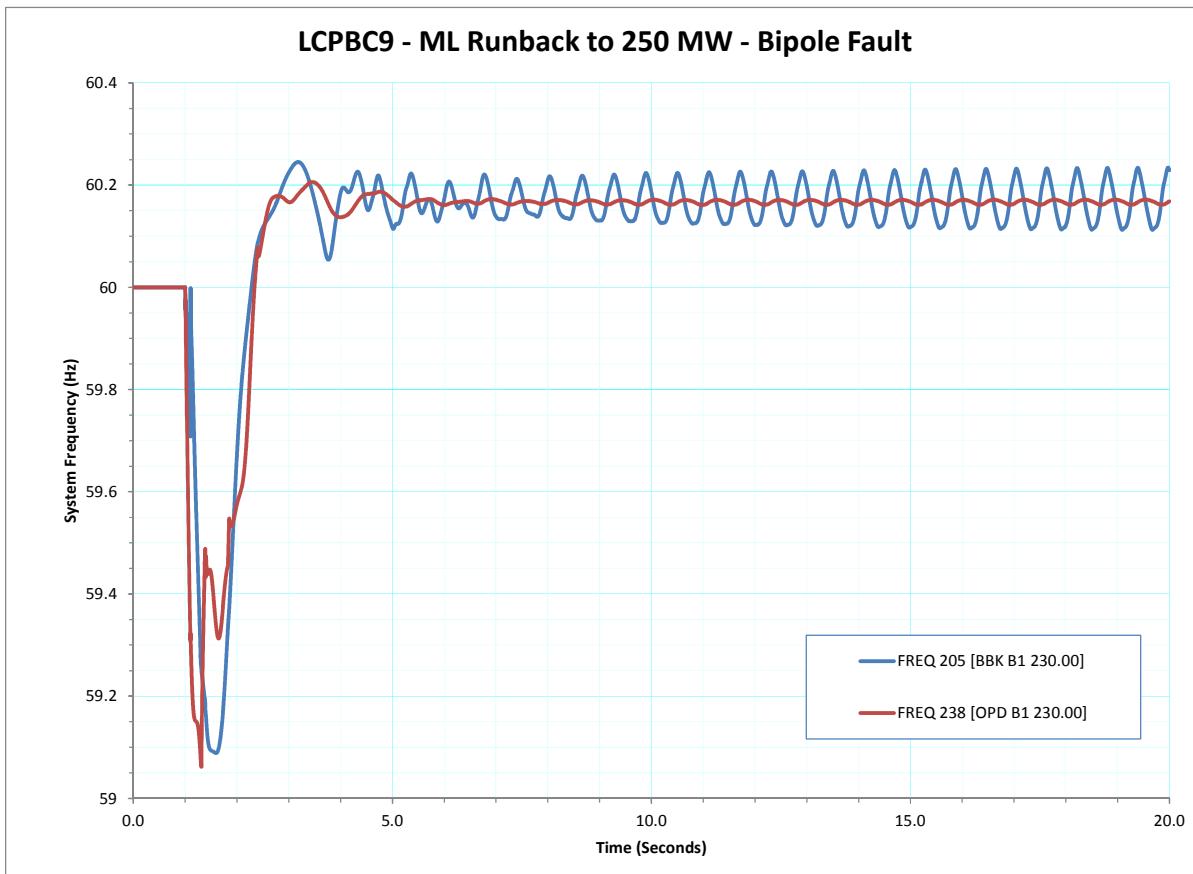
Figure 269 - LCPBC9 - ML Runback to 250 MW - Bipole Fault - System Frequency (Hz)

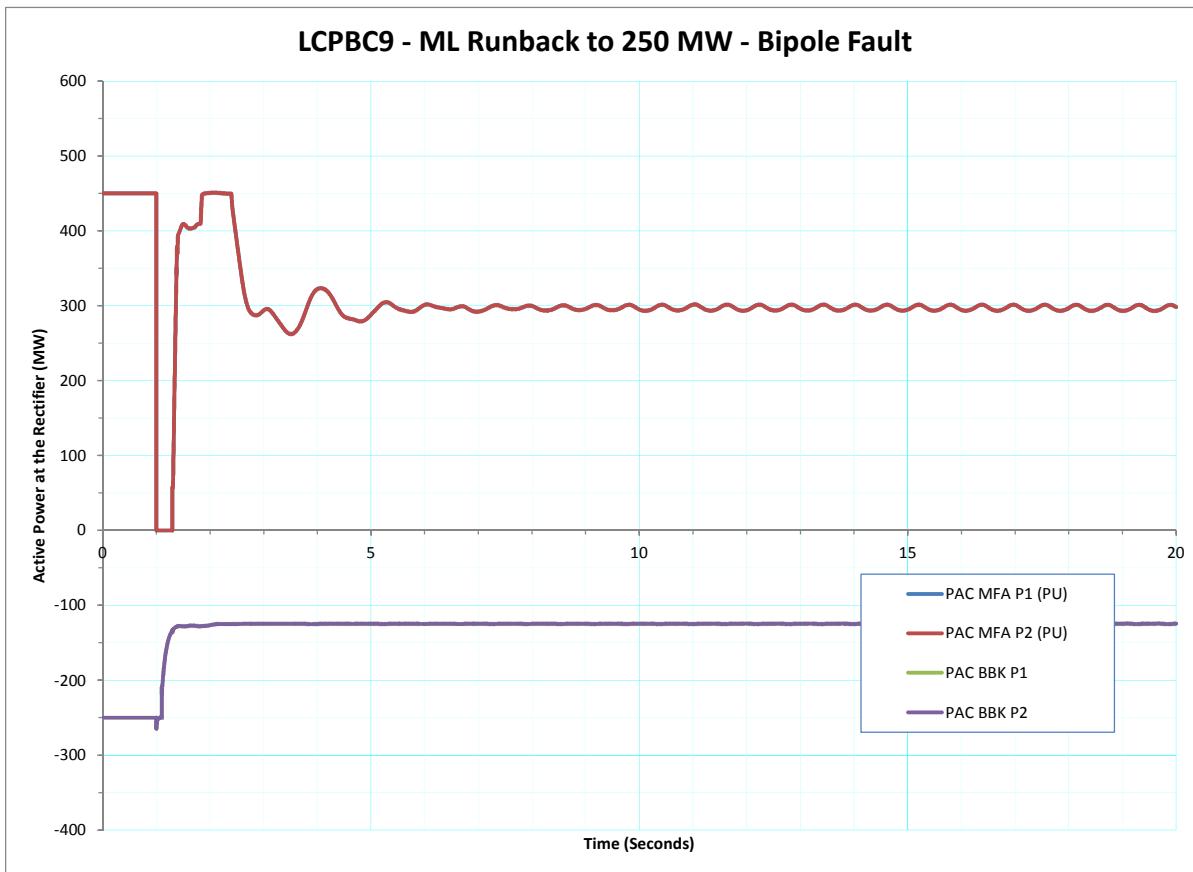
Figure 270 - LCPBC9 - ML Runback to 250 MW - Bipole Fault - Active Power at the Rectifier (MW)

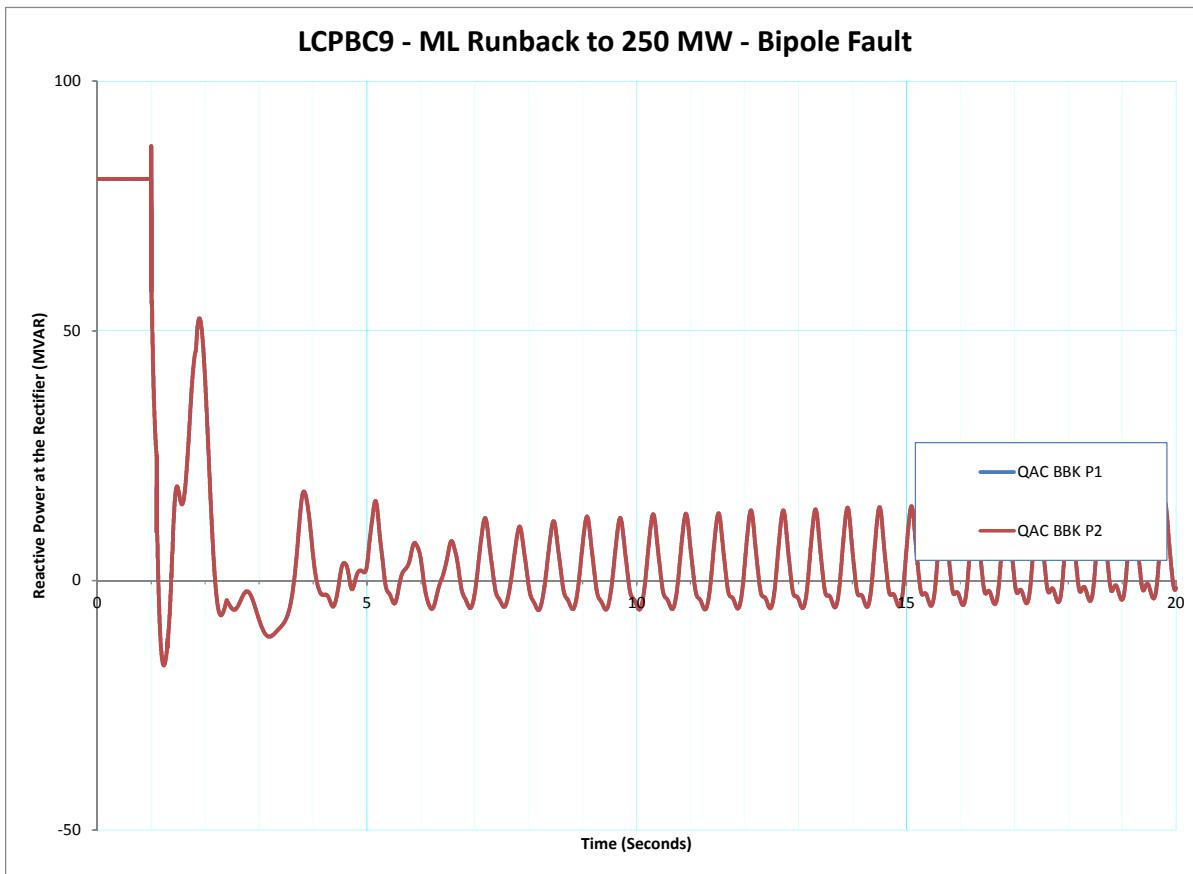
Figure 271 - LCPBC9 - ML Runback to 250 MW - Bipole Fault - Reactive Power at the Rectifier (MVAR)

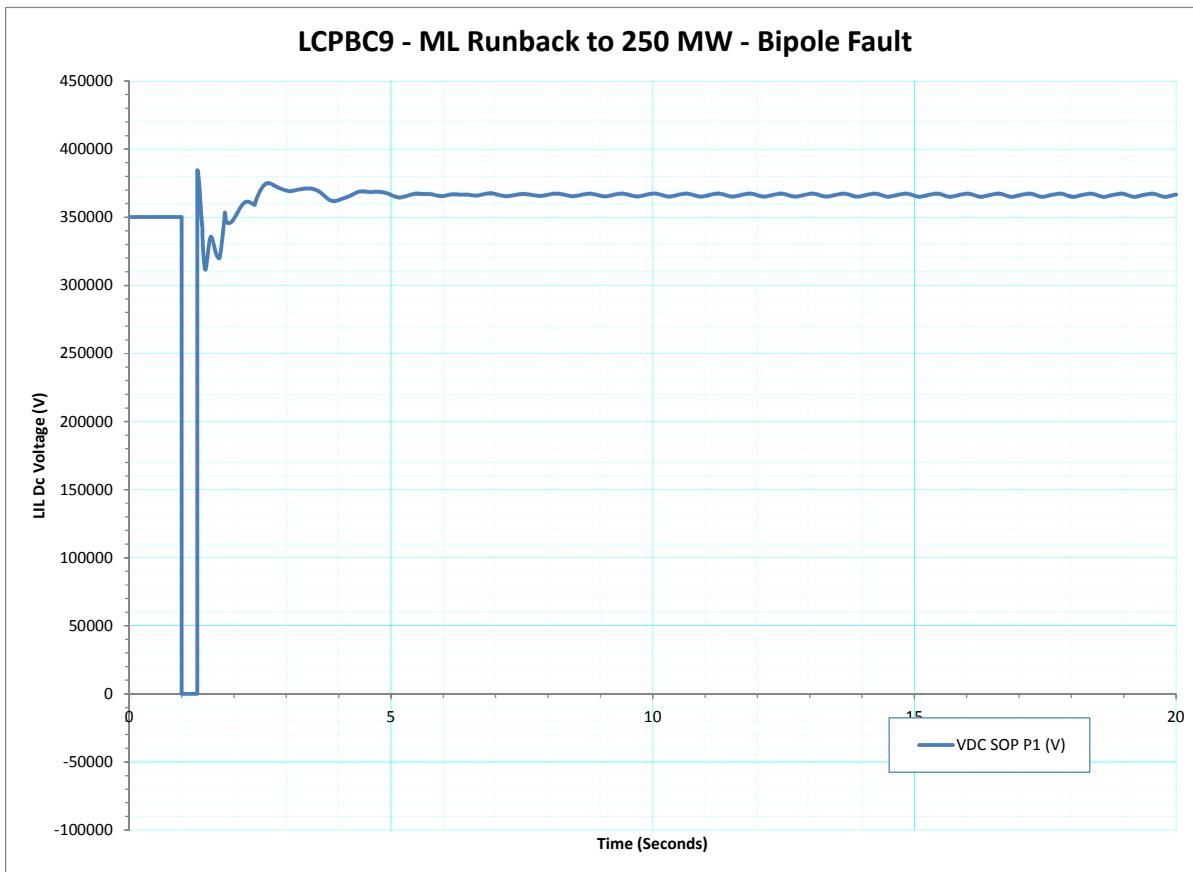
Figure 272 - LCPBC9 - ML Runback to 250 MW - Bipole Fault - LIL Dc Voltage (V)

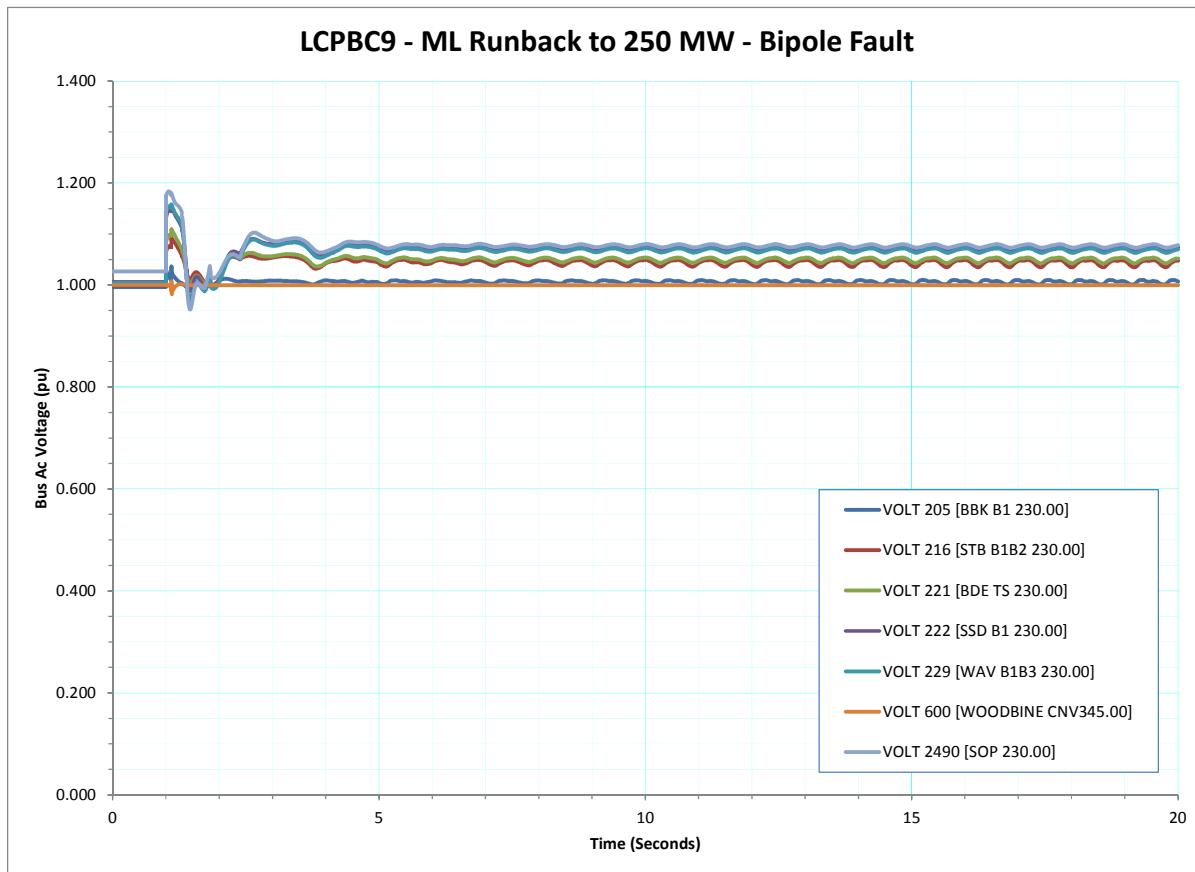
Figure 273 - LCPBC9 - ML Runback to 250 MW - Bipole Fault - Bus Ac Voltage (pu)
