MARITIME LINK PRELIMINARY INTERCONNECTION STUDY

Newfoundland and Labrador Hydro

July 2014

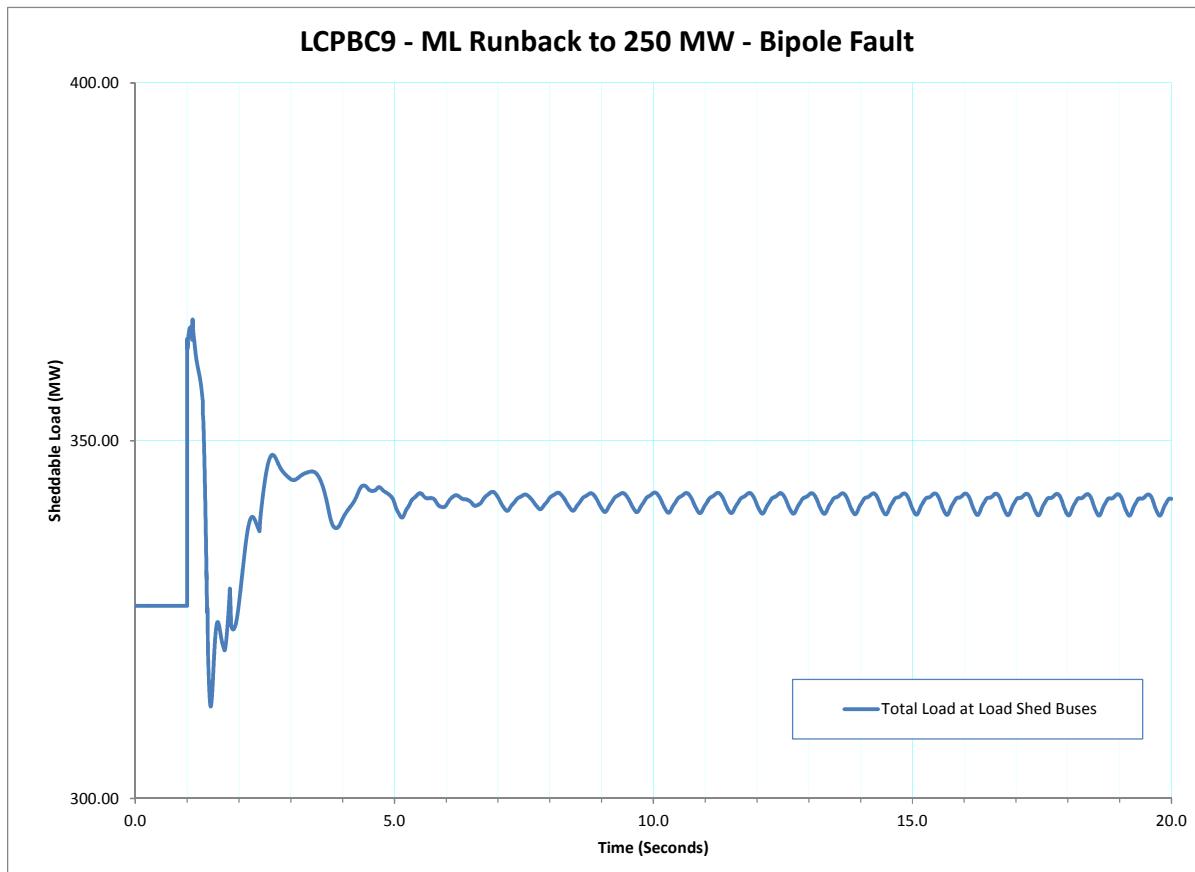
Figure 274 - LCPBC9 - ML Runback to 250 MW - Bipole Fault - Sheddable Load (MW)

The curtailment of ML export helps to maintain system stability and to improve system performance. Appendix D contains transient stability plots demonstrating system performance in all base cases when the ML export is curtailed. In BC6 and BC7, the curtailment of ML export from 500 MW to 250 MW was sufficient to eliminate UFLS. In monopolar cases (BC4 and BC10), ML export must be curtailed to 0 MW to ensure that there are no LIL commutation failures.

It should be noted that the curtailment of ML export resulted in an undamped system response for BC9. However, this base case represents an extreme operating scenario where both the LIL and ML are operating at rated capacity while minimal generation is dispatched within the Interconnected Island System. To avoid such a response, operating limitations must be defined for the system. Such limitations will ensure that extreme operating conditions are avoided and that system performance is acceptable.

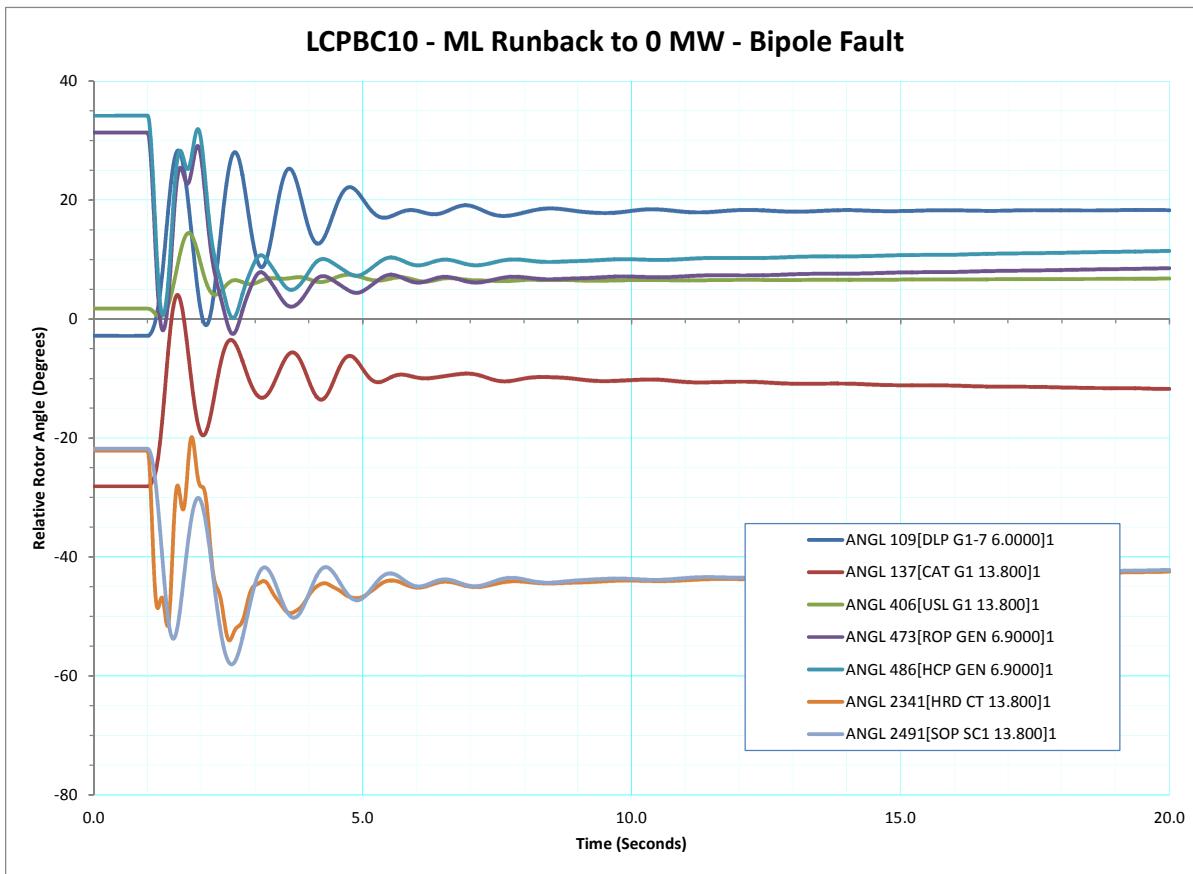
Figure 275 - LCPBC10 - ML Runback to 0 MW - Bipole Fault - Relative Rotor Angle (Degrees)

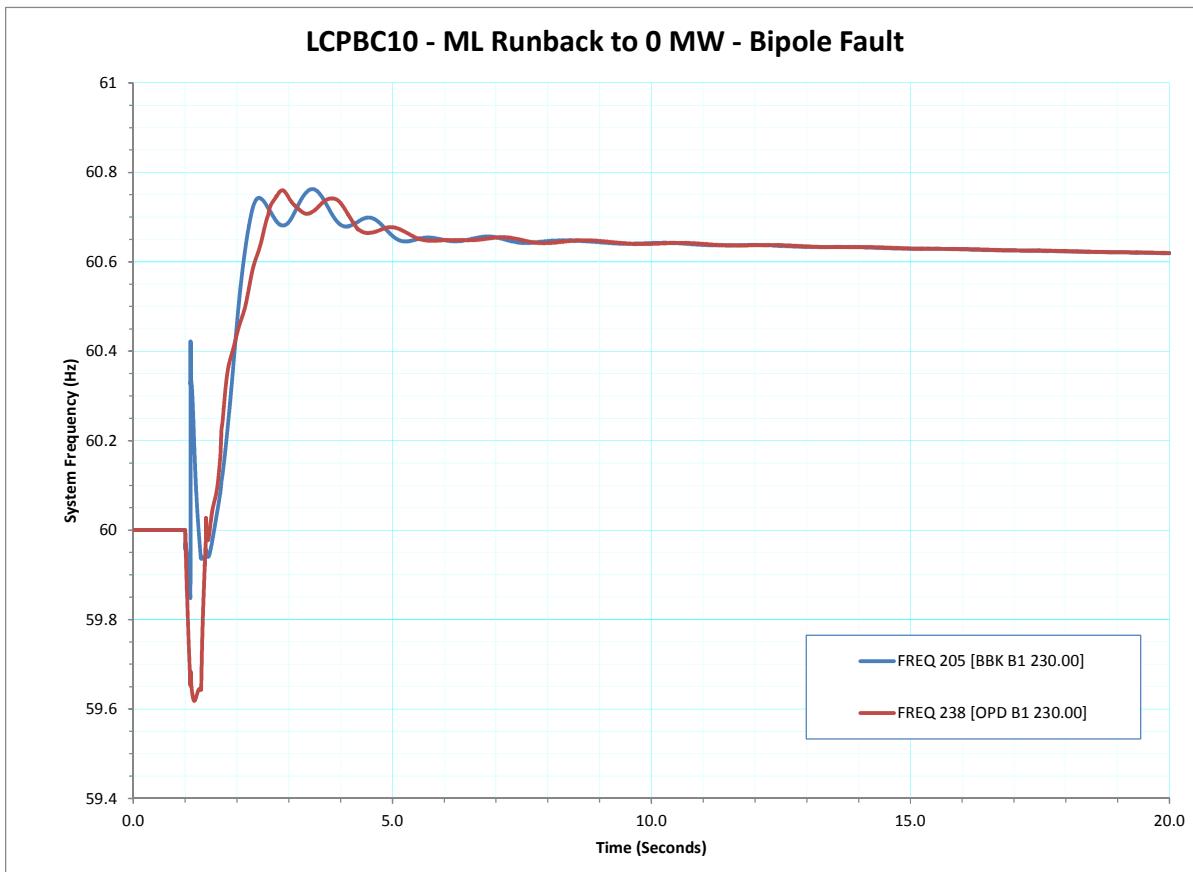
Figure 276 - LCPBC10 - ML Runback to 0 MW - Bipole Fault - System Frequency (Hz)

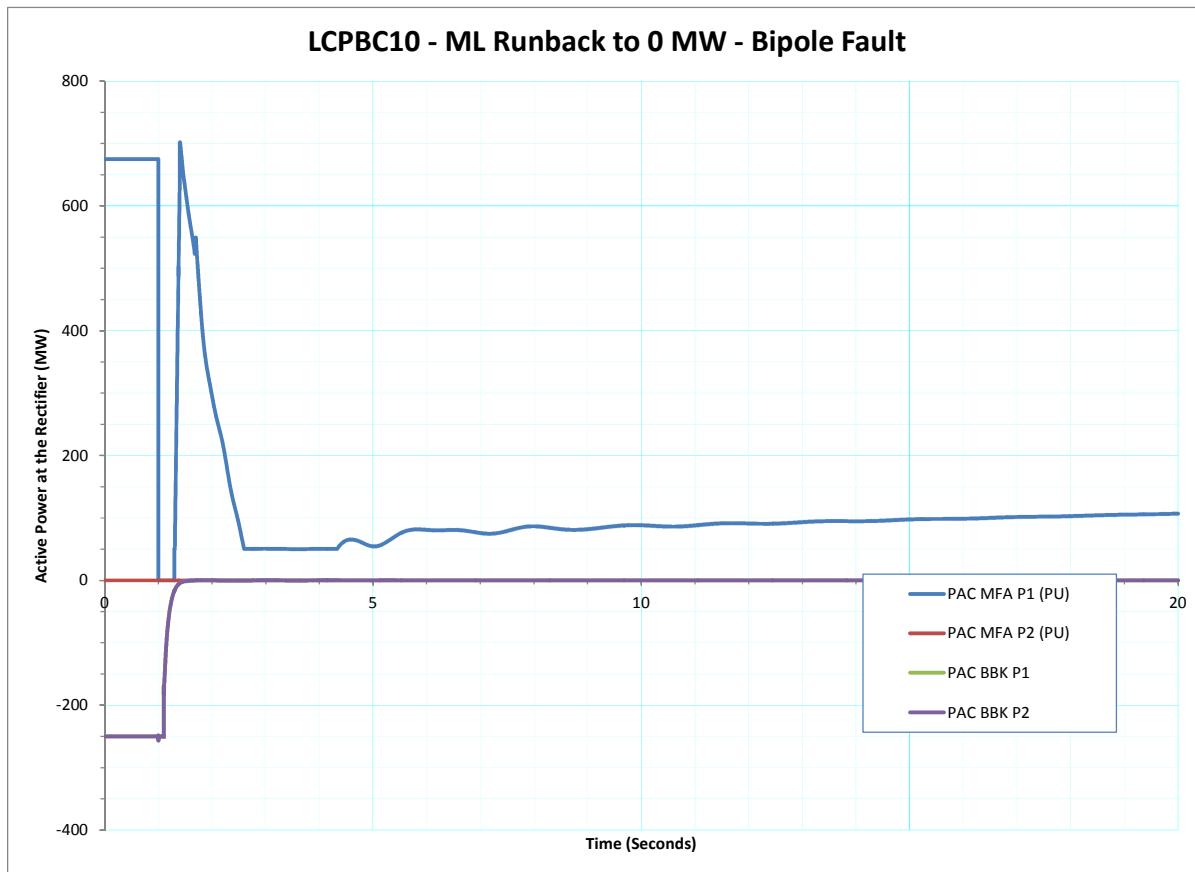
Figure 277 - LCPBC10 - ML Runback to 0 MW - Bipole Fault - Active Power at the Rectifier (MW)

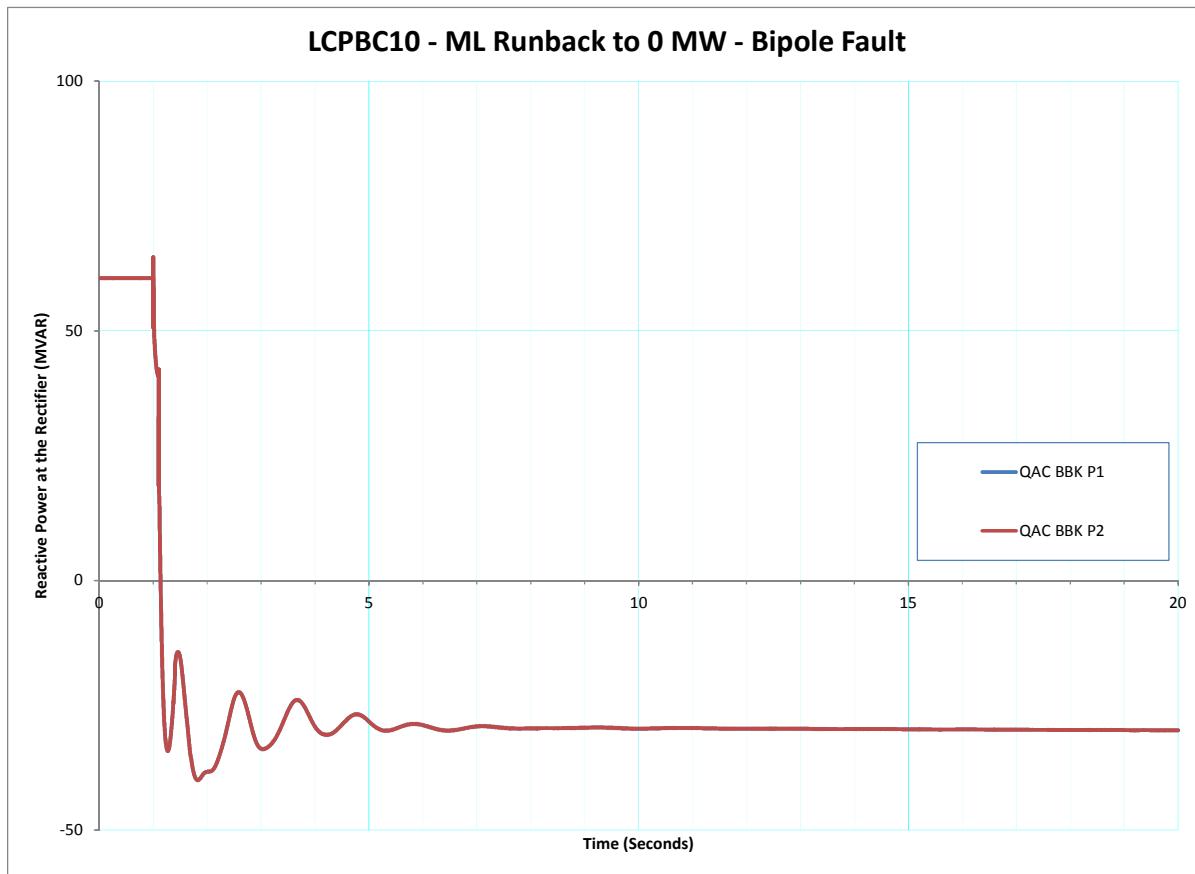
Figure 278 - LCPBC10 - ML Runback to 0 MW - Bipole Fault - Reactive Power at the Rectifier (MVAR)

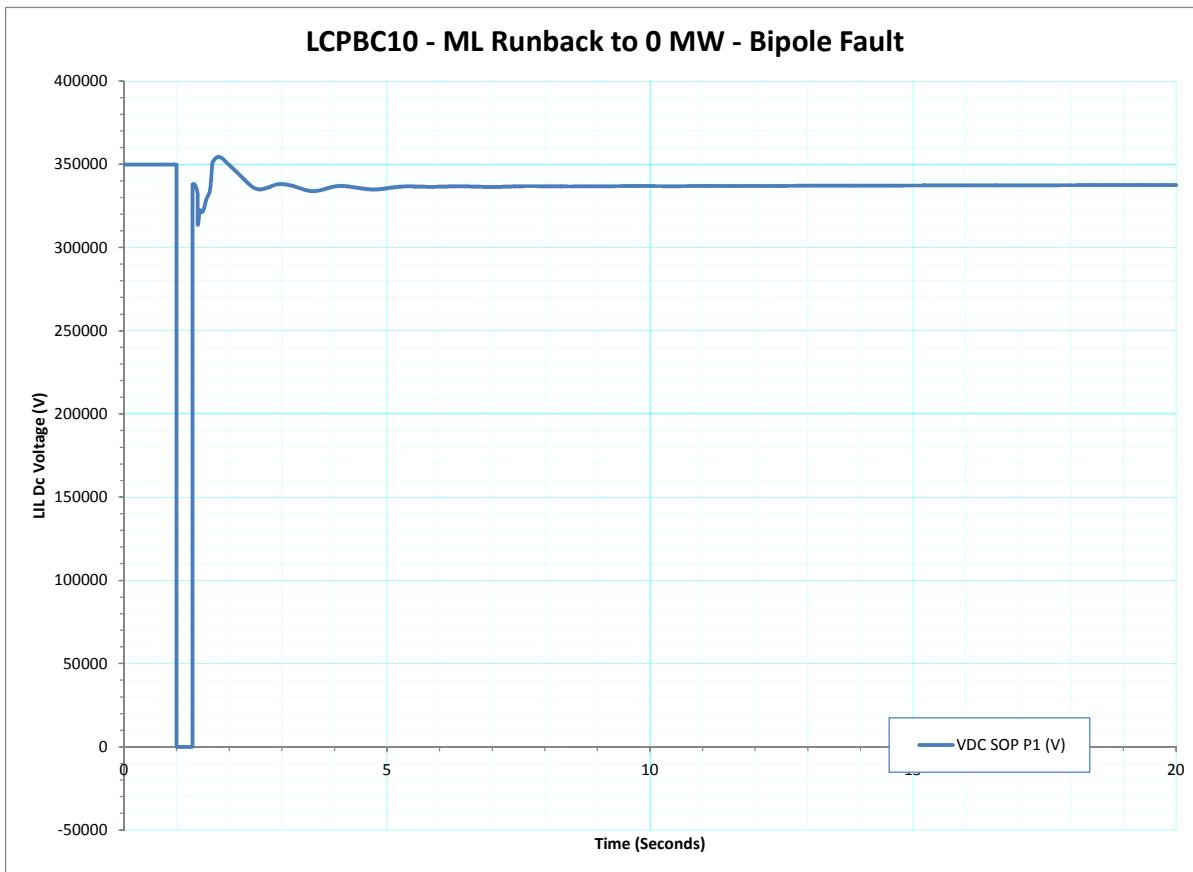
Figure 279 - LCPBC10 - ML Runback to 0 MW - Bipole Fault - LIL Dc Voltage (V)

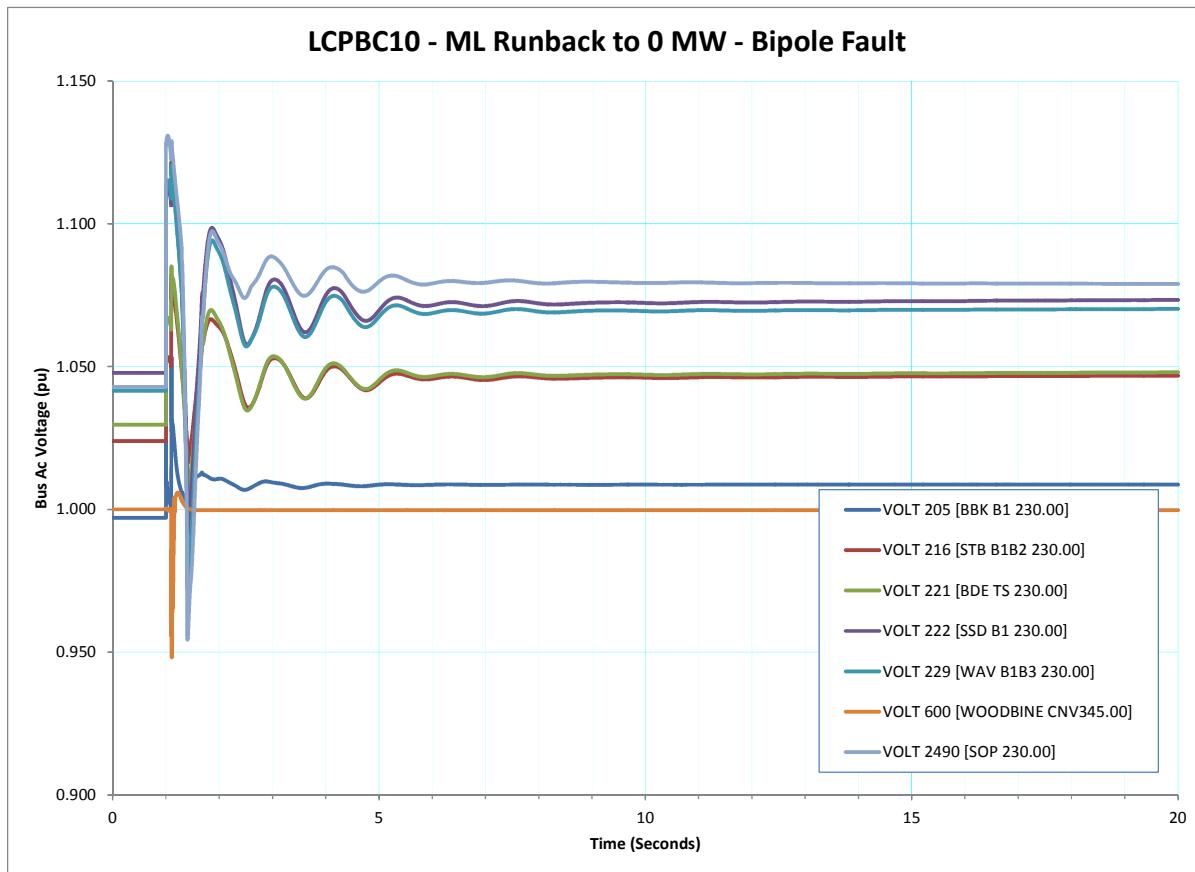
Figure 280 - LCPBC10 - ML Runback to 0 MW - Bipole Fault - Bus Ac Voltage (pu)

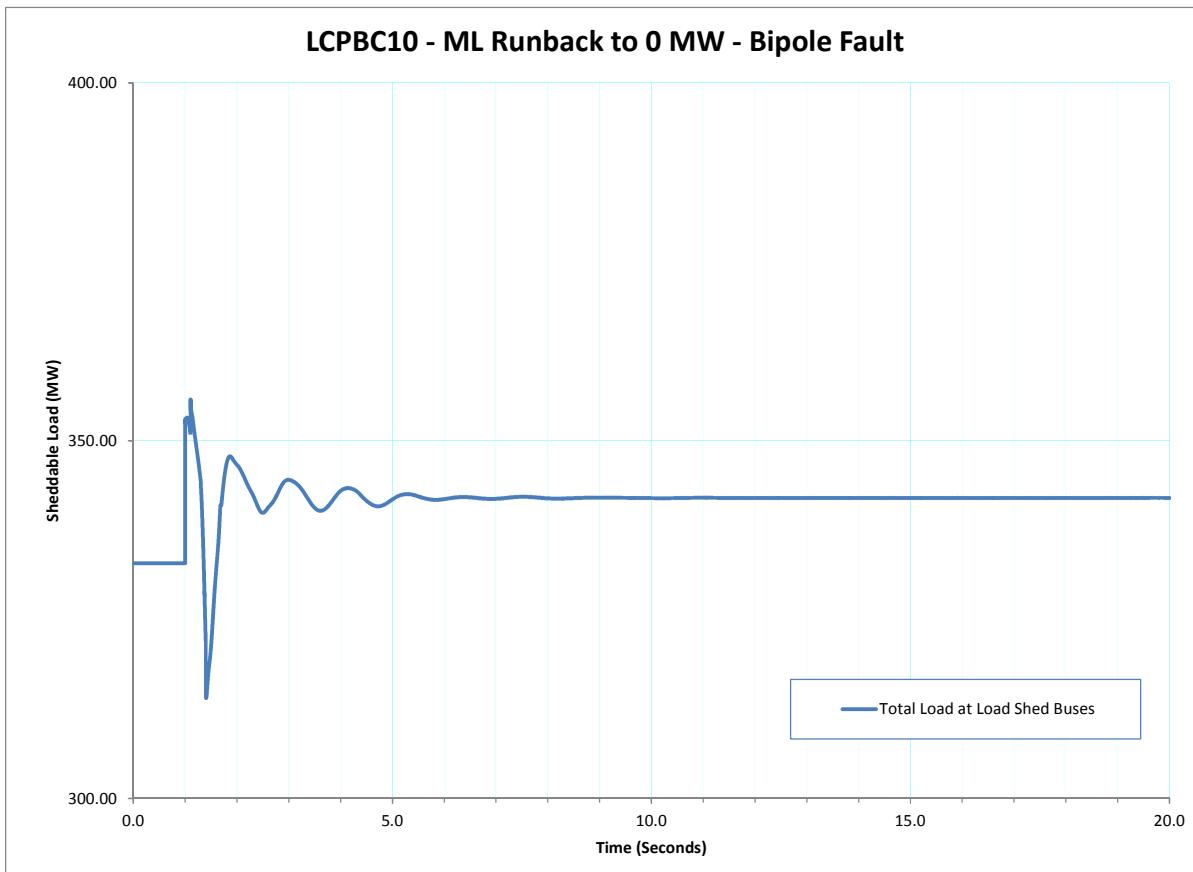
Figure 281 - LCPBC10 - ML Runback to 0 MW - Bipole Fault - Shedtable Load (MW)

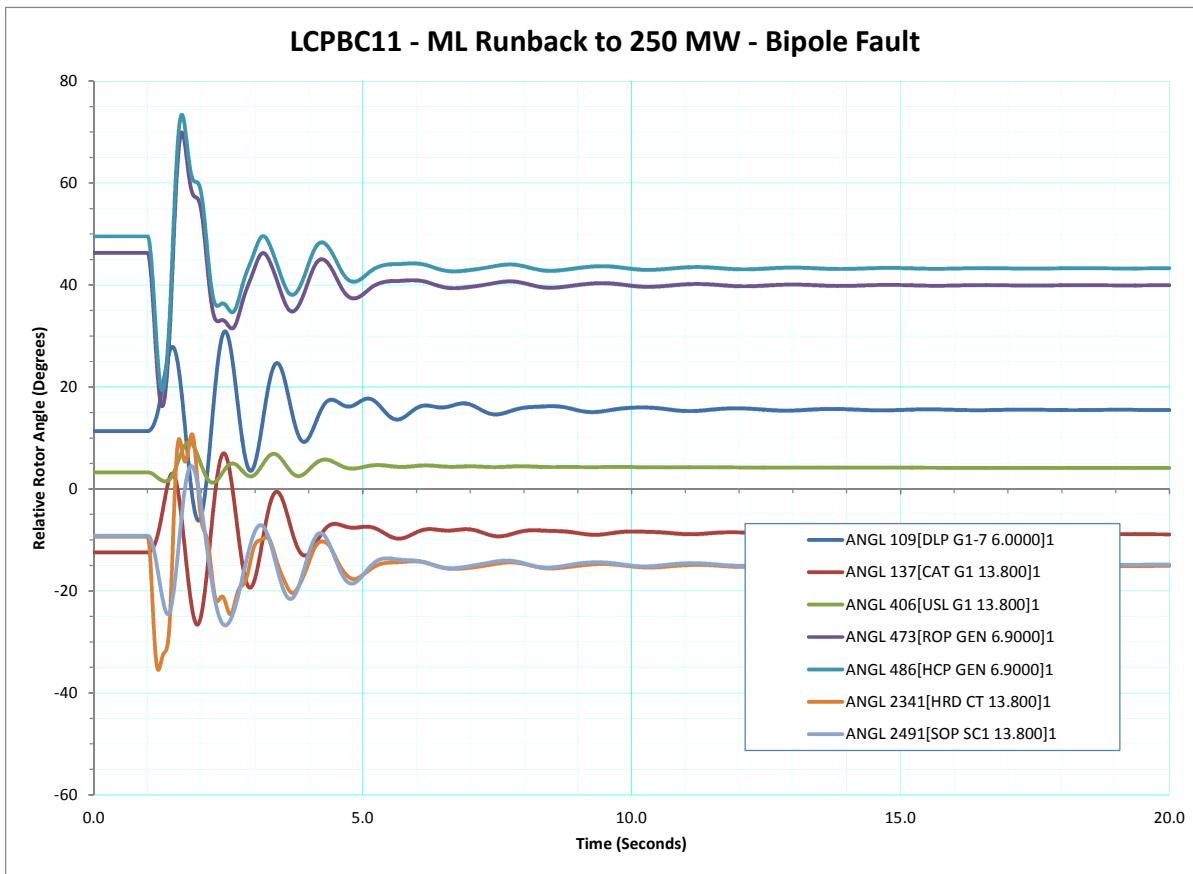
Figure 282 - LCPBC11 - ML Runback to 250 MW - Bipole Fault - Relative Rotor Angle (Degrees)

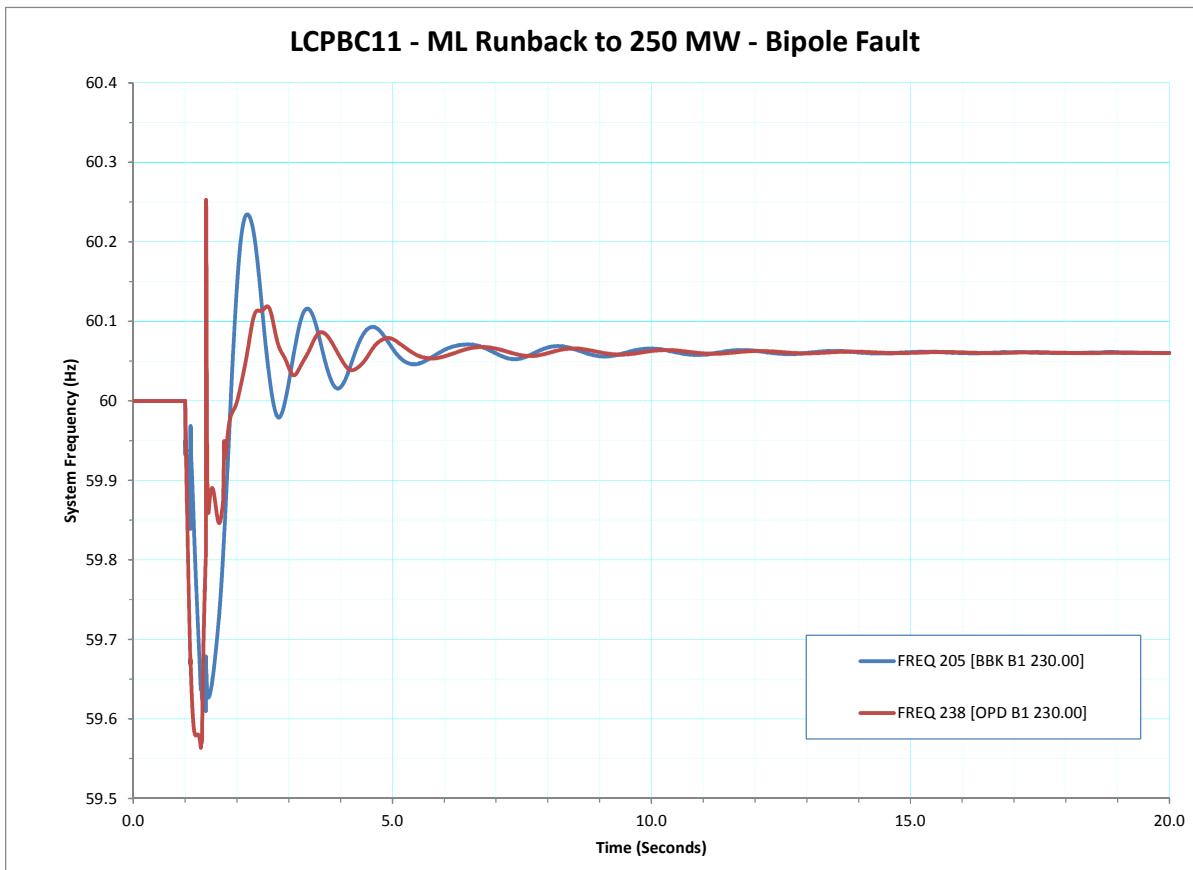
Figure 283 - LCPBC11 - ML Runback to 250 MW - Bipole Fault - System Frequency (Hz)

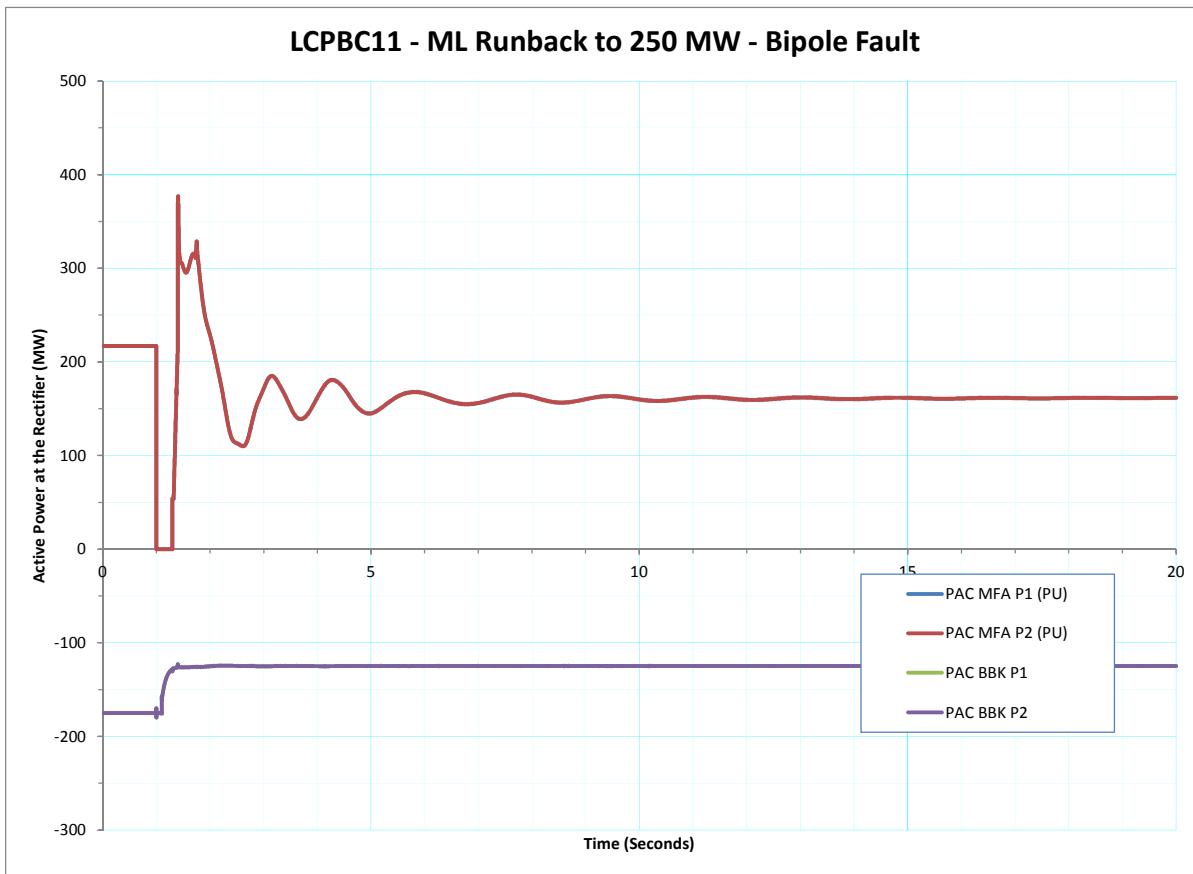
Figure 284 - LCPBC11 - ML Runback to 250 MW - Bipole Fault - Active Power at the Rectifier (MW)

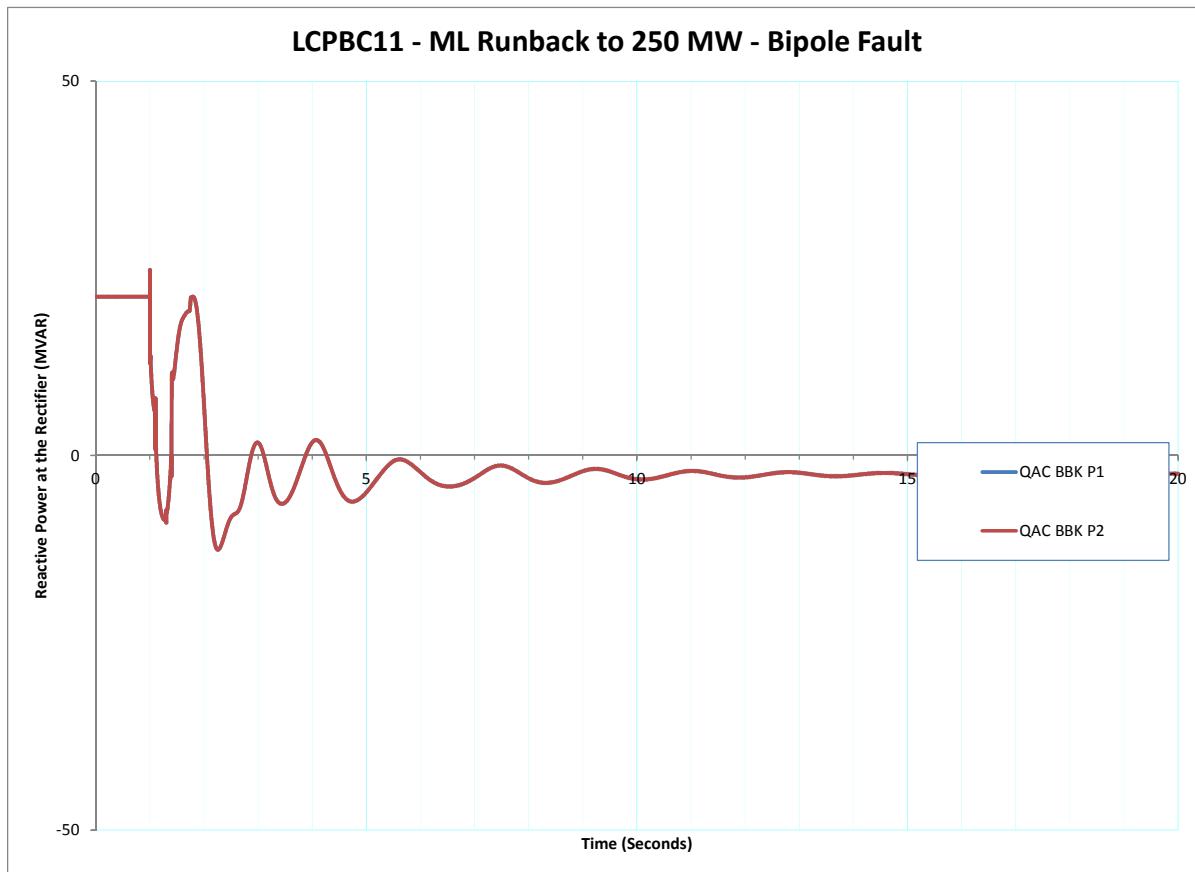
Figure 285 - LCPBC11 - ML Runback to 250 MW - Bipole Fault - Reactive Power at the Rectifier (MVAR)

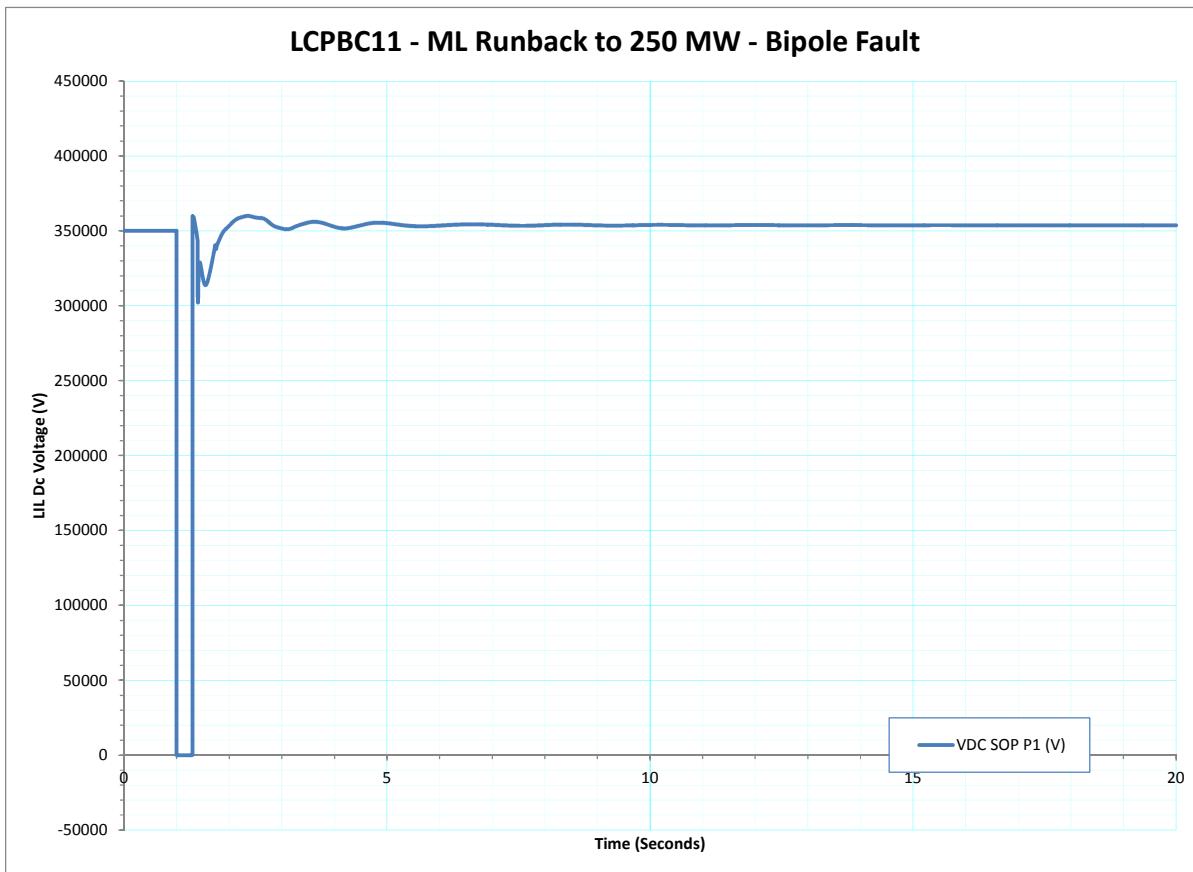
Figure 286 - LCPBC11 - ML Runback to 250 MW - Bipole Fault - LIL Dc Voltage (V)

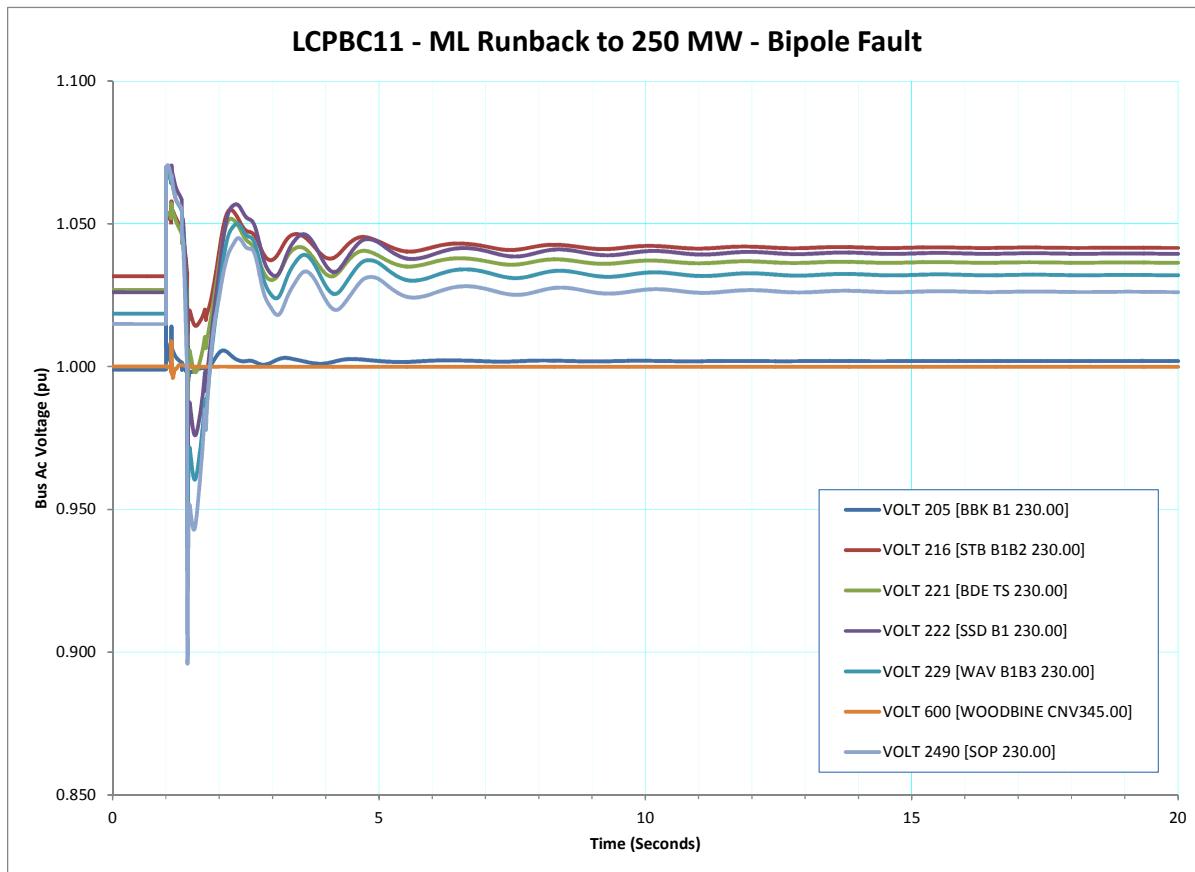
Figure 287 - LCPBC11 - ML Runback to 250 MW - Bipole Fault - Bus Ac Voltage (pu)

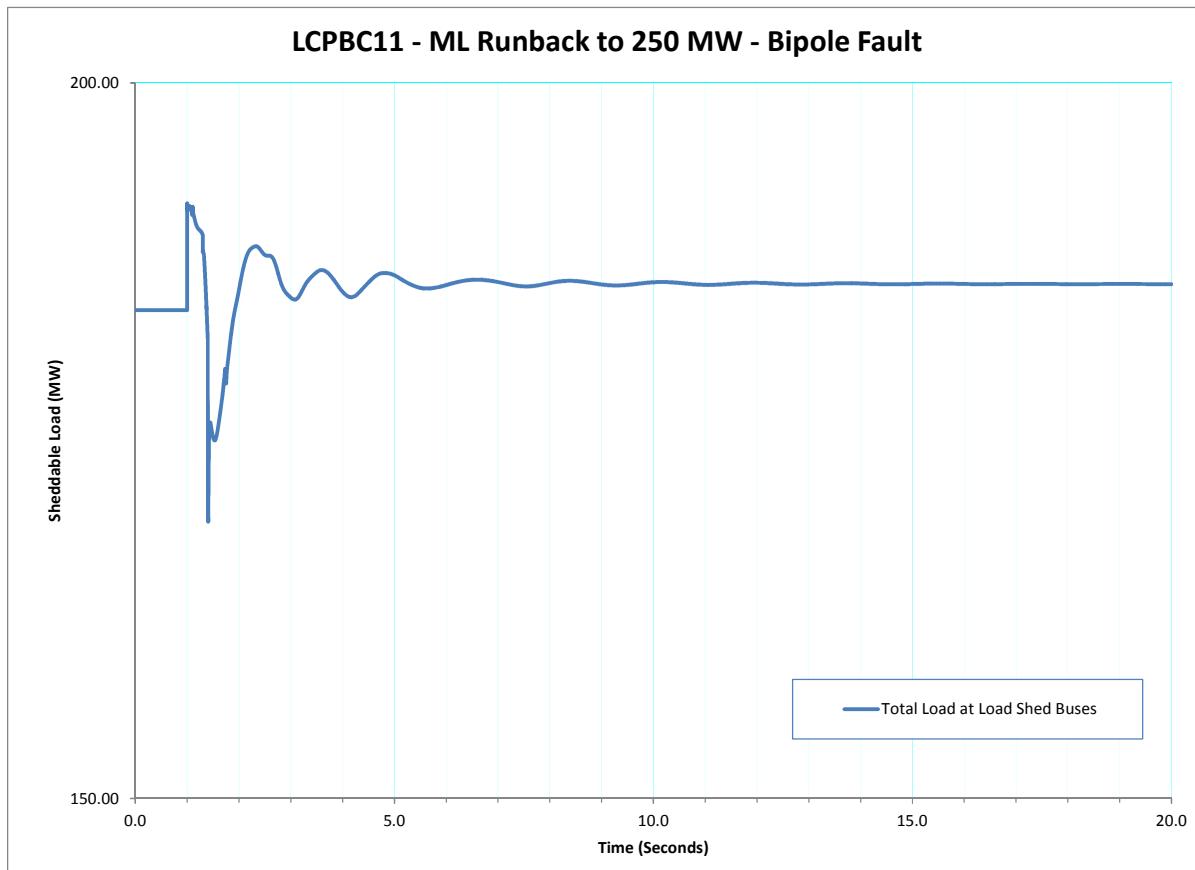
Figure 288 - LCPBC11 - ML Runback to 250 MW - Bipole Fault - Shedtable Load (MW)

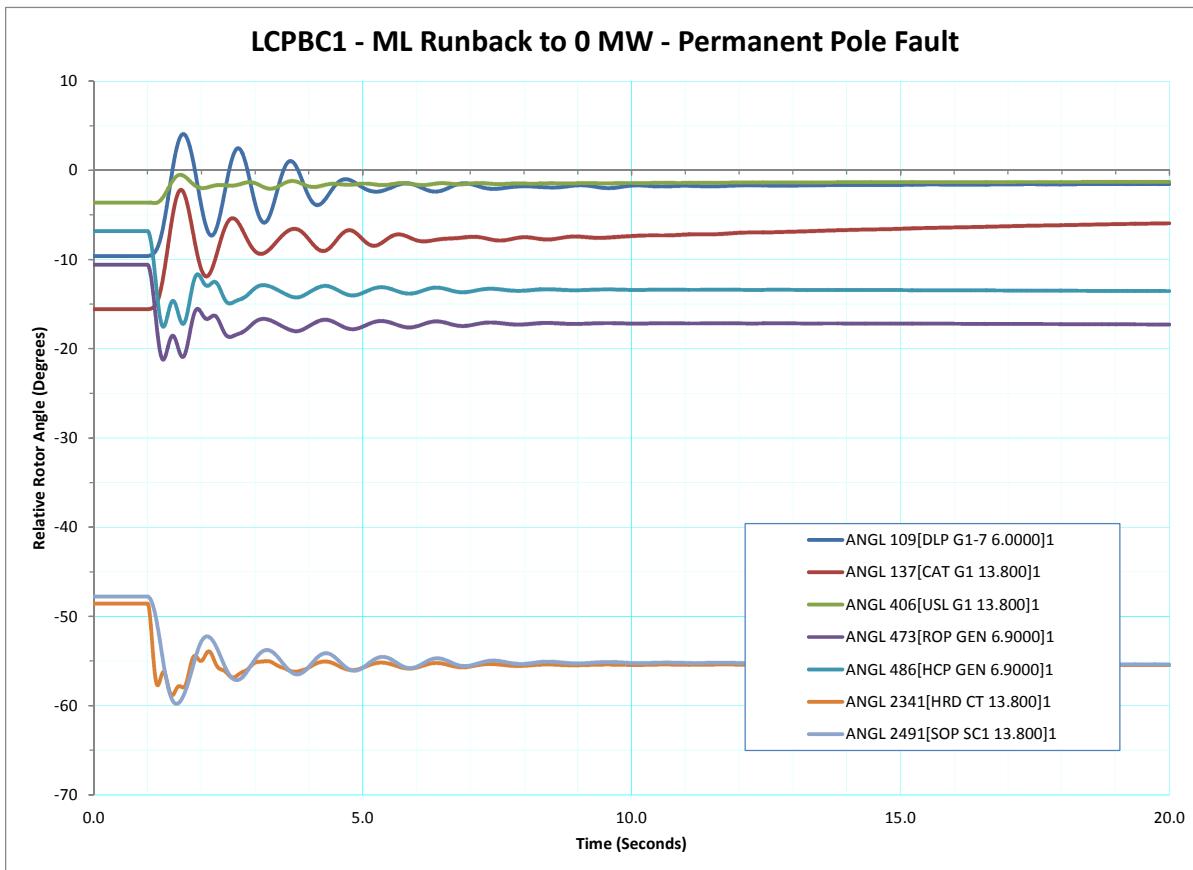
Figure 289 - LCPBC1 - ML Runback to 0 MW - Permanent Pole Fault - Relative Rotor Angle (Degrees)

It should be noted that for all other cases (with the exception of BC11) the permanent loss of a pole results in underfrequency load shedding within the Island Interconnected System if ML export is not curtailed. Appendix E illustrates how underfrequency load shedding can

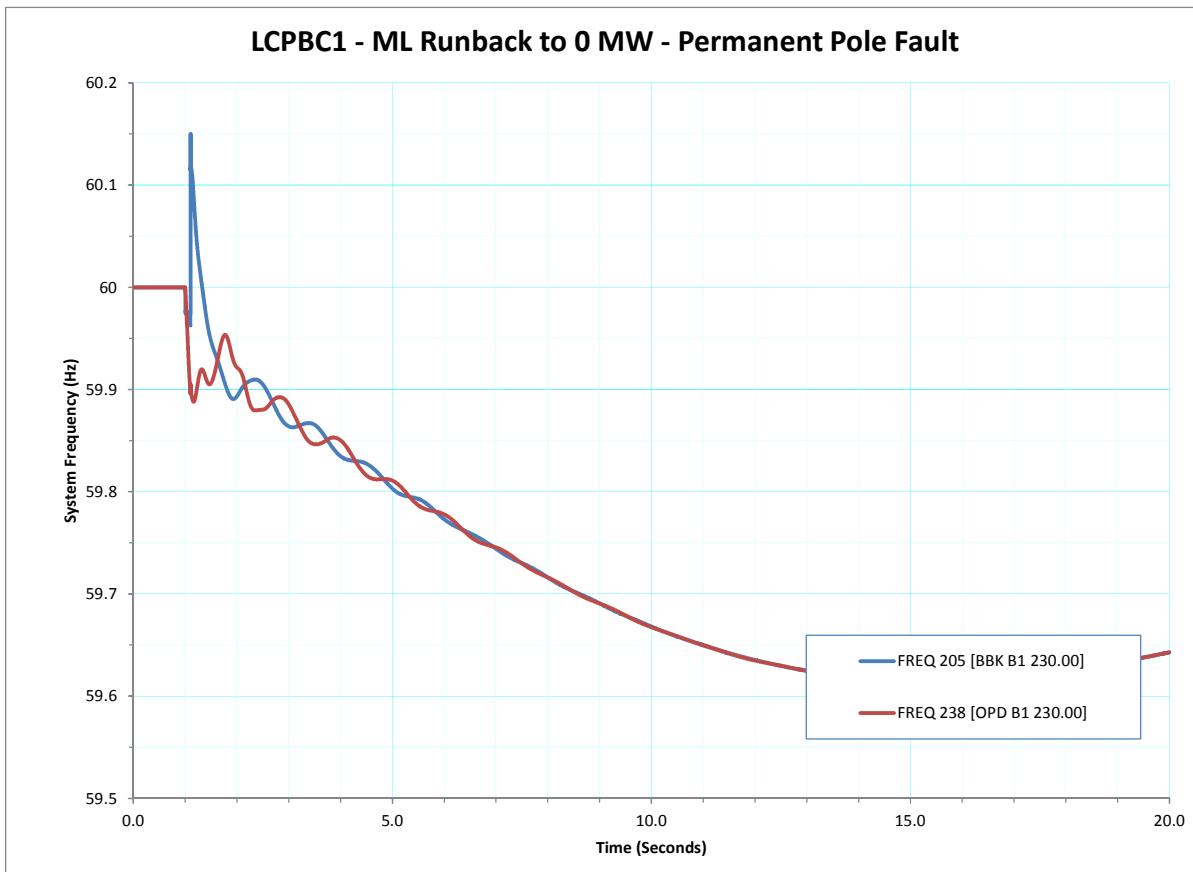
Figure 290 - LCPBC1 - ML Runback to 0 MW - Permanent Pole Fault - System Frequency (Hz)

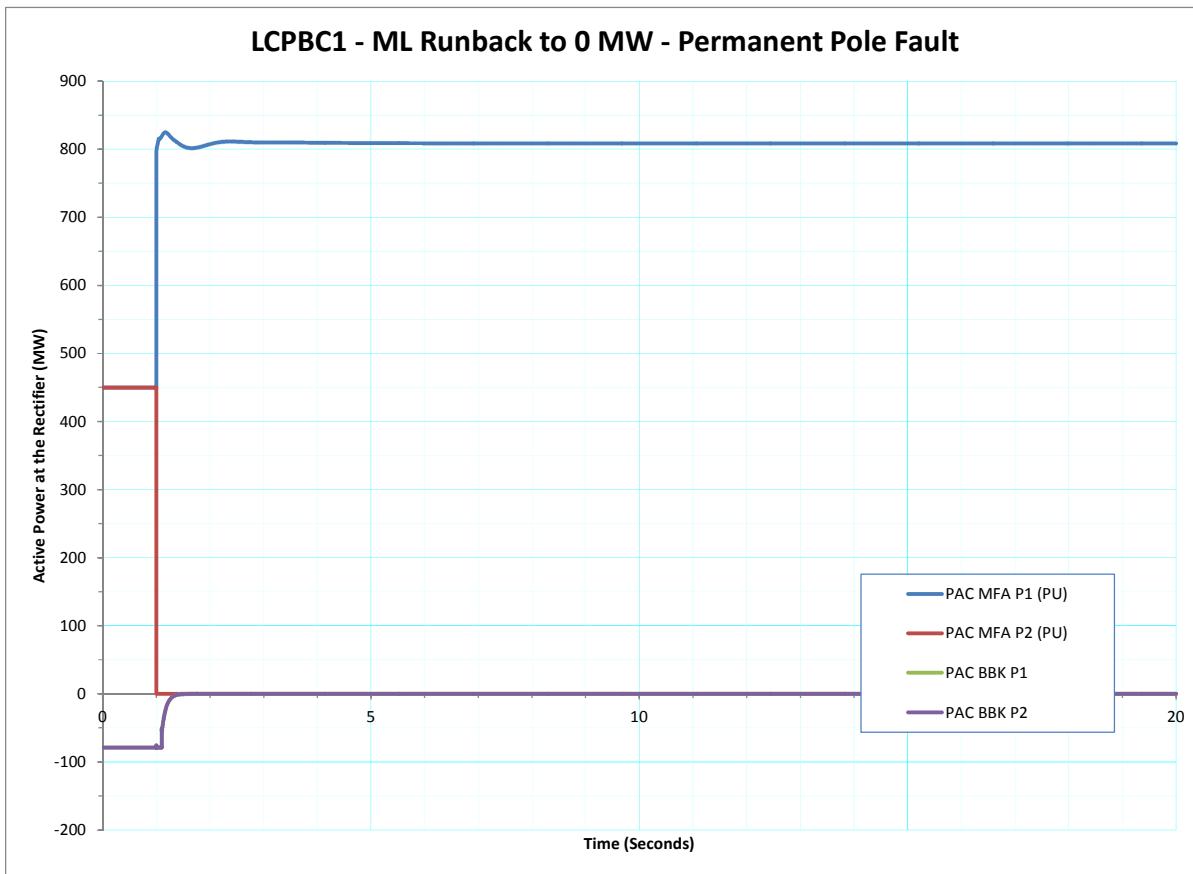
Figure 291 - LCPBC1 - ML Runback to 0 MW - Permanent Pole Fault - Active Power at the Rectifier (MW)

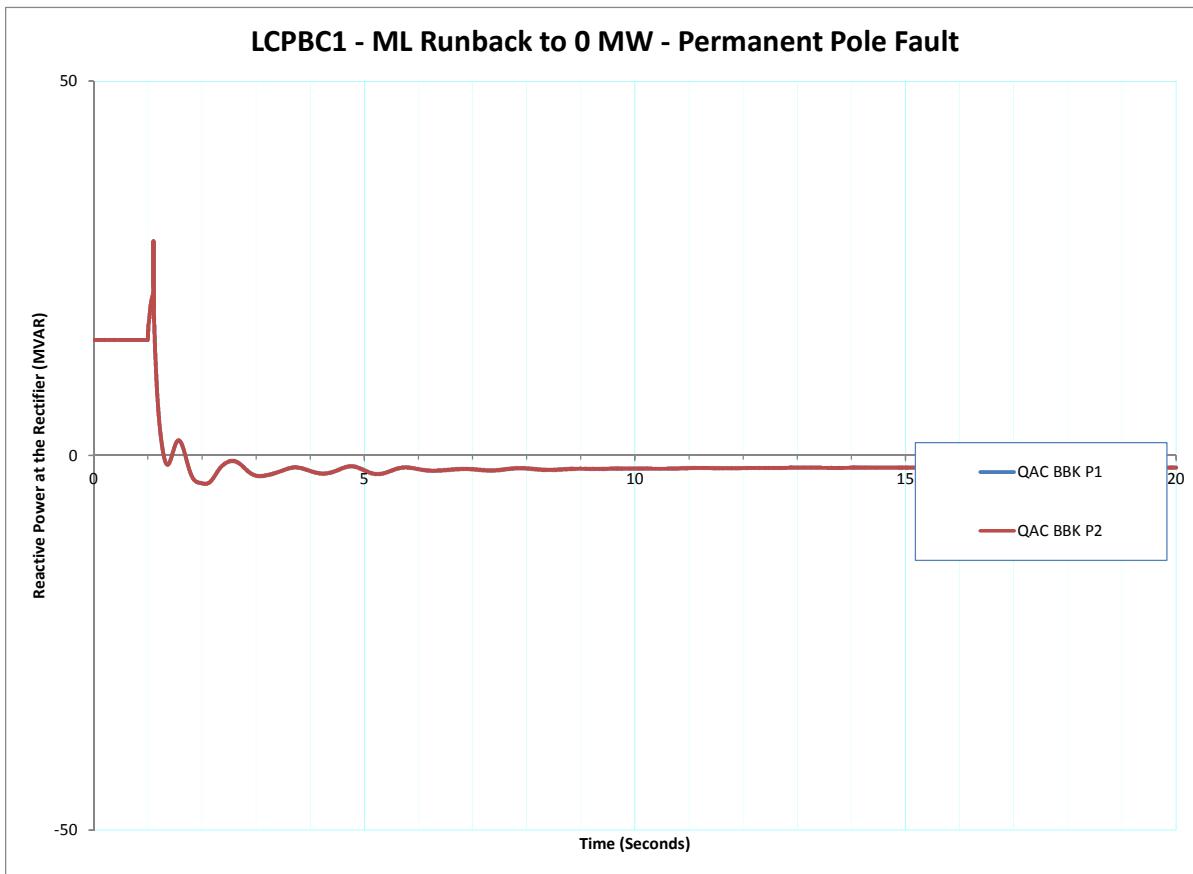
Figure 292 - LCPBC1 - ML Runback to 0 MW - Permanent Pole Fault - Reactive Power at the Rectifier (MVAR)

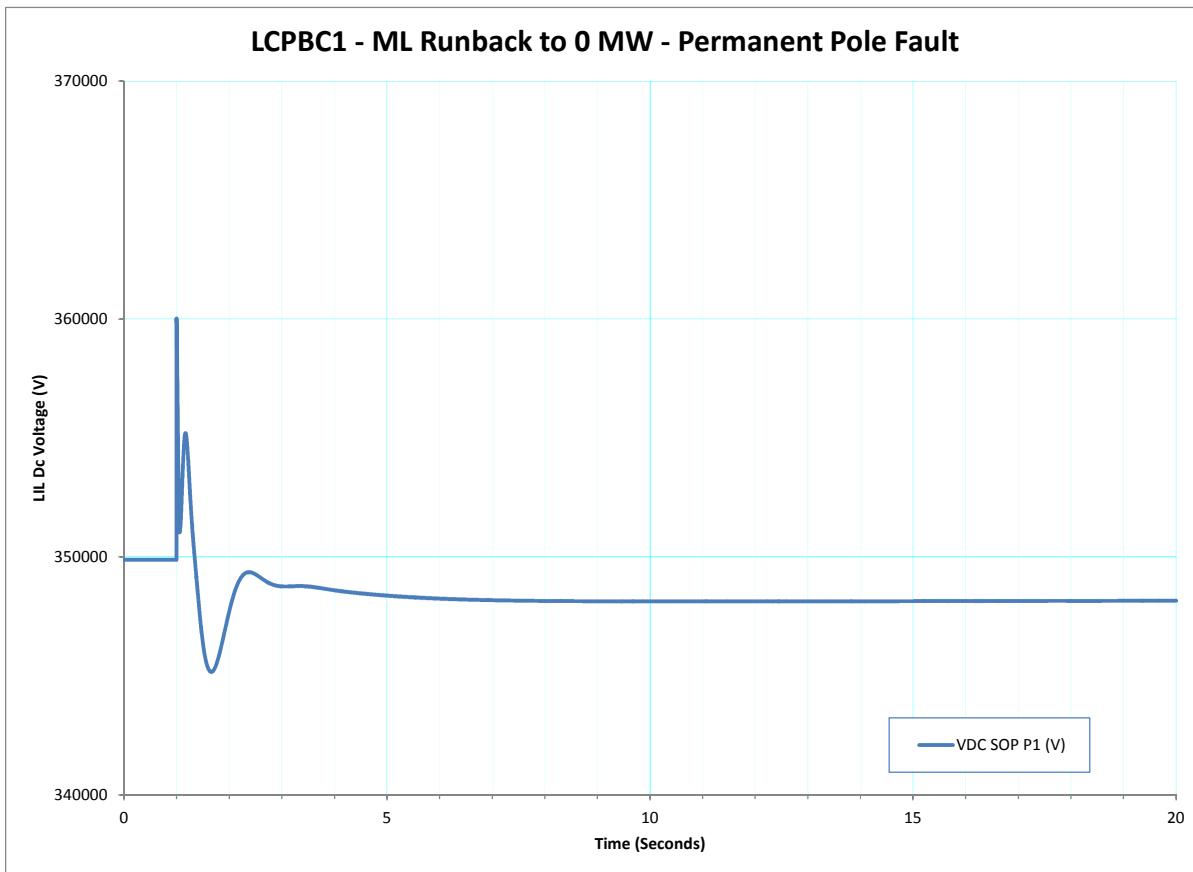
Figure 293 - LCPBC1 - ML Runback to 0 MW - Permanent Pole Fault - LIL Dc Voltage (V)

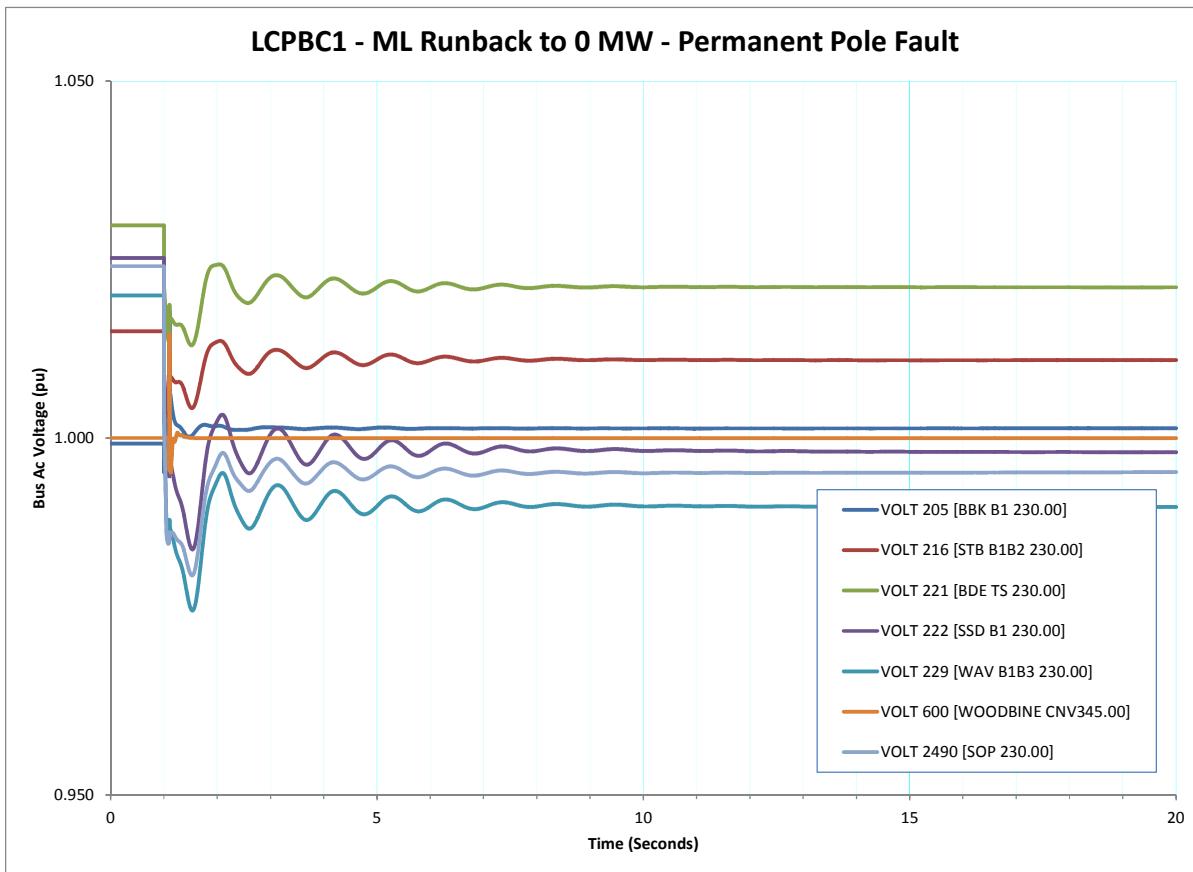
Figure 294 - LCPBC1 - ML Runback to 0 MW - Permanent Pole Fault - Bus Ac Voltage (pu)
