MARITIME LINK PRELIMINARY INTERCONNECTION STUDY

Newfoundland and Labrador Hydro

July 2014

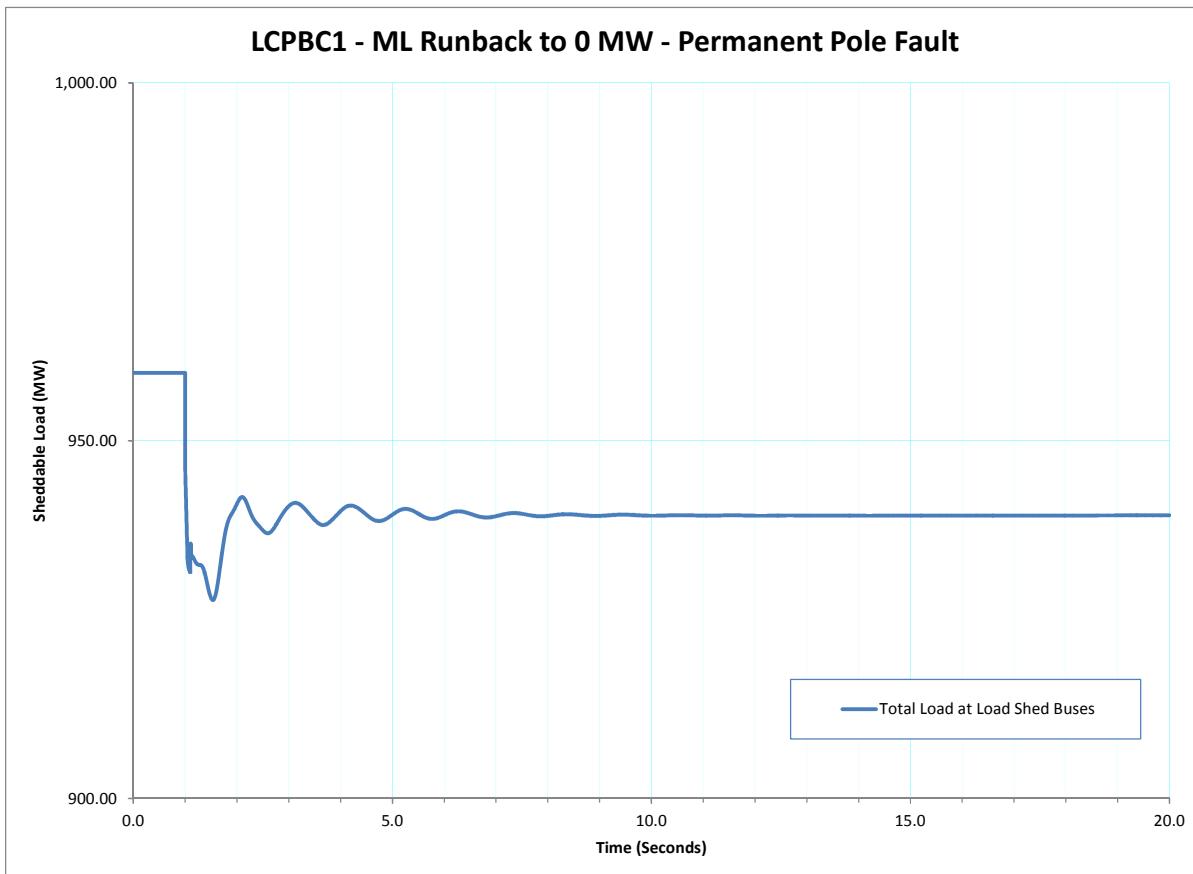
Figure 295 - LCPBC1 - ML Runback to 0 MW - Permanent Pole Fault - Shedtable Load (MW)

It should be noted that for all other cases (with the exception of BC11) the permanent loss of a pole results in underfrequency load shedding within the Island Interconnected System if ML export is not curtailed. Appendix E illustrates how underfrequency load shedding can

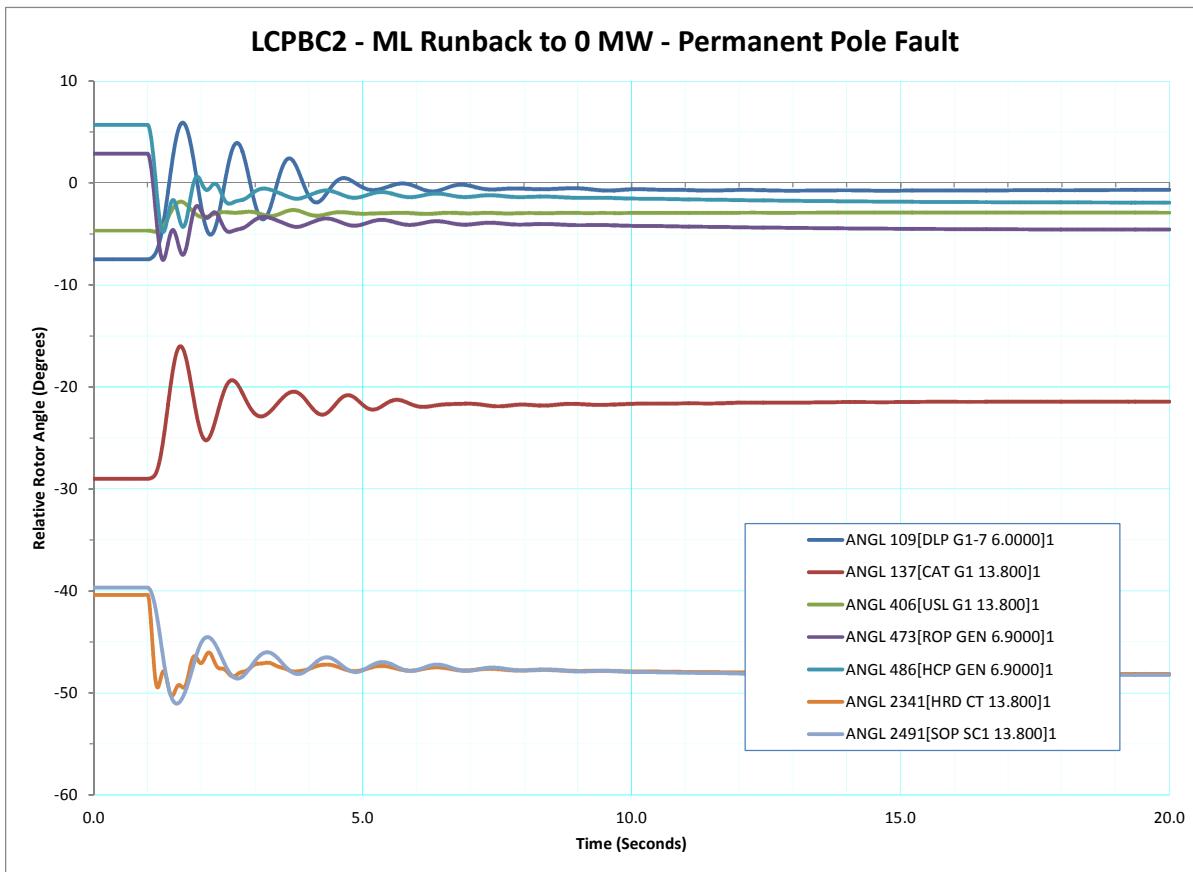
Figure 296 - LCPBC2 - ML Runback to 0 MW - Permanent Pole Fault - Relative Rotor Angle (Degrees)

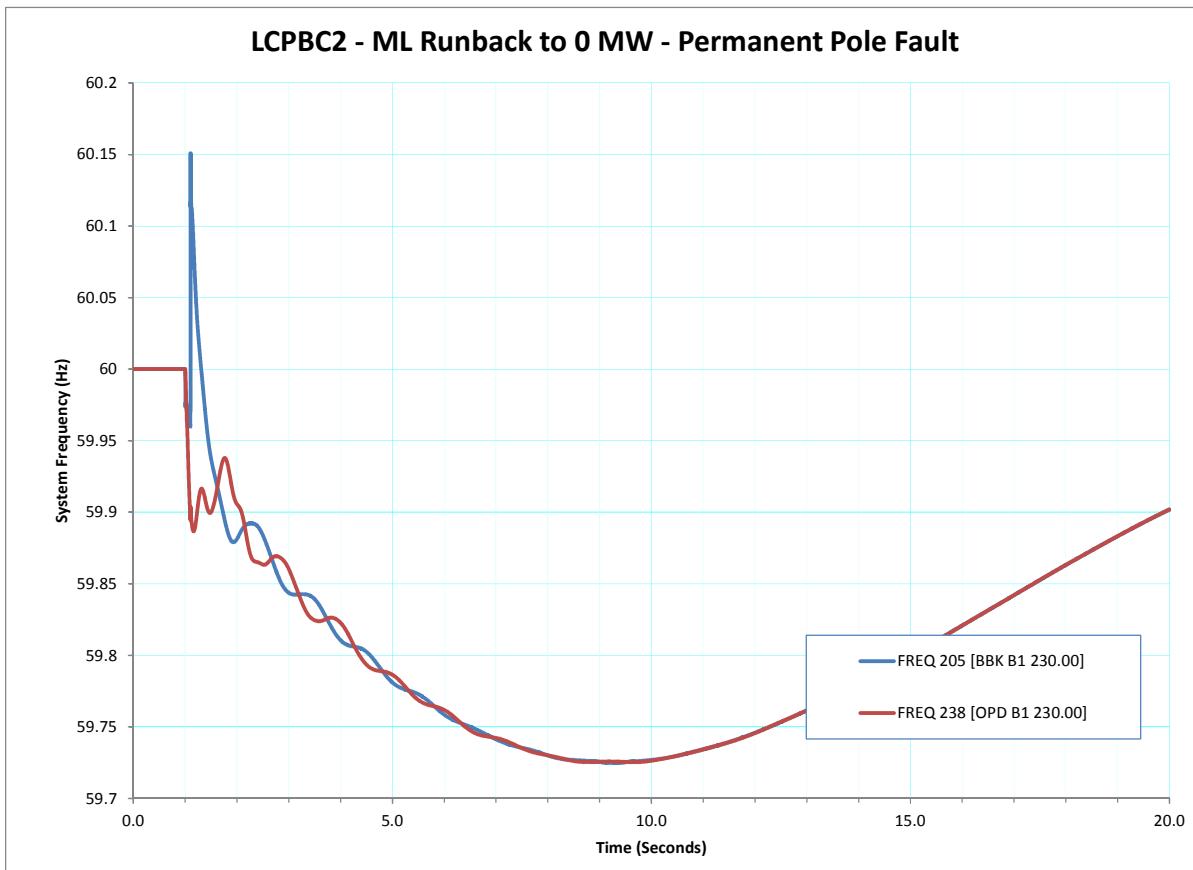
Figure 297 - LCPBC2 - ML Runback to 0 MW - Permanent Pole Fault - System Frequency (Hz)

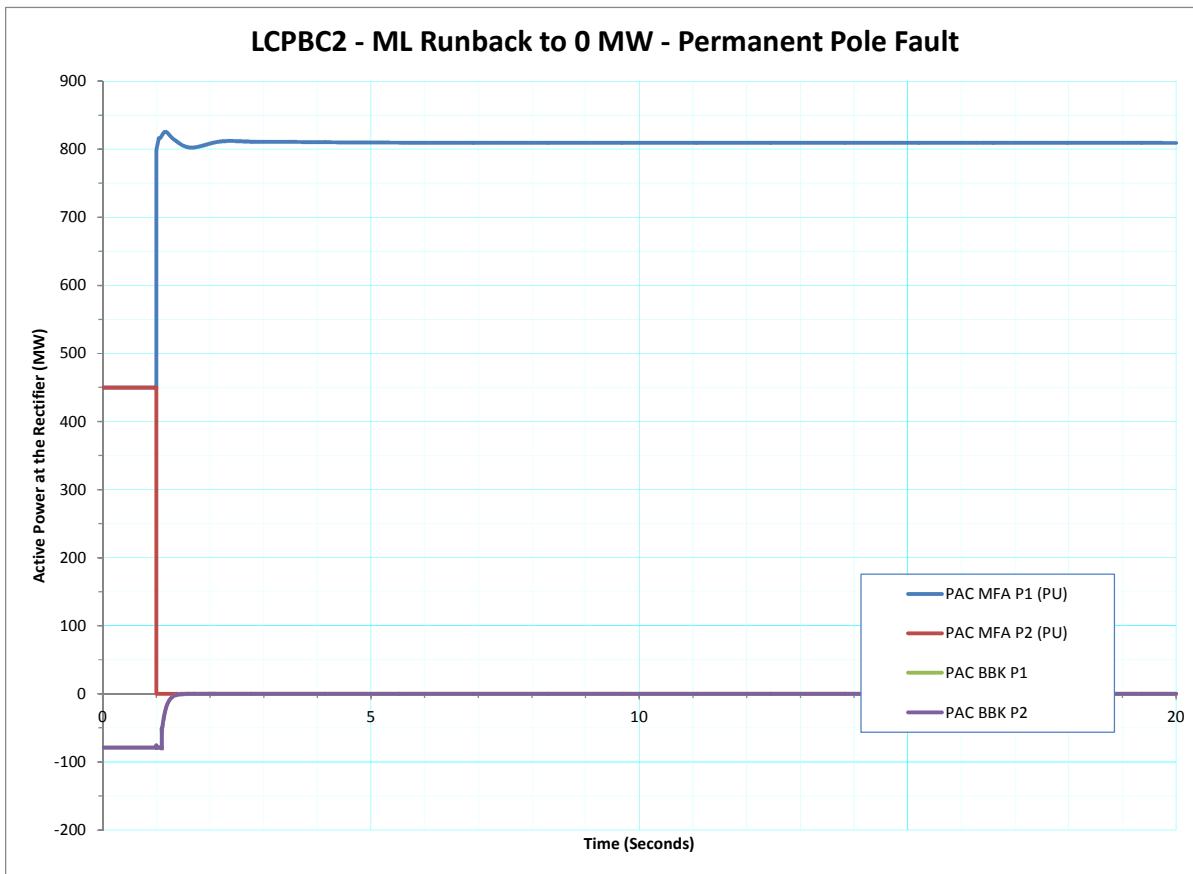
Figure 298 - LCPBC2 - ML Runback to 0 MW - Permanent Pole Fault - Active Power at the Rectifier (MW)

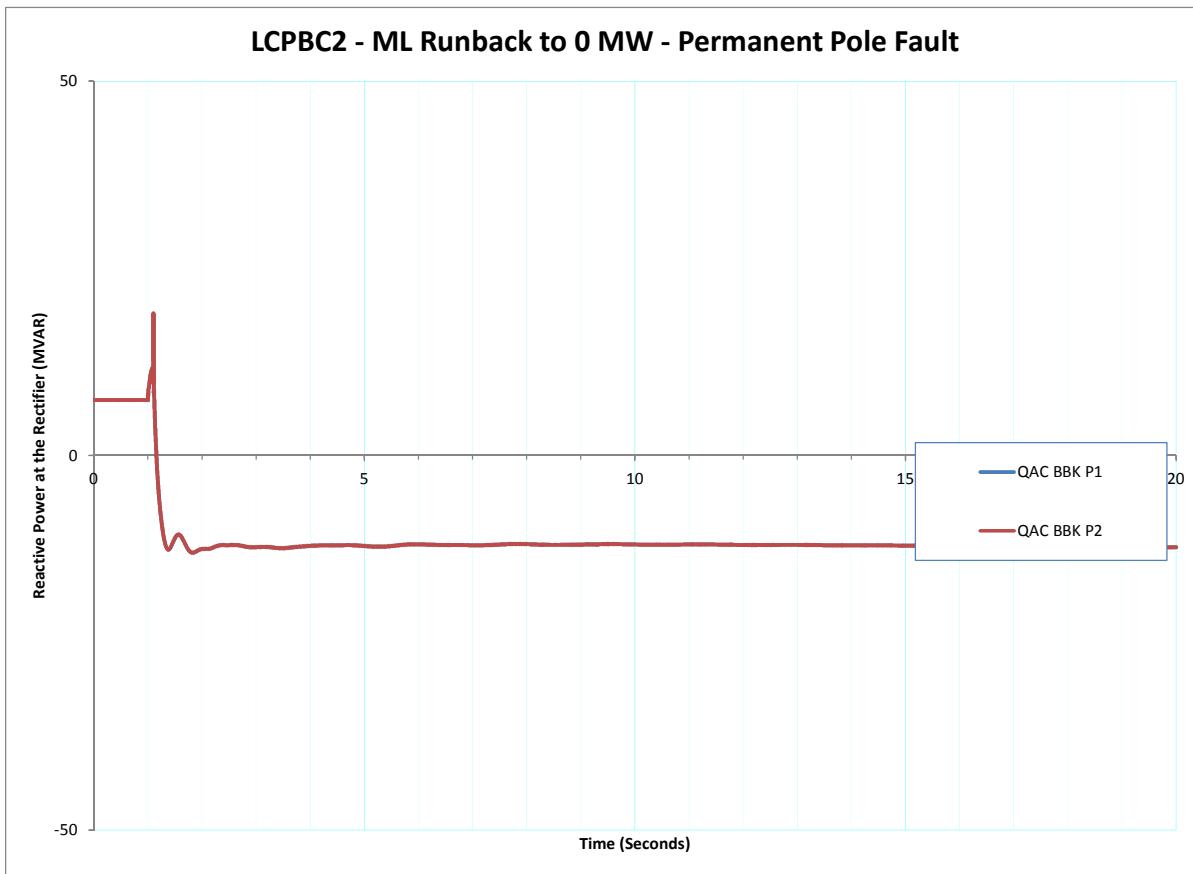
Figure 299 - LCPBC2 - ML Runback to 0 MW - Permanent Pole Fault - Reactive Power at the Rectifier (MVAR)

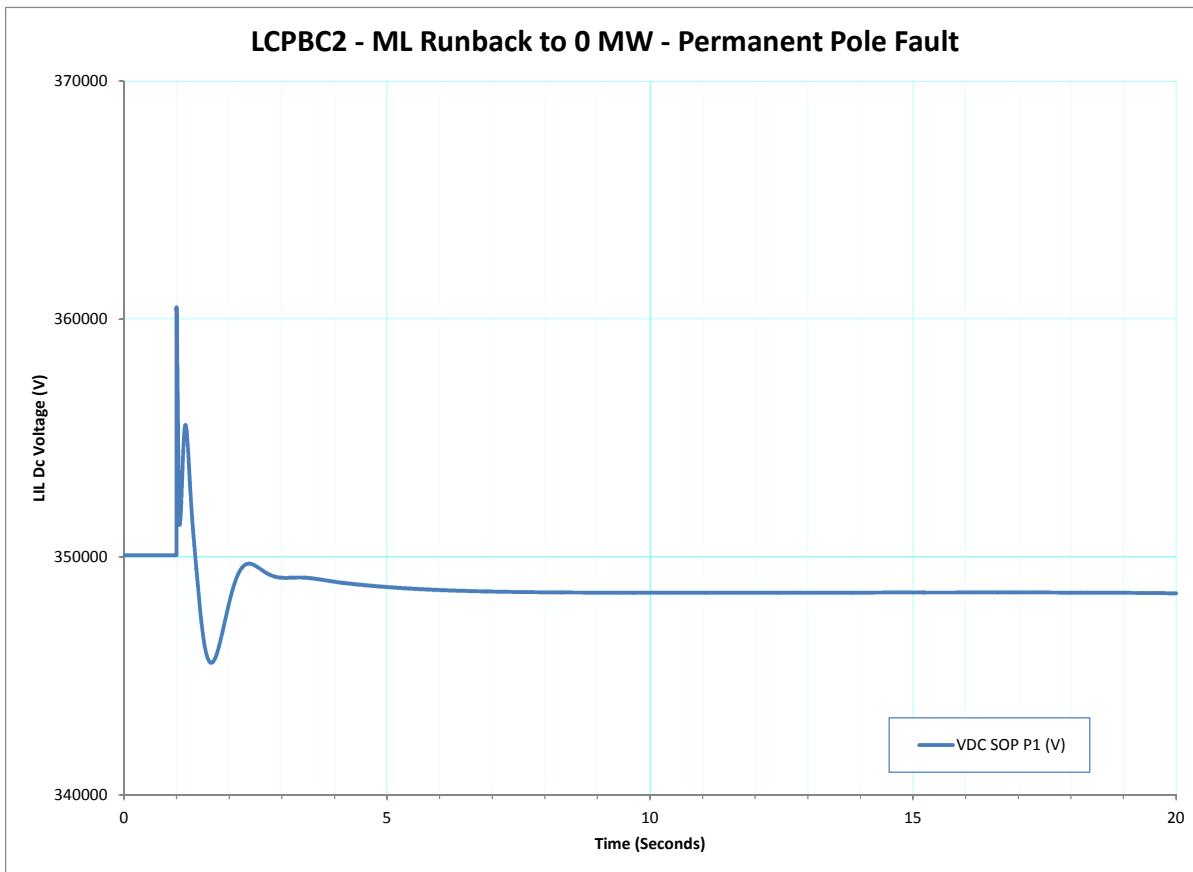
Figure 300 - LCPBC2 - ML Runback to 0 MW - Permanent Pole Fault - LIL Dc Voltage (V)

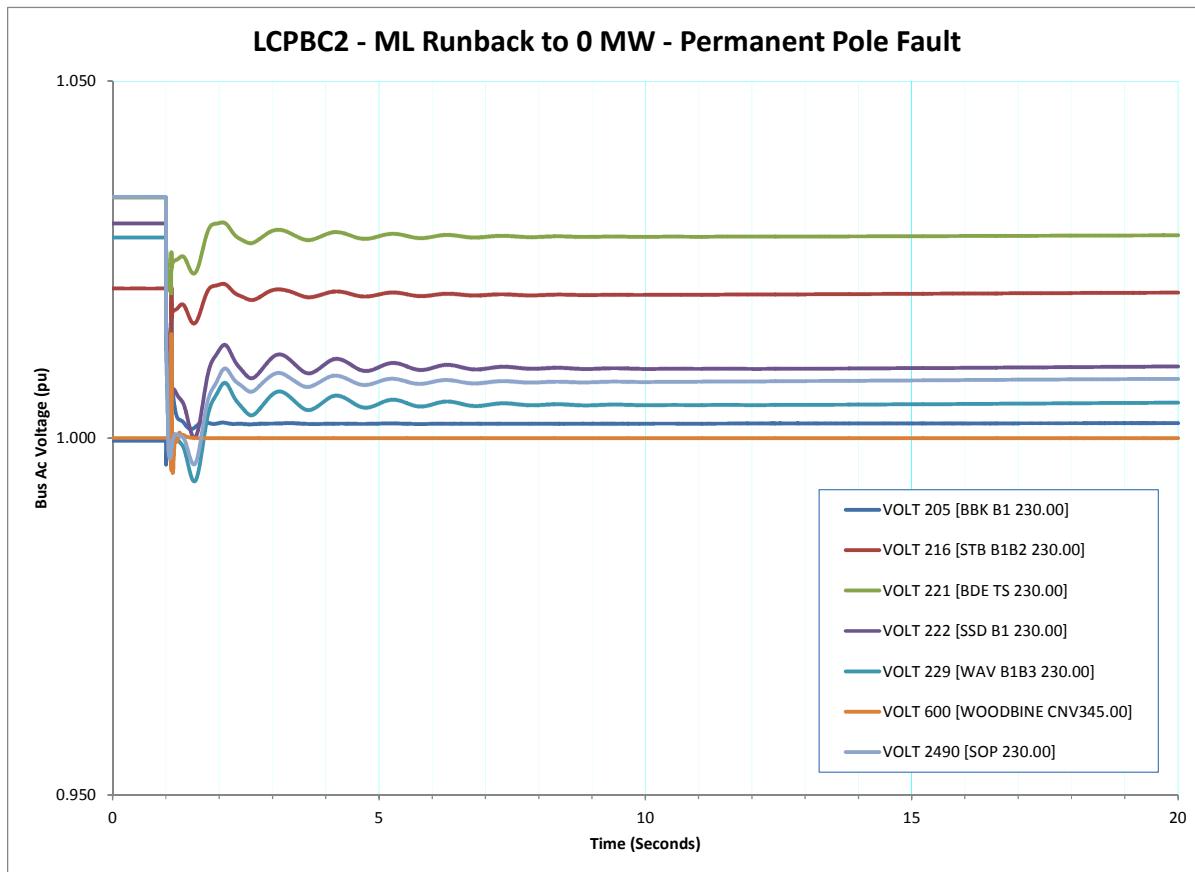
Figure 301 - LCPBC2 - ML Runback to 0 MW - Permanent Pole Fault - Bus Ac Voltage (pu)

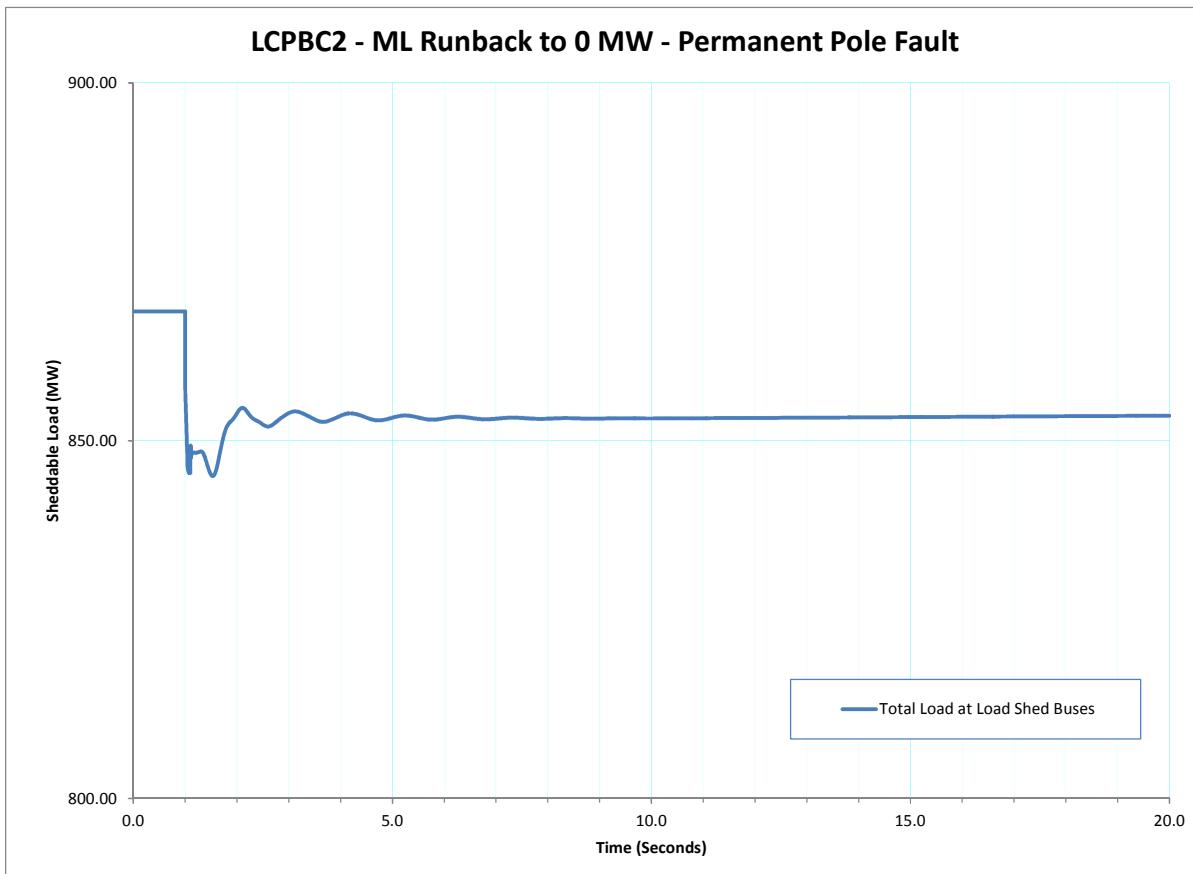
Figure 302 - LCPBC2 - ML Runback to 0 MW - Permanent Pole Fault - Shedtable Load (MW)

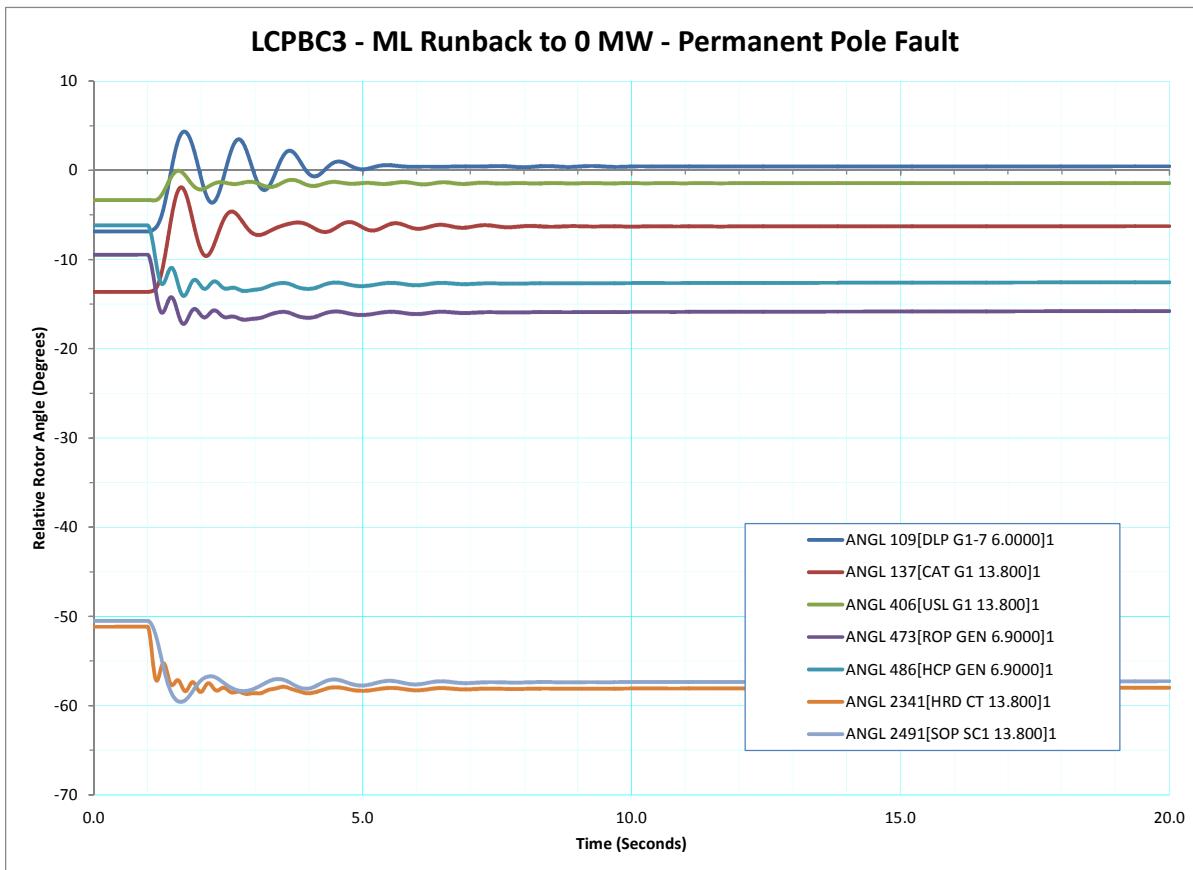
Figure 303 - LCPBC3 - ML Runback to 0 MW - Permanent Pole Fault - Relative Rotor Angle (Degrees)

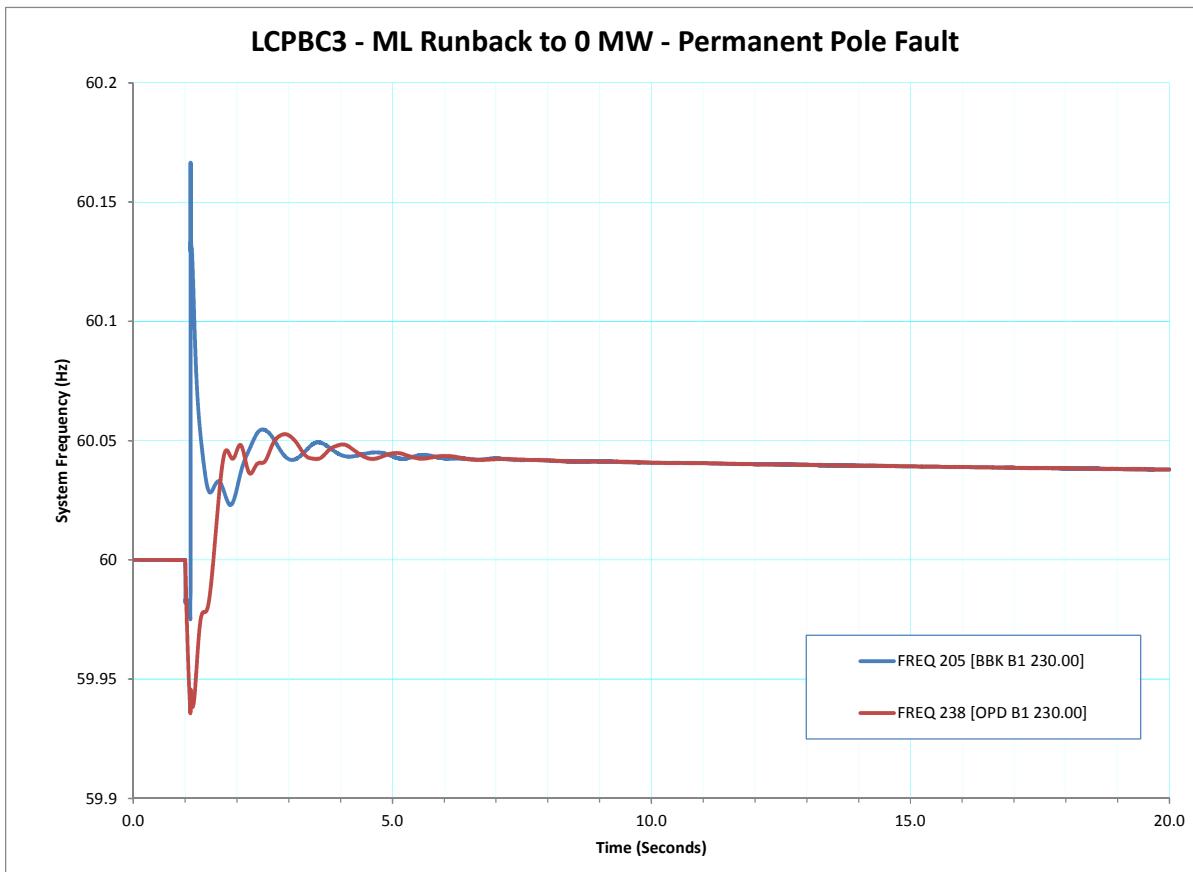
Figure 304 - LCPBC3 - ML Runback to 0 MW - Permanent Pole Fault - System Frequency (Hz)

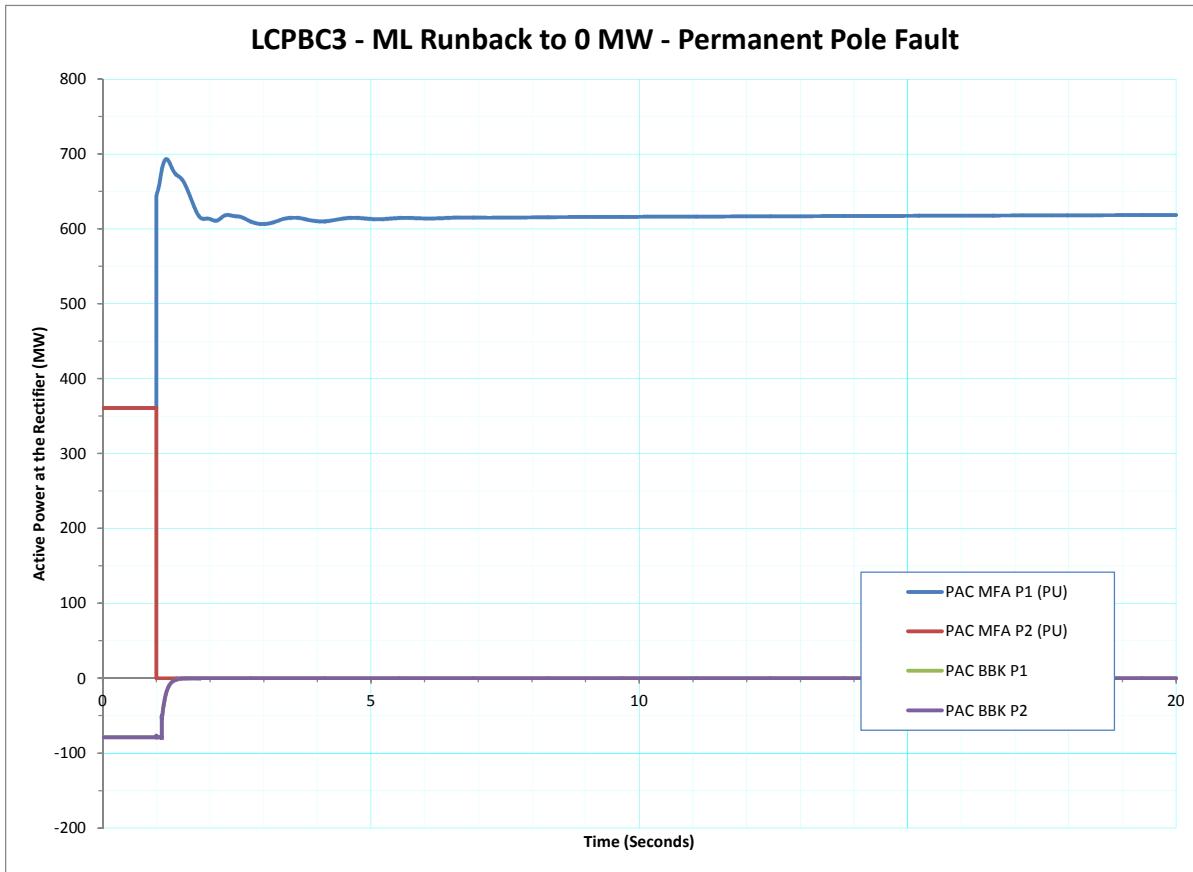
Figure 305 - LCPBC3 - ML Runback to 0 MW - Permanent Pole Fault - Active Power at the Rectifier (MW)

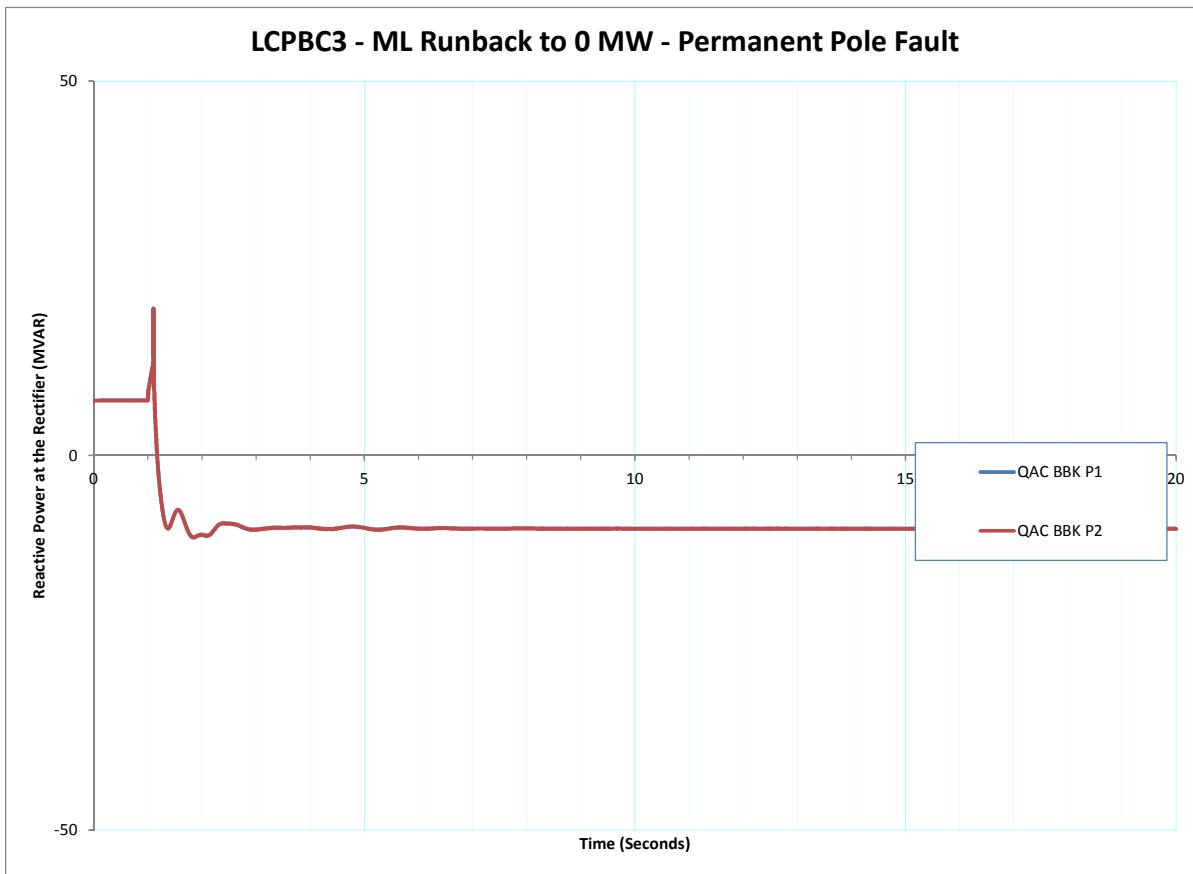
Figure 306 - LCPBC3 - ML Runback to 0 MW - Permanent Pole Fault - Reactive Power at the Rectifier (MVAR)

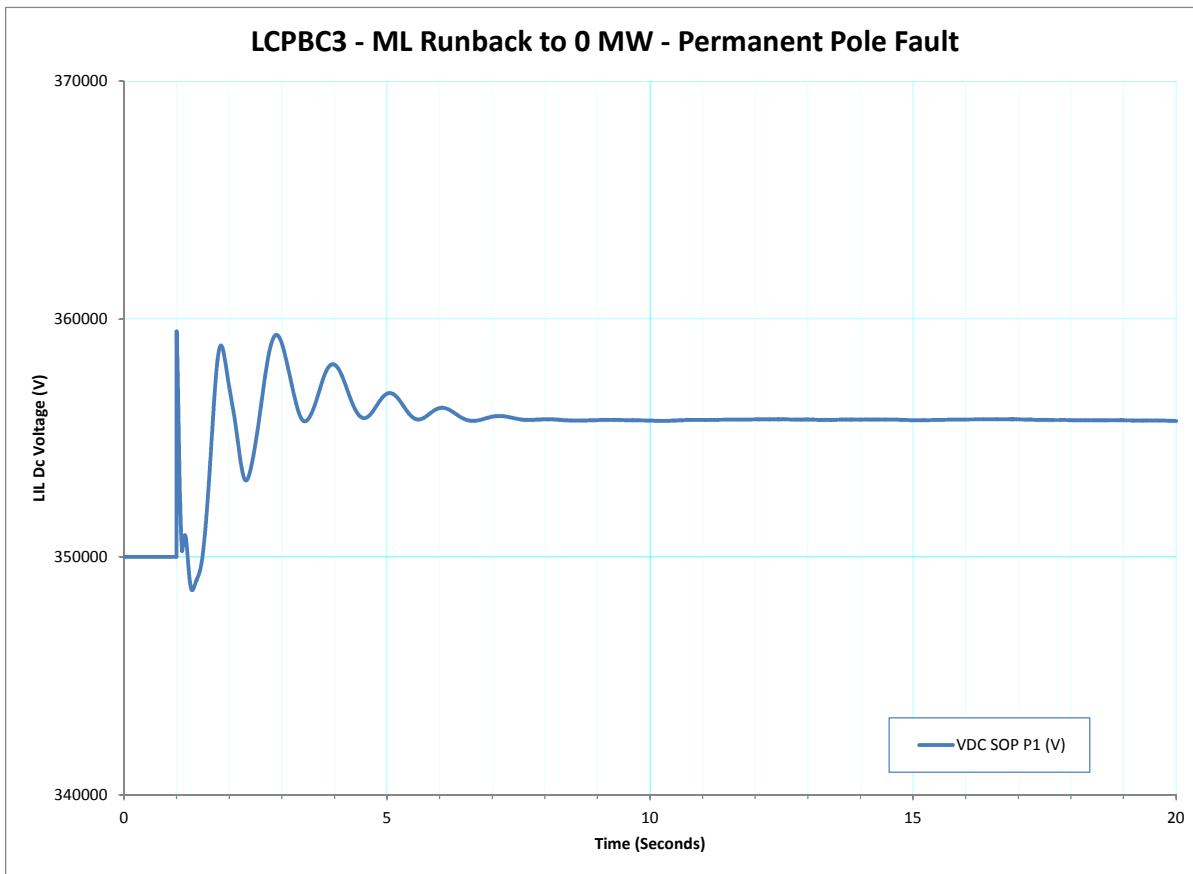
Figure 307 - LCPBC3 - ML Runback to 0 MW - Permanent Pole Fault - LIL Dc Voltage (V)

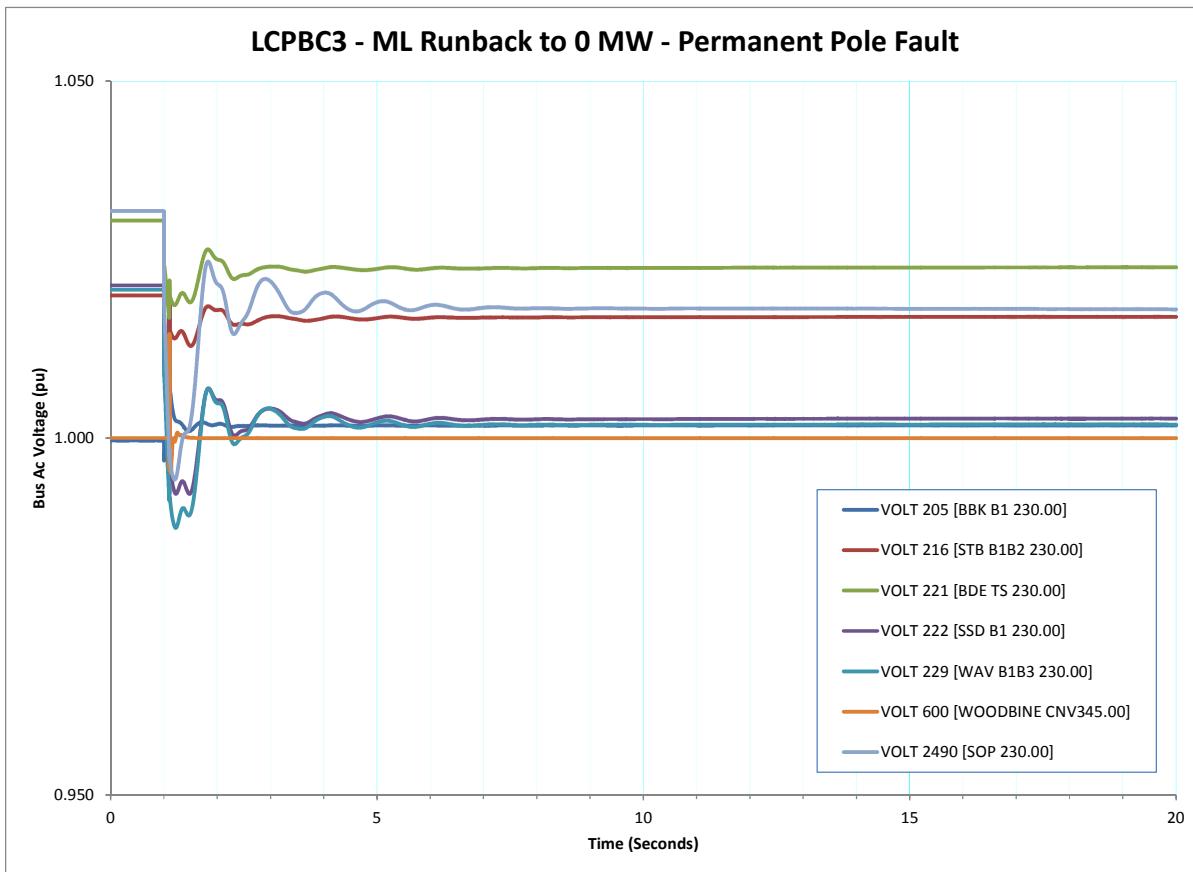
Figure 308 - LCPBC3 - ML Runback to 0 MW - Permanent Pole Fault - Bus Ac Voltage (pu)

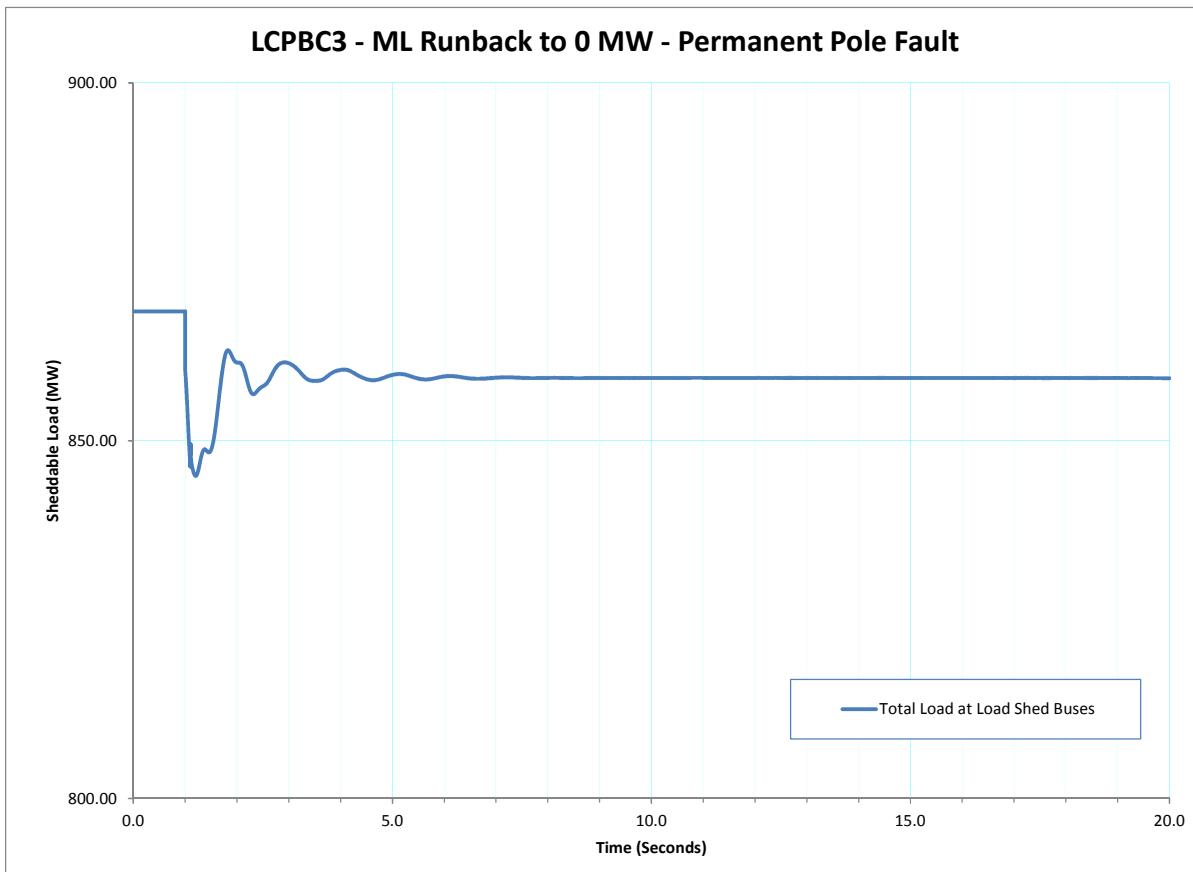
Figure 309 - LCPBC3 - ML Runback to 0 MW - Permanent Pole Fault - Sheddable Load (MW)

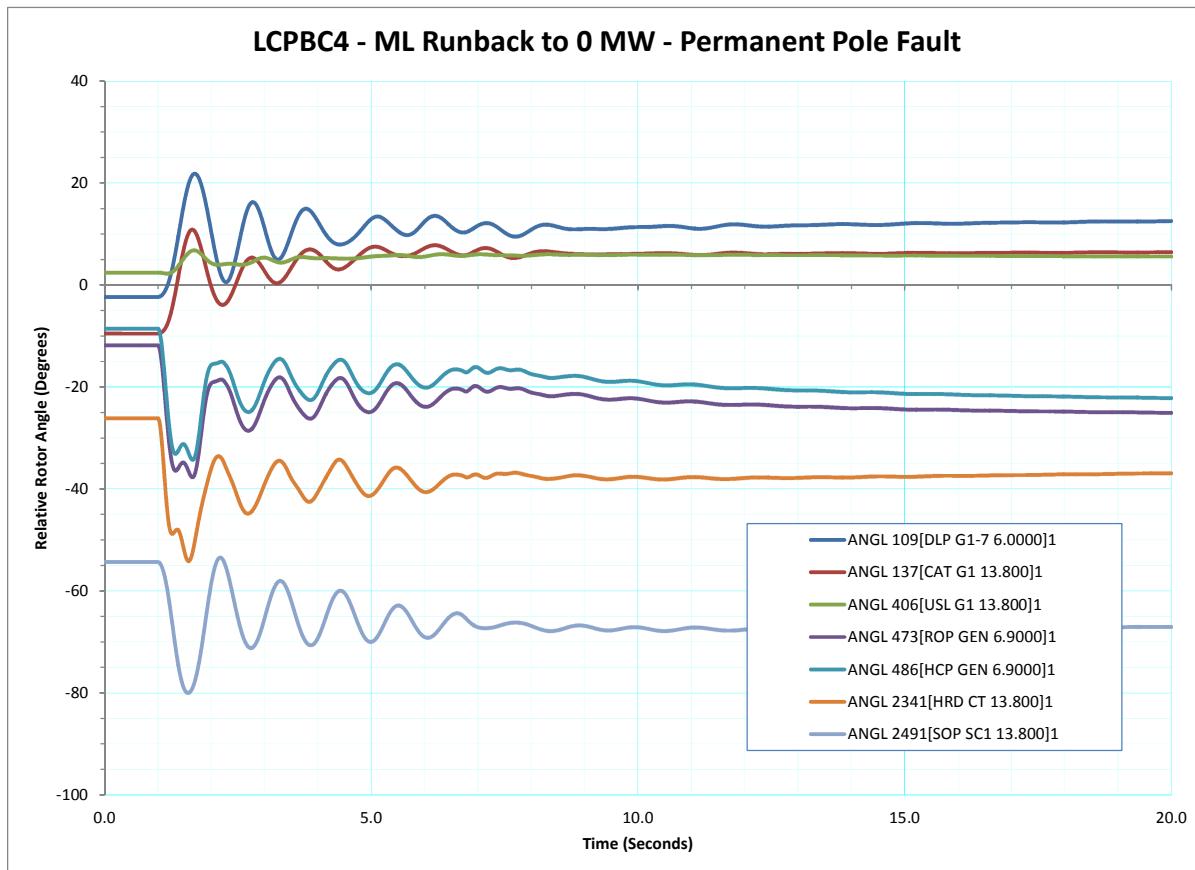
Figure 310 - LCPBC4 - ML Runback to 0 MW - Permanent Pole Fault - Relative Rotor Angle (Degrees)

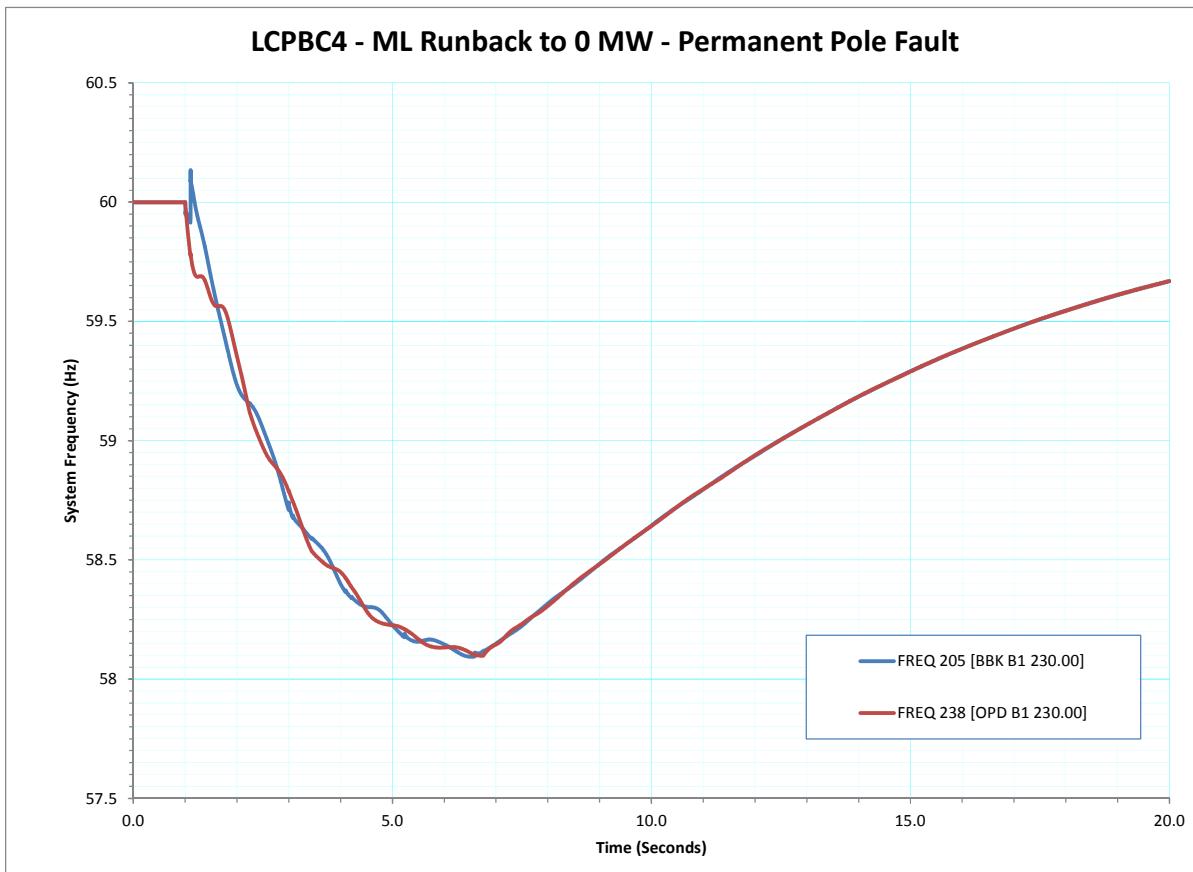
Figure 311 - LCPBC4 - ML Runback to 0 MW - Permanent Pole Fault - System Frequency (Hz)

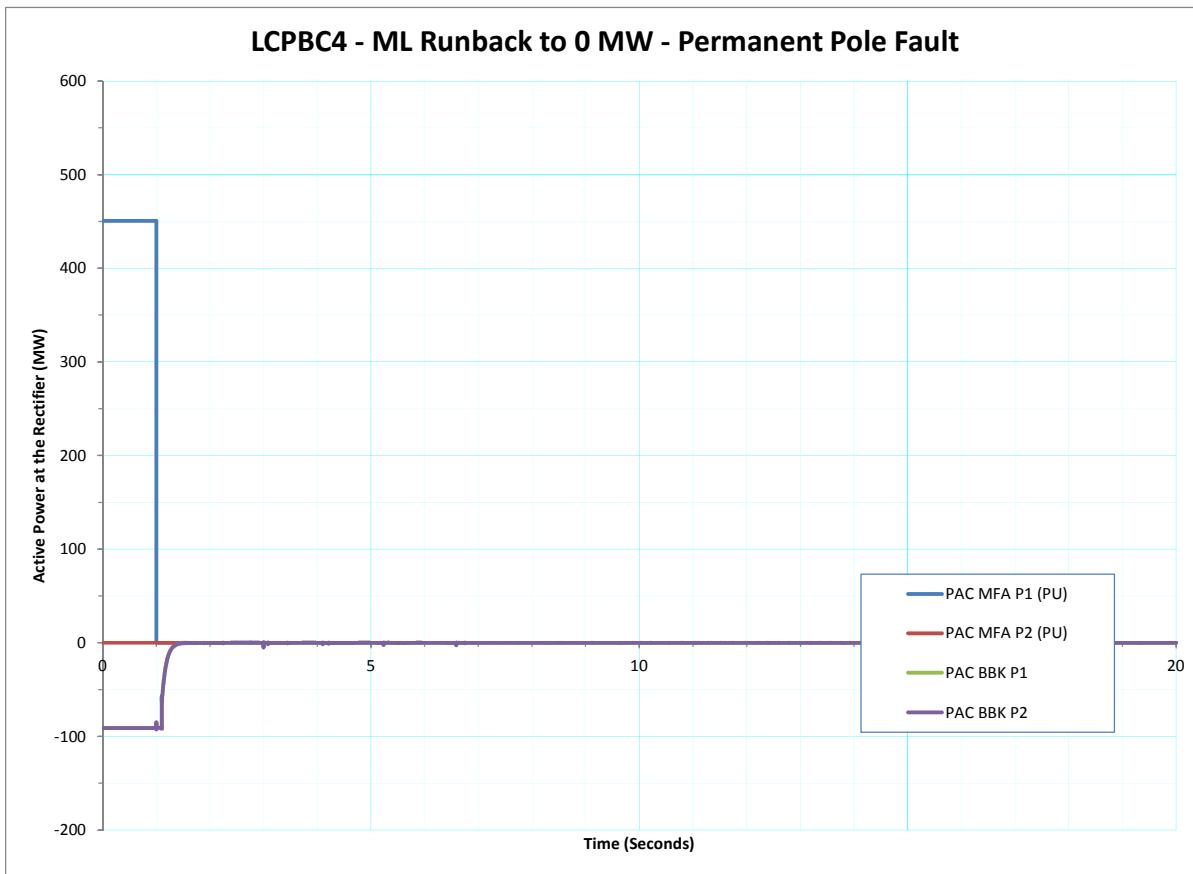
Figure 312 - LCPBC4 - ML Runback to 0 MW - Permanent Pole Fault - Active Power at the Rectifier (MW)

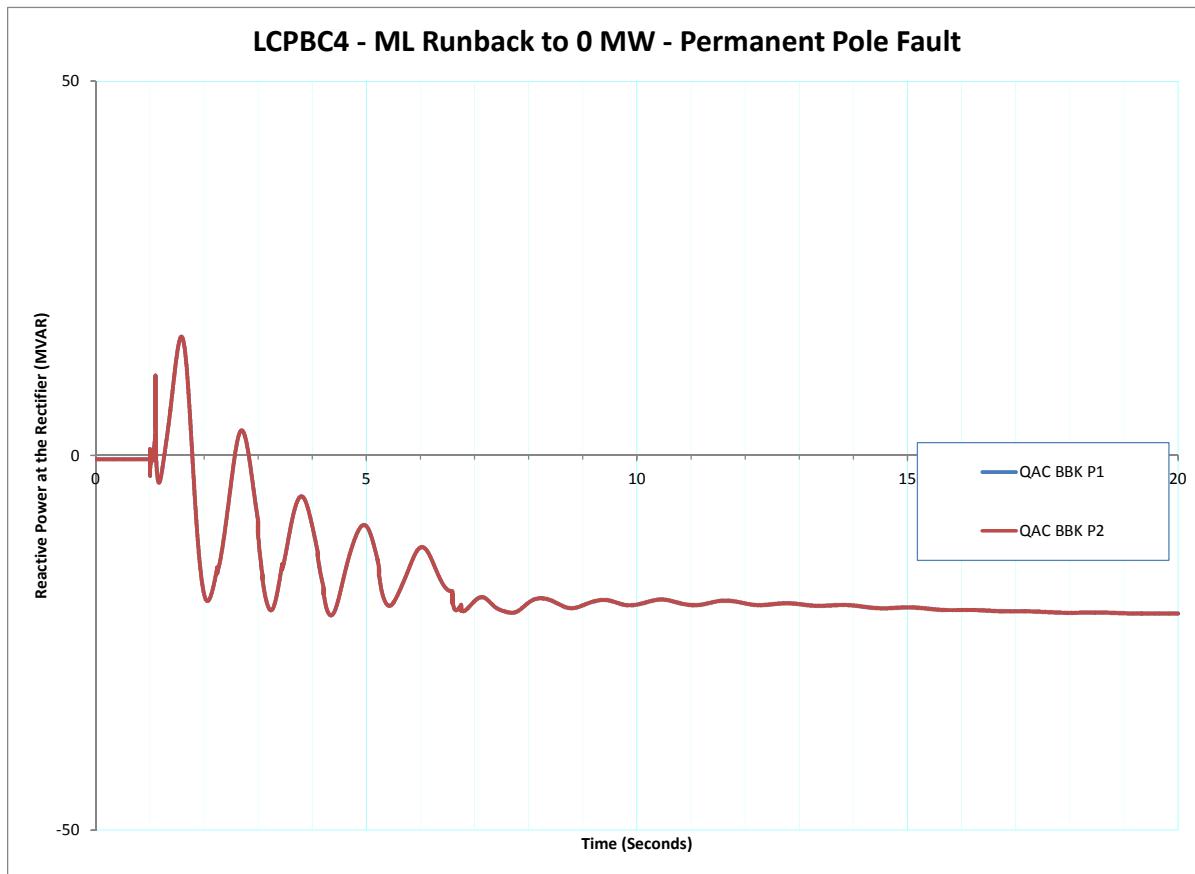
Figure 313 - LCPBC4 - ML Runback to 0 MW - Permanent Pole Fault - Reactive Power at the Rectifier (MVAR)

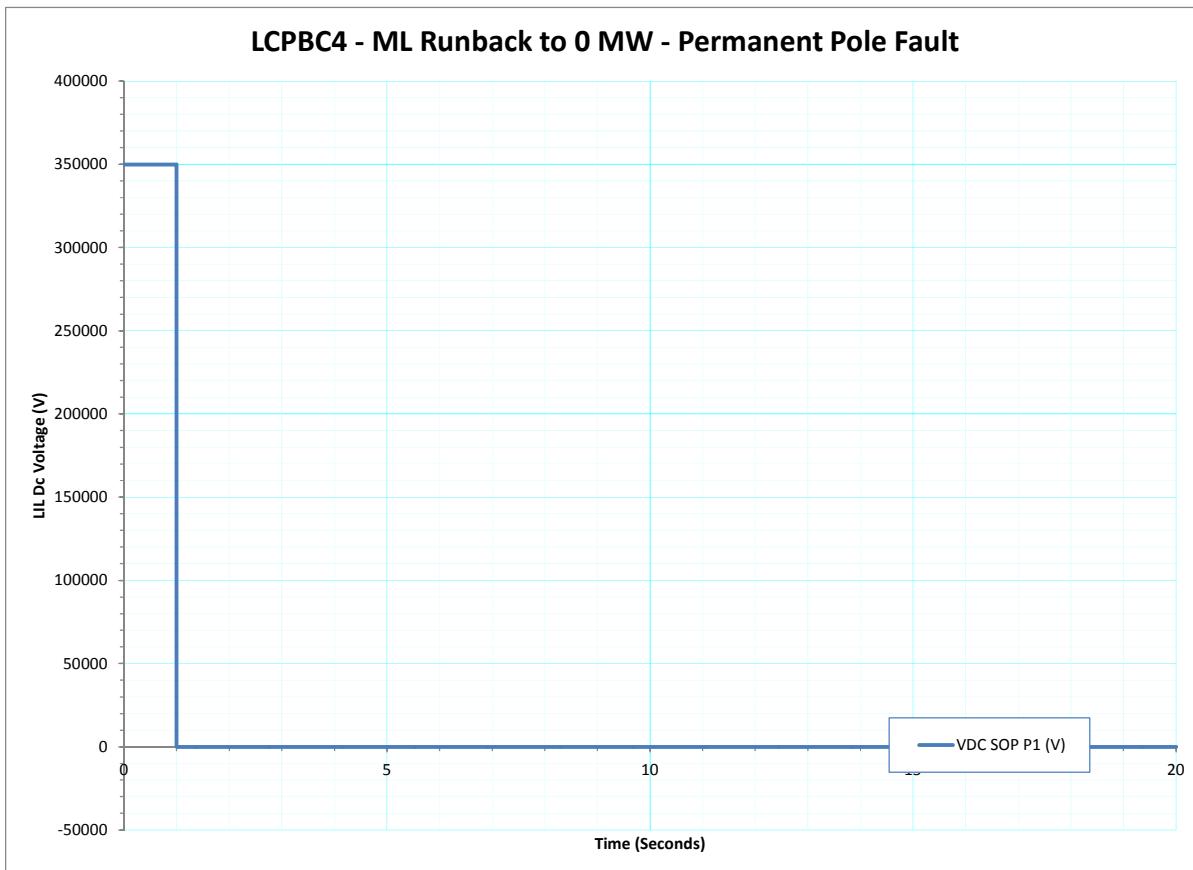
Figure 314 - LCPBC4 - ML Runback to 0 MW - Permanent Pole Fault - LIL Dc Voltage (V)

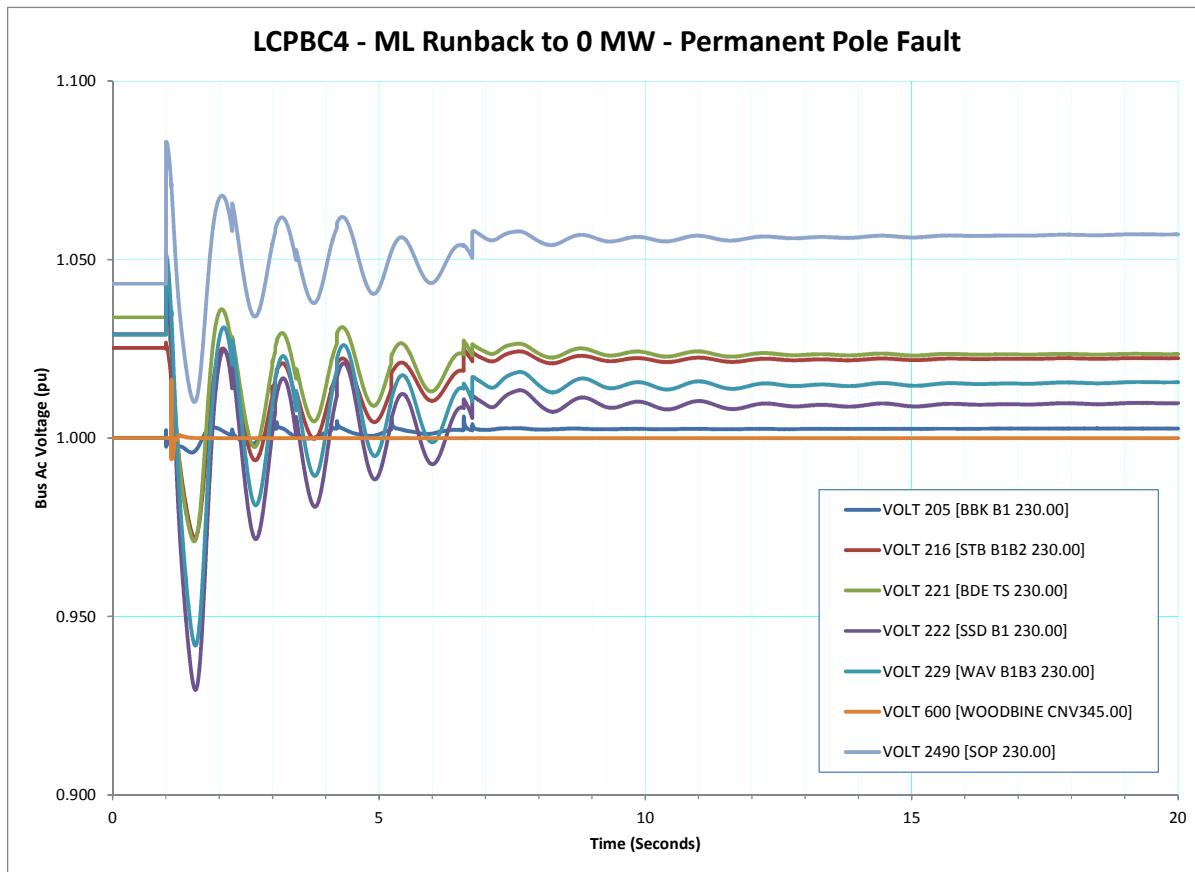
Figure 315 - LCPBC4 - ML Runback to 0 MW - Permanent Pole Fault - Bus Ac Voltage (pu)
