MARITIME LINK PRELIMINARY INTERCONNECTION STUDY

Newfoundland and Labrador Hydro

July 2014

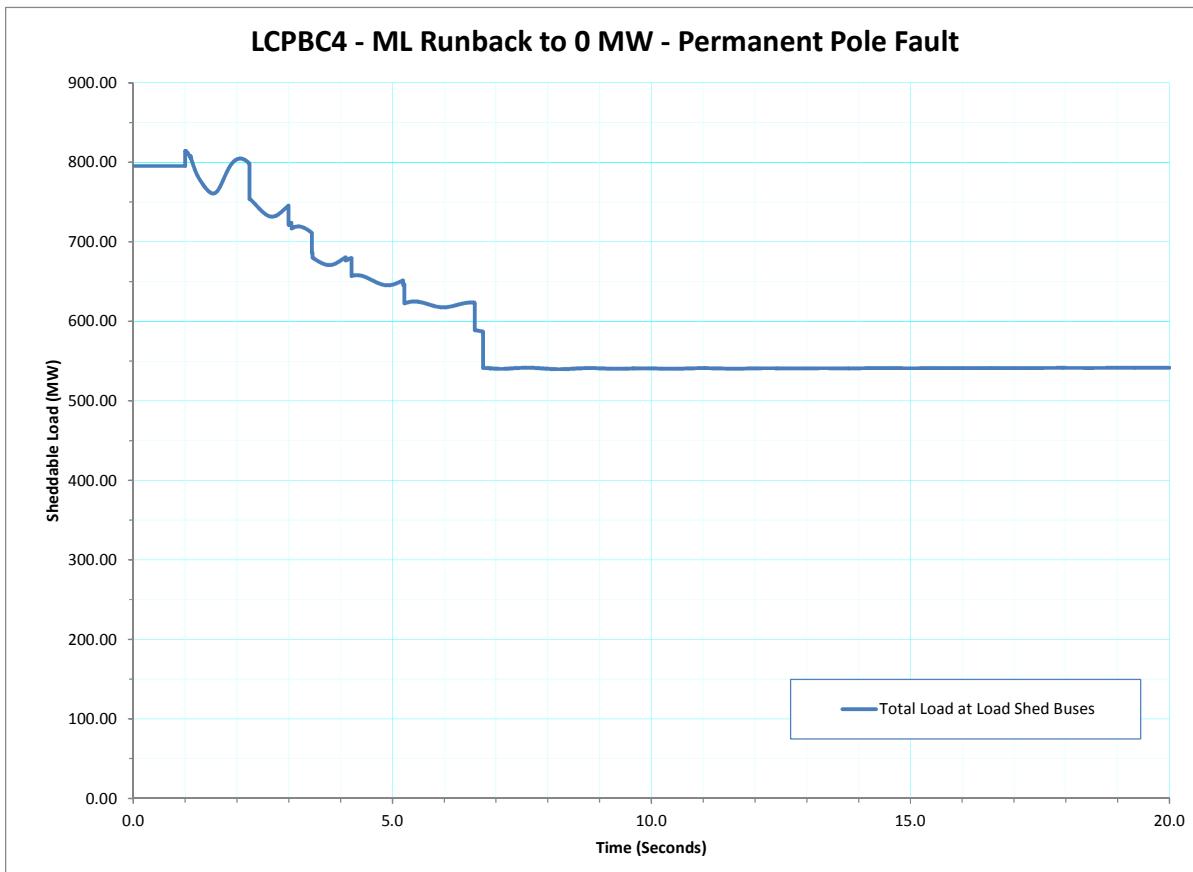
Figure 316 - LCPBC4 - ML Runback to 0 MW - Permanent Pole Fault - Sheddable Load (MW)

It should be noted that for all other cases (with the exception of BC11) the permanent loss of a pole results in underfrequency load shedding within the Island Interconnected System if ML export is not curtailed. Appendix E illustrates how underfrequency load shedding can

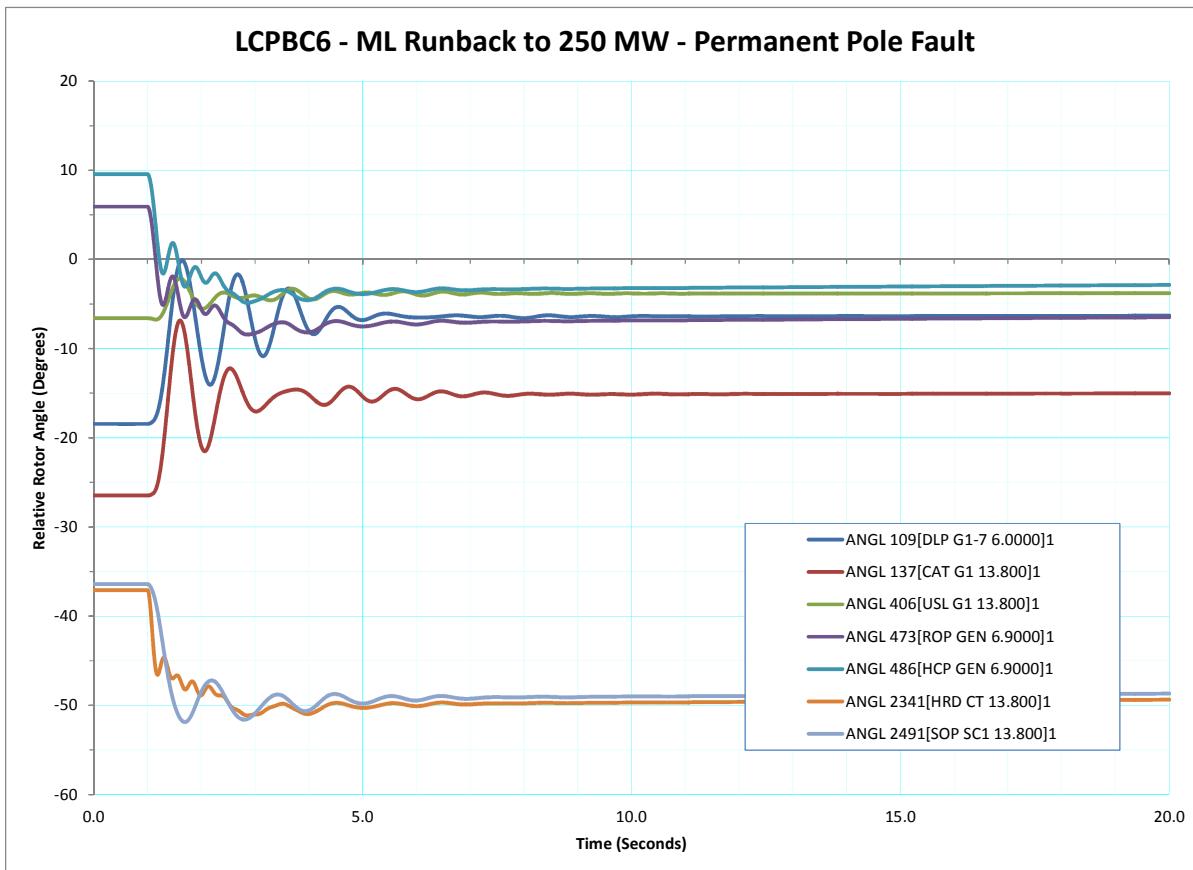
Figure 317 - LCPBC6 - ML Runback to 250 MW - Permanent Pole Fault - Relative Rotor Angle (Degrees)

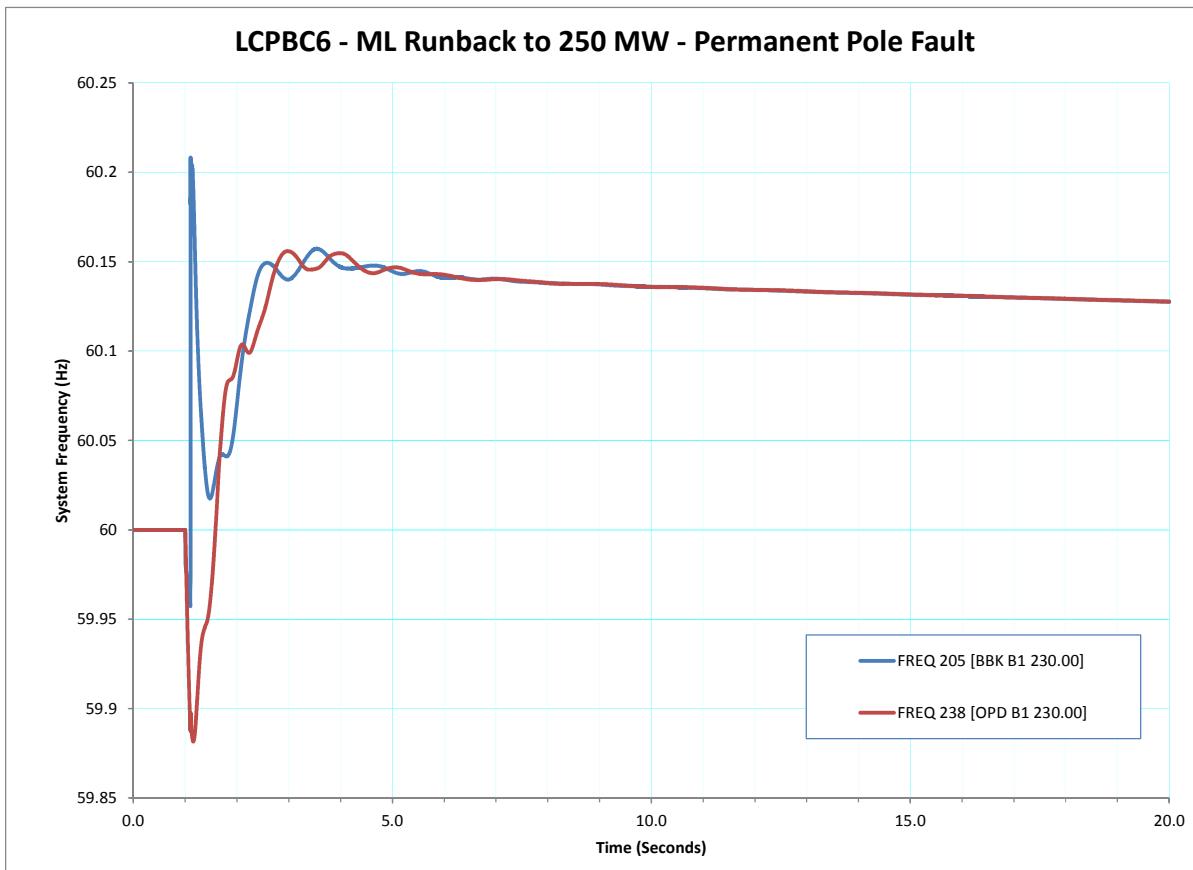
Figure 318 - LCPBC6 - ML Runback to 250 MW - Permanent Pole Fault - System Frequency (Hz)

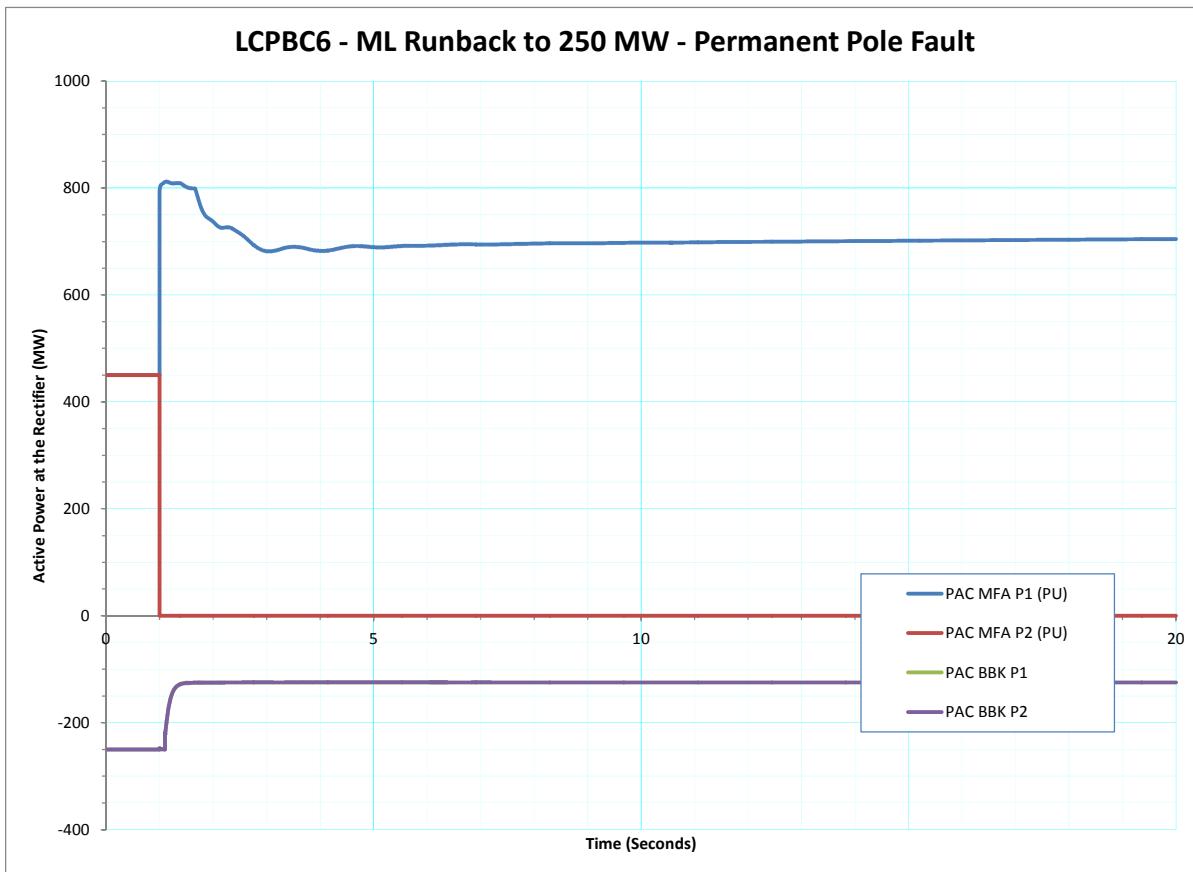
Figure 319 - LCPBC6 - ML Runback to 250 MW - Permanent Pole Fault - Active Power at the Rectifier (MW)

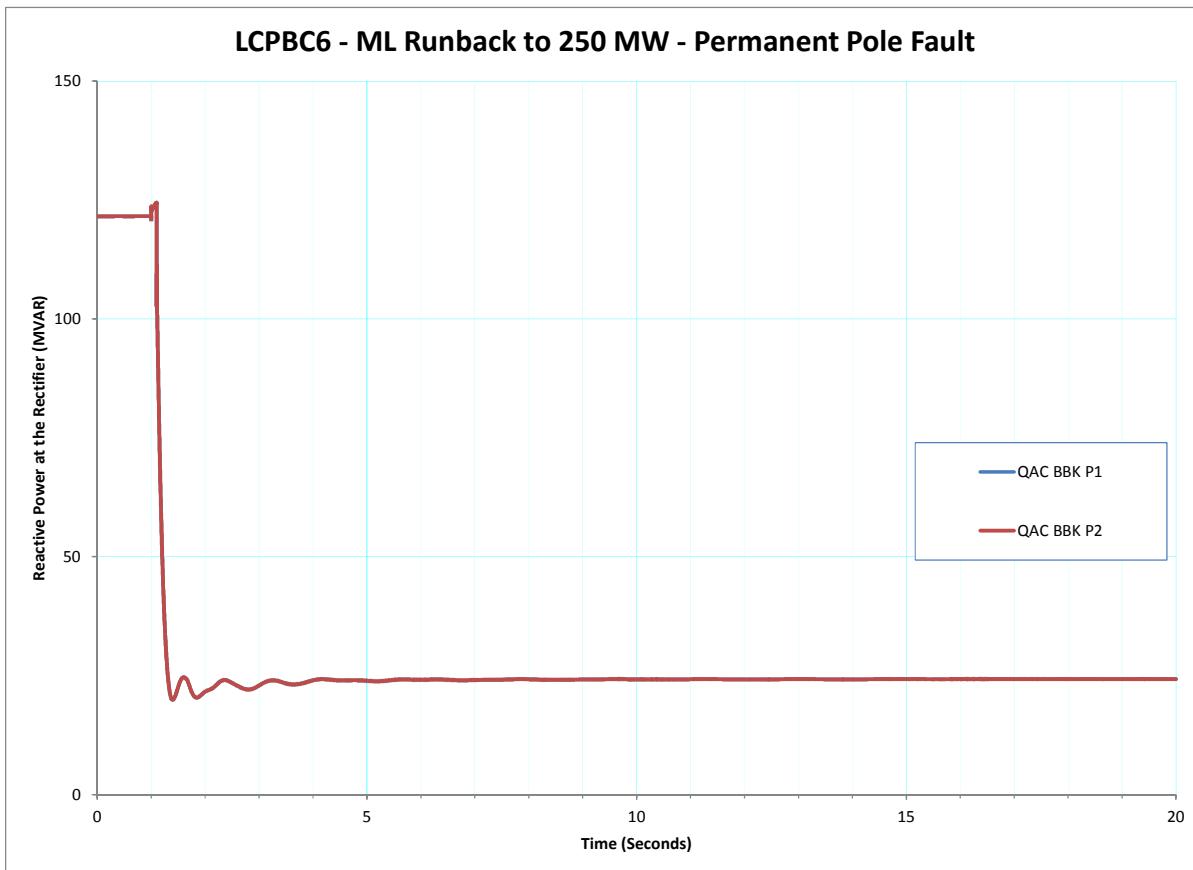
Figure 320 - LCPBC6 - ML Runback to 250 MW - Permanent Pole Fault - Reactive Power at the Rectifier (MVAR)

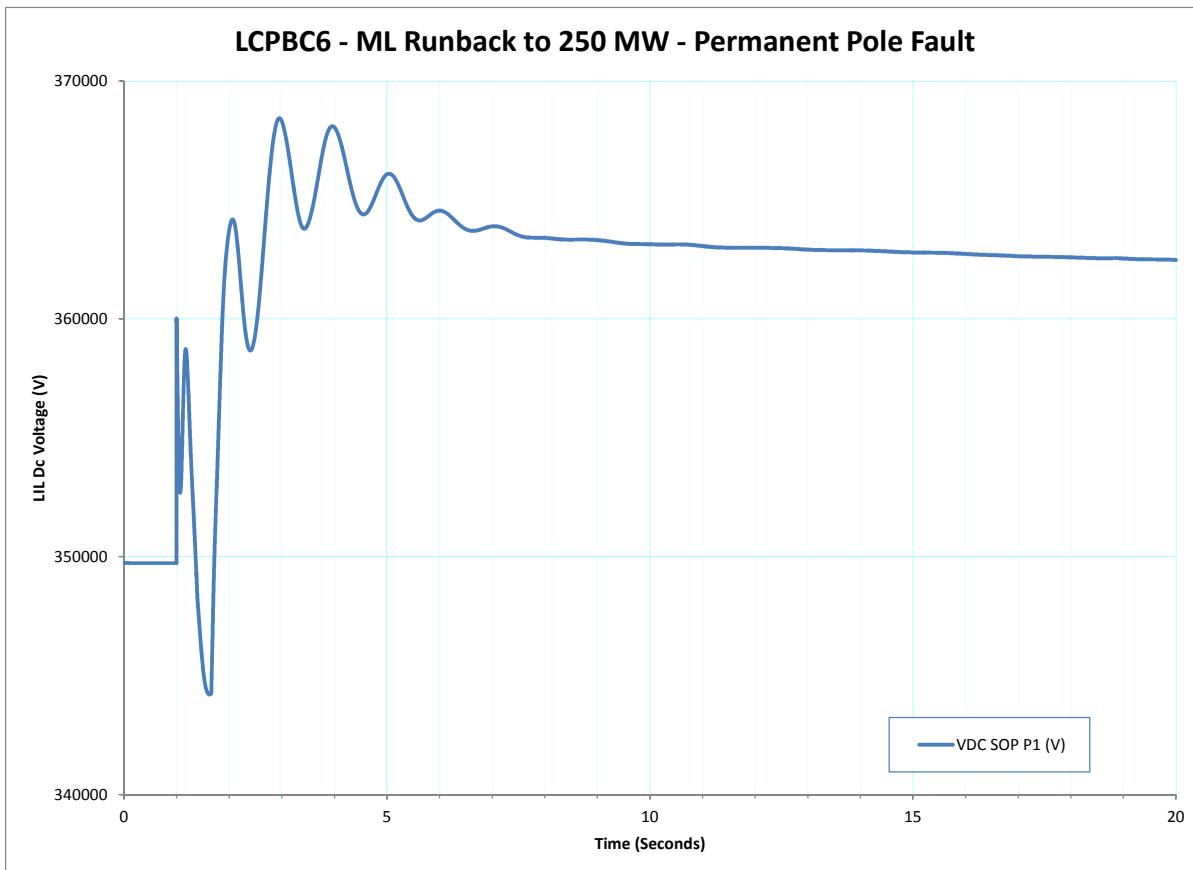
Figure 321 - LCPBC6 - ML Runback to 250 MW - Permanent Pole Fault - LIL Dc Voltage (V)

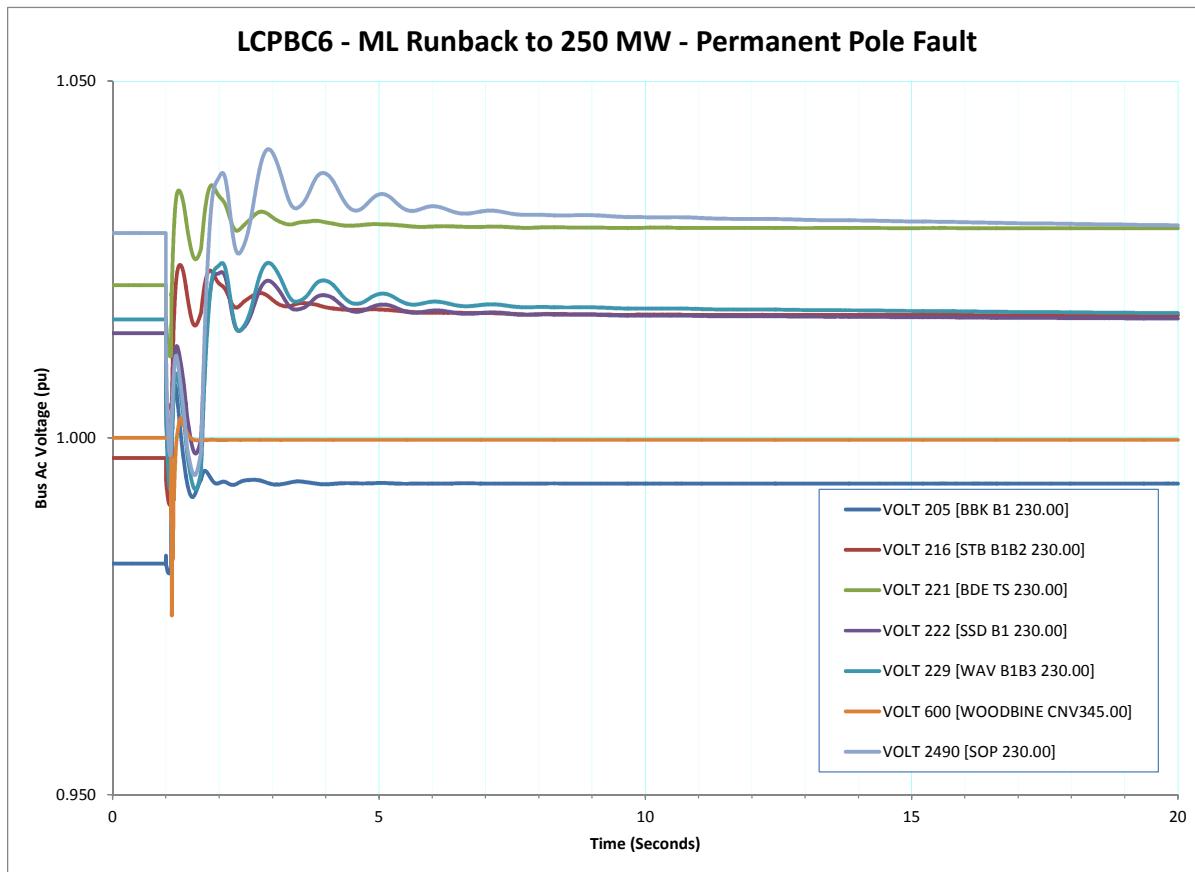
Figure 322 - LCPBC6 - ML Runback to 250 MW - Permanent Pole Fault - Bus Ac Voltage (pu)

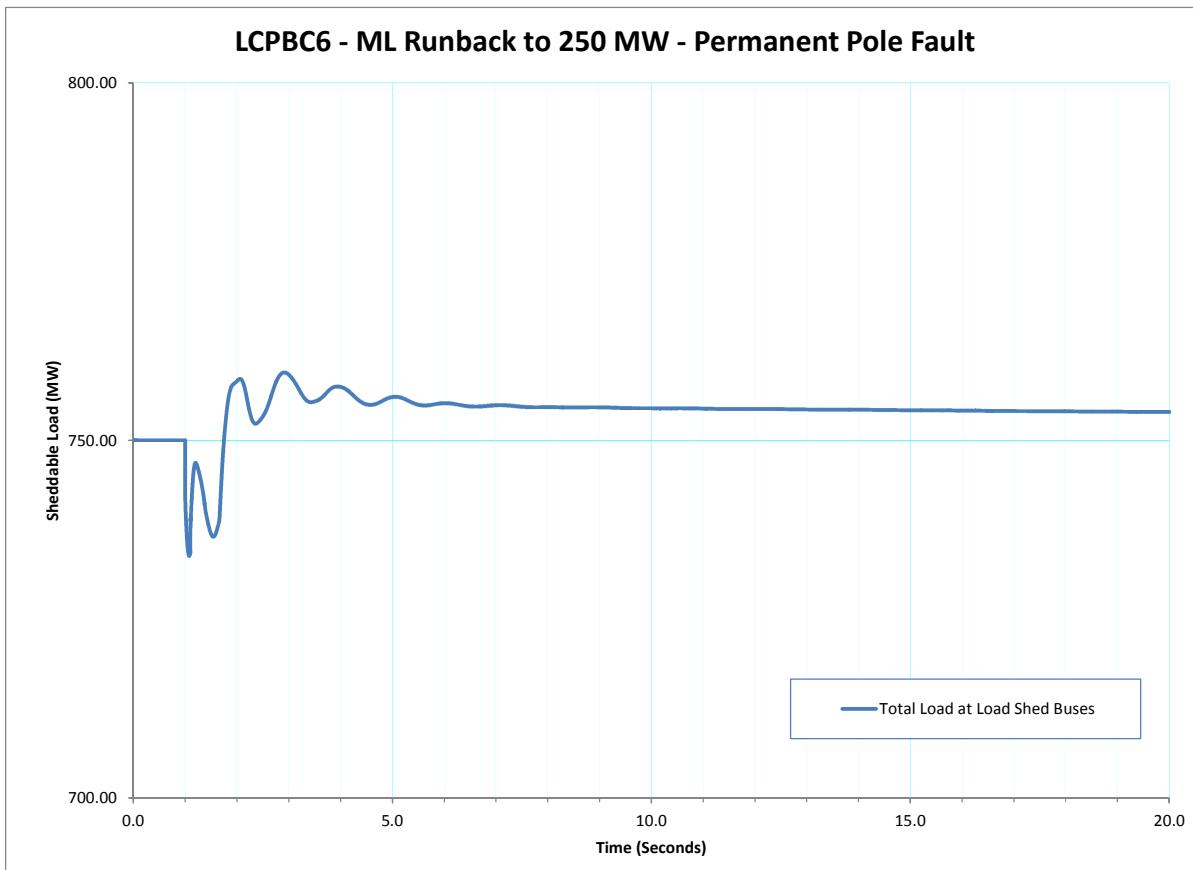
Figure 323 - LCPBC6 - ML Runback to 250 MW - Permanent Pole Fault - Sheddable Load (MW)

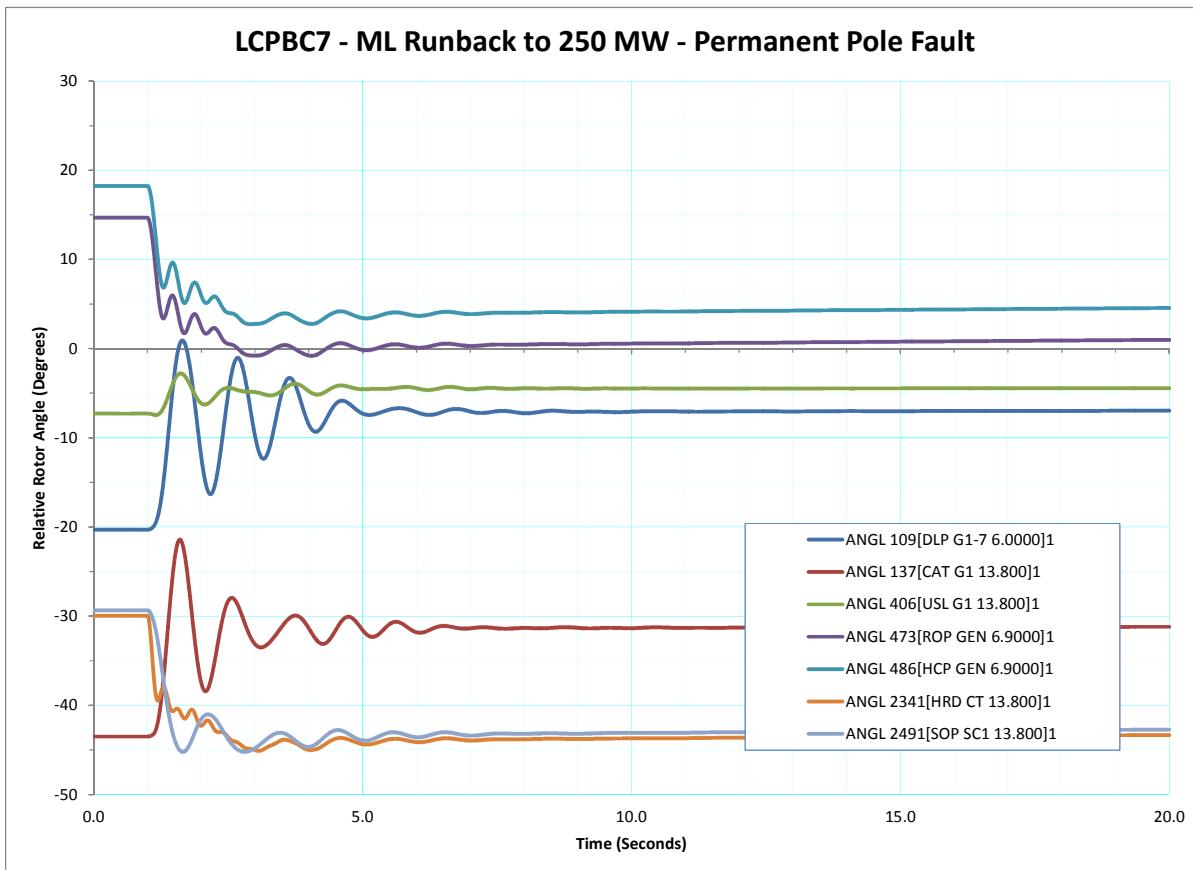
Figure 324 - LCPBC7 - ML Runback to 250 MW - Permanent Pole Fault - Relative Rotor Angle (Degrees)

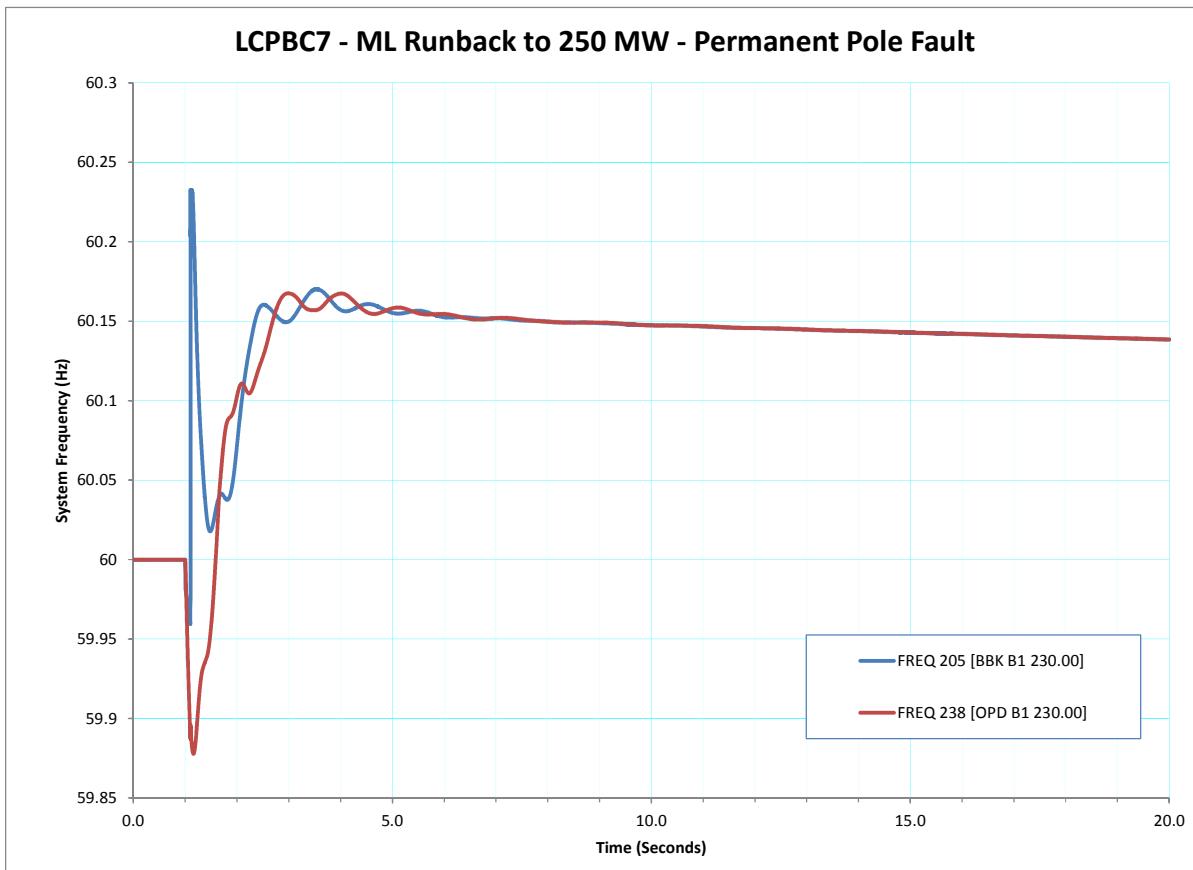
Figure 325 - LCPBC7 - ML Runback to 250 MW - Permanent Pole Fault - System Frequency (Hz)

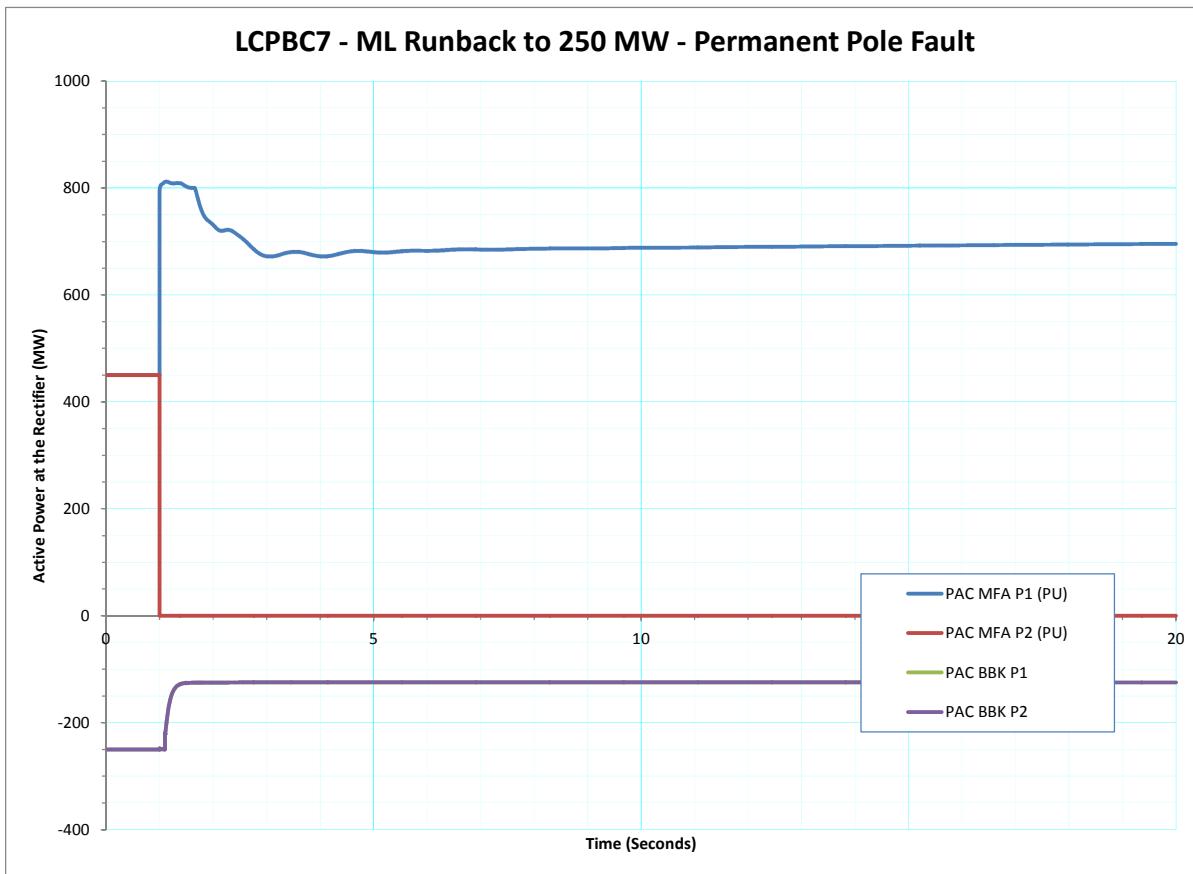
Figure 326 - LCPBC7 - ML Runback to 250 MW - Permanent Pole Fault - Active Power at the Rectifier (MW)

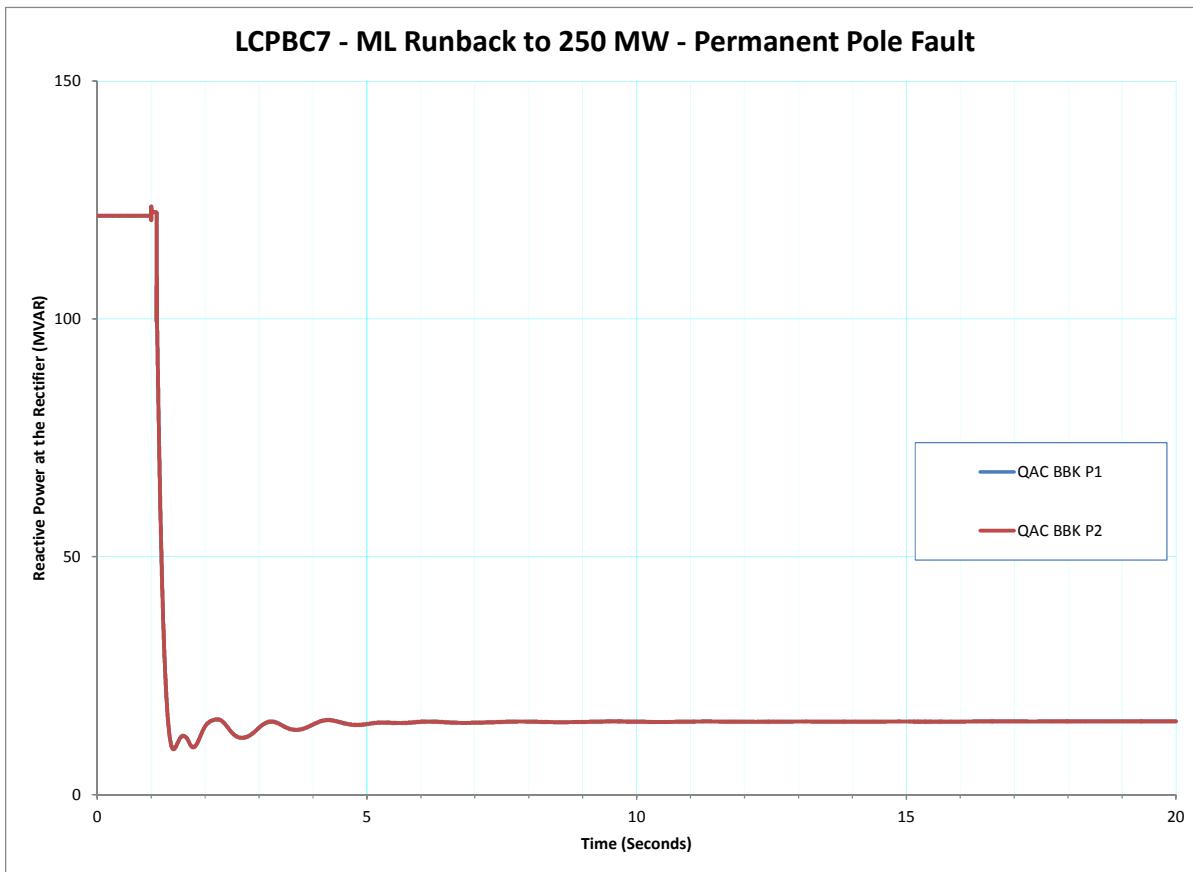
Figure 327 - LCPBC7 - ML Runback to 250 MW - Permanent Pole Fault - Reactive Power at the Rectifier (MVAR)

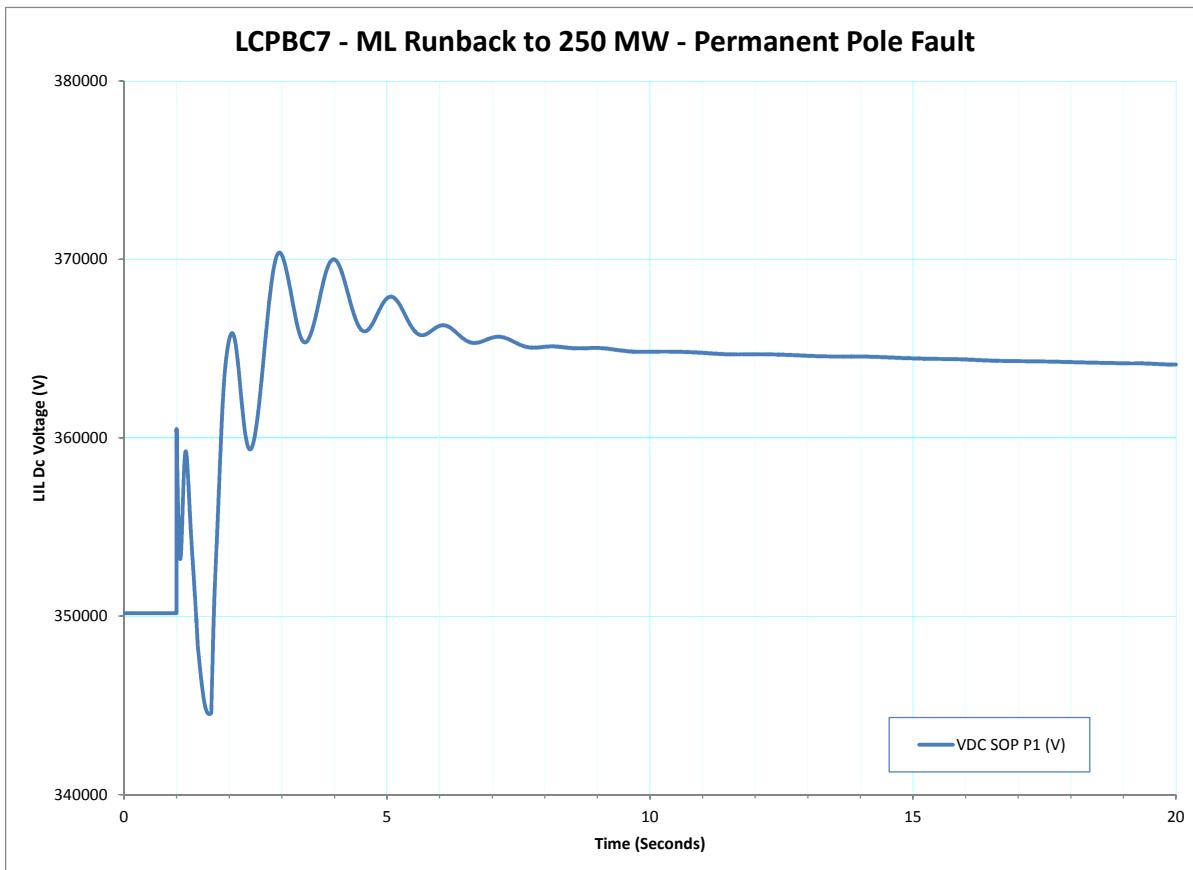
Figure 328 - LCPBC7 - ML Runback to 250 MW - Permanent Pole Fault - LIL Dc Voltage (V)

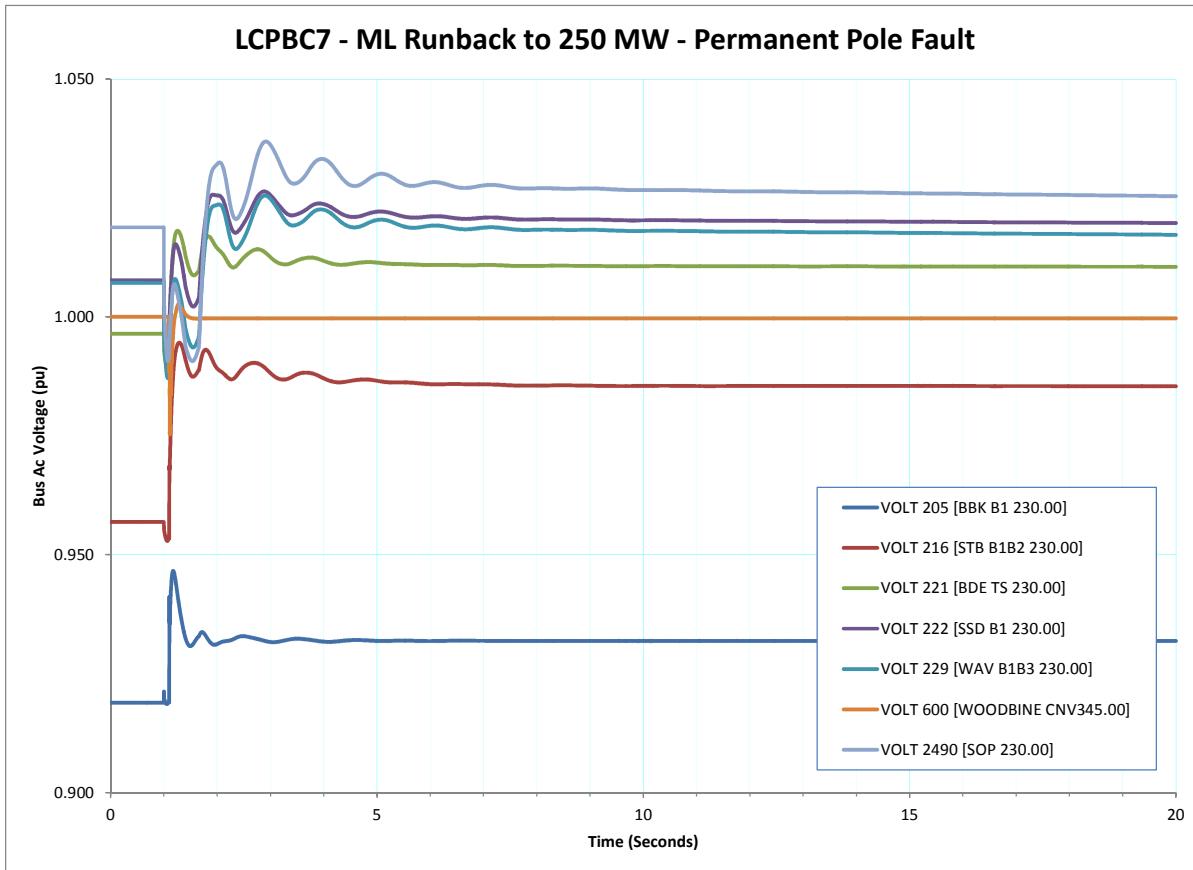
Figure 329 - LCPBC7 - ML Runback to 250 MW - Permanent Pole Fault - Bus Ac Voltage (pu)

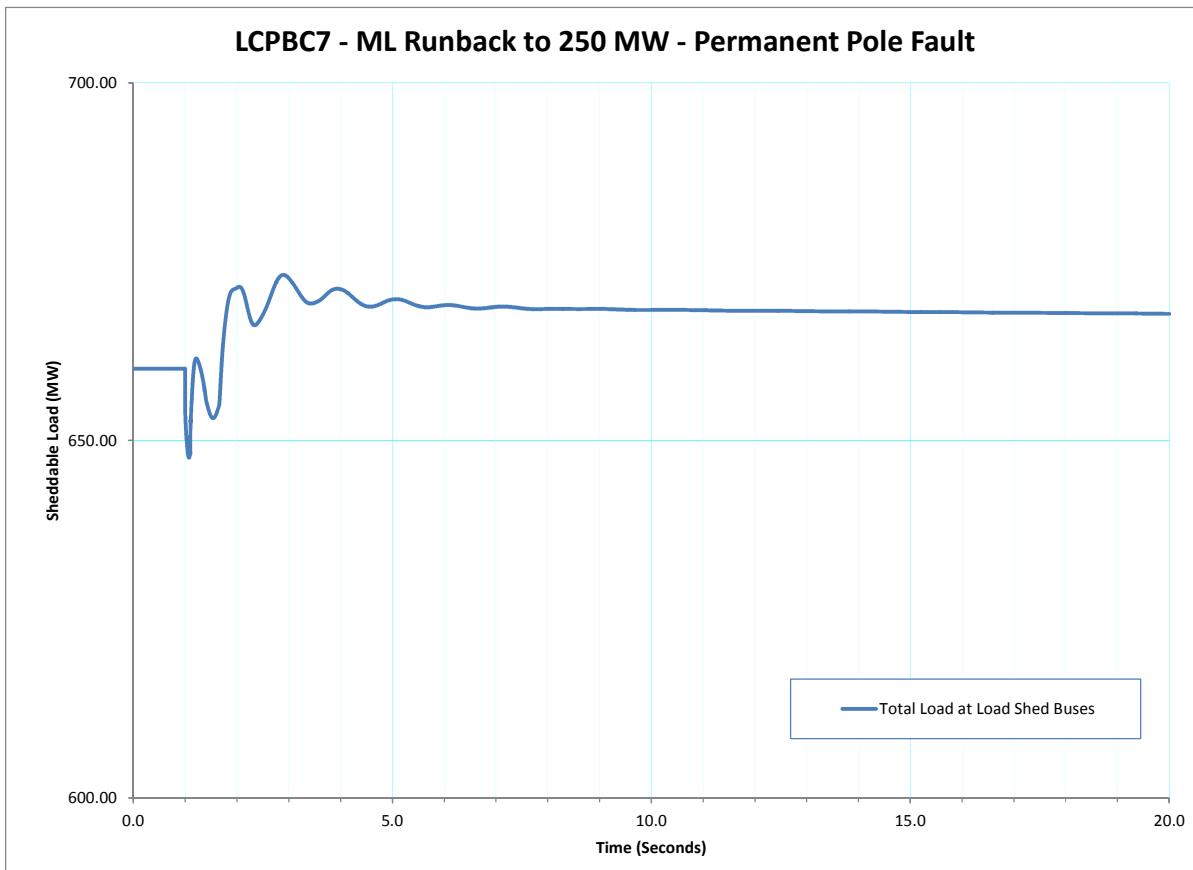
Figure 330 - LCPBC7 - ML Runback to 250 MW - Permanent Pole Fault - Sheddable Load (MW)

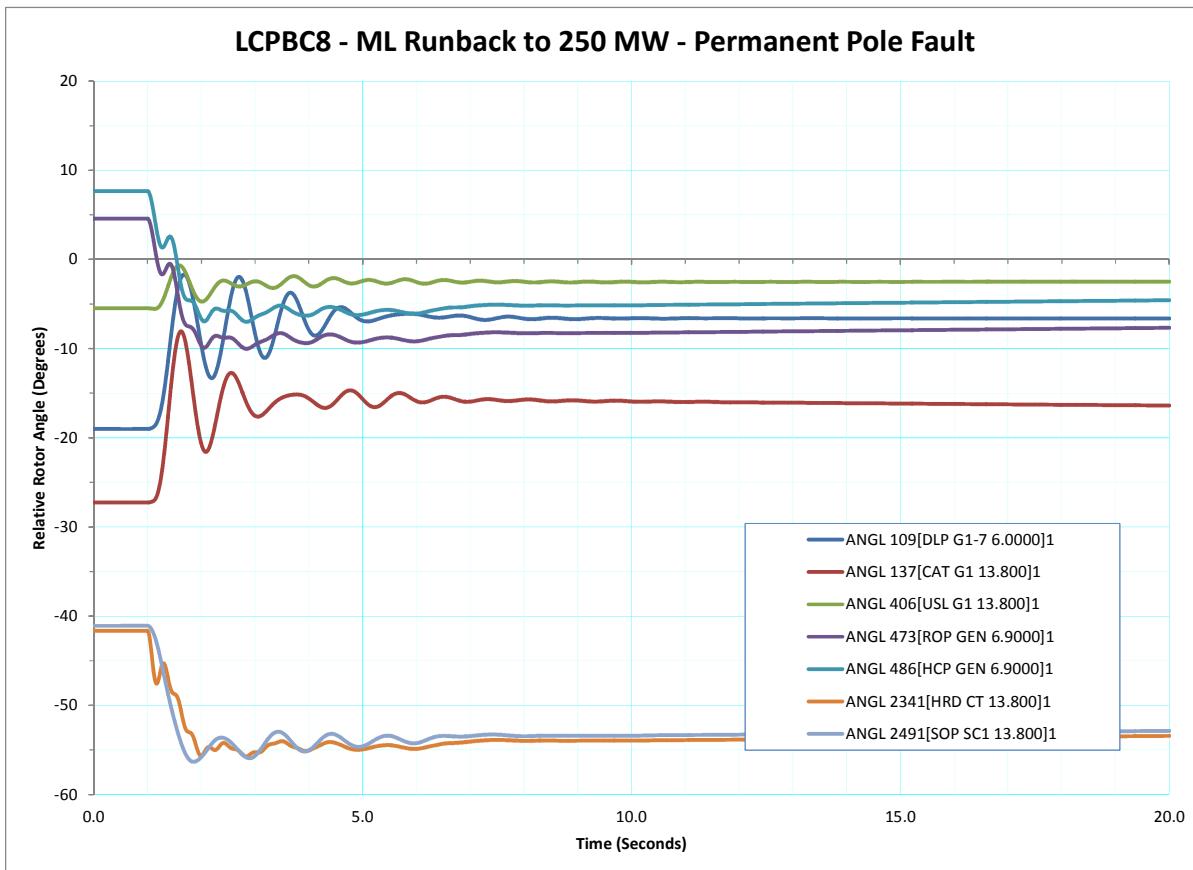
Figure 331 - LCPBC8 - ML Runback to 250 MW - Permanent Pole Fault - Relative Rotor Angle (Degrees)

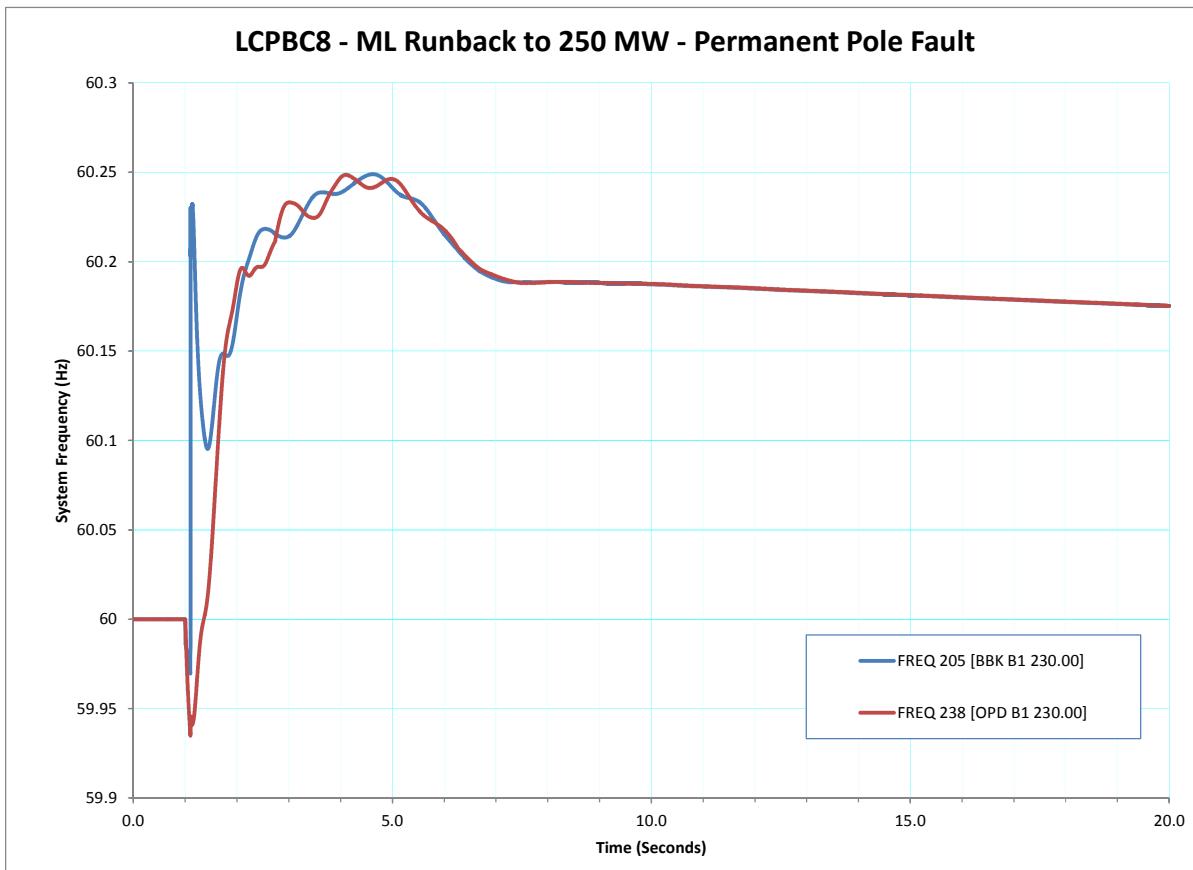
Figure 332 - LCPBC8 - ML Runback to 250 MW - Permanent Pole Fault - System Frequency (Hz)

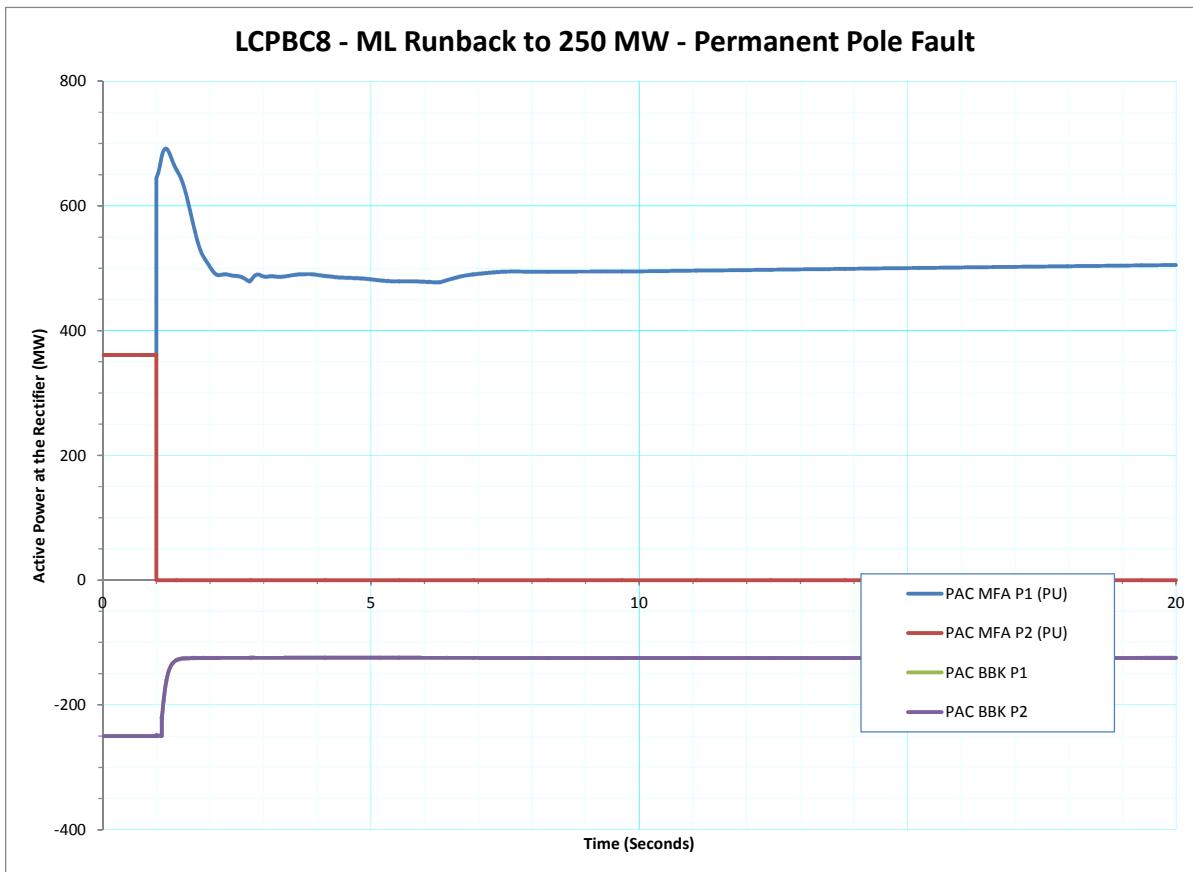
Figure 333 - LCPBC8 - ML Runback to 250 MW - Permanent Pole Fault - Active Power at the Rectifier (MW)

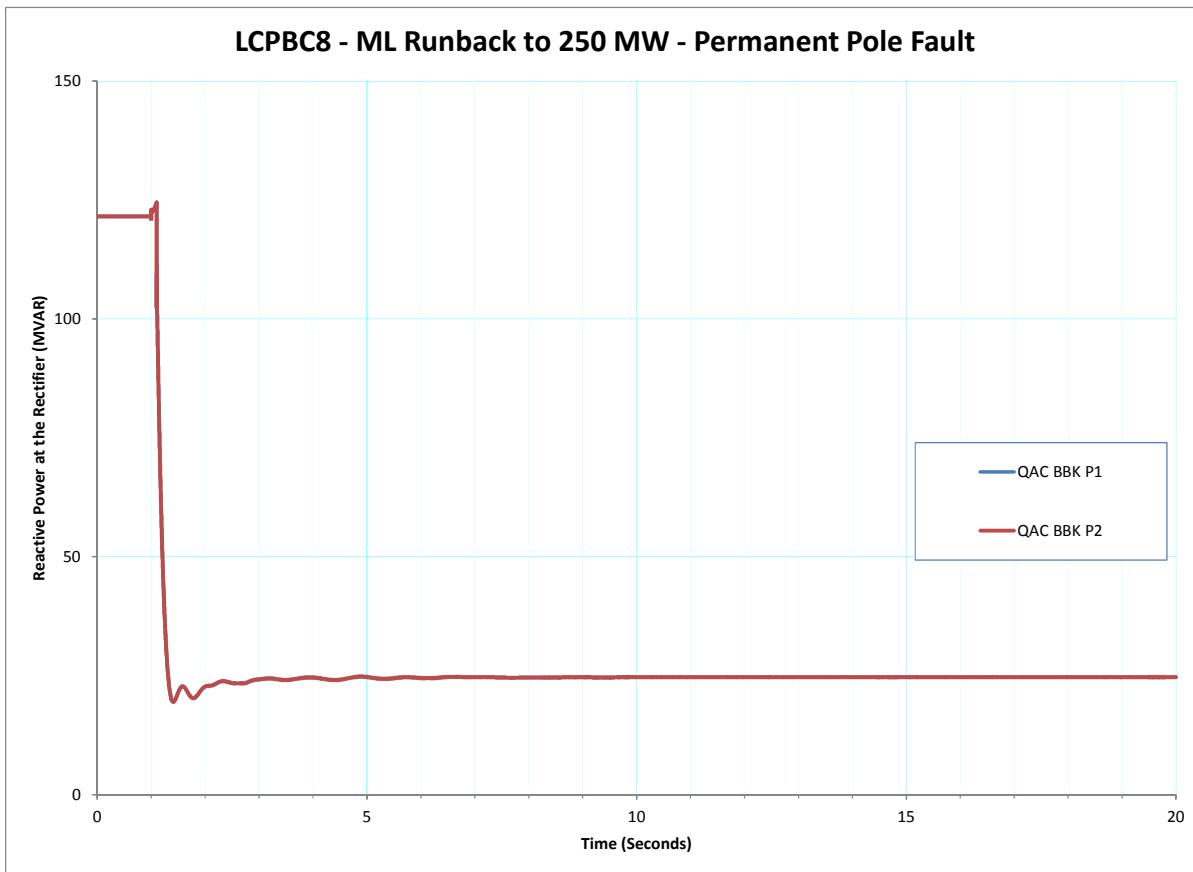
Figure 334 - LCPBC8 - ML Runback to 250 MW - Permanent Pole Fault - Reactive Power at the Rectifier (MVAR)

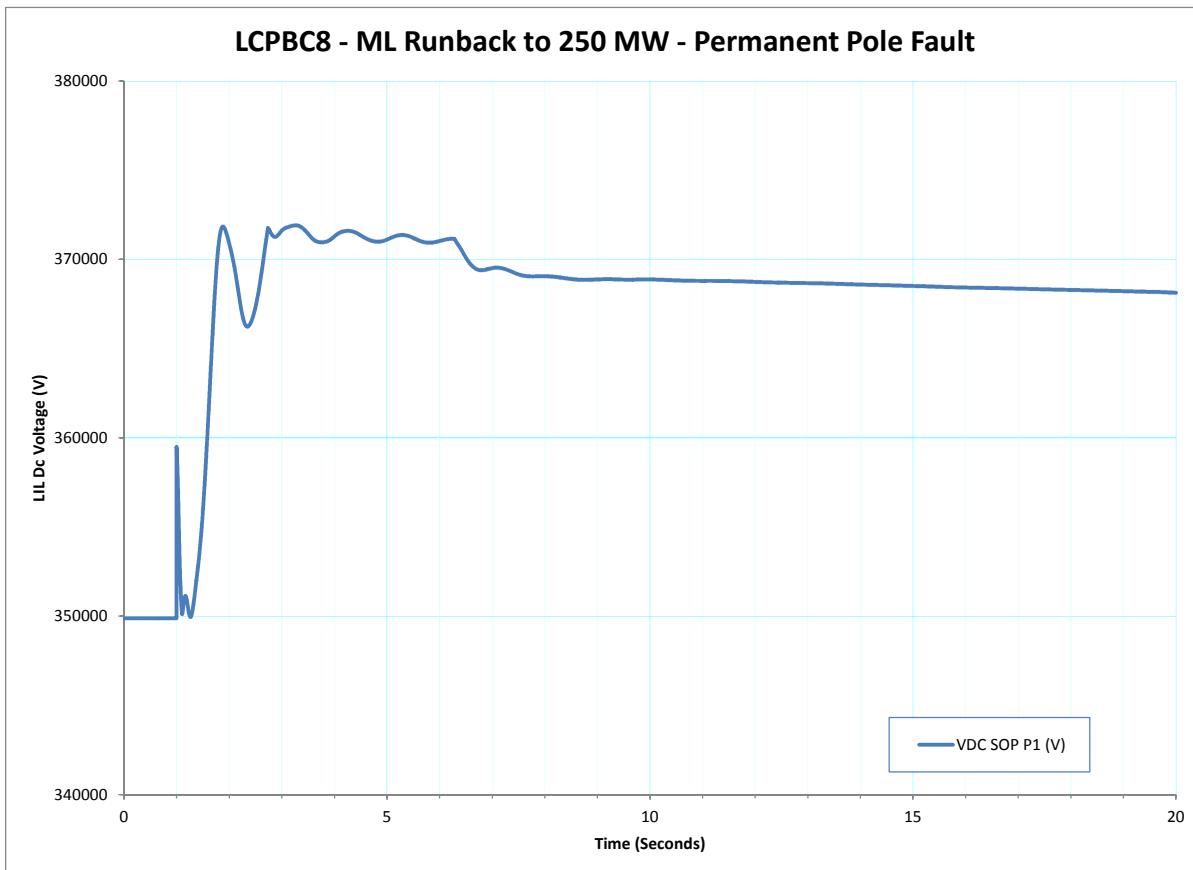
Figure 335 - LCPBC8 - ML Runback to 250 MW - Permanent Pole Fault - LIL Dc Voltage (V)

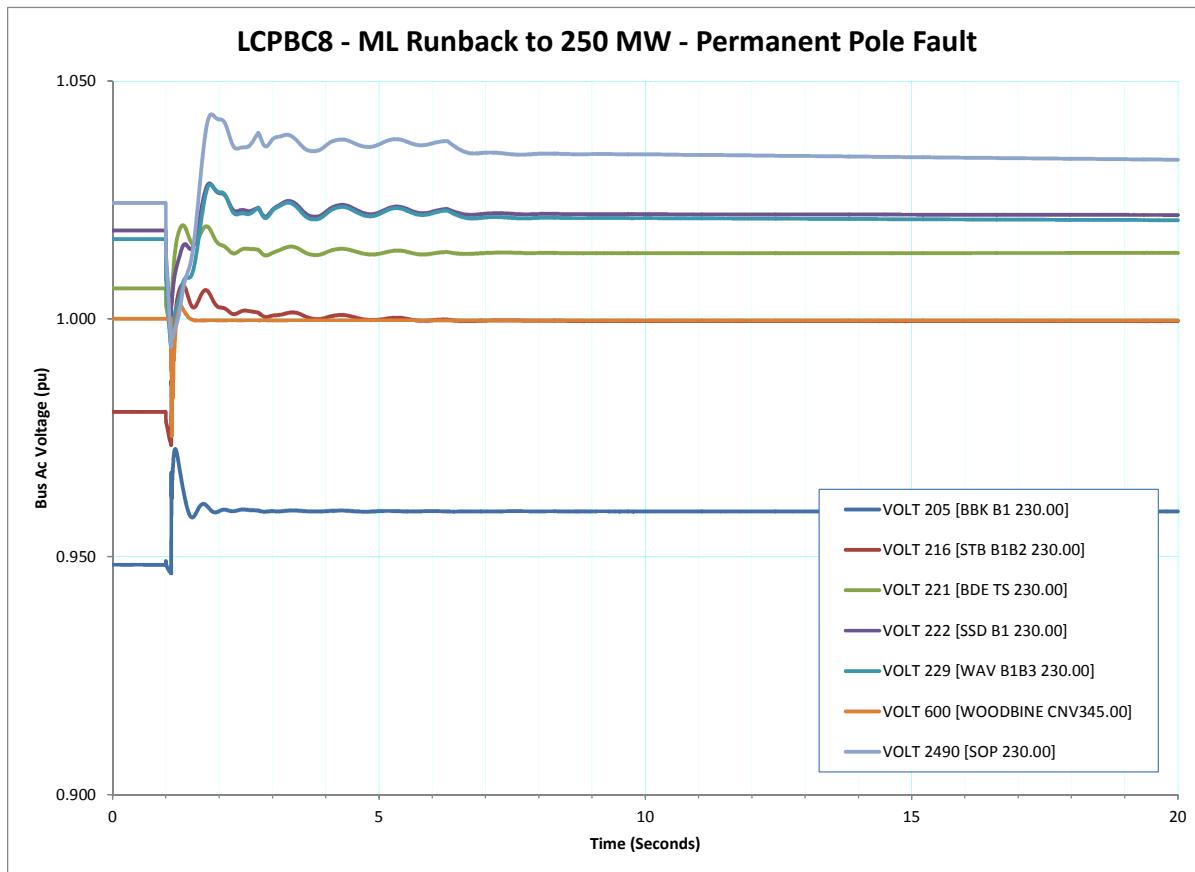
Figure 336 - LCPBC8 - ML Runback to 250 MW - Permanent Pole Fault - Bus Ac Voltage (pu)
