MARITIME LINK PRELIMINARY INTERCONNECTION STUDY

Newfoundland and Labrador Hydro

July 2014

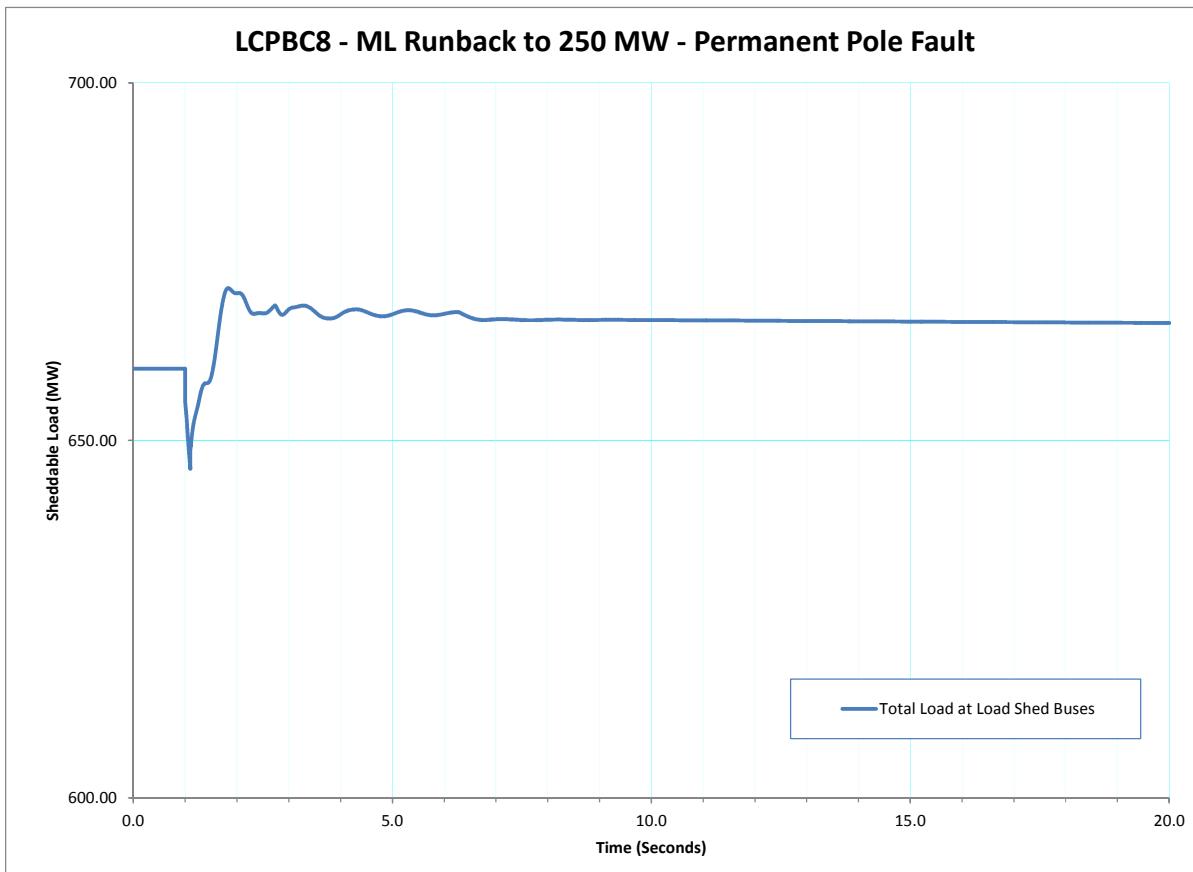
Figure 337 - LCPBC8 - ML Runback to 250 MW - Permanent Pole Fault - Sheddable Load (MW)

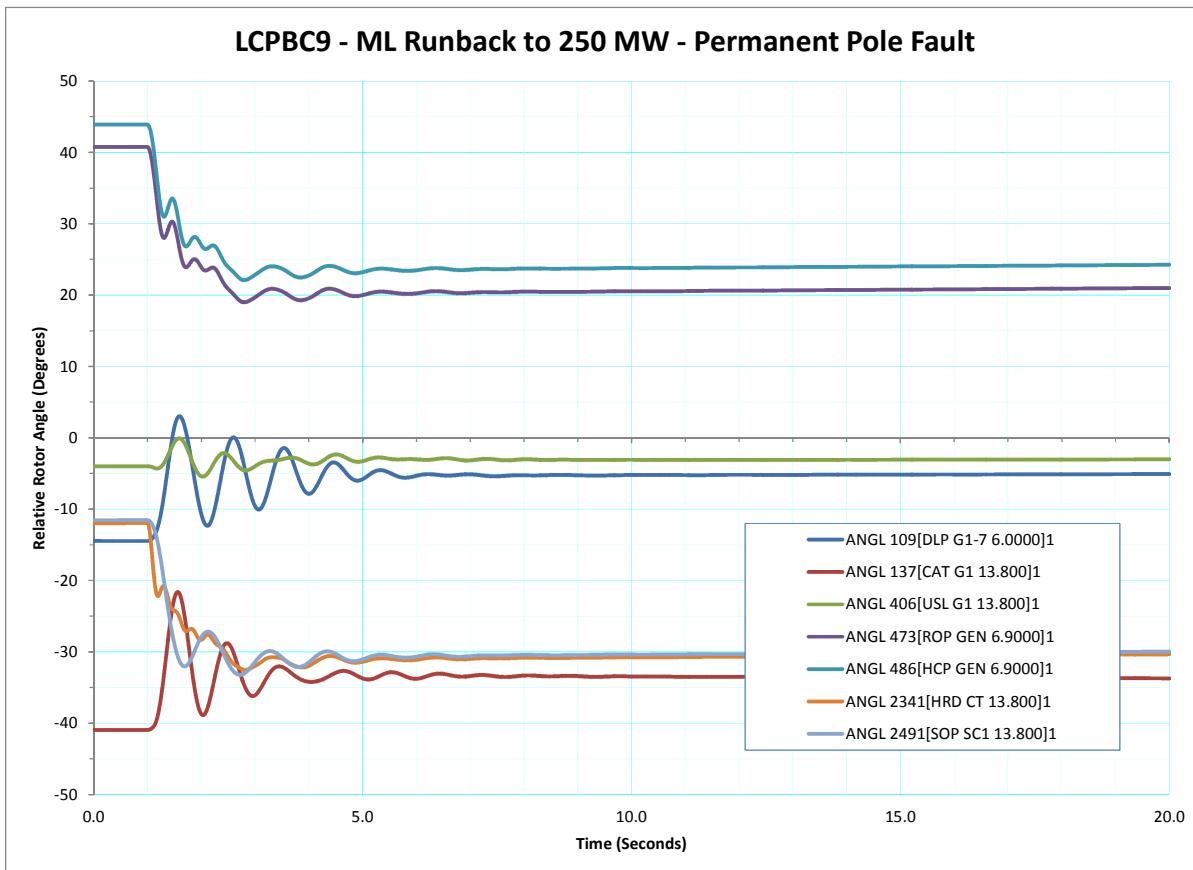
Figure 338 - LCPBC9 - ML Runback to 250 MW - Permanent Pole Fault - Relative Rotor Angle (Degrees)

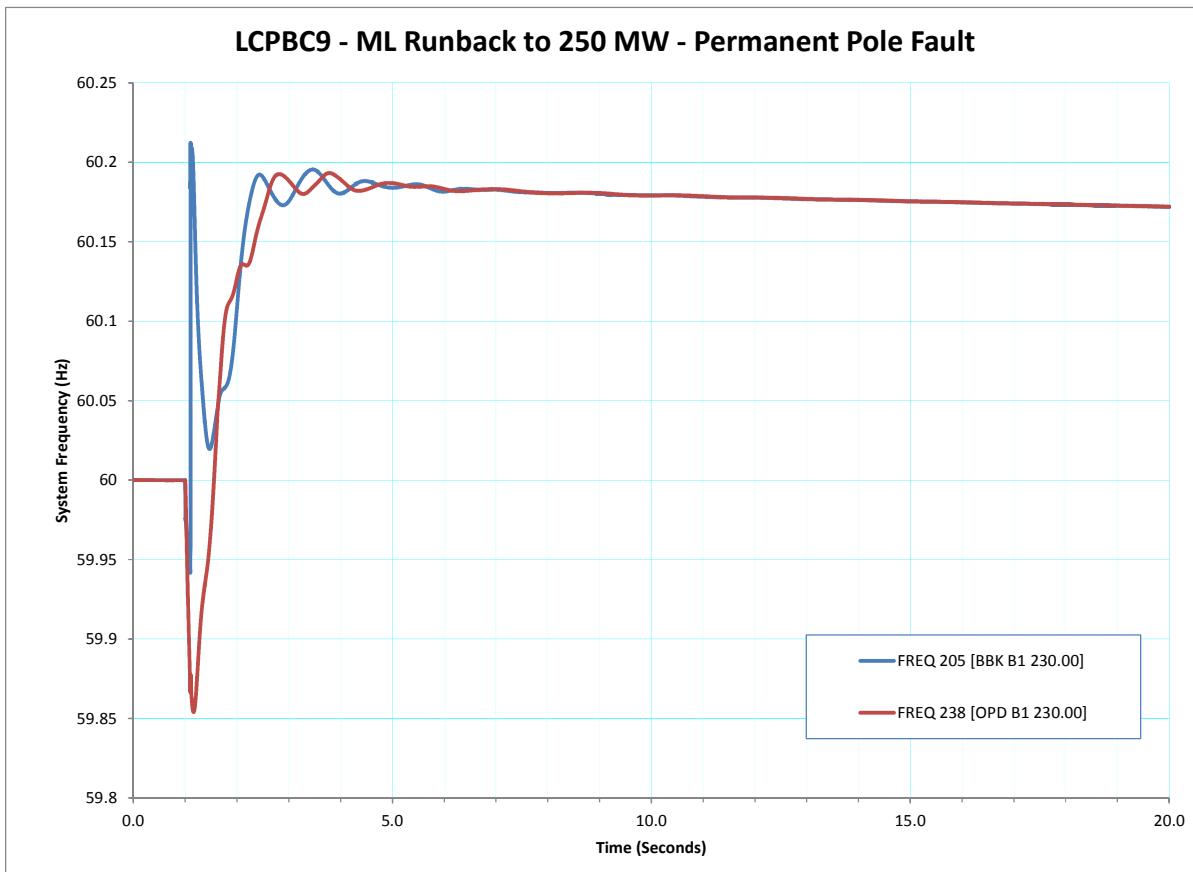
Figure 339 - LCPBC9 - ML Runback to 250 MW - Permanent Pole Fault - System Frequency (Hz)

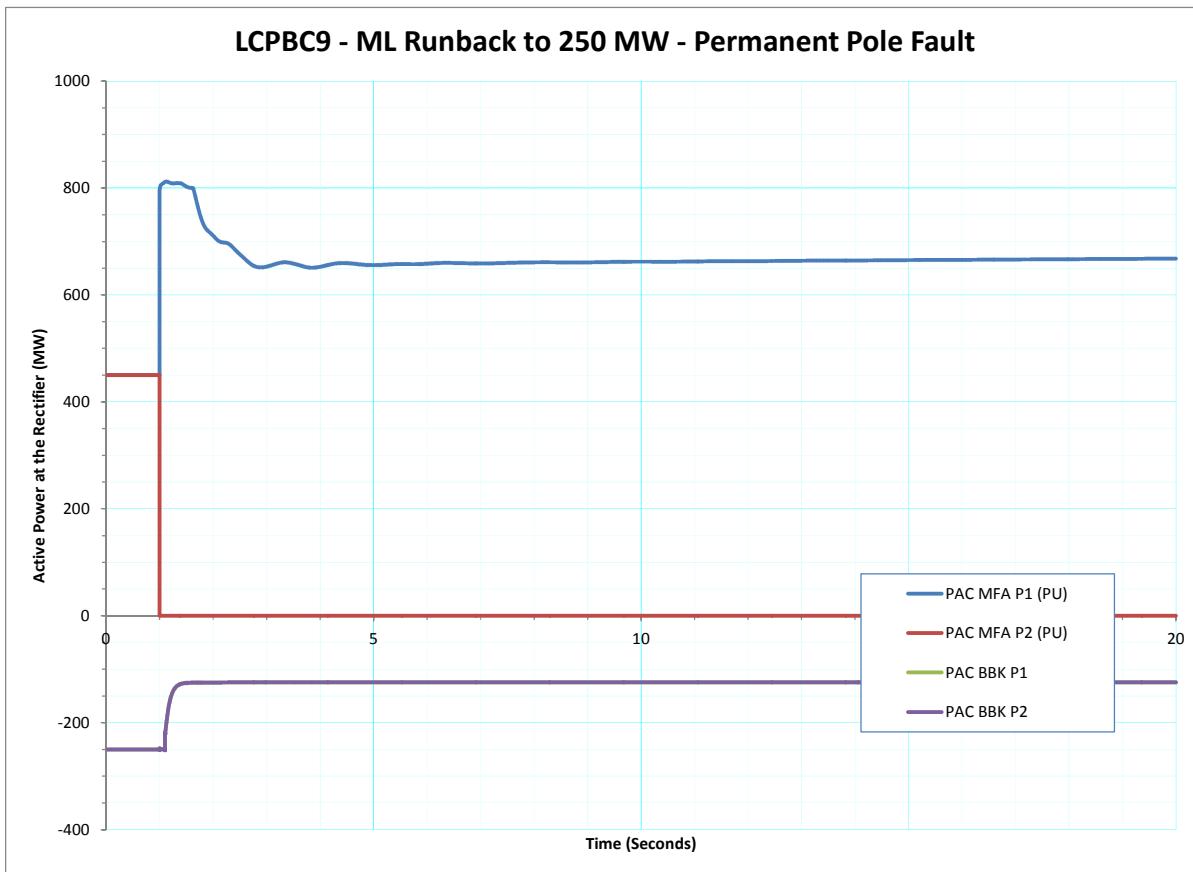
Figure 340 - LCPBC9 - ML Runback to 250 MW - Permanent Pole Fault - Active Power at the Rectifier (MW)

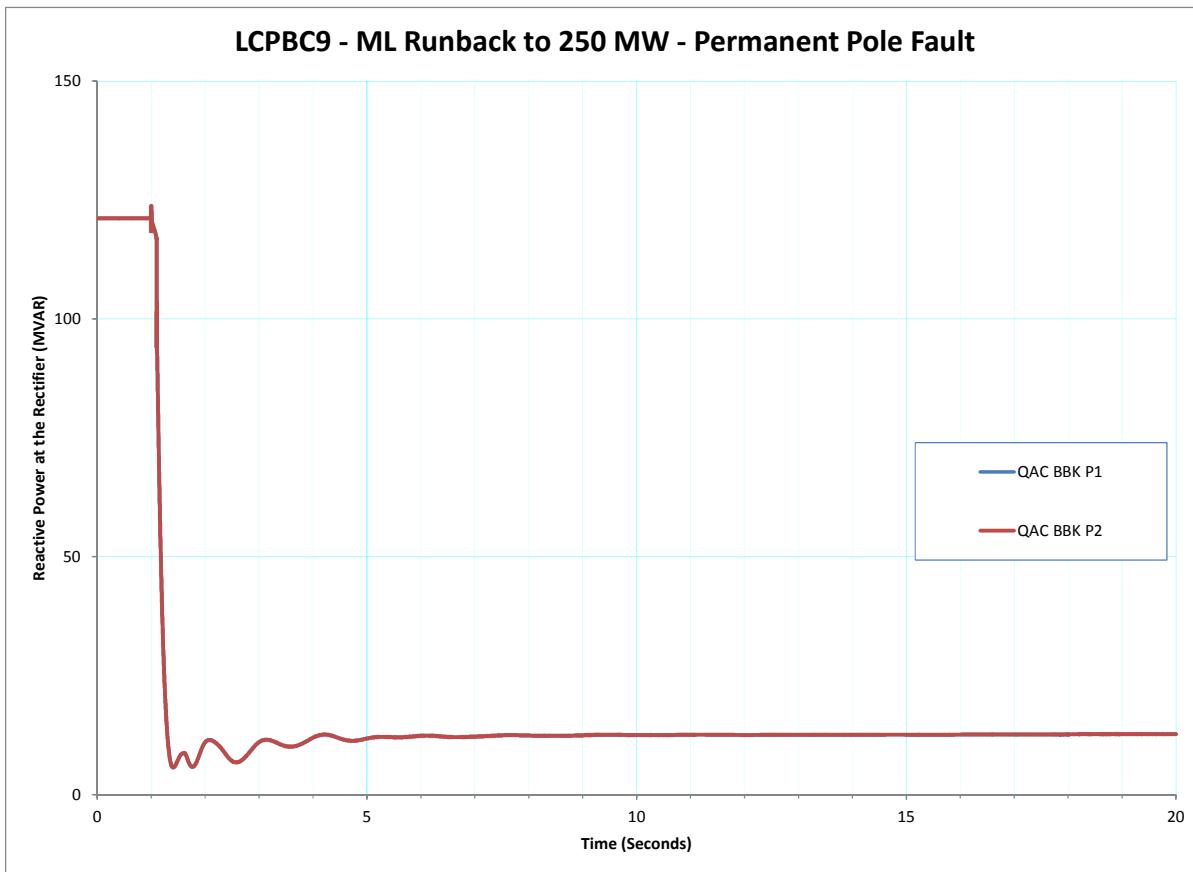
Figure 341 - LCPBC9 - ML Runback to 250 MW - Permanent Pole Fault - Reactive Power at the Rectifier (MVAR)

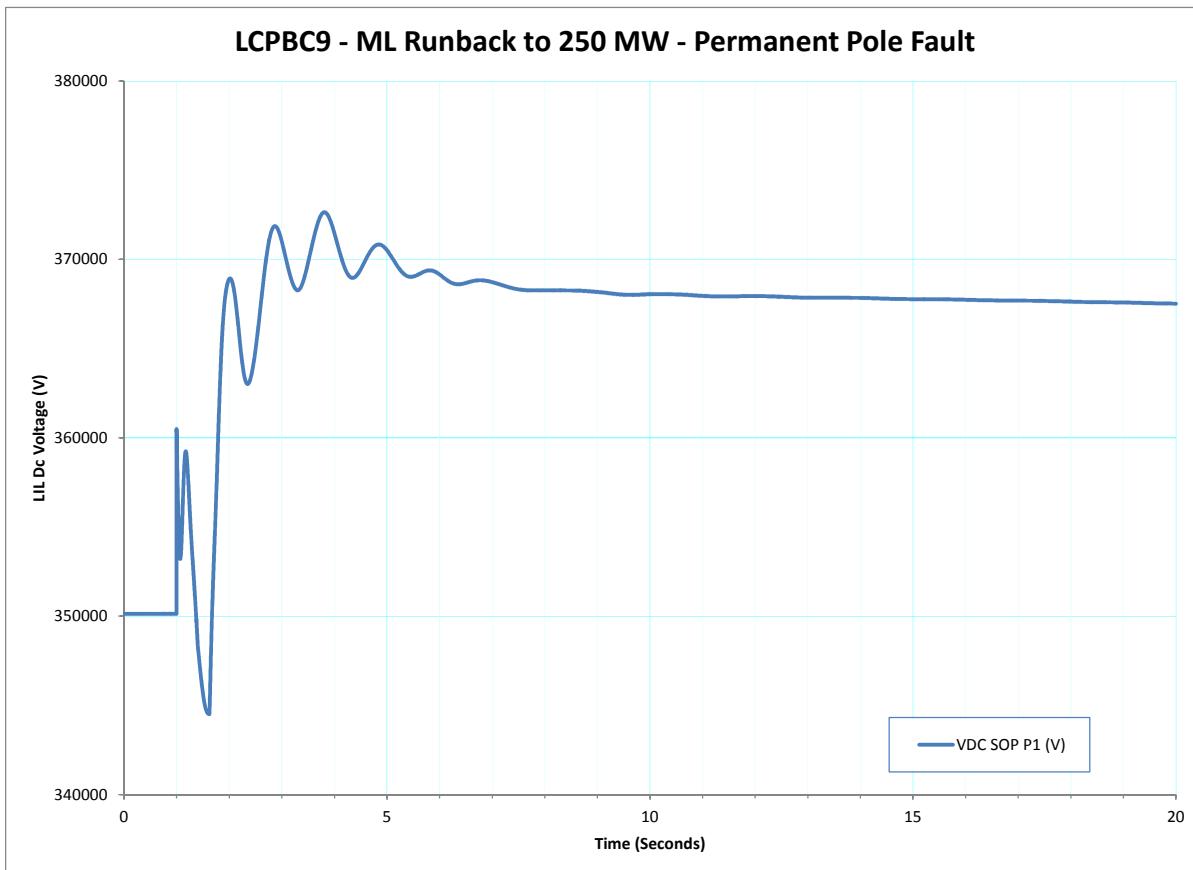
Figure 342 - LCPBC9 - ML Runback to 250 MW - Permanent Pole Fault - LIL Dc Voltage (V)

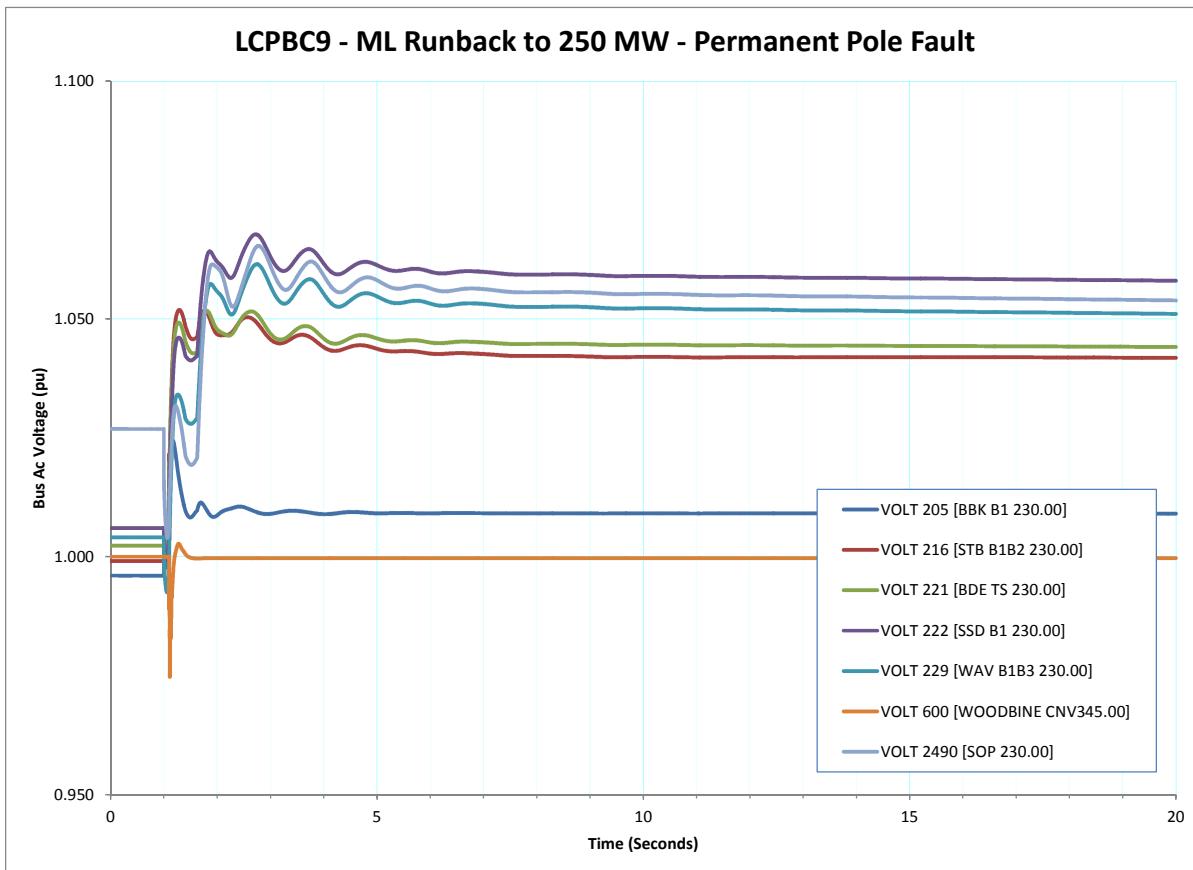
Figure 343 - LCPBC9 - ML Runback to 250 MW - Permanent Pole Fault - Bus Ac Voltage (pu)

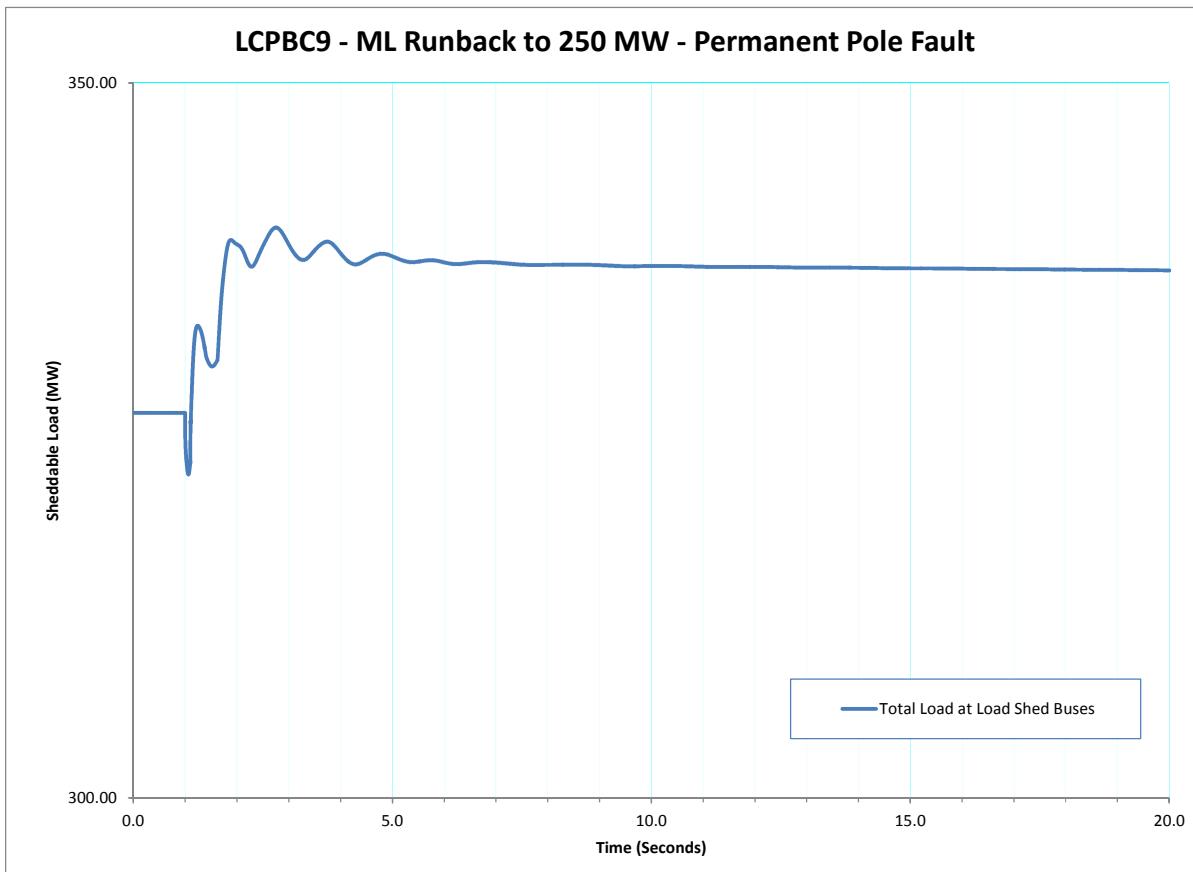
Figure 344 - LCPBC9 - ML Runback to 250 MW - Permanent Pole Fault - Sheddable Load (MW)

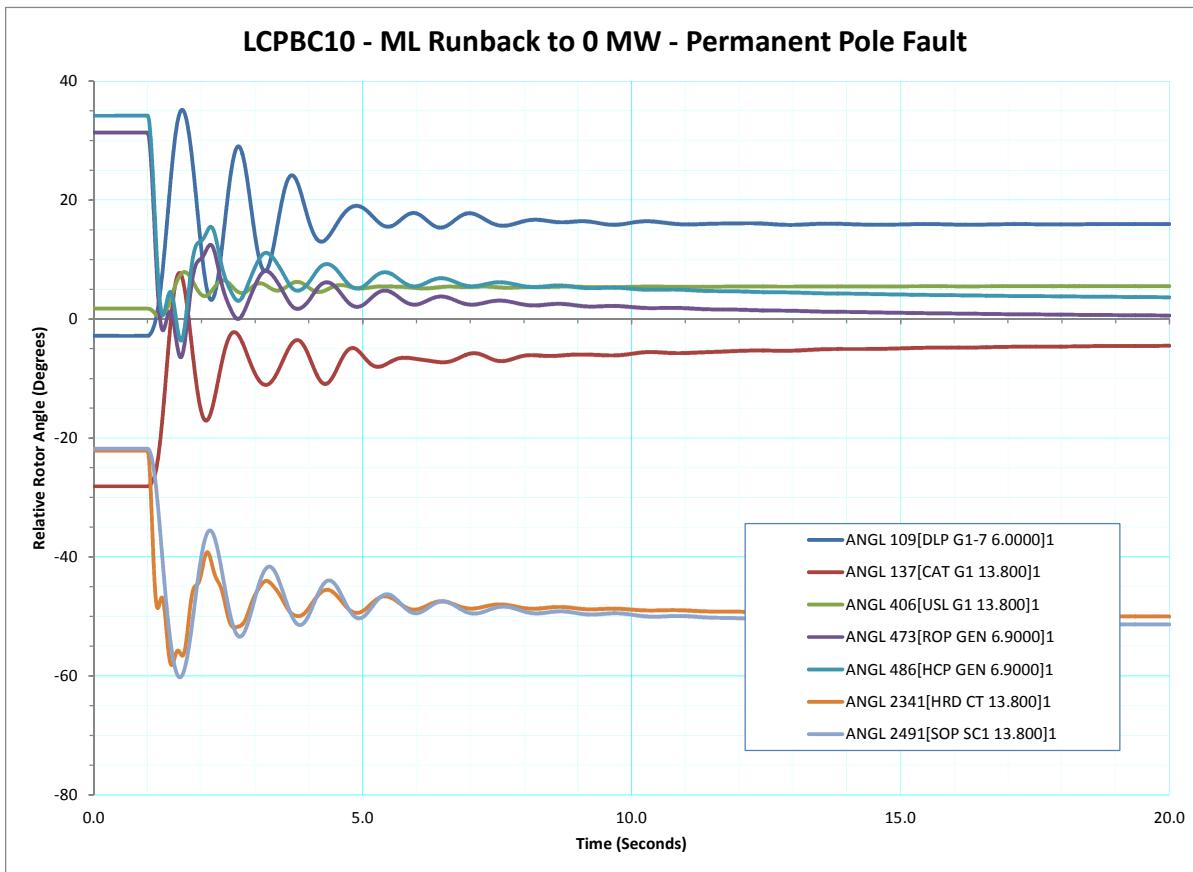
Figure 345 - LCPBC10 - ML Runback to 0 MW - Permanent Pole Fault - Relative Rotor Angle (Degrees)

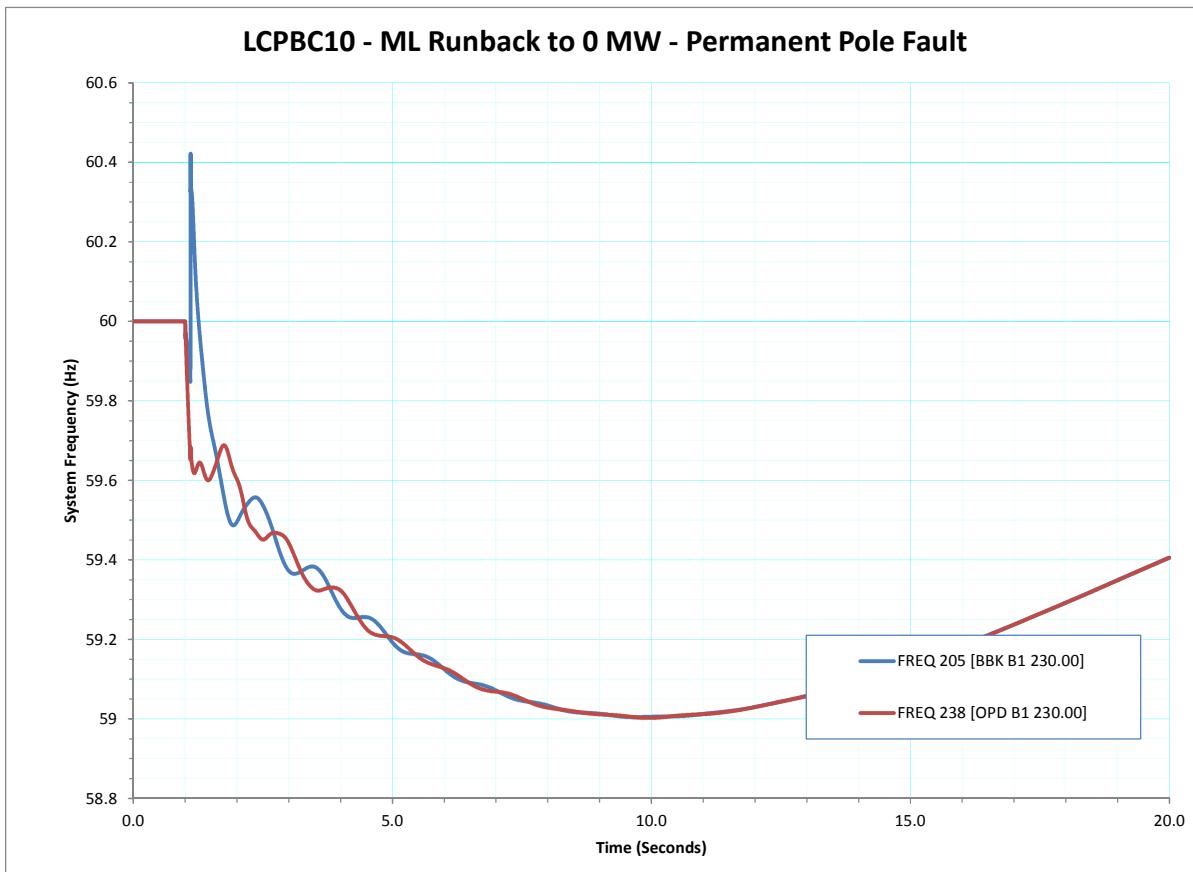
Figure 346 - LCPBC10 - ML Runback to 0 MW - Permanent Pole Fault - System Frequency (Hz)

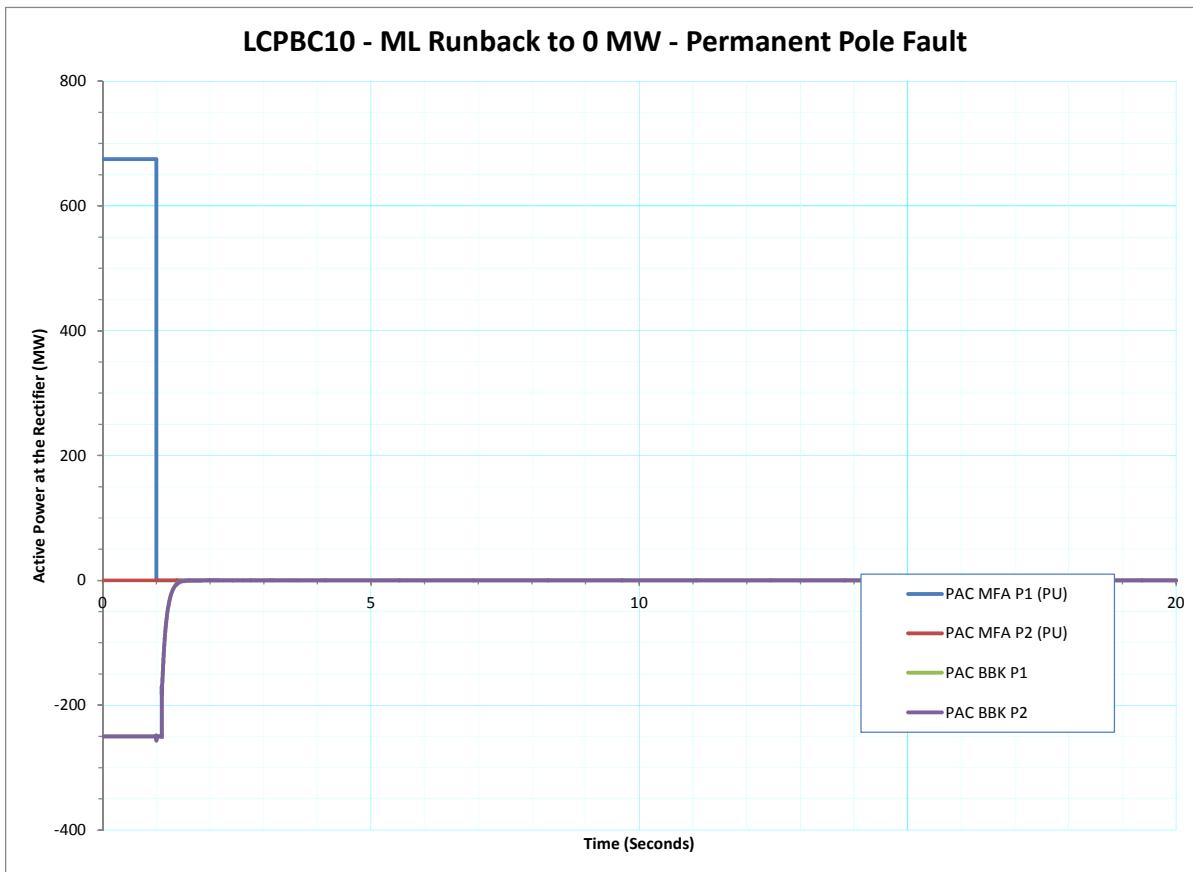
Figure 347 - LCPBC10 - ML Runback to 0 MW - Permanent Pole Fault - Active Power at the Rectifier (MW)

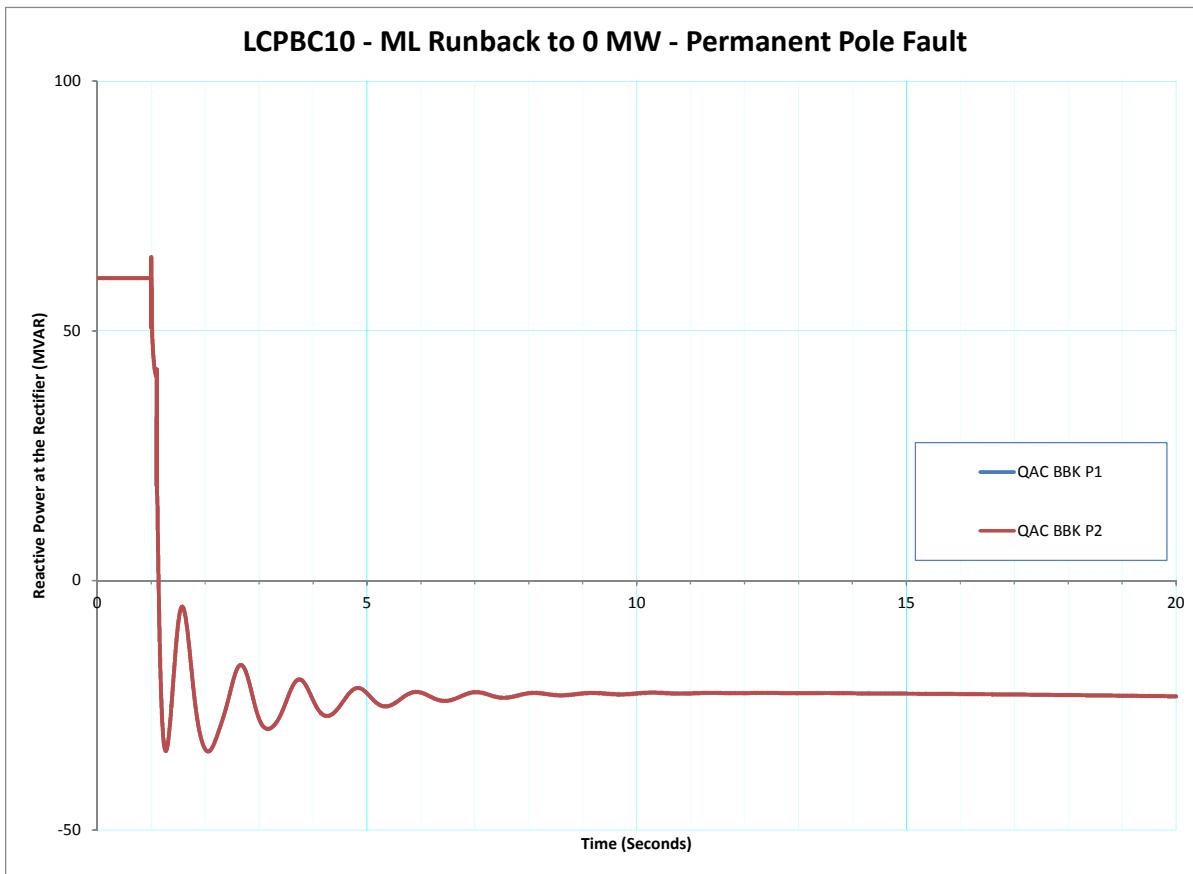
Figure 348 - LCPBC10 - ML Runback to 0 MW - Permanent Pole Fault - Reactive Power at the Rectifier (MVAR)

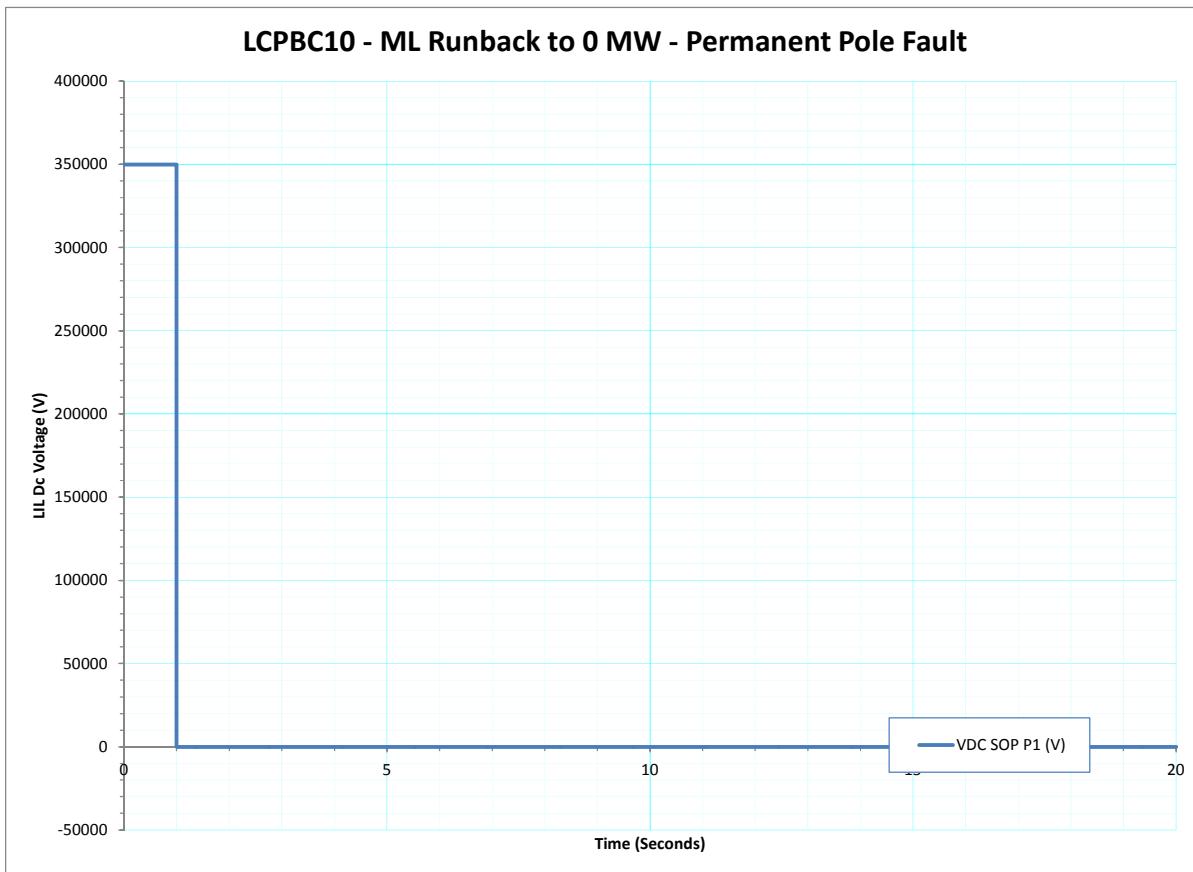
Figure 349 - LCPBC10 - ML Runback to 0 MW - Permanent Pole Fault - LIL Dc Voltage (V)

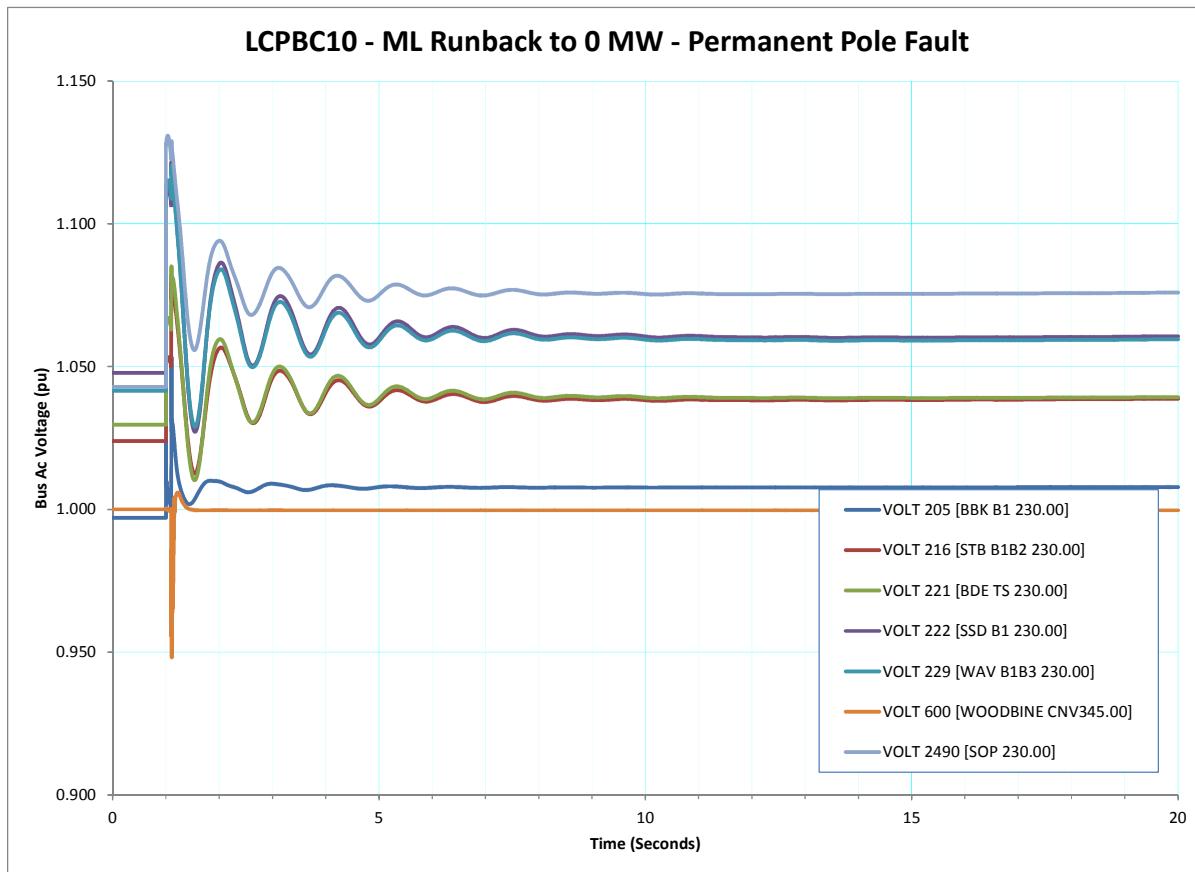
Figure 350 - LCPBC10 - ML Runback to 0 MW - Permanent Pole Fault - Bus Ac Voltage (pu)

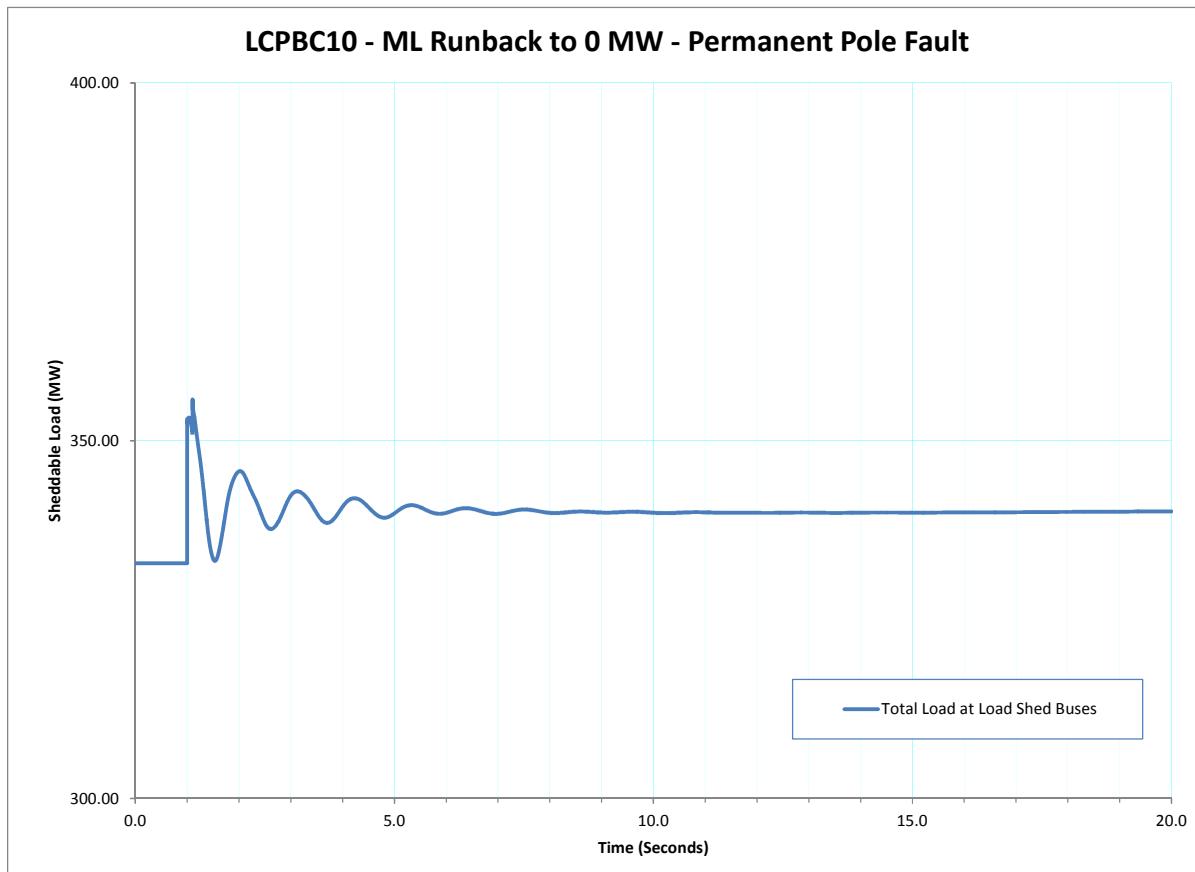
Figure 351 - LCPBC10 - ML Runback to 0 MW - Permanent Pole Fault - Shedtable Load (MW)

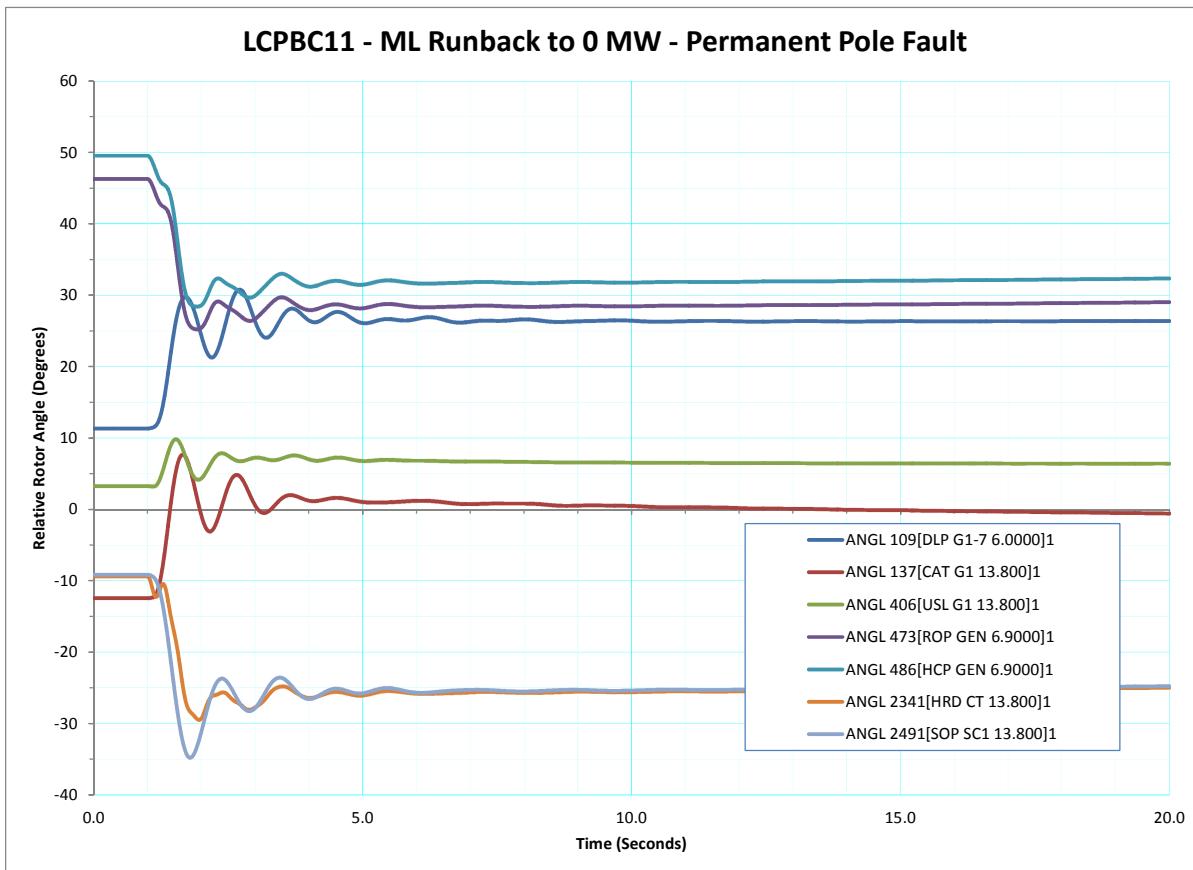
Figure 352 - LCPBC11 - ML Runback to 0 MW - Permanent Pole Fault - Relative Rotor Angle (Degrees)

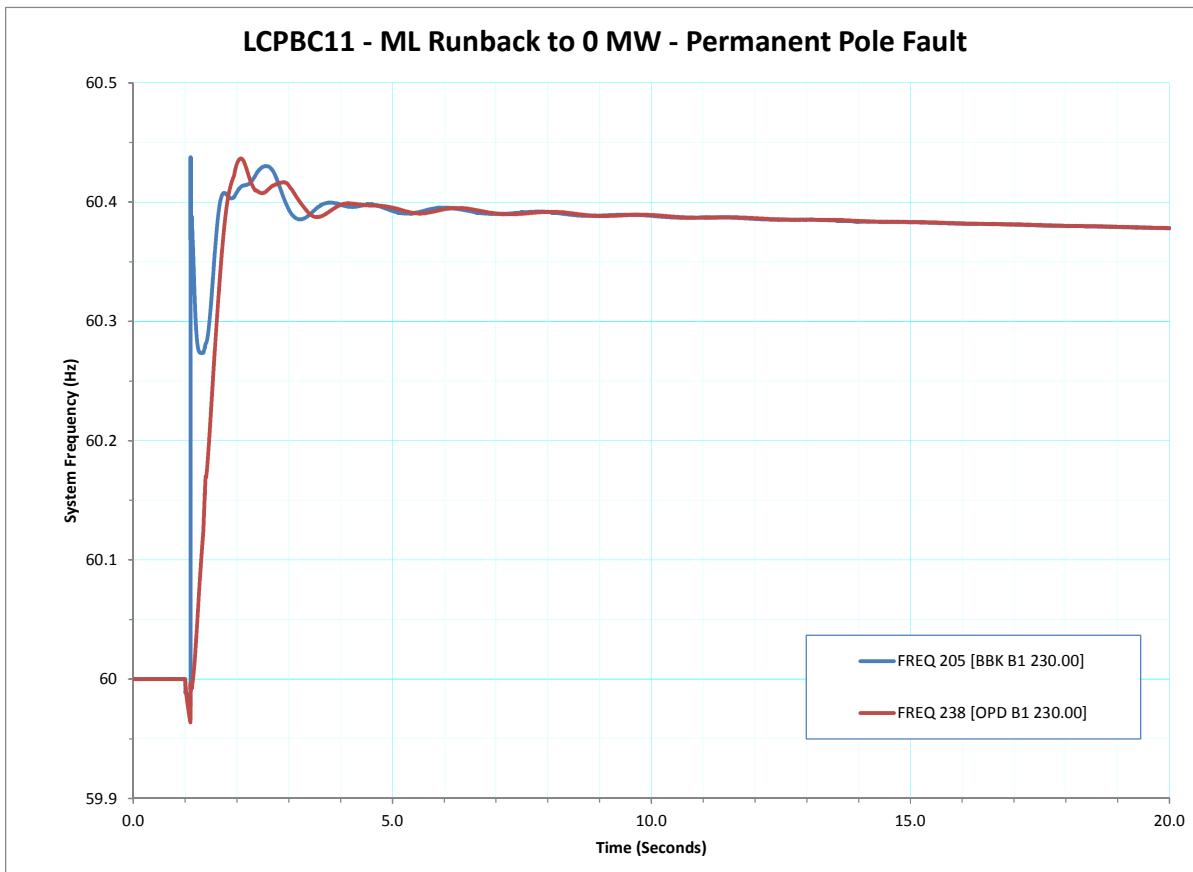
Figure 353 - LCPBC11 - ML Runback to 0 MW - Permanent Pole Fault - System Frequency (Hz)

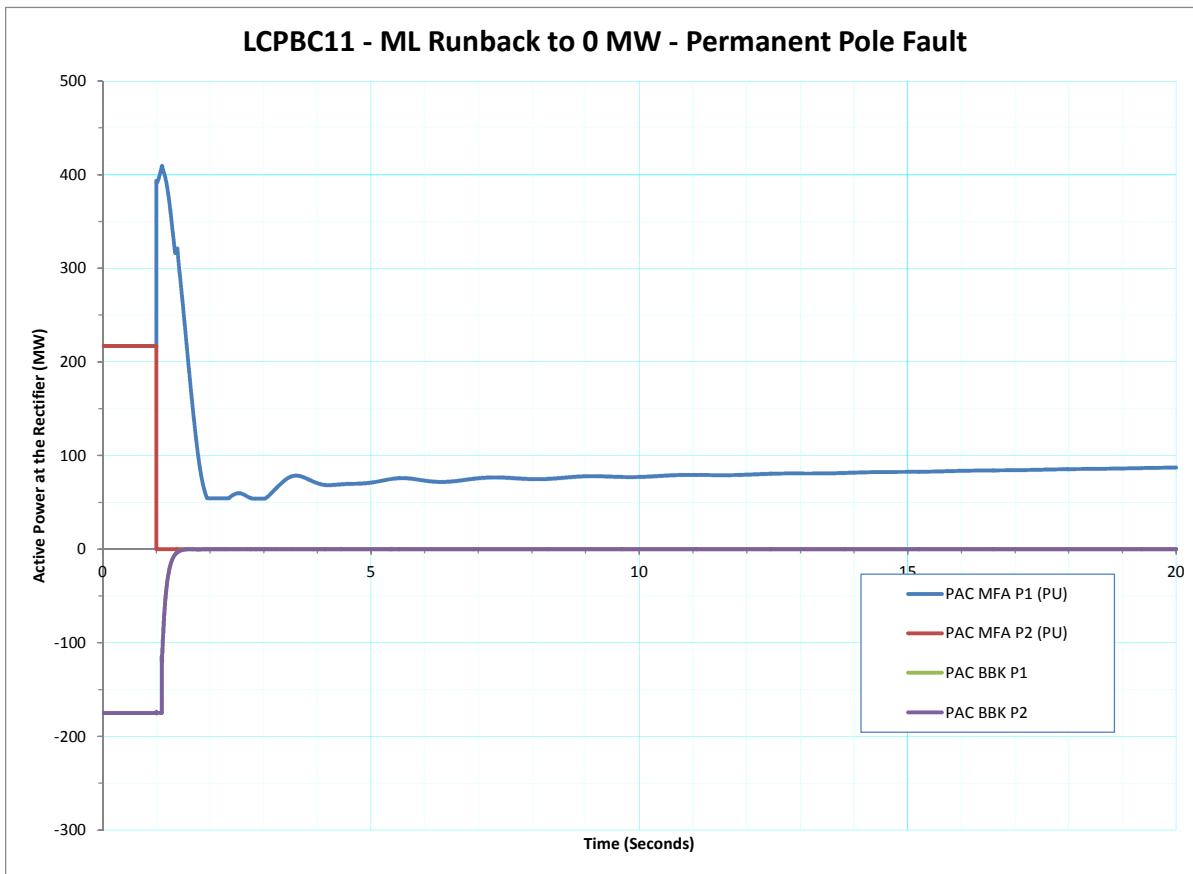
Figure 354 - LCPBC11 - ML Runback to 0 MW - Permanent Pole Fault - Active Power at the Rectifier (MW)

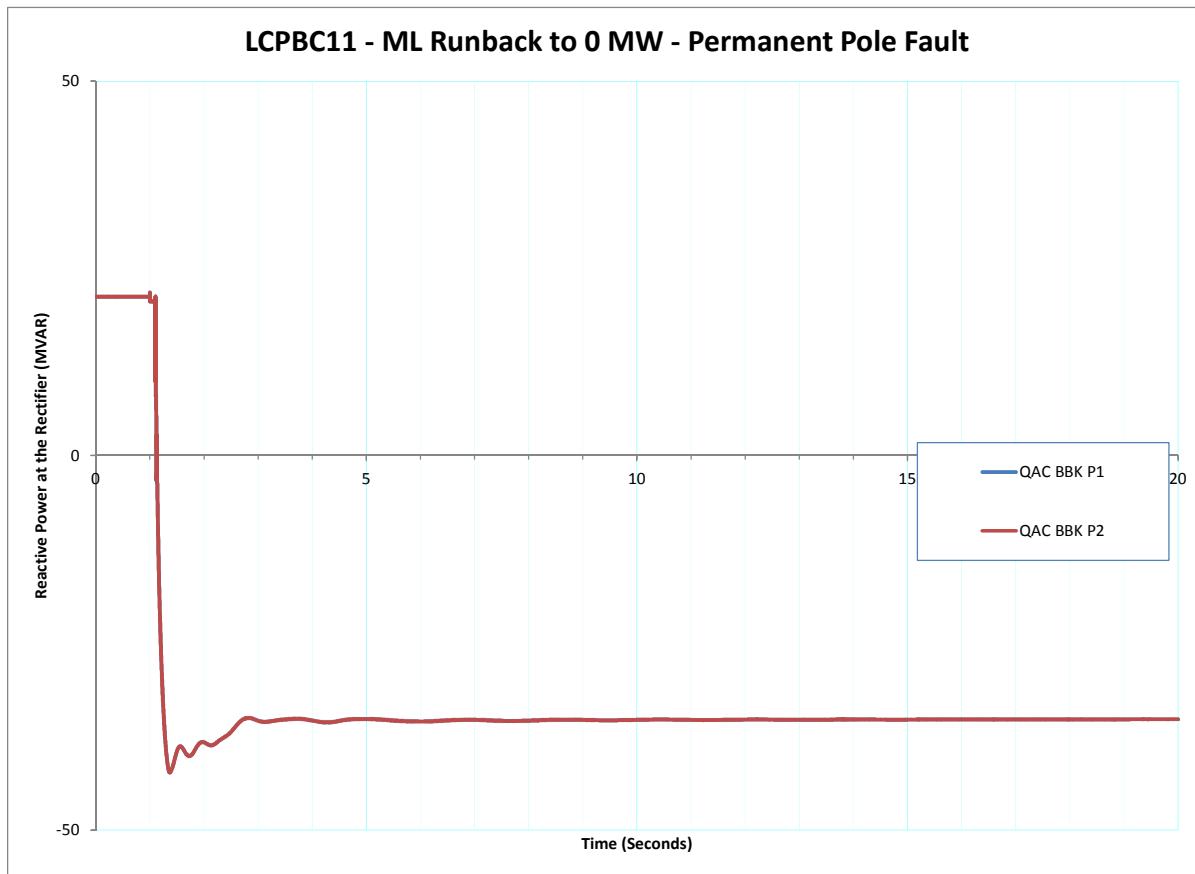
Figure 355 - LCPBC11 - ML Runback to 0 MW - Permanent Pole Fault - Reactive Power at the Rectifier (MVAR)

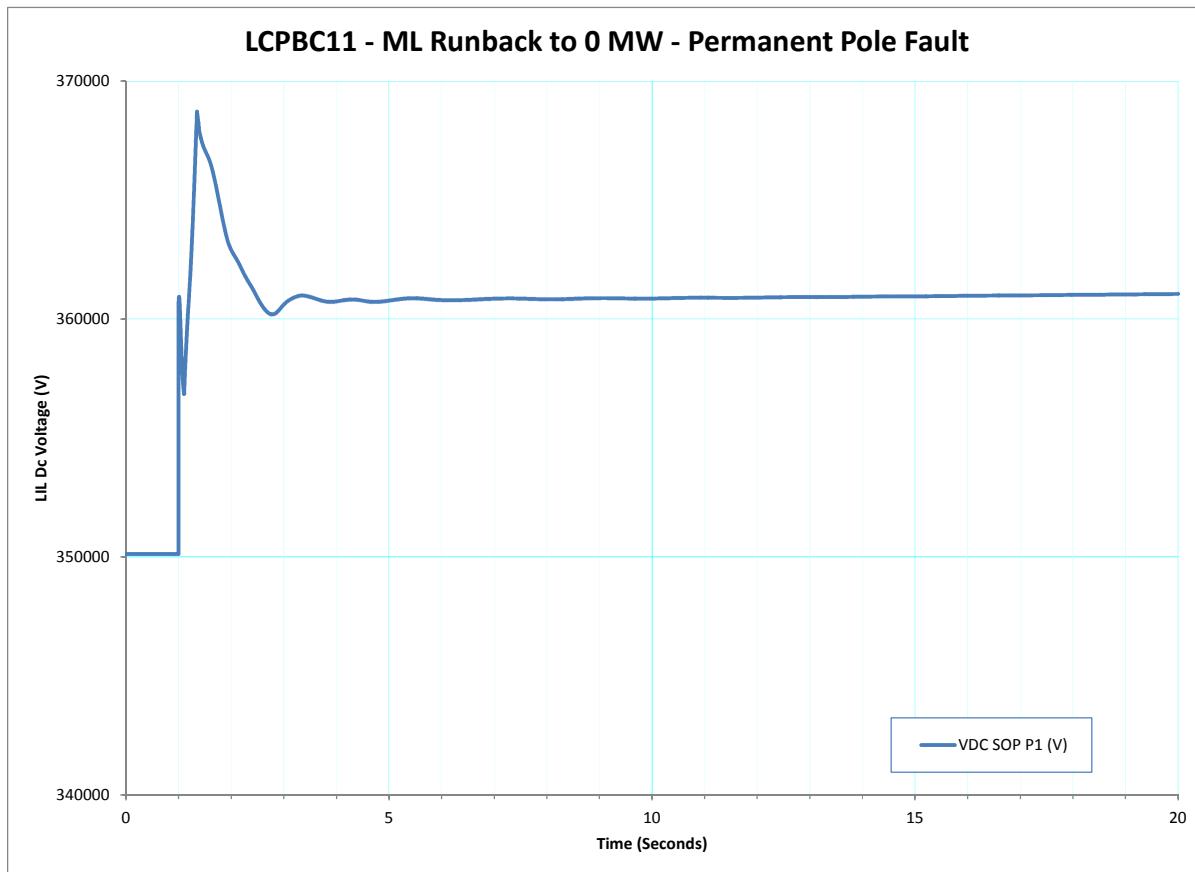
Figure 356 - LCPBC11 - ML Runback to 0 MW - Permanent Pole Fault - LIL Dc Voltage (V)

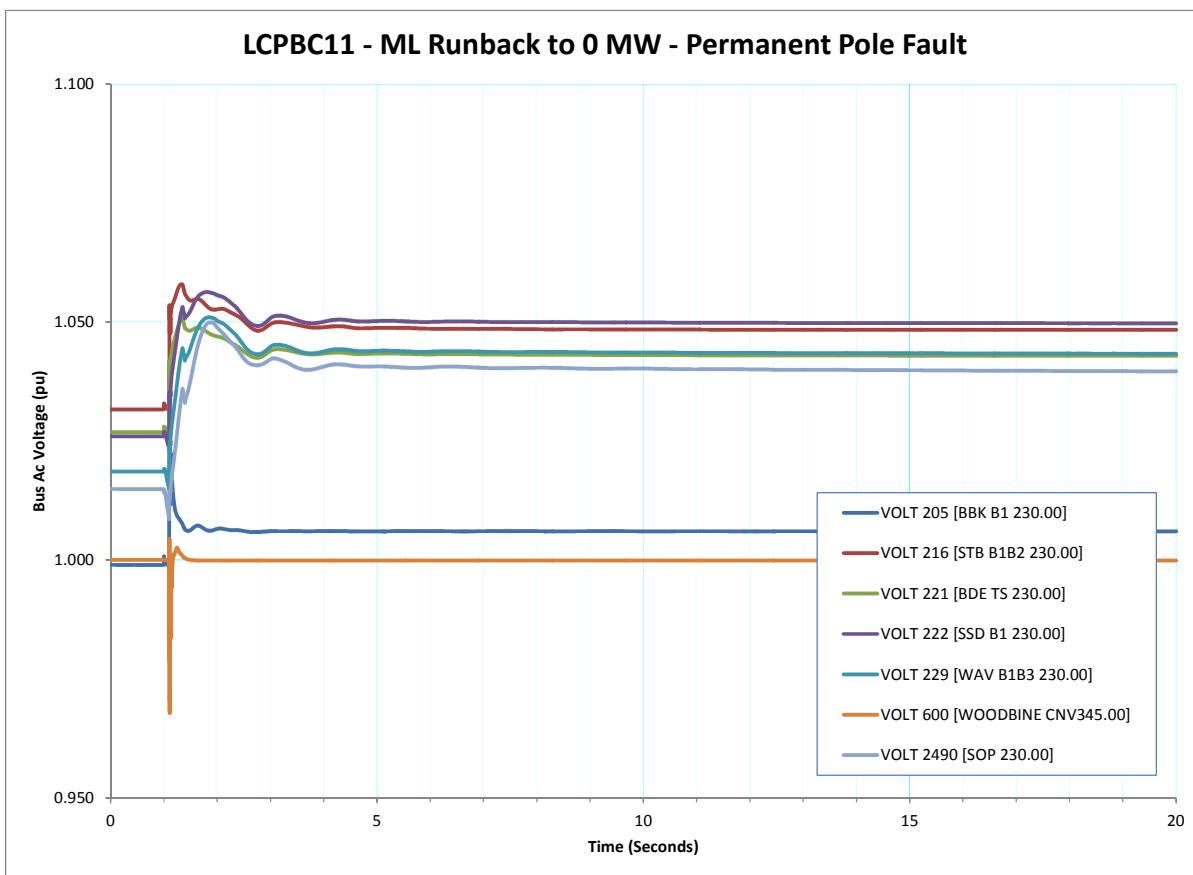
Figure 357 - LCPBC11 - ML Runback to 0 MW - Permanent Pole Fault - Bus Ac Voltage (pu)
