MARITIME LINK PRELIMINARY INTERCONNECTION STUDY

Newfoundland and Labrador Hydro

July 2014

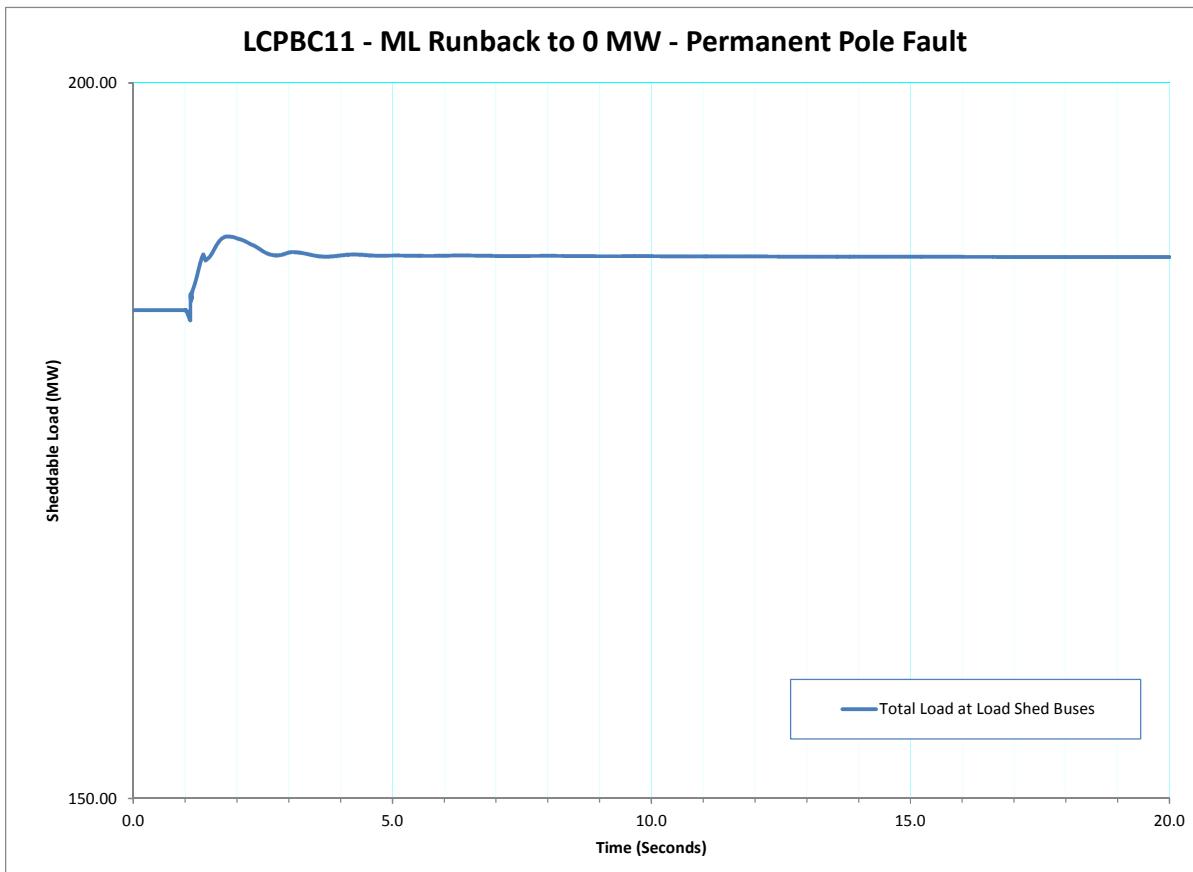
Figure 358 - LCPBC11 - ML Runback to 0 MW - Permanent Pole Fault - Sheddable Load (MW)

It should be noted that for all other cases (with the exception of BC11) the permanent loss of a pole results in underfrequency load shedding within the Island Interconnected System if ML export is not curtailed. Appendix E illustrates how underfrequency load shedding can

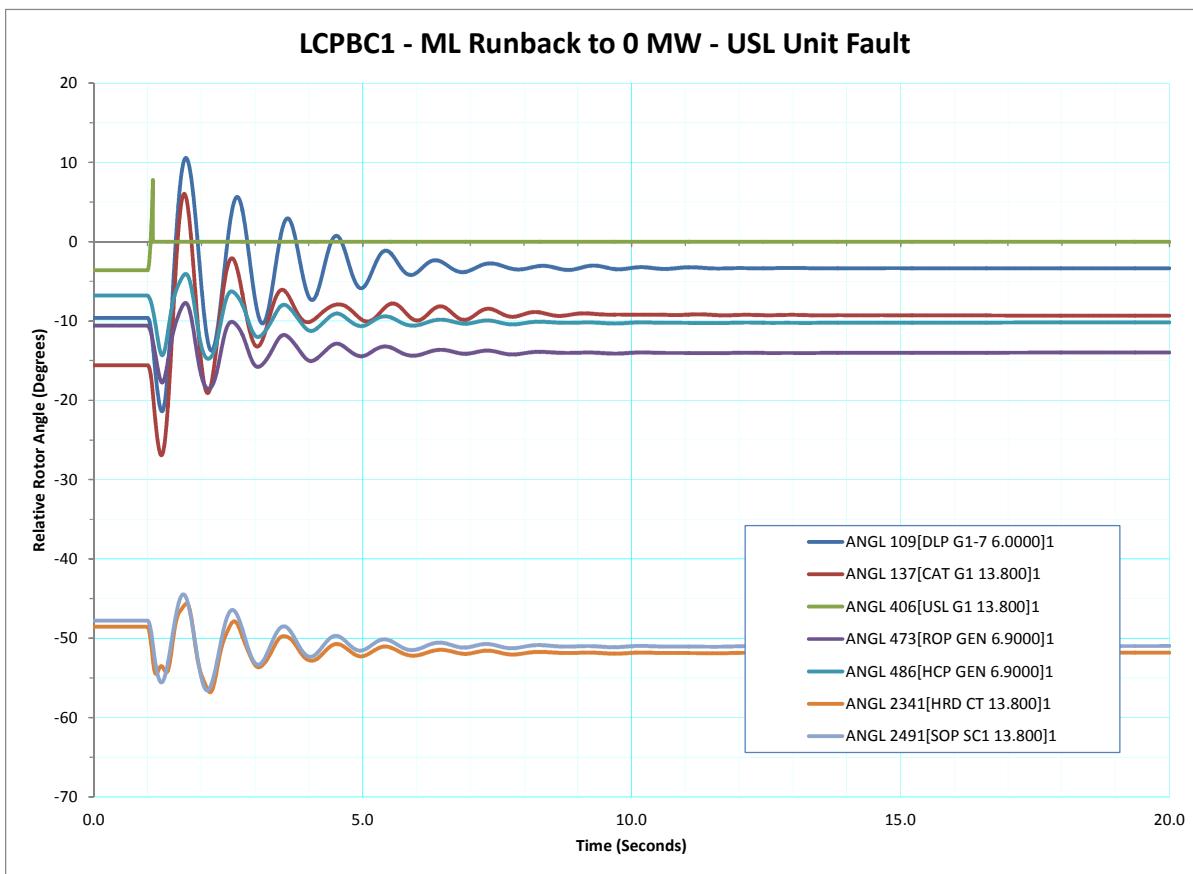
Figure 359 - LCPBC1 - ML Runback to 0 MW - USL Unit Fault - Relative Rotor Angle (Degrees)

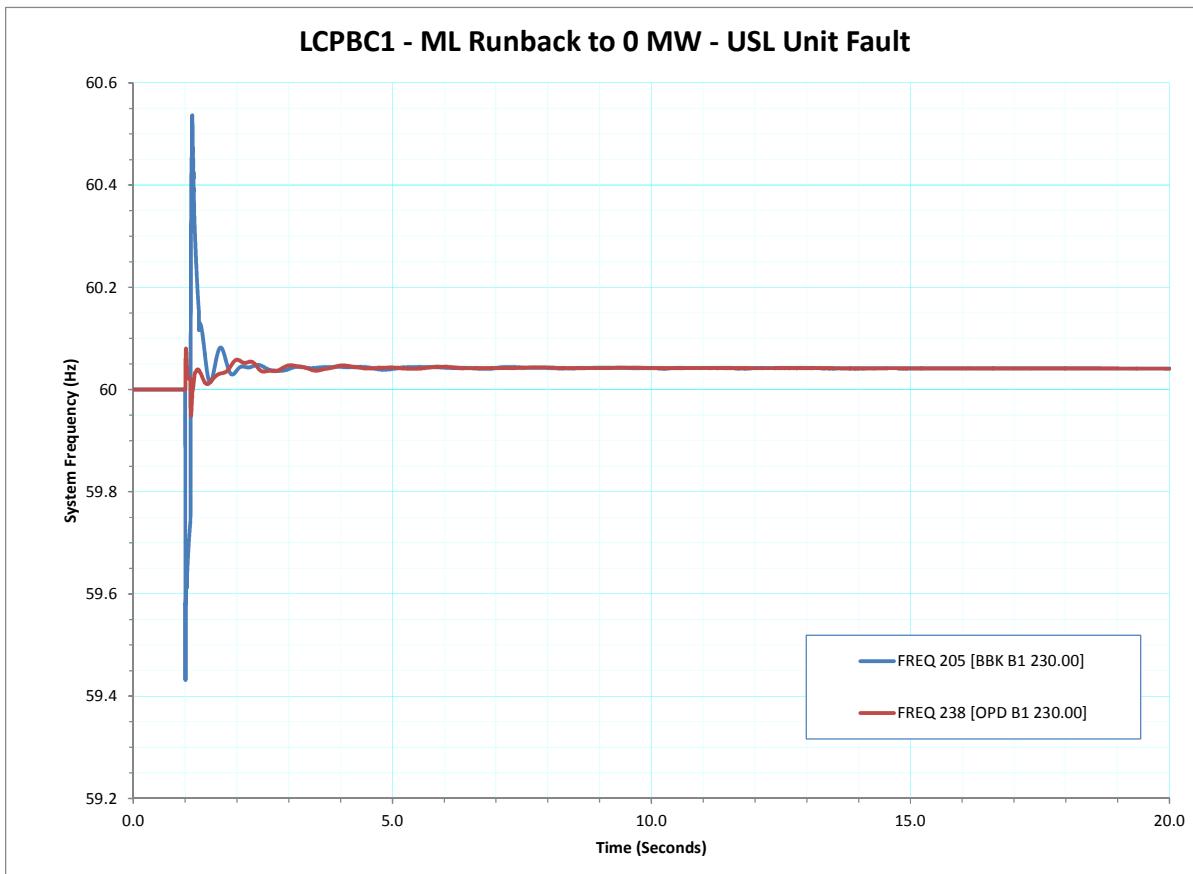
Figure 360 - LCPBC1 - ML Runback to 0 MW - USL Unit Fault - System Frequency (Hz)

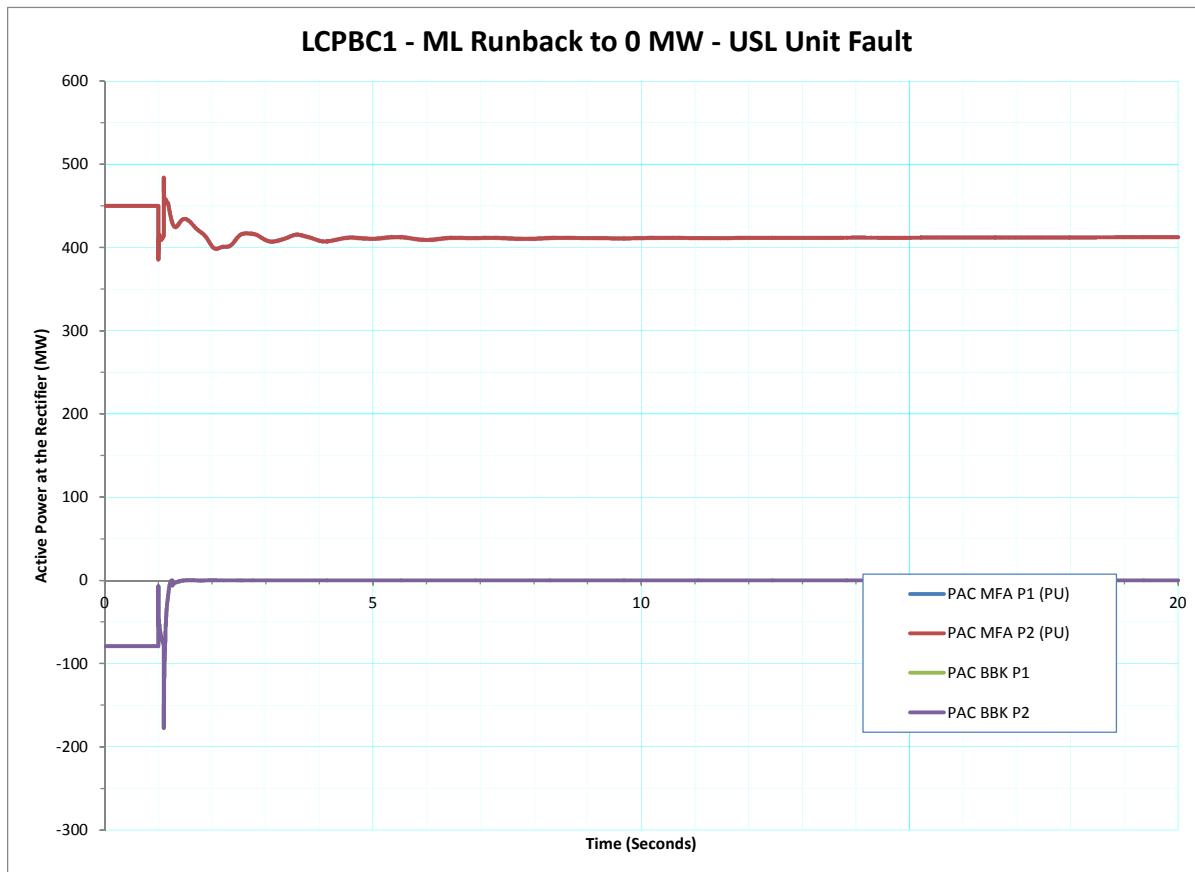
Figure 361 - LCPBC1 - ML Runback to 0 MW - USL Unit Fault - Active Power at the Rectifier (MW)

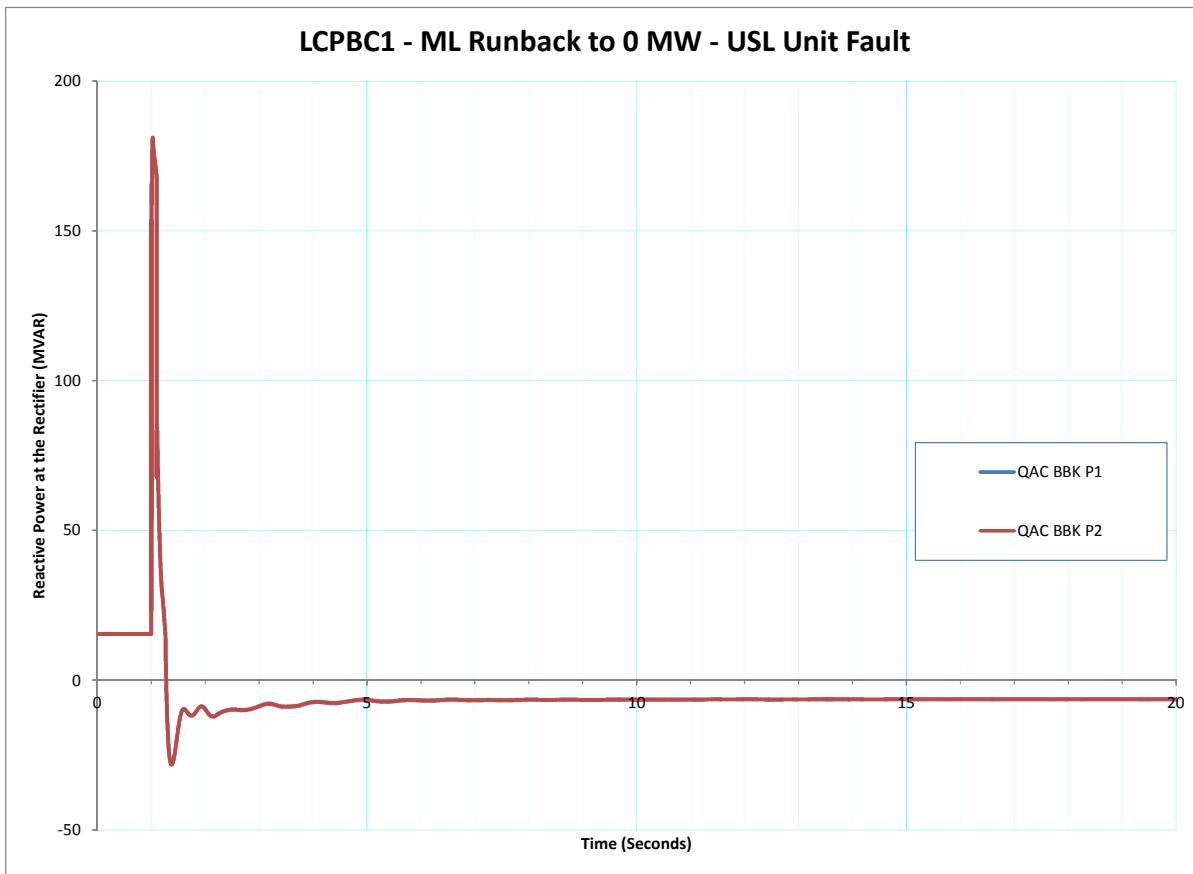
Figure 362 - LCPBC1 - ML Runback to 0 MW - USL Unit Fault - Reactive Power at the Rectifier (MVAR)

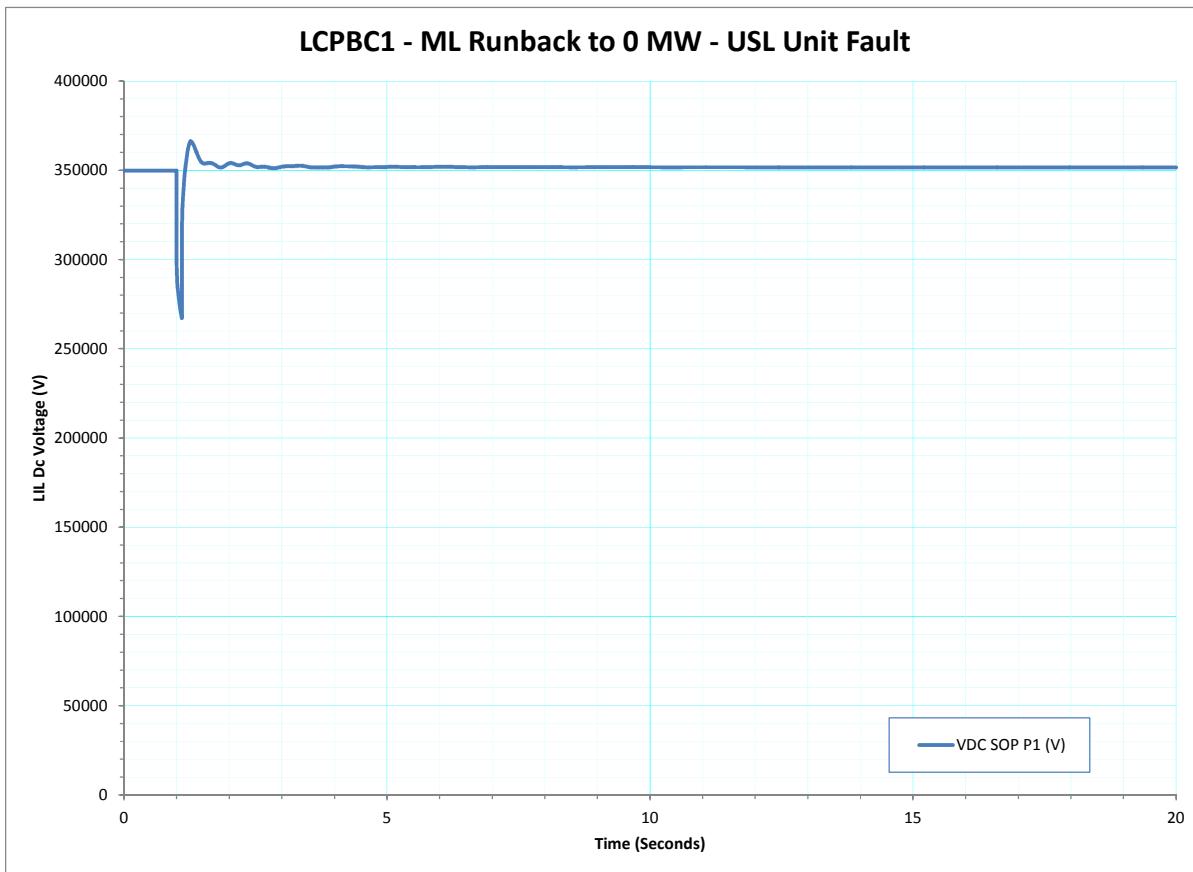
Figure 363 - LCPBC1 - ML Runback to 0 MW - USL Unit Fault - LIL Dc Voltage (V)

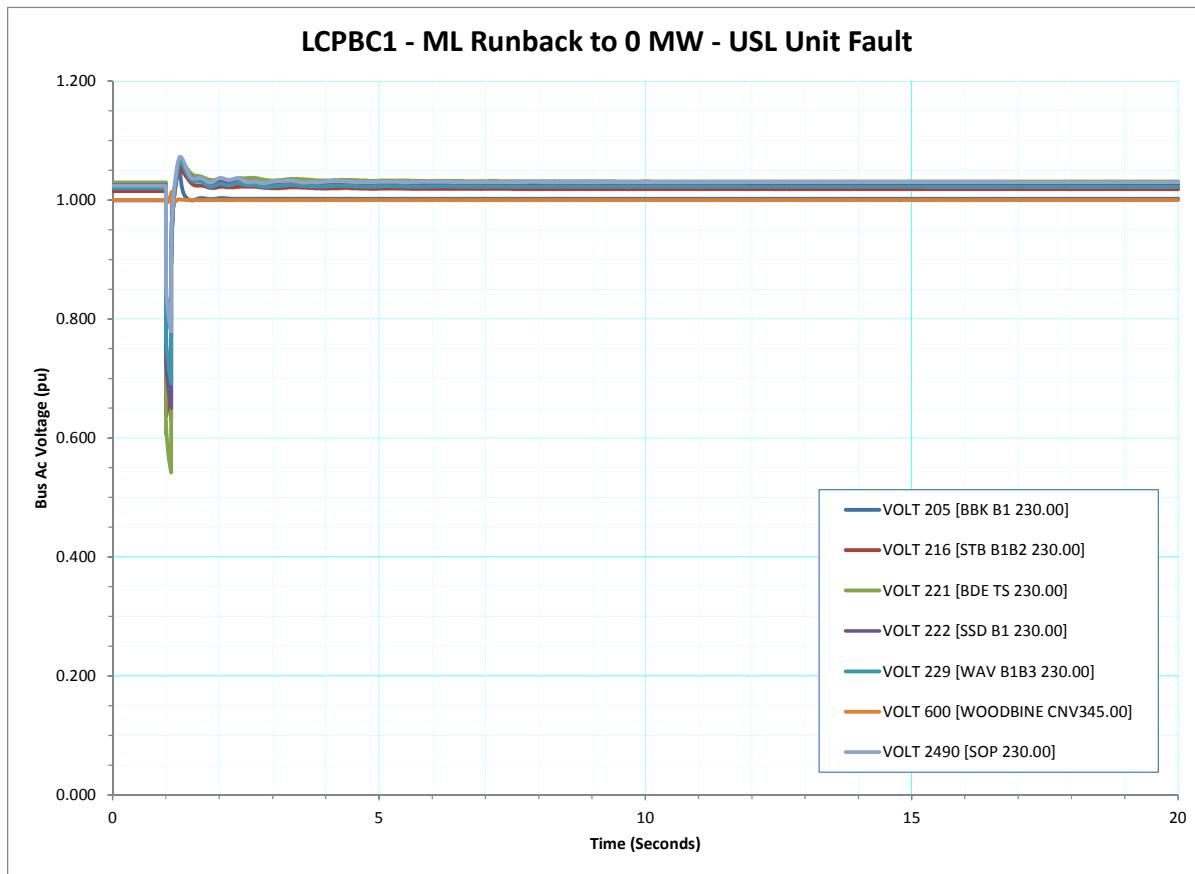
Figure 364 - LCPBC1 - ML Runback to 0 MW - USL Unit Fault - Bus Ac Voltage (pu)

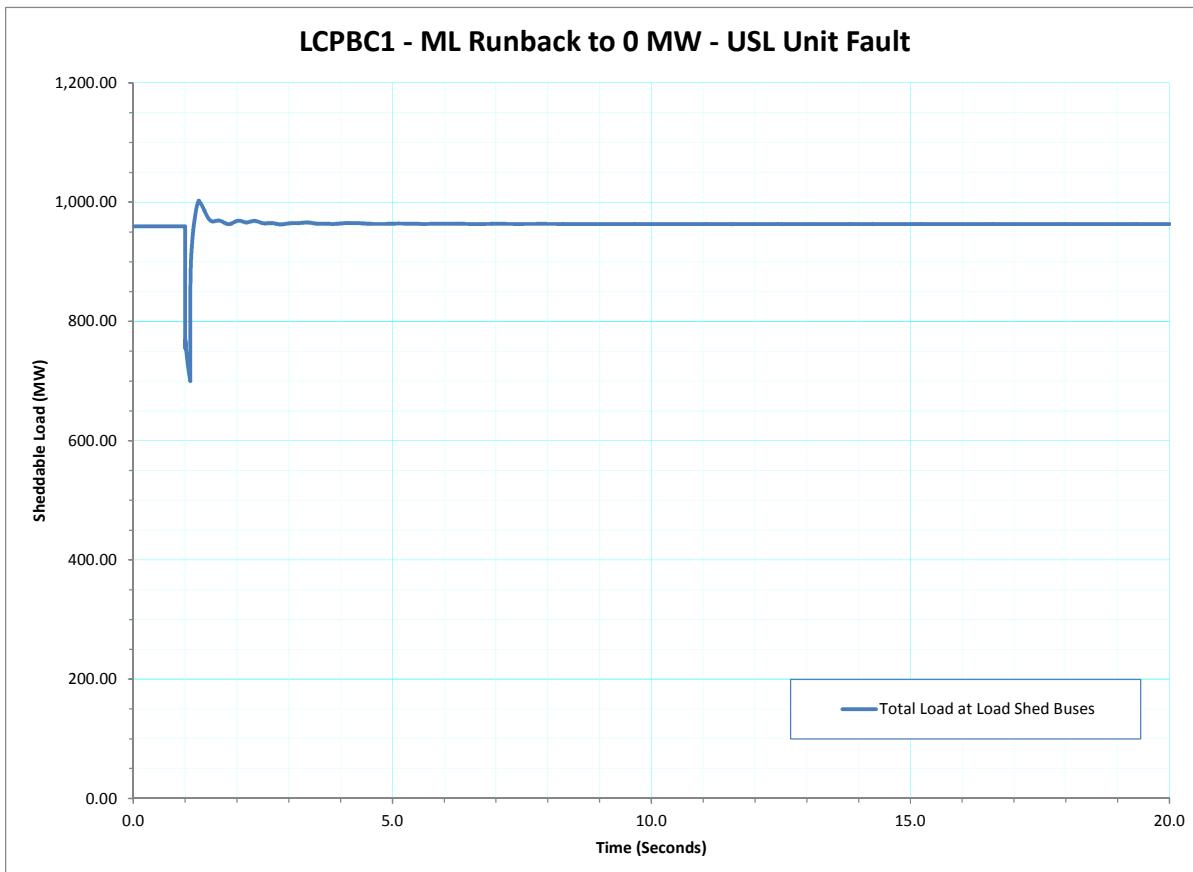
Figure 365 - LCPBC1 - ML Runback to 0 MW - USL Unit Fault - Shedtable Load (MW)

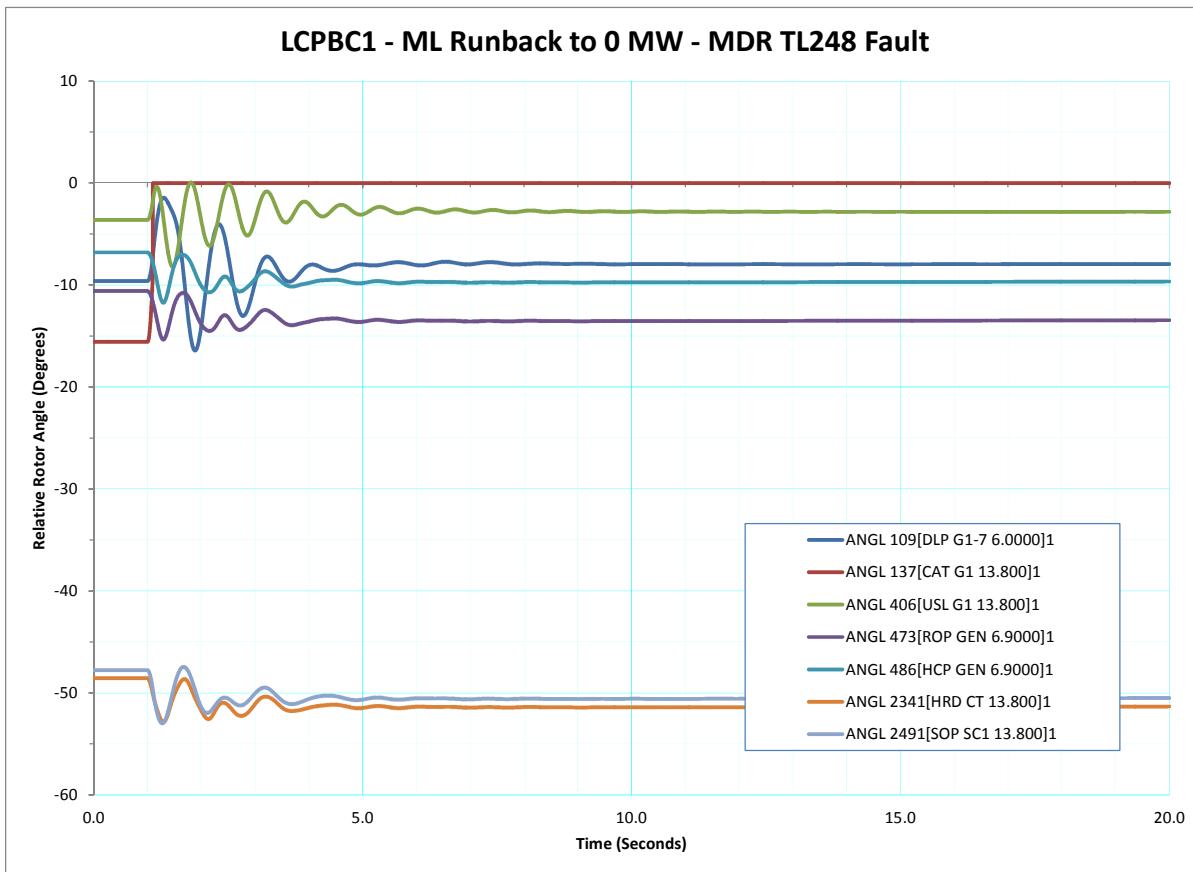
Figure 366 - LCPBC1 - ML Runback to 0 MW - MDR TL248 Fault - Relative Rotor Angle (Degrees)

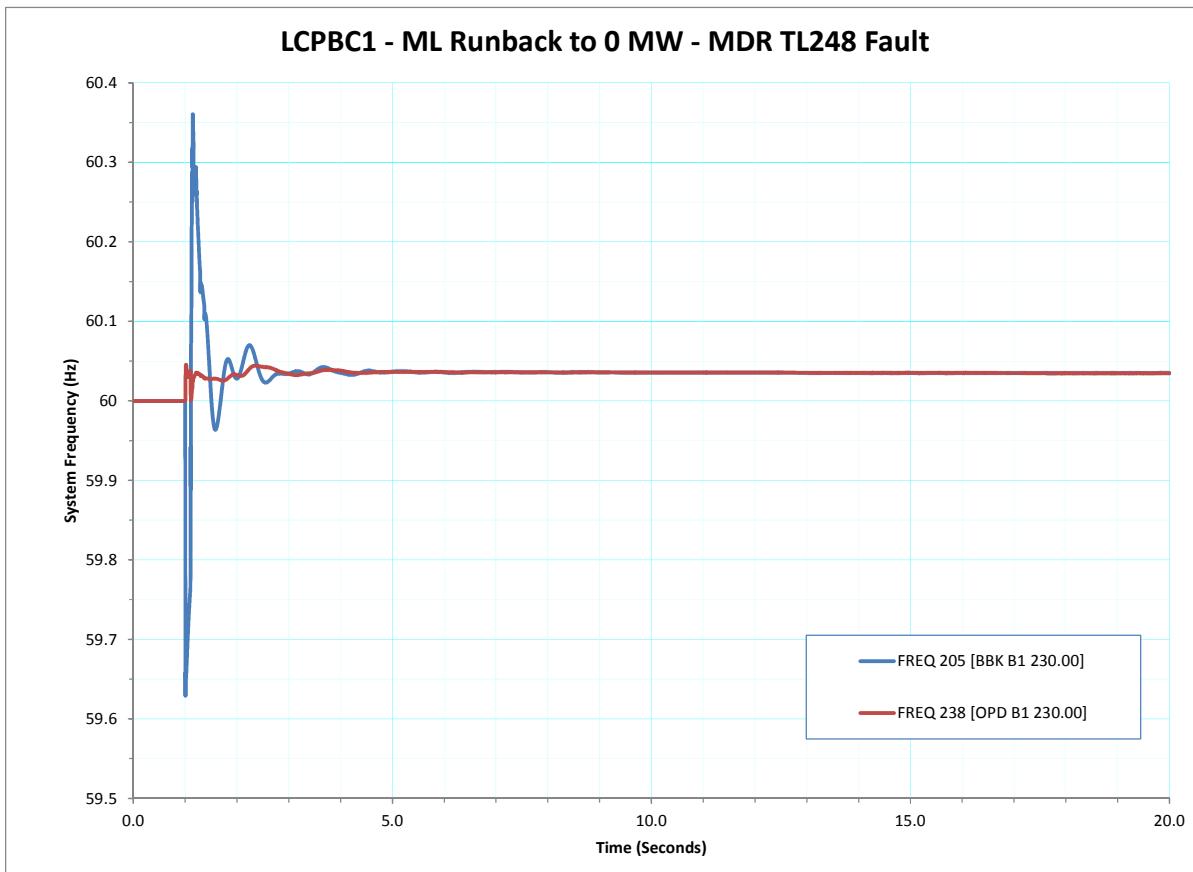
Figure 367 - LCPBC1 - ML Runback to 0 MW - MDR TL248 Fault - System Frequency (Hz)

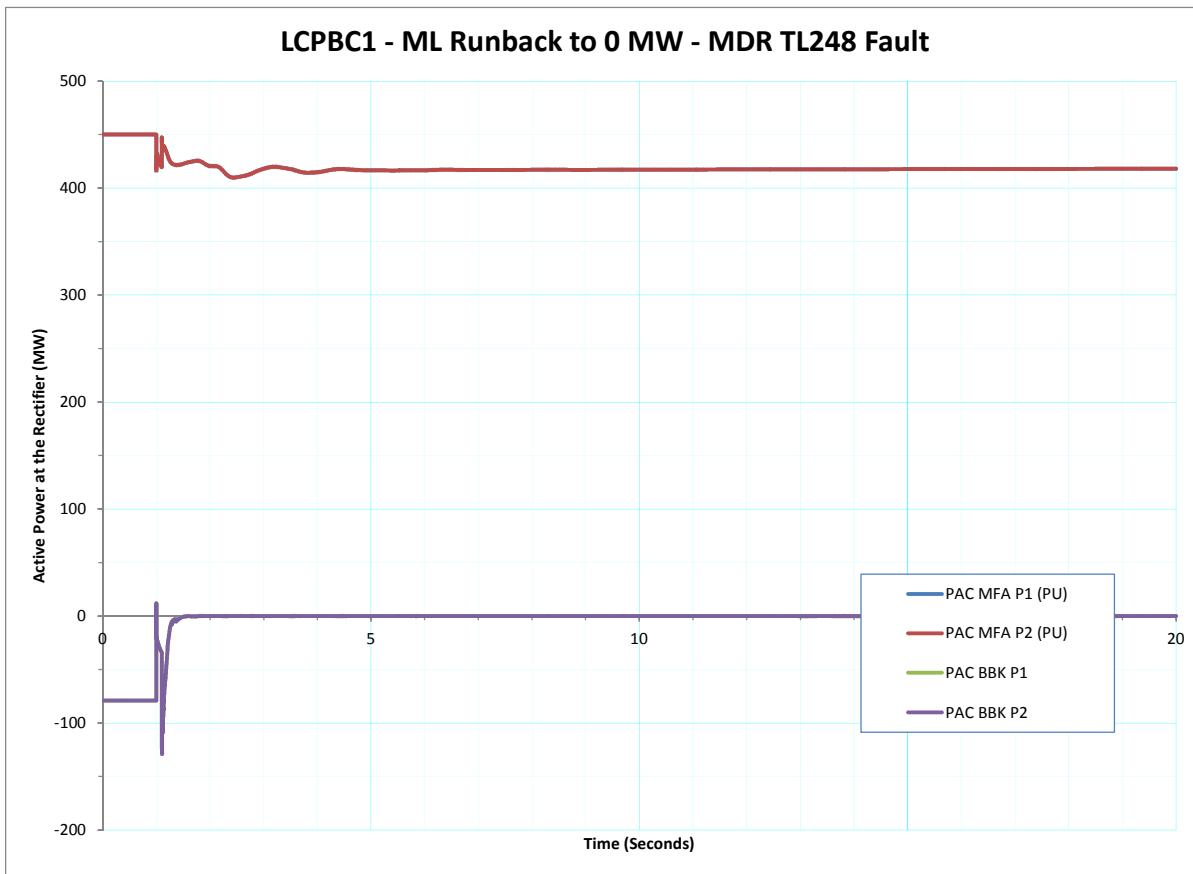
Figure 368 - LCPBC1 - ML Runback to 0 MW - MDR TL248 Fault - Active Power at the Rectifier (MW)

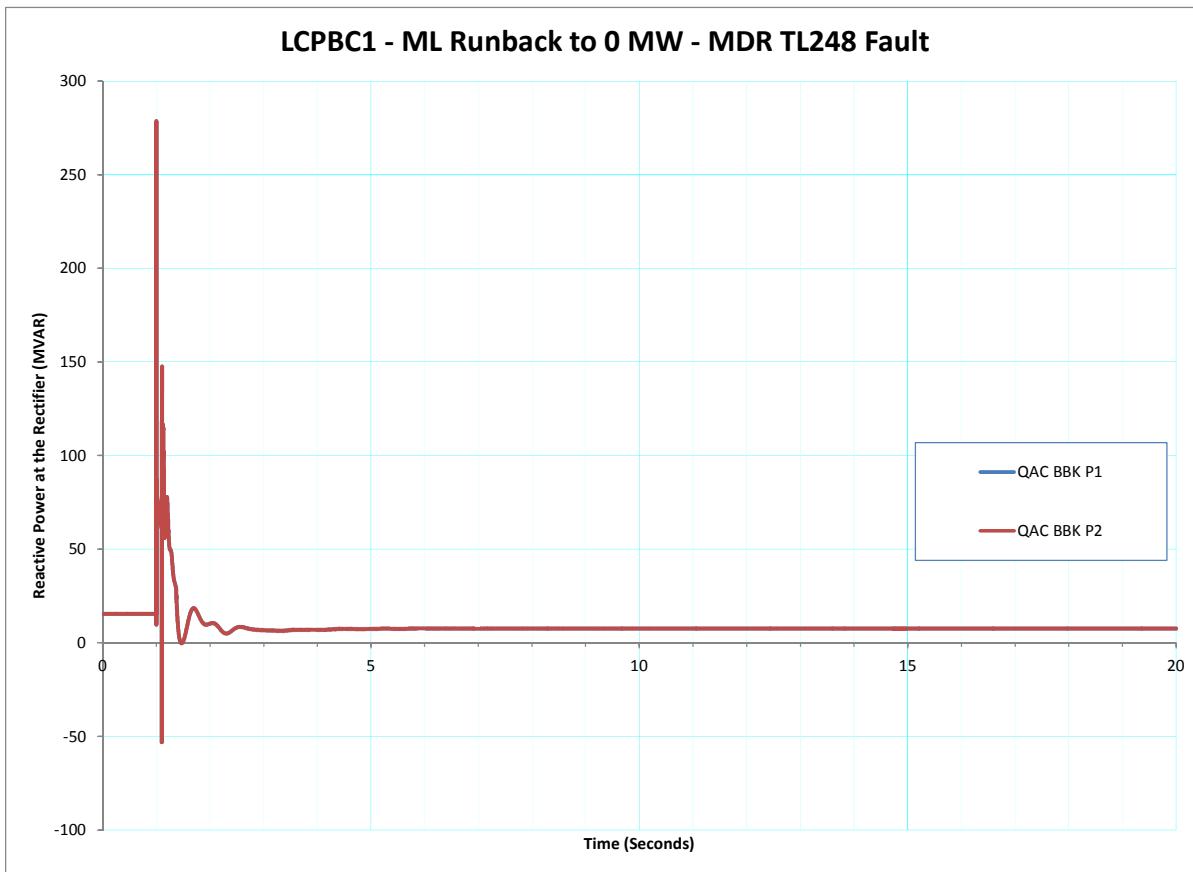
Figure 369 - LCPBC1 - ML Runback to 0 MW - MDR TL248 Fault - Reactive Power at the Rectifier (MVAR)

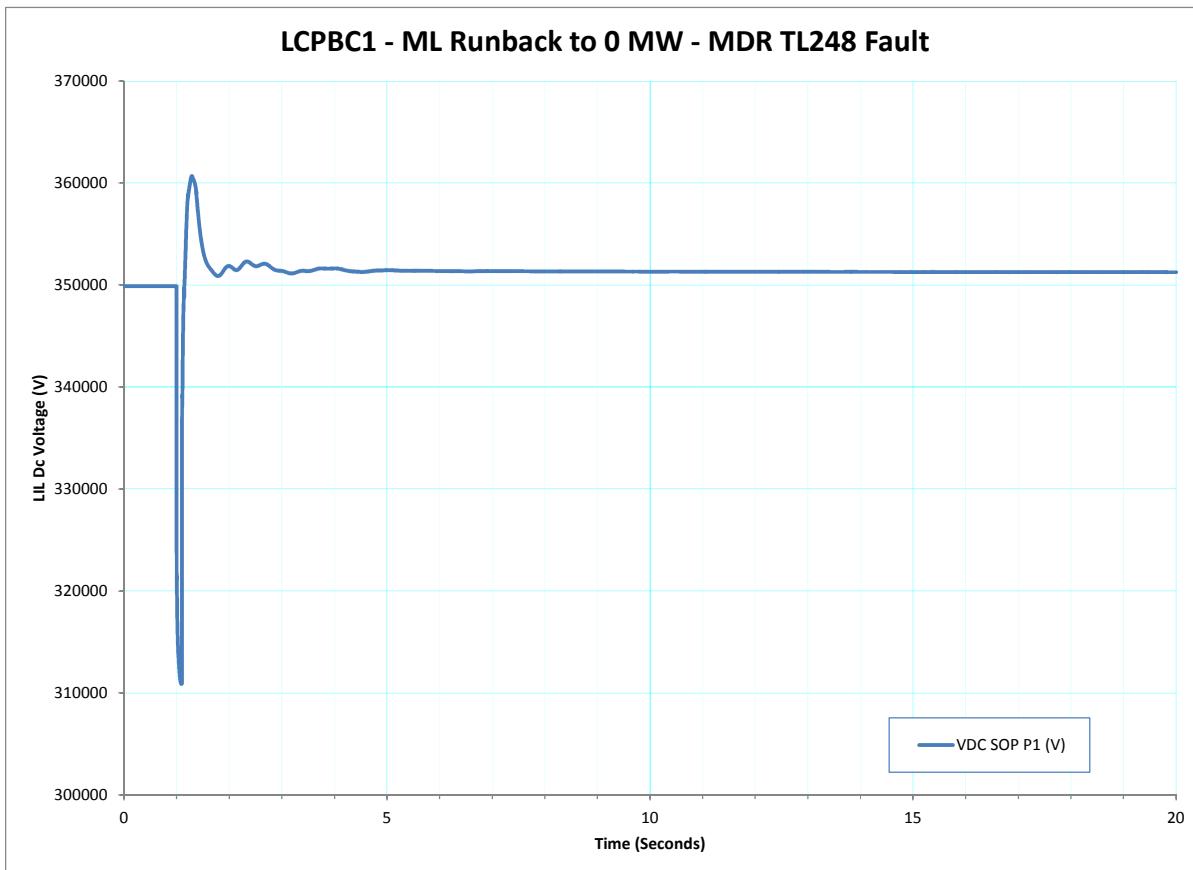
Figure 370 - LCPBC1 - ML Runback to 0 MW - MDR TL248 Fault - LIL Dc Voltage (V)

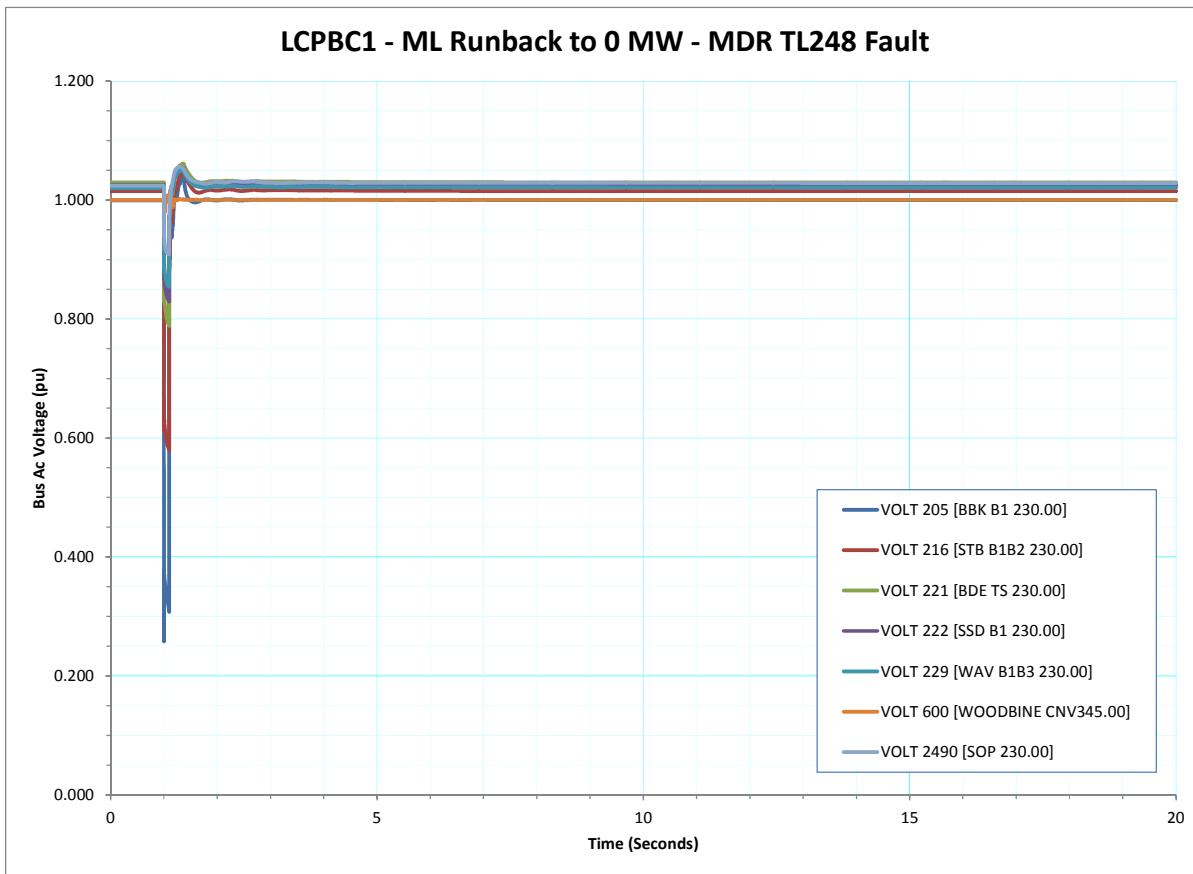
Figure 371 - LCPBC1 - ML Runback to 0 MW - MDR TL248 Fault - Bus Ac Voltage (pu)

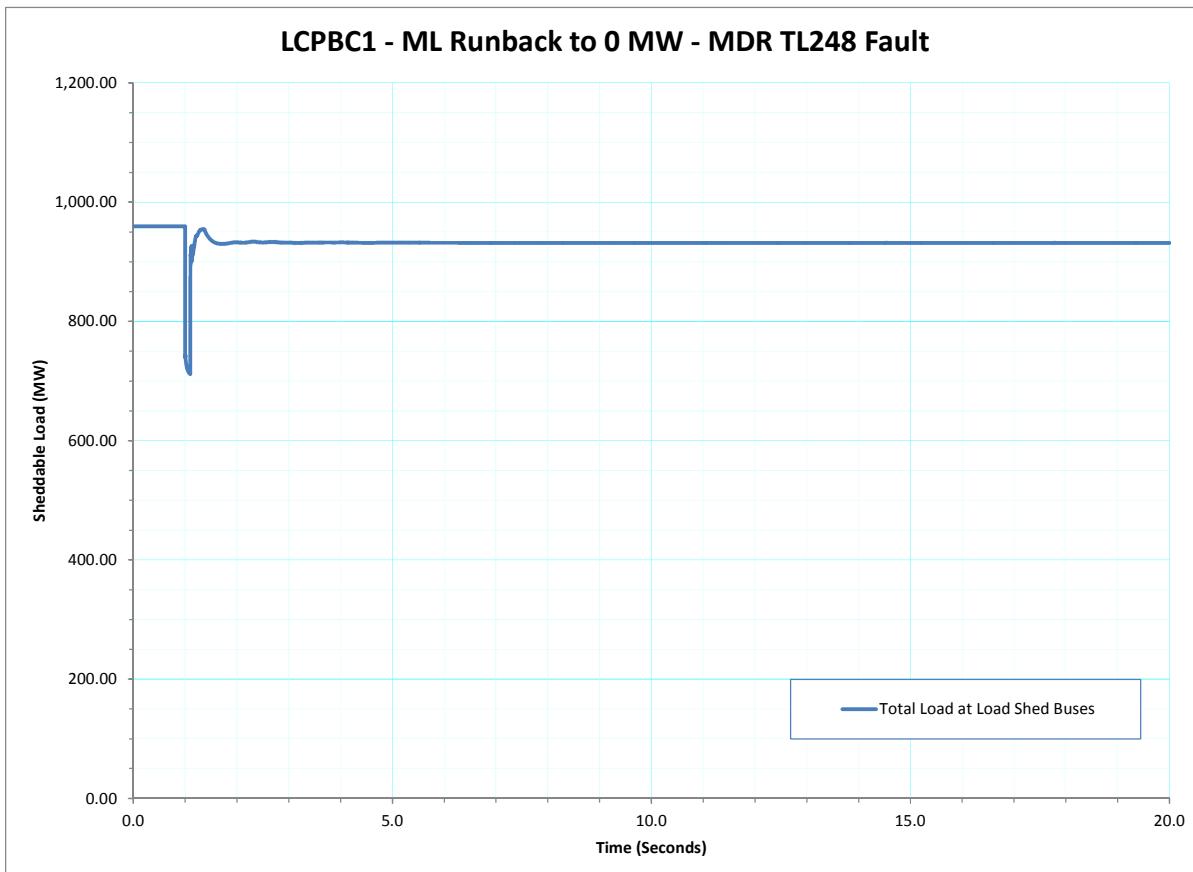
Figure 372 - LCPBC1 - ML Runback to 0 MW - MDR TL248 Fault - Sheddable Load (MW)

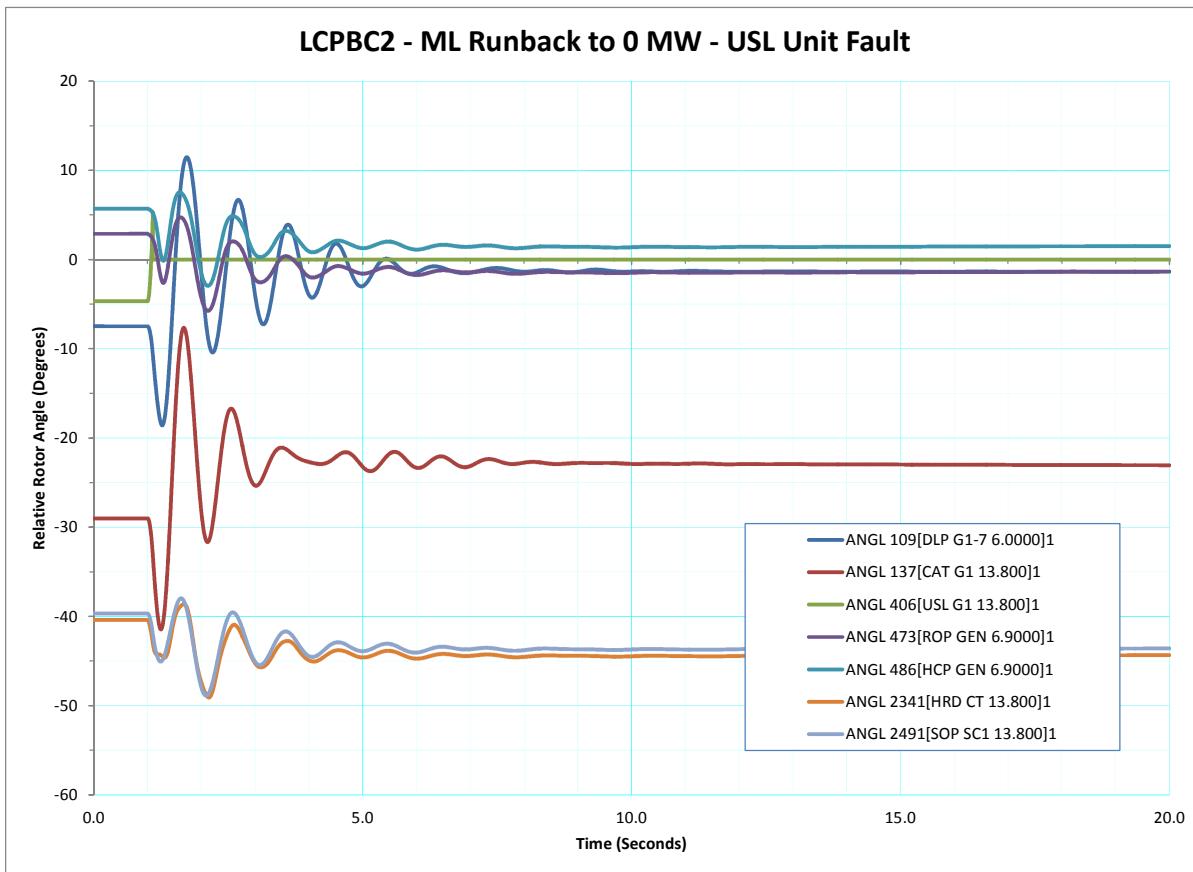
Figure 373 - LCPBC2 - ML Runback to 0 MW - USL Unit Fault - Relative Rotor Angle (Degrees)

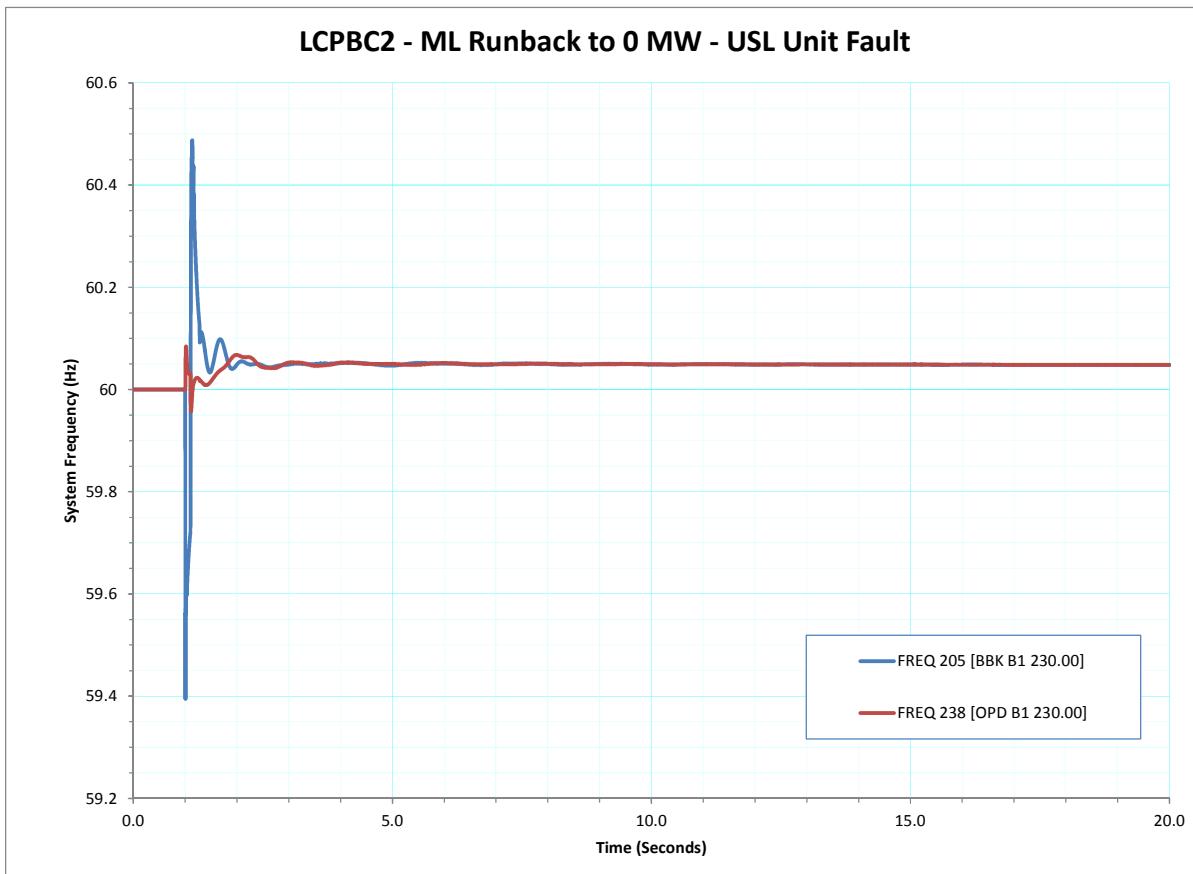
Figure 374 - LCPBC2 - ML Runback to 0 MW - USL Unit Fault - System Frequency (Hz)

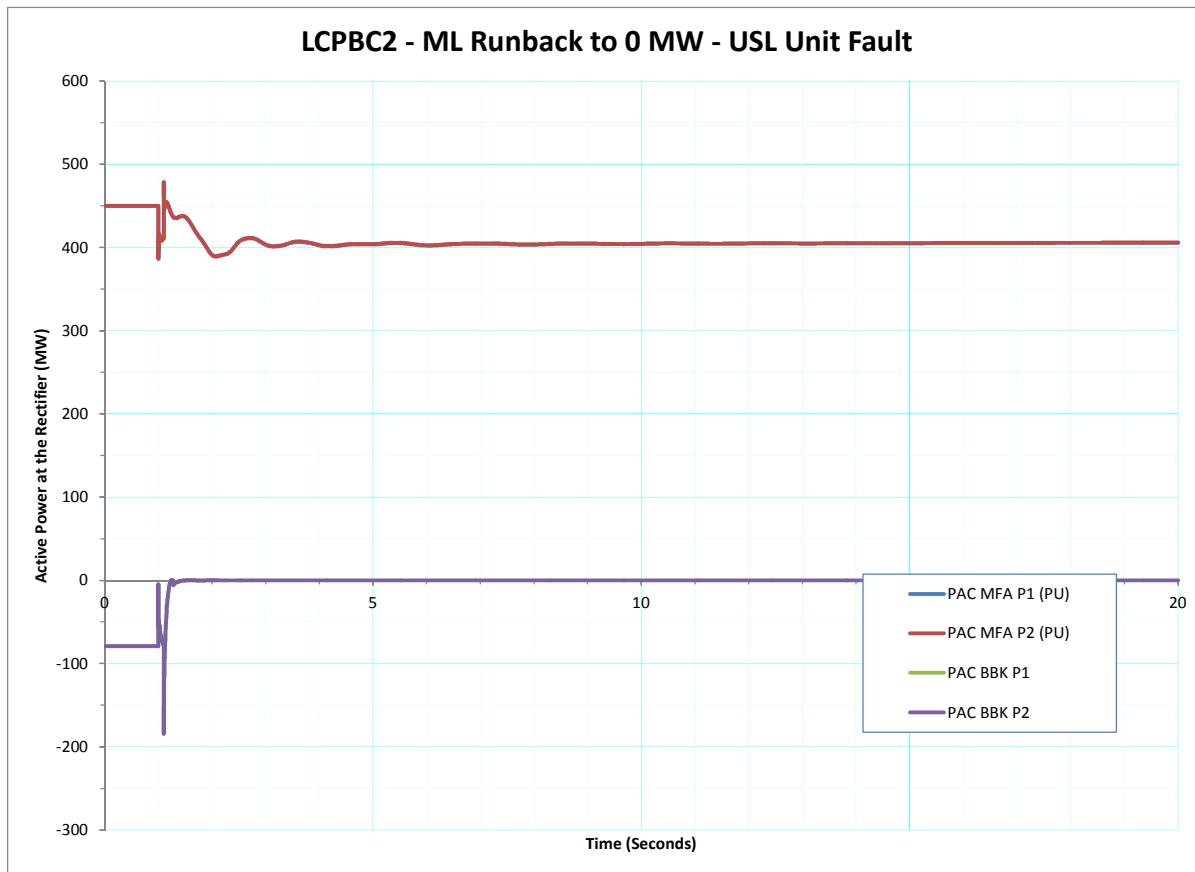
Figure 375 - LCPBC2 - ML Runback to 0 MW - USL Unit Fault - Active Power at the Rectifier (MW)

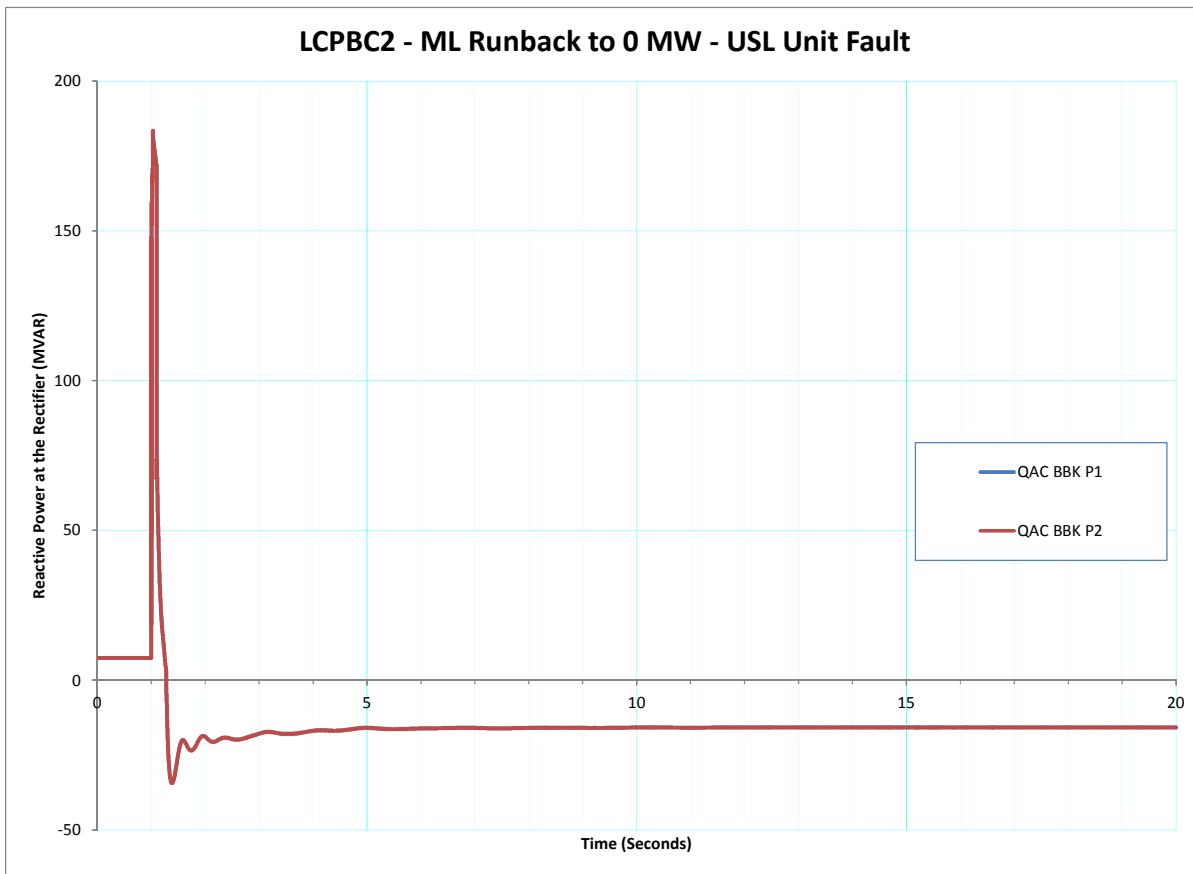
Figure 376 - LCPBC2 - ML Runback to 0 MW - USL Unit Fault - Reactive Power at the Rectifier (MVAR)

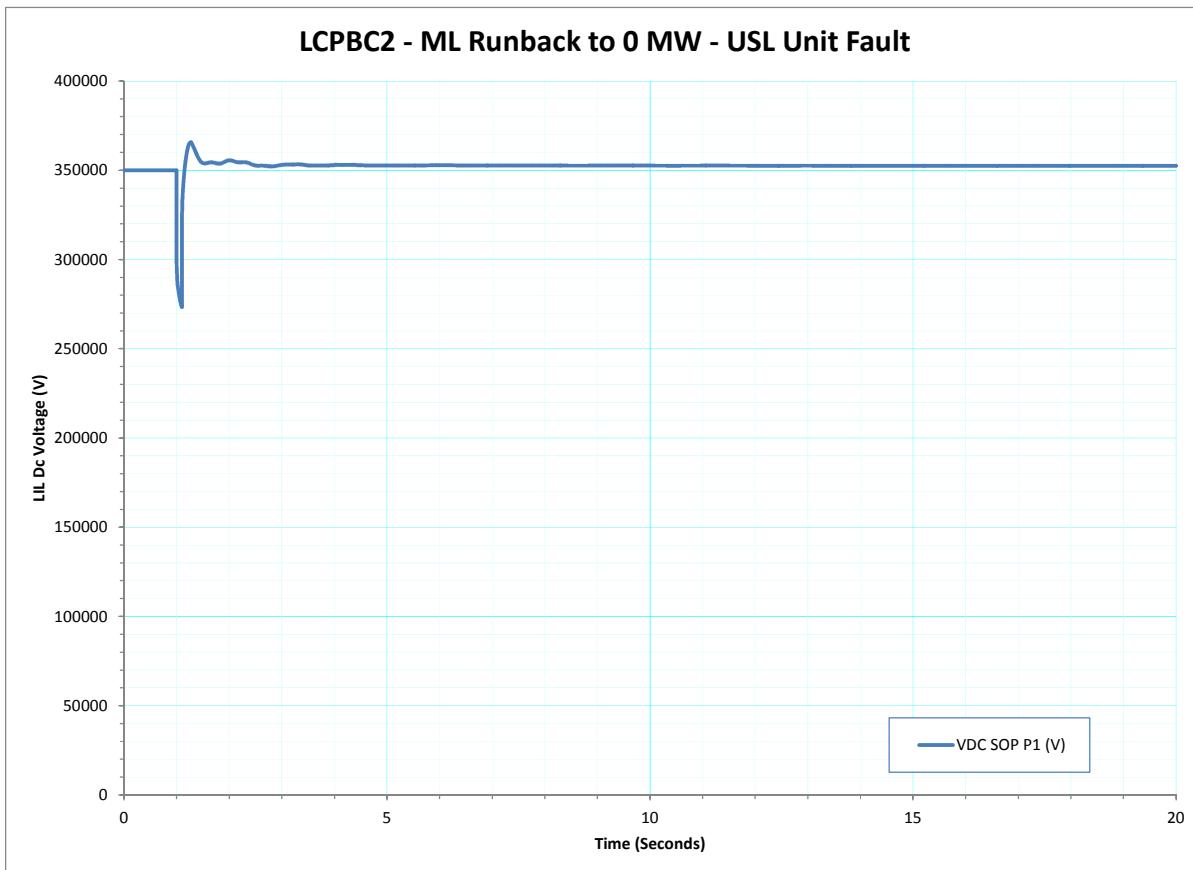
Figure 377 - LCPBC2 - ML Runback to 0 MW - USL Unit Fault - LIL Dc Voltage (V)

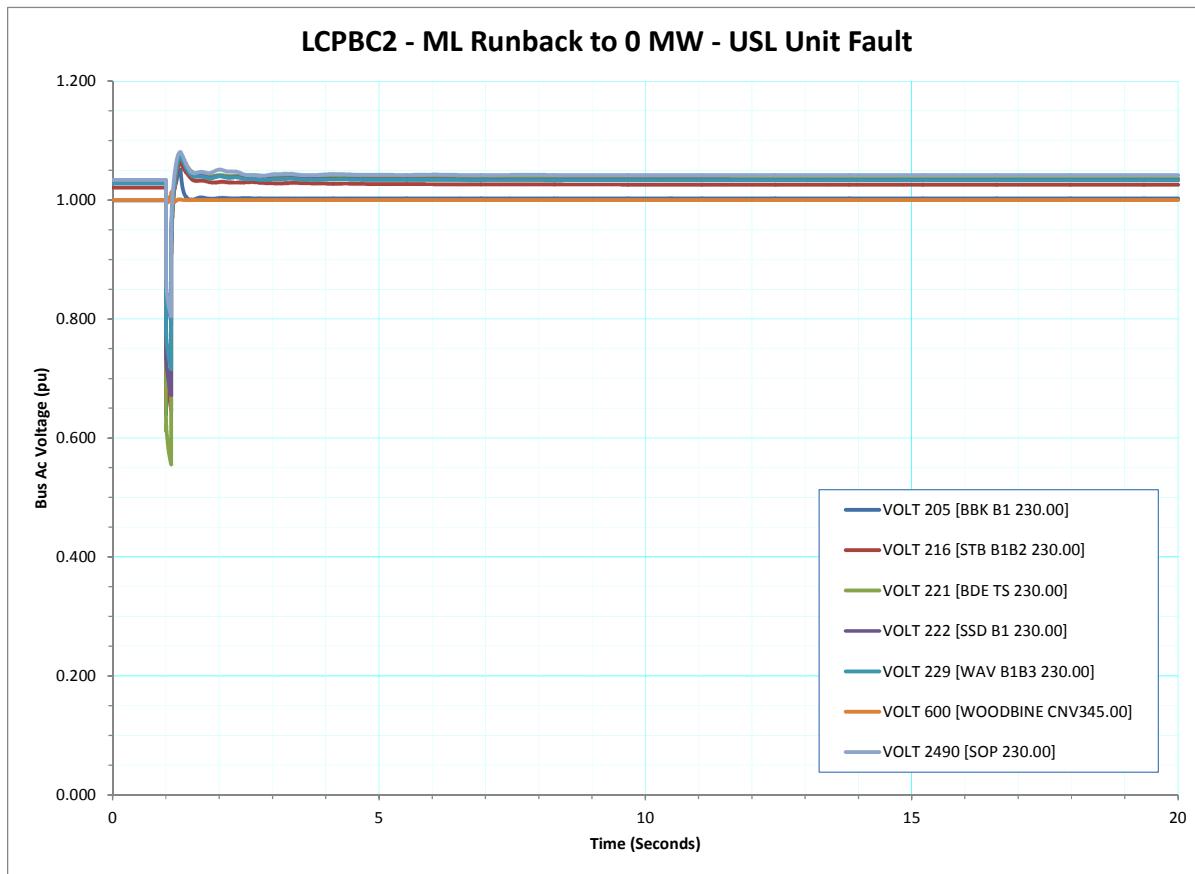
Figure 378 - LCPBC2 - ML Runback to 0 MW - USL Unit Fault - Bus Ac Voltage (pu)
