MARITIME LINK PRELIMINARY INTERCONNECTION STUDY

Newfoundland and Labrador Hydro

July 2014

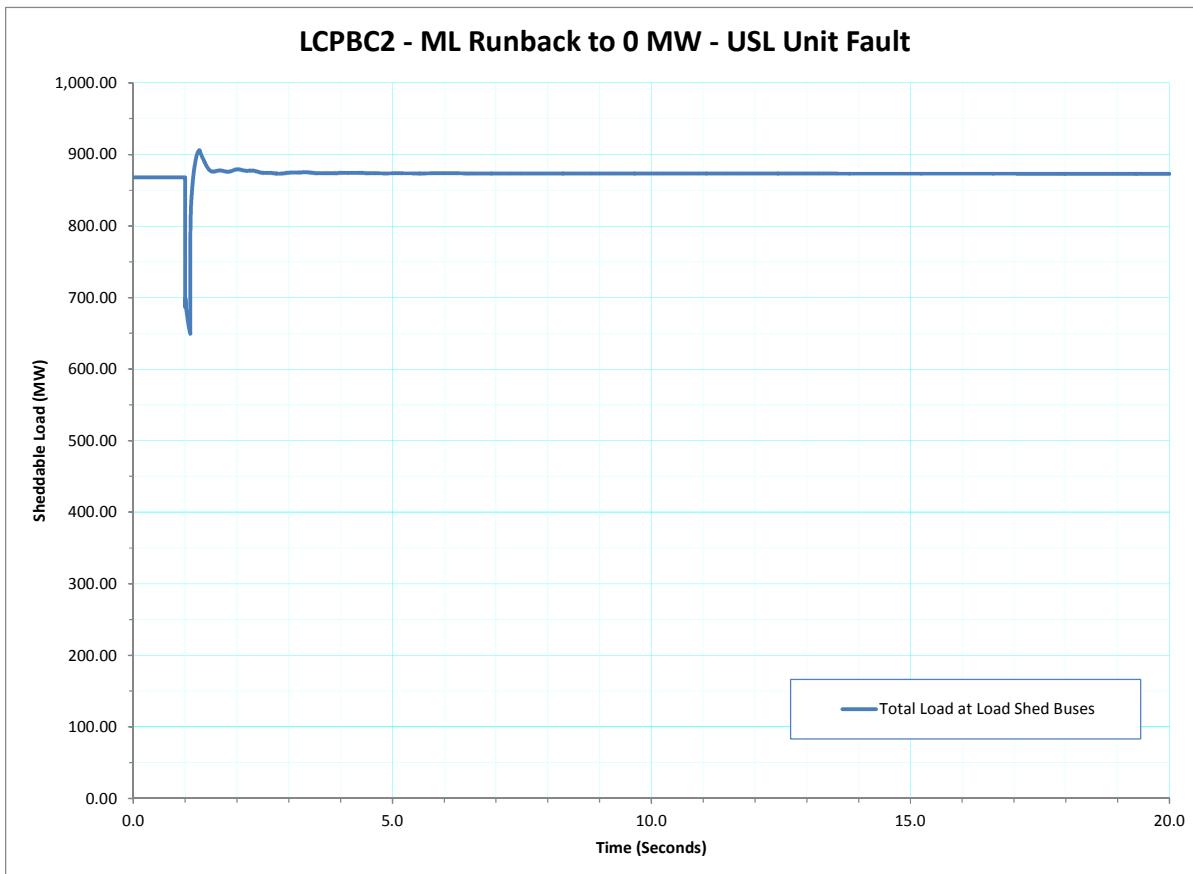
Figure 379 - LCPBC2 - ML Runback to 0 MW - USL Unit Fault - Shedtable Load (MW)

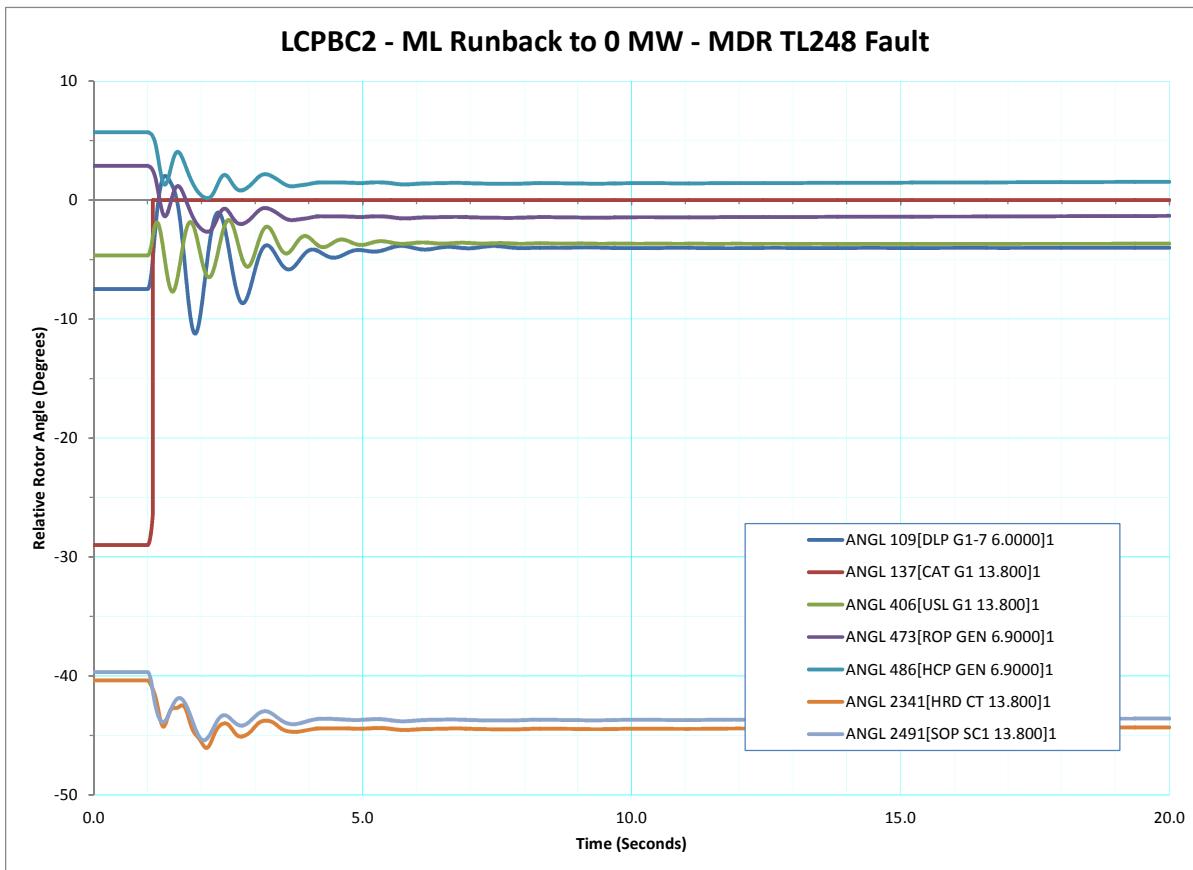
Figure 380 - LCPBC2 - ML Runback to 0 MW - MDR TL248 Fault - Relative Rotor Angle (Degrees)

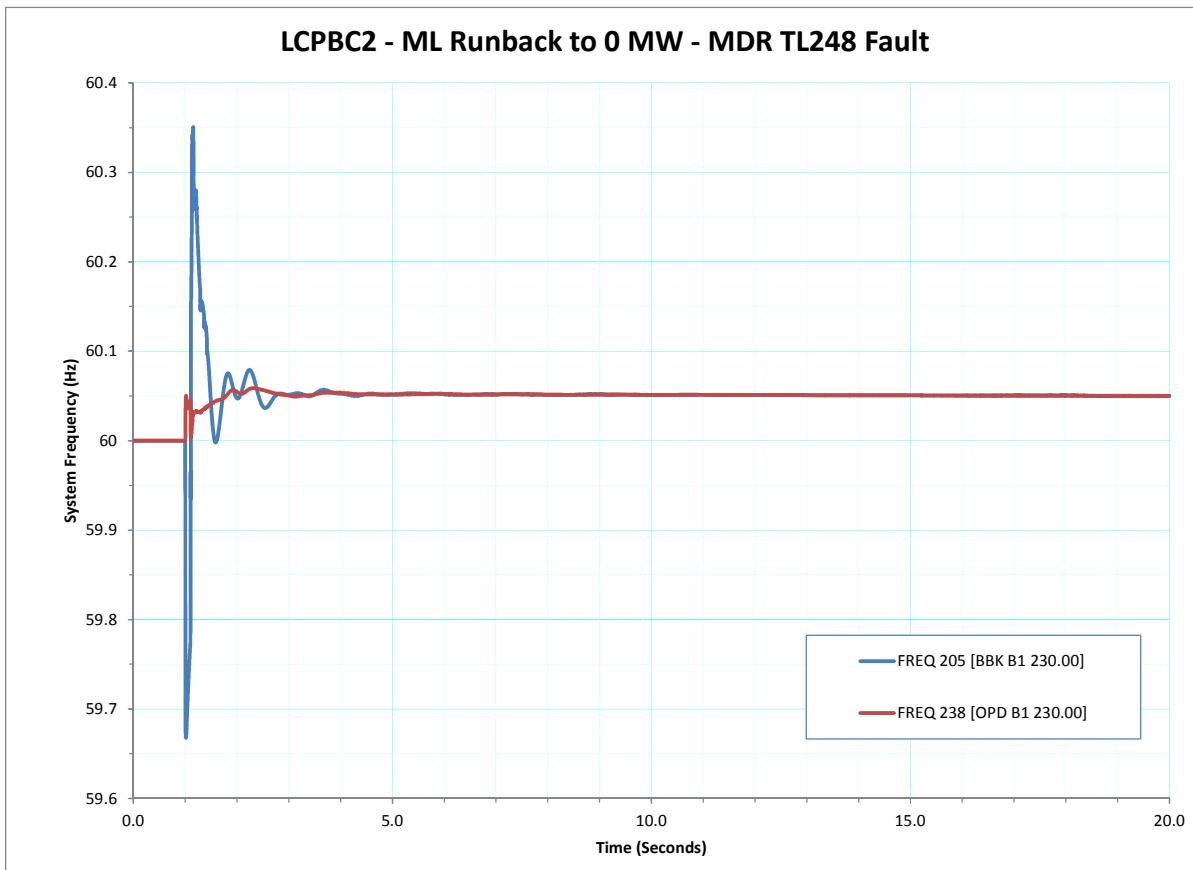
Figure 381 - LCPBC2 - ML Runback to 0 MW - MDR TL248 Fault - System Frequency (Hz)

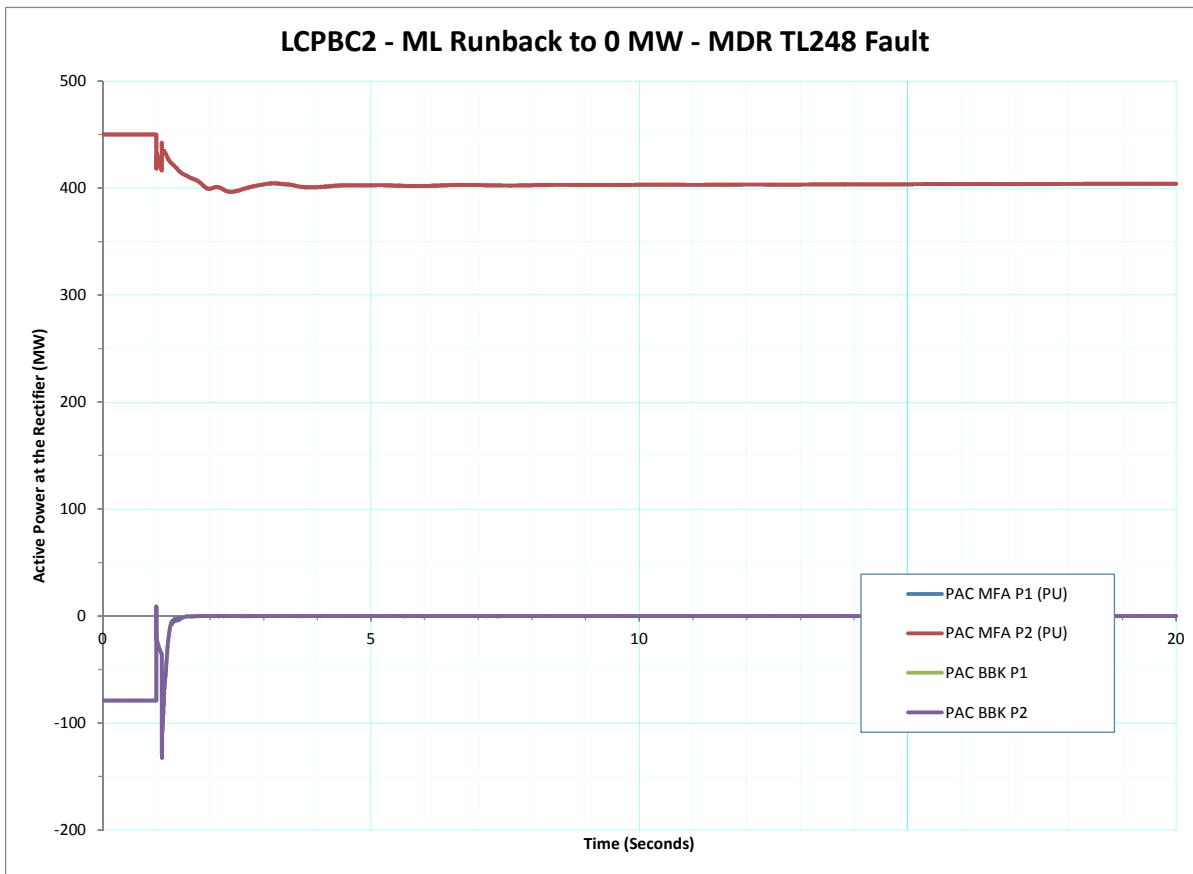
Figure 382 - LCPBC2 - ML Runback to 0 MW - MDR TL248 Fault - Active Power at the Rectifier (MW)

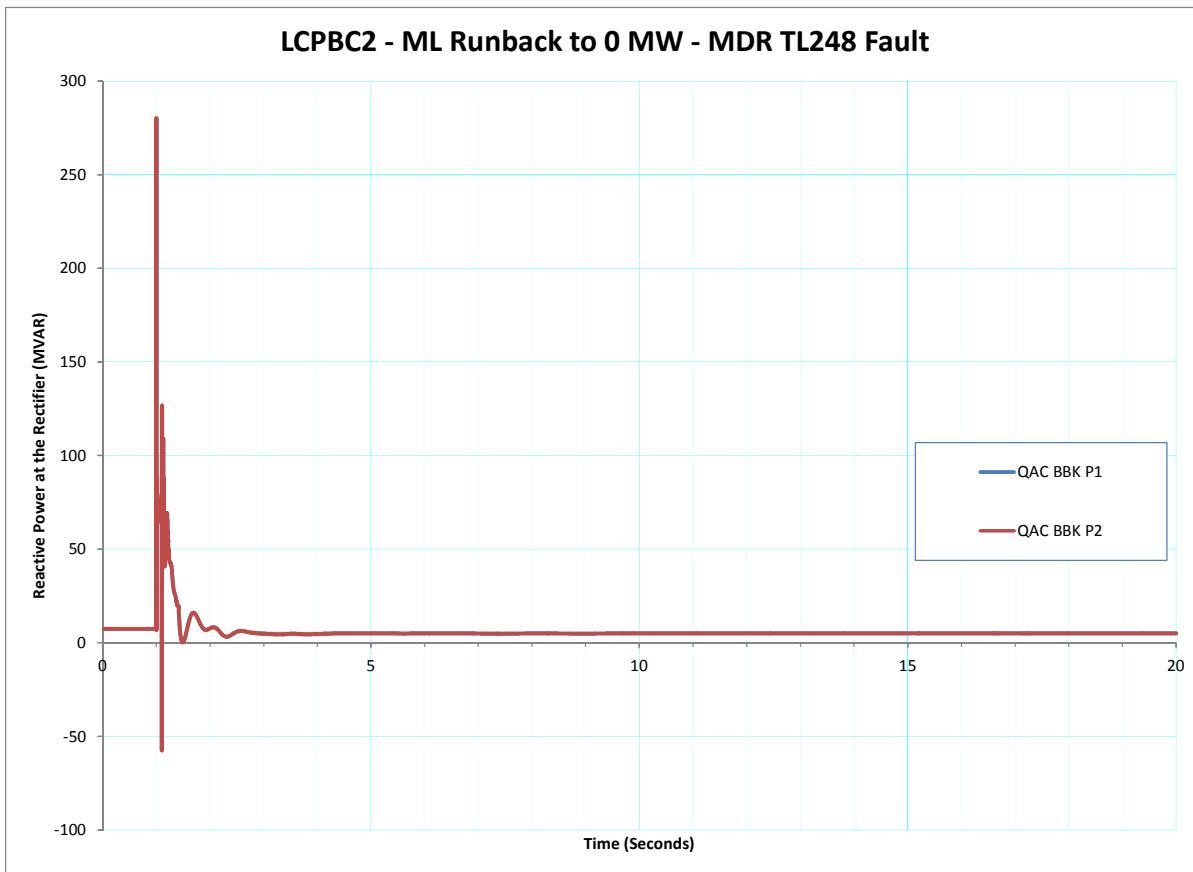
Figure 383 - LCPBC2 - ML Runback to 0 MW - MDR TL248 Fault - Reactive Power at the Rectifier (MVAR)

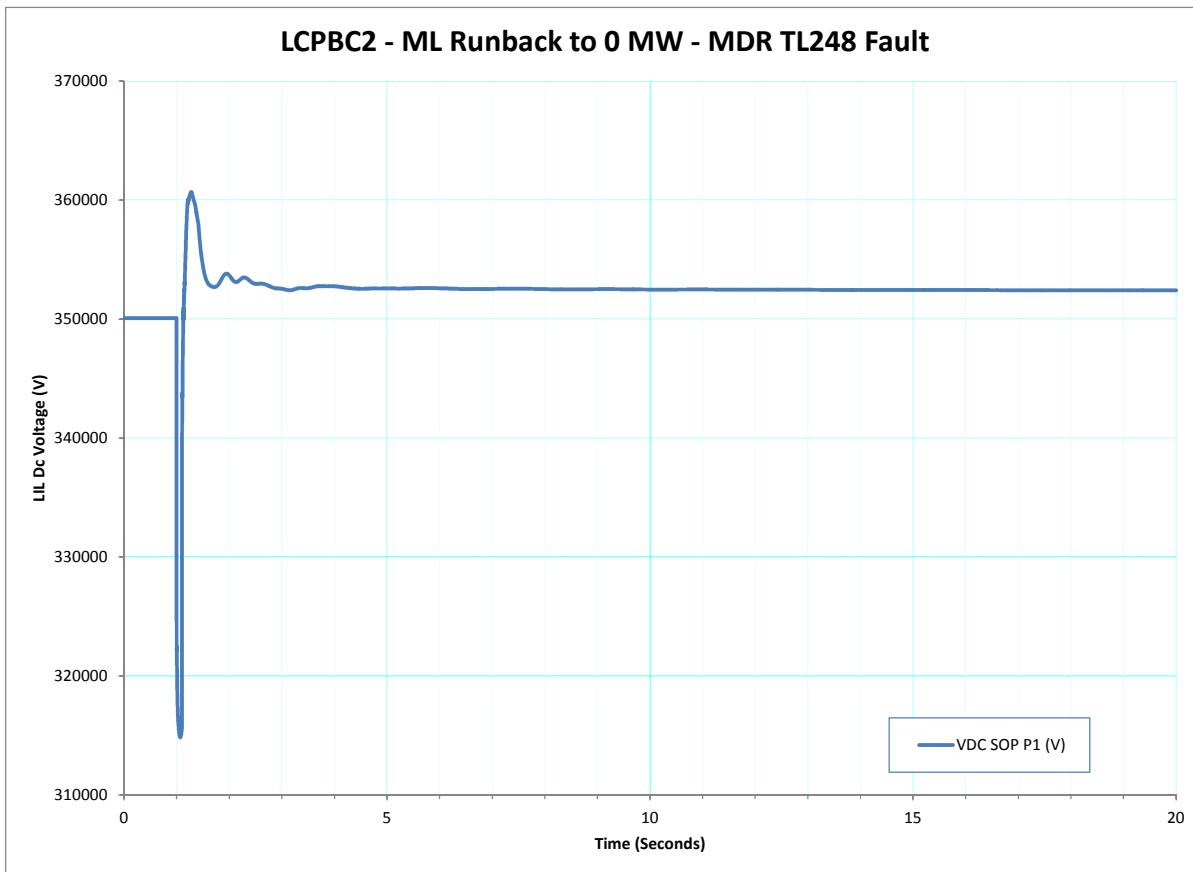
Figure 384 - LCPBC2 - ML Runback to 0 MW - MDR TL248 Fault - LIL Dc Voltage (V)

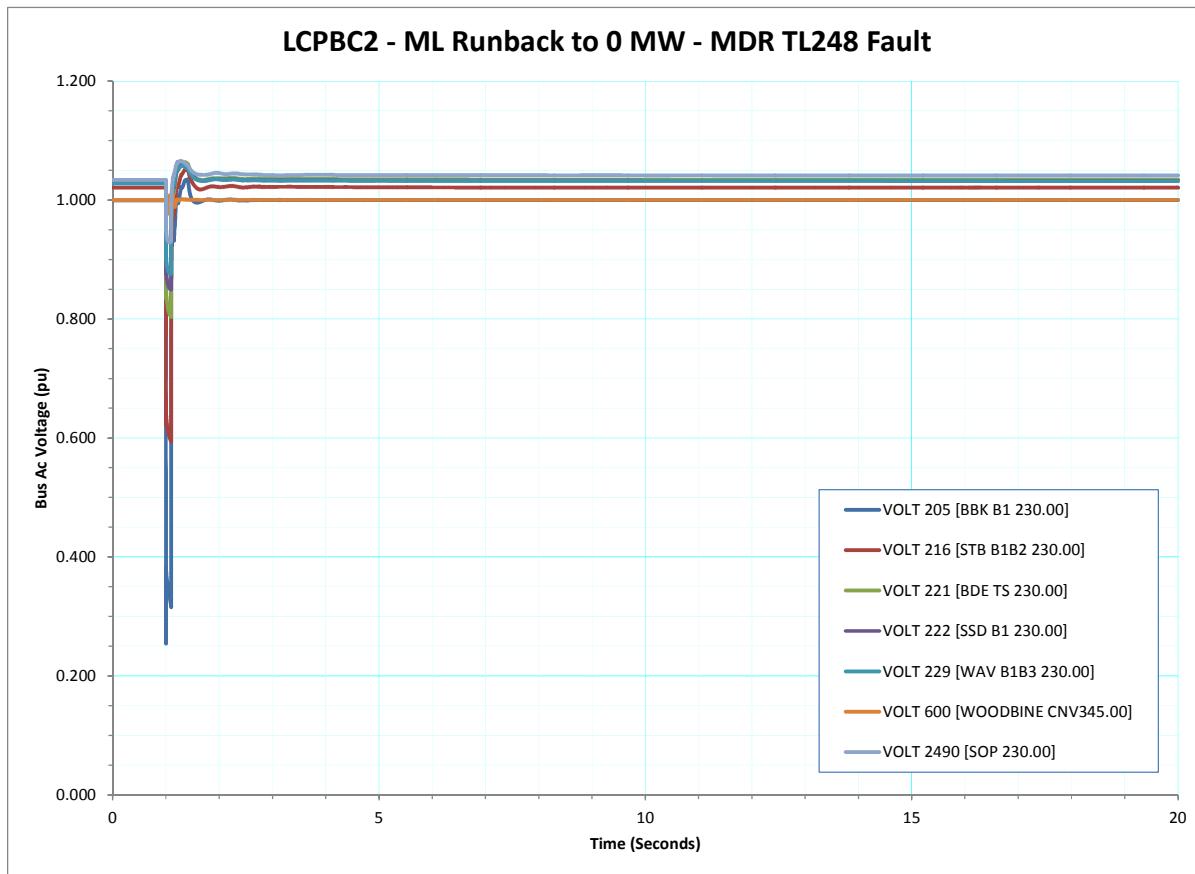
Figure 385 - LCPBC2 - ML Runback to 0 MW - MDR TL248 Fault - Bus Ac Voltage (pu)

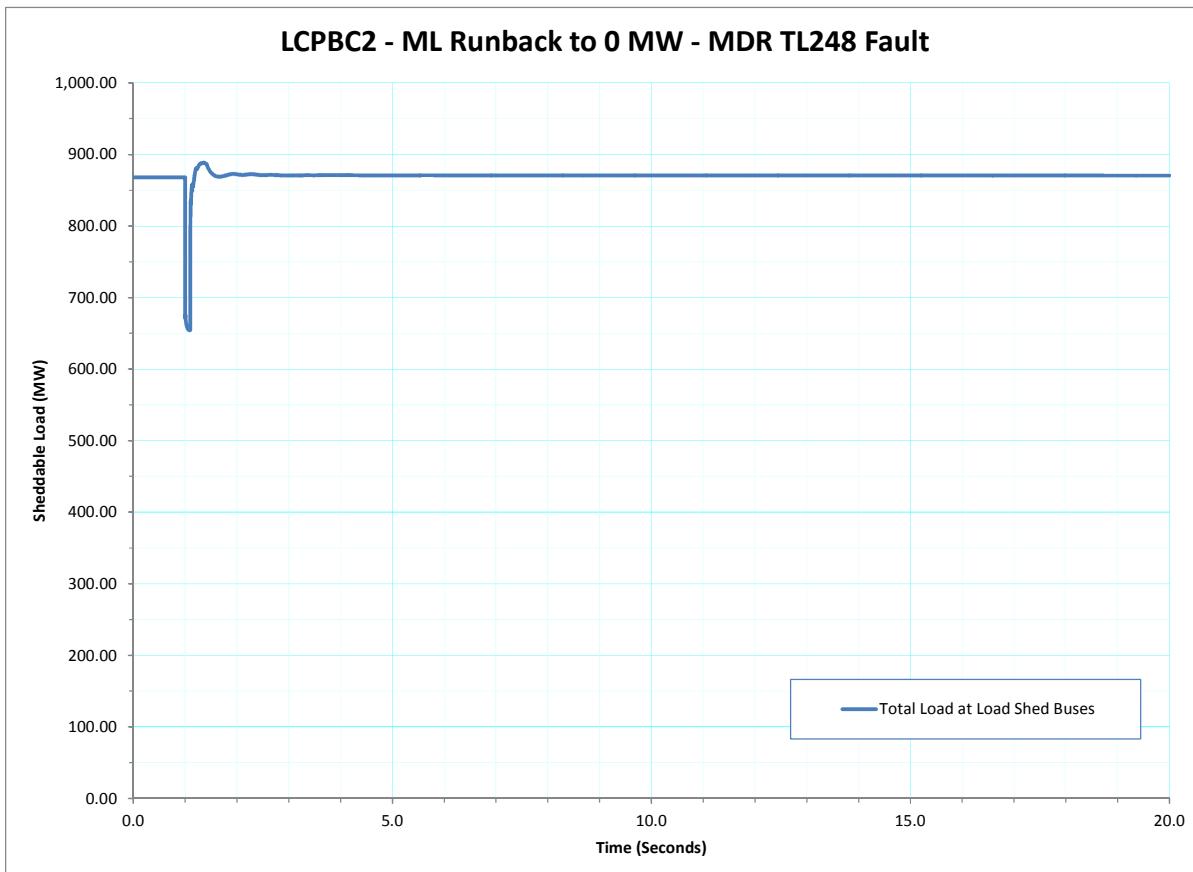
Figure 386 - LCPBC2 - ML Runback to 0 MW - MDR TL248 Fault - Shedtable Load (MW)

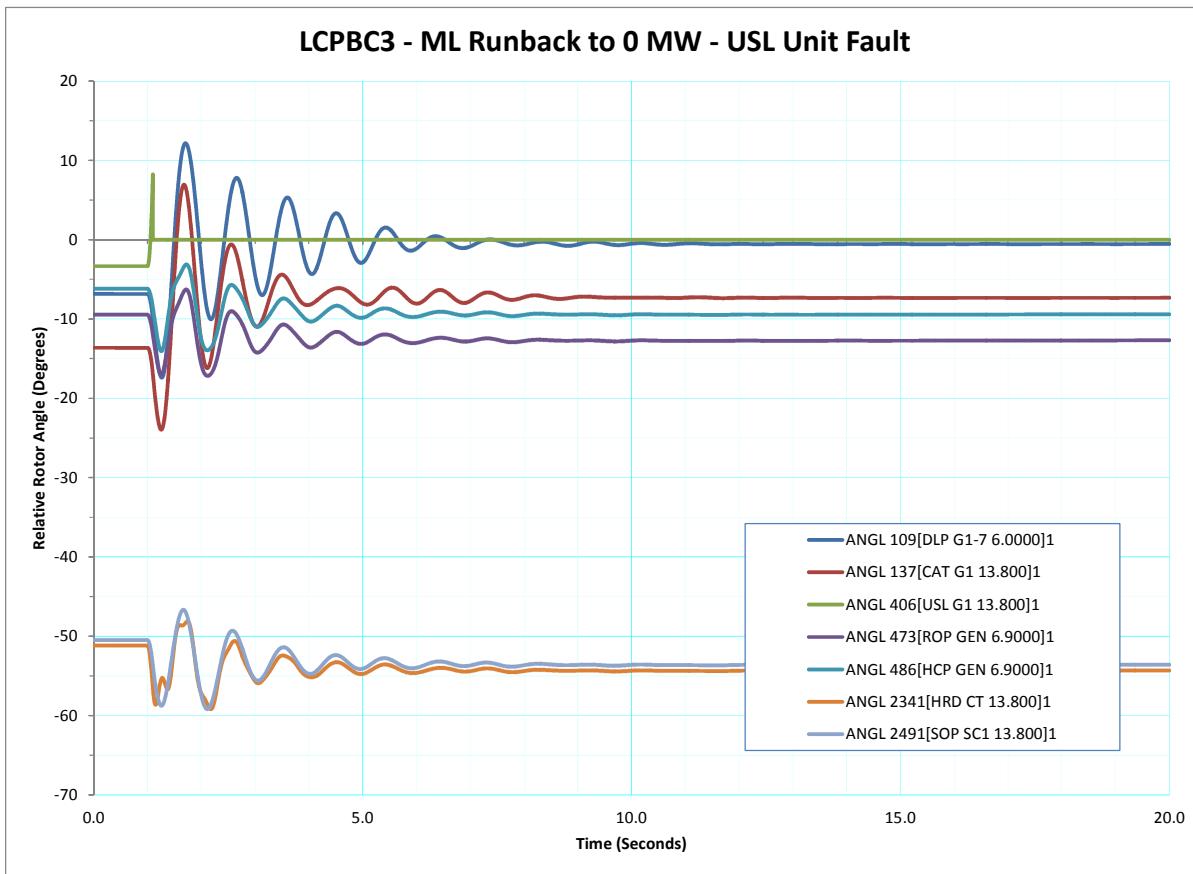
Figure 387 - LCPBC3 - ML Runback to 0 MW - USL Unit Fault - Relative Rotor Angle (Degrees)

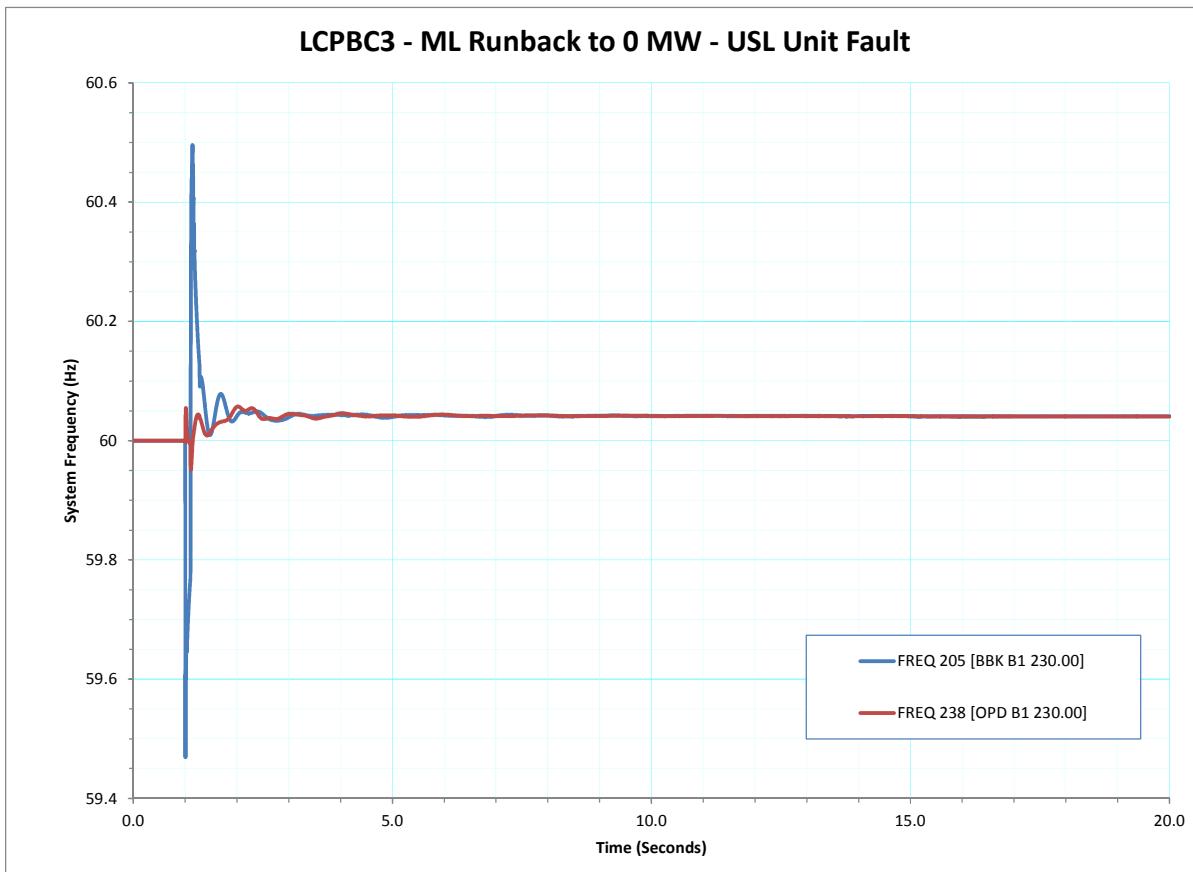
Figure 388 - LCPBC3 - ML Runback to 0 MW - USL Unit Fault - System Frequency (Hz)

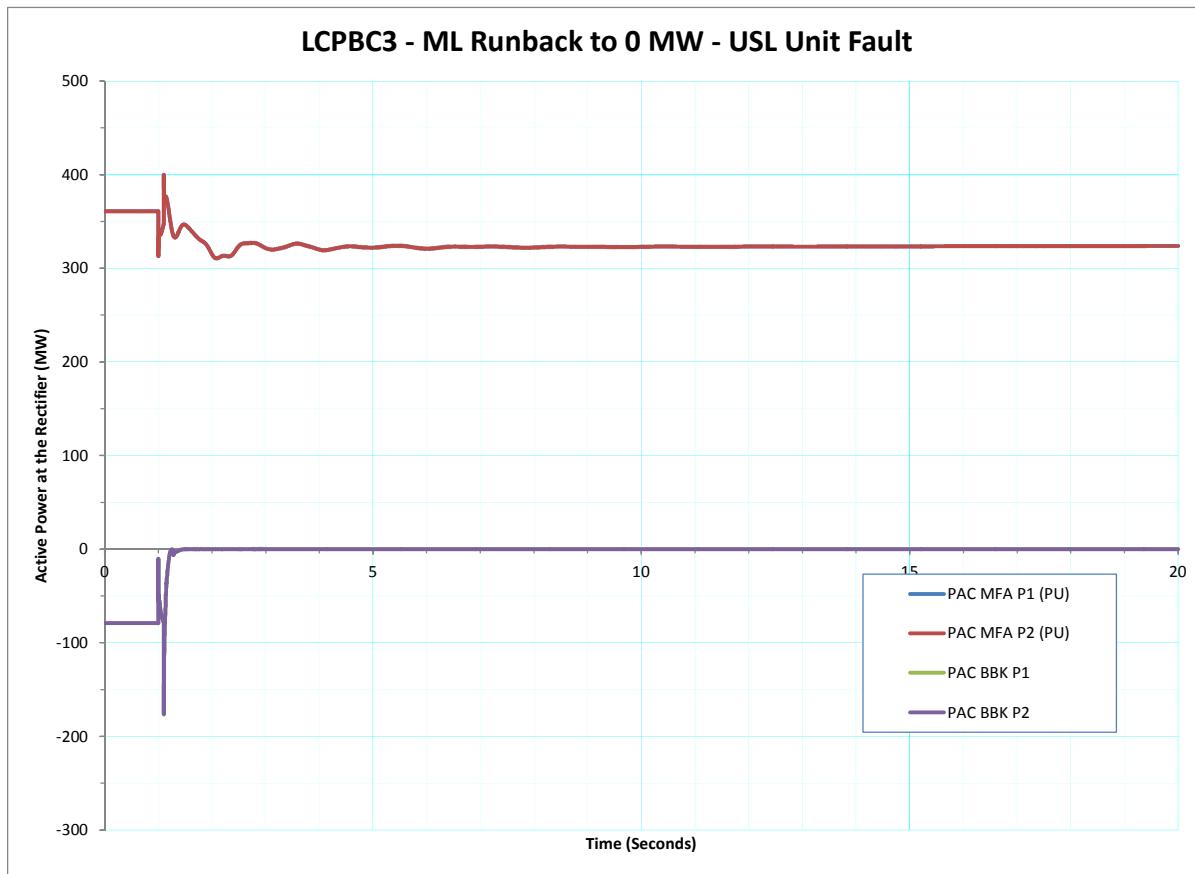
Figure 389 - LCPBC3 - ML Runback to 0 MW - USL Unit Fault - Active Power at the Rectifier (MW)

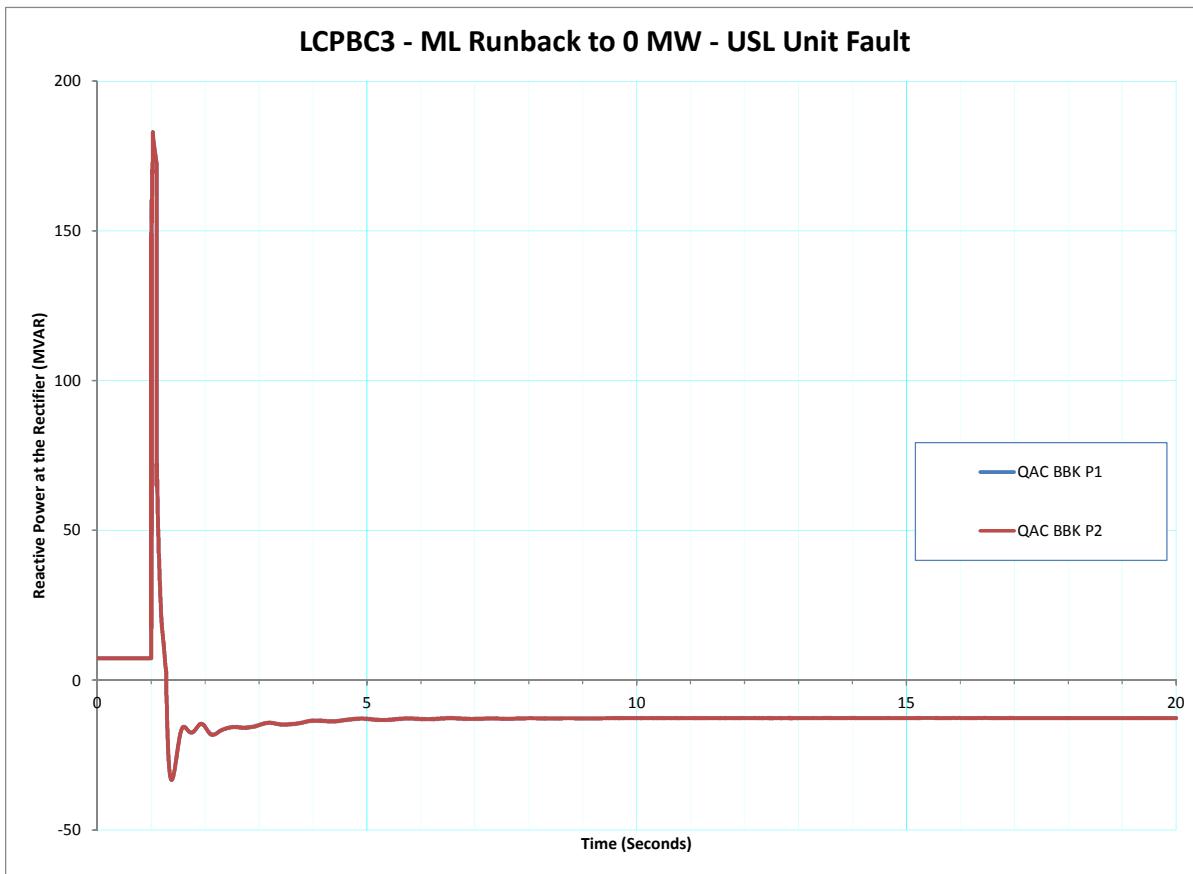
Figure 390 - LCPBC3 - ML Runback to 0 MW - USL Unit Fault - Reactive Power at the Rectifier (MVAR)

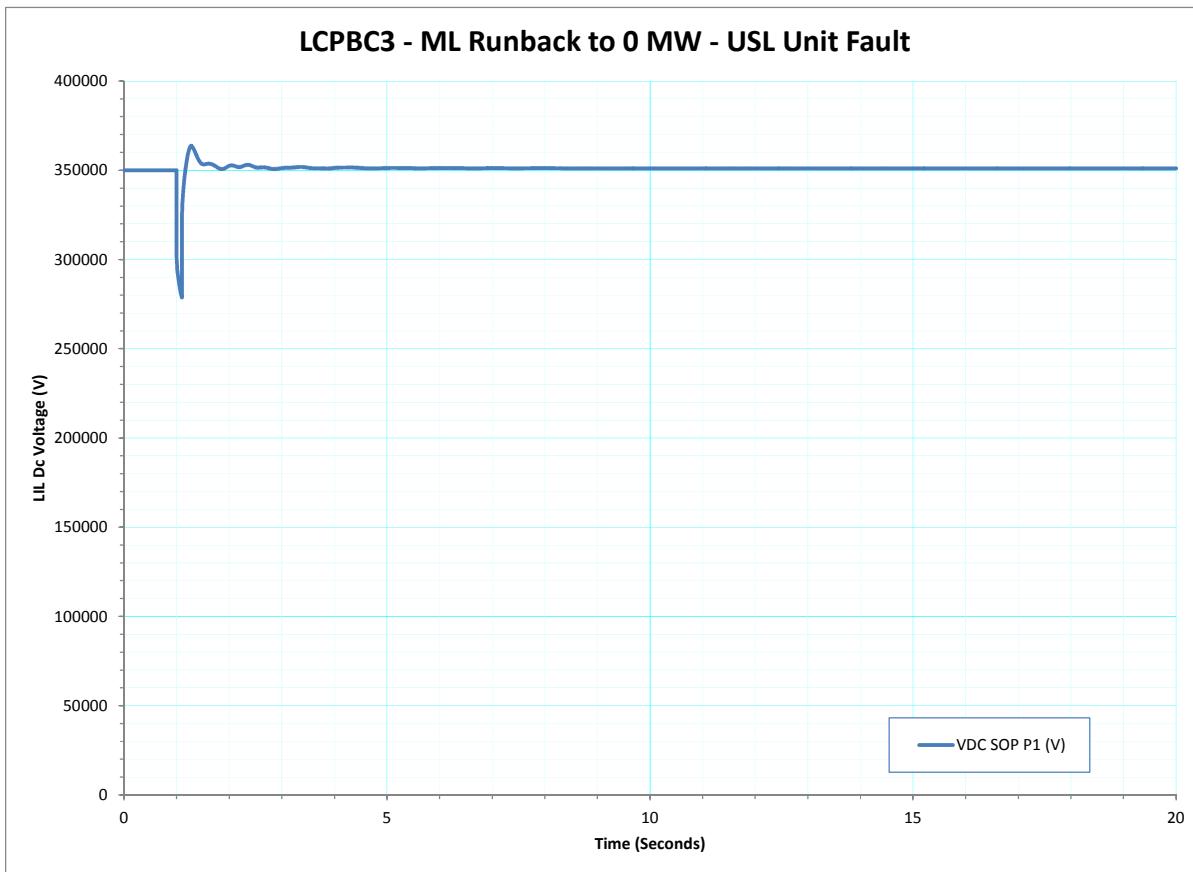
Figure 391 - LCPBC3 - ML Runback to 0 MW - USL Unit Fault - LIL Dc Voltage (V)

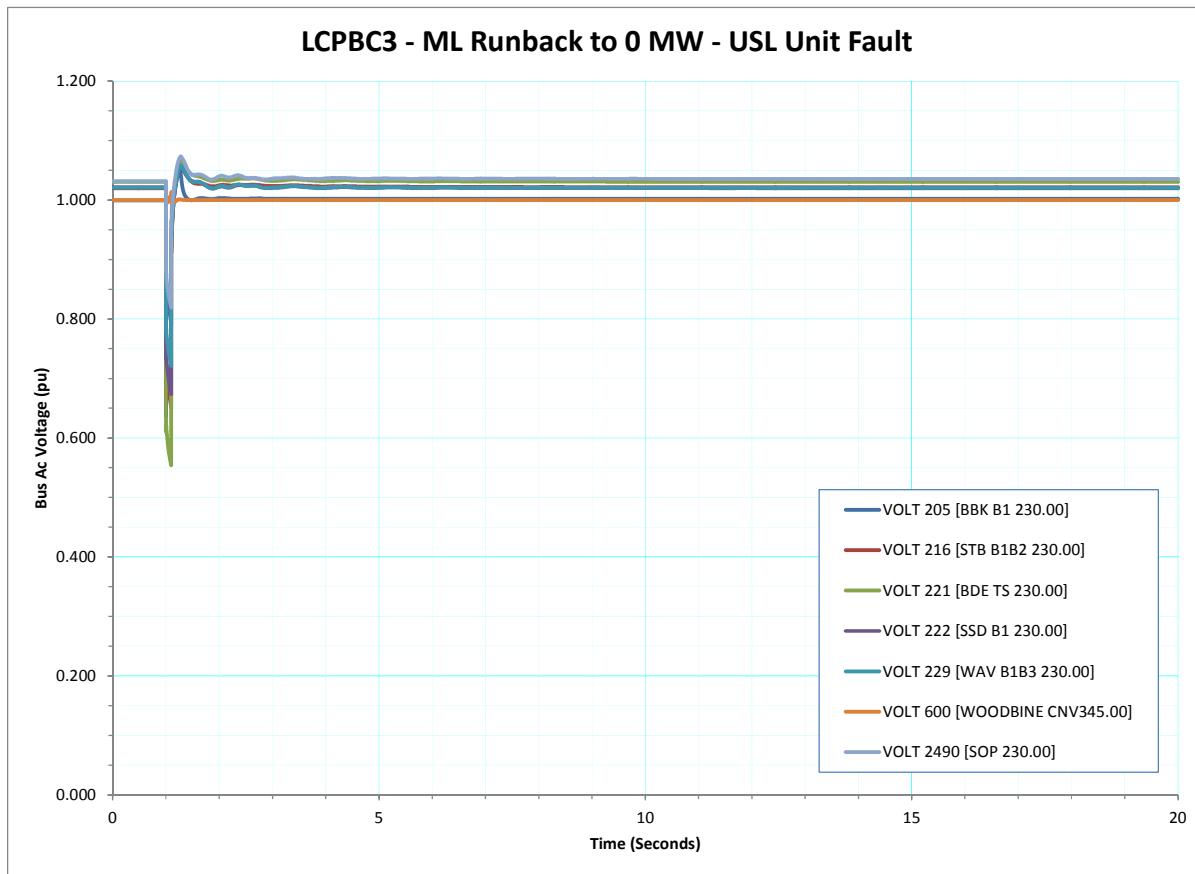
Figure 392 - LCPBC3 - ML Runback to 0 MW - USL Unit Fault - Bus Ac Voltage (pu)

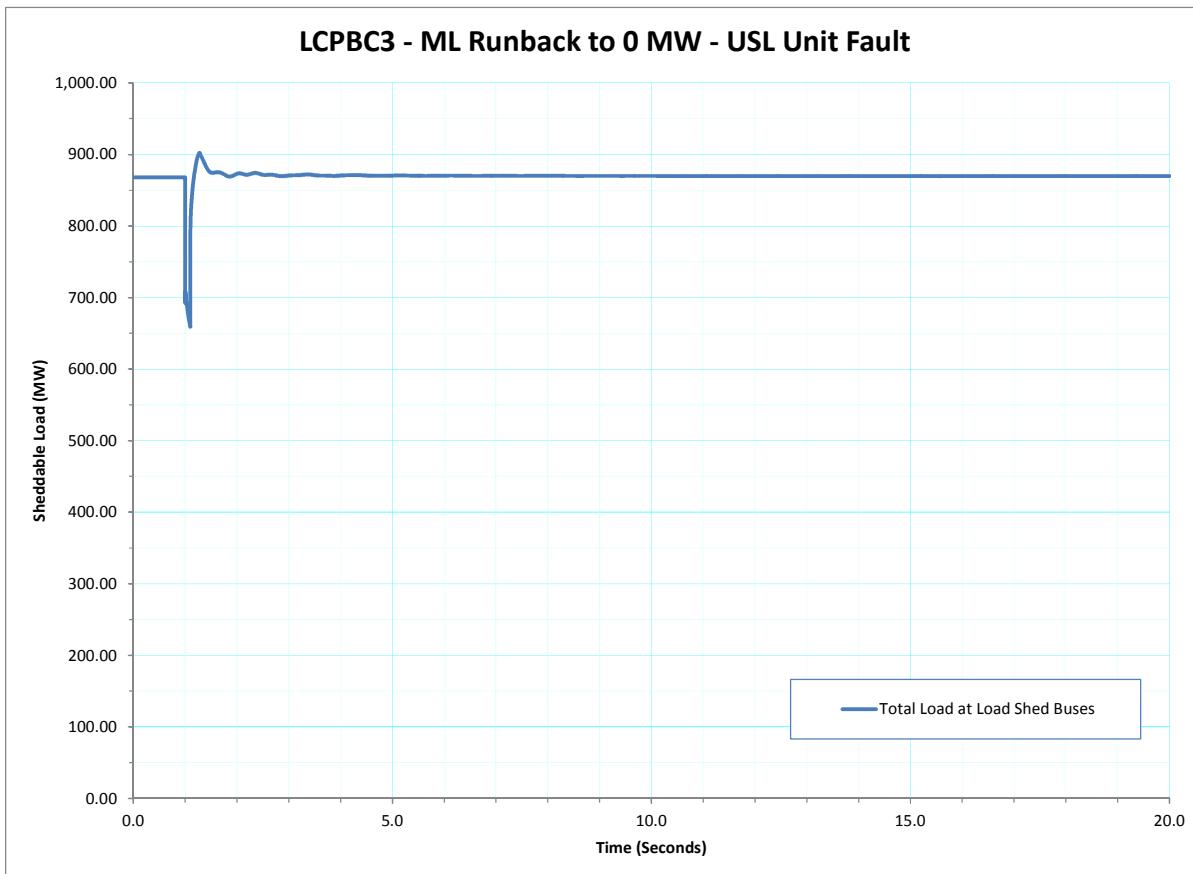
Figure 393 - LCPBC3 - ML Runback to 0 MW - USL Unit Fault - Shedtable Load (MW)

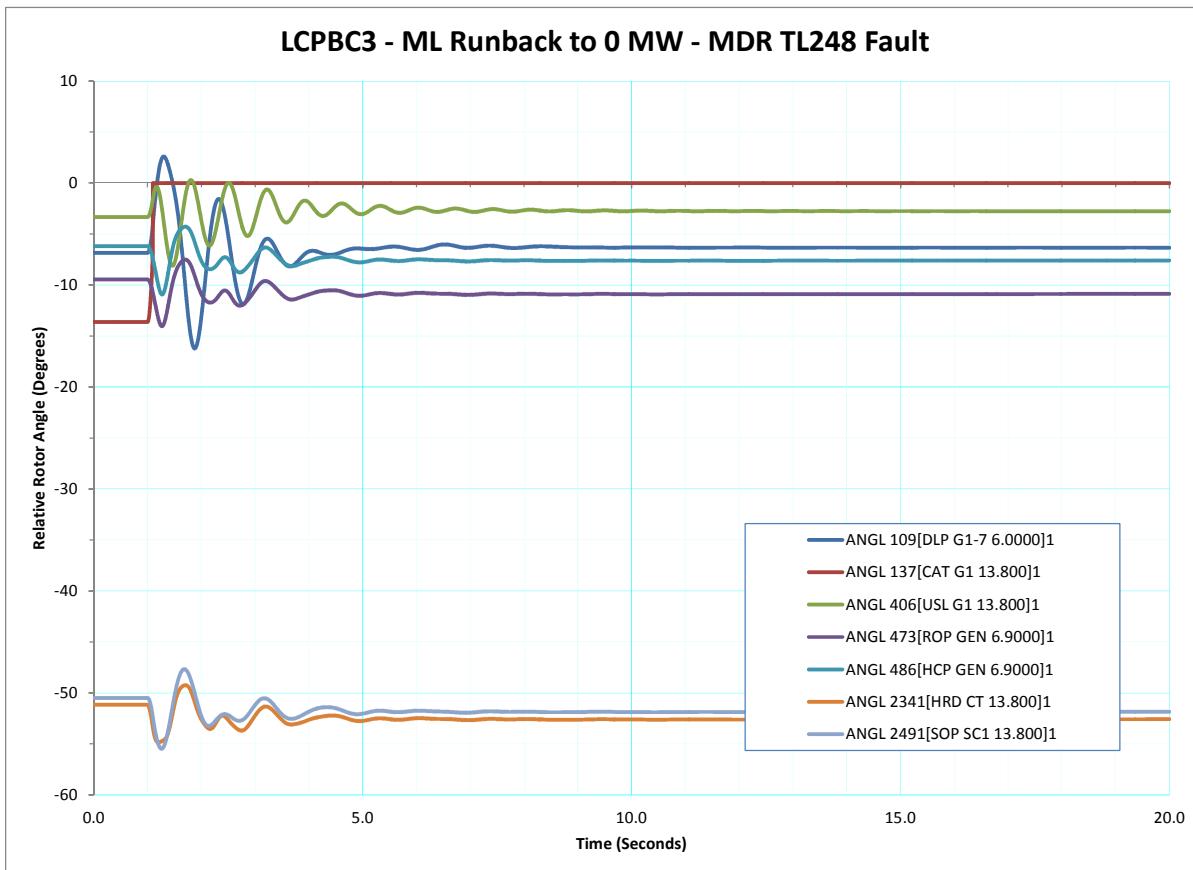
Figure 394 - LCPBC3 - ML Runback to 0 MW - MDR TL248 Fault - Relative Rotor Angle (Degrees)

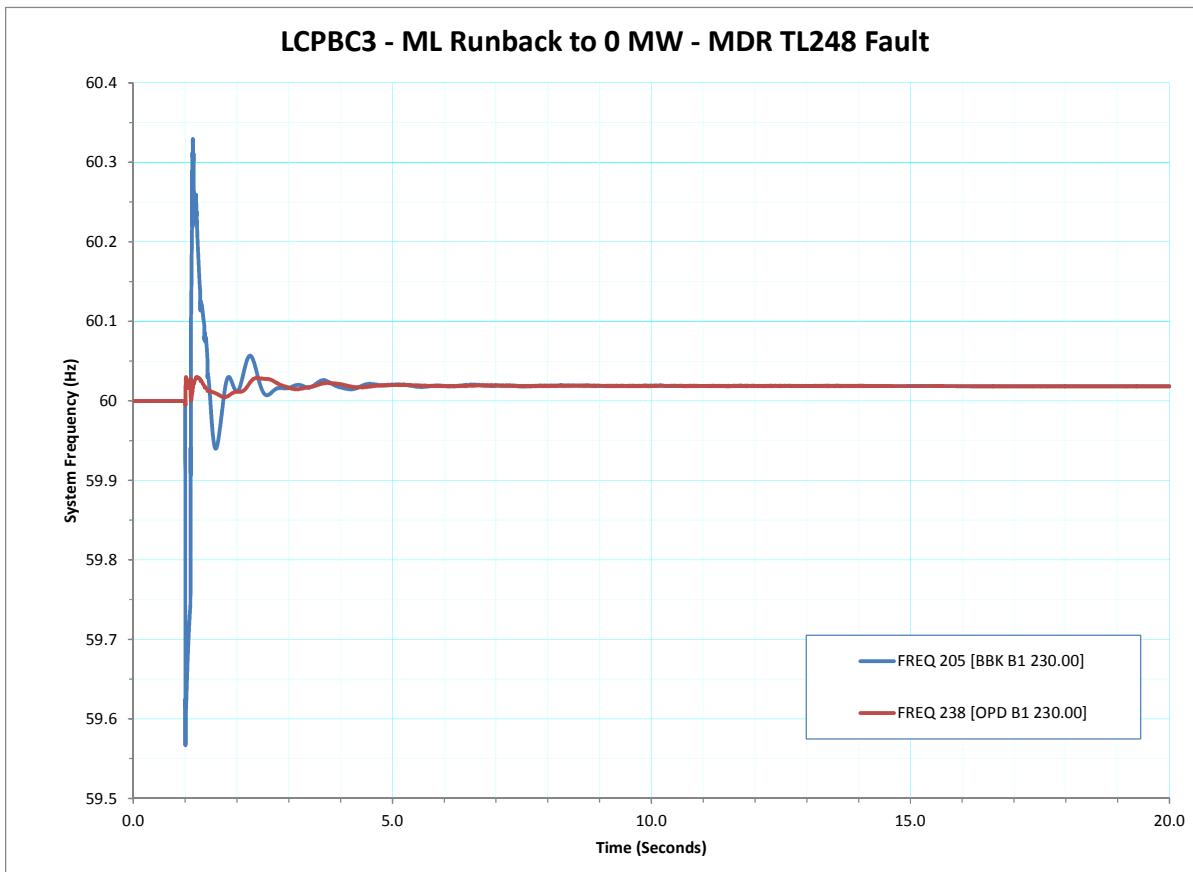
Figure 395 - LCPBC3 - ML Runback to 0 MW - MDR TL248 Fault - System Frequency (Hz)

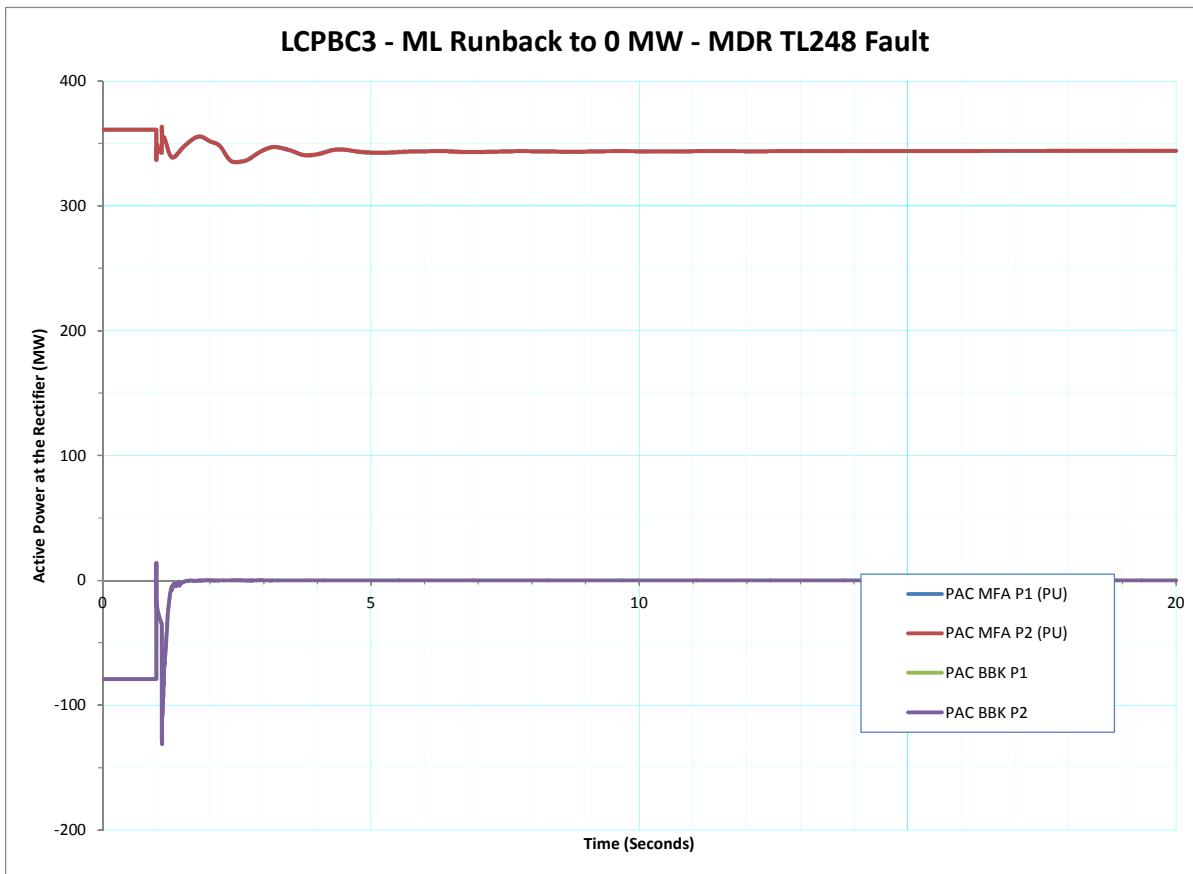
Figure 396 - LCPBC3 - ML Runback to 0 MW - MDR TL248 Fault - Active Power at the Rectifier (MW)

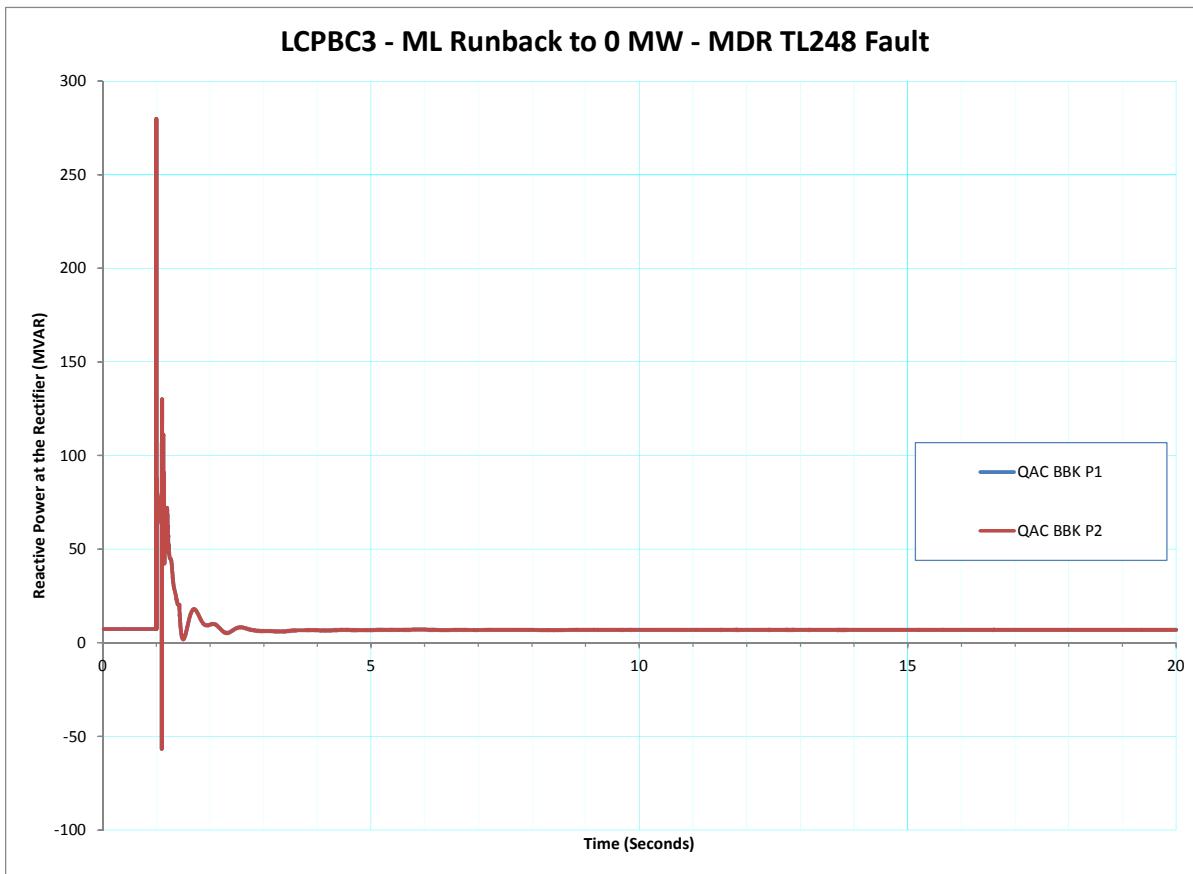
Figure 397 - LCPBC3 - ML Runback to 0 MW - MDR TL248 Fault - Reactive Power at the Rectifier (MVAR)

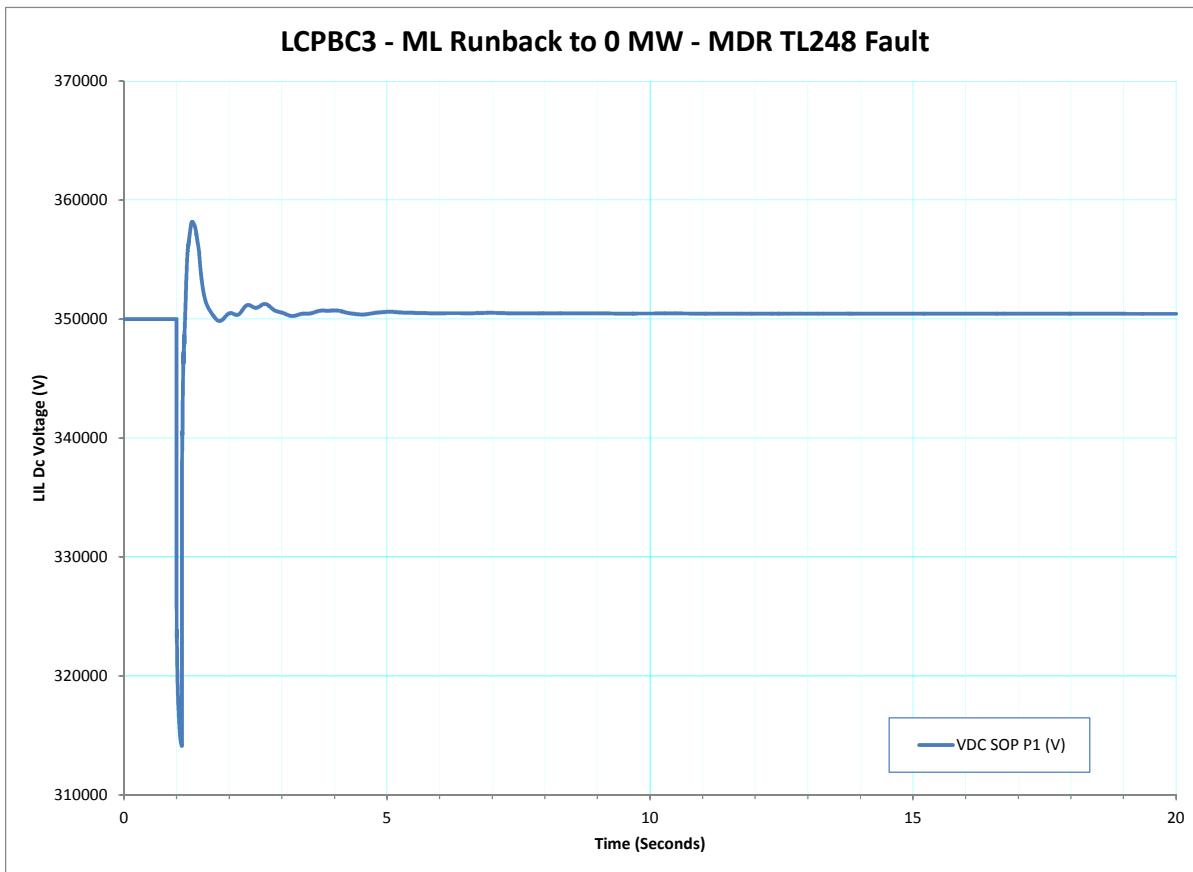
Figure 398 - LCPBC3 - ML Runback to 0 MW - MDR TL248 Fault - LIL Dc Voltage (V)

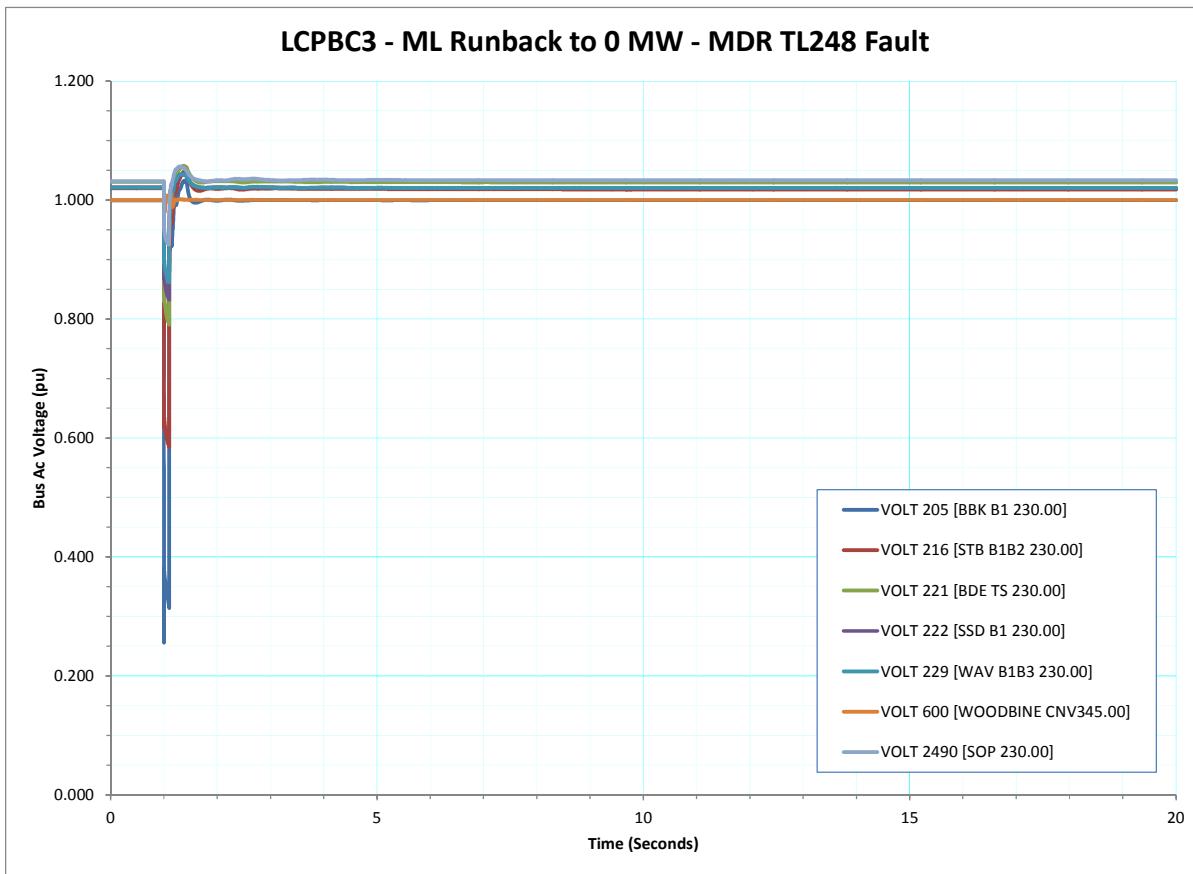
Figure 399 - LCPBC3 - ML Runback to 0 MW - MDR TL248 Fault - Bus Ac Voltage (pu)
