MARITIME LINK PRELIMINARY INTERCONNECTION STUDY

Newfoundland and Labrador Hydro

July 2014

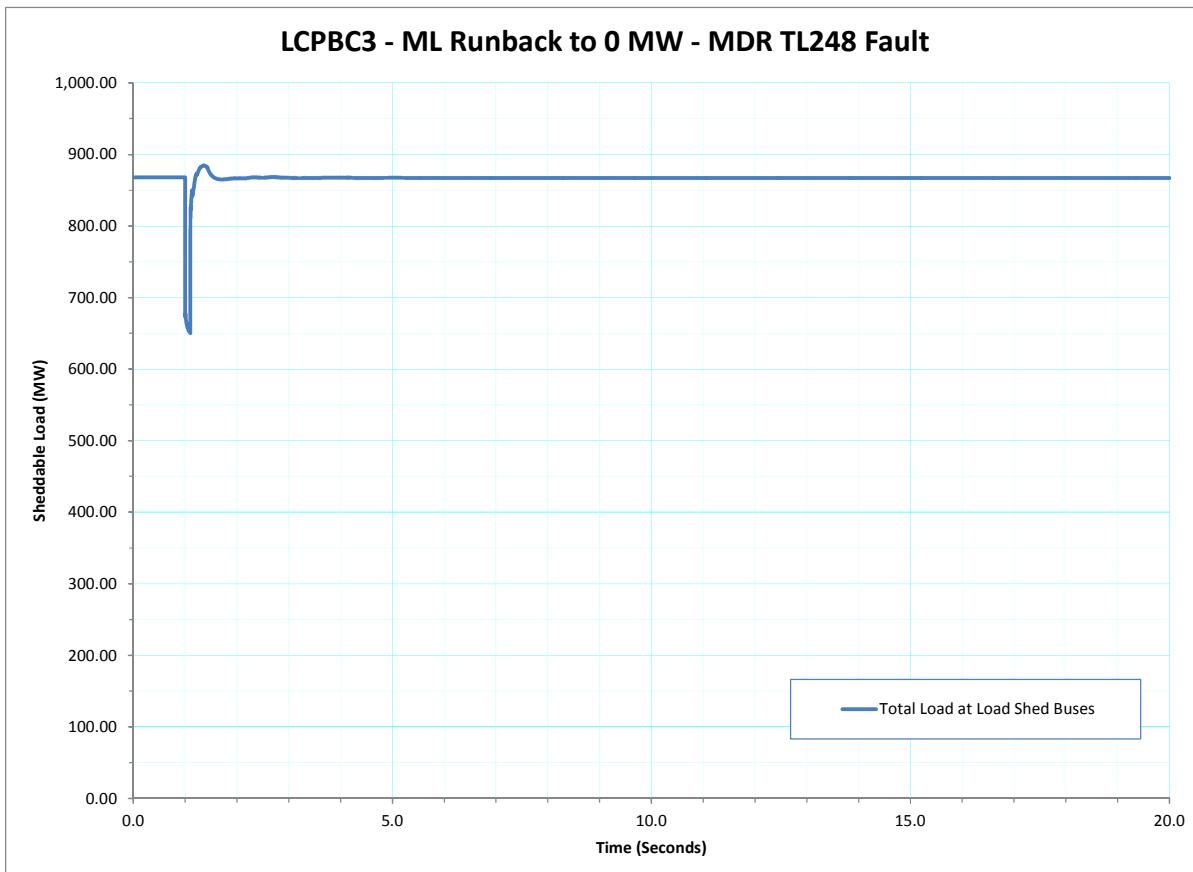
Figure 400 - LCPBC3 - ML Runback to 0 MW - MDR TL248 Fault - Shedtable Load (MW)

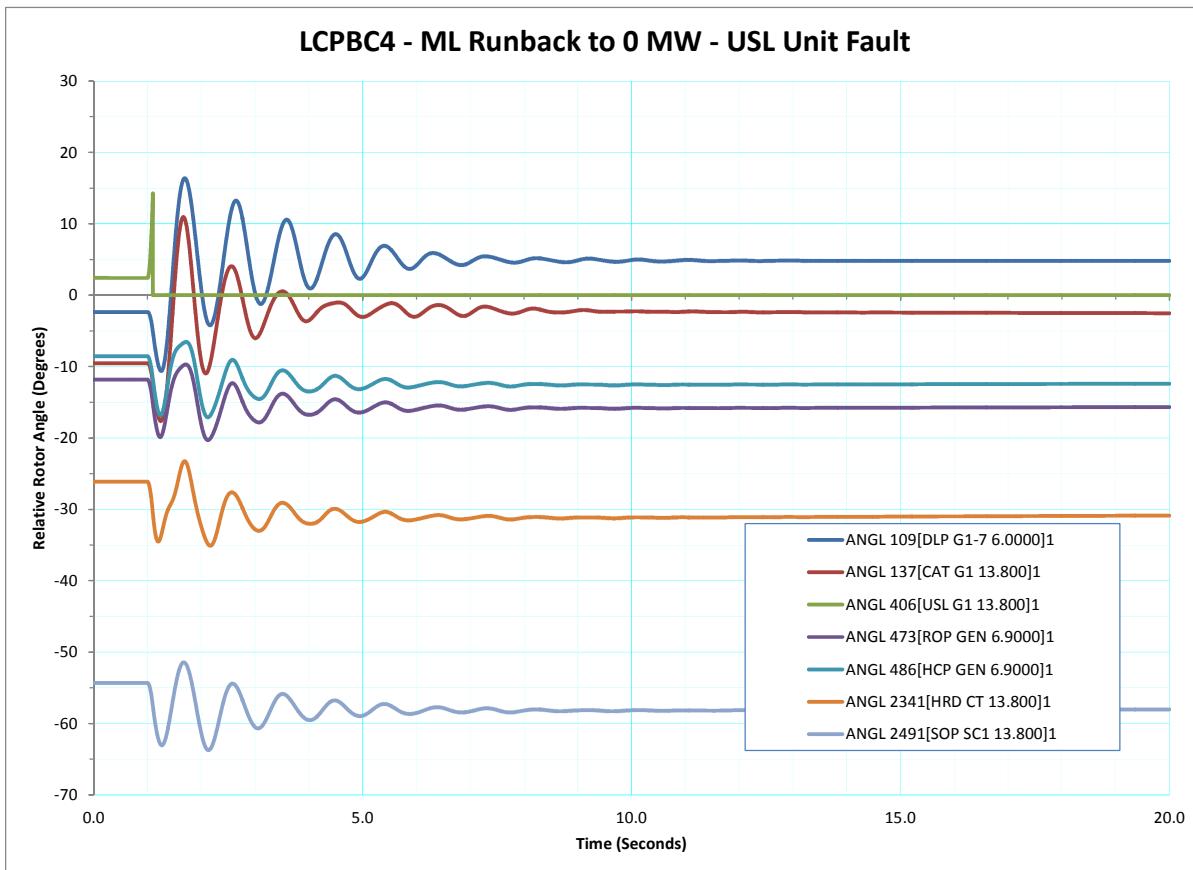
Figure 401 - LCPBC4 - ML Runback to 0 MW - USL Unit Fault - Relative Rotor Angle (Degrees)

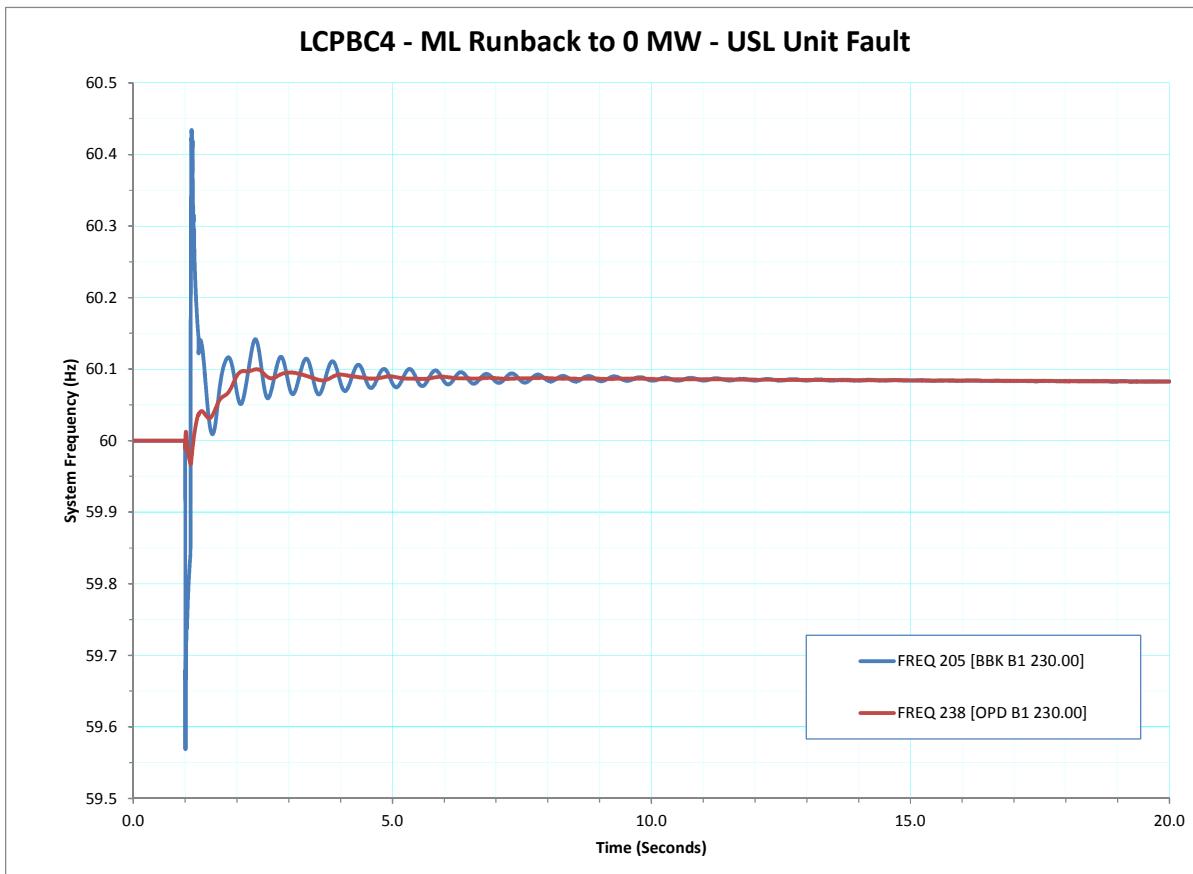
Figure 402 - LCPBC4 - ML Runback to 0 MW - USL Unit Fault - System Frequency (Hz)

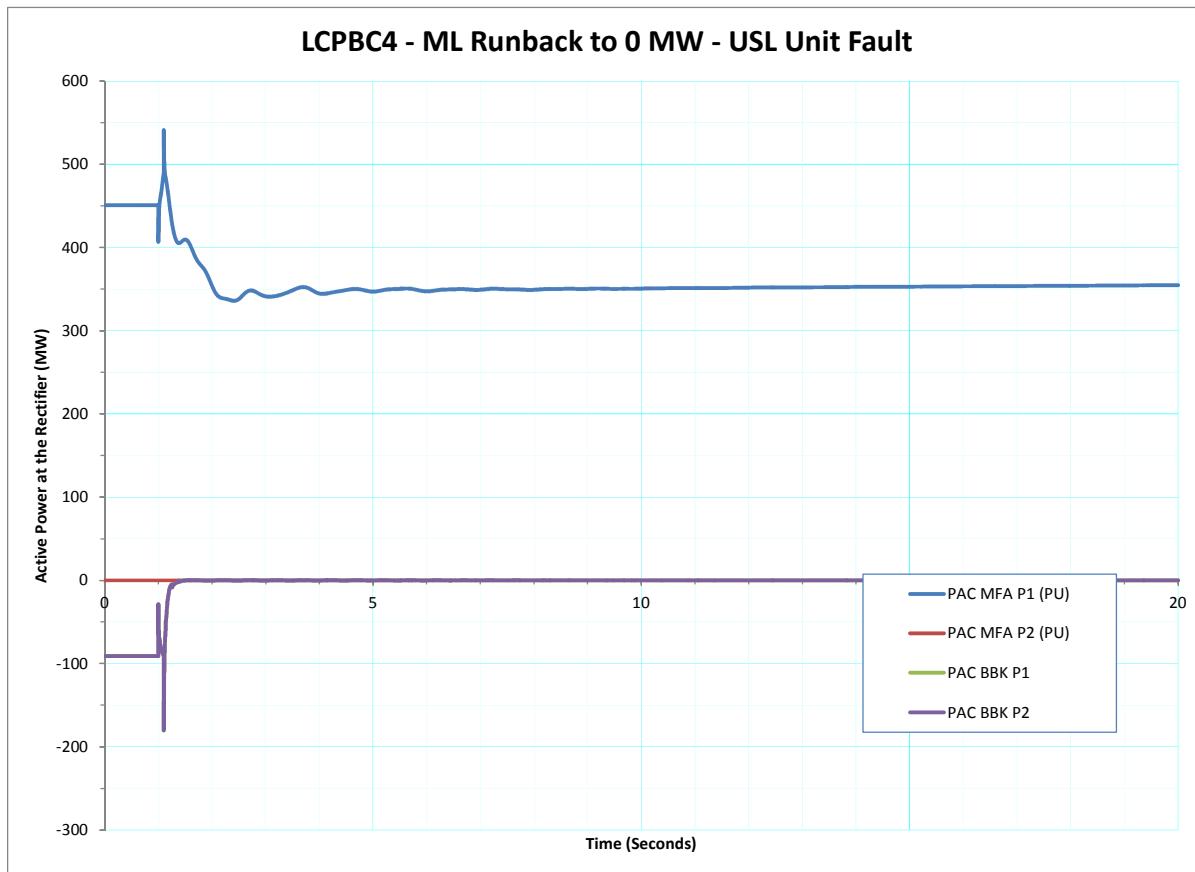
Figure 403 - LCPBC4 - ML Runback to 0 MW - USL Unit Fault - Active Power at the Rectifier (MW)

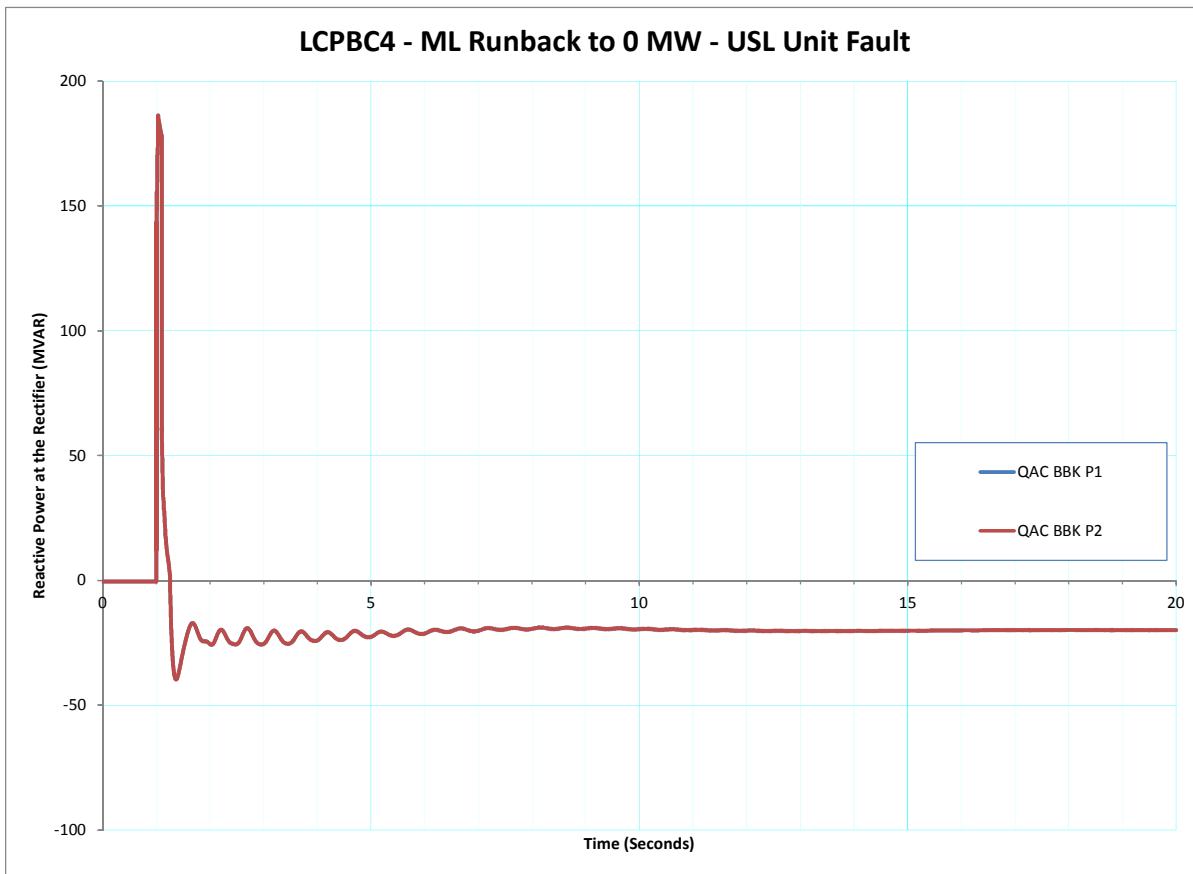
Figure 404 - LCPBC4 - ML Runback to 0 MW - USL Unit Fault - Reactive Power at the Rectifier (MVAR)

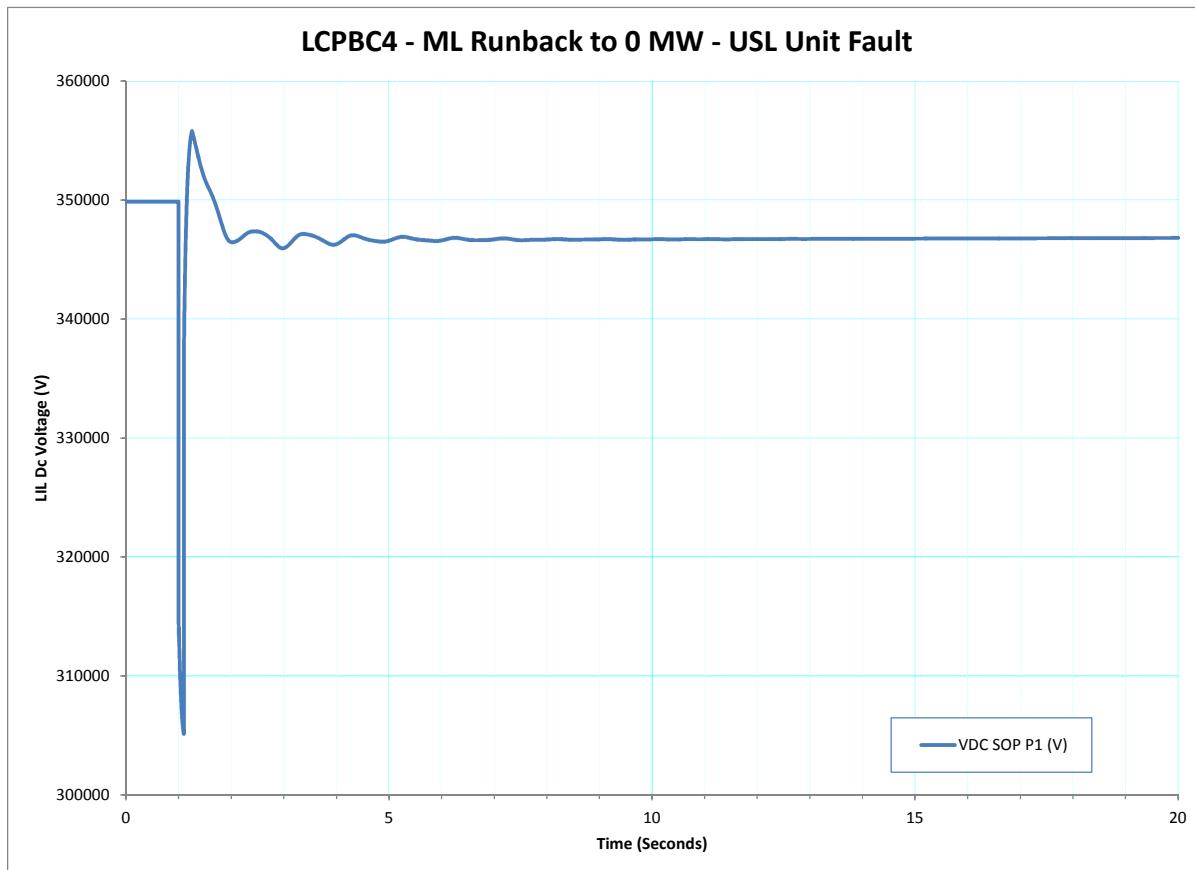
Figure 405 - LCPBC4 - ML Runback to 0 MW - USL Unit Fault - LIL Dc Voltage (V)

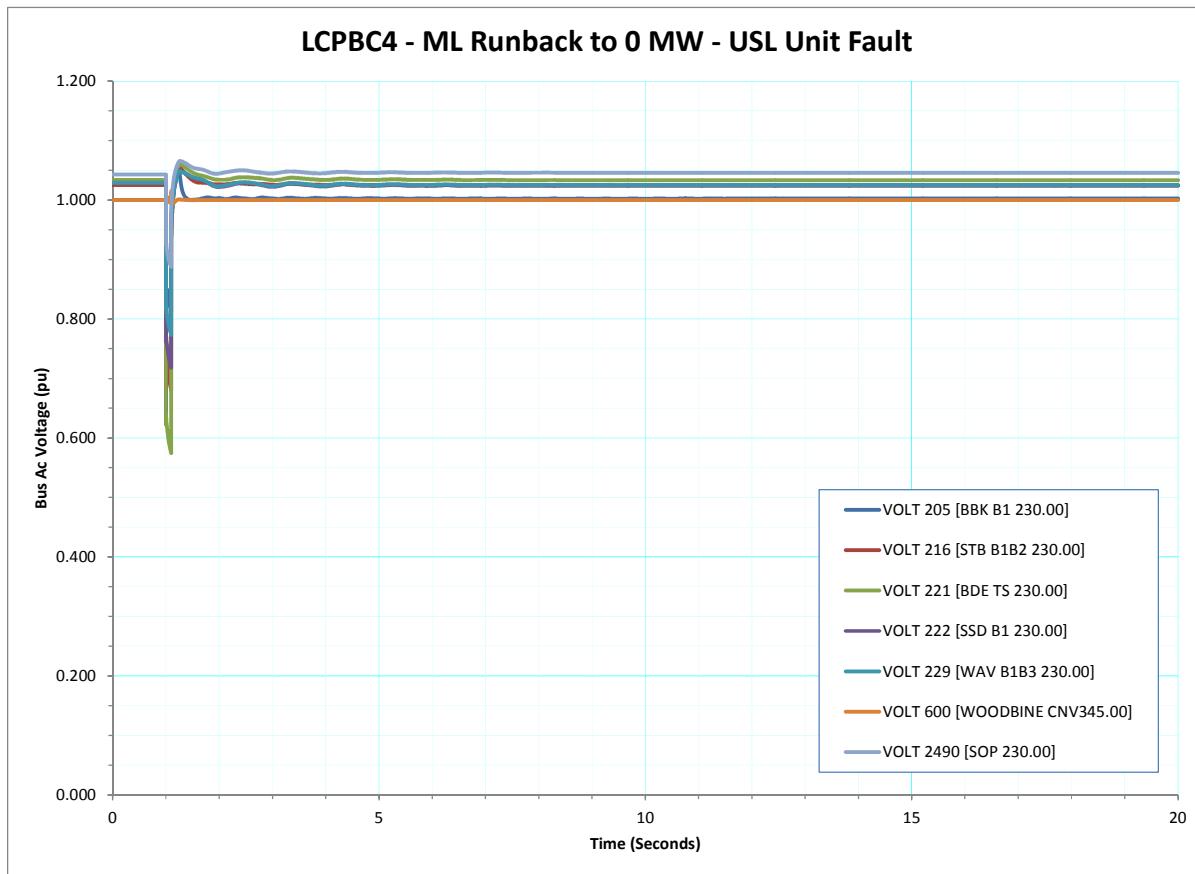
Figure 406 - LCPBC4 - ML Runback to 0 MW - USL Unit Fault - Bus Ac Voltage (pu)

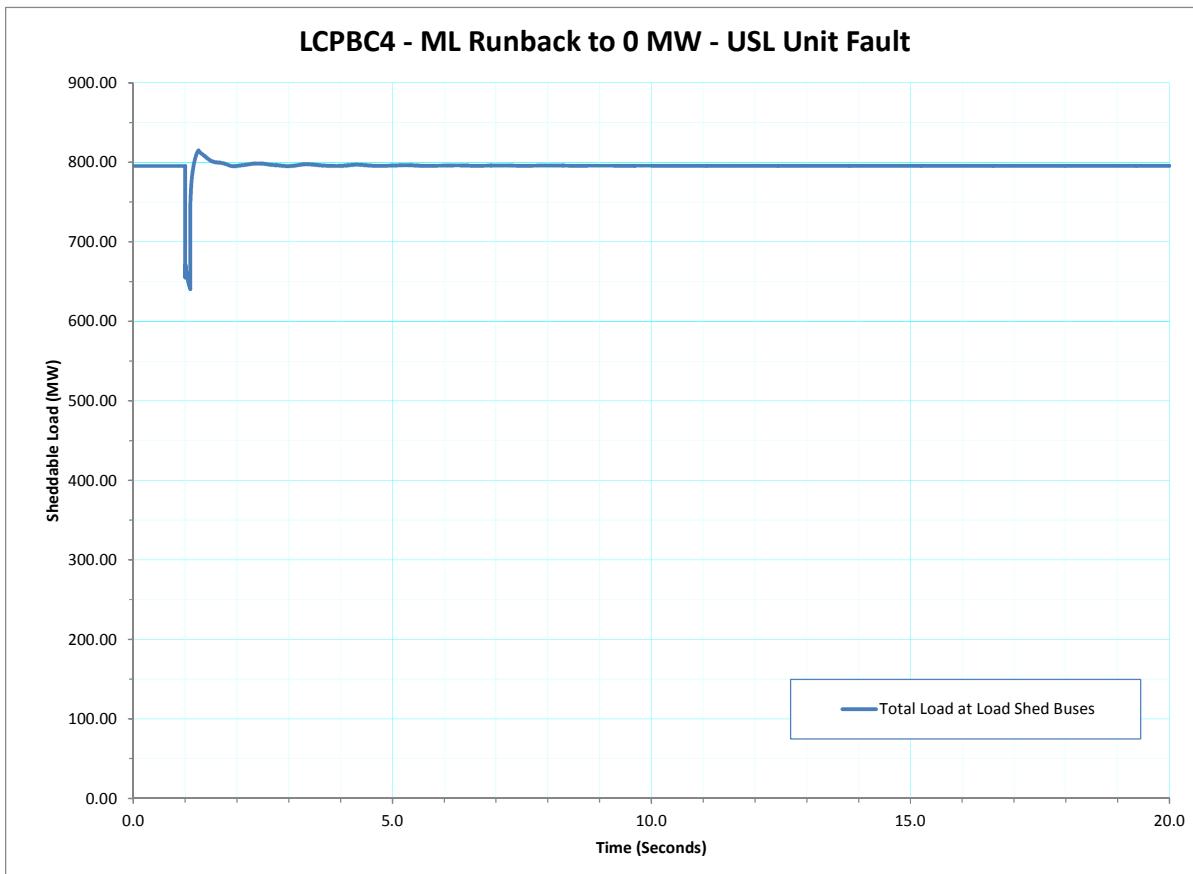
Figure 407 - LCPBC4 - ML Runback to 0 MW - USL Unit Fault - Sheddable Load (MW)

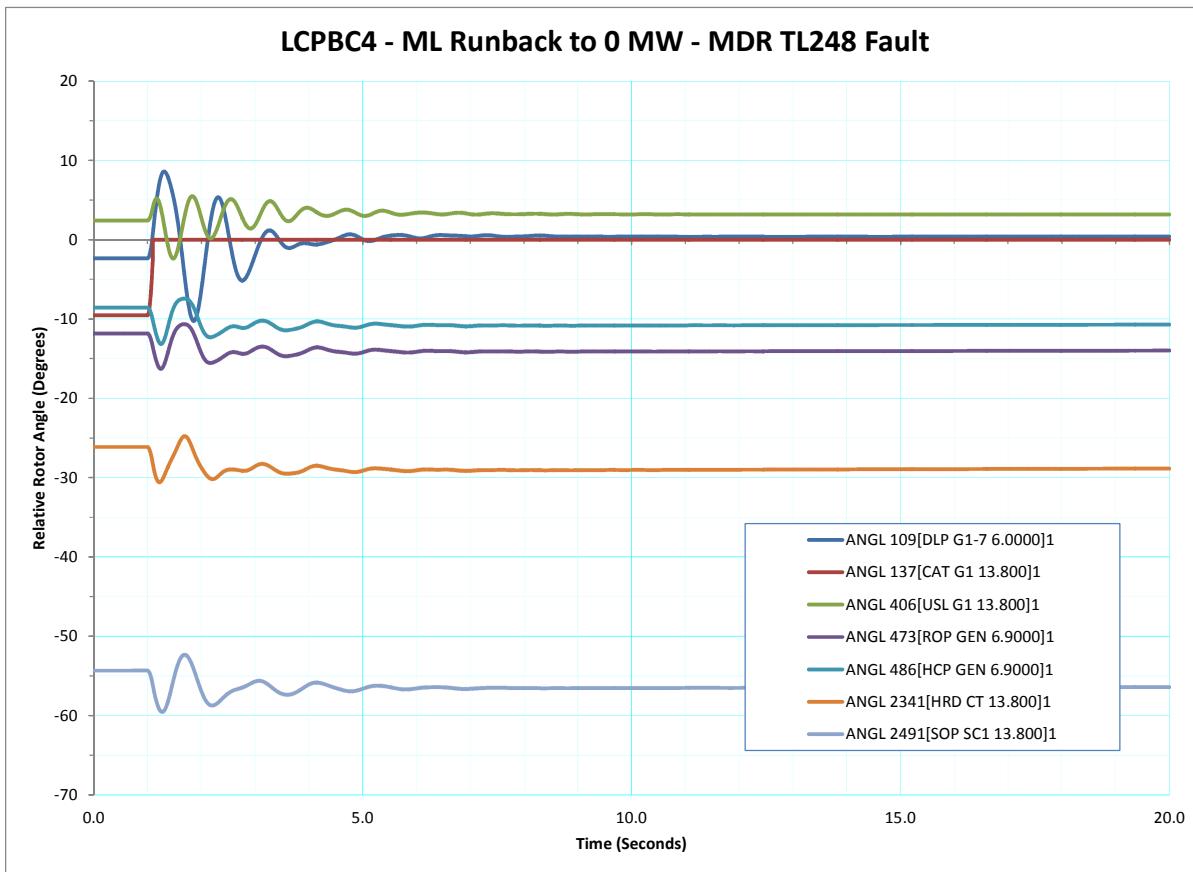
Figure 408 - LCPBC4 - ML Runback to 0 MW - MDR TL248 Fault - Relative Rotor Angle (Degrees)

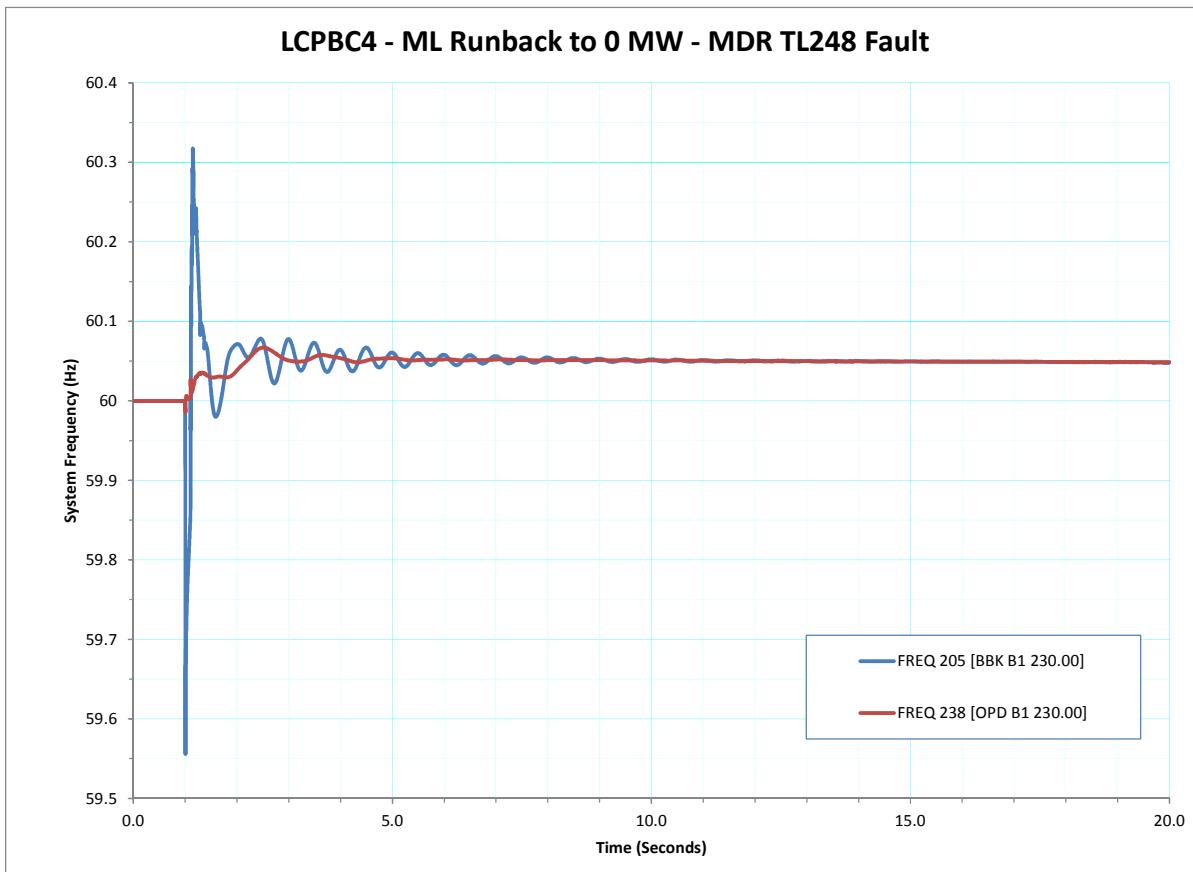
Figure 409 - LCPBC4 - ML Runback to 0 MW - MDR TL248 Fault - System Frequency (Hz)

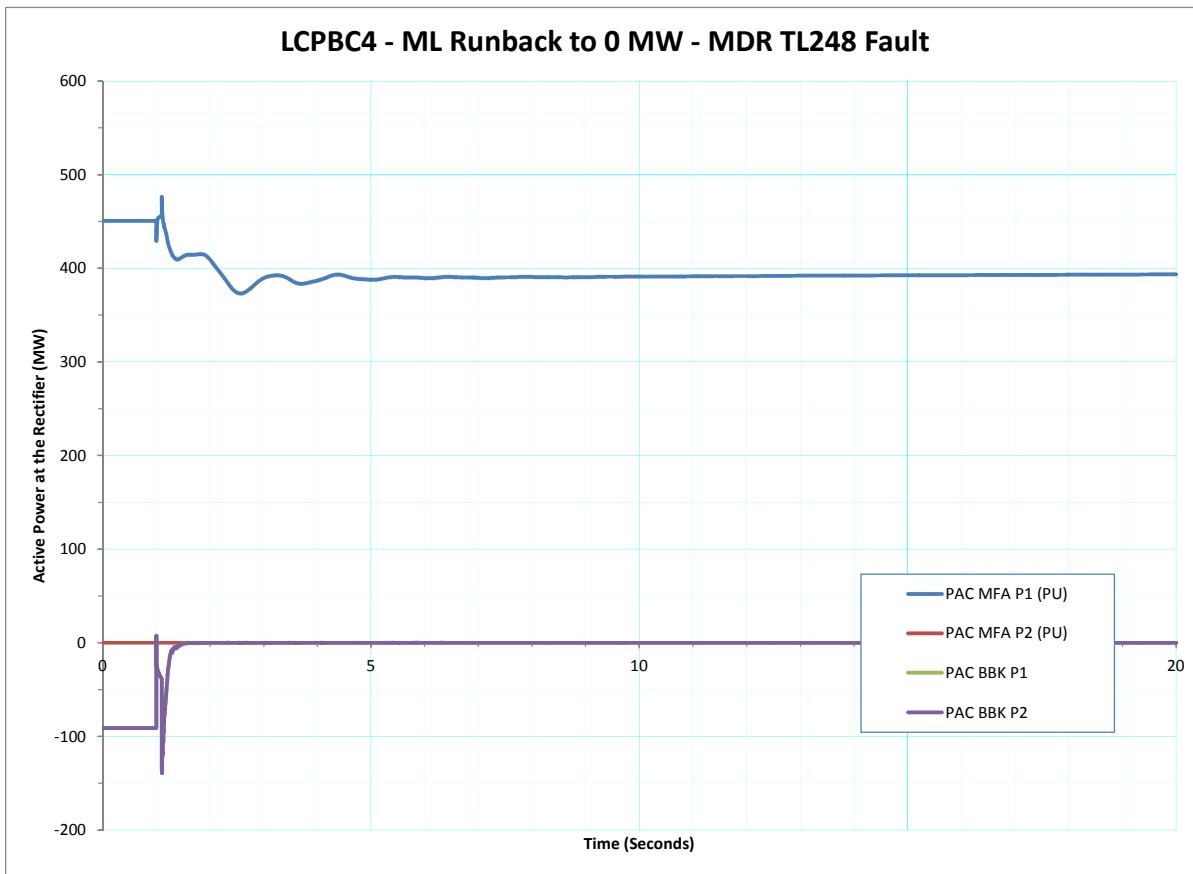
Figure 410 - LCPBC4 - ML Runback to 0 MW - MDR TL248 Fault - Active Power at the Rectifier (MW)

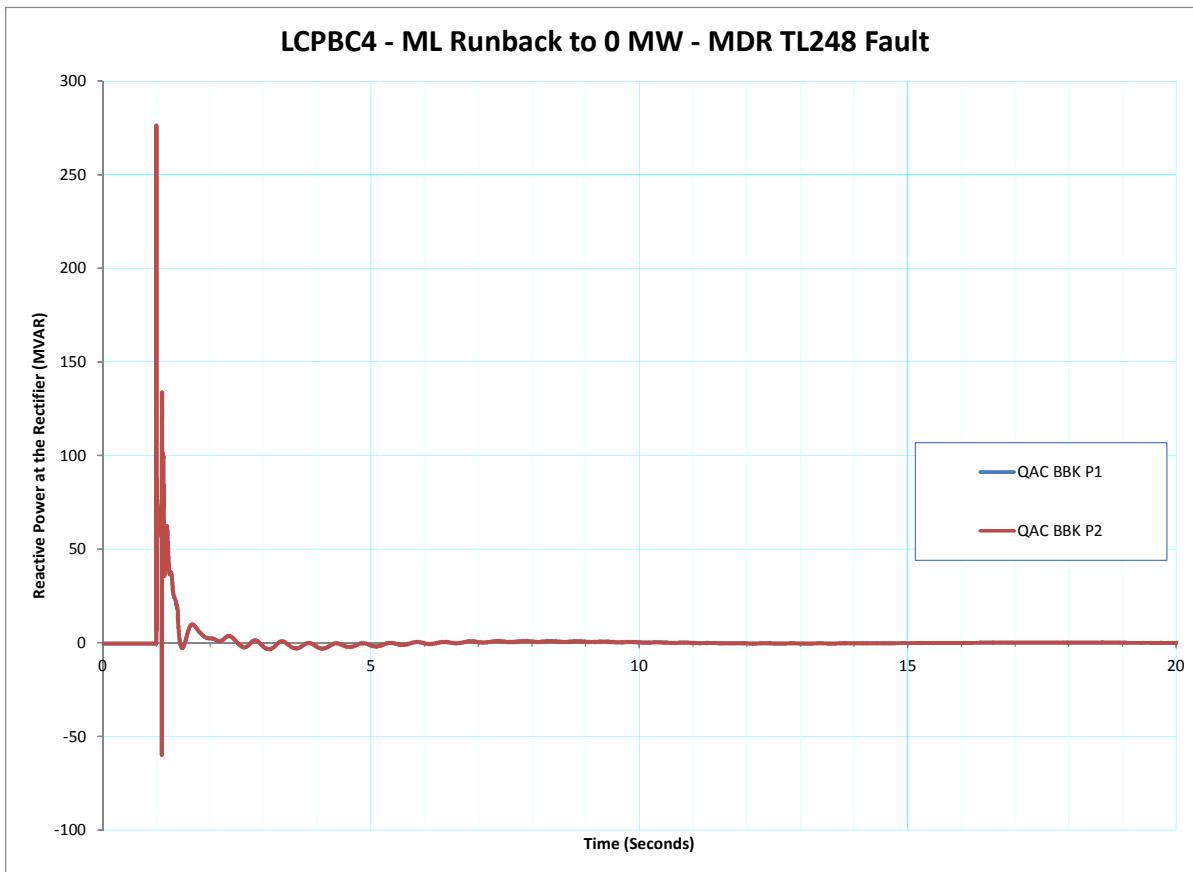
Figure 411 - LCPBC4 - ML Runback to 0 MW - MDR TL248 Fault - Reactive Power at the Rectifier (MVAR)

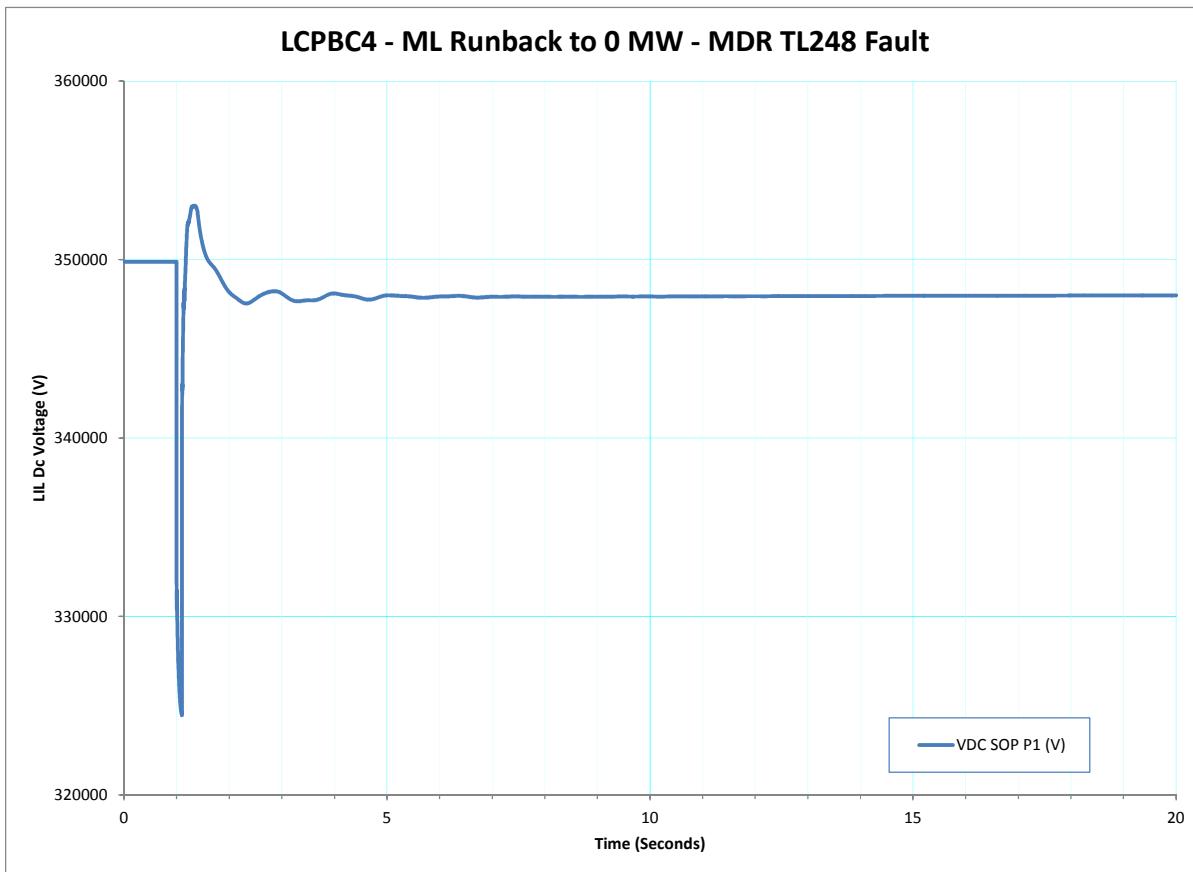
Figure 412 - LCPBC4 - ML Runback to 0 MW - MDR TL248 Fault - LIL Dc Voltage (V)

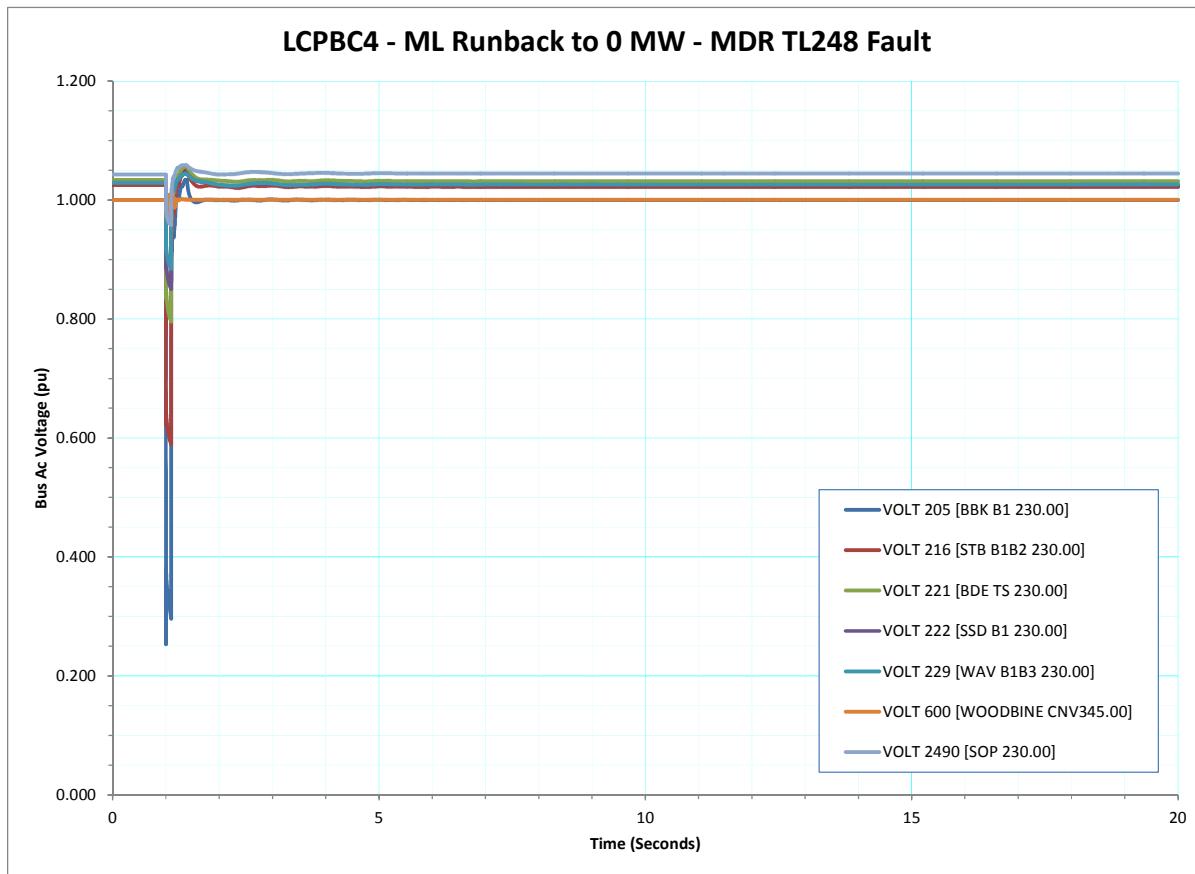
Figure 413 - LCPBC4 - ML Runback to 0 MW - MDR TL248 Fault - Bus Ac Voltage (pu)

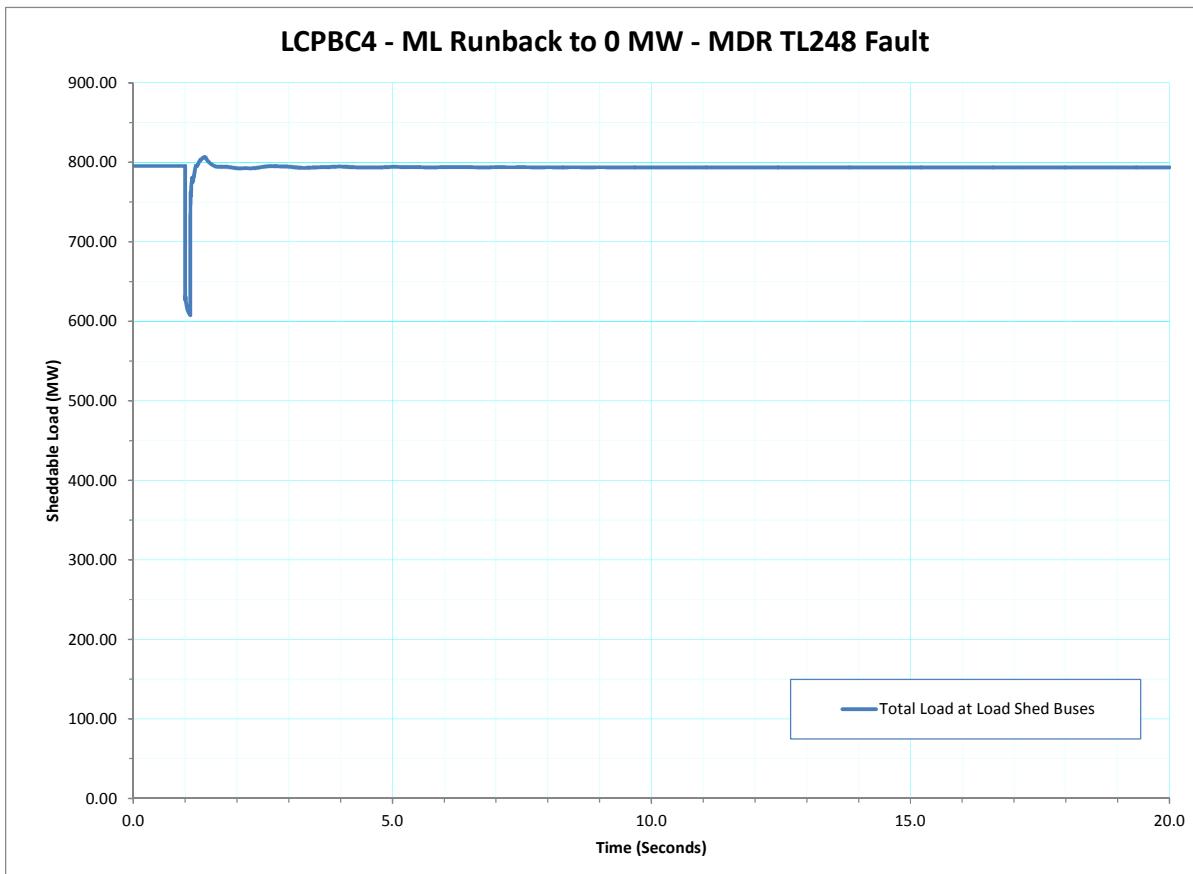
Figure 414 - LCPBC4 - ML Runback to 0 MW - MDR TL248 Fault - Sheddable Load (MW)

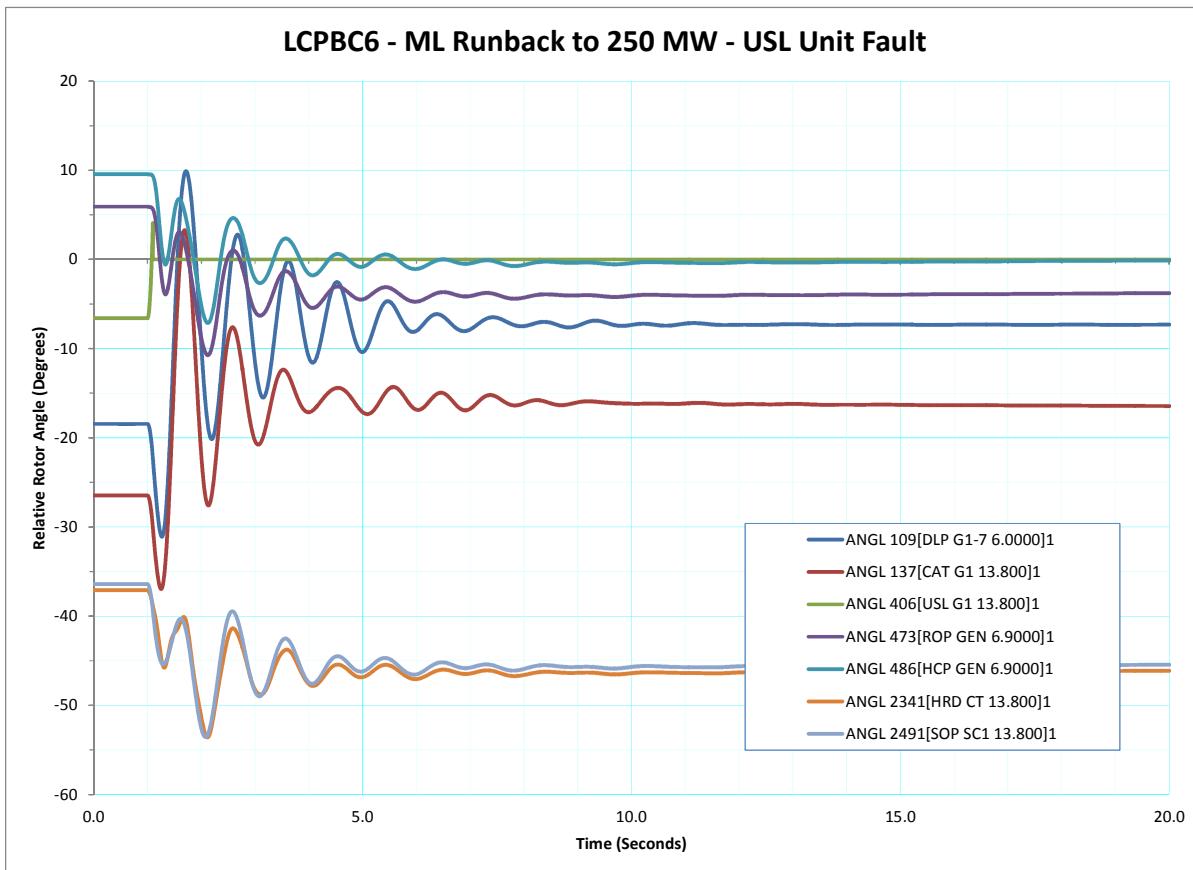
Figure 415 - LCPBC6 - ML Runback to 250 MW - USL Unit Fault - Relative Rotor Angle (Degrees)

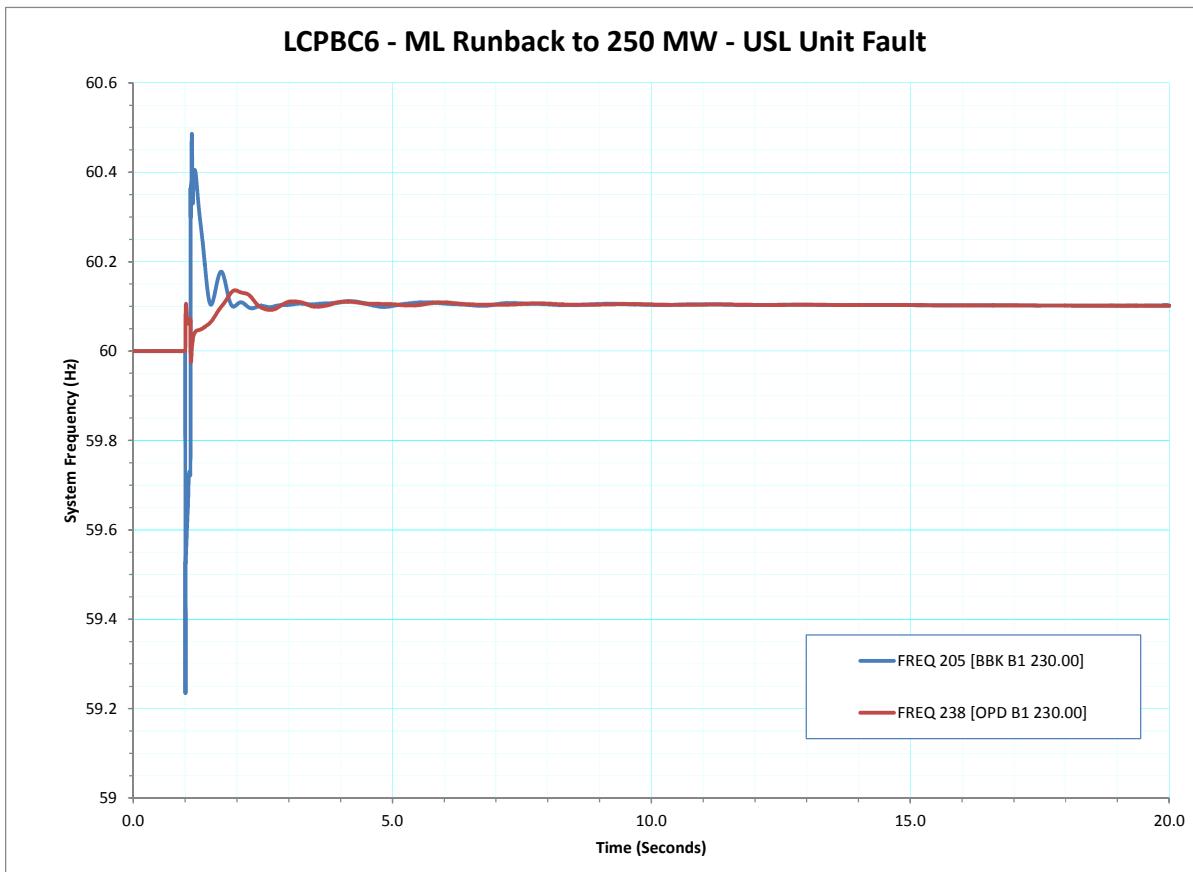
Figure 416 - LCPBC6 - ML Runback to 250 MW - USL Unit Fault - System Frequency (Hz)

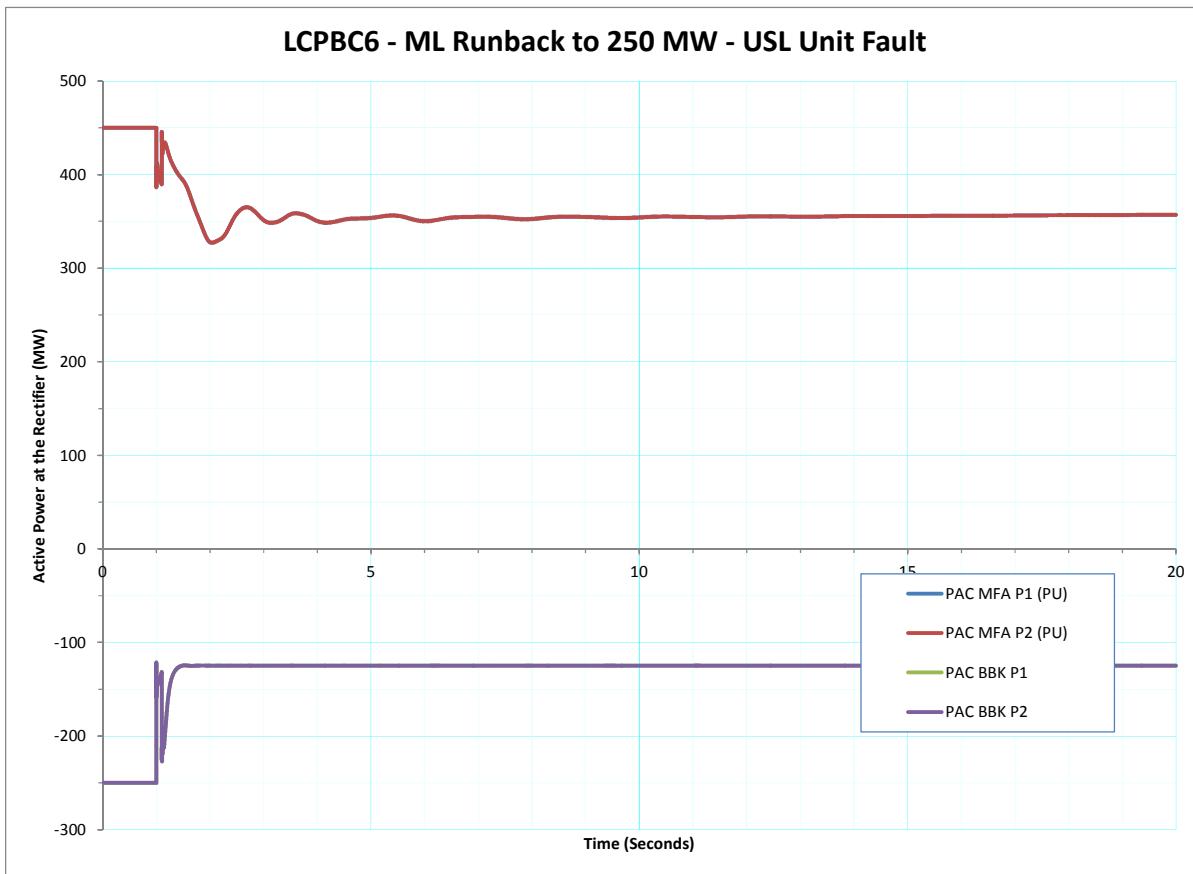
Figure 417 - LCPBC6 - ML Runback to 250 MW - USL Unit Fault - Active Power at the Rectifier (MW)

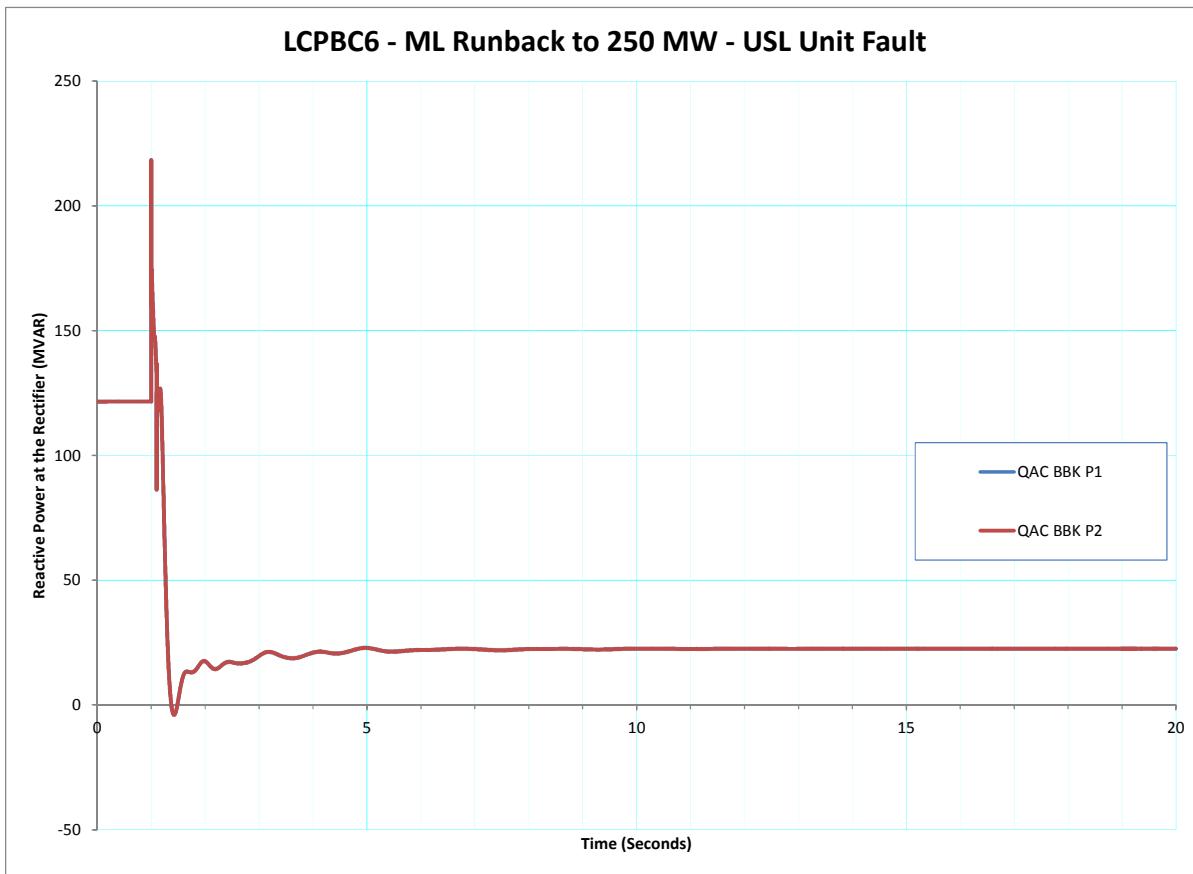
Figure 418 - LCPBC6 - ML Runback to 250 MW - USL Unit Fault - Reactive Power at the Rectifier (MVAR)

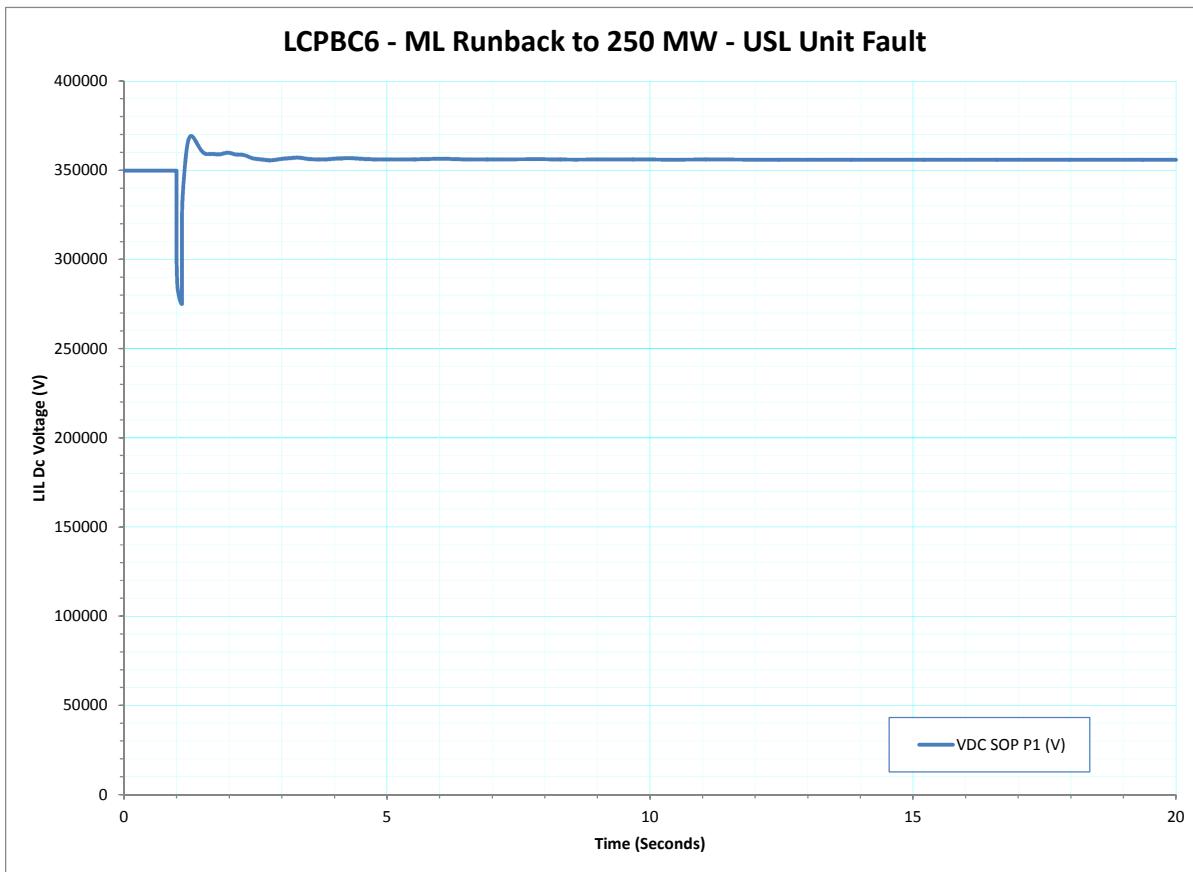
Figure 419 - LCPBC6 - ML Runback to 250 MW - USL Unit Fault - LIL Dc Voltage (V)

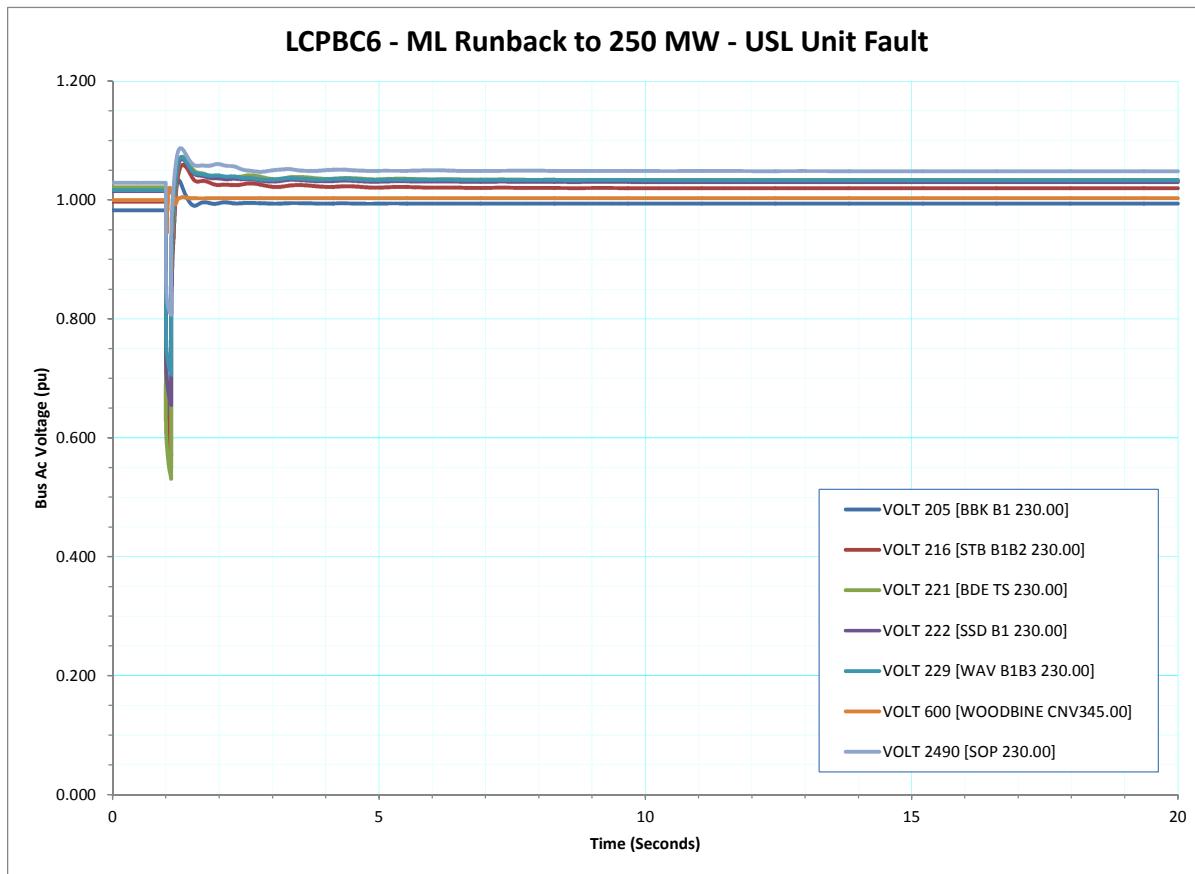
Figure 420 - LCPBC6 - ML Runback to 250 MW - USL Unit Fault - Bus Ac Voltage (pu)
