MARITIME LINK PRELIMINARY INTERCONNECTION STUDY

Newfoundland and Labrador Hydro

July 2014

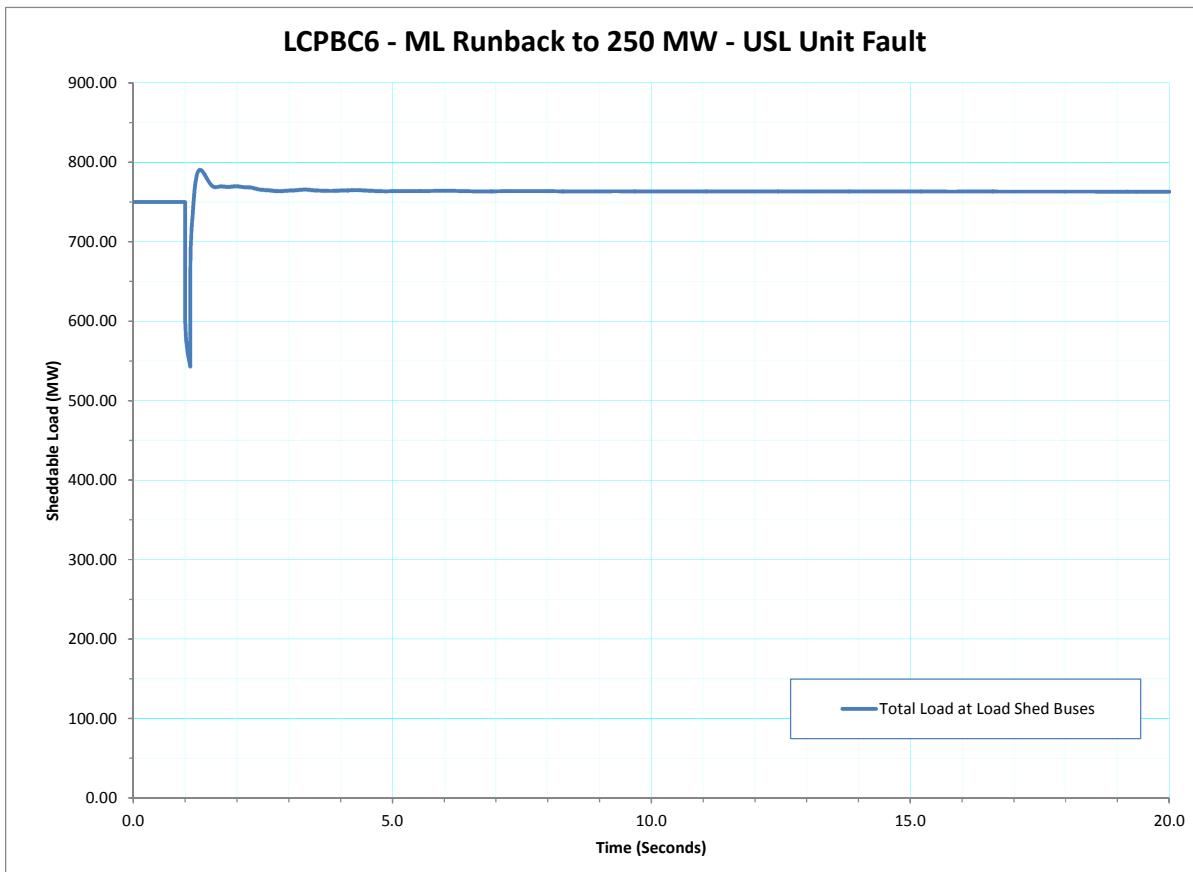
Figure 421 - LCPBC6 - ML Runback to 250 MW - USL Unit Fault - Sheddable Load (MW)

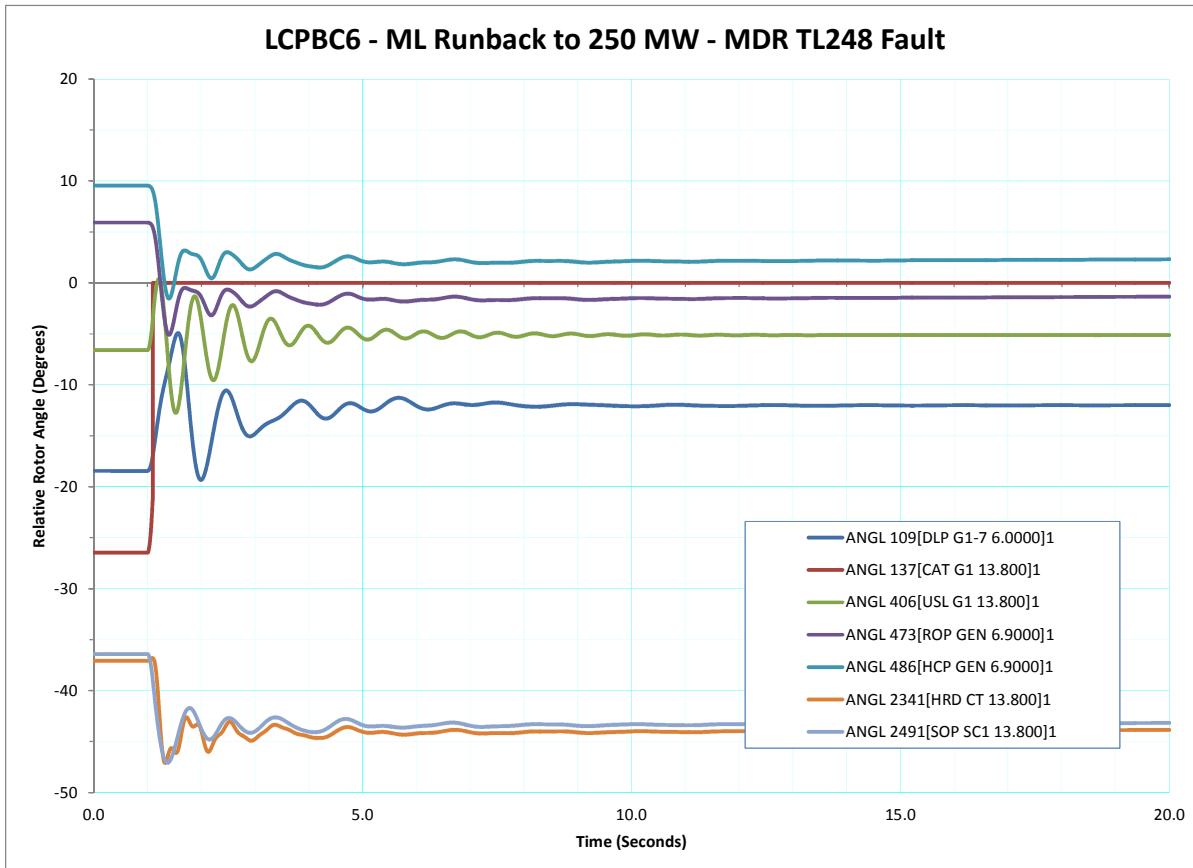
Figure 422 - LCPBC6 - ML Runback to 250 MW - MDR TL248 Fault - Relative Rotor Angle (Degrees)

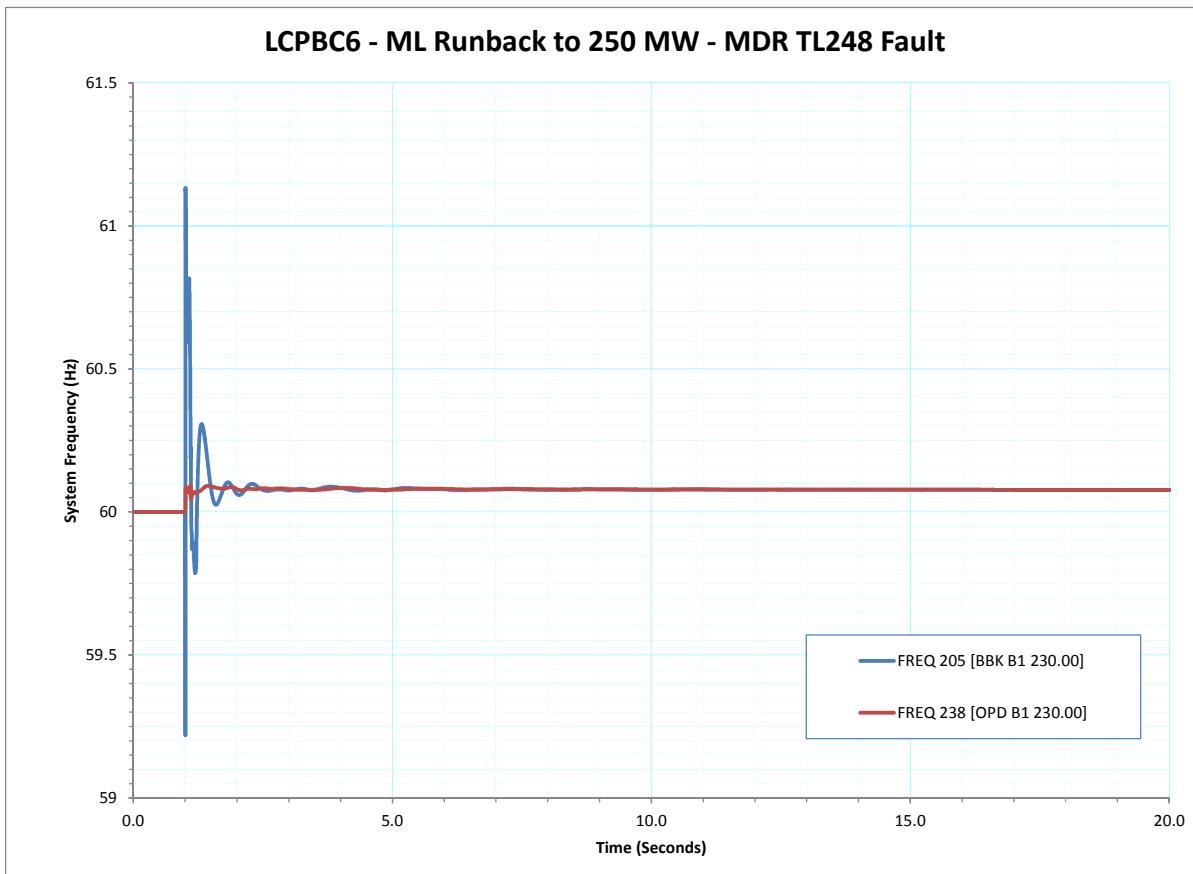
Figure 423 - LCPBC6 - ML Runback to 250 MW - MDR TL248 Fault - System Frequency (Hz)

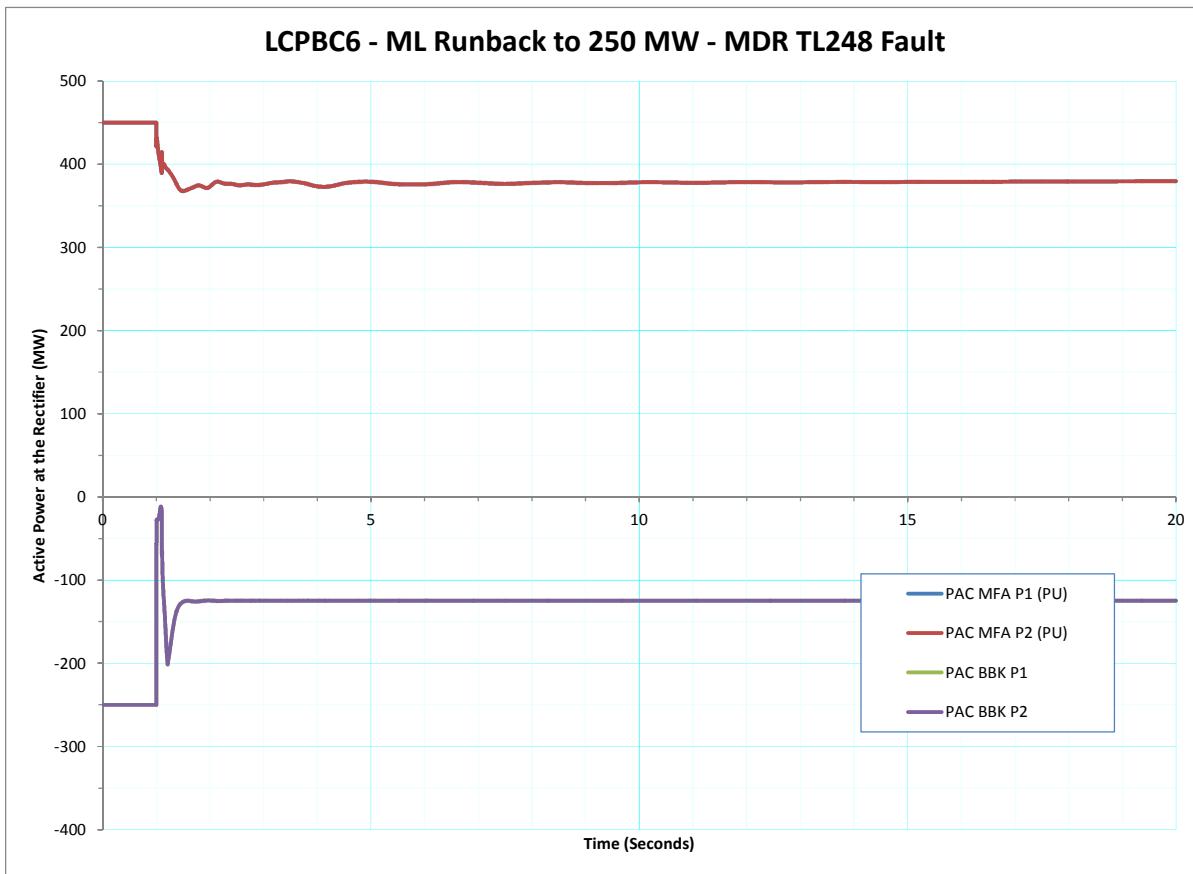
Figure 424 - LCPBC6 - ML Runback to 250 MW - MDR TL248 Fault - Active Power at the Rectifier (MW)

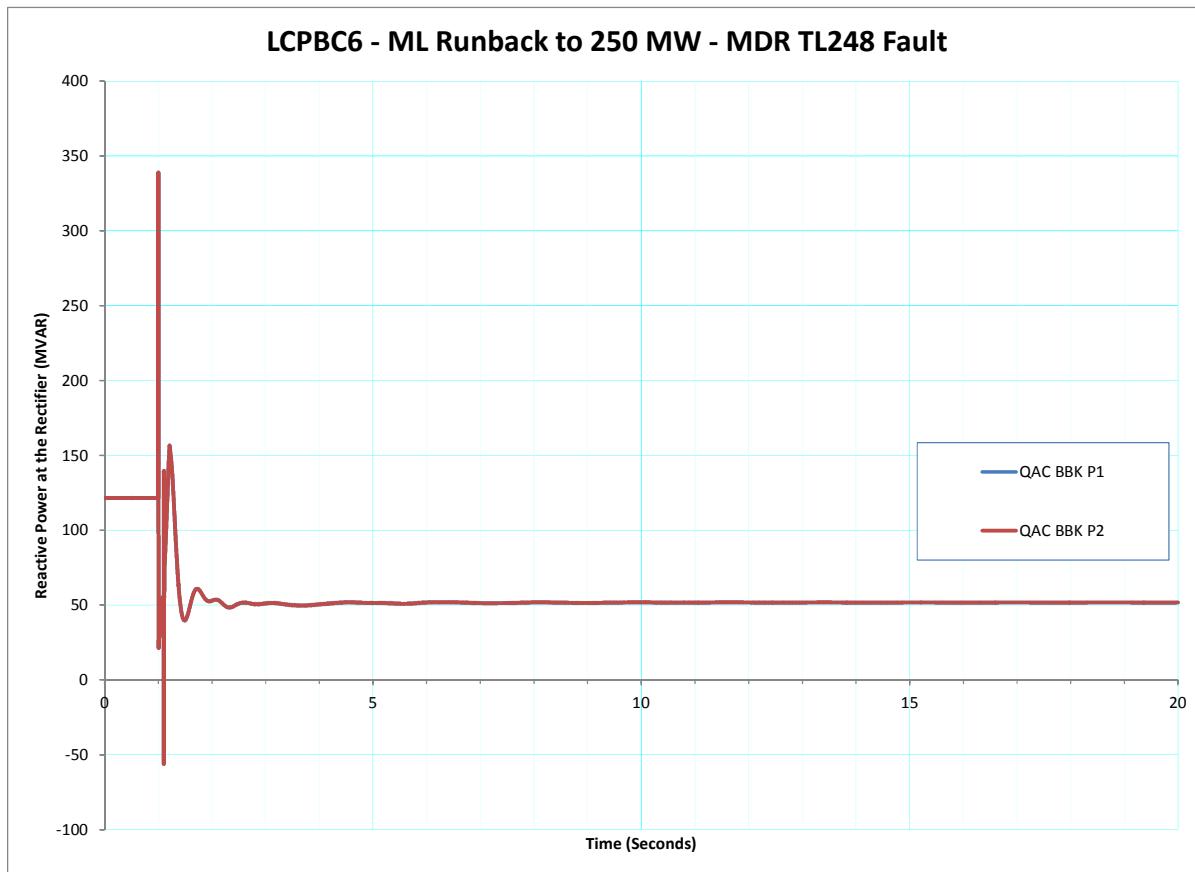
Figure 425 - LCPBC6 - ML Runback to 250 MW - MDR TL248 Fault - Reactive Power at the Rectifier (MVAR)

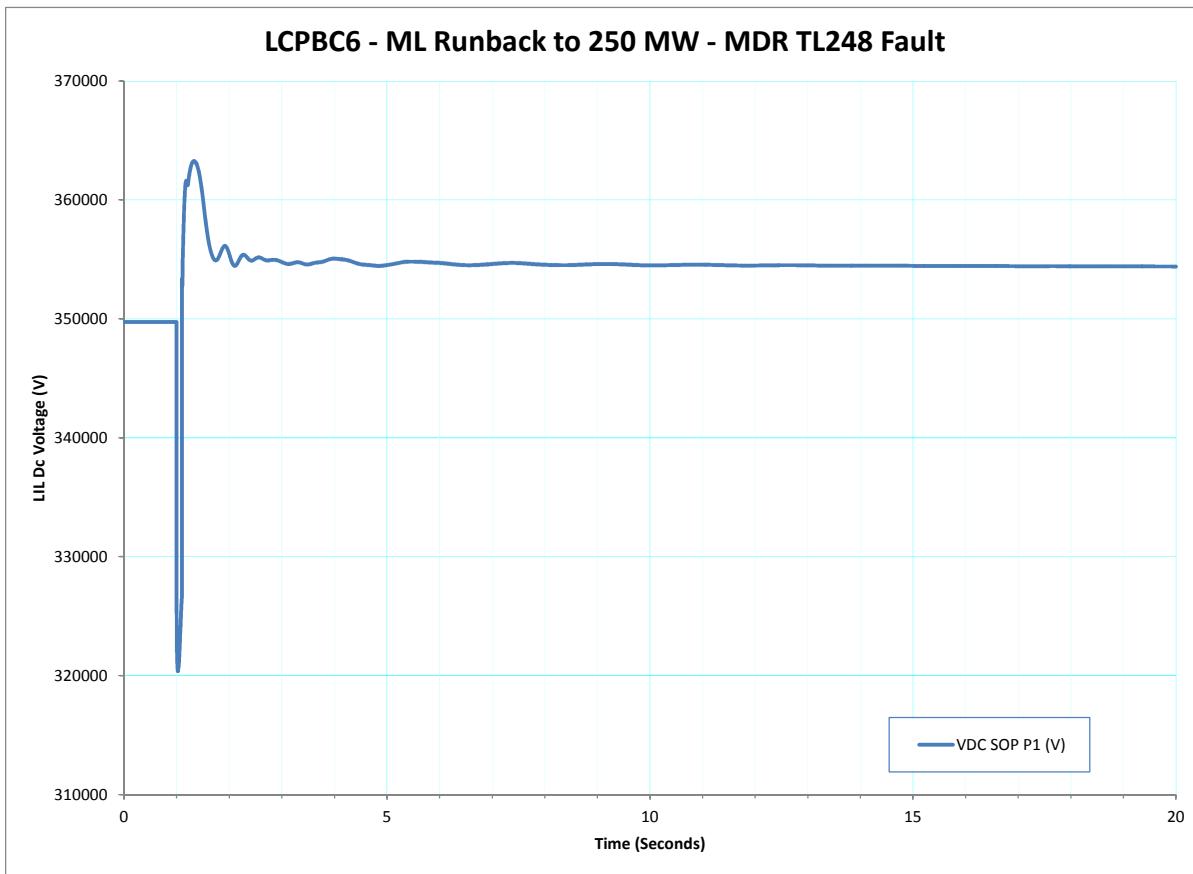
Figure 426 - LCPBC6 - ML Runback to 250 MW - MDR TL248 Fault - LIL Dc Voltage (V)

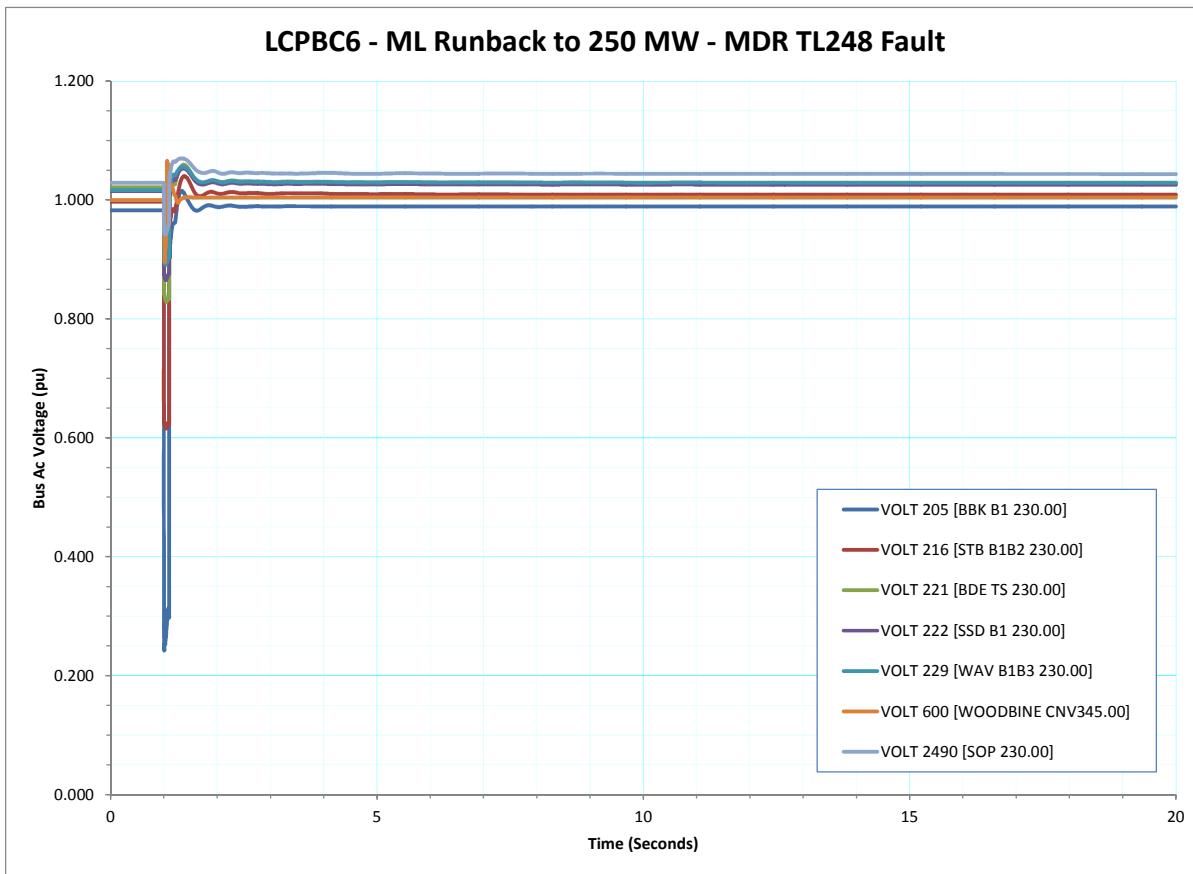
Figure 427 - LCPBC6 - ML Runback to 250 MW - MDR TL248 Fault - Bus Ac Voltage (pu)

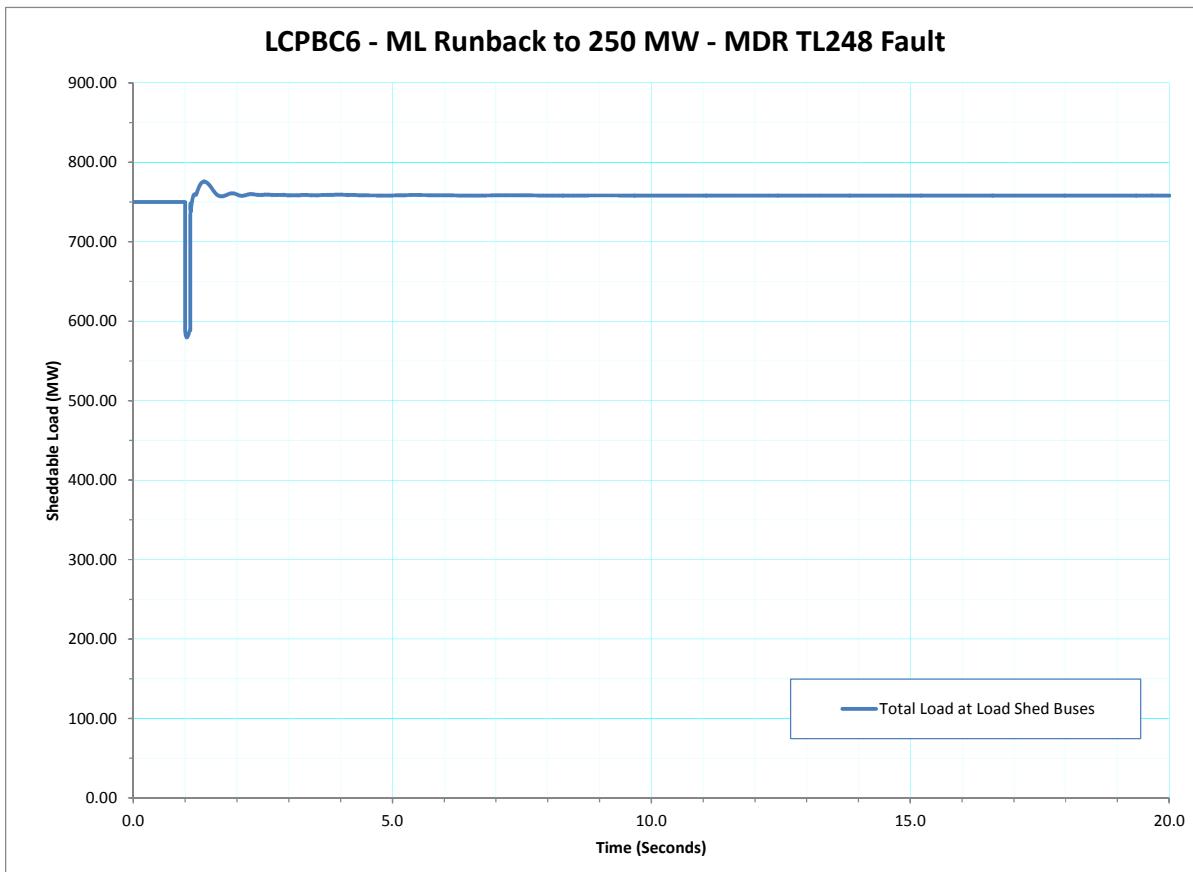
Figure 428 - LCPBC6 - ML Runback to 250 MW - MDR TL248 Fault - Sheddable Load (MW)

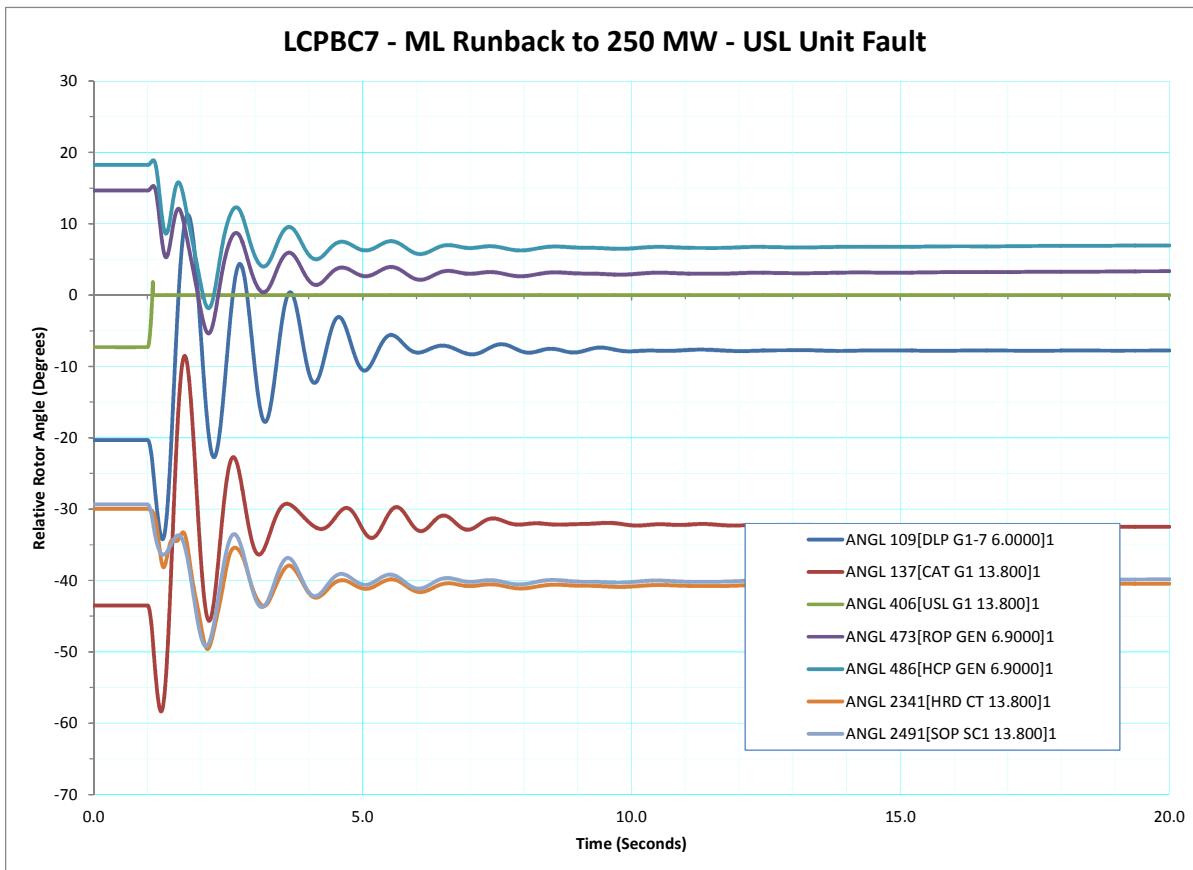
Figure 429 - LCPBC7 - ML Runback to 250 MW - USL Unit Fault - Relative Rotor Angle (Degrees)

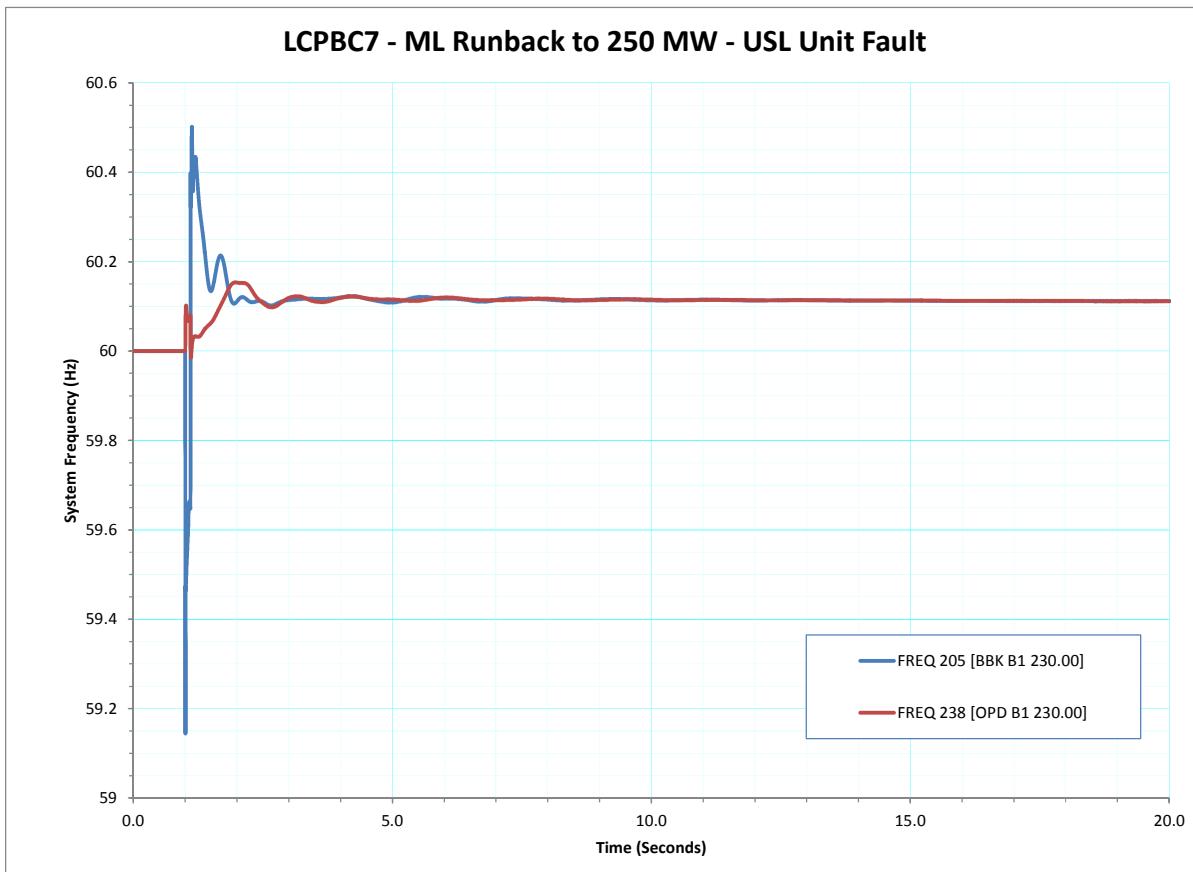
Figure 430 - LCPBC7 - ML Runback to 250 MW - USL Unit Fault - System Frequency (Hz)

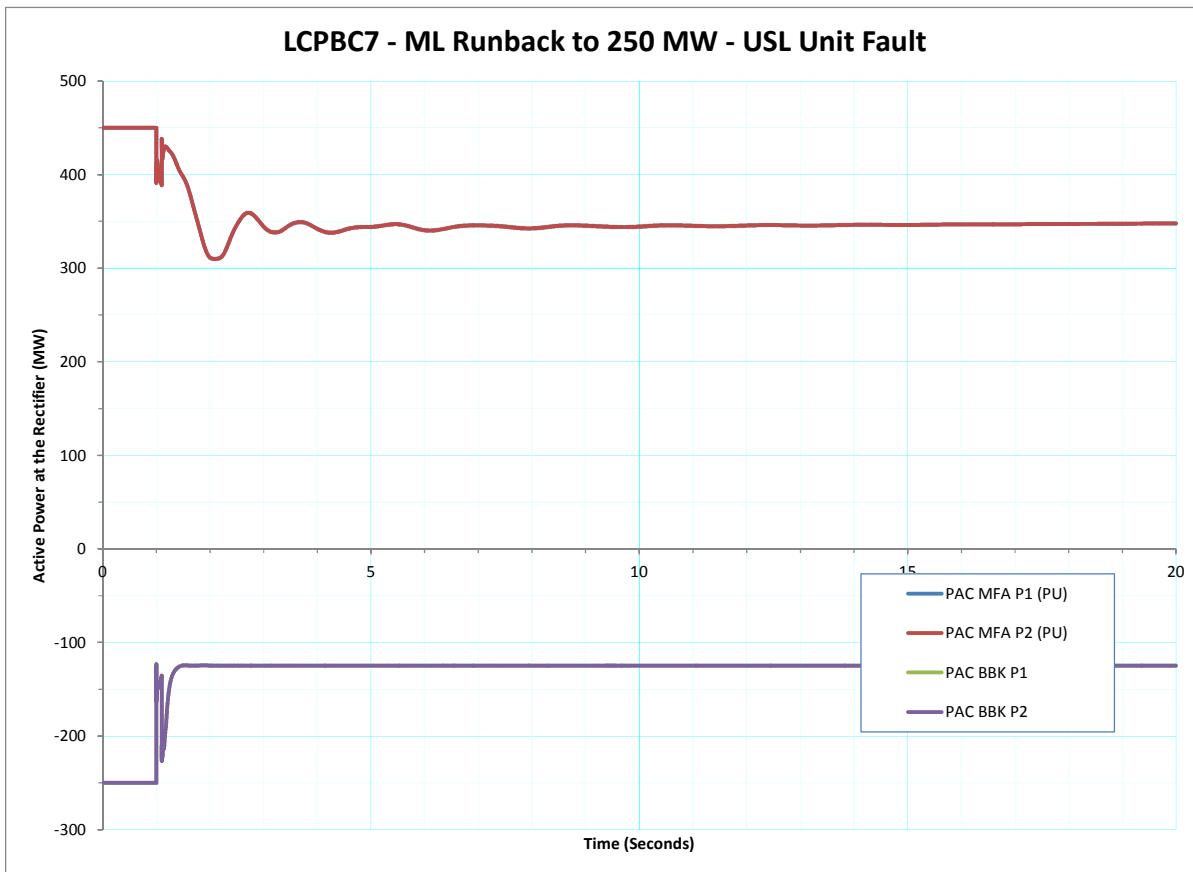
Figure 431 - LCPBC7 - ML Runback to 250 MW - USL Unit Fault - Active Power at the Rectifier (MW)

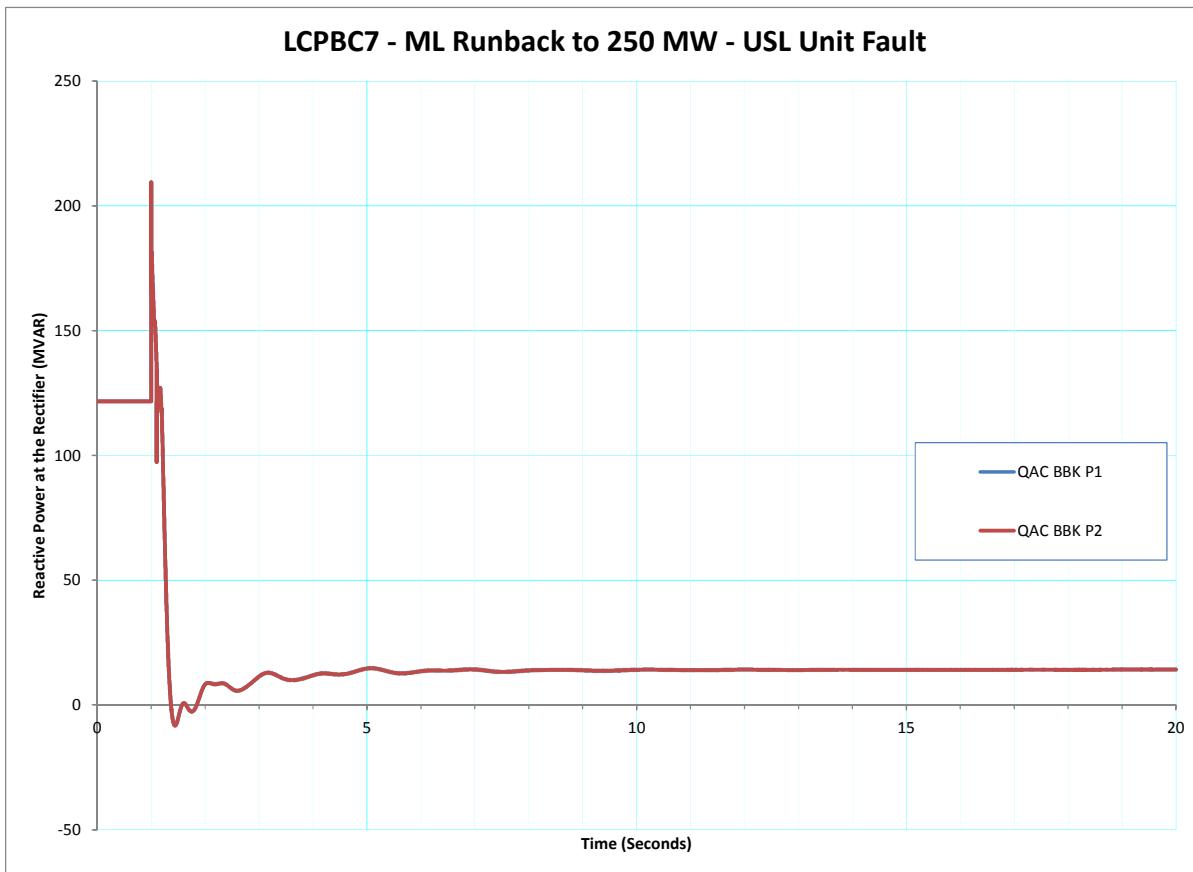
Figure 432 - LCPBC7 - ML Runback to 250 MW - USL Unit Fault - Reactive Power at the Rectifier (MVAR)

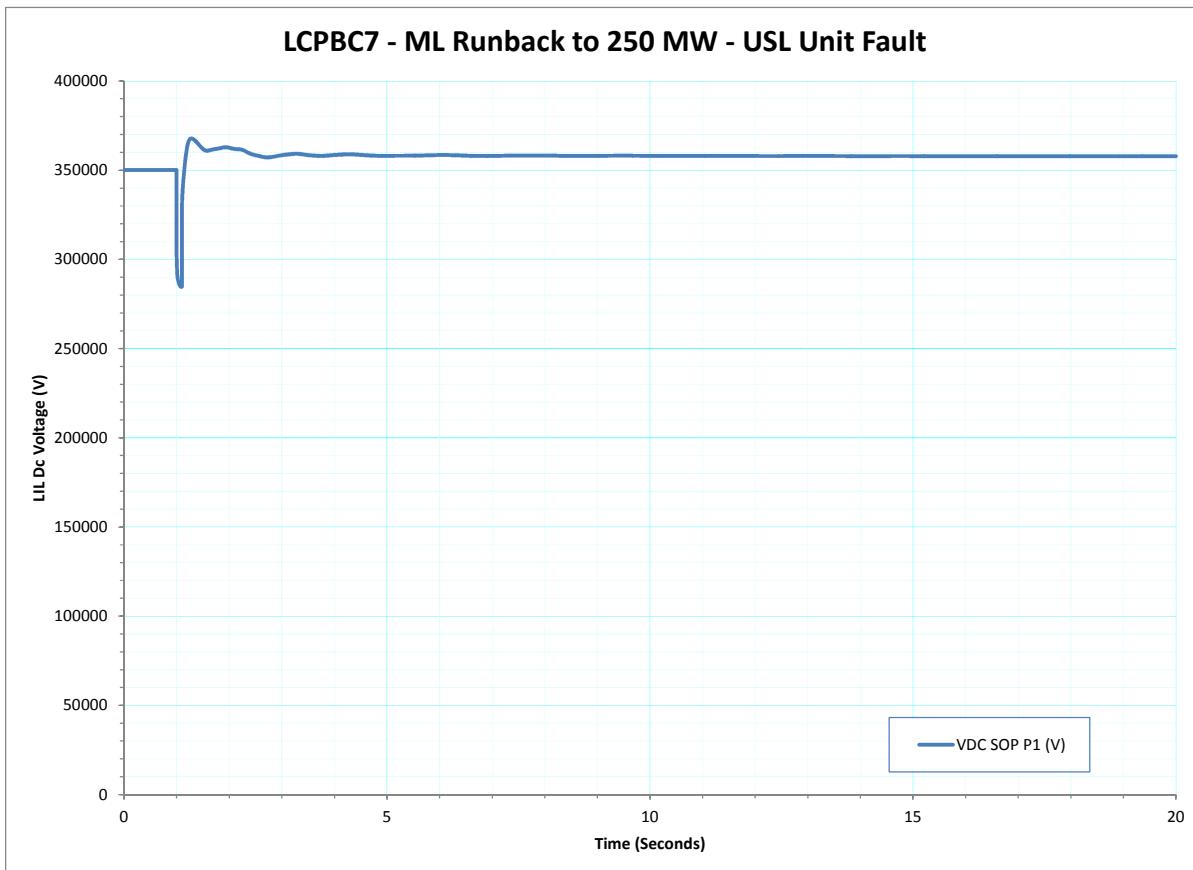
Figure 433 - LCPBC7 - ML Runback to 250 MW - USL Unit Fault - LIL Dc Voltage (V)

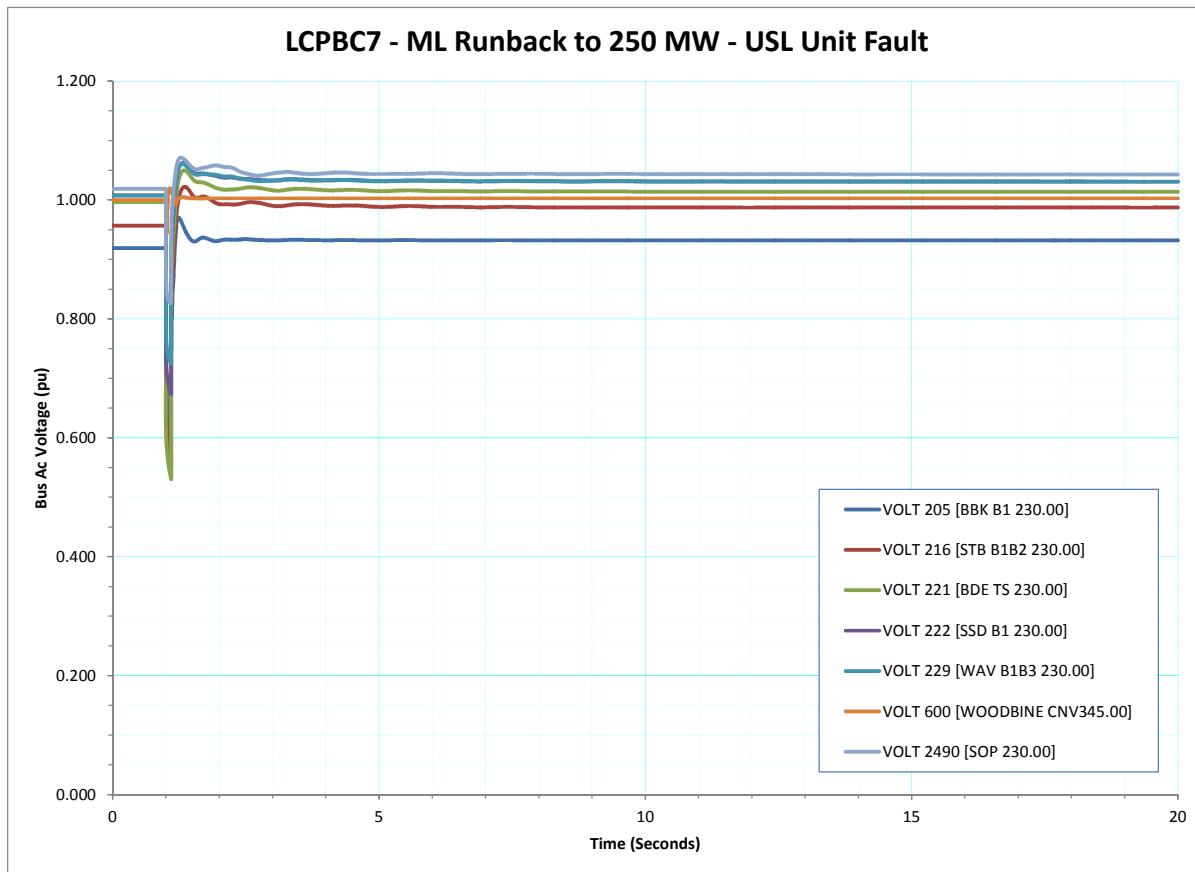
Figure 434 - LCPBC7 - ML Runback to 250 MW - USL Unit Fault - Bus Ac Voltage (pu)

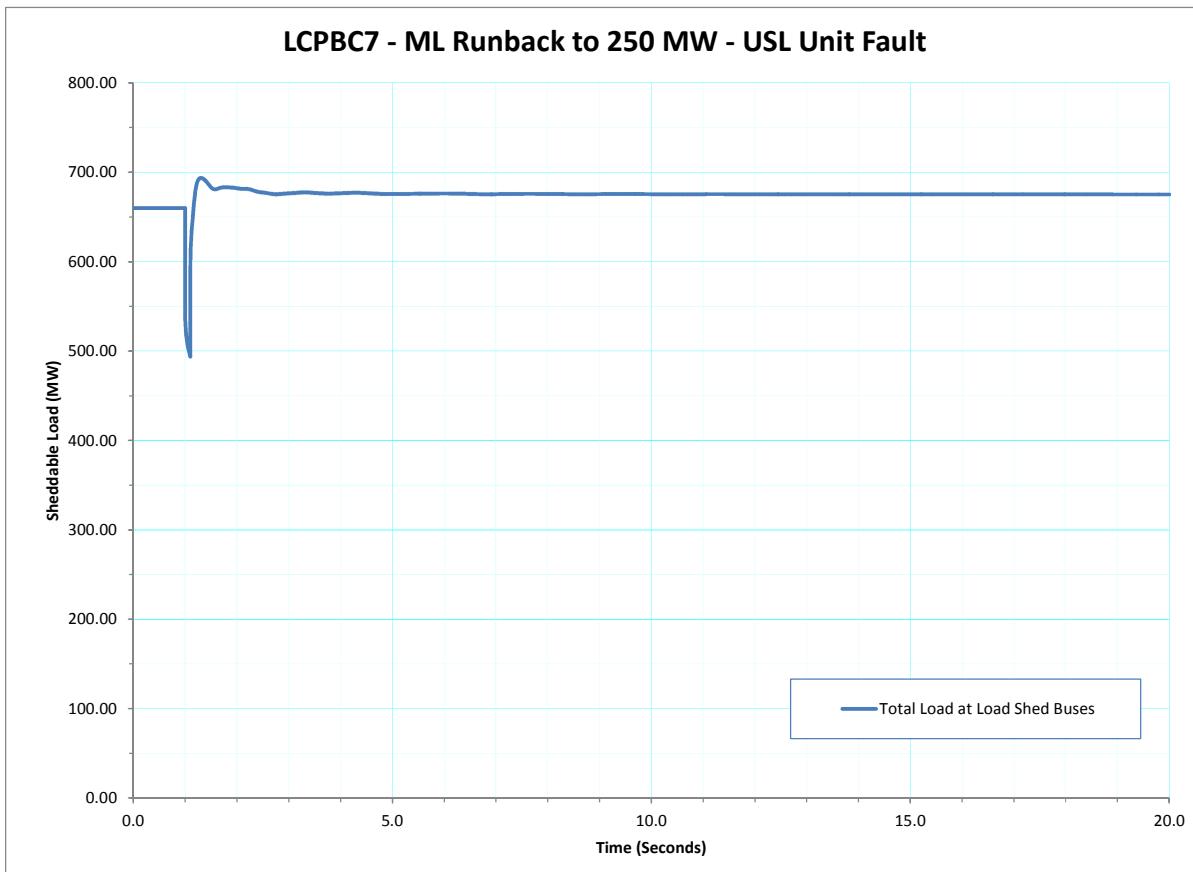
Figure 435 - LCPBC7 - ML Runback to 250 MW - USL Unit Fault - Sheddable Load (MW)

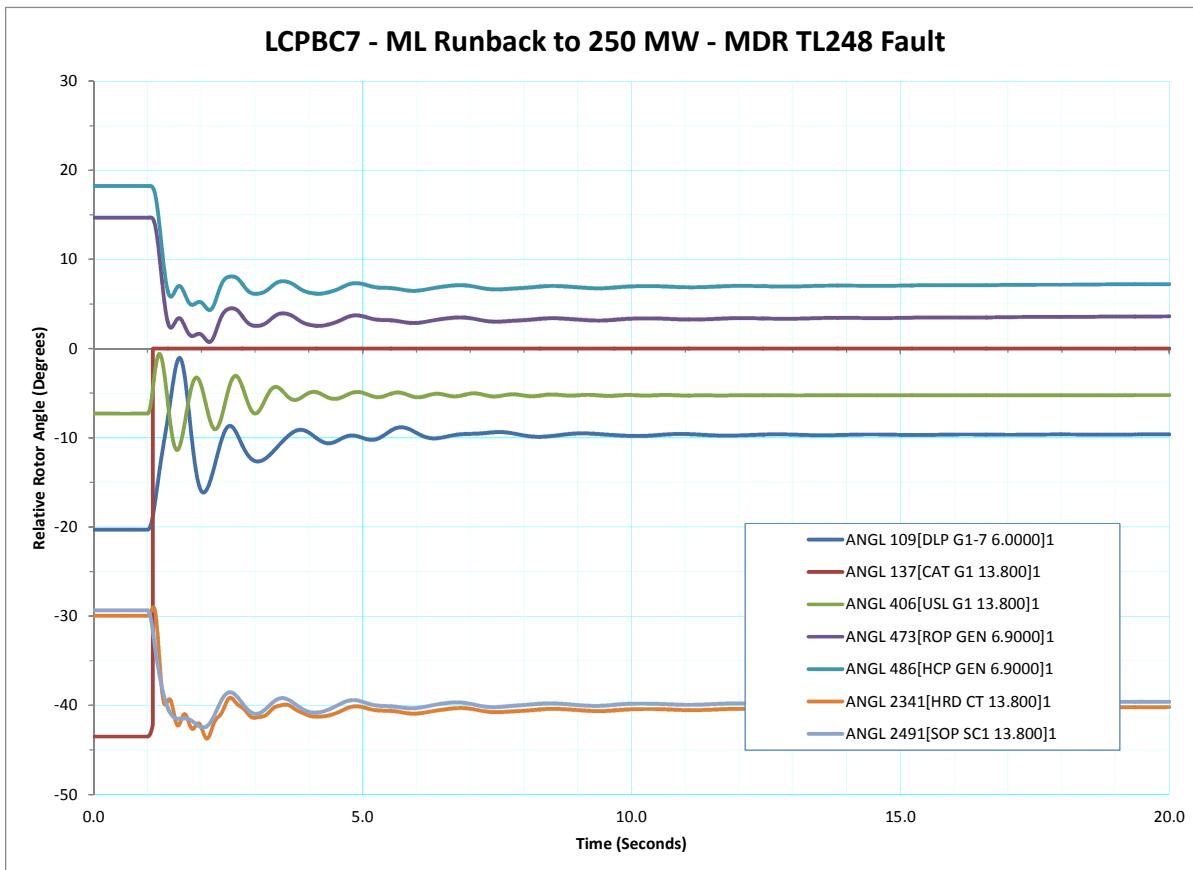
Figure 436 - LCPBC7 - ML Runback to 250 MW - MDR TL248 Fault - Relative Rotor Angle (Degrees)

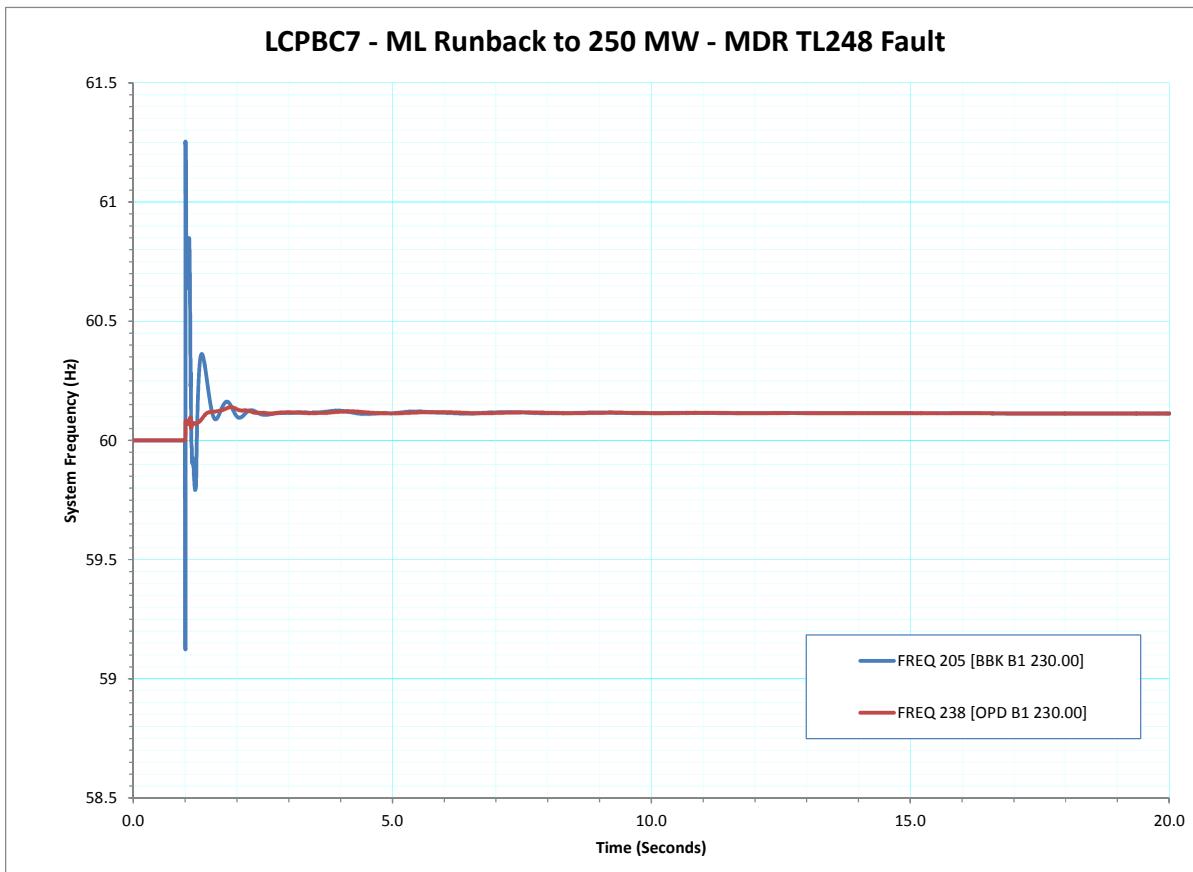
Figure 437 - LCPBC7 - ML Runback to 250 MW - MDR TL248 Fault - System Frequency (Hz)

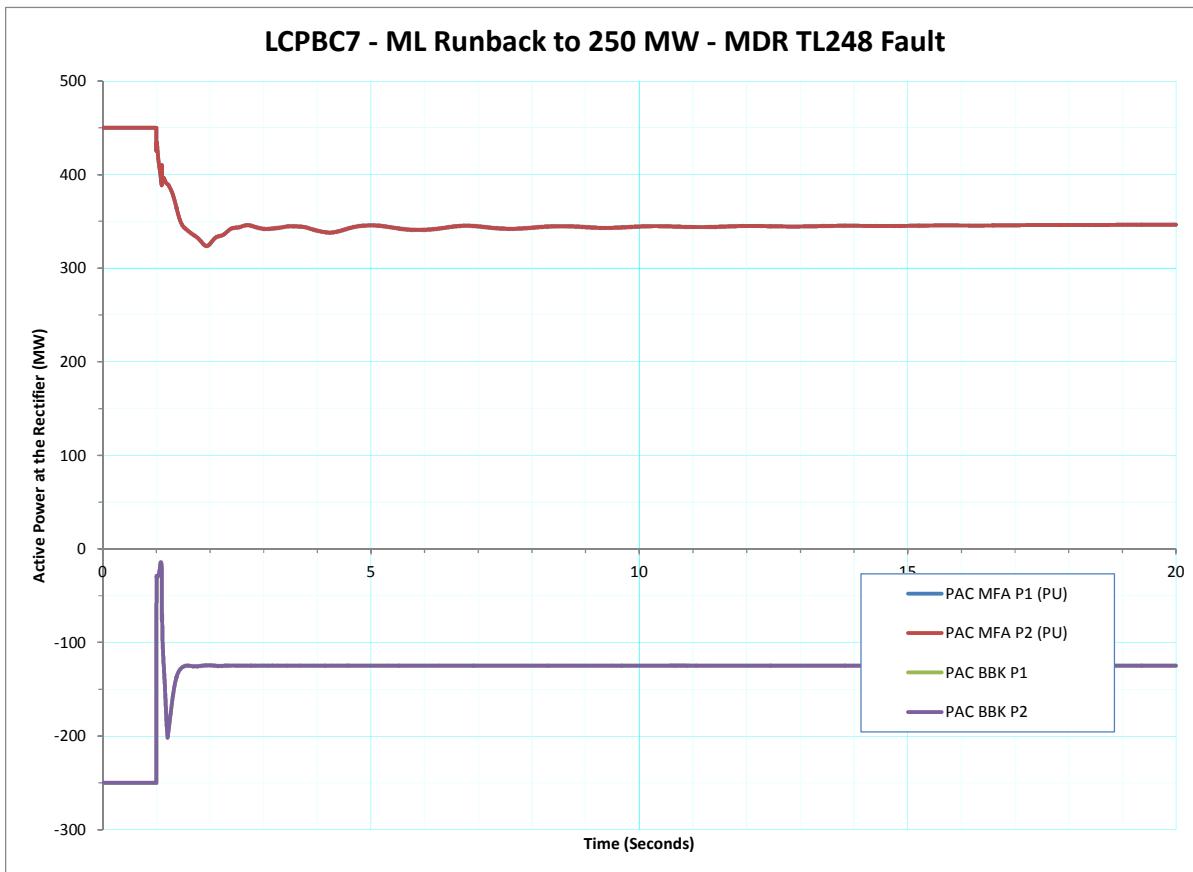
Figure 438 - LCPBC7 - ML Runback to 250 MW - MDR TL248 Fault - Active Power at the Rectifier (MW)

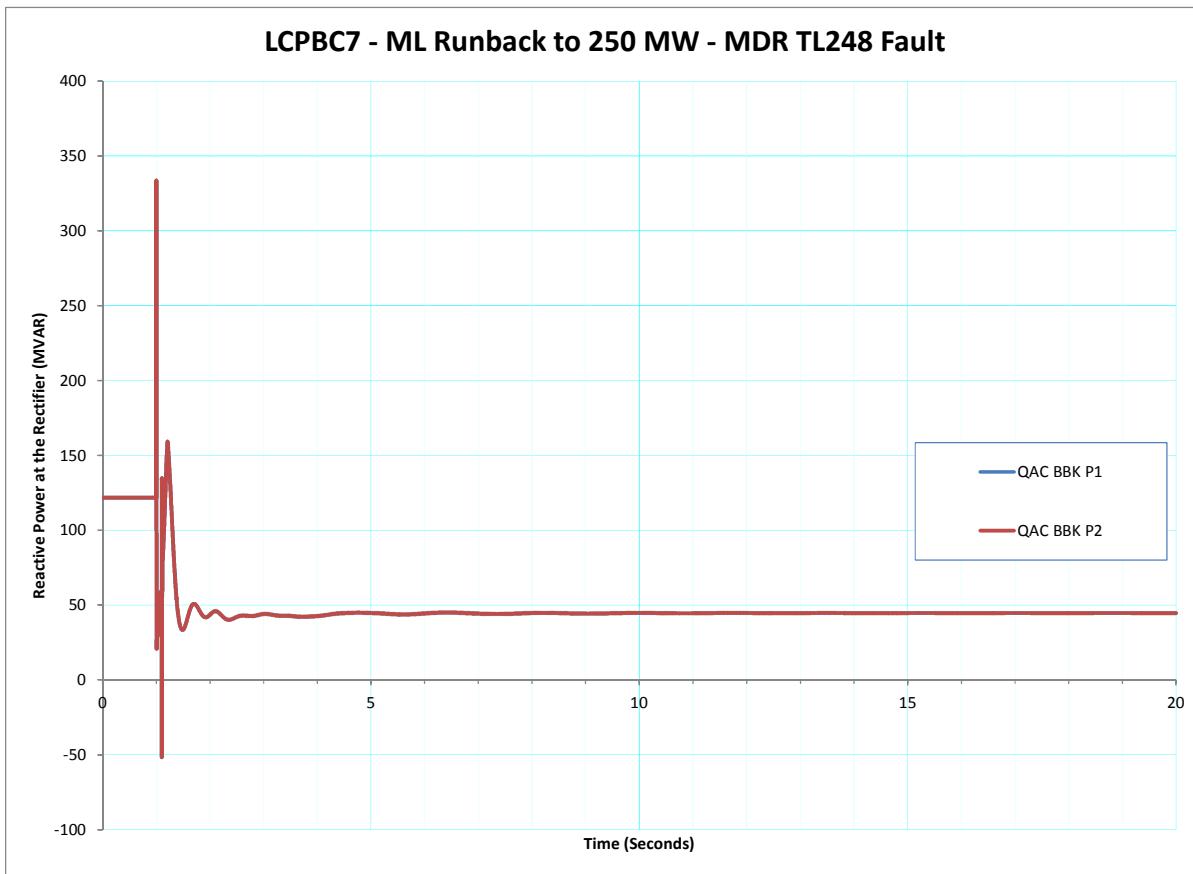
Figure 439 - LCPBC7 - ML Runback to 250 MW - MDR TL248 Fault - Reactive Power at the Rectifier (MVAR)

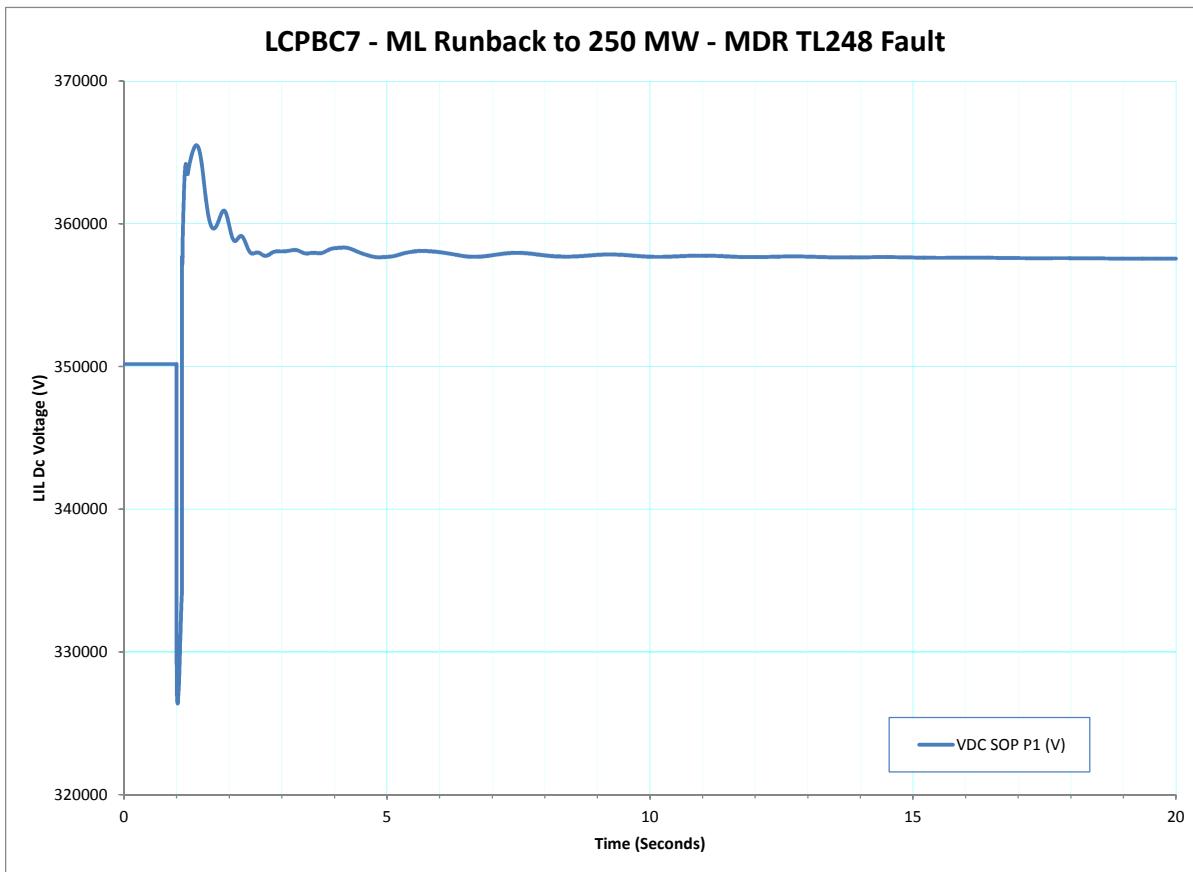
Figure 440 - LCPBC7 - ML Runback to 250 MW - MDR TL248 Fault - LIL Dc Voltage (V)

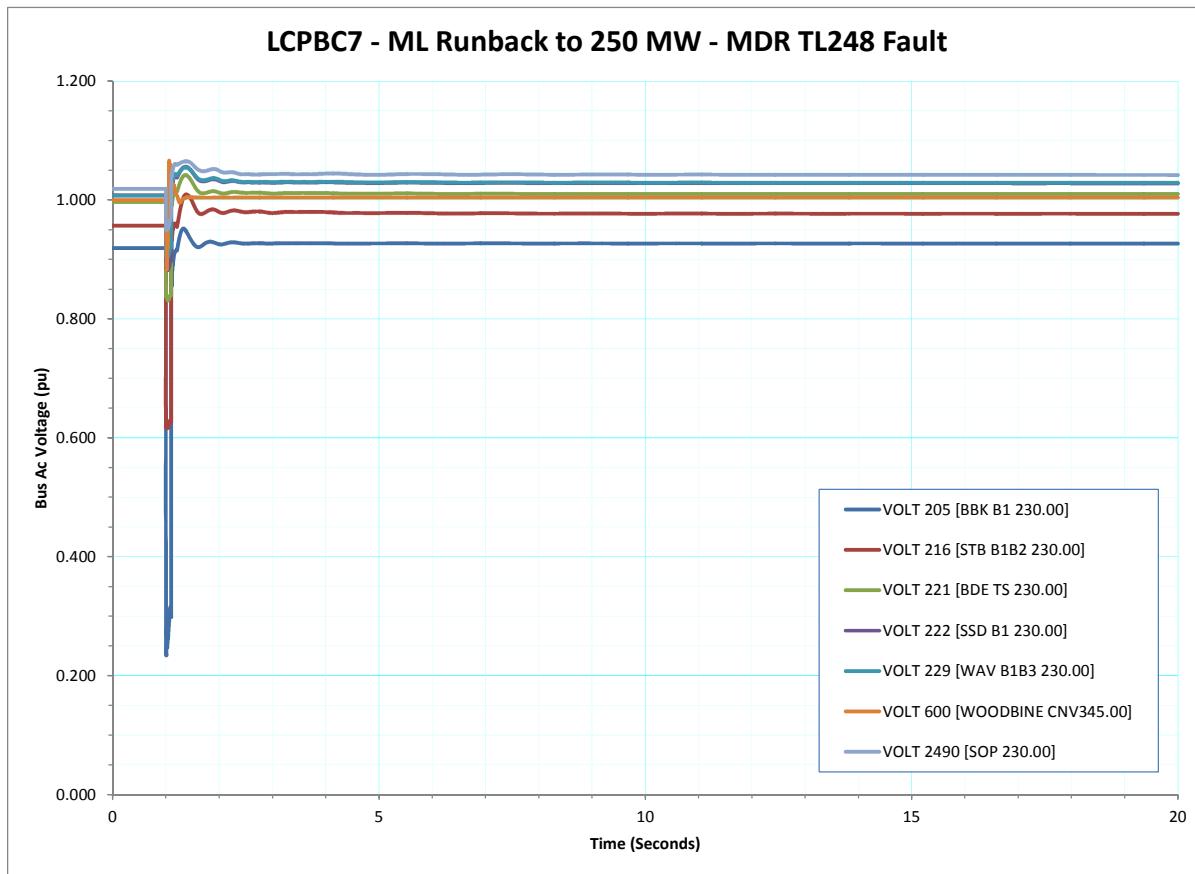
Figure 441 - LCPBC7 - ML Runback to 250 MW - MDR TL248 Fault - Bus Ac Voltage (pu)
