MARITIME LINK PRELIMINARY INTERCONNECTION STUDY

Newfoundland and Labrador Hydro

July 2014

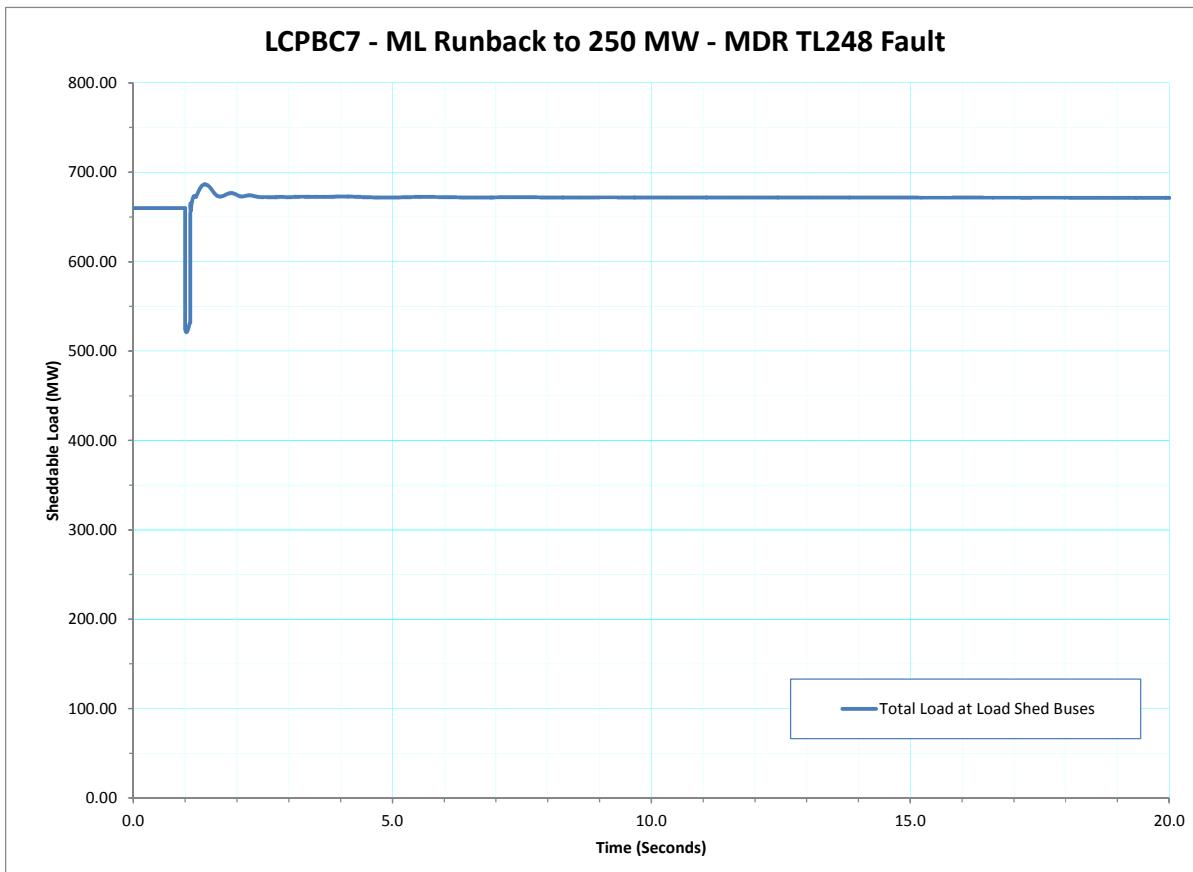
Figure 442 - LCPBC7 - ML Runback to 250 MW - MDR TL248 Fault - Sheddable Load (MW)

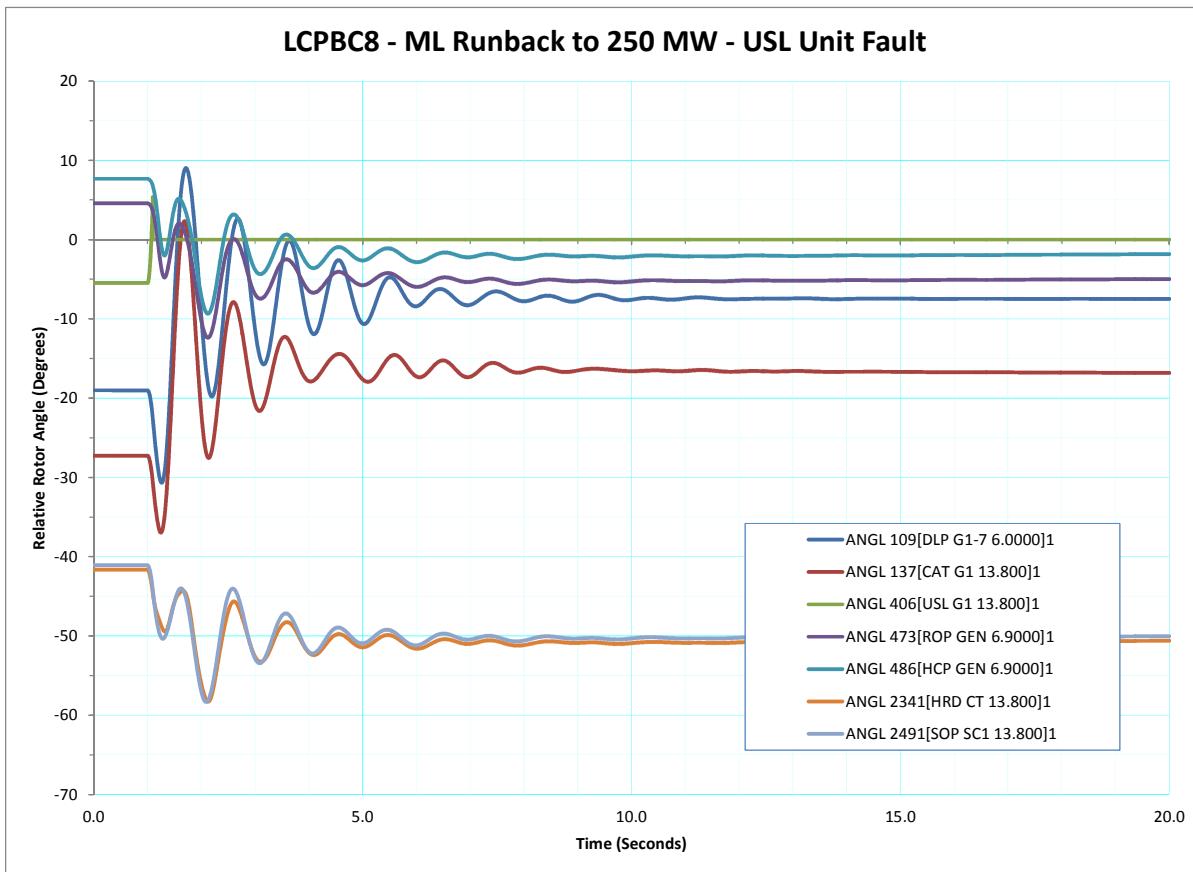
Figure 443 - LCPBC8 - ML Runback to 250 MW - USL Unit Fault - Relative Rotor Angle (Degrees)

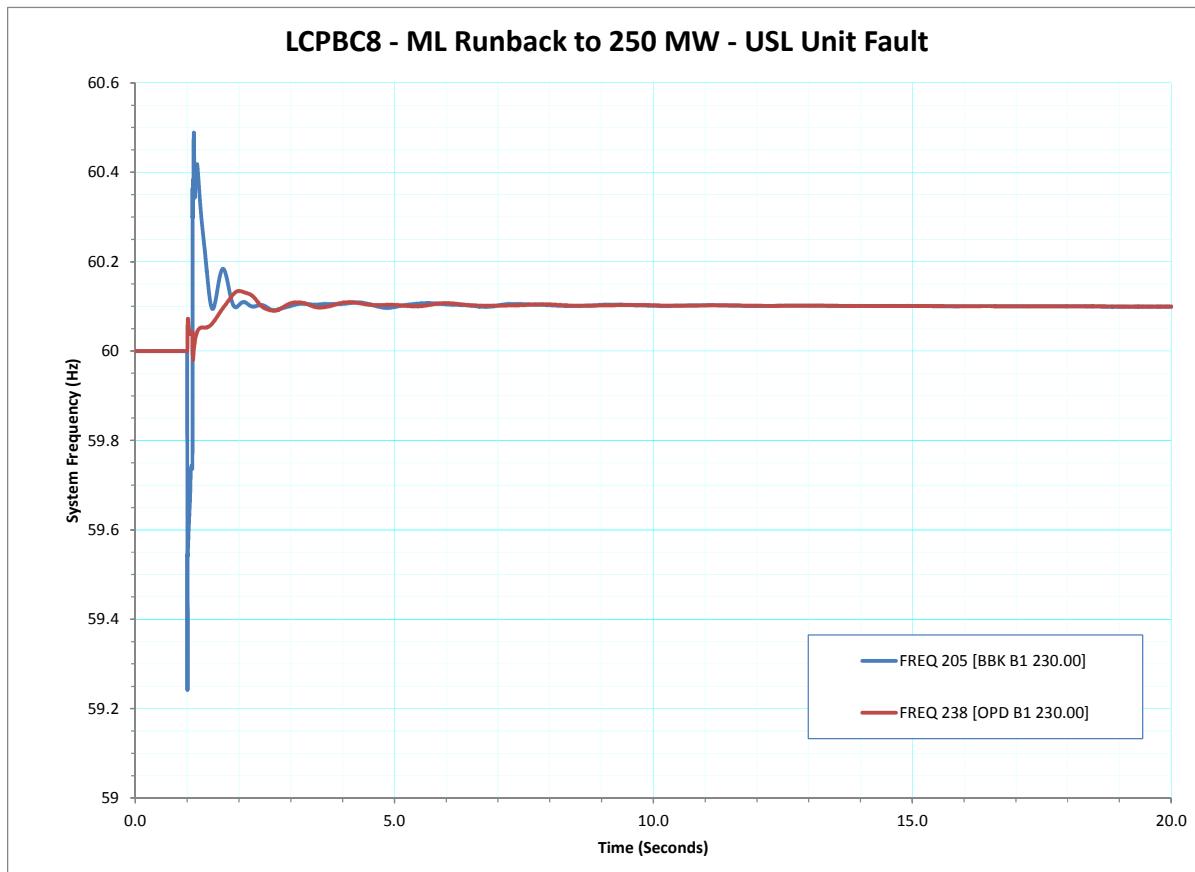
Figure 444 - LCPBC8 - ML Runback to 250 MW - USL Unit Fault - System Frequency (Hz)

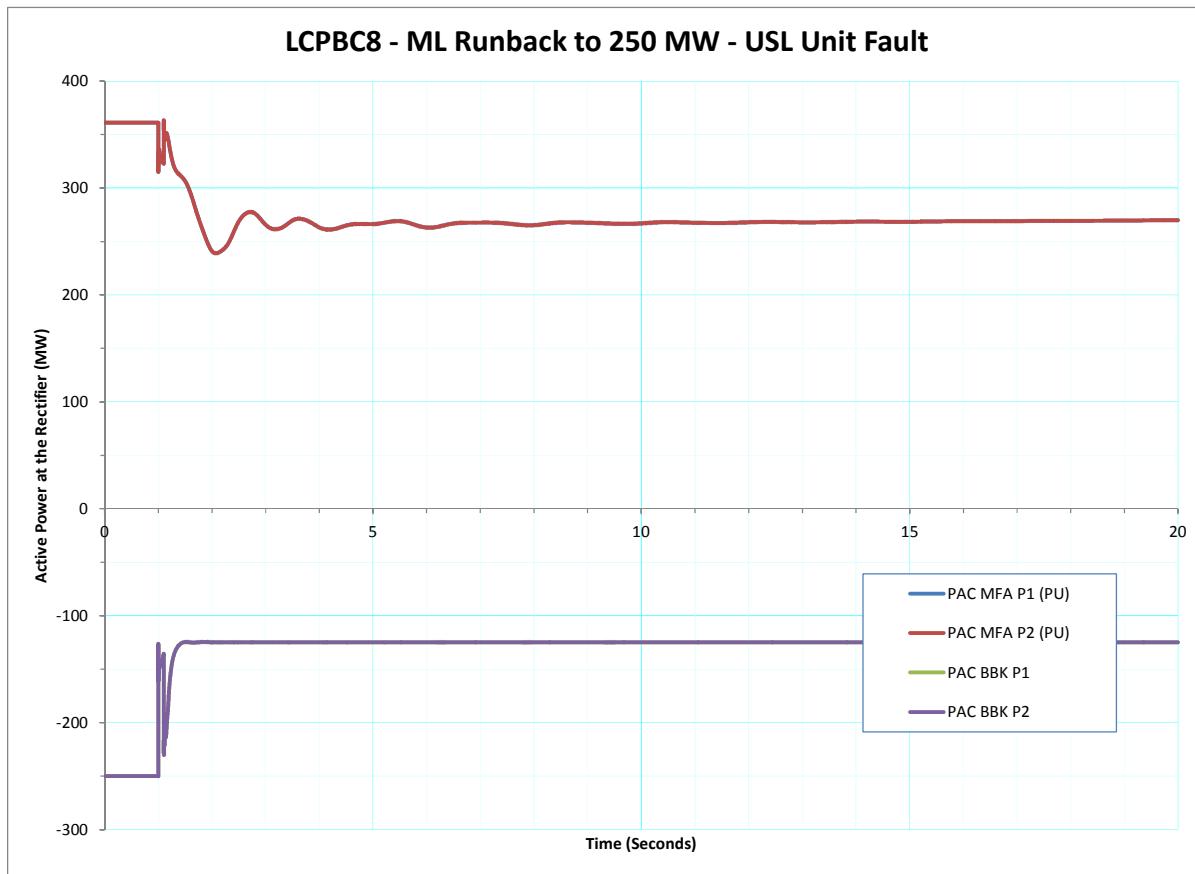
Figure 445 - LCPBC8 - ML Runback to 250 MW - USL Unit Fault - Active Power at the Rectifier (MW)

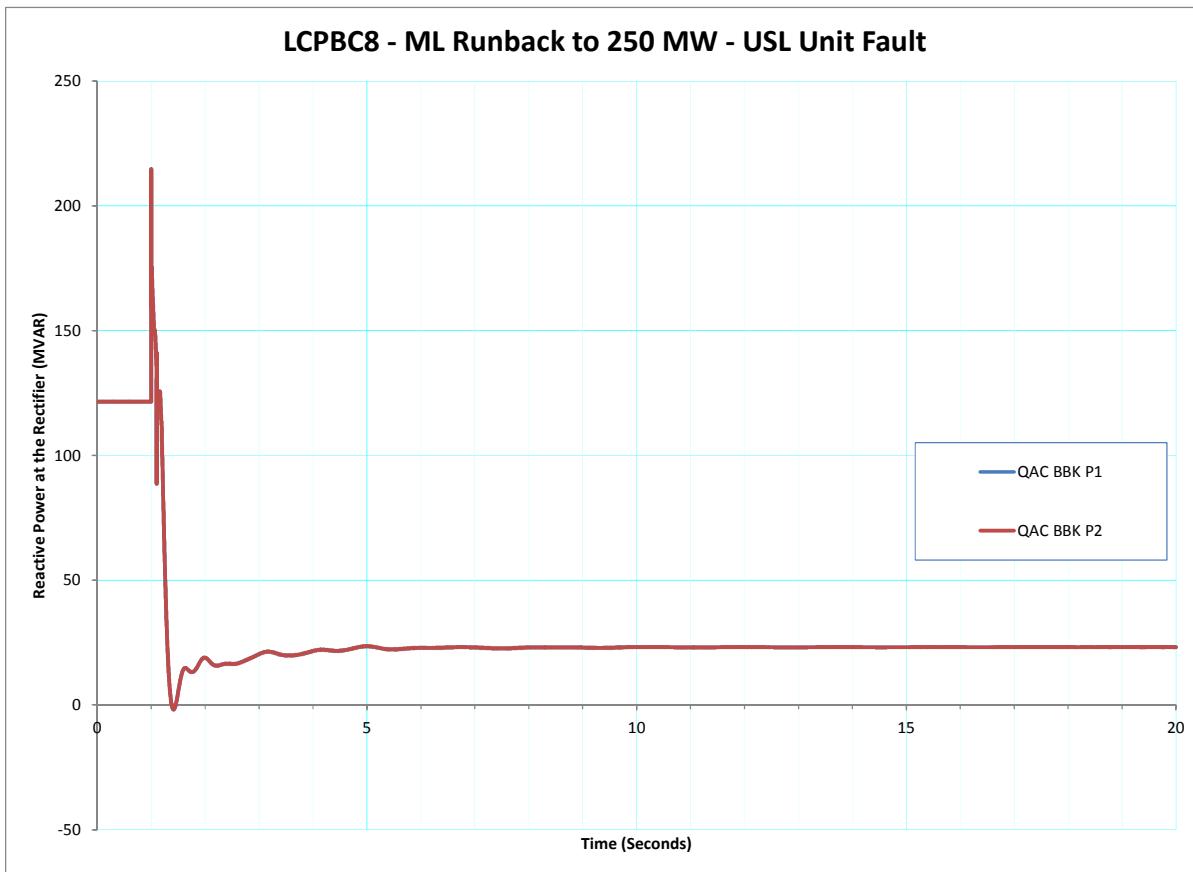
Figure 446 - LCPBC8 - ML Runback to 250 MW - USL Unit Fault - Reactive Power at the Rectifier (MVAR)

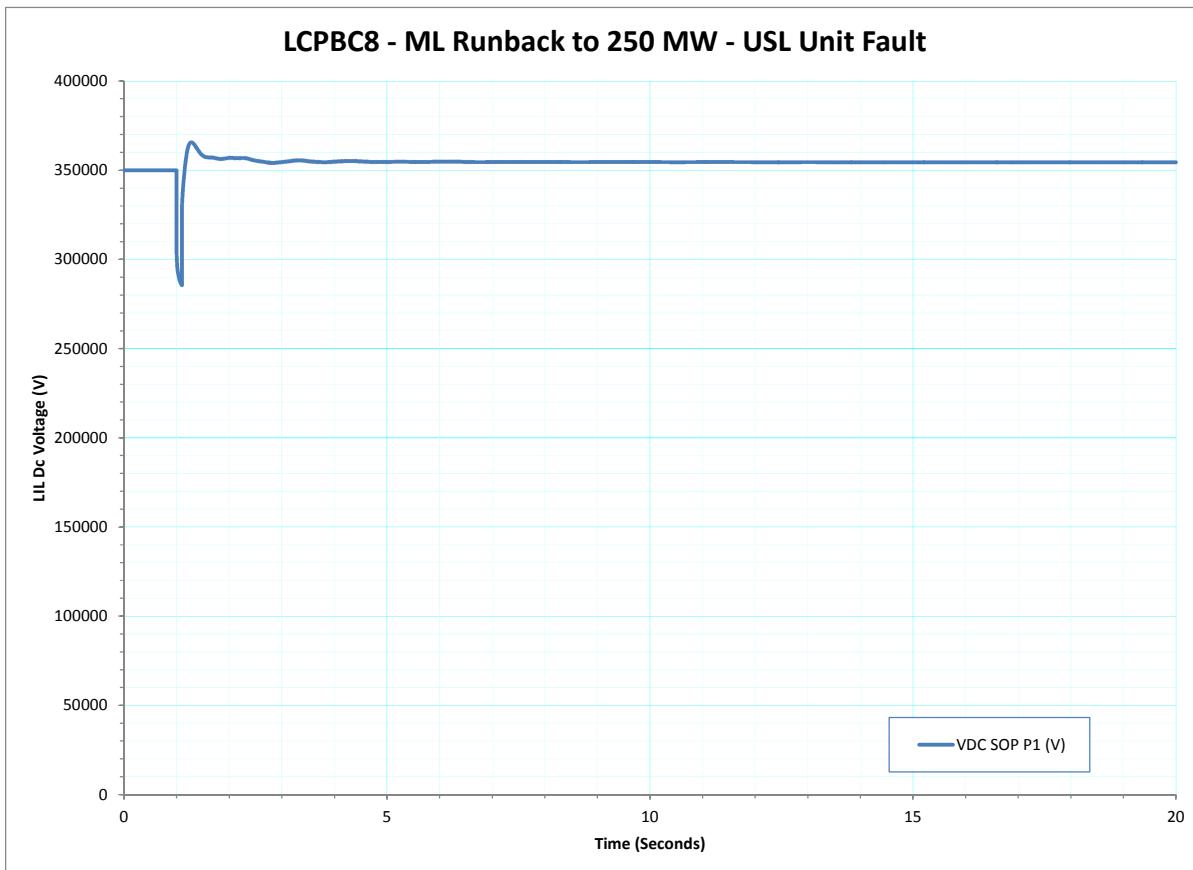
Figure 447 - LCPBC8 - ML Runback to 250 MW - USL Unit Fault - LIL Dc Voltage (V)

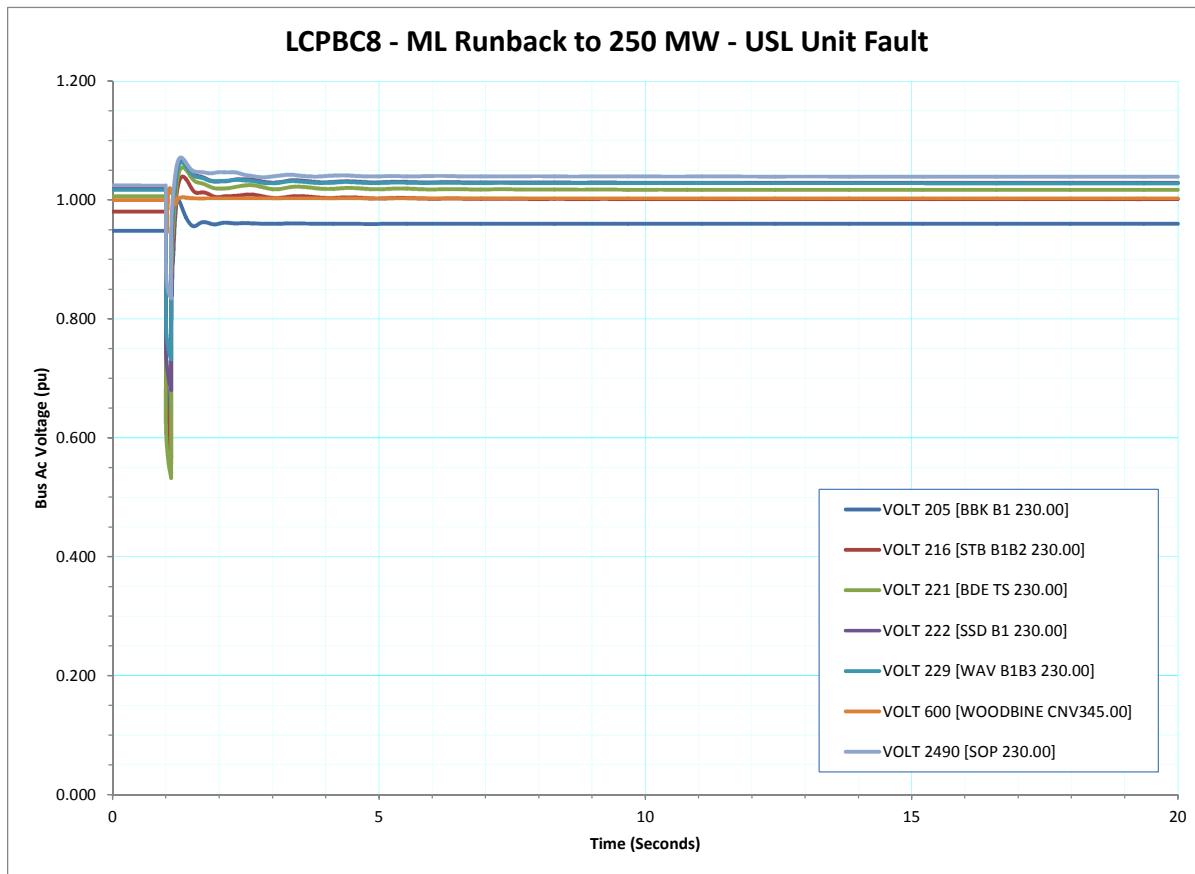
Figure 448 - LCPBC8 - ML Runback to 250 MW - USL Unit Fault - Bus Ac Voltage (pu)

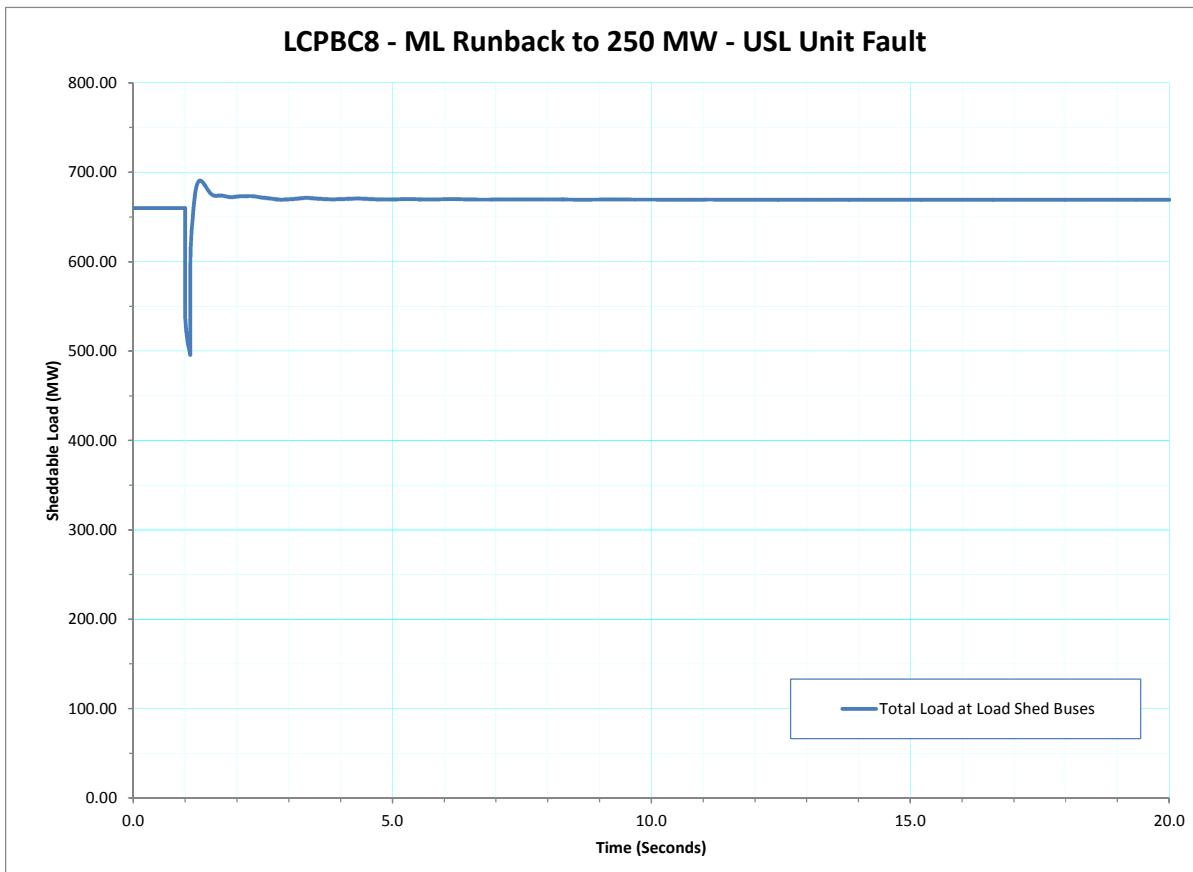
Figure 449 - LCPBC8 - ML Runback to 250 MW - USL Unit Fault - Sheddable Load (MW)

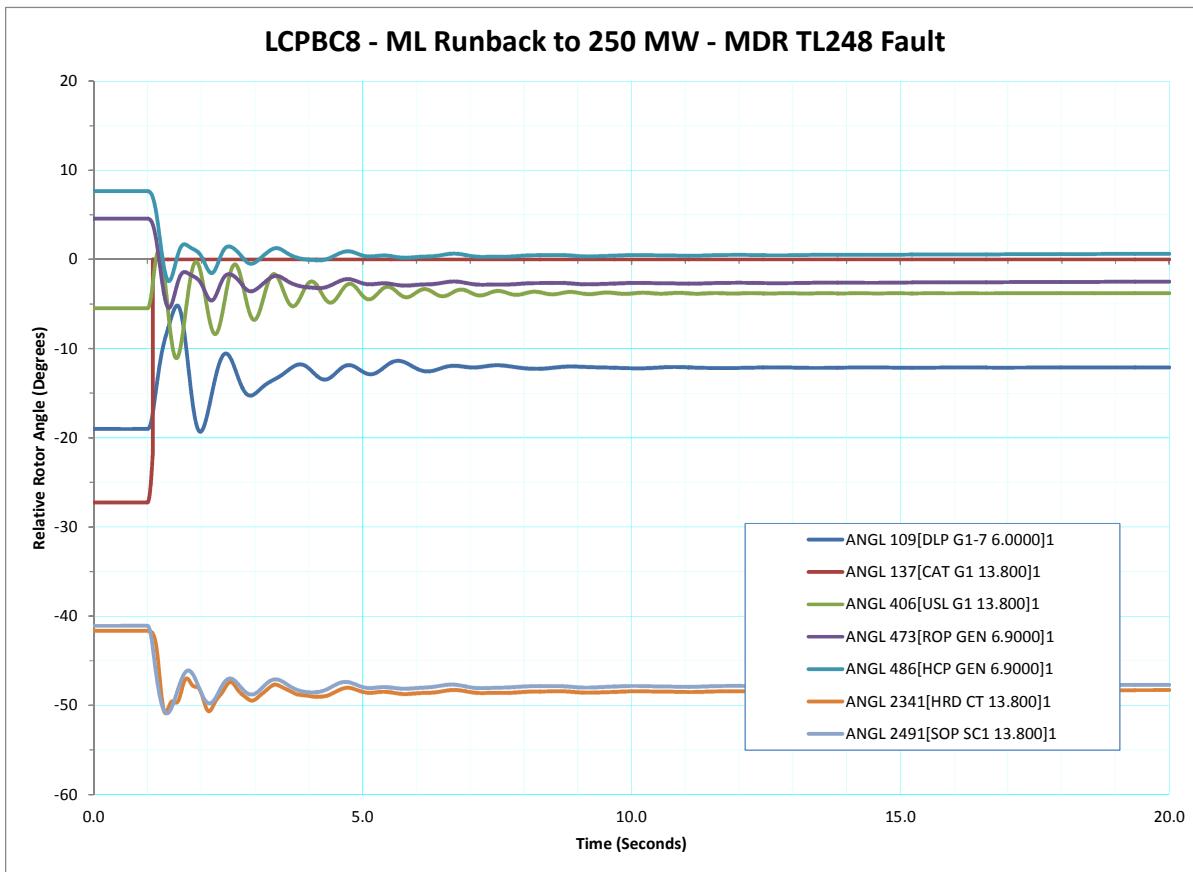
Figure 450 - LCPBC8 - ML Runback to 250 MW - MDR TL248 Fault - Relative Rotor Angle (Degrees)

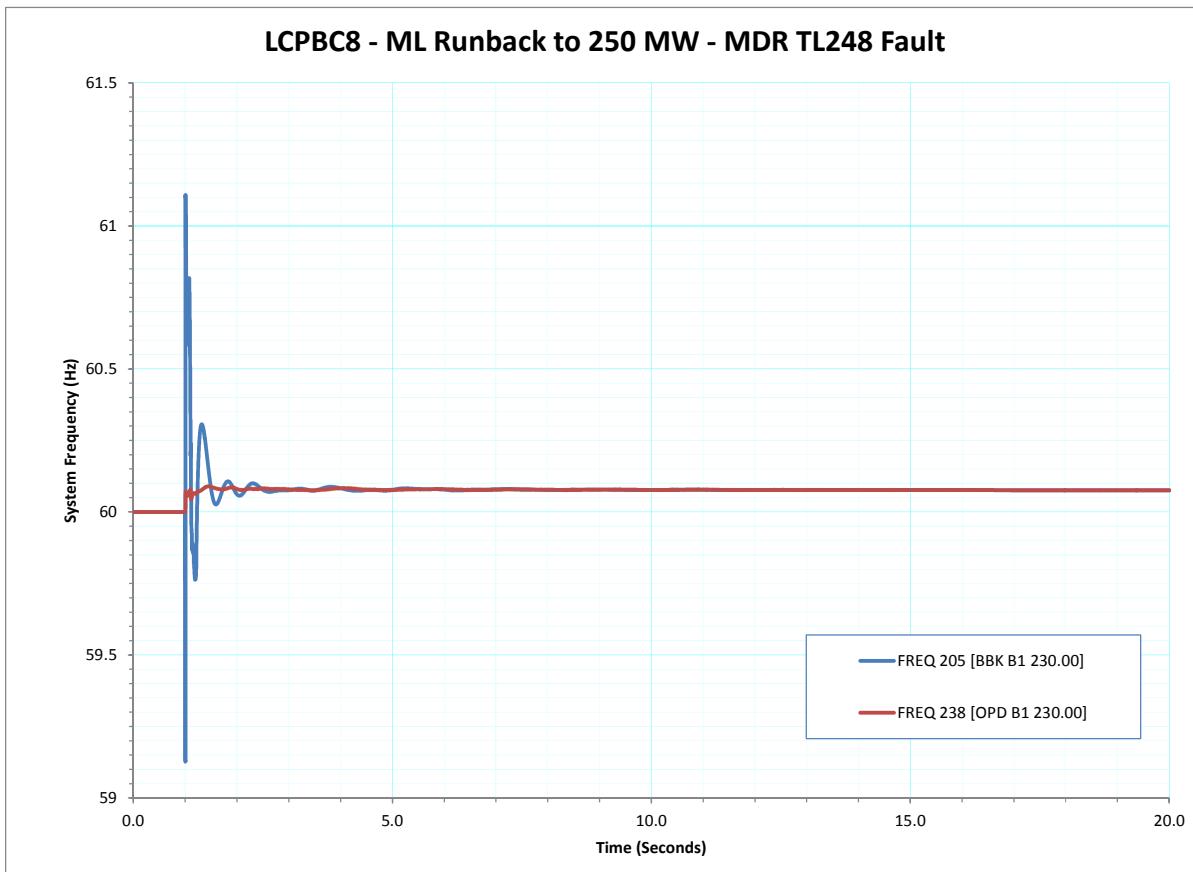
Figure 451 - LCPBC8 - ML Runback to 250 MW - MDR TL248 Fault - System Frequency (Hz)

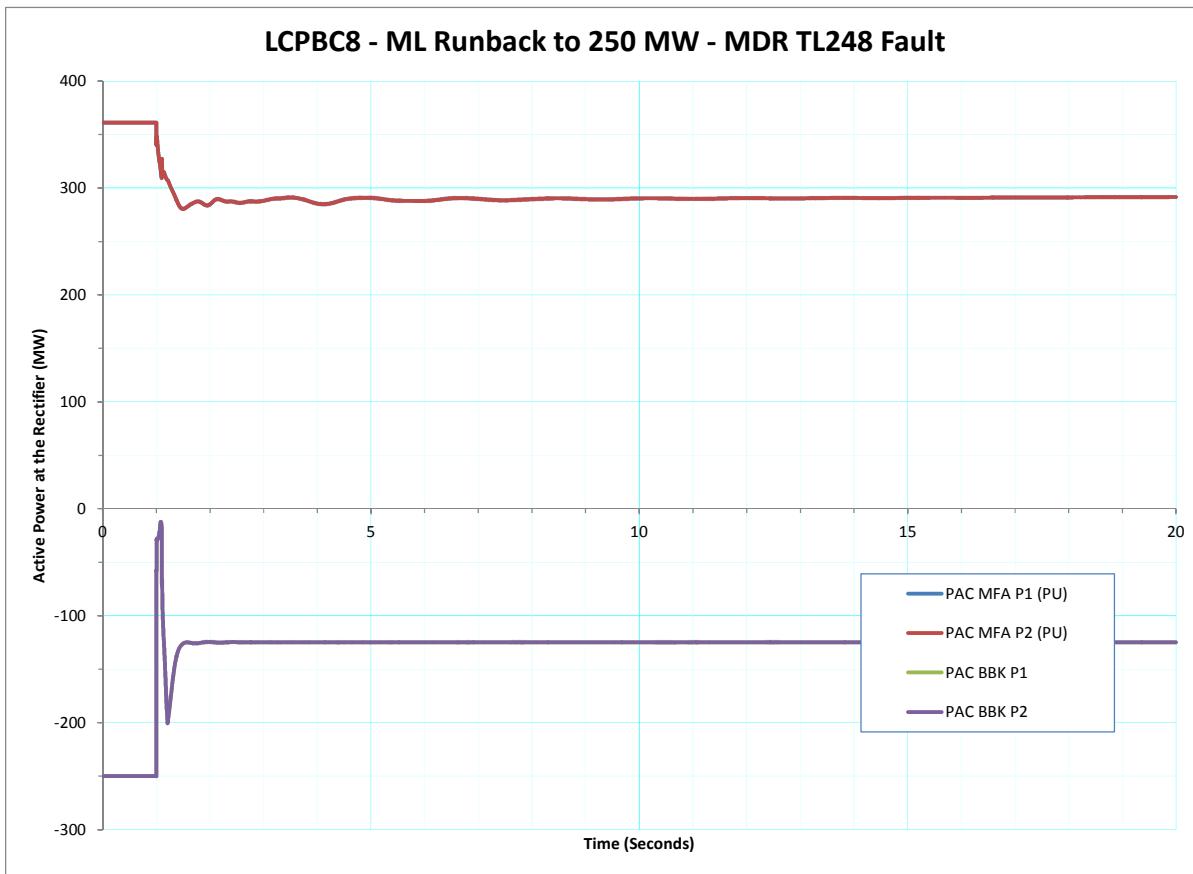
Figure 452 - LCPBC8 - ML Runback to 250 MW - MDR TL248 Fault - Active Power at the Rectifier (MW)

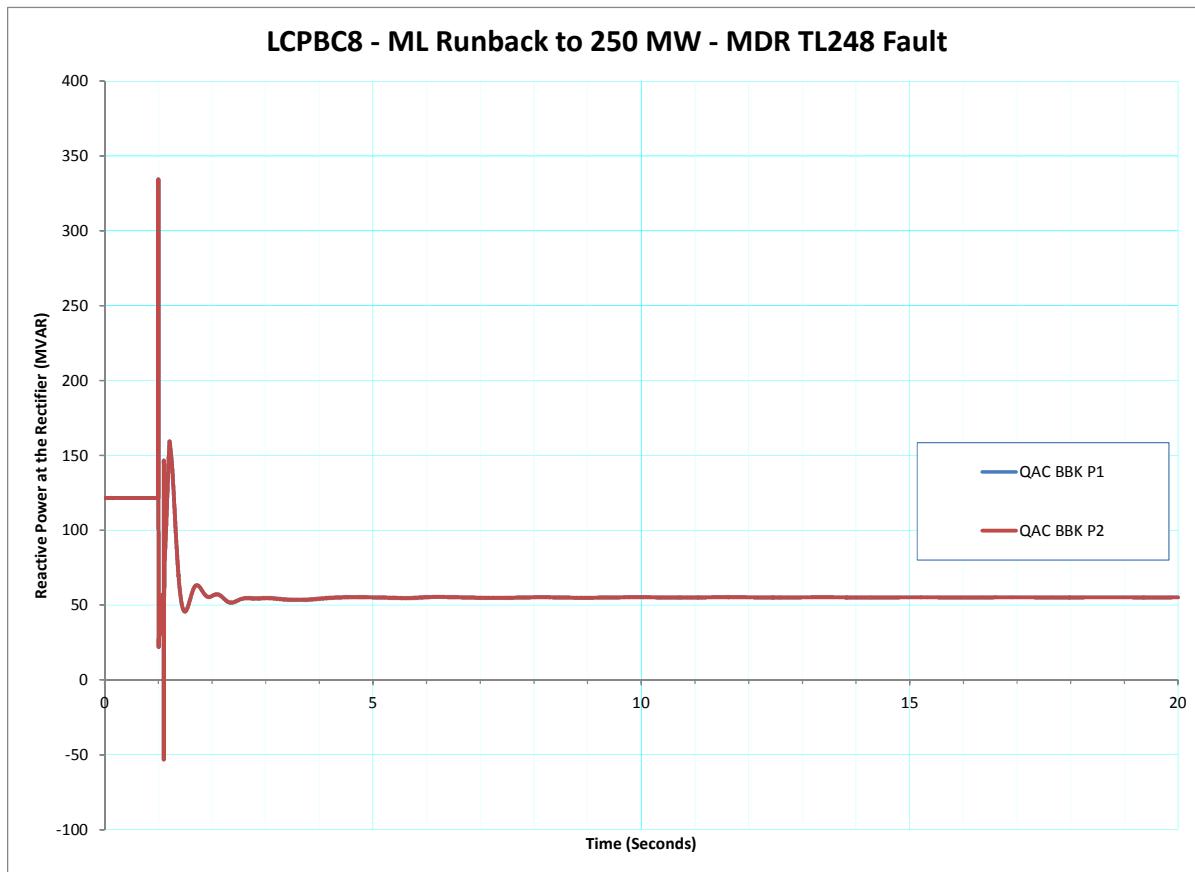
Figure 453 - LCPBC8 - ML Runback to 250 MW - MDR TL248 Fault - Reactive Power at the Rectifier (MVAR)

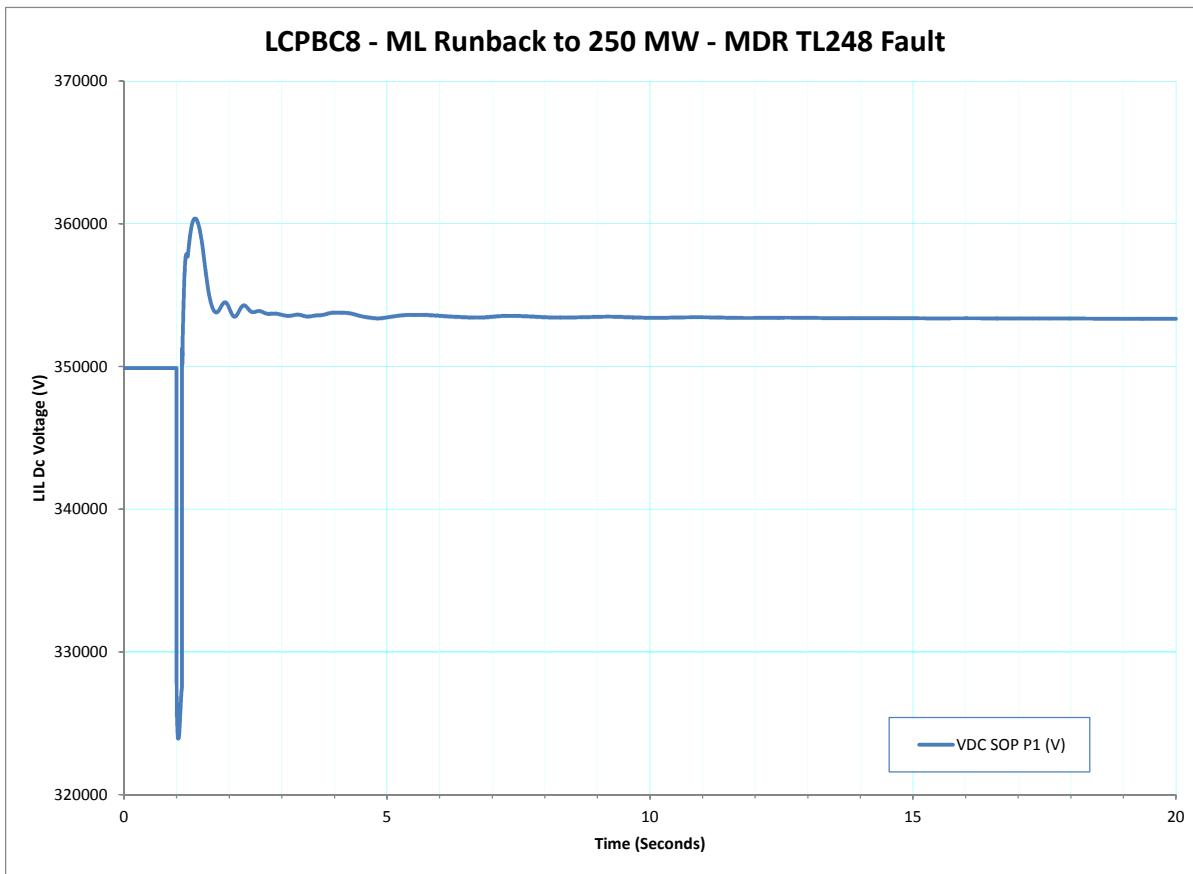
Figure 454 - LCPBC8 - ML Runback to 250 MW - MDR TL248 Fault - LIL Dc Voltage (V)

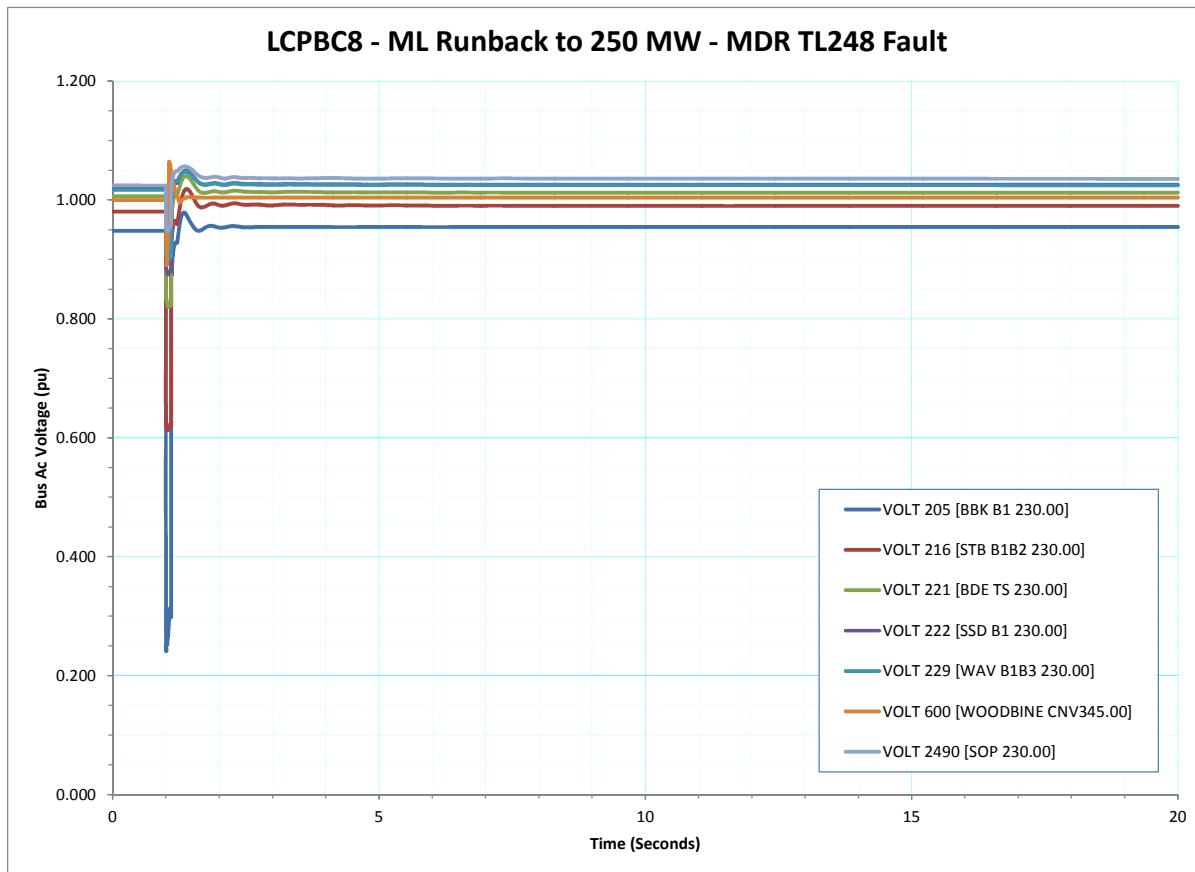
Figure 455 - LCPBC8 - ML Runback to 250 MW - MDR TL248 Fault - Bus Ac Voltage (pu)

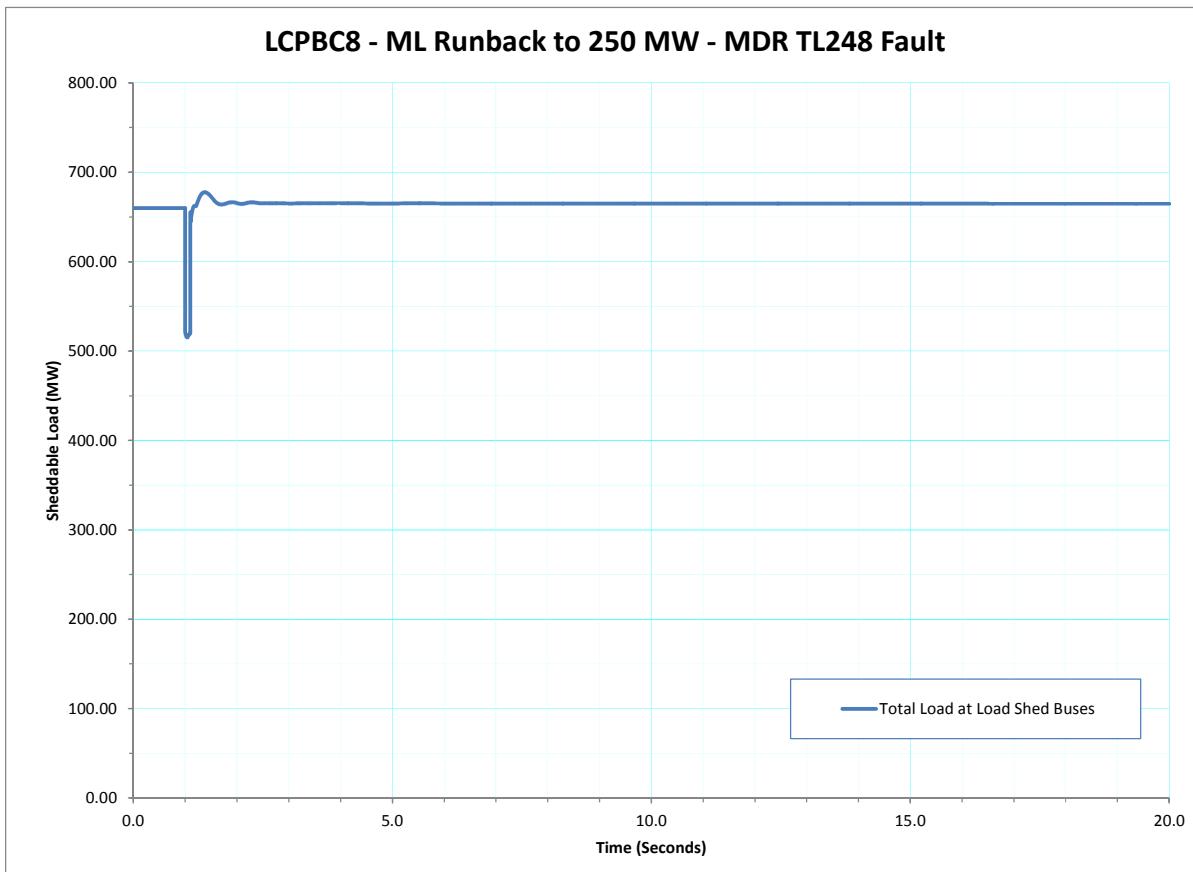
Figure 456 - LCPBC8 - ML Runback to 250 MW - MDR TL248 Fault - Sheddable Load (MW)

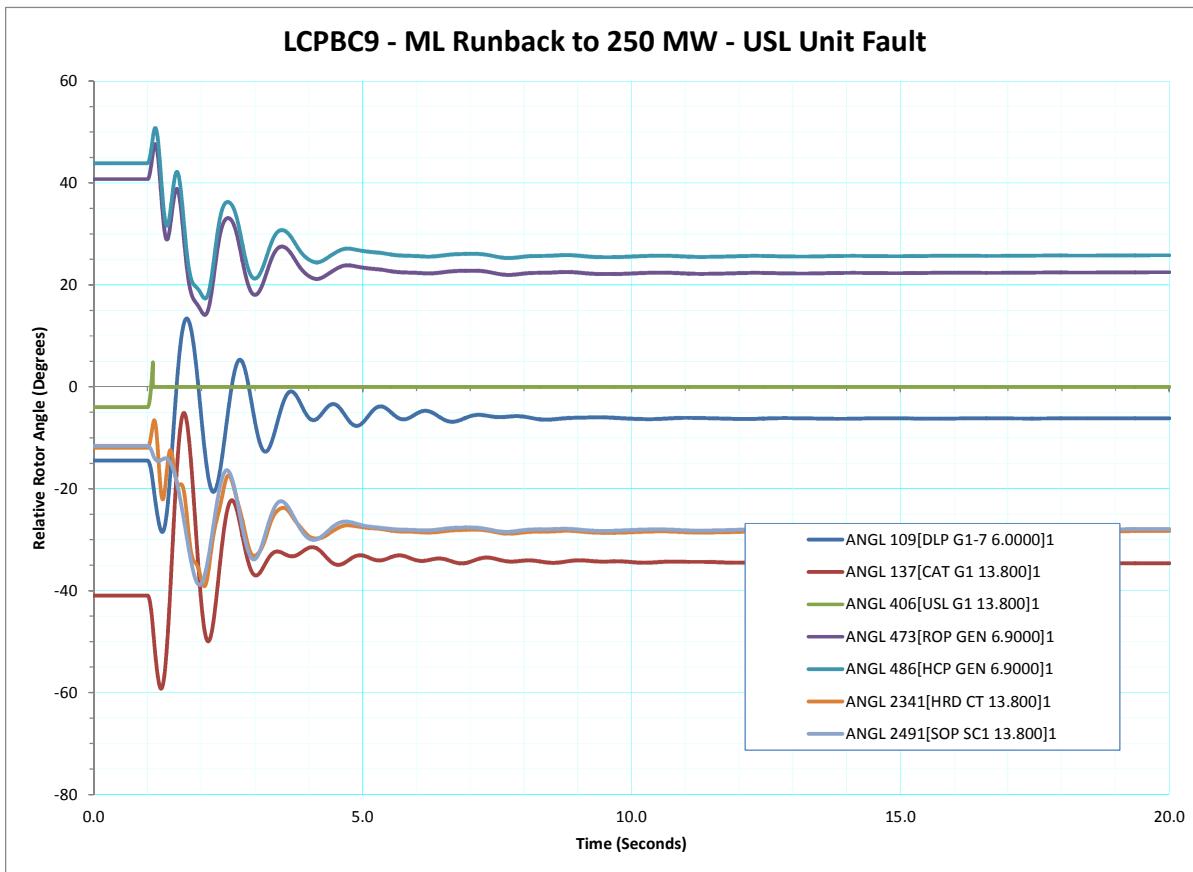
Figure 457 - LCPBC9 - ML Runback to 250 MW - USL Unit Fault - Relative Rotor Angle (Degrees)

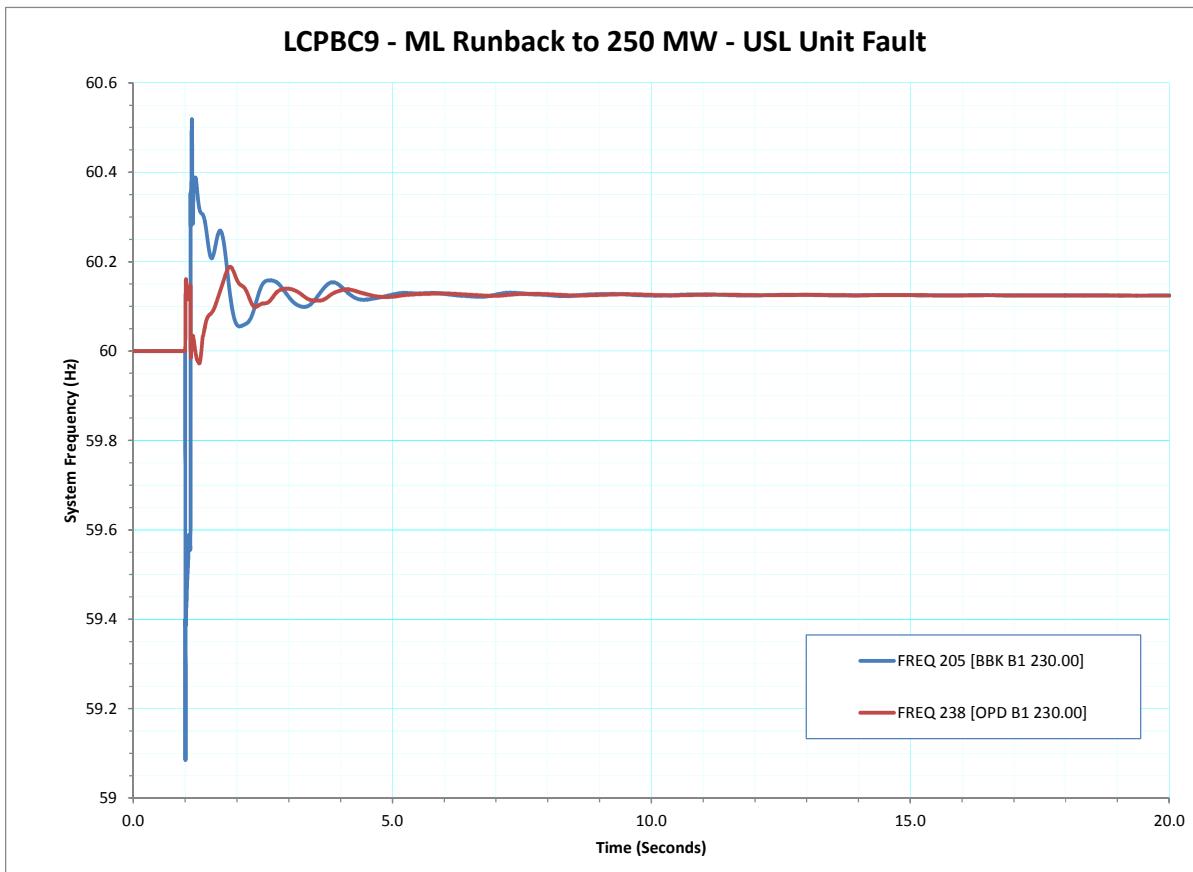
Figure 458 - LCPBC9 - ML Runback to 250 MW - USL Unit Fault - System Frequency (Hz)

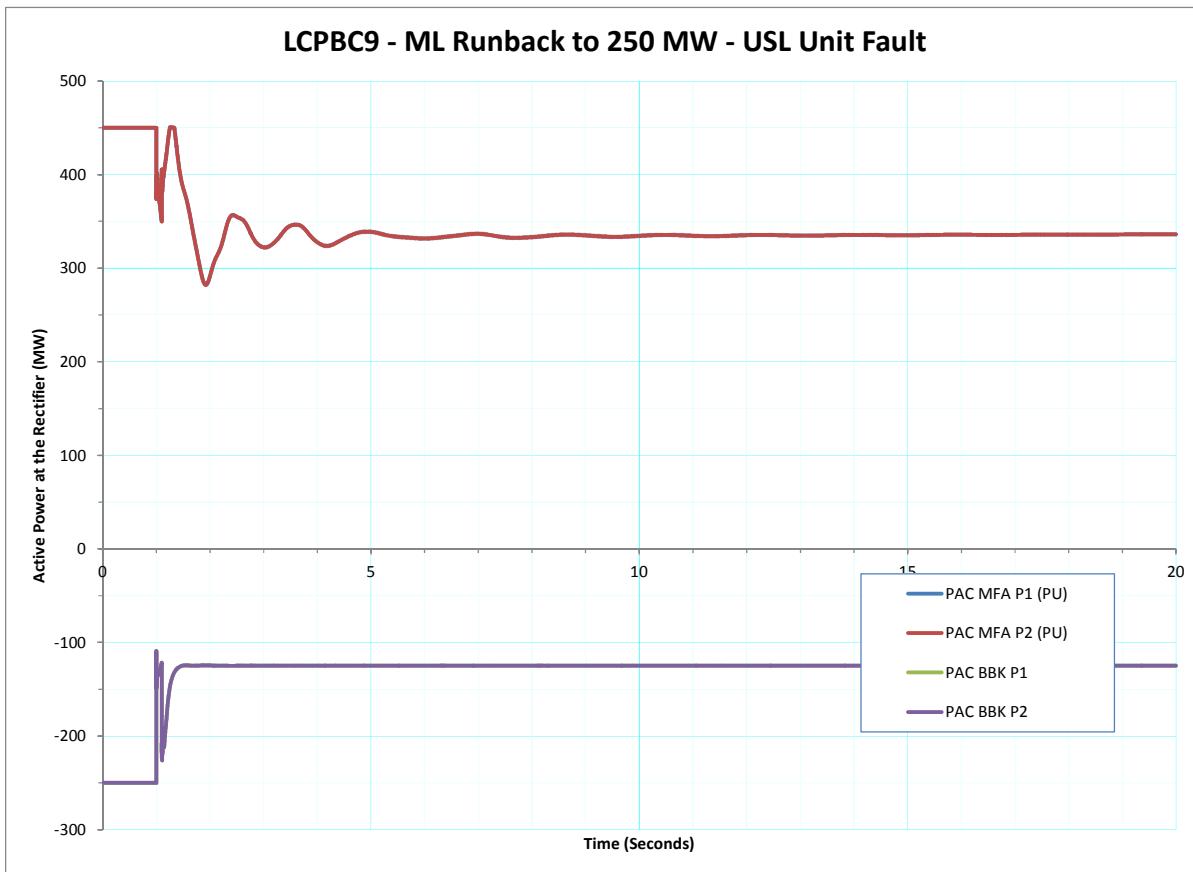
Figure 459 - LCPBC9 - ML Runback to 250 MW - USL Unit Fault - Active Power at the Rectifier (MW)

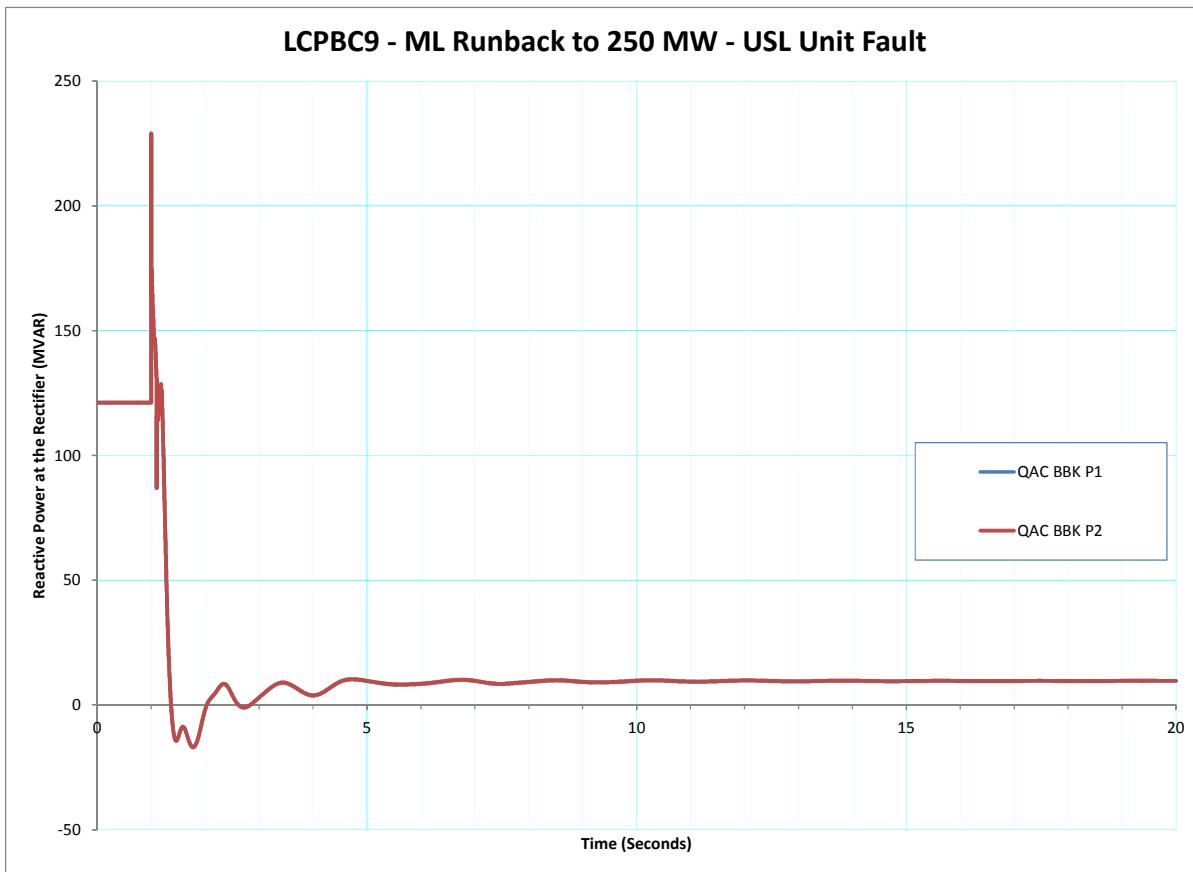
Figure 460 - LCPBC9 - ML Runback to 250 MW - USL Unit Fault - Reactive Power at the Rectifier (MVAR)

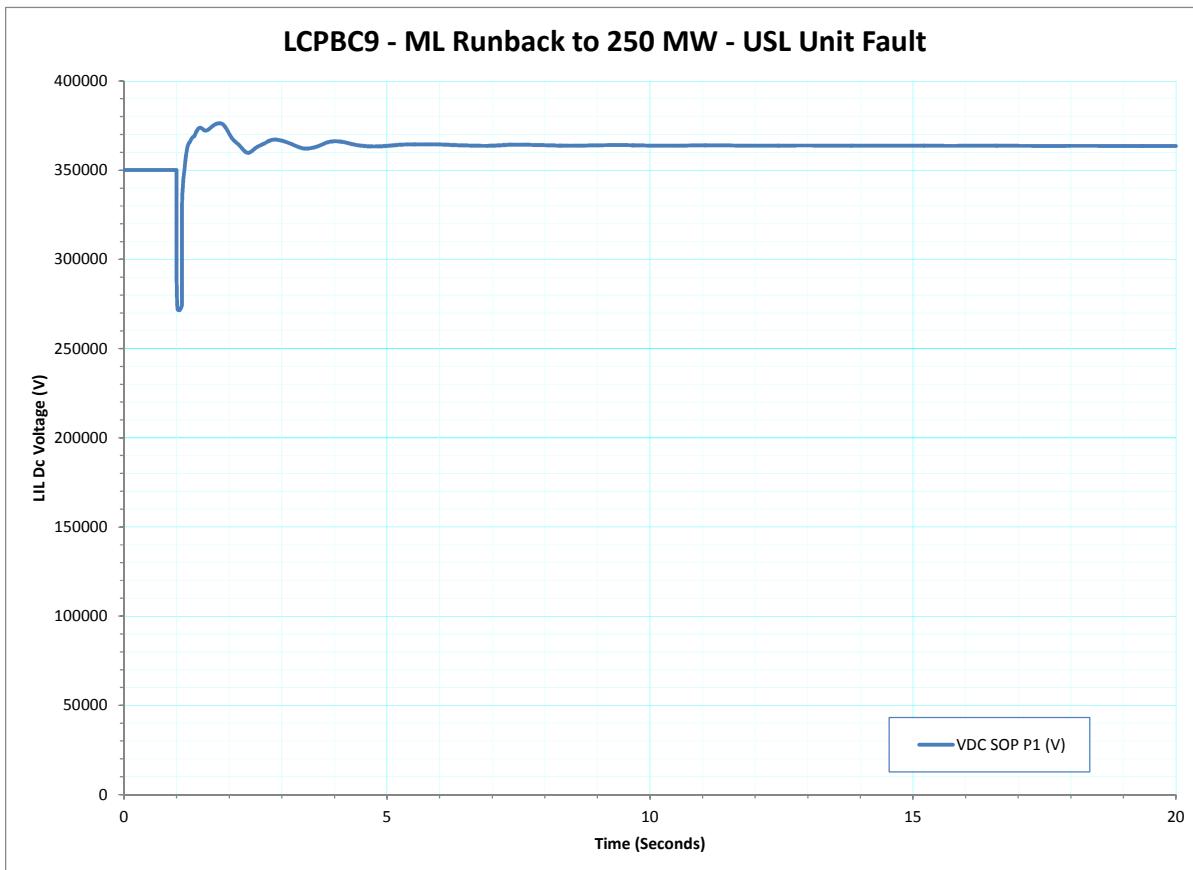
Figure 461 - LCPBC9 - ML Runback to 250 MW - USL Unit Fault - LIL Dc Voltage (V)

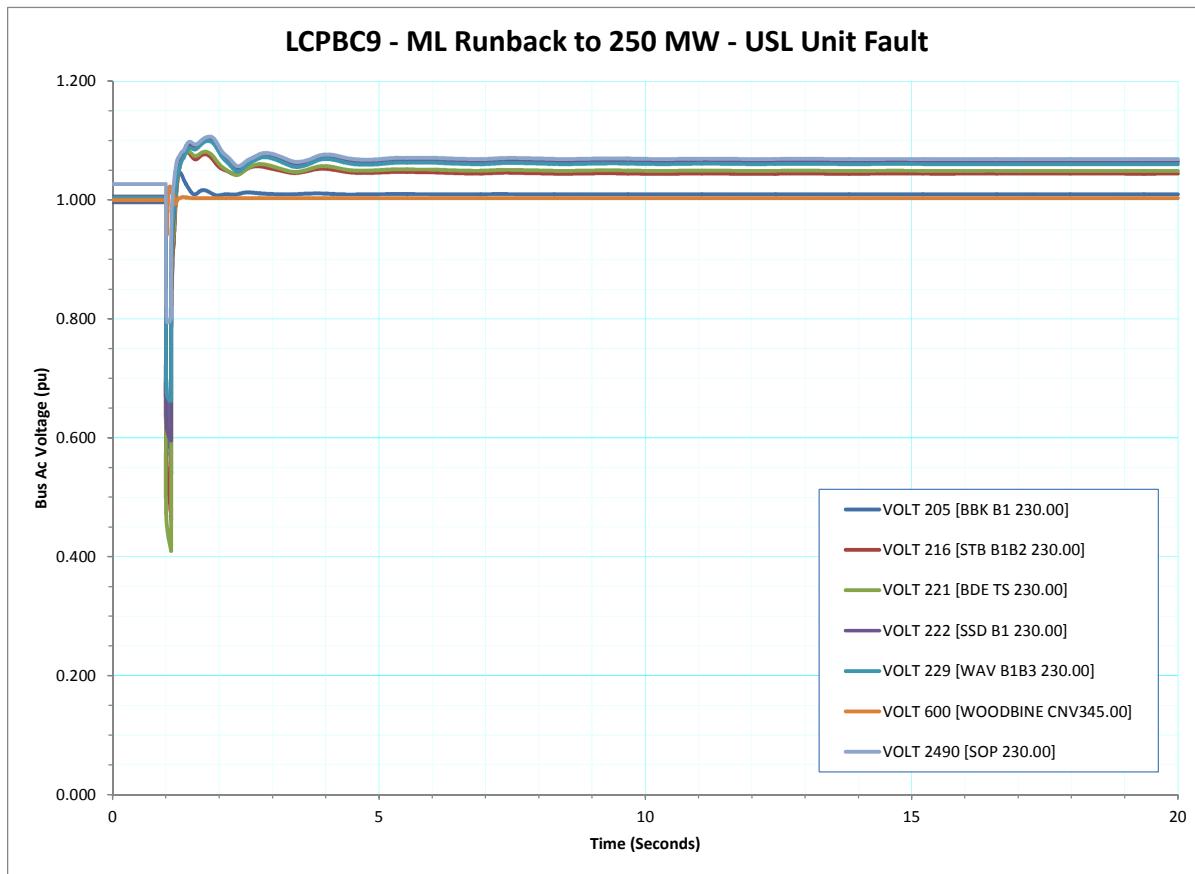
Figure 462 - LCPBC9 - ML Runback to 250 MW - USL Unit Fault - Bus Ac Voltage (pu)
