MARITIME LINK PRELIMINARY INTERCONNECTION STUDY

Newfoundland and Labrador Hydro

July 2014

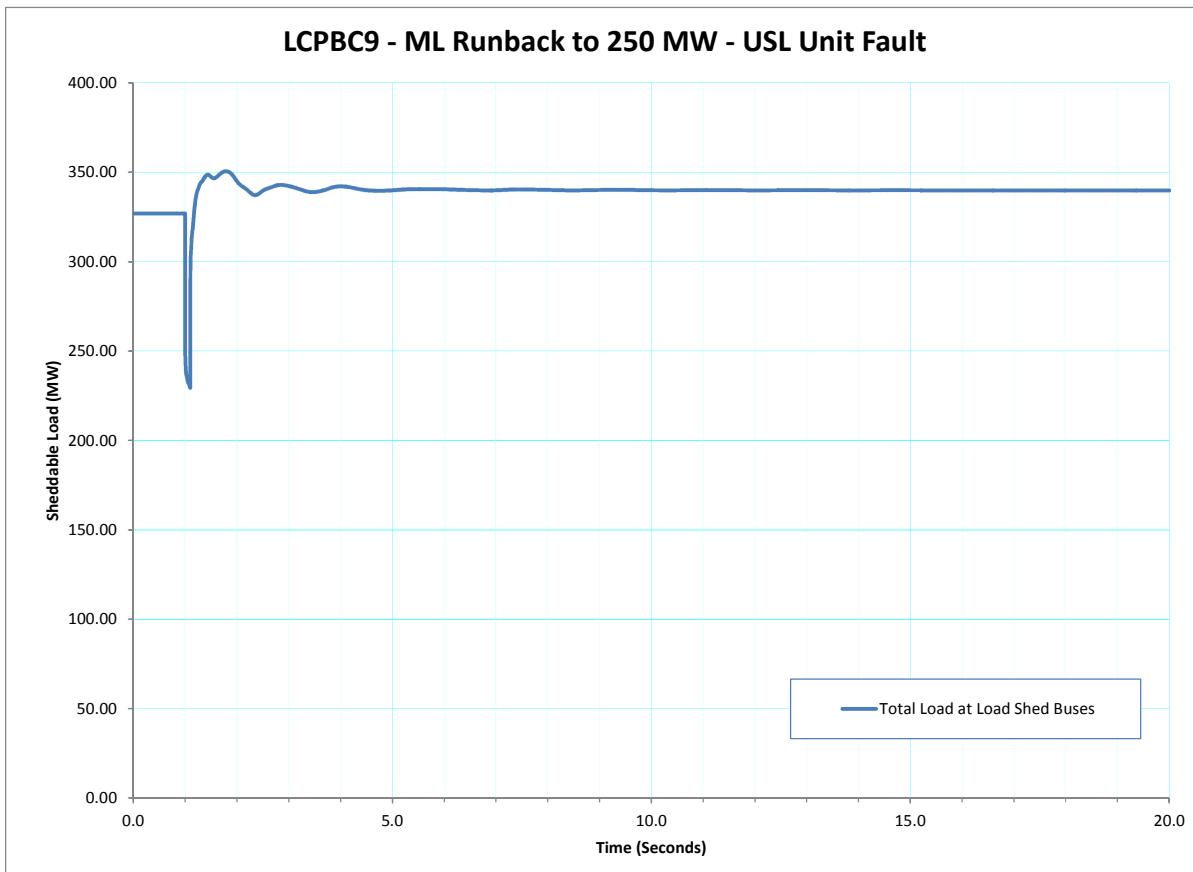
Figure 463 - LCPBC9 - ML Runback to 250 MW - USL Unit Fault - Shedtable Load (MW)

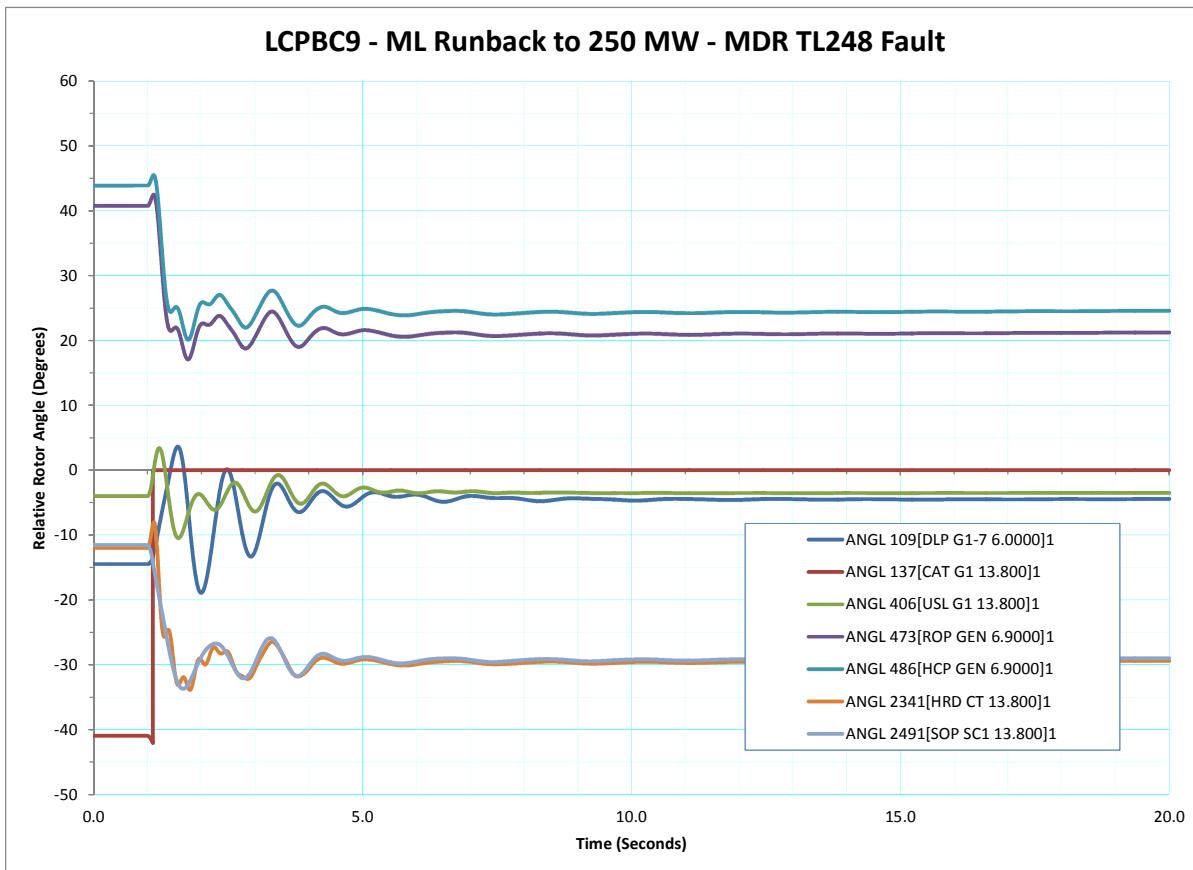
Figure 464 - LCPBC9 - ML Runback to 250 MW - MDR TL248 Fault - Relative Rotor Angle (Degrees)

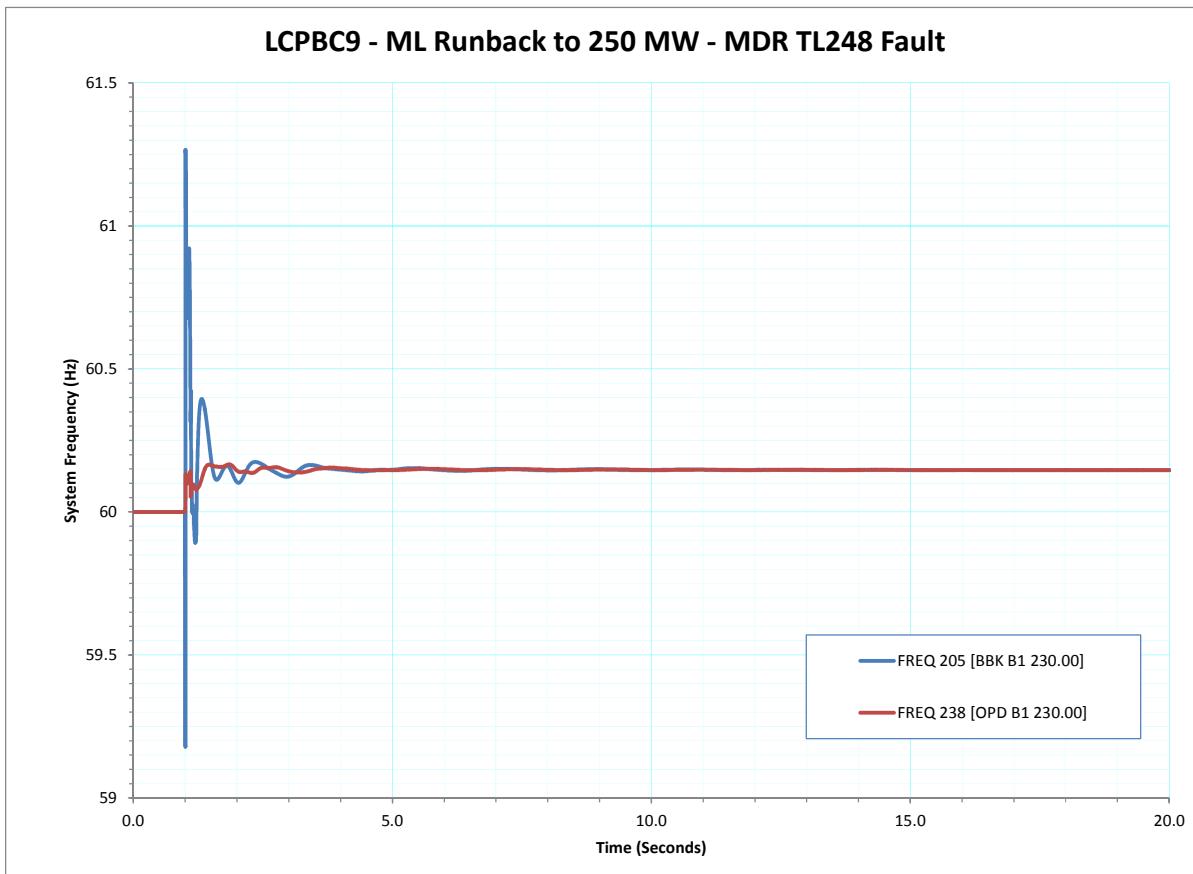
Figure 465 - LCPBC9 - ML Runback to 250 MW - MDR TL248 Fault - System Frequency (Hz)

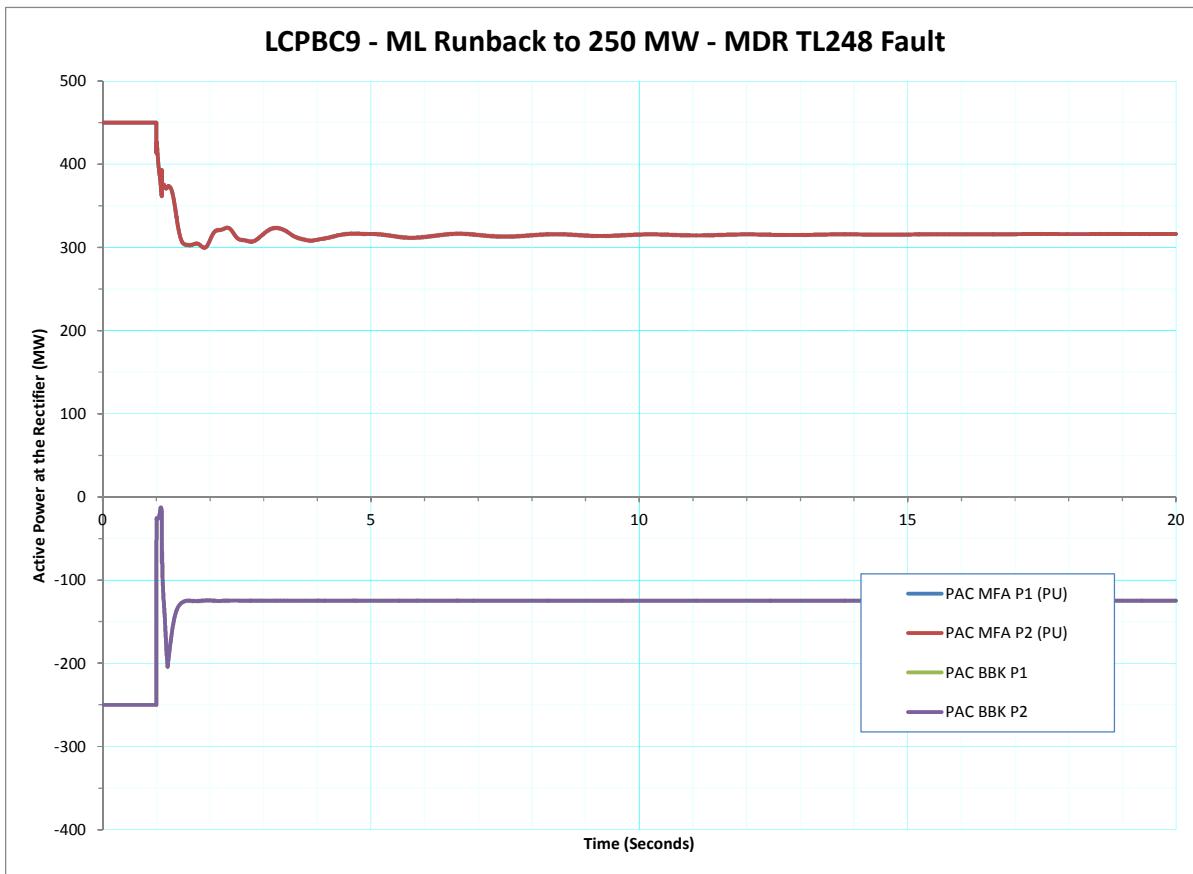
Figure 466 - LCPBC9 - ML Runback to 250 MW - MDR TL248 Fault - Active Power at the Rectifier (MW)

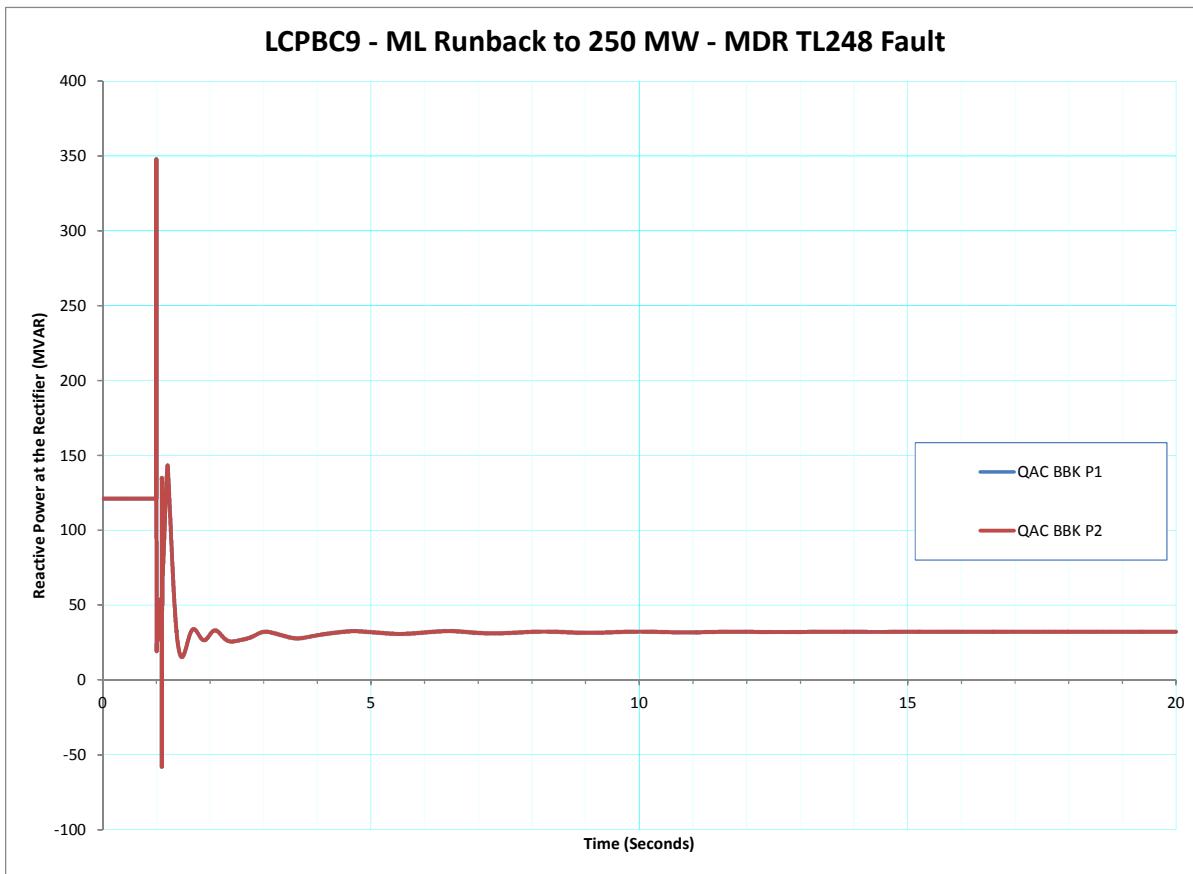
Figure 467 - LCPBC9 - ML Runback to 250 MW - MDR TL248 Fault - Reactive Power at the Rectifier (MVAR)

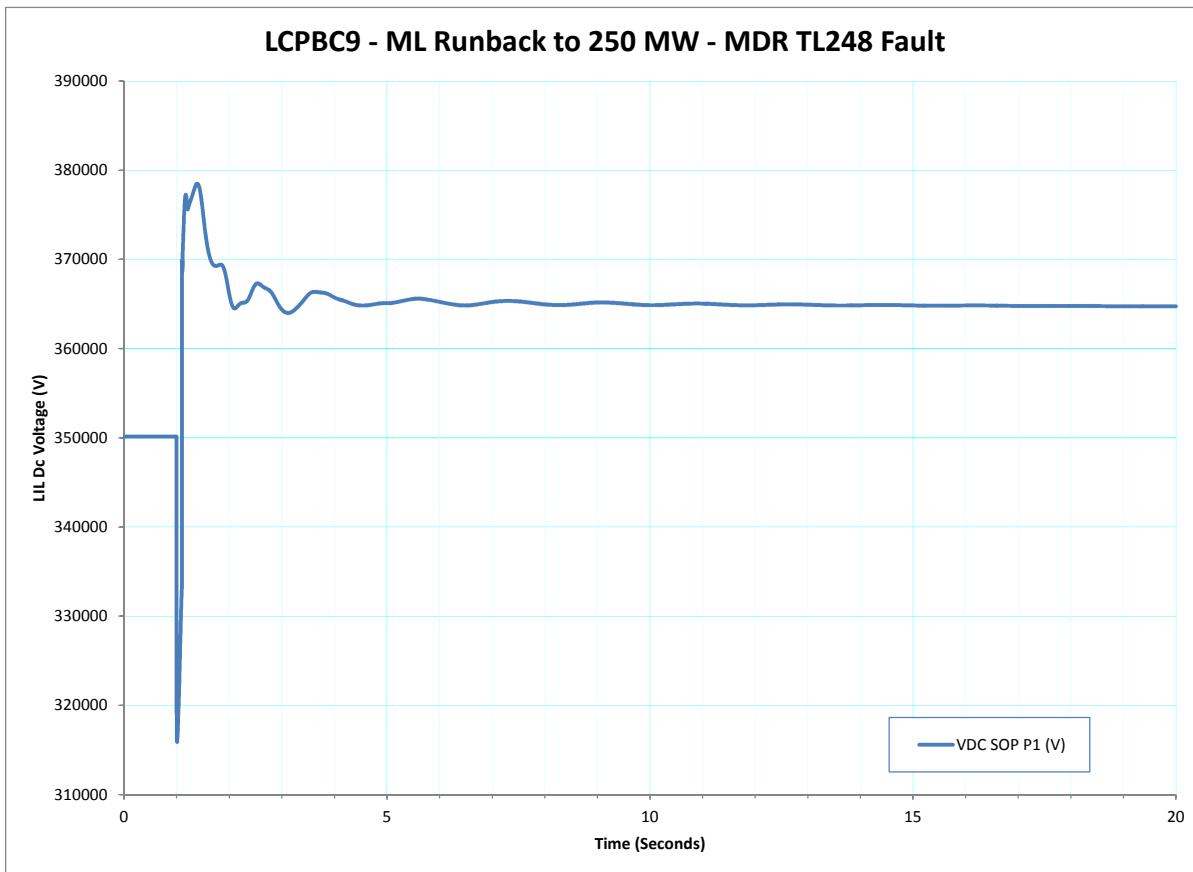
Figure 468 - LCPBC9 - ML Runback to 250 MW - MDR TL248 Fault - LIL Dc Voltage (V)

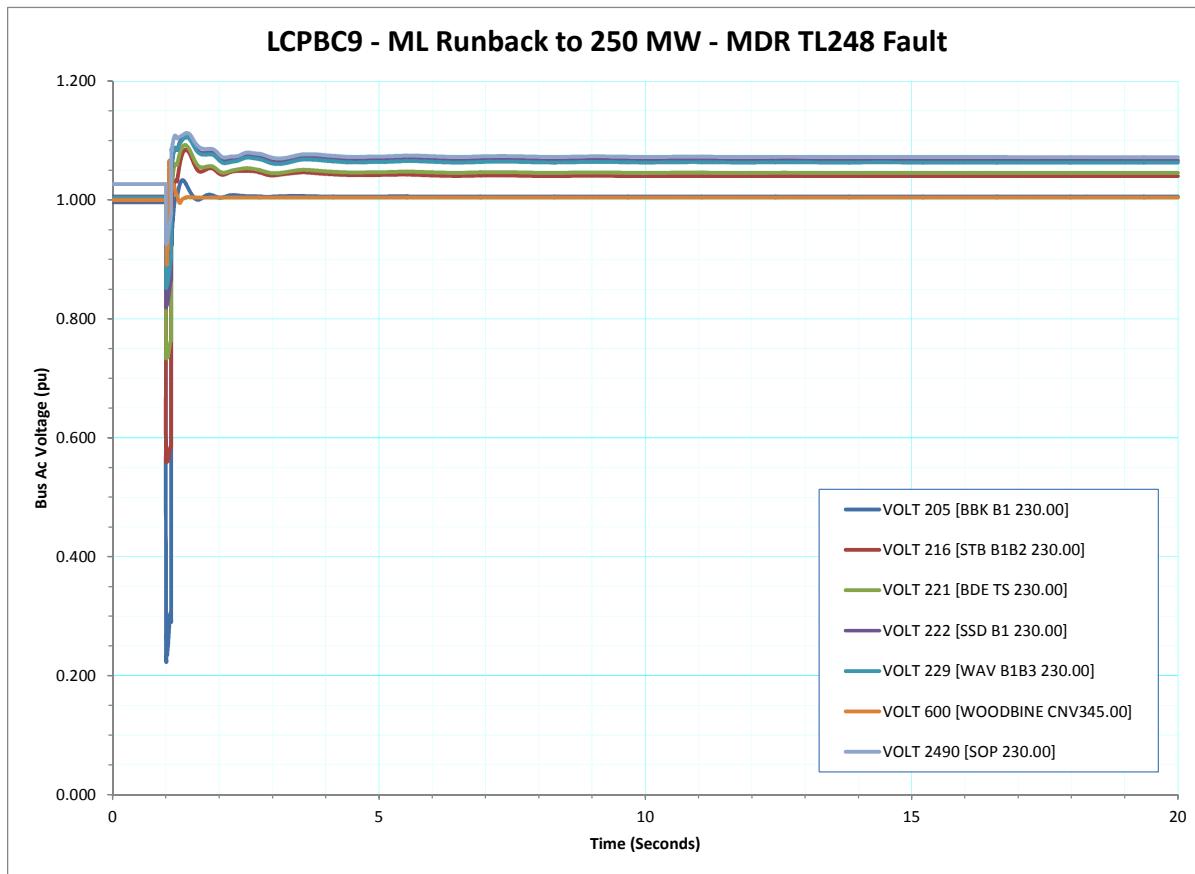
Figure 469 - LCPBC9 - ML Runback to 250 MW - MDR TL248 Fault - Bus Ac Voltage (pu)

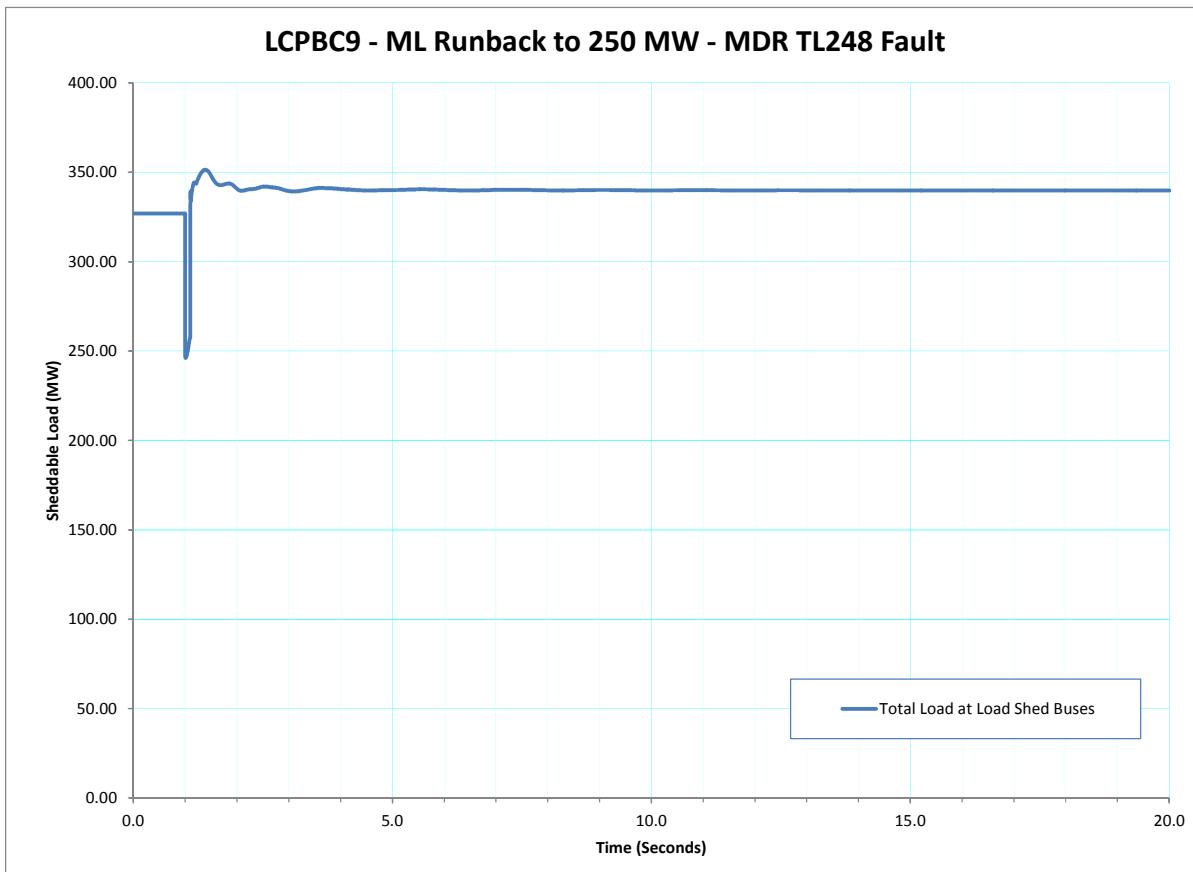
Figure 470 - LCPBC9 - ML Runback to 250 MW - MDR TL248 Fault - Sheddable Load (MW)

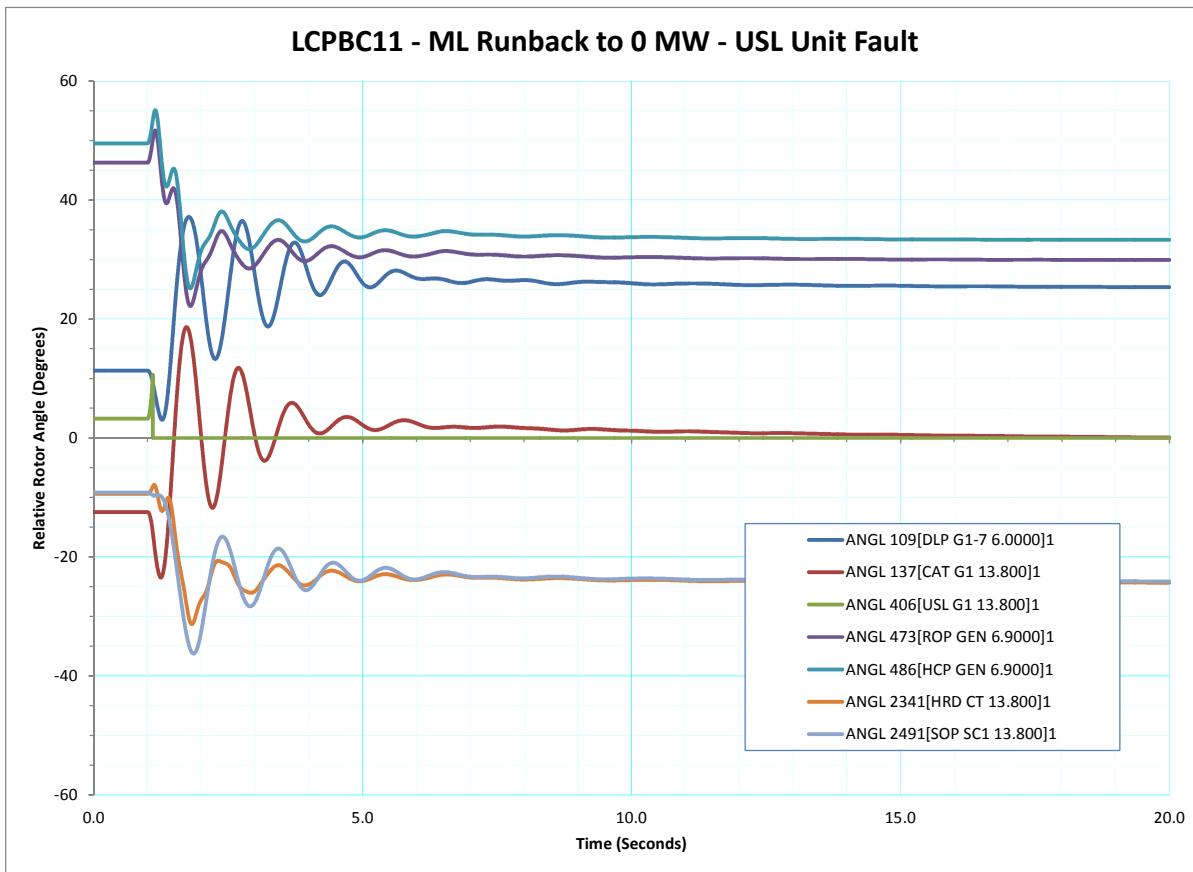
Figure 471 - LCPBC11 - ML Runback to 0 MW - USL Unit Fault - Relative Rotor Angle (Degrees)

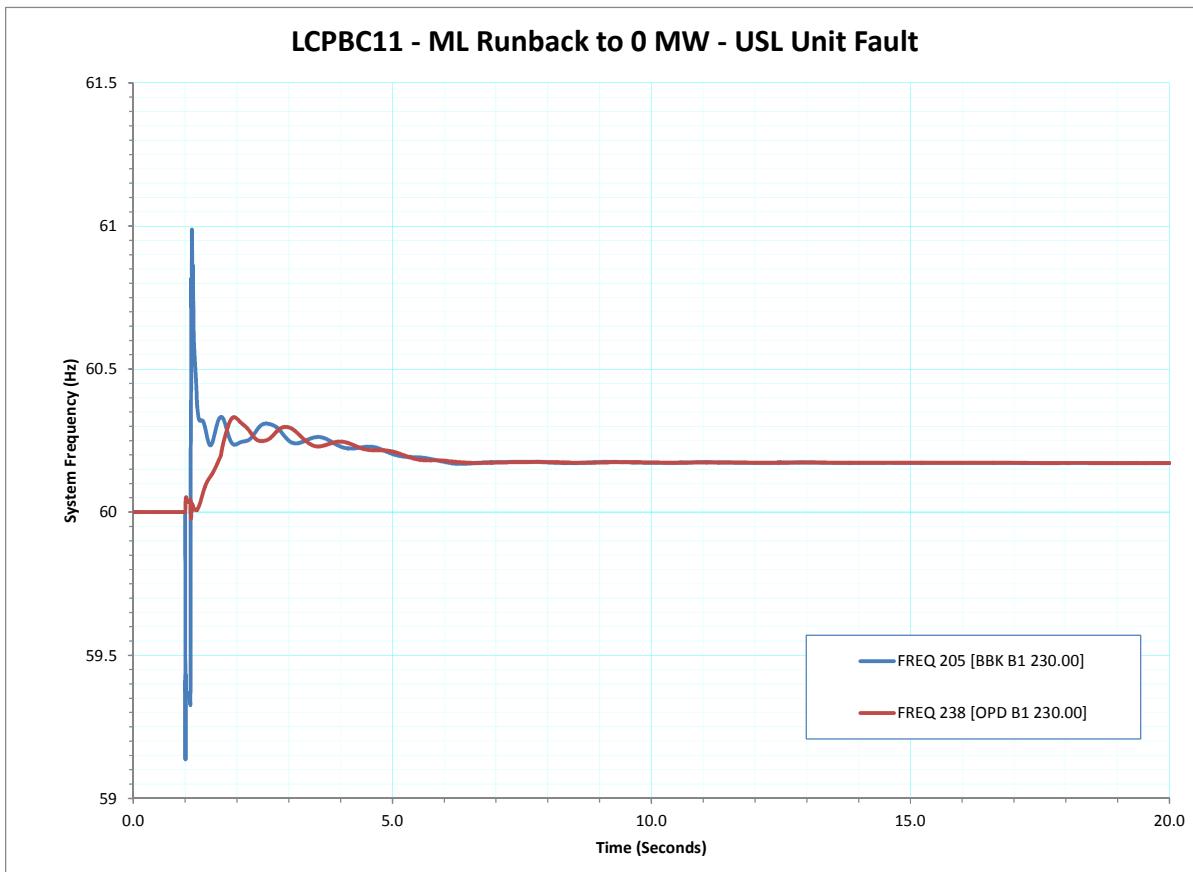
Figure 472 - LCPBC11 - ML Runback to 0 MW - USL Unit Fault - System Frequency (Hz)

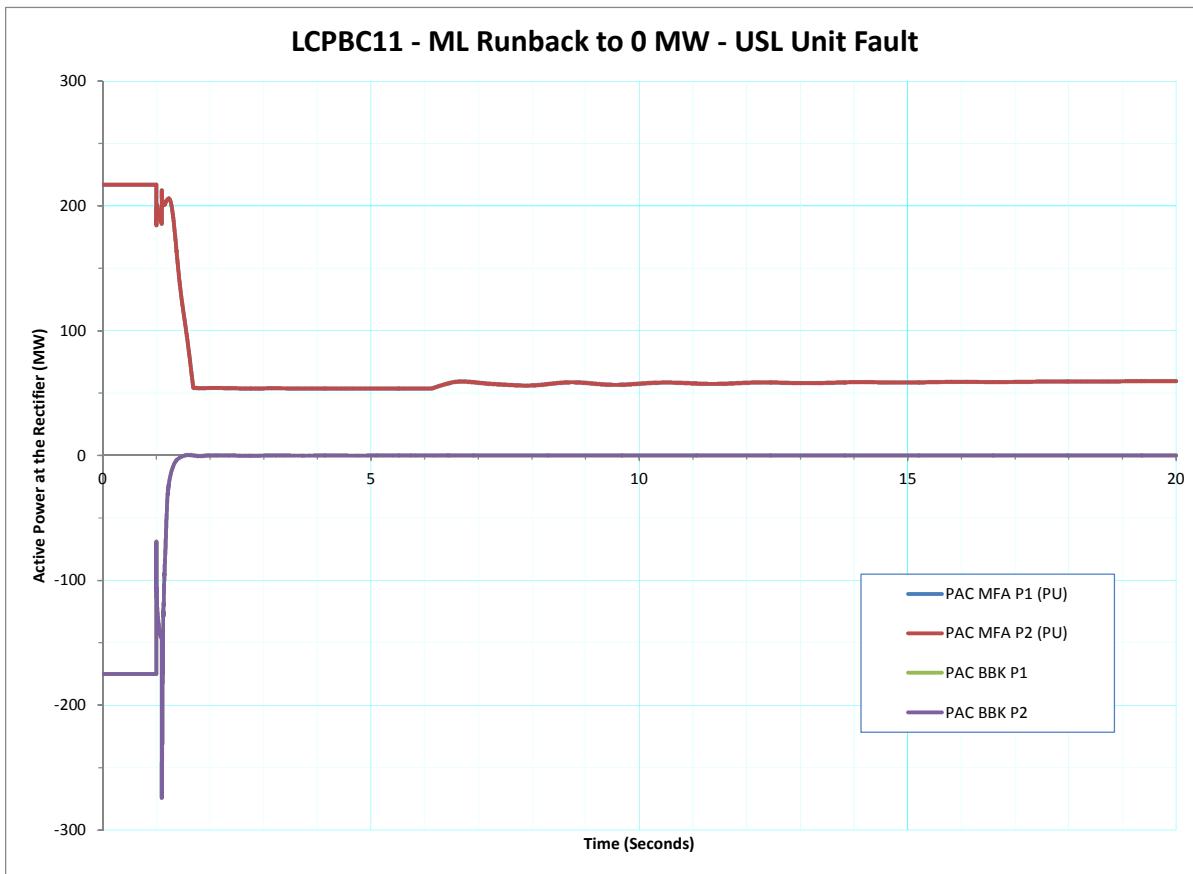
Figure 473 - LCPBC11 - ML Runback to 0 MW - USL Unit Fault - Active Power at the Rectifier (MW)

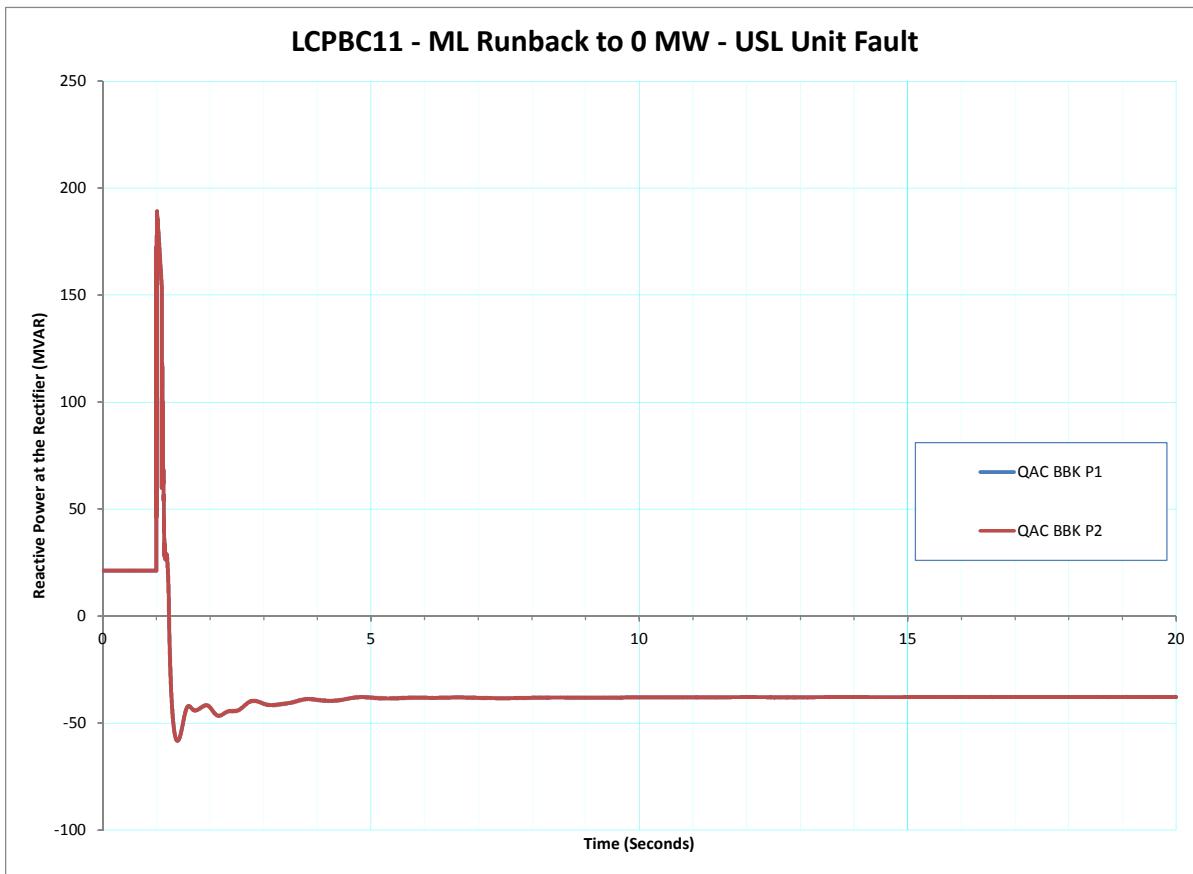
Figure 474 - LCPBC11 - ML Runback to 0 MW - USL Unit Fault - Reactive Power at the Rectifier (MVAR)

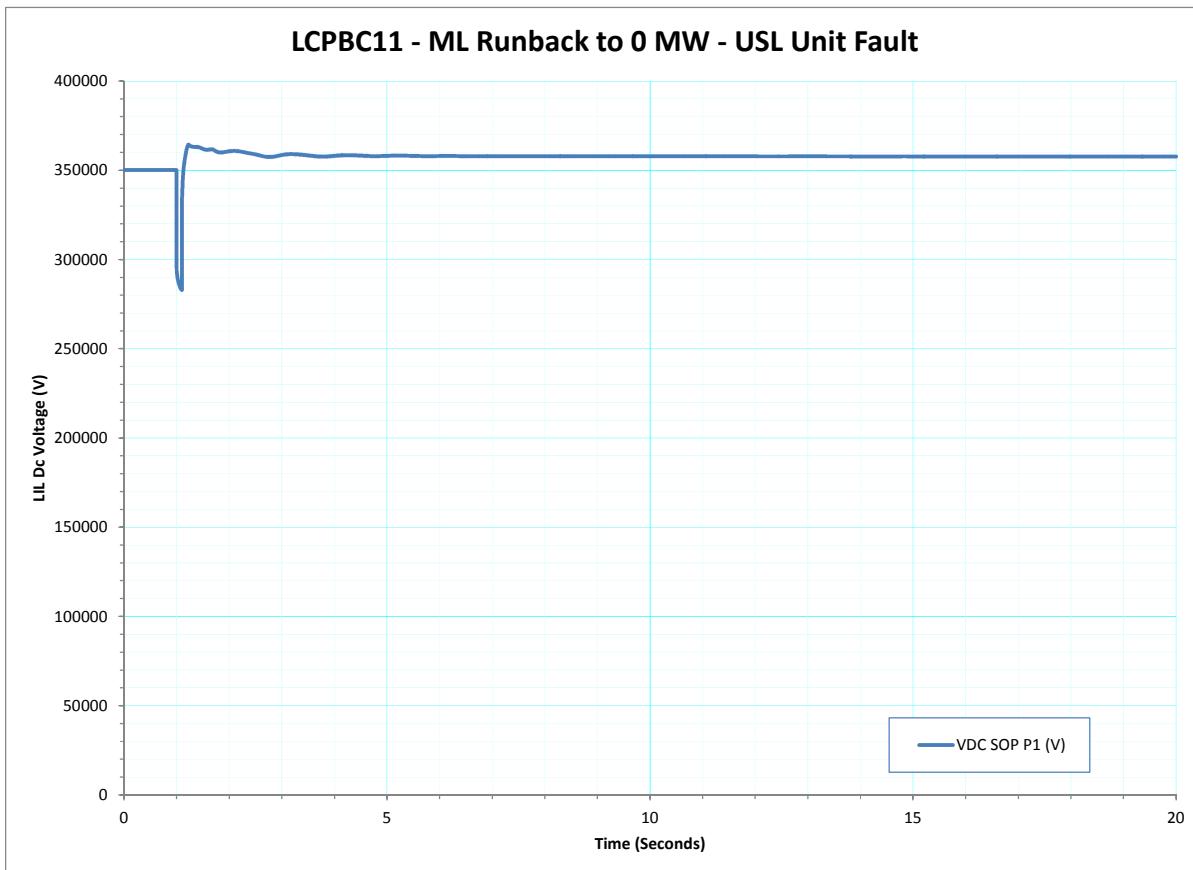
Figure 475 - LCPBC11 - ML Runback to 0 MW - USL Unit Fault - LIL Dc Voltage (V)

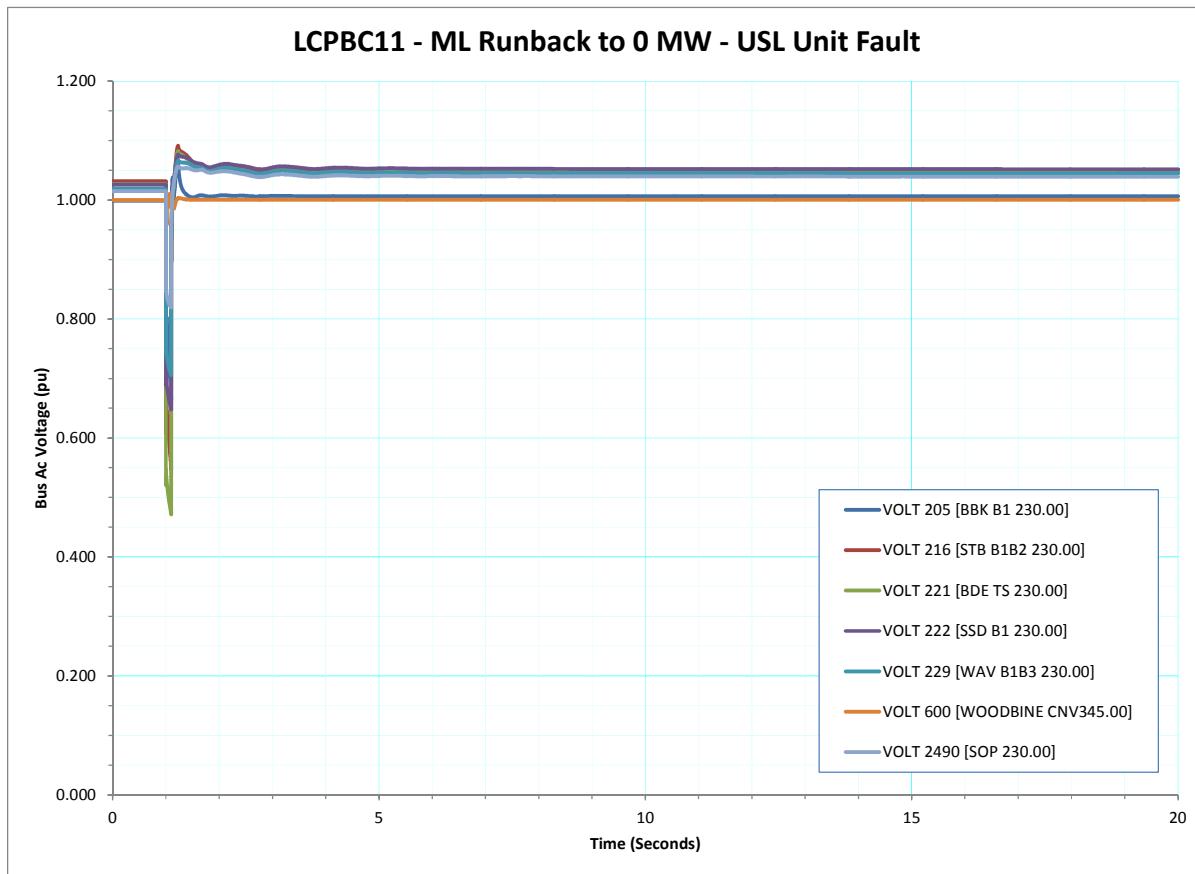
Figure 476 - LCPBC11 - ML Runback to 0 MW - USL Unit Fault - Bus Ac Voltage (pu)

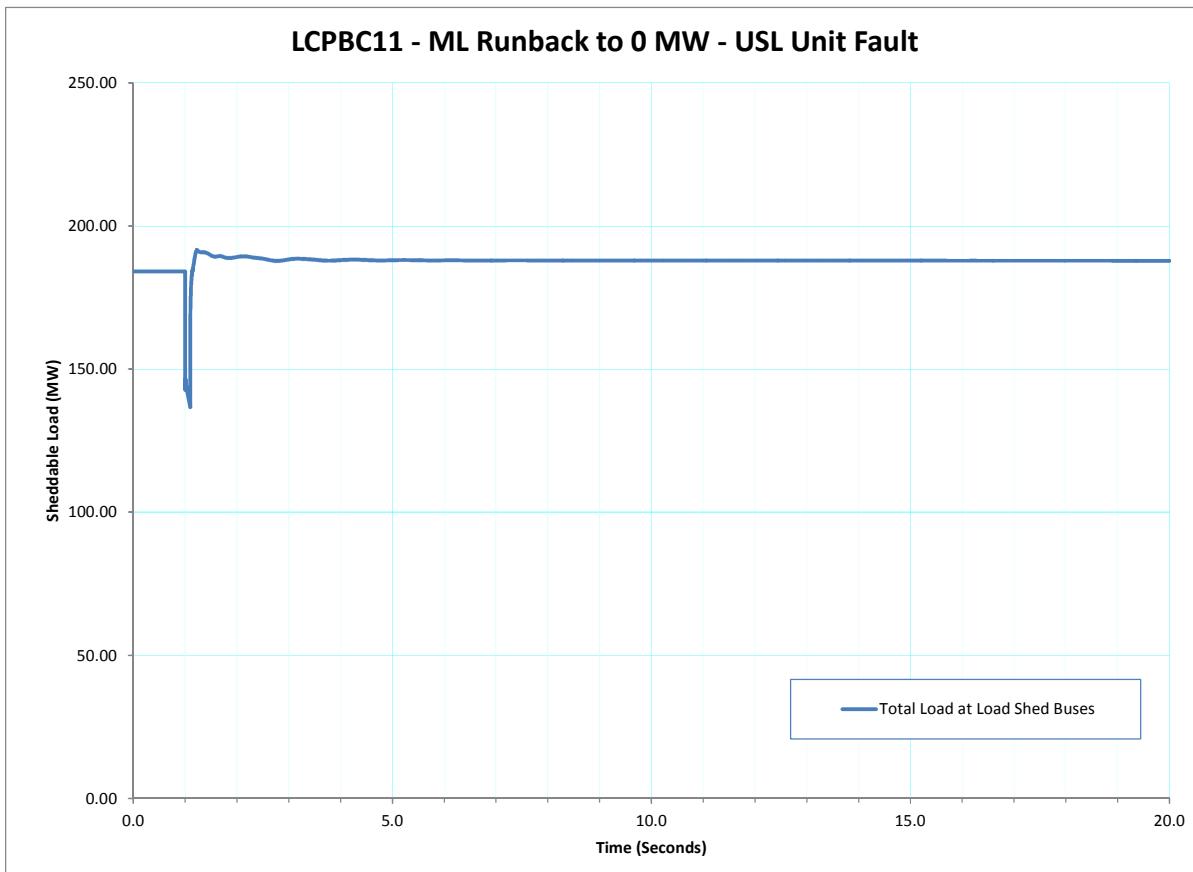
Figure 477 - LCPBC11 - ML Runback to 0 MW - USL Unit Fault - Sheddable Load (MW)

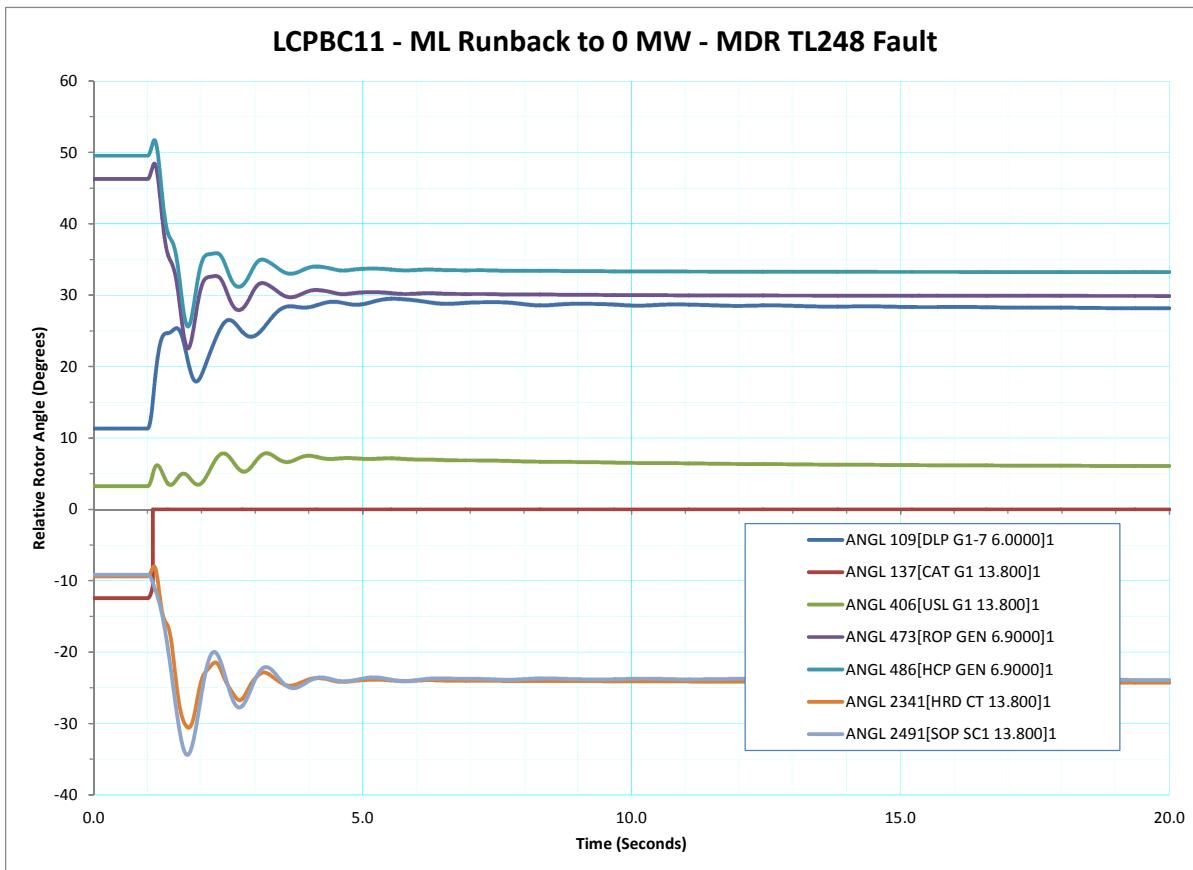
Figure 478 - LCPBC11 - ML Runback to 0 MW - MDR TL248 Fault - Relative Rotor Angle (Degrees)

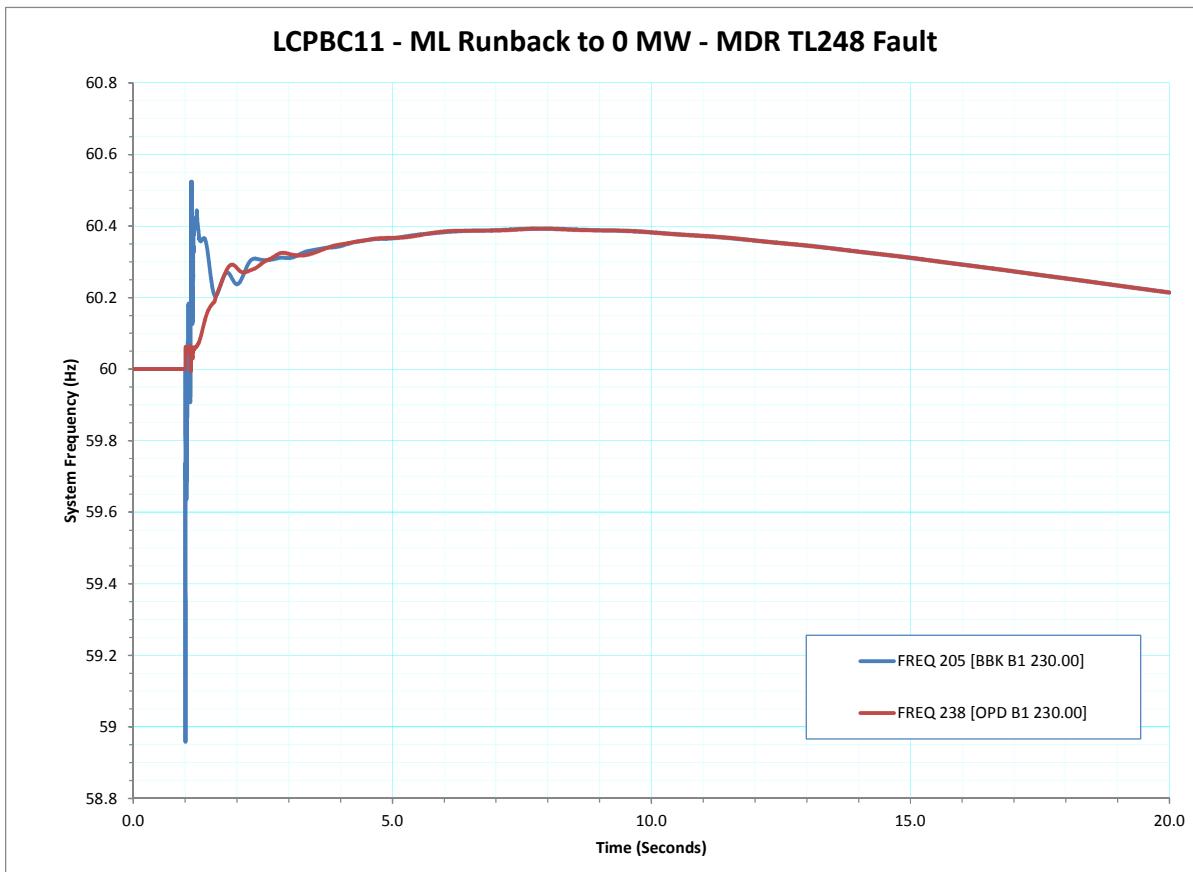
Figure 479 - LCPBC11 - ML Runback to 0 MW - MDR TL248 Fault - System Frequency (Hz)

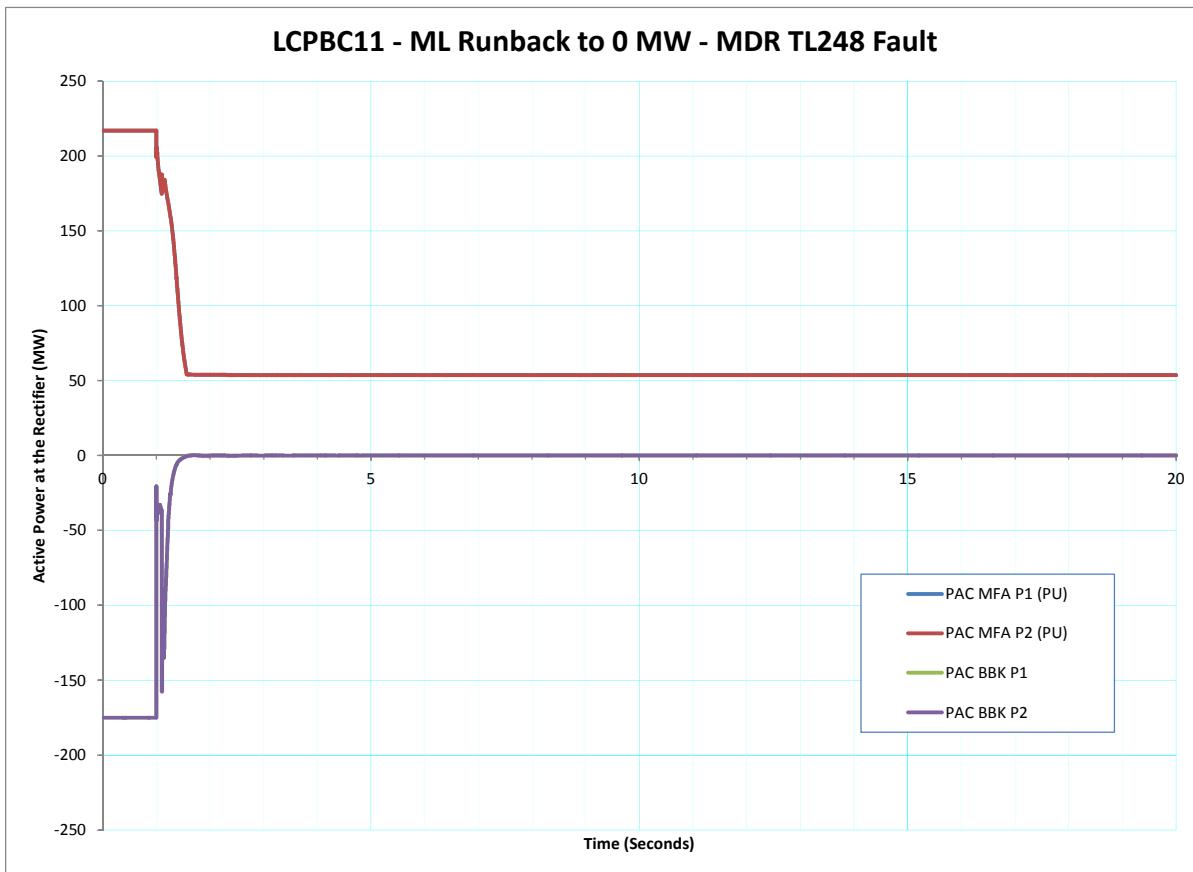
Figure 480 - LCPBC11 - ML Runback to 0 MW - MDR TL248 Fault - Active Power at the Rectifier (MW)

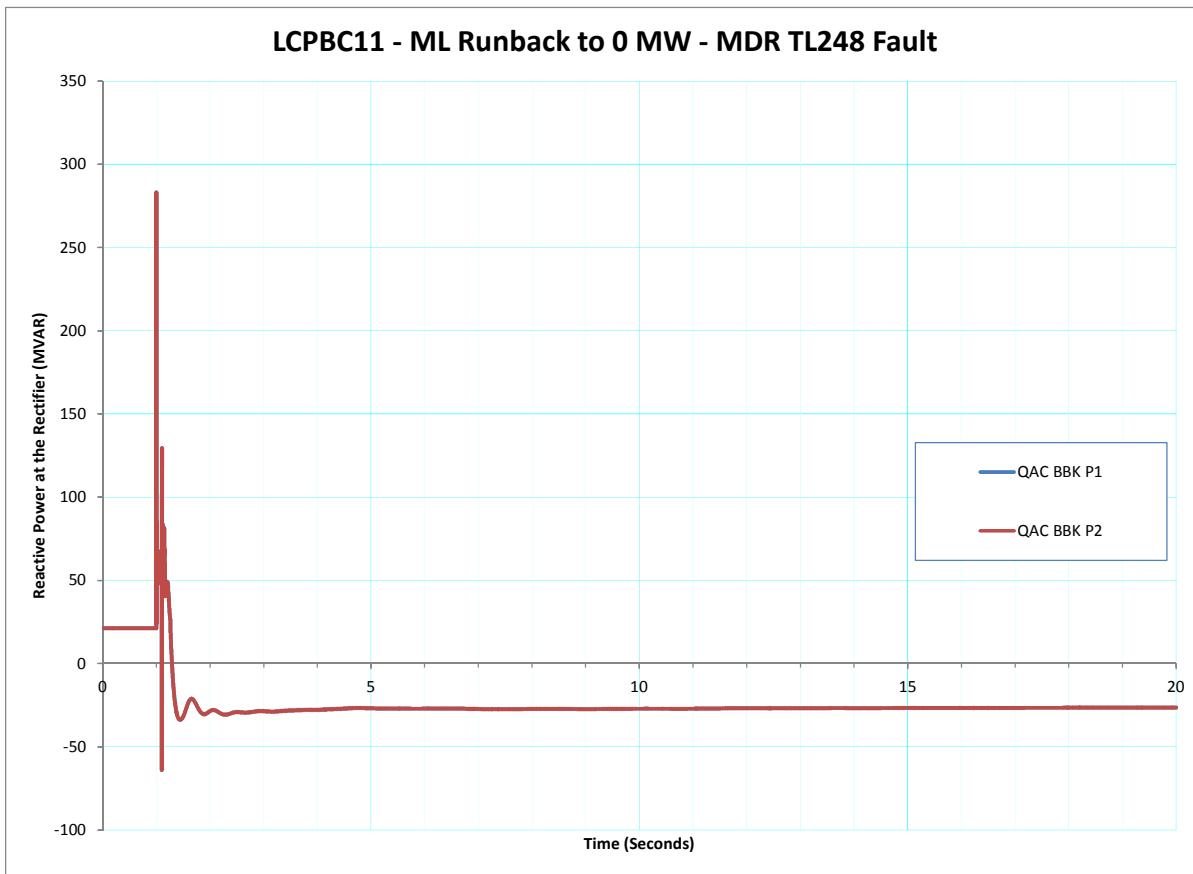
Figure 481 - LCPBC11 - ML Runback to 0 MW - MDR TL248 Fault - Reactive Power at the Rectifier (MVAR)

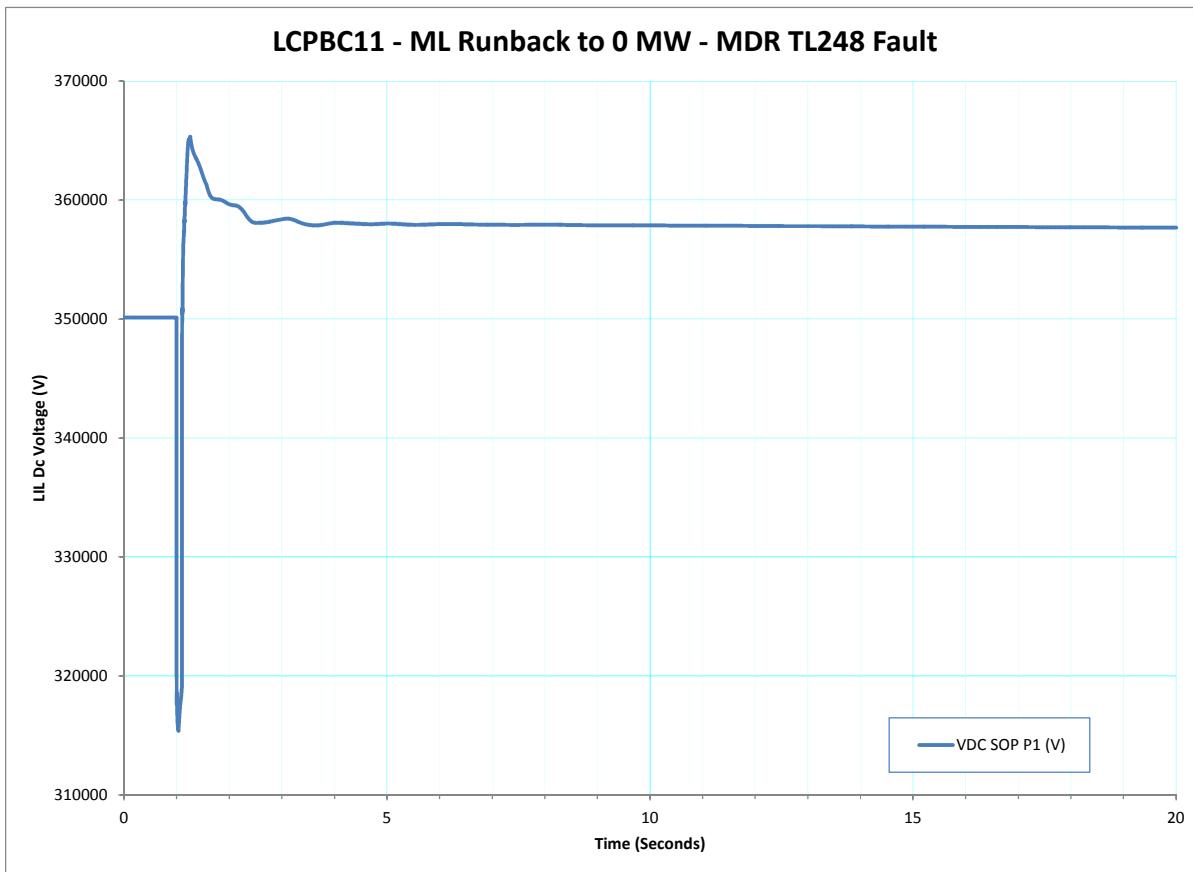
Figure 482 - LCPBC11 - ML Runback to 0 MW - MDR TL248 Fault - LIL Dc Voltage (V)

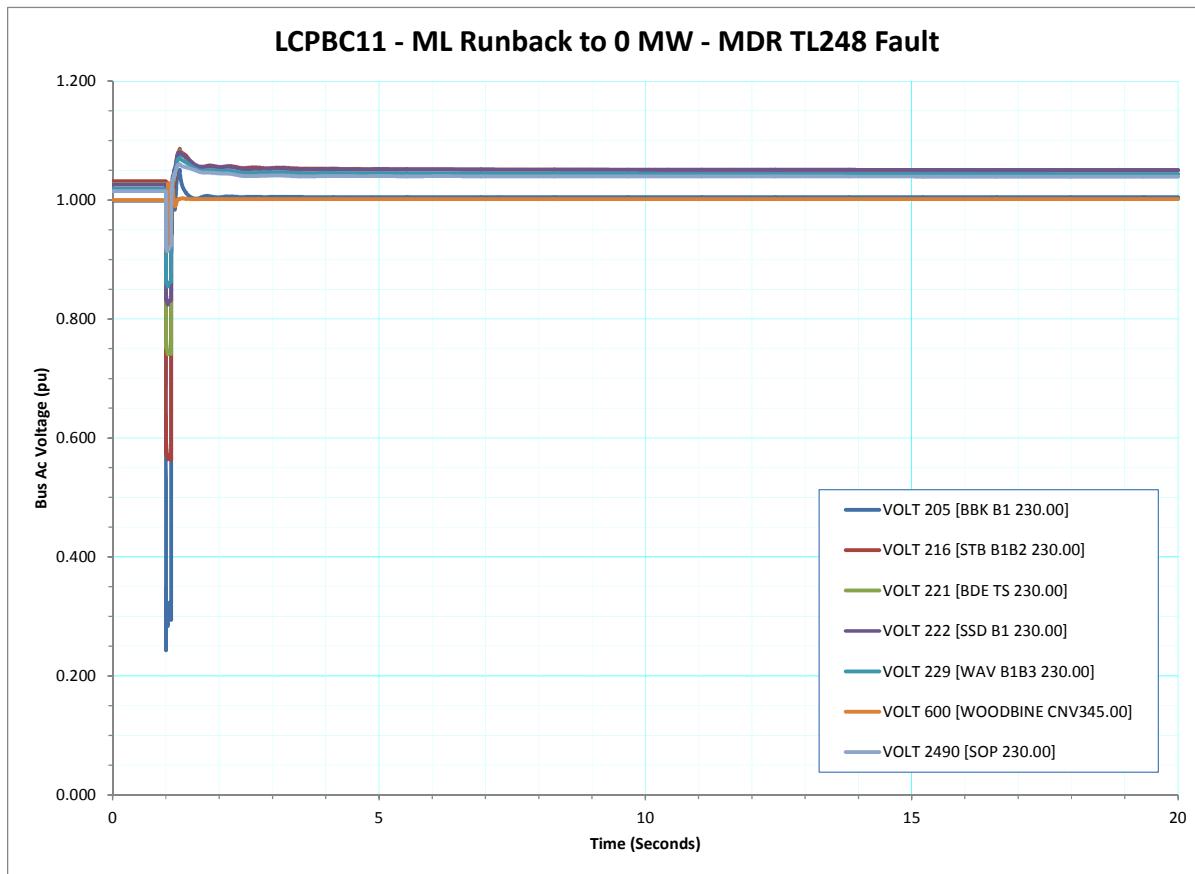
Figure 483 - LCPBC11 - ML Runback to 0 MW - MDR TL248 Fault - Bus Ac Voltage (pu)
