MARITIME LINK PRELIMINARY INTERCONNECTION STUDY

Newfoundland and Labrador Hydro

July 2014

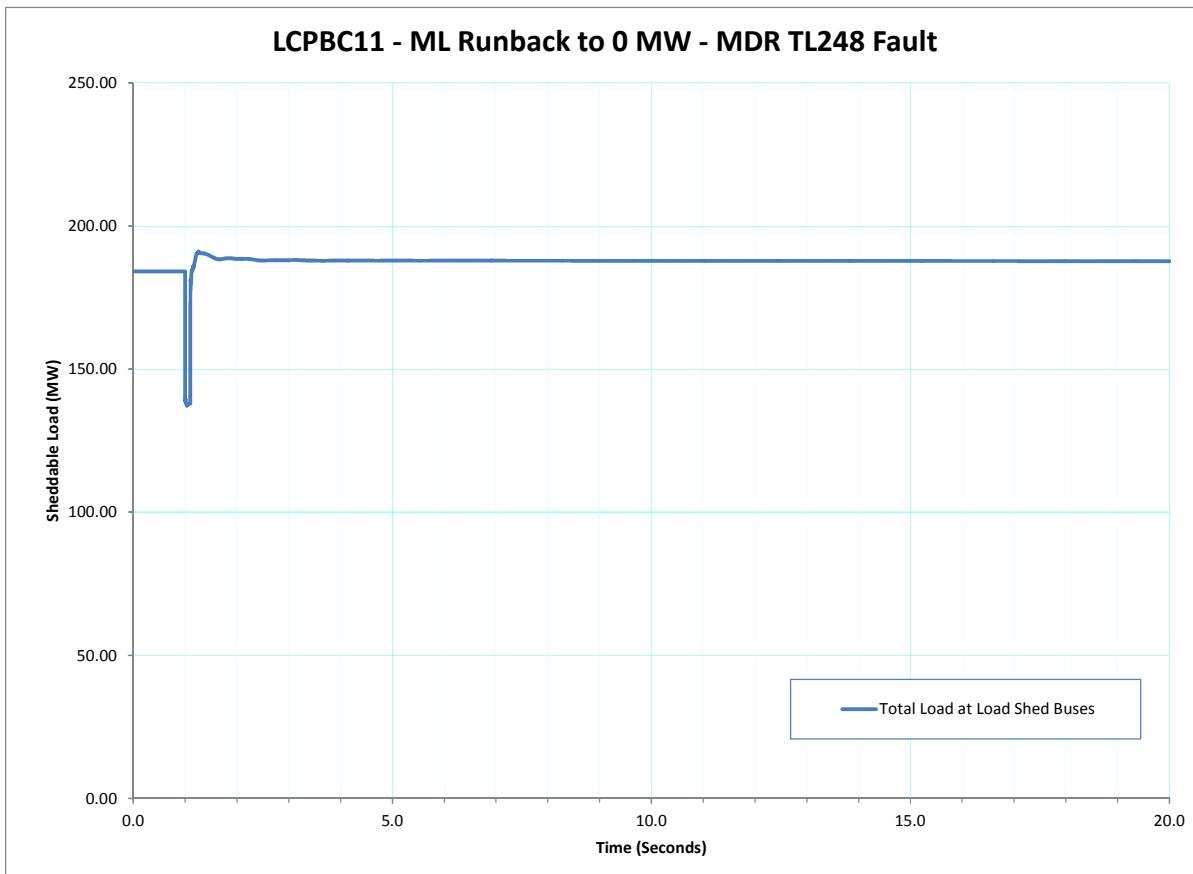
Figure 484 - LCPBC11 - ML Runback to 0 MW - MDR TL248 Fault - Sheddable Load (MW)
