Newfoundland and Labrador Hydro - The Board's Investigation and Hearing into Supply Issues and Power Outages on the Island Interconnected System - Rolling 12 month performance of Hydro's generating units

# A REPORT TO THE BOARD OF COMMISSIONERS OF PUBLIC UTILITIES

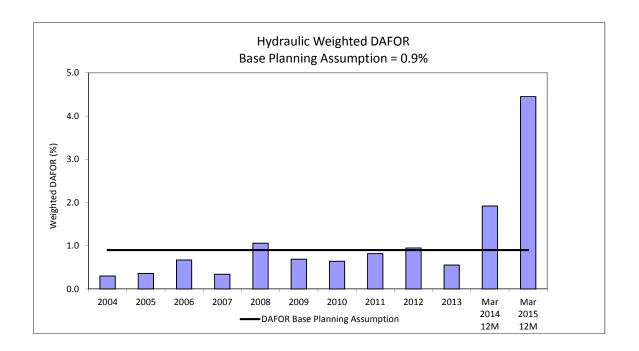
The hydraulic units forced outage rates are measured using DAFOR. Detailed results for the 12-month period ending March 31, 2015 is presented as well as the data for the 12-month period ending March 31, 2014 and the Hydro Generation Planning Assumption for the forced outage rate.

Generating Unit	Maximum Continuous Unit Rating (MW)	12 months ending March 2014 (%)	12 months ending March 2015 (%)	Hydro Generation Base Planning Assumption (%)
All Hydraulic Units - weighted	954.4	1.92	4.45	0.90
Hydraulic Units				
Bay D'Espoir 1	76.5	0.04	0.03	0.90
Bay D'Espoir 2	76.5	3.23	0.01	0.90
Bay D'Espoir 3	76.5	0.03	0.00	0.90
Bay D'Espoir 4	76.5	0.00	0.64	0.90
Bay D'Espoir 5	76.5	2.23	0.18	0.90
Bay D'Espoir 6	76.5	19.36	45.48	0.90
Bay D'Espoir 7	154.4	0.00	2.10	0.90
Hinds Lake	75	0.12	0.21	0.90
Upper Salmon	84	0.12	2.22	0.90
Granite Canal	40	1.42	0.32	0.90
Cat Arm 1	67	0.00	0.62	0.90
Cat Arm 2	67	1.06	1.34	0.90
Paradise River	8	0.65	0.00	0.90

1 The weighted "All Hydraulic Units" DAFOR was 4.45% for the current 12 month period 2 ending March 31, 2015. The forced outage to Unit 6 at Bay d'Espoir was the primary 3 contributor to the DAFOR of 4.45% as compared to a base planning assumption of 0.9%. 4 This one forced outage, contributed 86% of the total DAFOR in this asset class. 5 6 Considering the individual units performance for the current period, the assumed Hydro 7 Generation Planning DAFOR was materially exceeded for Bay d'Espoir Unit 6. Also, there 8 were minor exceedances compared to base planning assumption for Bay d'Espoir Unit 7, the 9 Upper Salmon Unit and Cat Arm Unit 2. 10 11 The DAFOR at Bay d'Espoir Unit 6 was as a result of a failure of the in-service rectifying 12 transformer, followed by a failure of the spare replacement transformer. The in-service 13 rectifying transformer failed on January 30, 2014 and the unit was returned to service on 14 February 1, 2014 using the spare transformer. This spare transformer failed on February 17, 15 2014 and, with no other spares available, a new transformer had to be procured. The unit 16 was returned to service on August 5, 2014 with a new rectifying transformer. 17 18 If the two rectifying transformer failures had not occurred, the DAFOR for Unit 6 would have 19 been 0.18% and the weighted "All Hydraulic Units" performance would have been 0.87%, 20 compared to the base planning assumption of 0.9%. If the in-service transformer had failed 21 but the spare had not, the Unit 6 DAFOR would have been 1.18% and the weighted "All 22 Hydraulic Units" DAFOR would have been 0.94%, compared to base planning assumption of 23 0.9%. 24 25 Prior to the failure of the Unit 6 rectifying transformer, Hydro had established a replacement 26 plan for all rectifying transformers in its 20 year capital plan. In support of this plan, a 27 condition review (oil analysis) of all Bay d'Espoir rectifying transformers was carried out in 28 late 2013, with results indicating a need to expedite the plan. As a result of the Unit 6 failure 29 and the 2013 condition review, Unit 6 and Unit 7 transformers were replaced in 2014. The 30 transformer replacement program is now ongoing, and by November 2015, all Bay d'Espoir

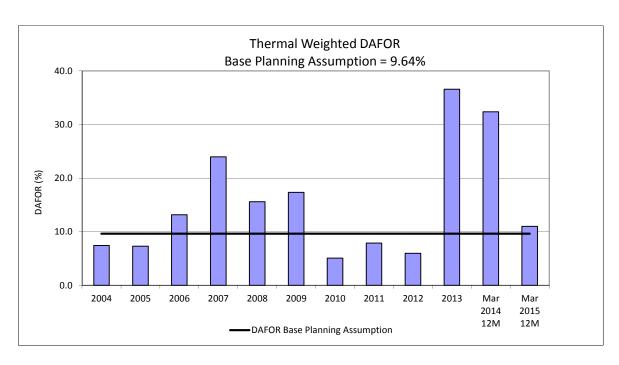
The thermal units forced outage rates are measured using DAFOR. Detailed results for the 12-month period ending March 31, 2015 is presented as well as the data for the 12-month period ending March 31, 2014 and the Hydro Generation Planning Assumption for the forced outage rate.

Maximum			Hydro Generation	
	<b>Continuous Unit</b>	12 months ending	12 months ending	Base Planning	
Generating Unit	Rating (MW)	March 2014 (%)	March 2015 (%)	Assumption (%)	
All Thermal Units - weighted	490	32.38	10.99	9.64	
Thermal Units					
Holyrood 1	170	57.65	15.45	9.64	
Holyrood 2	170	5.25	11.95	9.64	
Holyrood 3	150	19.37	5.55	9.64

For the 12-month period ending March 31, 2015, the weighted "All Thermal Units" DAFOR of 10.99% was not materially different than the assumed Hydro Generation Planning DAFOR value of 9.64%, and the DAFOR improved compared to the previous 12-month period DAFOR of 32.38%. The base planning assumption DAFOR for the three Holyrood units combined, at 10.99%, is less than the "Sensitivity" value of 11.64%.

1 The variance in "All Thermal Units" weighted DAFOR compared to base planning assumption 2 in the current period was attributable to exceedances for Units 1 and to a lesser extent, Unit 3 2. Unit 3 DAFOR materially improved compared to the previous period of 19.37% and 4 finished the current period at 5.55% compared to base planning assumption of 9.64%. 5 6 The DAFOR performance for Holyrood Unit 1 (170 MW) was affected by several events, with 7 the most significant discussed below. 8 9 From June 10 to 25, 2014, the unit was derated (to 150 MW from June 10-17 and to 130 MW 10 from June 17-25) to minimize the electrical load on the east air heater until an alignment 11 issue, caused by failed bolts, could be addressed. From June 25 to June 30, an outage was 12 taken to make necessary repairs. Later, both the east and west air heaters were inspected 13 by an expert during the 2014 maintenance outage for any additional concerns and none 14 were found. 15 16 From November 2 to 19, 2014, there was a forced extension to the 2014 planned 17 maintenance outage due to concrete damage found in the condenser cooling water sump. 18 The damage was a safety hazard that had to be mitigated prior to returning the unit to 19 service. 20 21 During the 2014 maintenance outage, repairs and adjustments were made to one of the 22 turbine bearings to improve operation. This work was a follow-up to the work that was done 23 in 2013 following the January 2013 failure. Subsequent to the turbine bearing adjustments, 24 the turbine rotor had to be re-balanced. This is an iterative and time consuming process that 25 requires the unit to be brought on line for measurements and calculations and taken off line 26 for placement of balance weights. Four iterations were required to successfully balance the 27 rotor. This work started November 19, and the unit was deemed within standards and 28 returned to service November 30. As system load permitted, Hydro took an additional day 29 to complete another adjustment, improving balancing results even further, on December 2

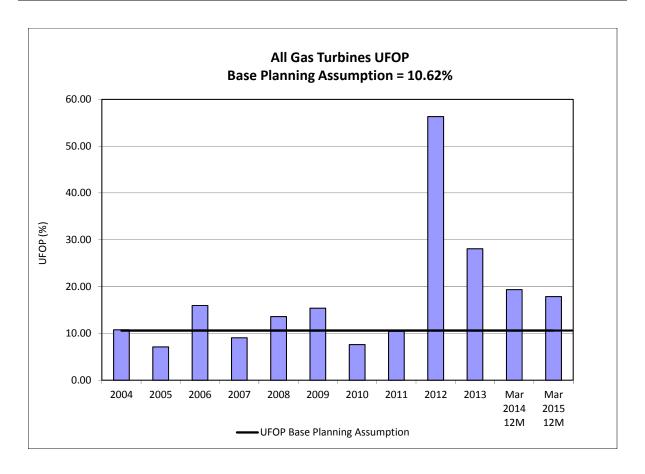
The combined UFOP for all gas turbines was 17.87% for the 12-month period ending March 31, 2015. This was higher than the base planning assumption of 10.62%, but was better than the "Sensitivity" UFOP of 20.62%, and was better than the previous period UFOP of 19.36%. The current period UFOP was impacted by the performance of the Hardwoods unit. Hardwoods UFOP for the current period was 33.98% compared to a base planning assumption of 10.62%. The Stephenville unit's current period UFOP of 9.44% improved compared to the previous period UFOP of 29.00%, and was better than the base planning assumption.

Gas Turbine Units	Maximum Continuous Unit Rating (MW)	12 months ending March 2014 (%)	12 months ending March 2015 (%)	Hydro Generation Base Planning Assumption (%)
All CTUs	248.5	19.36	17.87	10.62
Holyrood CT*	123.5	n/a	0.67	5.0
Stephenville	50	29.00	9.44	10.62
Hardwoods	50	16.34	33.98	10.62
Happy Valley	25	0.00	0.01	10.62

The All Gas Turbine Units UFOP base planning assumption was exceeded in the current period due to the Hardwoods Gas Turbine UFOP.
