Re: Newfoundland and Labrador Hydro – 2017 Capital Budget Application – Project "Overhaul Turbine/Generators - Bay d'Espoir and Cat Arm" (Volume I, D-31).

Thomas Johnson, QC – Consumer Advocate Dean Porter, Poole Althouse **Project Title:** Overhaul Turbine/Generator

Location: Cat Arm

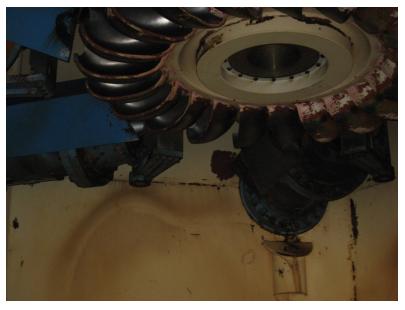
Figure 2: Cat Arm Pelton Turbine (Runner and jets)

An overhaul of water jets on the turbine at Cat Arm Unit 1 is also required. The water jets that direct water to the runner are hydraulically operated by the governor. These jets (six in total) are critical to the operation of the unit; they control the speed of the unit by adjusting the flow of water supplied to the runner. These jets are also used to stop the flow of water to shut down the unit as required. Since this equipment is located over a body of water and is hydraulically operated, maintenance is critical to ensure that there is no accidental release of oil into the environment and to prevent water from entering the governor oil circuit.
