Re: An Application by Newfoundland and Labrador Hydro (Hydro) pursuant to Subsection 41(3) of the Act for approval of the Restoration of Unit 1 Turbine and Generator at the Holyrood Thermal Generating Station

AND IN THE MATTER OF an Application by Newfoundland and Labrador Hydro pursuant to Subsection 41(3) of the *Act*, for the approval of the refurbishment of Unit 1 Turbine and Generator at the Holyrood Thermal Generating Station.

Holyrood Unit 1 Forced Outage
Results of Phase 1 Inspection and Recommendation for Further Inspection

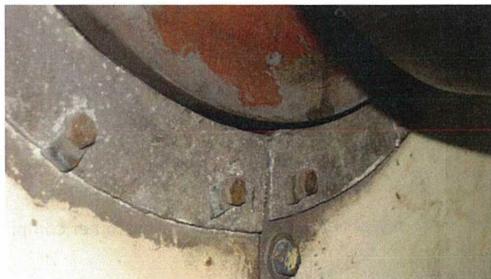
Outer Air Seal – The air seal shows light rubbing.

T5 air seal Bottom

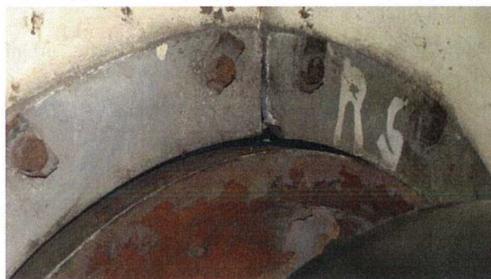
T5 air seal Top

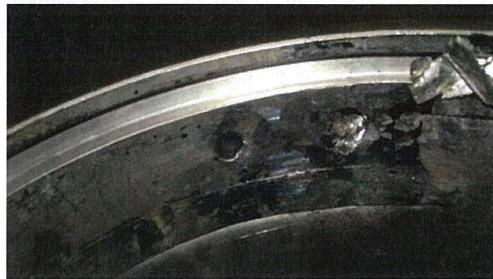
T5 Bearing – A feeler check of the clearance between the shaft and the T5 journal showed a clearance of .070", and the as built bearing clearance vertical was .018", showing .052" wear in the bearing bore. T5 Bearing oil bore, indicates the shaft to be approximately .068" low. This number is approximated as the closing oil bores at T5 were not recorded at the last or previous outages on this unit. This number is based on the assumption the oil bores are nearly equal L, R, B. The as found was L=11.233", R=11.268", B=11.182".

T5 Bearing U/H

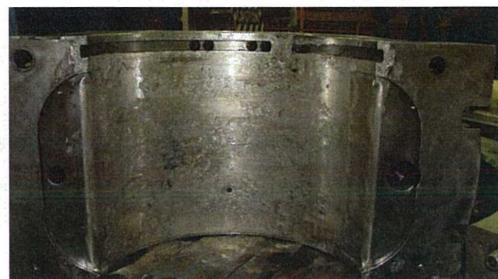
T5 Bearing L/H

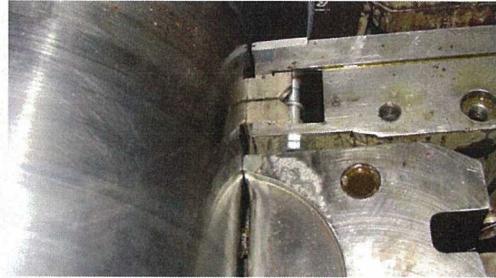
CE H2 Seal Casing L/H Right Side

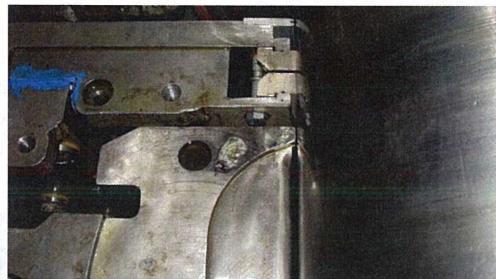
CE H2 Seal Casing L/H Left Side

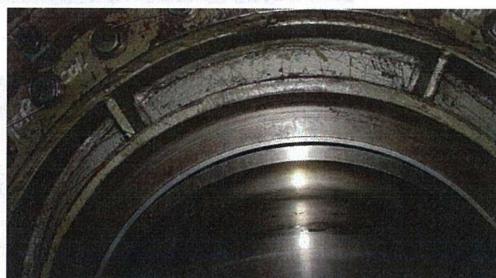
T5 Inner Oil Deflector – Prior to removal, a feeler check for clearance between the upper half and the shaft showed .113" vertical clearance. The as assembled vertical clearance in 2012 was .022", this is a delta of .091". Upper and Lower deflector is wiped.

T5 Inner Oil Deflector U/H prior to removal

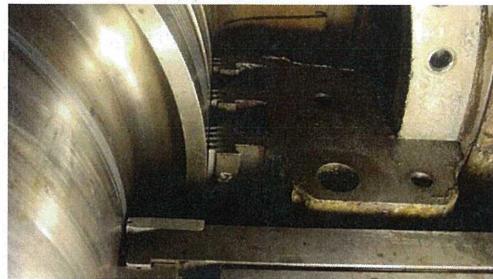
T5 Inner oil deflector L/H left side

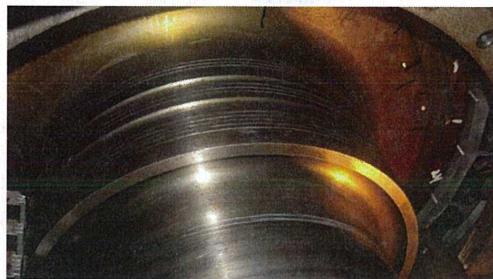
T5 inner oil Deflector shaft area showing rub

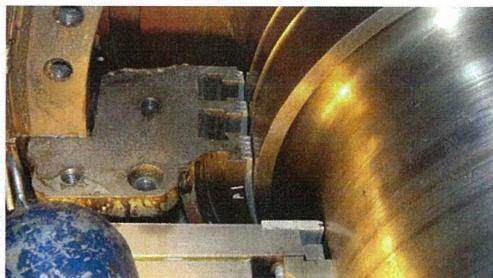
T5 Inner Oil Deflector L/H right side

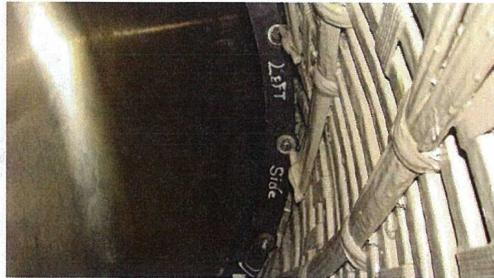
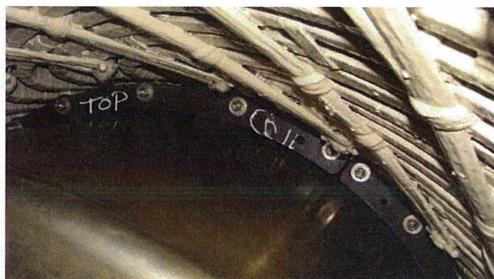
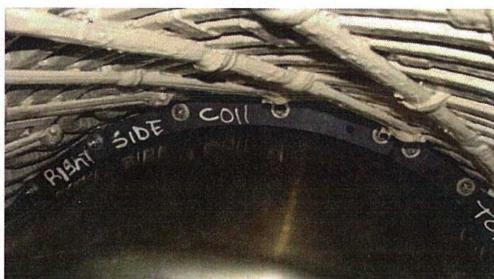
CE Air Gap Baffle – the air gap baffle does not appear to have rubbed, no signs of rubbing on the retaining rings or the baffles themselves.

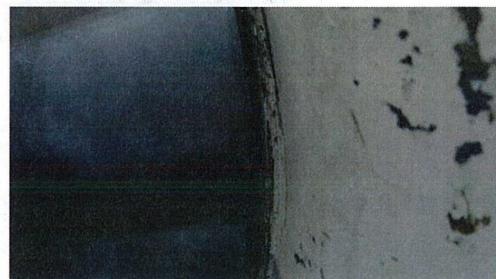
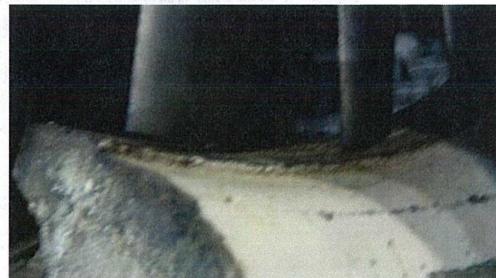
CE Fan Blades – the CE Fan Blades do not appear to have rubbed and are in good condition as is the Fan Shrouds. The Fan Blade radial clearances were recorded prior to removal of the shrouds or the blades. The lower blade radial clearance was found to be .032" as compared to the as assembled clearance in 2012 of .075". This indicated the shaft is low in the bore at the CE .043". This compares favorably with the H2 Seal Casing and reasonable with the T5 Bearing clearance and the rotor position.

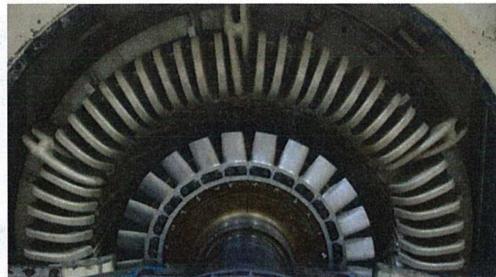
CE End Windings – No visual indication of Mechanical or Electrical damage to the CE ending windings due to this event. There are signs of greasing, indicating some bar movement has occurred.

View of CE End Windings with unit on Half Joint

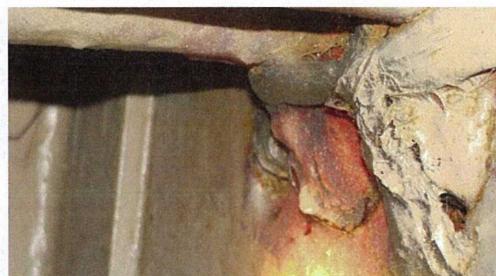
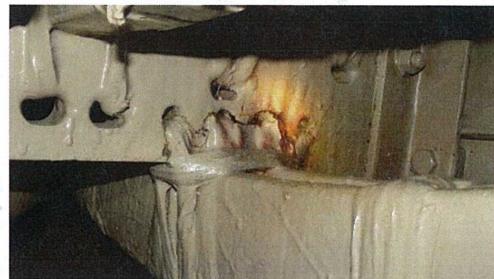
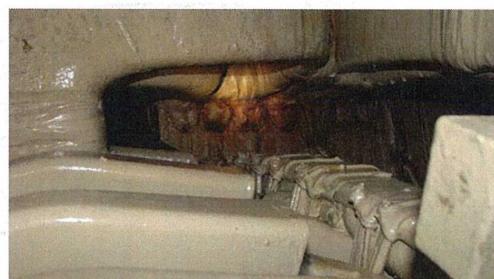
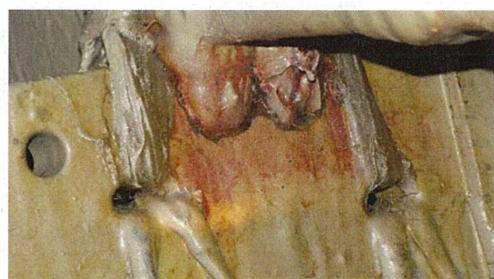
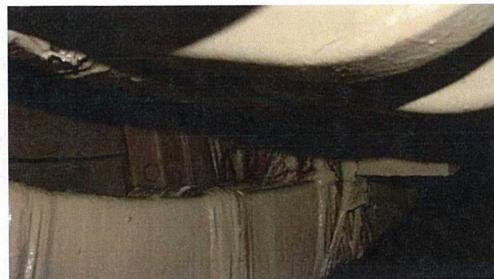
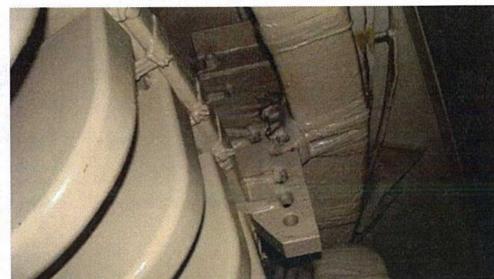
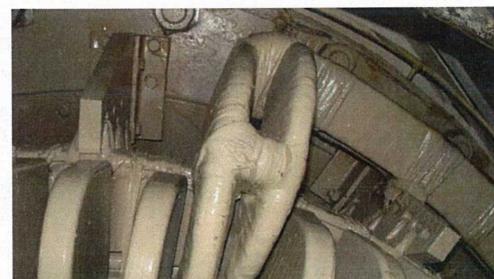
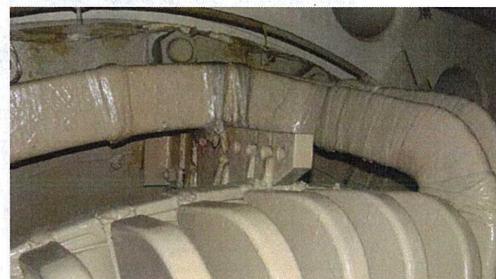
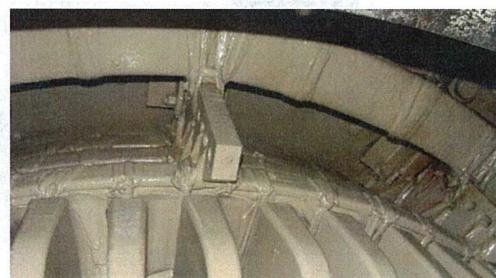
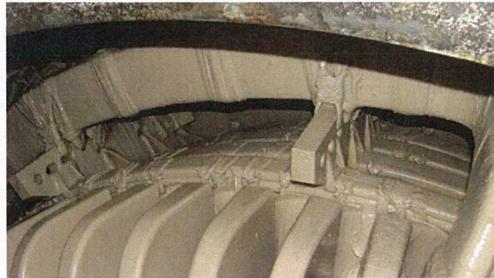
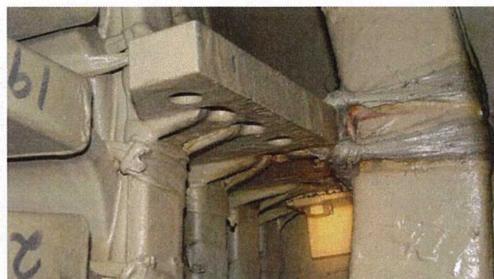
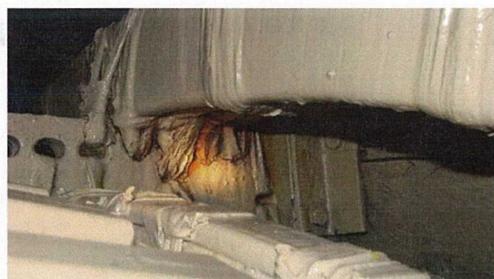
CE End Windings Greasing

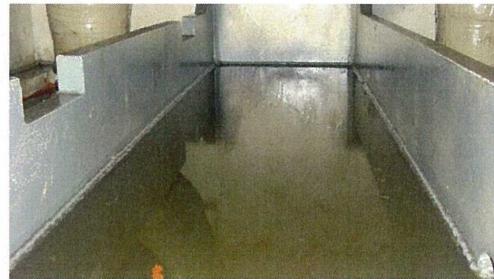
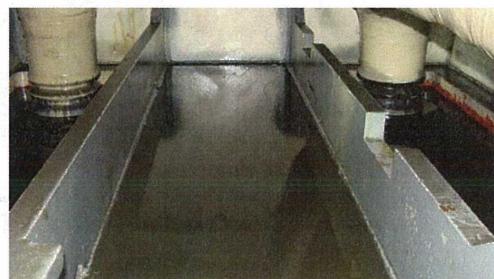
Bushing Box and Belly Bands – visual inspection inside of the Bushing Box does not reveal any visible or electrical damage. There is oil and water in the bottom of the bushing box.

Bushing Box – Oil and Water in bottom

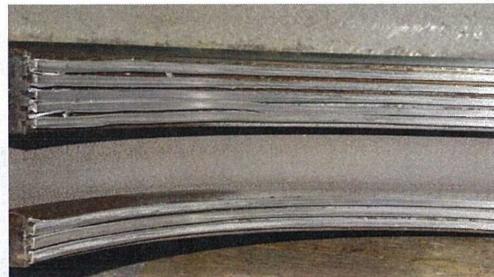
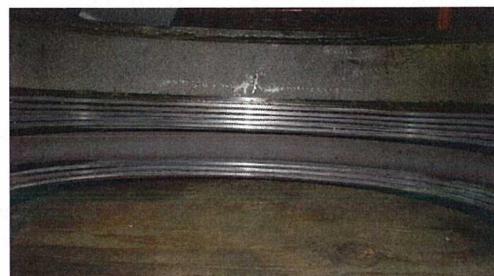
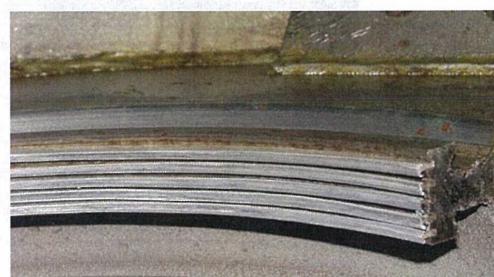
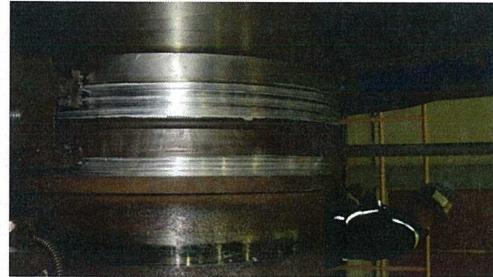
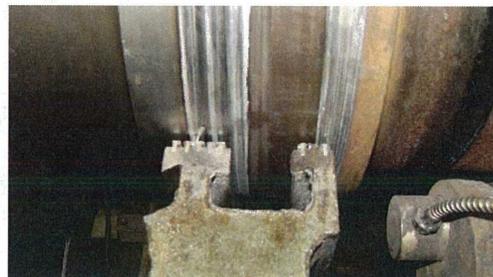
T4 Outer Oil Deflector – The T4 outer oil deflector, Upper and Lower half, is heavily rubbed and will need to be repaired. The lower oil deflector clearance is "0" and the upper oil deflector as found clearance was ".145" and the as built upper clearance in 2012 was ".024". This indicates ".121" wear in oil deflector bore.

T4 U/H Outer Oil Deflector

T4 L/H Outer Oil Deflector Left side

T4 L/H Outer Oil deflector Right side

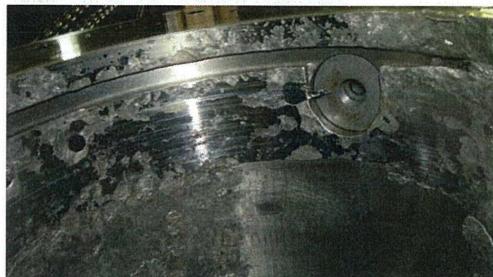
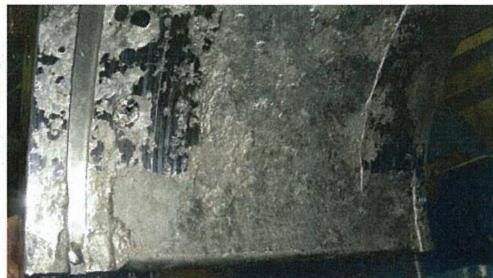
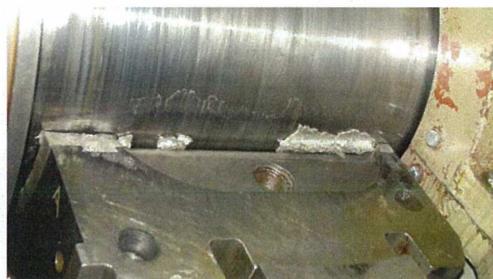
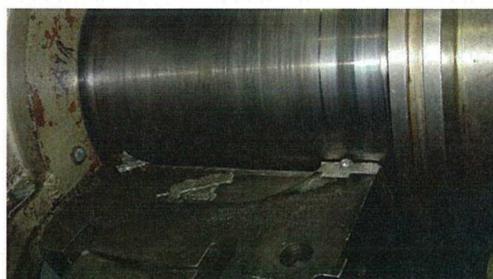
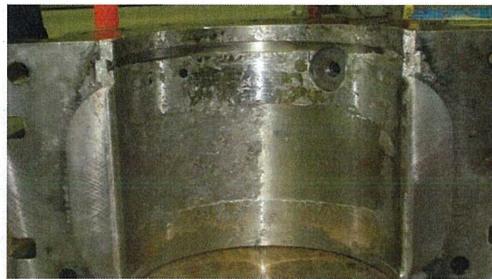
T4 Bearing – A feeler check of the clearance between the shaft and the T4 journal was not recorded due to limited access to the top of the bearing caused by the thrust runner on the Generator Rotor. The 2012 as built bearing clearance vertical was .0167". T4 Bearing oil bore, indicates the shaft to be approximately .103" low. This number is approximated as the closing oil bores at T4 were not recorded at the last or previous outages on this unit. This number is based on the assumption the oil bores are nearly equal L, R, B. The as found was L=9.887", R=9.856", B=9.768".

T4 Bearing U/H

T4 Bearing L/H Right side and Journal

T4 Bearing L/H Left side bearing and journal

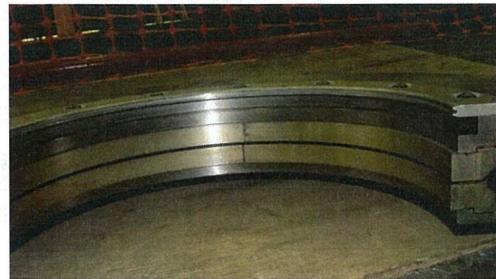
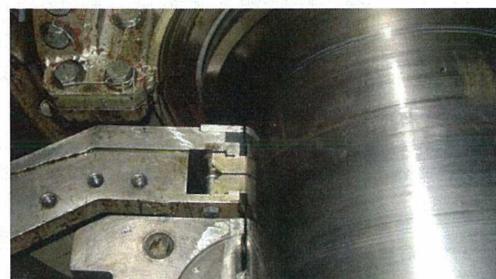
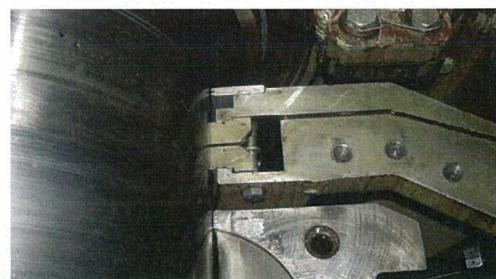
TE Hydrogen Seal Casing – the radial alignment of the H2 seal casing was taken and compared to the as assembled alignment prior to disassembly of the casing. Feeler check of the casing shows the shaft is .109" low in the bore. Casing should be centered to the shaft. L=.195", T=.295", R=.177" are the as found readings. The gas side oil deflector upper half and lower half are heavily rubbed. The H2 Seals has slight rubbing on the I.D. and seals can be moved in the bore. The TE H2 Seals had a large gap between the seals and the shaft on initial inspection. The clearance was well above the normal and could have been the source of gas leakage at TE.

TE Hydrogen Seal Casing U/H removed – upper gas side oil seal heavy rub

TE Hydrogen Seal L/H Left side

TE Hydrogen Seal L/H Right Side

TE Hydrogen Seal Journal

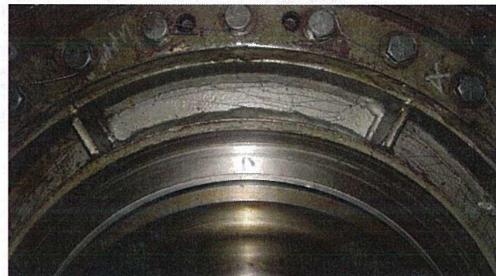
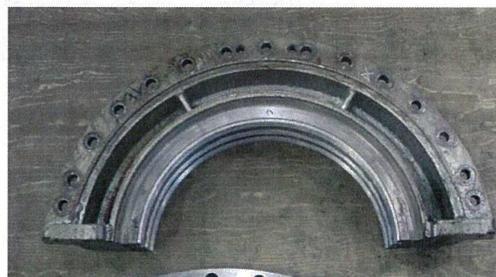
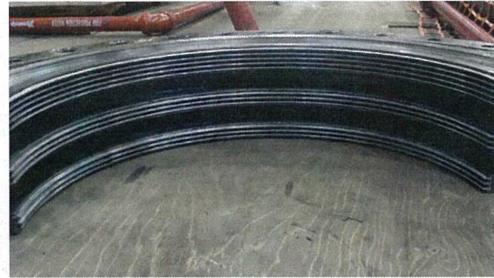
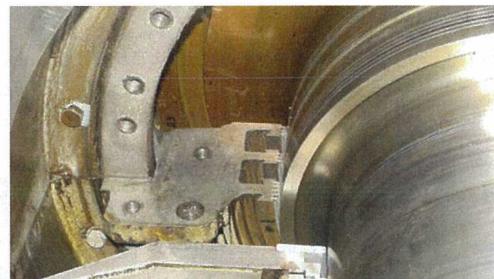
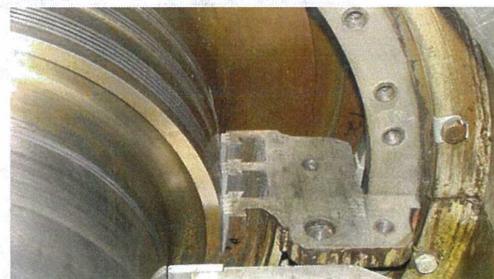
T4 Inner Oil Deflector – Prior to removal, a feeler check for clearance between the upper half and the shaft showed .120" vertical clearance. The as assembled vertical clearance in 2012 was .022", this is a delta of .098". Upper and Lower deflector is wiped.

T4 Inner Oil Deflector prior to removal

T4 U/H Inner Oil Deflector removed

T4 U/H Inner Oil Deflector damaged teeth

T4 L/H Inner Oil Deflector Left Side

T4 L/H Inner Oil Deflector Right side

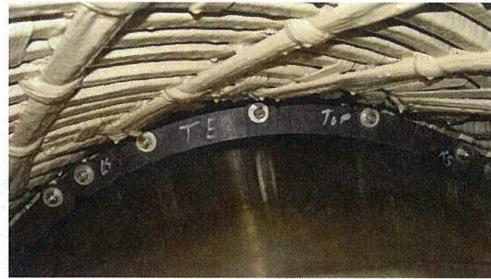
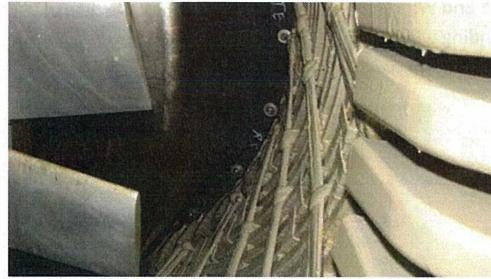
TE Air Gap Baffle – the air gap baffle does not appear to have rubbed, no signs of rubbing on the retaining rings or the baffles themselves.

TE Air Gap Baffles Top

TE Air Gap Baffles Right Side

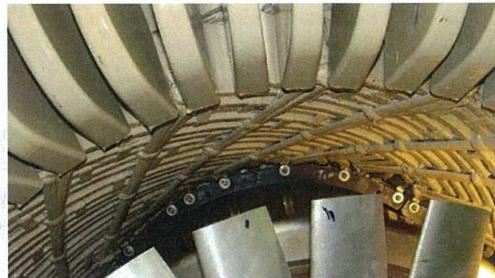
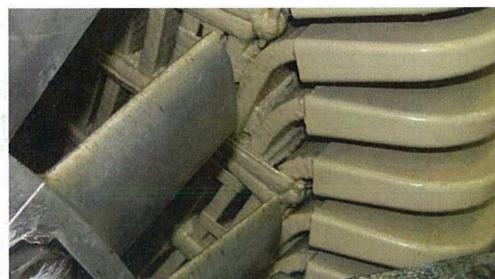
TE Fan Blades – the TE Fan Blades do not appear to have rubbed and are in good condition as is the Fan Shrouds. The Fan Blade radial clearances were recorded prior to removal of the shrouds or the blades. The upper blade radial clearance was found to be .202" as compared to the as assembled clearance in 2012 of .097". This indicated the shaft is low in the bore at the TE .105". This compares favorably with the H2 Seal Casing and reasonable with the T5 Bearing clearance and the rotor position.

TE Fan Blades Typical

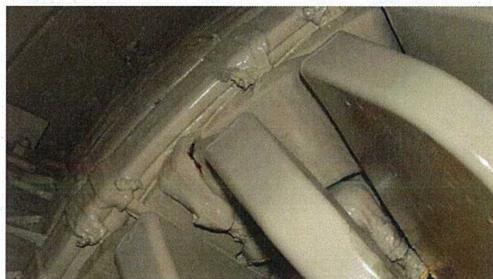
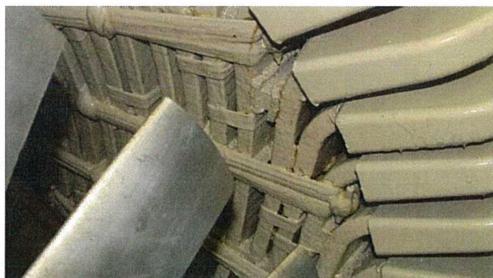
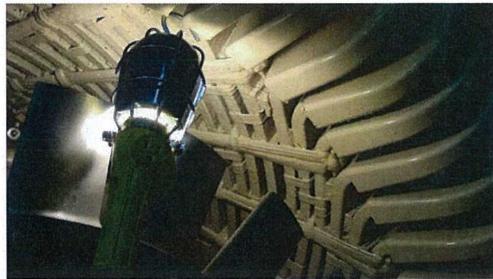
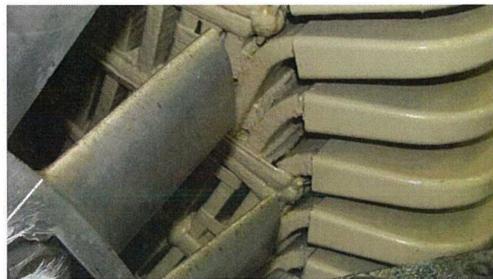
TE End Windings – No visual indication of Mechanical or Electrical damage to the TE ending windings due to this event. There are signs of greasing, indicating some bar movement has occurred.

TE End Winding Greasing

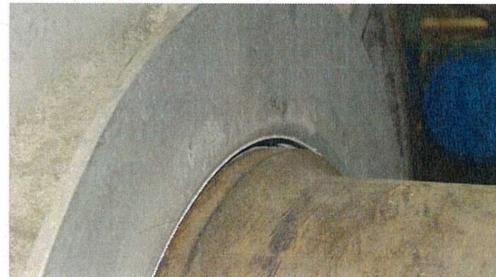
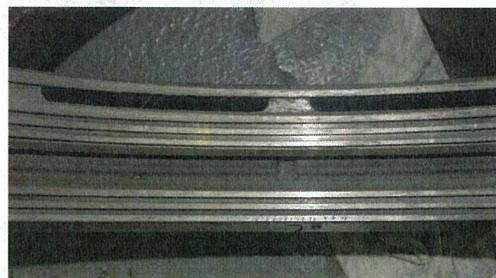
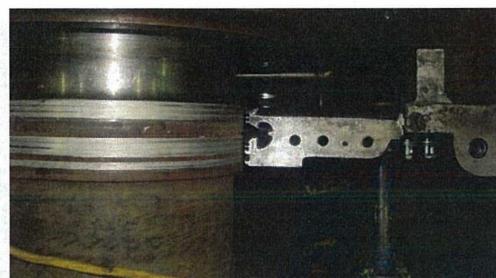
T3 Outer Oil Deflector – The T3 outer oil deflector, Upper and Lower half, is heavily rubbed and will need to be repaired or replaced. The lower oil deflector clearance is “0” and the upper oil deflector as found clearance was .171” and the as built upper clearance in 2012 was .030”. This indicates .141” wear in oil deflector bore. Accurate measurements could not be taken due to smeared and rolled material.

T3 Outer oil deflector prior to removal

T3 U/H outer oil deflector

T3 L/H outer oil deflector L/S

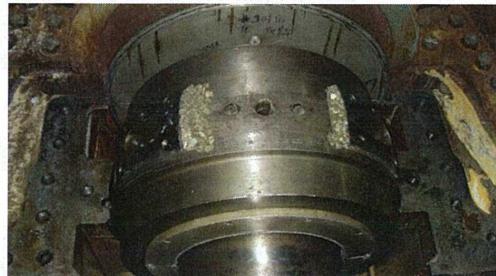
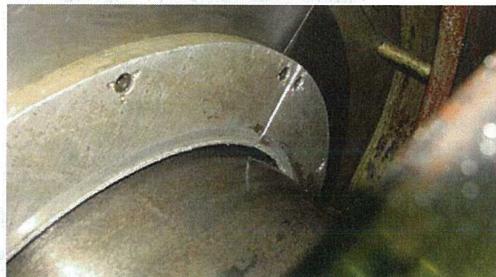
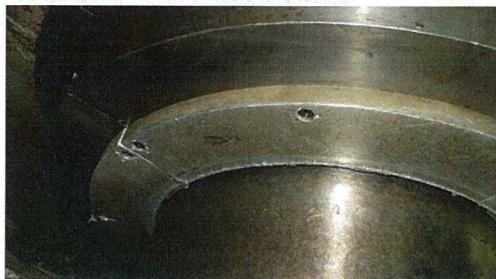
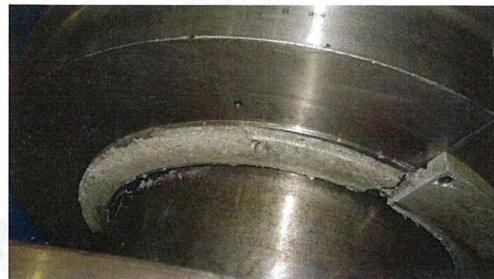
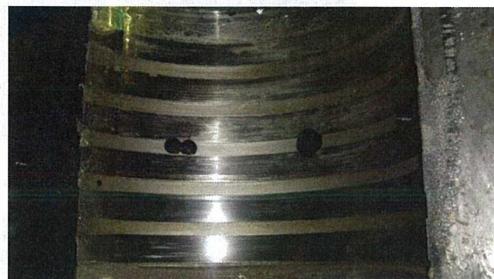
T3 Bearing – Bearing is wiped. There is Melted Babbitt on the top of the bearing, inside the eyebolt holes and around the bearing pads. Once the top half of the bearing was removed, the Babbitt was found to be melted down to the dovetails on the Upper half and the lower half shows melted down to the dovetails at the horizontal joint. The feeler check between the upper half and the journal prior to removal, showed .270"

clearance. Assembly clearance in 2012 was .016". This indicates .254" wipe in bearing. The as found oil bore at T3 outer was L=8.637", B=8.497", R=8.606". The as assembled oil bore was L=8.621", B=8.629", R=8.628". This shows shaft low in bore .132" at outer fit. The as found oil bore at T3 inner was L=5.892", B=5.692", R=5.858". The as assembled oil bore was L=5.870", B=5.858", R=5.882". This shows the shaft low in the bore .166" at the inner oil bore.

T3 Bearing U/H prior to removal

T3 Bearing U/H L/S joint

T3 Bearing U/H R/S joint

T3 Bearing U/H with upper bolt on seal removed – notice Babbitt

T3 Bearing U/H severe wipe down to dovetails

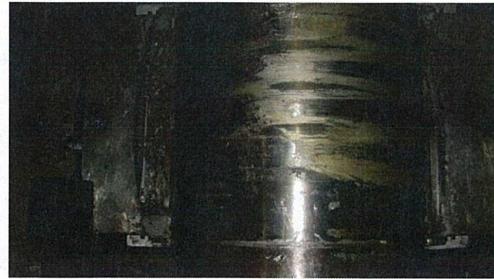
T3 Bearing and Journal L/H

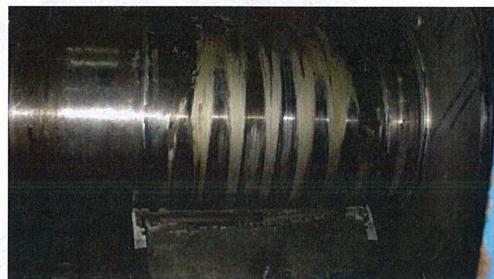
T3 Bearing and Journal L/H

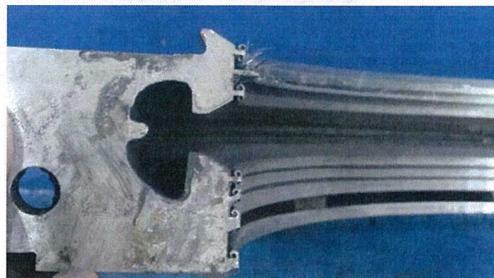
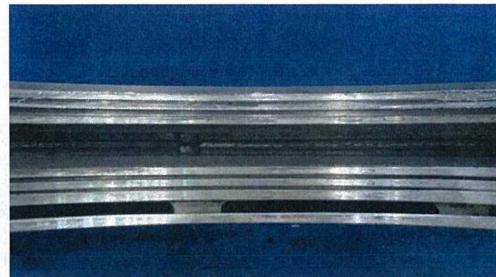
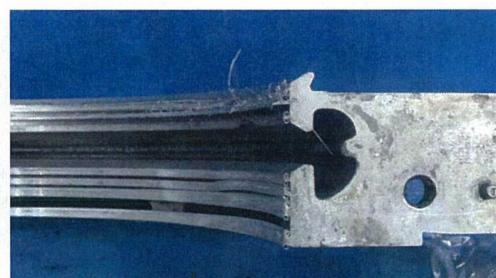
T3 Inner Oil Deflector – The T3 Inner oil deflector, Upper and Lower, is wiped and need to be replaced. The feeler check on the upper half of the T2 inner showed .175" clearance as found, and compared to the as assembled in 2012 of .031", the clearance is opened up .144".

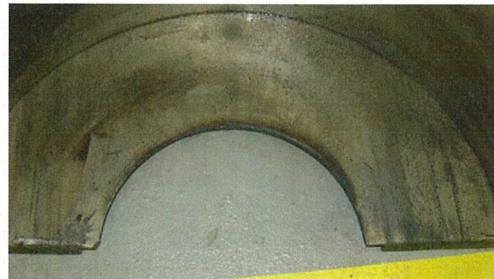
Coupling Guard – the upper coupling guard was found loose and sitting on the top or the supports. The lower coupling guard was found loose and sitting in bottom of sump. The guard bolting that bolts the upper and lower together are missing and the support bolts for the U/H attachment to the support tabs in the pedestal show 2 missing and 2 broken off. The lower guard shows heavy rubbing in the bottom bore front and rear and the top guard shows minor rubbing front and rear bores at the horizontal joint.

Lower Half coupling guard showing rub in bore

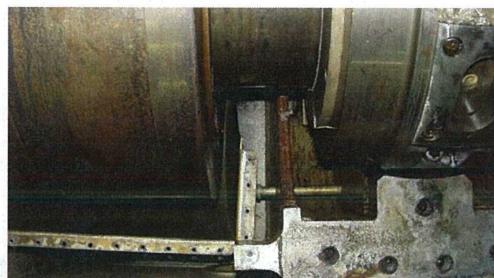
Lower Half coupling guard found lying in bottom of sump

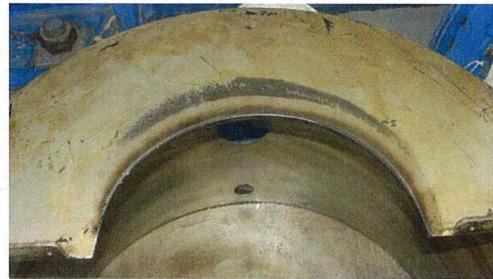
Lower half coupling guard with rubbing in bore

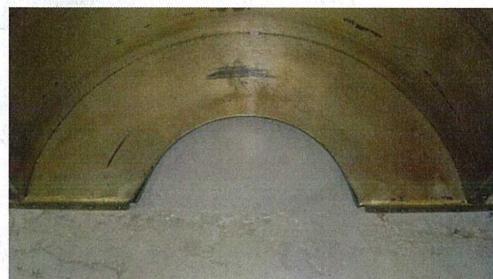
Upper half coupling guard showing rub in bore at horizontal joint area – one axial rub

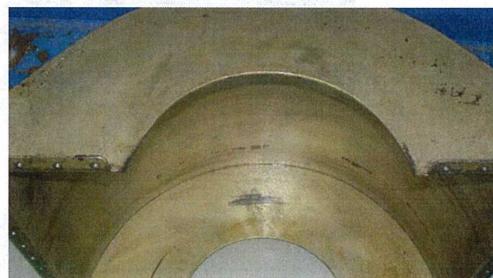
Upper half coupling guard showing rub in bore at horizontal joint area – on axial rub

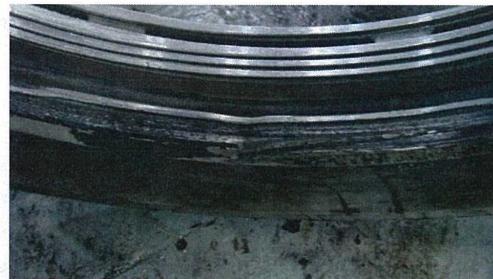
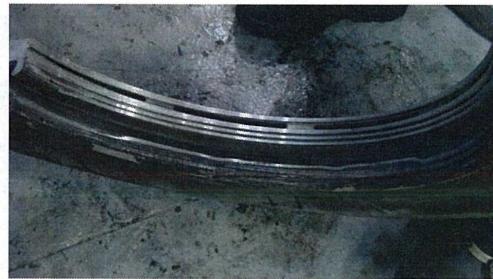
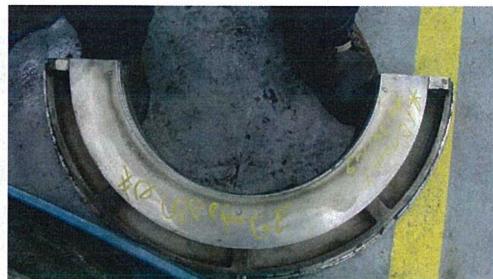
T2 Outboard Oil Deflector U/H

T2 Outer Oil Deflector (GE) – The T2 outer oil deflector, Upper and Lower half, is heavily rubbed and will need to be repaired or replaced. The lower oil deflector clearance is “0” and the upper oil deflector as found clearance was .340” and the as built upper clearance in 2012 was .032”. This indicates .308” wear in oil deflector bore. Accurate measurements could not be taken due to smeared and rolled material.

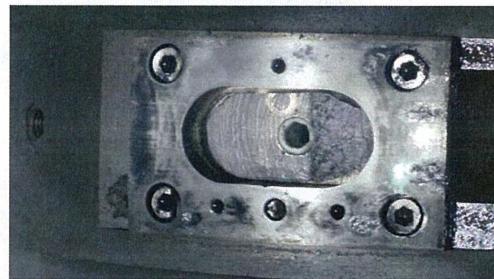
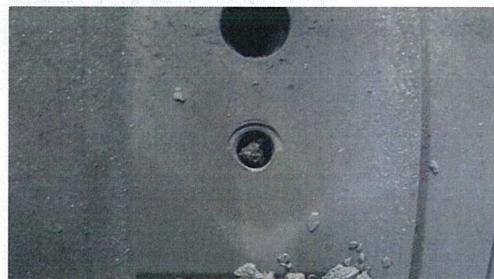
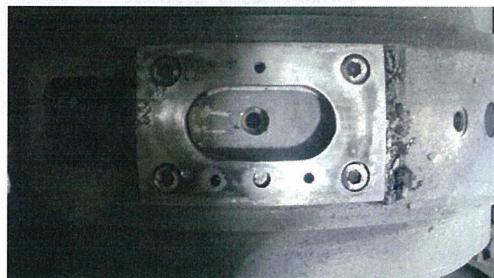
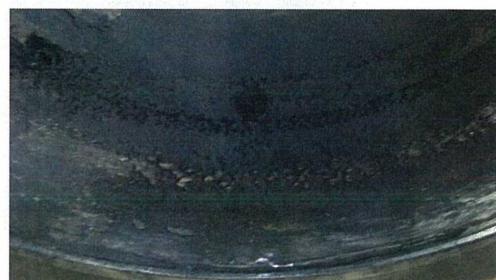
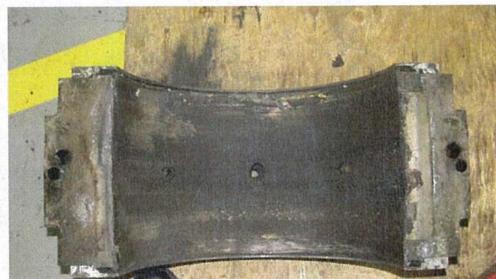
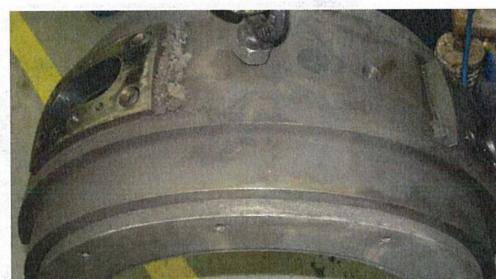
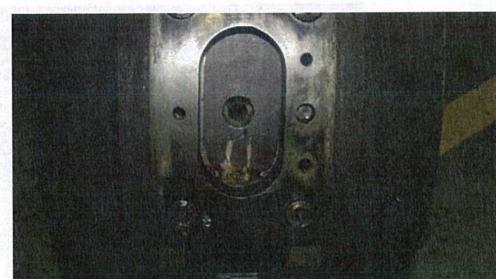
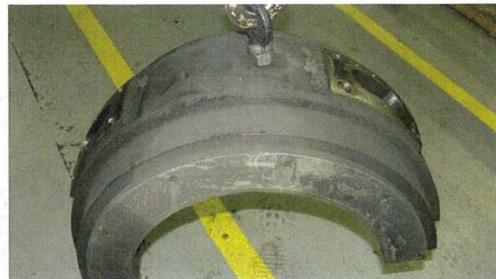
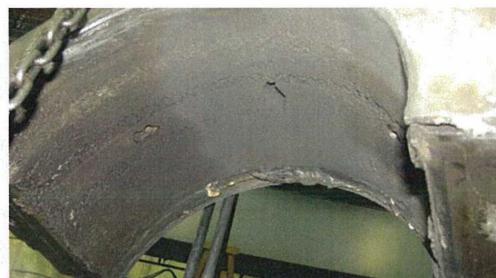
T2 Bearing – Bearing is wiped. There is Melted Babbitt on the top of the bearing, inside the eyebolt holes and around the bearing pads and what appears to be soot on the outside of the bearing. Once the top half of the bearing was removed, the Babbitt was found to be melted down to the dovetails on the Upper half and the lower half shows melted down to the dovetails at the horizontal joint. The feeler check between the upper half and the journal prior to removal, showed .308" clearance. Assembly clearance in 2012 was .024". This indicates .284" wipe in bearing. The as found oil bore

at T2 outer was L=5.373", B=5.148", R=5.382". The as assembled oil bore was L=5.372", B=5.359", R=5.371". This shows shaft low in bore .211" at outer fit. The as found oil bore at T2 inner was L=5.376", B=5.160", R=5.382". The as assembled oil bore was L=5.373", B=5.359", R=5.371". This shows the shaft low in the bore .199" at the inner oil bore.

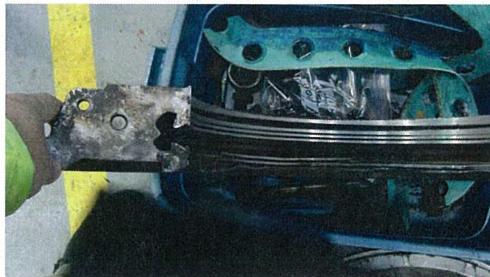
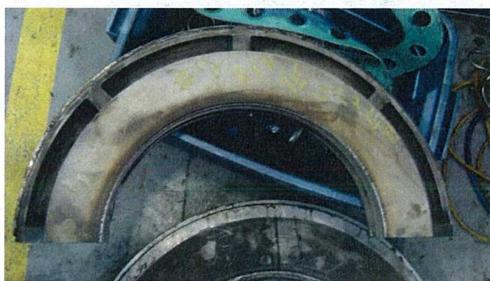
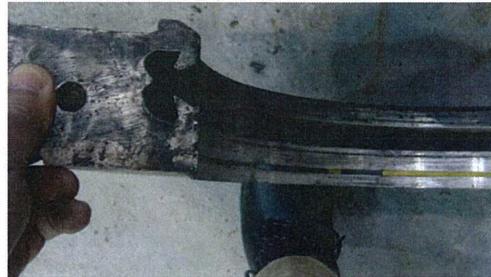
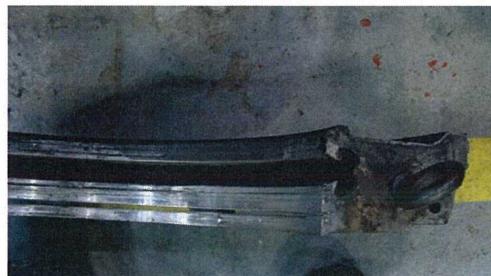
T2 Inner Oil Deflector (TE) – The T2 inner oil deflector, Upper and Lower half, is heavily rubbed and will need to be repaired or replaced. The lower oil deflector clearance is “0” and the upper oil deflector as found clearance was .343” and the as built upper clearance in 2012 was .030”. This indicates .313” wear in oil deflector bore. Accurate measurements could not be taken due to smeared and rolled material.

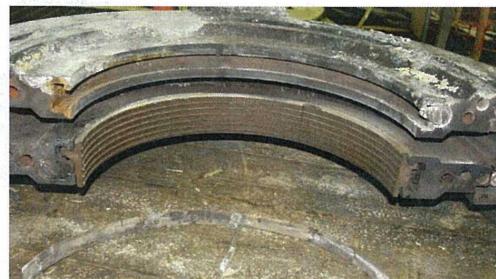
N1 Gland Casing U/H

N1 Upper Packing Gland – the upper packing gland was removed to allow removal of the Front standard cover. Upon removal, the R1 ring of packing fell out as the springs were severely damaged from the fire at the front end of the unit. The packing is severely damaged from rubbing as is R2 packing upper half. The Lower half R1 and R2 packing are also severely damaged. Once the gland was removed, you can see that the

inner gland, containing R3 and R4 packing, appears to have separated as there is clearance between the upper and lower joints.

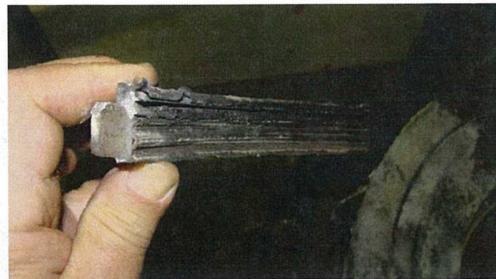
R1 Packing Ring Damage

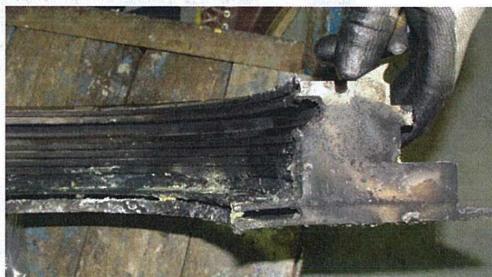
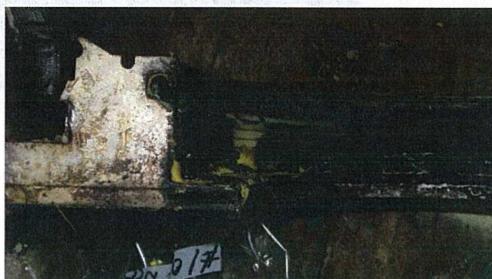
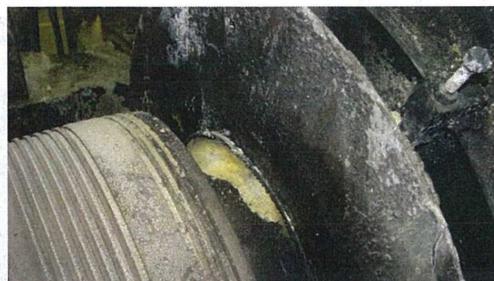
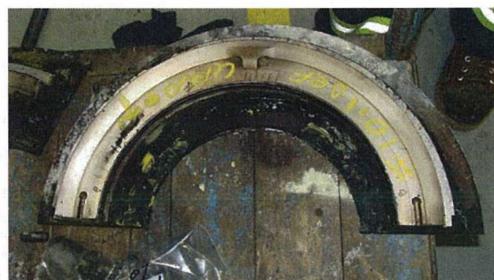
T1 Upper Oil Deflector

T1 Outer Oil Deflector (GE) – The T1 outer oil deflector, Upper and Lower half, is heavily rubbed and will need to be repaired or replaced. The lower oil deflector clearance is “0” and the upper oil deflector as found clearance was .343” and the as built upper clearance in 2012 was .020”. This indicates .323” wear in oil deflector bore. Accurate measurements could not be taken due to smeared and rolled material.

18. *T1 Oil Deflector – wiped. Need to replace*
19. *T1 Bearing – Wiped. Need to replace liner as a minimum*
20. *Thrust Bearing*
 - a. *Active Plate – wiped. Replace*

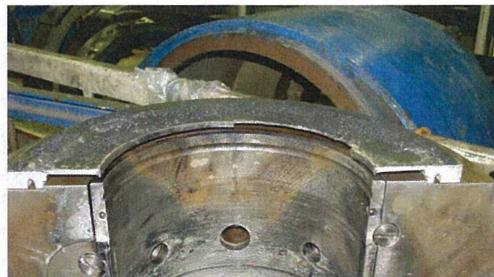
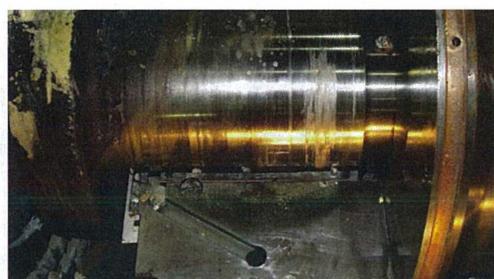
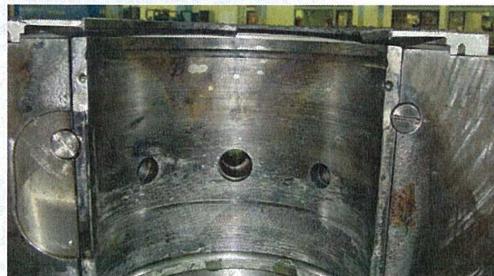
T1 U/H Bearing

T1 Bearing – Bearing is wiped. Once the top half of the bearing was removed, the Babbitt was found to be heavily wiped in the upper and lower half. The feeler check between the upper half and the journal prior to removal could not be performed due to space limitations. The as found oil bore at T1 outer was $L=2.274"$, $B=2.105"$, $R=2.357"$. The as assembled oil bore was $L=2.295"$, $B=2.251"$, $R=2.327"$. This shows shaft low in bore $.146"$ at outer fit.

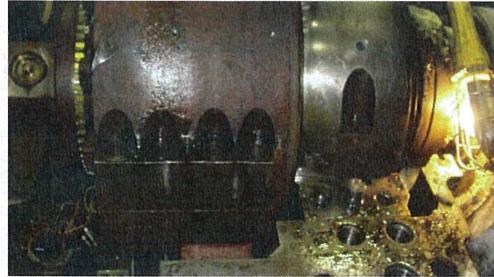
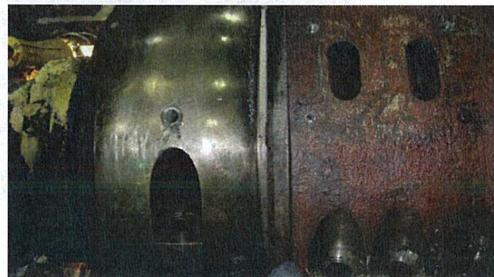
T1 Bearing and Thrust Right side

Thrust Bearing – The thrust bearing Active Plate is heavily damaged as the thrust runner is embedded in the Copper back of the thrust plate. A Feeler check of the thrust shows the Rotor .140" plus downstream. This measurement taken between the Inactive thrust plate and the Inactive thrust shim. An accurate measurement of just how far downstream the rotor is cannot be taken at this time. The Inactive thrust plate still has the Babbitt on the plate and the profile and can be moved radially.

- b. *Thrust Runner on Rotor – Damaged on Active side as minimum. Machine to remove scoring and hot spots.*
 - c. *Inactive Plate – moderate damage. Replace*

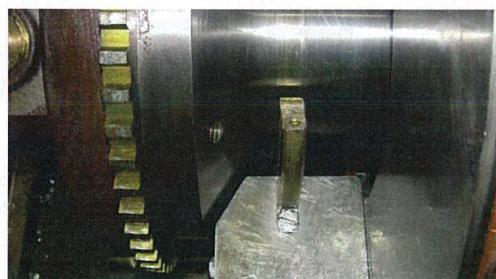
Thrust Bearing oil seal ring – rolled up and broken retainer screw

- d. *Casing oil Seal – Damaged. Replace*
 - e. *Casing Bronze seal – Damaged. Replace*
21. *60 tooth wheel – Damaged. Replace or repair.*
22. *Speed Probes – Damaged. Replace*

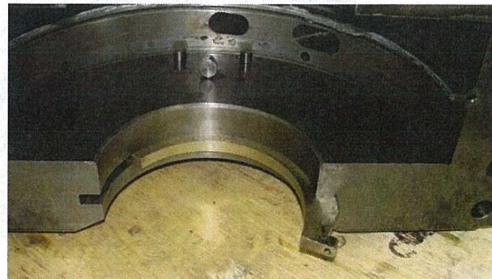
Thrust Cover U/H Rolled Oil Seal ring and broken screw

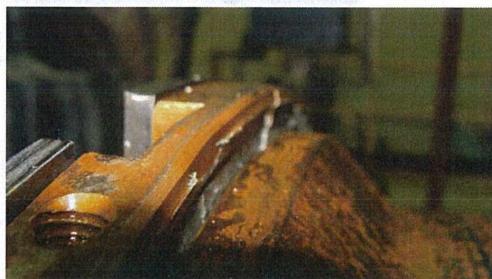
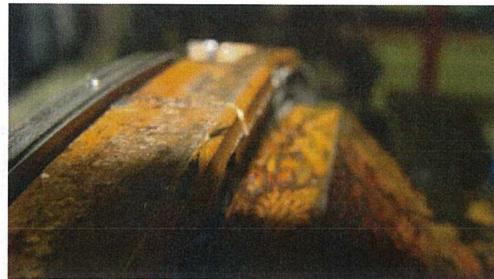
Thrust Active Side – Thrust Runner Rubbed into Thrust Plate

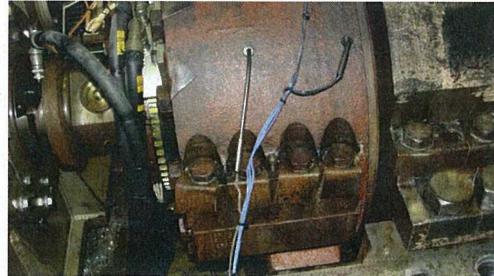
Speed probes and Instrumentation LS

Speed Probes and FS Instrumentation – There are 4 speed probes that have become disconnected and the lower probes have rubbed hard on the 60 tooth wheel and damaged the wheel. The lower probes are no longer useable. The upper probes need to be checked out by I&C to verify if they still work.

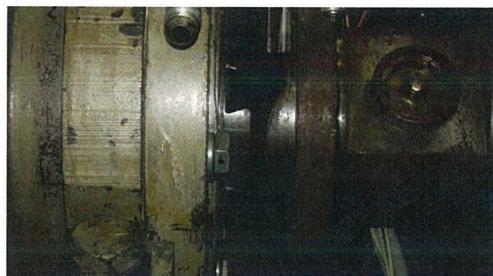
Turning Gear Clutch

Turning Gear – the Jaw clutch on the turbine rotor is below the jaw clutch on the Turning gear, thus the clutch cannot engage. Other than this, the Turning Gear appears to be in good condition.

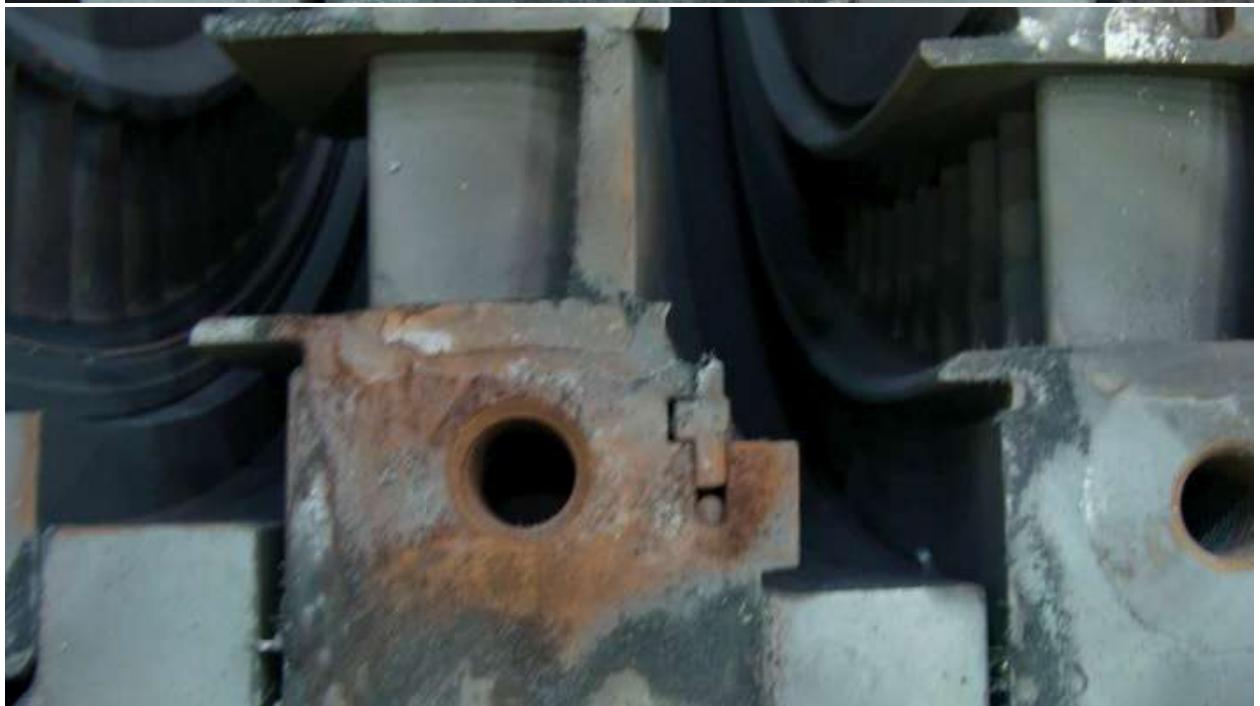
- Row 3 diaphragm U/H

- o Hard Axial rub at the outer setback face (caused by contact with bucket cover) and the inner setback face (caused by contact with bucket root appendage)

- o No signs of partition damage as viewed from the horizontal joint
 - o Radial spill strip is hard rubbed radial and axial
- Stage 4 Diaphragm

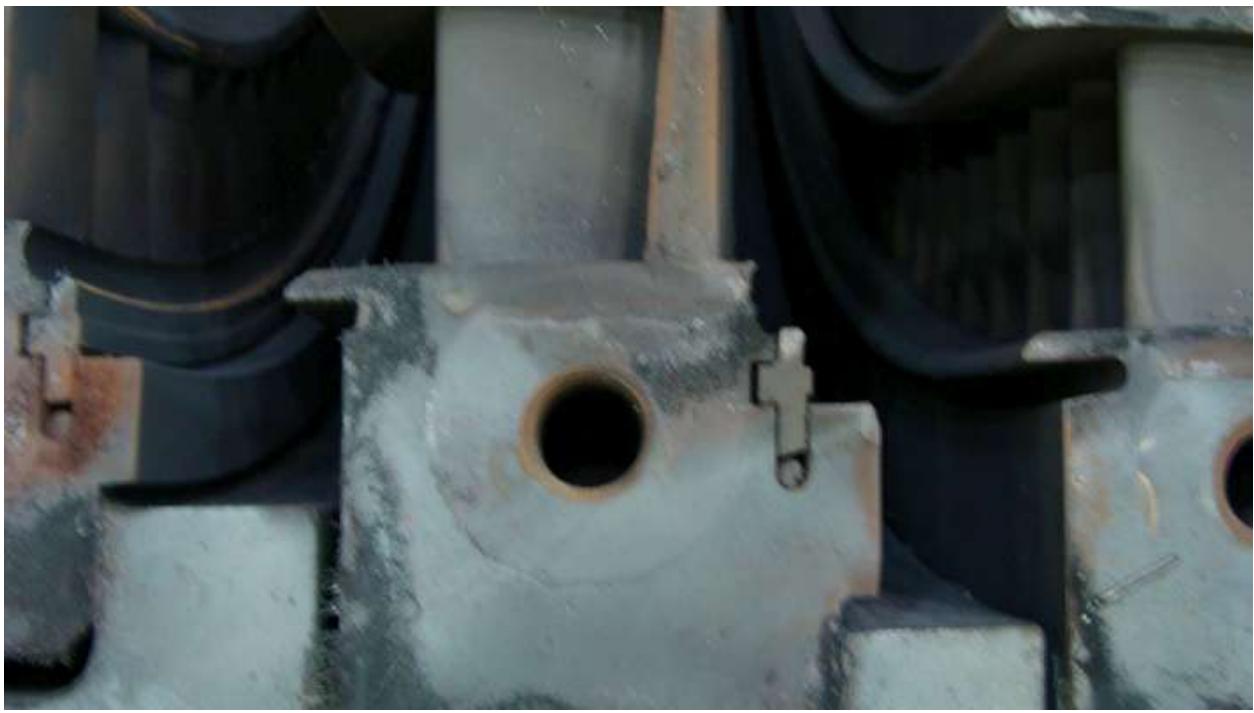
- Row 4 diaphragm U/H

- No sign of rubbing between diaphragm inner web and the 4th stage wheel
- Hard Axial rub at the outer setback face (caused by contact with bucket cover) and the inner setback face (caused by contact with bucket root appendage)

- No signs of partition damage as viewed from the horizontal joint
- Radial spill strip is hard rubbed radial and axial
- Stage 5 Diaphragm
 - No sign of rubbing between diaphragm inner web and the 5th stage wheel

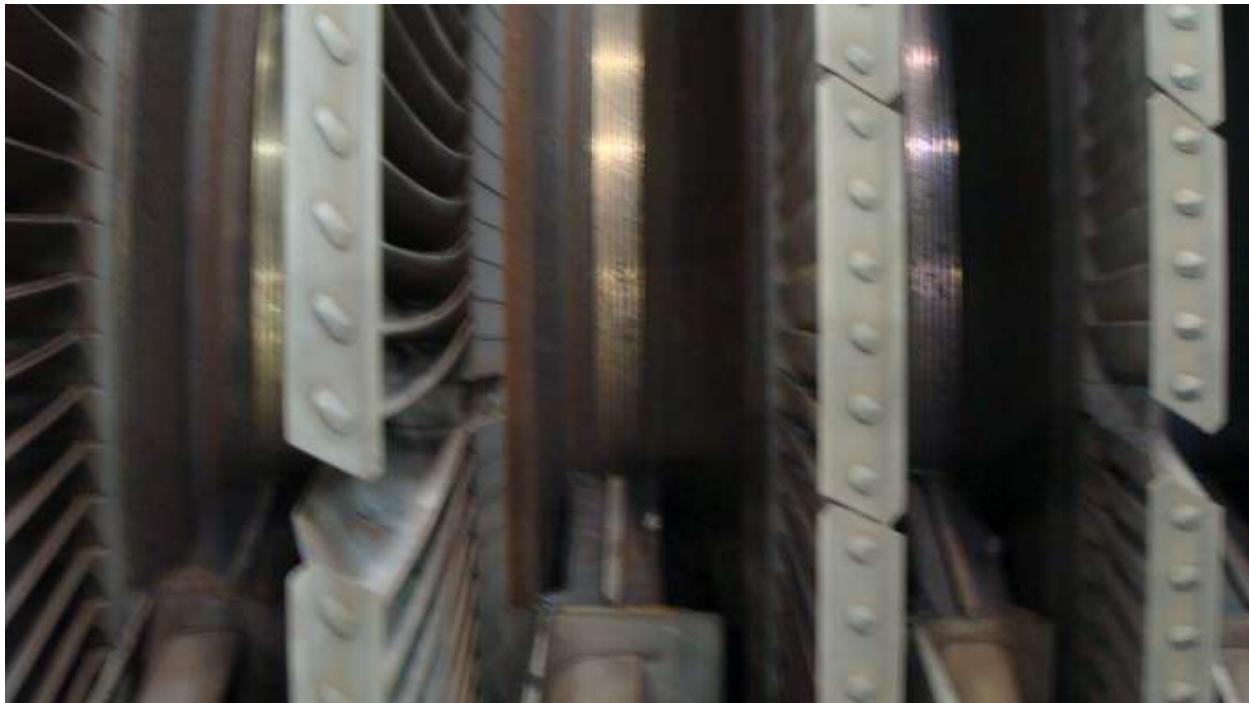
LPTE row 4 packing

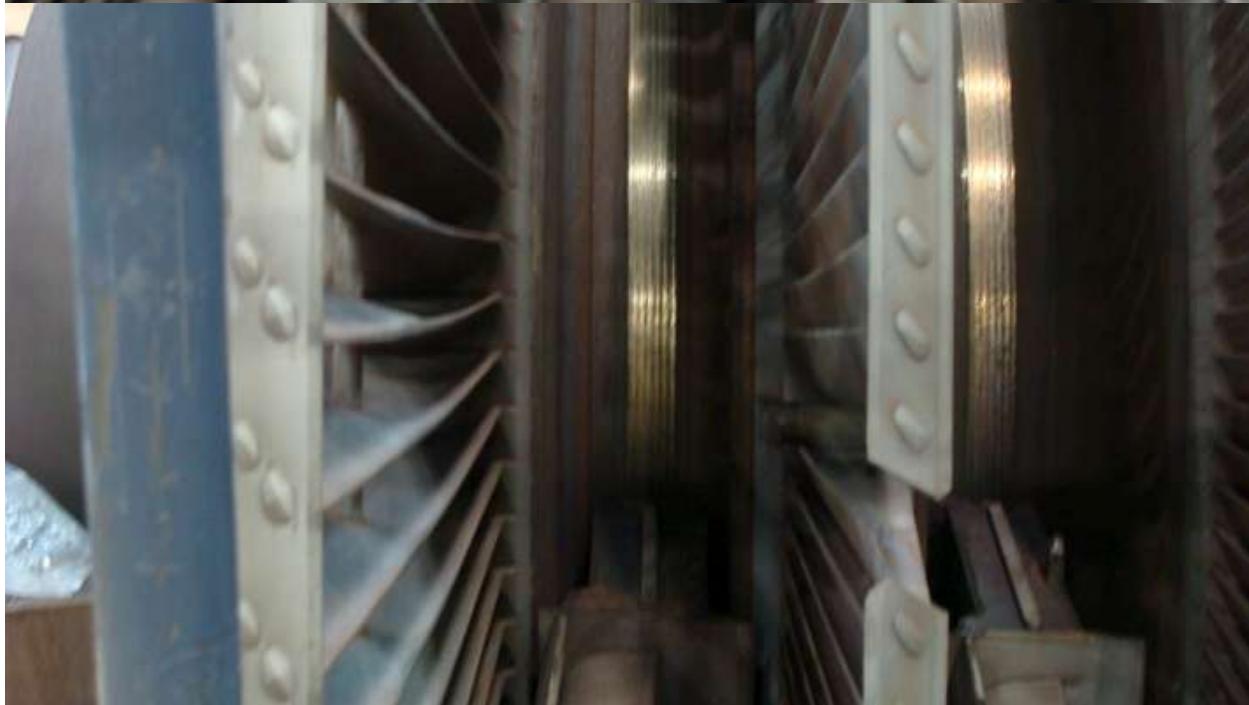
LPTE row 5 packing
