Re: An Application by Newfoundland and Labrador Hydro (Hydro) pursuant to Subsection 41(3) of the Act for approval of the Restoration of Unit 1 Turbine and Generator at the Holyrood Thermal Generating Station

AND IN THE MATTER OF an Application by Newfoundland and Labrador Hydro pursuant to Subsection 41(3) of the *Act*, for the approval of the refurbishment of Unit 1 Turbine and Generator at the Holyrood Thermal Generating Station.

Holyrood Unit 1 Forced Outage
Results of Phase 1 Inspection and Recommendation for Further Inspection

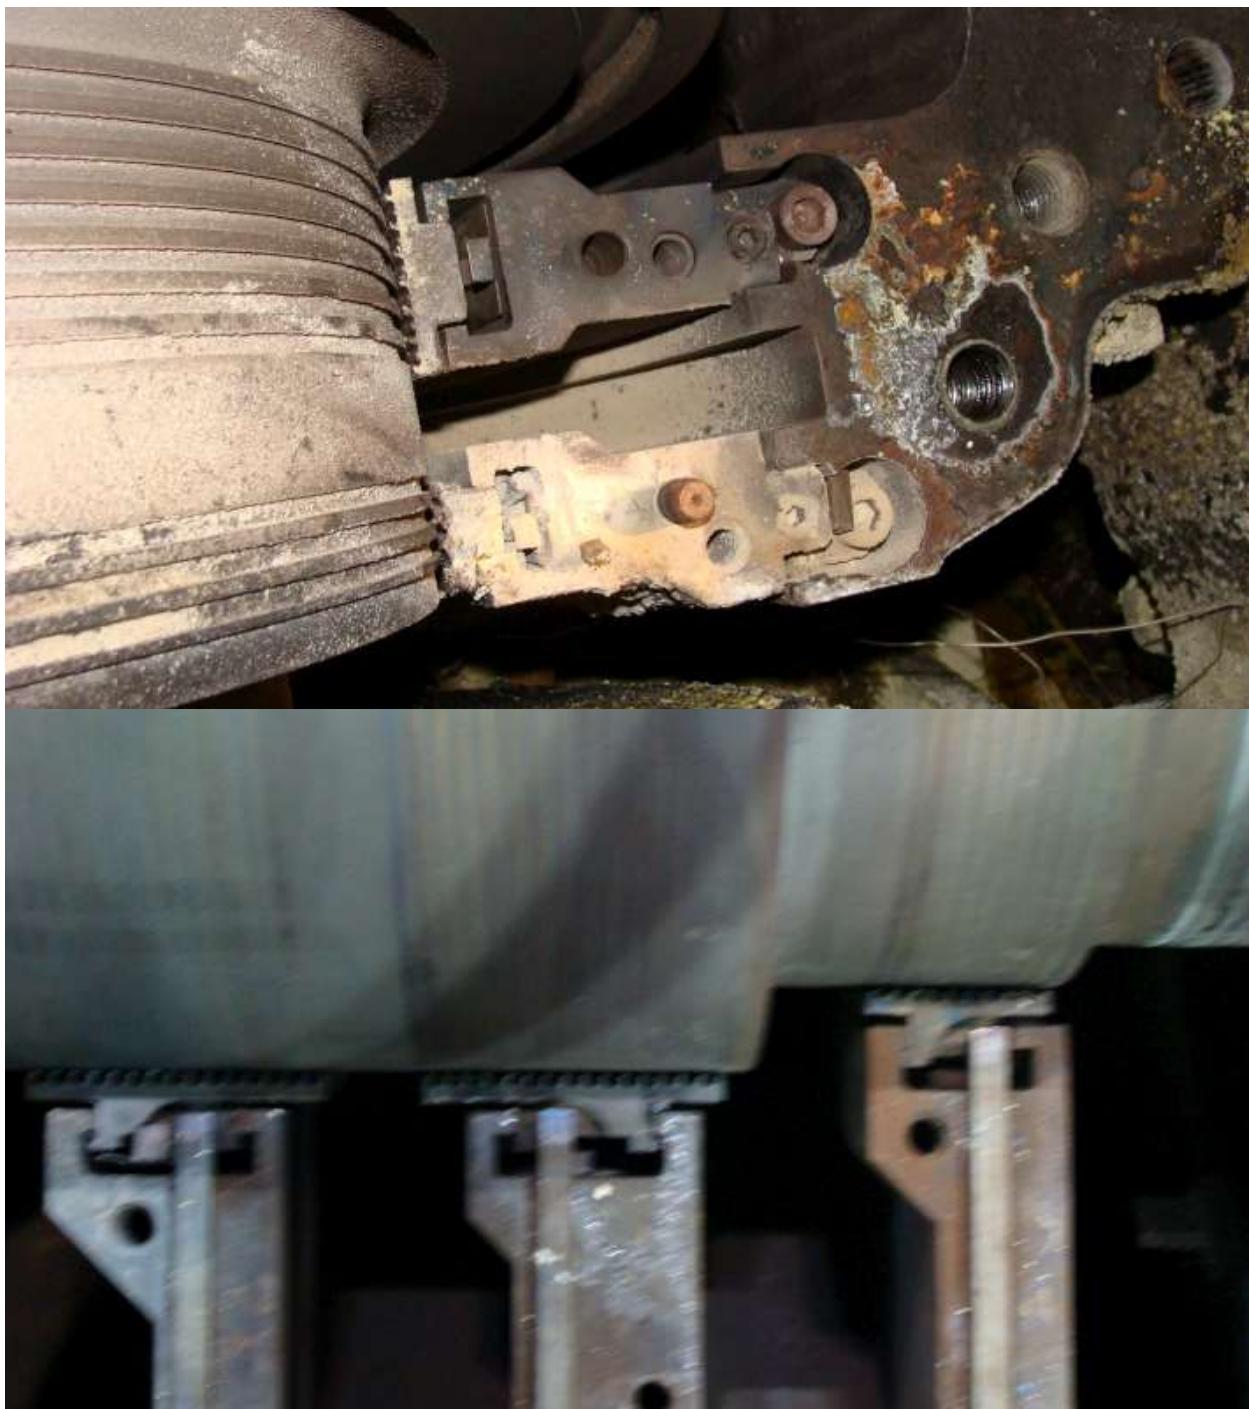
LP N4 outer gland packing

LP N3 inner gland packing

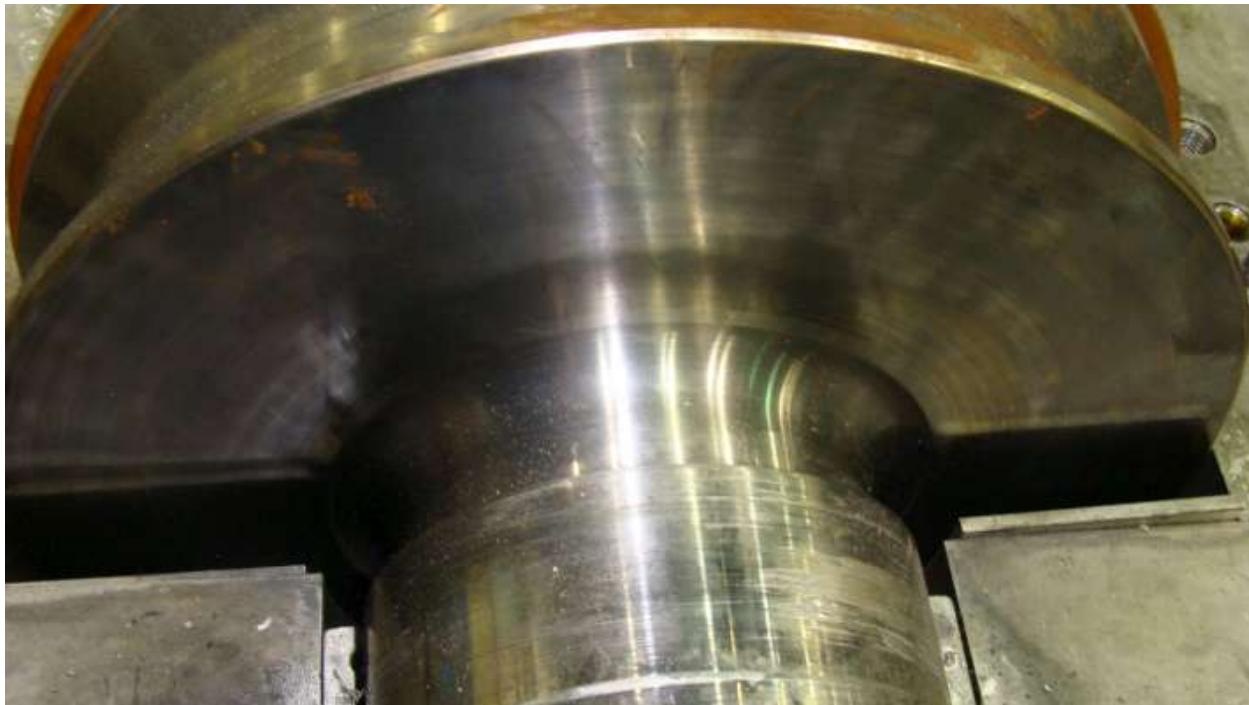
Thrust runner condition

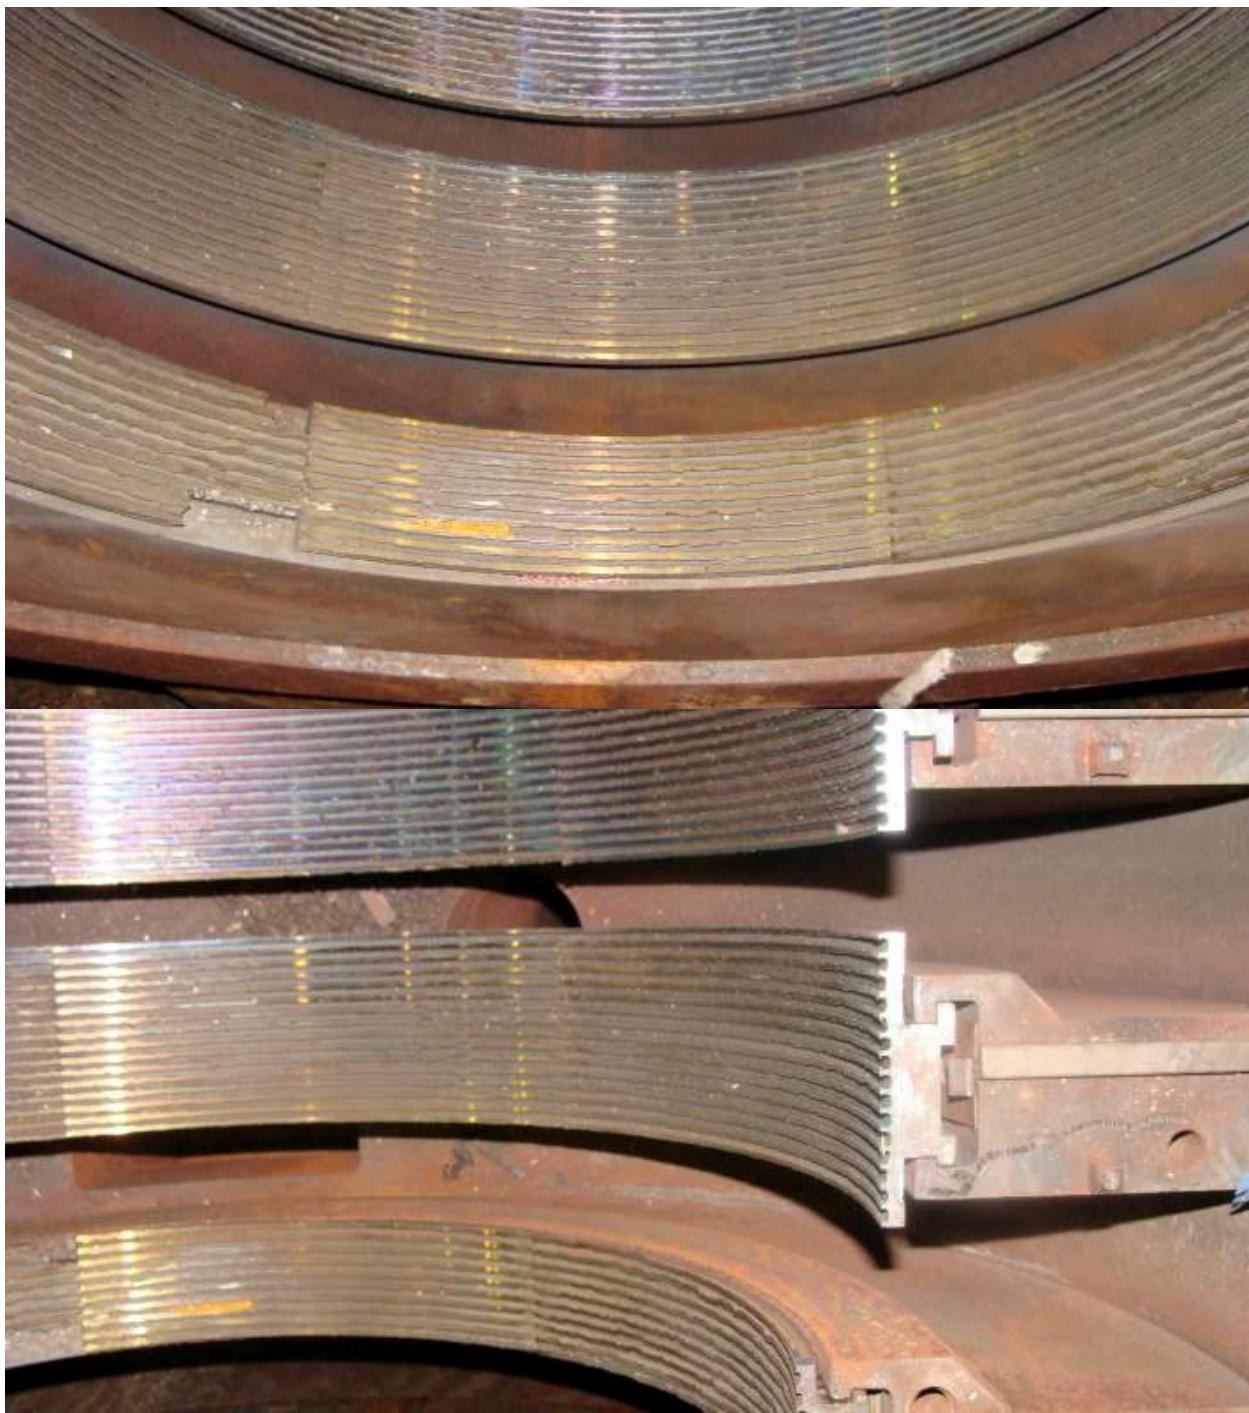
L/H N3 packing gland

L/H N4 packing gland

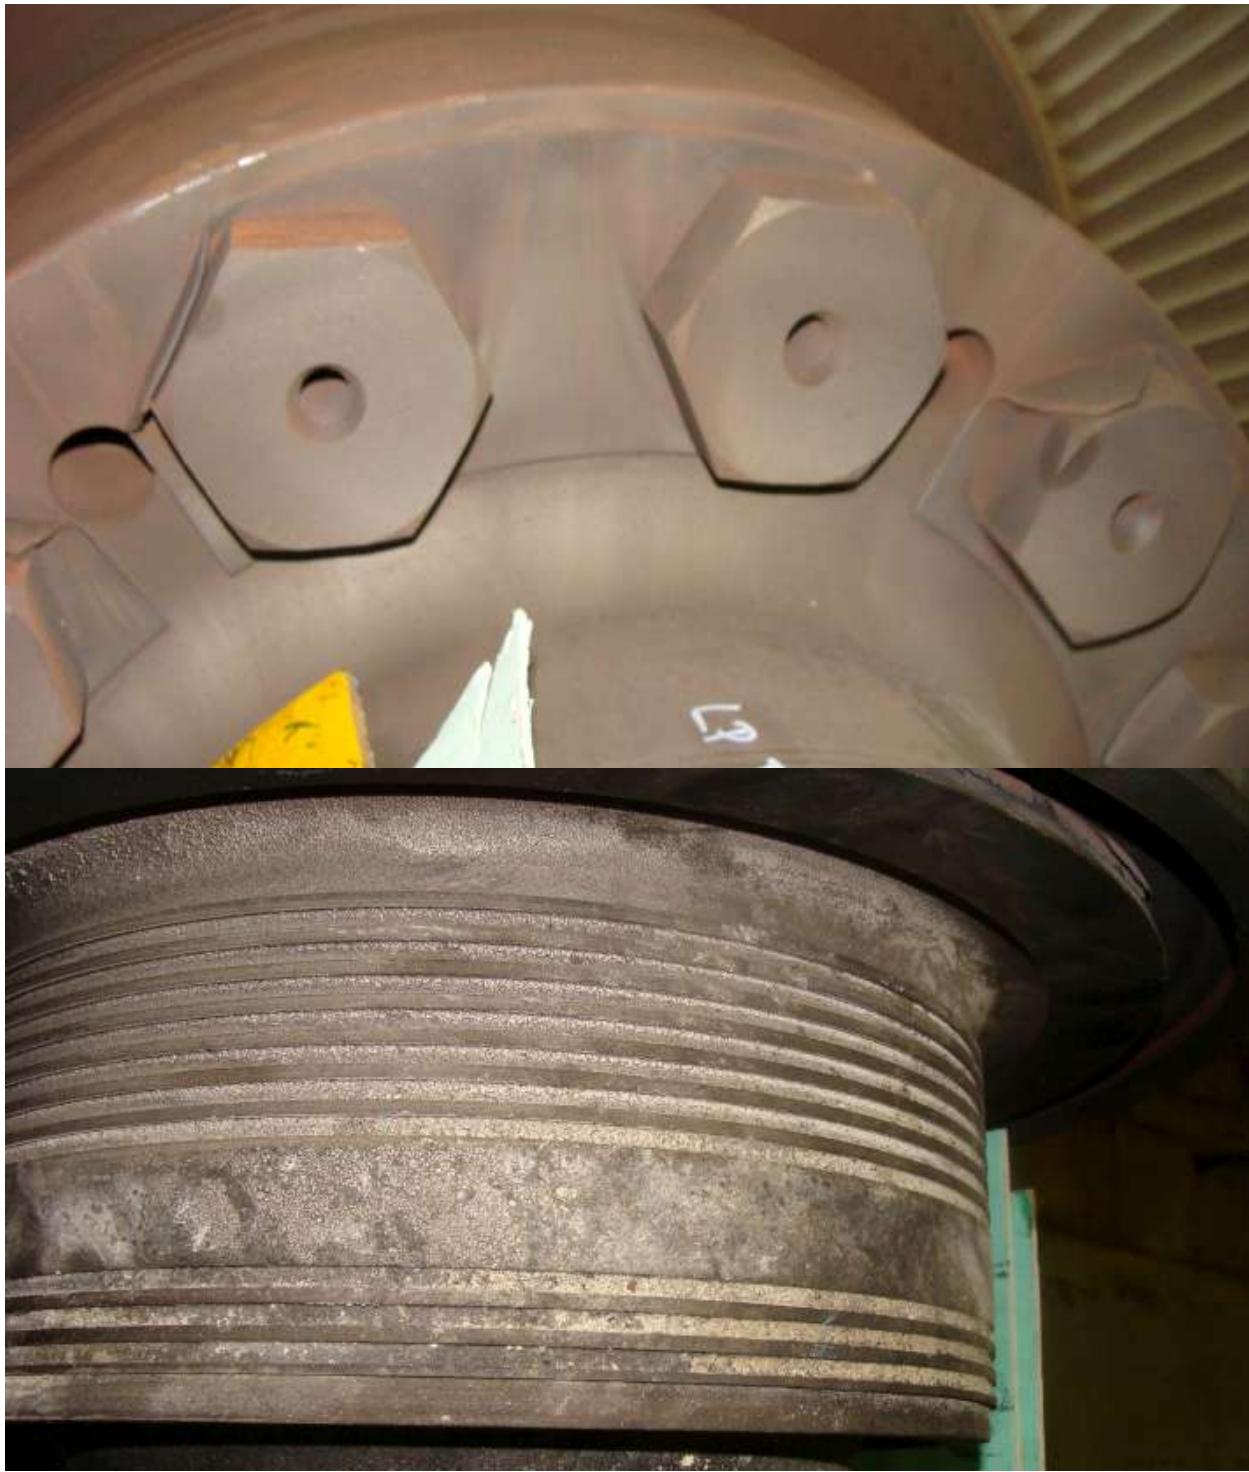
HP/LP coupling bolts

N1 outer gland area

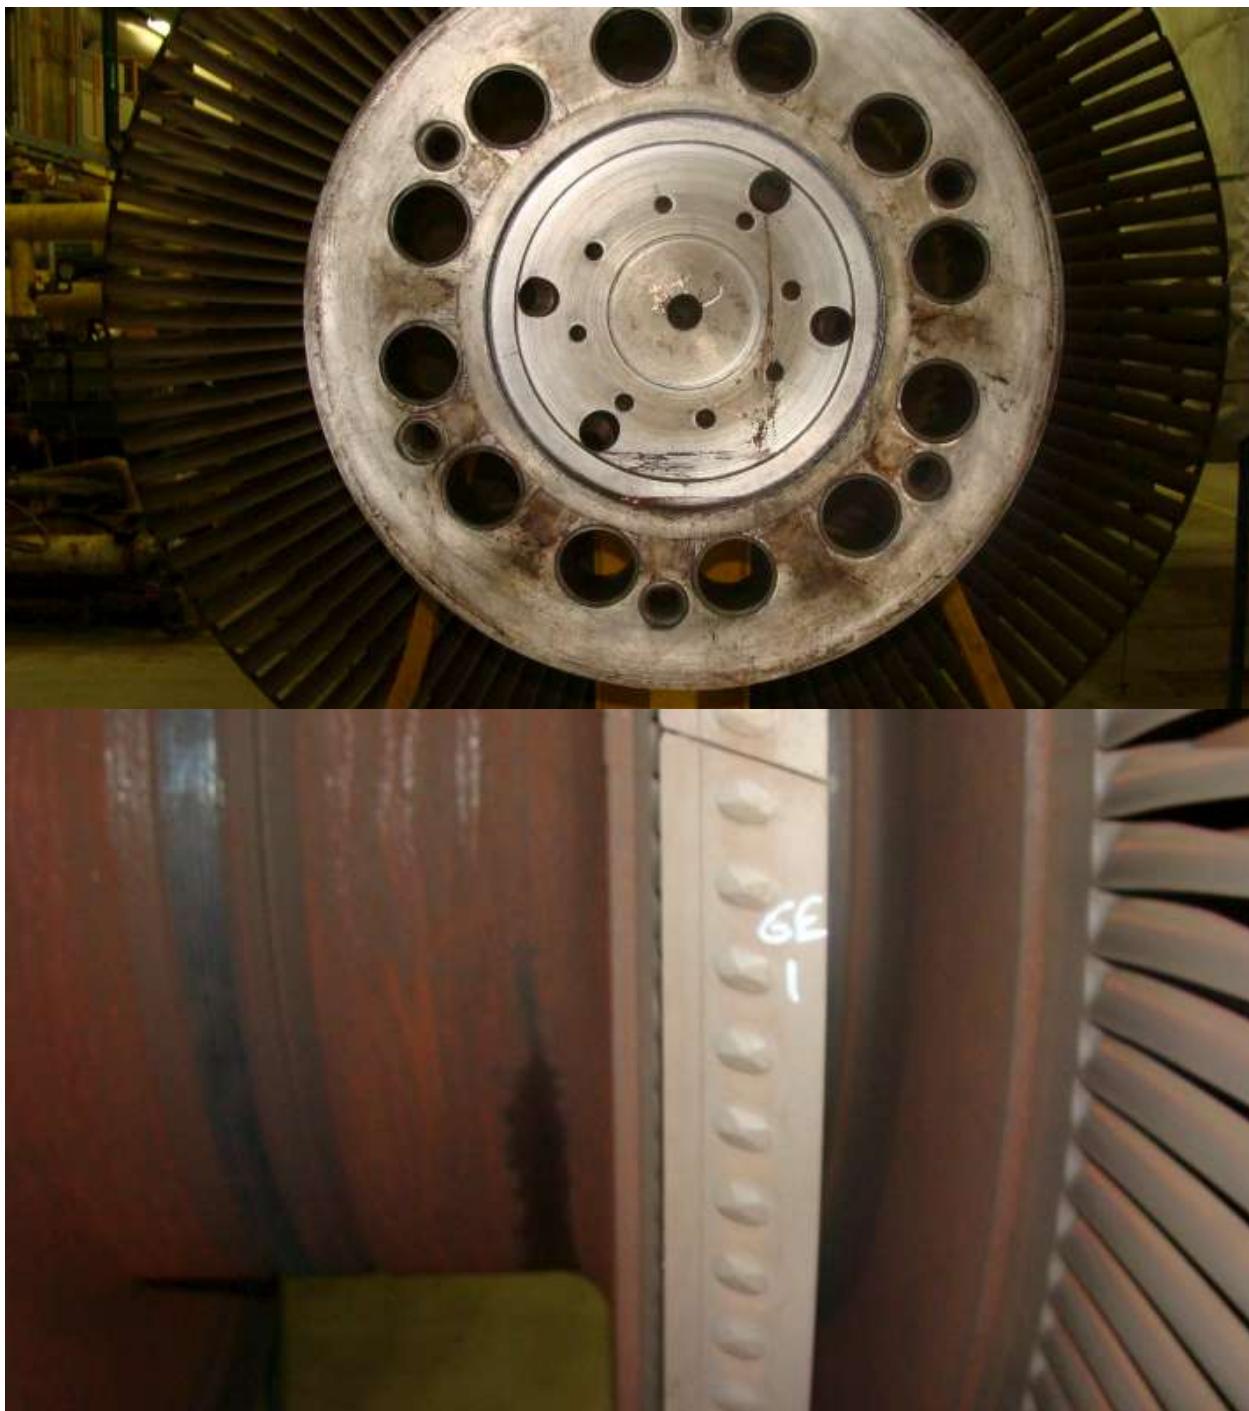
LP/Gen coupling

LPGE stage 1 covers

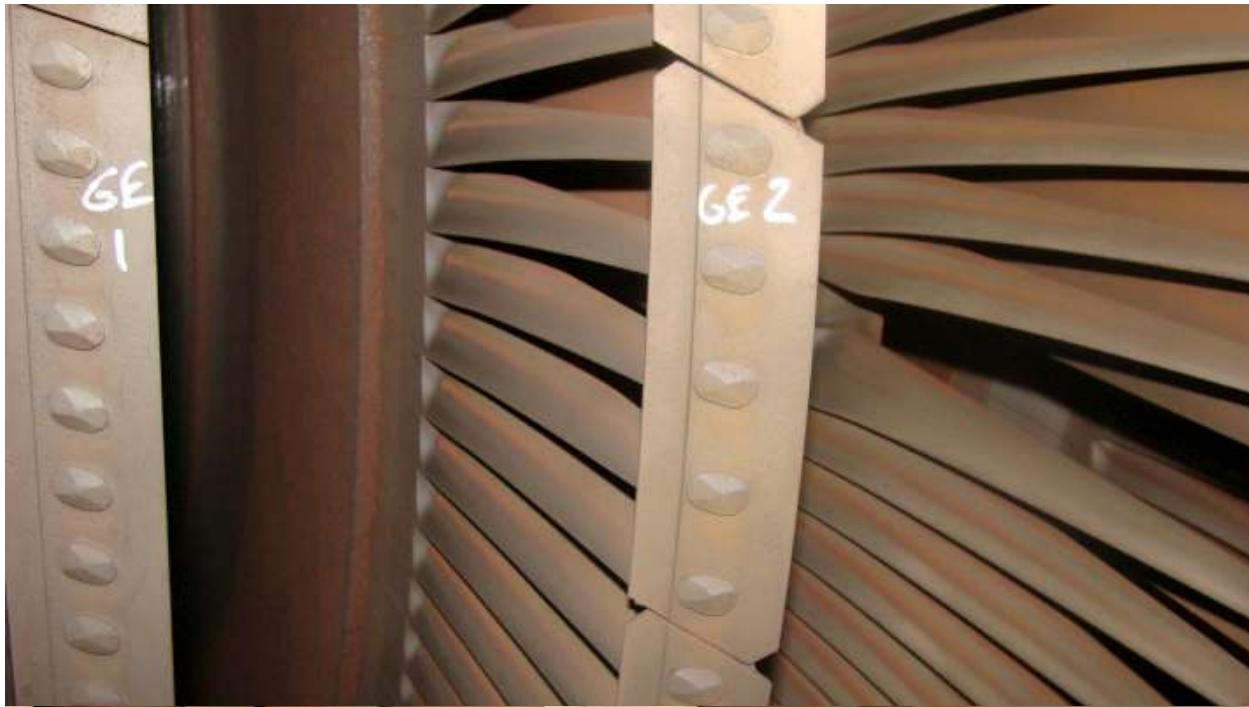
LPGE stage 1,2 covers

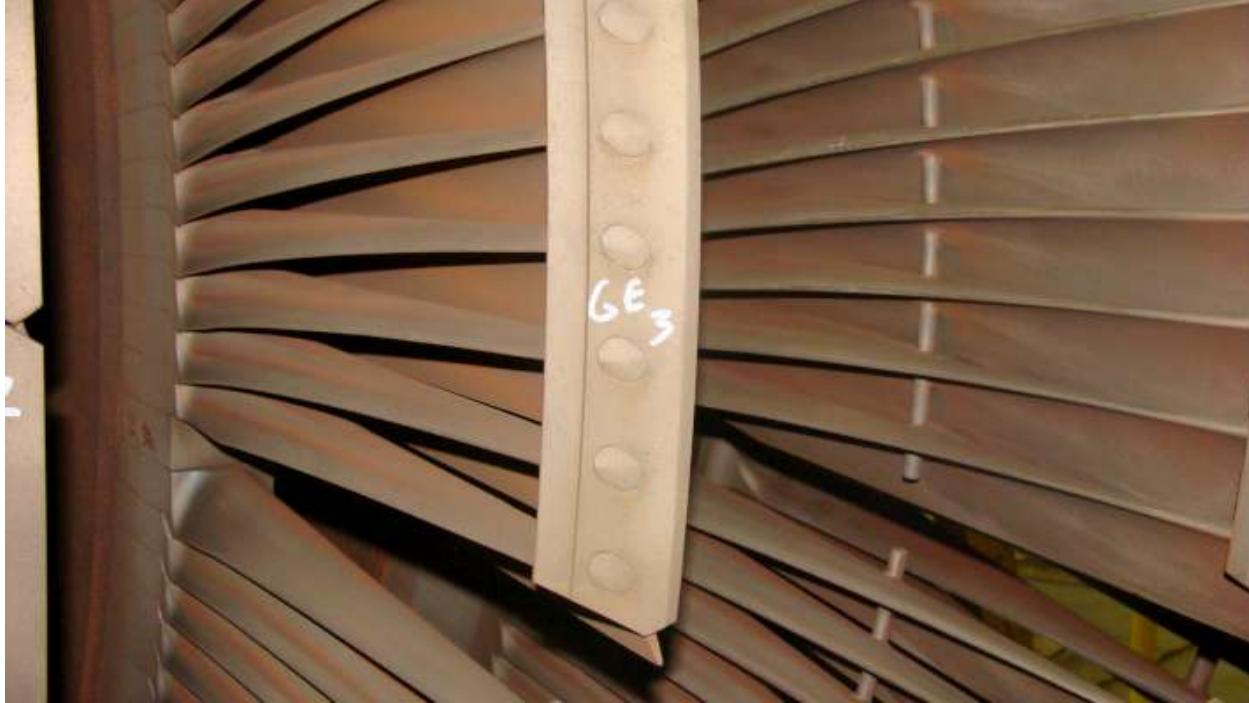
LPGE stage 3 covers

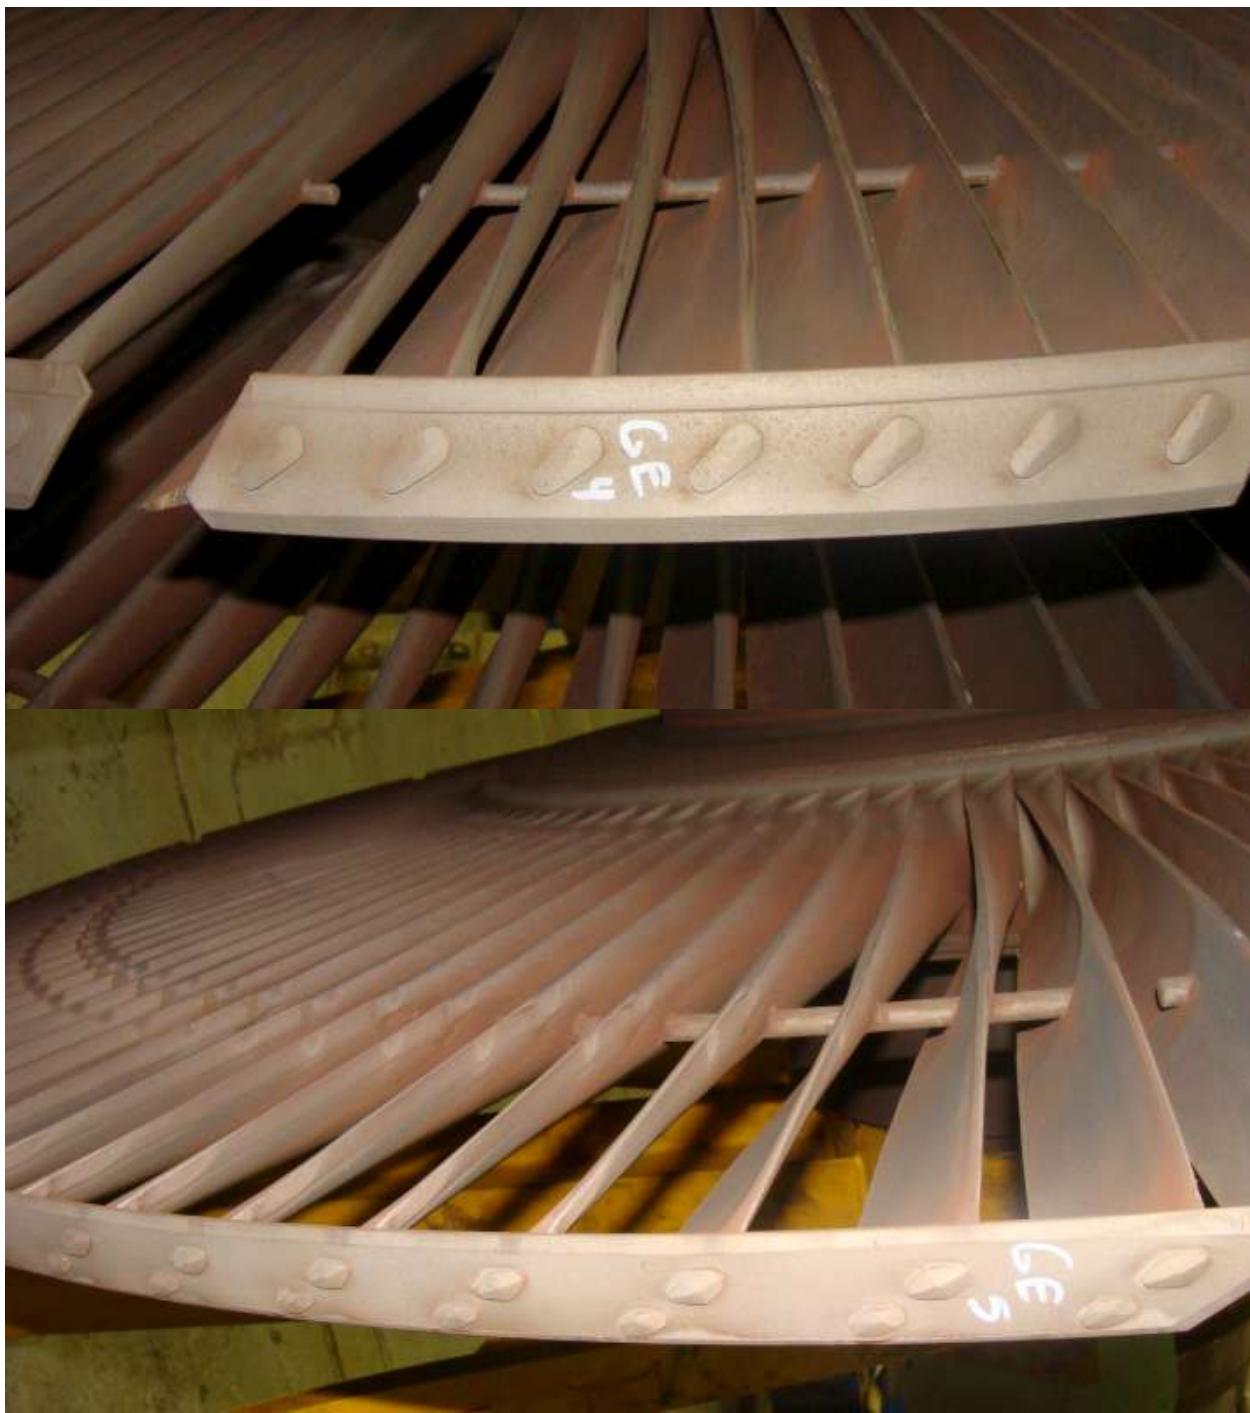
LPGE stage 4 covers

LPGE stage 5 covers

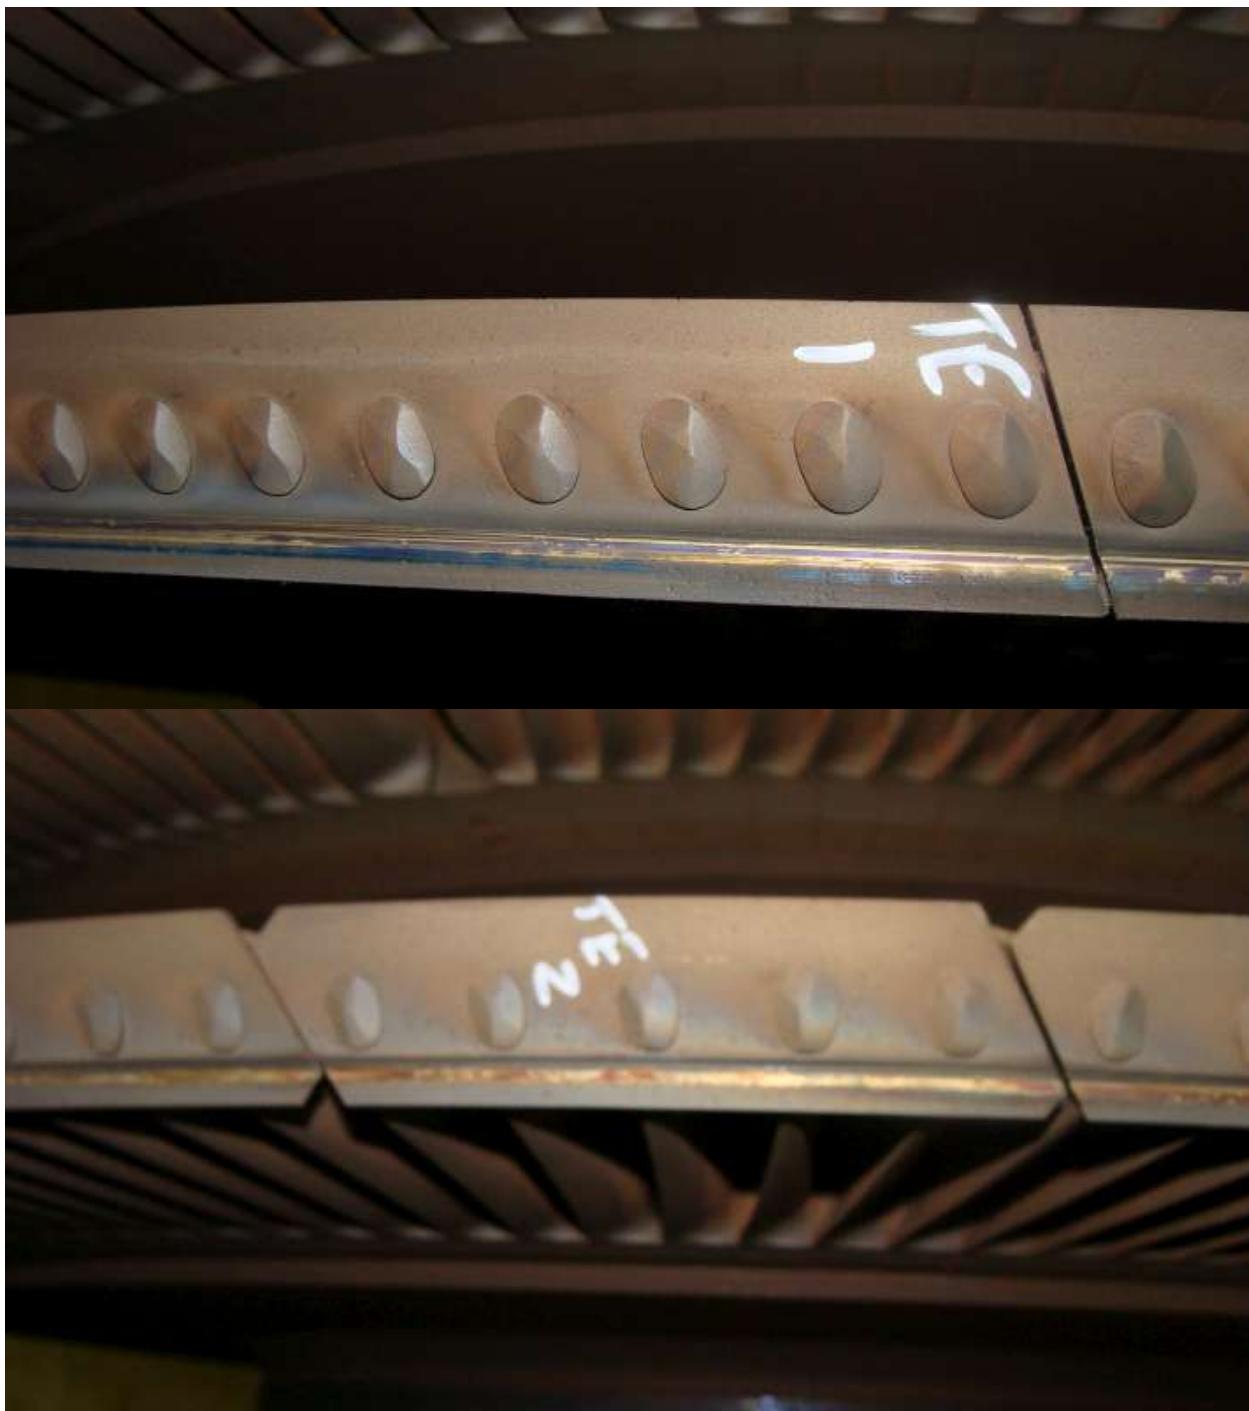
LPTE stage 1 cover rub

LPTE stage 2 cover rub

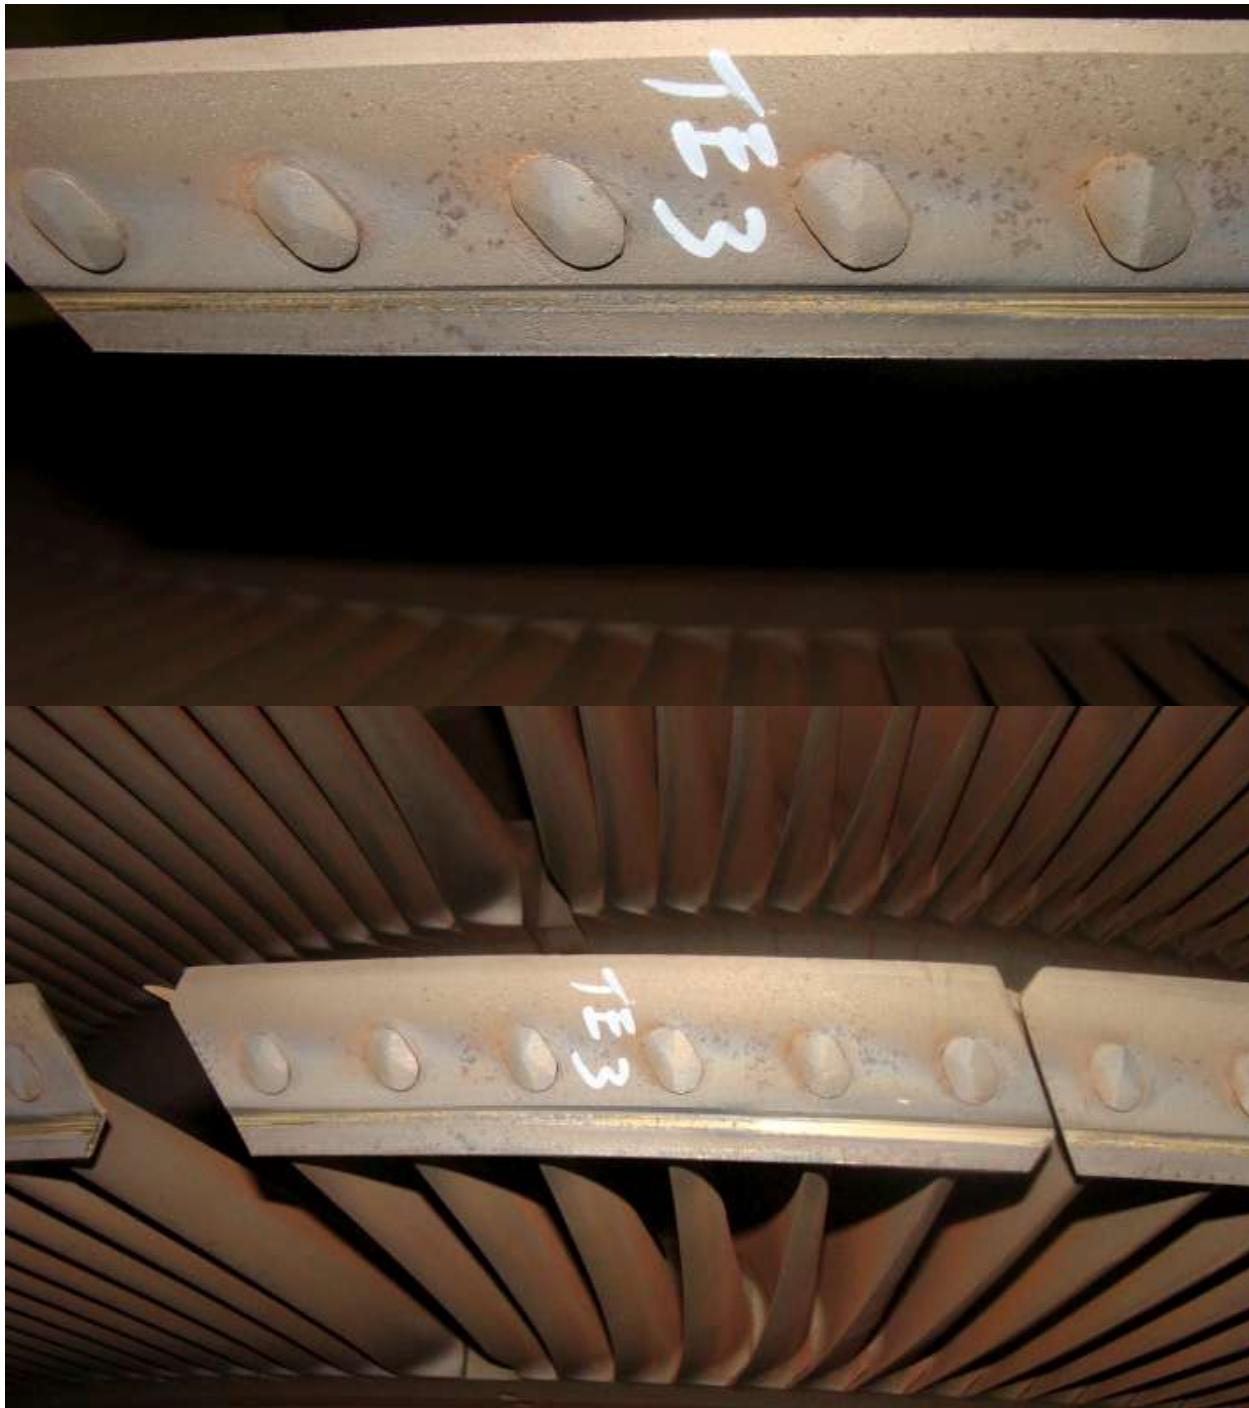
LPTE stage 3 cover rub

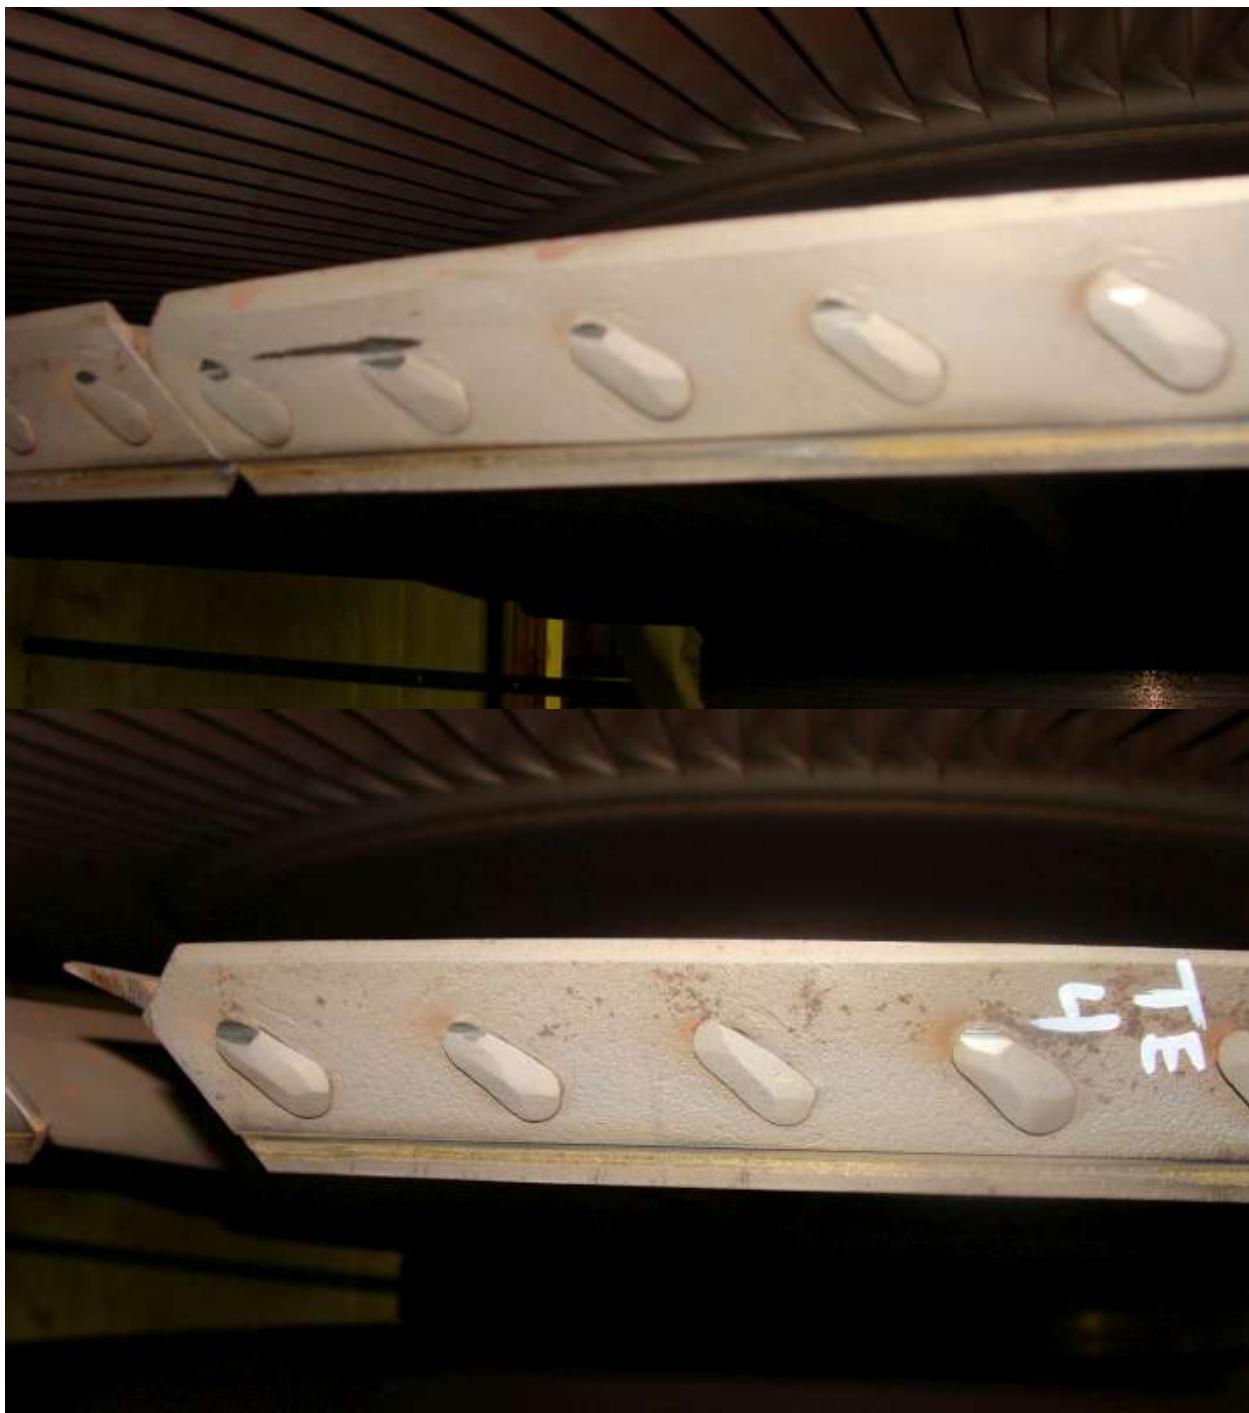
LPTE stage 4 cover rub

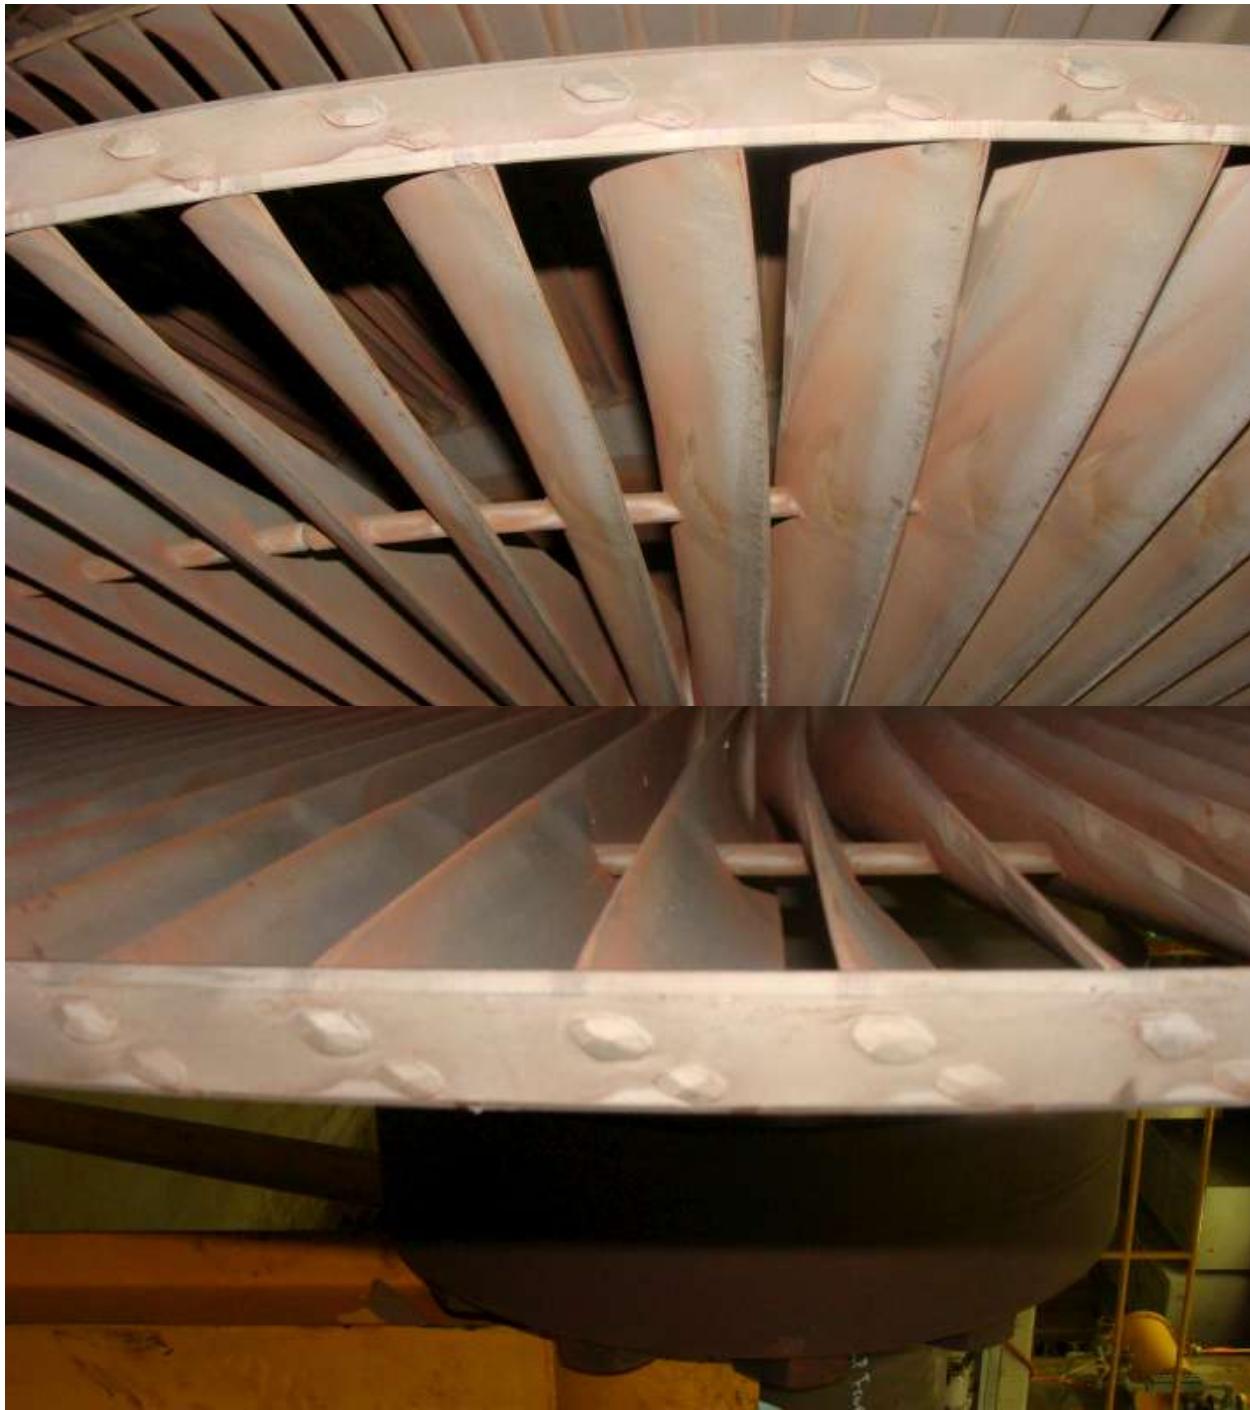
LPTE stage 5

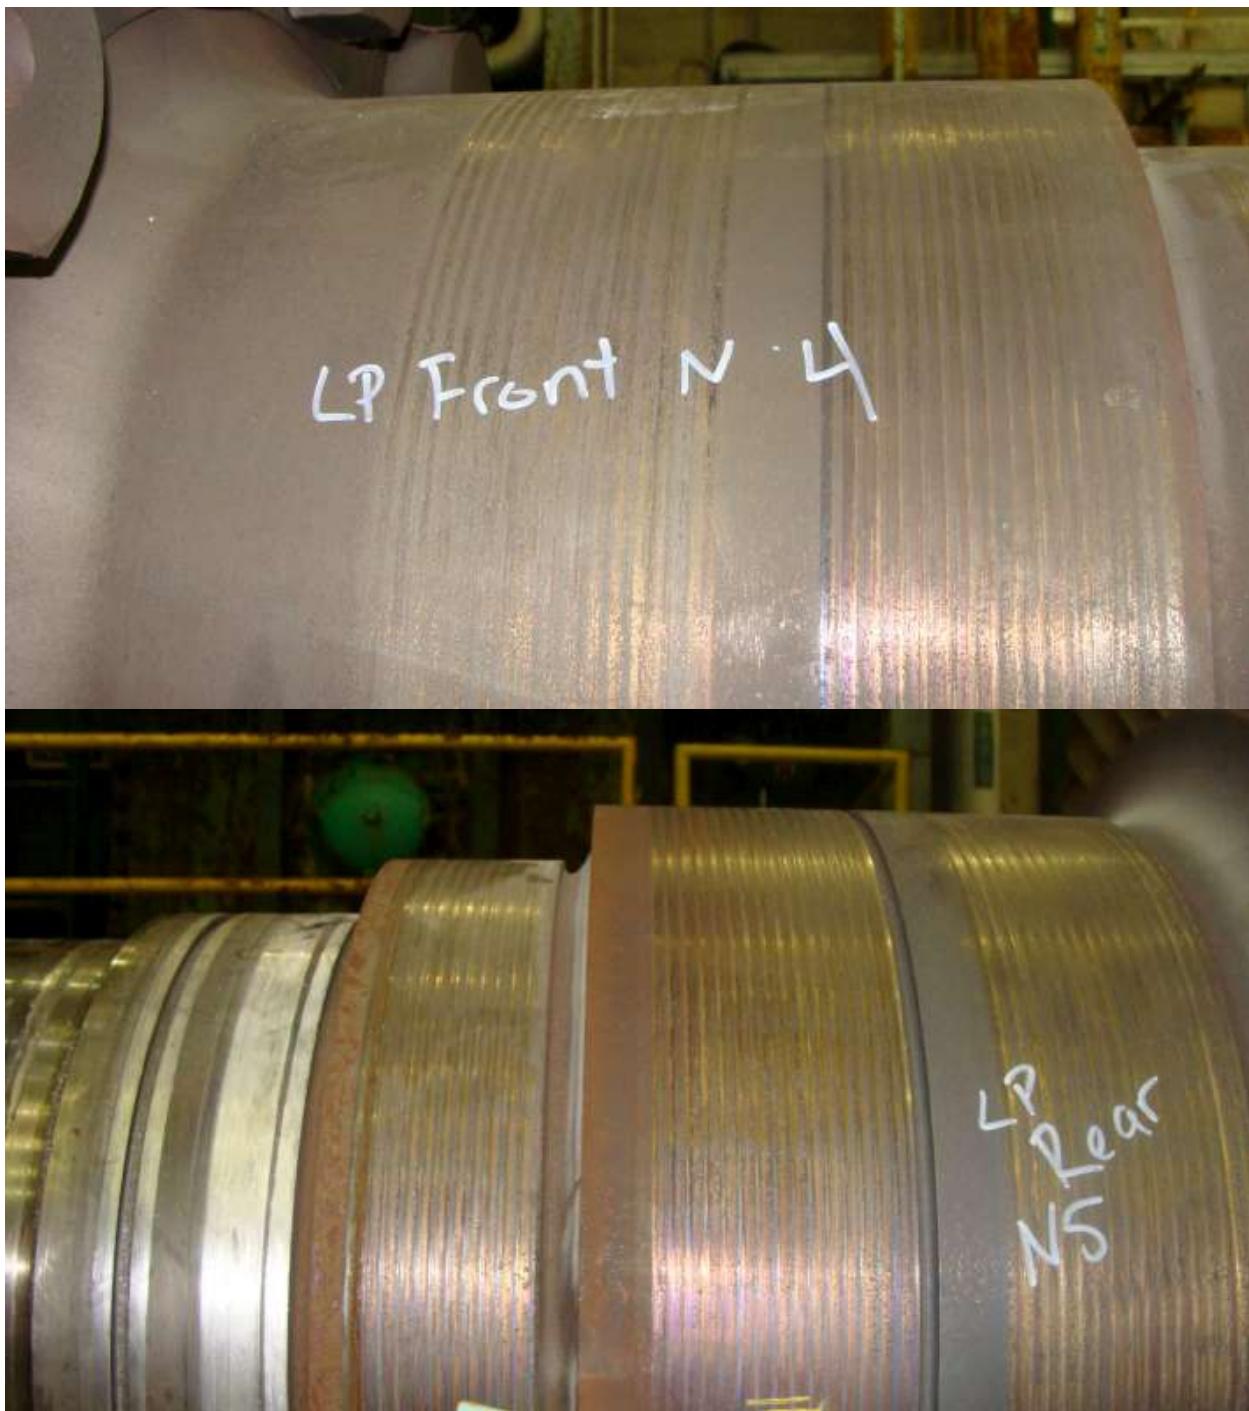
N4 packing gland location

N5 packing gland location

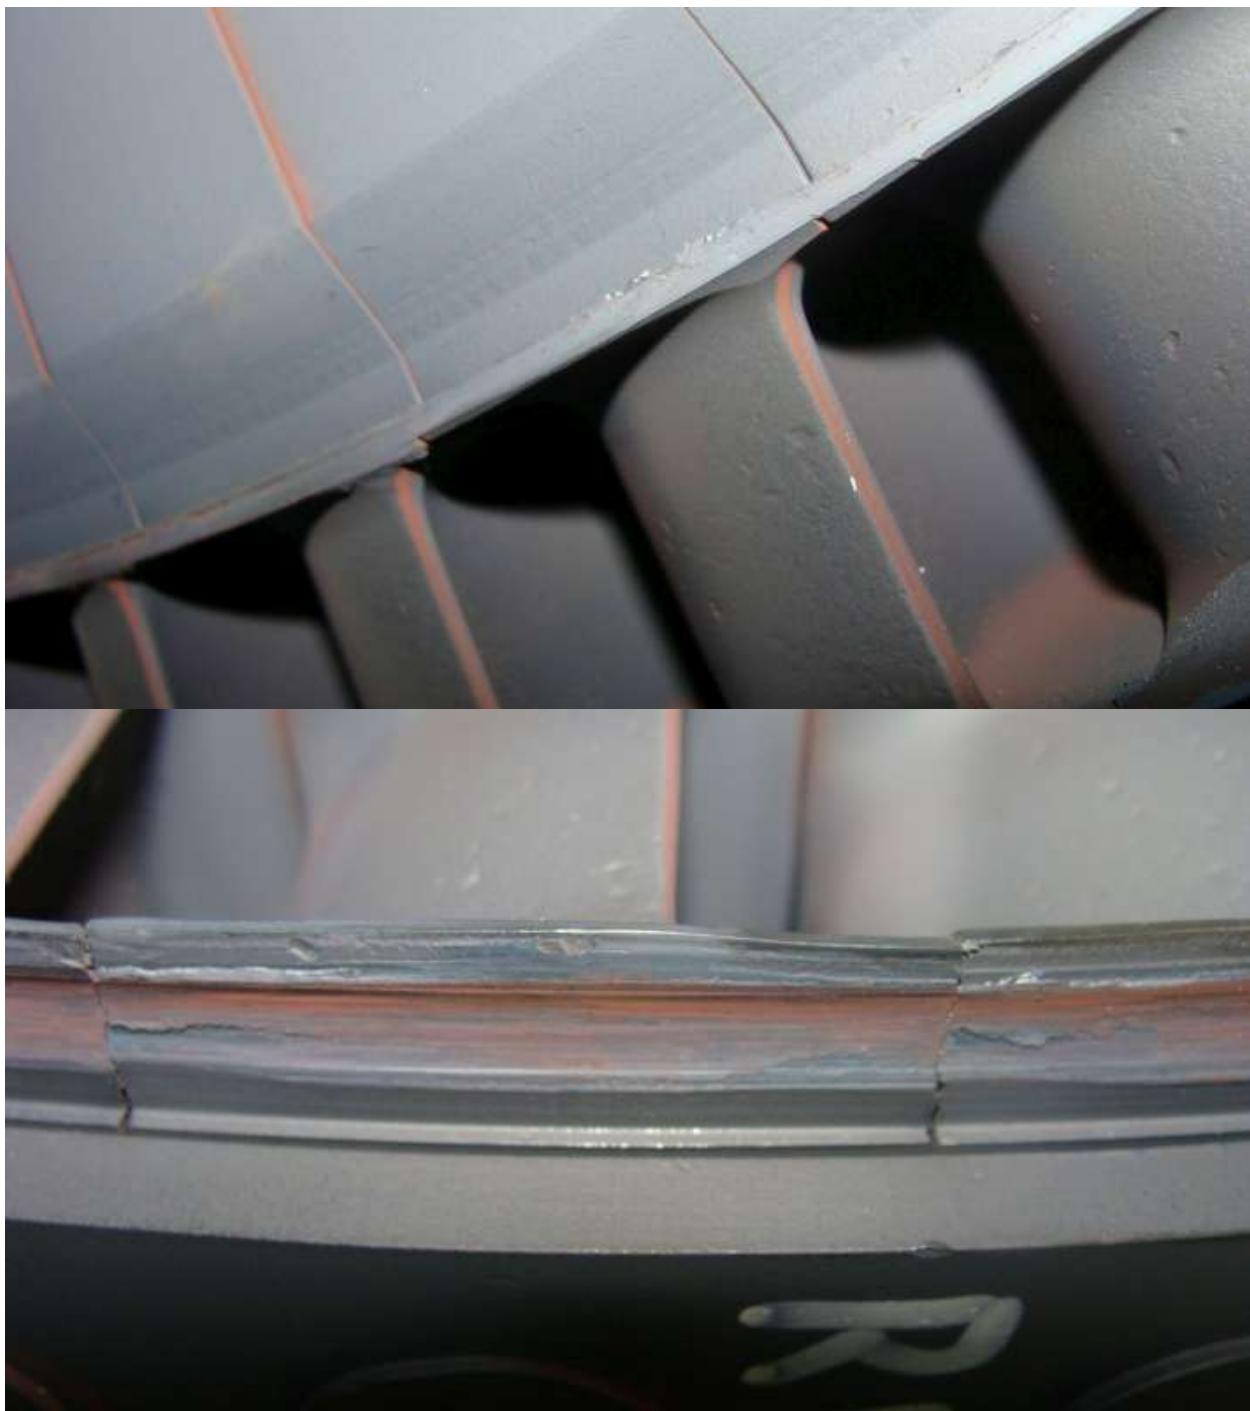
Stage 1 blade root rub

Stage 1 blade integral cover rub
