Re: An Application by Newfoundland and Labrador Hydro (Hydro) pursuant to Subsection 41(3) of the Act for approval of the Restoration of Unit 1 Turbine and Generator at the Holyrood Thermal Generating Station

AND IN THE MATTER OF an Application by Newfoundland and Labrador Hydro pursuant to Subsection 41(3) of the *Act*, for the approval of the refurbishment of Unit 1 Turbine and Generator at the Holyrood Thermal Generating Station.

Holyrood Unit 1 Forced Outage
Results of Phase 1 Inspection and Recommendation for Further Inspection

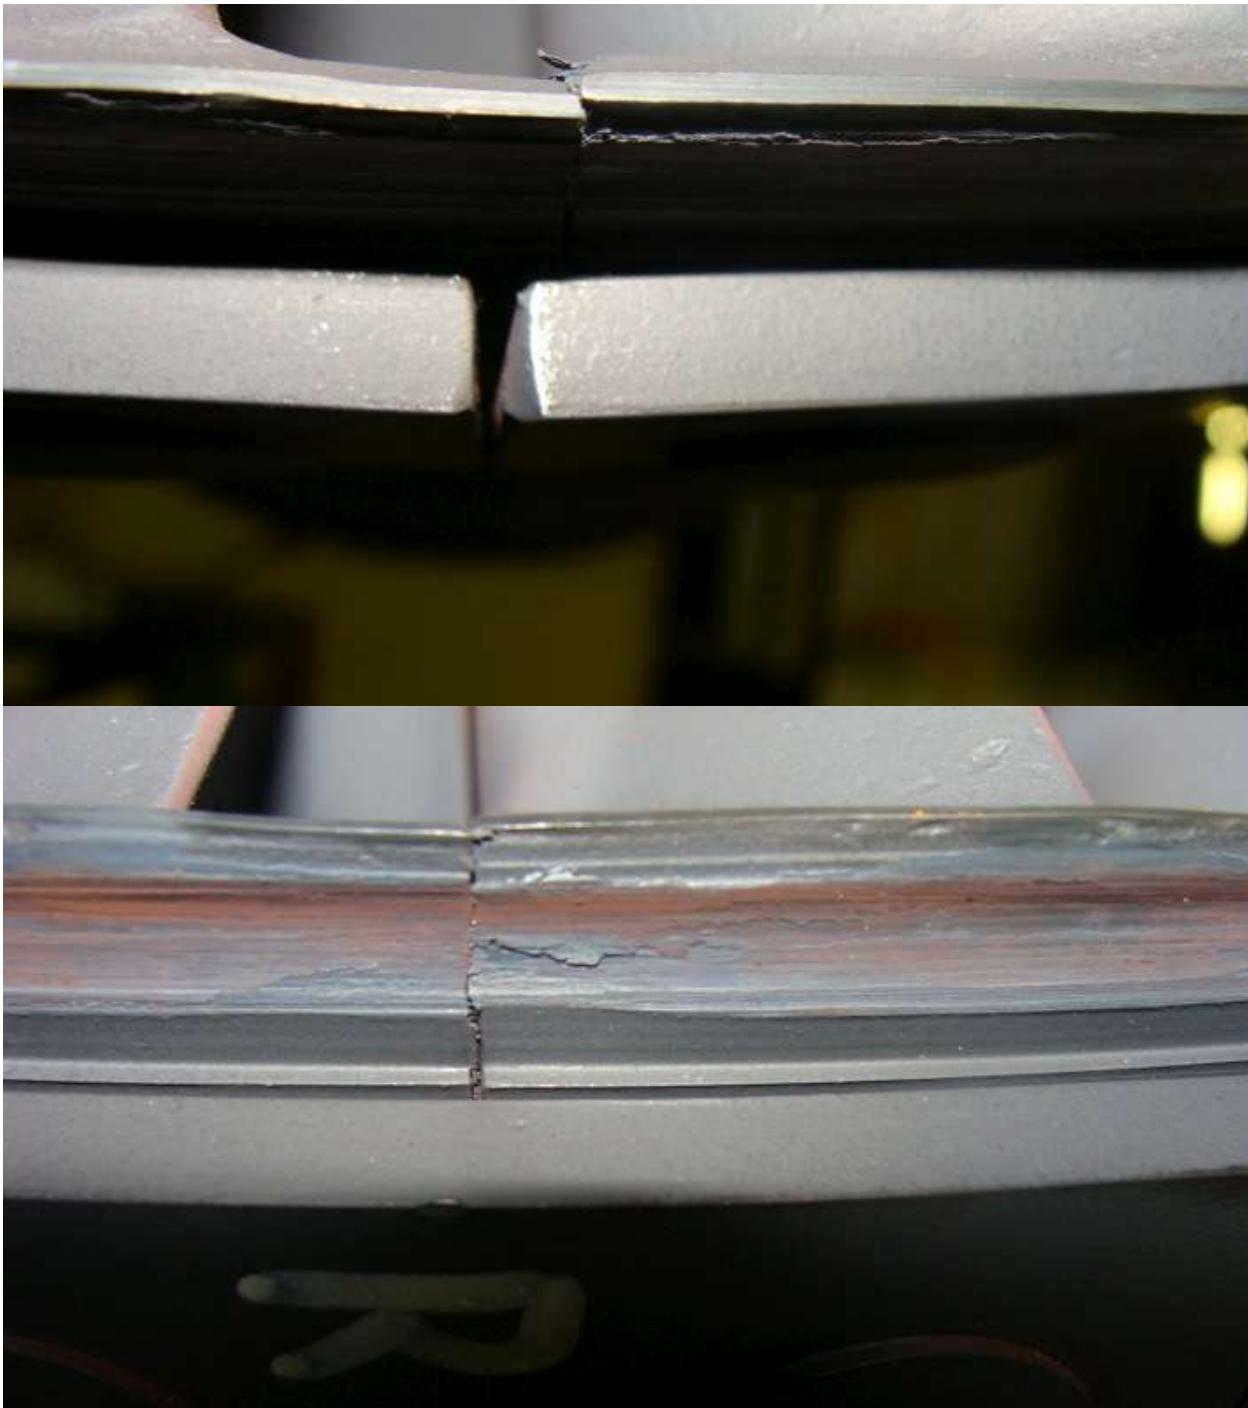
Stage 1 integral cover rub and cover position

Stage 1 integral cover rub

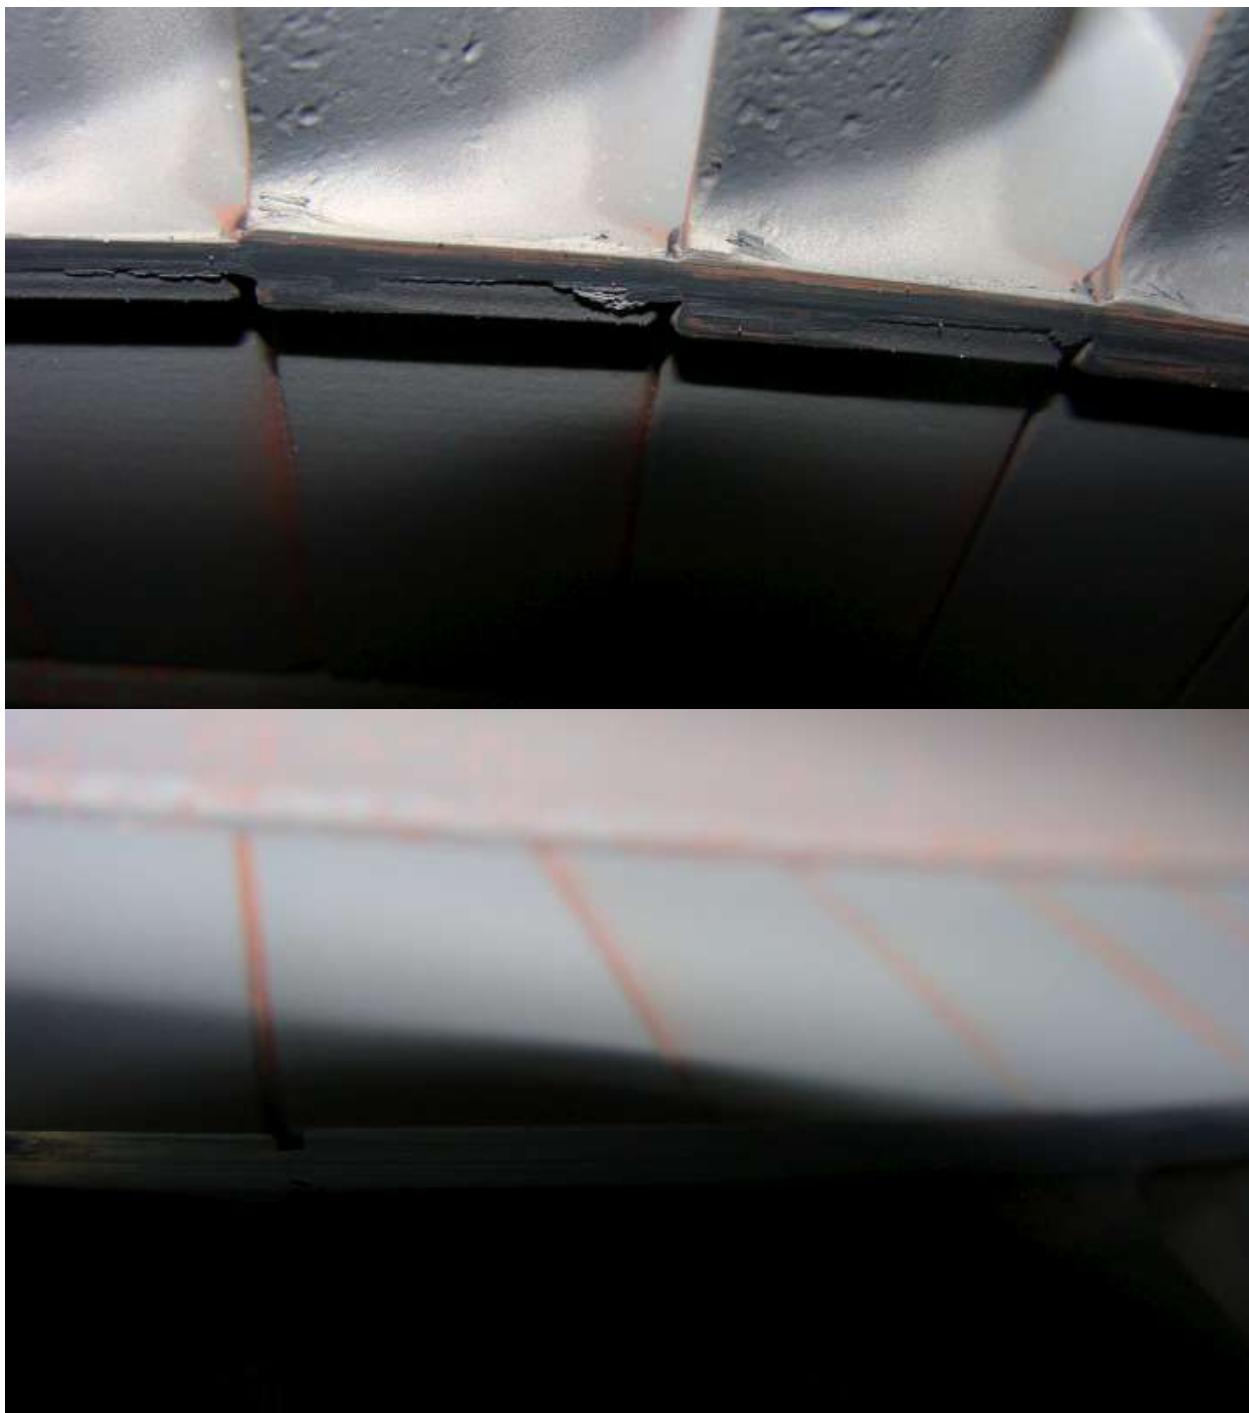
Row 2 blade root rub

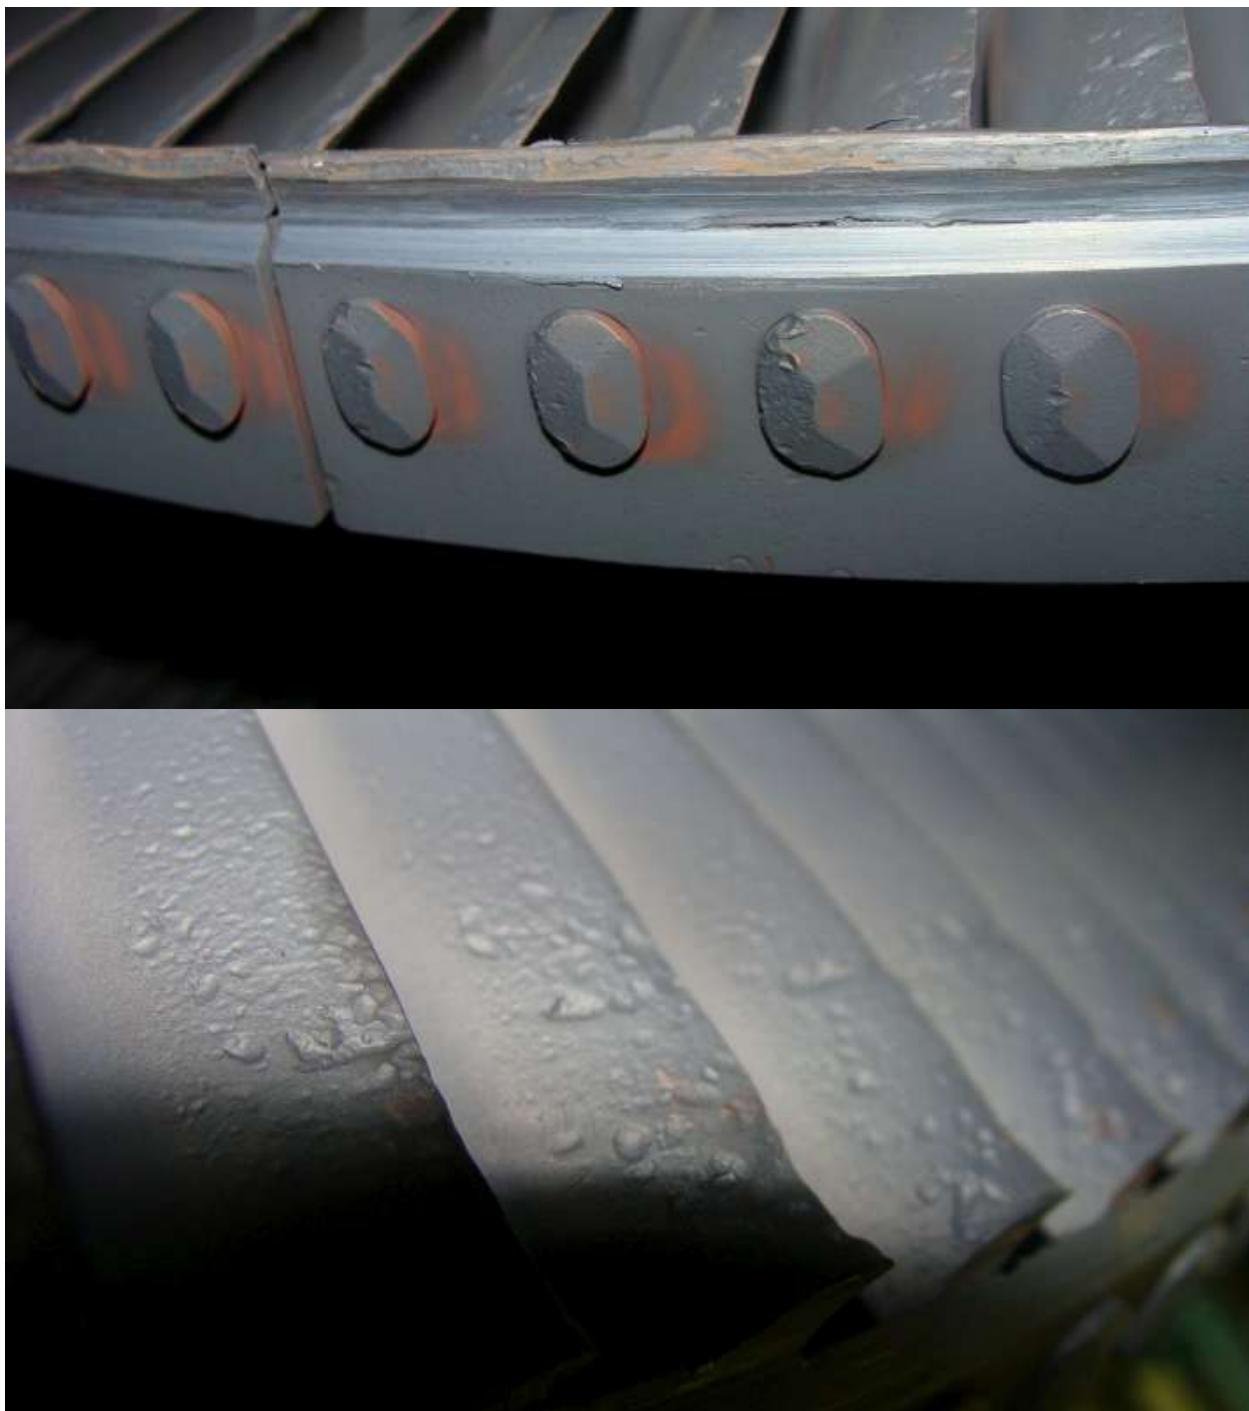
Row 2 heavy rubs

Row 2 blade inlet condition

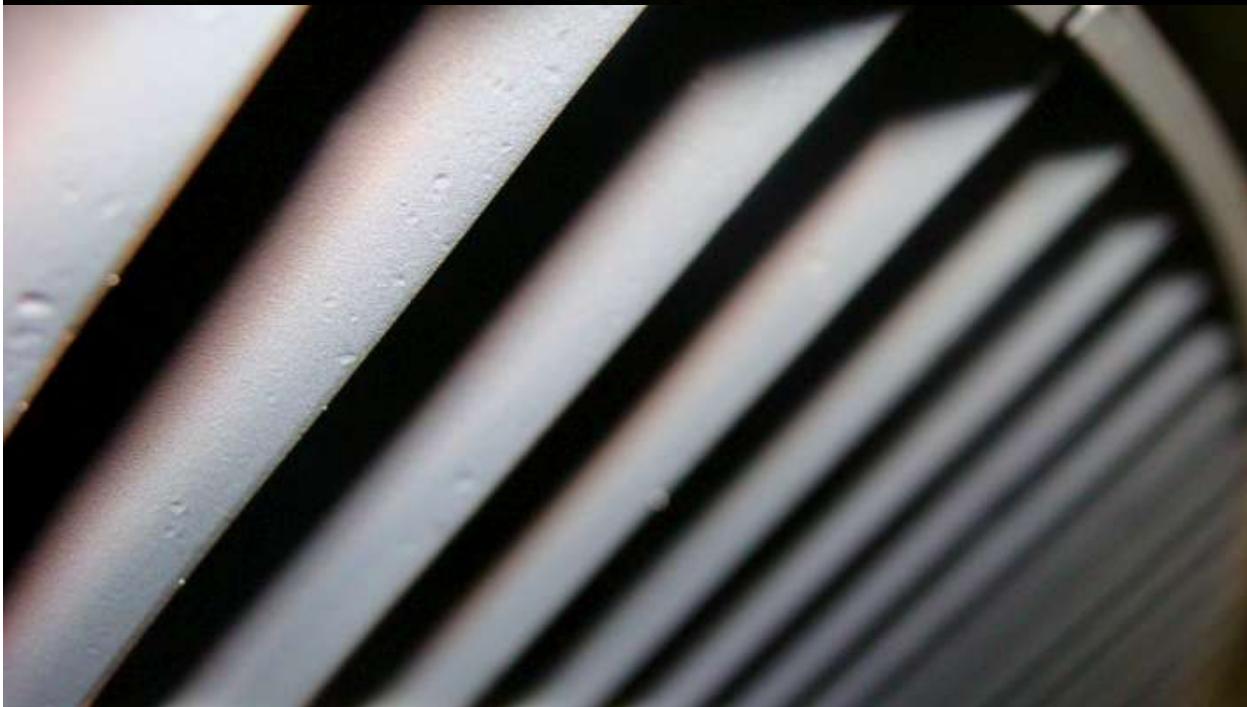
Row 2 blade exit condition

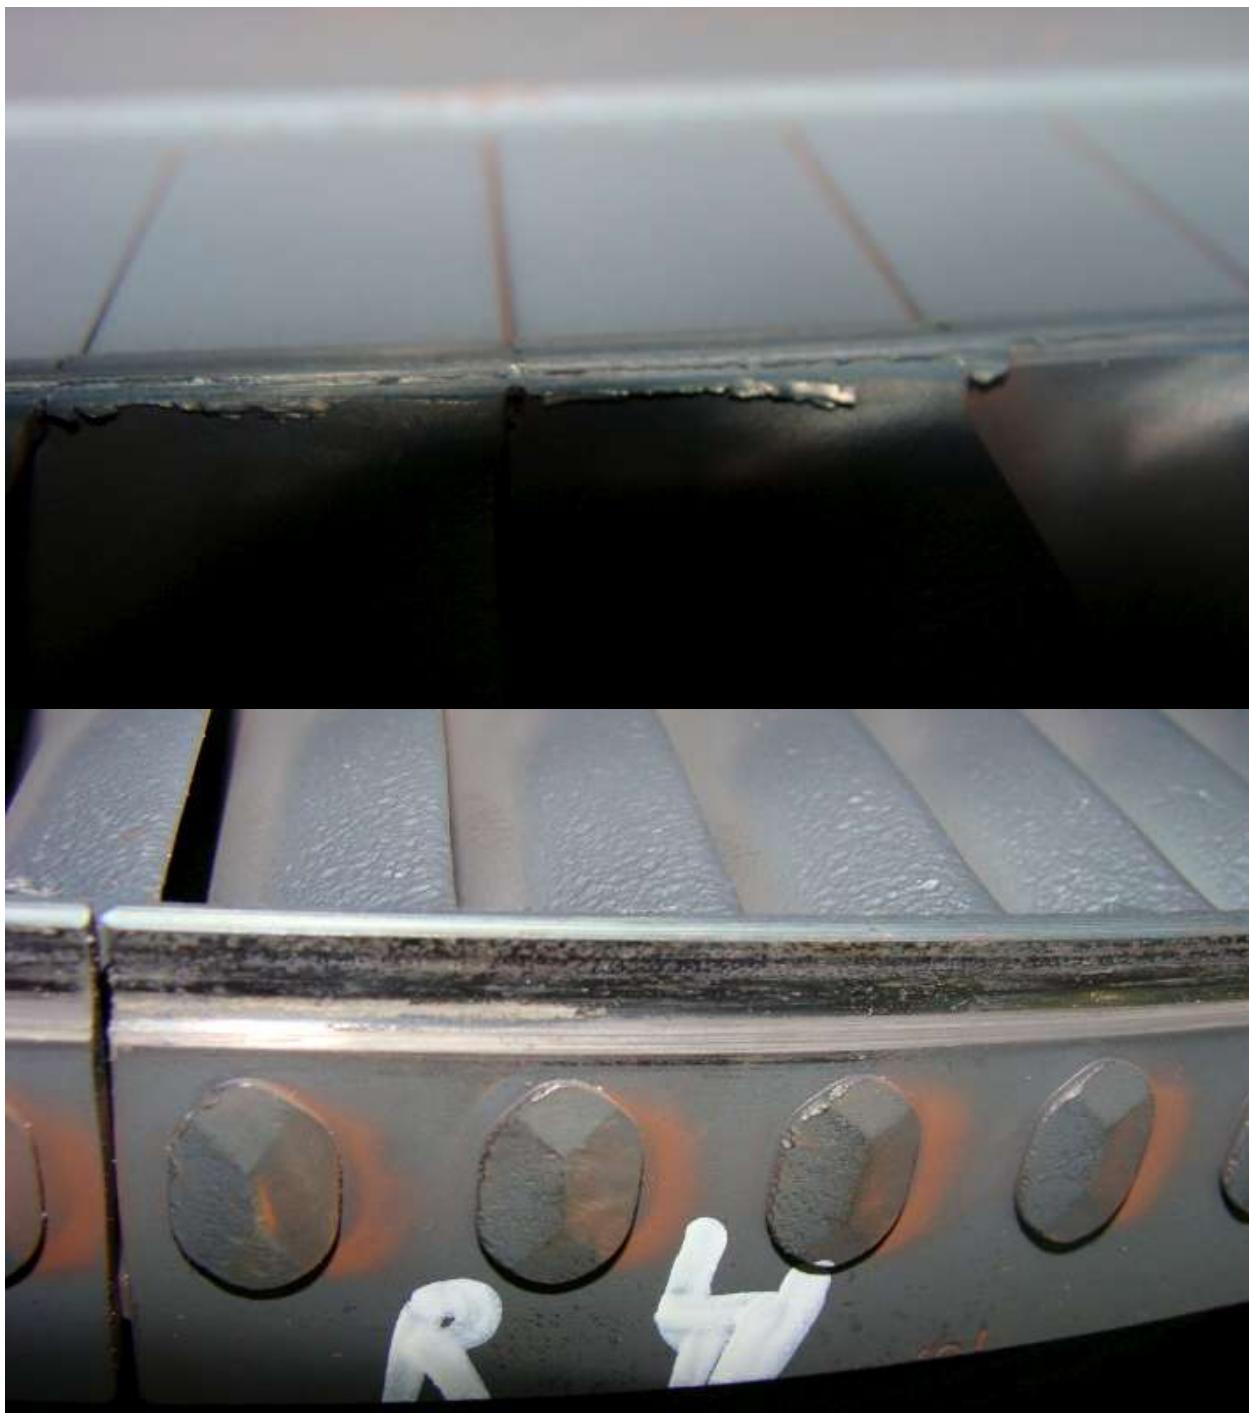
Row 3 blade root rub

Row 4 cover condition

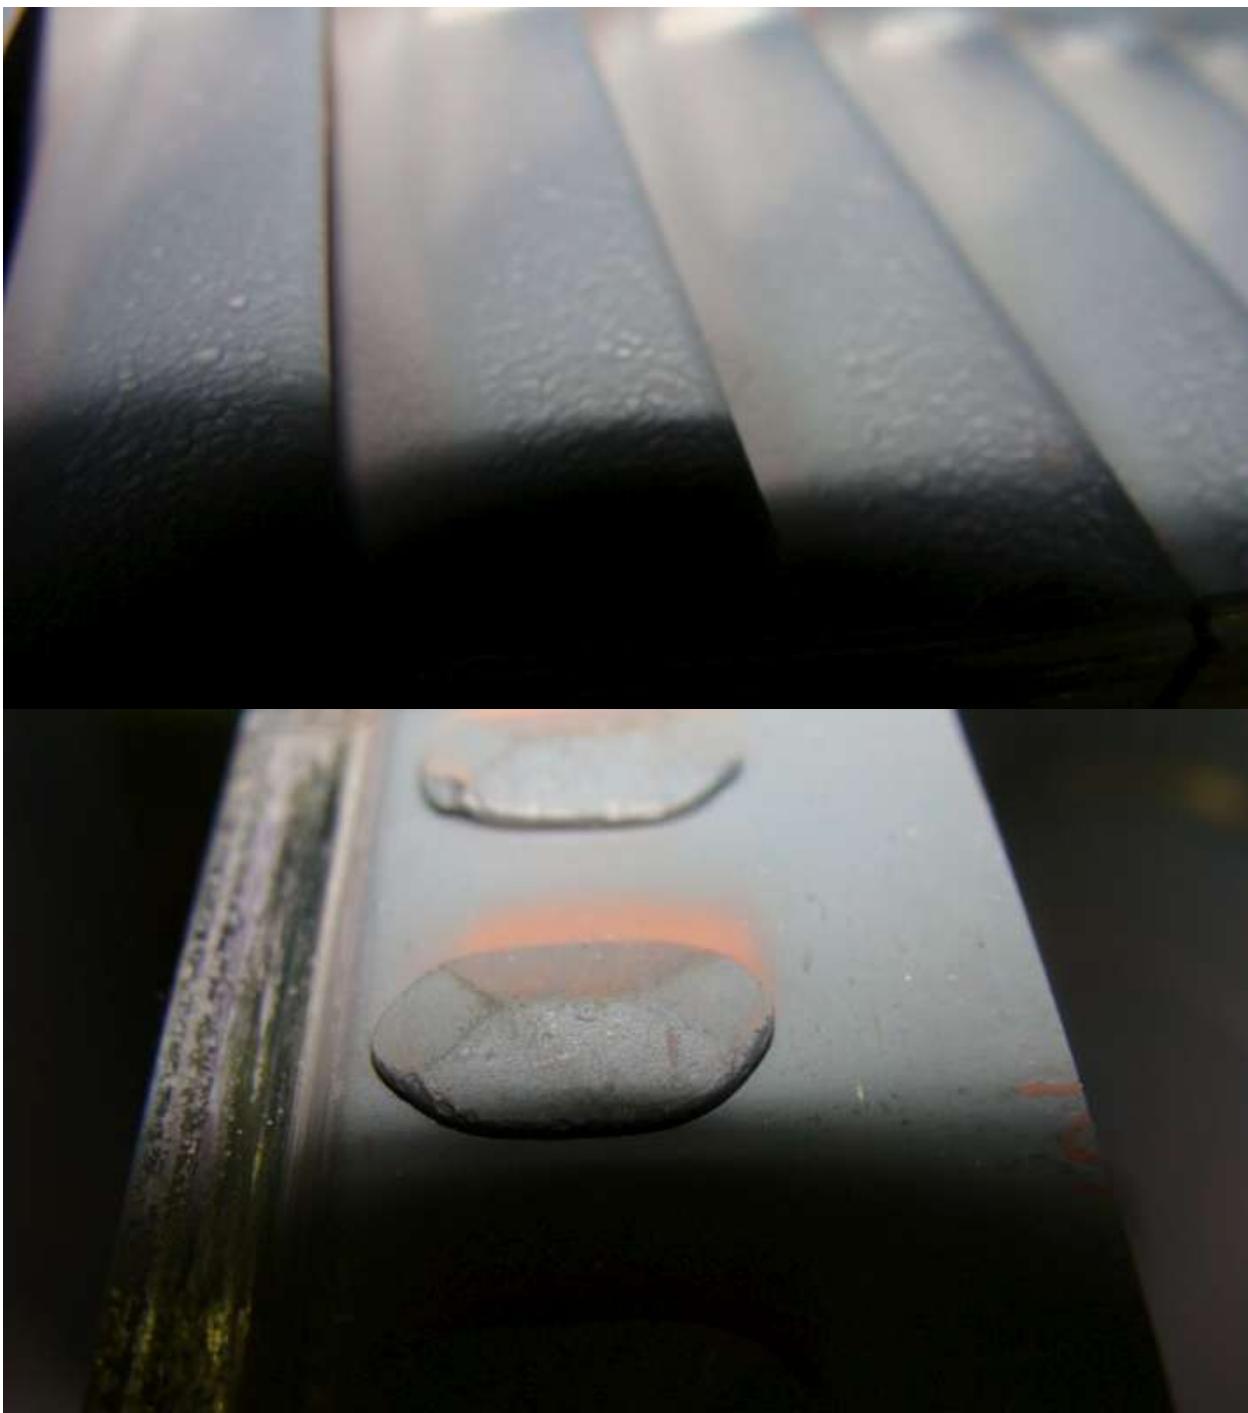
Row 4 blade inlet condition

Row 4 tenon and cover condition

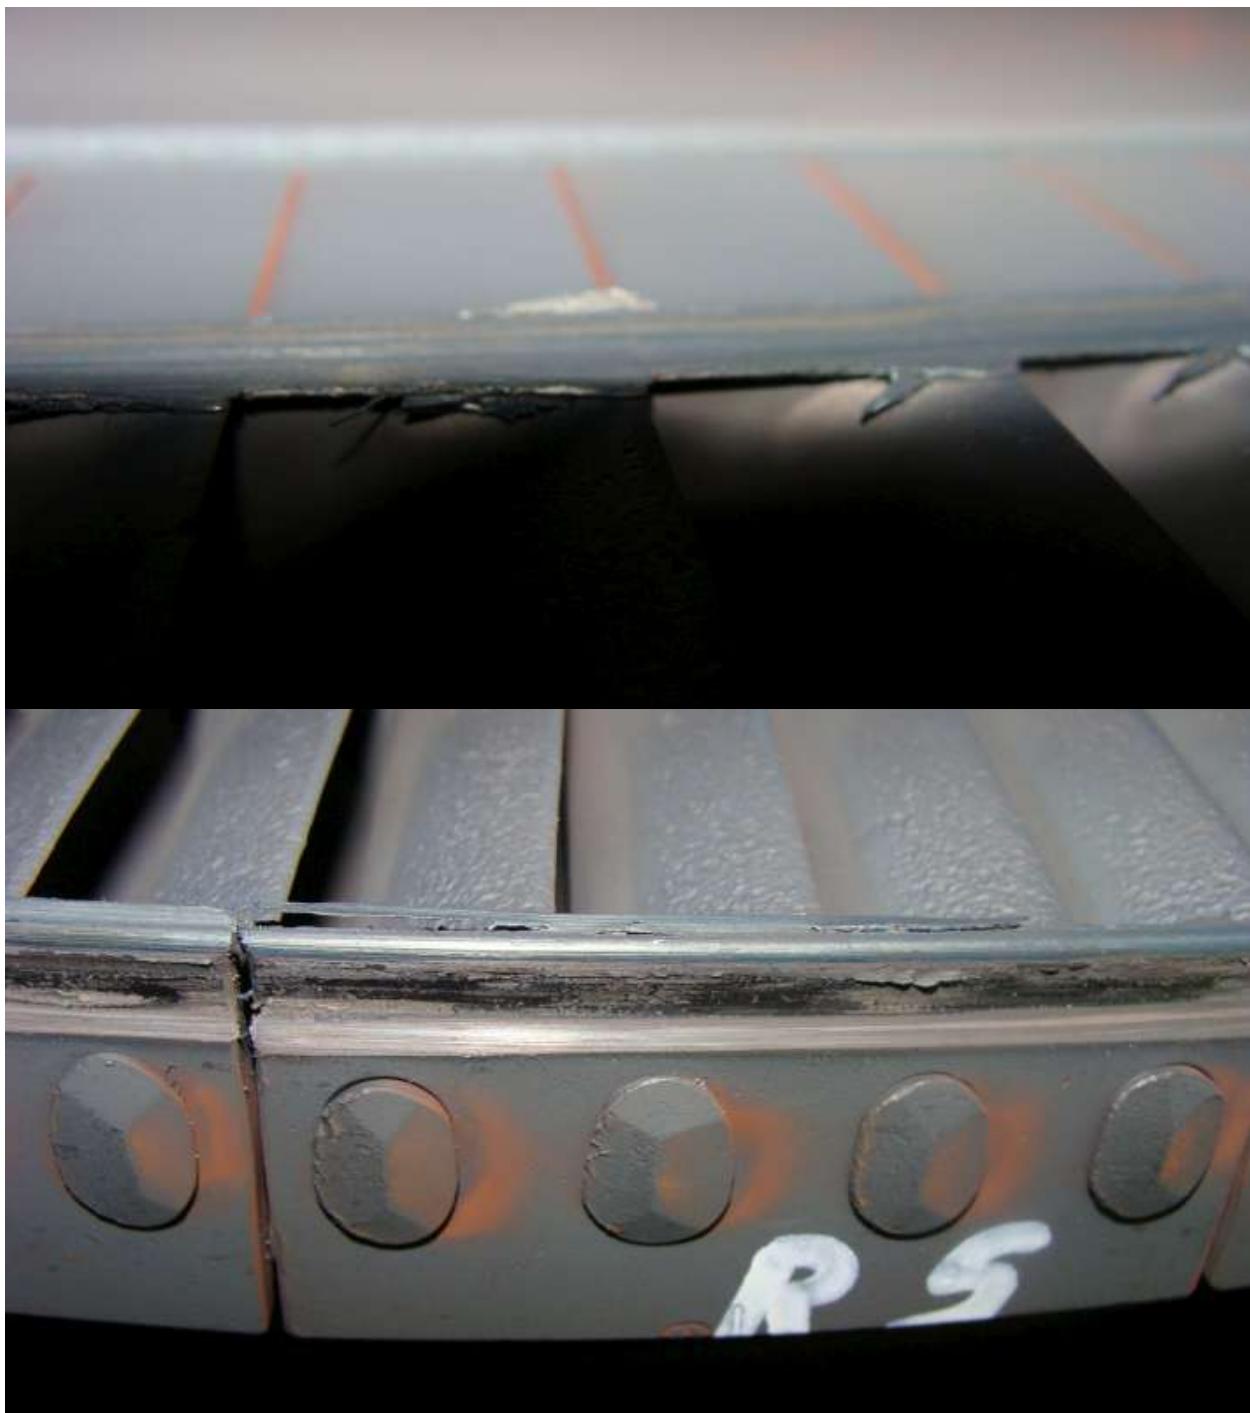
Row 4 blade root rub

Row 5 cover and tenon condition

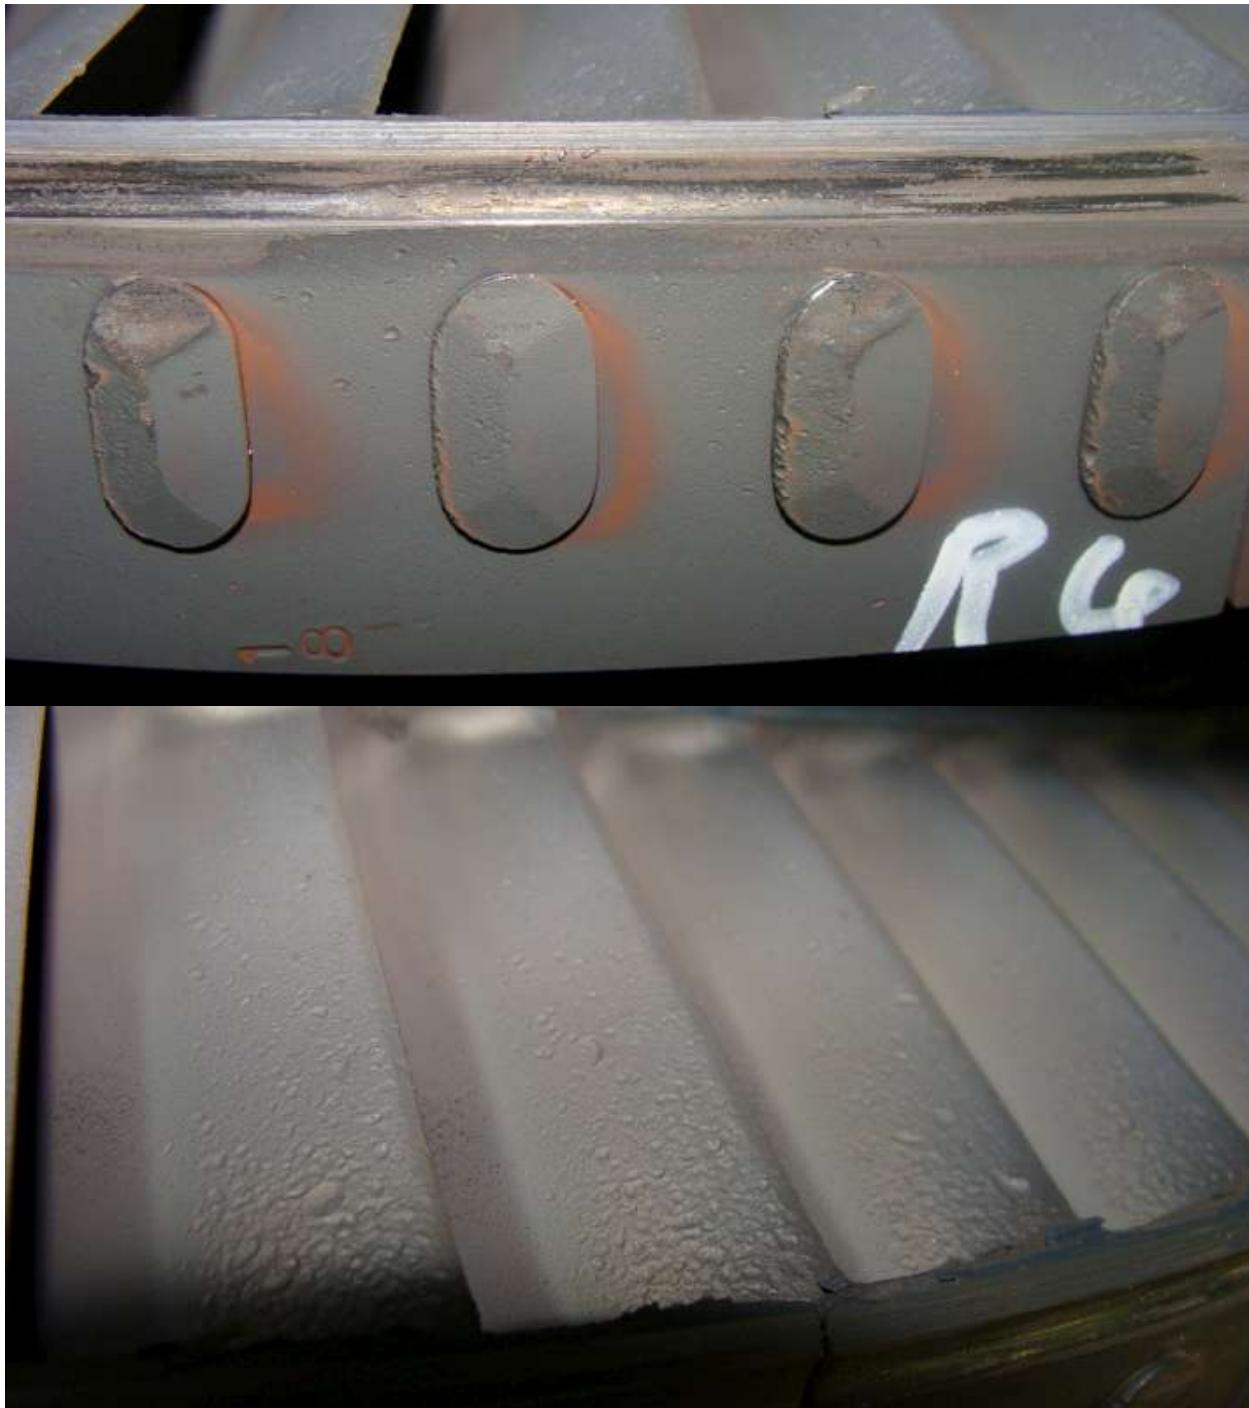
Row 6 cover and tenon condition

Row 6 blade inlet condition

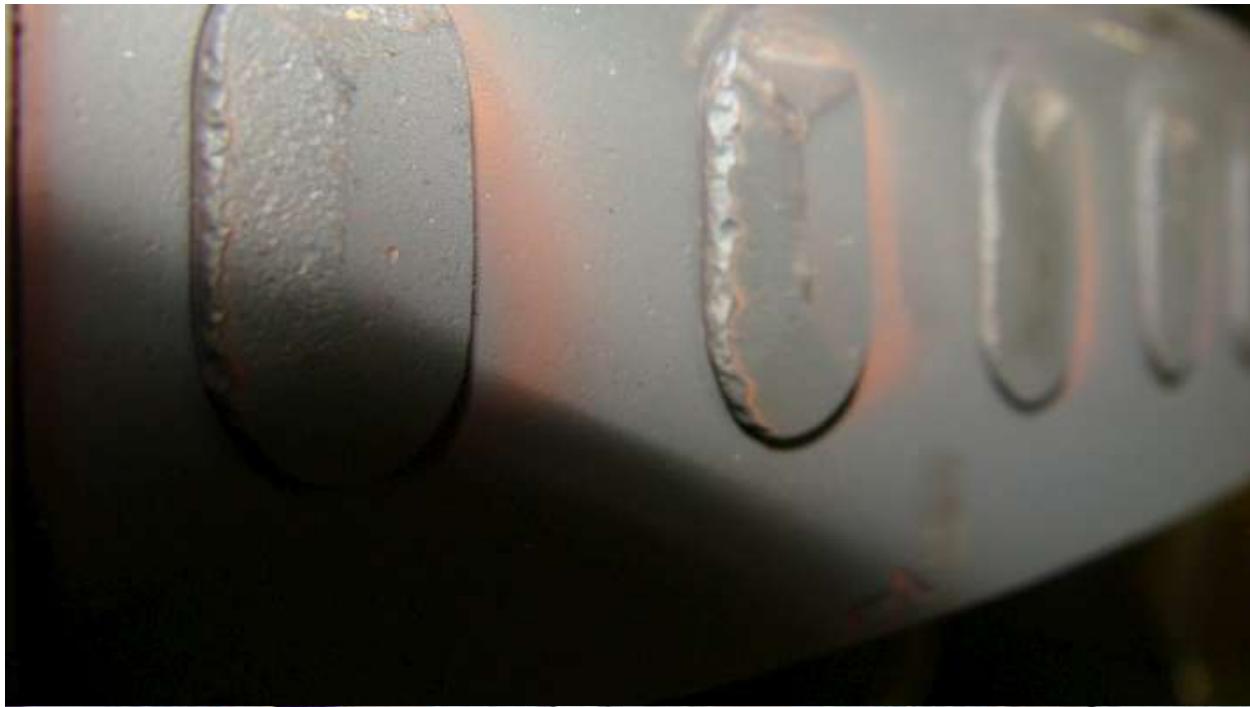
Row 6 tenon condition

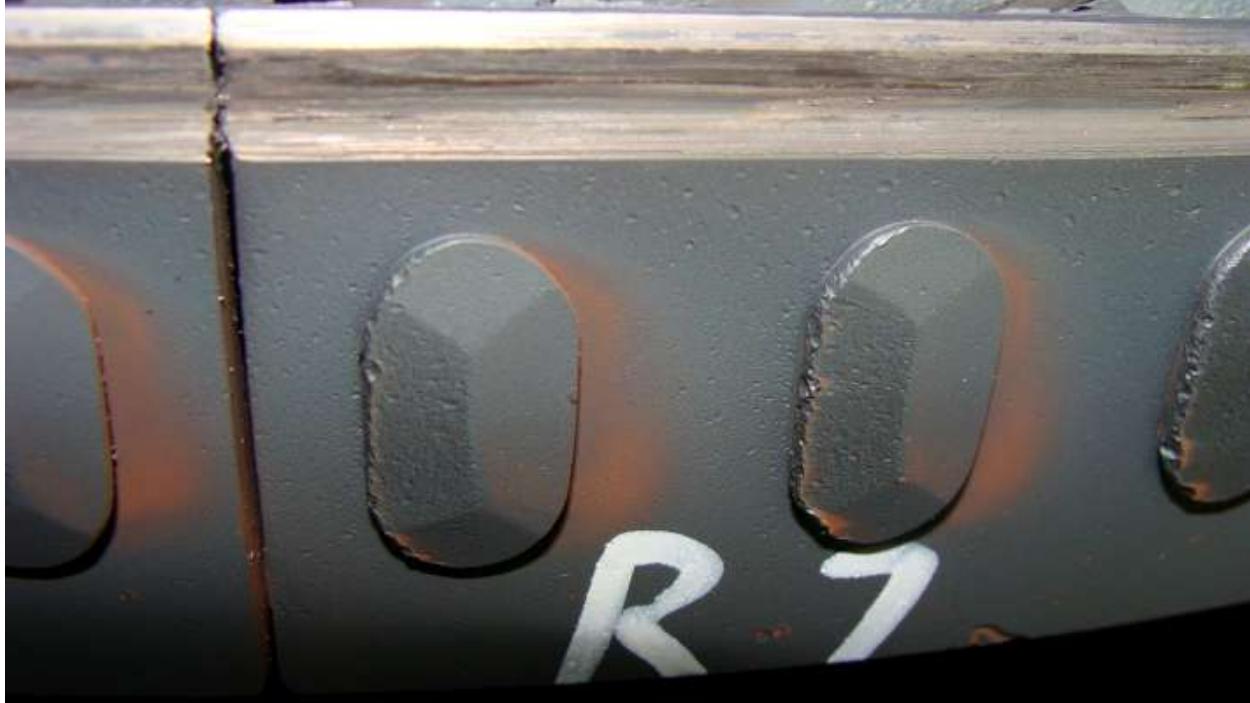
Row 7 cover and tenon condition

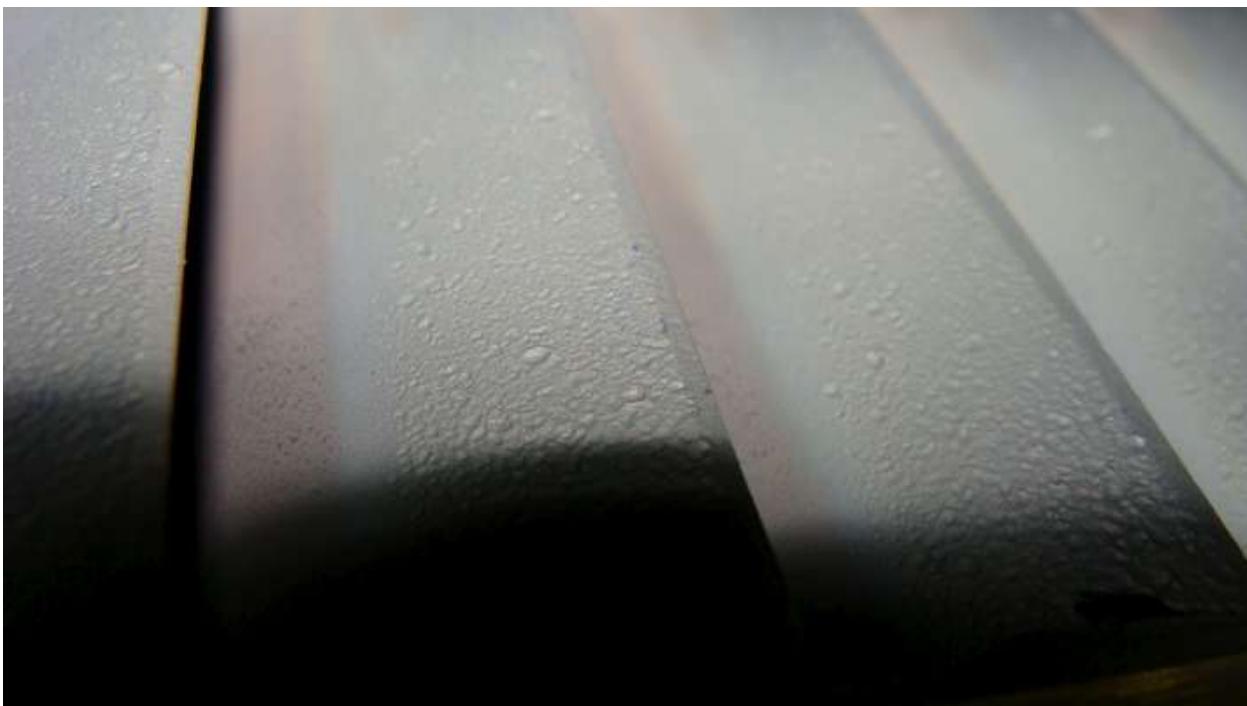
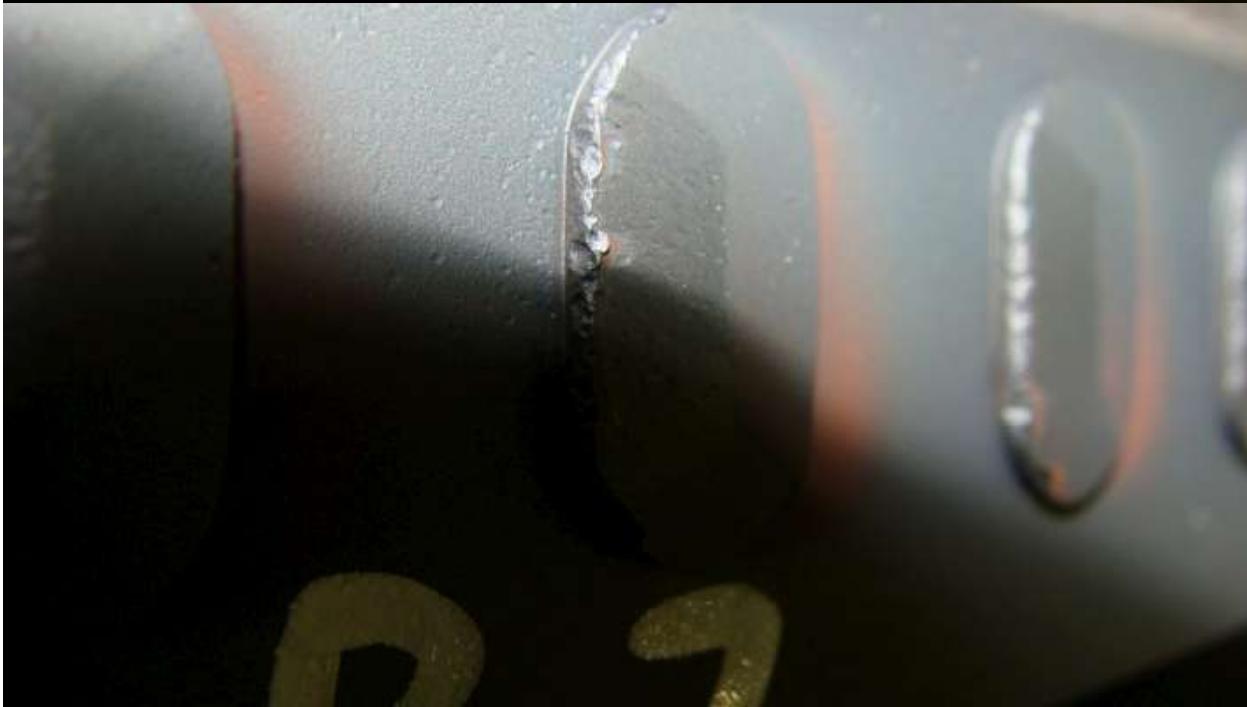
Row 7 blade inlet condition

Row 7 tenon condition

Stg 7	Machine cover to remove rolled over material and true up	X	X	X
		Machine to clean up root appendage	X	X	X
		Replace row 7 bucket covers to re-establish axial clearance. Covers will have to be removed, Tenons nde'd, new fox holed covers installed and peened, covers machined for diameter, profile and axial clearance		X	
	Stg 6	Machine cover to remove rolled over material and true up	X	X	X
		Machine to clean up root appendage	X	X	X
		Replace row 6 bucket covers to re-establish axial clearance. Covers will have to be removed, Tenons nde'd, new fox holed covers installed and peened, covers machined for diameter, profile and axial clearance		X	
	Stg 5	Machine cover to remove rolled over material and true up	X	X	X

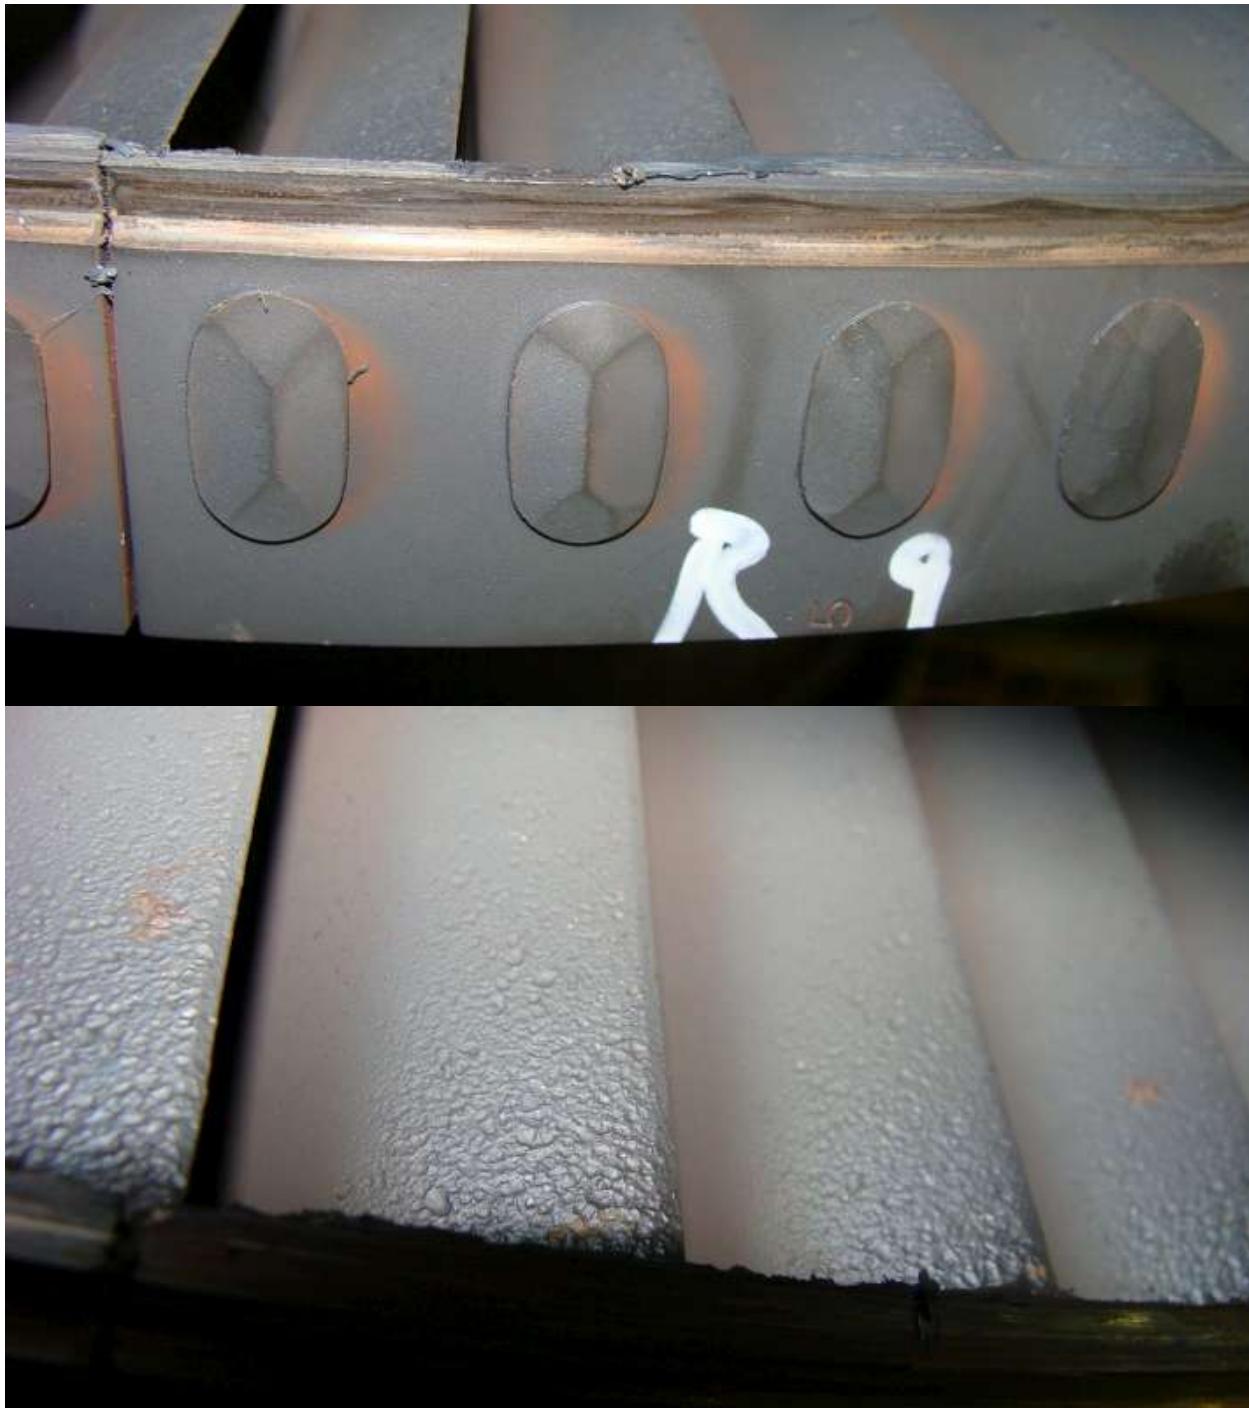
Row 9 cover and tenon condition

Row 9 blade inlet condition

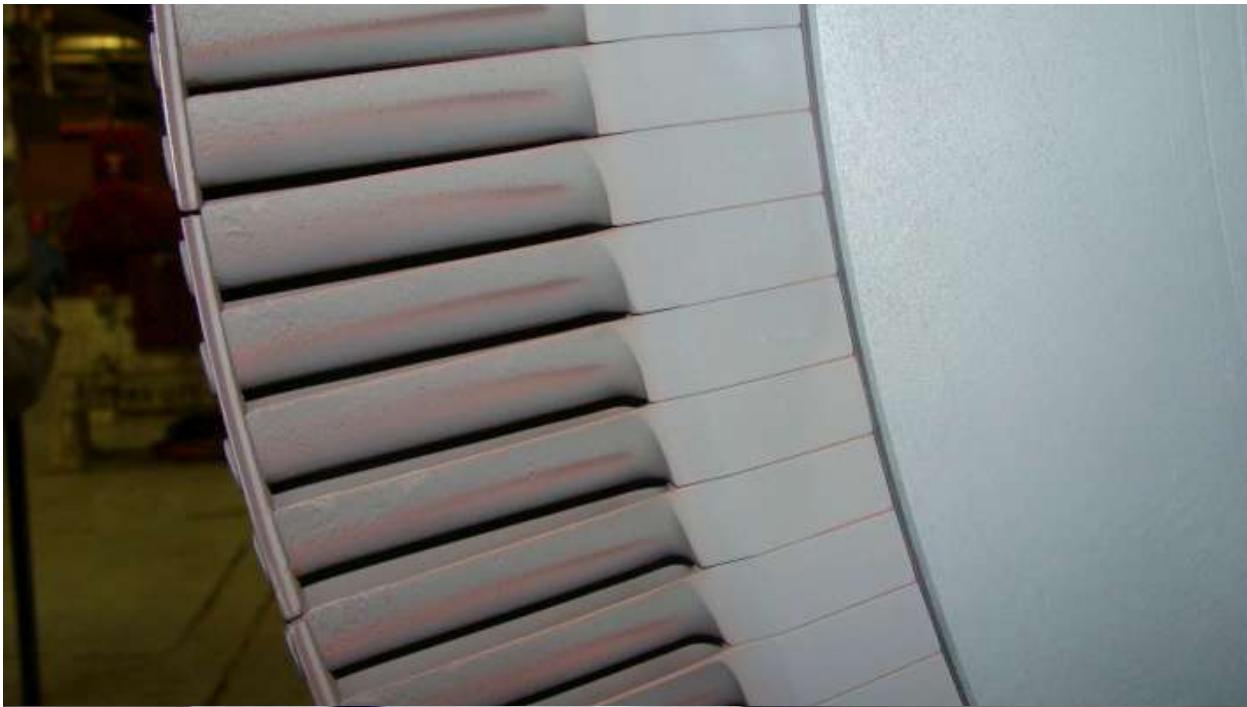
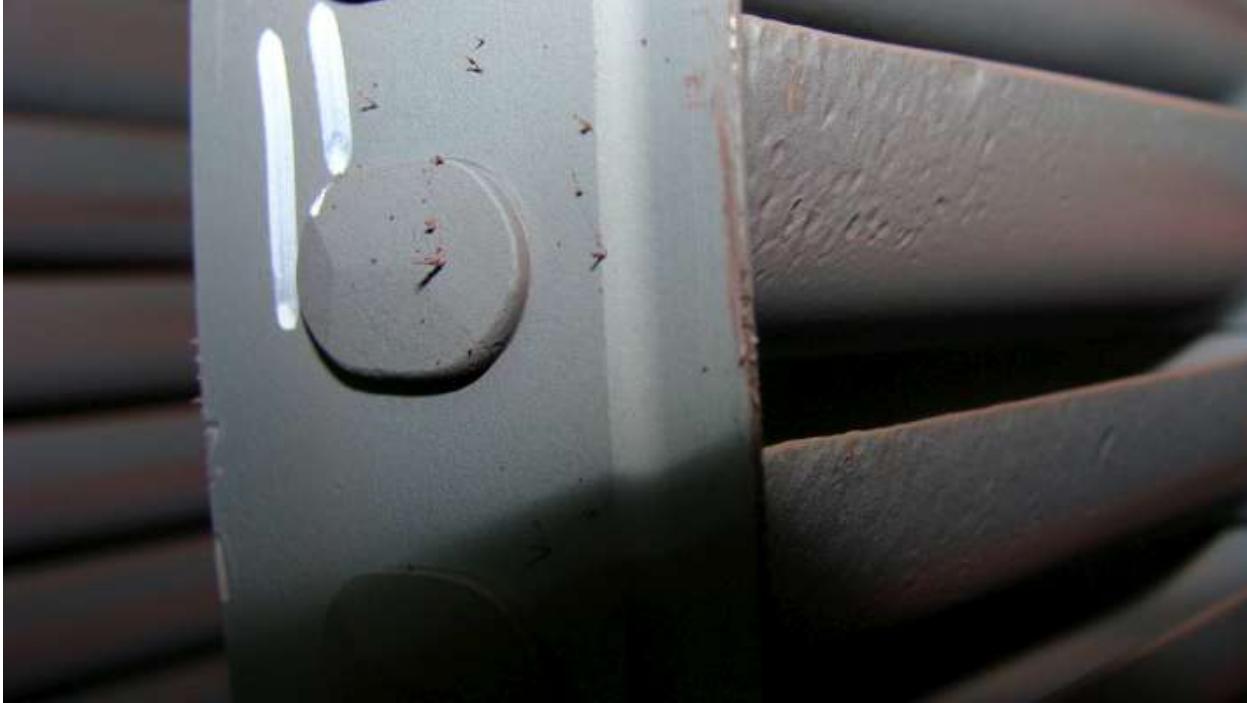
Row 11 general condition

Row 11 cover condition

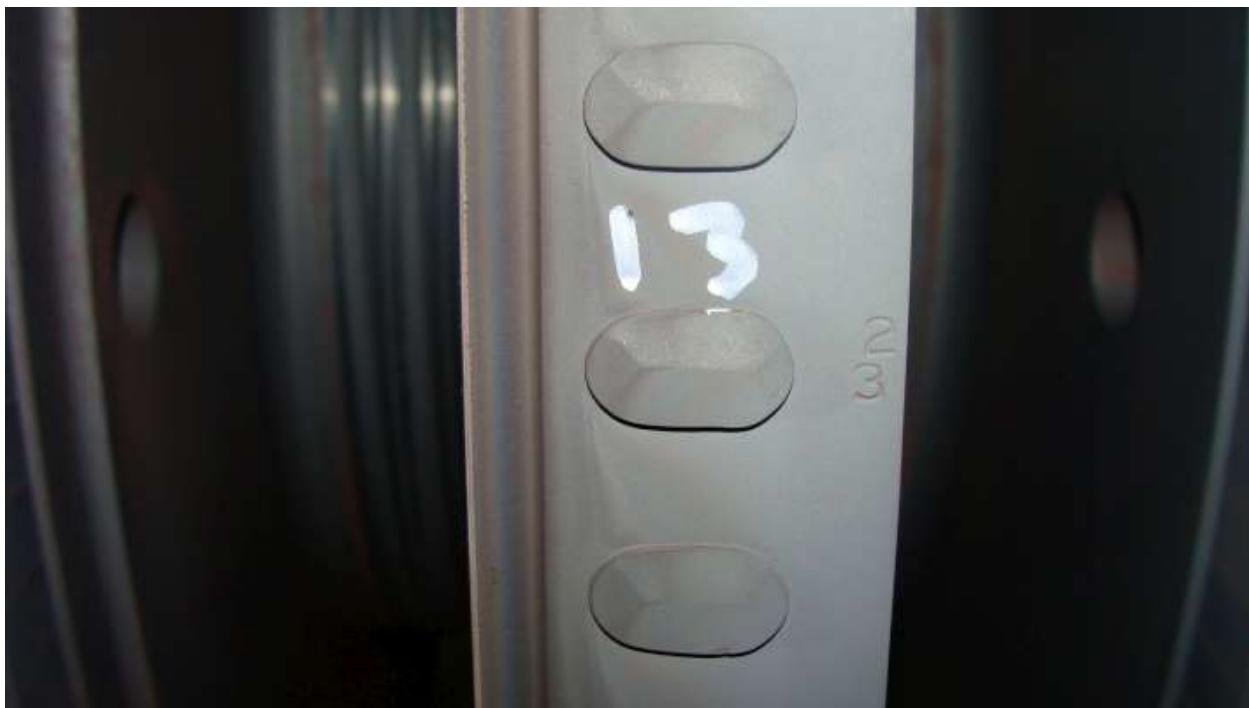
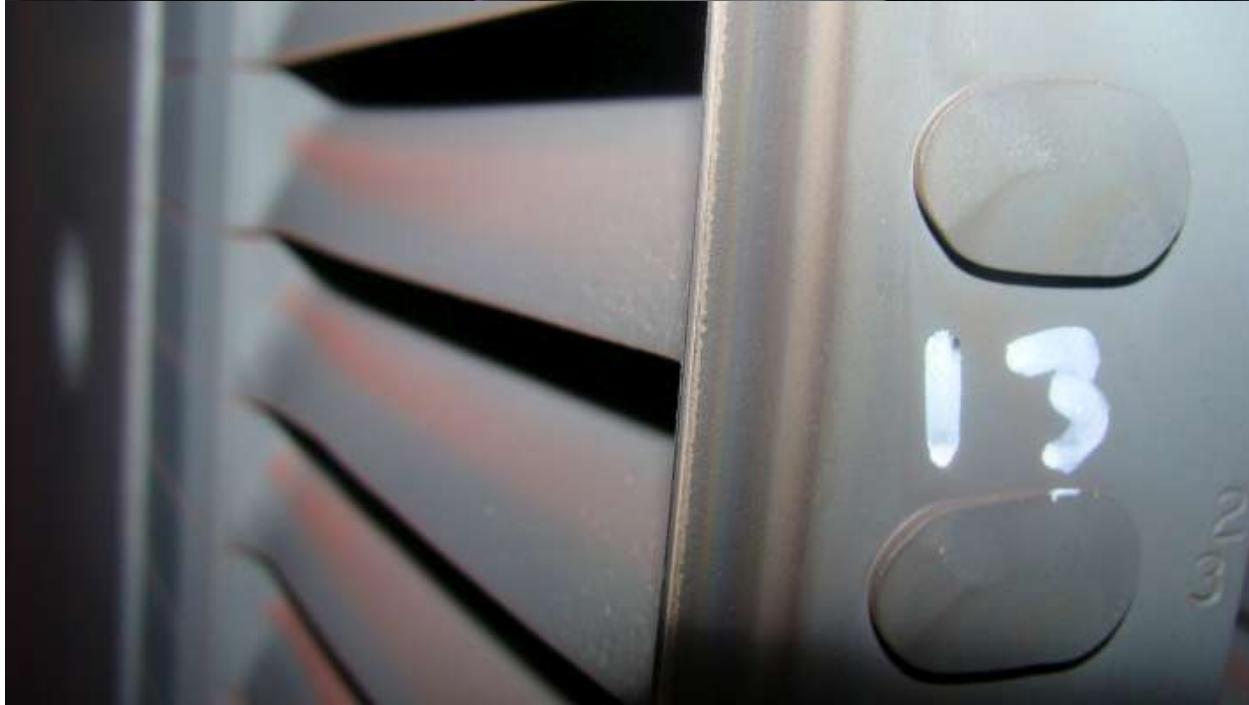
Row 13 cover

Row 13 cover and tenon
