Re: An Application by Newfoundland and Labrador Hydro (Hydro) pursuant to Subsection 41(3) of the Act for approval of the Restoration of Unit 1 Turbine and Generator at the Holyrood Thermal Generating Station

AND IN THE MATTER OF an Application by Newfoundland and Labrador Hydro pursuant to Subsection 41(3) of the *Act*, for the approval of the refurbishment of Unit 1 Turbine and Generator at the Holyrood Thermal Generating Station.

Holyrood Unit 1 Forced Outage
Results of Phase 1 Inspection and Recommendation for Further Inspection

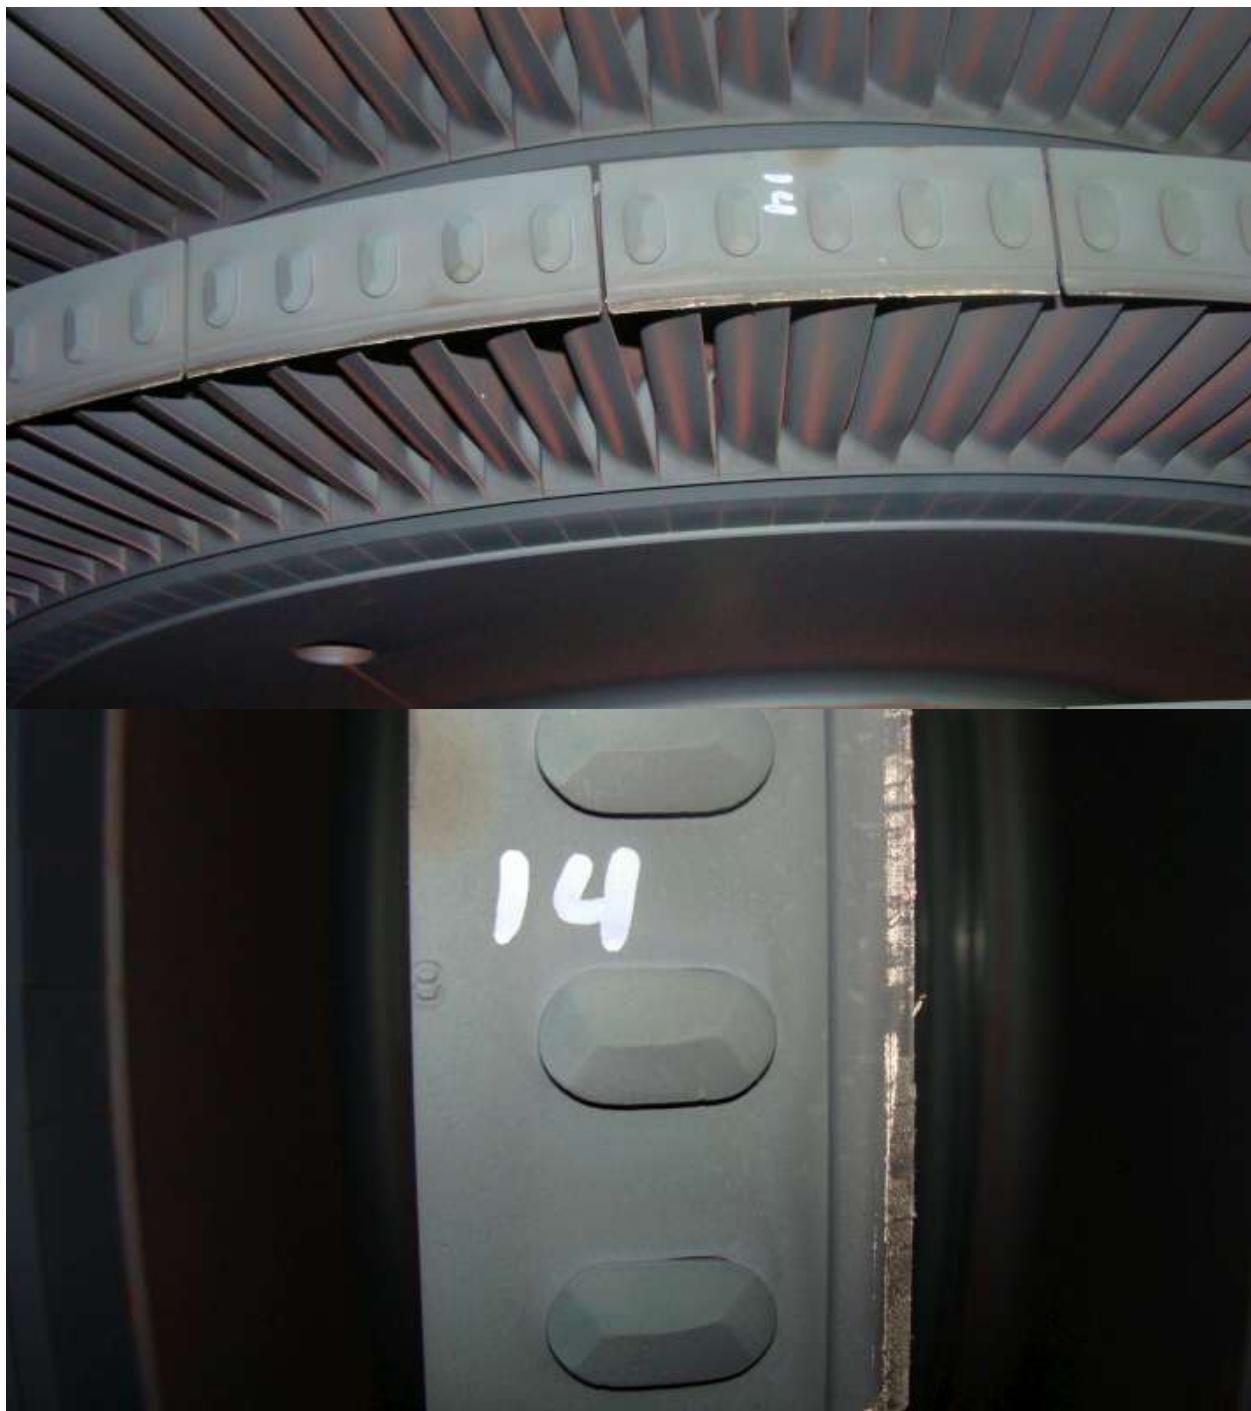
Row 14 cover

Row 14 cover and tenon

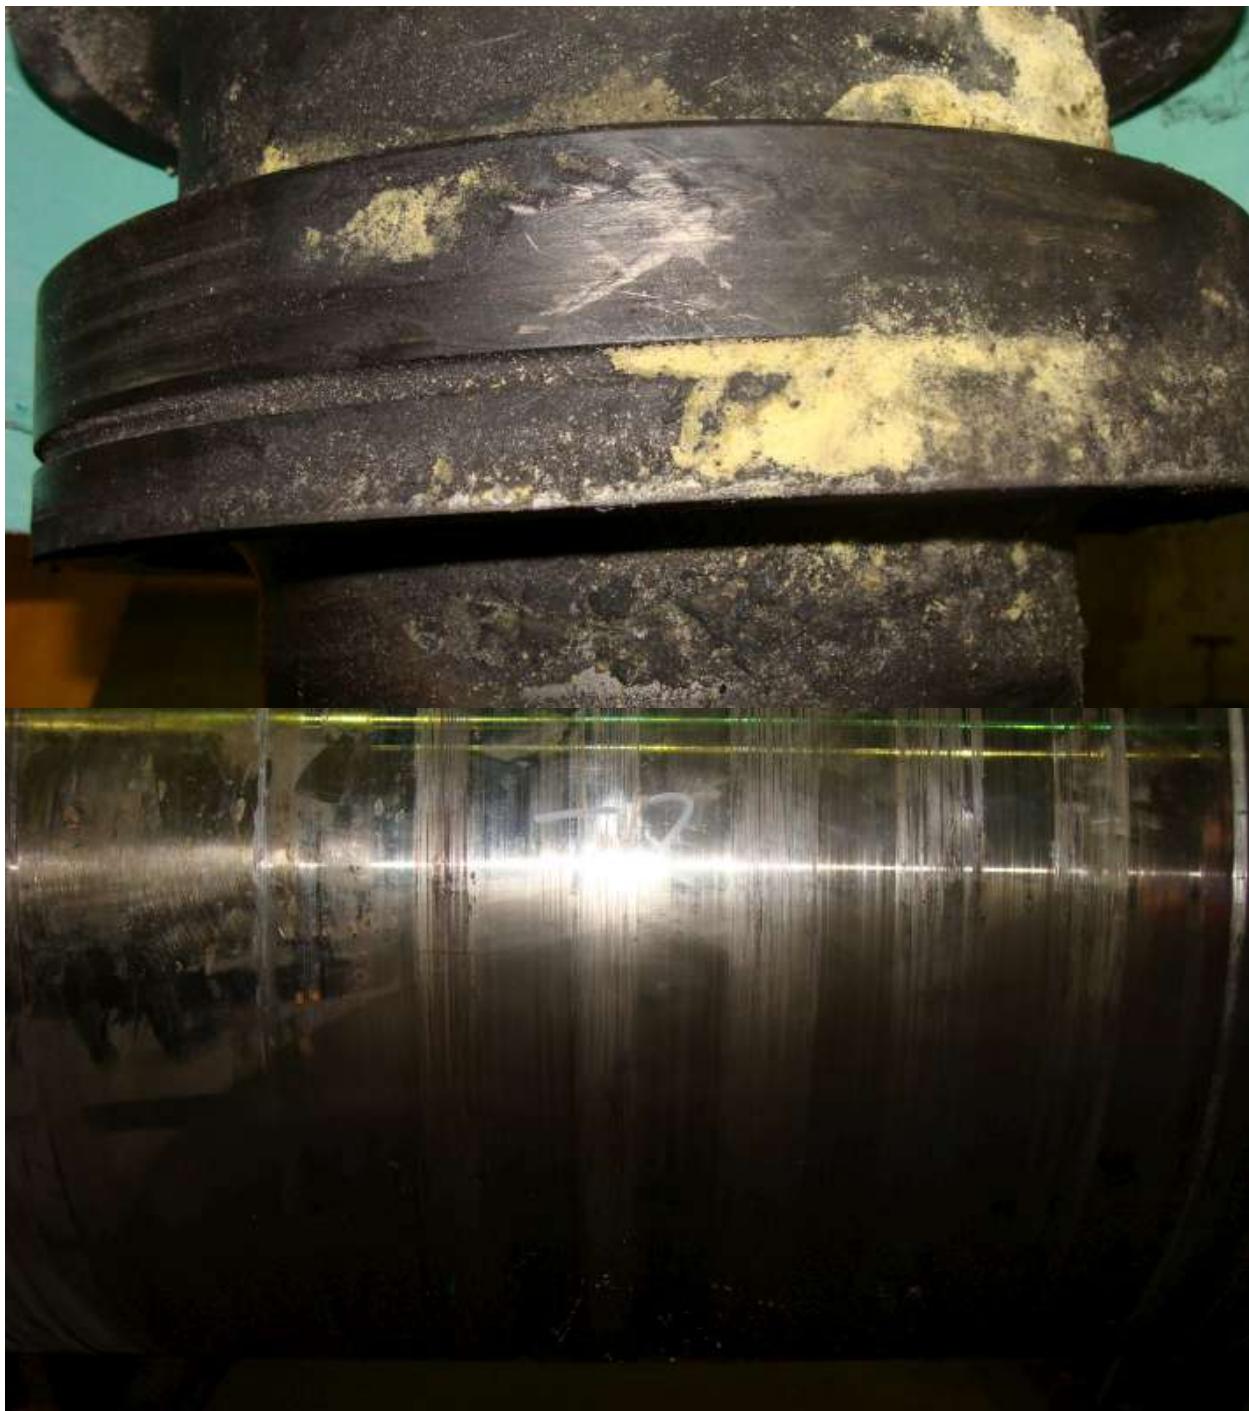
T1 oil deflector location and T2 journal

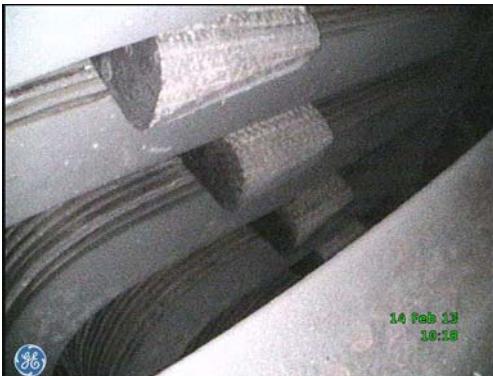
Coil wedges in position, heavy black dust present.

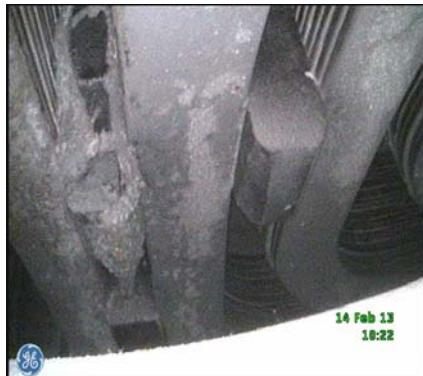
Again heavy contamination.

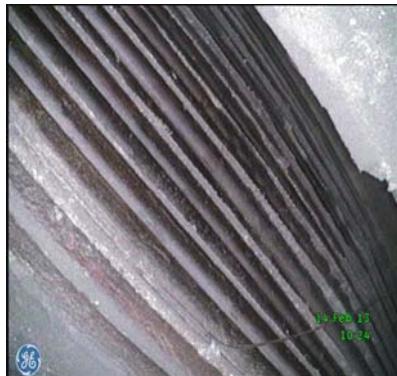
Interturn insulation has seen high heat levels

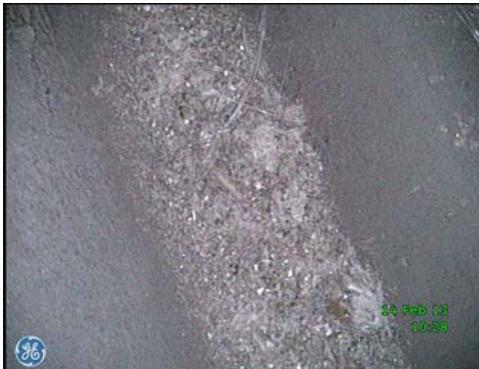
Contamination @ base of stack of coil 1.

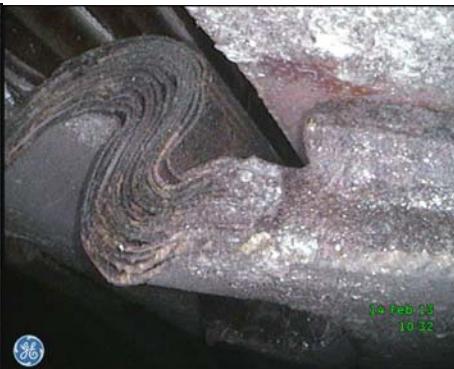
Brasied joints require cleaning

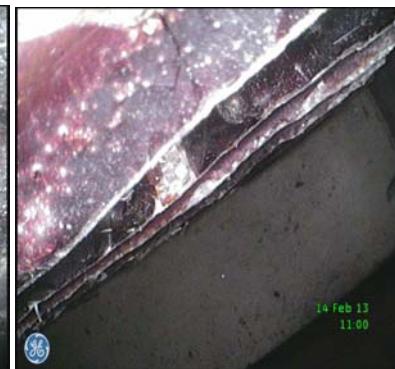
Blackened inter turn insulation

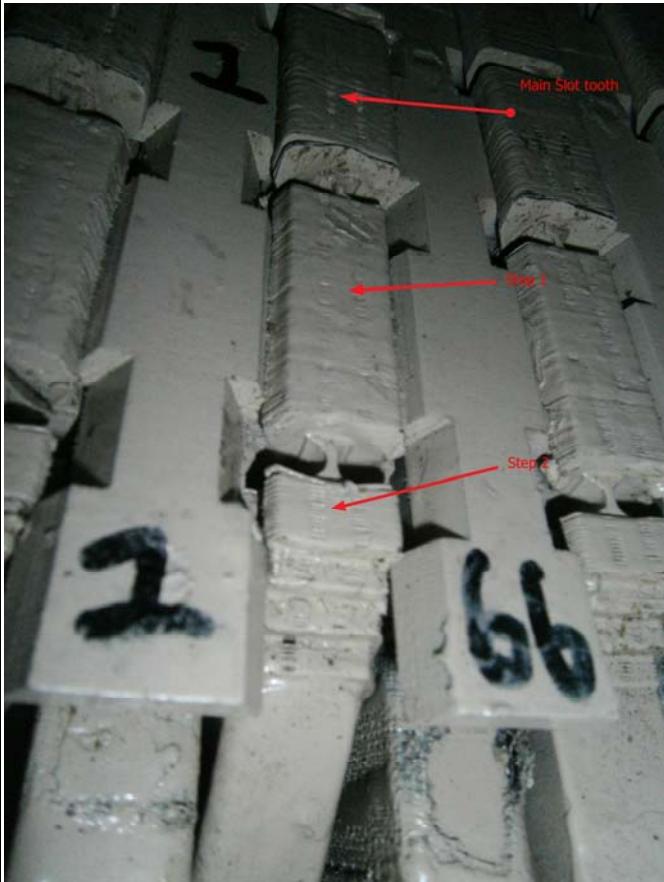
Picture showing accessible step packets:
