Holyrood Thermal Generating Station

Gas Turbine Condition Assessment & Options Study

December 19, 2011

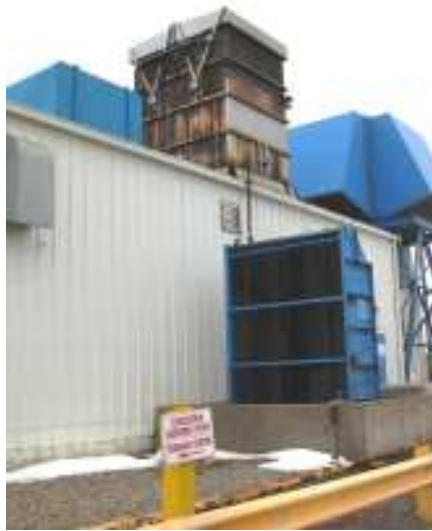
FIGURE 2-4 LIGHT OIL RECEIVING & LUBE OIL RADIATOR

- b. Venting system modifications required to reduce lube oil pressure buildup
 - c. Lube oil pump system requires upgrade for start-ups.
 - d. Lube oil cooling fan is experiencing some leaks and snow and ice and water build-ups in its containment can cause start-issues

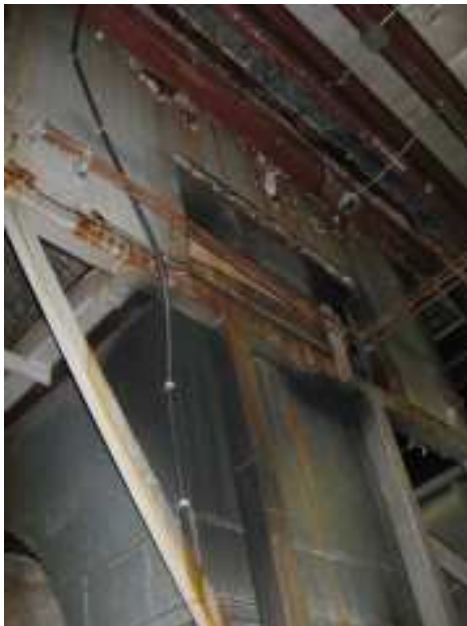
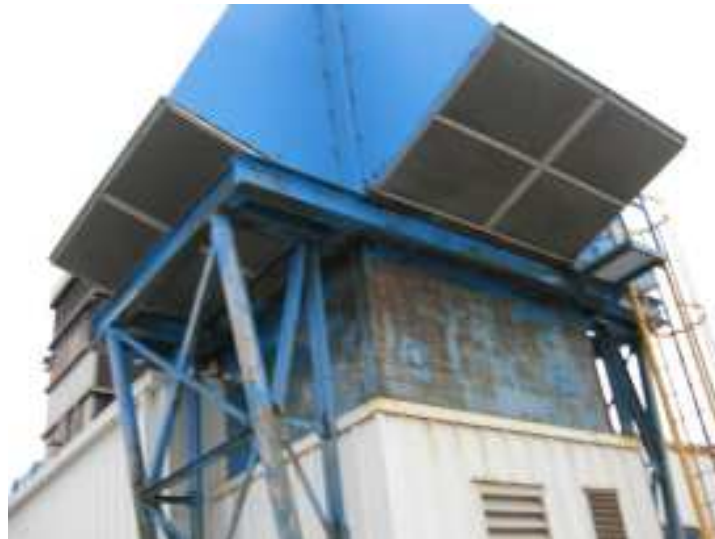
FIGURE 2-5 GTG EXHAUST STACK & AIR INTAKE

- v) Exhaust stack requires replacement or extensive repairs
 - vi) Gearbox lube oil system requires modification and refurbishment
 - a. Seals require replacement/modification

- i) Major leaks in and around the GT exhaust stack which are impacting the gas turbine power turbine volute and back end blades;
 - ii) Minor leaks at generator ventilation stack; and

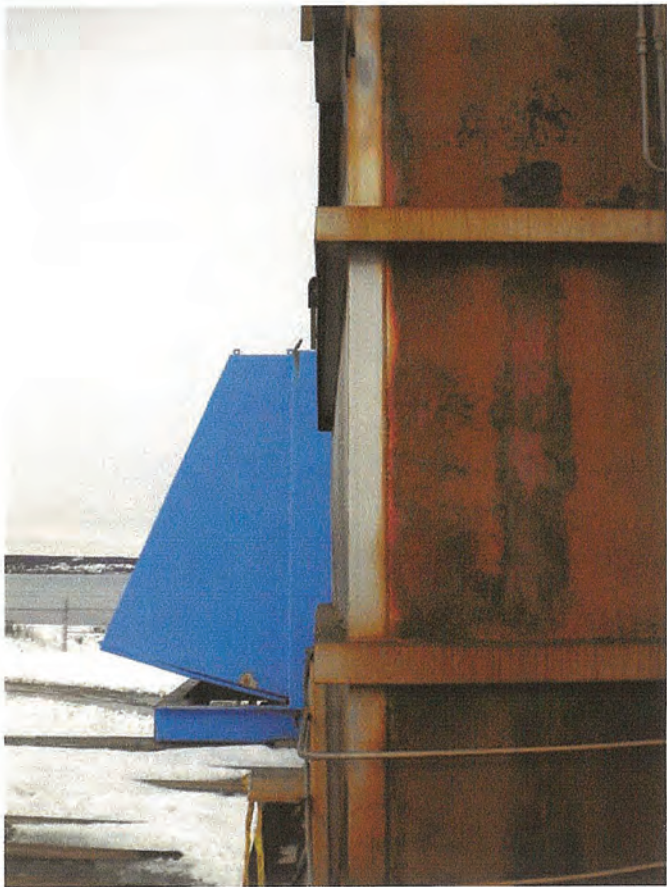
1. The exterior condition of the exhaust stack shows significant carbon steel crystallization, peeling of the carbon. CS casing is typically good for temperatures up to 750F (400C) There was no fatigue or cracking of any of the visual welds or any failure of welds (inspection was performed from roof on top of the turbine building). The top of the exhaust stack has a "snow-hood" which opens during operation to allow the exhaust gases to vent atmosphere. On the "south" side of the stack shows "bulging" of the stack, see photo 3.

Figure 3 – Slight bulge in sidewall.

1. If the owners plan for the turbine – generator is long-term for generation and black-start duration, then the solution is stack replacement with the major OEM recommendation of the internal floating liner exhaust system. (see SP-37626 proposal)
2. Cosmetic coating of the exhaust stack with high temperature primer and high temperature final coatings. International Protective Coatings is recommended.
 - a) Scrape or sandblast the “loose” flakes of the carbon steel to get to a clean surface.
 - b) Zinc Primer; Inter-zinc 22.
 - c) High Temp Alumn – Intertherm 50 (no heat cure required).

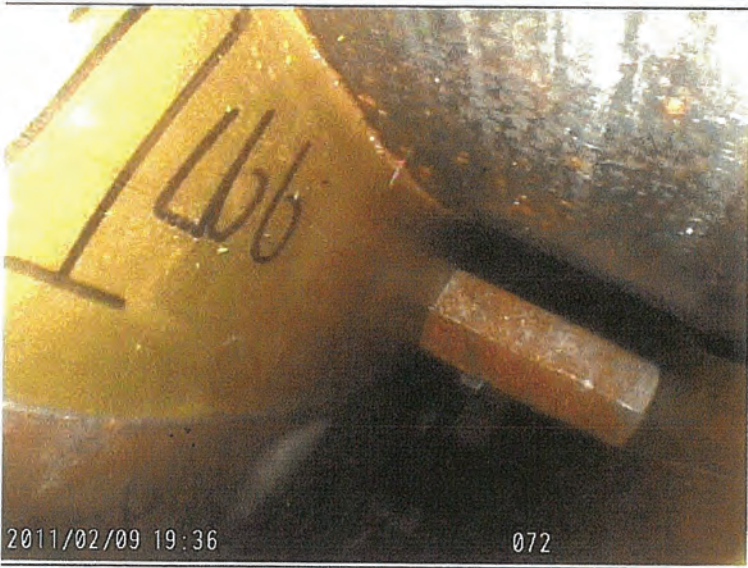
on this gland, i.e. new wipers were fitted with more drainage holes, and though initially it appeared successful the lube oil leakage reappeared. Photo 17. Damage of this nature would indicate that the driven machine is out of alignment with the gearbox output shaft. Checks need to be made on this alignment to ensure correct operation.

Photo 17. Showing the rub/distortion of the upper wiper on the shaft gland after contact with the main shaft. (photo taken upside down).

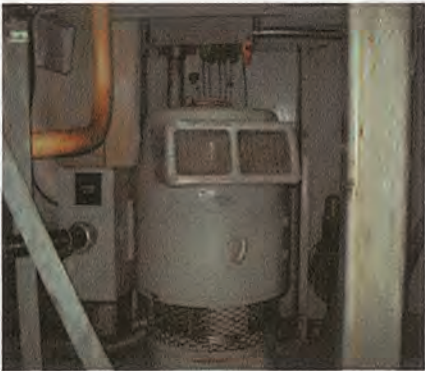
Equipment Name: DC backup lube oil pump motor

- Prior to conducting any electrical tests on this unit a visual inspection was performed.
- Externally the motor appears to be in good shape with all screens and covers installed and conduit connectors in good physical condition.
 - Internally the inspection was limited due to accessibility. Therefore a full determination of condition cannot be made. However, it was noted that the armature coils appeared to be dry with some signs of overheating at the armature riser section.
 - Due to time limit and permitting issues, this motor was not run up for vibration analysis test.

- Receive unit at our O'Leary Ave. facility.
- Dismantle and overhaul unit to steam clean stator and armature windings.
- Perform a stator and armature VPI to recover insulation integrity and improve PI factor.
- Dynamically balance armature.
- Recondition brush rigging and check spring tension.
- Check all mechanical fits and change bearings.
- Refurbish commutator, undercut and bevel copper bar segments for smooth operation.
- Perform no-load run test and capture vibration trend data for future reference.
- Budget Price for this service is \$ 3,500.00 TNIP Budget Only**

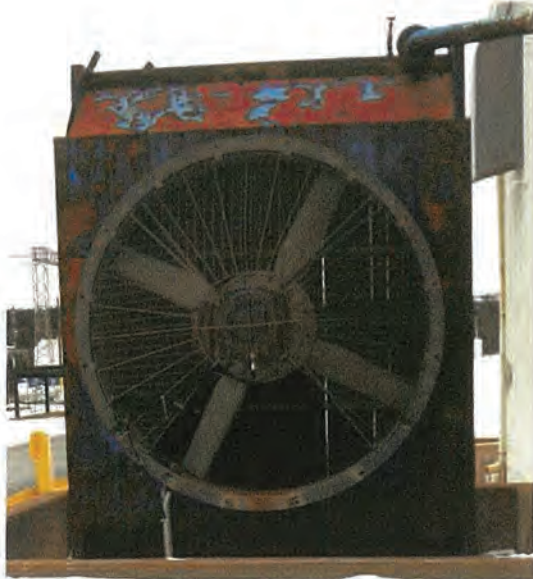
- Externally this fan unit is rusty on the outside, the stator frame and rotor shaft extension show signs of environmental corrosion but is mostly superficial.
- Disregarding the overall appearance, the motor appears to be in good shape with all screens and covers installed and conduit connectors in good physical condition. A screen was removed to gain access to the unit as shown in the picture above.
- Internally the inspection was limited due to accessibility. Therefore a full determination of condition cannot be made.

- Insulation Resistance to ground @ 1 minute = 5520 MΩ
- Polarization Index Test = $\frac{10 \text{ minute reading}}{1 \text{ minute reading}} = \frac{7550 \text{ M}\Omega}{5520 \text{ M}\Omega} = 1.37$ Damp and dirty.
- Phase to phase resistance:
 - Ø A to Ø B = 404.5 mΩ
 - Ø A to Ø C = 403.7 mΩ
 - Ø B to Ø C = 406.4 mΩ
- Vibration analysis:
 - The vibration analysis test indicated dry anti-friction bearings on both ends of the motor; adding grease into the bearings was suggested after the assessment testing and prior to the screen being installed.
 - Small amount of couple imbalance indicated at NDE of motor due to large fan at the DE of the motor.

- Overhaul unit to steam clean stator.
- Perform a stator dip & bake to recover insulation integrity and improve PI factor.
- Recondition fan unit and motor frame.
- Paint fan unit and motor with epoxy paint to prevent corrosion.
- Check all mechanical fits and change bearings.
- Perform no-load run test and capture vibration trend data for future reference.
- Anti condensation heater installation is recommended to prevent moisture build-up.

- Receive unit at our O'Leary Ave. facility.
- Overhaul unit to steam clean stator.
- Perform a stator dip & bake to recover insulation integrity and improve PI factor.
- Recondition fan unit and motor frame.
- Paint fan unit and motor with epoxy paint to prevent corrosion.
- Check all mechanical fits and change bearings.
- Perform no-load run test and capture vibration trend data for future reference.
- Budget Price for this service is \$ 3,050.00 TNIP Budget Only

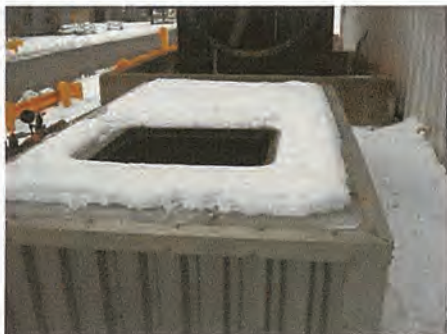
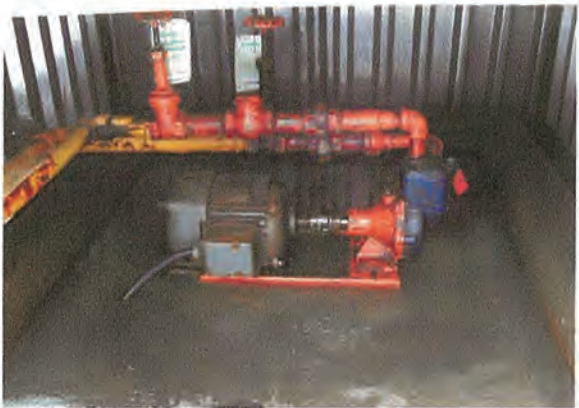
Equipment Name: East Fuel Oil Motor

- Externally the motor appears to be in fair shape with some surface corrosion.
- All covers installed and conduit connectors in good physical condition.
- Internally the inspection was very limited due to accessibility. Therefore a full determination of condition cannot be made.
- This motor should not be confused with the 25 HP pump unit (25 HP pump unit is for pumping fuel to the storage tank not to supply fuel to turbine).
- Due to time limit and permitting issues, this motor was not run up for vibration analysis test.

- Overhaul unit to steam clean windings.
- Perform a stator dip & bake to recover insulation integrity and improve PI factor.
- Measure and record all mechanical fits and change bearings.
- Perform no-load run test and capture vibration trend data for future reference.
- Unit is installed in an area with a high delta in temperature (cold during idle, hot during operation). Anti condensation heater installation is recommended to prevent moisture build-up.

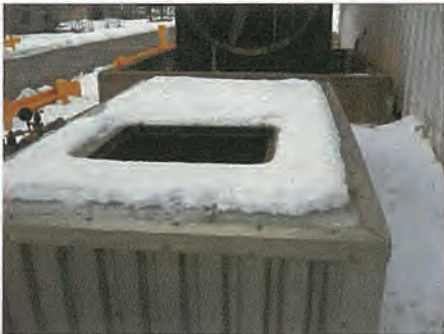
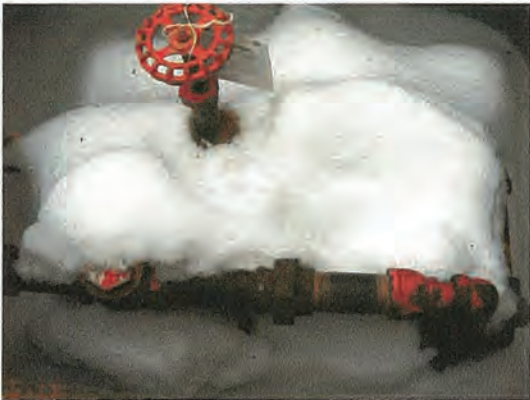
Equipment Name: West Fuel Oil Motor

- Hatch on enclosure was not in place and unit is covered in snow. Snow was removed to perform visual and tests.
- Externally the motor appears to be in fair shape with some surface corrosion.
- All covers installed and conduit connectors in good physical condition.
- Internally the inspection was very limited due to accessibility. Therefore a full determination of condition cannot be made.
- Due to time limit and permitting issues, this motor was not run up for vibration analysis test.

- Insulation Resistance to ground @ 1 minute = 1250 MΩ
- Polarization Index Test = $\frac{10 \text{ minute reading}}{1 \text{ minute reading}} = \frac{1190 \text{ M}\Omega}{1250 \text{ M}\Omega} = 0.95$ Damp and dirty.
- Insulation Resistance and PI Factor could be skewed due to motor being covered in snow, temperature will affect the conductors.
- Phase to phase resistance:
 - Ø A to Ø B = 9.952 Ω
 - Ø A to Ø C = 9.938 Ω
 - Ø B to Ø C = 9.956 Ω

- Overhaul unit to steam clean windings.
- Perform a stator dip & bake to recover insulation integrity and improve PI factor.
- Measure and record all mechanical fits and change bearings.
- Perform no-load run test and capture vibration trend data for future reference.
- Unit is installed in an area with a high delta in temperature (cold during idle, hot during operation). Anti condensation heater installation is recommended to prevent moisture build-up.

- Receive units at our O'Leary Ave. facility.
- Dismantle and overhaul unit to steam clean windings.
- Perform a stator Dip & Bake to recover insulation integrity and improve PI factor.
- Dynamically balance rotor.
- Recertify for explosion proof application.
- Measure and record all mechanical fits and change bearings.
- Perform no-load run test and capture vibration trend data for future reference.
- Budget Price for this service is \$ 1,875.00 TNIP each Budget Only

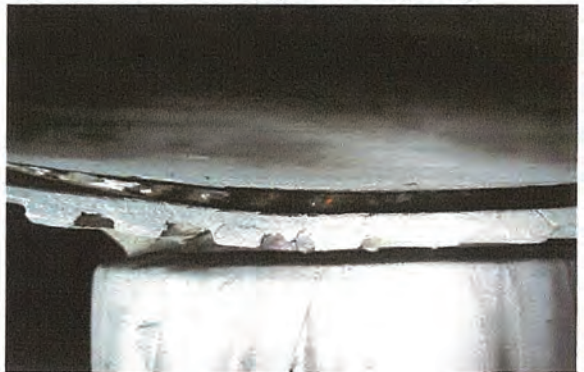
Figure 6 – View 2 air gap.

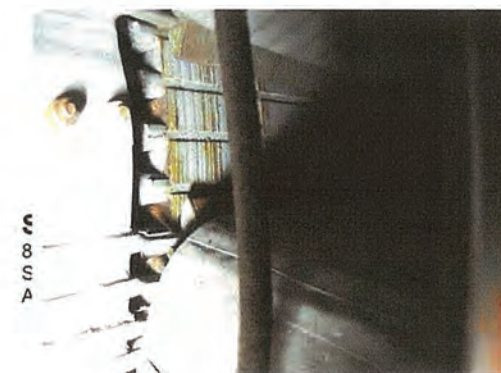
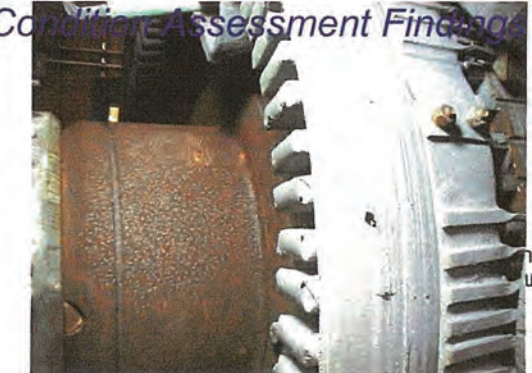
Figure 7 - Rust at the end of rotor iron

Figure 8 - Rusty exciter rotor shaft

- All fasteners are in good condition and solid.
- All electrical connections are in good condition.
- The air gap between the rotor and stator of exciter are very even in both directions (within 4%) which indicate the wear on the main bearing is very minimal from the original.
- The rectifier is in good condition in both physically and electrically.
- The exciter field stator appears to be dry which coincides with the PI reading.
- There is evidence of condensation in the unit due to the surface rust and corrosion of the rotor iron and shaft, figures 7 & 8 above.

- Overhaul unit to steam clean windings.
- Perform a VPI on stator to recover insulation integrity on stator and improve PI factor.
- Rotor should have VPI treatment to maintain the PI factor and increase the reliability.
- While overhauling unit a recondition rotor iron and shaft to remove rust should be performed. Once complete and rust removed a coating from the VPI and epoxy paint should be applied to prevent future corrosion.
- Measure and record all mechanical fits.
- Unit is installed in an area with a high delta in temperature (cold during idle, hot during operation). Anti condensation heater installation is recommended to prevent moisture build-up.

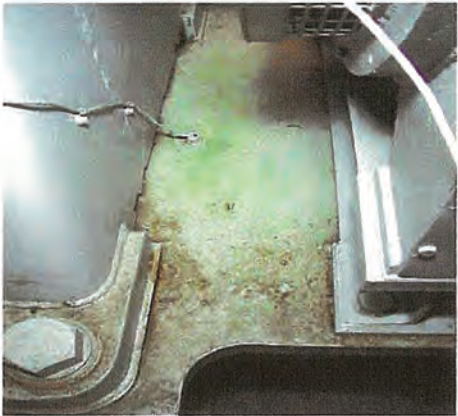
Leakage on bearing foundation

- All fasteners are in good condition and solid.
- This bearing is still in good physical shape despite some oil leakage through the labyrinth seals.
- The air gap between the rotor and stator of exciter are very even in both directions (within 4%) which indicate the wear on the main bearing is very minimal from the original.
- There is wear and grooving on the shaft seals at both ends of the bearing.
- Oil leakage was apparent from the residue left on the bearing housing and foundation under the bearing.

- Bearing shells should be removed and sent for recondition and polishing of Babbitt areas and faces.
- Several sets of bearing measurements should be conducted with the bearing clamped together (inboard side, middle and outboard side).
- Labyrinth seals should be adjusted to prevent further grooving and the shaft should be polished to remove present grooves.
- Inboard oil wiper should be replaced, near end of life.
- When installed in the housing a fit test should be performed to verify bearing contact with shaft.
- For future preservation the rotor should be turned on a monthly basis to prevent shaft marking and maintain an oil film in the bearing.

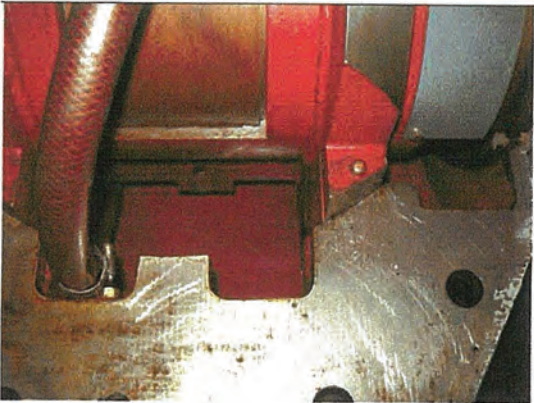
Self align bearing shell setup

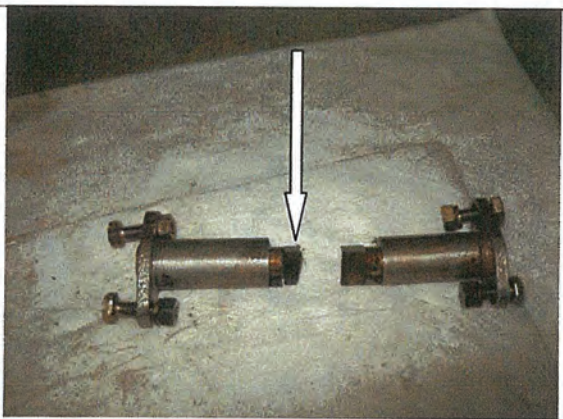
Inboard and outboard oil wiper comparison

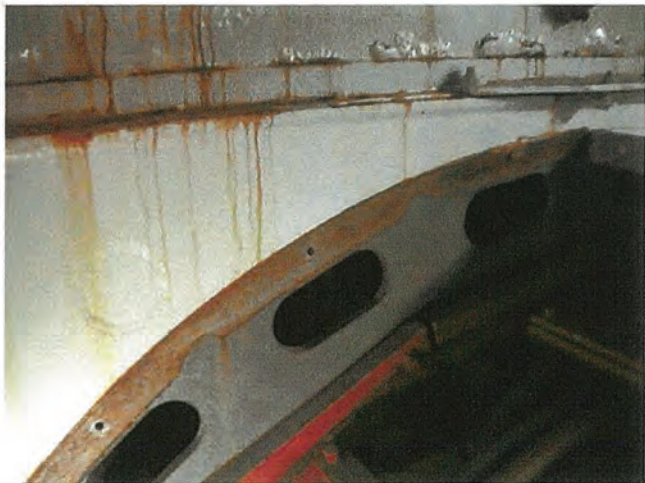
Roof top exhaust/ventilation is showing signs of corrosion and moisture ingress.

- Roof top exhaust/ventilation is corroded and rusted.
- Rust flaking from exhaust/ventilation is present on top of stator core and in bottom of generator enclosure.
- Rotor appears to be in good condition, connections and pole clamps appear to be solid and do not show signs of movement.
- Stator iron and wedging appear to be in good condition.
- Stator coils show signs of over heating and heating discoloration pattern is present in coil system.
- Stator insulation system appears to be degraded, dry and flaking throughout the unit.
- Fan blades have contact wear pattern on edge of blades. This coincides with the wear pattern on the fan cover.

- The exhaust/ventilation unit should be removed, reconditioned or replaced and a corrosion resistant coating applied to prevent future corrosion issues.

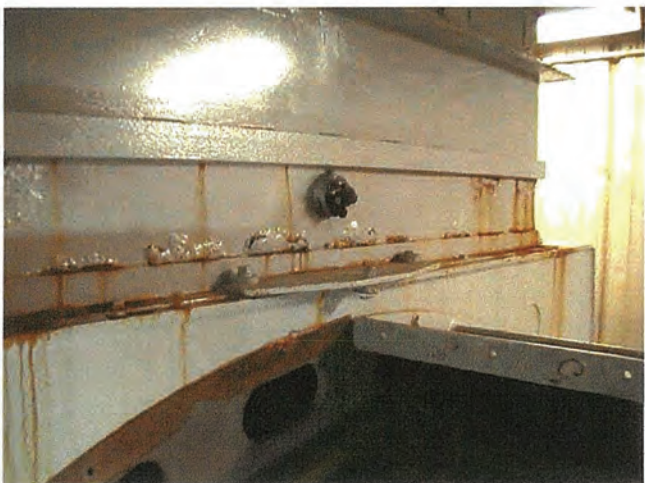
View #2 of the roof top exhaust/ventilation.

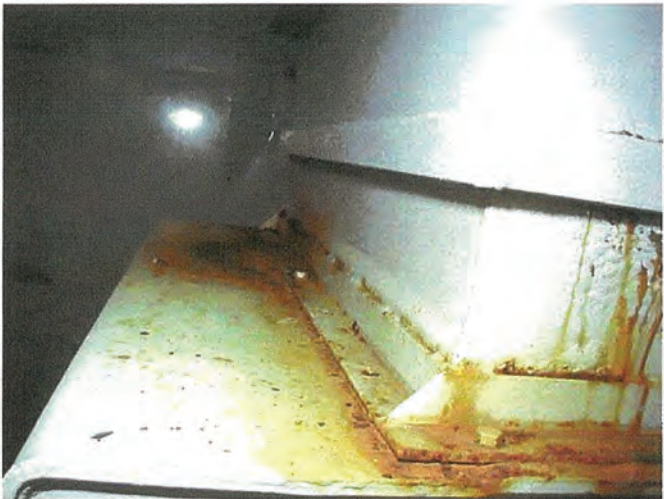
Roof top exhaust/ventilation paint flaking and corrosion.

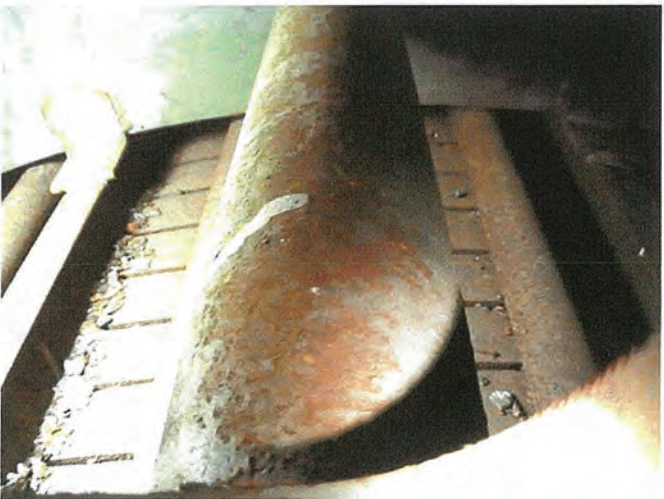
Rust flakes present on top stator core from exhaust/ventilation.

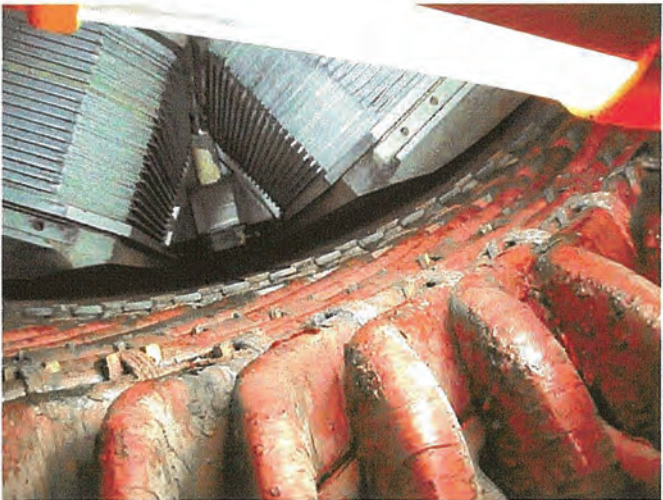
Connections between poles appear in good condition.

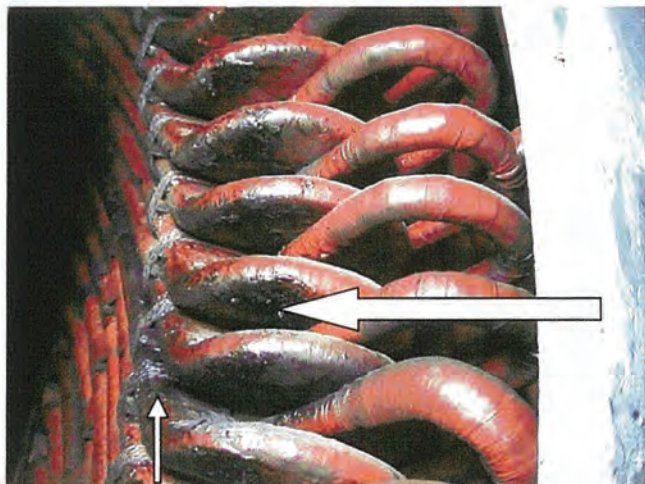
Over heating has occurred in the past: discoloration and resin melted at knuckles.

- Once readings have been improved the rotor should be sealed with a resin treatment to maintain the insulation system integrity.
- With star point of stator disconnected, the insulation resistance to ground of the stator winding is fair; however, the resistance between each phase is unbalanced (30% unbalance). Possible cause of undesirable readings could be Turn to Turn shorts in coil system or grounded coils cut out of coil system (discoloration in some coils are good indication).

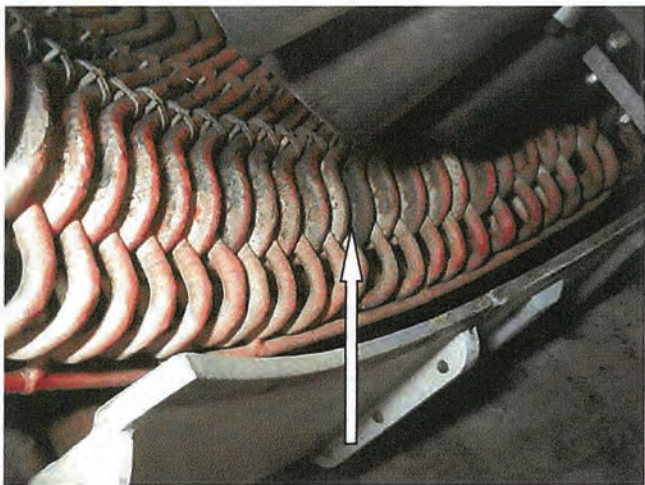
Discoloration heating pattern on some coils.

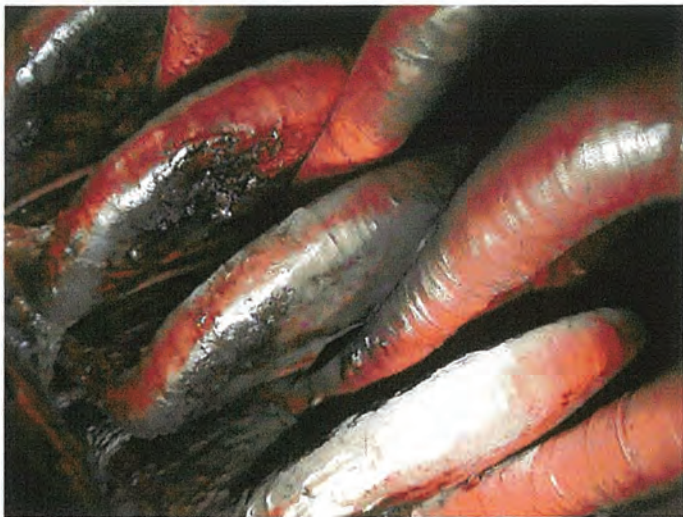
Resin present on knuckles is an indication of overheating.

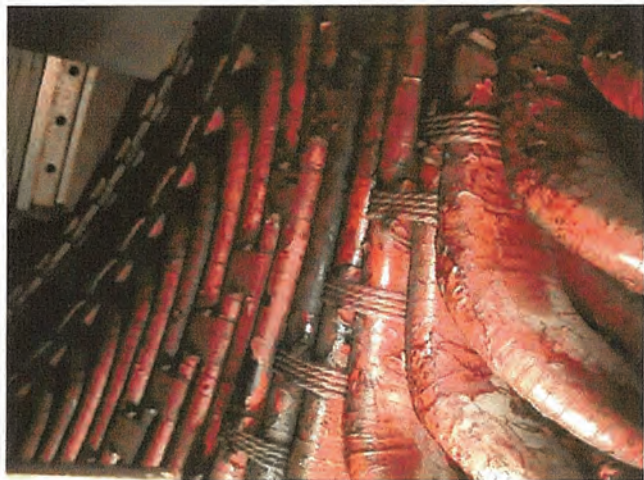
Dry brittle flaking insulation on coils

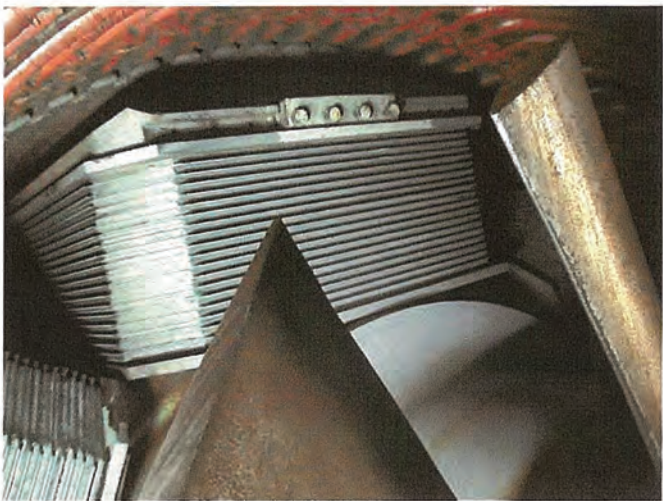
Rub mark on fan blade edge showing previous contact with fan cover.

- The fan blade assembly and fan cover should be reconditioned and adjusted to prevent future contact and wear.
- The rotor winding insulation resistance to ground is not in the desired range (only 2.95 MΩ @500 volts).

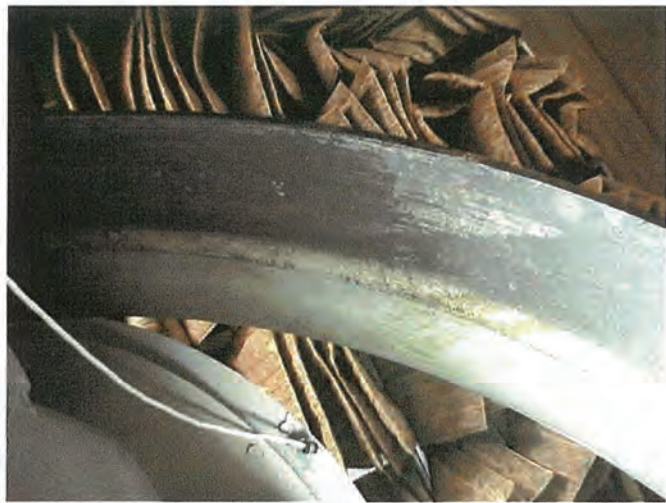
Wear marks on fan cover showing previous blade contact

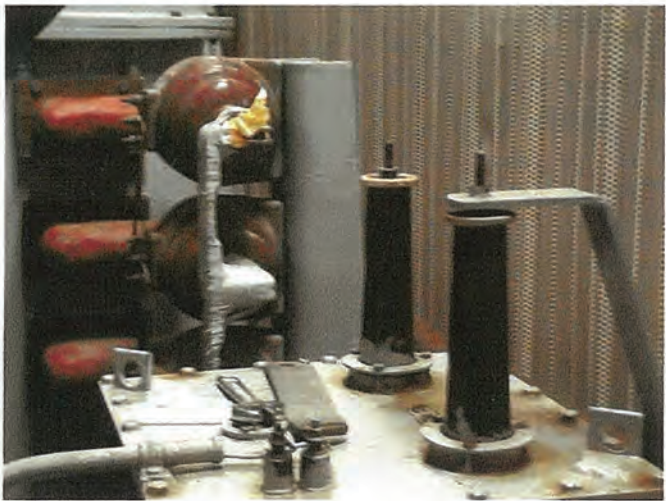
Star Point had to be disconnected from transformer for true reading.
With this point connected insulation resistance to ground reading is 2000 Ω.

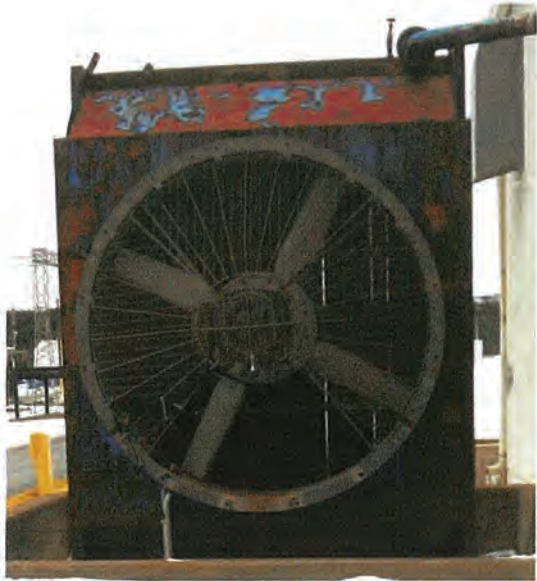
Equipment Name: AC Lube Oil Cooler Fan

- Externally this fan unit is rusty on the outside, the stator frame and rotor shaft extension show signs of environmental corrosion but is mostly superficial.
- Disregarding the overall appearance, the motor appears to be in good shape with all screens and covers installed and conduit connectors in good physical condition. A screen was removed to gain access to the unit as shown in the picture above.
- Internally the inspection was limited due to accessibility. Therefore a full determination of condition cannot be made.

- Overhaul unit to steam clean stator.
- Perform a stator dip & bake to recover insulation integrity and improve PI factor.
- Recondition fan unit and motor frame.
- Paint fan unit and motor with epoxy paint to prevent corrosion.
- Check all mechanical fits and change bearings.
- Perform no-load run test and capture vibration trend data for future reference.
- Anti condensation heater installation is recommended to prevent moisture build-up.

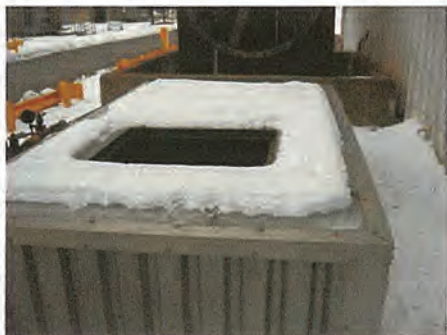
Equipment Name: East Fuel Oil Motor

Both fuel oil pump (East and West) are in this enclosure

- Externally the motor appears to be in fair shape with some surface corrosion.
- All covers installed and conduit connectors in good physical condition.
- Internally the inspection was very limited due to accessibility. Therefore a full determination of condition cannot be made.
- This motor should not be confused with the 25 HP pump unit (25 HP pump unit is for pumping fuel to the storage tank not to supply fuel to turbine).
- Due to time limit and permitting issues, this motor was not run up for vibration analysis test.

- Overhaul unit to steam clean windings.
- Perform a stator dip & bake to recover insulation integrity and improve PI factor.
- Measure and record all mechanical fits and change bearings.
- Perform no-load run test and capture vibration trend data for future reference.
- Unit is installed in an area with a high delta in temperature (cold during idle, hot during operation). Anti condensation heater installation is recommended to prevent moisture build-up.

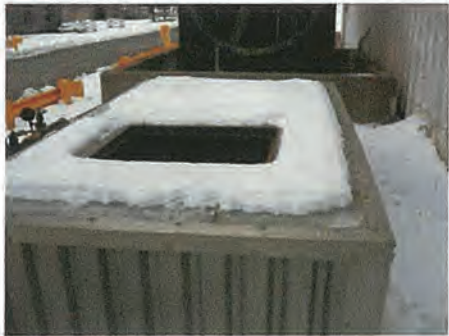
Equipment Name: West Fuel Oil Motor

Both fuel oil pump (East and West) are in this enclosure

- Hatch on enclosure was not in place and unit is covered in snow. Snow was removed to perform visual and tests.
- Externally the motor appears to be in fair shape with some surface corrosion.
- All covers installed and conduit connectors in good physical condition.
- Internally the inspection was very limited due to accessibility. Therefore a full determination of condition cannot be made.
- Due to time limit and permitting issues, this motor was not run up for vibration analysis test.

- Overhaul unit to steam clean windings.
- Perform a stator dip & bake to recover insulation integrity and improve PI factor.
- Measure and record all mechanical fits and change bearings.
- Perform no-load run test and capture vibration trend data for future reference.
- Unit is installed in an area with a high delta in temperature (cold during idle, hot during operation). Anti condensation heater installation is recommended to prevent moisture build-up.

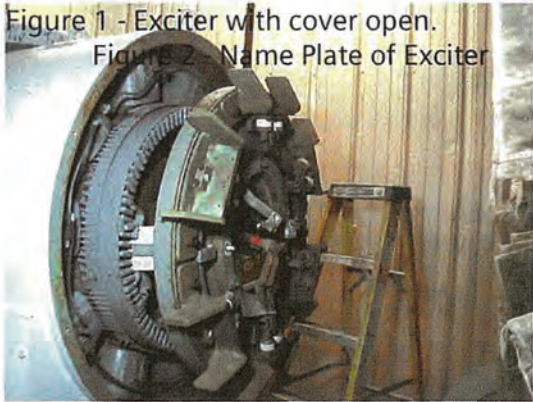
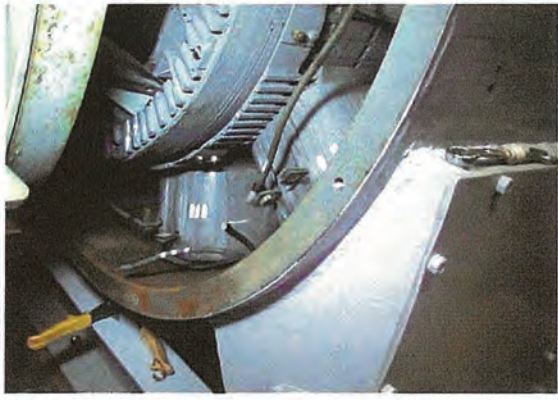
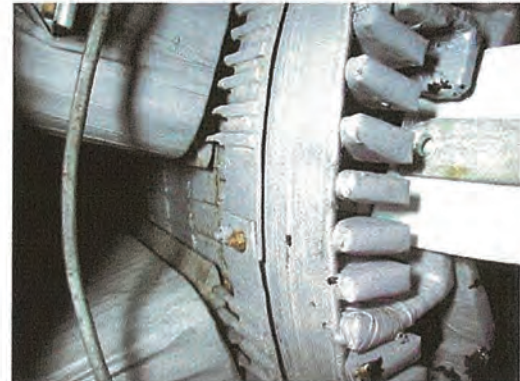
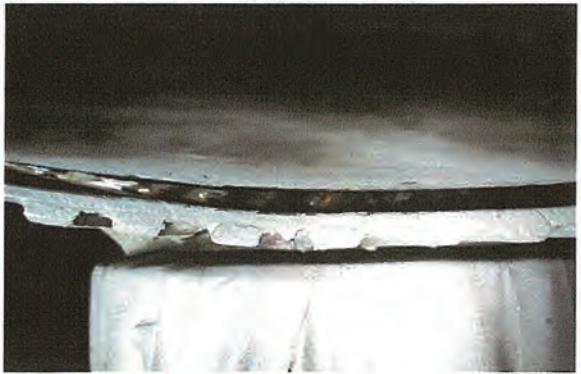
Figure 5 – Small air gap (shorting ring)

Figure 6 – View 2 air gap.

- All fasteners are in good condition and solid.
- All electrical connections are in good condition.
- The air gap between the rotor and stator of exciter are very even in both directions (within 4%) which indicate the wear on the main bearing is very minimal from the original.
- The rectifier is in good condition in both physically and electrically.
- The exciter field stator appears to be dry which coincides with the PI reading.
- There is evidence of condensation in the unit due to the surface rust and corrosion of the rotor iron and shaft, figures 7 & 8 above.

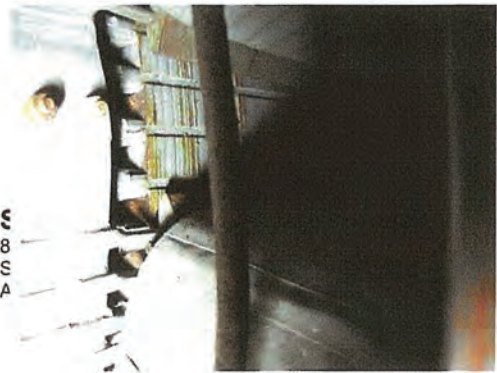
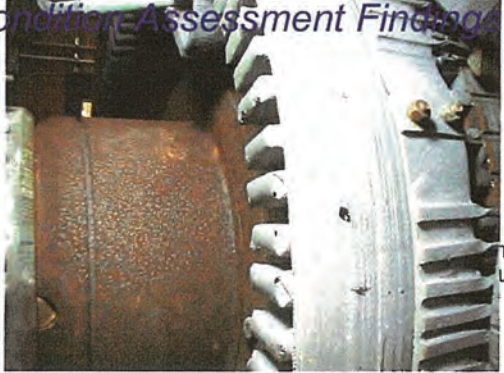
Figure 7 - Rust at the end of rotor iron

Figure 8 - Rusty exciter rotor shaft

- Overhaul unit to steam clean windings.
- Perform a VPI on stator to recover insulation integrity on stator and improve PI factor.
- Rotor should have VPI treatment to maintain the PI factor and increase the reliability.
- While overhauling unit a recondition rotor iron and shaft to remove rust should be performed. Once complete and rust removed a coating from the VPI and epoxy paint should be applied to prevent future corrosion.
- Measure and record all mechanical fits.
- Unit is installed in an area with a high delta in temperature (cold during idle, hot during operation). Anti condensation heater installation is recommended to prevent moisture build-up.

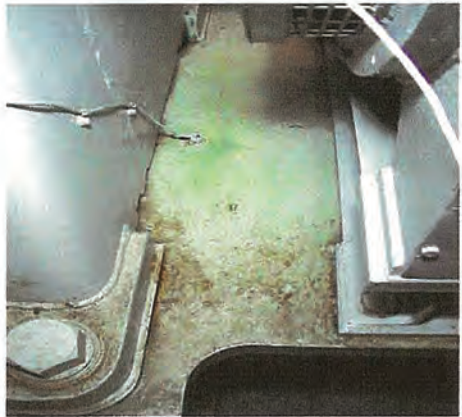
Leakage on bearing foundation

- All fasteners are in good condition and solid.
- This bearing is still in good physical shape despite some oil leakage through the labyrinth seals.
- The air gap between the rotor and stator of exciter are very even in both directions (within 4%) which indicate the wear on the main bearing is very minimal from the original.
- There is wear and grooving on the shaft seals at both ends of the bearing.
- Oil leakage was apparent from the residue left on the bearing housing and foundation under the bearing.

- Bearing shells should be removed and sent for recondition and polishing of Babbitt areas and faces.
- Several sets of bearing measurements should be conducted with the bearing clamped together (inboard side, middle and outboard side).
- Labyrinth seals should be adjusted to prevent further grooving and the shaft should be polished to remove present grooves.
- Inboard oil wiper should be replaced, near end of life.
- When installed in the housing a fit test should be performed to verify bearing contact with shaft.
- For future preservation the rotor should be turned on a monthly basis to prevent shaft marking and maintain an oil film in the bearing.

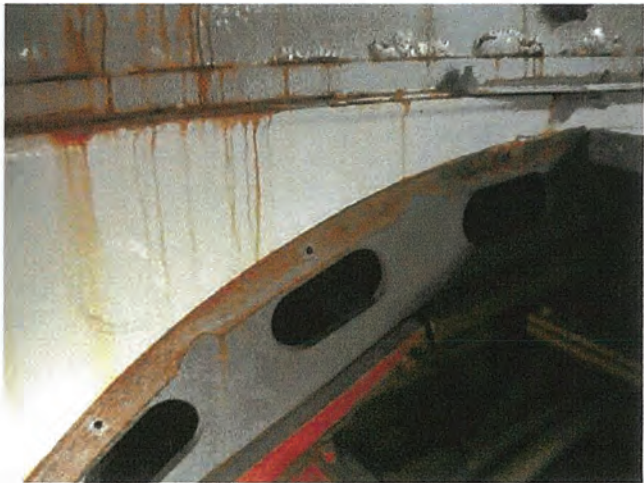
Roof top exhaust/ventilation is showing signs of corrosion and moisture ingress.

- Roof top exhaust/ventilation is corroded and rusted.
- Rust flaking from exhaust/ventilation is present on top of stator core and in bottom of generator enclosure.
- Rotor appears to be in good condition, connections and pole clamps appear to be solid and do not show signs of movement.
- Stator iron and wedging appear to be in good condition.
- Stator coils show signs of over heating and heating discoloration pattern is present in coil system.
- Stator insulation system appears to be degraded, dry and flaking throughout the unit.
- Fan blades have contact wear pattern on edge of blades. This coincides with the wear pattern on the fan cover.

- The exhaust/ventilation unit should be removed, reconditioned or replaced and a corrosion resistant coating applied to prevent future corrosion issues.

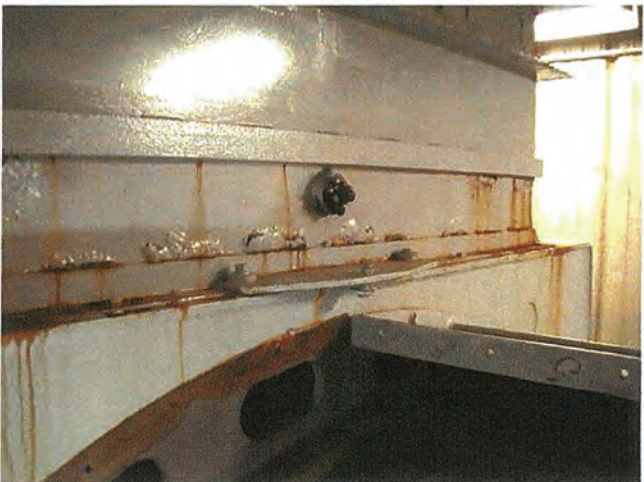
View #2 of the roof top exhaust/ventilation.

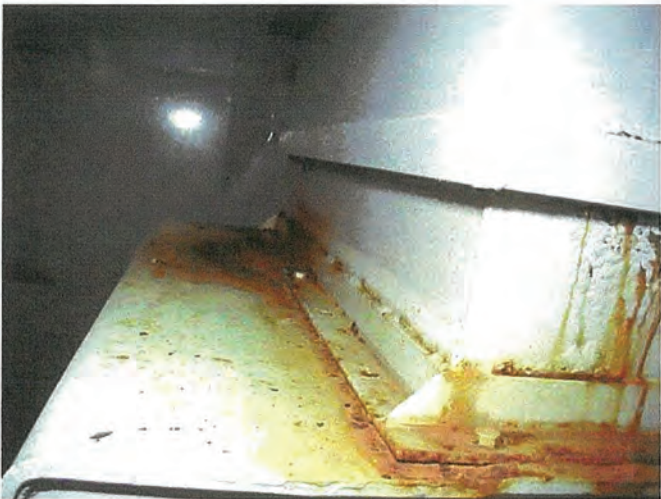
Roof top exhaust/ventilation paint flaking and corrosion.

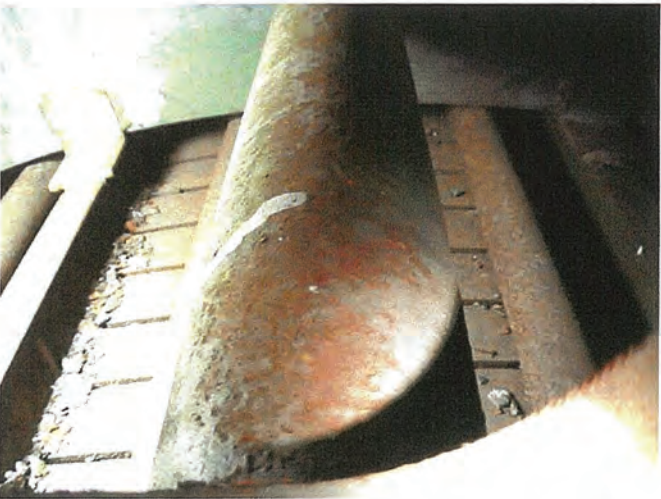
Rust flakes present on top stator core from exhaust/ventilation.

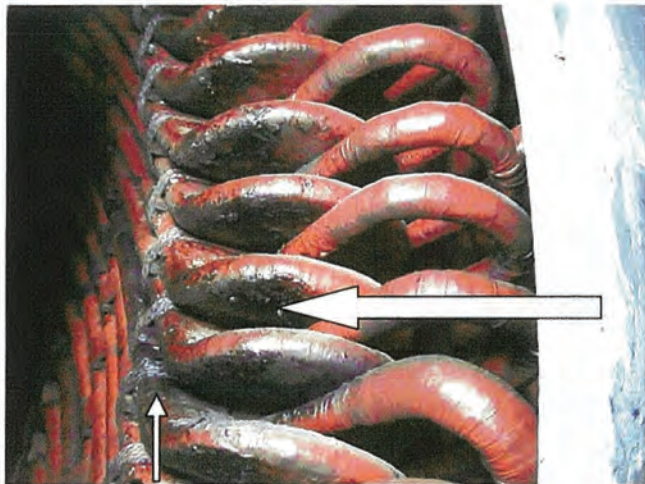
Over heating has occurred in the past: discoloration and resin melted at knuckles.

- Once readings have been improved the rotor should be sealed with a resin treatment to maintain the insulation system integrity.
- With star point of stator disconnected, the insulation resistance to ground of the stator winding is fair; however, the resistance between each phase is unbalanced (30% unbalance). Possible cause of undesirable readings could be Turn to Turn shorts in coil system or grounded coils cut out of coil system (discoloration in some coils are good indication).

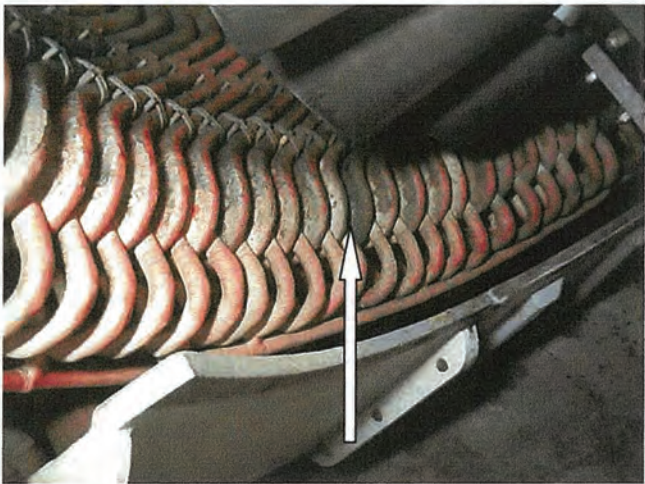
Discoloration heating pattern on some coils.

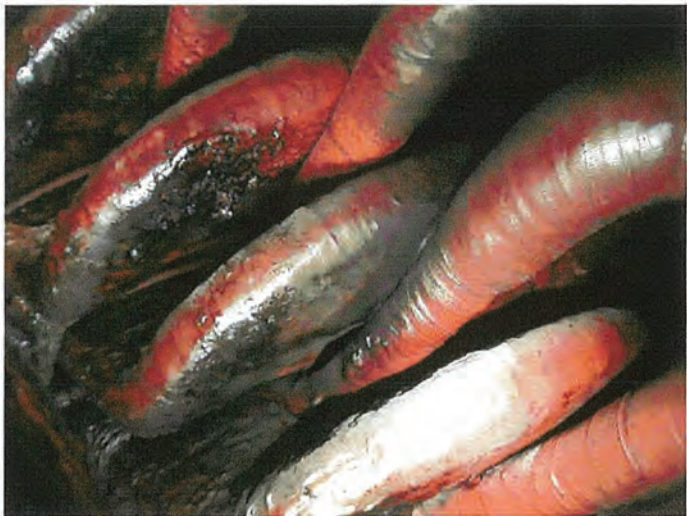
Resin present on knuckles is an indication of overheating.

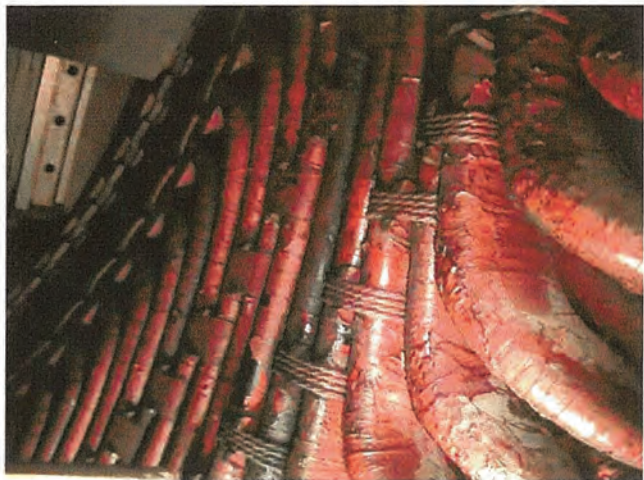
Dry brittle flaking insulation on coils

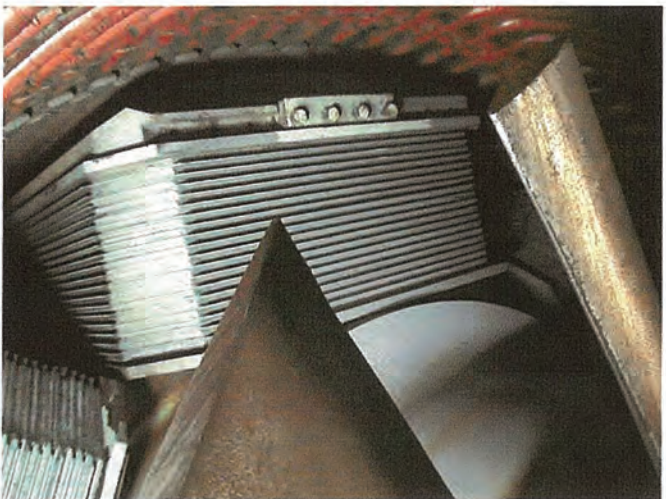
Rub mark on fan blade edge showing previous contact with fan cover.

- The fan blade assembly and fan cover should be reconditioned and adjusted to prevent future contact and wear.
- The rotor winding insulation resistance to ground is not in the desired range (only 2.95 MΩ @500 volts).

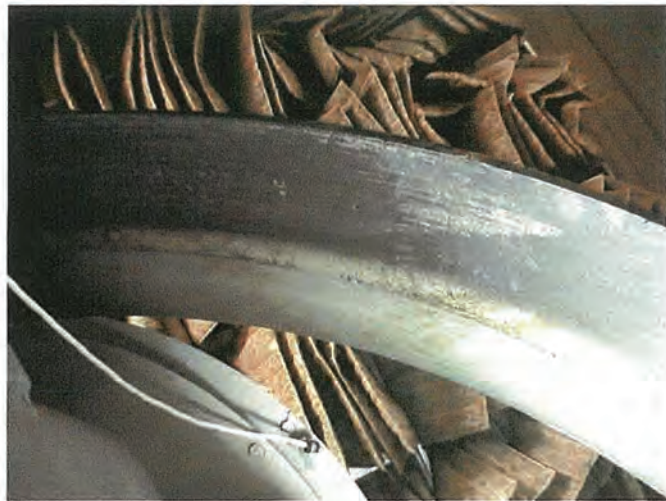
Wear marks on fan cover showing previous blade contact

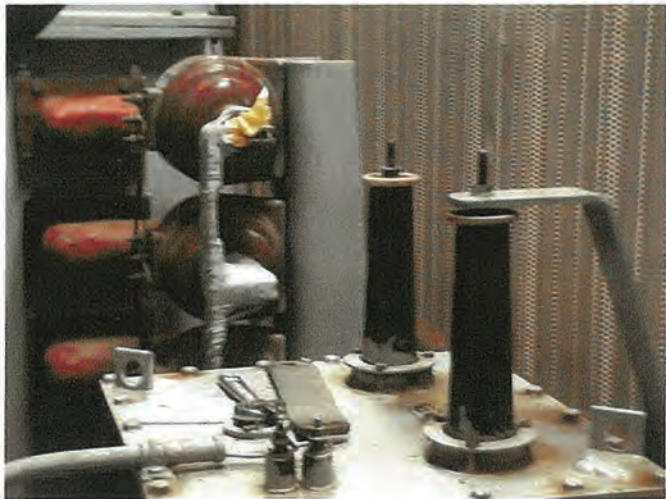
Star Point had to be disconnected from transformer for true reading.
With this point connected insulation resistance to ground reading is 2000 Ω.
