10    A.    Please see Hydro's response to IC-NLH-006, Attachment 1 - Site Recommendations,  
11           IC-NLH-006 Attachment 2 – Air Intake Inspection Report, IC-NLH-006 Attachment 3 -  
12           Gas Turbine Capital Plan, and NP-NLH-13, Attachment 1 - Stantec Condition  
13           Assessment Study Report.

# Site Recommendations

**Customer: Newfoundland Labrador Hydro**

**Project Number: Alba 4927**

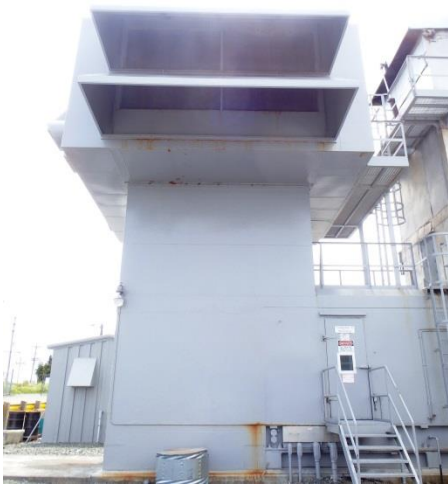
Inlet Air system A was found to be in overall fair condition throughout the inspection (photo 3). The inlet air structure is constructed of structural steel plate and supported by concrete foundations. Foundations are in good condition with no visible signs of cracking or deterioration noted. All exterior structural steel was found to be in good condition. As mentioned earlier, coatings on both Inlet air systems were done in 2013. Because of this, coatings on the exterior of the inlet system were noted to be in fair condition. Isolated areas of coating breakdown were also noted. From inspection, it could be told that coatings were installed in poor weather allowing previous corrosion to leak through to the new top layer of coatings (photo 35). Steel cladding surrounding inlet air system are in fair condition throughout with coating failures noted in isolated areas. One hole noted on the West side underside of vent (photo 36).

Photo 3 – General overview of Inlet Air System A looking West.

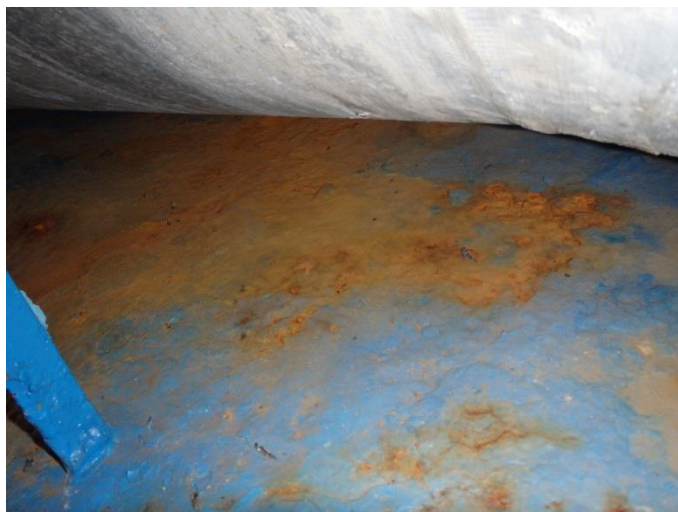
Steel deck plating is in poor condition with heavy pitting noted, mainly focused to the deck directly located below the cyclomatic filtration unit (photo 5). Coating breakdown and scale up to 10mm mainly focused below the cyclomatic filtration unit and at connection between deck plate and vertical (photos 4, 6 and 8).

Photo 5 – Heavy pitting, coating breakdown and scale on steel deck plating below cyclomatic filtration system.

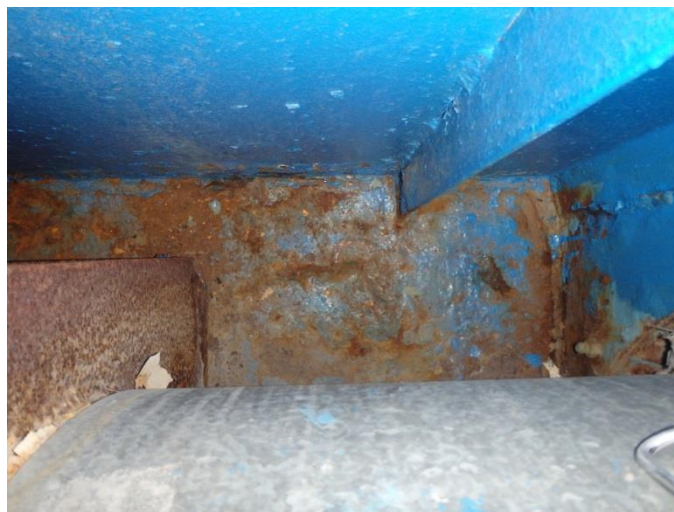
Photo 6 – Coating breakdown and light scaling in Southeast corner, located below cyclomatic filtration system.

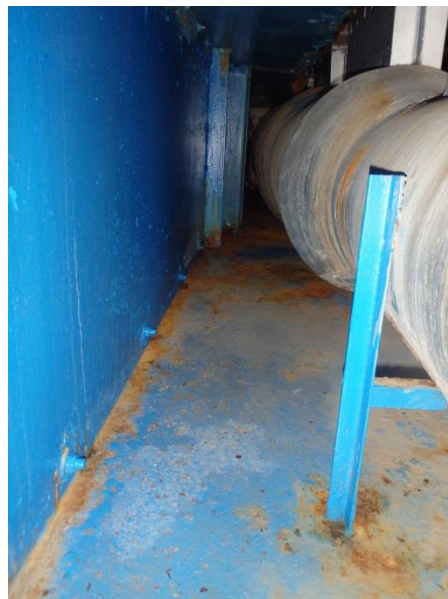
Photo 8 – General view of steel deck plating looking South. Coating breakdown and surface corrosion throughout.

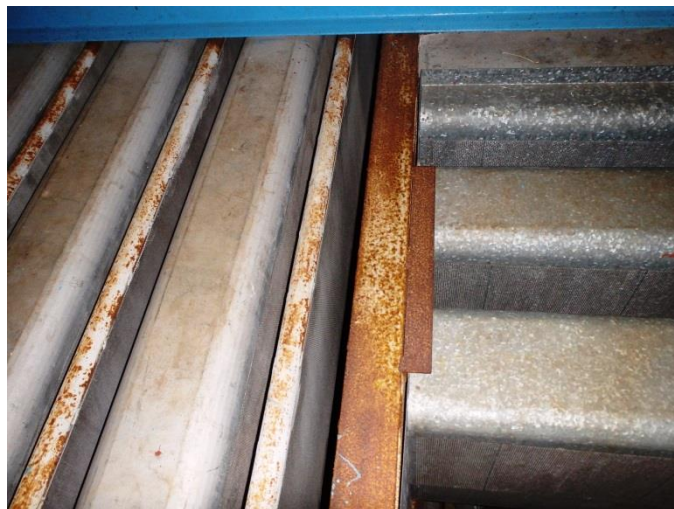
Inspections revealed extensive coating breakdown on horizontal structural beams at floor level, surface corrosion was also noted in these areas (photo 12). Coating breakdown also noted in isolated areas of connections between steel floor plating and vertical sections of I-beams at floor level (photo 14). Isolated coating breakdown with scale up to 5mm scale noted on corner section of I-beams located on the East side of this portion of the inlet, directly below the filter which was removed to allow for inspections (photo 13).

40% coating breakdown and surface corrosion noted on top side of emergency inlet filtration vertical sections, rated using ASTM rust grade D610-08 as 1-G (photo 12).

Photo 12 – Coating breakdown on horizontal structural beams.

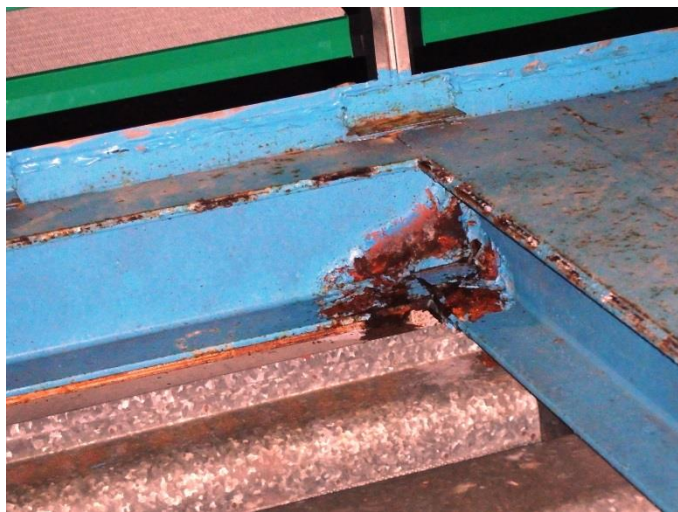
Photo 13 – Isolated area of coating breakdown and scaling.

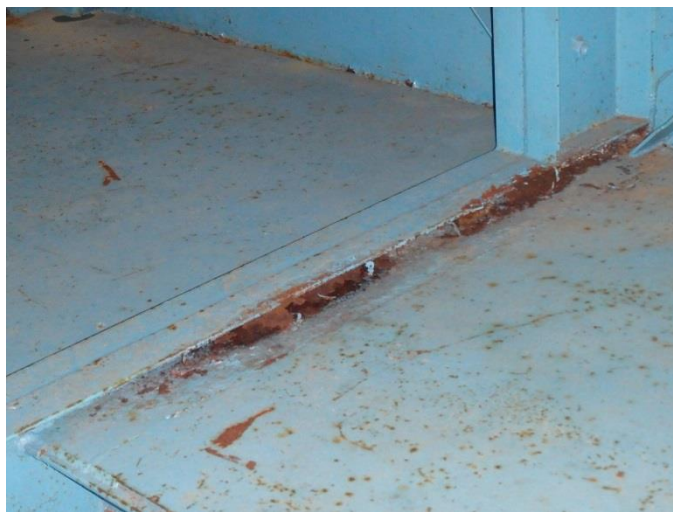
Photo 14 – Isolated sections coating breakdown between connection of horizontal I-beams and deck plating.

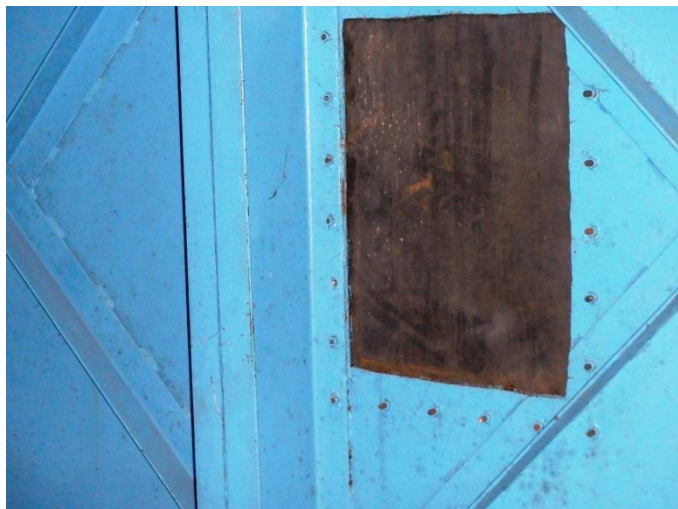
100% coating breakdown and surface corrosion noted on internal portion of hatchway door on North side of inlet (photo 15). This condition was not repeated on the outside of this hatch.

Photo 15 – 100% coating breakdown on hatch door.

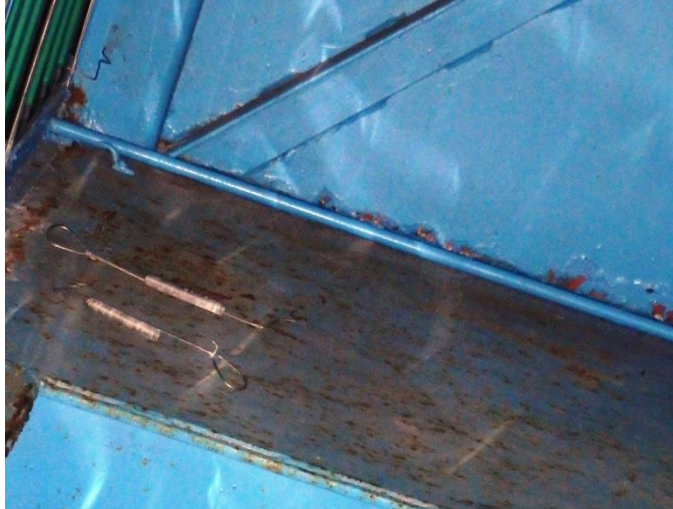
- I. Debris located at the South end with the potential to cause damage (photo 16).

Photo 16 – Debris located inside emergency air filter on the South side.

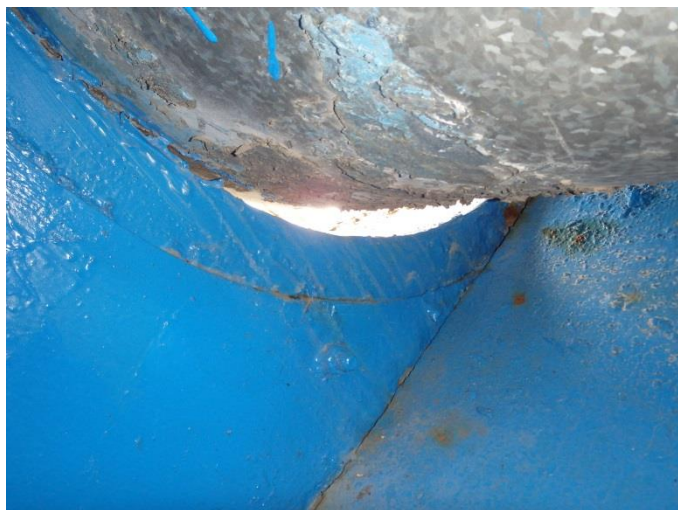
Air gap noted, exposing internal elements of inlet air filter room to water ingress, is present on the South side (photo 17). This was found to be different to Inlet B, with the difference been that B was found to have a machined piece attached to eliminate water ingress (photo 45).

Air gap noted, exposing internal elements of inlet air filter room to water ingress was present on the South side (photo 17). This was found to be different to Inlet B, with the difference been that B was found to have a machined piece attached to eliminate water ingress (photo 45).

Photo 17 – Air gap located around section of cyclomatic filtration system allowing internal of air filter room open to the elements.

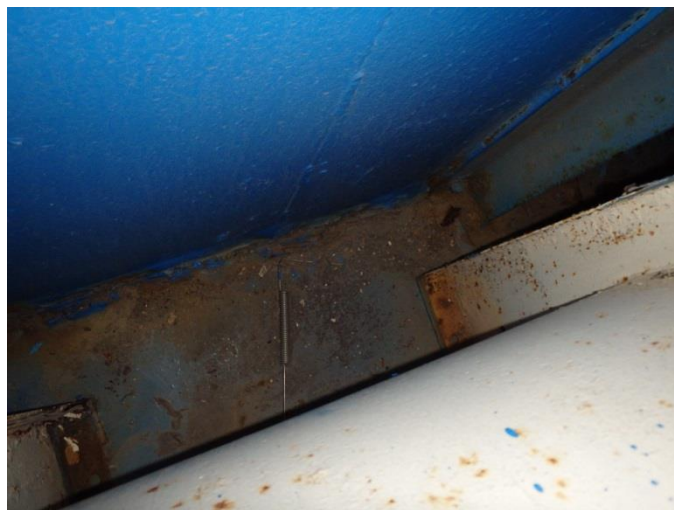
Photo 18 – Coating breakdown, scaling and debris located below cyclomatic filtration unit in West side air filter room.

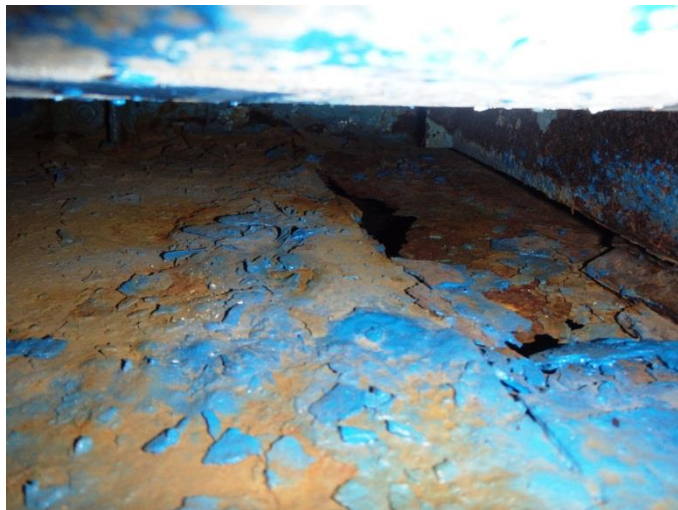
Steel deck plating is in poor condition with holes noted. Worst of these are triangle shaped measuring 250mmx100mm and is located below the cyclomatic filtration unit, at the connection between the deck and outside wall (photo 23). Furthermore to this finding, holes were found throughout the deck plating (photos 19 and 21). This area would need to be further investigated to confirm wall thickness remaining in these areas.

Photo 19 – Coating breakdown and holes on steel deck plating below cyclomatic filtration unit.

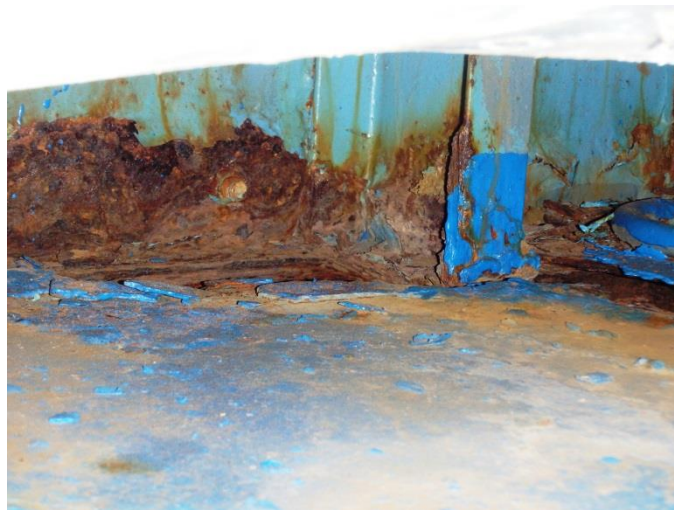
Photo 20 – Coating breakdown, heavy scaling and holes below cyclomatic filtration unit.

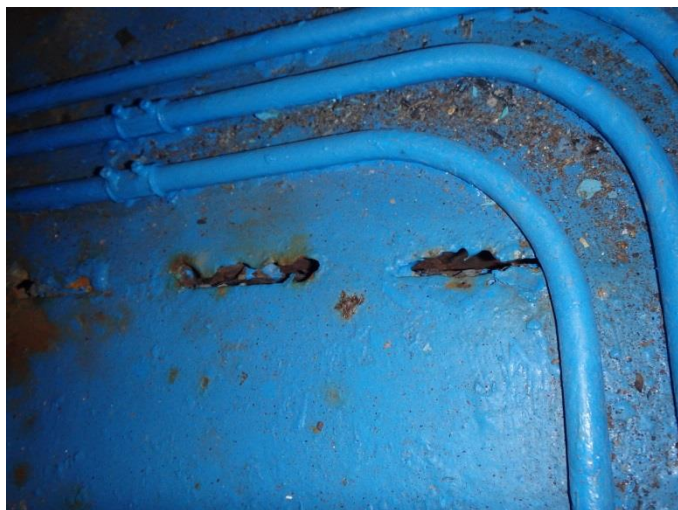
Photo 21 – Numerous holes located on deck plating in West side Air Filter room.

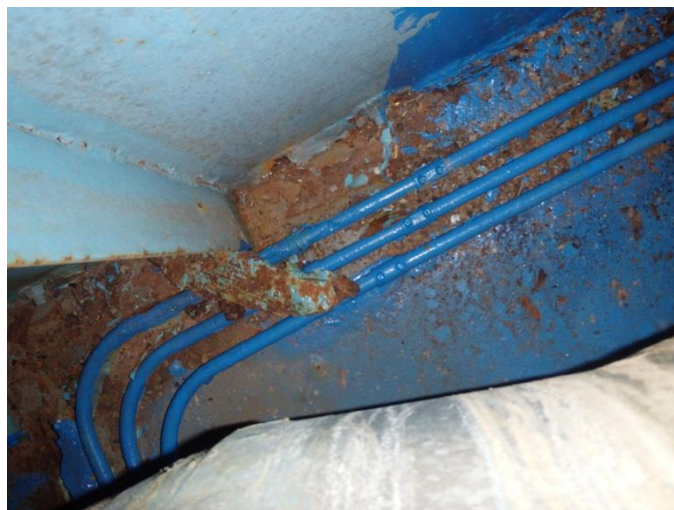
Photo 22 – Coating breakdown and light scaling on steel deck plating.

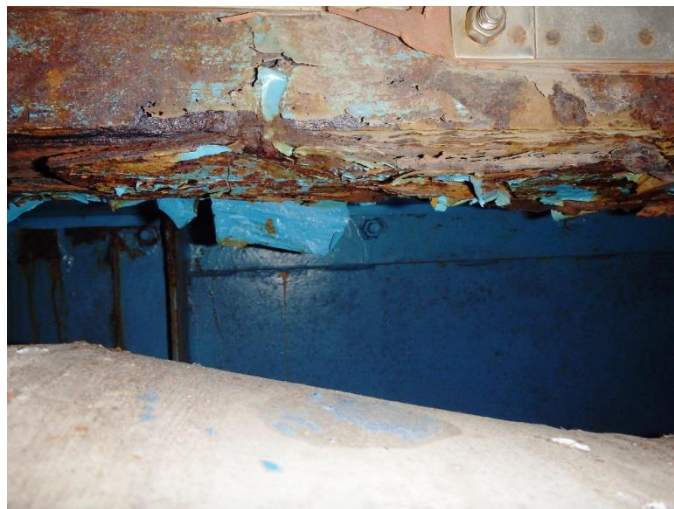
Base plate of cyclomatic filtration unit is in poor condition with greater than 50% coating breakdown and scale up to 10mm in isolated areas. Rated using ASTM rust grade D610-08 as 0-G (photo 24).

Photo 24 – Coating breakdown and scaling on base plate of cyclomatic filtration unit.

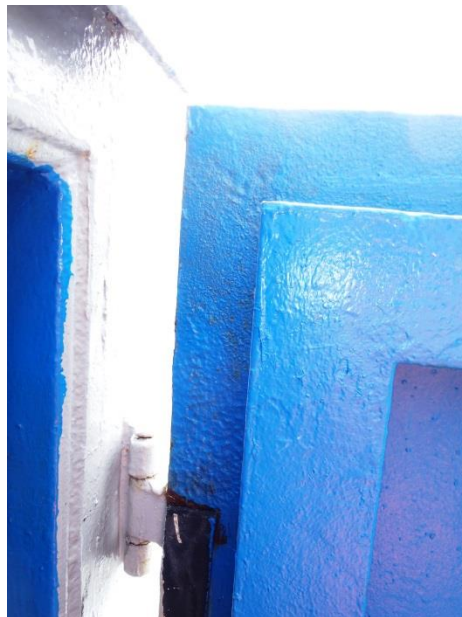
- I. Power outlet located below access platform on the East side of Inlet A with no weather cover, open to elements and potential to cause harm (photo 31).
- II. Broken electrical box located on the West side of Inlet A is open to elements and potential to cause harm (photo 34).
- III. Light on the South side of inlet are in poor condition (photo 33). In the condition it is at the current time, there is potential to harm due to water ingress potential.
- IV. Broken electrical box located on the West side of inlet and a gap allowing for water ingress with the potential to harm (photo 37).
- V. Mesh on bottom section of inlet overhangs on East side and is in poor condition. Gap noted at top section of mesh. Further investigation required to fully report the extent of this issue (photo 32).
- VI. Seal on West access door on top level platform with deteriorating door seal (photo 26).

Photo 26 – Door seal on West side door with onset of deterioration.

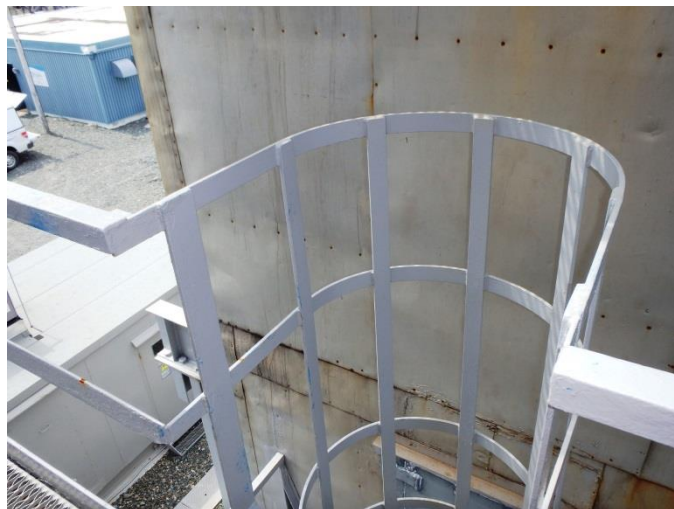
Photo 28 – No safety chain located at the top of ladders. This was typical of all access ladders on Inlet Air System A.

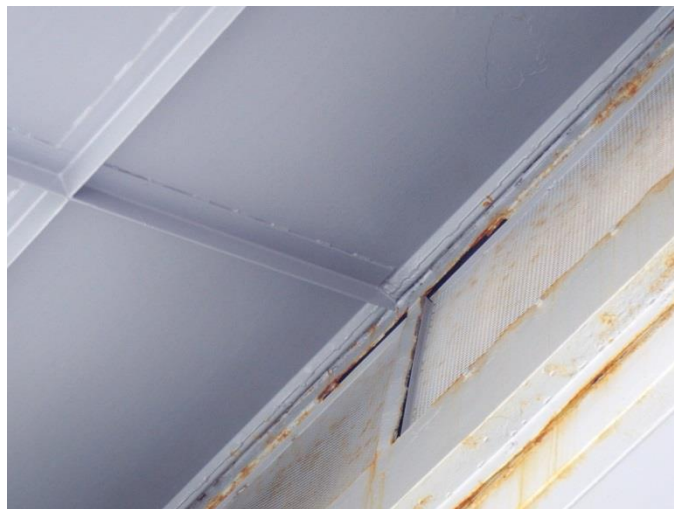
Photo 32 – Mesh parting from steel structure on East side.

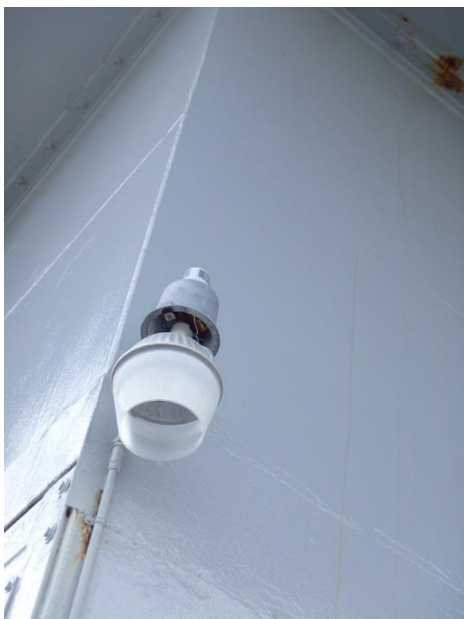
Photo 33 – Light on South side in poor condition, allowing water ingress.

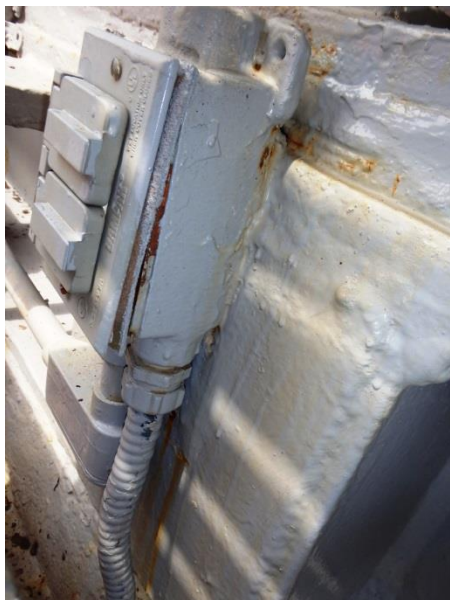
Photo 37 – Damaged electrical source, allowing water ingress and potential to harm.

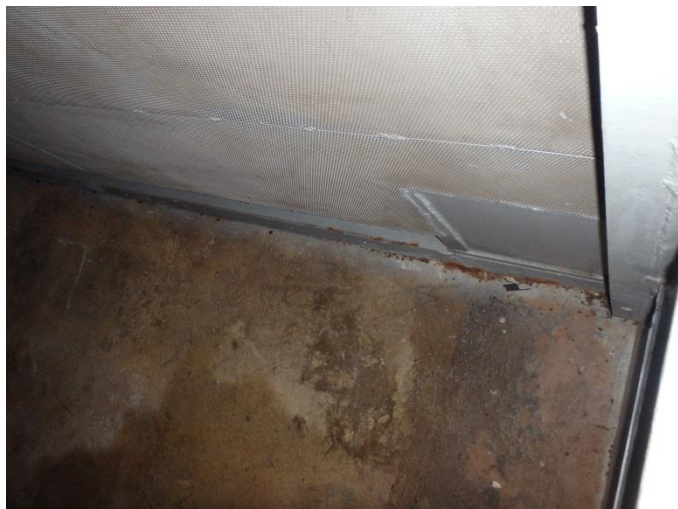
Photo 39 – Water collected on concrete floor of confined space.

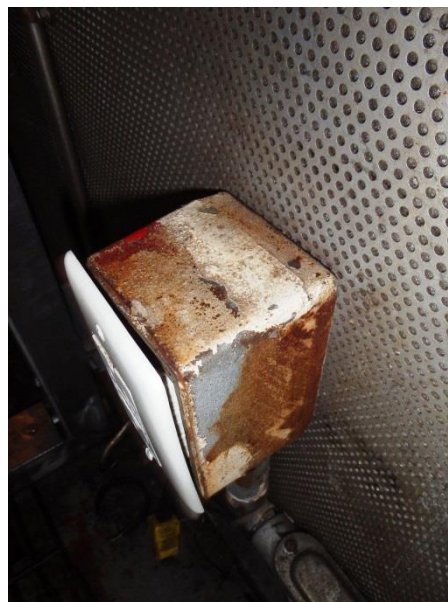
Photo 44 – Damaged electrical box.

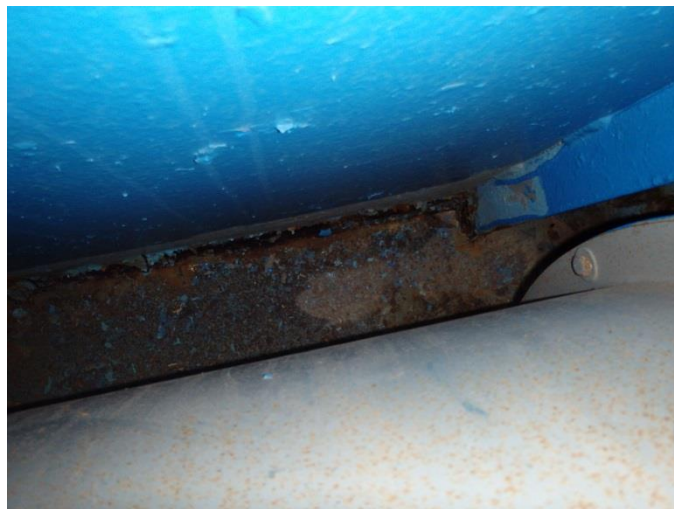
Photo 4 – Coating breakdown and scale noted on deck plating in West side air filter room.

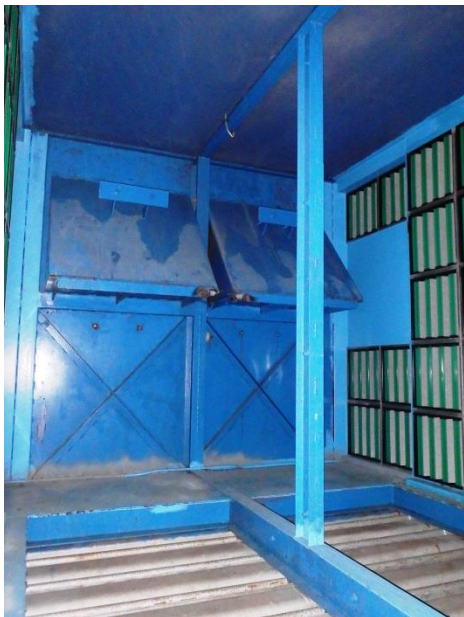
Photo 9 – General overview of emergency air filter system. Small levels of coating breakdown noted.

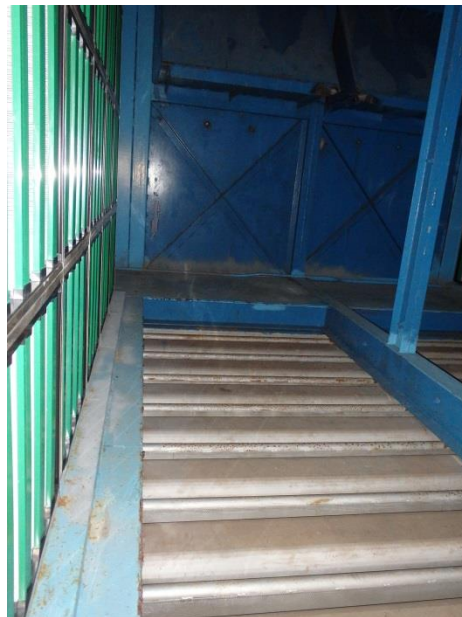
Photo 10 – Emergency air filter system with coating breakdown noted on vertical sections.

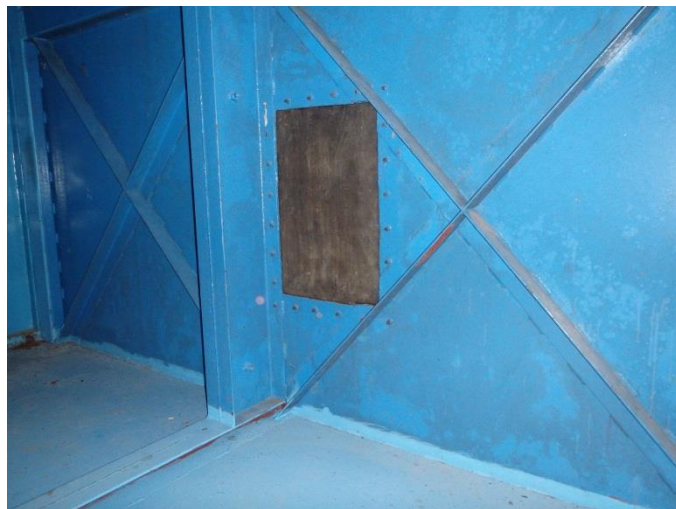
Photo 12 – 100% coating breakdown on hatchway door.

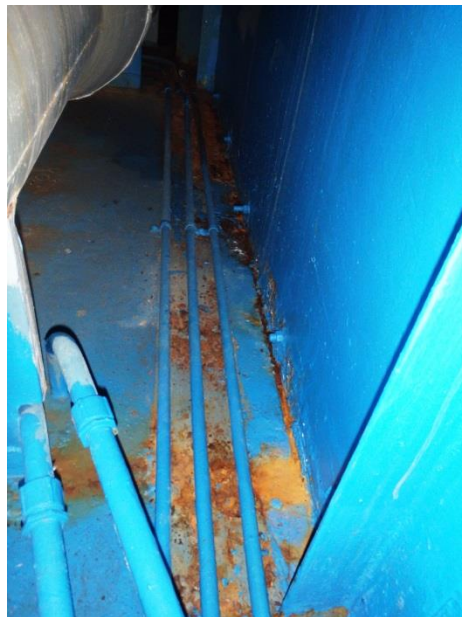
Photo 14 – Coating breakdown/corrosion on deck plating in East side air filter room.

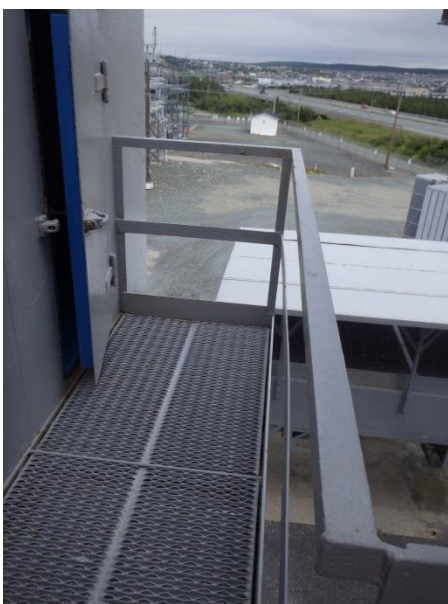
Photo 19 – General overview of top level platform looking East.

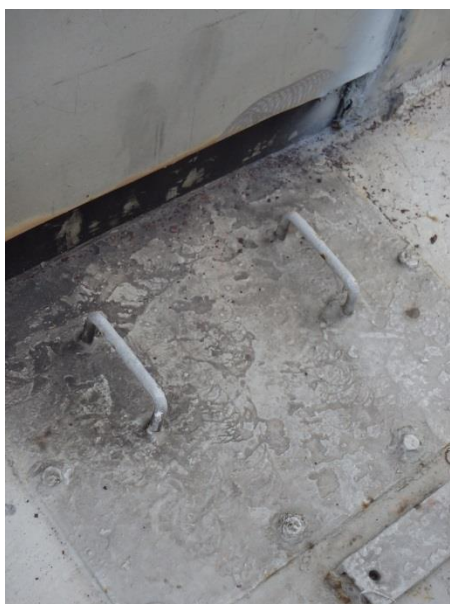
Photo 23 – Middle platform ground level. Hatchway handles causing tripping hazard.

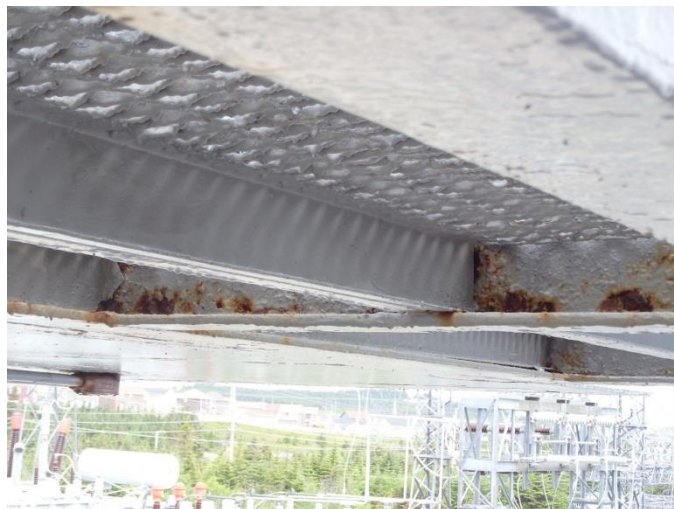
Photo 24 – Isolated sections of coating breakdown on platform supporting structural members.

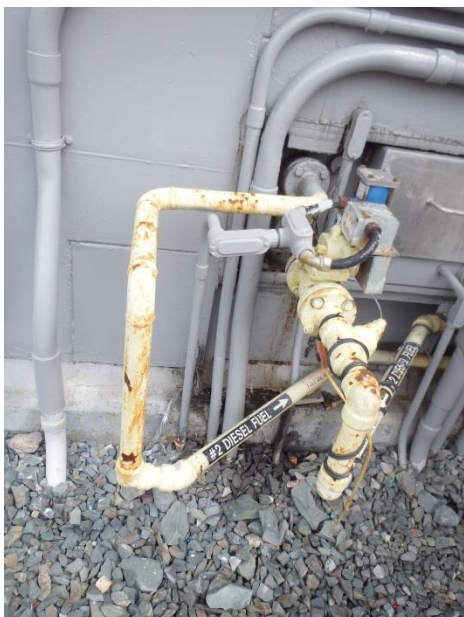
Photo 25 – Associated piping in fair condition with coating breakdown and surface corrosion.

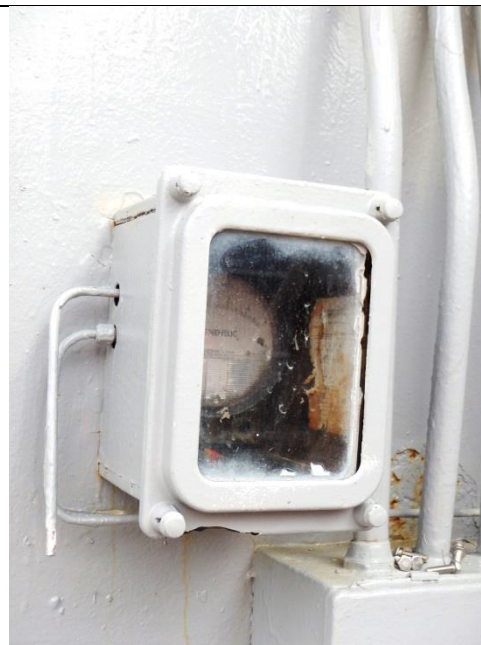
Photo 26 – Damaged electrical box allowing water ingress.

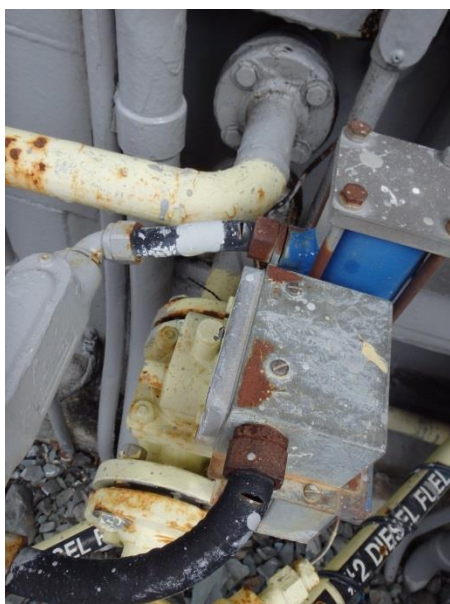
Photo 27 – Damaged rubber hose on associated piping allowing for water ingress.

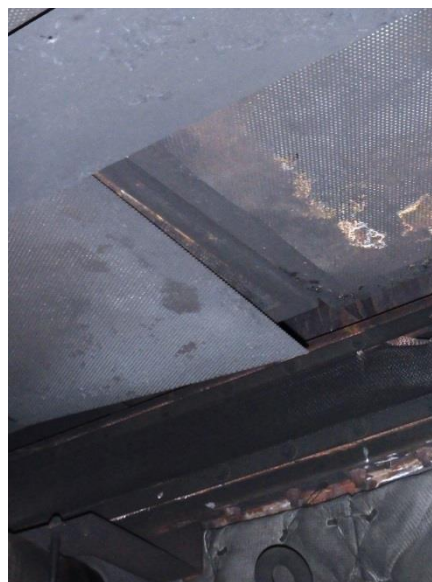
Photo 32 – Damaged and hanging mesh.

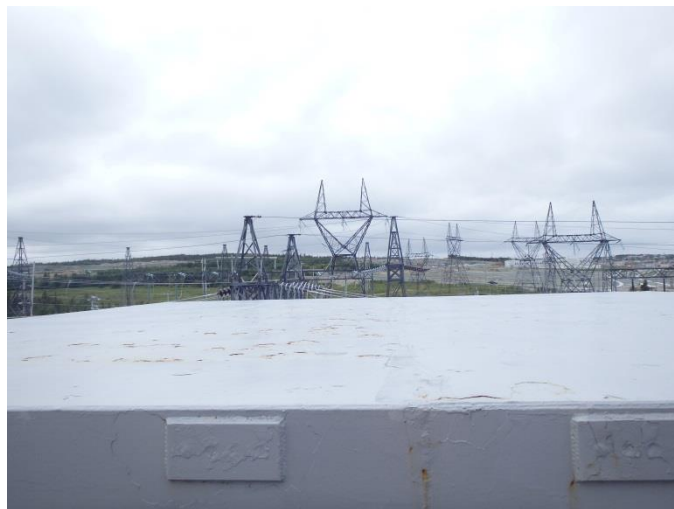
Photo 36 – Roof structural steel in fair condition.

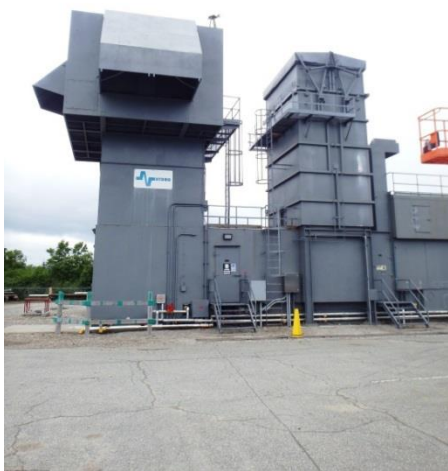
Inlet Air system A was found to be in overall fair condition throughout the inspection (photo 1). The inlet air structure is constructed of structural steel plate and supported by concrete foundations. Foundations are in good condition with no visible signs of cracking or deterioration noted. All exterior structural steel was found to be in good condition. In regards to the coating condition on the exterior of the inlet system, it was noted to be in fair condition. Isolated areas of coating breakdown were also noted. Moderate levels of coating breakdown and small levels of corrosion were noted on the roof steel plating (photo 35). Steel cladding surrounding inlet air system are in fair condition throughout with isolated coating failures noted in isolated areas.

Photo 1 – General overview looking East.

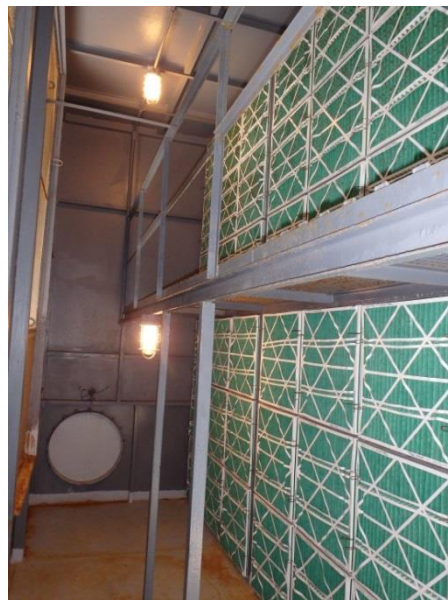
Equipment inside of Inlet air filter room West is in overall good condition. Condition of the filters were found to be in very good condition as all filters were replaced in the summer of 2014 (photos 4 and 5). Cyclomatic Filtration unit found to have been removed (photo 2).

Photo 2 – Overview of West side Air Filter room looking north from doorway.

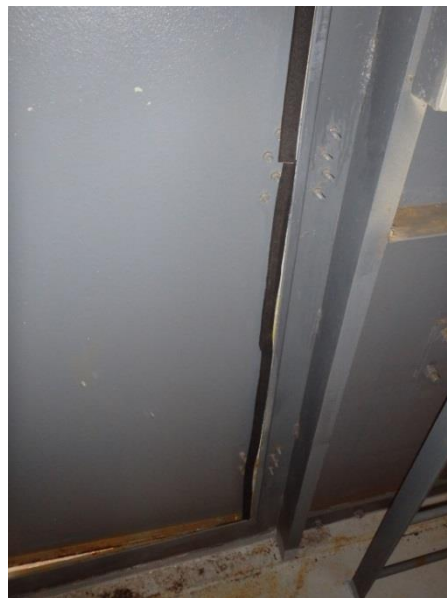
Photo 6 – Broken seal around access door.

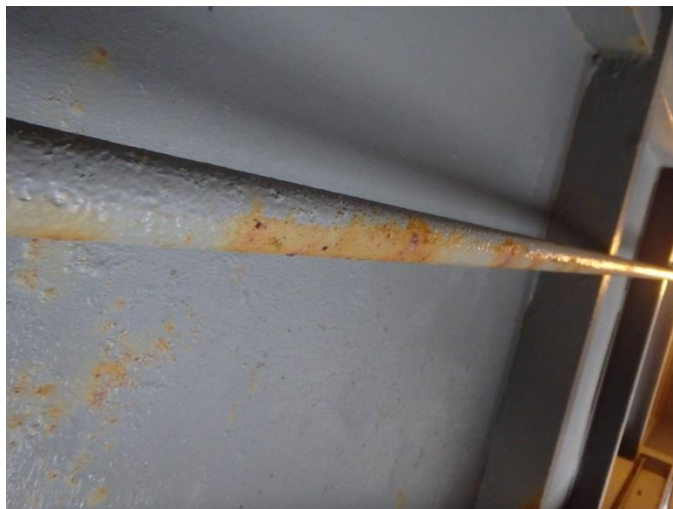
Photo 8 – Coating breakdown noted on casing for electrical wires.

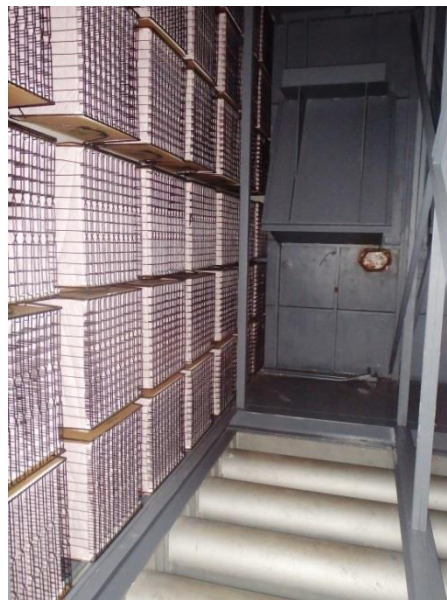
Photo 10 – General overview of emergency air filter room looking North from access door.

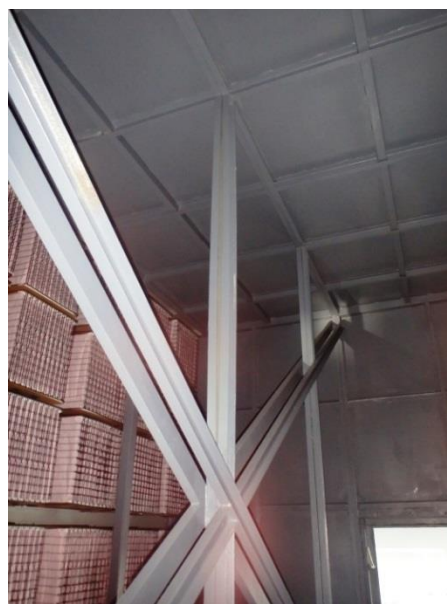
Photo 12 – Overview of supporting steel members and ceiling steel work.

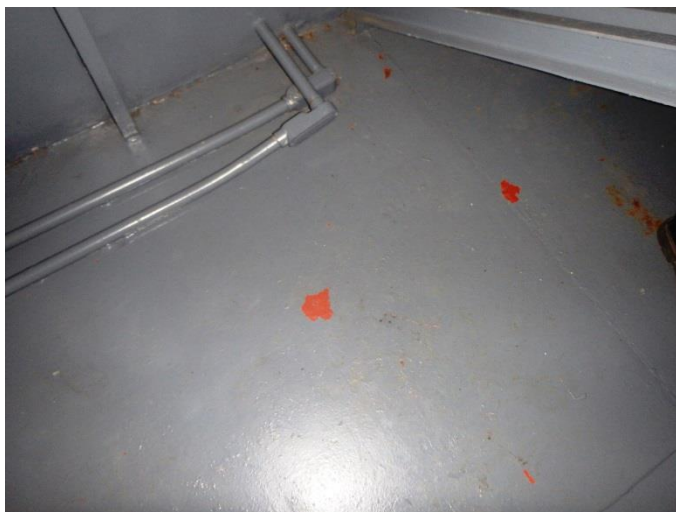
Photo 13 – Isolated area of coating breakdown.

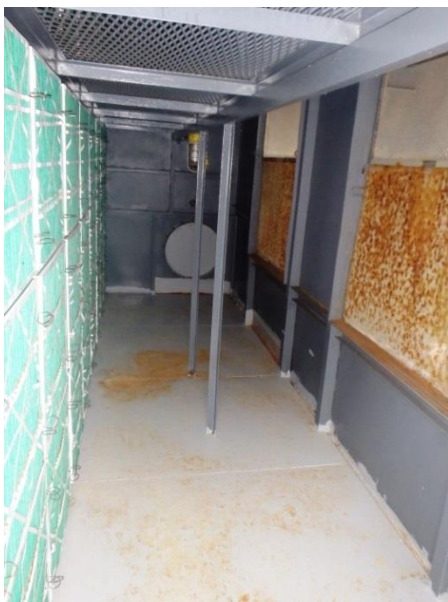
Photo 15 – General overview of East Side air Filter room looking North from access door.

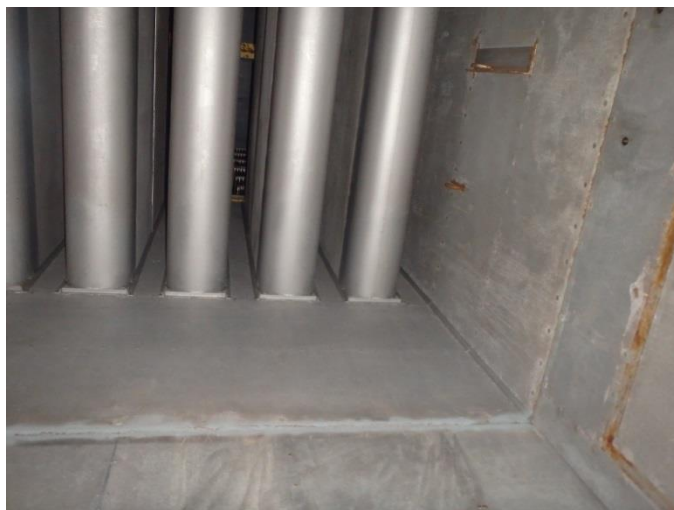
Photo 22 – Coating found to be in good condition with no signs of coating breakdown or scale.

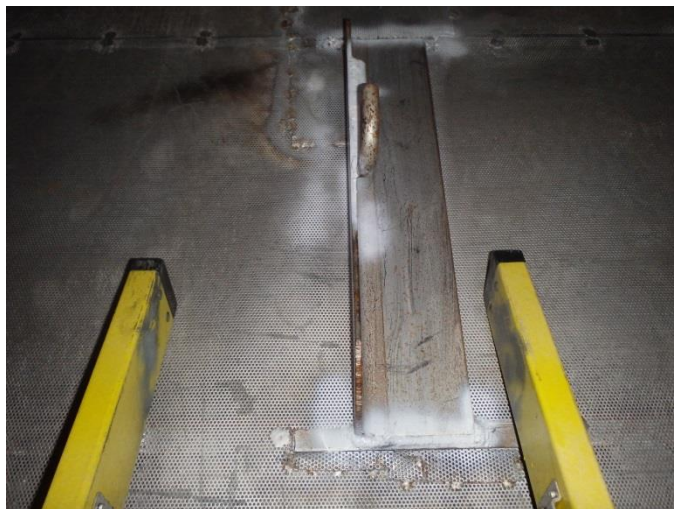
Photo 24 – MPI inspections in progress.

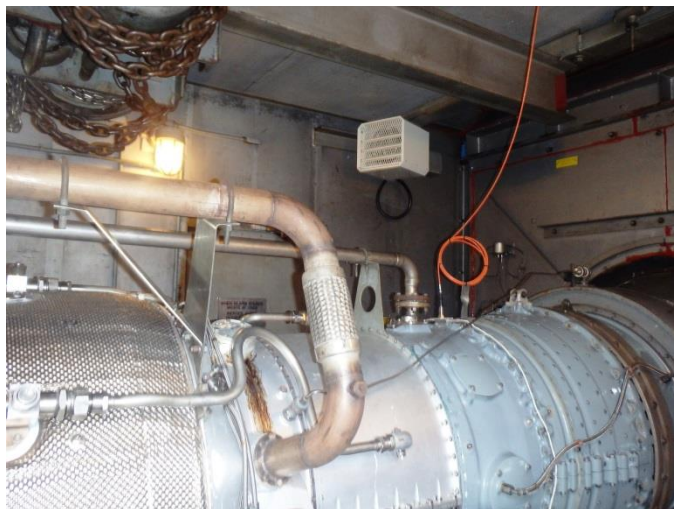
Photo 28 – General overview of Turbine room looking East.

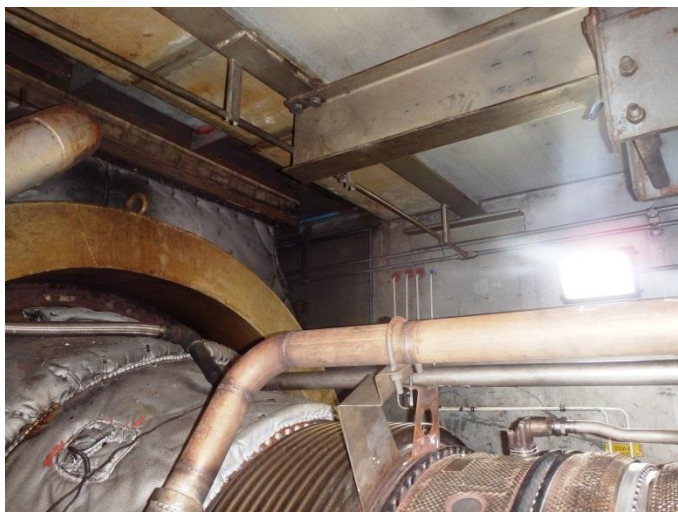
Photo 29 – General overview of Turbine room.

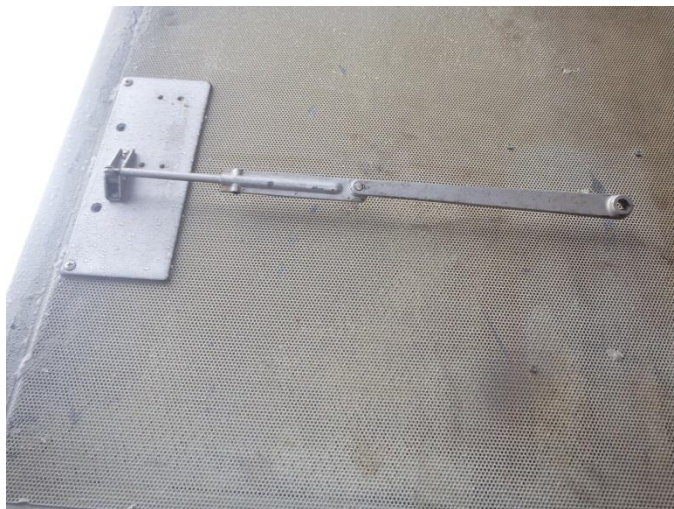
- I. Door closure mechanisms were broken on the East and West access doors (photo 32).

Photo 32 – Broken access door closing attachment.

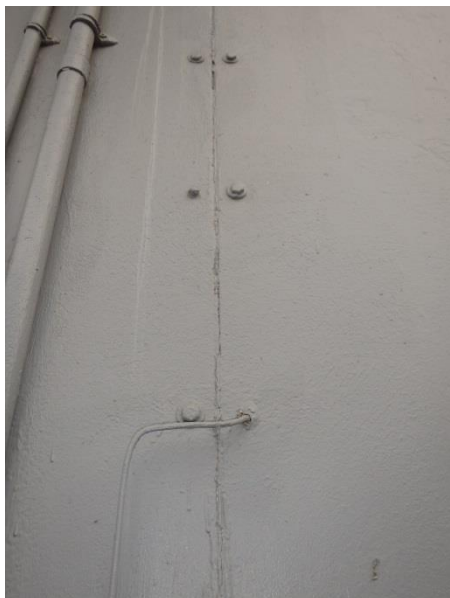
Photo 37 – Facturing noted on sealane throughout Inlet A structure.

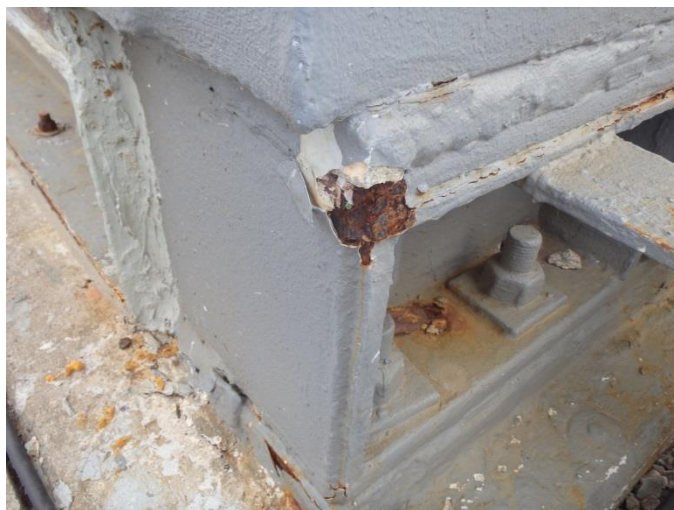
Photo 38 – Damage noted on structure at Northwest corner.

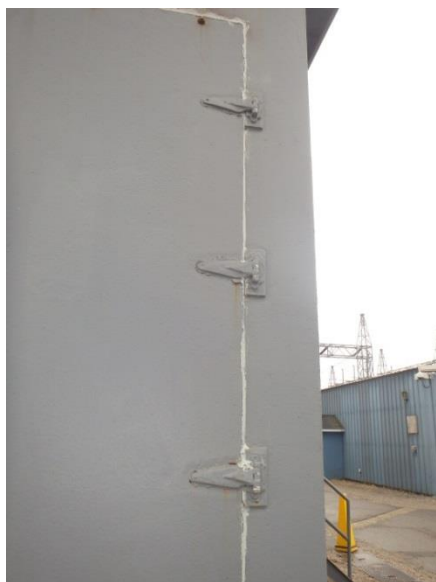
Photo 39 – Door hinges in poor condition.

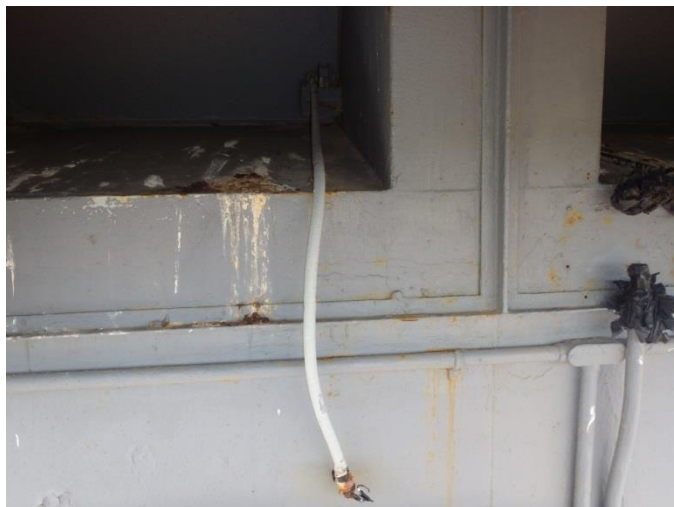
- I. Loose wire hanging from underneath the North side inlet hood. Upon inspection, wire was found attached inside the hood. While inspectors were on site, this item was rectified and wire folded over into the inside of the hood (photos 40 and 41).
- II. One supporting brace member found to be in poor condition on the West side of the inlet. Weld found to be broken, causing a potential dropped object. This item was

Photo 40 – Loose cable found to be hanging from inlet hood.

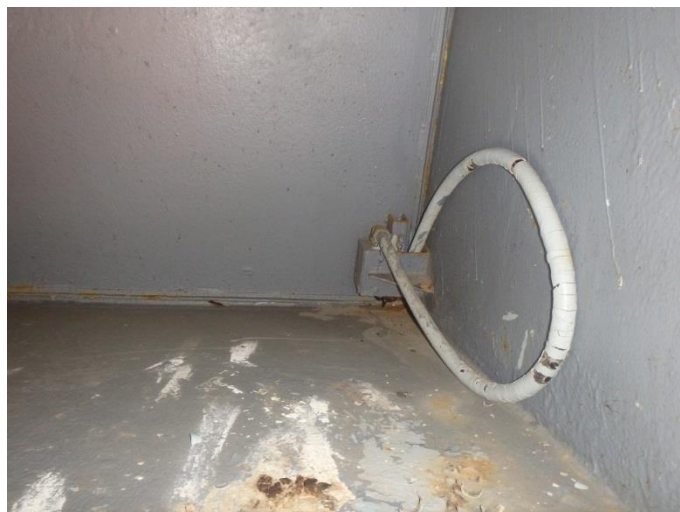
Photo 41 – Cable tied back into place during inspections.

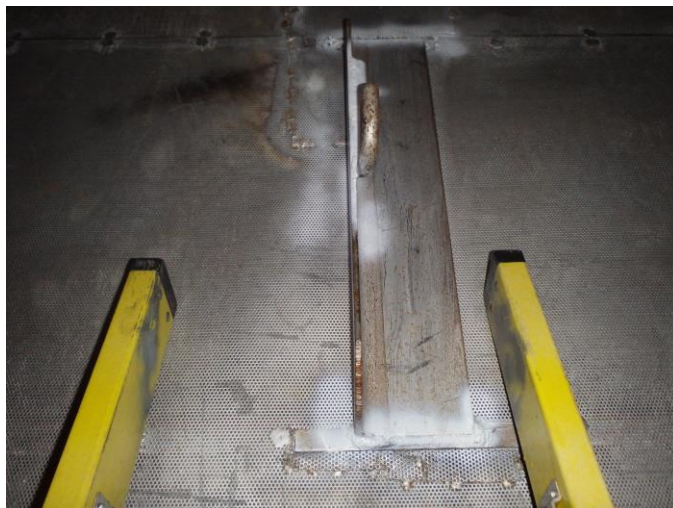
Photo 2 – White contrast paint applied for MPI inspections.

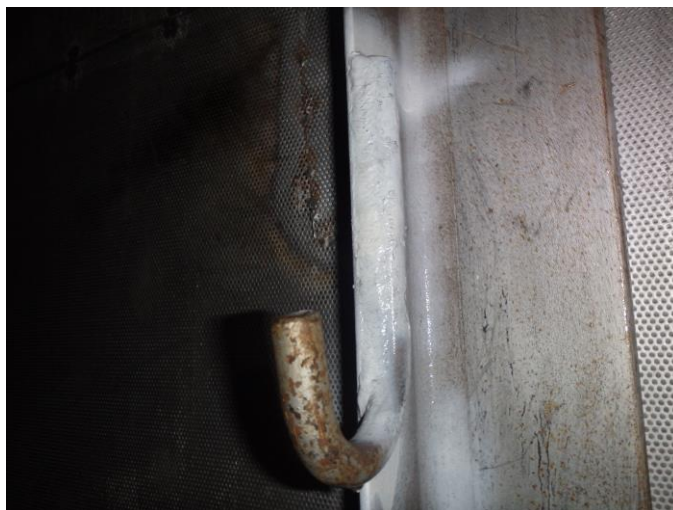
Photo 4 –No indications noted on center weld.

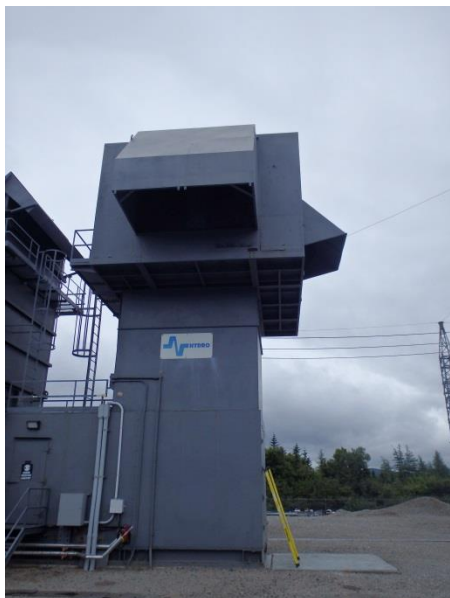
Photo 1 – General overview of Inlet B looking East.

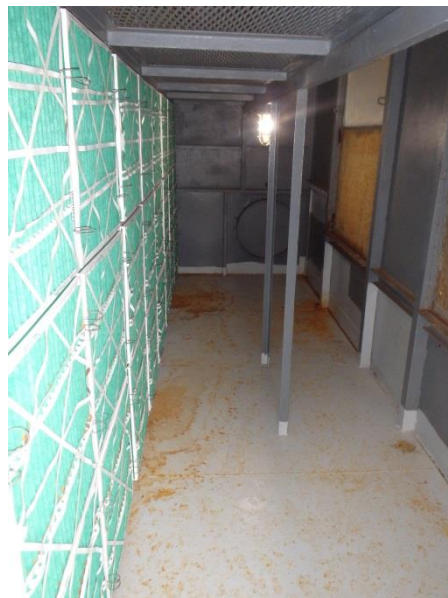
Photo 2 – General overview of West air filter room.

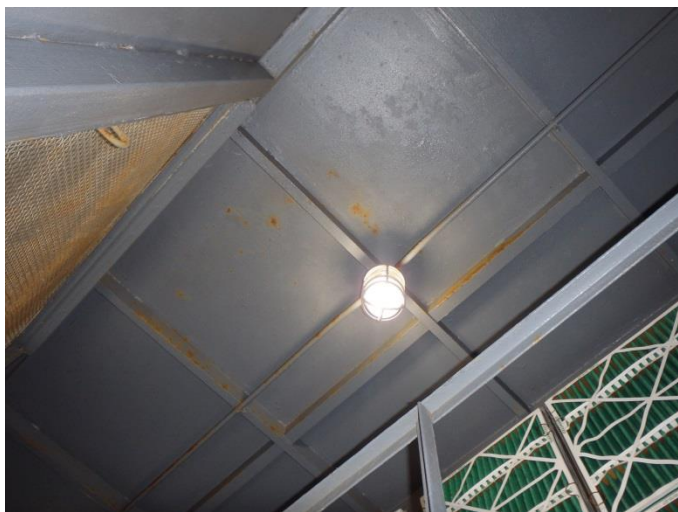
Photo 5 – Isolated coating breakdown on ceiling steel plating.

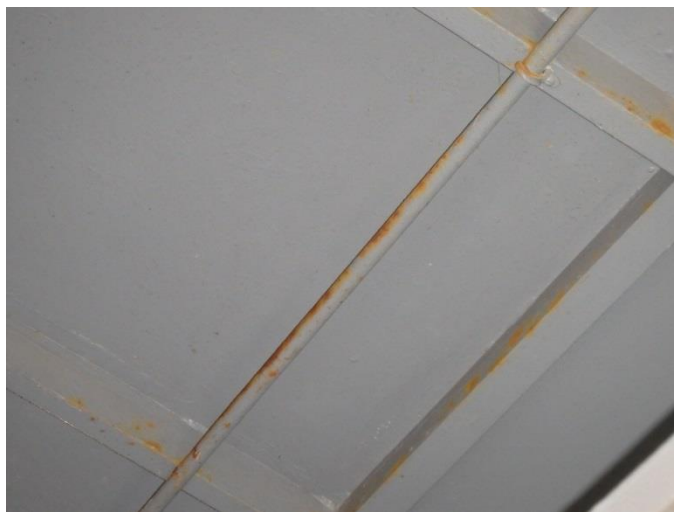
Photo 6 – Isolated coating breakdown on electrical wire casing.

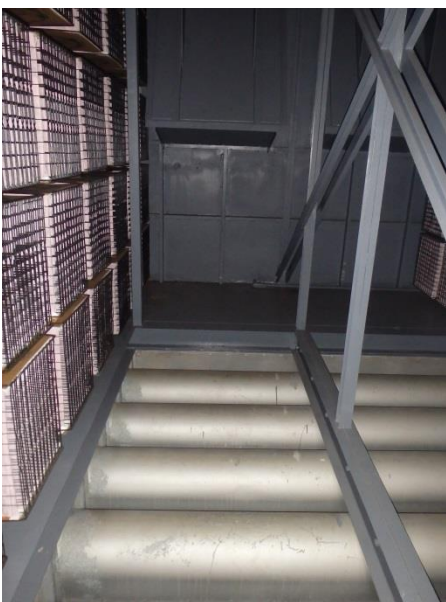
From inspections it was noted that on supporting vertical members of structural steel, tack welds were broken on the top sections of the verticals. Photos 7 and 8 show the difference between the bottom and top sections of the vertical supporting steel members.

Photo 7 – General overview of emergency air filter room.

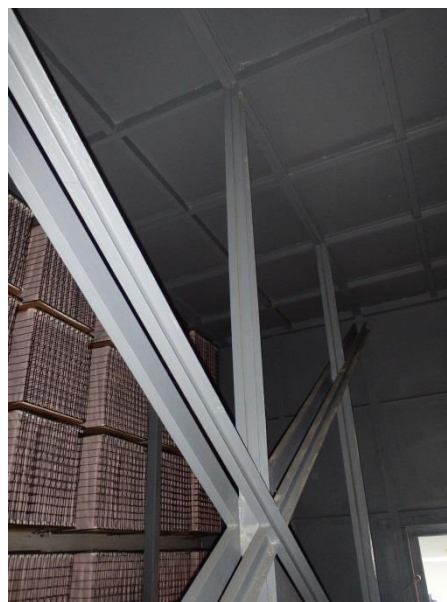
Photo 8 – General overview of steel work inside of emergency air filter room in good condition.

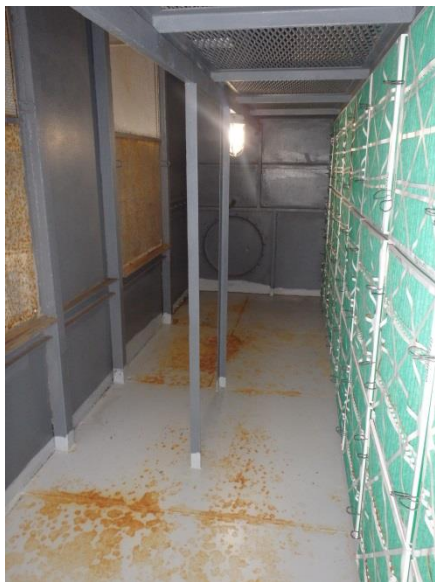
Equipment inside of Inlet air filter room West, is in overall good condition. The filters were found to be in very good condition as all were replaced in the summer of 2014 (photo 14). Cyclomatic Filtration unit has been removed (photo 11).

Photo 11 – General overview of East side air filter room, looking South from access door.
