10    A.    Please see Hydro's response to IC-NLH-006, Attachment 1 - Site Recommendations,  
11           IC-NLH-006 Attachment 2 – Air Intake Inspection Report, IC-NLH-006 Attachment 3 -  
12           Gas Turbine Capital Plan, and NP-NLH-13, Attachment 1 - Stantec Condition  
13           Assessment Study Report.

# Site Recommendations

**Customer: Newfoundland Labrador Hydro**

**Project Number: Alba 4927**

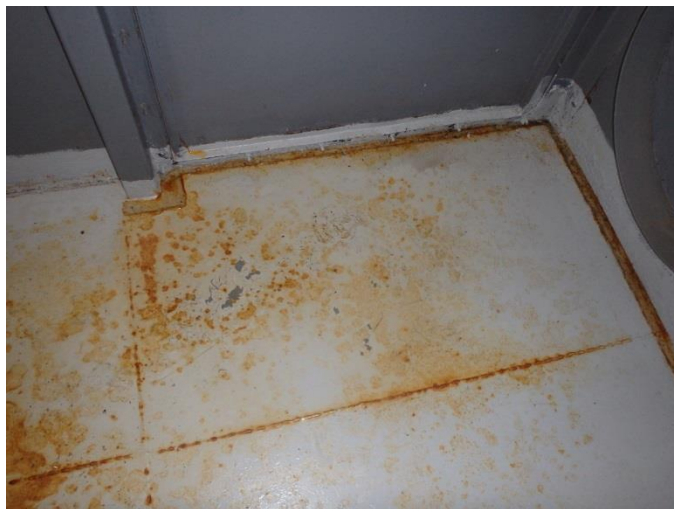
Steel deck plating is in good condition with majority of coating found to be intact. New deck coating was applied in the summer of 2014. Small areas of rust staining was noted (photos 12 and 13).

Photo 12 – Rust staining and isolated spots of coating breakdown noted on steel deck plating.

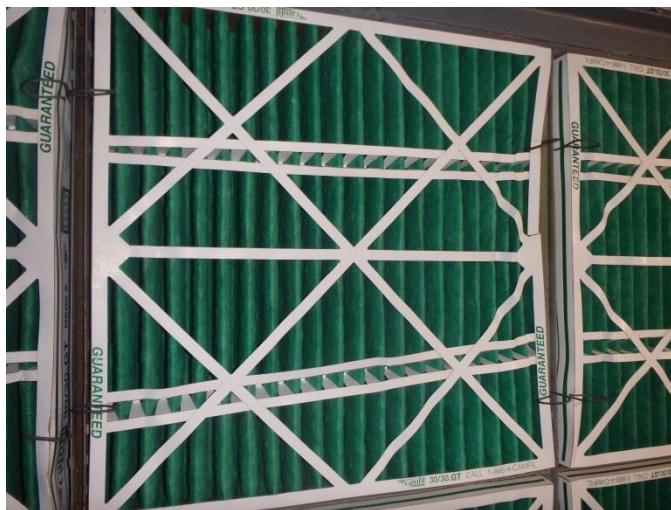
Equipment inside of Inlet air filter room West, is in overall good condition. The filters were found to be in very good condition as all were replaced in the summer of 2014 (photo 14). Cyclomatic Filtration unit has been removed (photo 11).

Photo 14 – Filters in good condition.

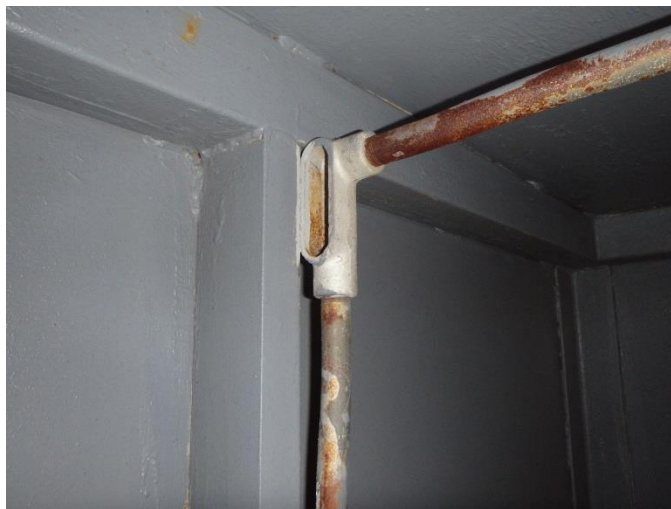
- I. Pin holes noted in welds and steel plate of hatch access door in Northwest corner (photo 13).
- II. Electrical cover plate missing from electrical wire casing (photo 16).
- III. 80% coating breakdown noted on all electrical wire casings throughout inspection (photo 15).

Photo 16 – Electrical casing box top missing allowing for direct contact to electrical wiring.

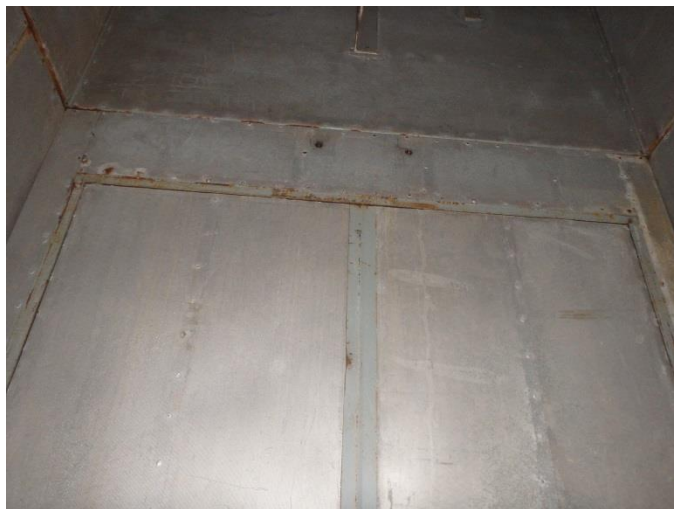
Photo 20 – Isolated coating breakdown/corrosion around main access doors on the South side.

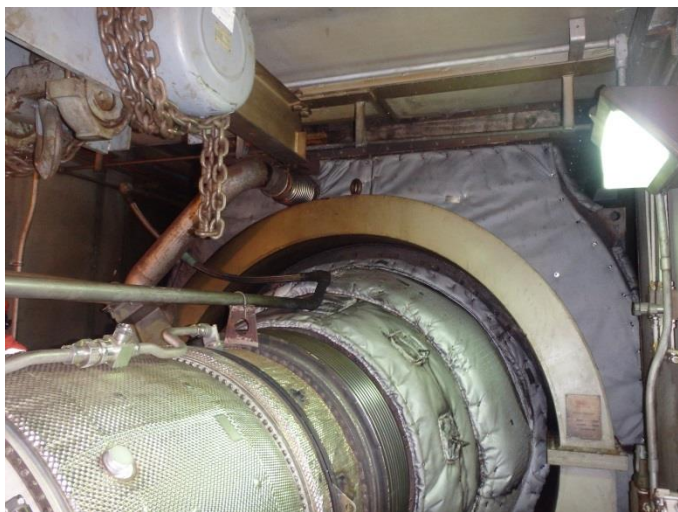
Photo 21 – General overview of Gas Turbine room.

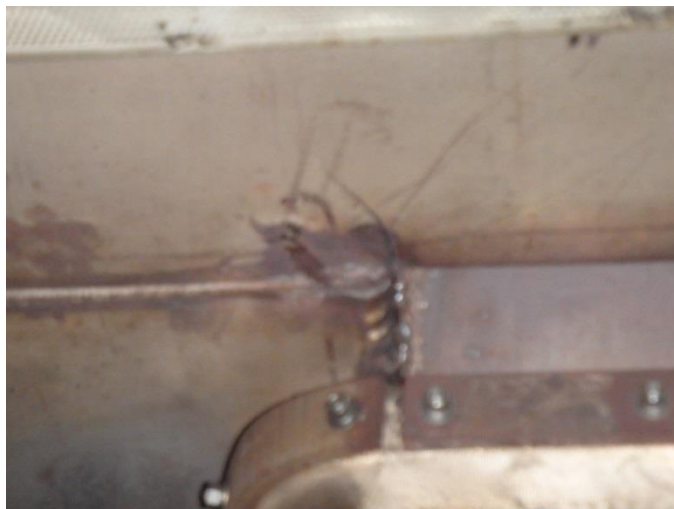
Two fractures were noted on the lower South side of Exhaust B which is located in the Gas Turbine room, these were noted on the East and West corners, noted in this report however will be mentioned again in the report for Exhaust B (photos 23 and 24).

Photo 24 – Fracture noted at bottom of exhaust B.

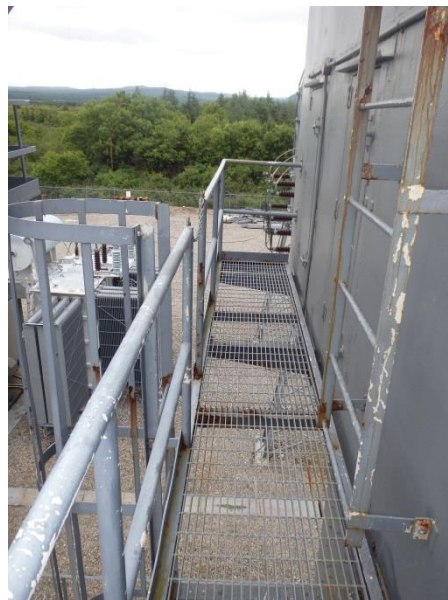
Photo 26 – General overview of top platform looking East.

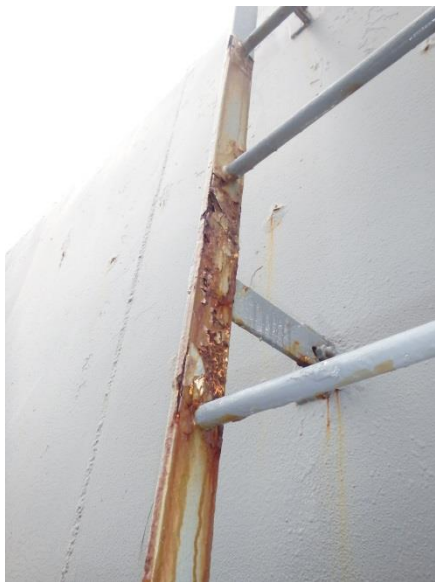
Small isolated areas of coating breakdown with moderate corrosion and scale up to 8mm noted on access ladders (photo 27). Low level of coating breakdown and scale noted on all decks. Rated using ASTM rust grade D610-08 as 4-S for all platforms located on Inlet B (photo 28).

Photo 27 – Coating breakdown and scale in isolated areas on access ladders.

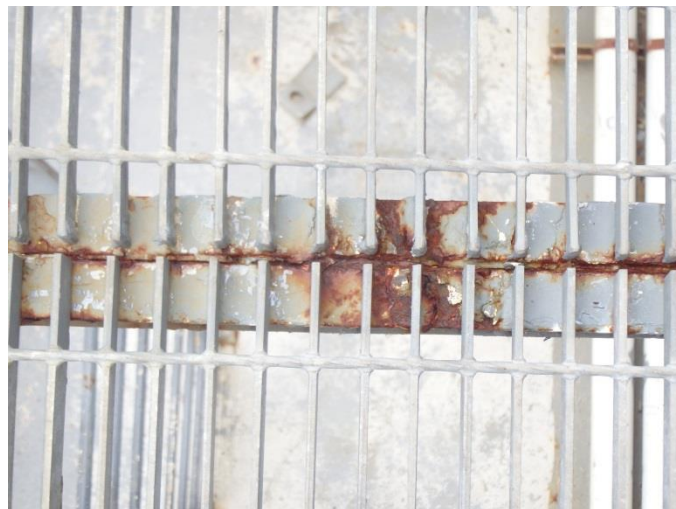
Photo 28 – Isolated coating breakdown on supporting members for platforms.

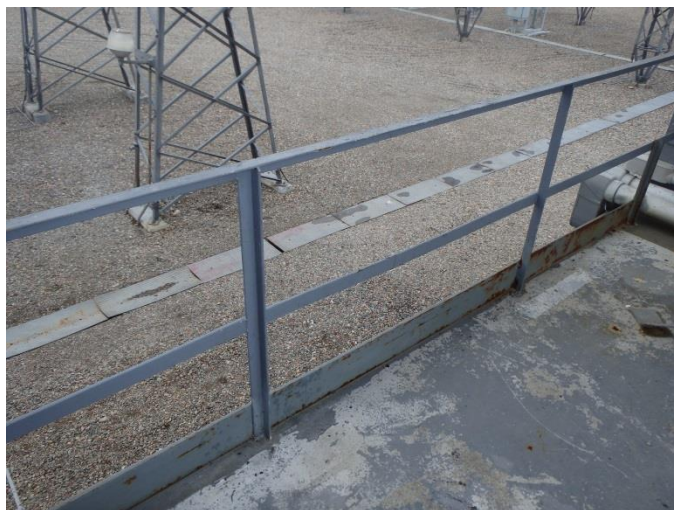
- I. Handrails on all decks were noted to be 36" in height (photo 30). Regulation height is 42".
- II. Lifting lugs located on the middle deck causing a tripping hazard (photo 29).

Photo 30 – Handrails at a height of 36".

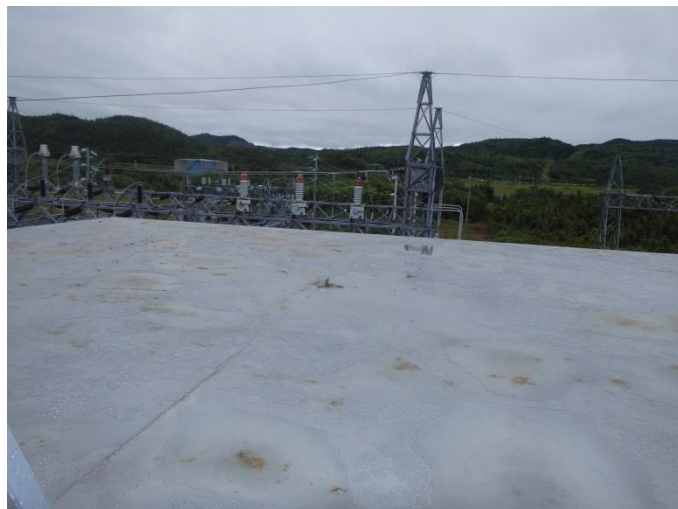
Photo 31 – Isolated coating breakdown and light scaling on inlet roof plating.

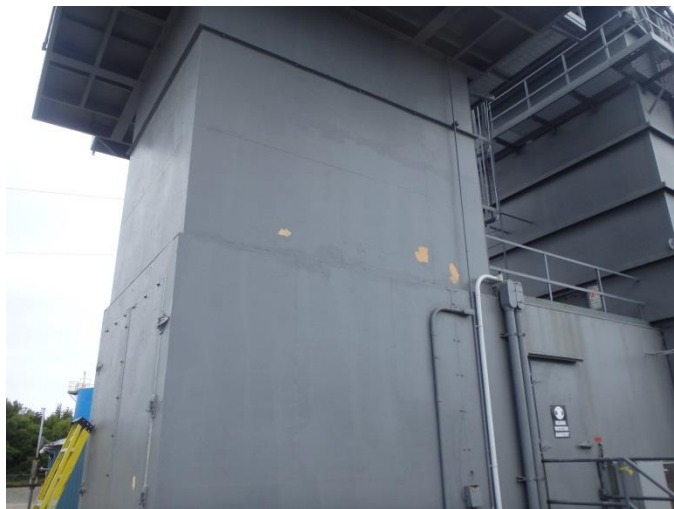
Photo 32 – Low levels of coating breakdown noted in isolated areas on East side of inlet.

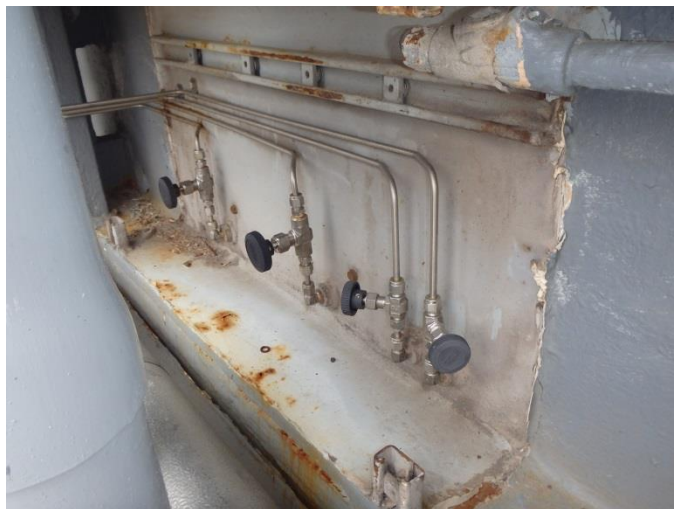
Photo 36 – Missing steel plating on West side.
