**NALCOR Holyrood GS**

**Outage Reports 2012**

# Turbine Generator Summary Report - 2012 Newfoundland & Labrador Hydro - Holyrood TGS

Reference # Nalcor-Holyrood –STG- ESO-000326/399-01

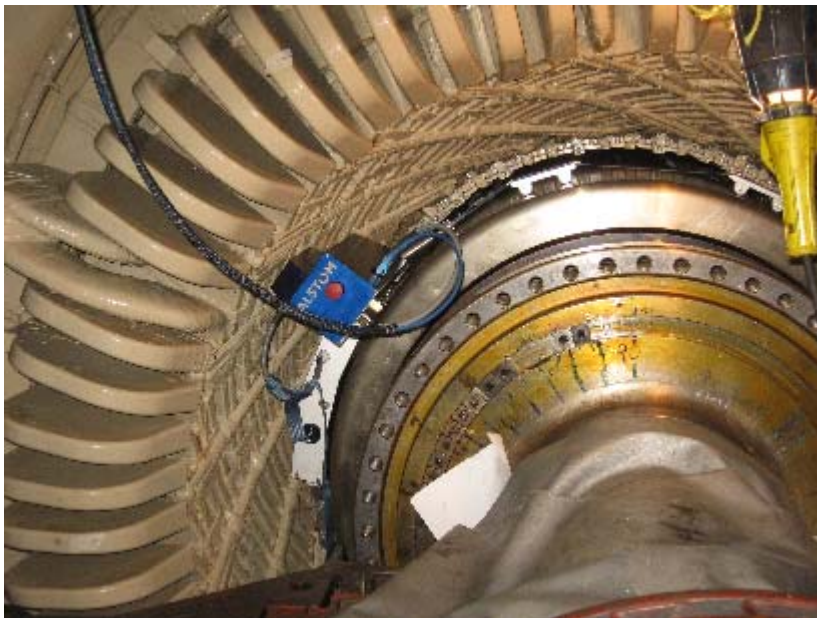
Figure 8.2 DIRIS Unit Installed in Air Gap

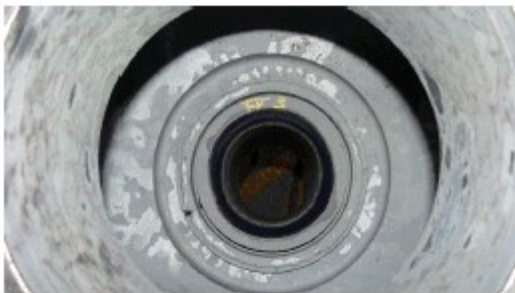
Blue Chk Seat #3

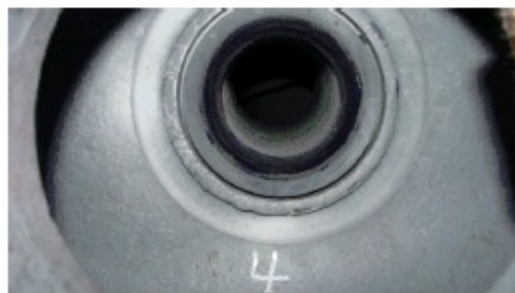
Blue Chk Seat #4

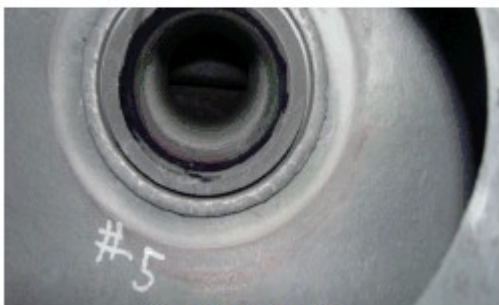
Blue Chk Seat #5

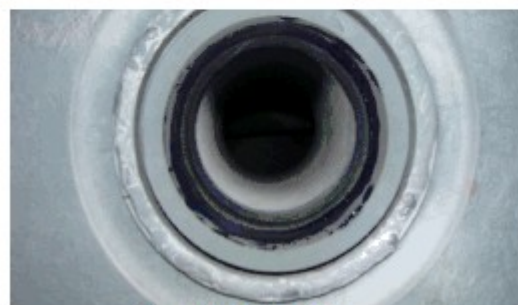
Blue Chk Seat #6

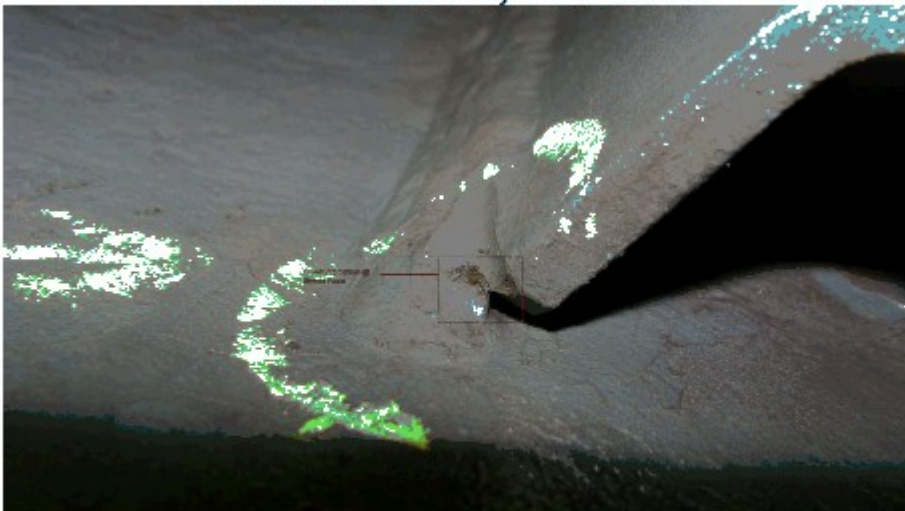
Anti-Swirl Vane Indication no Black Light

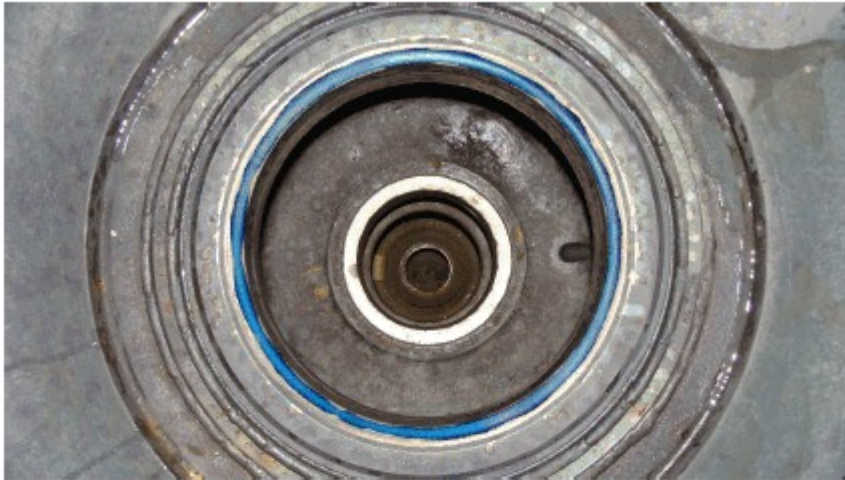
**MSV Seat Blue Chk.**

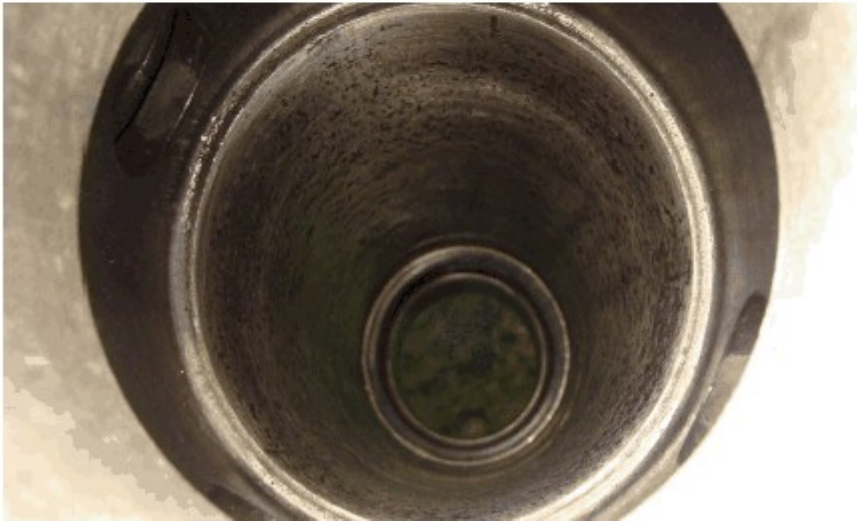
**Blue Chk. MSV Stem Seal**  
Visual shows good blue contact

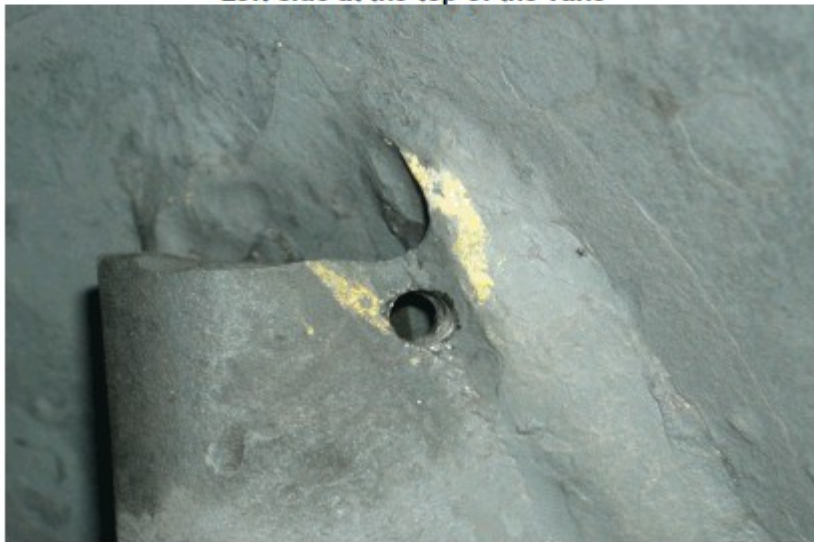
**Crack Indications MSV Anti Swirl Vane**

Right side at the top of the vane

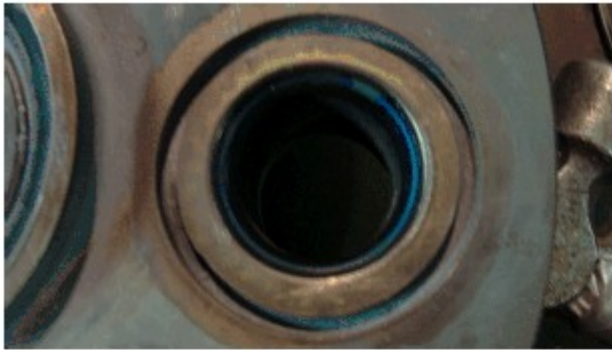
Lifting Plug #1 Blue Check

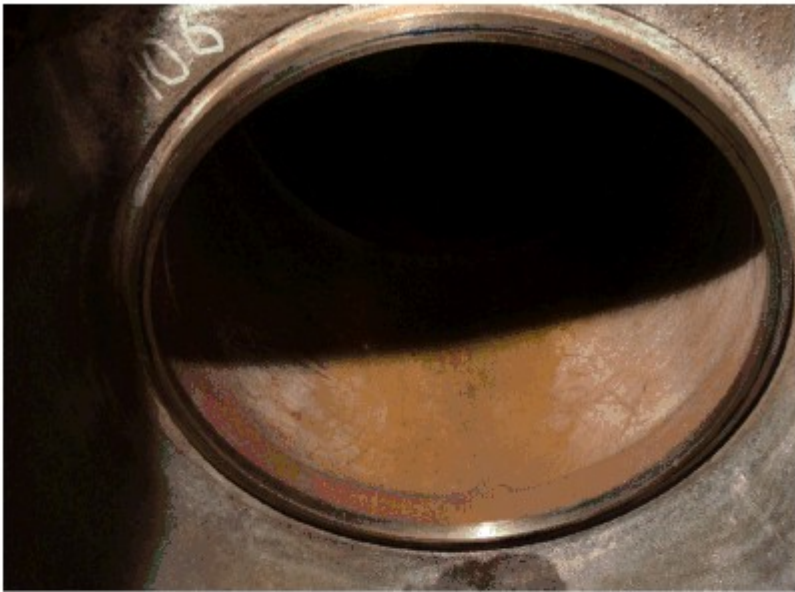
Blue Chk #V106

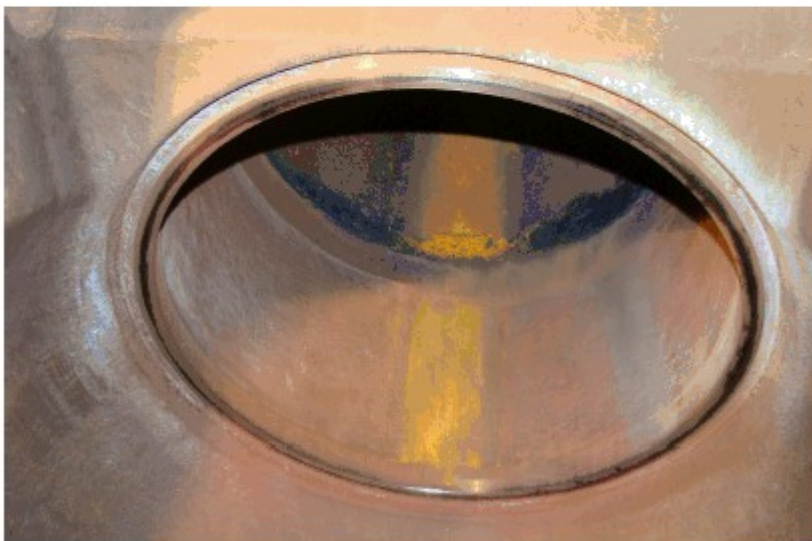
Blue Chk #V109

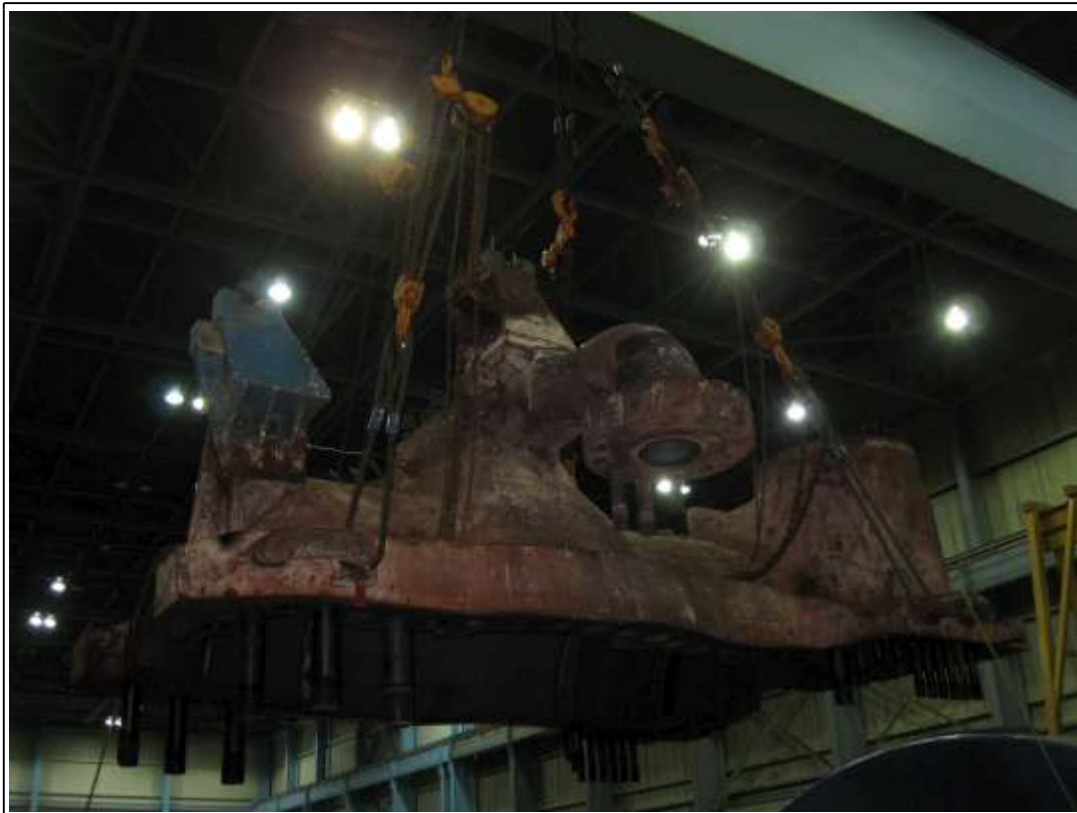
Unit / Component	HOLYROOD 1 / HP Outer Shell
Appendix No.	1
Description	Outer shell removal

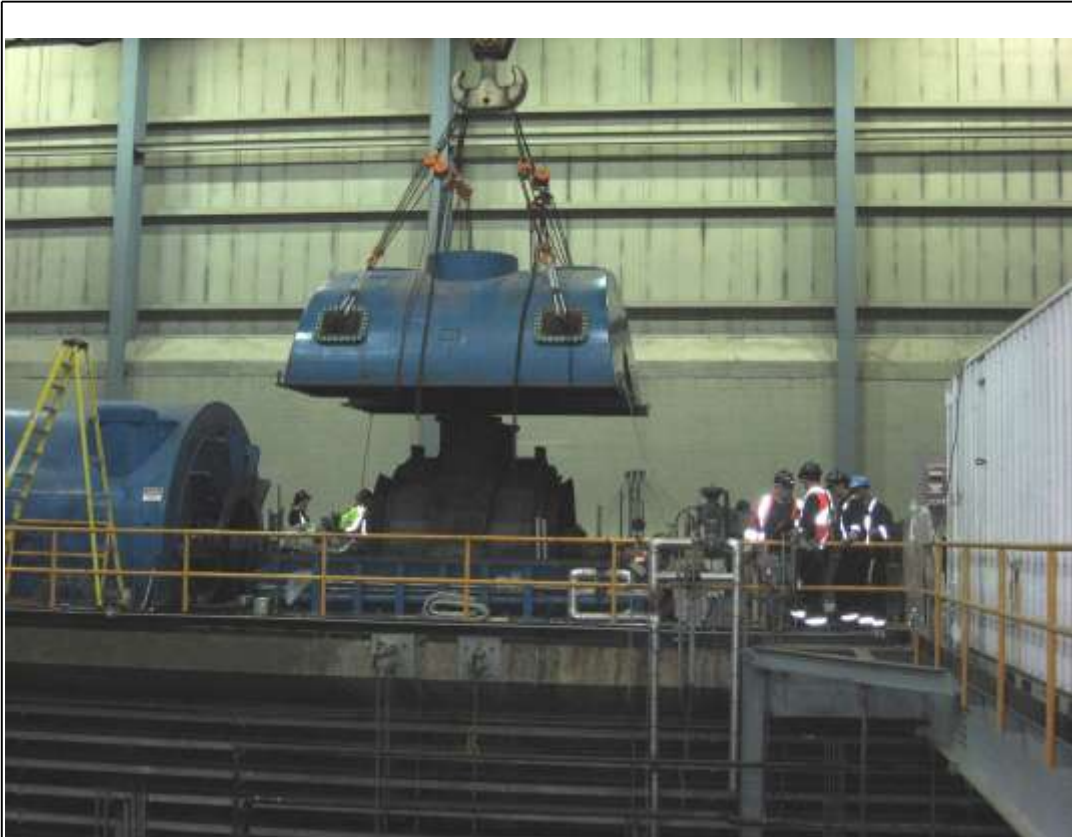
Unit / Component	HOLYROOD 1 / LP Hood
Appendix No.	2
Description	LP Hood removal

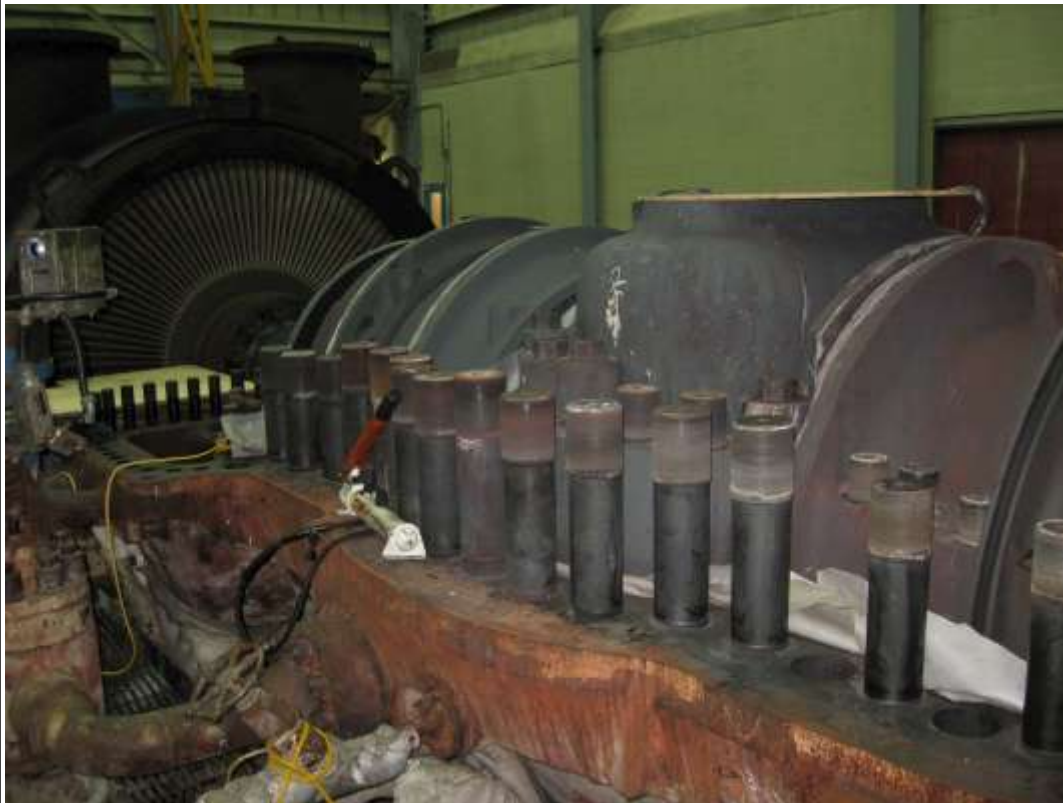
Unit / Component	HOLYROOD 1 / HP/IP Inner cylinder
Appendix No.	3
Description	HP/IP Inner cylinders prior to removal

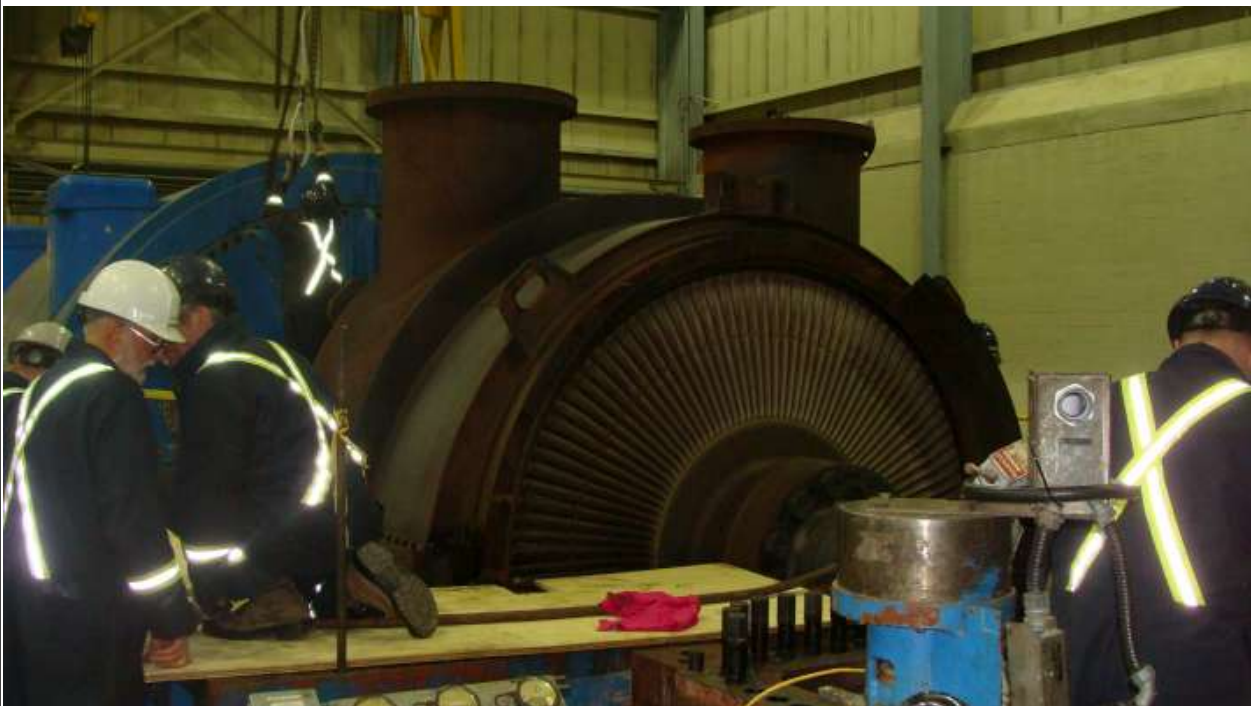
Unit / Component	HOLYROOD 1 / LP
Appendix No.	4
Description	LP Inner cylinder prior to removal

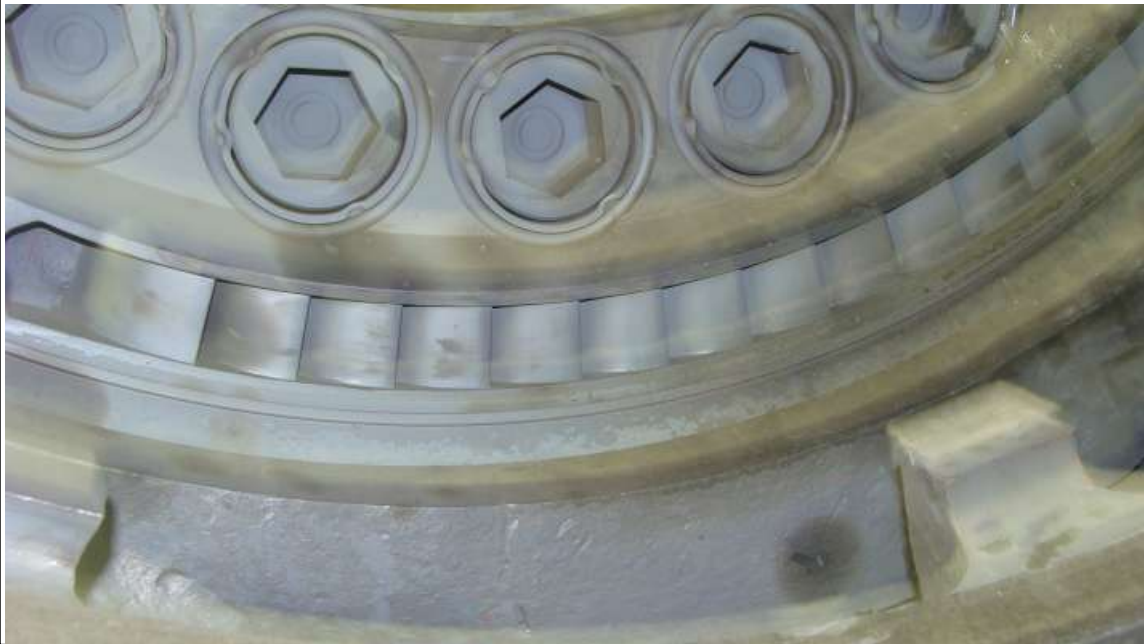
Unit / Component	HOLYROOD 1 / HP Lower Nozzle
Appendix No.	5
Description	Lower Nozzle

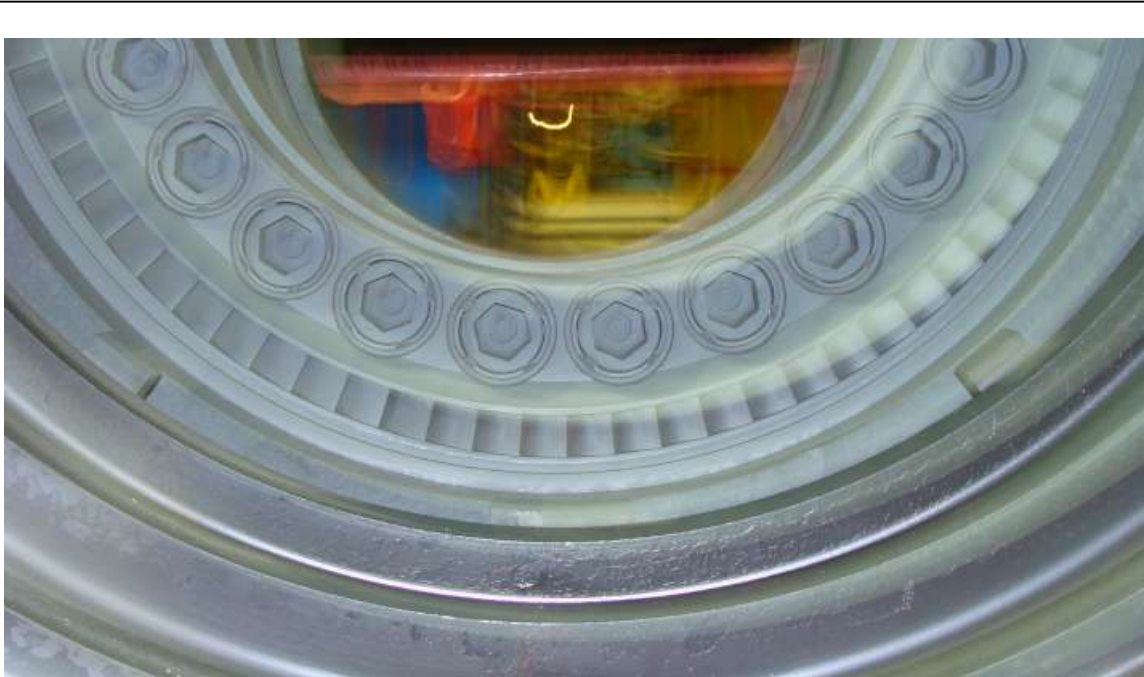
Unit / Component	HOLYROOD 1 / HP Upper Nozzle Plate
Appendix No.	7
Description	Upper Nozzle Plate

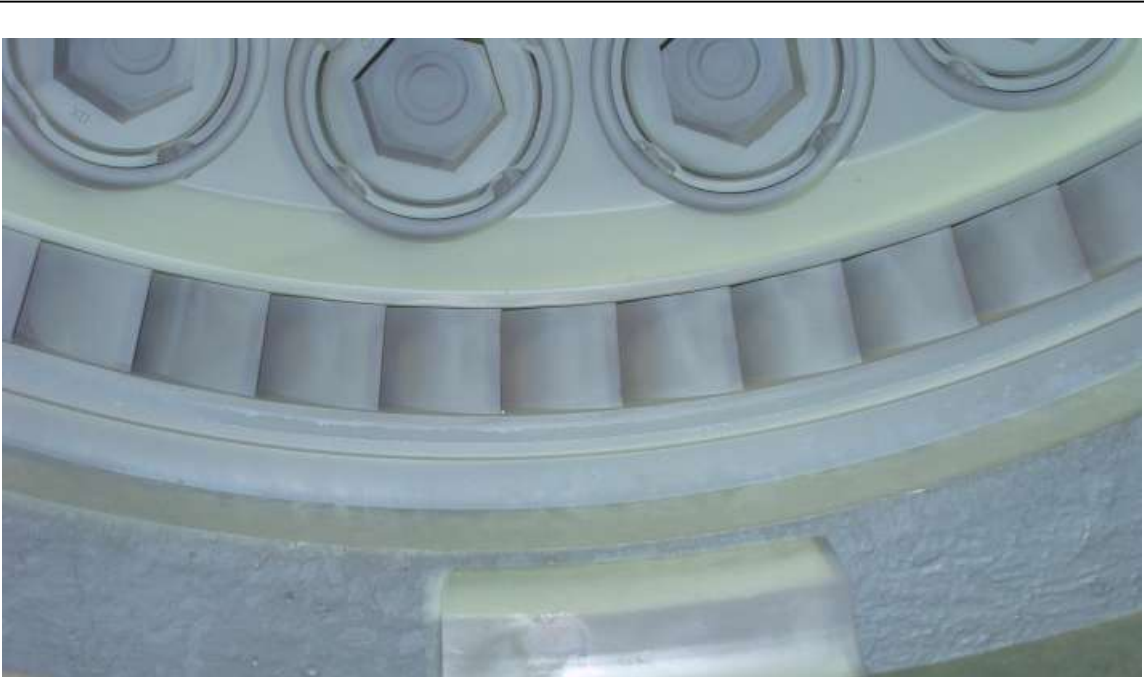
Unit / Component	HOLYROOD 1 / Upper Nozzle Plate
Appendix No.	8
Description	Upper Nozzle Plate

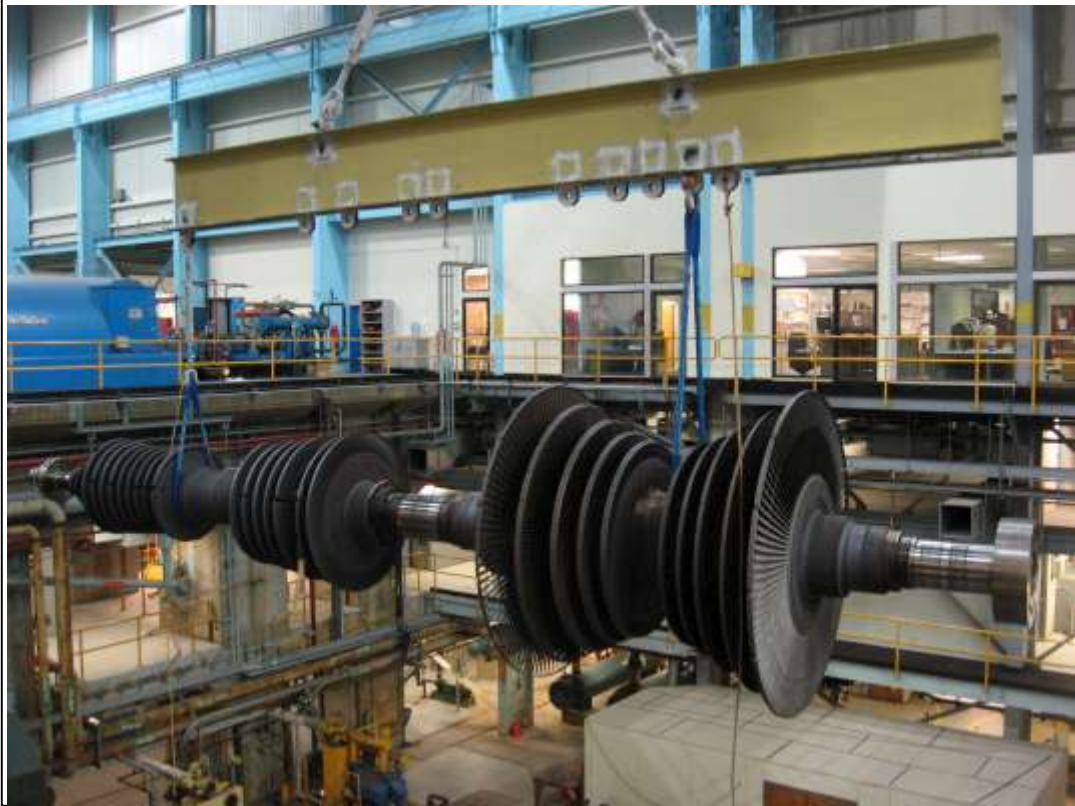
Unit / Component	HOLYROOD 2 / HP/IP/LP rotor
Appendix No.	9
Description	Rotor removal

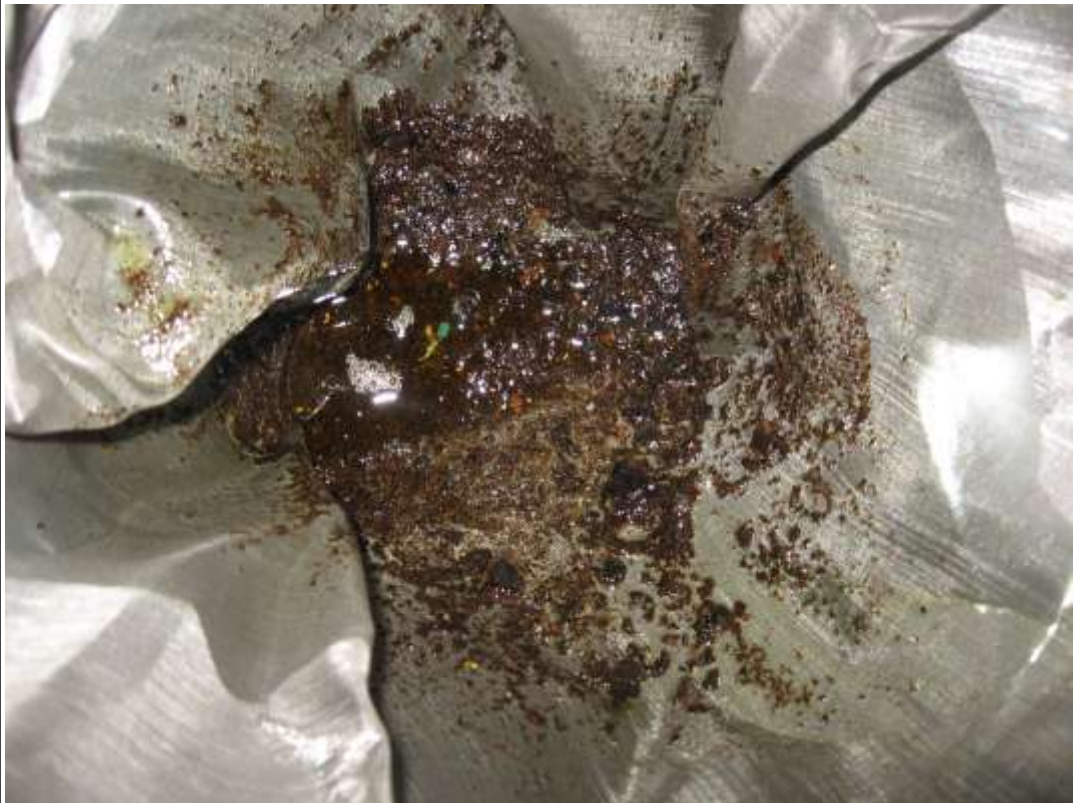
Unit / Component	HOLYROOD 1 / H2 Detraining Tank
Appendix No.	10
Description	Debris from H2 detraining tank during oil flush

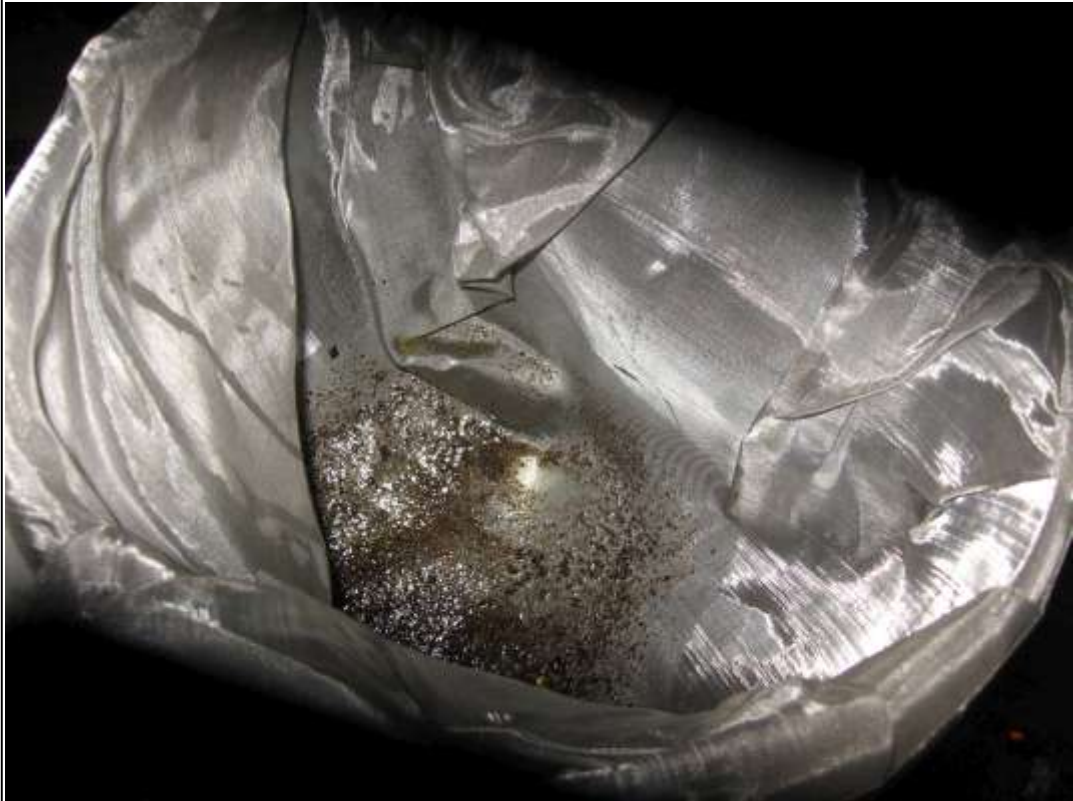
Unit / Component	HOLYROOD 1 / T4/T5 Bearing Drain enlargement
Appendix No.	11
Description	Debris from Bearing Drain enlargement during oil flush

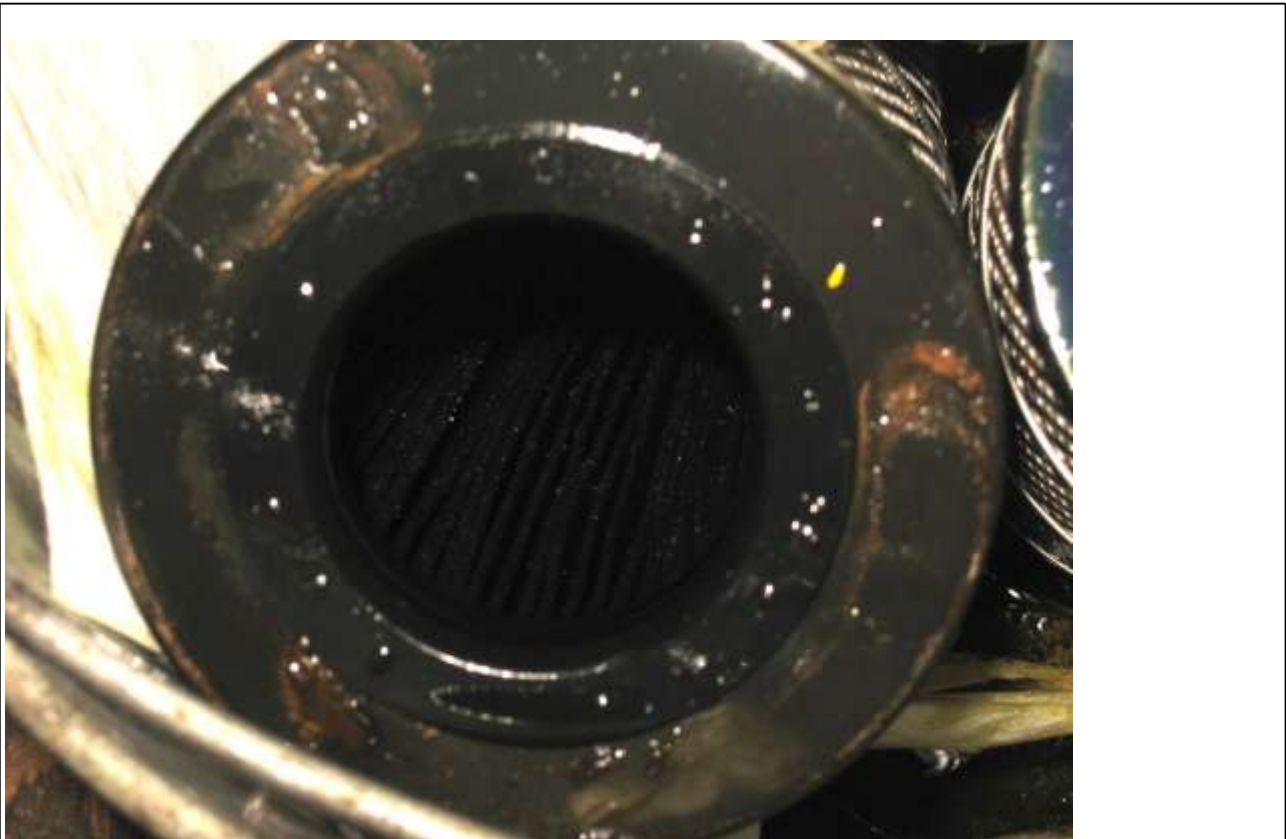
Unit / Component	HOLYROOD 1 / Cuno filters
Appendix No.	12
Description	Cuno filter that was in service

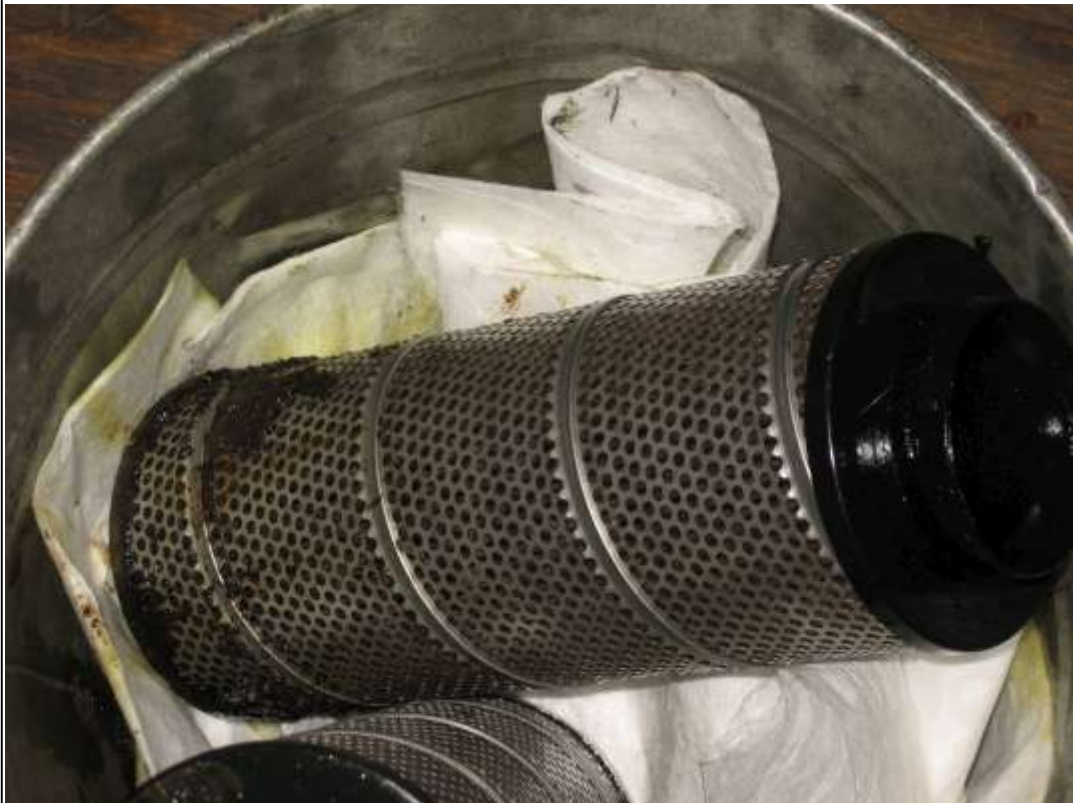
Unit / Component	HOLYROOD 1 / Cuno Filters
Appendix No.	13
Description	Cuno Filters that were in service

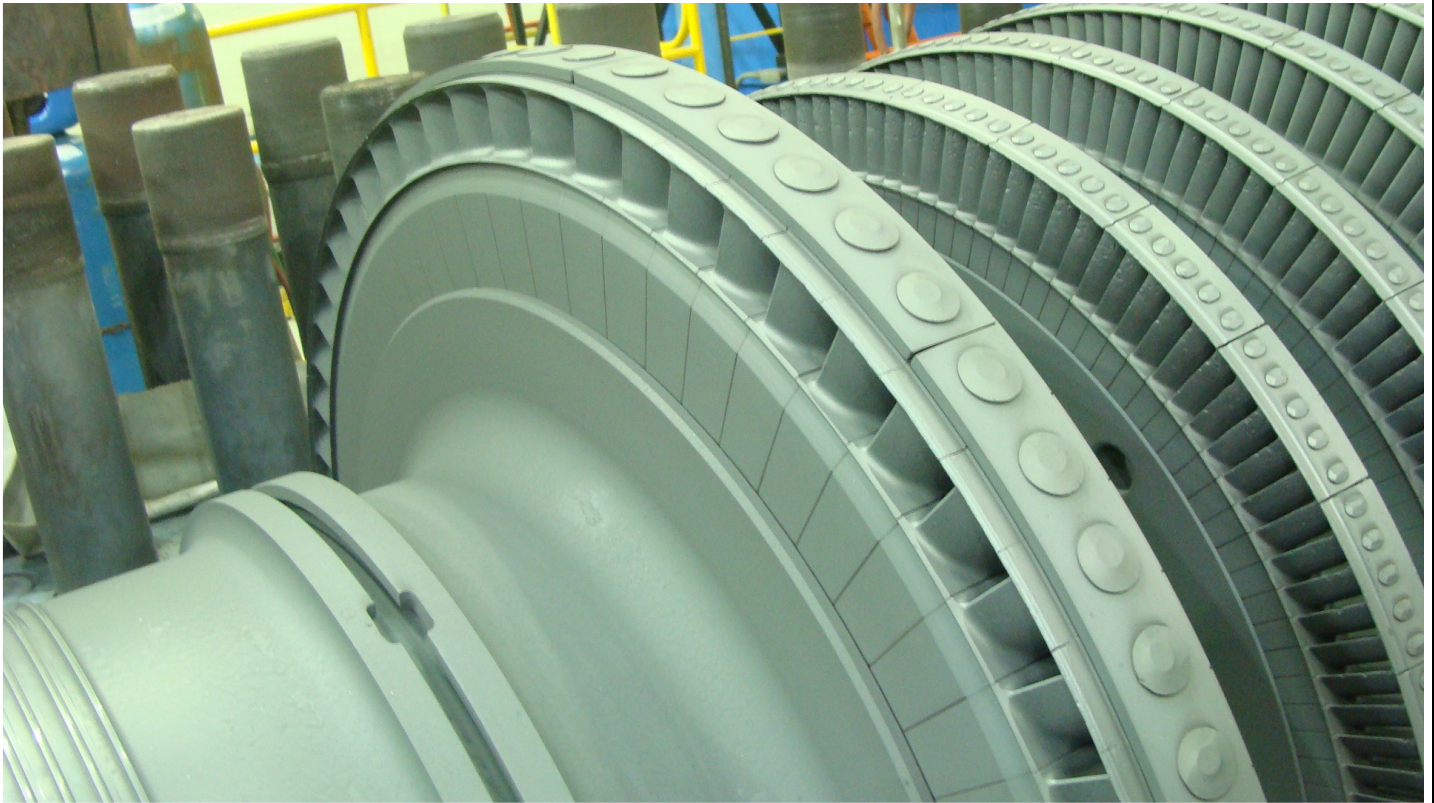
Evidence of minor Foreign Object Damage (FOD) to the first 3 stages of the HP section (rows 1,2,3). In reviewing the previous reports, FOD was found and repaired at previous inspections). This appears “not” to be new FOD.

Blast Clean and NDE areas. Blend and Polish as required to remove any indications or high spots, that may be found.

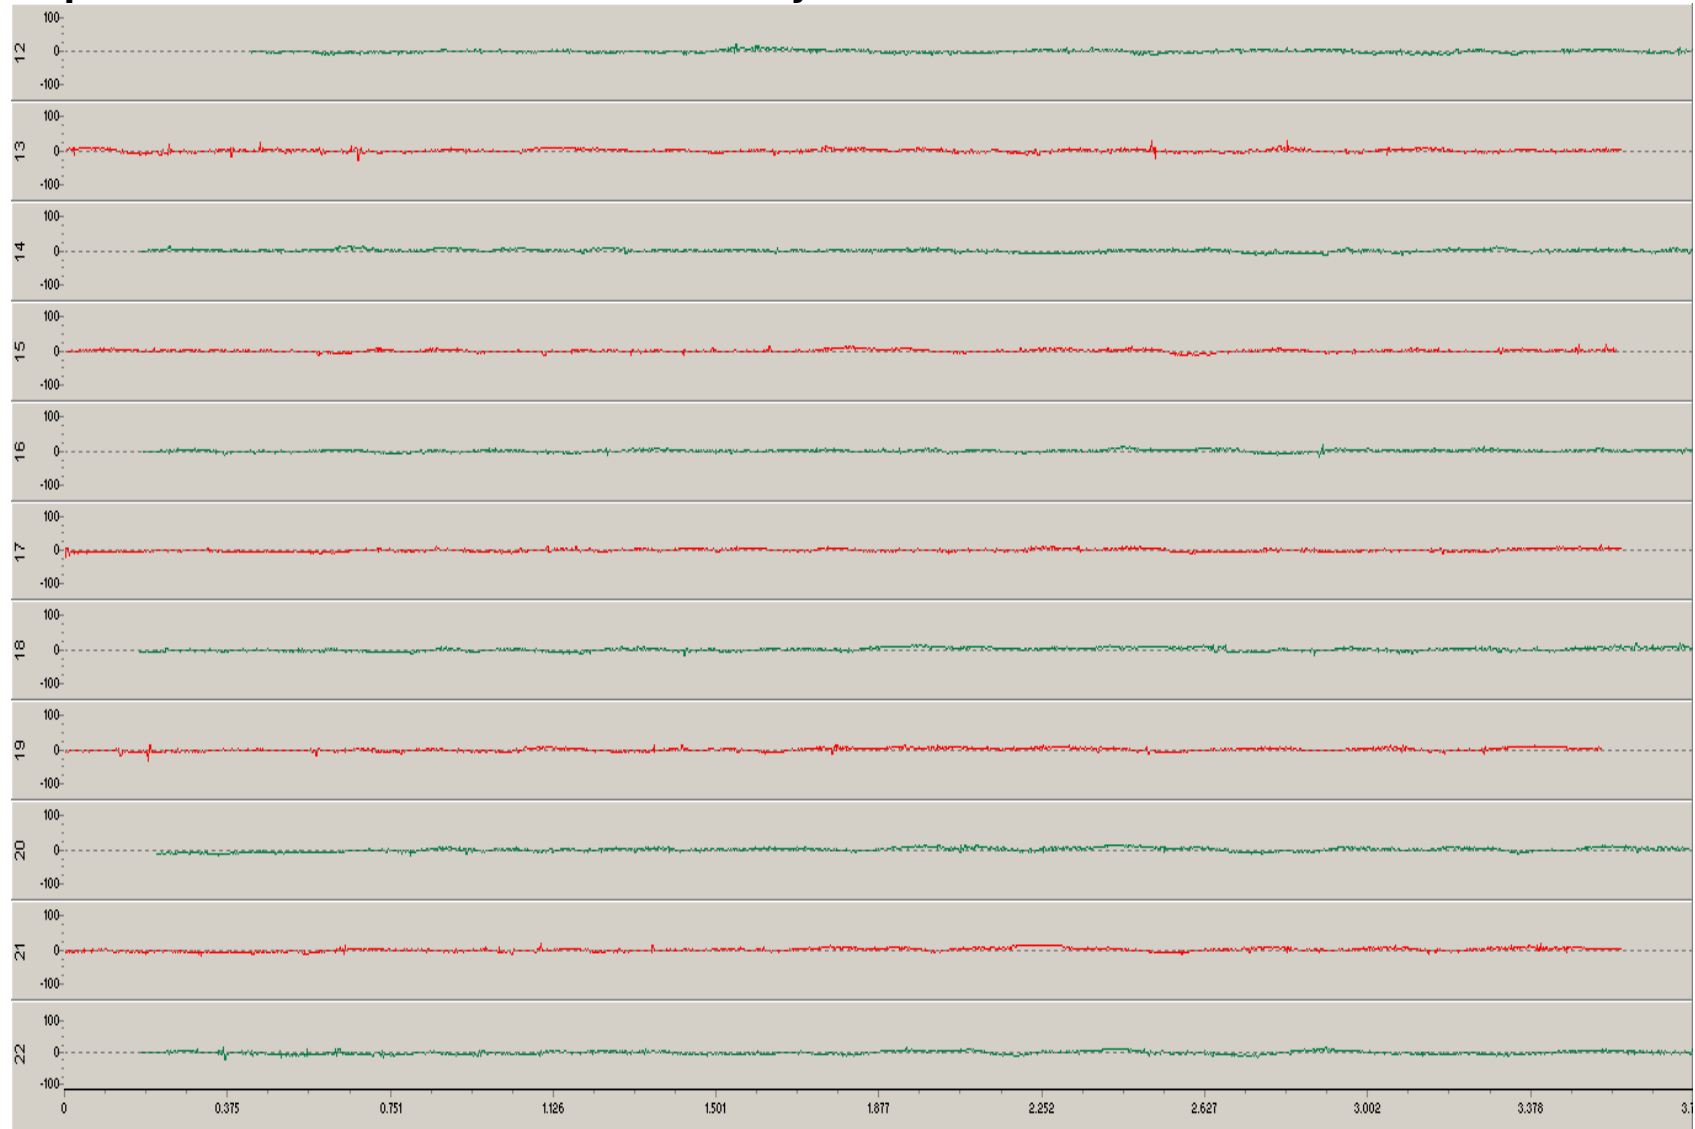
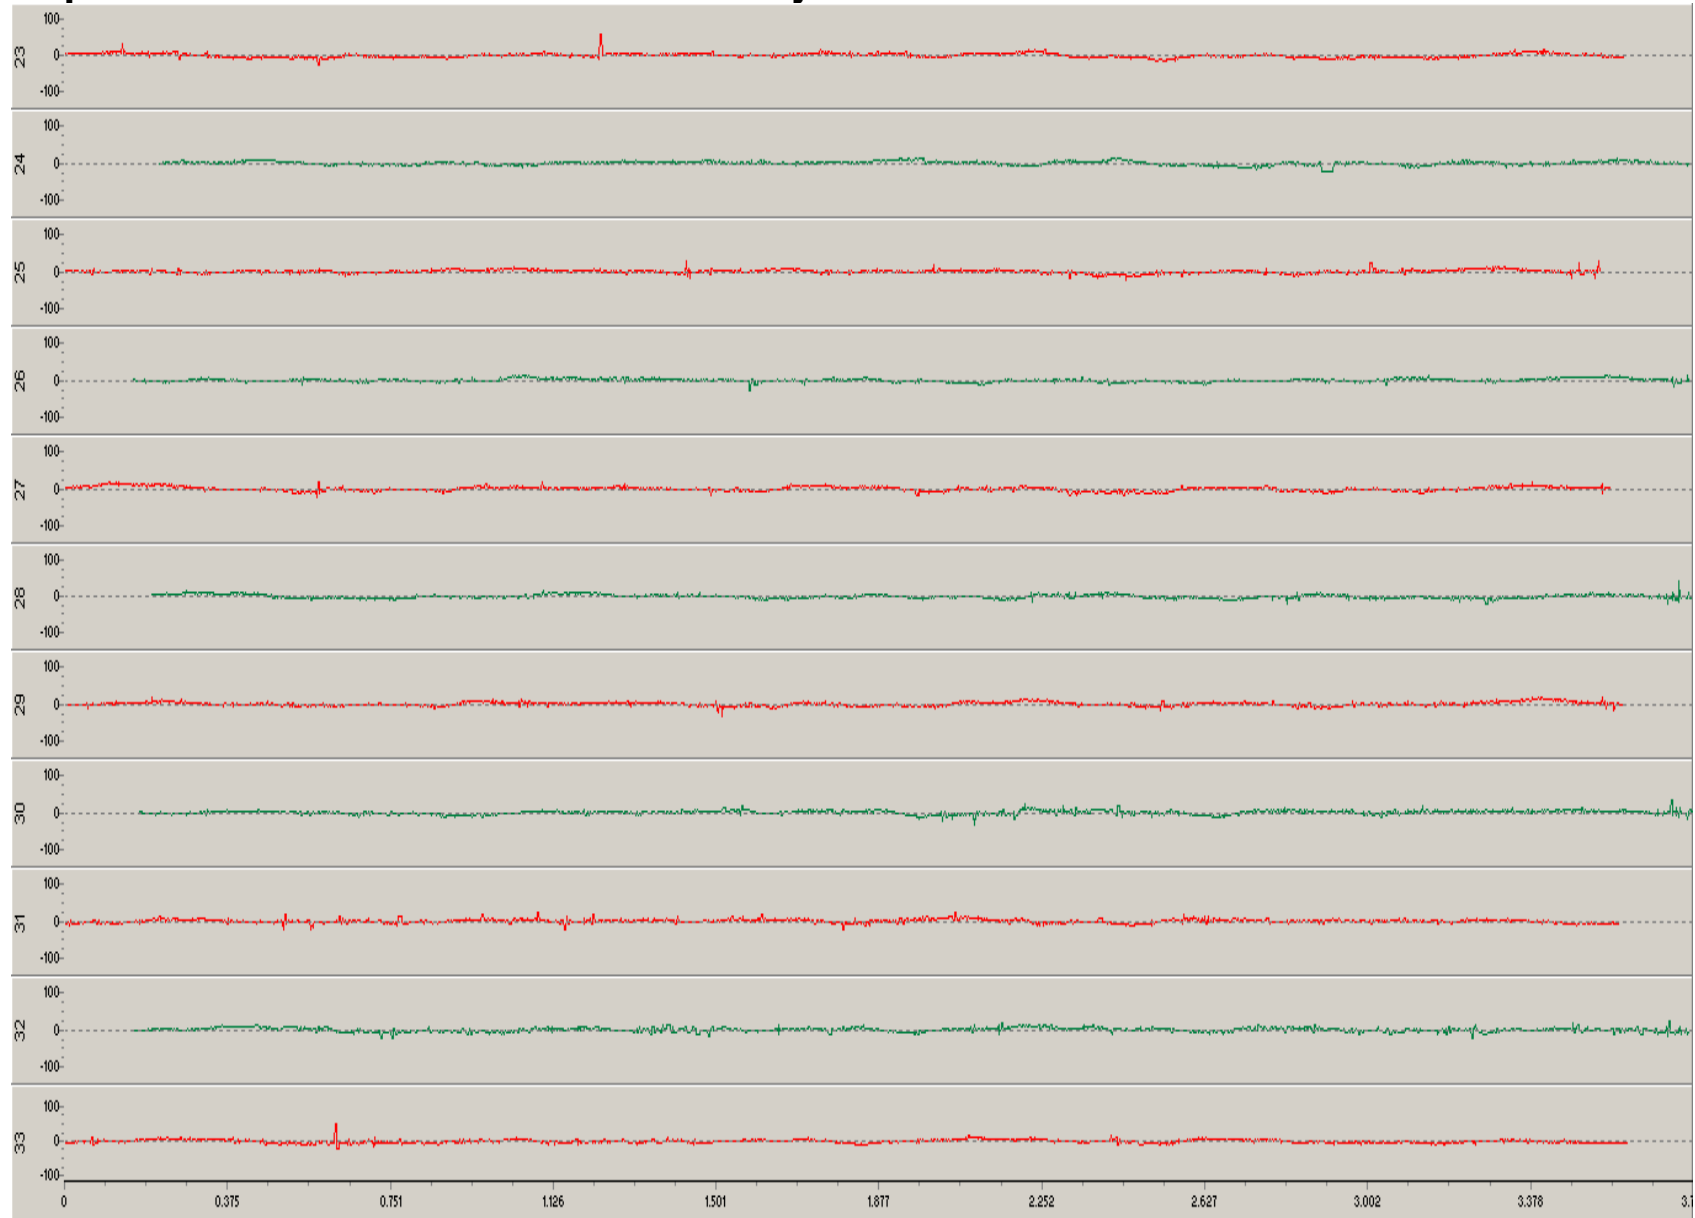
The EL CID low flux test of the core, as well of the step iron area on the NDE and DE, showed no abnormality. The enclosed graphic representation of the stator low flux test was carefully analyzed and the results reported in enclosure C. ALSTOM will retain the recorded data, enabling a trend analysis to be conducted in addition to an assessment of the current condition.

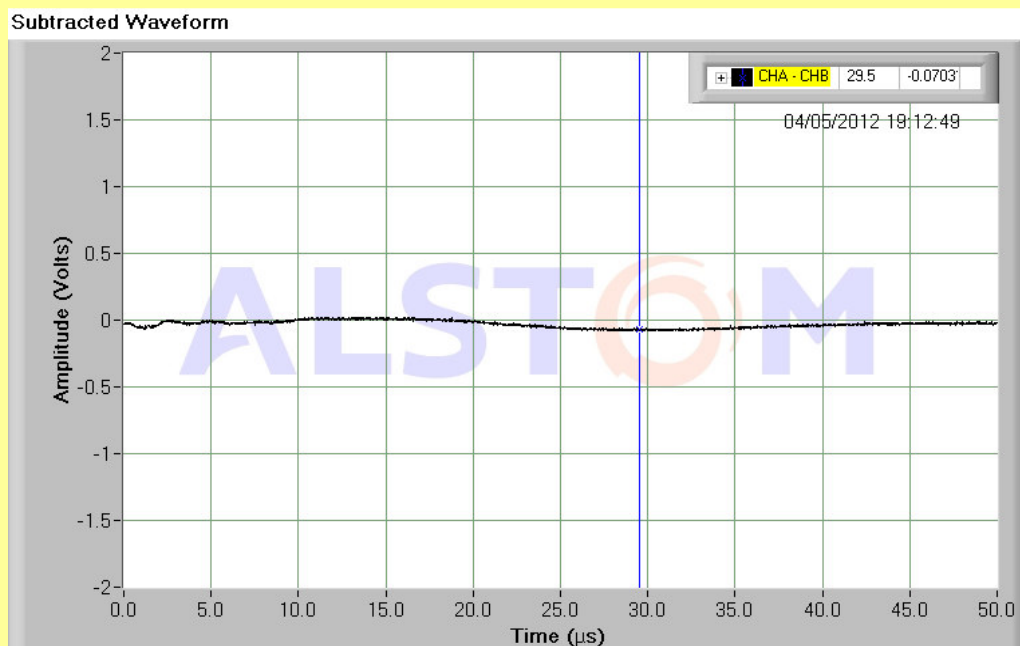
Picture 2

RSO results, Channel 1 and Channel 2, traces subtracted, time base 5 $\mu$ s.

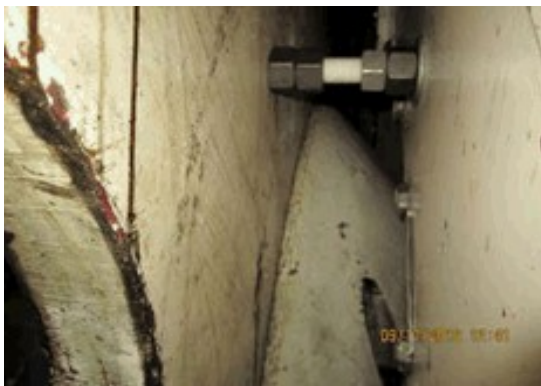
The generator man hole doors were opened and the inner end shield bolts were removed from both ends. The bearing covers, keeps and top half bearings were removed. It was noted on the NDE that there were no vertical dowels in place. The top half H2 seals were removed and the inner oil deflector clearances were taken. The NDE upper inner baffle stand off fiber bolts were broken on disassembly. Site had 3 new ones.

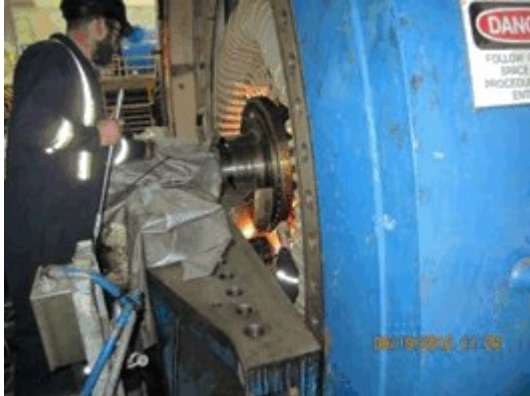
The centre gas baffle was removed on the TE  
The GE end lower inner end shield had to be rotated out to accommodate the gas baffle removal.

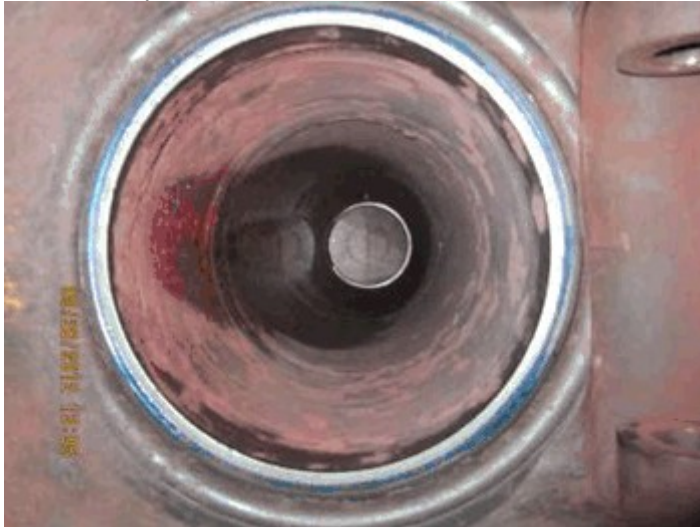
NRV101 Sept 20th

lapped using the new swing arms and lubricated discs with stick back emery. It was driven by a 1/2" air ratchet. The disc to arm clearance was .100"-.120" to allow full seat contact between seat and disc. Photos were taken for disc to seat blue contact. Some of these valves had older weld repairs that may have caused distortion. On the next planned outage a valve contractor should be brought in with a seat lapping tool. The cylinders were not overhauled at this time. All the seats had good contact. The Blue contacts for the valves may have required more than one shot due to the flash reflection.

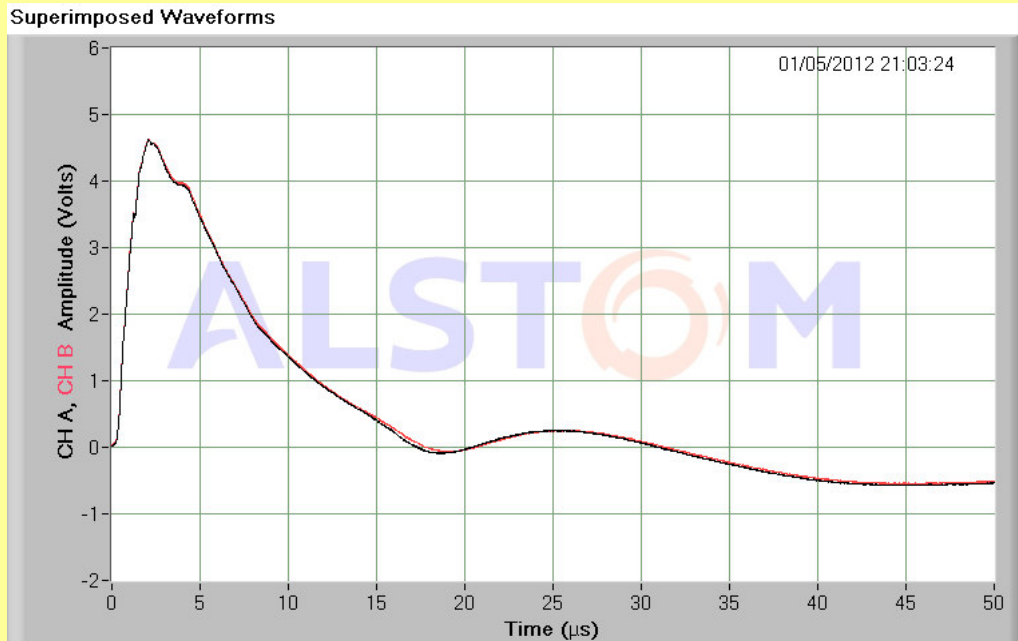
Picture 1

The RSO test performed at speed and during shutdown showed very minor indications of inter-turn shorts in the rotor windings which were within the Alstom acceptance criteria for this test. Another finding was the presence of electro-erosion on the shaft surface which is an indication of poor shaft grounding and a recommendation was made to replace the shaft grounding device with a direct contact braided grounding strap.

RSO results, Channel 1 and Channel 2, traces superimposed, time base 5 $\mu$ s.
