**NALCOR Holyrood GS**

**Outage Reports 2012**

# Turbine Generator Summary Report - 2012 Newfoundland & Labrador Hydro - Holyrood TGS

Reference # Nalcor-Holyrood –STG- ESO-000326/399-01

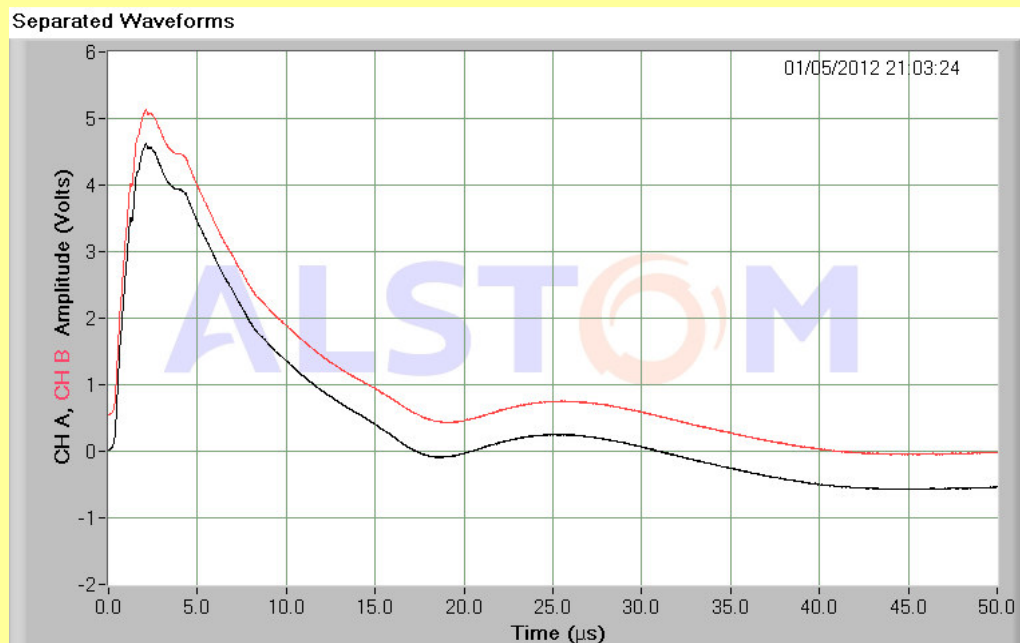
Picture 3

RSO results, Channel 1 and Channel 2, traces separated, time base 5 $\mu$ s.
