Re: Application for Approval of Various Supplemental Capital Projects at the Holyrood Thermal Generation Station

Application for Approval of Various Supplemental Capital Projects at the Holyrood Thermal Generating Station

Schedule 1
Refurbishment of Day Tank
Holyrood Thermal Generating Station

**OUT OF-SERVICE INSPECTION
OF
Bunker C # 6 fuel Oil Tank**

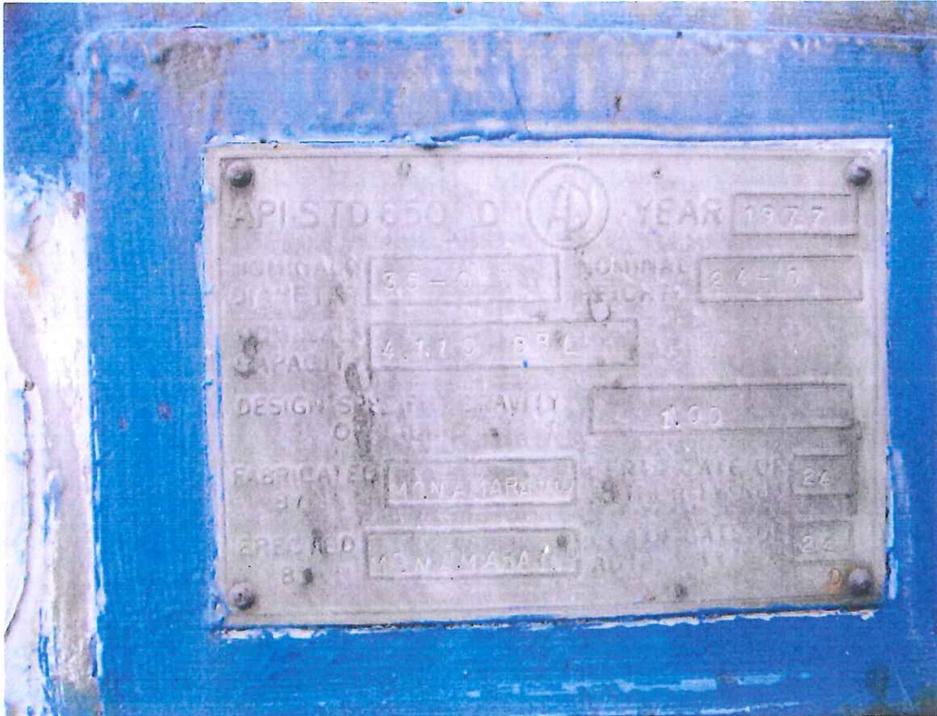
Name Plate.

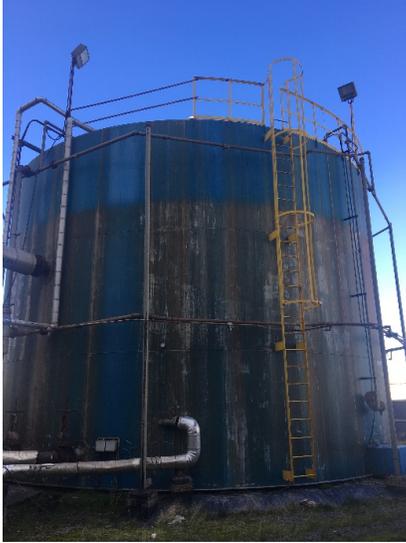
Figure 1: View of tank and roof access ladder.

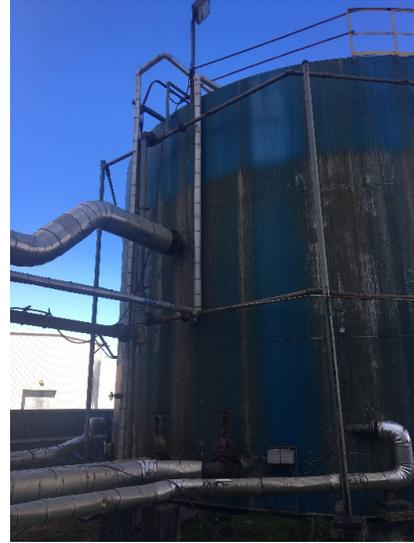
Figure 2: View of tank and associated piping.

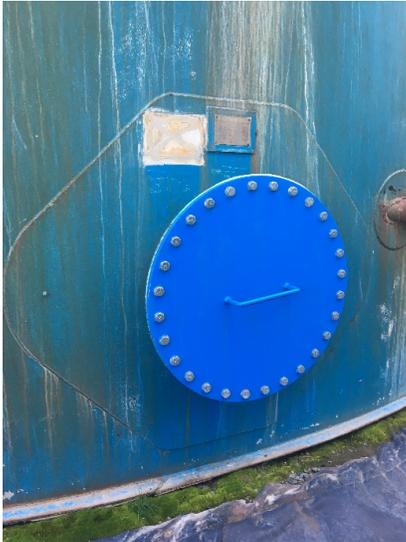
Figure 3: View of tank manway.

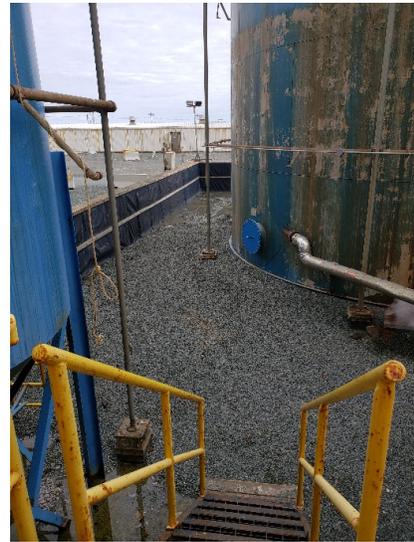
Figure 4: View of tank compound.

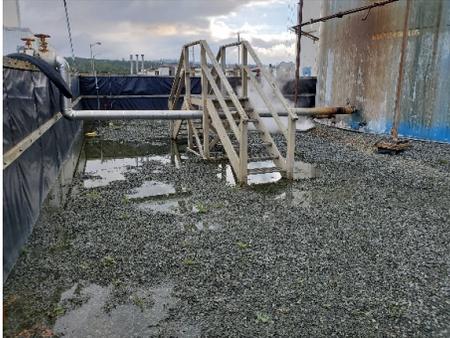
Figure 5: View of compound and access stairs.

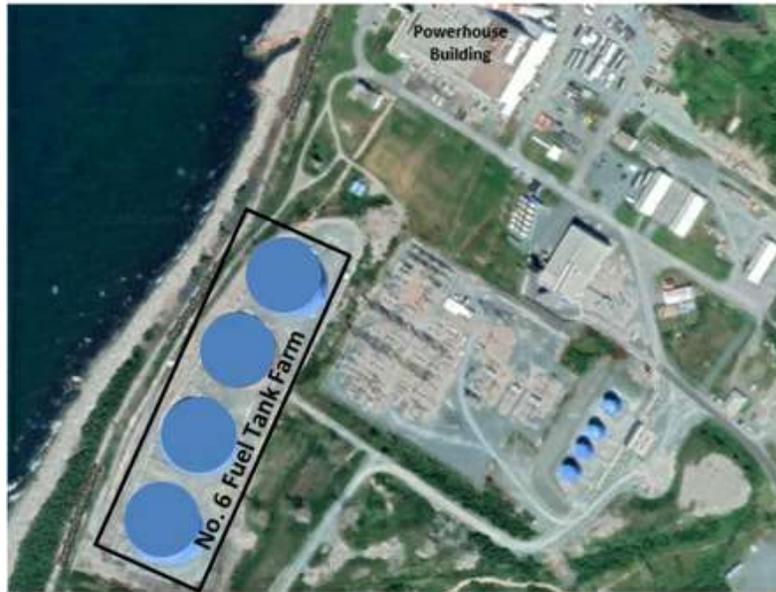
Figure 1: No. 6 Fuel Oil Tank Farm at the Holyrood TGS

1 The firewater loop surrounding the No. 6 fuel oil tank farm is composed of asbestos cement piping with
2 a diameter of 10 inches and associated isolation valves and hydrants that are made of cast iron. This
3 firewater loop was originally installed during the construction of generating Units 1 and 2 in 1969 and
4 the construction of generating Unit 3 in 1979. The asbestos cement piping has an expected lifespan of
5 50–70 years, depending on factors such as the type of soil surrounding the pipes, water composition,
6 and operating conditions (e.g., water pressure and temperature). The asbestos cement pipe material
7 undergoes gradual degradation in the form of corrosion and erosion resulting in pipe thinning, making
8 failures more likely to occur.

10 The tank farm firewater loop provides fire protection to the tank farm. Currently, the tank farm
11 firewater loop is in a deteriorated condition. Failures to the underground firewater distribution system
12 at the Holyrood TGS have been occurring regularly since 2018. Two hydrants and four isolation valves on
13 the tank farm firewater loop failed in 2019 and 2020 and required replacement. Figure 2 shows
14 firewater system leakage that resulted from a break in the tank farm firewater loop in 2019. The leakage
15 caused flooding to the surrounding area near the terminal station and the replacement of a valve and
16 section of pipe was required. The HTGS Study highlighted the deteriorated condition of the underground
17 firewater distribution system at the Holyrood TGS, including the tank farm firewater loop.
