July 15, 2025

**Re: 2026 Capital Budget Application**

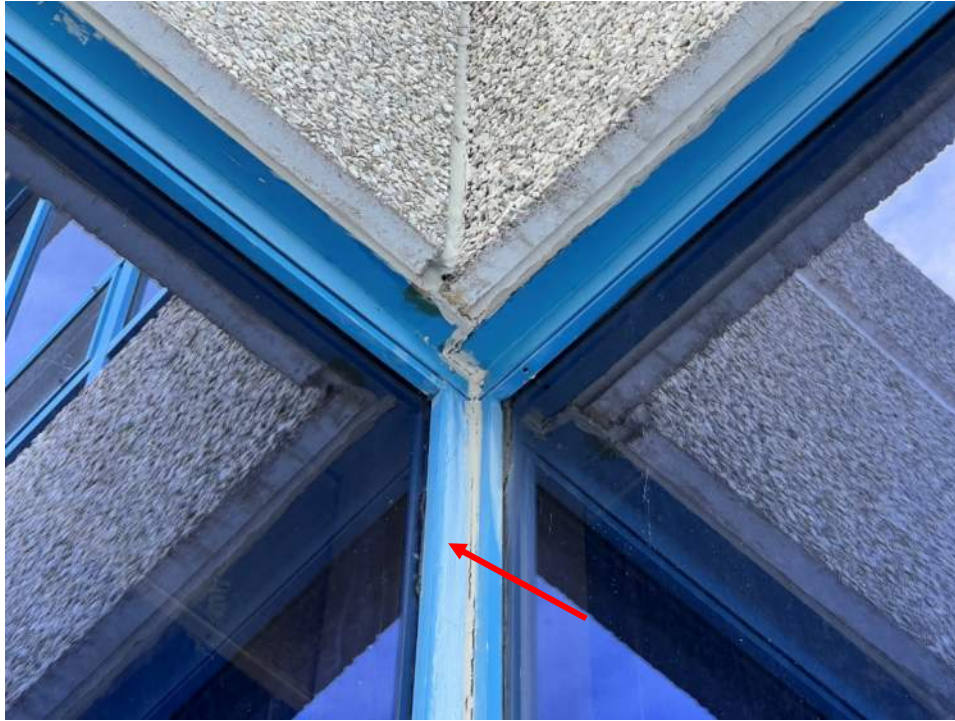
- .9 Local areas of spalled precast where noted during the review. (*Refer to Photo No. 22 in Appendix A*).
- .10 Overall, the sealants between the window and precast, as well as metal-to-metal seals, are in poor condition which increases risk of leaks (*Refer to Photo No. 26 and 27 in Appendix A*).

Photo No. 27: Typical view of adhesive sealant (red arrow)

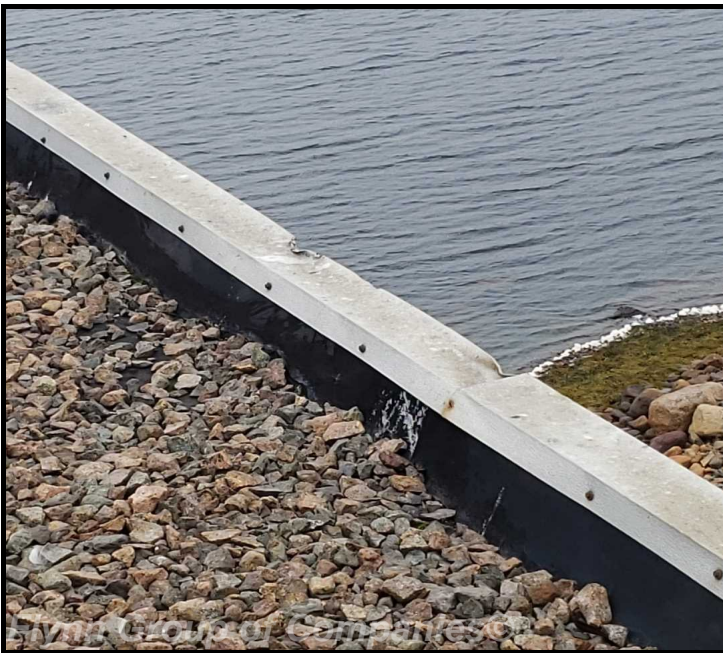
pump house #2:  
Areas of damaged metal

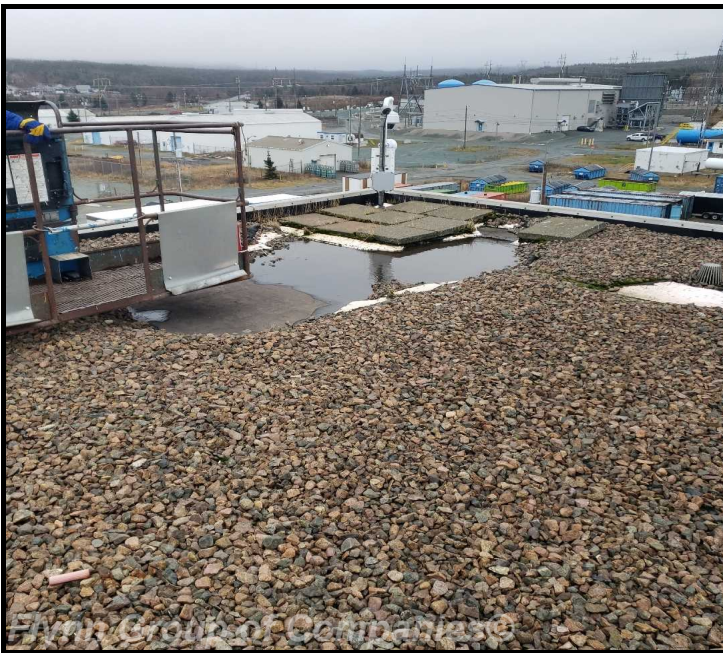
pump house #2:  
View of wind damaged area

Minor preventative maintenance recommended immediately to fix open wind swept areas as well as additional minor preventative maintenance

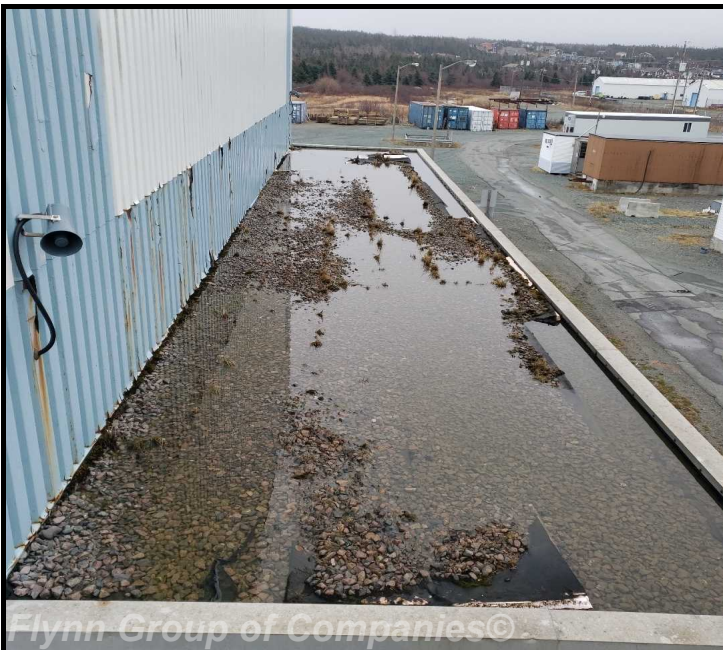
pump house #2:  
View of area of roof on  
pump house #2 at lower roof  
drain plugged and wind  
damage to roofing

visual inspection of roof area  
lower roof flooded due to drain plugged with debris and area of wind damage on upper roof level to be addressed

Minor preventative maintenance recommended immediately to fix open wind swept areas as well as additional minor preventative maintenance. Plugged drain needs to be cleared.

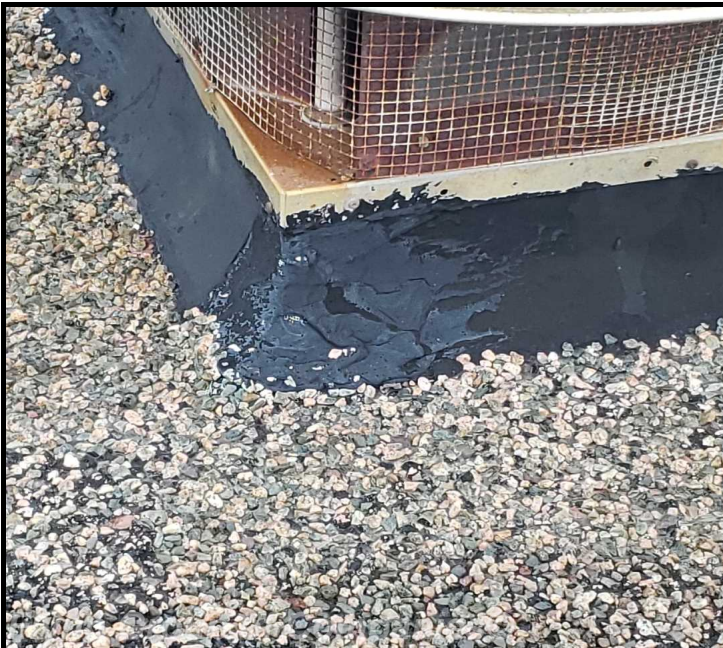
pump house #1:  
Areas of detail flashing in  
need of some sealant

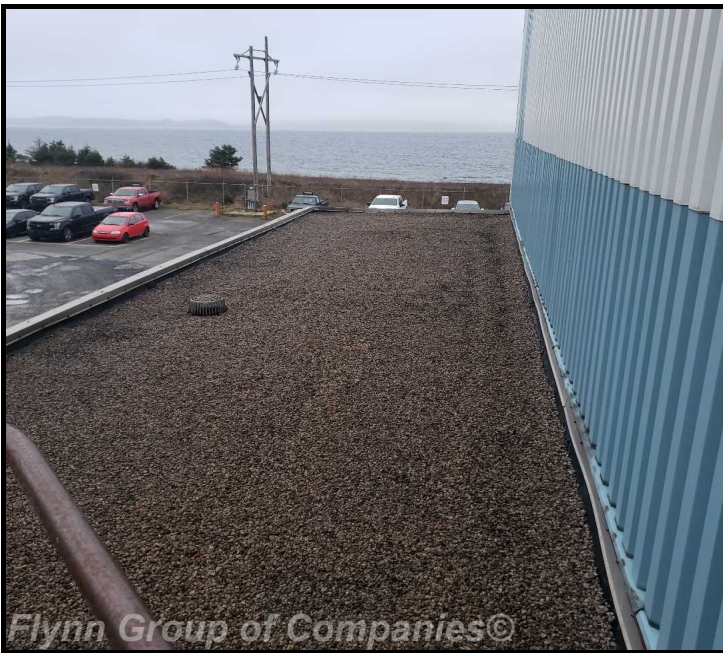
Day#1:  
Overview of roof area - in  
good condition

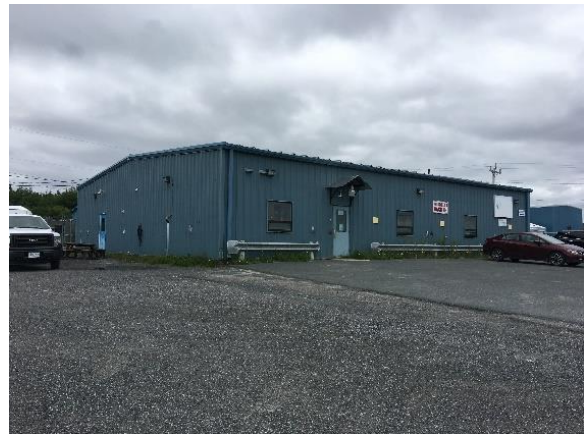
The building was originally constructed circa 1995 as a combined office/customer service/line depot facility. It has been renovated and currently houses administrative, customer service functions, and a small line depot. The original larger line depot section was converted into office spaces. The building is in excellent condition.

The single level on grade pre-engineered steel structure is some 390m<sup>2</sup> in gross floor area. Interior finished ceiling height is 2580 mm. Exterior walls are of steel frame with vertical metal siding, vinyl faced glass fibre insulation with drywall interior finish. Partitions are metal stud and drywall and masonry block with ceilings principally acoustic tile. The building is drafty as reported by staff but is in excellent condition with little upgrading required.

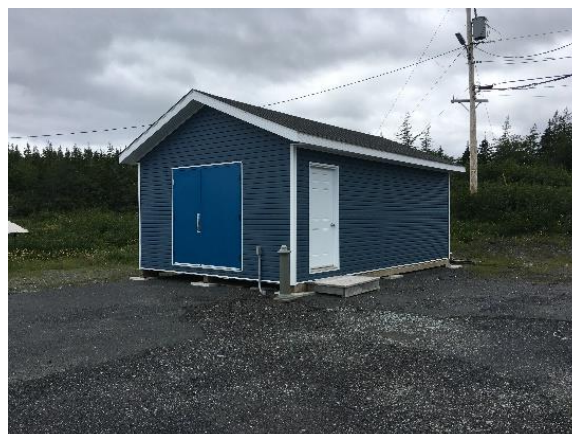
The building is of contemporary vintage. The single open storage room building is some 37m<sup>2</sup> in area. It is constructed of 38 x 140 mm wood stud frame with horizontal vinyl siding, vinyl clad eaves and asphalt shingle roofing. The floor is of wood joists with plywood finish. The building has pre-engineered wood roof trusses. It is uninsulated and principally unfinished at the interior with the exception of a small area of plywood wall finish. Access is via one residential steel door with a pair of steel doors at the front for loading. The building has one vinyl window which is in good condition. The floor has sagged noticeably. It is mounted on concrete patio blocks and is some 500 mm above finish grade. Other than the floor sag and overly high steps rise the building is in good condition.

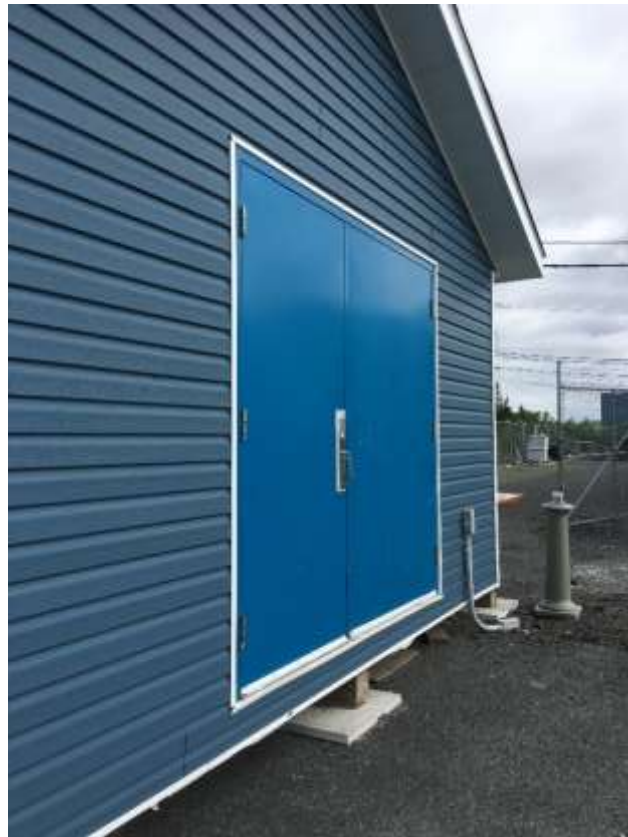
Loading doors.

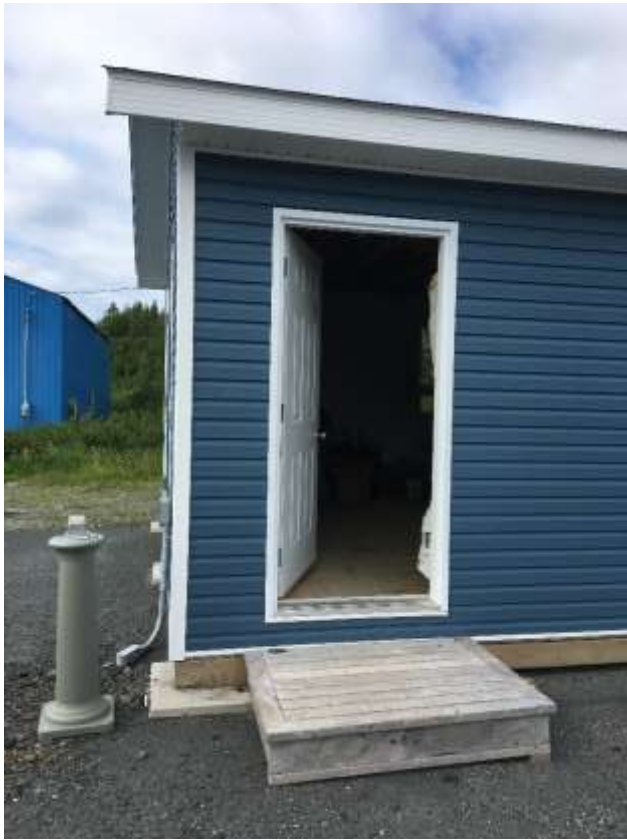
Personnel door. Note risers height.

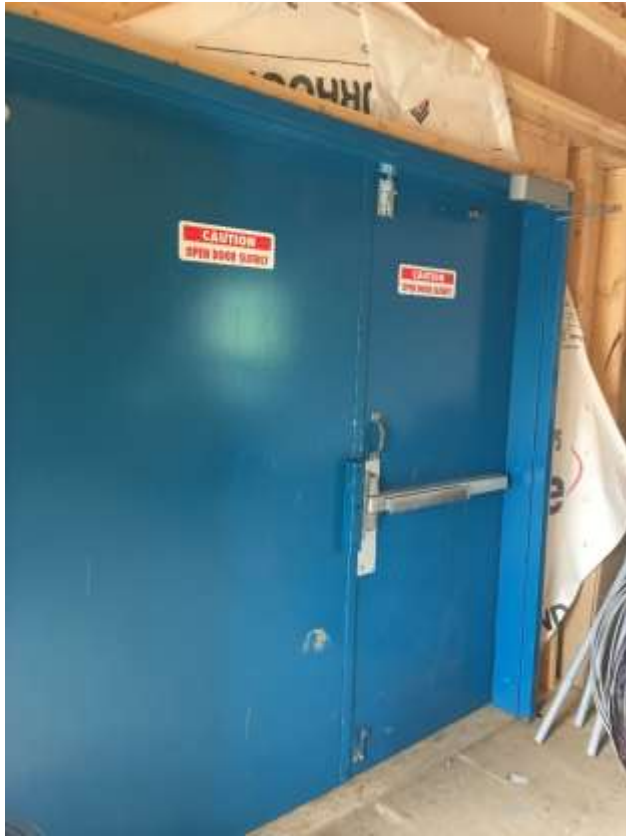
Loading doors.

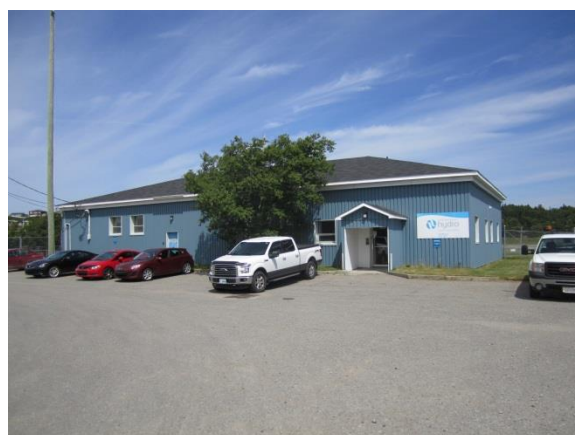
#### 1.3.1 Office Building

The 445m<sup>2</sup> single level on grade steel frame building appears to have been originally constructed circa 1942 by the US Air Force as part of Harmon Air Force Base. Extensive modification and upgrades have taken place since its original construction. The building currently houses Newfoundland and Labrador Hydro's administration, staff training, small warehouse and three workshops namely; Protection and Control, Transmission, and Terminals shops. The building has a contemporary sloped hip roof with asphalt shingles which was added in recent years and exterior walls cladding is of vertical pre-painted steel siding. Windows are fixed over projected aluminum with double hermetically sealed glazing, which are contemporary and in good condition. The main entrance door is glazed aluminum in aluminum frame, other exterior doors are steel in pressed steel frames. The exterior envelope appears to have been upgraded in recent years and is in excellent condition.

Interiors consist of demountable type vinyl wallcovering, finished drywall partitions with vinyl battens on metal stud, some masonry partitions (in the warehouse and corridor separating the shops wing from the remainder of the building), and suspended acoustical tile ceilings with the exception of the warehouse which has an exposed steel original roof structure. Flooring is generally vinyl tile with carpeting in the meeting/training room, all are in good condition.

Shops appear to be undersized as reported by staff and as observed, building expansion is recommended. (*Refer to conceptual floor plan drawing.*)

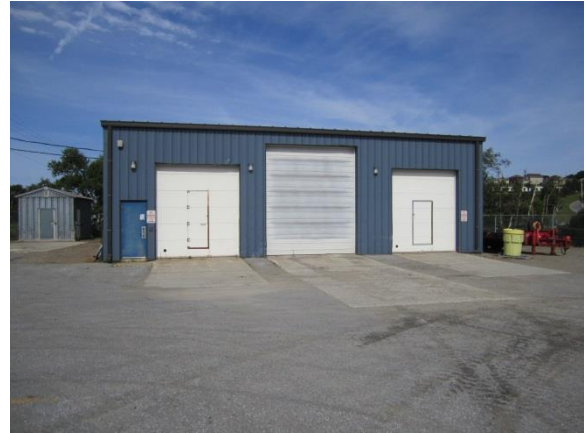
The building is a single level on grade pre-engineered steel structure of 166m<sup>2</sup> area with insulated envelope and bare interior finish. The space is principally a three bay repair garage. Ancillary rooms include; washroom, office, lunch, parts, storage and two small low ceiling storage lofts. Interior rooms are primarily masonry construction. A service pit is located in the center bay of the building. The building is estimated to be 20-25 years of age. It is in good condition.

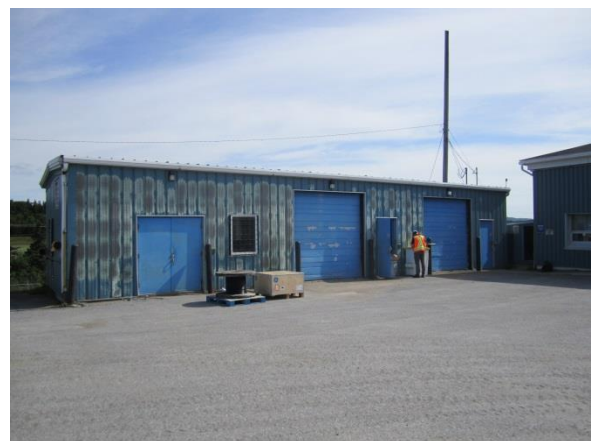
### 1.3.3 Warehouse Building

The building is a single level on grade pre-engineered steel structure of 134m<sup>2</sup> area. It is sub-divided into three rooms each with metal demising partitioning walls, two rooms have sectional overhead doors plus a single swing steel personnel door. The third room has a pair of steel swing doors. Each room is used for line crew equipment storage. The roof is low slope gable metal clad. Windows are steel with corroded steel security screening. Personnel doors are metal in pressed steel frames with commercial hardware. The building exterior should be painted. The building is in better condition than it first appears. Its age appears to be 30 plus years.

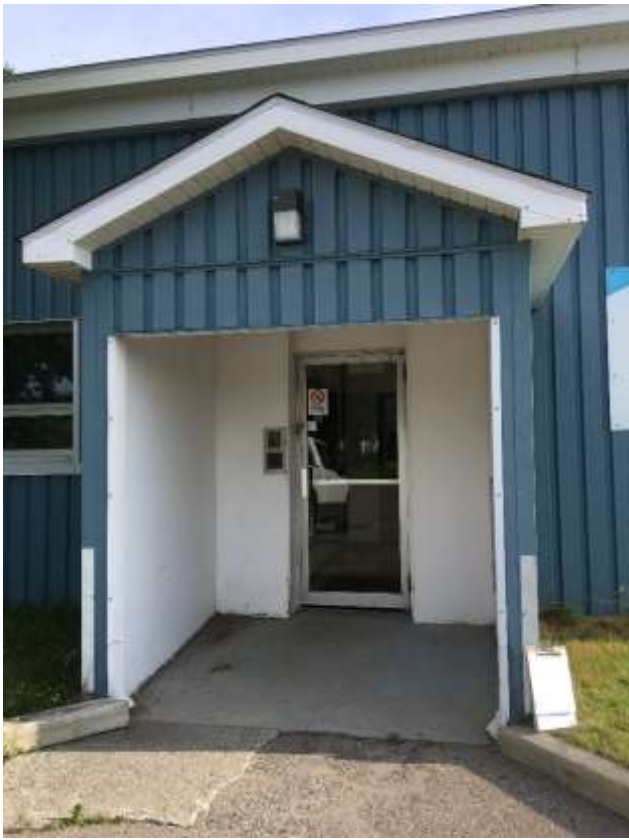
Typical roof soffit/fascia. Note double roof.

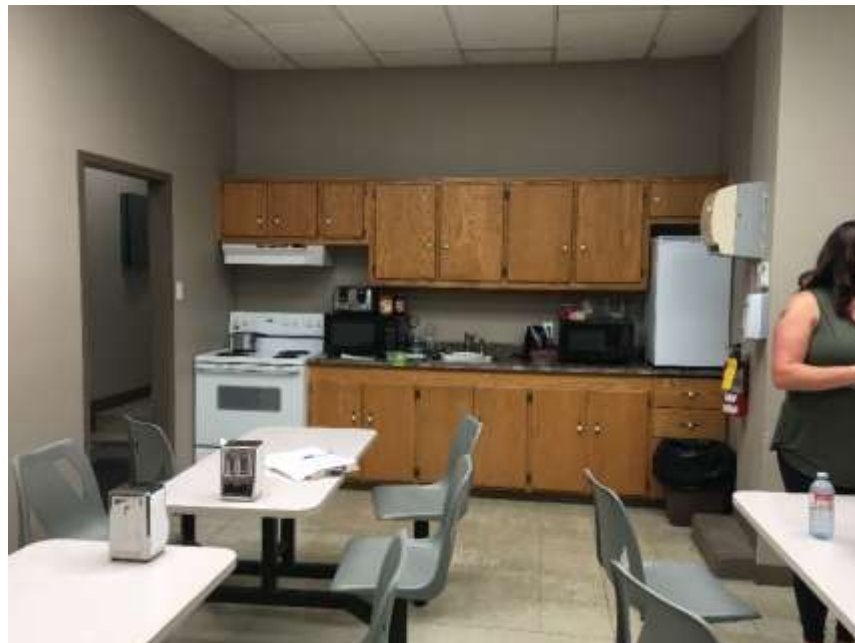
Kitchen/lunch/ main circulation route to second exit and shops wing.

- Enclose janitorial supplies in 60 minute fire rated room.
- Continue main corridor through existing kitchen to create continuous dedicated exit path to eliminate current dead ending.
- Eliminate existing lean to flammable storage shed at rear of building.
- Replace male washroom and lunch flooring.
- Removed loose stored items from electrical and data rooms.
- Add upper area attic vents.
- Add attic access hatches.

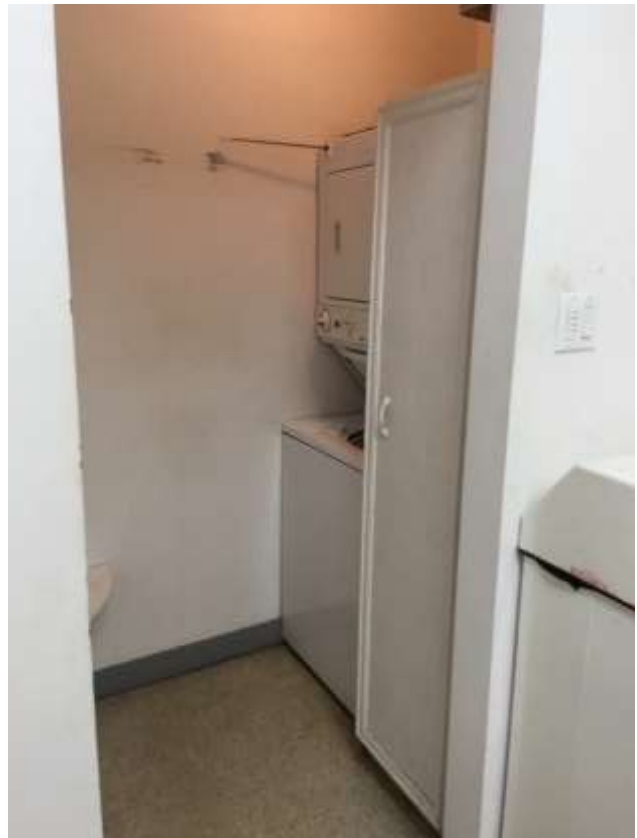
Electrical/ communications room. Note items stored hazard.

- Consider installation of new fire alarm system panel with detectors and alarm devices. Reuse existing fire alarm pull stations.
- Remove the materials stored in the electrical room and install warning sign on electrical room door “Electrical Room – No storage permitted”.
- Install the panel cover on the panelboard in the space above the electrical room.
- Relocate the communication rack installed in front of the main disconnect to provide a 1 m working space.
- Replace missing acrylic lenses on wraparound fluorescent lighting fixtures.
- Replace both outdoor standard duplex receptacles and faceplates with new GFCI receptacles c/w weatherproof faceplates.

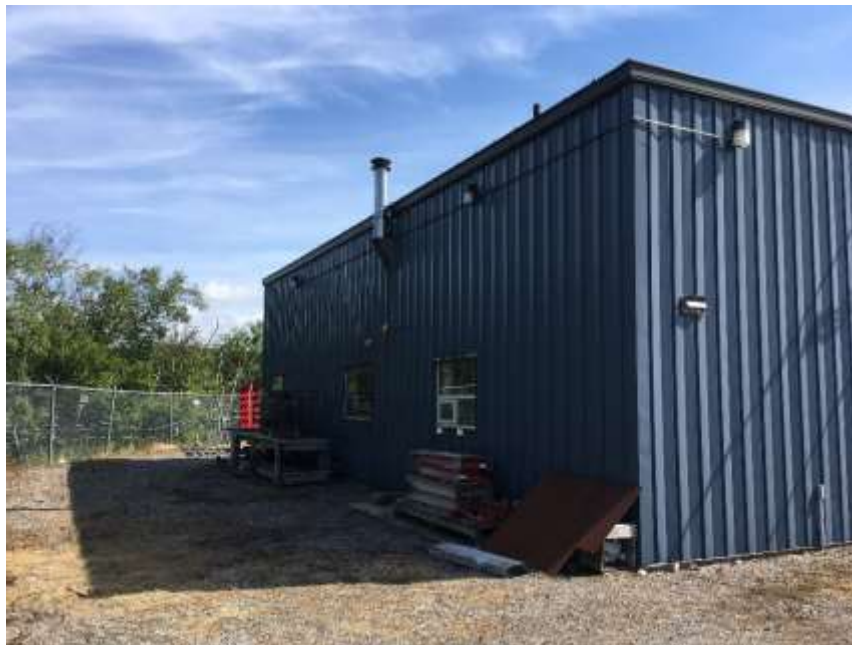
Rear façade.

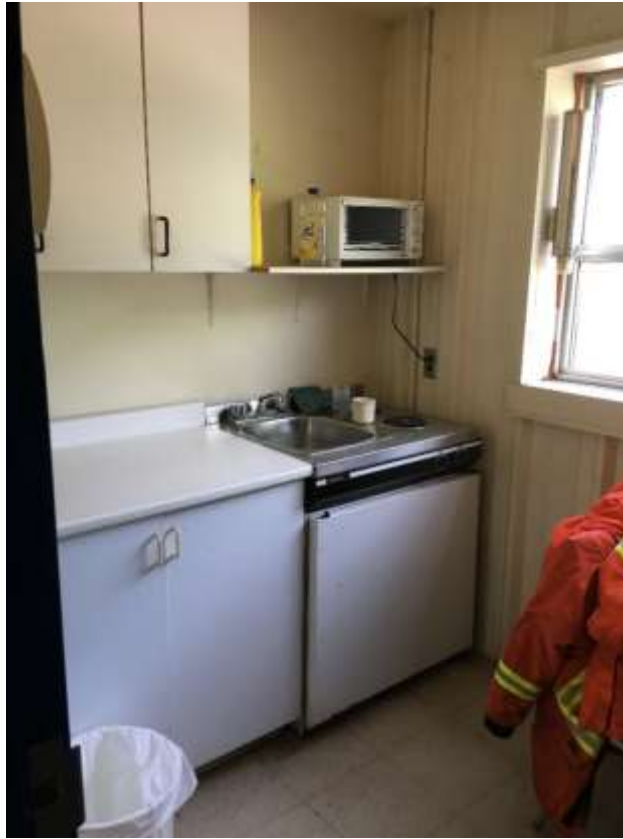
Kitchen / Lunch

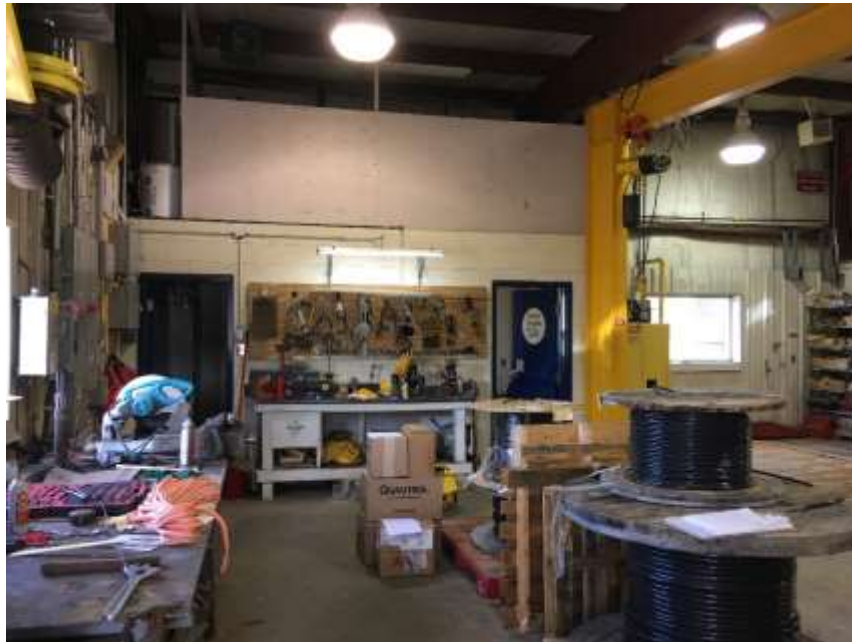
Service area.

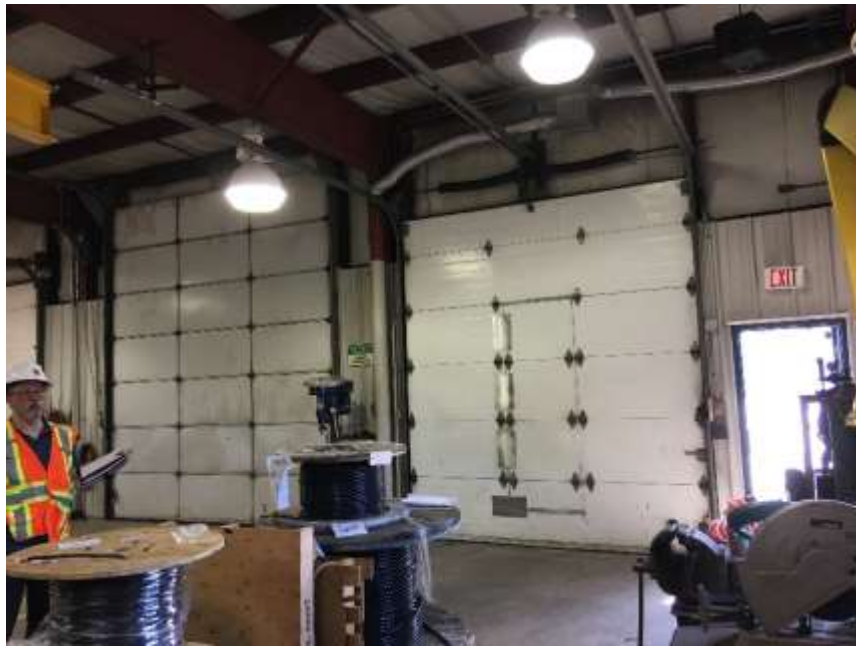
Overhead doors.

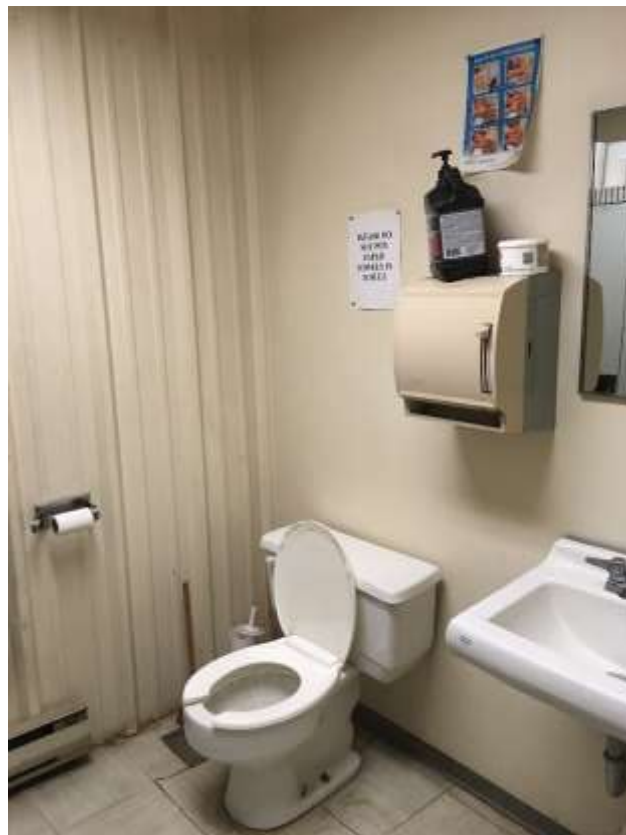
Washroom

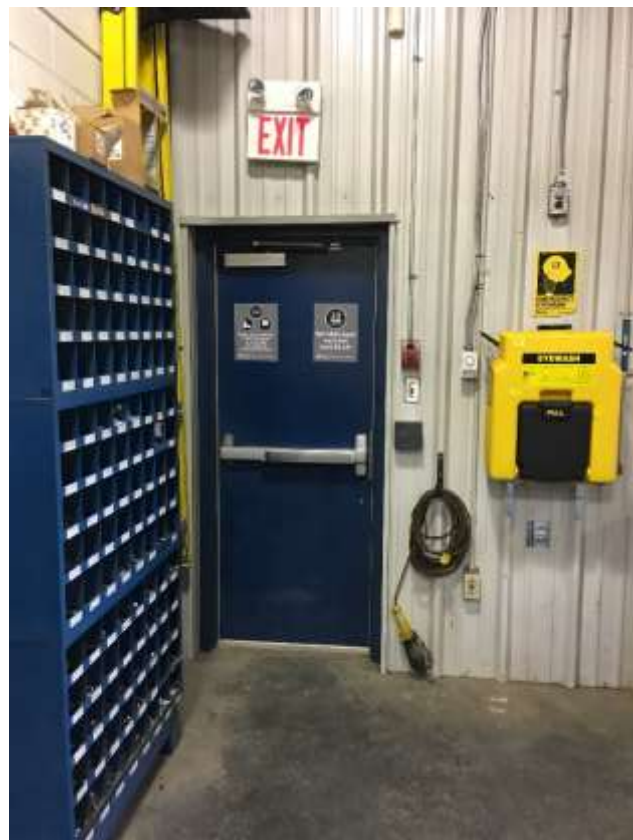
Emergency exit.

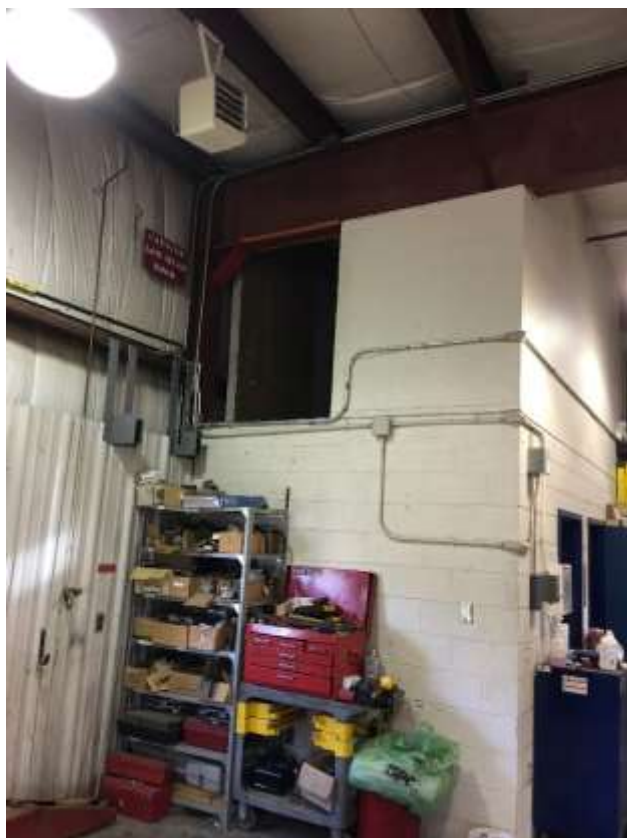
Storage mezzanine.

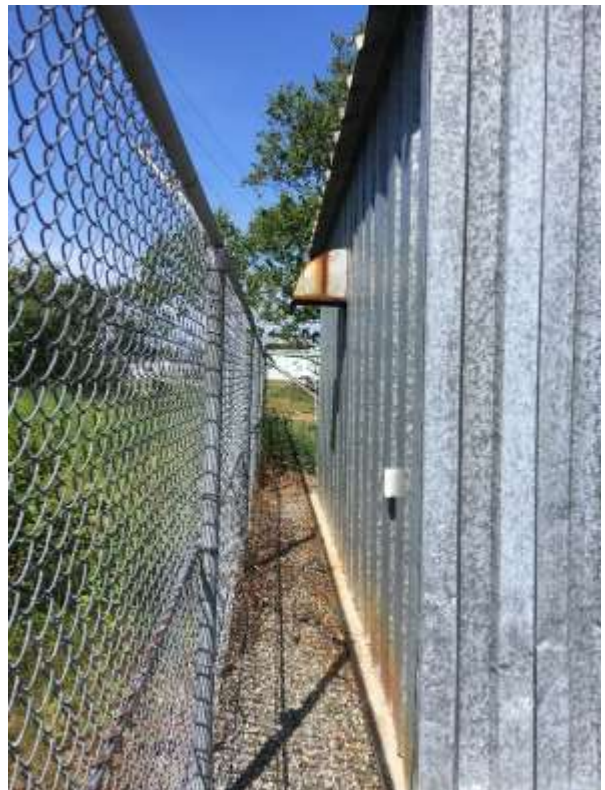
Rear façade.

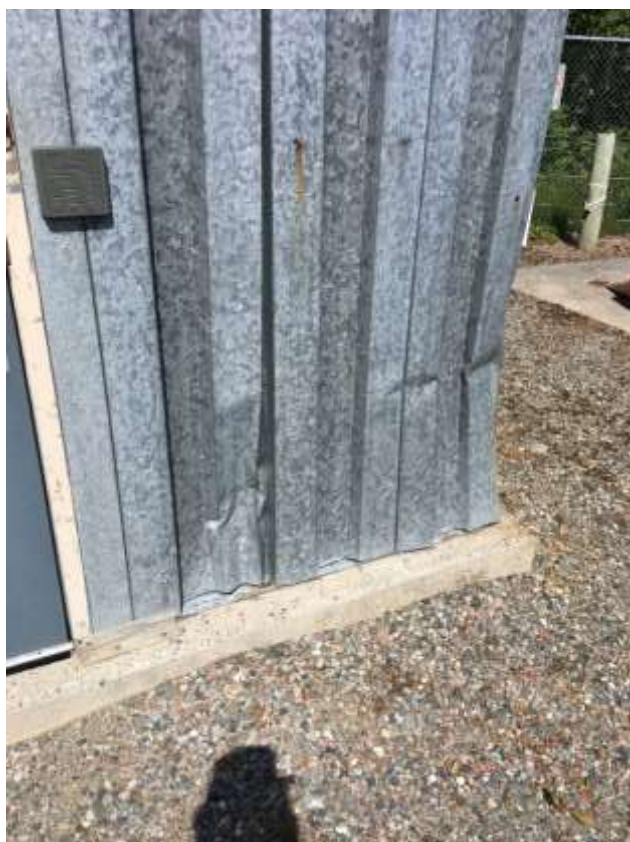
Cladding damage.

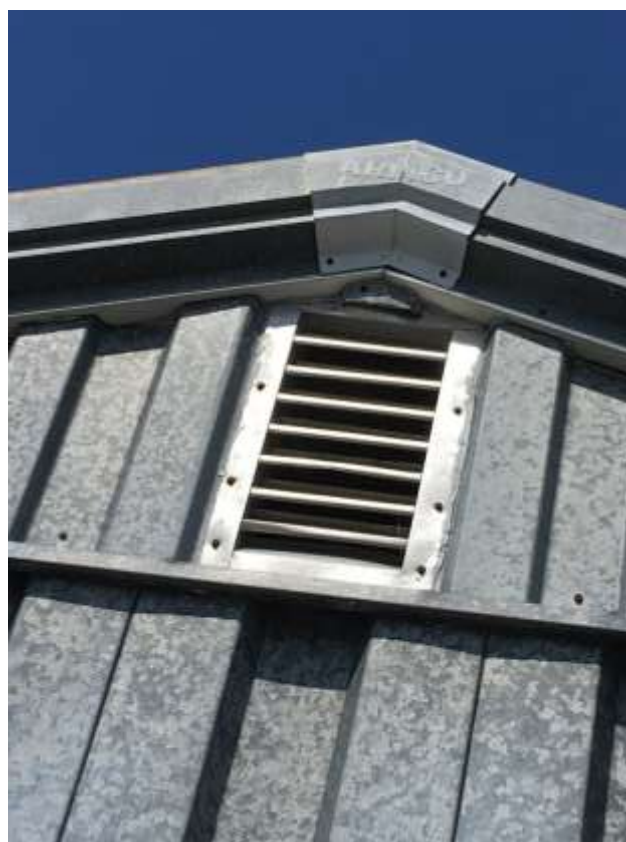
Attic ventilation.

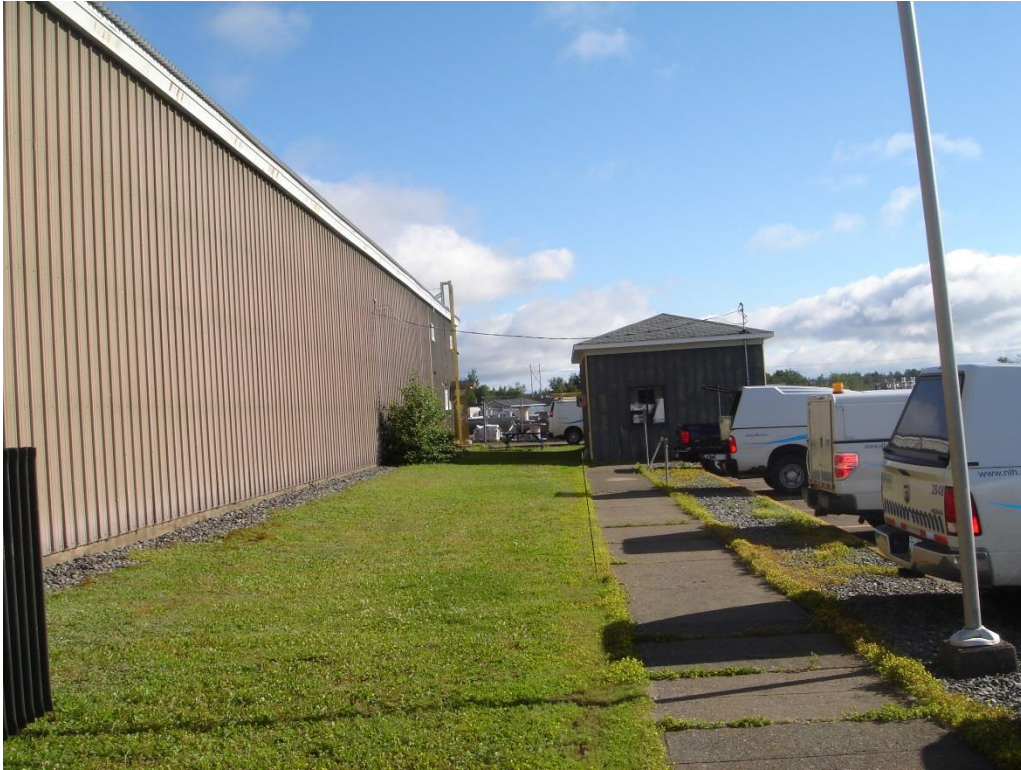
Photo 5 - Concrete Walkway

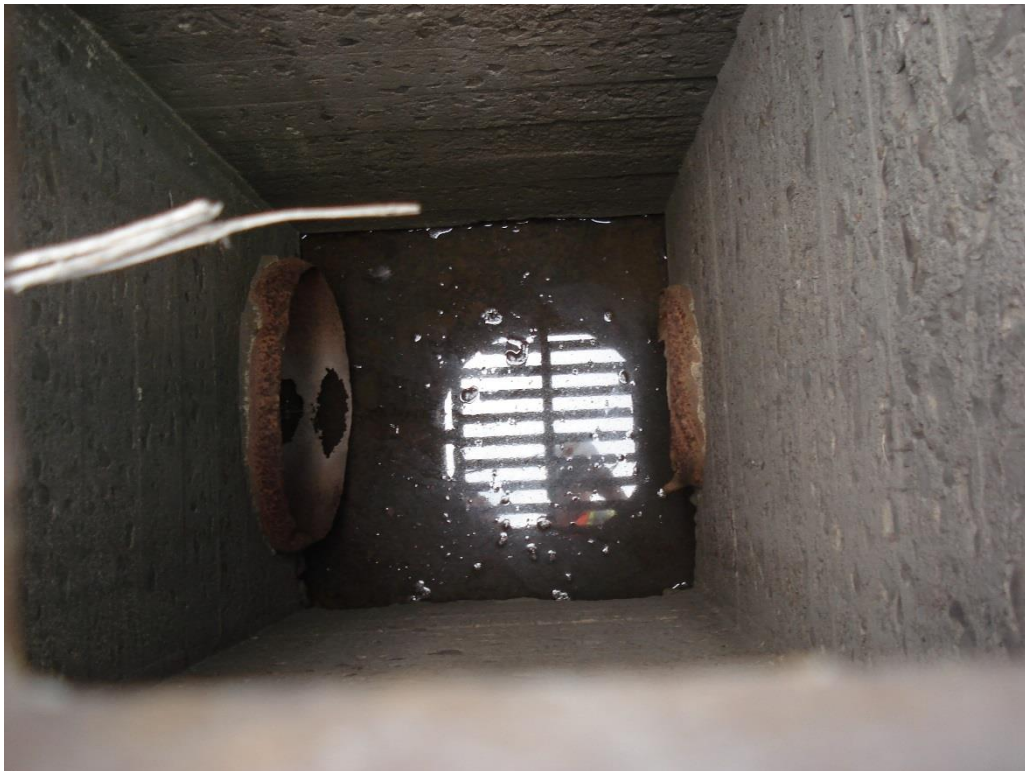
Photo 10 - Catch Basin

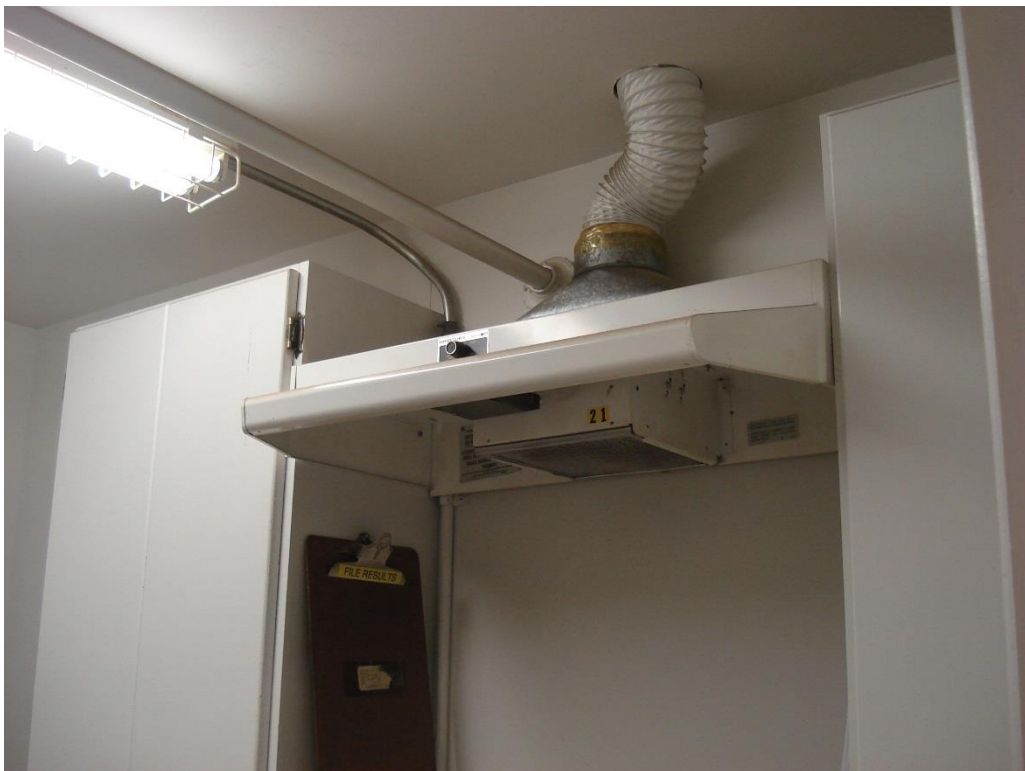
The Paint Storage room is provided with an inline exhaust fan. The fan is ducted to an exhaust grille near the floor and exhaust is ducted to a wall cap on the exterior wall (see Mechanical photo 39). The observer was unable to get this fan to function during the site visit.

Photo 39 - Paint Storage Exhaust Air Grille and Ducting

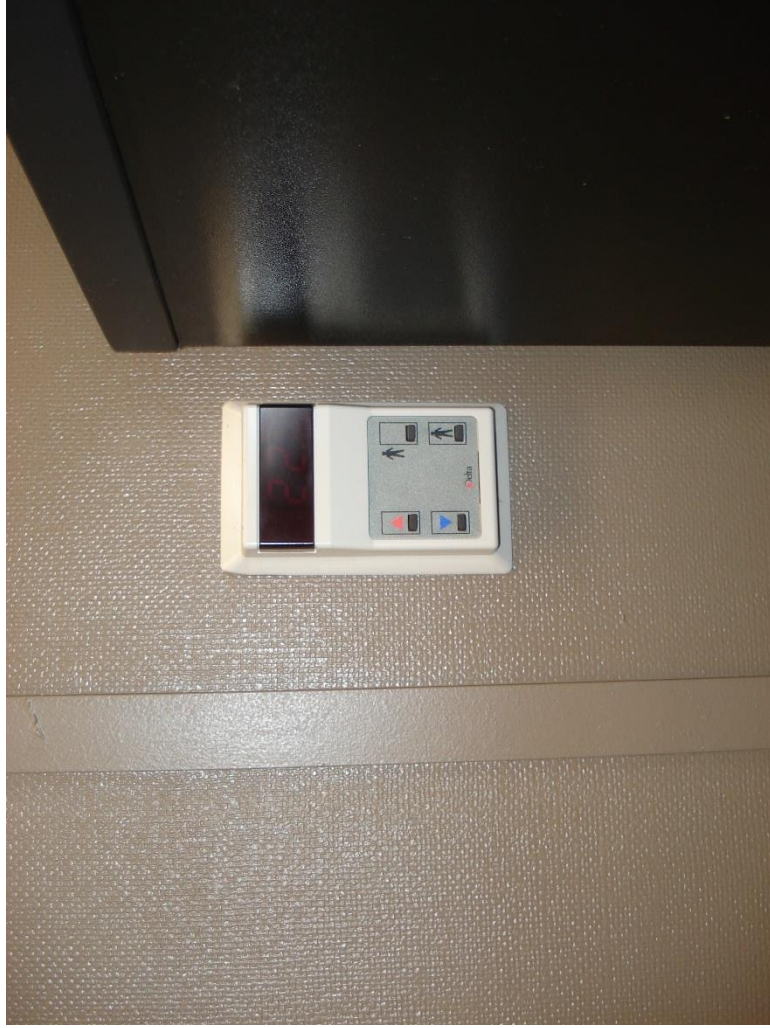
The building has a combination of stand alone controls and a Building Automation System (BAS). The BAS services the main office area of the building and second floor area and was installed during the renovation project of 1999. The BAS controls operation of the rooftop unit, zone duct heaters, baseboard heaters, and rooftop washroom exhaust fan. The BAS is composed of control panels, zone thermostats, sensors, and other end devices (see Mechanical photos 41 and 42). The main BAS panel is located in the office area server room.

Photo 41 - BAS Control Panel

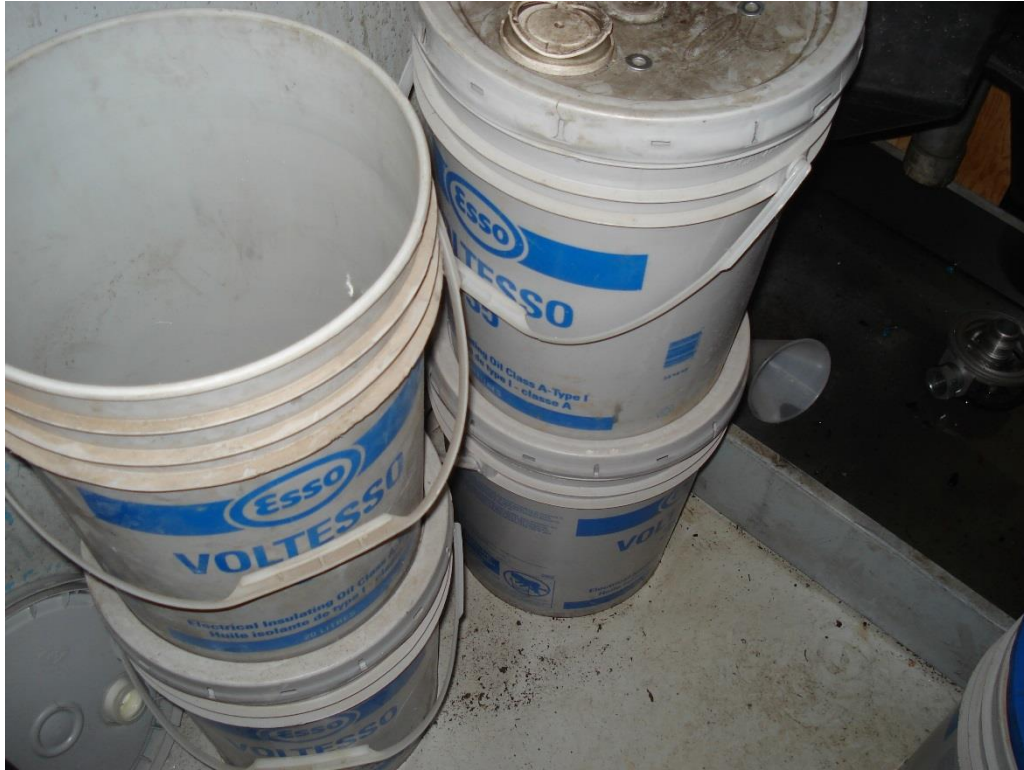
Photo 5 – Transformer Shop Oil Pails

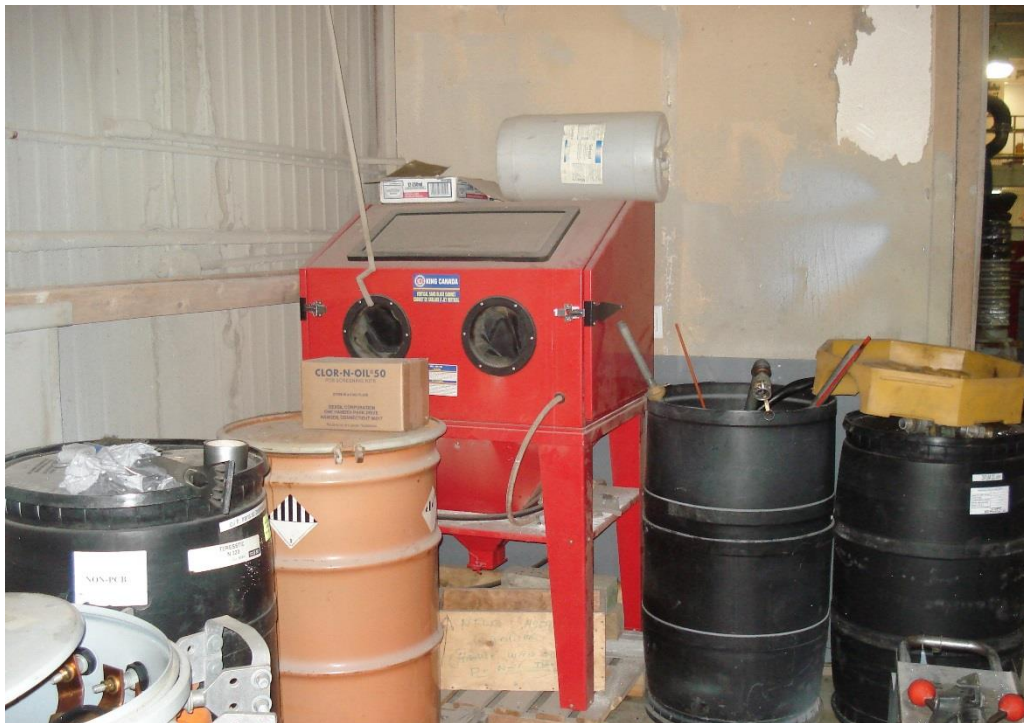
Photo 6 – Paint Room Oil Drums

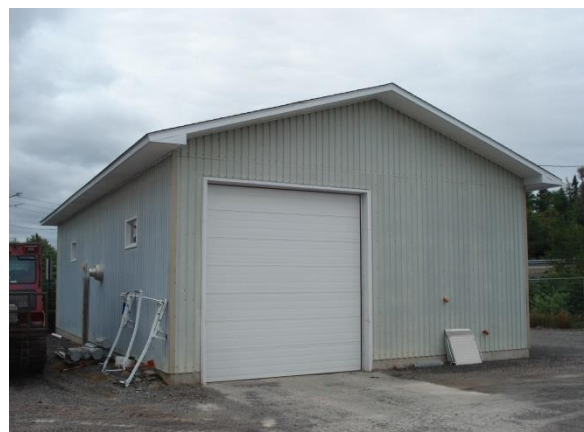
This maintenance garage building has a 133 square metre footprint/first floor area plus a small 18.4 square meter second floor. The age of the building is unknown but it is not contemporary. The building houses a repair garage with an in floor repair pit and equipment workspace. A single washroom/laundry and storage room complete the first floor. The second floor, accessed via open wood stairs houses an office plus a compressor and parts storage room. The building is of wood frame with sloped roof clad in asphalt shingles. Siding consists of vertical pre-painted metal which is in several colours and is significantly faded. Exterior doors

include one hollow metal personnel door in a pressed steel frame which requires re-painting. One large pre-painted insulated steel overhead door provides vehicle access. The building is in fair condition with significant upgrading required. Interior finishes of the walls and ceilings consist of painted hardboard. Foundations are of poured concrete with the first floor being poured in placed concrete slabs.

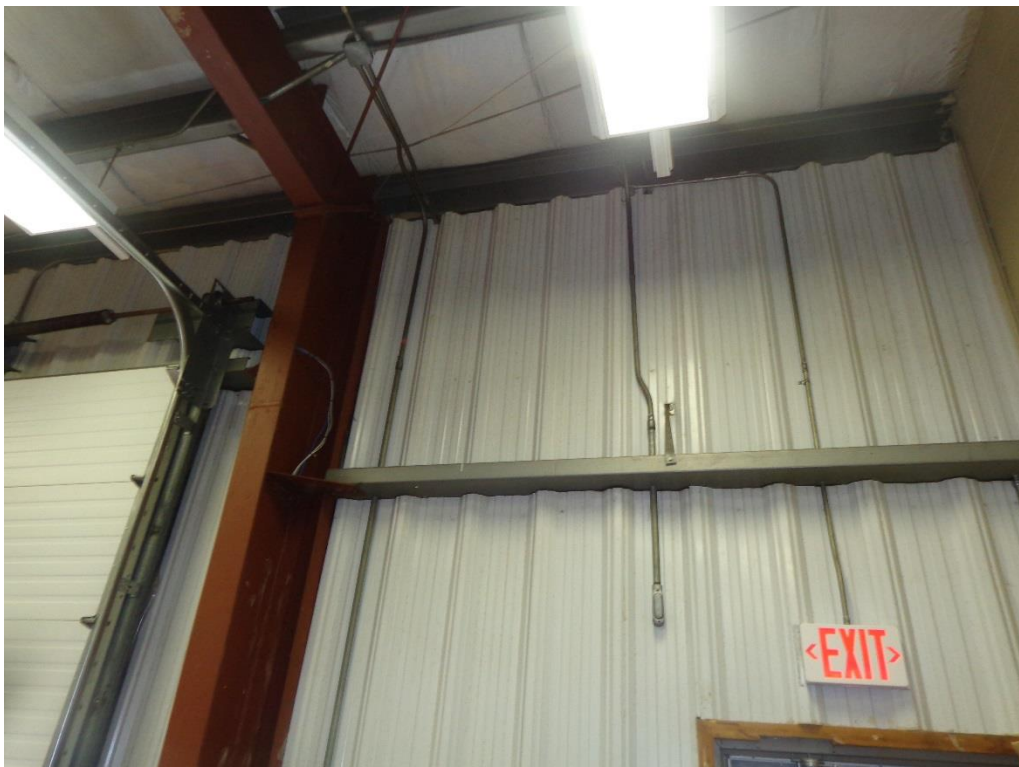
Photo 7 - Deformation of Purlin

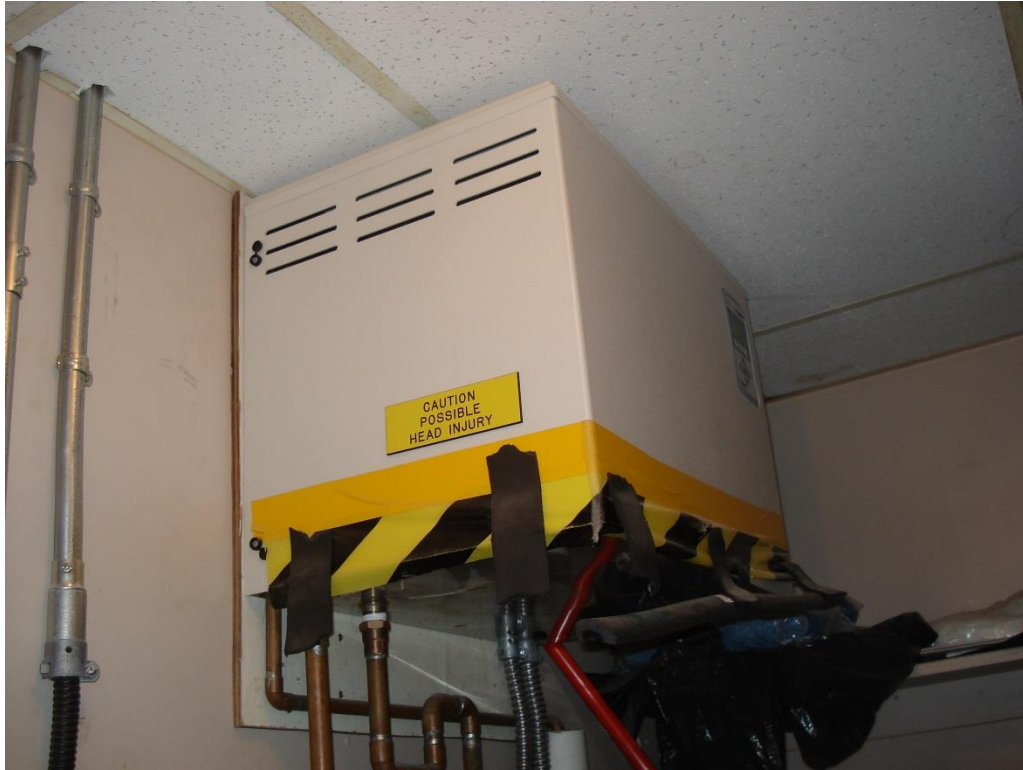
Photo 23 - Humidifier

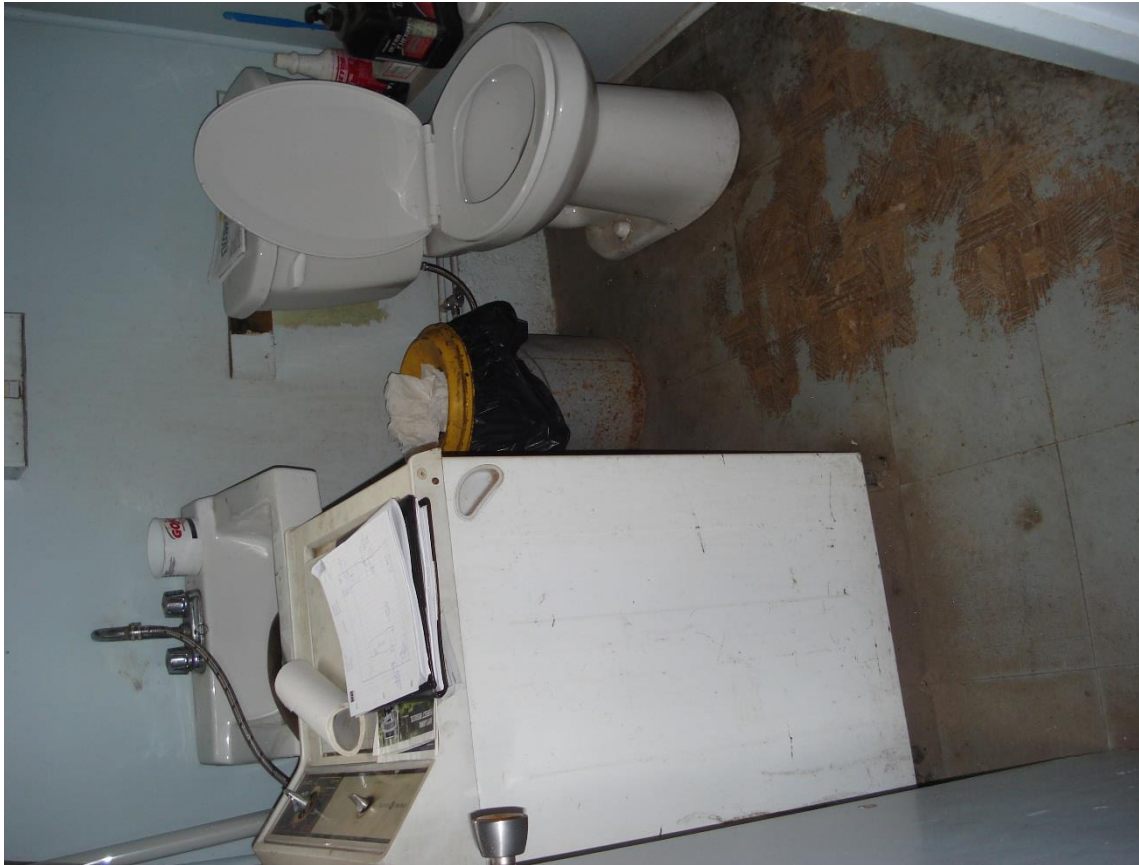
Photo 1 - Washroom Fixtures
