July 15, 2025

**Re: 2026 Capital Budget Application**

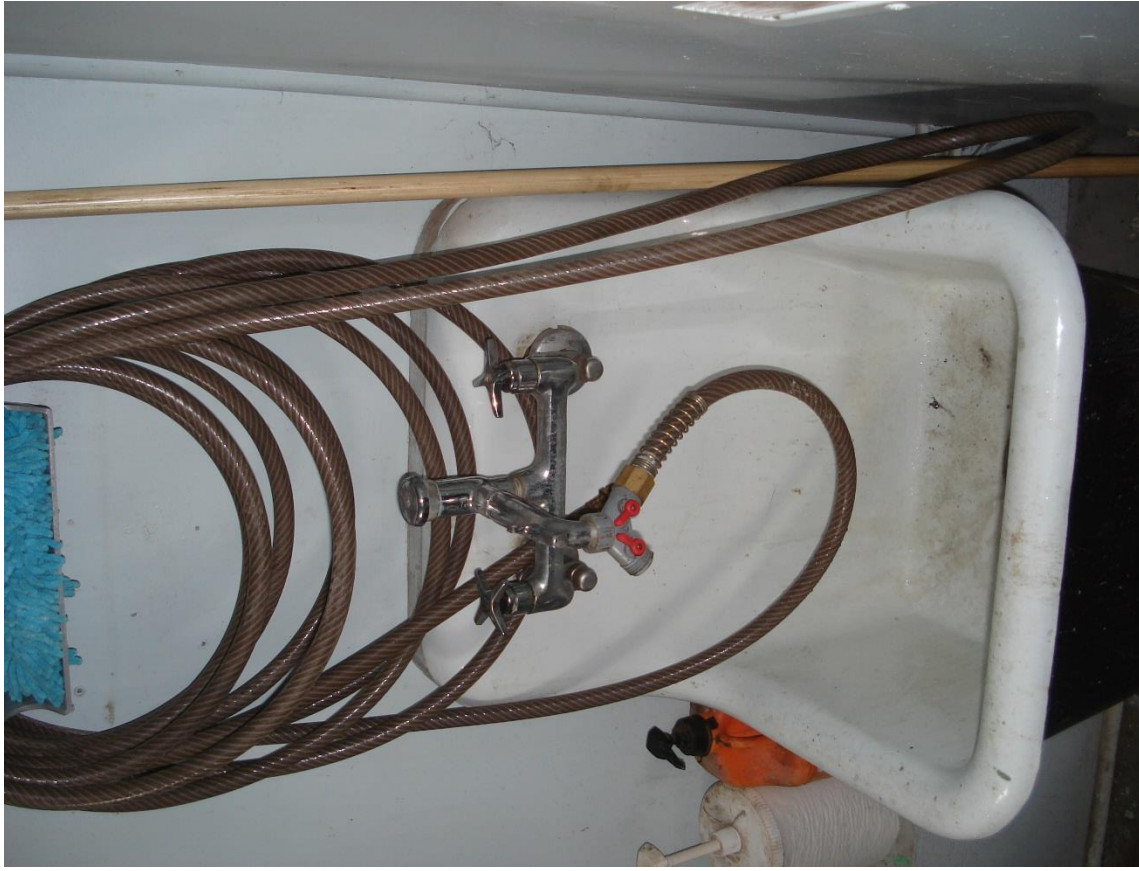
Photo 2 - Service Sink

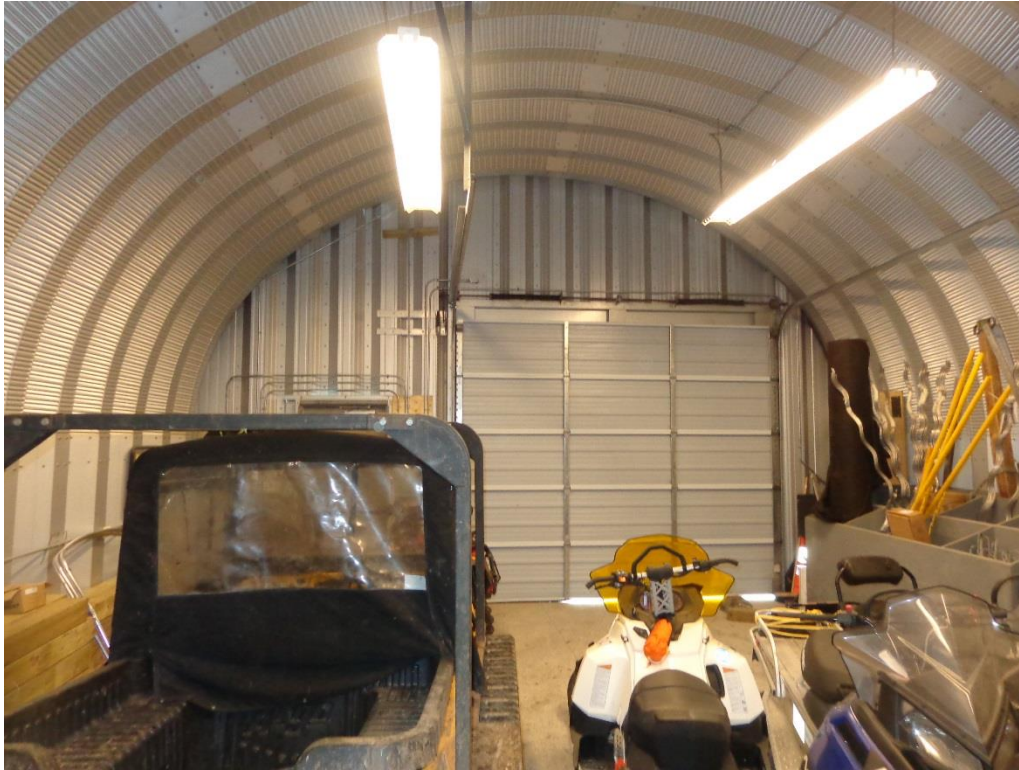
Photo 3 - Interior Structure

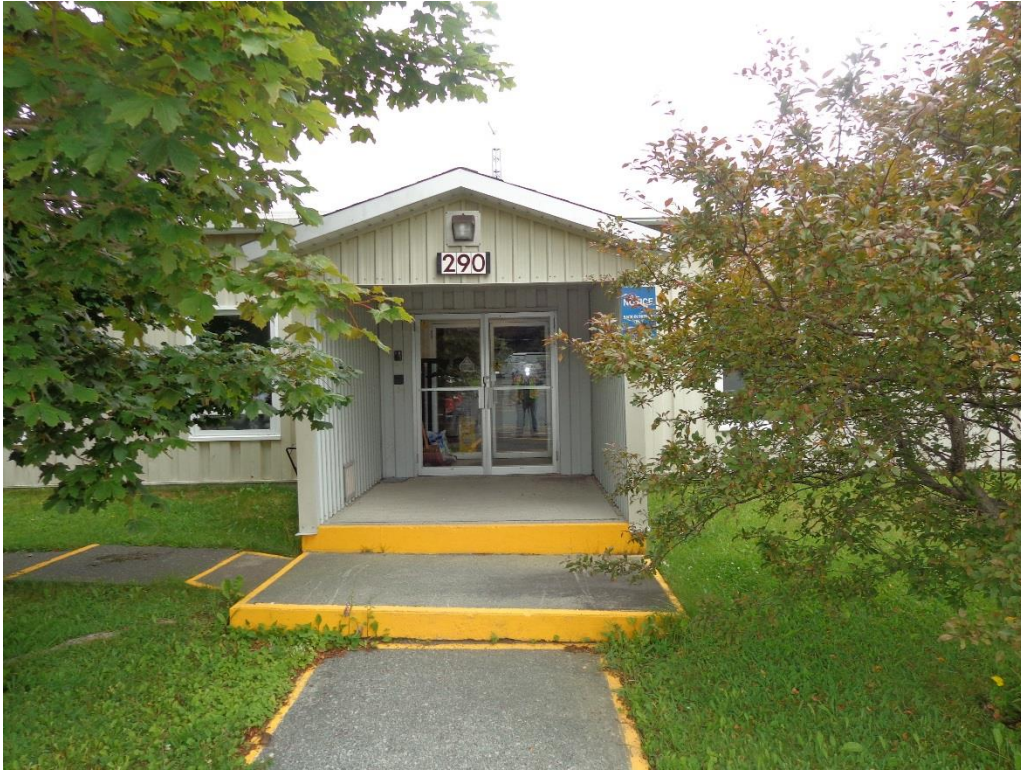
Photo 1 - Office Entrance

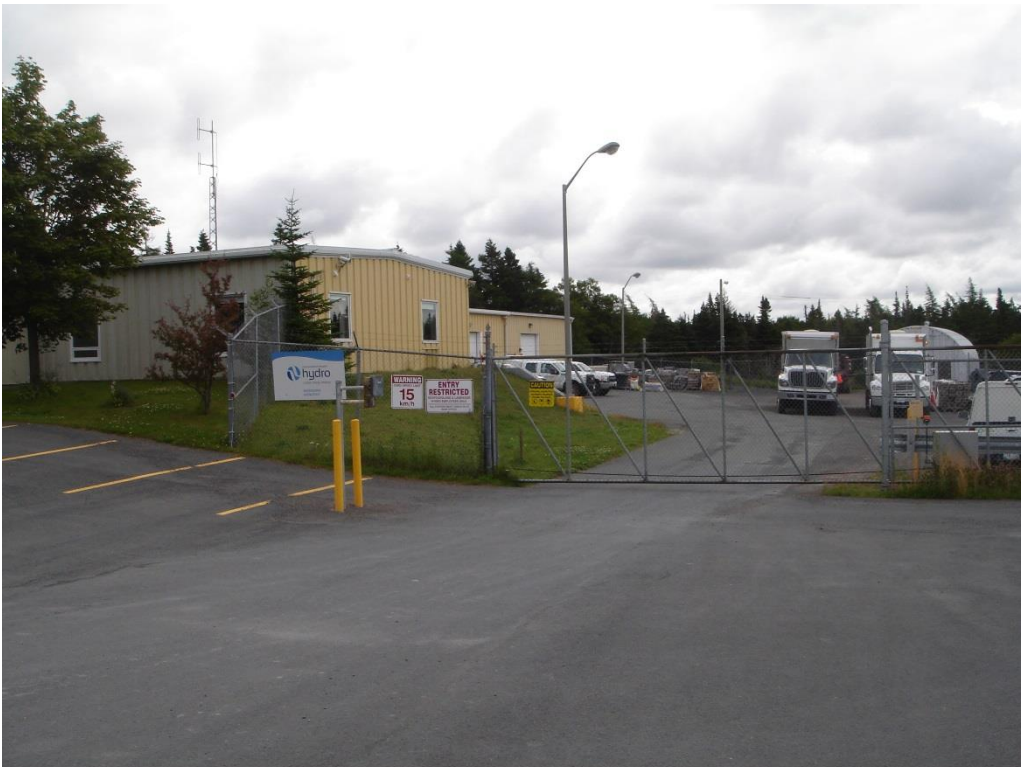
Photo 2 - Front Parking Area

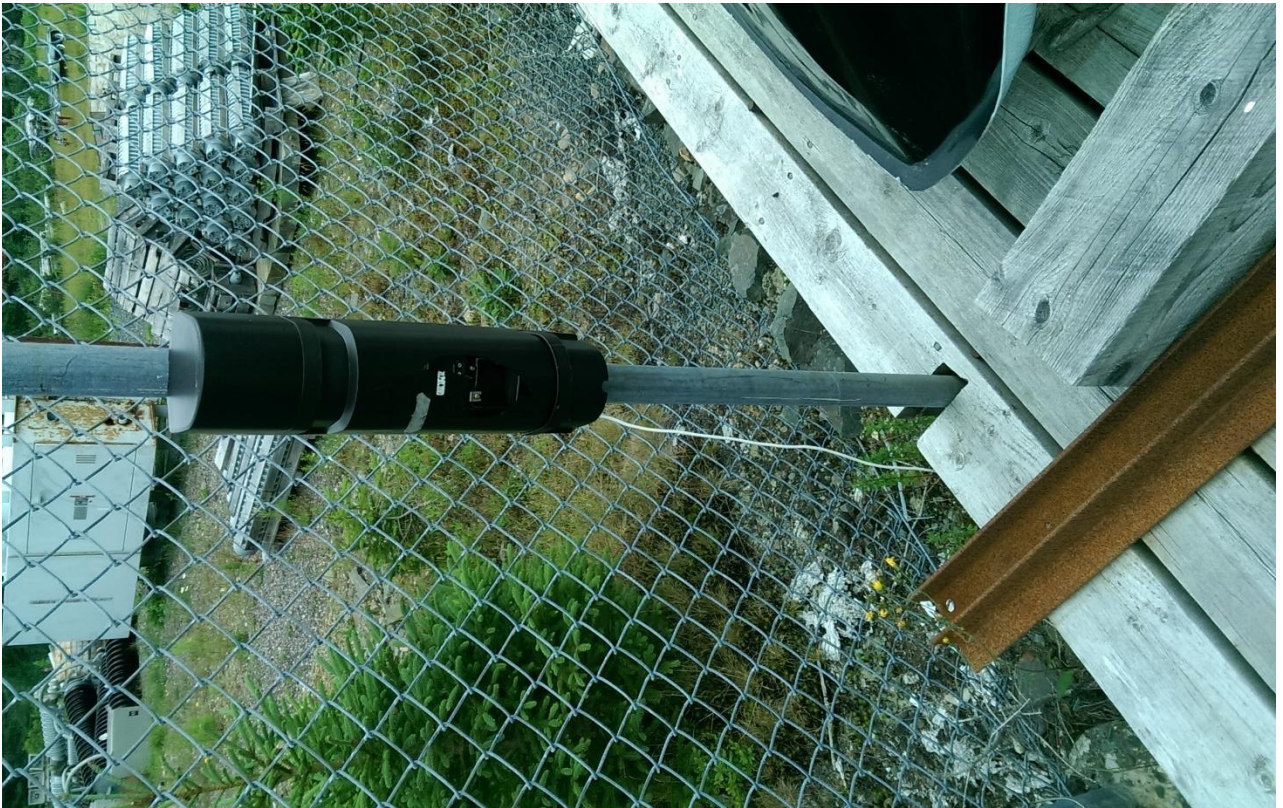
Photo 9 – Fencing Off From Bottom

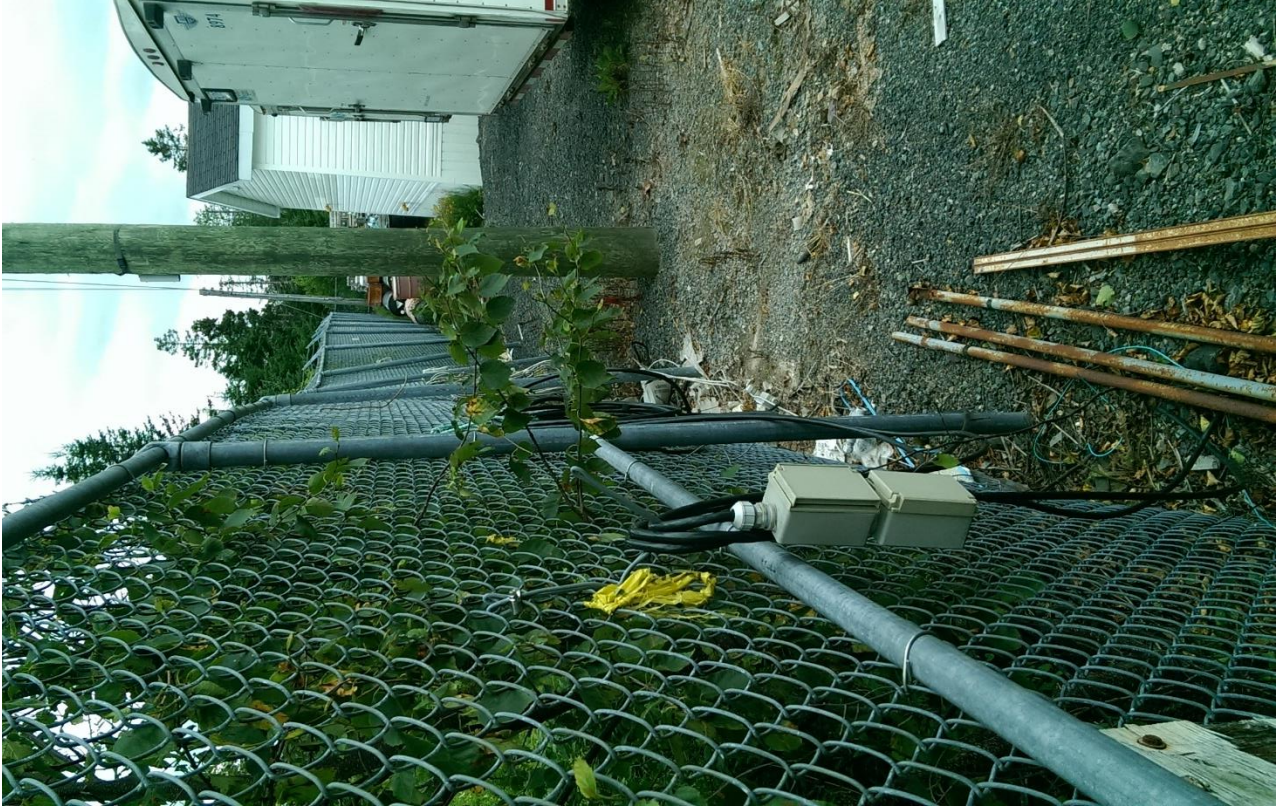
Photo 10 – Fence Learning

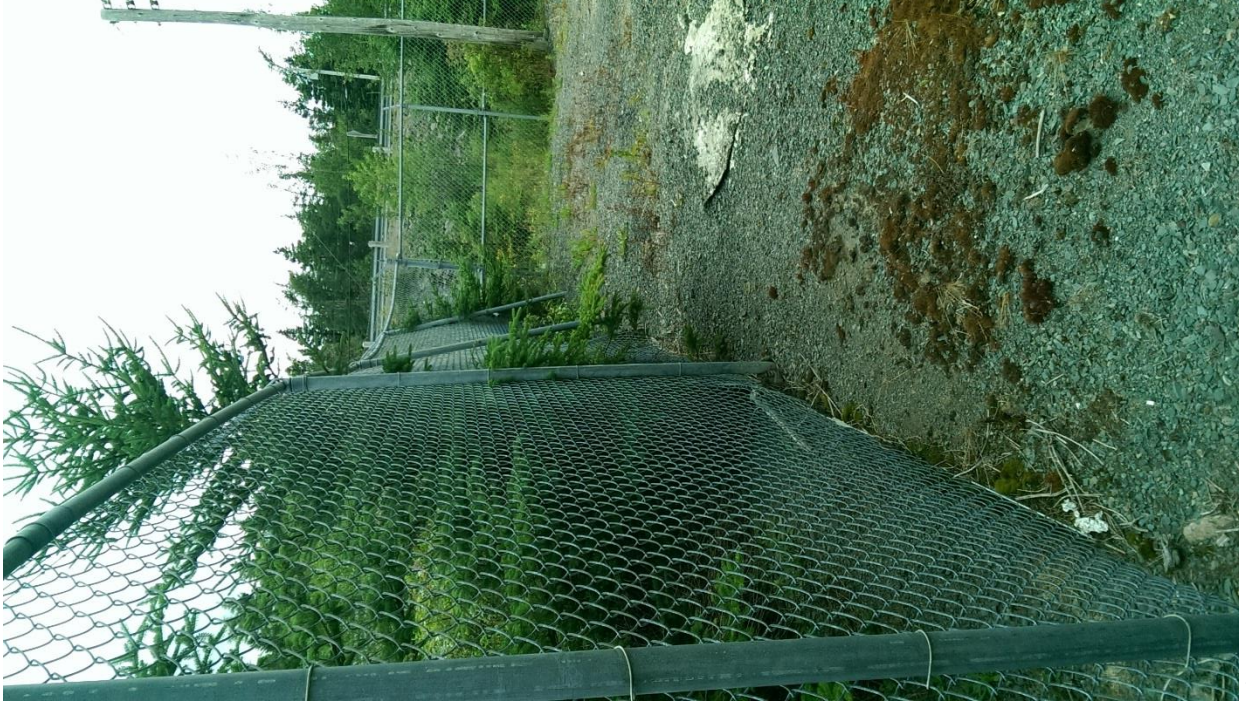
Photo 12 - Fence Leaning

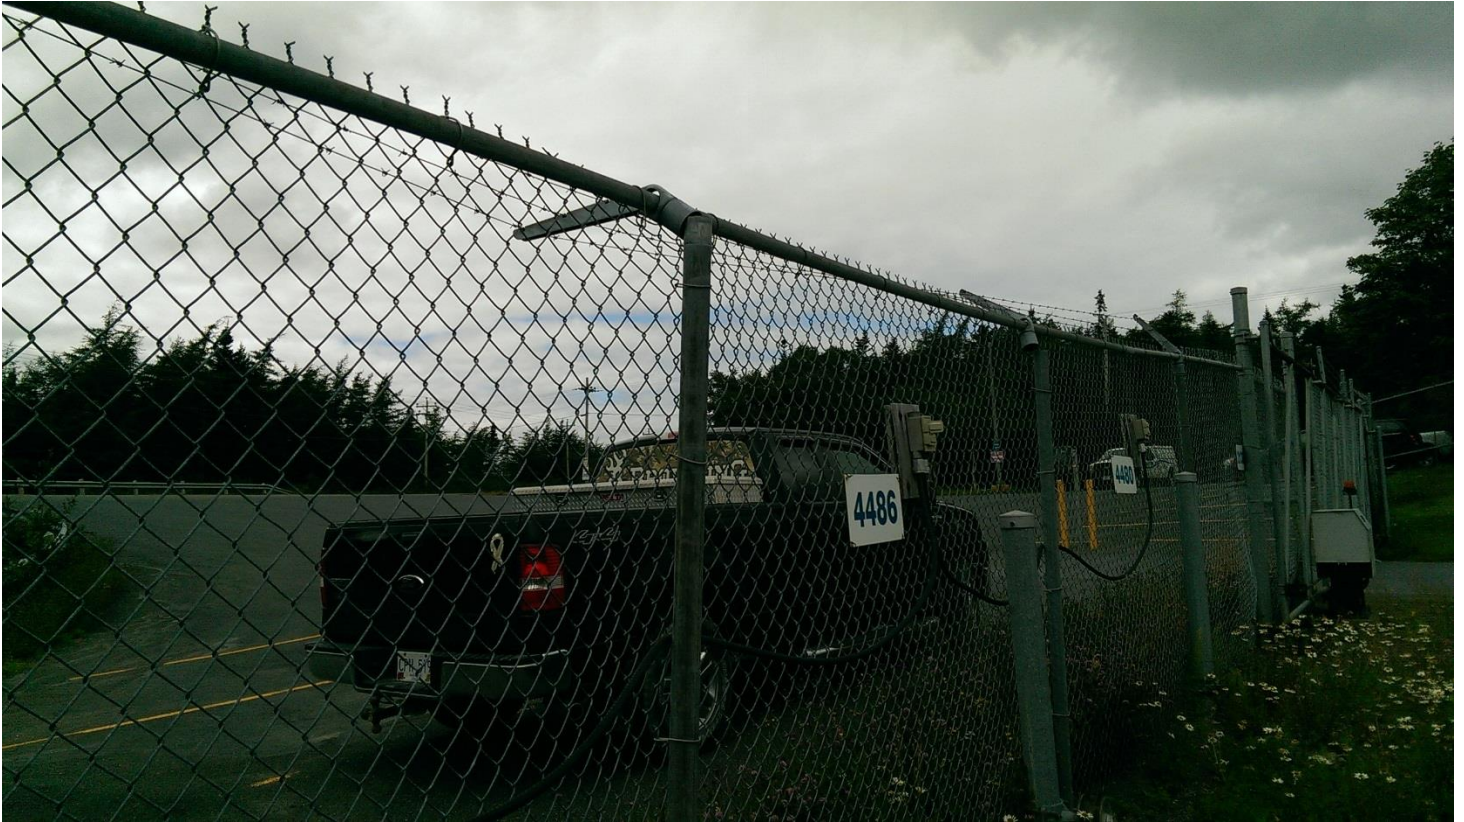
Photo 19 - Barbed Wire Supports Off

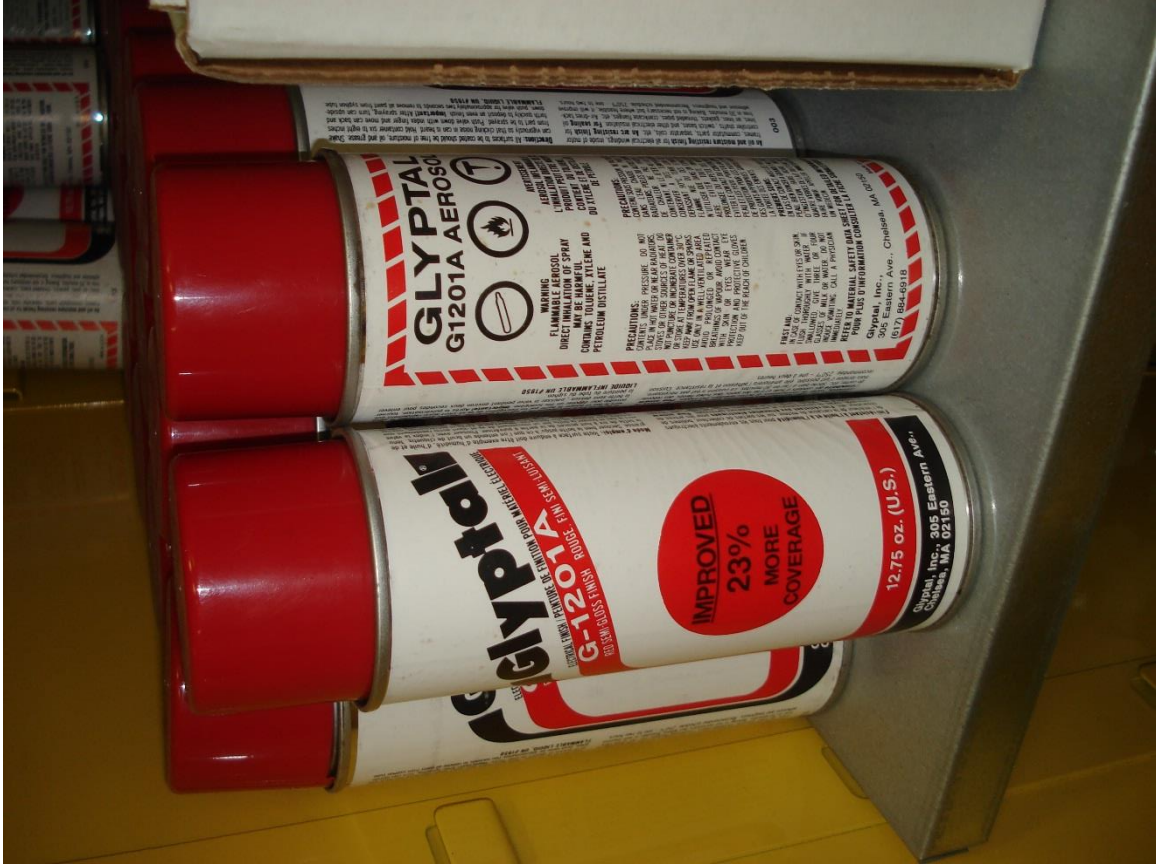
Photo 6 - Aerosol Spray Paint in Safety Cabinet

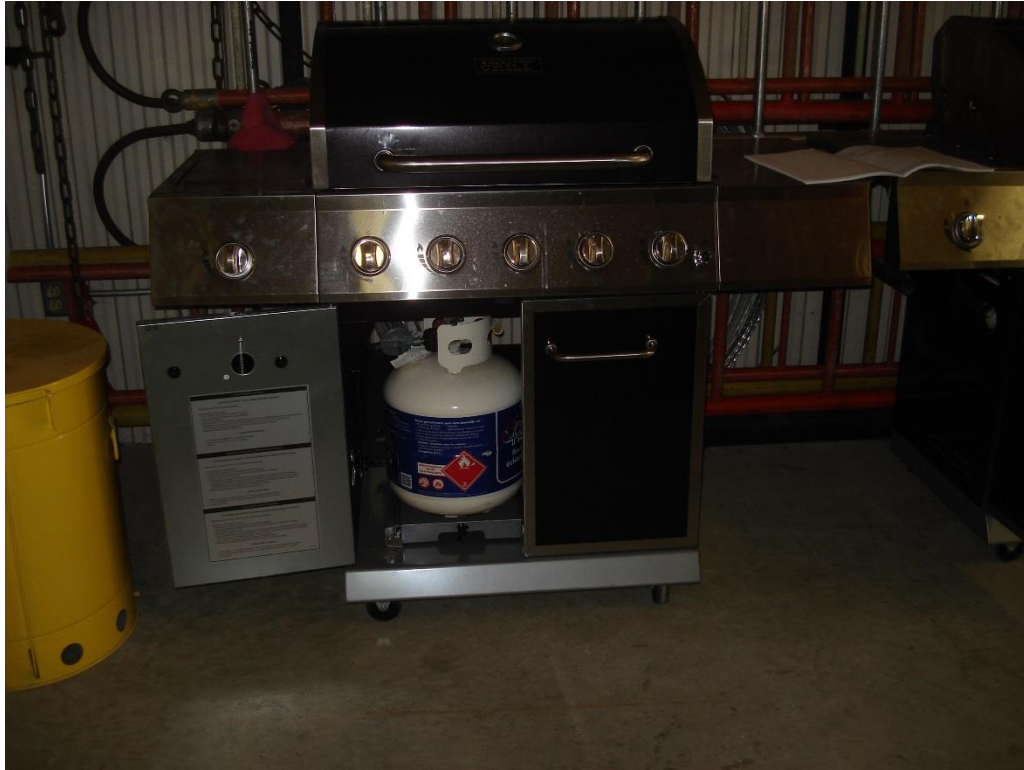
Photo 19 - Propane BBQ with Cylinder

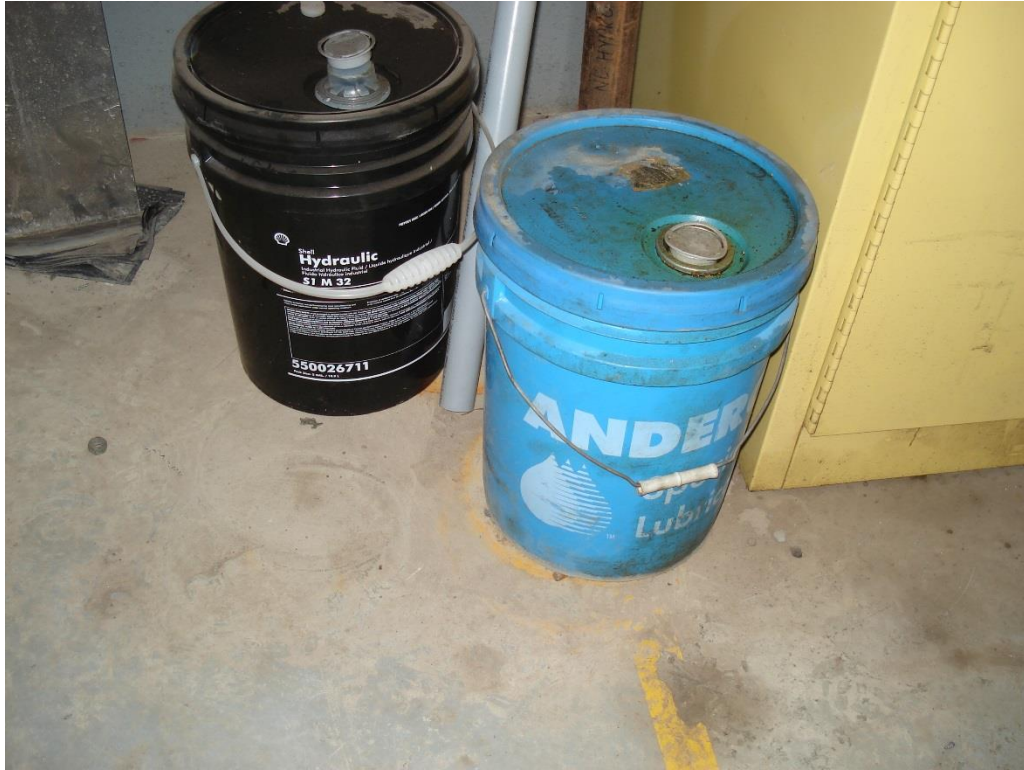
Photo 25 - Oil Containers

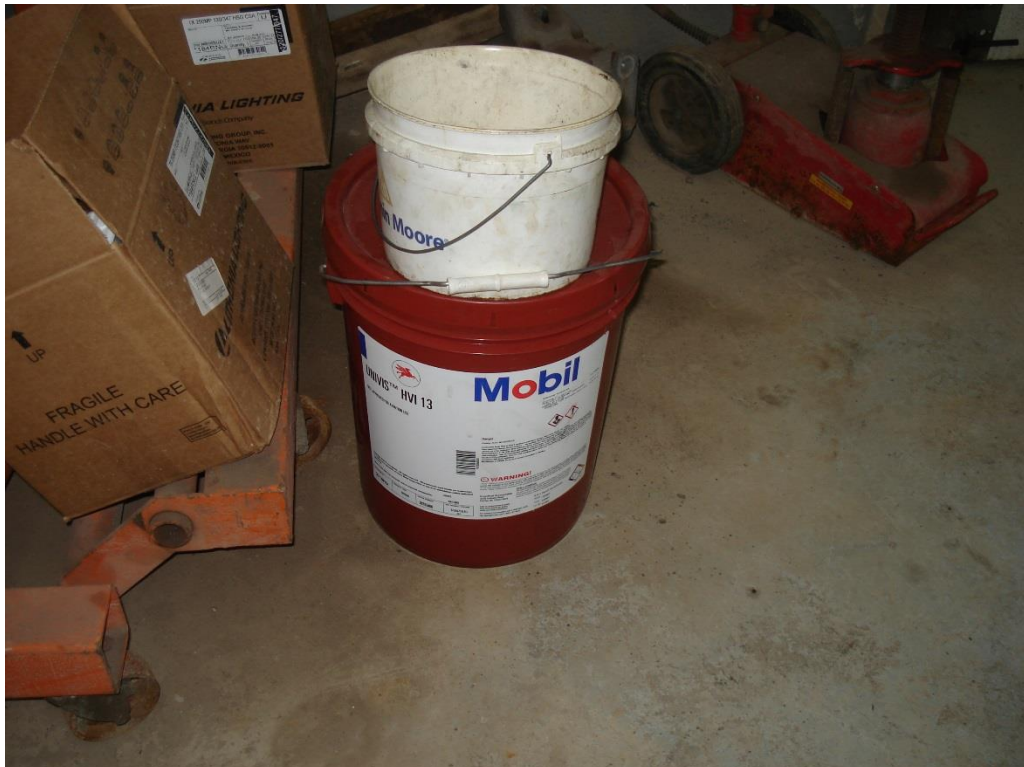
Photo 26 - Oil Container

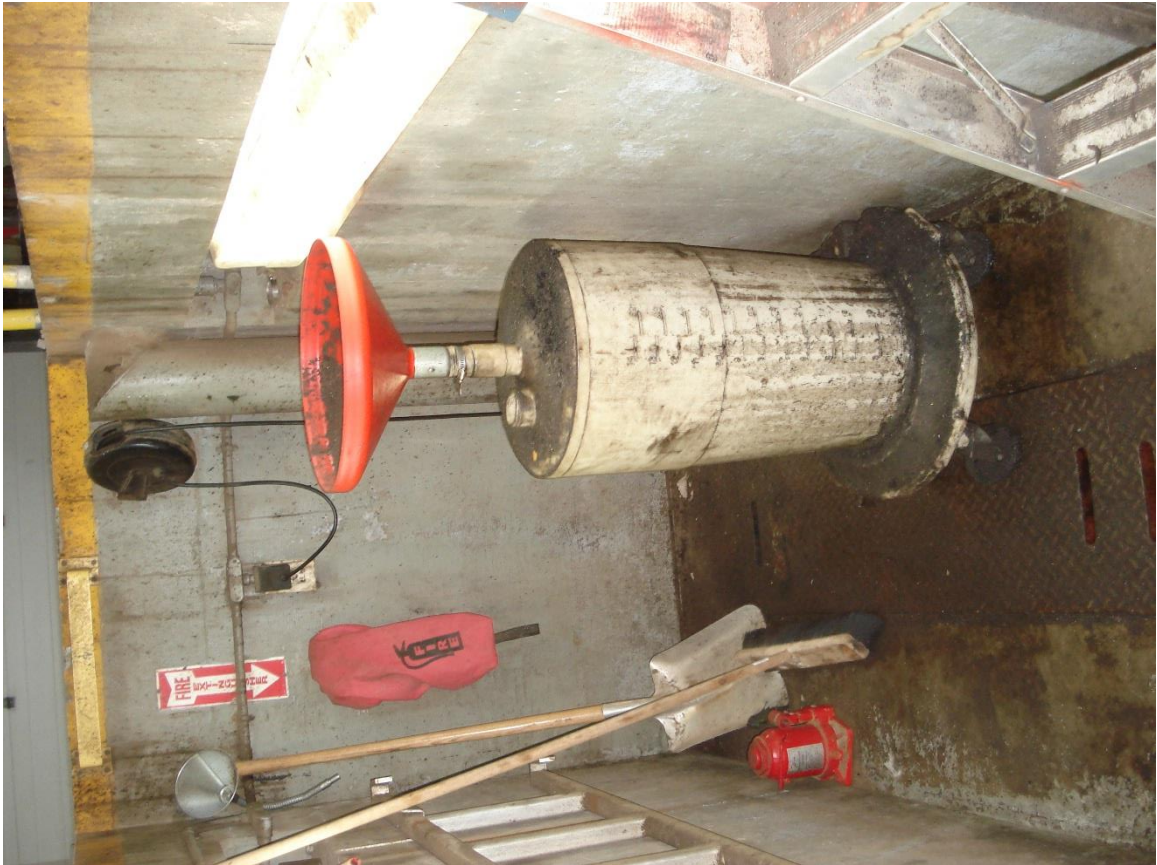
Photo 27 - Waste Oil Receptacle

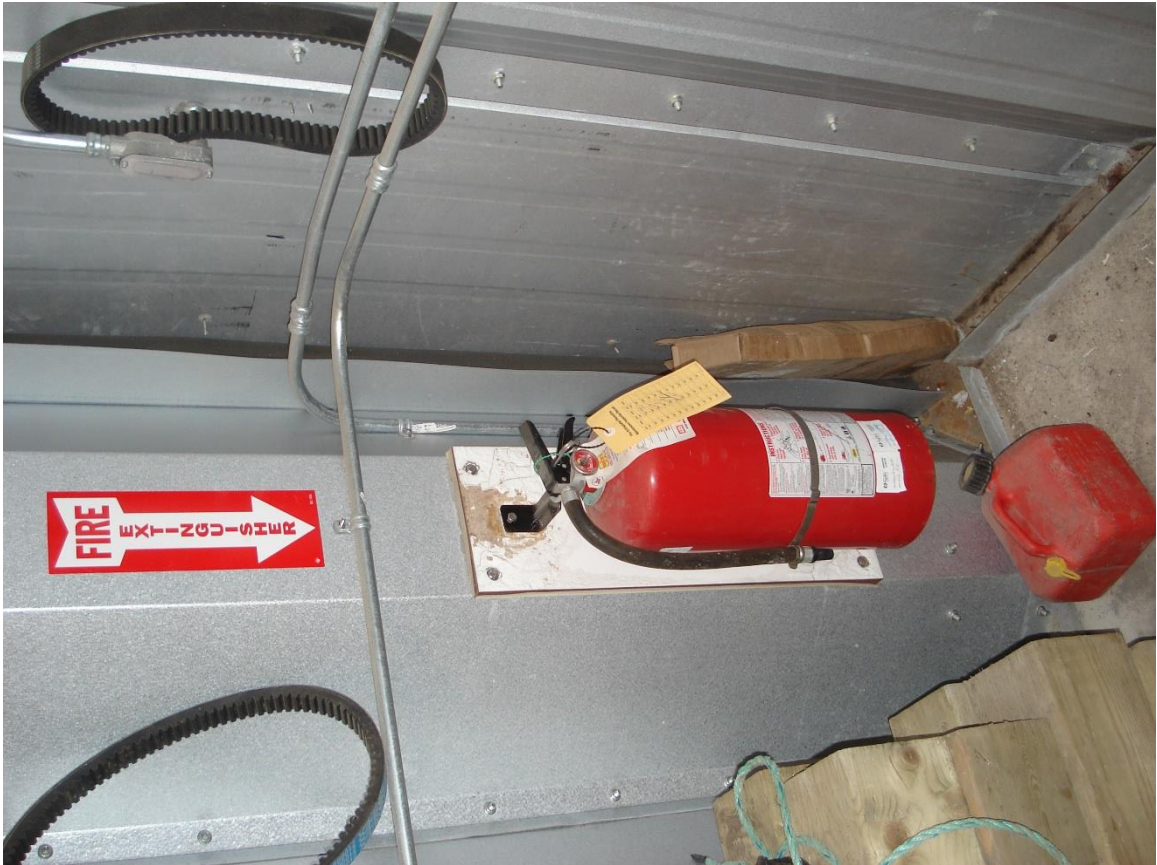
One small gasoline container was present in the building (see Environmental photo 29).

Photo 29 - Small Gasoline Can

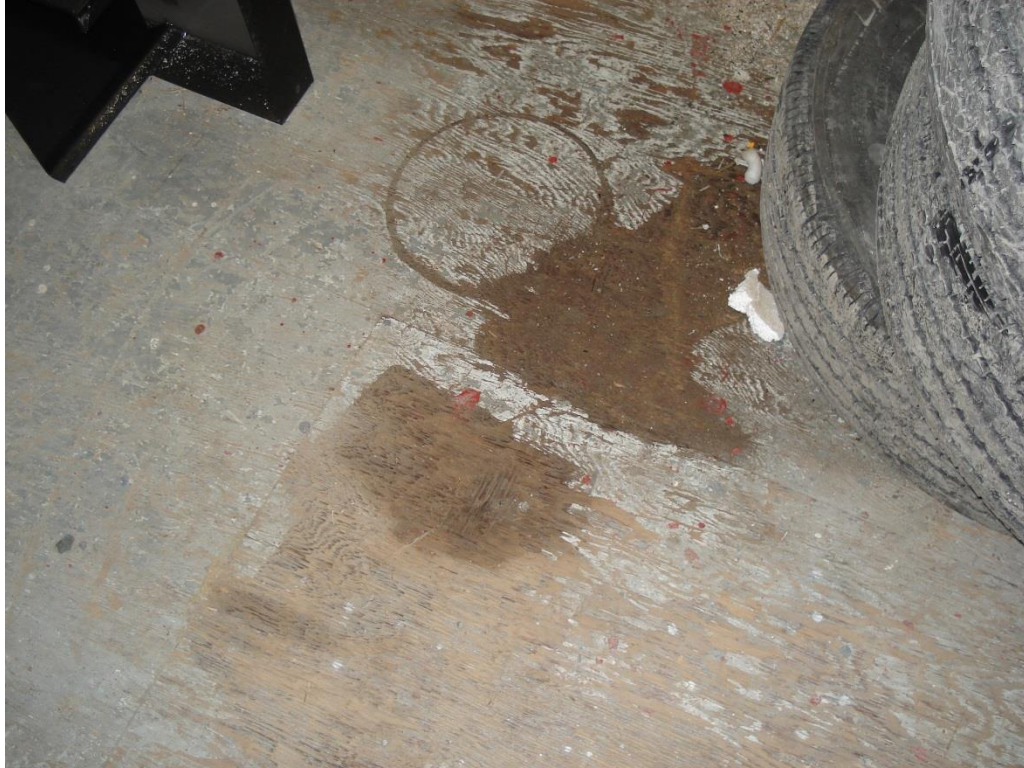
Photo 31

The building has wood floors and some stains likely from petrochemicals were observed (see Environmental photos 30 and 31). The stains appear to be surface stains only and likely did not penetrate the flooring system to contaminate the ground below, however this could not be confirmed.

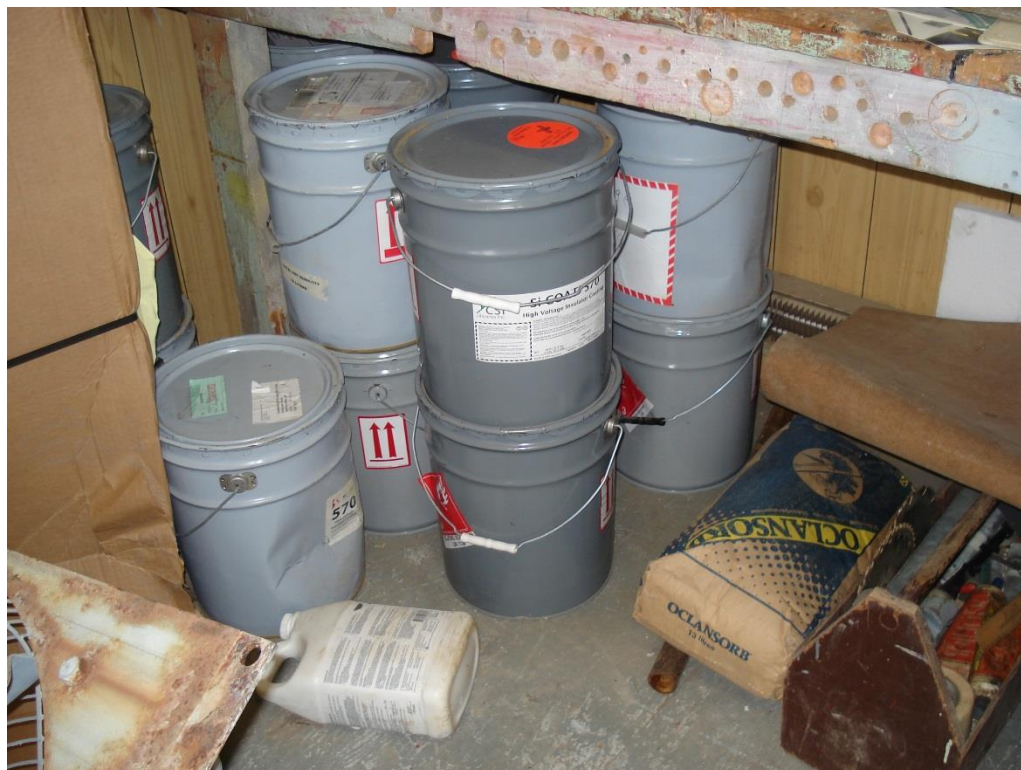
Flammable and combustible liquids were found to be present in the Carpentry Shop in the safety cabinet and around the building (see Environmental photos 32 to 34). Liquids found included:

Photo 34 - Insulator Coating
